**MYRA FALLS TAILINGS STORAGE FACILITIES
2015 DAM SAFETY INSPECTION REPORT**

31 March 2016

Amec Foster Wheeler File: NX14001B

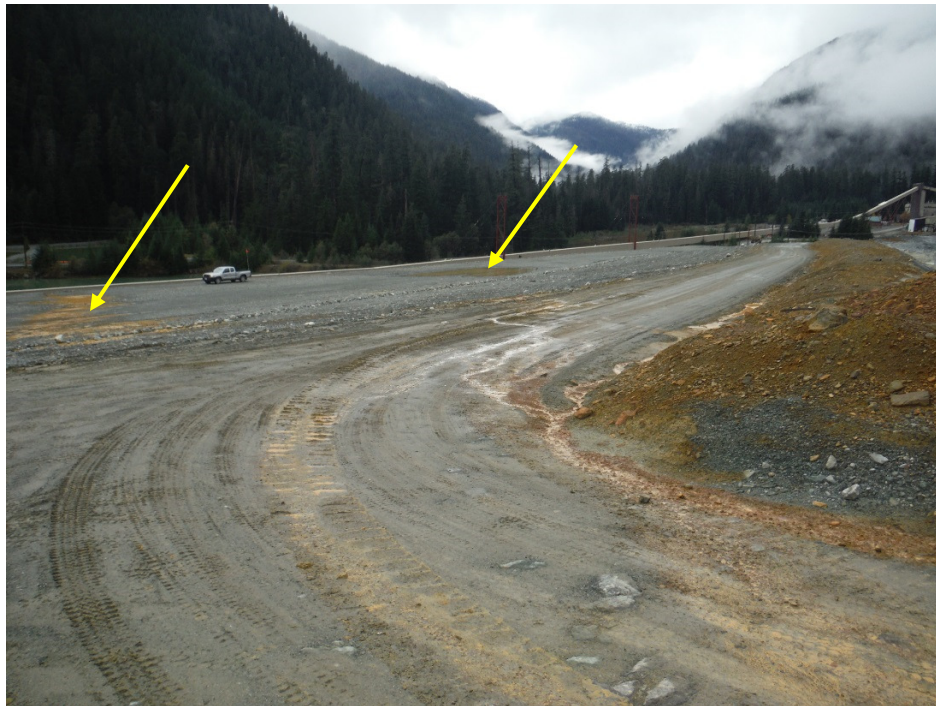
Photo 5: Areas of ARD seepage on the Seismic Berm caused by runoff from the access road between the West Strip and the RSA, looking southwest (October 23, 2014).

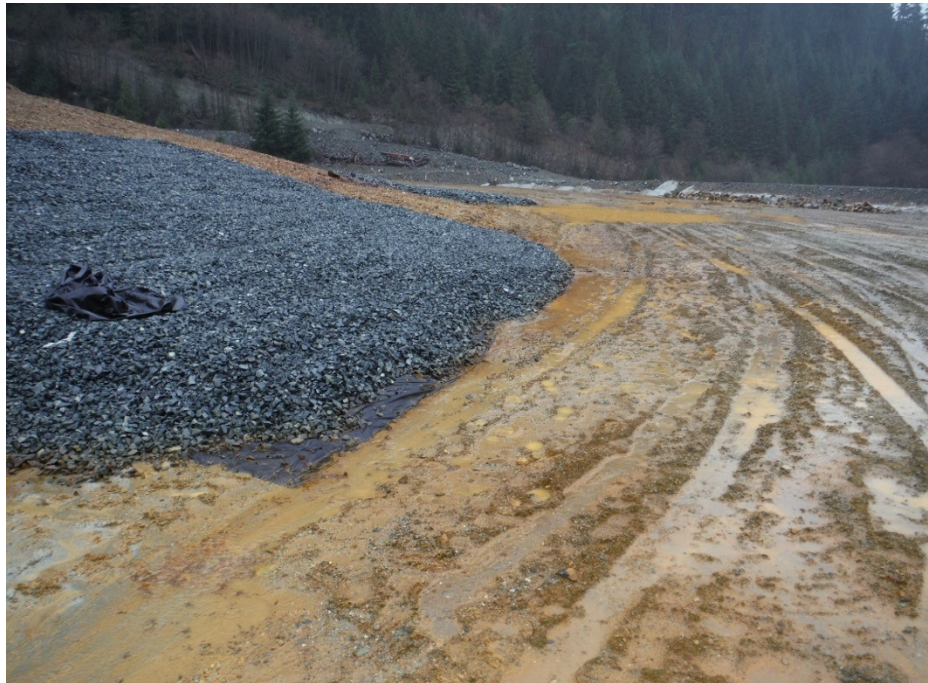
Photo 6: Patching work completed for the piping erosion at the Paste Berm toe, constructed using geotextile filter fabric and free draining material, looking northeast (November 27, 2014).

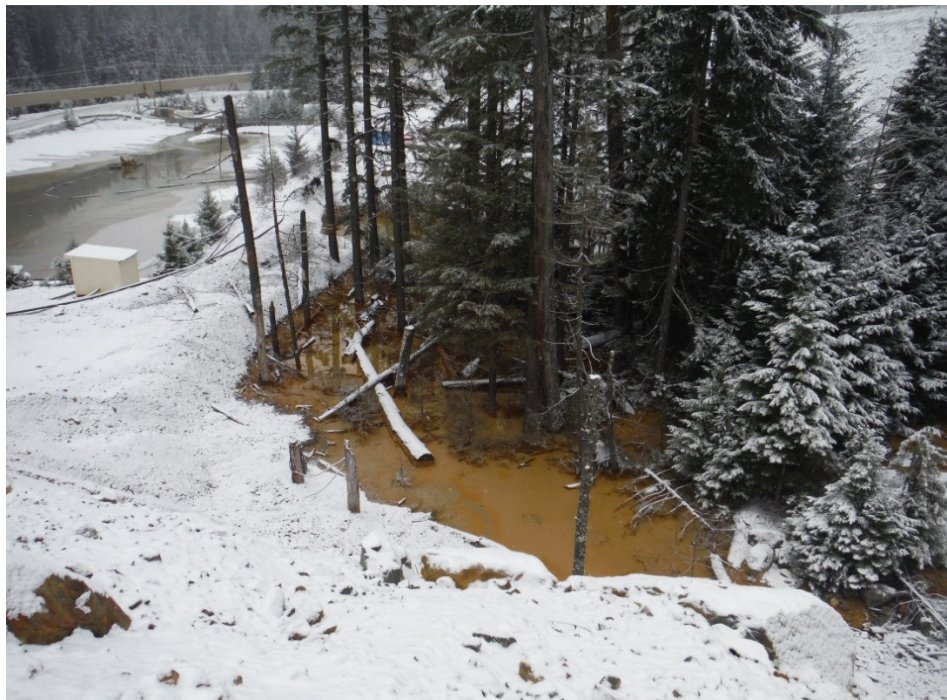
Photo 8: Ponded water observed in trees around Phillips Reach sump after major flooding, tailings/sediments from Phillips Reach inflow, looking southwest (December 2, 2014).

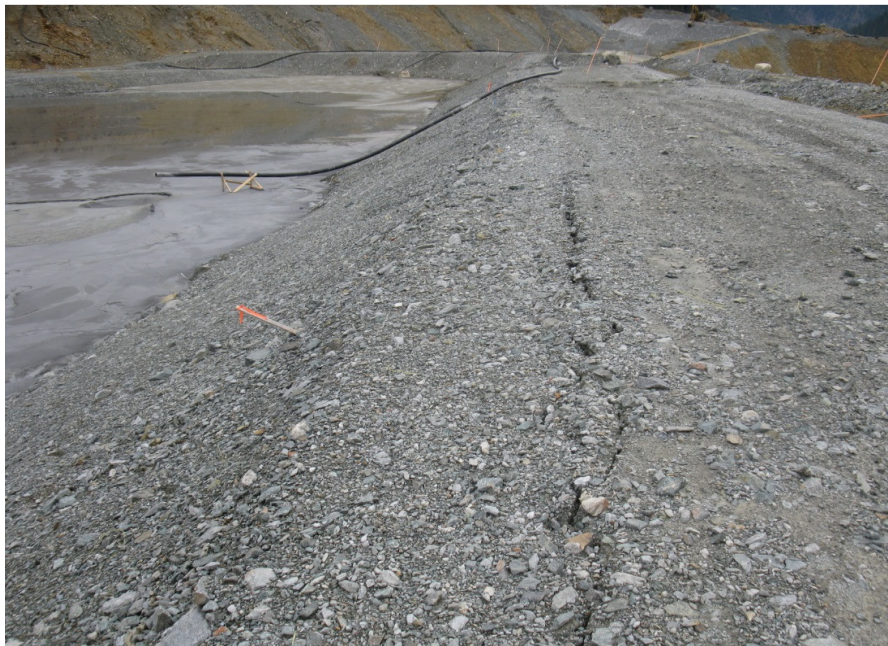
Photo 18: Crack along the upstream side of Lynx Dam south arm, looking east (March 5, 2015).

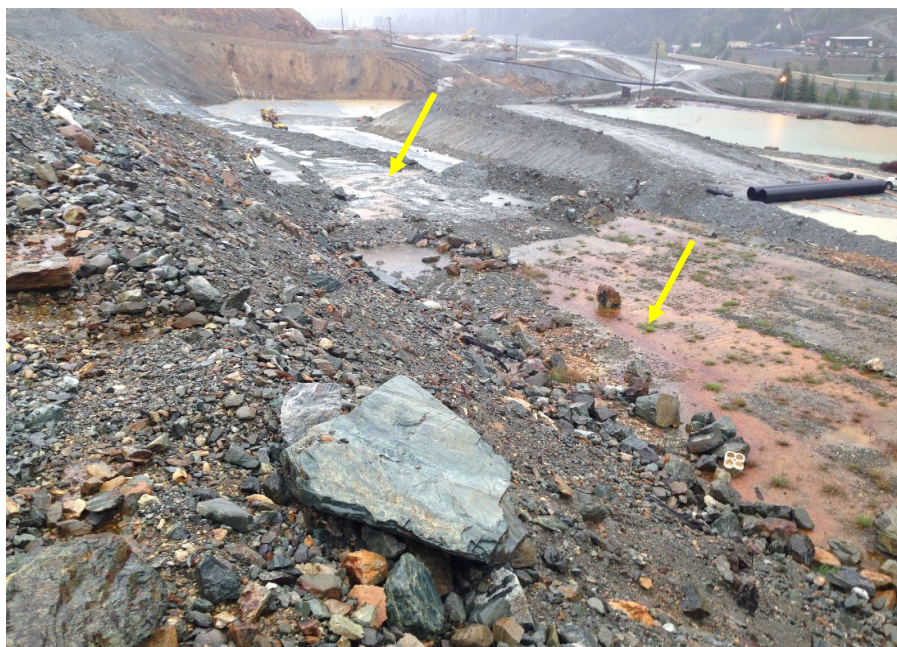
Photo 26: Seepage and surface runoff on Lynx Dam mid-level "2011" bench, looking southeast (September 24, 2015).

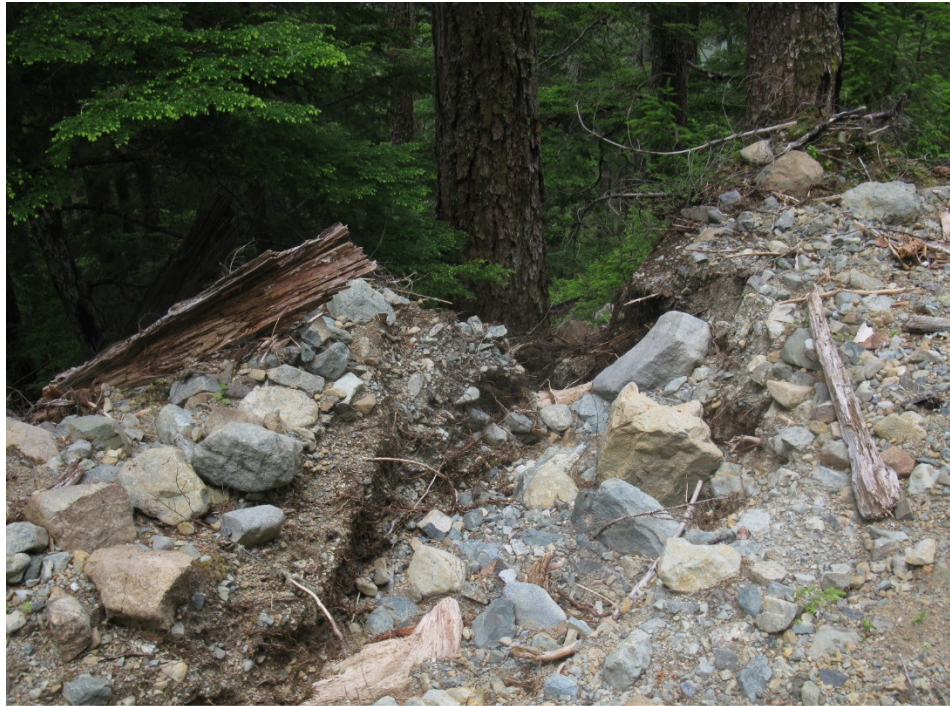
Photo 47: Lower Arnica Reach Ditch breach of the side of the slope caused by lack of freeboard (Taken June 17, 2015).

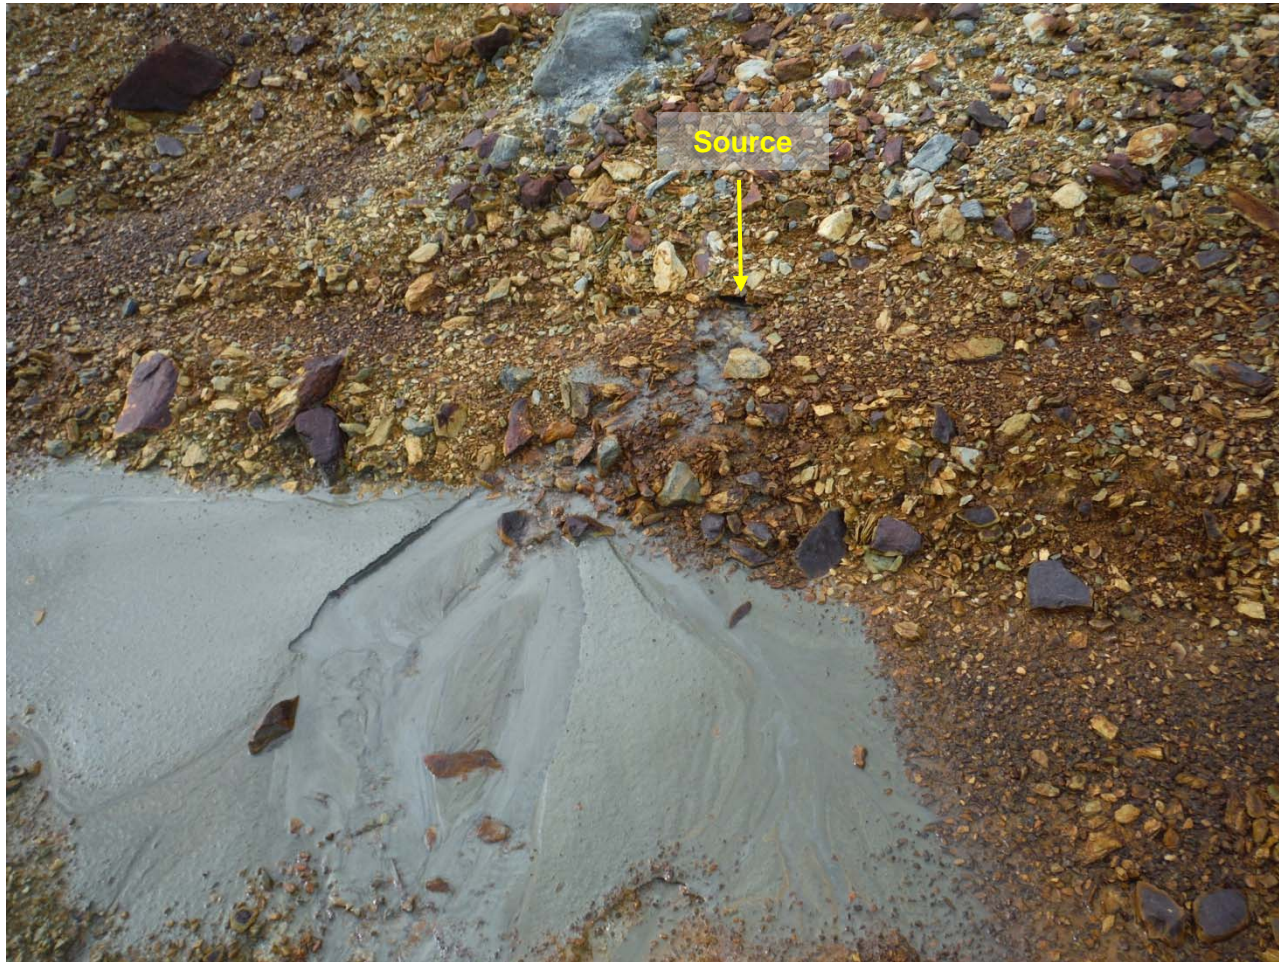
Photo 4 – Close-up of source area. Sand deposited along surface flow path and accumulated on level area at toe. Seepage water observed at the time of inspection was clear and free of sediment.

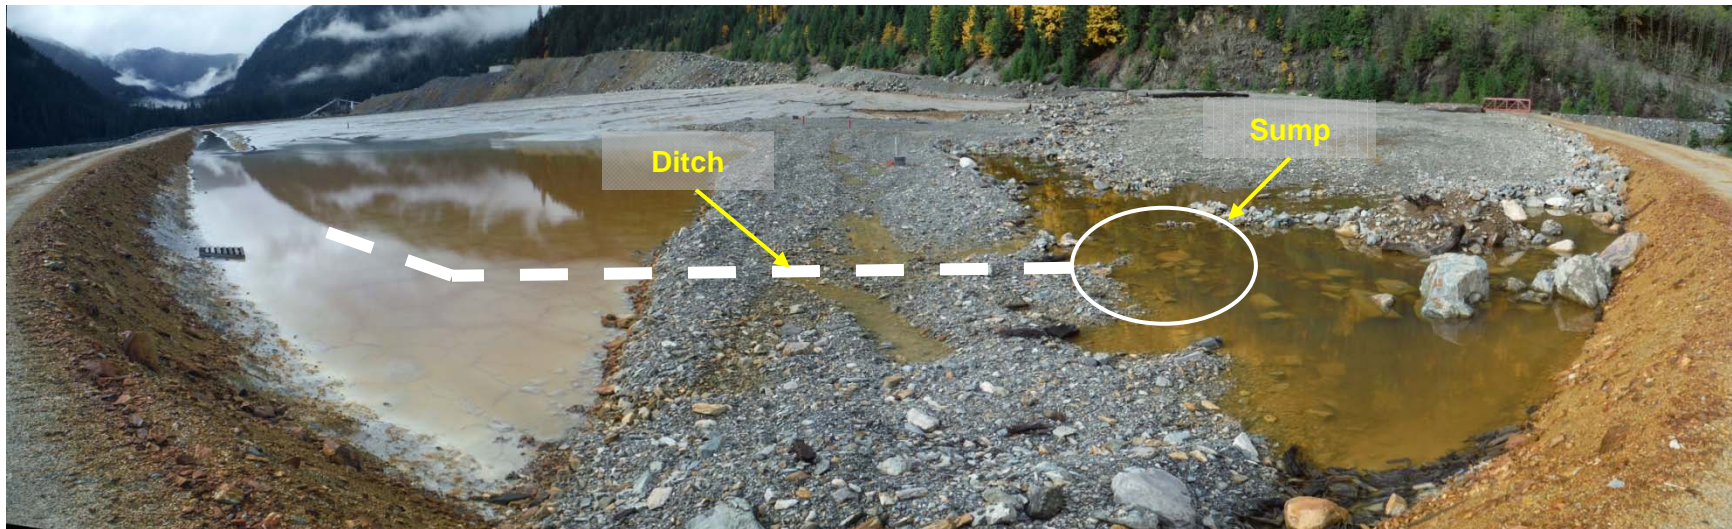
Photo 5 – panorama showing area of ponding water in APA. Recommended sump and ditch areas are indicated in white.

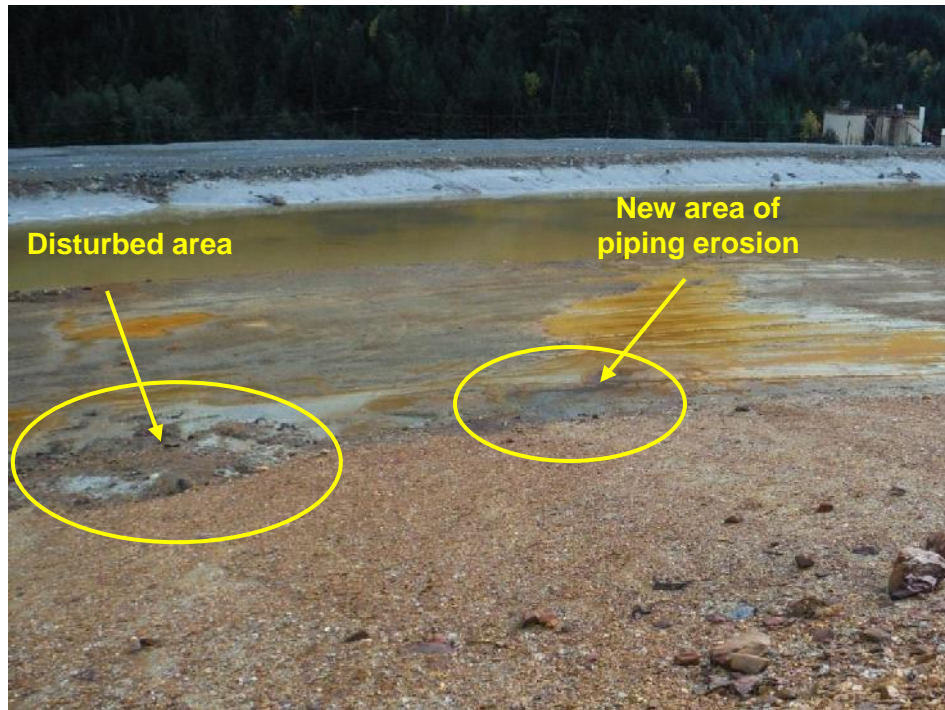
Photo 1 – View looking south, down from crest of Paste Berm near the southeast corner. New area of piping erosion and adjacent area of former disturbance to the east.

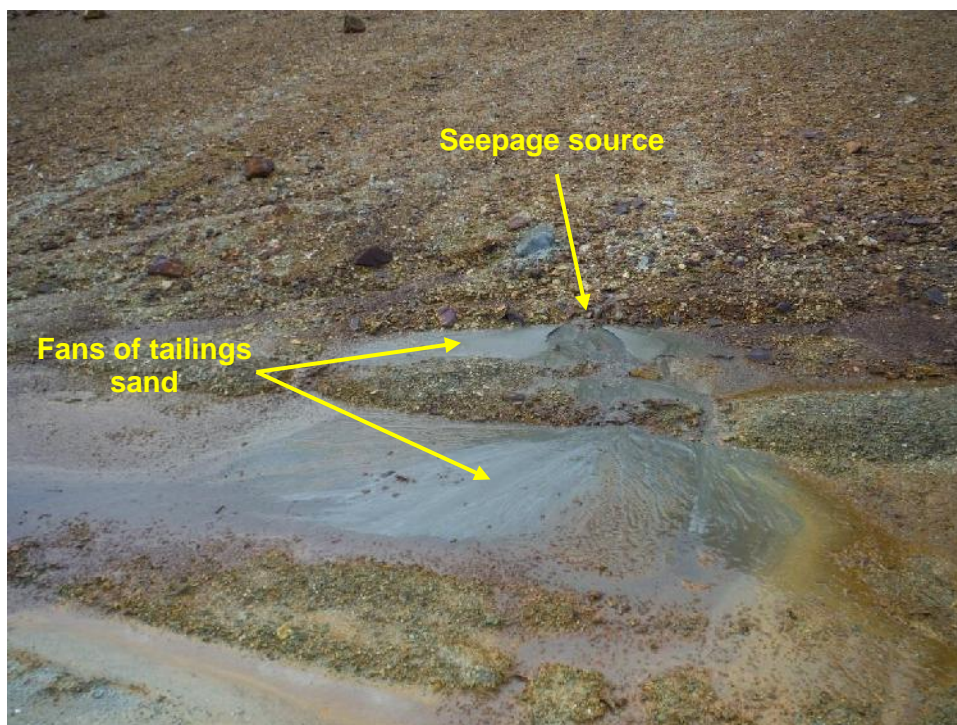
Photo 2 – Close-up of source area. Sand deposited along surface flow path and accumulated on level area at toe. Seepage water observed at the time of inspection was clear.

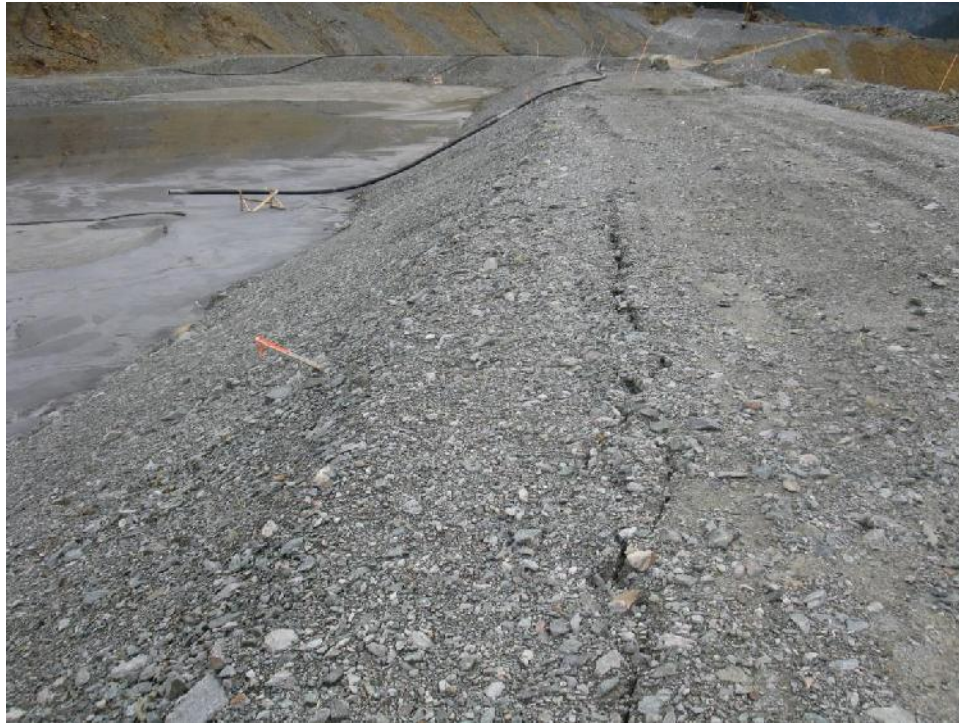
Photo 17 – Crack along the upstream crest of Lynx Dam south arm, looking east.

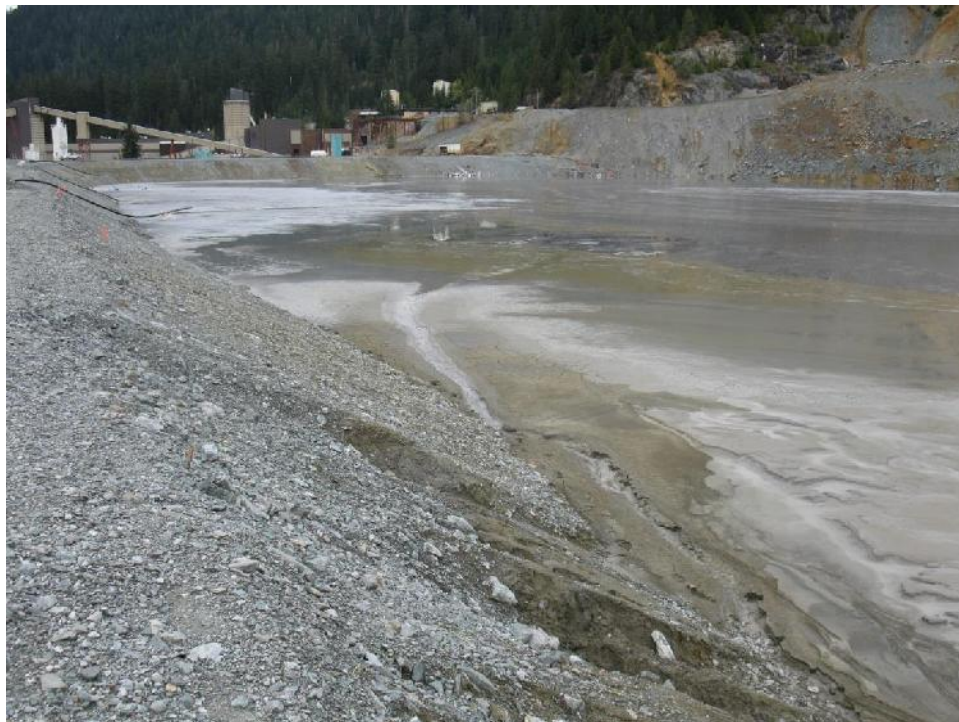
Photo 18 – Minor sloughing of Lynx Dam upstream face of south arm, looking west.

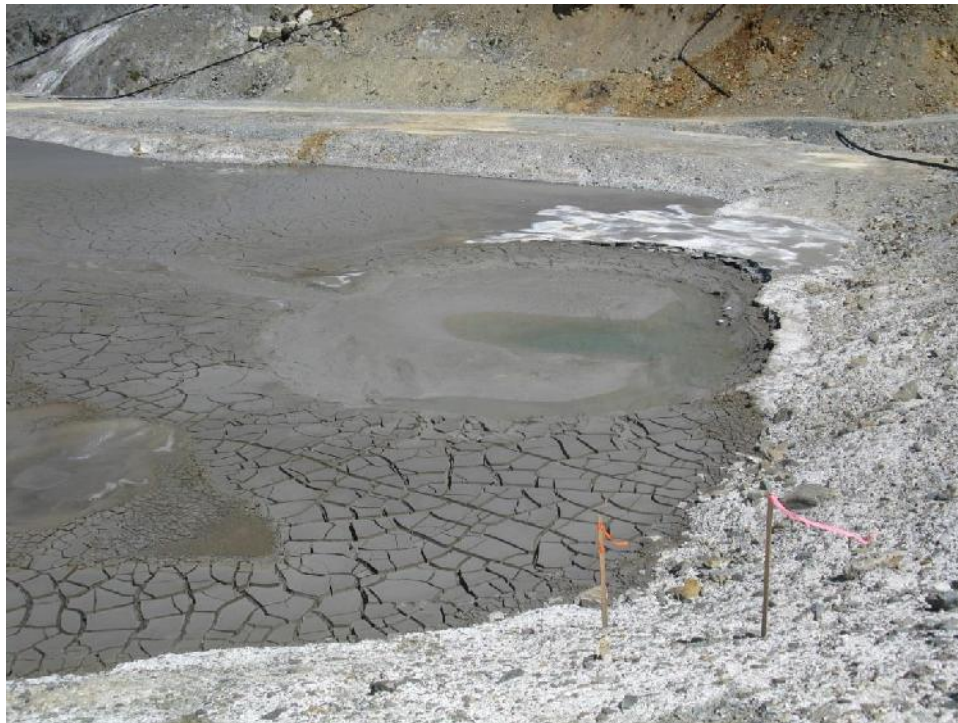
Photo 19 – Desiccation cracking on the paste surface at the east end of Lynx TDF, looking north.

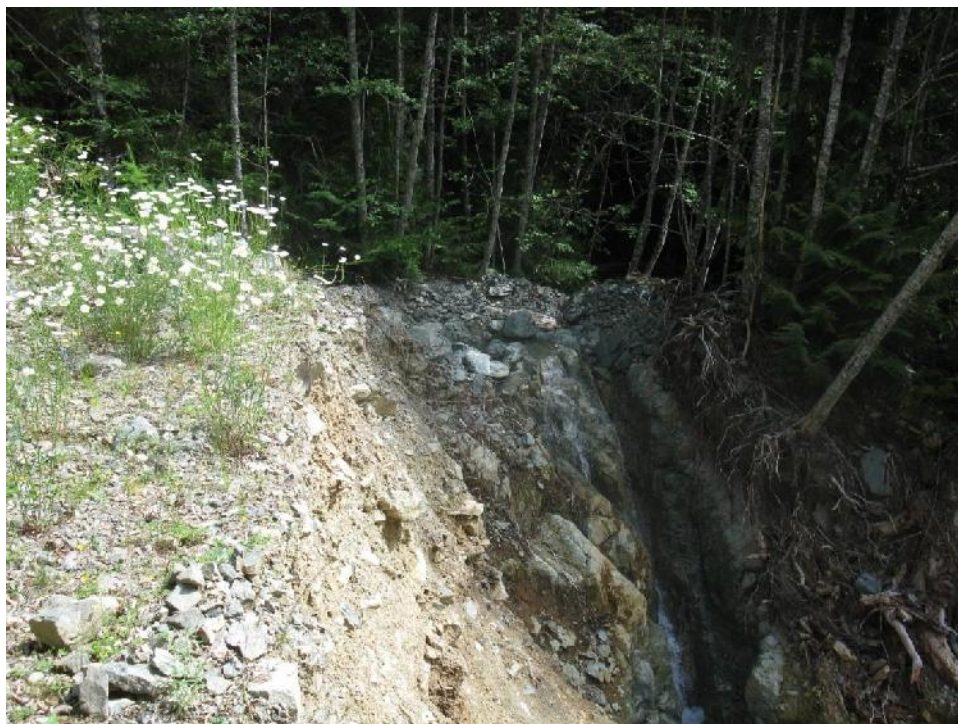
Photo 30 – Headscarp of failure at switchback at lower end of Upper Lynx Diversion. Diversion formerly flowed left to right to the edge of the photo, now captured by the headscarp.

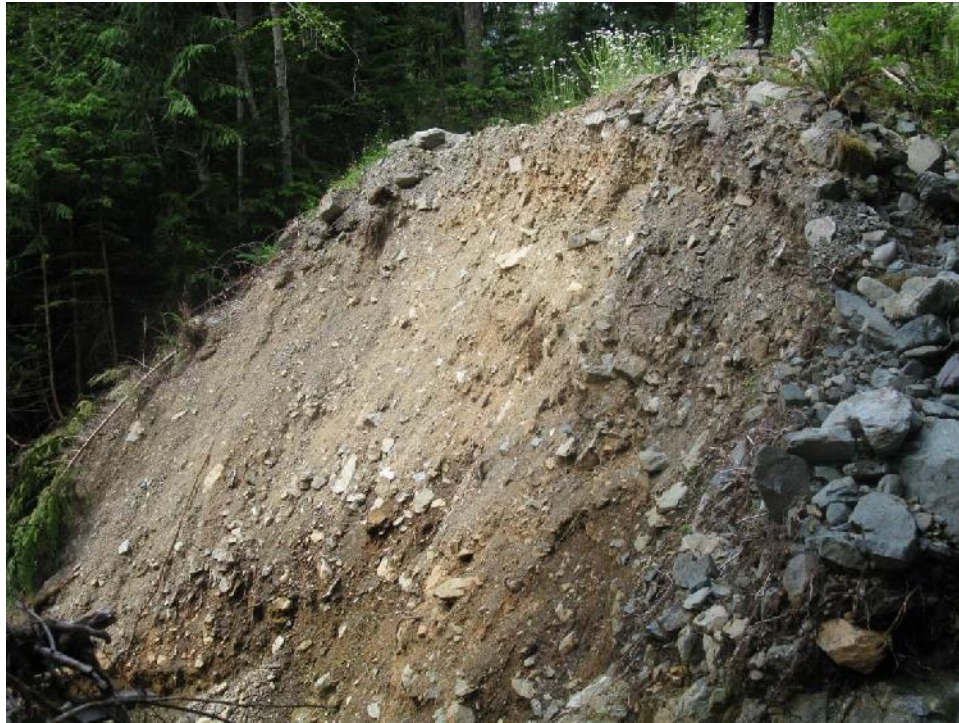
Photo 45 – Headscarp of failure area looking south from the diversion channel.

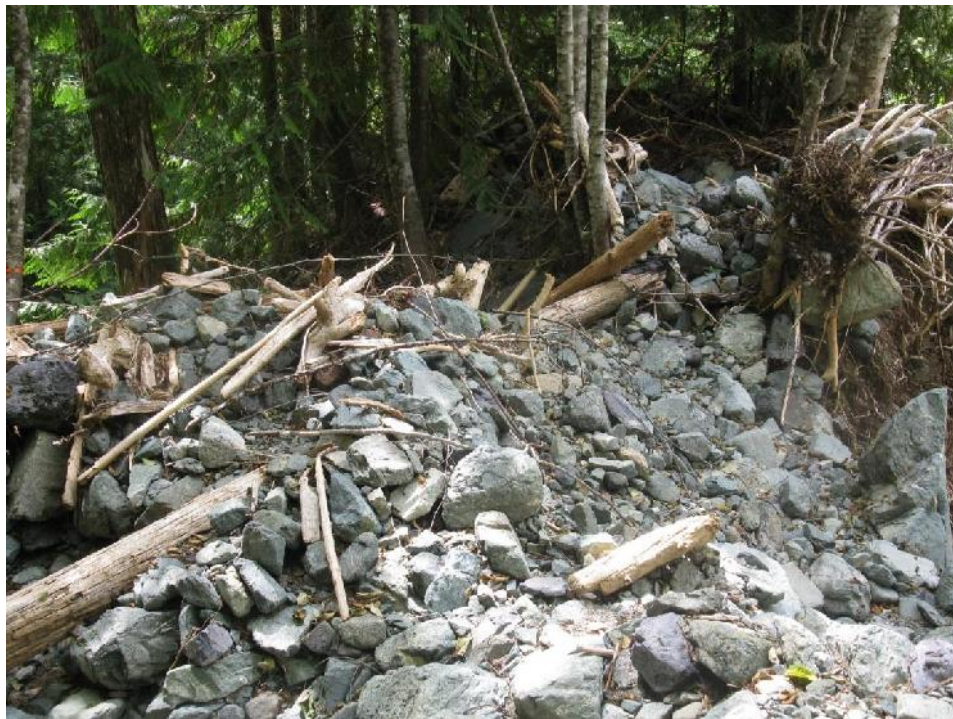
Photo 46 – Small to medium sized wood debris in former channel, which diverted the flow onto the switchback area. Debris was arrested by small trees in the invert at the end of the channel.

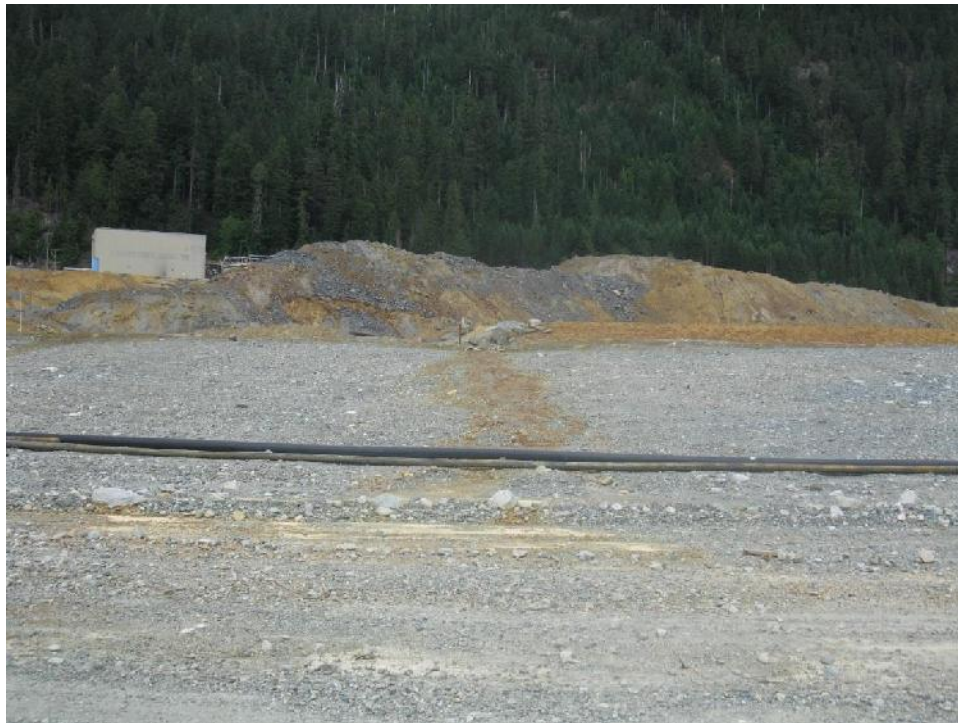
Photo 7 – ARD staining on the Seismic Upgrade 6:1 Slope and main bench below the access road at the west end of the Strip, looking north.

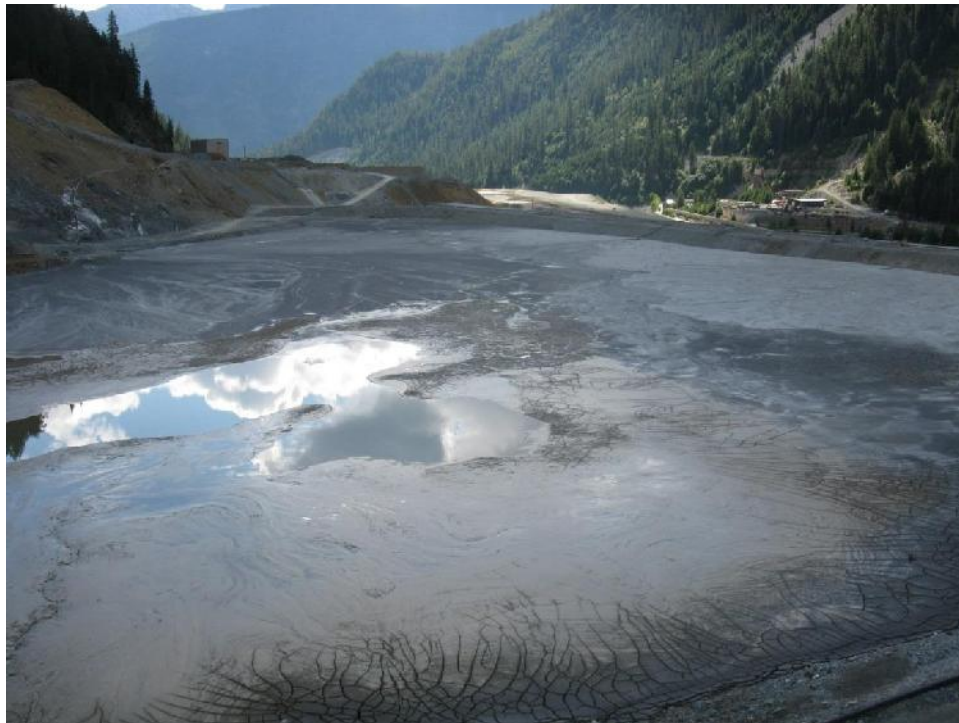
Photo 10 – Lynx TDF with desiccation cracking in fine tailings on exposed beach, looking east.

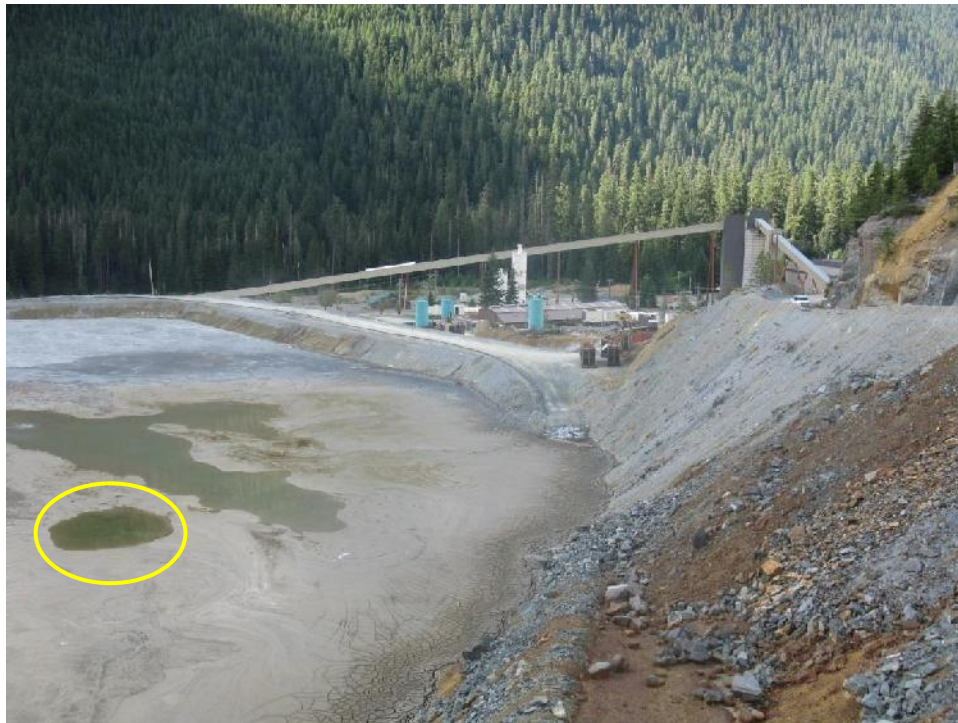
Photo 11 – Lynx TDF, looking southwest at the pump ramp area (no pumps, circled area showing the recurrent depression).

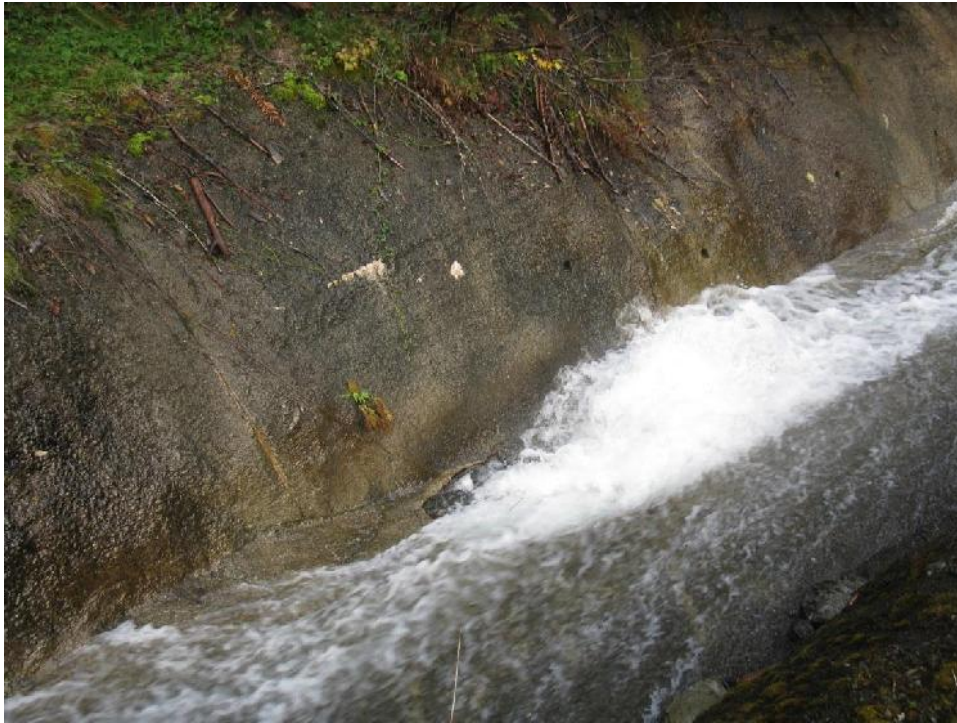
Photo 11 – Damaged shotcrete lining in the Lower Lynx Diversion Ditch.

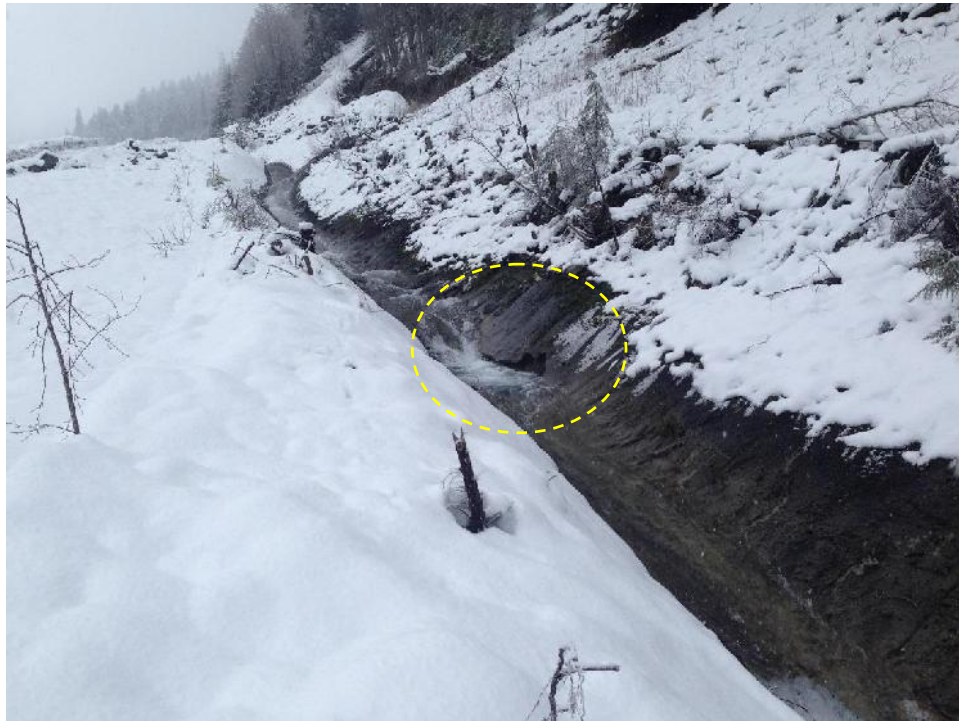
Photo 19 – Damaged section of the Lower Lynx Diversion Ditch shotcrete lining.

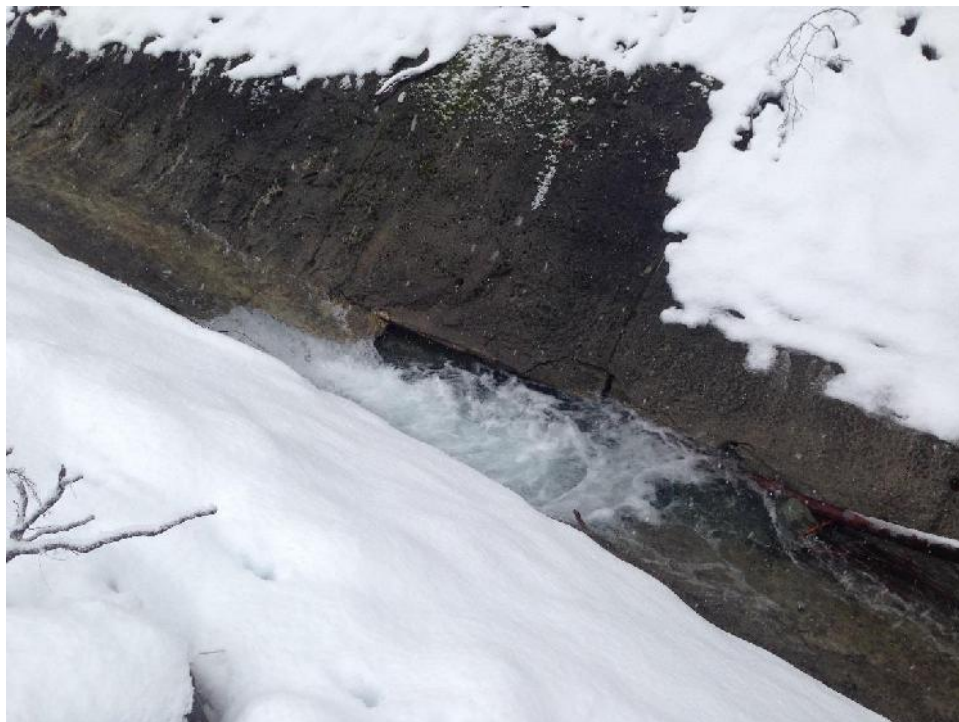
Photo 20 – Close-up view of a hole in the shotcrete lining of the Lower Lynx Diversion Ditch (see the circled area on the previous photo).
