2015 ANNUAL DAM SAFETY INSPECTION

2-North Pit Tailings Disposal Facility

Reference Number: 1528261-003-R-Rev0-1000

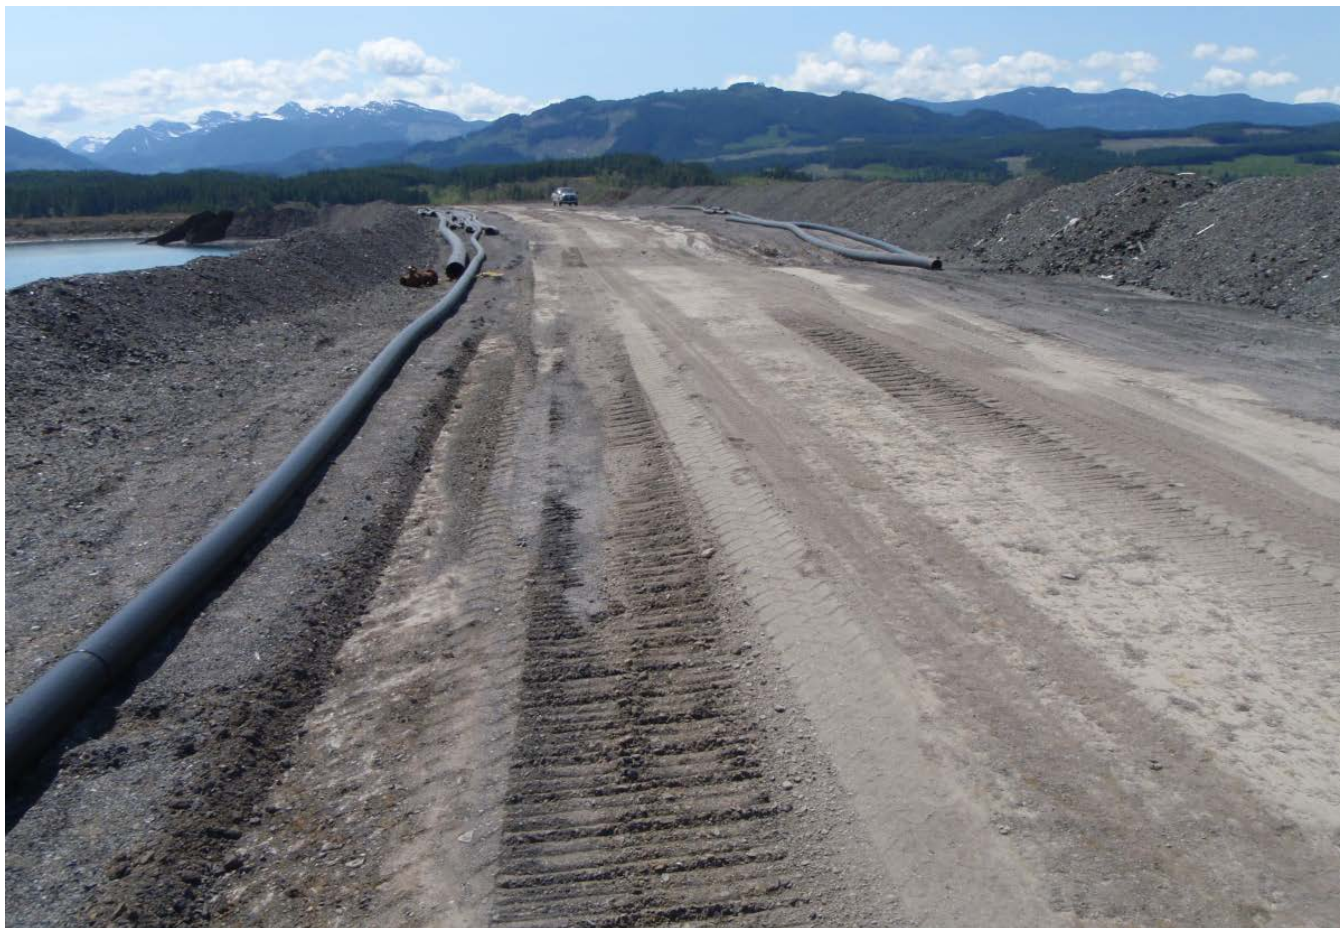
Photograph 1: North Embankment Crest, Looking West, May 26, 2015.

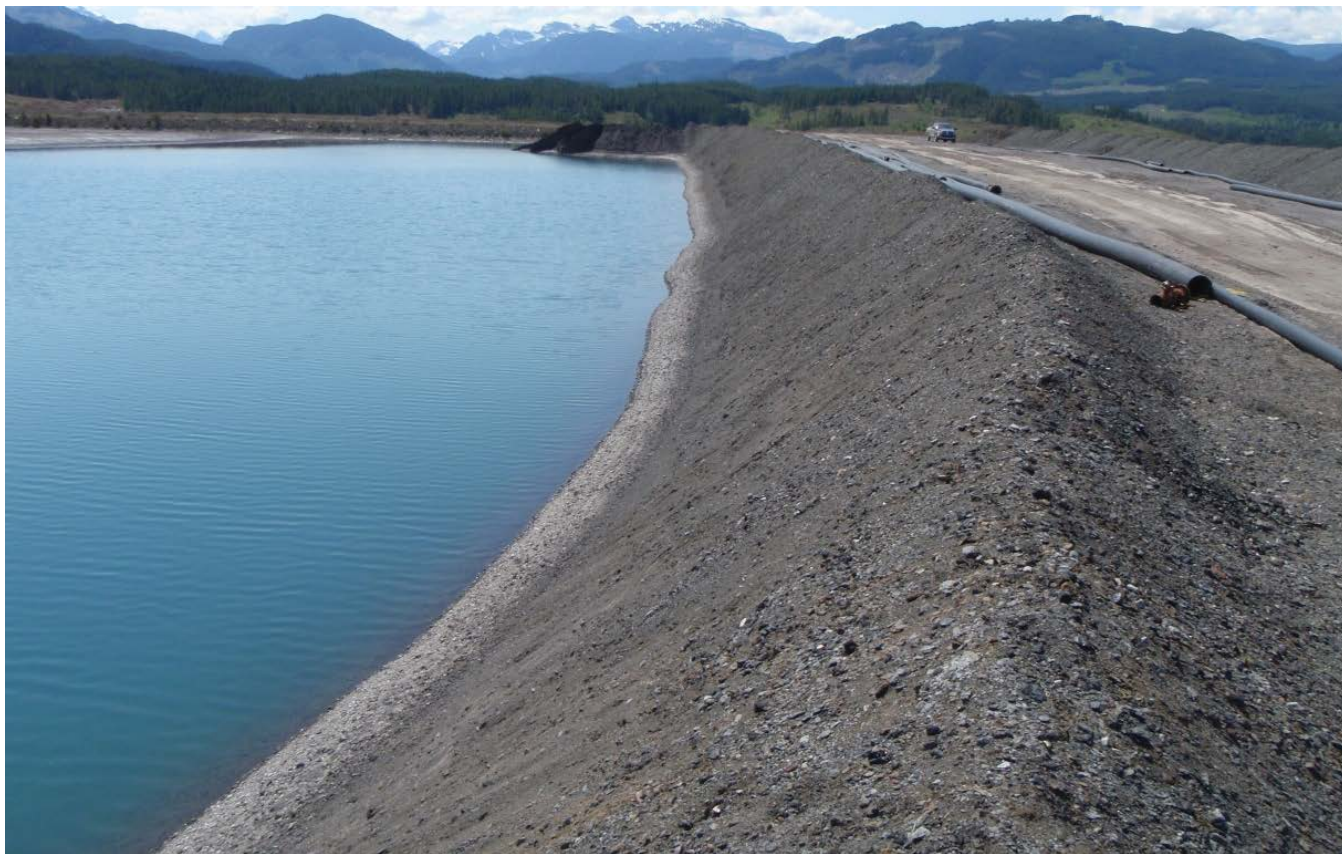
Photograph 2: North Embankment Upstream Slope, Looking West, May 26, 2015.

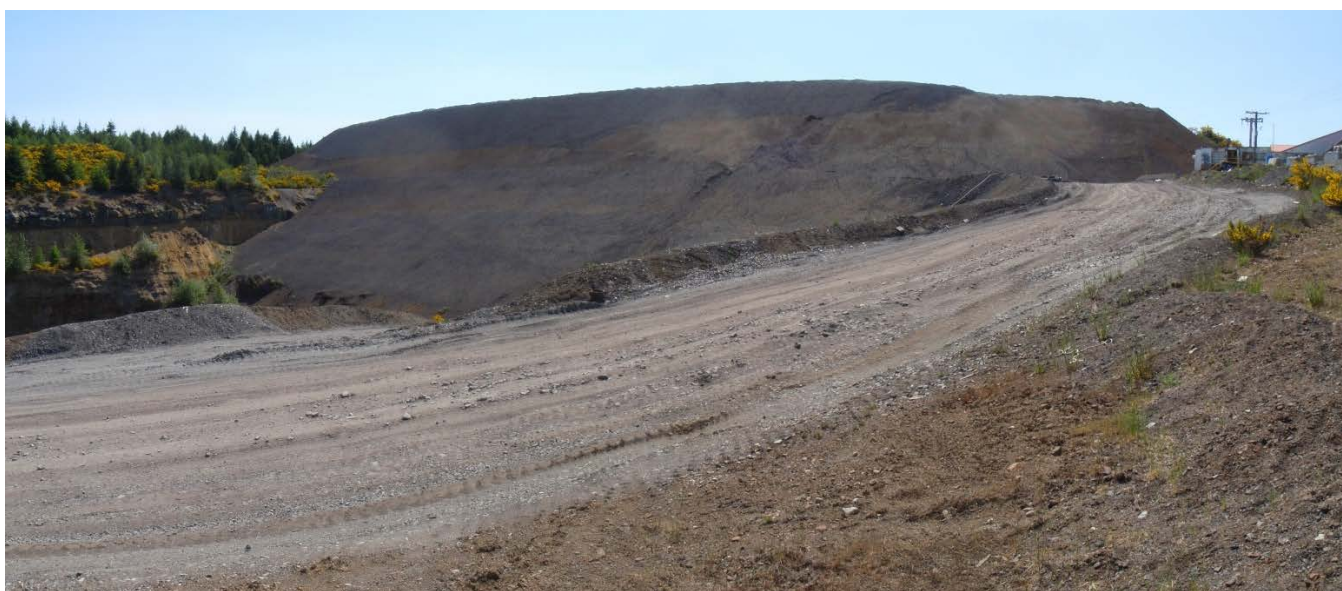
Photograph 3: North Embankment Downstream Slope, Looking Southeast, May 26, 2015.

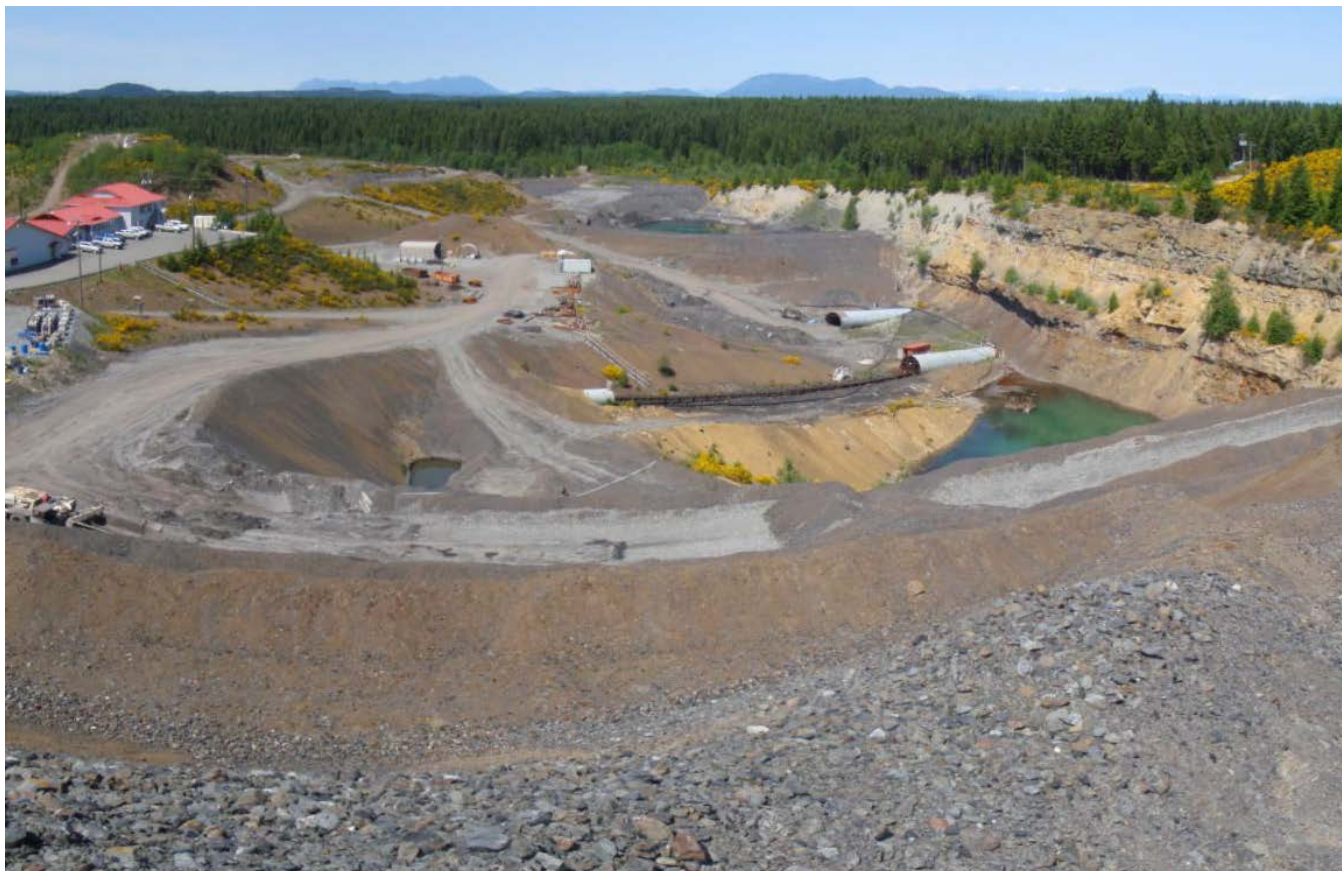
Photograph 4: North Embankment Downstream Slope and Toe Area, Looking North, May 26, 2015.

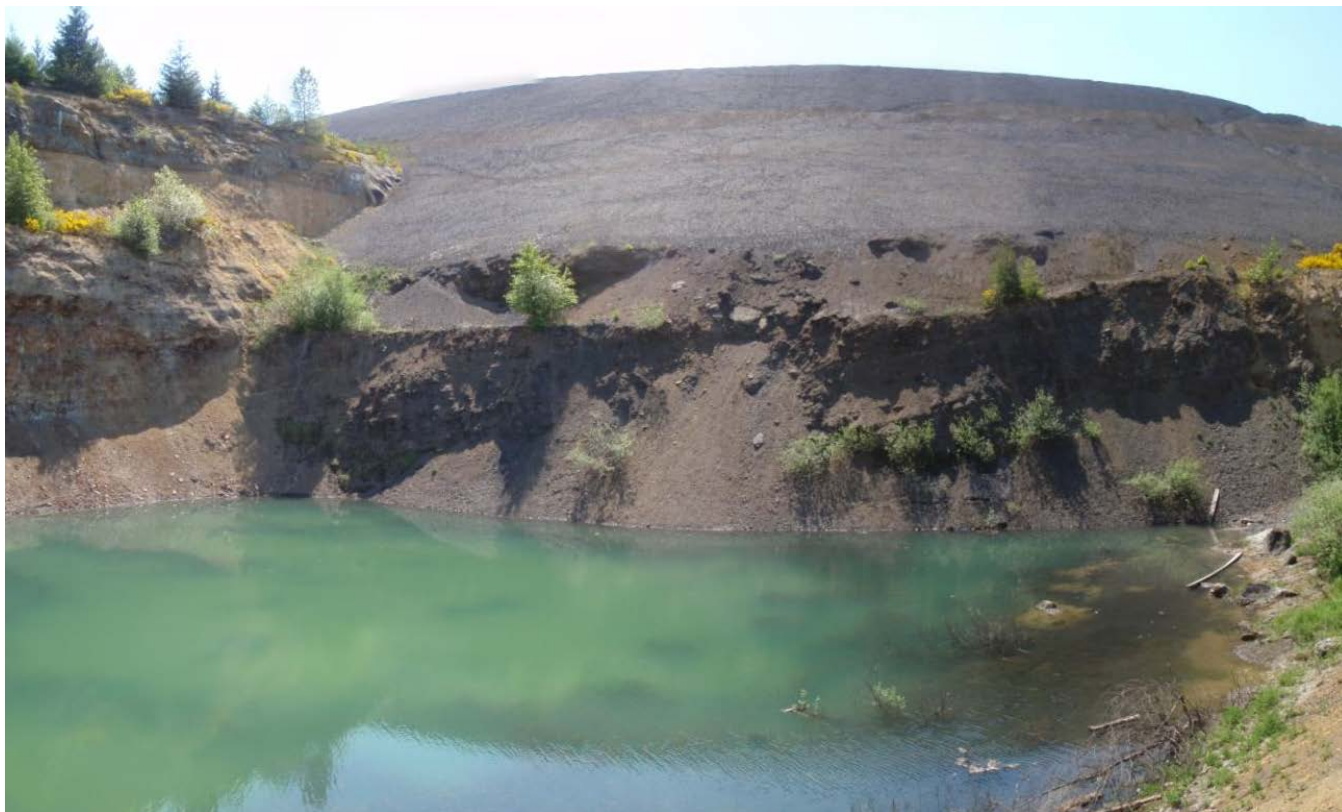
Photograph 5: North Embankment Downstream Toe Area, Looking South, May 26, 2015.

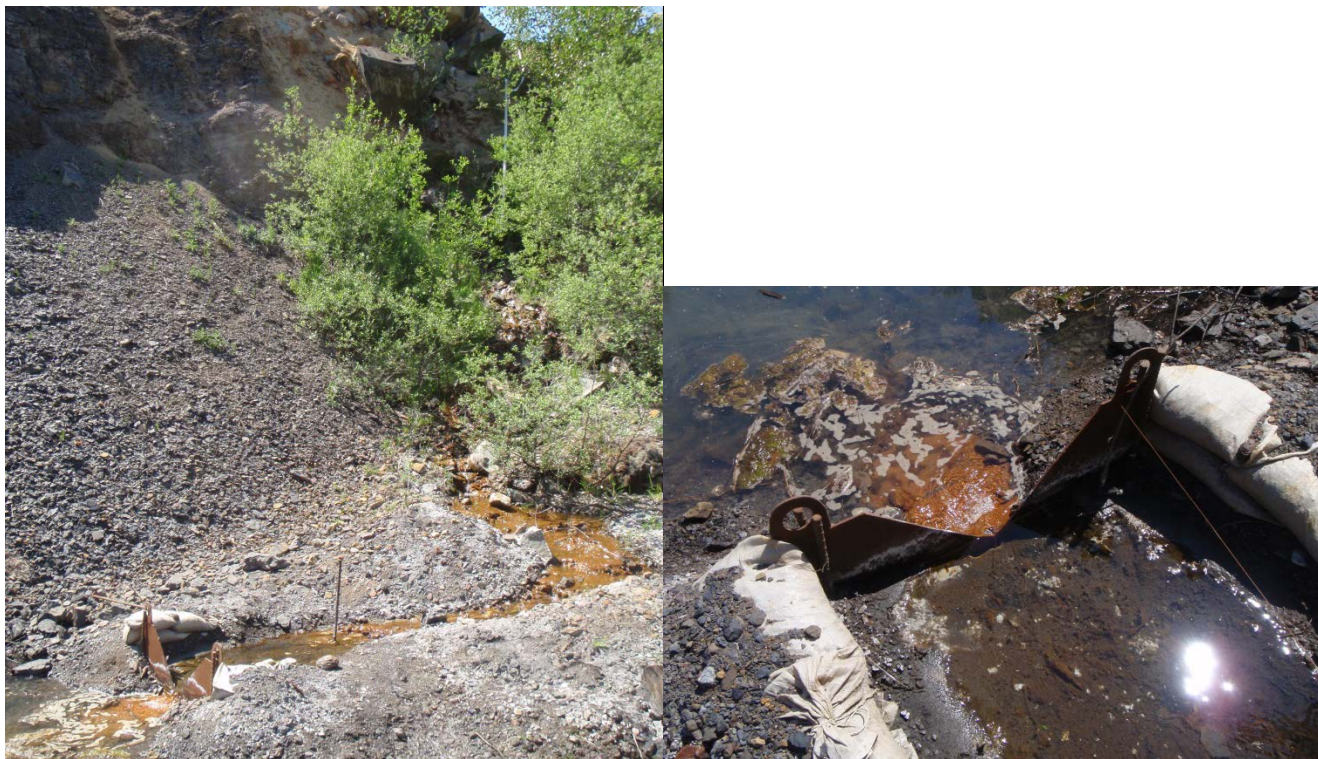
Photograph 6a (left): North Embankment Abutment Seep, Looking Southwest, and 6b (right) Weir, Looking East, May 26, 2015.

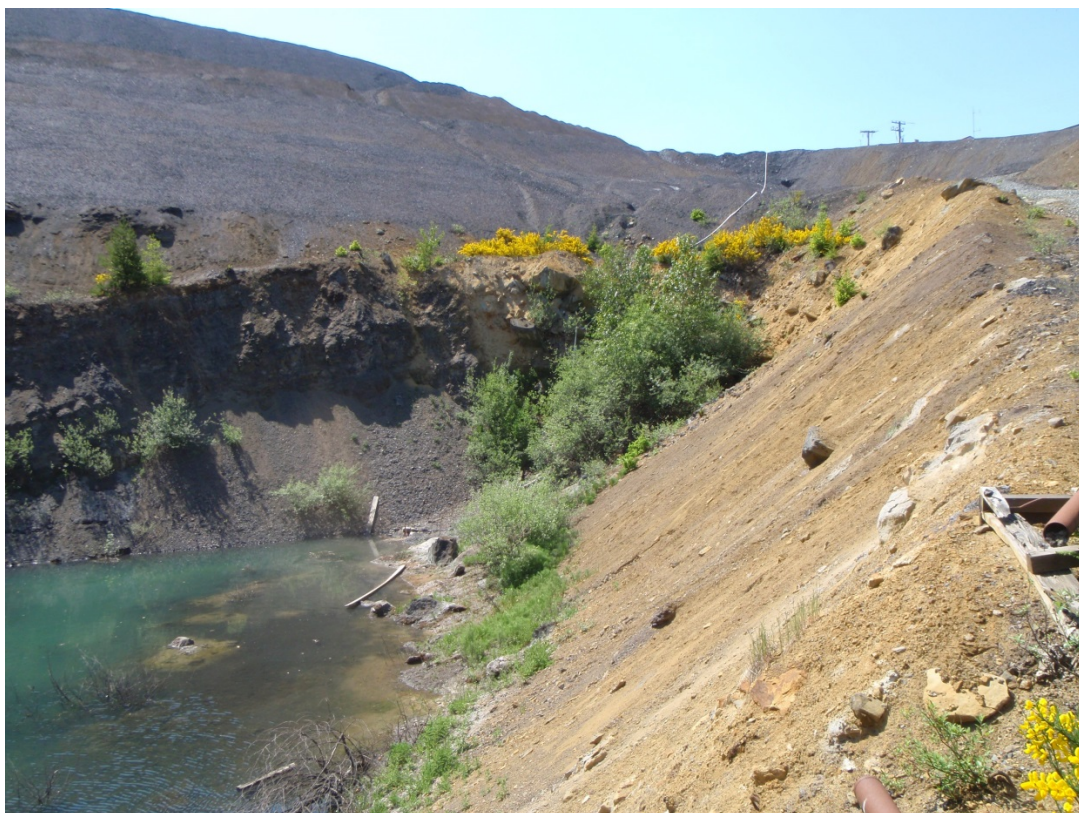
Photograph 7: North Embankment West Abutment, Looking Southwest, May 26, 2015.

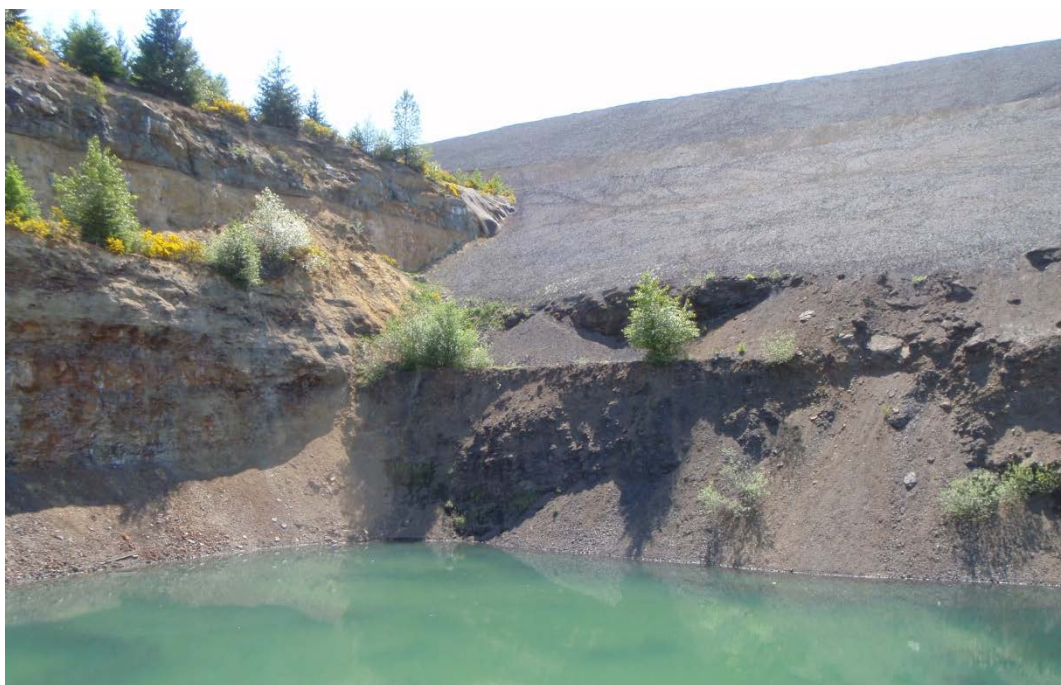
Photograph 8: North Embankment East Abutment, Looking Southeast, May 26, 2015.

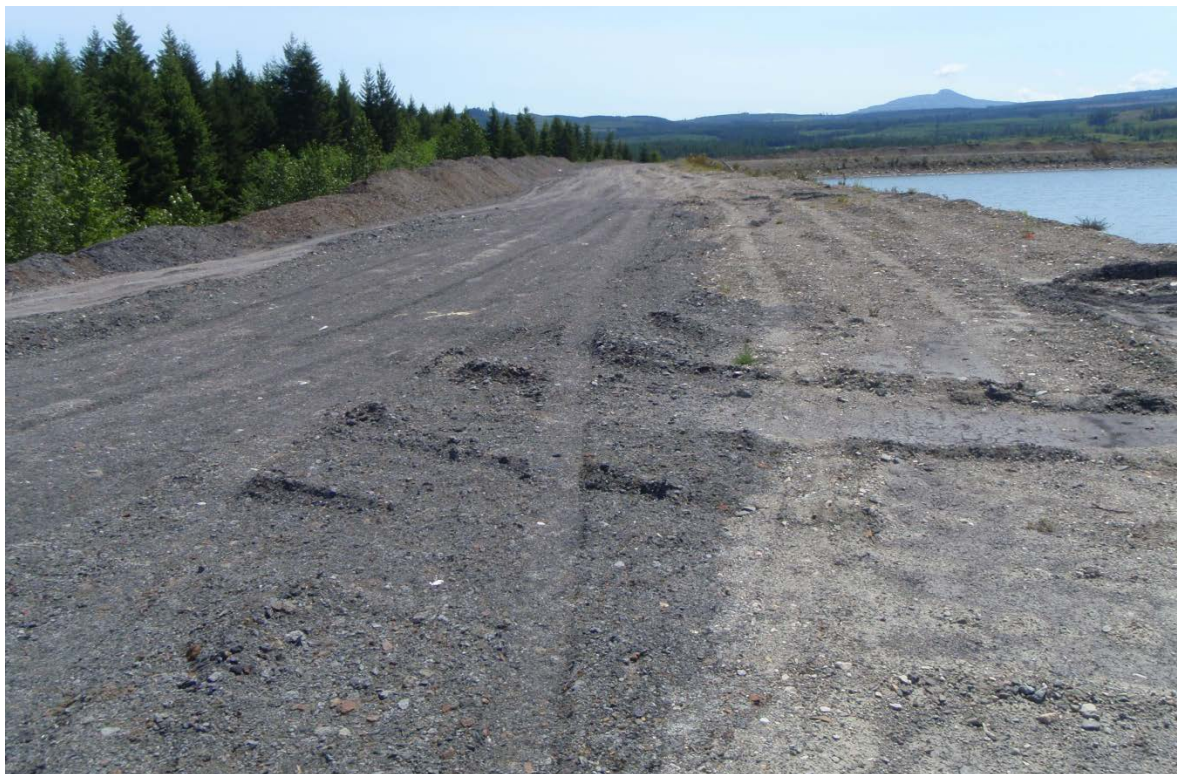
Photograph 9: East Embankment Crest, Looking South, May 26, 2015.

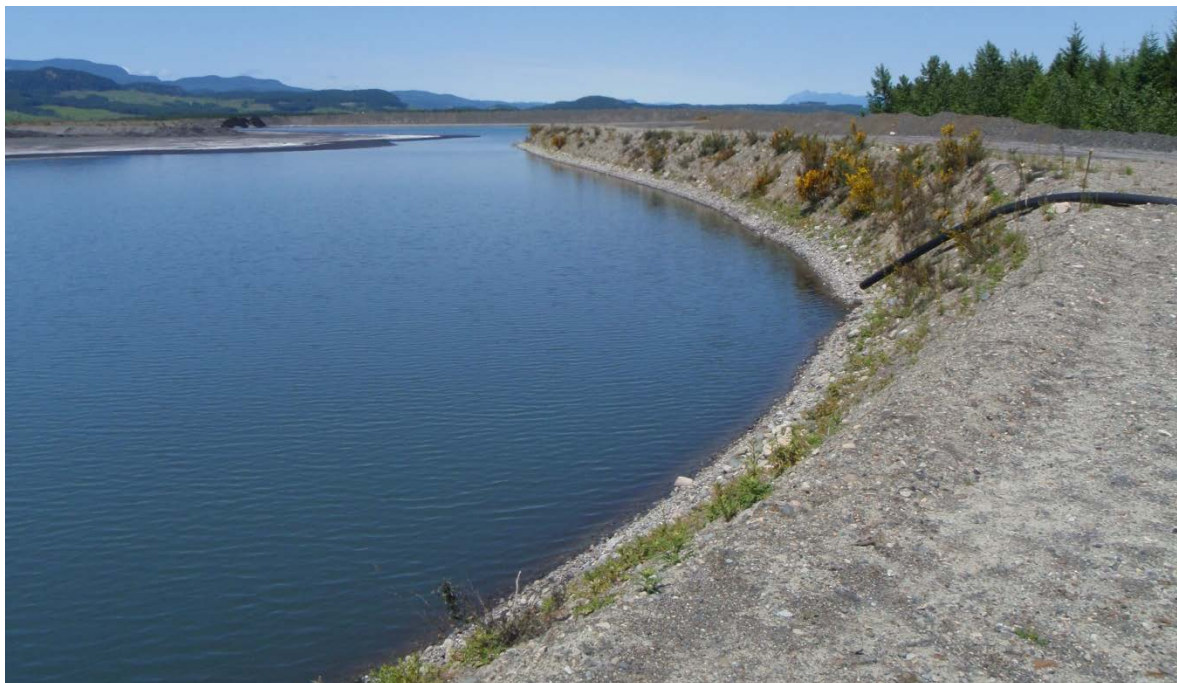
Photograph 10: East Embankment Upstream Slope, Looking North from South Embankment, May 26, 2015.

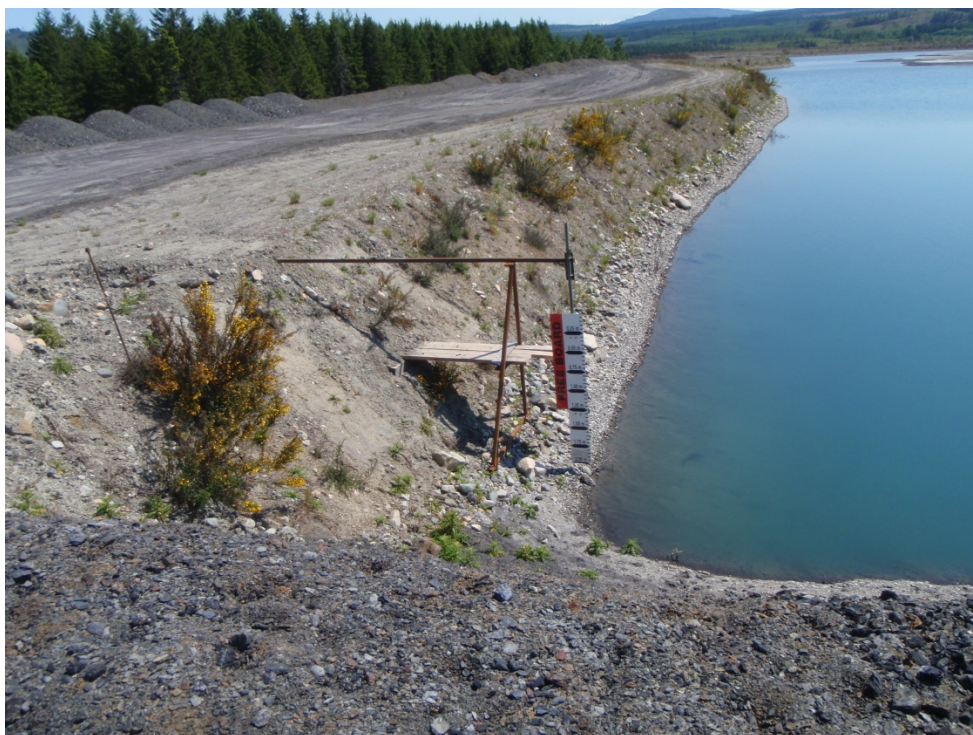
Photograph 11: East Embankment Upstream Slope with Freeboard Gage, Looking South, May 26, 2015.

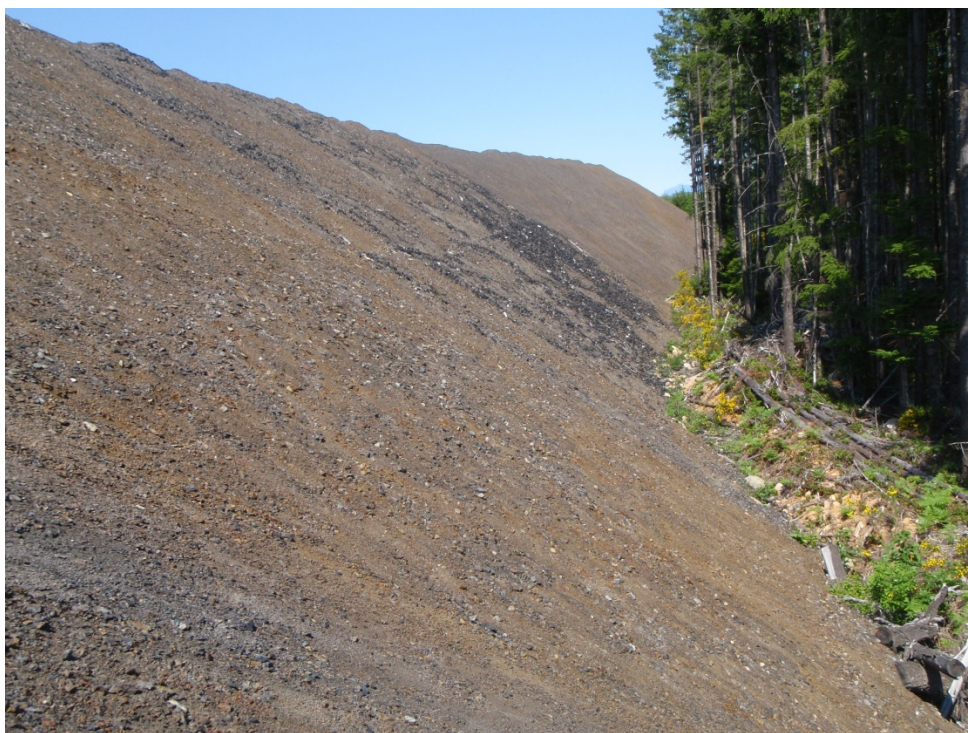
Photograph 12: East Embankment Downstream Slope, Looking North, May 26, 2015.

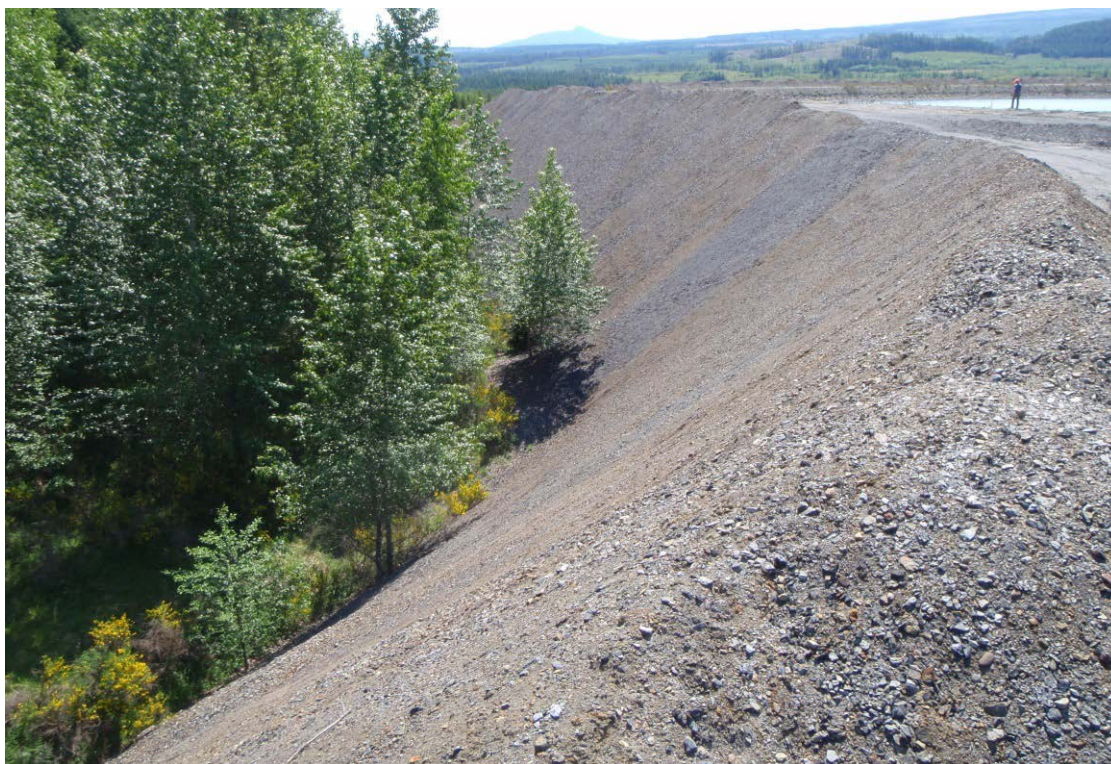
Photograph 13: East Embankment Downstream Slope, Looking South, May 26, 2015.

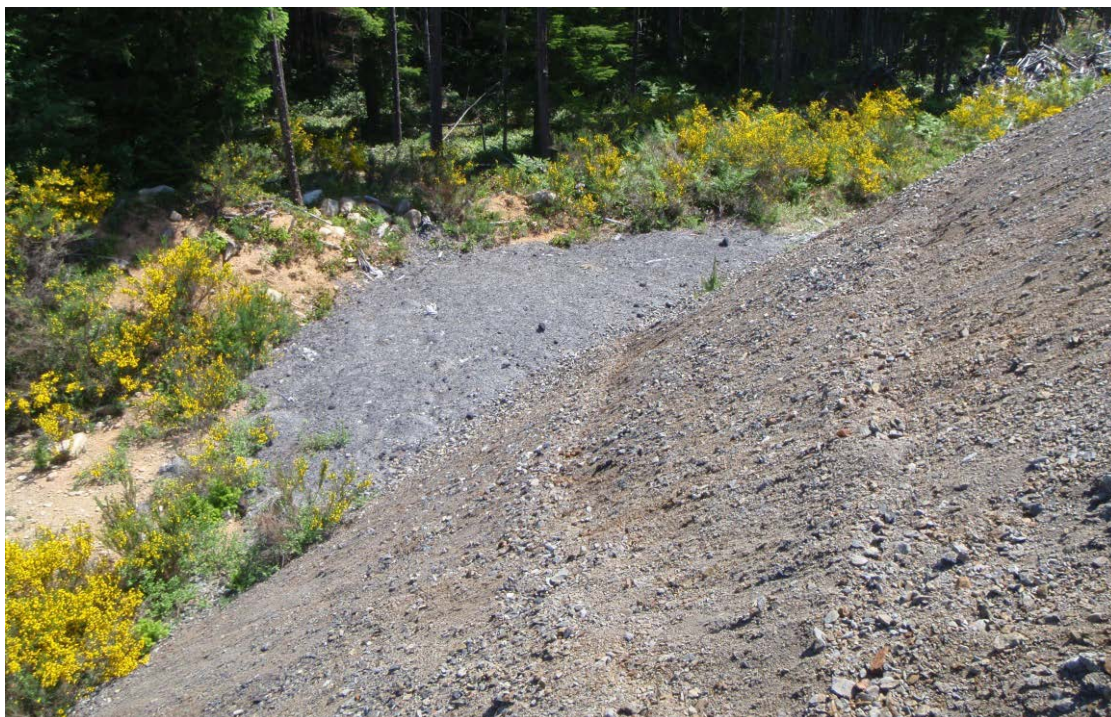
A pond has been noted periodically near the downstream toe of the East Embankment, north end (Photograph 14). The pond size varies with rainfall, and is therefore attributed to the collection of precipitation, rather than seepage from the impoundment. Weekly inspections indicate the pond dried up by May 21, 2015. The area appeared to be filled with coarse coal rejects during the May 26, 2015 site inspection.

Photograph 14: East Embankment Downstream Toe Area, Looking Southeast, May 26, 2015

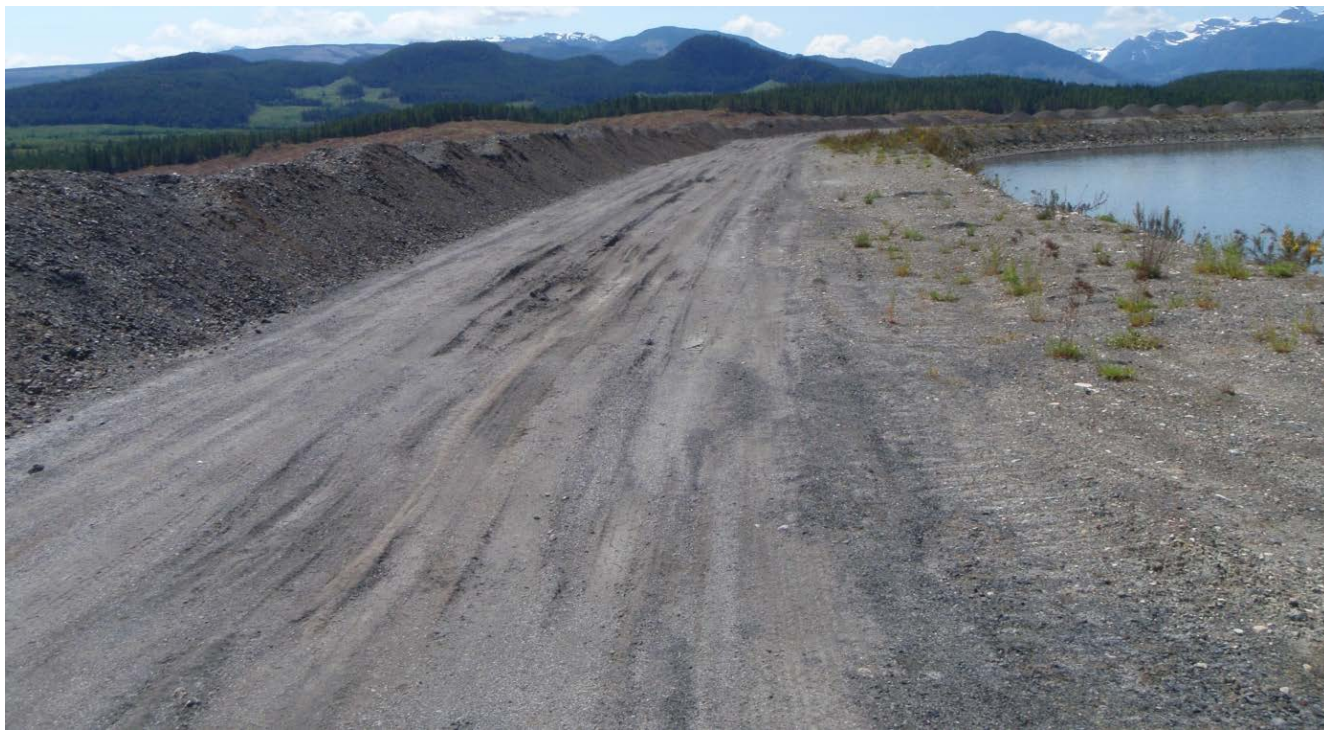
Photograph 15: South Embankment Crest, Looking West, May 26, 2015.

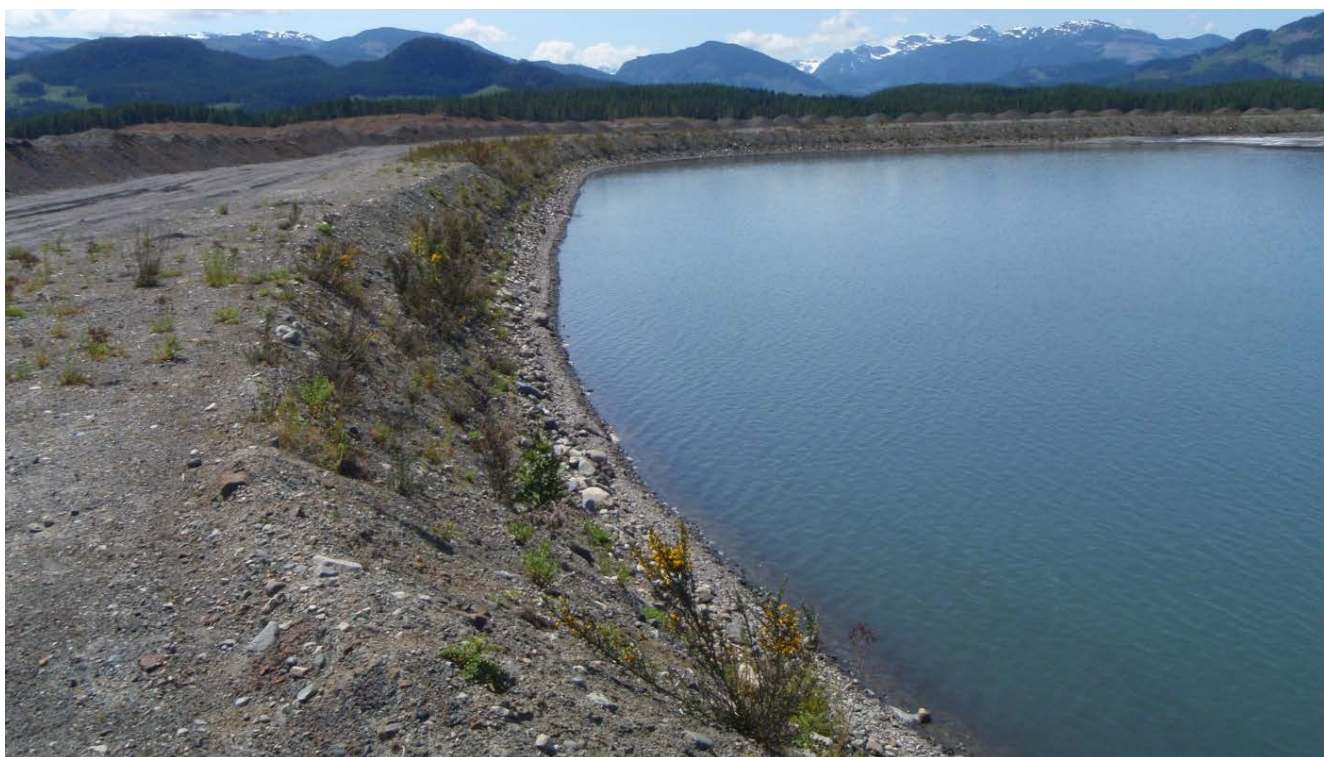
Photograph 16: South Embankment Upstream Slope, Looking West, May 26, 2015.

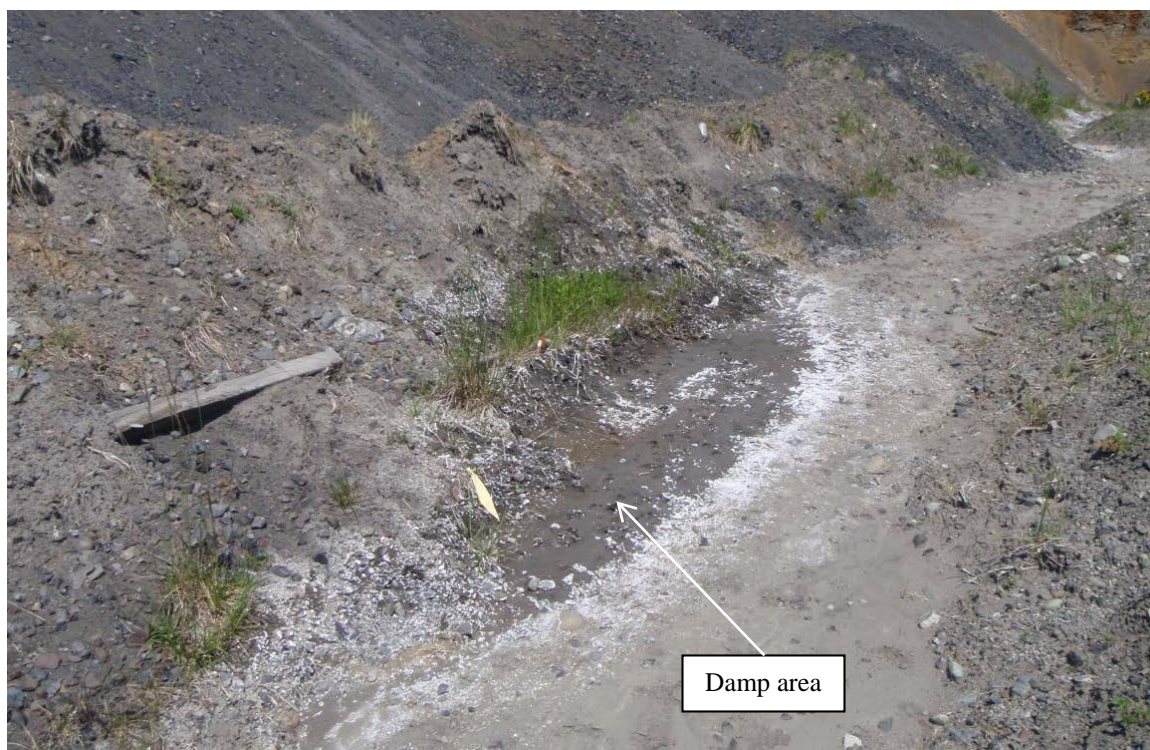
Photograph 17: South Embankment Downstream Slope and Toe Area, Looking East, May 26, 2015.

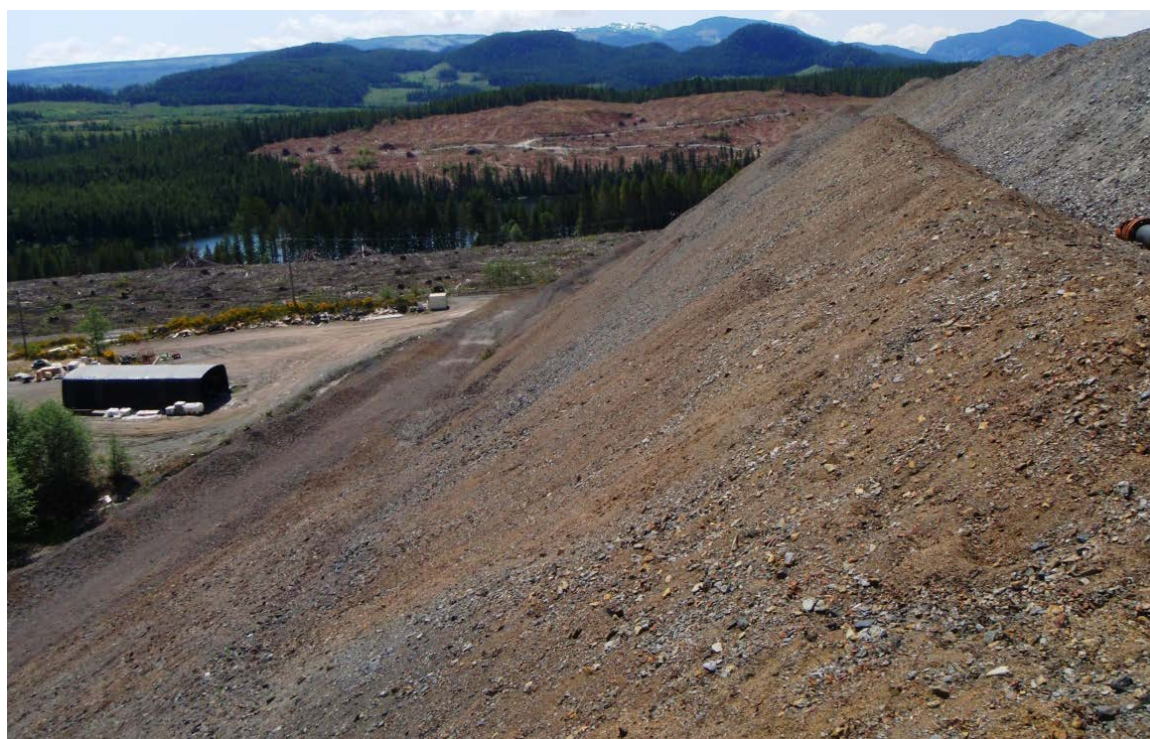
Photograph 18: South Embankment Downstream Slope, Looking West, May 26, 2015.

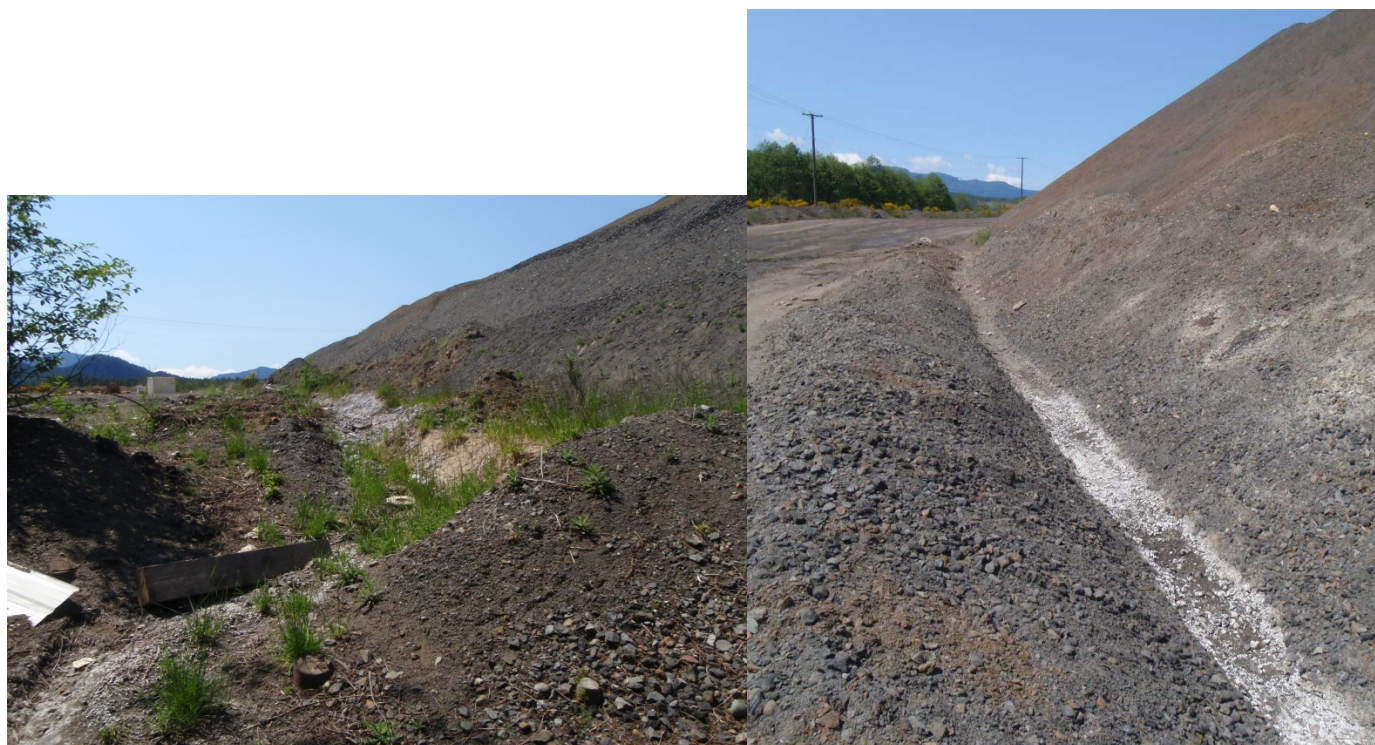
Minor erosion and exposed cobbles were observed on the upstream till slope during the May 26, 2015 inspection, attributed to the action of the former water line. Vegetation was present on the upstream slope along the length of the embankment and on the crest of the till (Photograph 16). A damp area was identified in the drainage ditch at the toe of the embankment. Water has been observed at this location during previous inspections (Photograph 17). There were no signs of flowing seepage at the time of the May 26, 2015 inspection. Dry, white salt stains were visible on the downstream slope near the access road about 2 m above the toe (Photograph 19b).

Photograph 19a (left): South Embankment Drainage Ditch Along Downstream Toe, Looking West, and 19b (right): Looking Northwest, May 26, 2015.

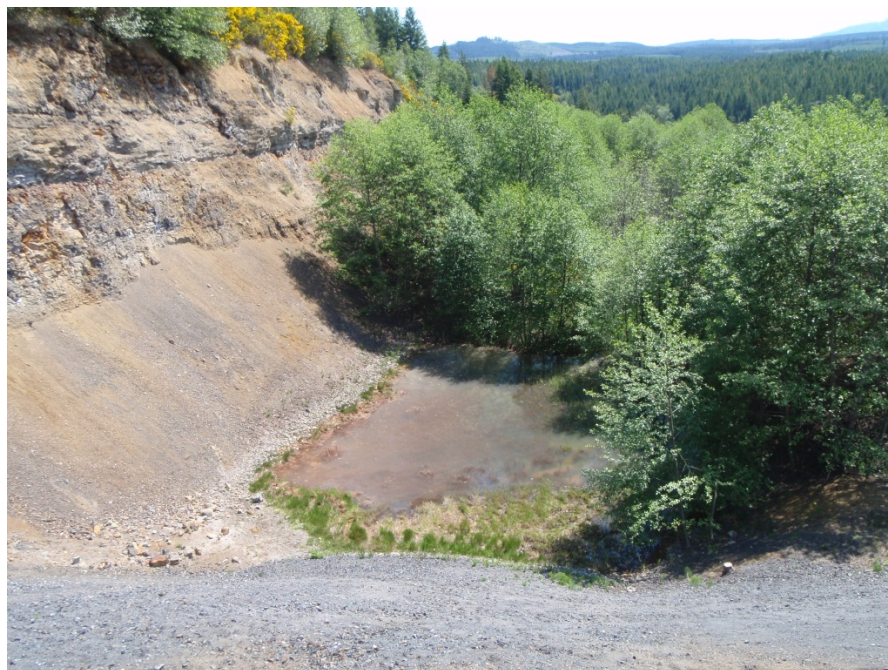
Photograph 20: Pond at South Embankment Downstream Toe, Looking South, May 26, 2015.

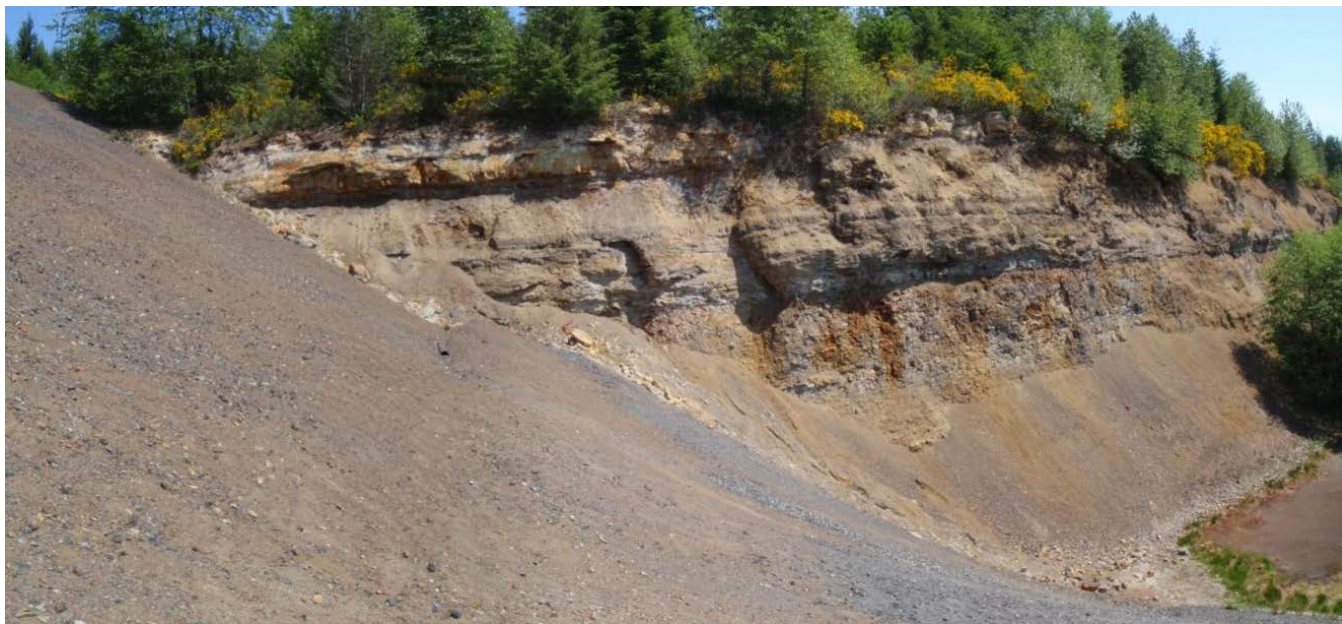
Photograph 21: South Embankment Downstream Slope and East Abutment, Looking East, May 26, 2015.

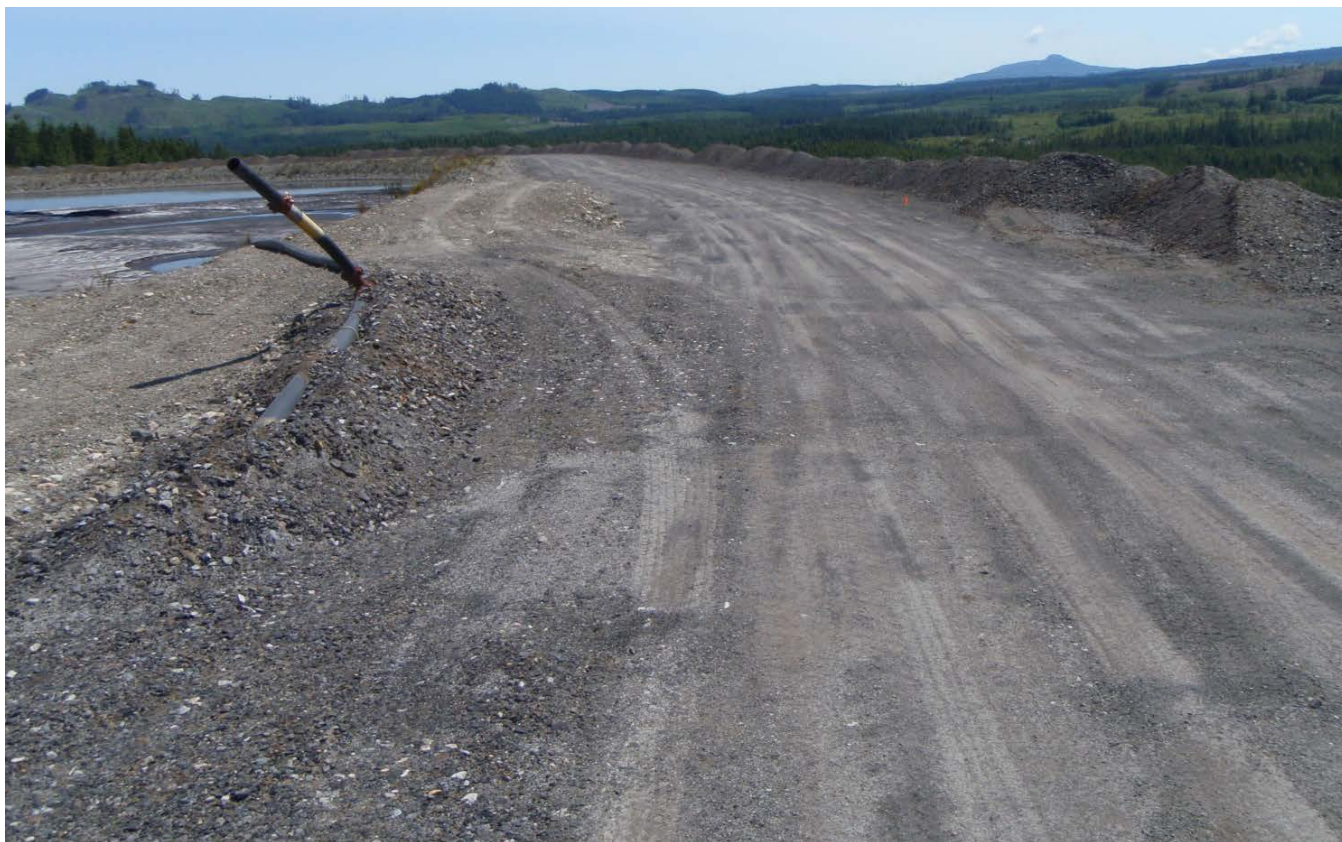
Photograph 22: West Embankment South Crest, Looking South May 26, 2015.

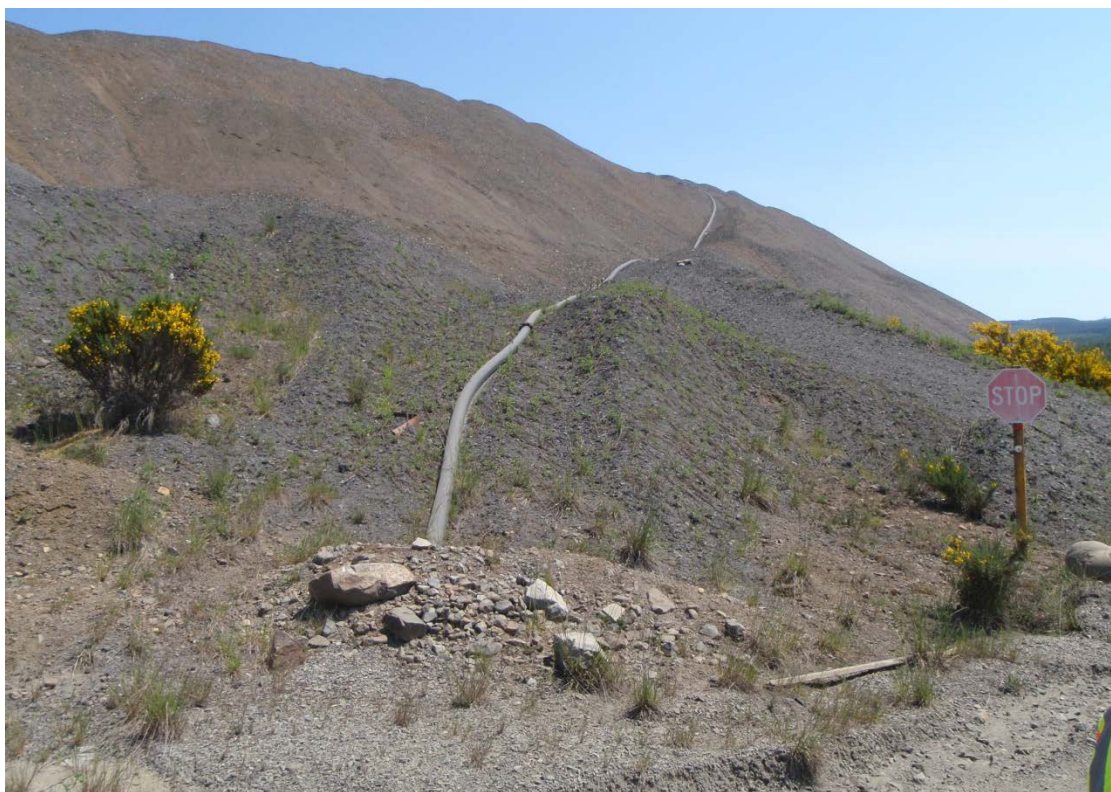
Photograph 23: West Embankment Downstream Slope with Wash Plant Pipeline, Looking Southeast, May 26, 2015.

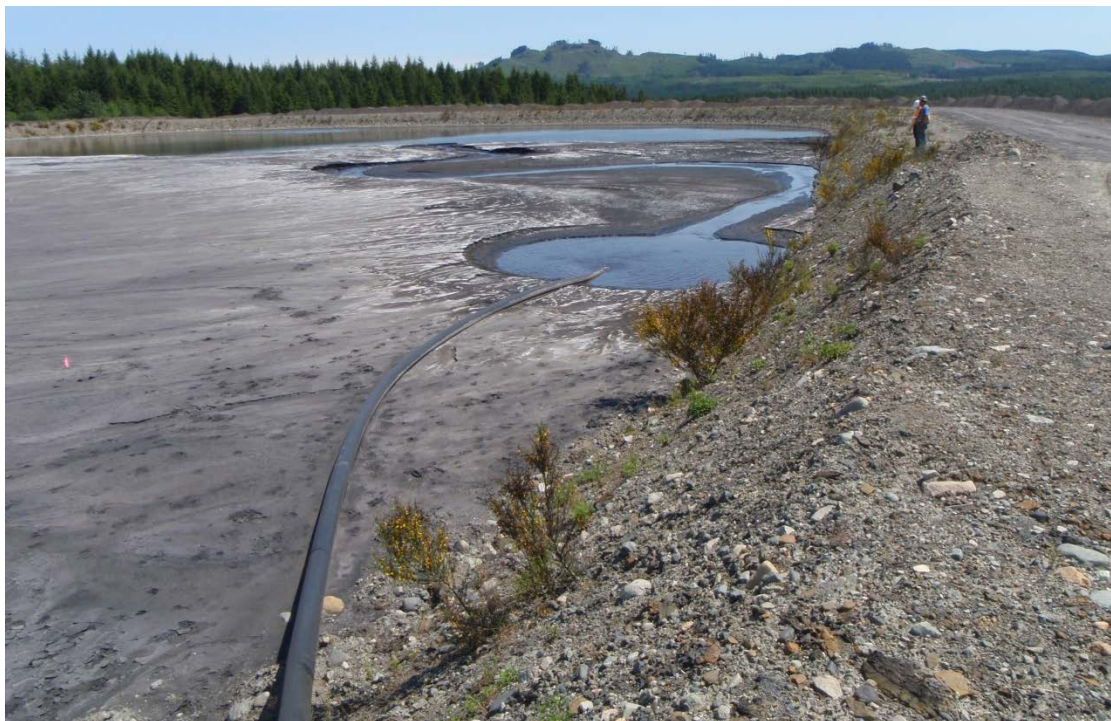
Photograph 24: West Embankment Upstream Slope and Wash Plant Pipeline Discharge, Looking South, May 26, 2015.
