2015 ANNUAL DAM SAFETY INSPECTION

2-North Pit Tailings Disposal Facility

Reference Number: 1528261-003-R-Rev0-1000

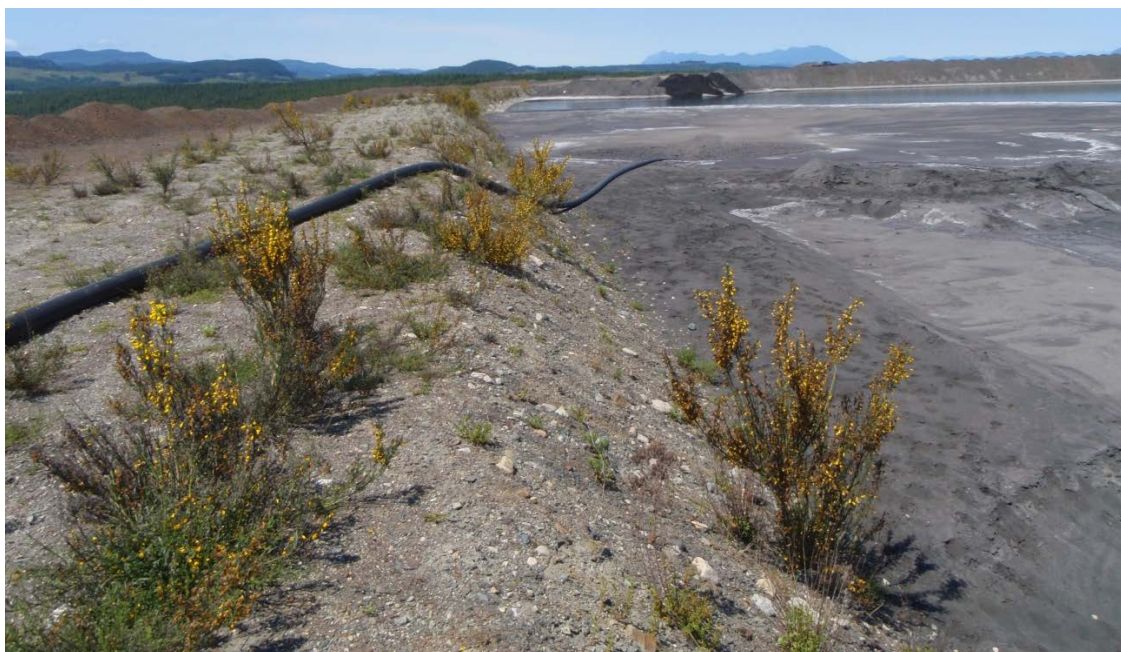
Photograph 25: West Embankment Upstream Slope, Looking North, May 26, 2015.

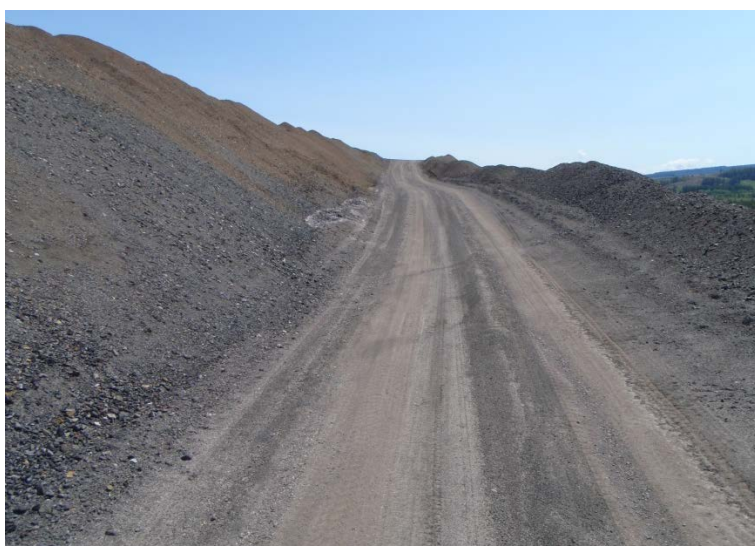
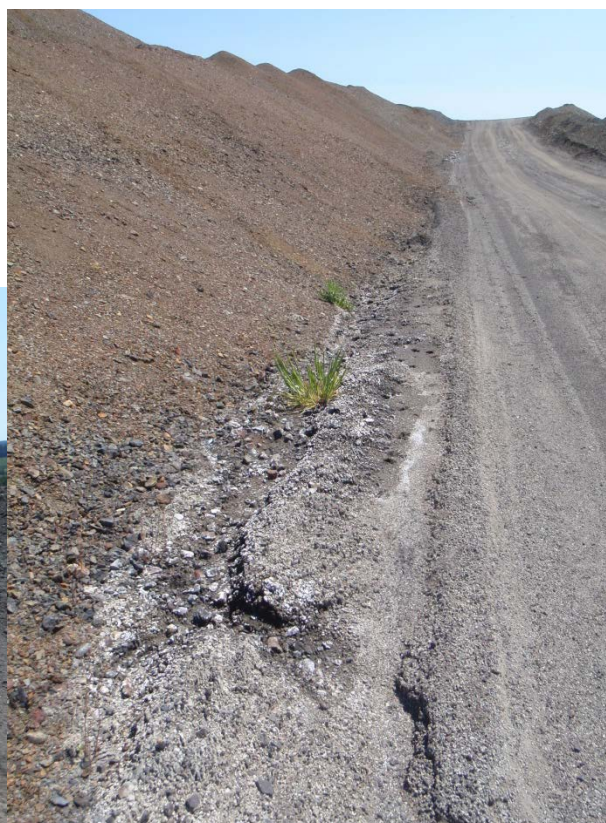
Photograph 26a (left): West Embankment Access Ramp, Looking South, and 26b (left) Seep and Soft Ground, Looking South, May 26, 2015.

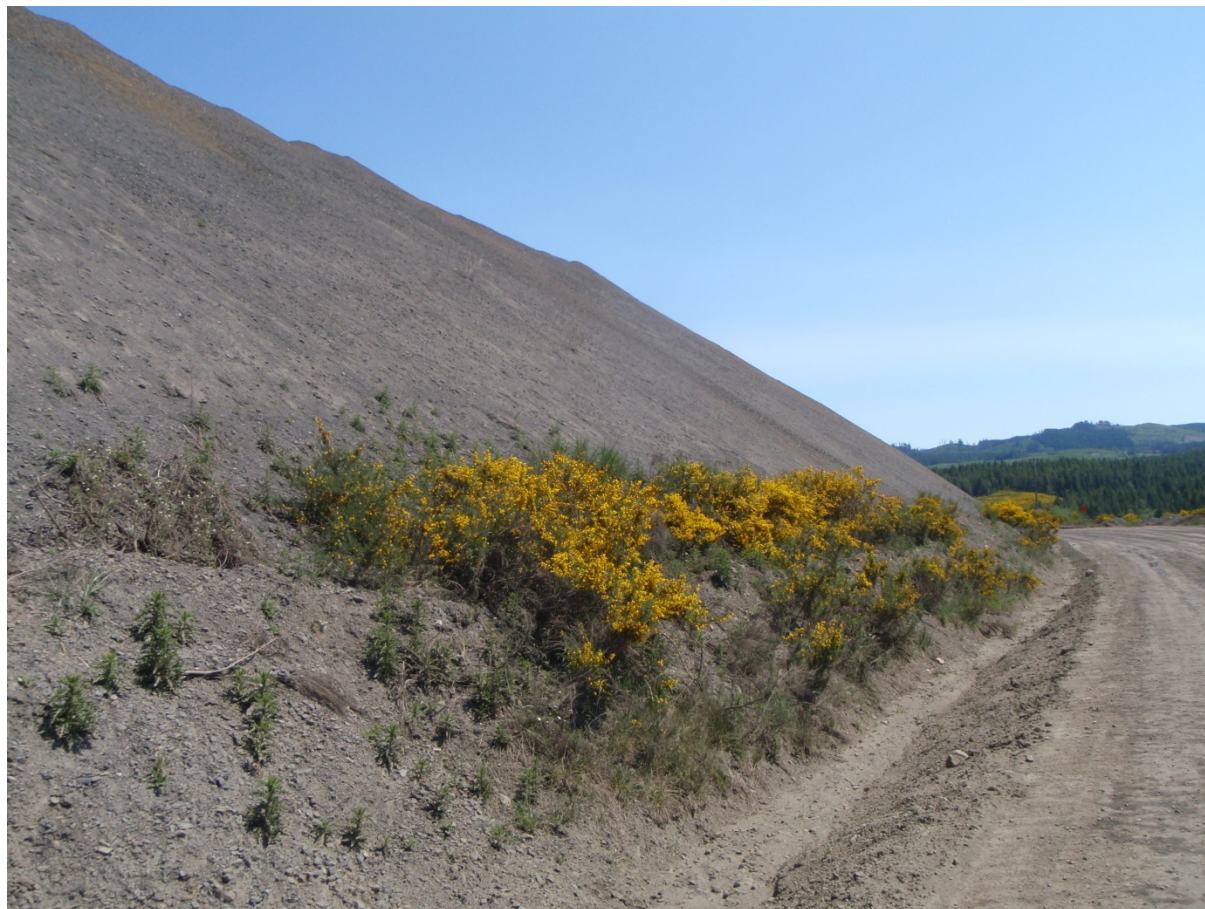
Photograph 27: West Embankment Downstream Slope and Toe, Looking South, May 26, 2015.

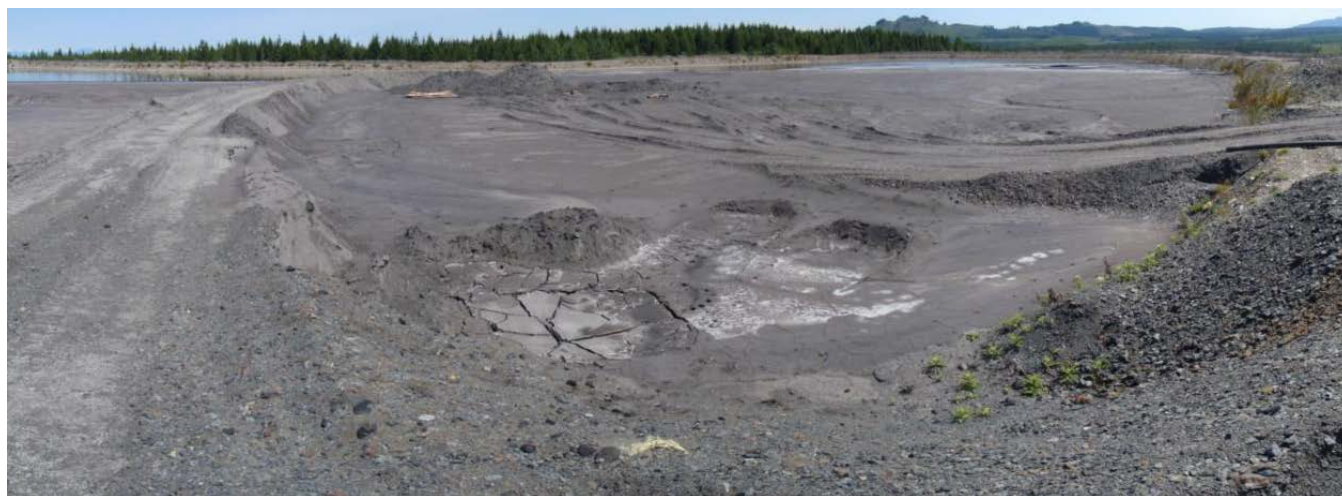
Photograph 28: Interior Berm and Tailings Area, Looking Southeast, May 26, 2015.

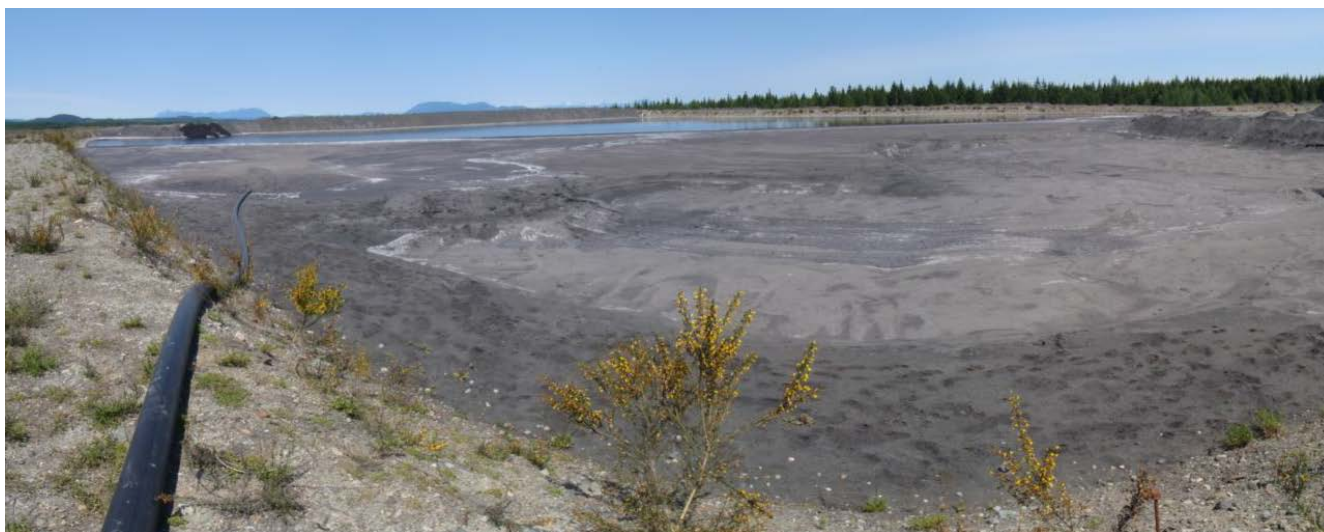
Photograph 29: Tailings on North Side of Interior Berm, Looking Northeast, May 26, 2015.

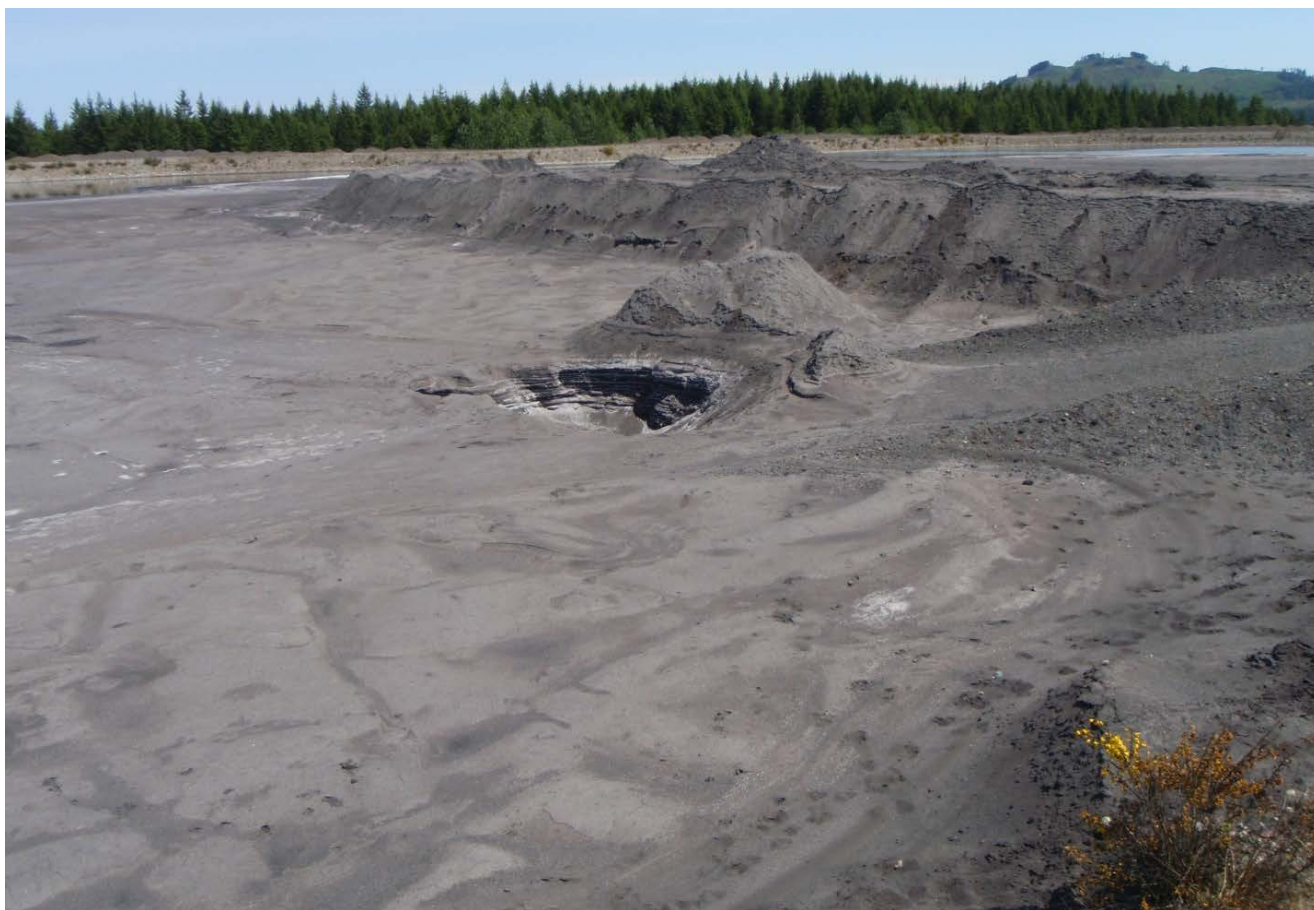
Photograph 30: Tailings Beach North Side of Interior Berm, Looking East, May 26, 2015.

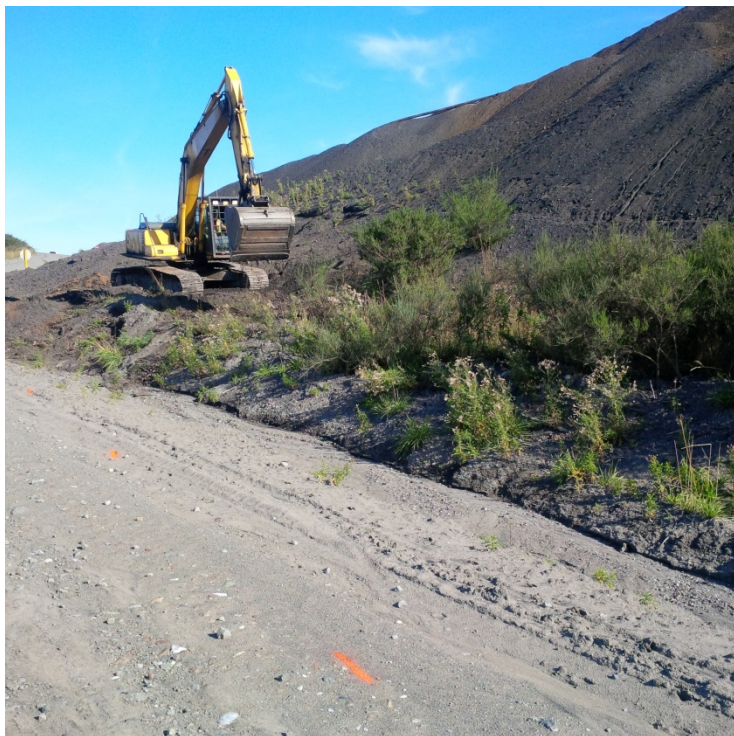
Photograph 1: Removing Vegetation From The Downstream Slope Of The West Embankment, Looking North August 17, 2015.

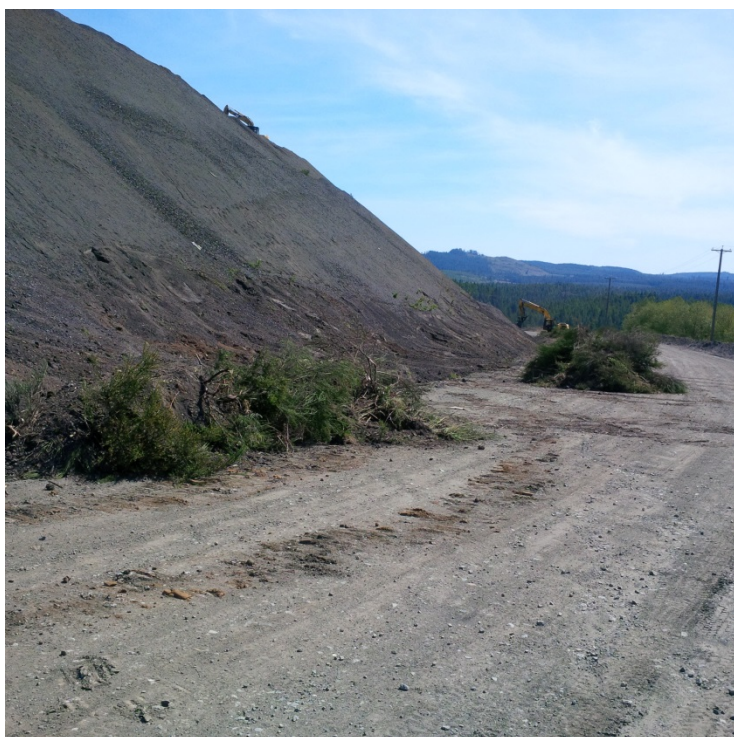
Photograph 2: Vegetation Removal, Looking South, August 17, 2015.

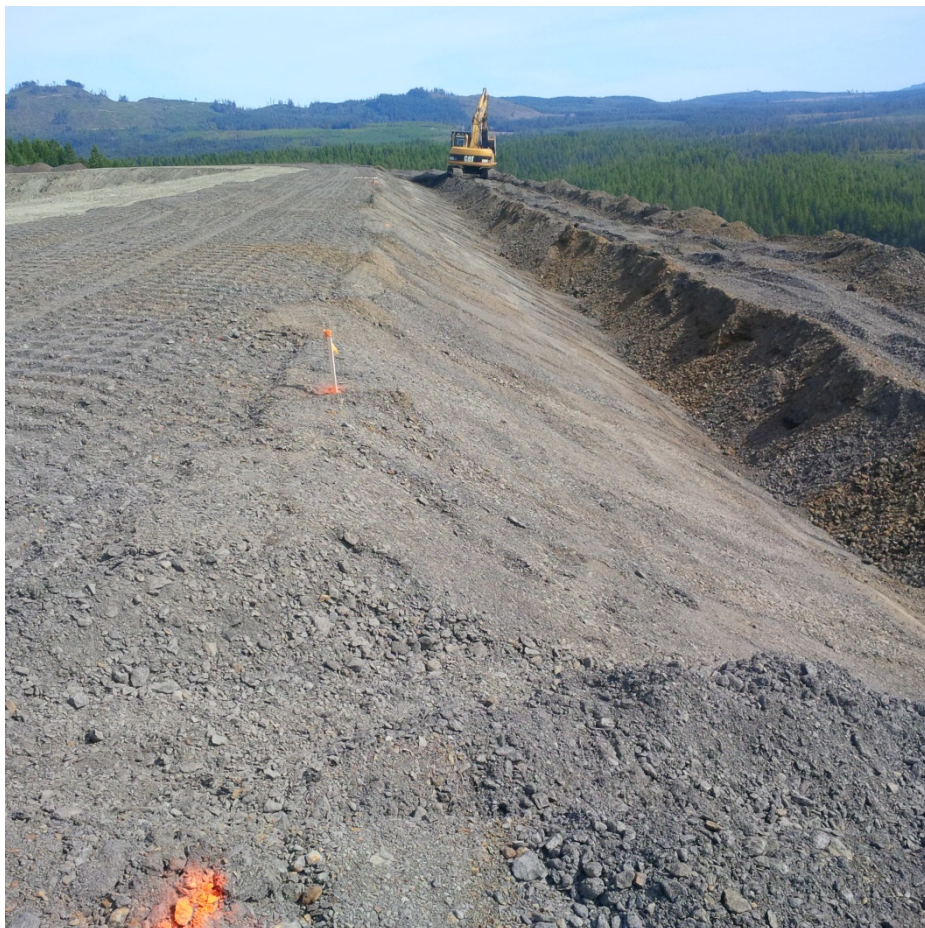
Photograph 3: Re-sloping At Downstream Crest, Looking South, August 17 2015.

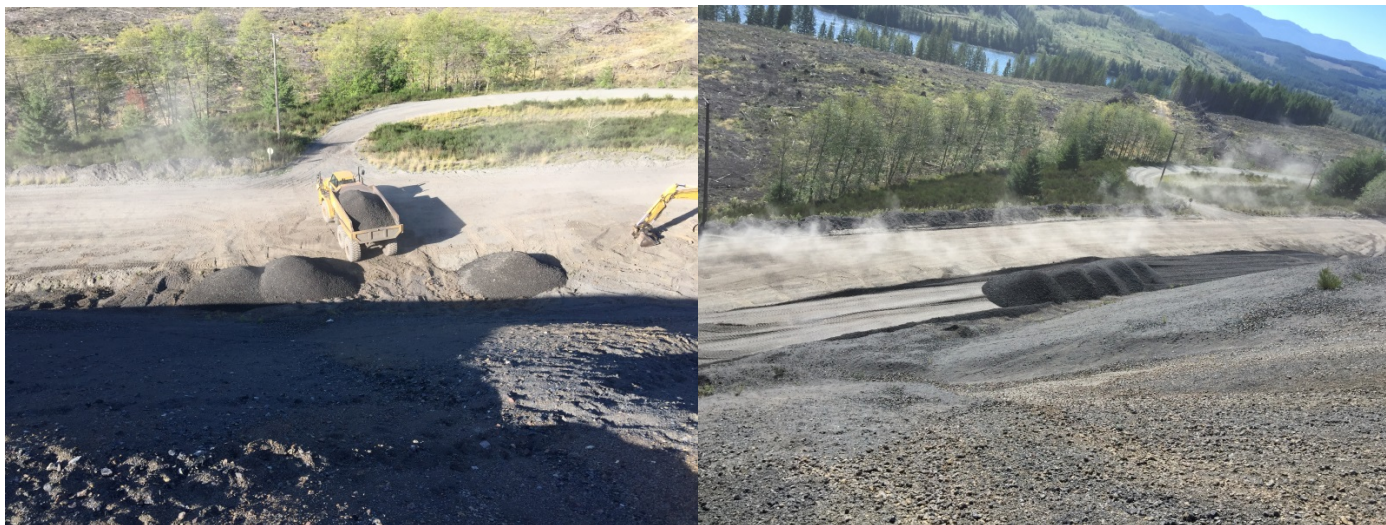
Photograph 4: Placement Coarse Coal Rejects To Widen The Downstream Toe, Looking West, August 18, 2015.

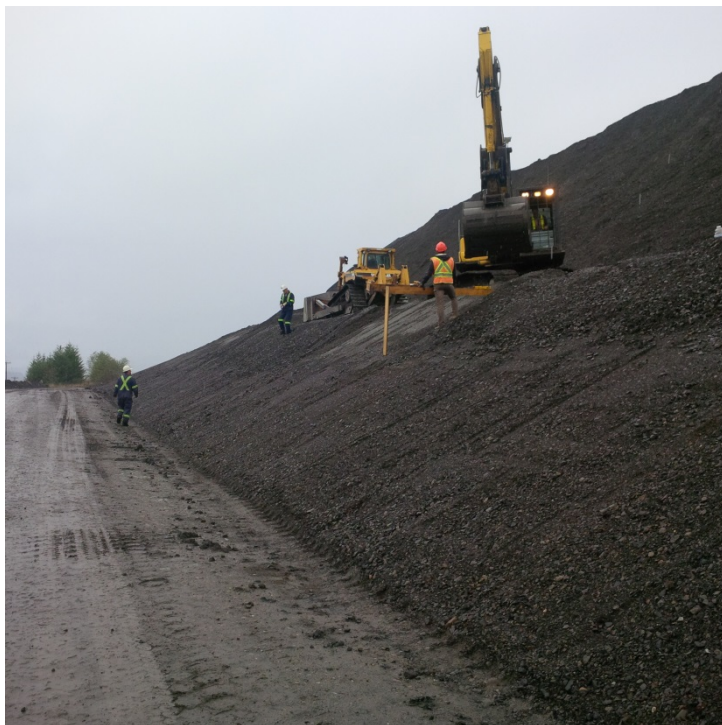
Photograph 5: Placing Coarse Coal Rejects, Looking North, September 2, 2015.

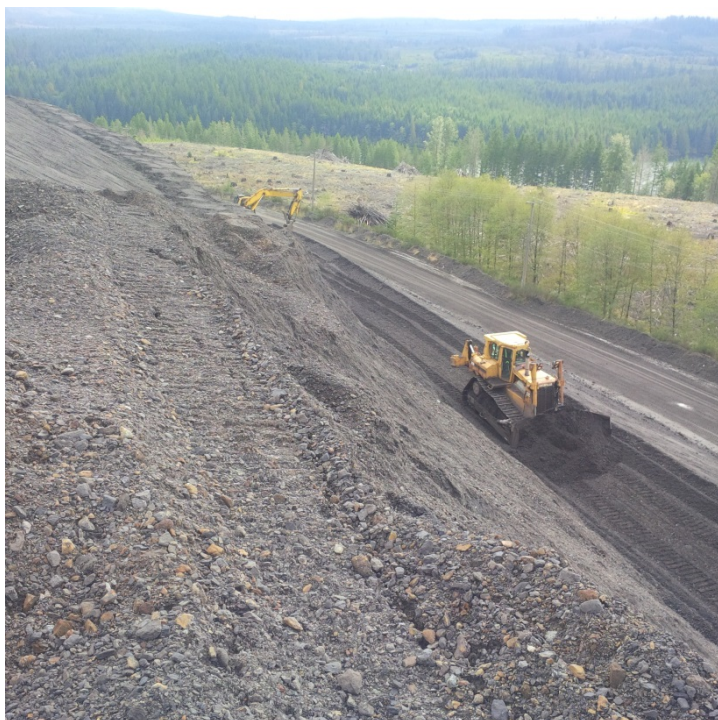
Photograph 6: Widening The Downstream Slope, Looking South September 8, 2015.

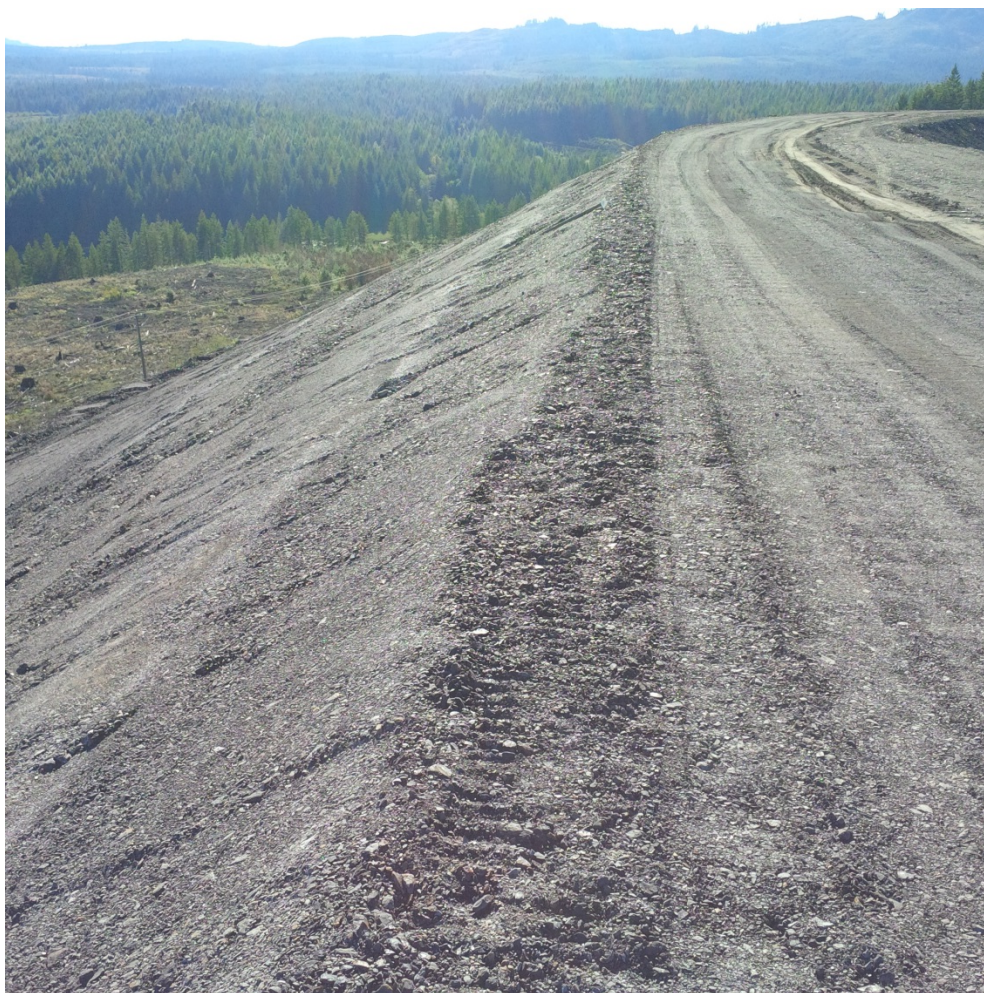
Photograph 7: Downstream Face After Re-sloping, Looking Northwest, September 11, 2015.
