Report of Inspector of Mines - Mechanical

Mine Name/Number	MYRA FALLS - HW 0800007	Visit Date	2018-04-10
Type of Mining	MU. METAL MINE UNDERGROUND	Location	
Latitude/Longitude		Northing/Easting/Zone	
Manager	Glen Smith	Permittee	Nyrstar Myra Falls Ltd.
Phone Numbers	(604) 336 8314	Address	2840 - 650 West Georgia Street Vancouver, BC V6B 4N8
Email			
Inspector	James Robinson, INSPECTOR	Accompanying Inspector	Barry Tracey, Inspector; Tryfan Jones, Inspector;
Address	PO Box 9395, STN PROV GOVT Victoria, B.C. V8W 9M9		
In Attendance	Glen Smith, Nyrstar; Kevin LeDrew, Nyrstar; Joe Armstrong, Nyrstar; Dave Williams, Nyrstar		
Copies to

Area Inspected 1: Process Mill, Maintenance Shops

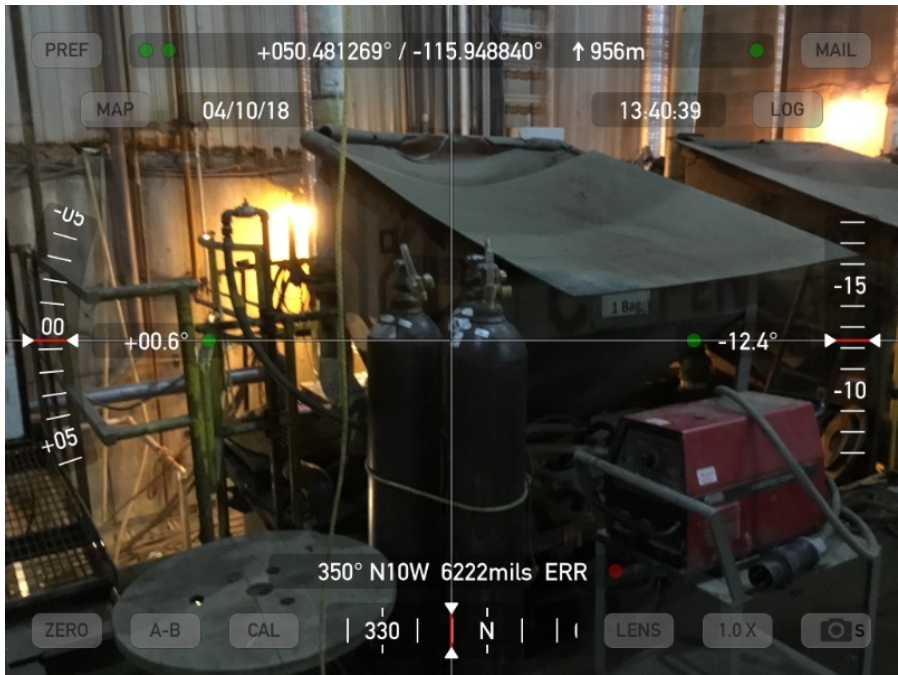
In the mill there were numerous compressed cylinders not in use that did not have there valve protection caps in place.

No valve protection cap

The Manager shall perform an audit of all compressed gas cylinders (surface and underground) to ensure when not in use they have a securely fastened, approved valve protection cap and be adequately secured by chains or other acceptable means to prevent it from being knocked over.

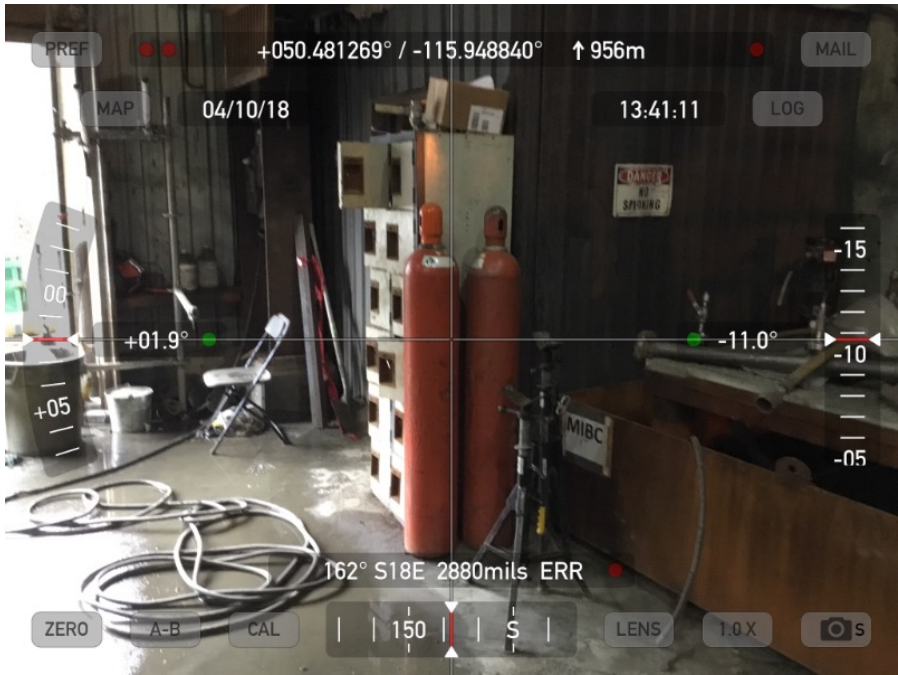
Unsecured cylinders

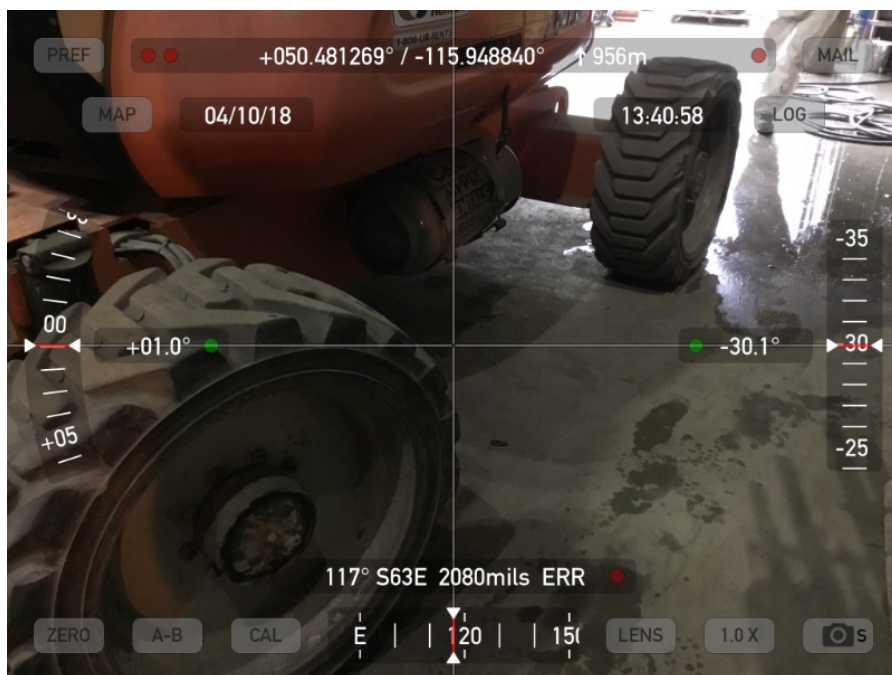
In the mill there was a Genie lift on the bottom floor that was parked unattended and did not have the required wheel chocks in place.

No wheel chocks in place

The Manager shall ensure that all rubber tired mobile equipment over 7000kg gvw (surface and underground) has a minimum of two wheel chocks used whenever necessary.

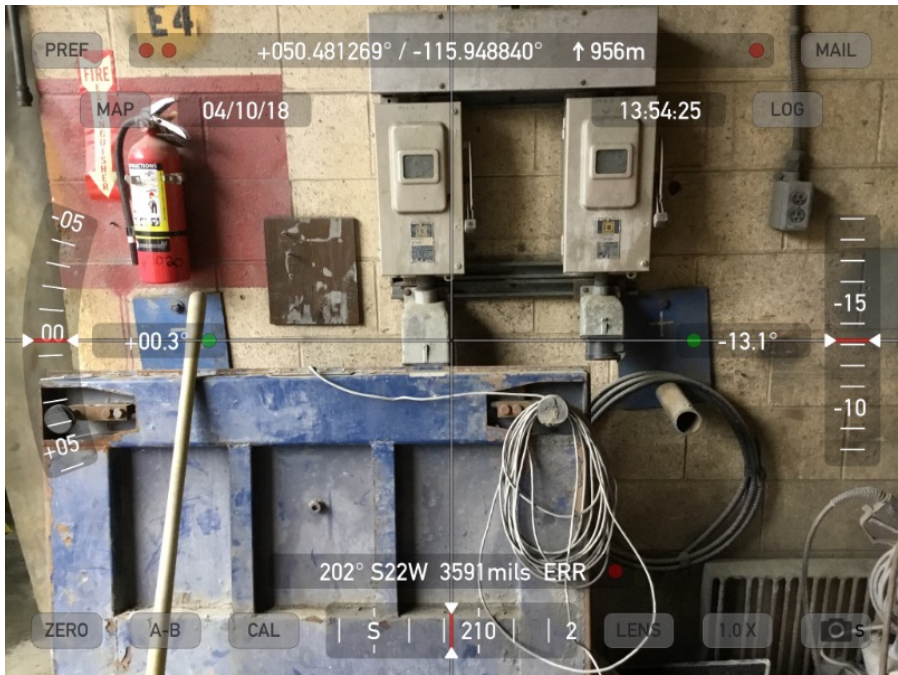
In the mill and shop there were several electrical panels that had there access blocked due to having material stored in front of them. Also, there were several bare exposed wires from outlet holes not yet completed in the areas under construction.

Material stored in front of electrical panel

The manager shall ensure that these areas are kept clear of storage in accordance with CSA Standard M421-00 Use of Electricity in Mines.

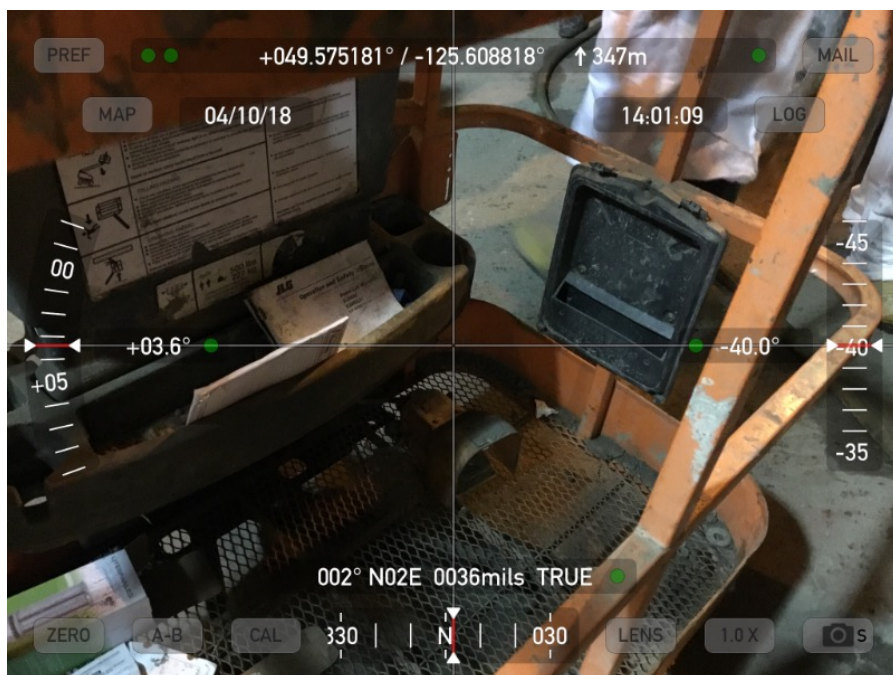
In the mill a Genie lift aerial device was not equipped with the required logbook.

Logbooks missing

The Manager shall ensure a logbook be maintained for self-propelled boom-type elevating platform in which any defect, operating difficulty, inspection, test, maintenance, modification and repair work is to be recorded. All entries shall be dated and signed.

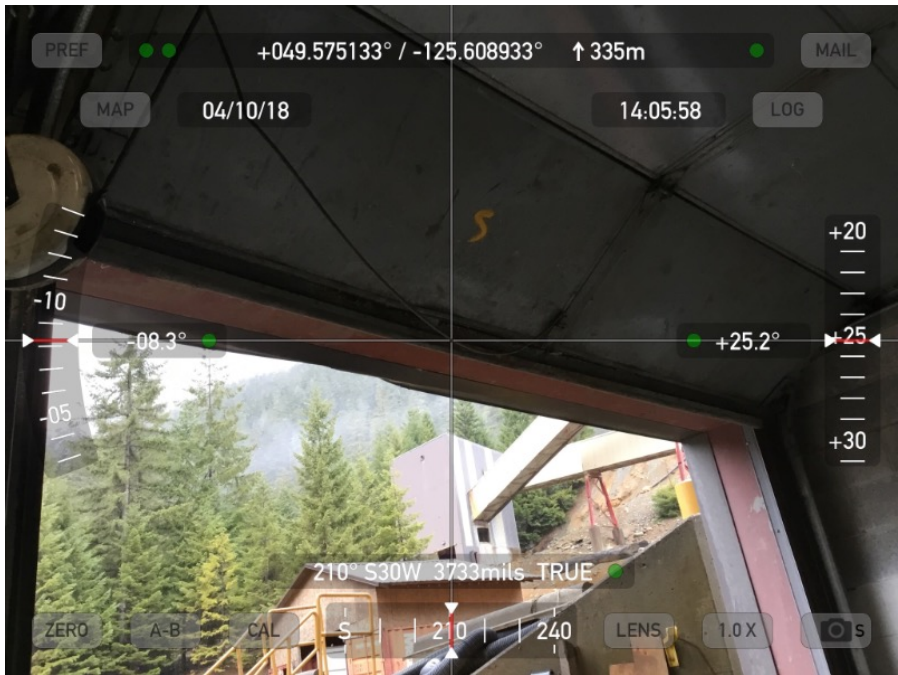
In the mill and the maintenance shops there were several overhead power operated doors that did not have the automatic sensing device along the lower edge of the door to stop movement of the door upon sensing an obstruction.

Bump stop not working

The manager shall perform an audit of all overhead power operated doors to ensure these safety devices along the lower edge of the doors are repaired/replaced or apply to the Chief Inspector of Mines for a variance to operate these doors with another means of entrapment protection that offers equal or greater protection.

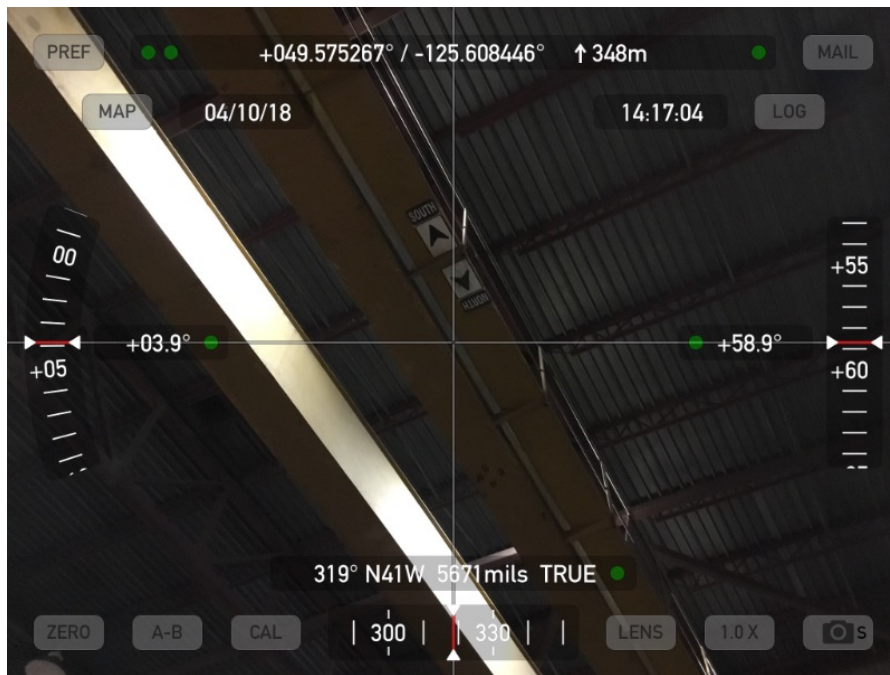
In the mill and maintenance shops there were several overhead traveling bridge cranes that were not in compliance with logbook requirements.

Logbook requirement for overhead cranes

The Manager shall perform an audit of all the overhead bridge cranes (surface and underground) to ensure they are in compliance with all logbook requirements within the Code for these types of cranes.

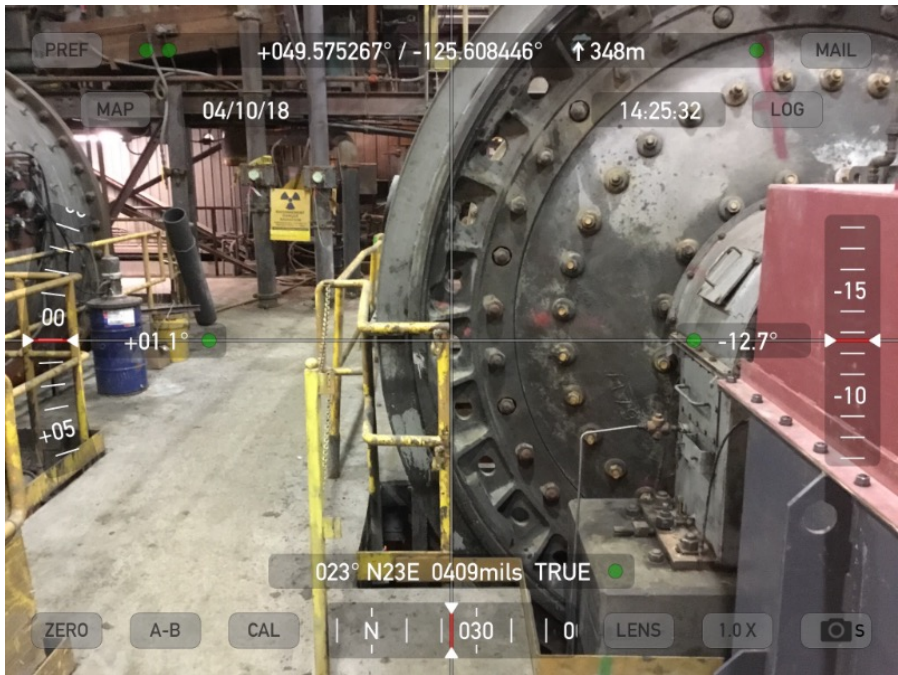
In the mill the area around the ball mills requires improved guarding than what was in place at the time of inspection. The guarding in place would not prevent a person from coming into accidental contact with the mills.

Chains not adequate for guarding

The Manager shall ensure that any revolving part that projects unevenly from the surface shall be effectively enclosed, covered or guarded to prevent a worker from coming into accidental contact with it.

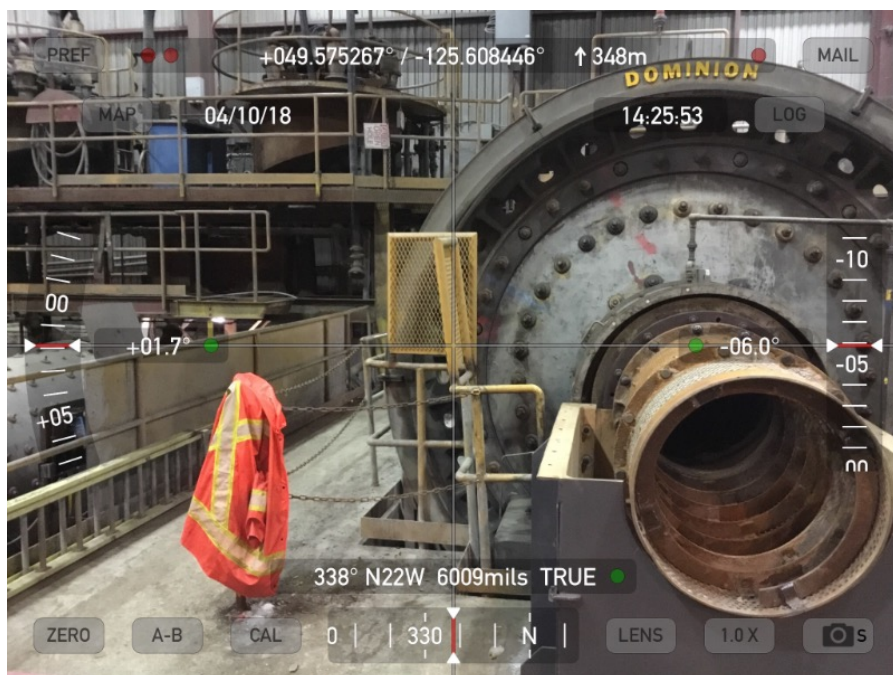
Guarding is weak

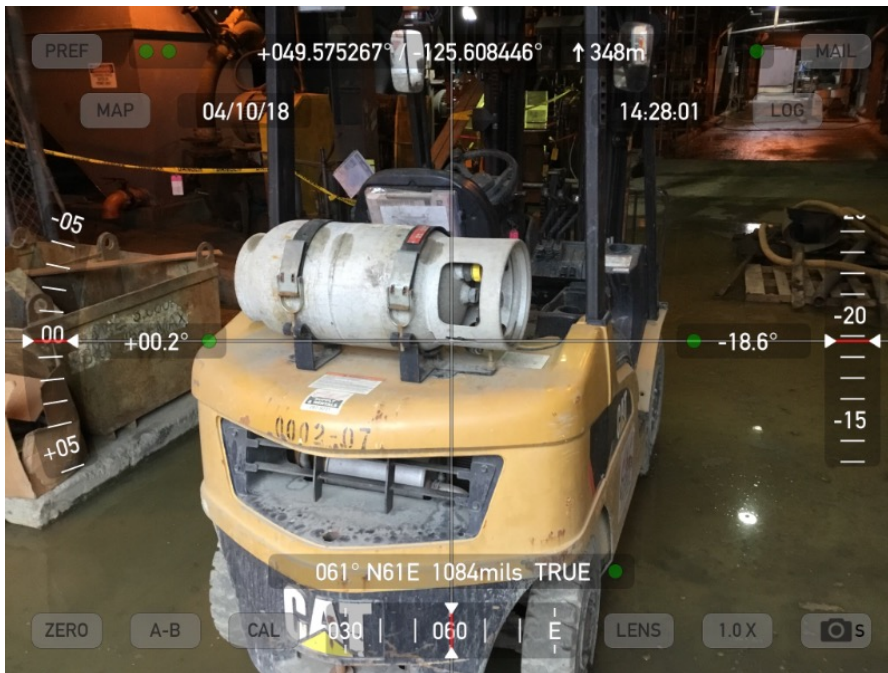
In the mill there was a forklift on the bottom floor that did not have the required fire extinguisher present.

No fire extinguisher

The Manager shall ensure that every vehicle is equipped with at least one fire extinguisher of adequate size and type.

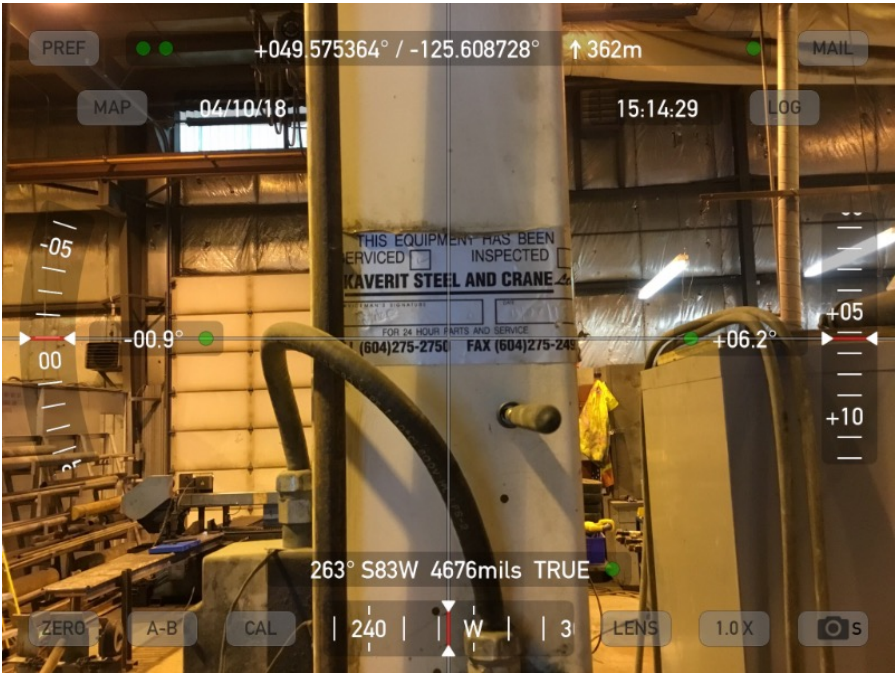
It was observed on inspection of the light duty bay that the vehicle hoist was not displaying its annual certification sticker and it was further discussed with management if this lifting device had been NDT this year to which they were going to look into this information.

Display out of date

The Manager shall ensure that all lifting devices be examined and tested by a qualified person before initial use and thereafter at intervals not exceeding one year.

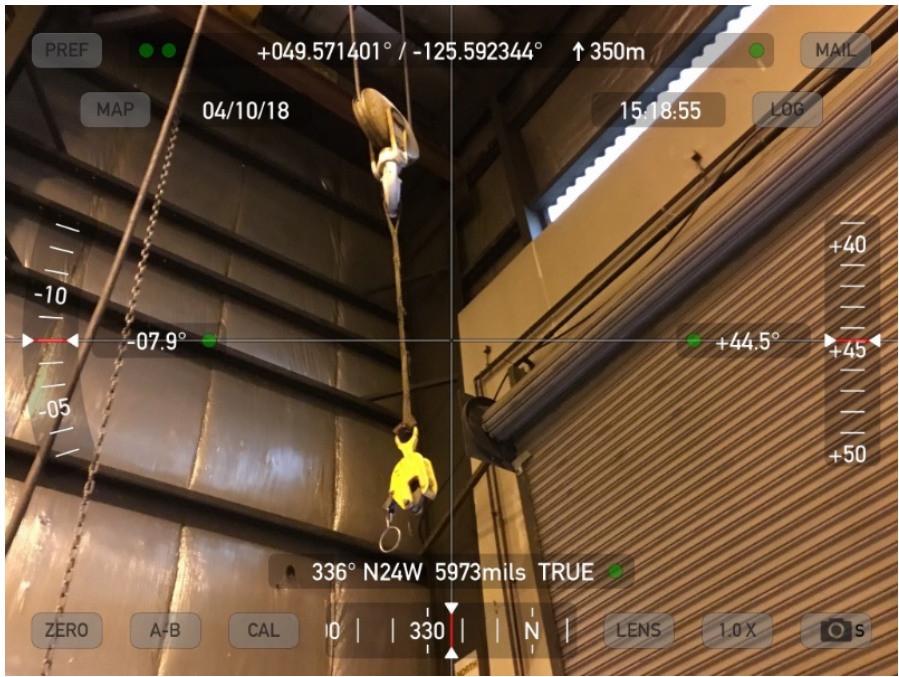
In the welding bay of the maintenance shop there was a damaged fiber webbing sling hanging from the crane with a sheet metal clamp used for moving and lifting plate steel attached and in use.

Damaged Fibers webbing sling

The Manager shall immediately remove this sling from service and all other fiber webbing slings that are damaged.

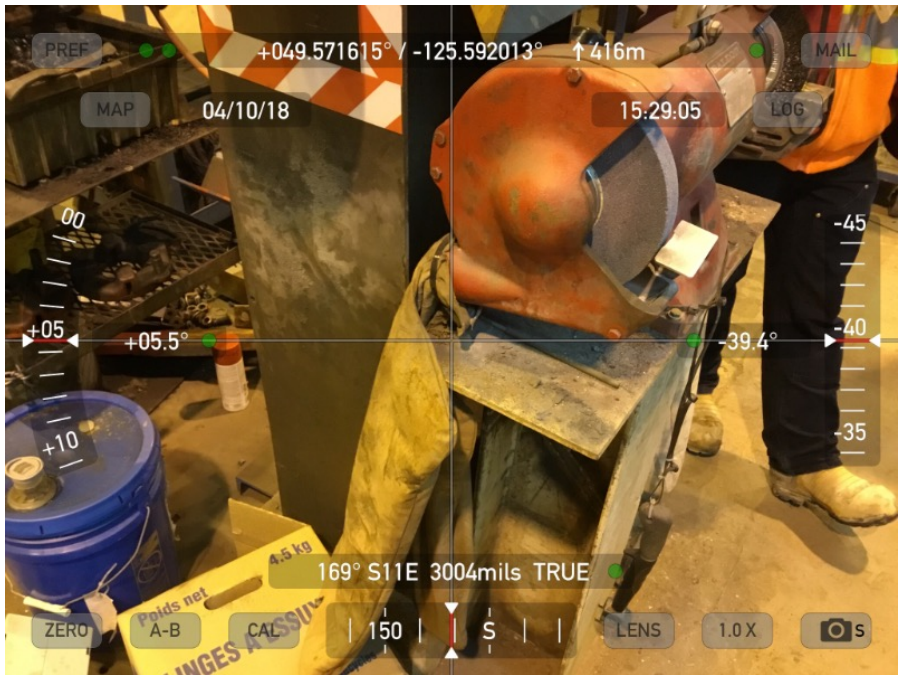
In the mill, maintenance shops and welding shops there were numerous bench grinders with their tool rests out of adjustment and exhaust systems not meeting the Code.

Bench grinder out of compliance

The Manager shall perform an audit of all bench grinders (surface and underground) and make sure they are meeting the provisions of the Code.

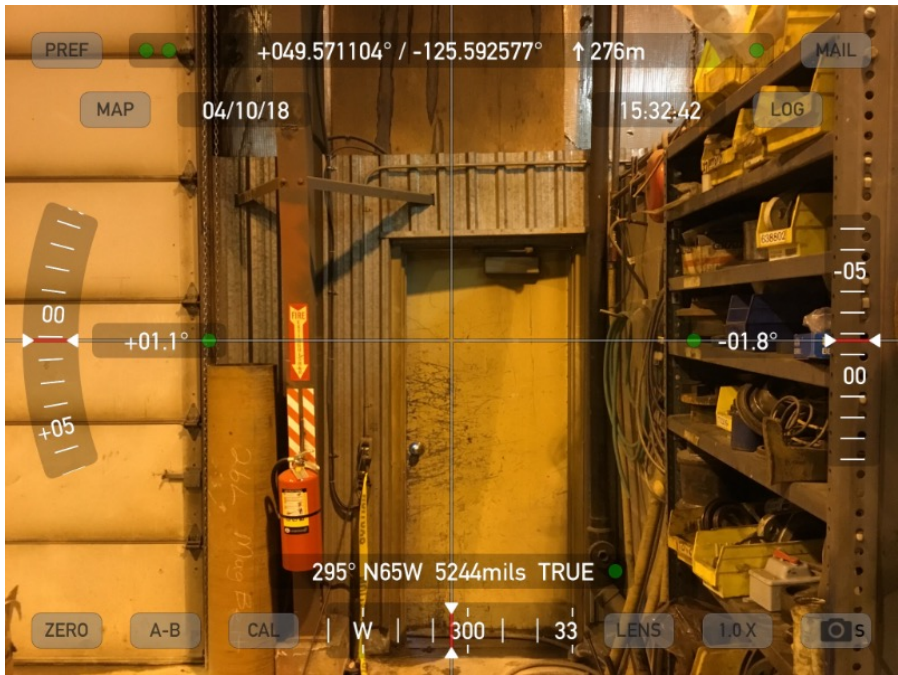
It was observed in the maintenance shops that there were several exit doors that did not have the required markings and signage as per the requirements of the code for exit doors.

No exit door markings

The Manager shall ensure that all emergency exits are clearly marked and designed to provide quick an unimpeded exit from the building.
