Report of Inspector of Mines - Permitting

Mine Name/Number	MYRA FALLS - HW 0800007	Visit Date	2018-06-26
Type of Mining	MU. METAL MINE UNDERGROUND	Location	
Latitude/Longitude	49.57125, -125.59369	Northing/Easting/Zone	312480, 5494194, 10U
Manager	Nicole Pesonen	Permittee	Nyrstar Myra Falls Ltd.
Phone Numbers	(604) 336 8314	Address	2840 - 650 West Georgia Street Vancouver, BC V6B 4N8
Email			
Inspector	Paul Beddoes, INSPECTOR	Accompanying Inspector	Andrew Craig, B.Sc., G.I.T., Inspector; Jennifer Brash, M.Eng., P.Eng., Inspector; Paul Hughes, Inspector;
Address	PO Box 9395, STN PROV GOVT Victoria, B.C. V8W 9M9		
In Attendance			
Copies to

General Observation: Kick off meeting at HW complex

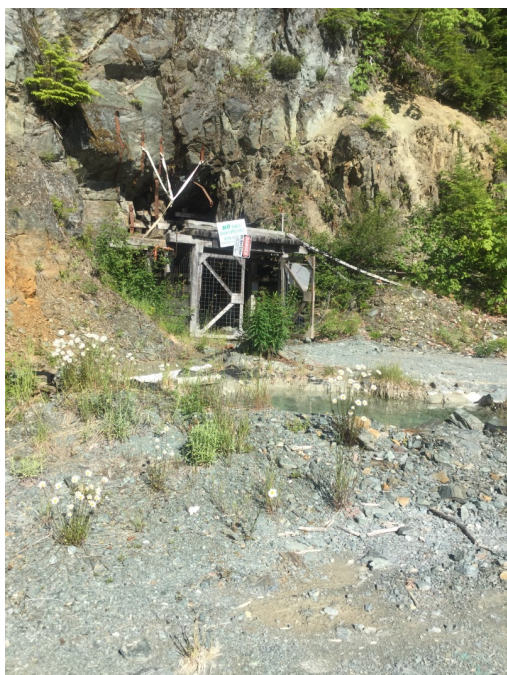
Water flowing from the Price 4 Portal was being collected in a series of two small settling ponds (Photos 1 and 2). The first, smaller pond was lined with a geofabric. The second pond was unlined and overflowed into a pipe which conveys water to the Price 5 Portal (Photo 3). Ms. Pesonen indicated that water does seep from the second pond, but seepage would also report to the Price 5 Portal. Flow at the Price 4 Portal ultimately reports to the Price 13 level where it is directed to the existing treatment system in the Myra Creek watershed.

Photo 1: Price 4 Portal.

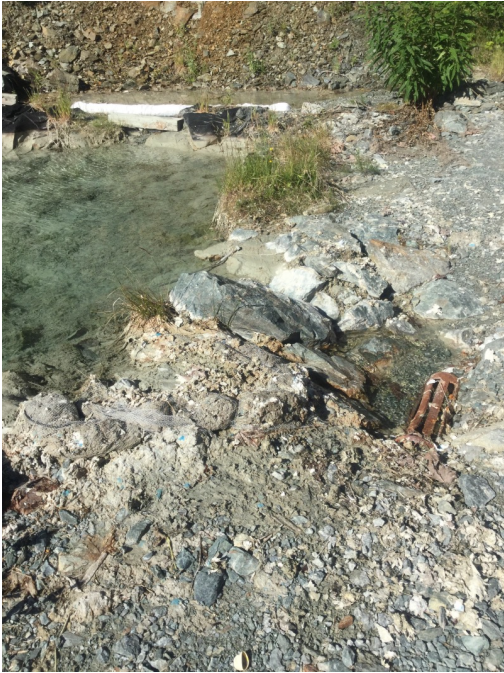
Photo 2: Second pond at Price 4 Portal and overflow.

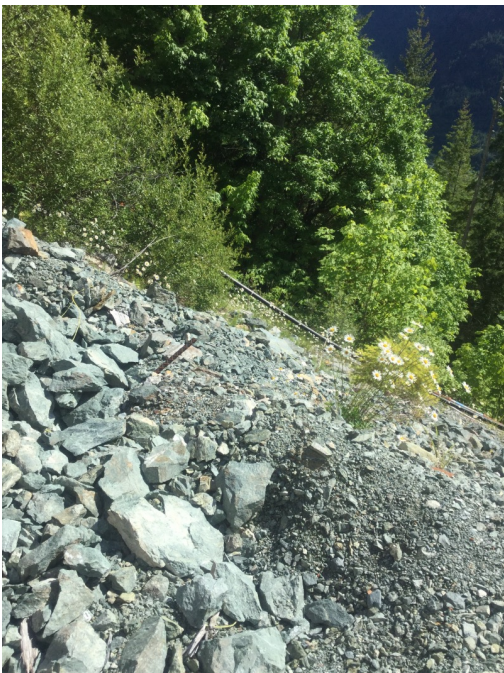
Photo 3: Conveyance pipe from Price 4 ponds to Price 5.

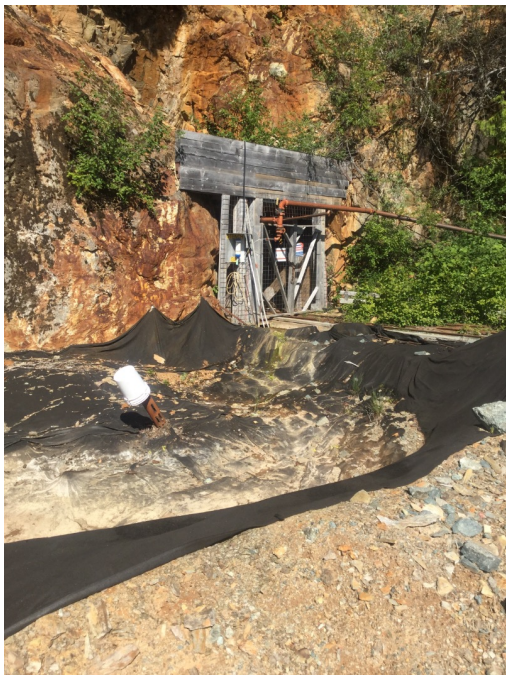
A lined sump was located next to the Price 5 Portal (Photo 4). The sump was dry at the time of inspection, but Ms. Pesonen indicated that this pond does collect water from the portal. A pipe at the bottom of the sump directed water to the Price 13 level so that it can be conveyed to the existing treatment system in the Myra Creek watershed. The pipe conveying water from the Price 4 Portal also directs water to the Price 13 level through a small sump at the Price 5 level pad (Photo 5). Ms. Pesonen indicated that sediment buildup in this sump would be cleaned out prior to starting mining in the Price areas.

Photo 4: Price 5 Portal and sump.

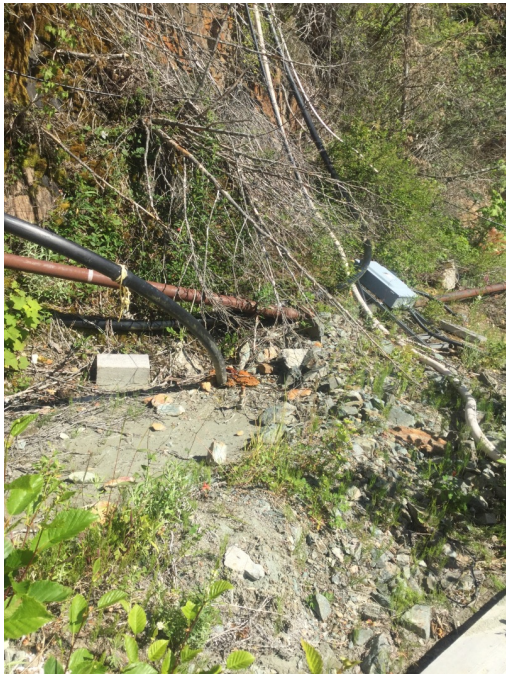
Photo 5: Outlet of pipe from Price 4 ponds to Price 5 level.

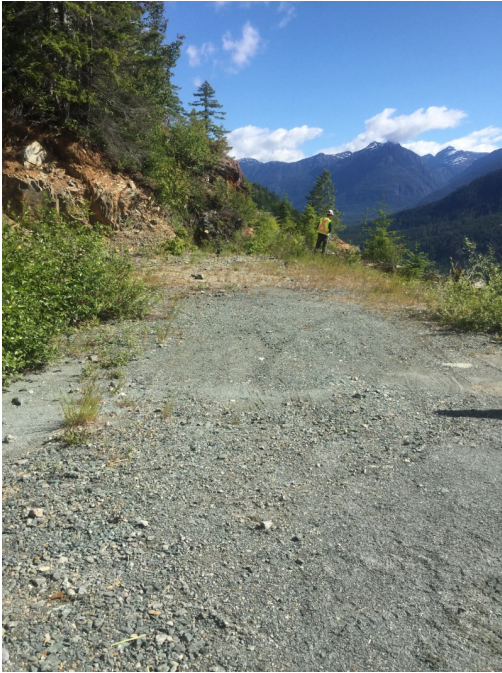
Ms. Pesonen indicated that any PAG waste rock identified in the Price 5 Portal pad would be prioritized for backfill in the underground during closure of the Price area (Photo 6).

Photo 6: Price 5 Portal pad.

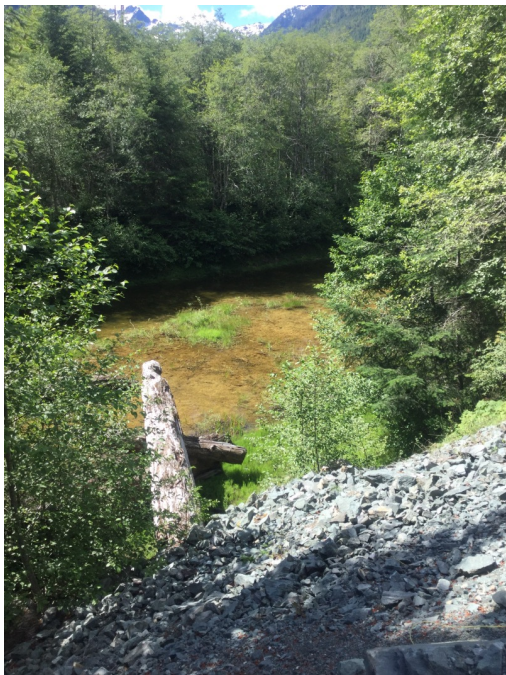
The Price pond was observed below the Jim Mitchell road (Photo 7). Water from the Price 13 Portal is conveyed to the pond by a box culvert under the road and then exfiltrates to ground.

Photo 7: Price pond, exfiltration basin

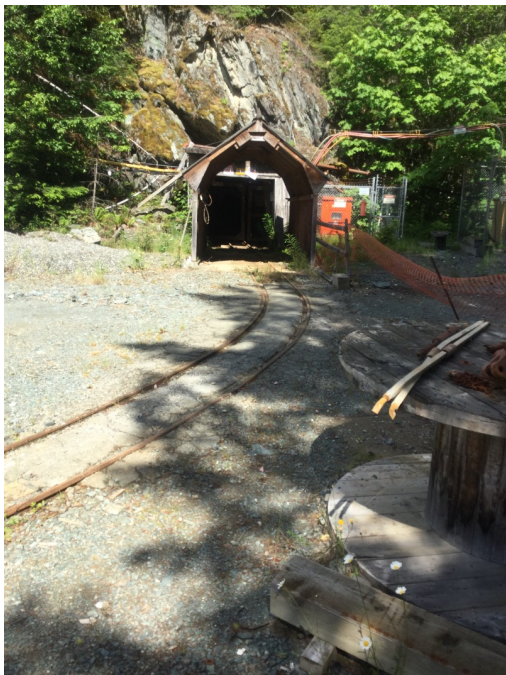
Ms. Pesonen indicated that flow from the Price 13 Portal into the Thelwood watershed is fed from the first 400 m to 600 m of the workings (Photo 8). Water passed this point will report to the existing treatment system in the Myra Creek watershed, along with flow redirected from the Price 4 and 5 portals.

Photo 8: Price 13 portal

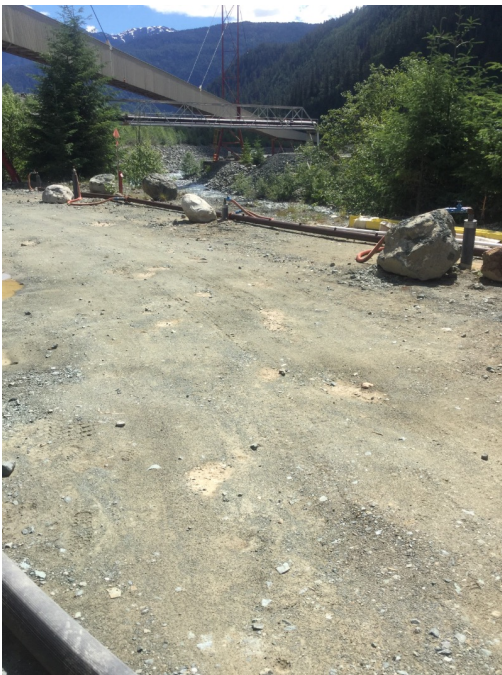
A series of four dewatering wells have been installed along Myra Creek just before the Car Bridge (Photo 9), which are intended to intercept seepage flow into the creek that had been observed in January. A vacuum pump was being used to dewater the wells to the Superpond (Photo 10). Ms. Pesonen indicated that the seep orientation has changed since installation; the seeps are now diffuse enough that the seepage plume was not visible (Photo 11) and static water levels have been drawn down by approximately 1 m. Future plans for a possible cut off wall along the seep area were discussed. Ms. Pesonen indicated that

Photo 9: Test interception wells

Construction of a cut off wall to intercept the seeps along Myra Creek will require a Mines Act permit amendment. Monitoring data and engineered designs are needed to support the application for any new permanent seepage intercept system.

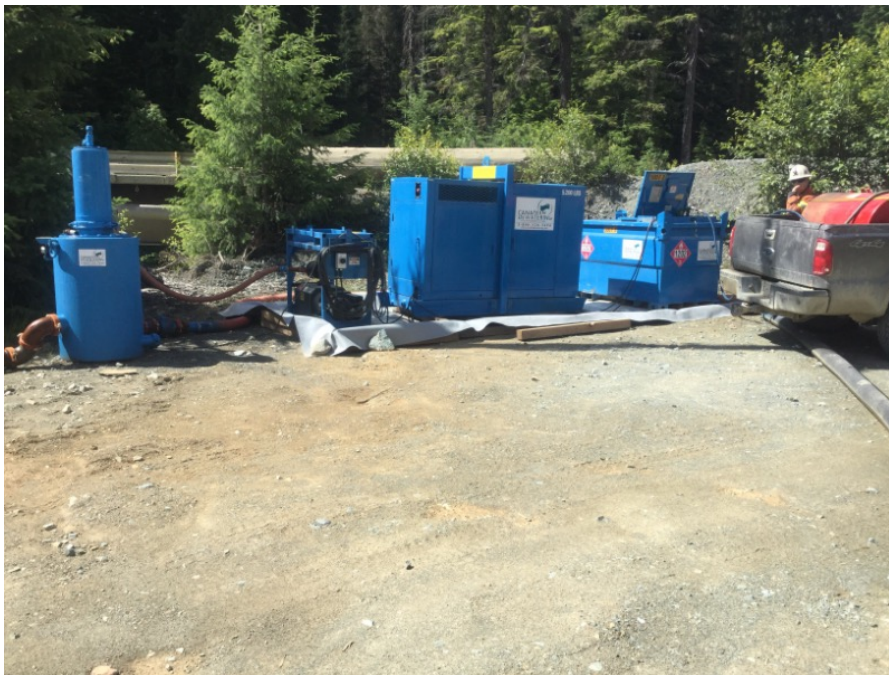
Photo 10: Vacuum pump system

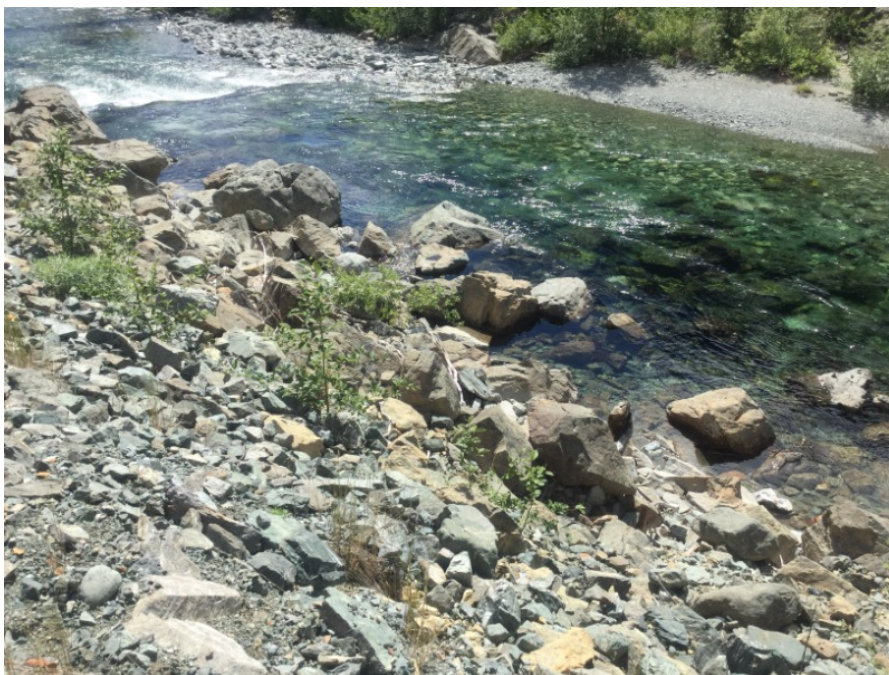
Photo 11: Seepage area in Myra creek

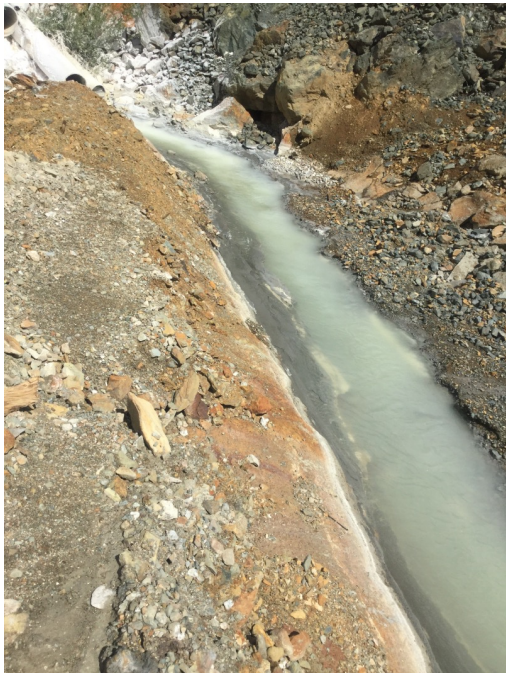
Incomplete mixing of lime was observed along the inlet ditch that flows to the Superpond (Photo 12). Ms. Pesonen indicated that plans for drop structures and baffles are being considered to improve passive mixing of lime along the ditch. At the Superpond, four of the six lime agitators were in operation while the two inoperative agitators were in the same series (Photo 13). Ms. Pesonen indicated that scaling buildup on the agitator rods often caused breakdown and frequent repairs are required.

Photo 12: Lime addition and settling in Superpond inlet ditch.

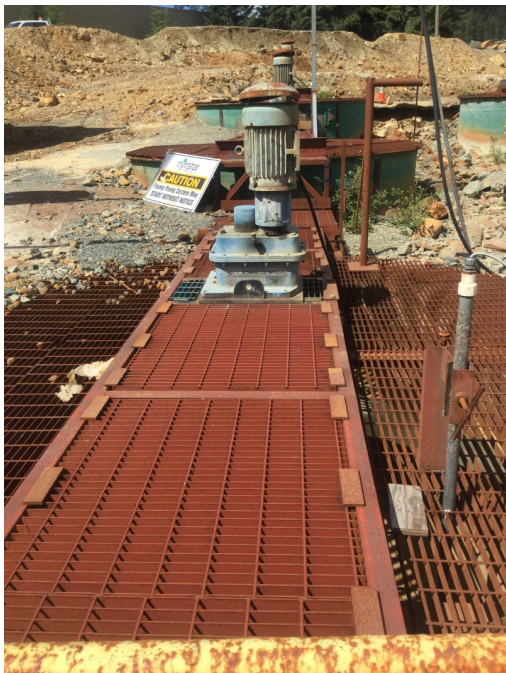
Only four of the six lime agitators at the inflow of the Superpond were operating at the time of the inspection. As per inspection Order 1 from the October 25, 2017 geoscience inspection (#81262), all six agitators must be operating to ensure contact water is being effectively treated.

Photo 13: Lime agitators.

The Mine Manager shall ensure that all agitators are functioning and implement a maintenance and repair plan to ensure proper operation. Until passive mixing systems are installed and demonstrated to be effective to the satisfaction of the Chief Inspector, all agitators must remain in operation.

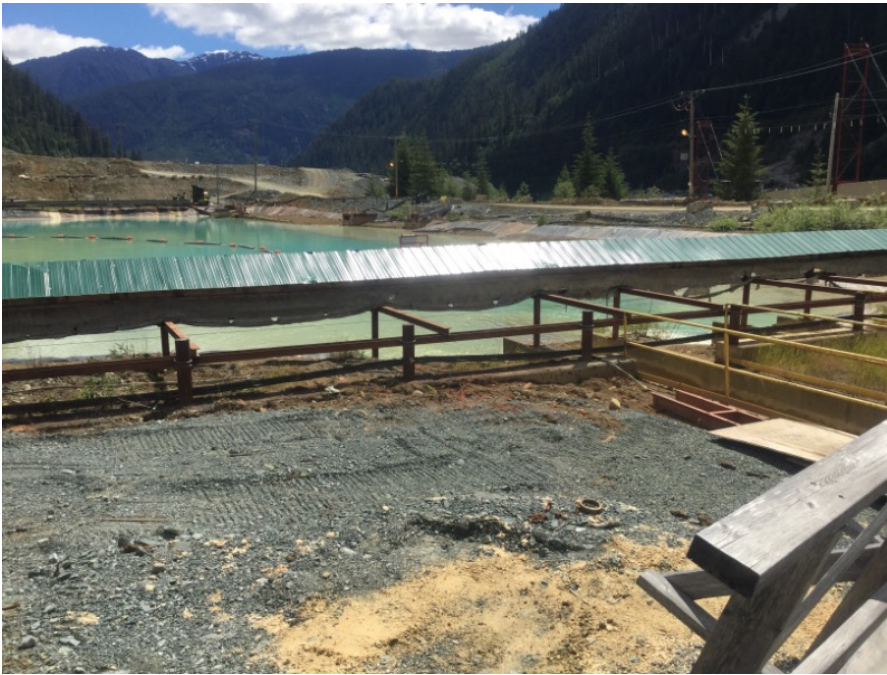
The new dredge system was observed in the Superpond (Photo 14). Ms. Pesonen indicated that the new

dredge had improved efficiency because the system has a built in agitator and reaches the bottom of the pond. Sludge is currently placed in the Tailings Disposal Facility, but is ultimately planned to be stored underground once the Operations Phase commences.

Photo 14: Superpond and dredge.

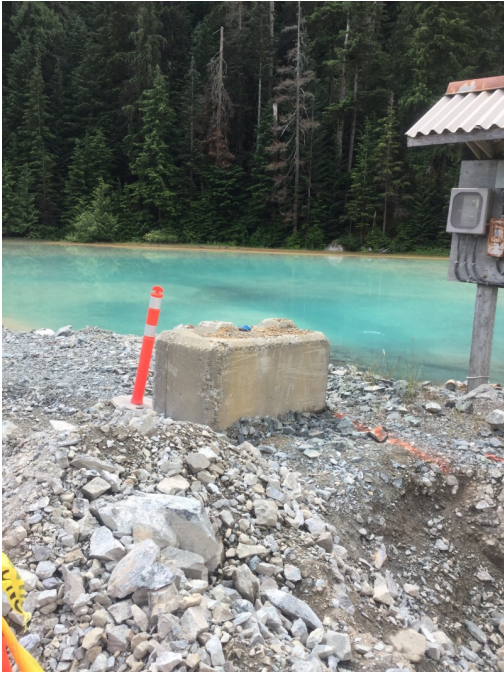
Sediment buildup was observed in Ponds 1, 2, and 2a (Photo 15). Repair work is planned in these ponds for 2018, including dredging, repair of wooden decant structures, and replacement of the pipe from Pond 1 to re-establish flow to Pond 2a. Ms. Pesonen indicated that with installation of the new dredge in the Superpond, the treatment ponds should not require dredging again in the future.

Photo 15: Treatment Pond 1.

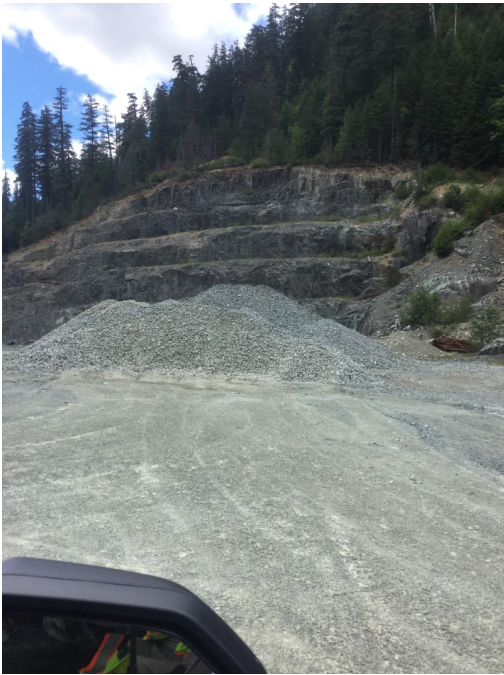
Ms. Pesonen indicated that Mines Act permit amendment application will be prepared for expansion of the quarry area (Photo 16). A tree count has been submitted to BC Parks and once this has been reviewed, a Mines Act permit amendment application will be prepared and submitted to the Chief Inspector of Mines. Expansion will comprise a new borrow area to the east of the existing quarry (Photo 17).

Photo 16: Current borrow area.

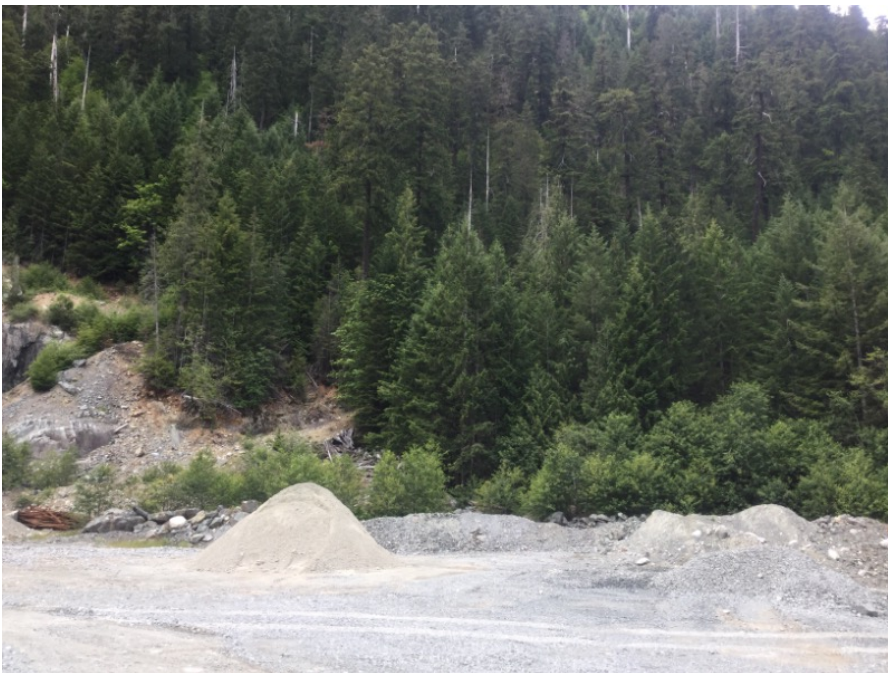
Photo 17: Expansion area of the quarry.

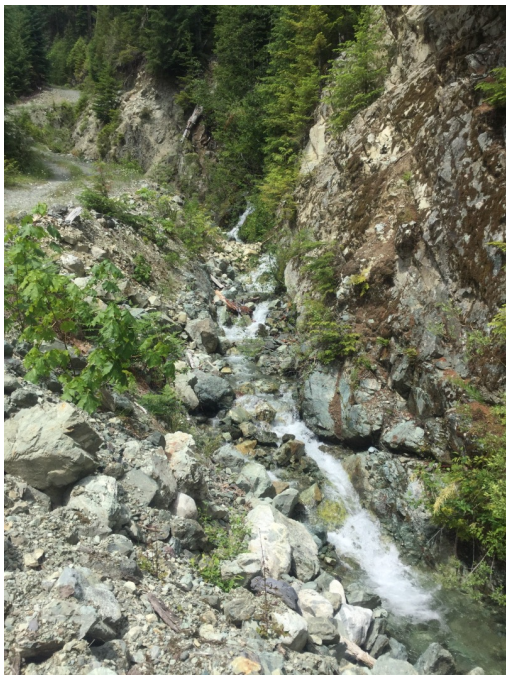
The Upper Lynx Diversion Ditch redirects three permanent creeks and several ephemeral creeks to Cascade Creek, then to the Lower Diversion Ditch (Photo 18). The Upper Lynx Diversion Ditch is sized to a 1 in 50 year event and Ms. Pesonen indicated there is no space to build a larger ditch in the current ditch location. Ms. Pesonen indicated that there is a plan to replace the ditch during removal of the waste rock dumps below, and the new ditch would be sized for a larger event to meet closure objectives.

Photo 18: Upper Lynx Diversion Ditch.
