Province of British Columbia  
MINISTRY OF ENERGY, MINES AND  
PETROLEUM RESOURCES

Report of Inspector of Mines

Geotechnical

Inspection No.: 91561  
Mine No.: 0800007  
Permit No.: M-26  
Total Orders: 2

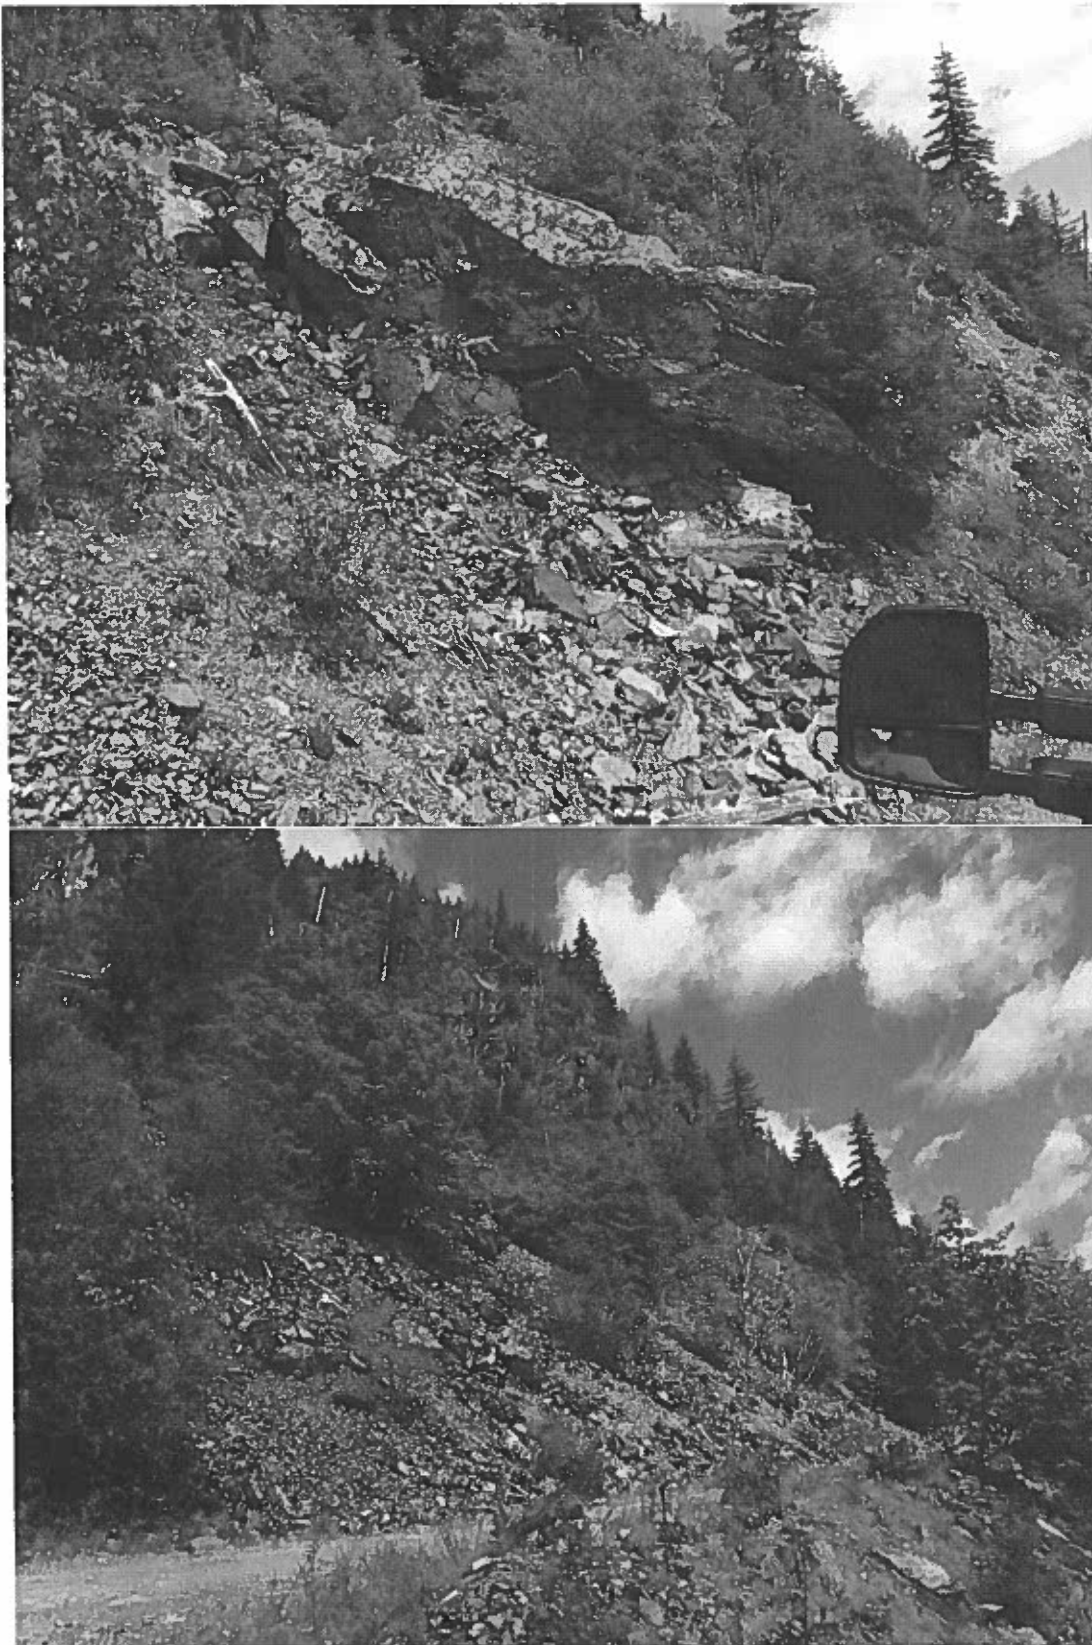
The Price Access Road was investigated by vehicle. Numerous areas were noted where scaling may reduce the rock fall hazard along the access road. Further, there were areas noted where a large volume of fallen material had been side cast below the road prism and was resting on alder trees. This poses a risk as the road switchbacks immediately below the perched rocks and is to be rectified as part of the road upgrades. Photo 1 shows the current state of the Price Access Road.

**Photo 1: Debris and rock blocks upslope of Price Access Road**

- The mine is to seek guidance on rock scaling as part of the road upgrades in the Price Area.
- The use of the road in high precipitation and high antecedent precipitation is to be considered by the mine in terms of risk management.
- The use of the road during winter snowfall with associated avalanche risk is to be considered.

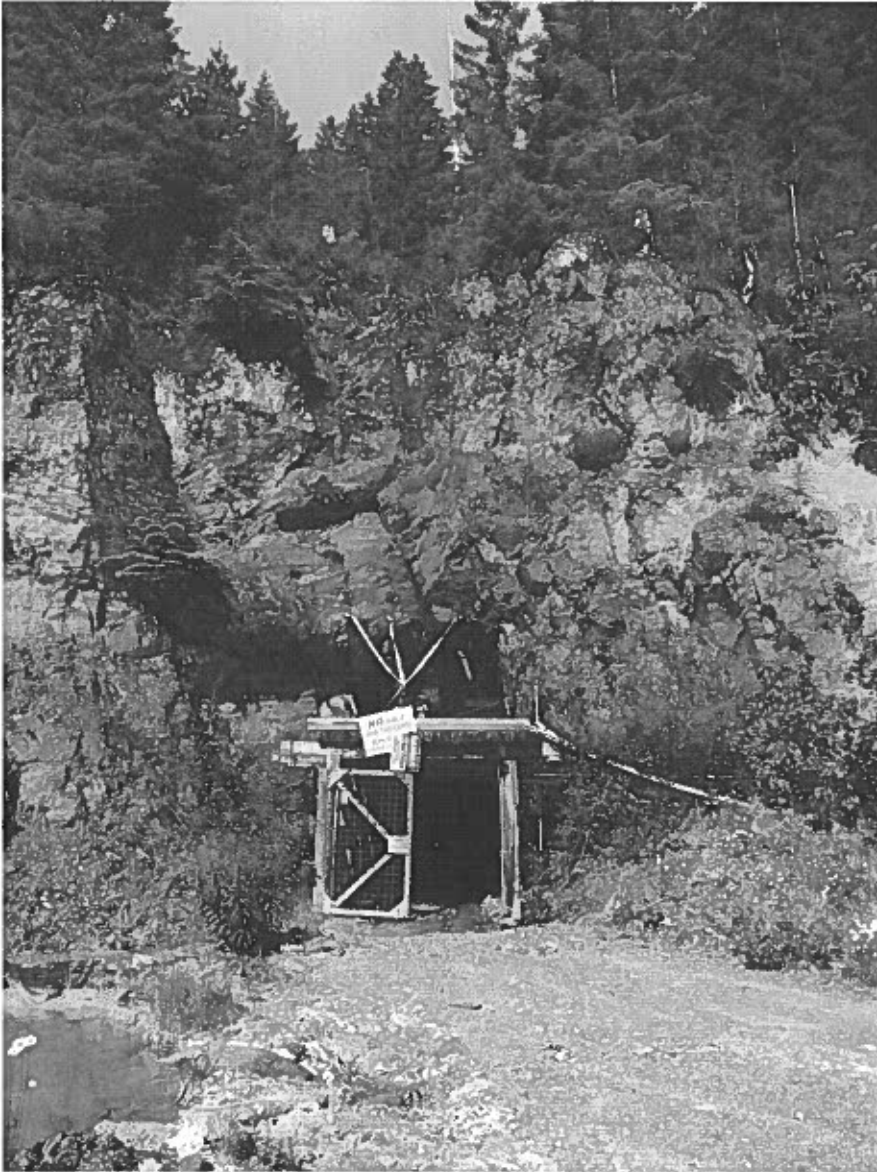
The Price 4 Portal is the upper portion of the Price mine and is accessed by road. The Price 4 portal was caged off to prevent unauthorized human ingress. Straps were supporting the overhanging rock nose above the portal entryway (Photo 2).

The headcover of the portal has yet to be rehabilitated from previous mining and will need completed prior to commencement of mining activity. The Mine is allowed to perform the rehabilitation work of the portal head cover prior to granting the mine permit provided that suitable road upgrades have been performed such that equipment can travel safely on the Price Access Road.

**Photo 2: Price 4 Portal**

**Advisory 2:** The Mine shall submit a "Notice of Work" to the Chief Inspector for approval prior to commencing portal headcover/area rehabilitation.

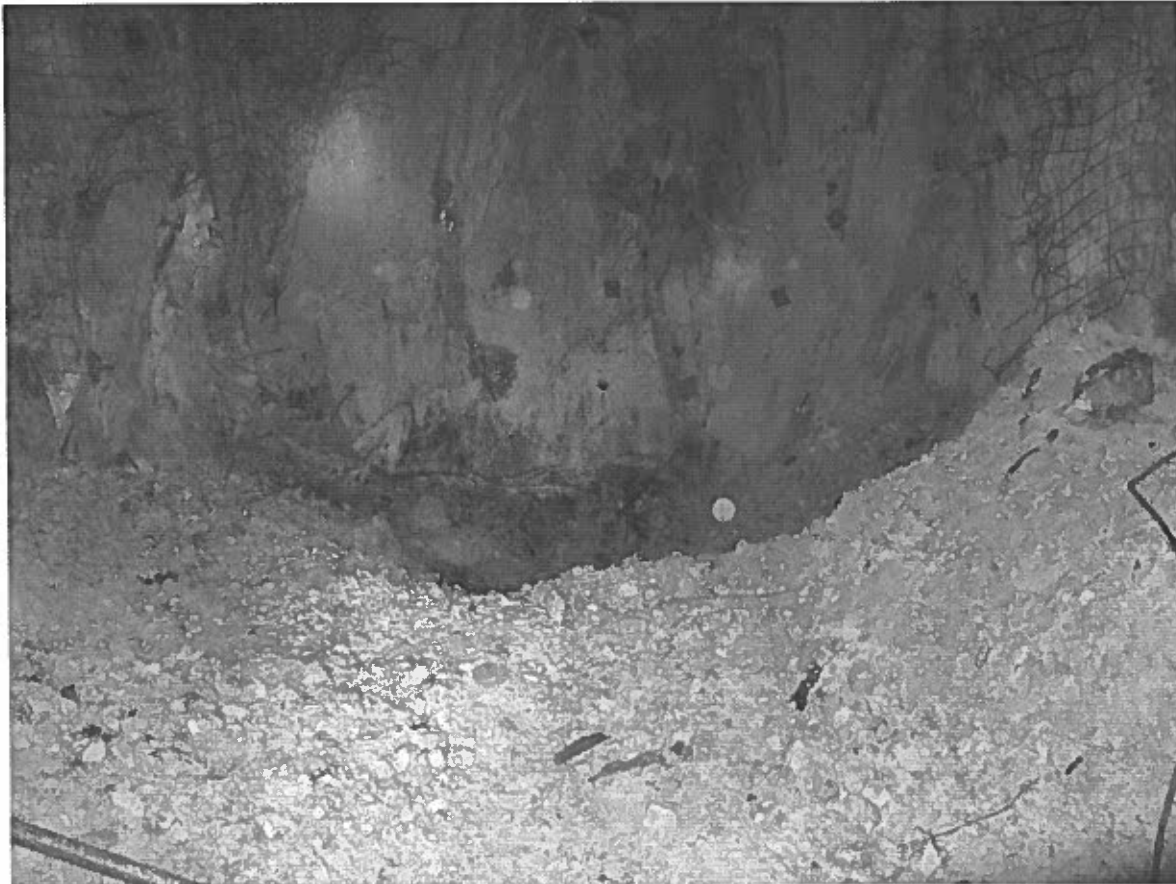
The Ore Pass that connects Price 4 and Price 5 to Price 13 Level is currently blocked. The mine has previously attempted to unplug the ore pass. It is understood that a first attempt to unplug the ore pass consisted of blasting on top of the ore pass in the Price 4 Portal (top of ore pass shown in Photo 3). The second attempt was performed recently and was unsuccessful. The recent work to unplug the ore pass is discussed further in the following section on Price 5.

Mine personnel have determined from back calculations that the ore pass plug is likely between the top of the Price 4 portal and likely 15 m below the connection between the Price 5 finger and the main chute. Based on this estimate, the Mine is proposing the drill fan holes from the main Price 5 access to 1) delineate the extents of the plug in the ore pass and 2) to provide an adequate location within the plug to detonate a charge to unplug the pass.

**Photo 3: Price 4 Plugged Ore Pass**

**Advisory 3:** No further work towards unplugging the Price ore pass is to proceed until a "Notice of Work" is approved by the regional Health and Safety Inspectors that includes, but not limited to, the full scope of the work, the equipment necessary, plan and section views of the proposed work, estimate of location of ore plug based on volume calculations, estimated amount of explosives required, safety procedures in place on Price 4, Price 5 and Price 13, location of primary and secondary egress, and the number of personnel required to complete the task.

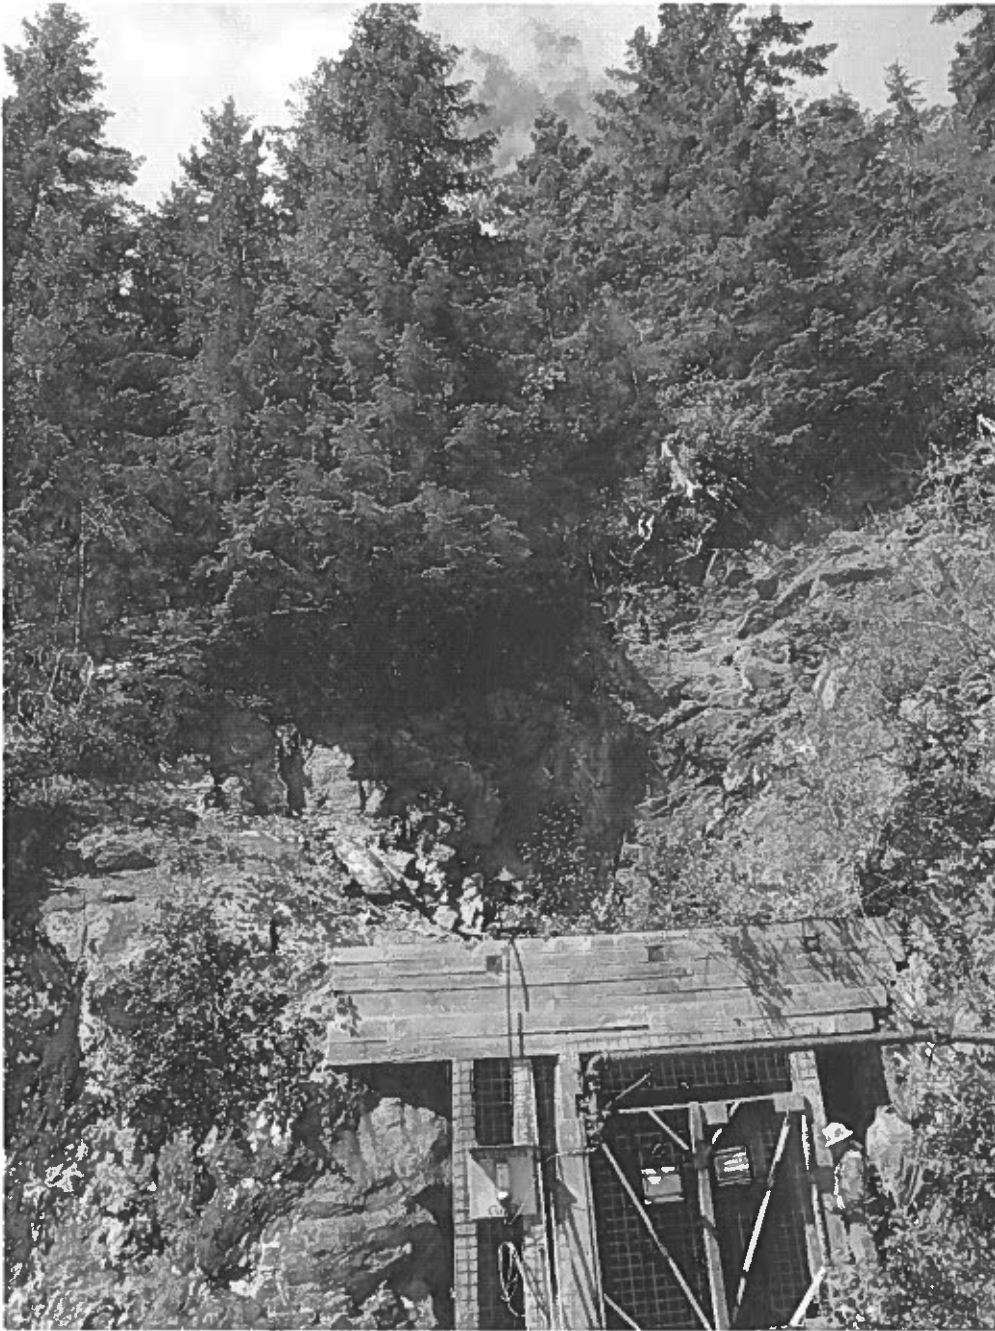
The portal (as shown in Photo 4) has not been rehabilitated for current mining. The Mine is allowed to perform the rehabilitation work of the portal head cover prior to granting the mine permit provided that the suitable road upgrades have been performed such that equipment can travel safely on the Price Access Road. The scope of the work is to be provided to Mine Inspector as "Notice of Work" for approval prior to commencement of the activity (see Advisory 2 above).

**Photo 4: Price 5 Portal**

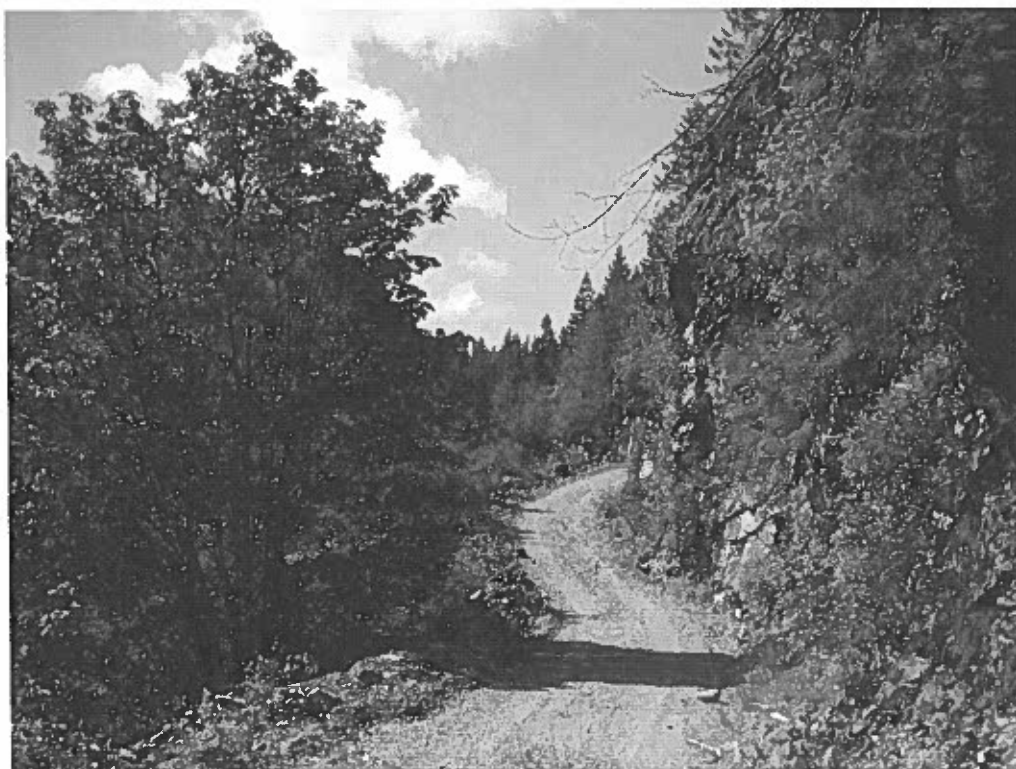
The Price 5 Portal provides access to the majority of future ore within the Price Mine. The Price 5 portal was secured with a steel grid to prevent unauthorized human ingress. The area above the portal has some loose rock and overhanging trees/debris (Photo 4). A small filtering pond is located outside the portal, which discharges via a drillhole to lower elevation mine workings (Price 13). The portal area is accessed by a narrow road in steep terrain, with adjacent vertical to overhanging rock slopes and small grader berms (Photo 5). Outside the portal is a platform created by historical mine waste dumps and timber supports (Photo 6); berms were not evident around the entirety of the platform area.

The area outside the Price 5 portal does not restrict access to the steep waste dump slope drop-offs, potentially posing a hazard to personnel and equipment utilizing this area.

**Photo 5: Price 5 Portal Area**

Pursuant to Code clause 1.1.2, the Mine Manager shall put in place measures to restrict access to the steep slopes at the edge of the Price 5 portal. This order is to be completed prior to July 31, 2018 or before mining commences in the area, whichever comes first. The order will be considered satisfied upon submittal of a memorandum with photographic evidence written by a Qualified Person.

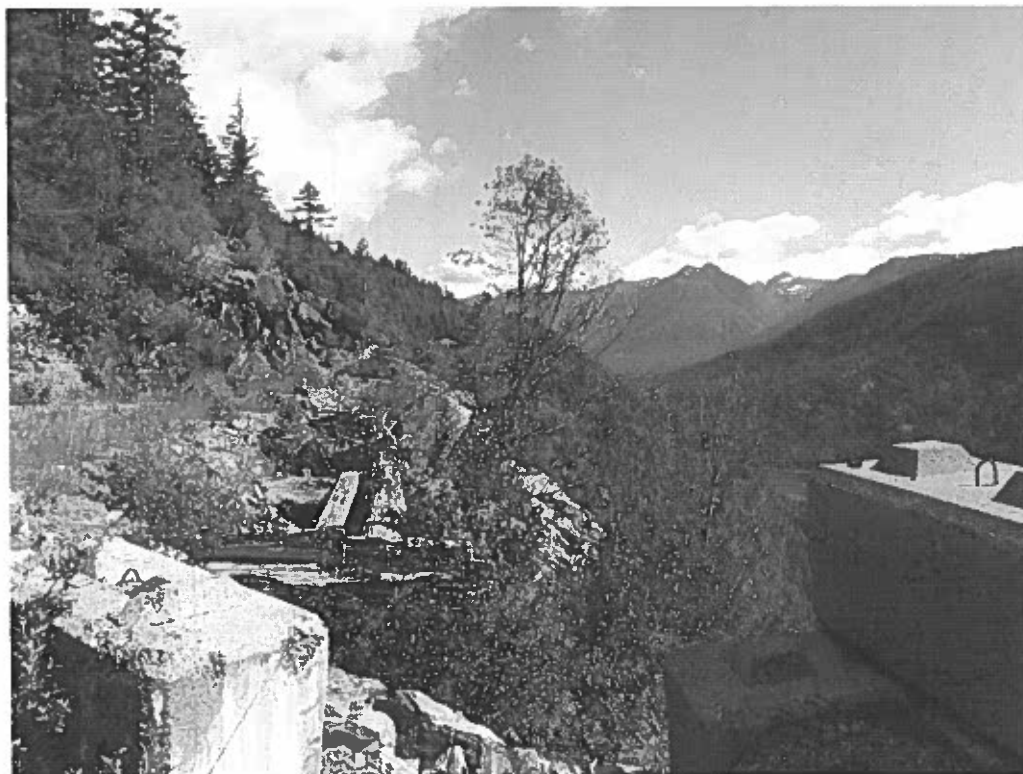
**Photo 6: Price 5 Portal Area**

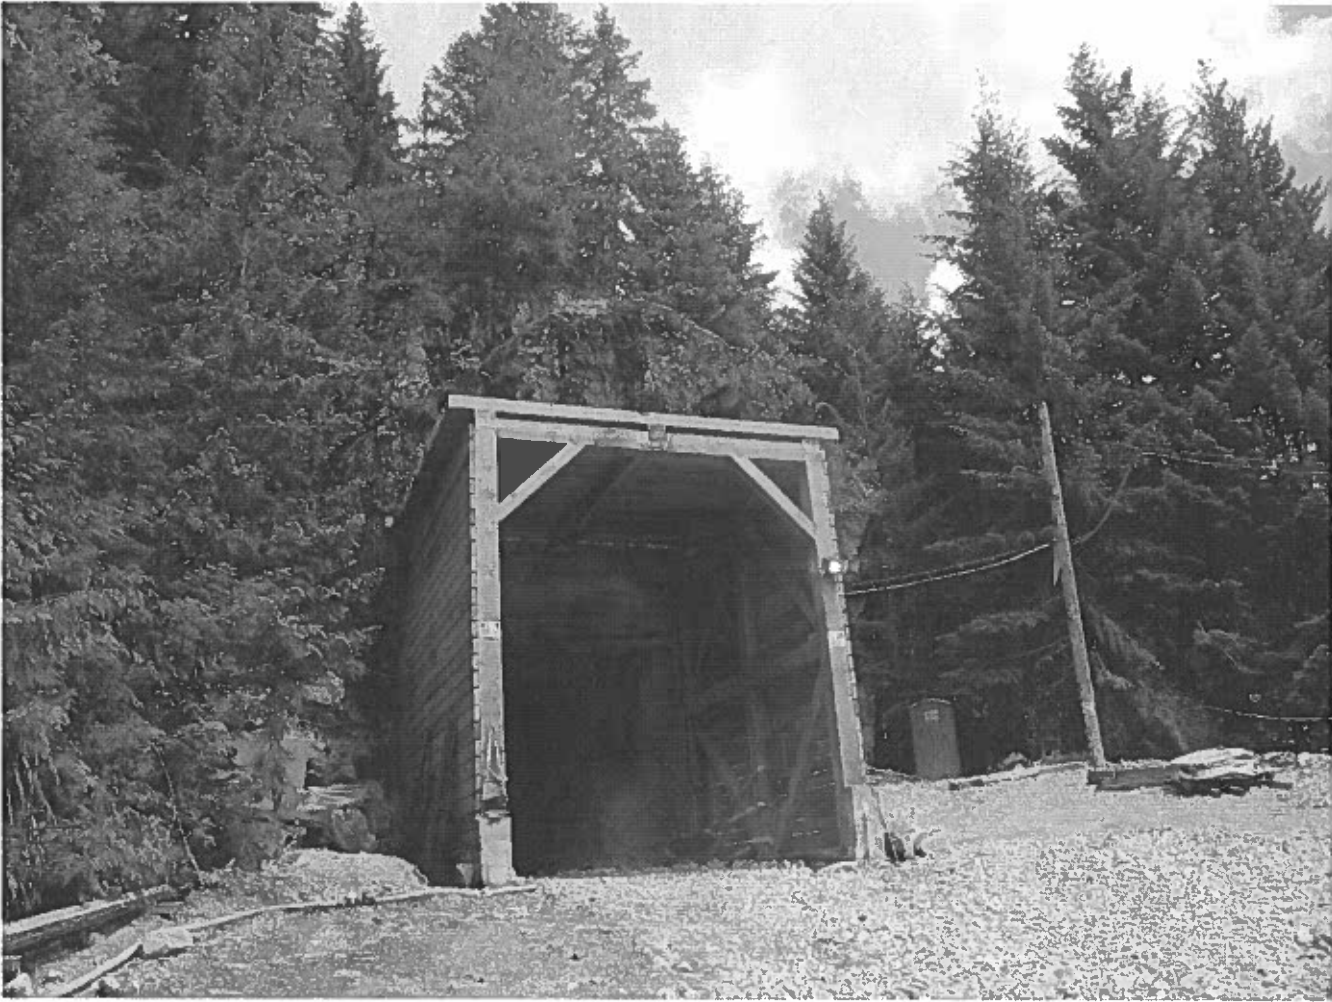
It is understood that the Lynx Portal will be the first ore body mined upon restart. As part of the Geotechnical Inspection of January 18, 2018, an Inspection order regarding the construction of a head cover at the portal was to be completed. Photo 6 is evidence that this order has been completed.

**Photo 6: Lynx 6 Portal Headcover**

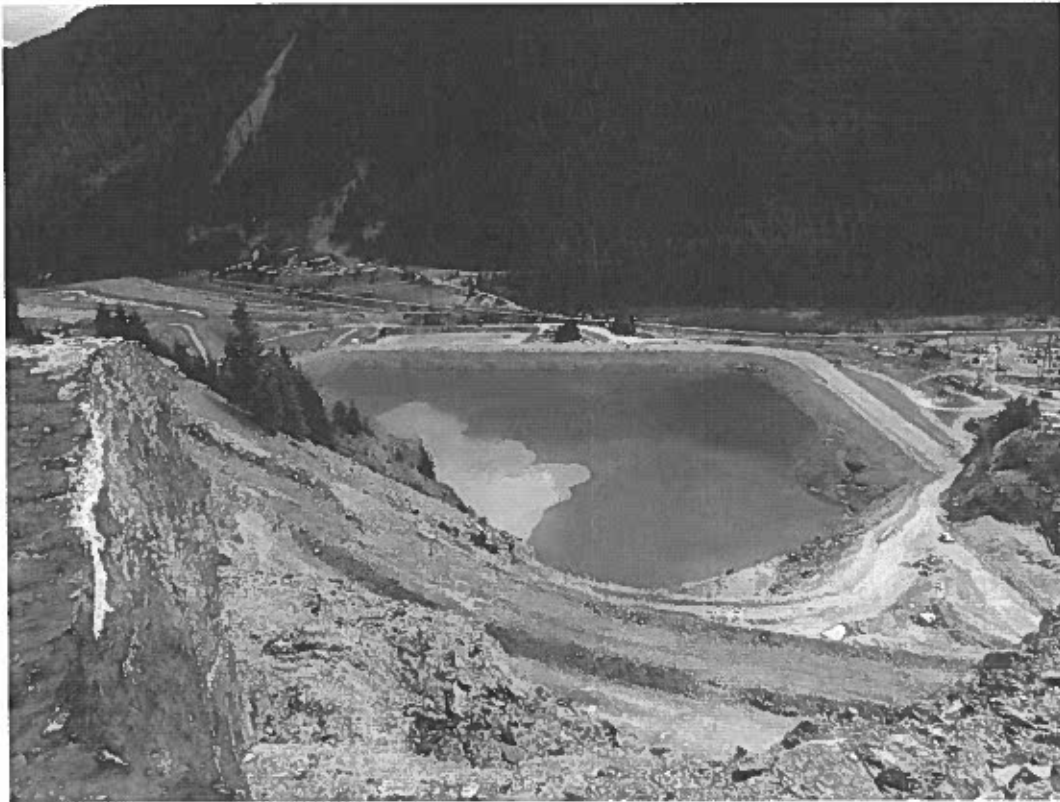
At the time of inspection the Lynx TDF appeared to be in much the same condition as was observed in January 2018. No recent construction works were evident. A plume of sediment was observed in the TDF impoundment, which Nyrstar advised was arising from deposition of dredgeate (Photo 8). Nyrstar advised that they would soon be installing survey monuments on the TDF crest. Nyrstar advised that planning is underway, in consultation with the TDF Engineer-of-Record, to investigate a prior observation of deleterious materials in the starter dam materials.

**Photo 8: Lynx TDF**

**Advisory 6:** Per Code clause 10.5.1, the Mine should prepare a plan to investigate and remediate the observation of deleterious material within the Lynx TDF, signed and sealed by the Lynx TDF EoR. This document should include sufficient plans and sections to explain any excavations required and should be submitted to the Chief Inspector for approval prior to commencing investigation or remedial works.

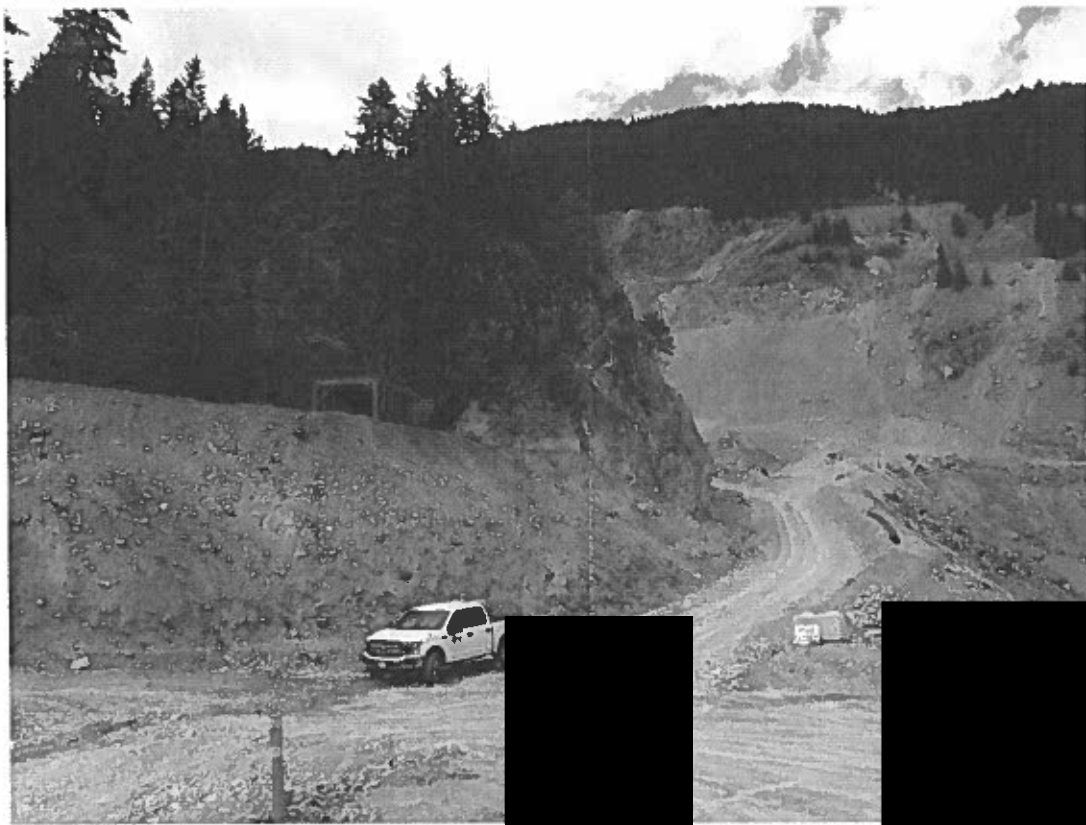
During excavation of the haul route to the ore chute, a historical portal was found along the alignment of the Lynx TDF (Photo 9). The rock exposed in this area also includes some open joints and blocky structure (Photo 10). Nyrstar advised that engineering design work on the dam abutment, including a portal plug, will occur this year.

**Photo 9: Portal in Lynx TDF Dam Abutment**

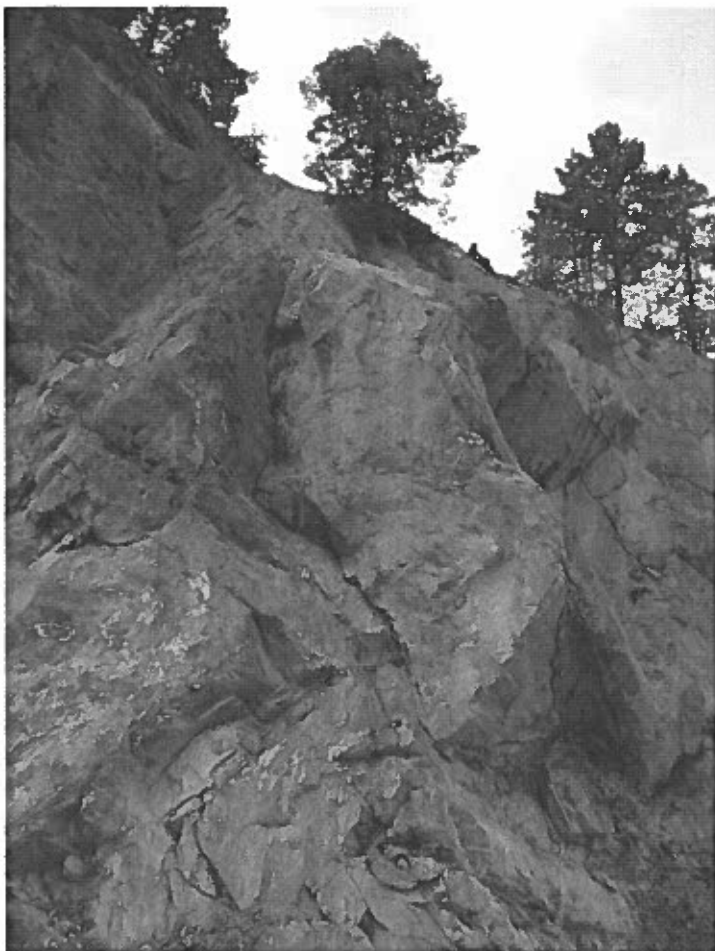
The rock slope above the Lynx TDF and new ore chute haul road contains open joints and blocks that appear to be potentially unstable.

**Photo 10: Open joint and blocky structure at ore chute haul road cut**

Pursuant to Code clause 1.9.1, the Mine Manager shall have a Professional Engineer assess the rock slope for stability and implement mitigative measures. A report documenting this assessment and the implemented mitigative measures shall be submitted to the Chief Inspector by the date below or prior to usage of the road for haulage, whichever is earlier.

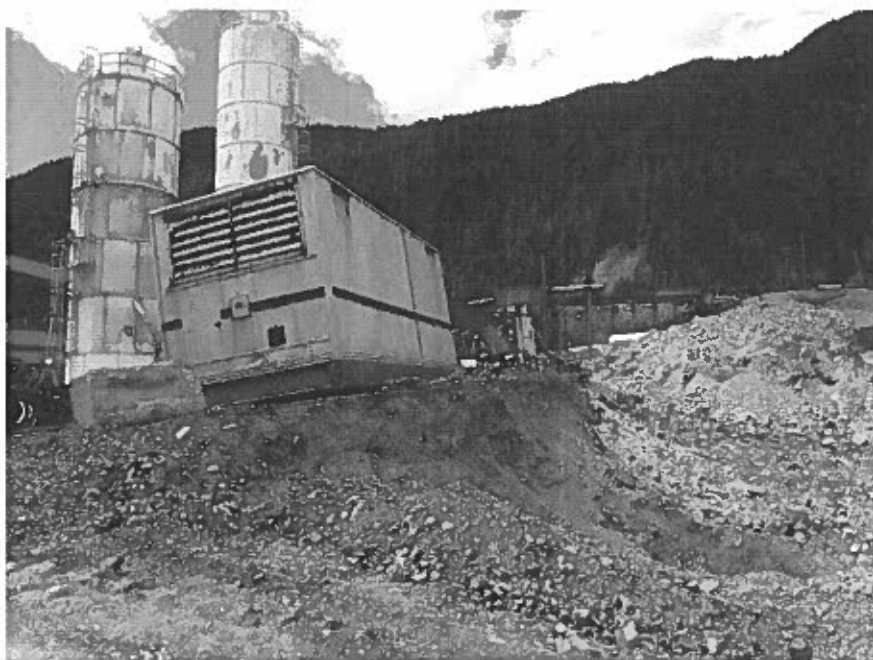
Several small excavations were observed downstream of the Lynx TDF, which Nyrstar advised were due to use of materials for mill testing. Some excavations appeared to be undercutting infrastructure (Photo 11).

**Photo 11: Excavation in area downstream of Lynx TDF**

**Advisory 5:** EMPR advises that the Mine assess the potential for the small excavations downstream of the Lynx TDF to impact nearby infrastructure and implement remedial actions if required.

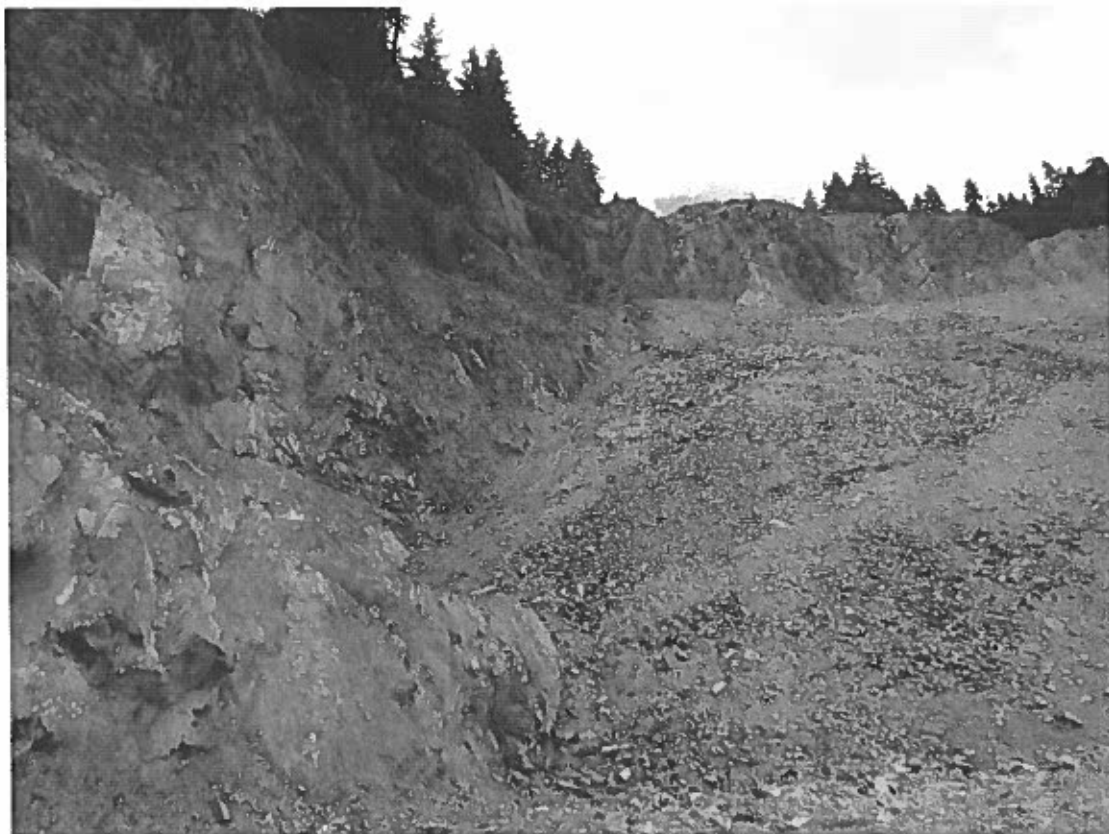
The proposed alignment/location of the ore/waste chute connecting the Lynx 6 portal with the mill runs over very steep ground comprising areas of both natural ground and historic waste rock dumps. Onsite Engineering representatives outlined the work completed to date. Work on preparing the alignment had begun; resloping of the lower Waste Dump 3 slopes was partially complete, the haul road alignment had been established, rock scaling on exposed slopes had been completed, and mesh had been installed on the upper rock slope (Photo 12). Waste materials already removed were hauled to the TDF and to Waste Dump 6. Onsite described how the next phases of work would be executed; in general:

**Photo 12: Waste Dump 3 in ore chute area**
