**MINISTRY OF ENERGY, MINES AND PETROLEUM RESOURCES**  
Mines and Mineral Resources Division

**REPORT OF GEOTECHNICAL INSPECTOR**  
(Issued pursuant to Section 15 of the Mines Act)

**Name of Property:** Myra Falls **Permit No.: M-26**

**Date of Inspection:** January 18, 2018

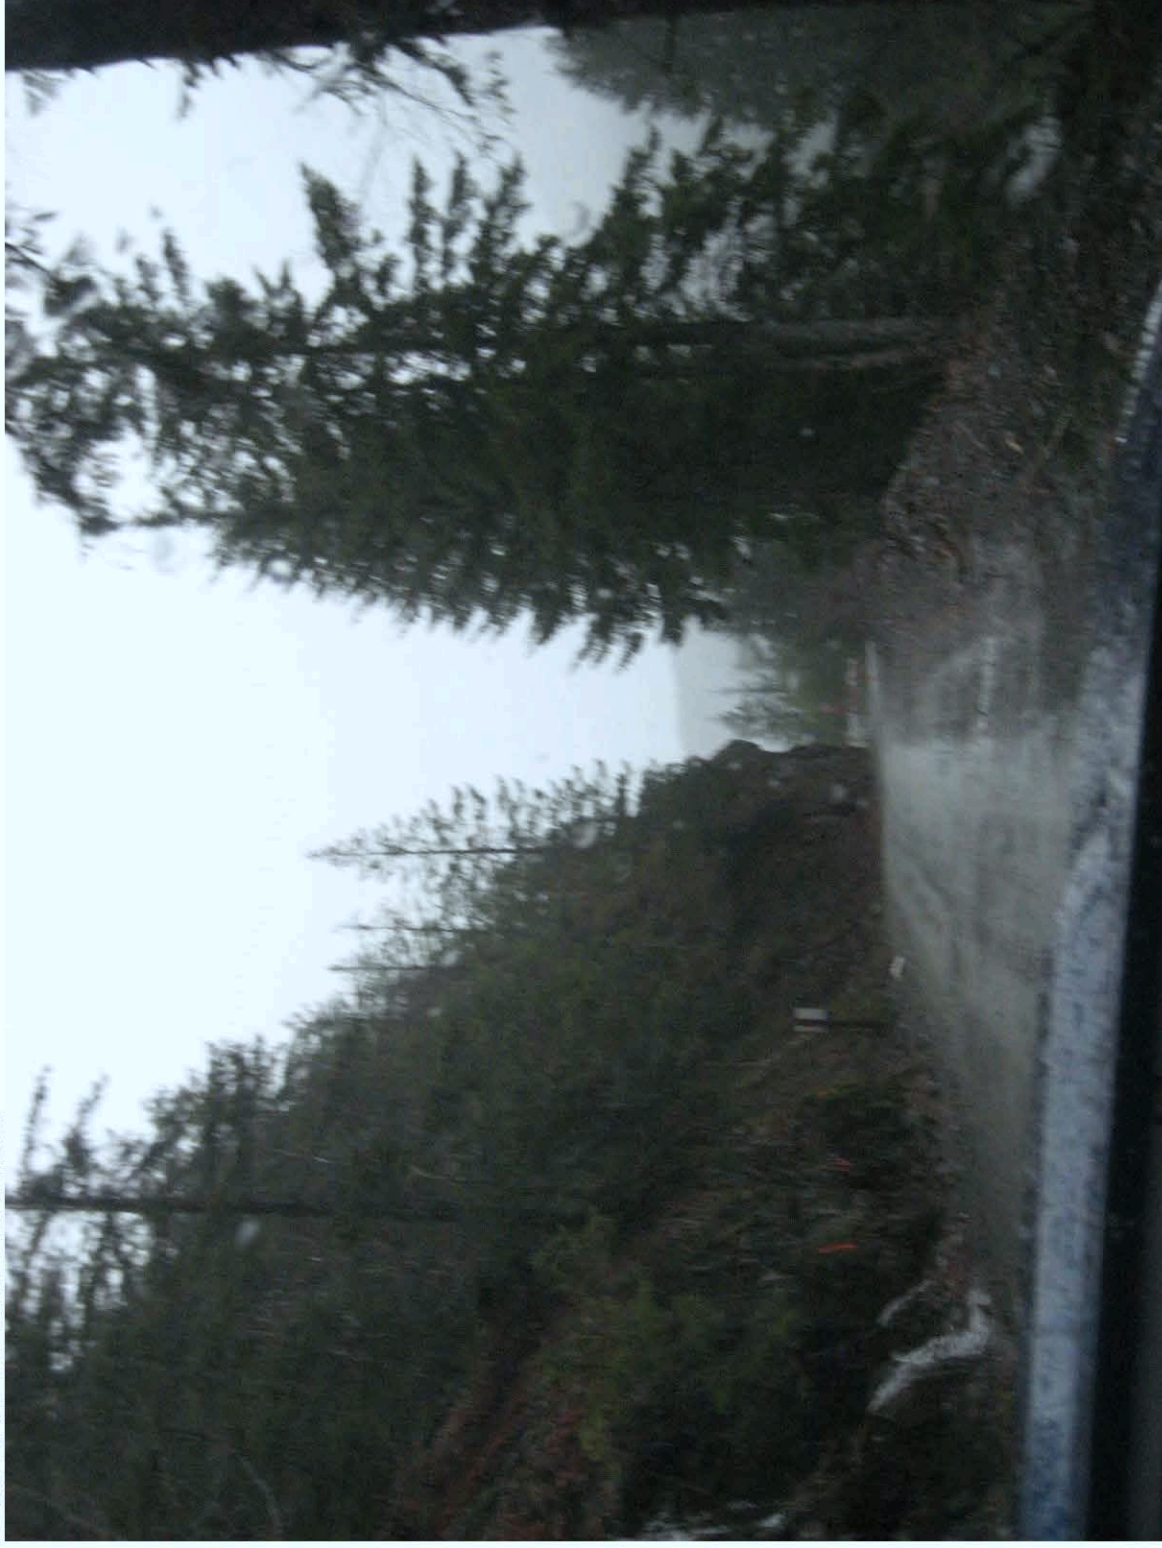
**Photo 1: Jim Mitchell Lake Road**

The Jim Mitchell Lake Road is a public road. It is generally located between the adjacent creek and rocky slopes, which have been locally blasted (Photo 1). Nyrstar is proposing to use this road for hauling ore and waste to the mill area. As such, proposed upgrades to the roadway to incorporate berms and provide the required haul road dimensions were presented in the *Mines Act* permit amendment application. Work completed to date includes routine maintenance and marking of blast/scaling areas for road upgrades. Nicole Pesonen (Nyrstar) noted that mine ore and waste hauling would use highway trucks, and would occur on one weeknight per week, with public access fully restricted during these times.

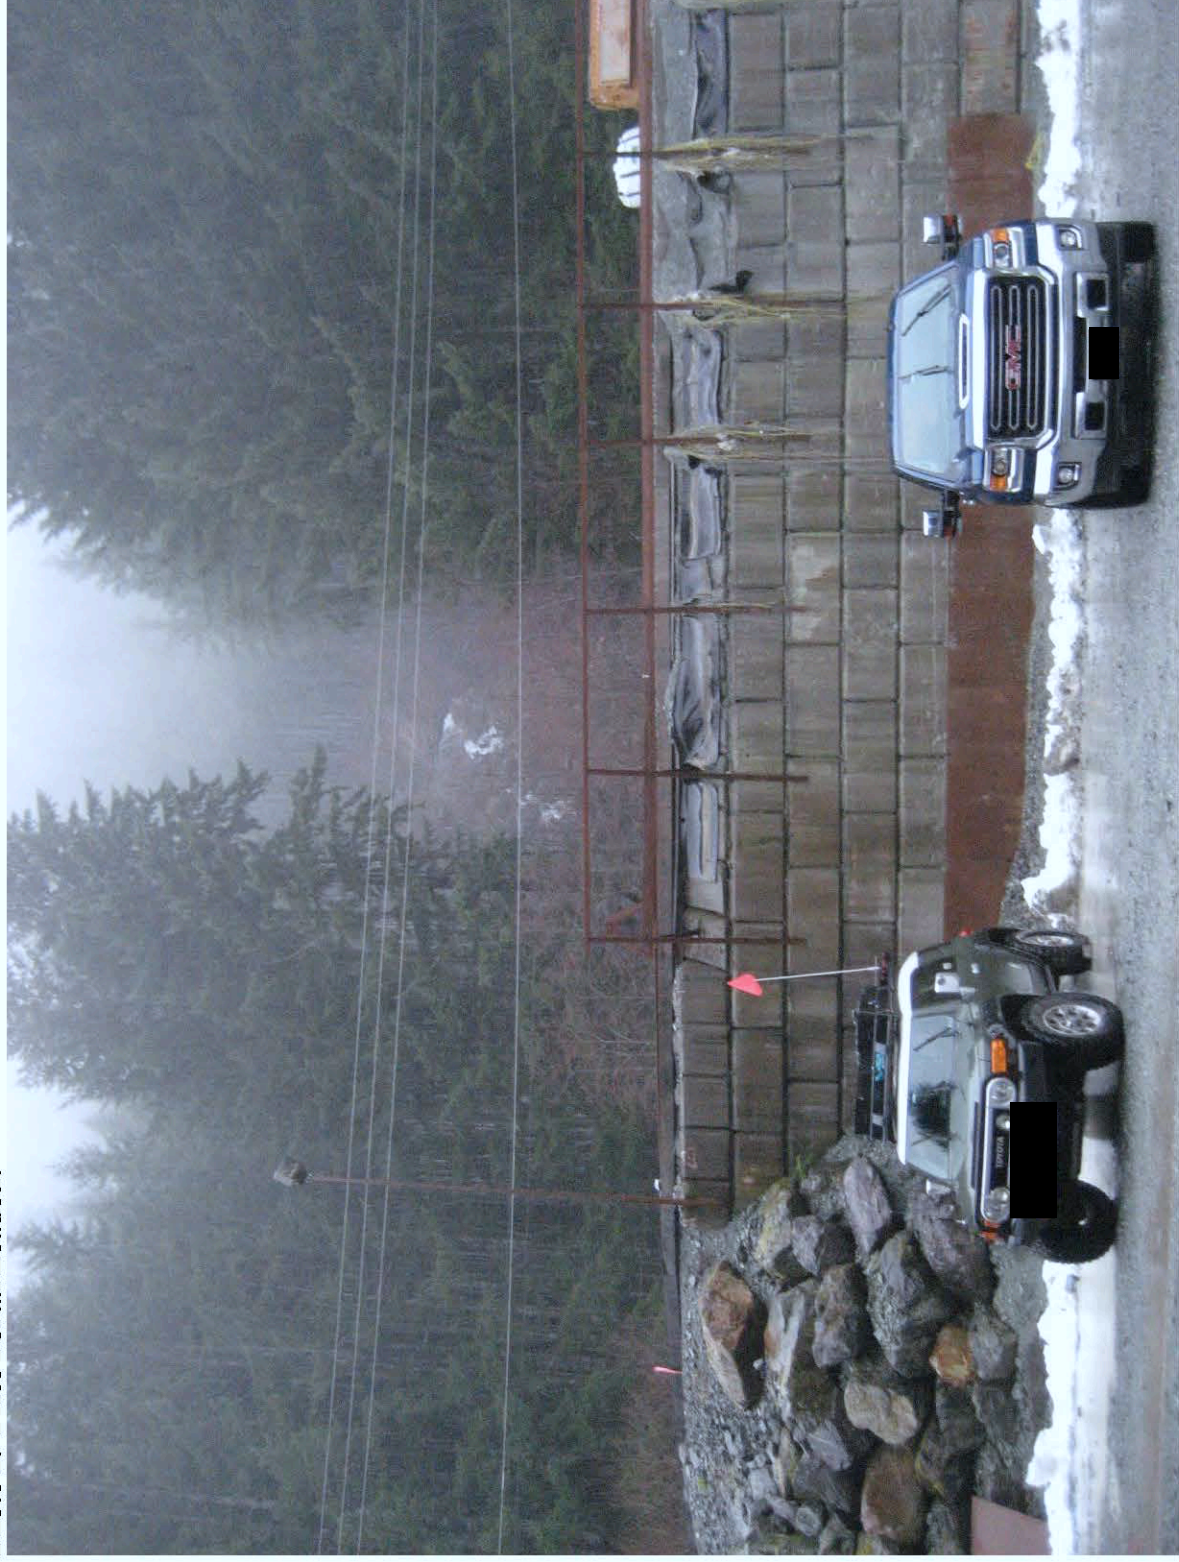
**Photo 2: Price Portal Loadout**

The Price Mine 13 Loadout Area (Photo 2) is located off the Jim Mitchell road, previously allowing railcars from the Price 13 portal to dump to a loadout area. The Nyrstar identified Polishing Pond 2 is located downstream of the loadout area. The proposed upgrades to this area include provision of a turn-around area for trucks, realignment/grading of the roadway, culvert upgrades, and provision of separation between the loadout area and the public road.

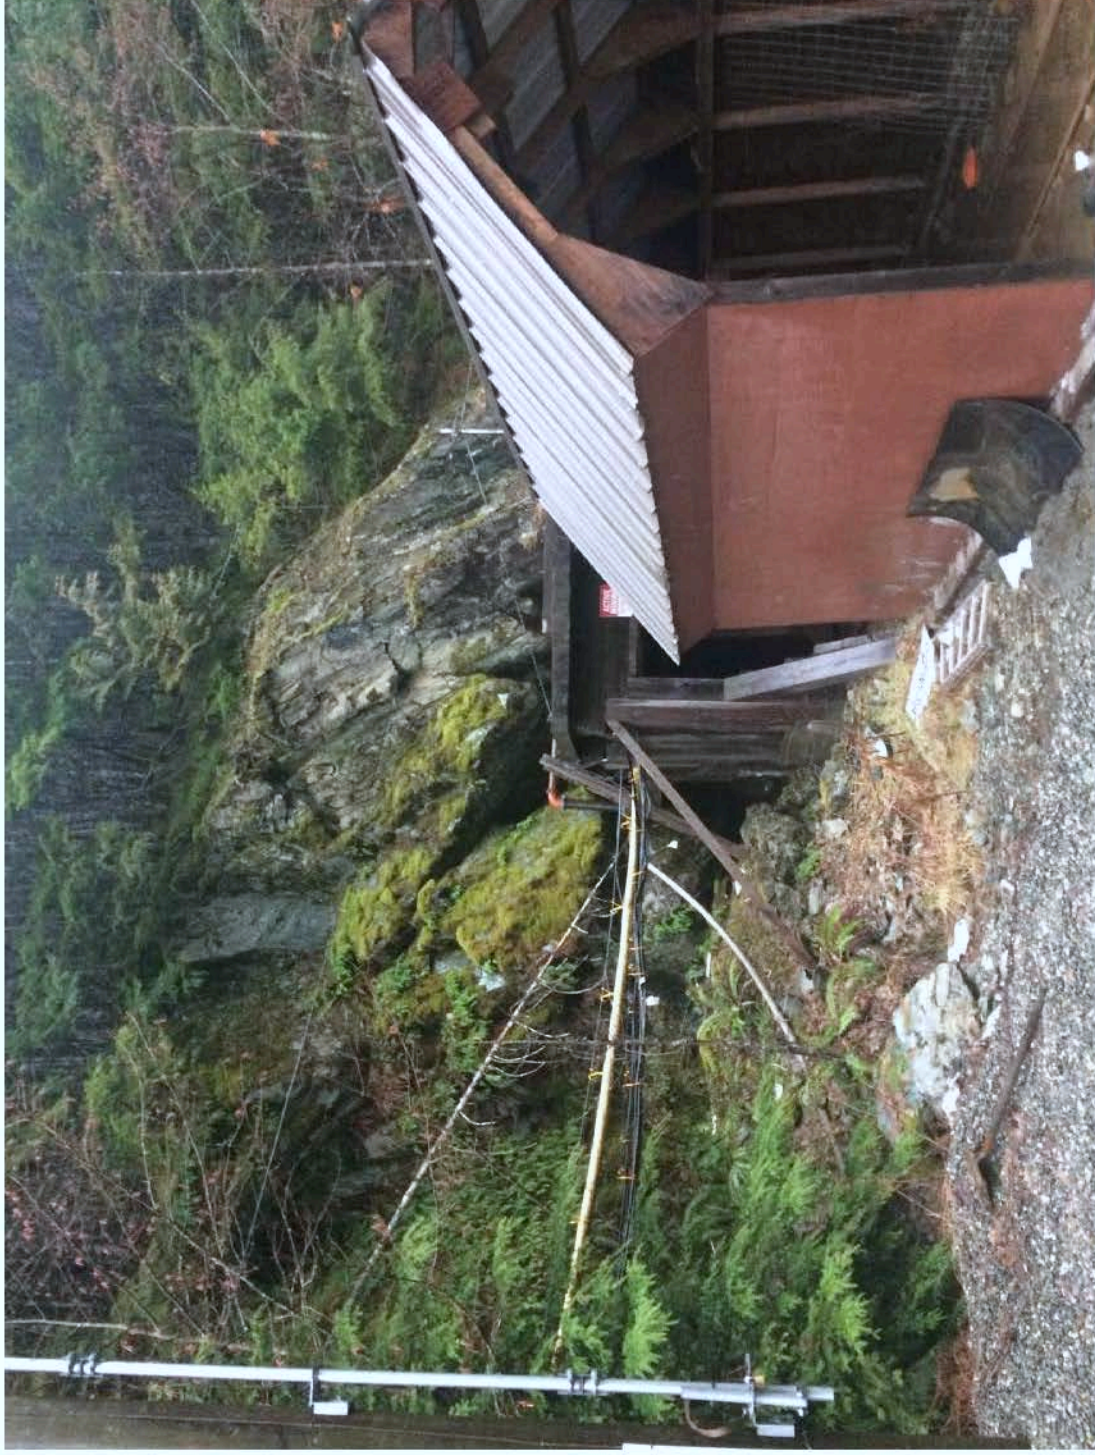
**Photo 3: Price Portal**

The Price Mine 13 Portal appeared secured against entry, and has an existing headcover structure. The slope above the portal appeared to be overhanging with a wedge block visible (Photo 3).

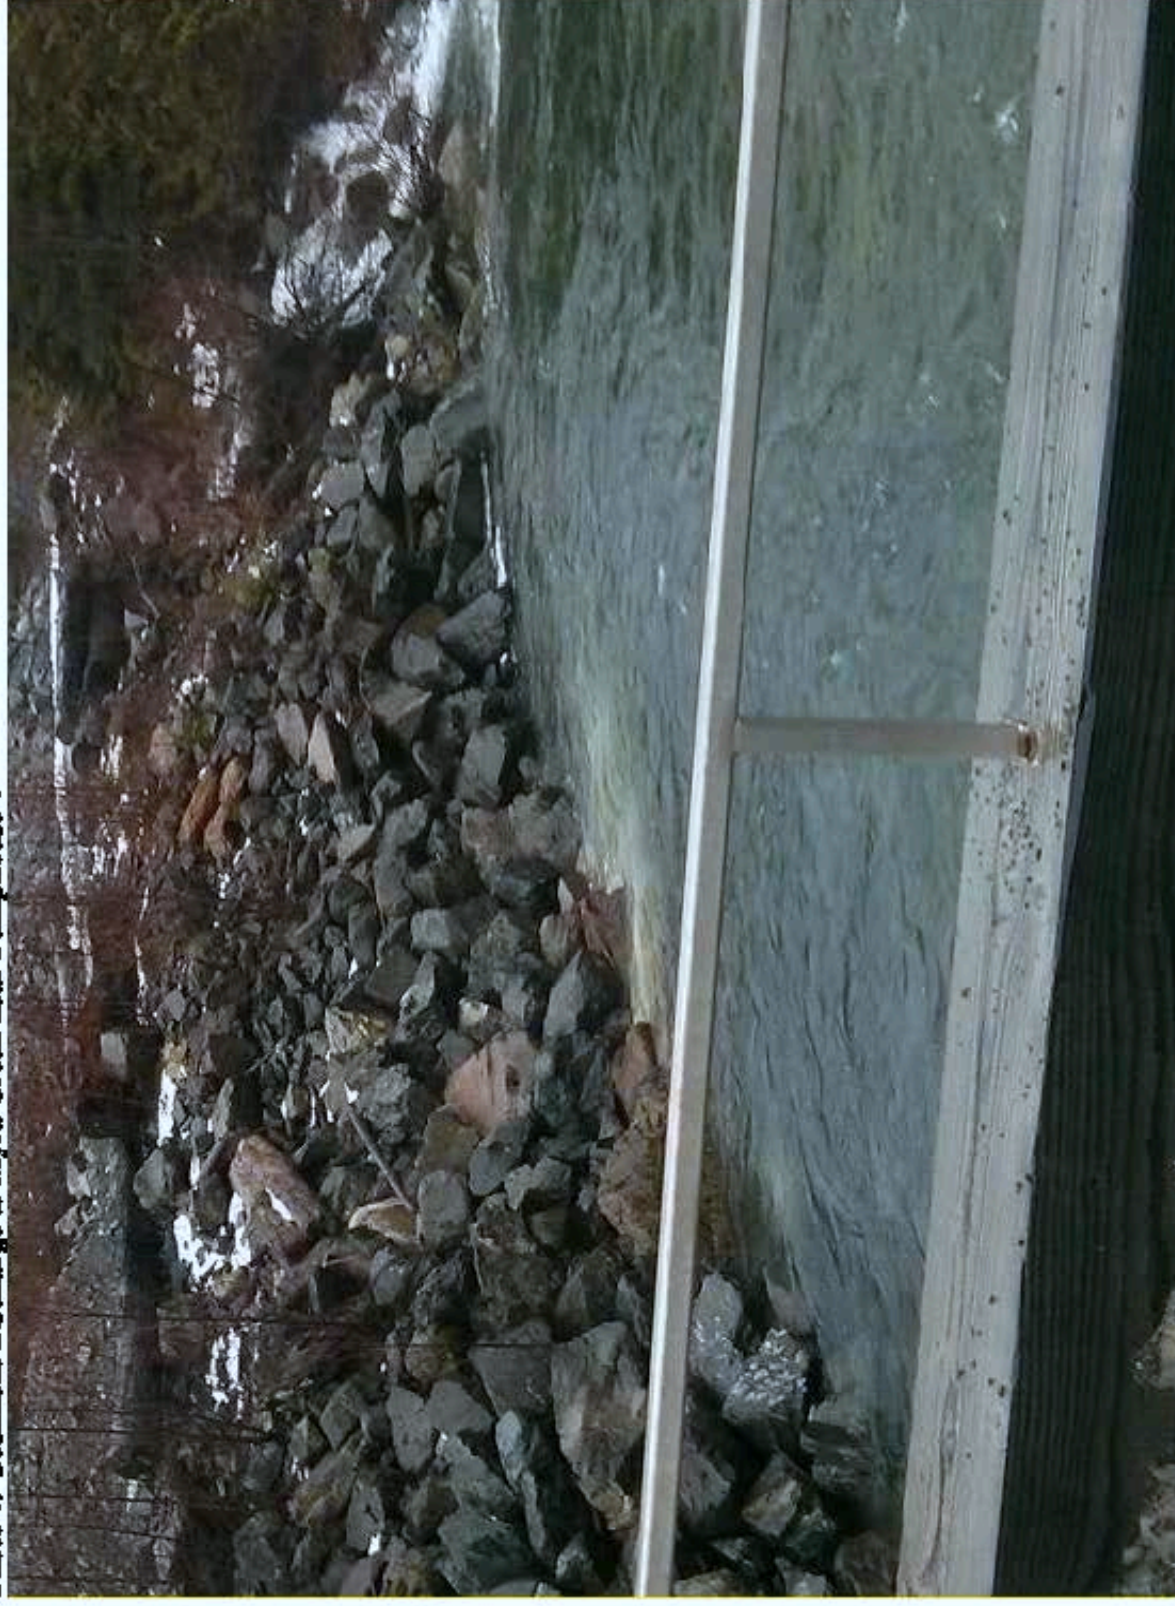
It was observed that several points of sediment-laden water were observed to be either entering Myra Creek or to have potential to enter Myra Creek. This includes flows off the South abutment of the bridge, ponding/flows near Pumphouse 4 (Photo 4), and ponding/flows near the end of the NAG Quarry road. An Inspection Order was previously issued with respect to erosion control and management of sediment laden waters (Site Inspection dated October 25, 2017 Inspection Order 1). At that time Nyrstar committed to redirection of sediment laden waters away from the creek immediately, and provision of an Operation Erosion Control Plan on March 31, 2018.

**Photo 4: Sediment Discharge to Myra Creek near Pumphouse 4**

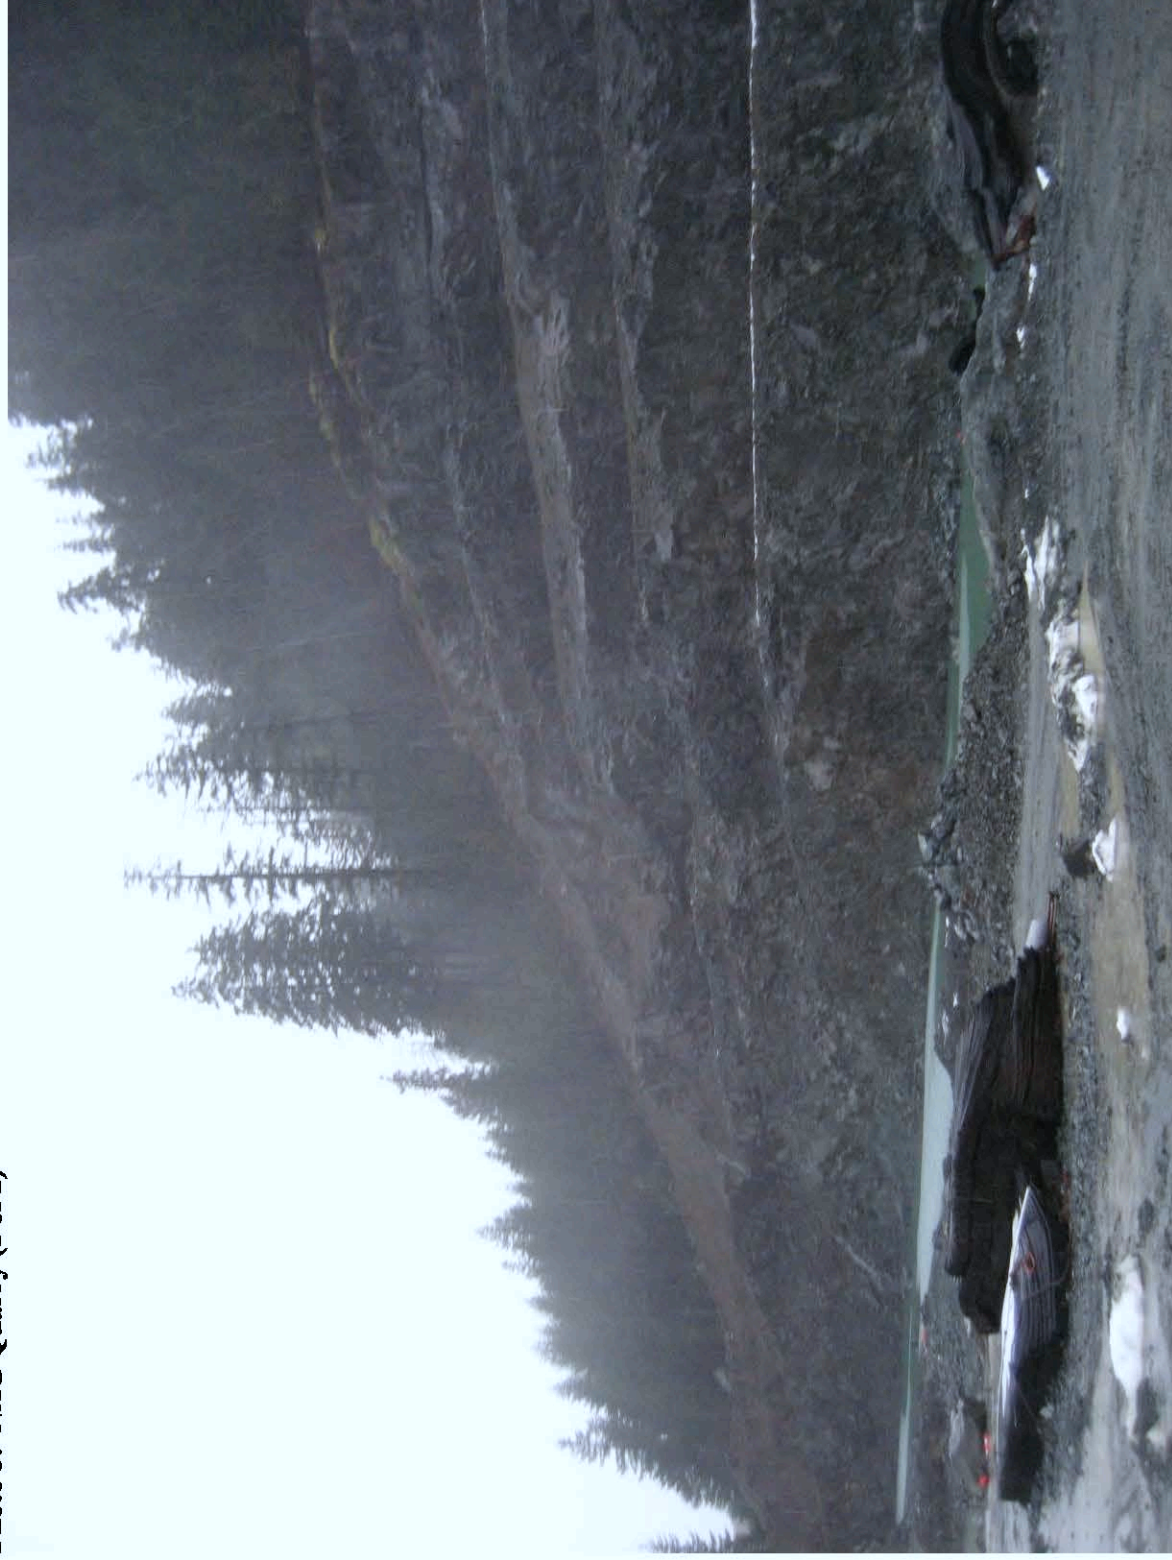
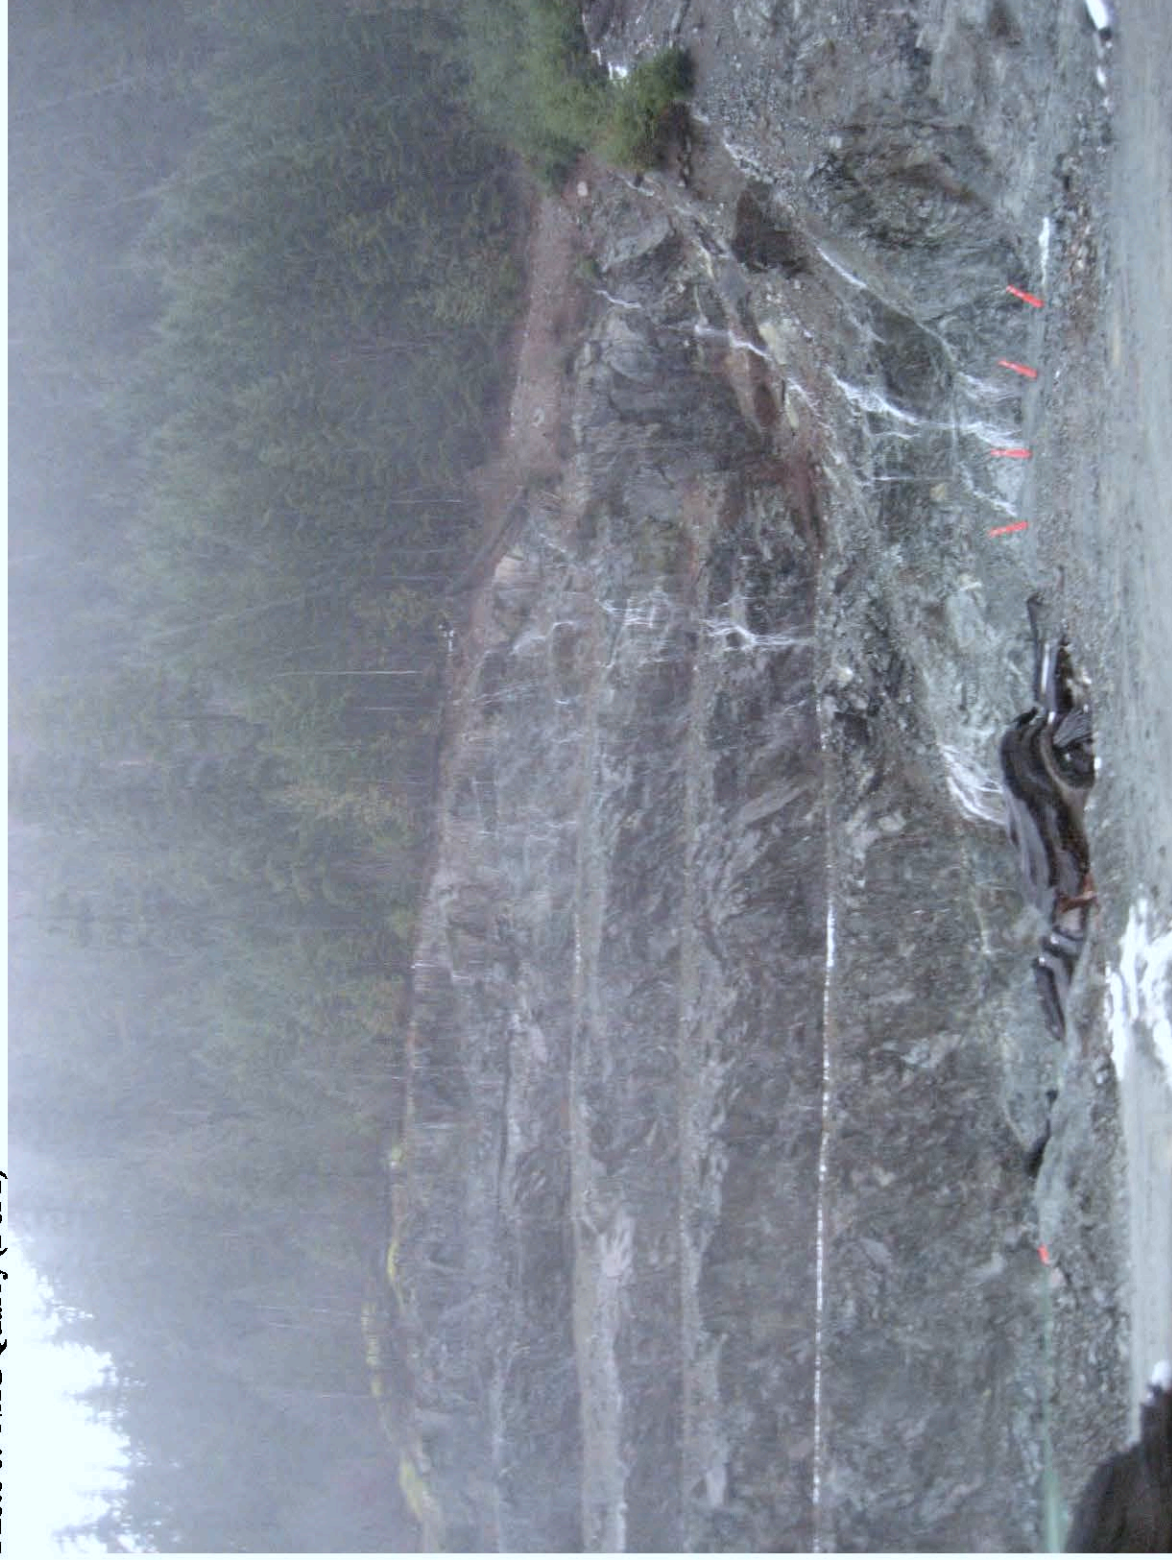
The NAG Quarry is currently inactive, however expansion of this quarry is proposed under the mine restart permitting application. At the time of inspection, the upslope diversion ditches were not operational and water was flowing down the quarry face and accumulating in low spots at the base of the quarry (Photos 5 and 6).

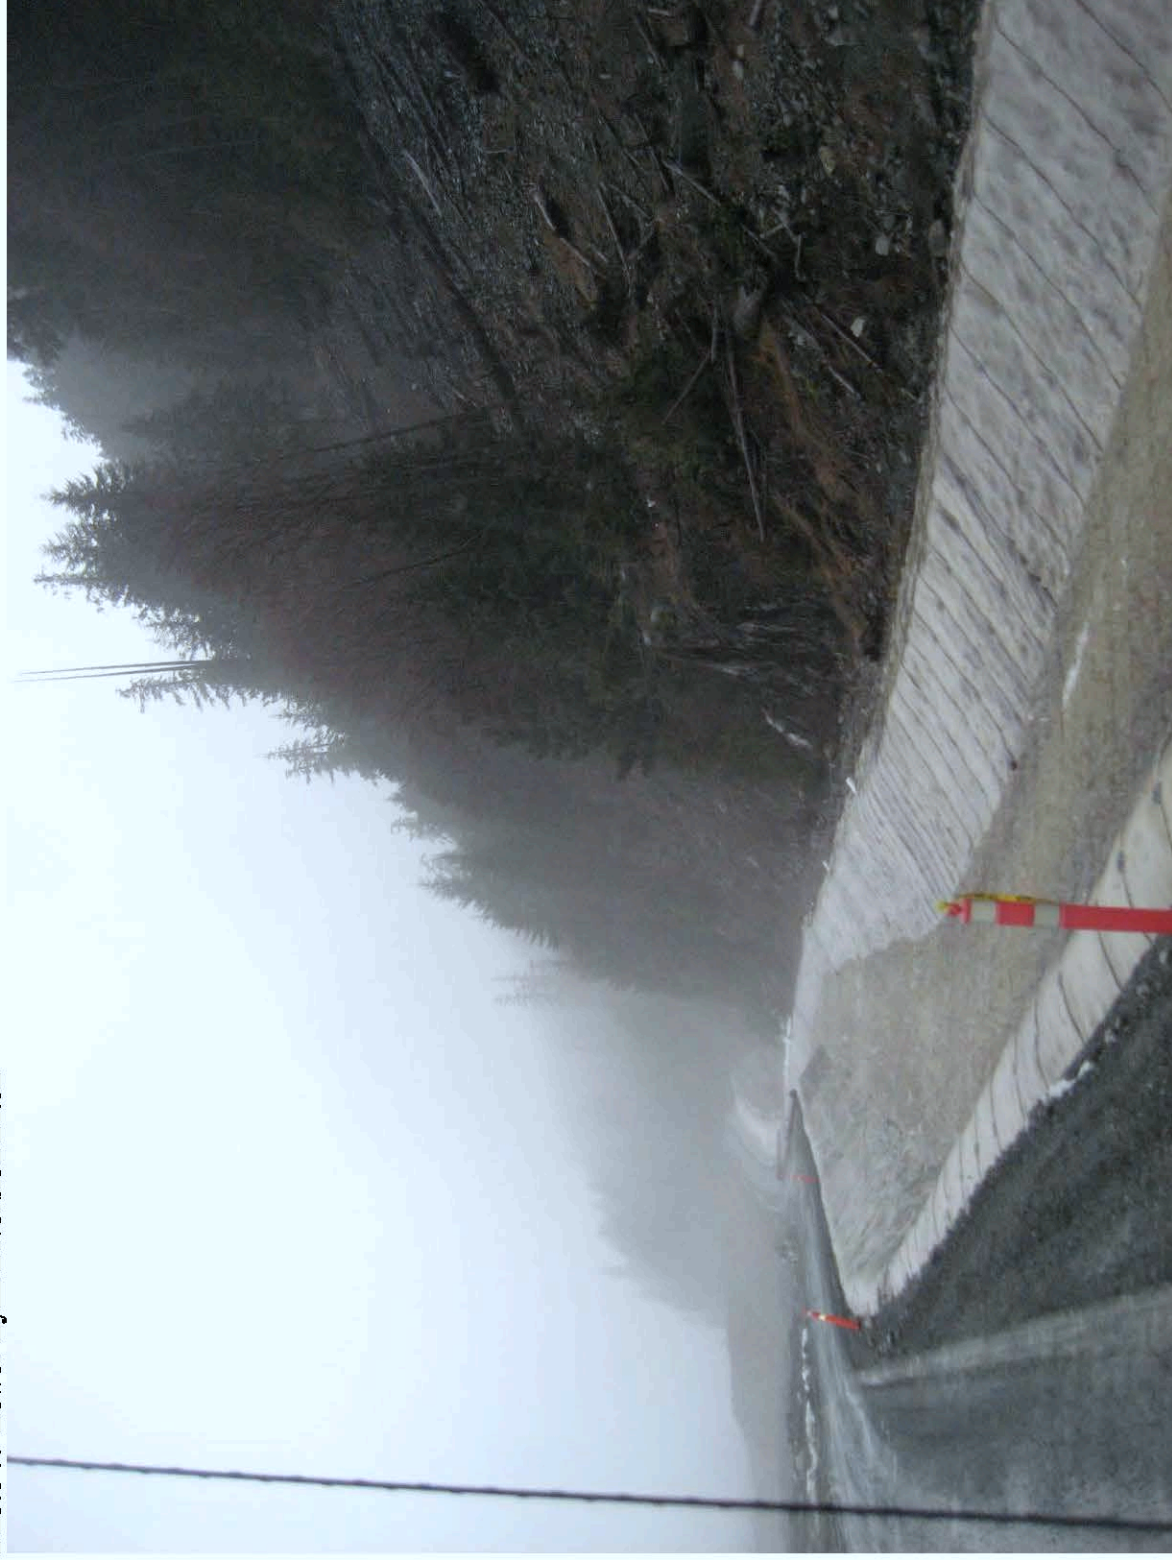
**Photo 7: Lower Lynx Diversion Ditch**

The upslope diversion ditch with concrete cloth erosion protection (Photo 7) and a debris catch barrier (Photo 8) were toured as part of the inspection. Several instances of upslope water entering the fill surrounding the ditch (and thus bypassing its containment) were observed. The debris catch area was empty, despite significant antecedent rain.

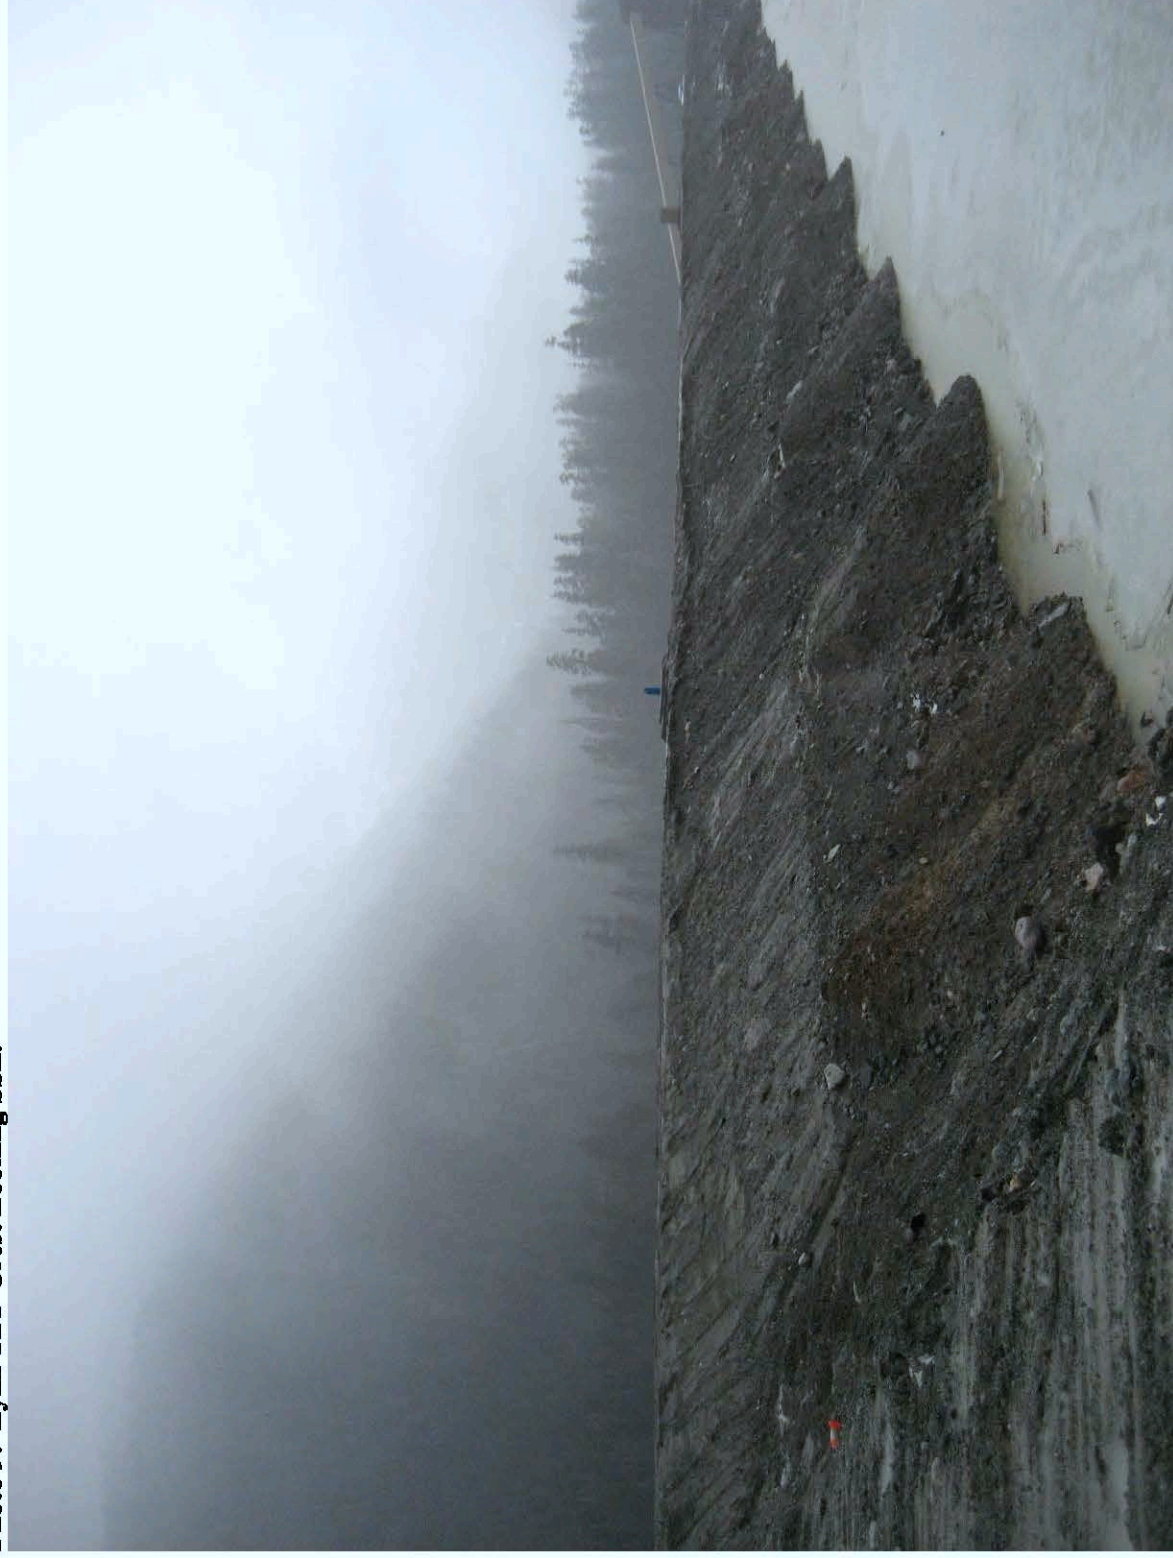
**Photo 9: Lynx TDF Crest Looking SSE.**

At the time of the site visit, the EoR (Amec Foster Wheeler) was on site performing an inspection of the facility. A raise was recently completed on the Lynx TDF dam. Amec Foster Wheeler (Dan Hughes-Games) noted that the upper portion of the upstream zone was completed with till, as other material was not available. Adequate freeboard was noted in the Pond (Photo 9). Surface flows from the upslope waste rock dumps were reporting to the TDF pond (Photo 10).

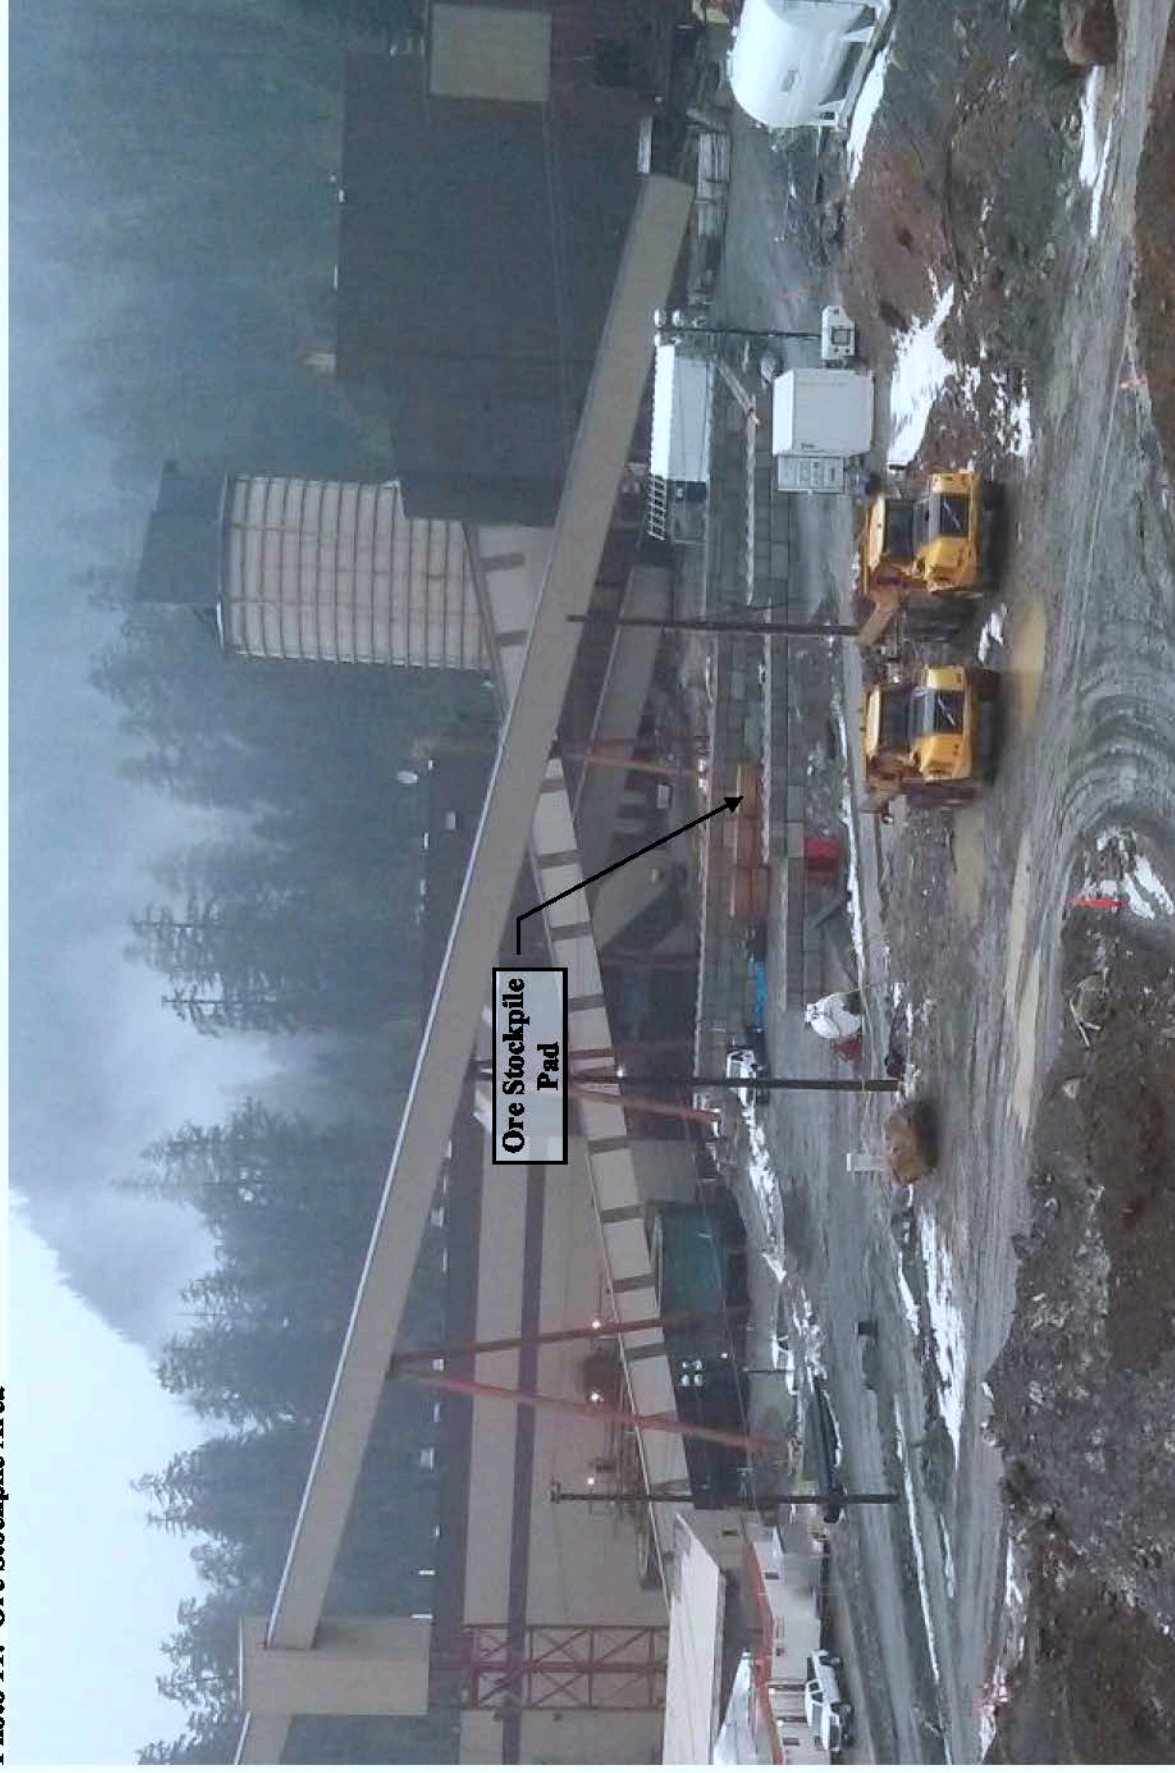
**Photo 11: Ore Stockpile Area**

The proposed Ore Stockpile Area (Photo 11) is located near the mill and conveyors. The design of the stockpile pad is currently under review by EMPR as part of the ongoing *Mines Act* permit amendment process. However, at site, it was observed that the ore stockpile pad had already been largely constructed. Onsite [REDACTED] noted that the pad was constructed largely in accordance with the Rev. 4 IFC drawing plans that were submitted to the Ministry for permitting, with the addition of a retaining wall at the east limit of the pad. Remaining works to be constructed for the ore stockpile pad include placement of a rockfall fence and local site grading/backfilling. [REDACTED] Nyrstar's design engineer for the stockpile, reported that construction of the unpermitted ore stockpile pad occurred between early December 2017 and early January 2018.

During the inspection, EMPR notified Nyrstar staff that construction of the stockpile had yet to be approved as part of the Permit Amendment application and it is an unpermitted facility. Jaime Delgado (Nyrstar) explained that the decision was made to construct the stockpile pad without a permit in order to get the geomembrane liner installation done prior to the adverse

construction weather expected in the winter and to have the area ready in time for the planned ore production.

*Construction of the ore stockpile pad without a permit is in violation of Sections 10.1.2(2) and 10.1.18 of the Code. 'all construction works at the ore stockpile pad shall immediately cease and shall not resume until a Mines Act permit for this work has been granted by the Chief Inspector. The information requirements for permitting will be communicated through the ongoing permit application review process.*

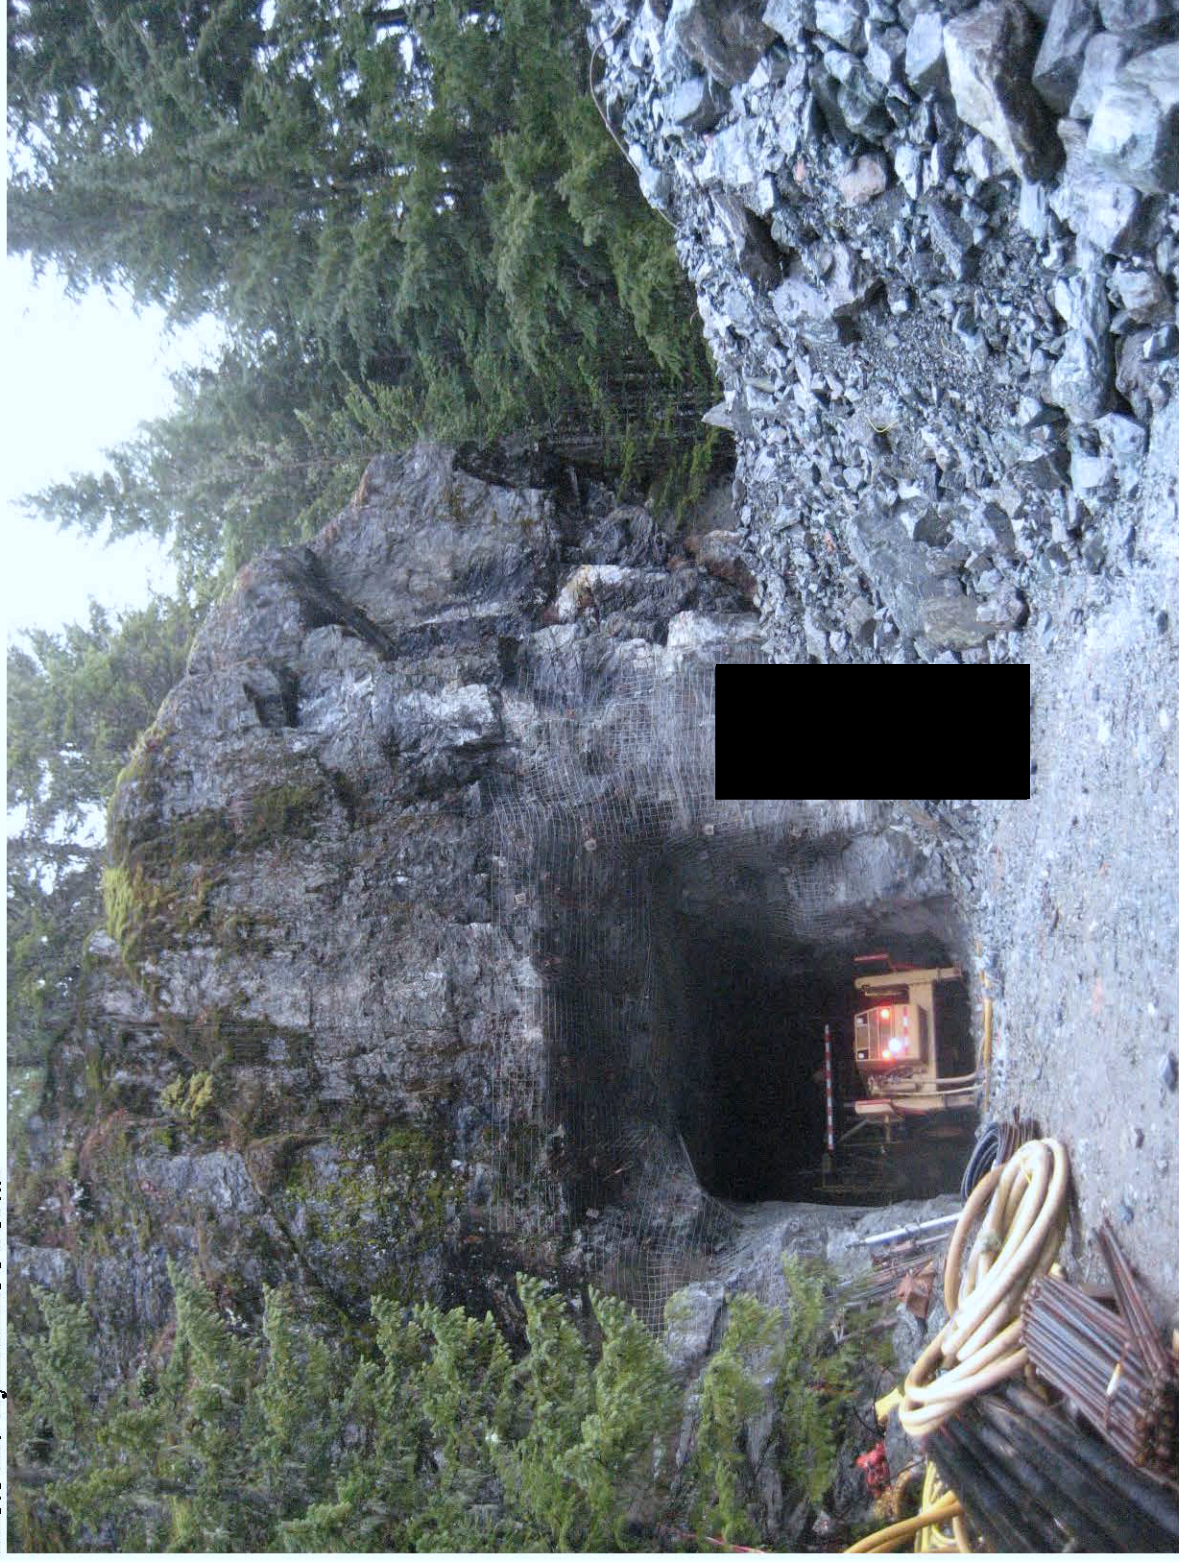
**Photo 12: Lynx Mine 6 Portal**

The Lynx 6 portal is located in an overhanging rock face (Photo 12). Dumas crews have installed new support (strapping and bolts) at the portal area and portal nose. Slashing and installation of ground support had advanced approximately 20 m into the Lynx workings. Dumas advised that a headcover would be installed once the development within the portal has advanced a sufficient distance that fly rock would not damage the headcover.

Waste from the slashing is currently being piled at the portal area. At present, the Mine is nearing the physical limit of placing waste rock around the portal area. Nyrstar is now considering alternative options for waste handling (see commentary below).

*Per Section 6.1.1 of the Code, the Mine shall submit to the Chief Inspector the design and installation schedule for the Lynx 6 portal headcover, by March 31, 2018. No mining in the Lynx area is permitted without the installation of a head cover outside of the portal.*
