Appendix D – EOR Monthly Dam Inspections

Myra Falls Mine Tailings Facility Field Review Report

Date of Field Review:	21 January 2019	Date of Memo:	24 September 2019
File No.:	NX14001B1	Client:	Nyrstar Myra Falls Ltd.
Engineer:	Dan Hughes-Games, P.Eng.	To:	Keith Watson, P.Eng.
With:	n/a	Cc:	
Weather:	Sunny, few degrees below zero. Most of site in shade of Mt. Myra throughout the day. Discontinuous snow cover on site, particularly in the shade.

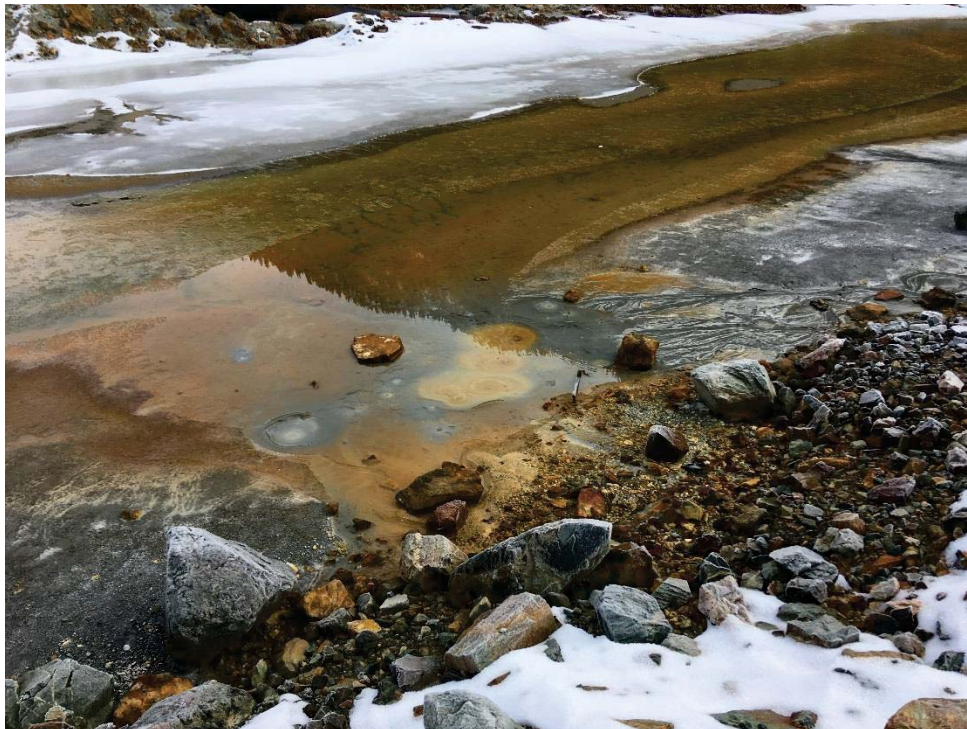
Photo 2: Groundwater boils in the East Strip. Light to moderate activity.

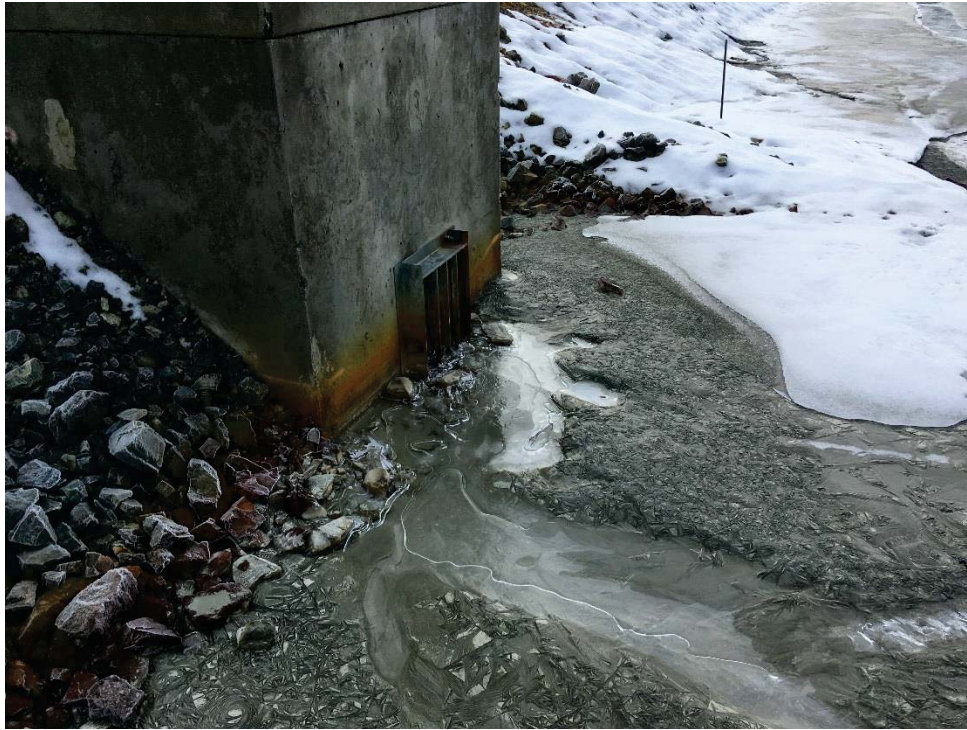
Photo 3: APA East Decant. Clear of debris. Frozen surface, no significant flow.

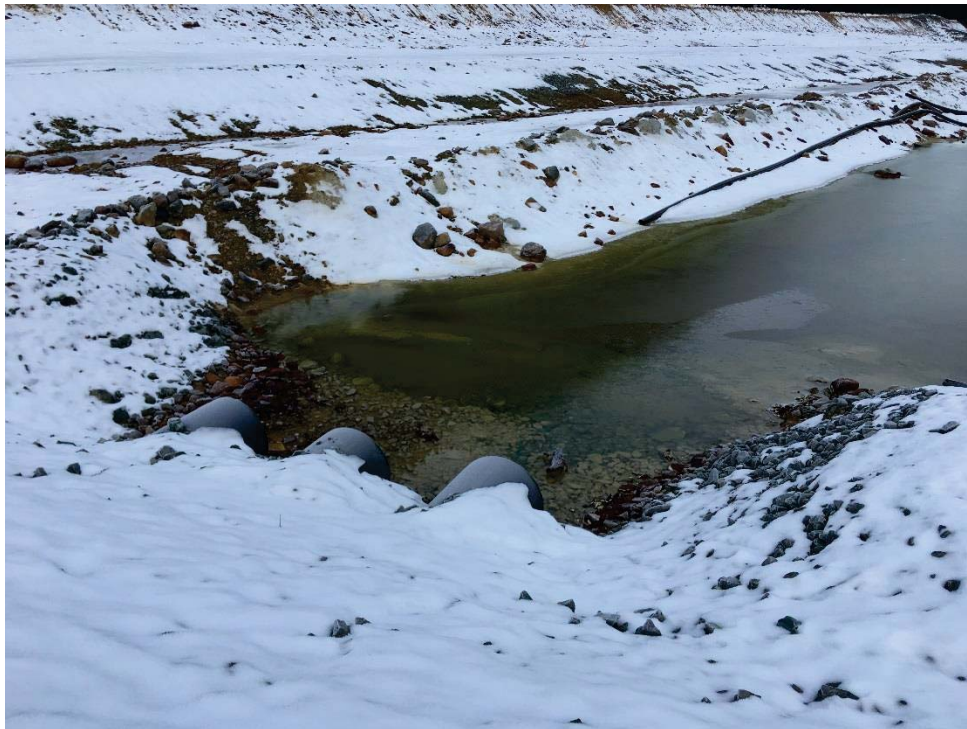
Photo 4: Water ponded upstream of APA Spillway Culverts. Depth is controlled by pipe invert.

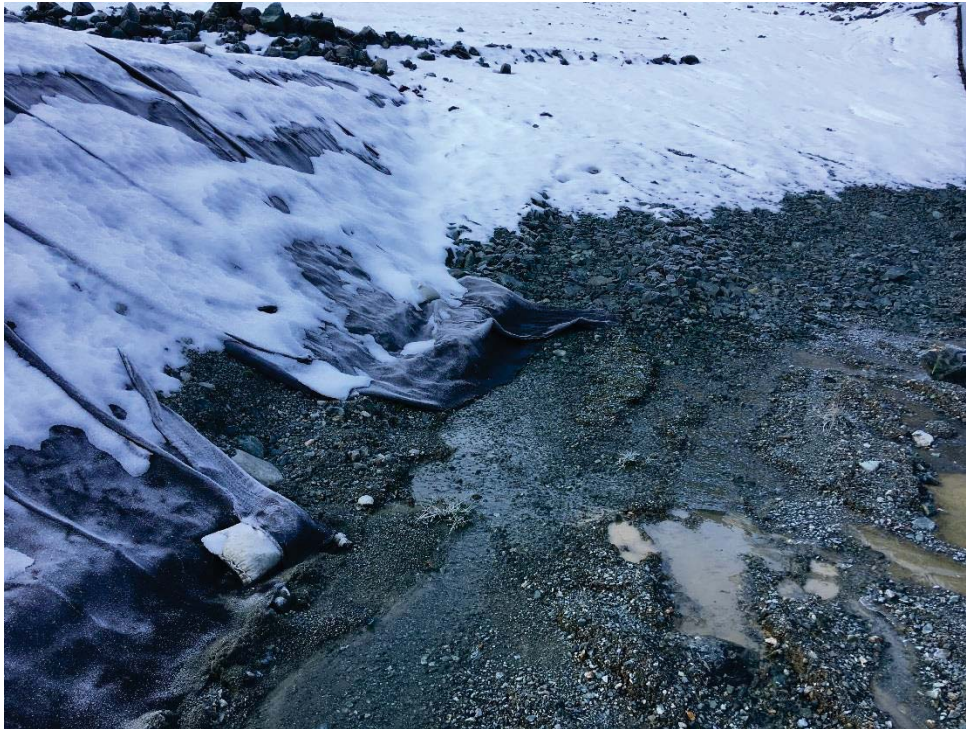
Photo 7: Seepage adjacent to the Lynx Spring Drain

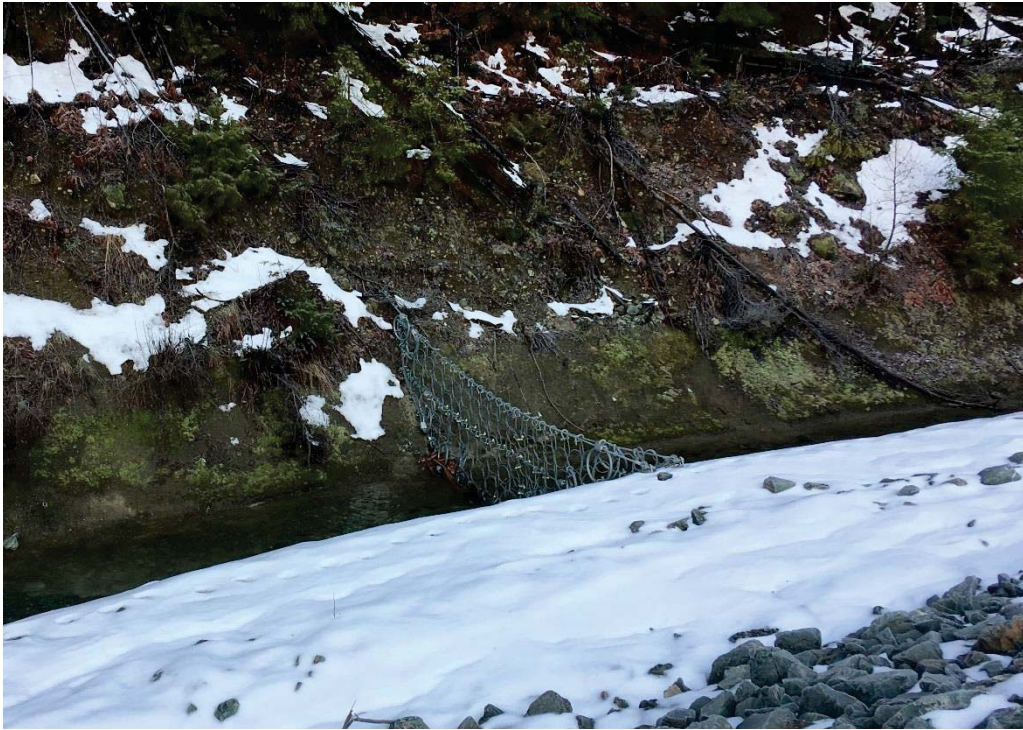
- Minor debris caught in bottom edge of the debris basin cable net.
- Moderate flow in LLDD. Moderate flow at Alder Reach waterfalls.
- Upper diversions not accessed due to snow cover on roads.

Photo 9: Minor debris in the bottom edge of the debris net.

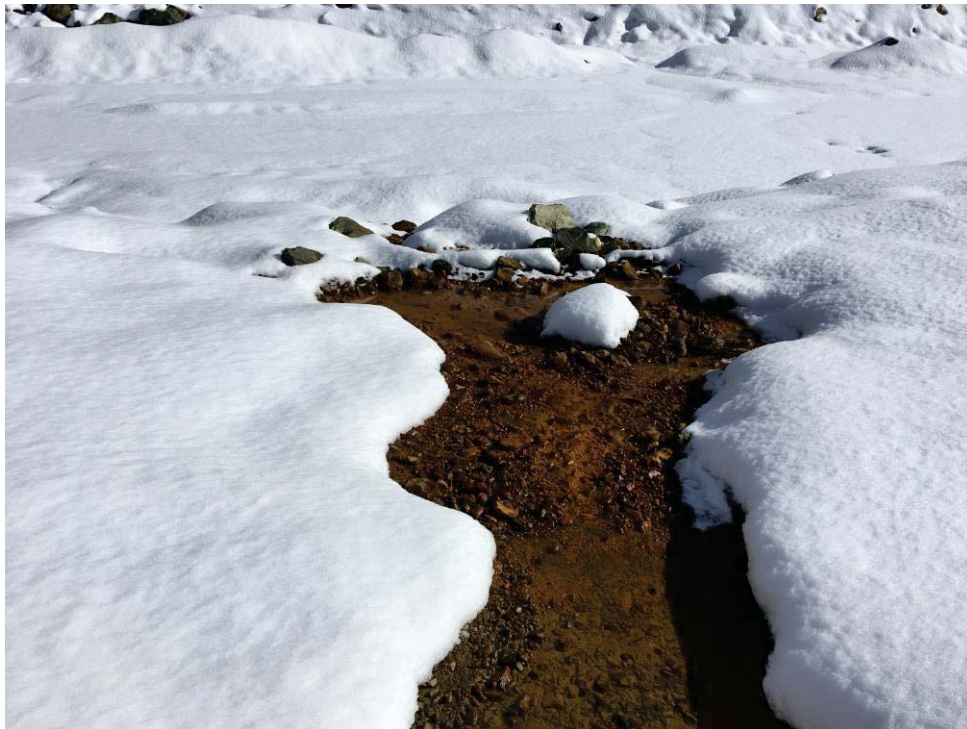
Photo 4: Seepage from the APA buttress drain outlet.

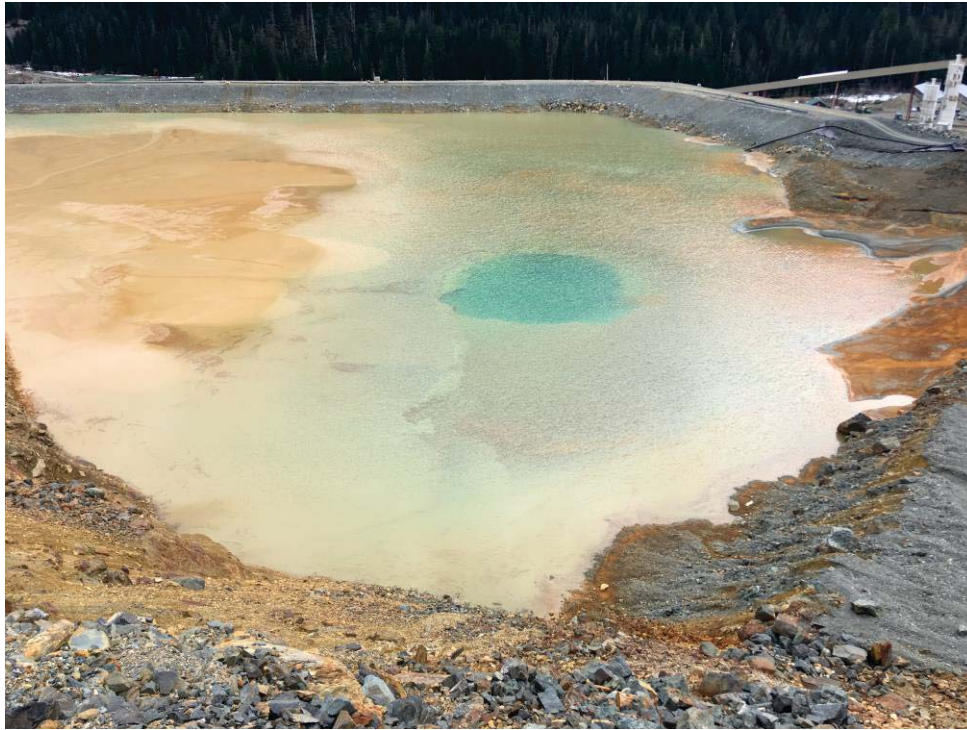
Photo 5: Lynx TDF sinkhole. The diameter is much larger than prior observations.

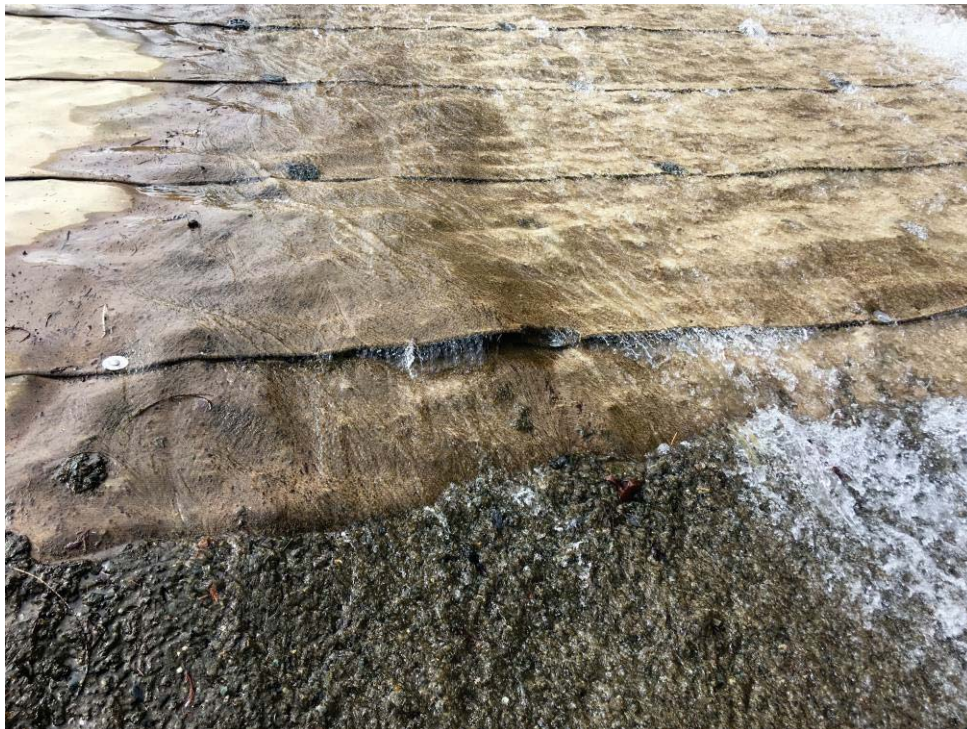
- Minor debris in the base of the LLDD debris net. Debris basin is clear.
- LLDD clear and functioning. Low to moderate flow.
- Concrete cloth liner has blistered up at the existing tear in the LLDD concrete cloth near the top of DD Hill. Bottom of the panel with the tear is delaminated and flow appears to be passing below the liner.
- Delamination damage noted on the terminal steep section near the Old TDF east abutment. Repairs will be needed.

Photo 10: Example delamination near the terminal section of the LLDD.

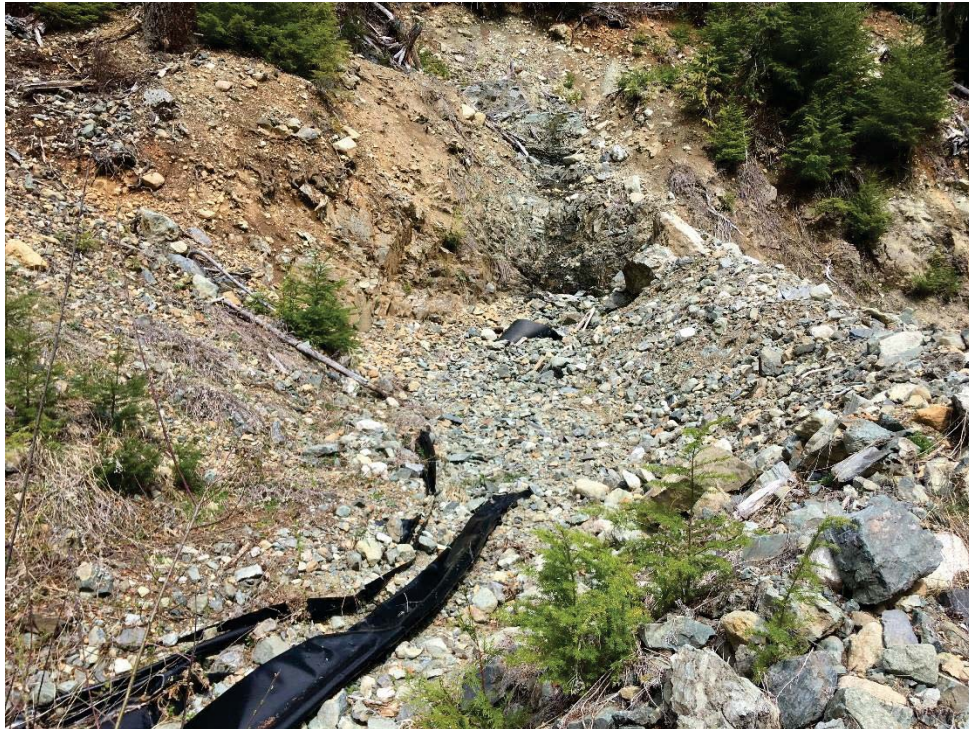
Photo 7: Damaged geomembrane liner at the Upper Arnica/Lower Arnica Diversion transition.

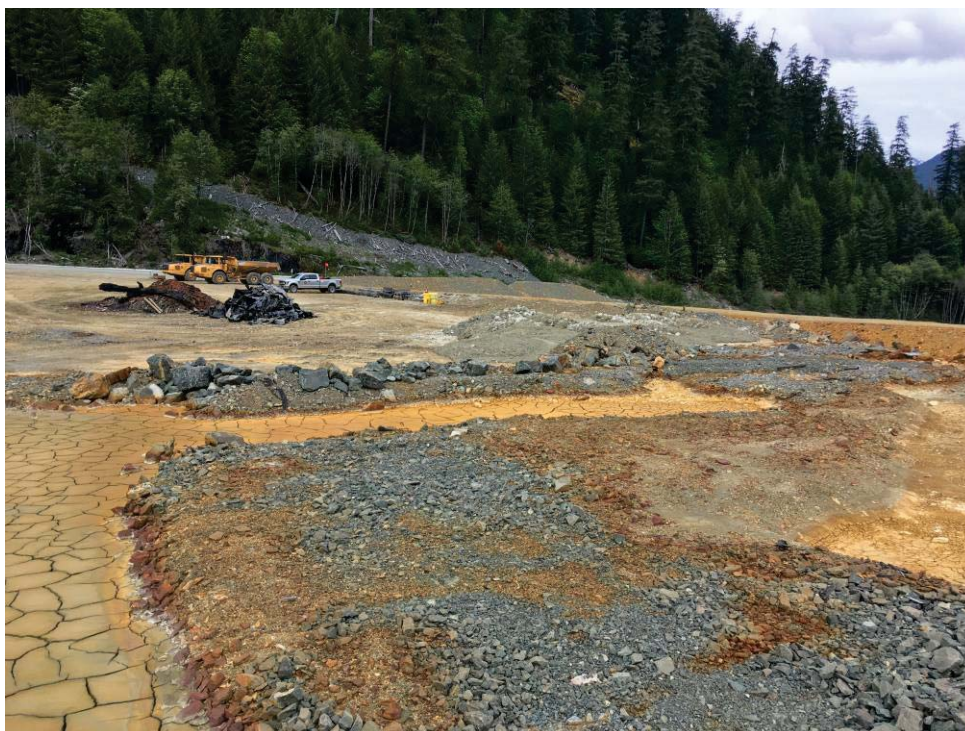
Photo 1: Waste piles to be removed from within 30 m of the APA Berm near Plane C. Prohibit further dumping in this area.

- The Old TDF and Lynx TDF facilities were reviewed by Wood.
- Action Items:
 1. Remove dumped waste piles situated within 30 m of the APA Berm Crest as noted near Plane C.
 2. Remove Scotch broom infestation on the Old TDF Surge Pond spillway fuse plug.

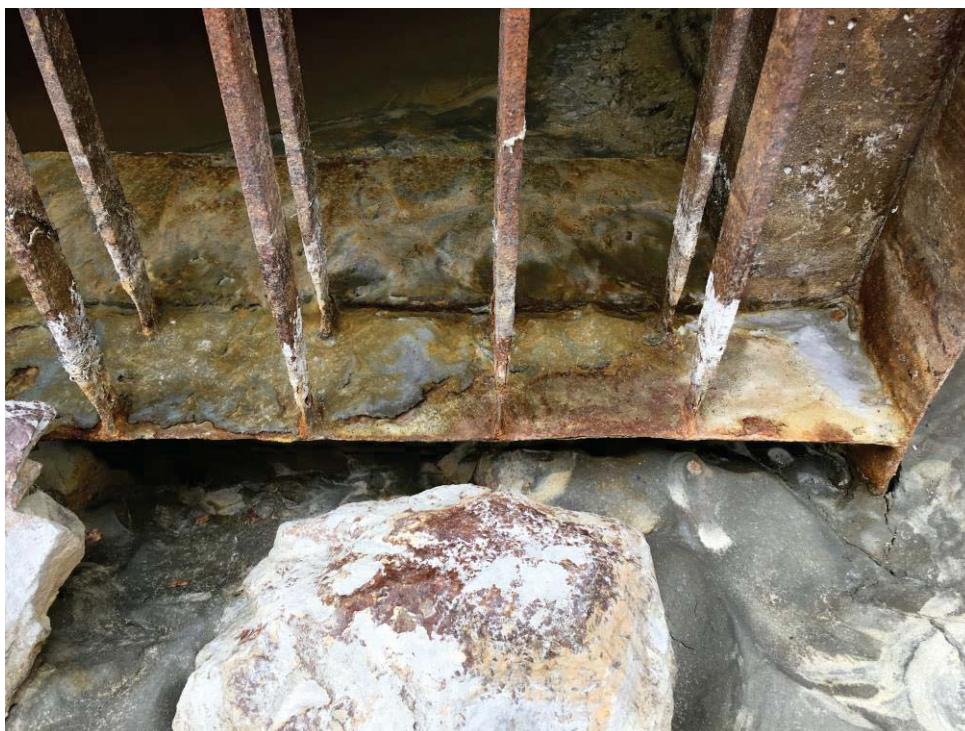
- APA surface free of significant accumulation of surface water. Minimal flow in decants. Decants clear and functioning as intended. Some corrosion of trash rack bars noted.

Photo 3: Corrosion damage to the trash rack at the APA West Decant

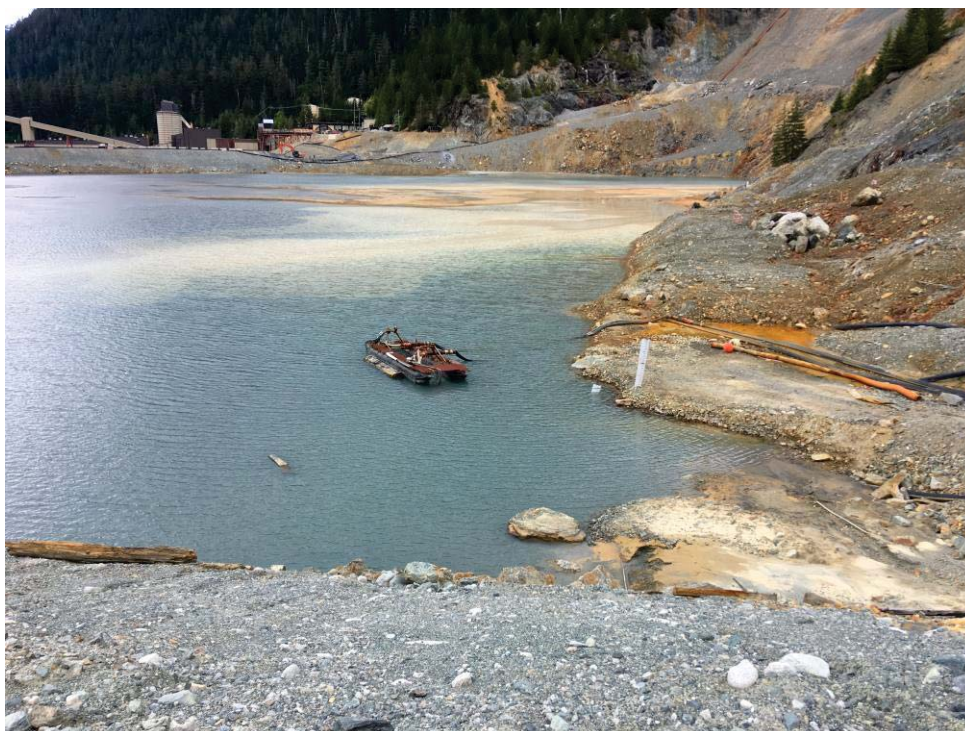
- Water level is at 0.71 on the staff gauge (355.02 m), 2 cm above maximum Normal Operating Water Level.
- Sinkhole is visible in similar location and size as the inspection of 04 April 2019.
- Reviewed the dam crest for cracking. Cracking near Plane F consistent with prior observations. No additional cracking noted.
- Minor areas of puddling at the dam toe, mainly Panel 7 and 13. No significant seepage or runoff at the toe.
- Downstream slope appears as constructed. No sags/cracks/bulges.
- Twin tails line was freshly broken at the time of the inspection, discharging clear water on the dam crest at the west abutment. Repairs were underway.

Photo 5: Lynx TDF pumping area. Water level at 0.71 m on the gauge, 355.02 m elevation.

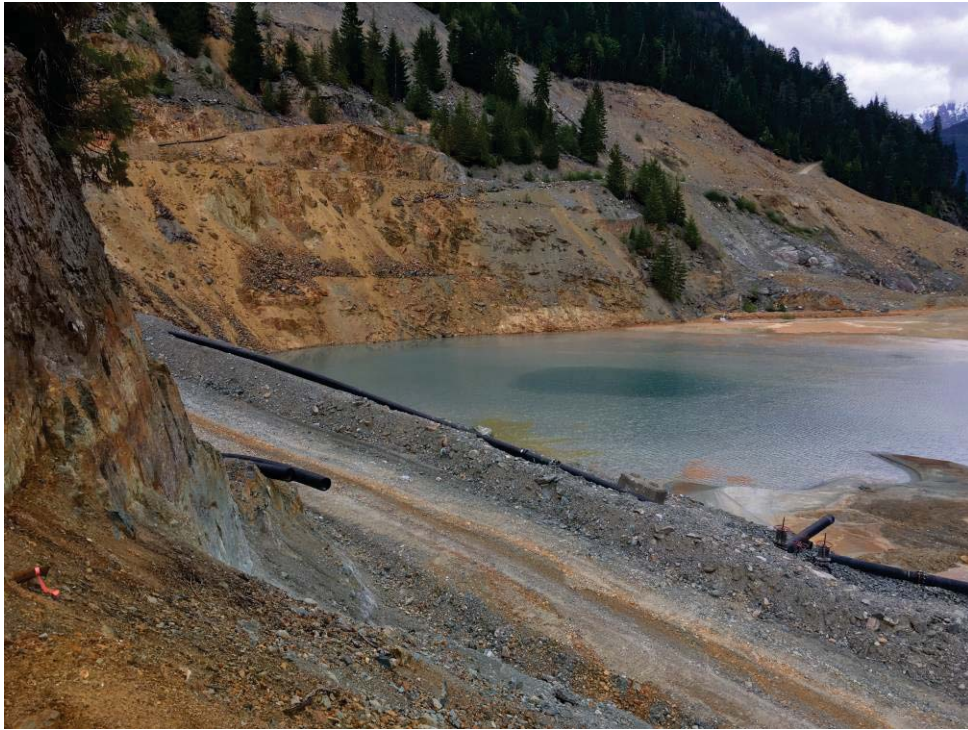
Photo 7: Lynx Sinkhole viewed from 10L East portal

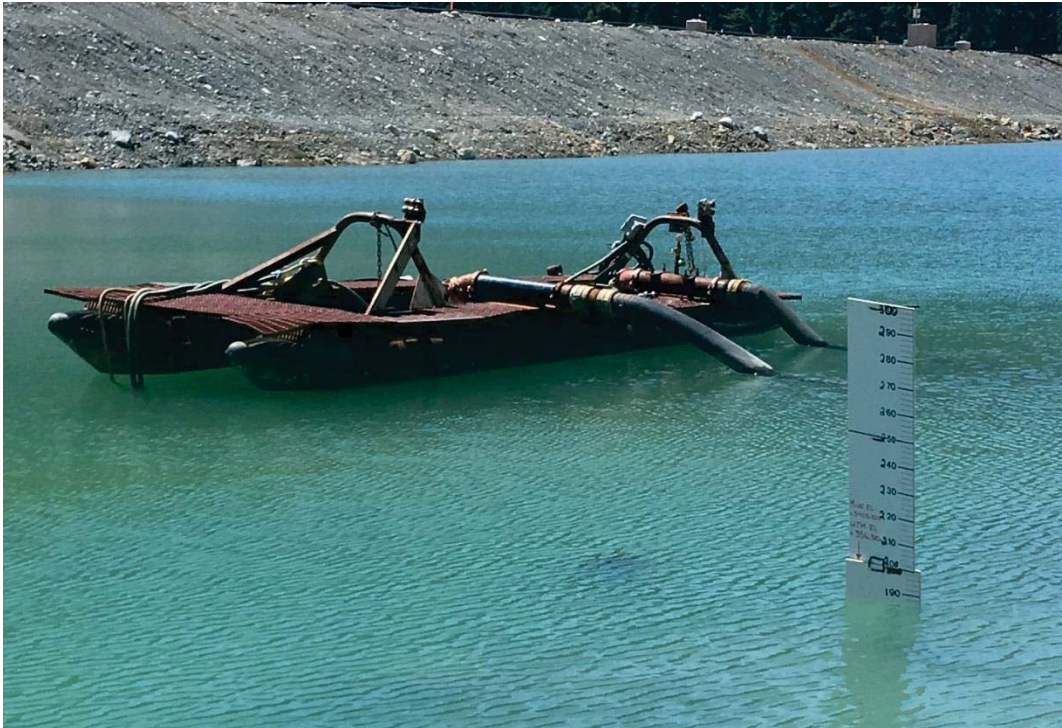
- Lynx TDF water level is at 1.88 m on the staff gauge, 356.19 m elevation, 1.19 m above maximum Normal Operating Water Level. Reduce and maintain the water level as close as practical to 355.0 m elevation.
- Sinkhole is faintly visible, partly obscured by water depth.
- Spillway armouring has been removed for construction. Foundation preparation and continuation of the raise to 365.1 m (started in 2018) are underway.

Photo 5: Water level in Lynx TDF is 1.88 on the staff gauge, 356.19 m elevation. Maximum Normal Operating Water Level is 355.0 m.

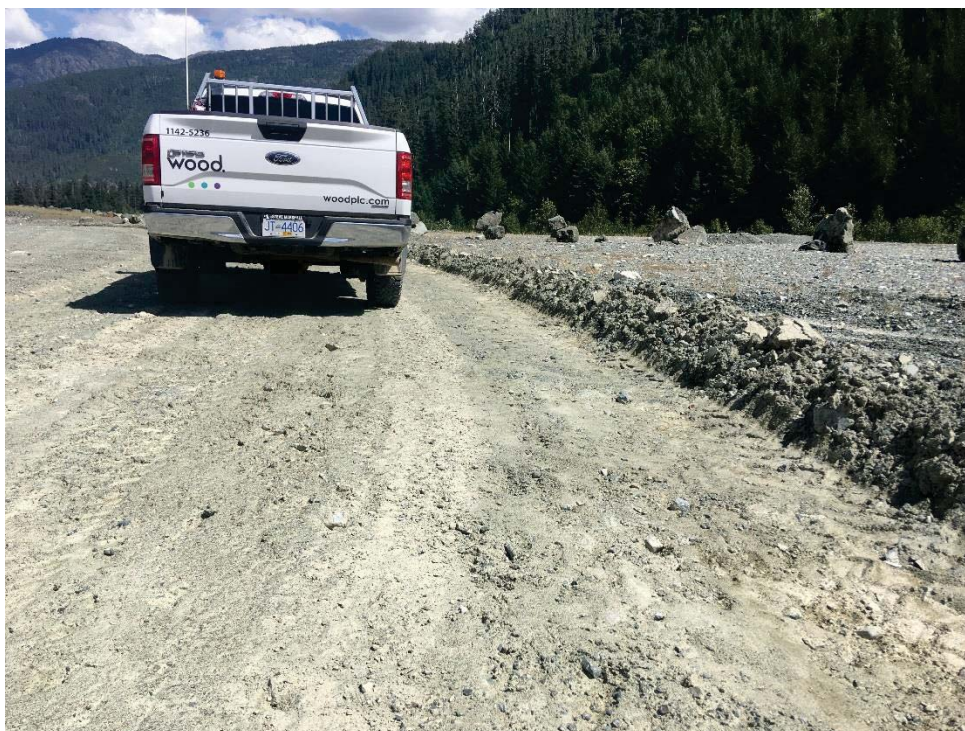
- Grading activities on the Old TDF Seismic Upgrade Berm have created a windrow along the haul route (22 July). The windrow is up to about 0.4 m high and would pond significant water. The road surface has been carved down several centimetres below the adjacent surface. Given the sensitivity of the area to drainage and ponding of water, and the design intent that it shed runoff, Wood recommends regrading to remove these windrows (completed prior to 29 July) and then permanently closing the Upgrade Berm as a haul route/road. Vehicle access should be for maintenance of the area only, with the exception of access to the helicopter area near 0+700. Consideration could be given to accessing the helicopter area from the OEB via the side of the Operations Spillway or by a new designated route constructed down the 6H:1V slope.

Photo 3: Windrow on the Seismic Upgrade Berm (22 July). This was regraded prior to 29 July.

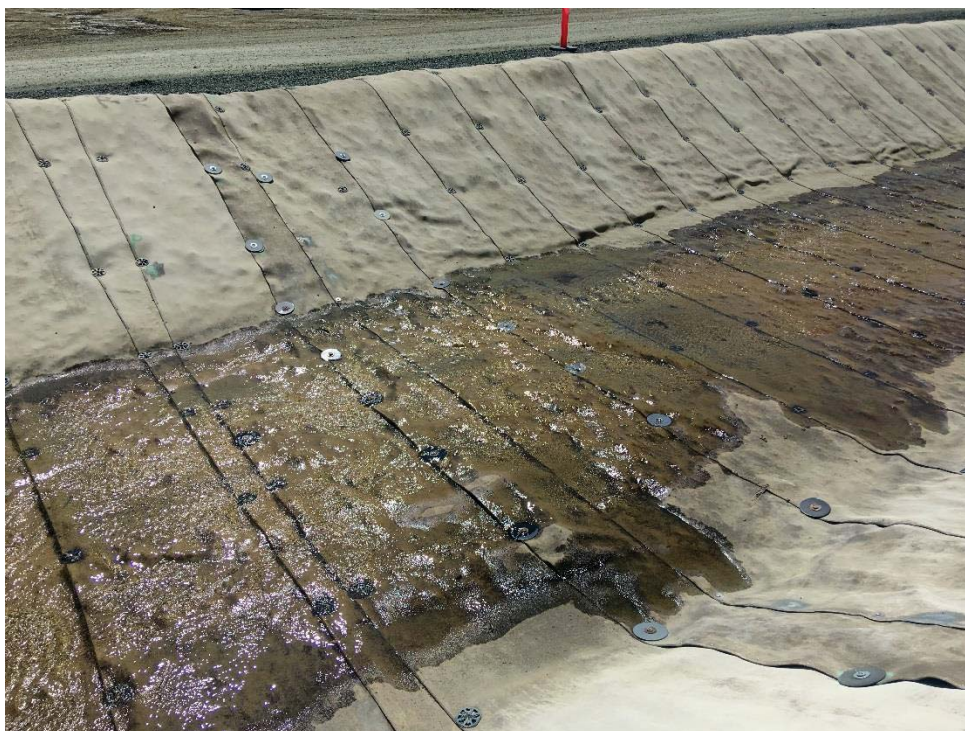
Photo 9: Example delaminated area in the LLDD.

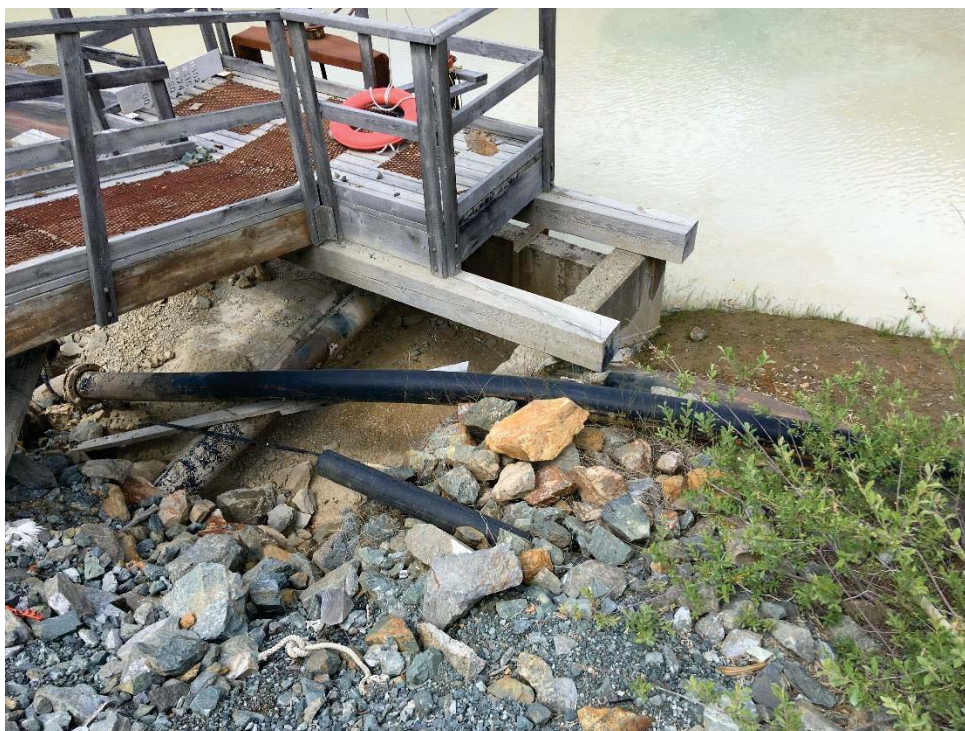
Photo 11: Poor condition of the upstream sump box for the secondary Superpond outlet.

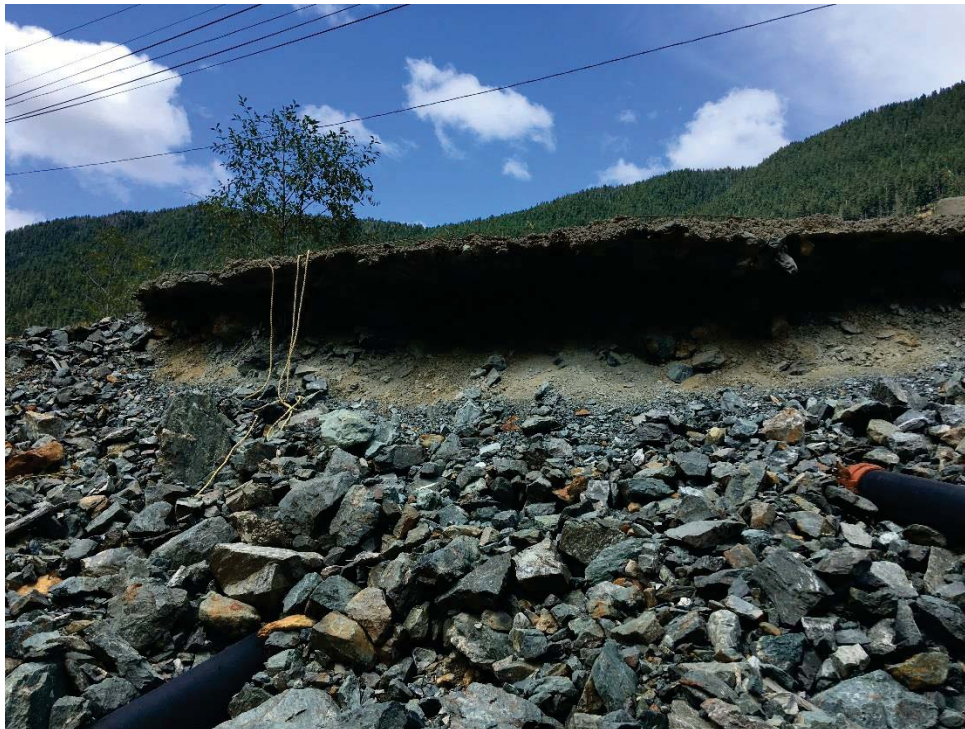
Photo 12: Undermined condition of the secondary outlet sump on the downstream side of the Superpond embankment.

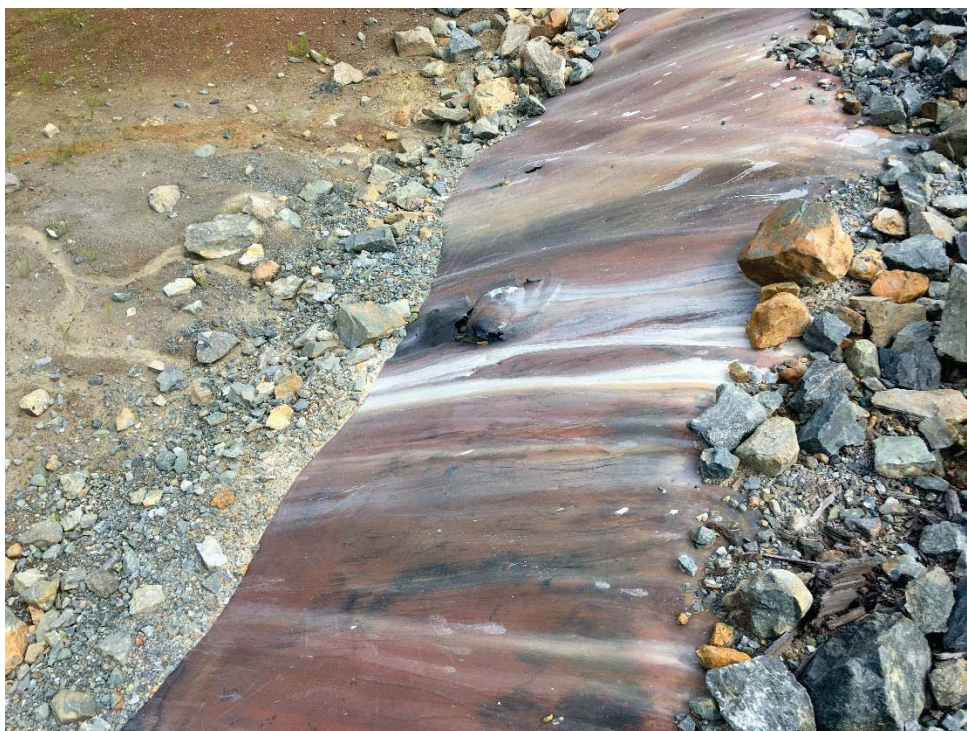
Photo 13: Example of a tear in the Superpond liner, this one just east of the primary outlet.

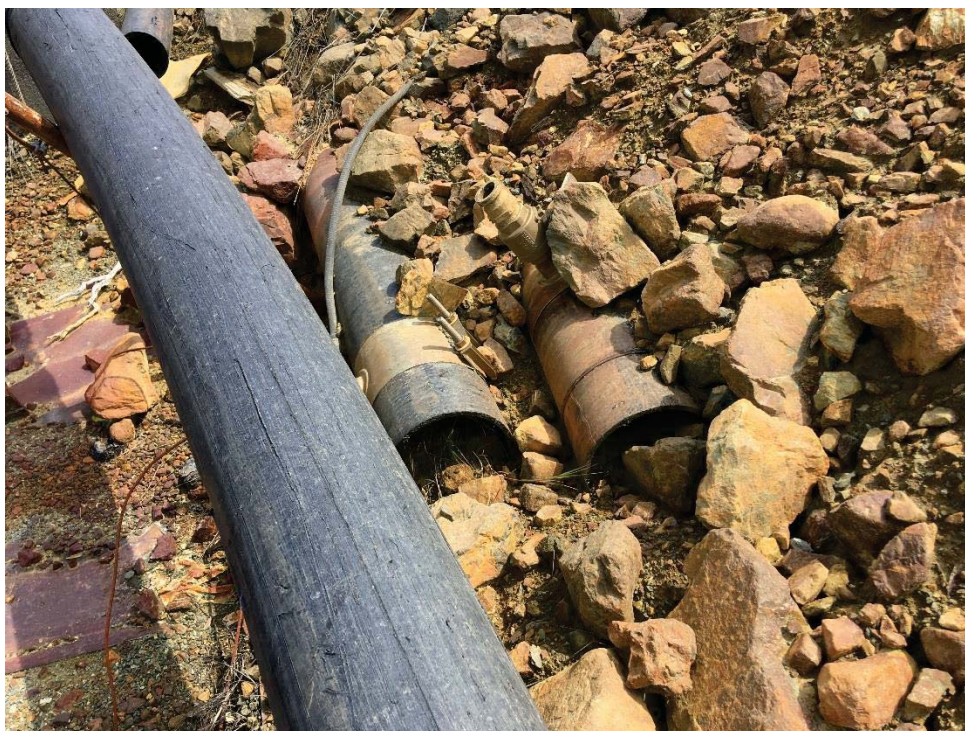
Photo 15: Example of stray disused pipes just above the Superpond liner.

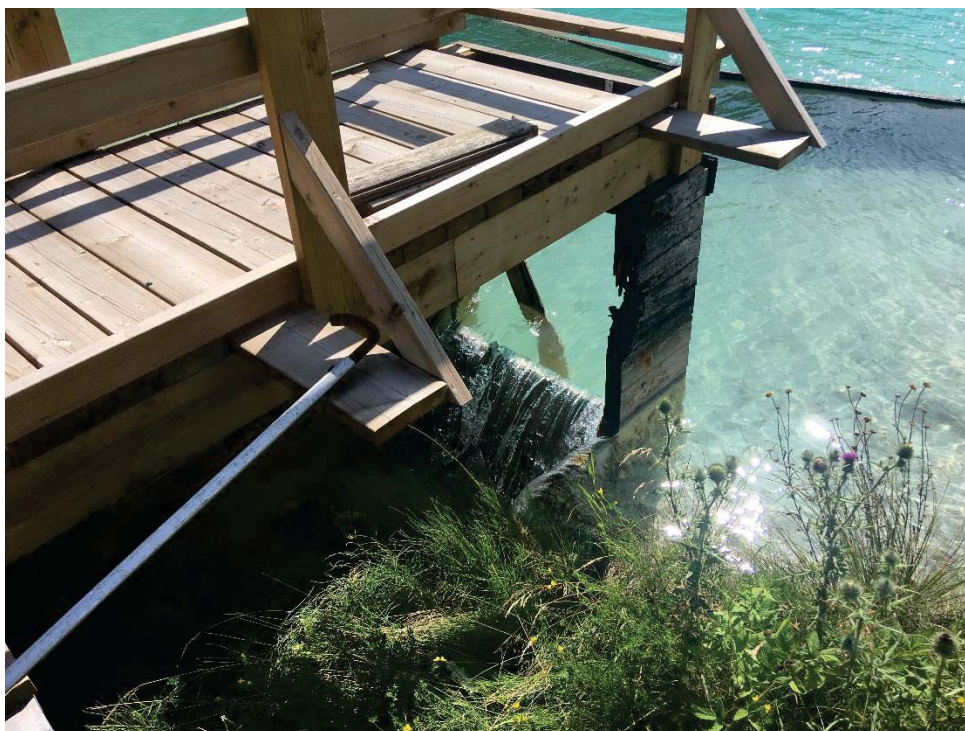
Photo 17: Example of a timber decant in poor condition.

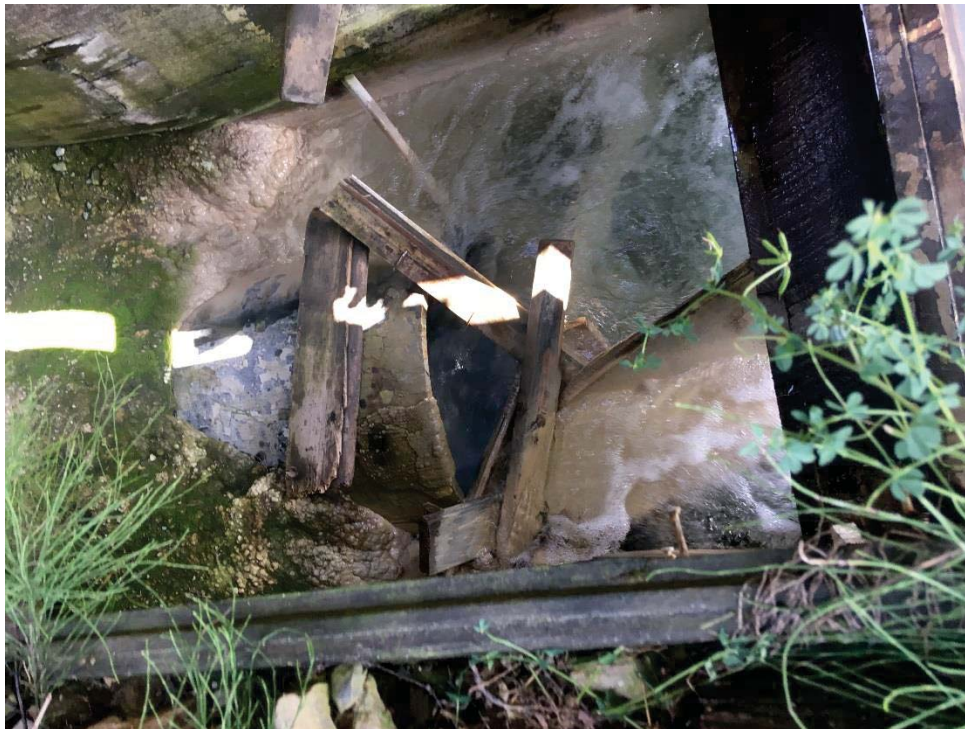
Photo 18: Wood debris partially blocking the decant shown above. This debris would be difficult to remove safely.

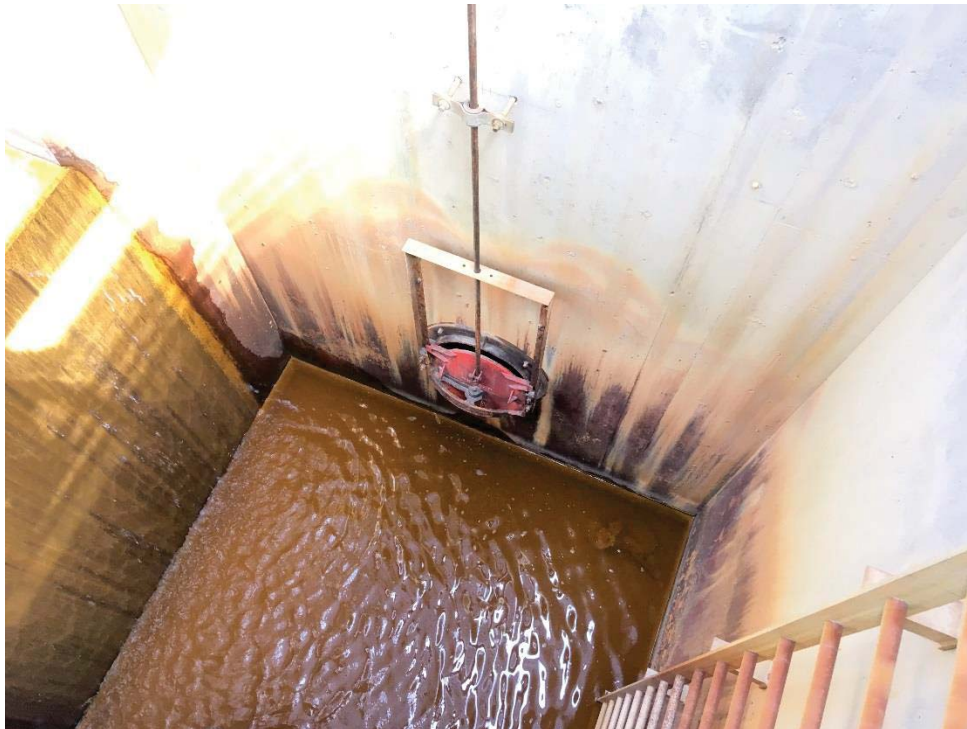
Photo 2: Patch over the Surge Pond low level outlet appears to be holding water with minimal leakage. The plate is likely blinded off by sediment.

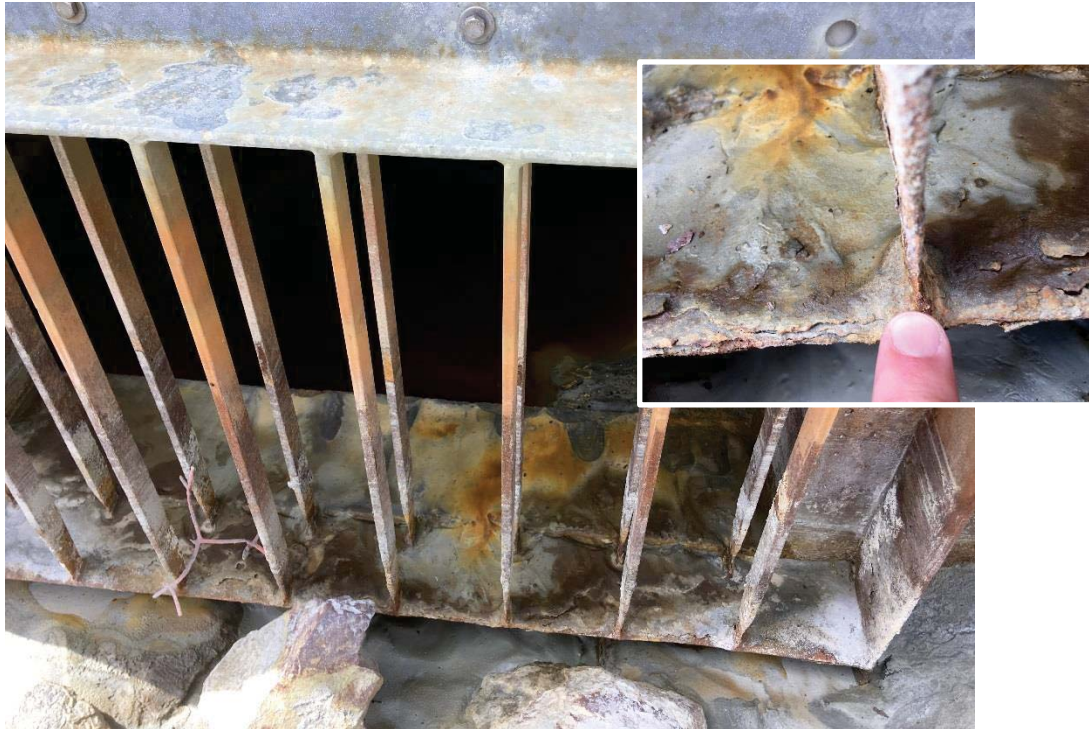
Photo 3: Corroded trash rack bars on the APA West Decant. East Decant is in similar condition.

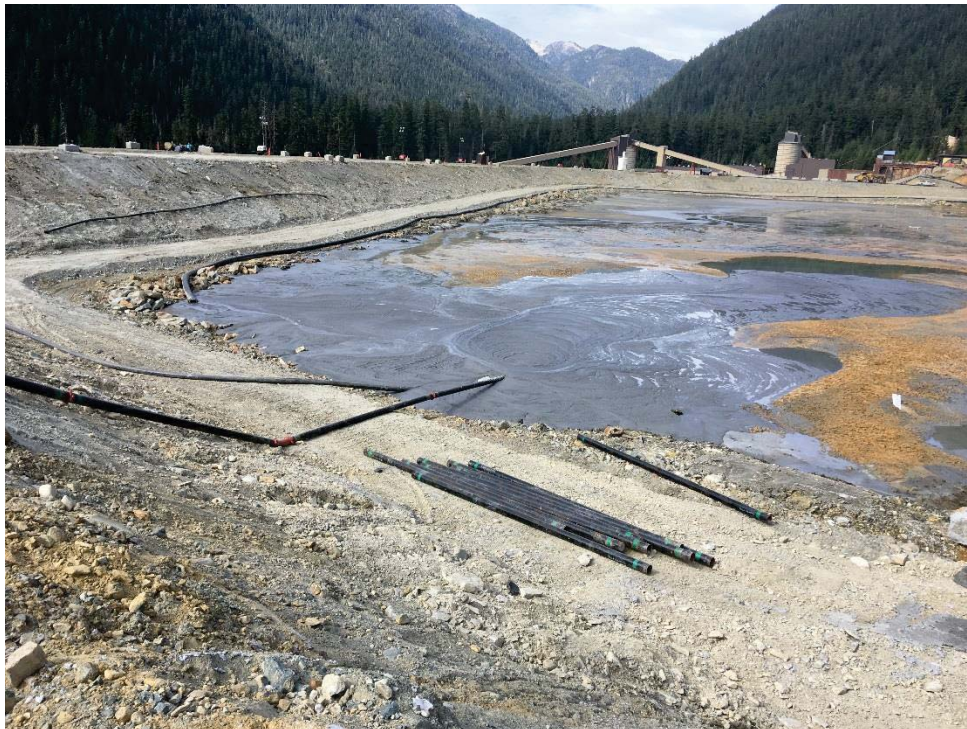
Photo 4: Paste deposition has commenced from the east arm of Lynx TDF Dam. The paste is displacing the dredgate, creating a significant mud wave.

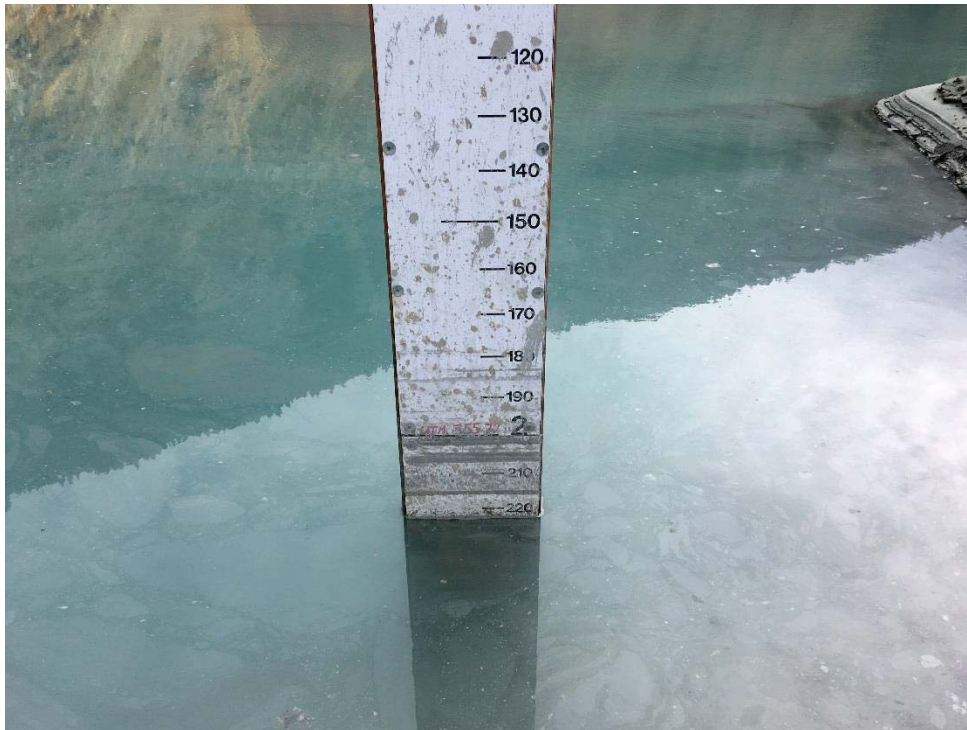
Photo 5: Water level in Lynx TDF is at 2.22 m on the gauge = 355.55 m. NOWL is 355.0 m.

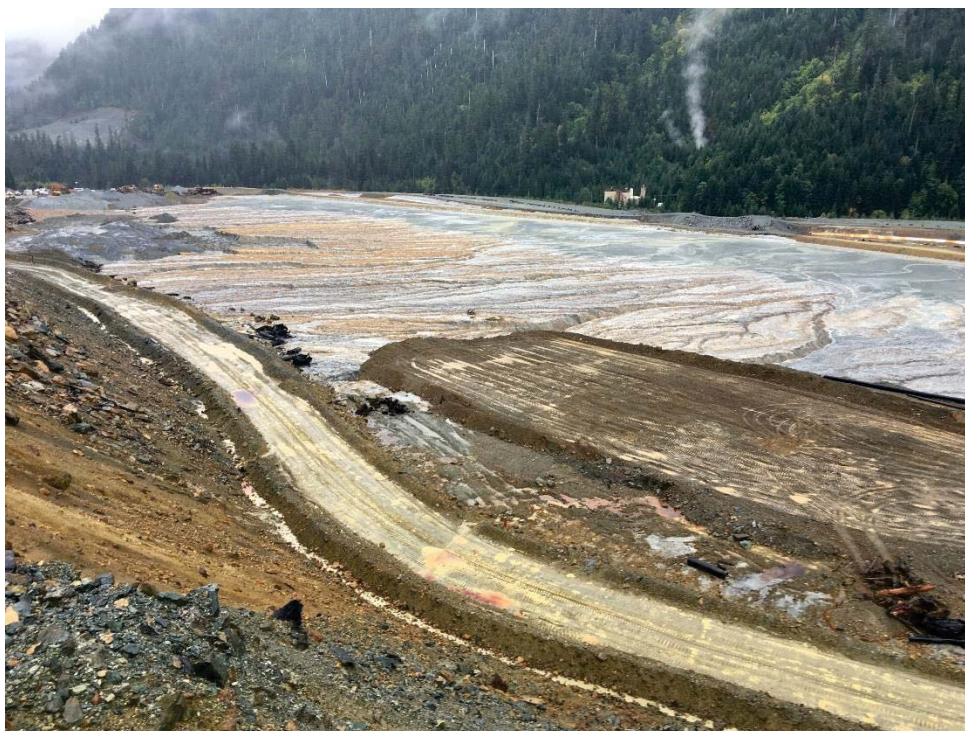
Photo 1: Overview of the Old TDF. Fill has been advanced from the laydown area to the east, covering a significant gully. Gullies should be filled with materials consistent with the tailings in order to reduce formation of preferential seepage pathways at closure.

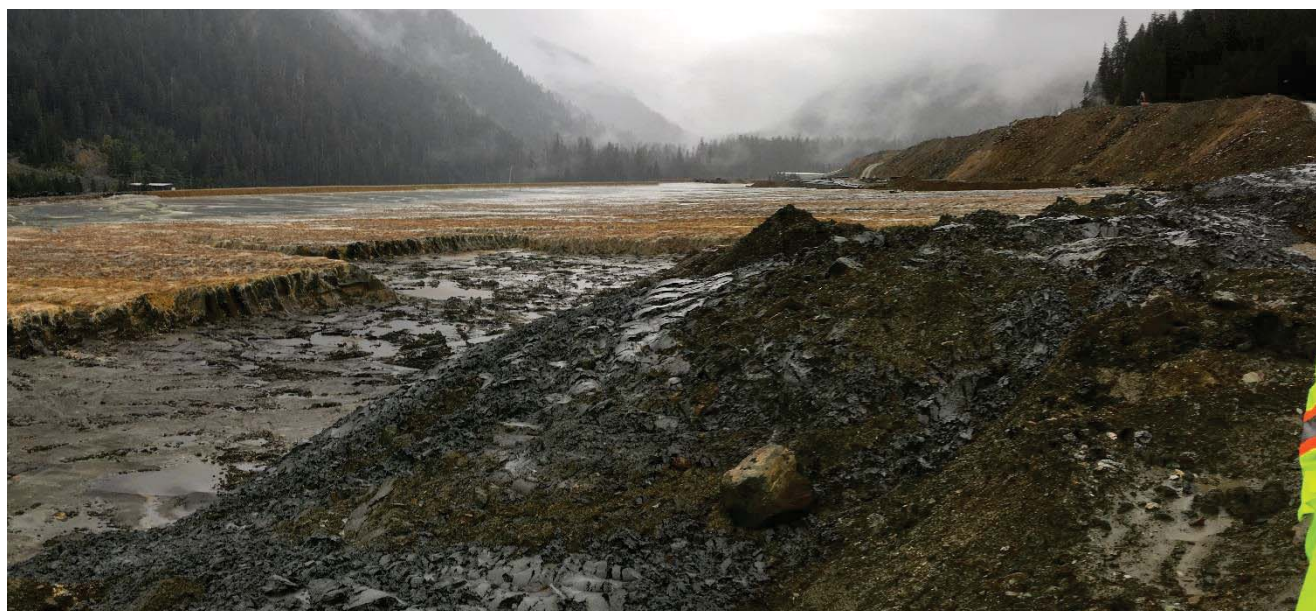
Photo 2: Cake material dumped above the excavations created during the summer. This material should be spread into the excavation if practical.

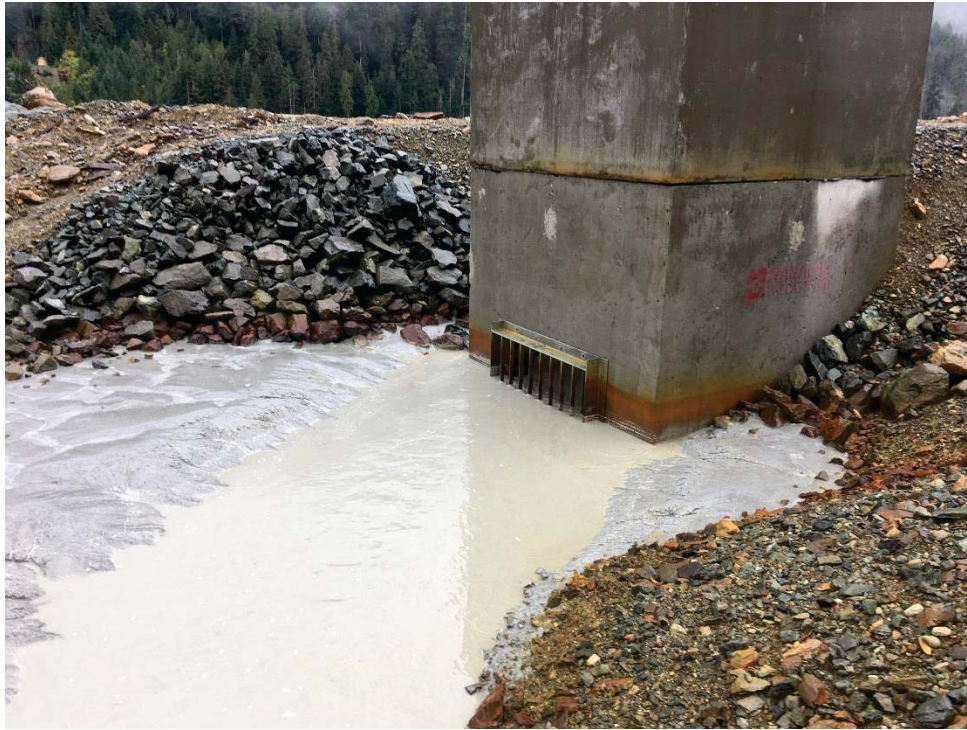
Photo 3: Moderate flow through the APA west decant. Note the turbidity of the water.

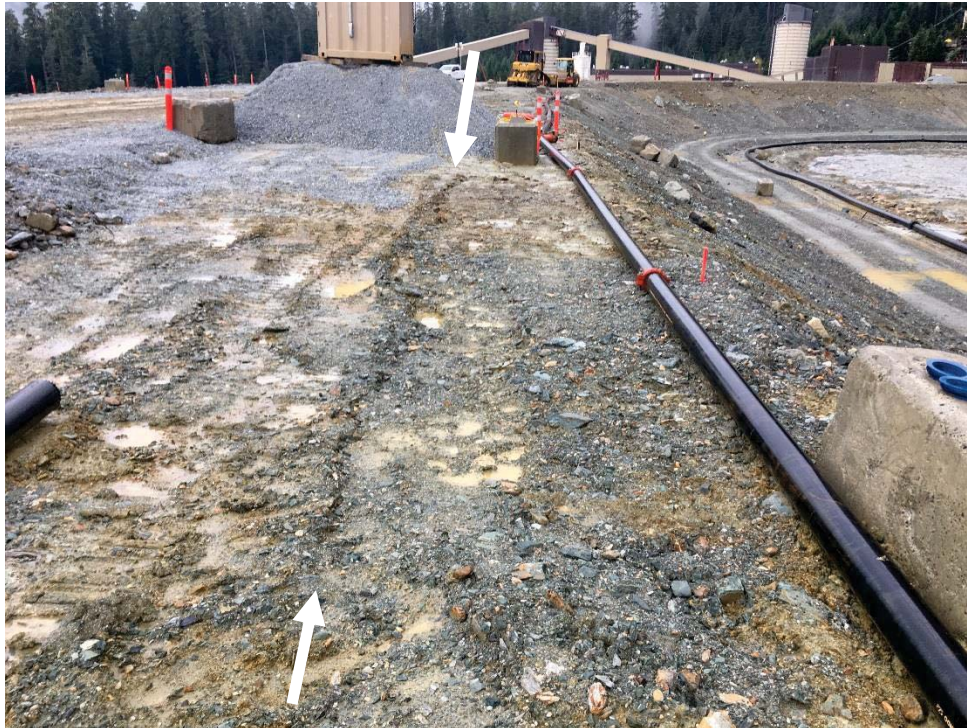
Photo 7: Crack on Lynx TDF Dam upstream crest near Plane E. The crack has apparent opening up to about 5 cm and has an apparent vertical offset of similar magnitude. This crack should be monitored for further development.
