Appendix D – EOR Monthly Dam Inspections

Myra Falls Mine Tailings Facility Field Review Report

Date of Field Review:	21 January 2019	Date of Memo:	24 September 2019
File No.:	NX14001B1	Client:	Nyrstar Myra Falls Ltd.
Engineer:	Dan Hughes-Games, P.Eng.	To:	Keith Watson, P.Eng.
With:	n/a	Cc:	
Weather:	Sunny, few degrees below zero. Most of site in shade of Mt. Myra throughout the day. Discontinuous snow cover on site, particularly in the shade.

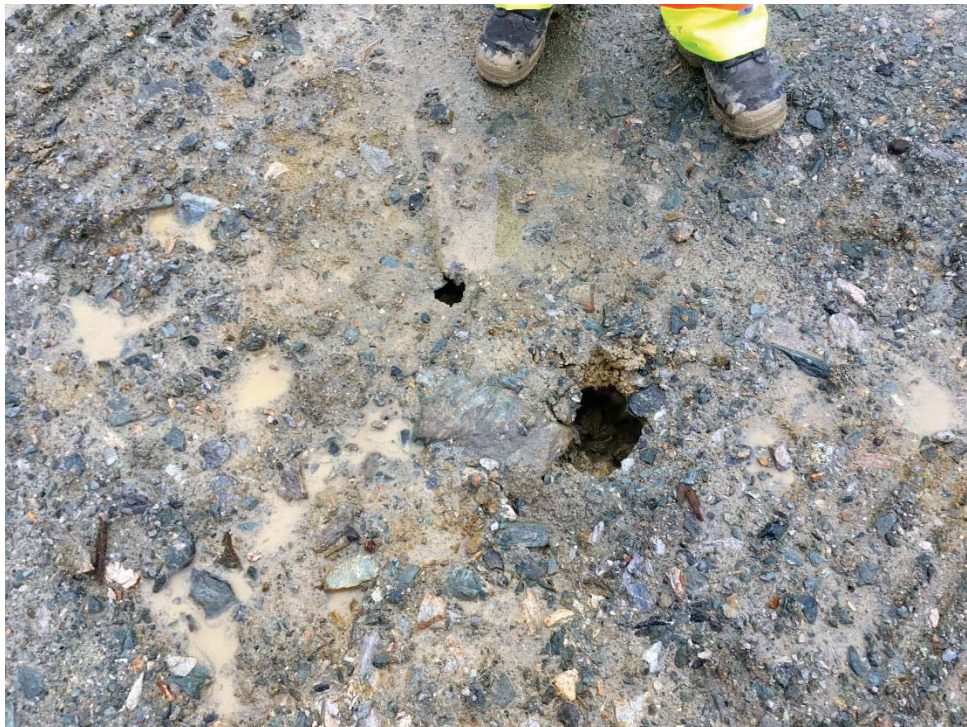
Photo 8: Voids found along the continuation of the alignment of the crack shown in Photo 7.

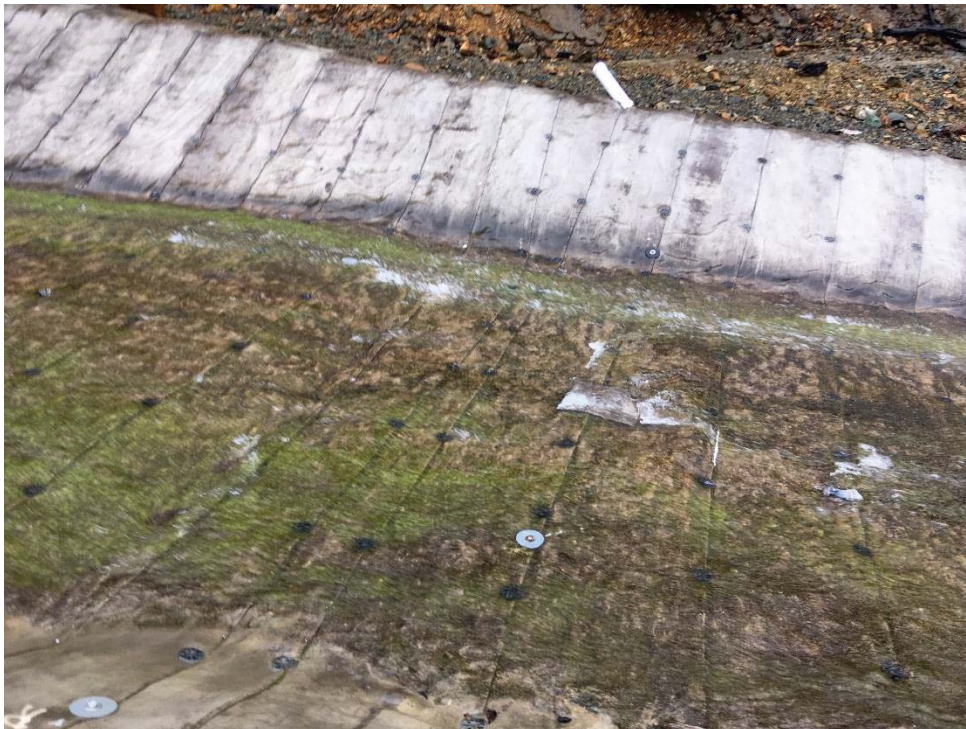
Photo 10: Repairs in the LLDD near the crest of the DD Hill, at the site of a puncture and delamination. The puncture has been patched and the delamination has been sealed with a caulking-type compound. This area should be monitored for performance in high-flows.
