## **Quinsam Coal Mine 2020 Dam Safety Inspections:**

**2 North Pit TDF and South Dam  
2 South Pit and 3 South Pit PAG-CCR Disposal Facilities  
Settling Pond 1 and Settling Pond 4**

PRESENTED TO  
**Bowra Group Inc.**

JUNE 16, 2021  
ISSUED FOR USE  
FILE: 704-ENG.DMPA03006-01

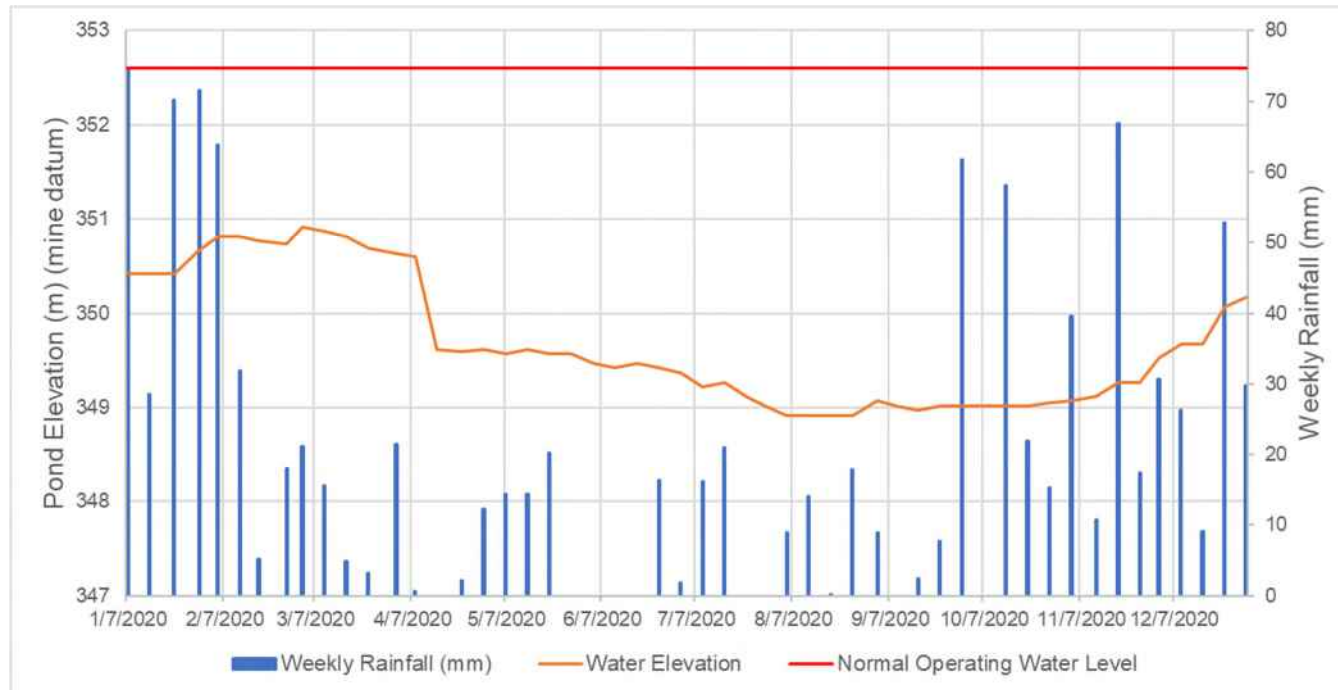
**Figure 6-1: North TDF Pond Elevation Compared to Weekly Rainfall**

Reported pond elevation and weekly total rainfall records provided by Quinsam, are shown on Figure 6-1, as can be seen water levels in 2020 were below the NOWL. Water levels in the pond were drawn down in early April in response to an ITRB recommendation that water levels in the TDF should be kept as low as reasonably possible to reduce immediate risk while the future of the dam is uncertain. The water level in the pond does not appear to be significantly influenced by rainfall. Based on the provided measurements the facility operated with more than sufficient freeboard throughout 2020 and there are no related dam safety concerns.

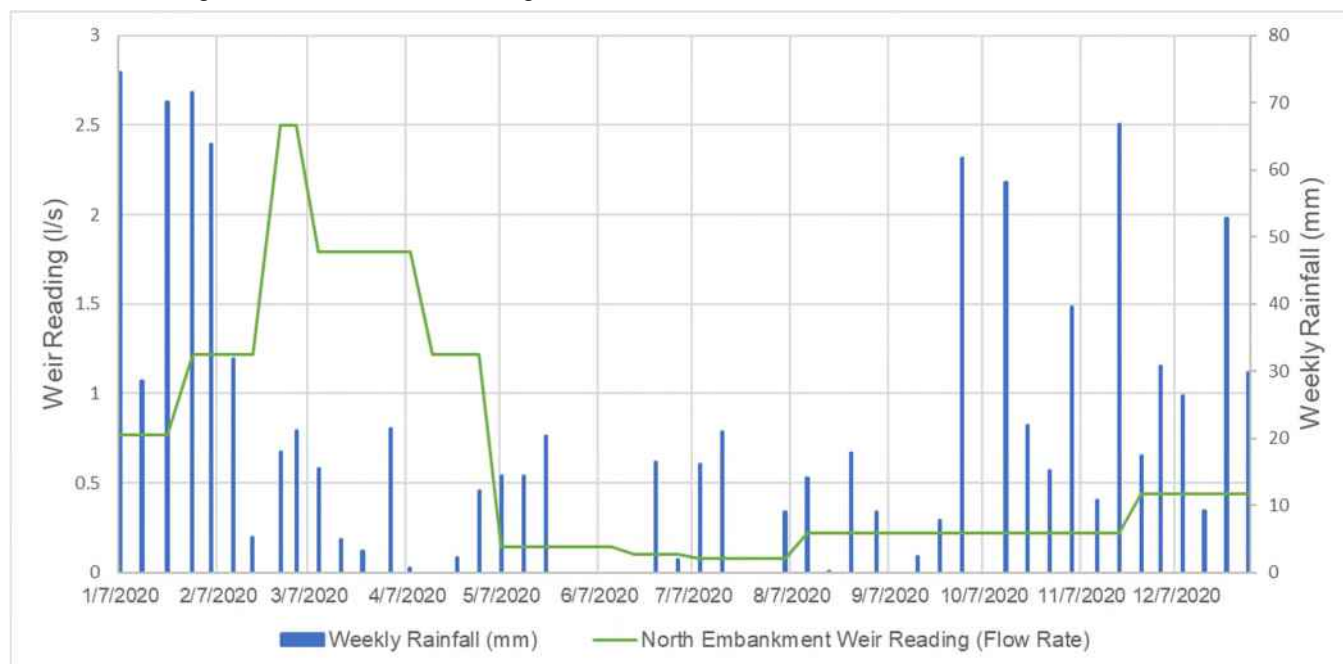
**Figure 6-2: North TDF, Flow Rate at Toe Weir Compared to Weekly Rainfall**

A weir is installed near the seepage discharge location to measure and track flow rates. The largest calculated flow rate at the weir in 2020 was 2.5 L/s, the largest flow rate since installation in 2014, was 21.7 L/s on October 19, 2017. Figure 6-2 shows the 2020 calculated seepage flow rates provided by Quinsam, and total rainfall for the week before the weir measurement was collected. It is noted in the weekly inspections that the weir is frequently submerged by the ponded water at the toe of the North Embankment, when this occurs seepage flow rates are estimated by Quinsam personnel. It is understood that in early 2021 the operation of pumping the pond at the toe of the North Embankment changed so that the weir is no longer routinely flooded. Weekly rainfall does not appear to significantly influence the seepage rate based on the provided data. The highest seepage rates occurred in February and March which is when the pond level was highest, and following periods of high rainfall and therefore higher groundwater levels. There are no apparent related dam safety concerns based on the provided seepage measurements as seepage is expected in this location and seepage rates measured were lower than previous measurements so do not indicate signs of deterioration or change.

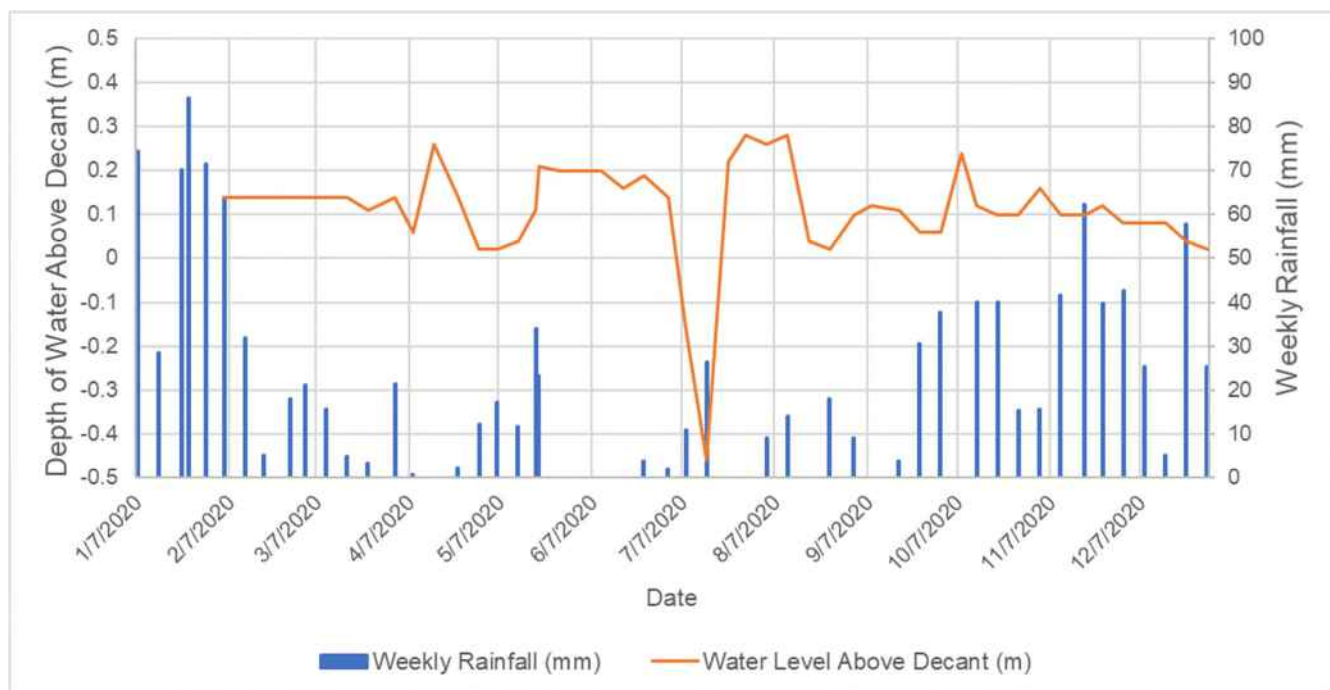
**Figure 8-1: SP4, Depth of Water Above Decant Compared to Weekly Rainfall**

Based on the readings the water level in the pond was relatively constant throughout the year. Based on these readings, and design elevations, about 2 m of freeboard below the spillway was maintained throughout the year. Water in the pond was often above the level of the decant (i.e. the pond was discharging) except for 1 week in mid July, when it was noted in the weekly inspections that the plant pump was turned on and water from underground was being diverted into the 2 North PAG Pond. Rainfall does not appear to significantly influence pond levels in the facility. As most of the water entering the pond is being pumped from other locations on site, this would be expected as the water level would be controlled by pumping rate. Based on the provided measurements the facility operated with 2 m or more of freeboard to the spillway, so there are no related dam safety concerns.

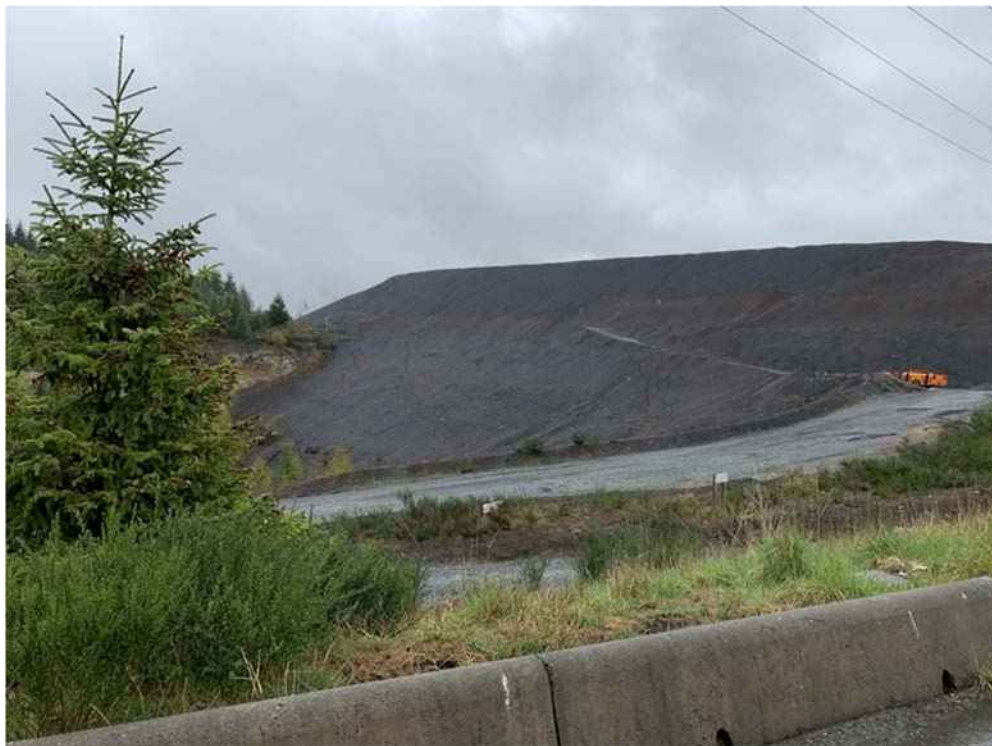
**Photo 1: 2-North Pit TDF, Downstream Slope of North Embankment Taken From the Site Office Parking Lot Looking Southeast.**

- Vegetation near northwest corner and west side of north embankment should be removed.
- Ponding on crest should be monitored and crest regraded if it increases in size.
- No cracking, slumping or evidence of instability was observed.
- No seepage was observed from the embankments, except at the North Embankment where it is expected.

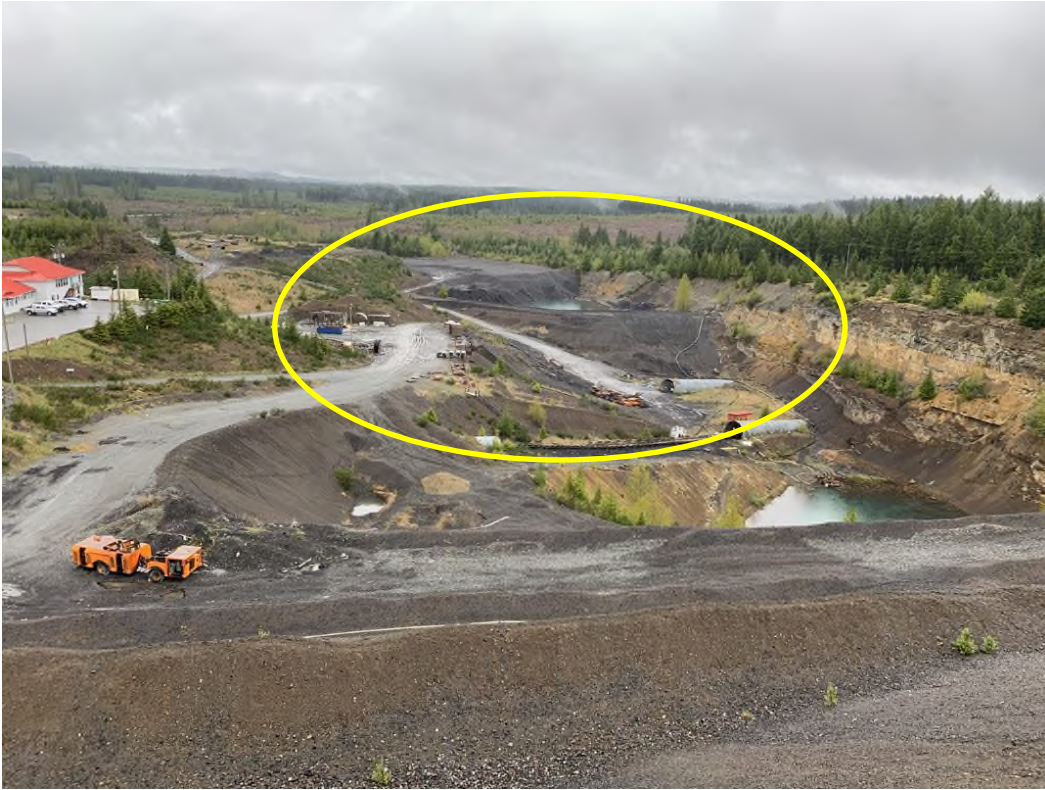
**Photo 1: Old TDF, South Dam circled in yellow, View of Facility Taken from the North Embankment of 2-North TDF, Looking North.**

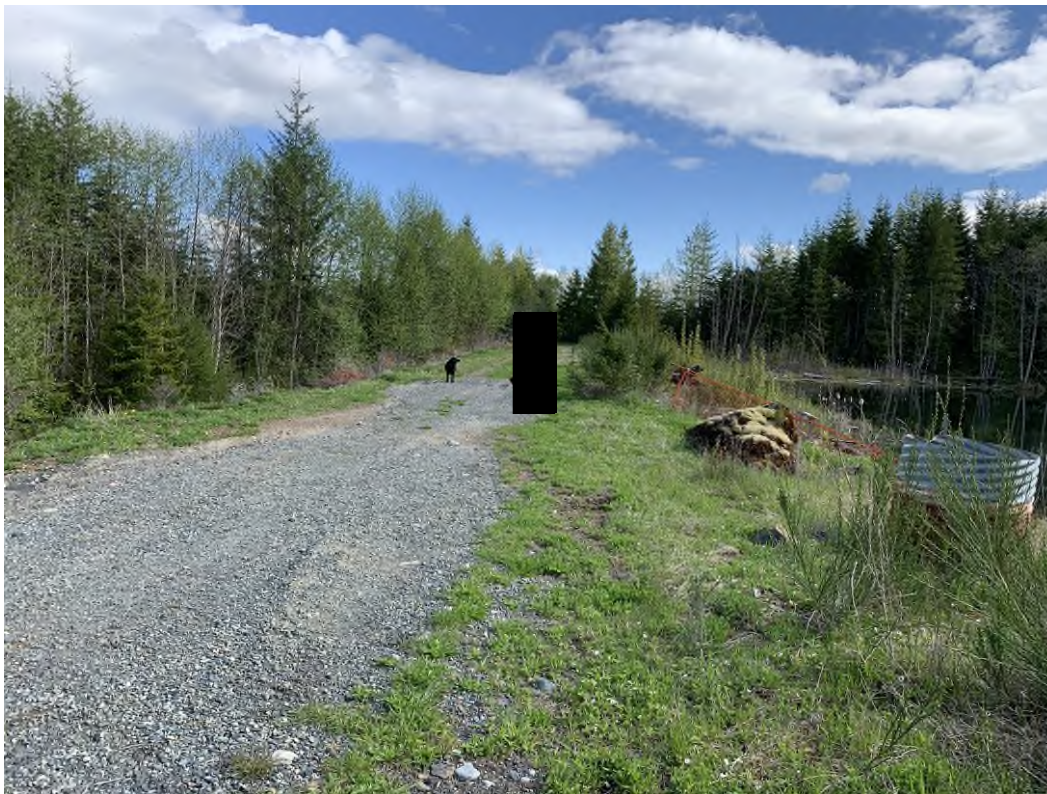
**Photo 1: Settling Pond 1 Dam Crest, Small Vegetation Growing on Upstream Slope, Ruts in the Centre of the Dam Have Been Infilled.**

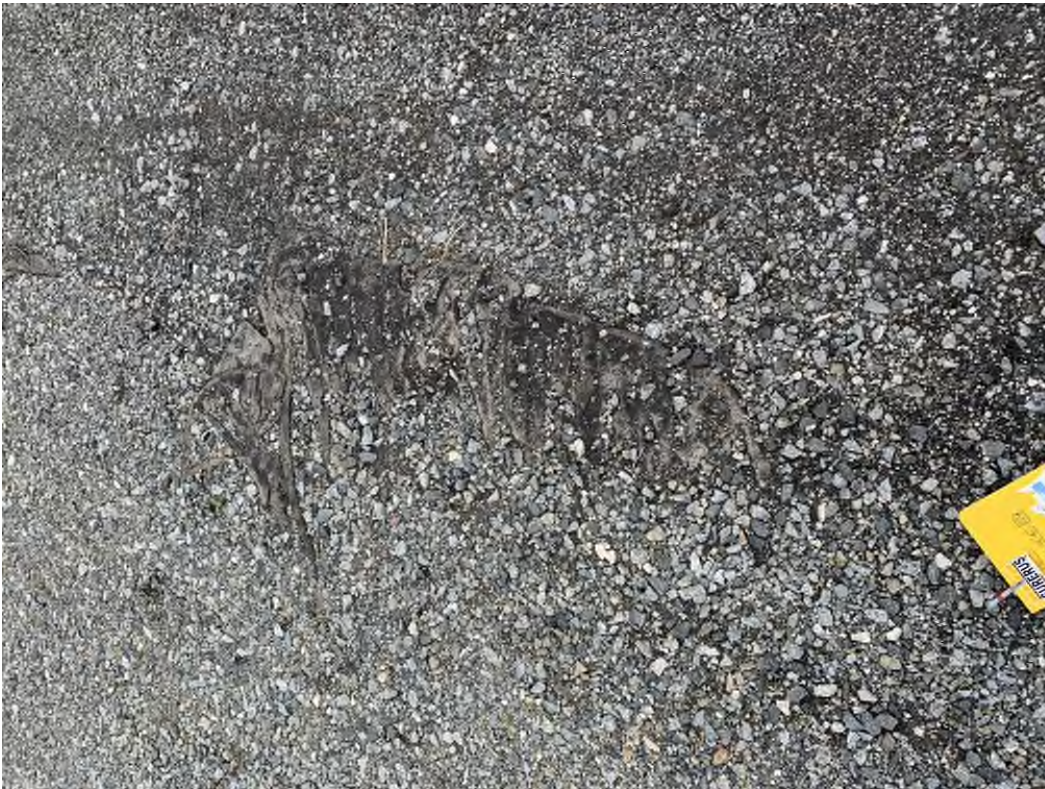
**Photo 36: Settling Pond 4 Exposed Geotextile on crest, from 2004 Low Level Outlet Repairs.**

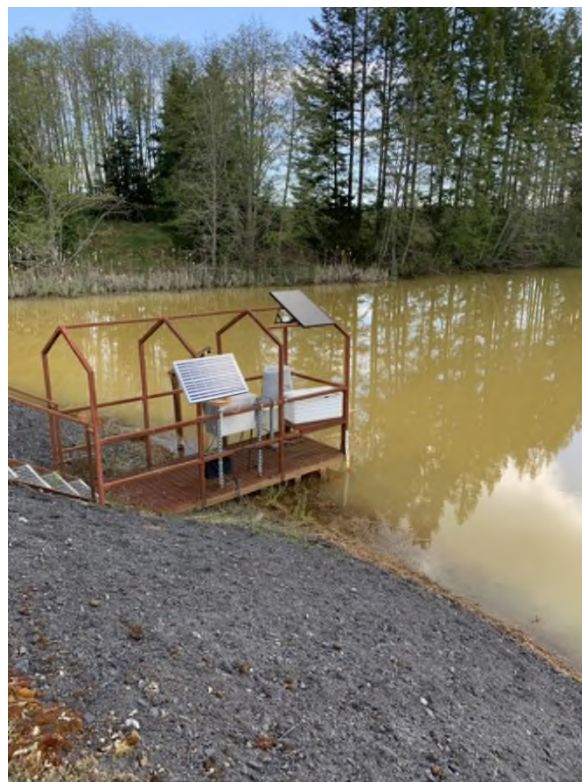
**Photo 37: Settling Pond 4 Inlet to Low Level Outlet Upstream and Staff Gauge, Looking Northeast.**

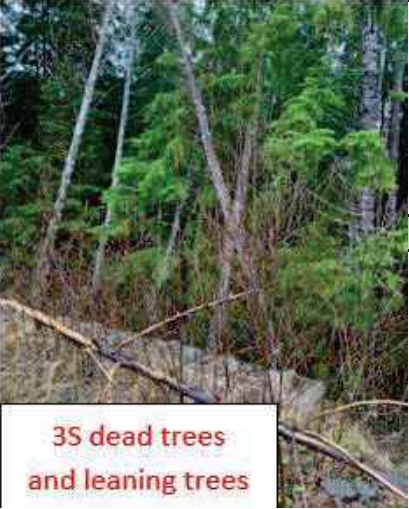
</div> <div>3S dead trees and leaning trees</div>
Settling Pond #1 (SP1)-South Water Management System		
Notes: Discharging at SP1, spillway is inspected, no issue.		
<div>Crest and Slopes Stability:</div> <div>Vegetation:</div> <div>Seepage:</div> <div>Animal Activity:</div> <div>Spillway:</div> <div>Water Management:</div> <div>pondings on the crest; no cracks, sinkholes, slides obseved on the downstream and upstream</div> <div>Maintained</div> <div>No</div> <div>Controlled</div> <div>No overflow in the spillway</div> <div>discharging at SP1</div>
