Report On
Quinsam Coal Mine Subsidence Assessment

Prepared for
Hillsborough Resources
Suite 950-1090 West Georgia
Vancouver B.C.
V6E 3V7

April 9, 2011

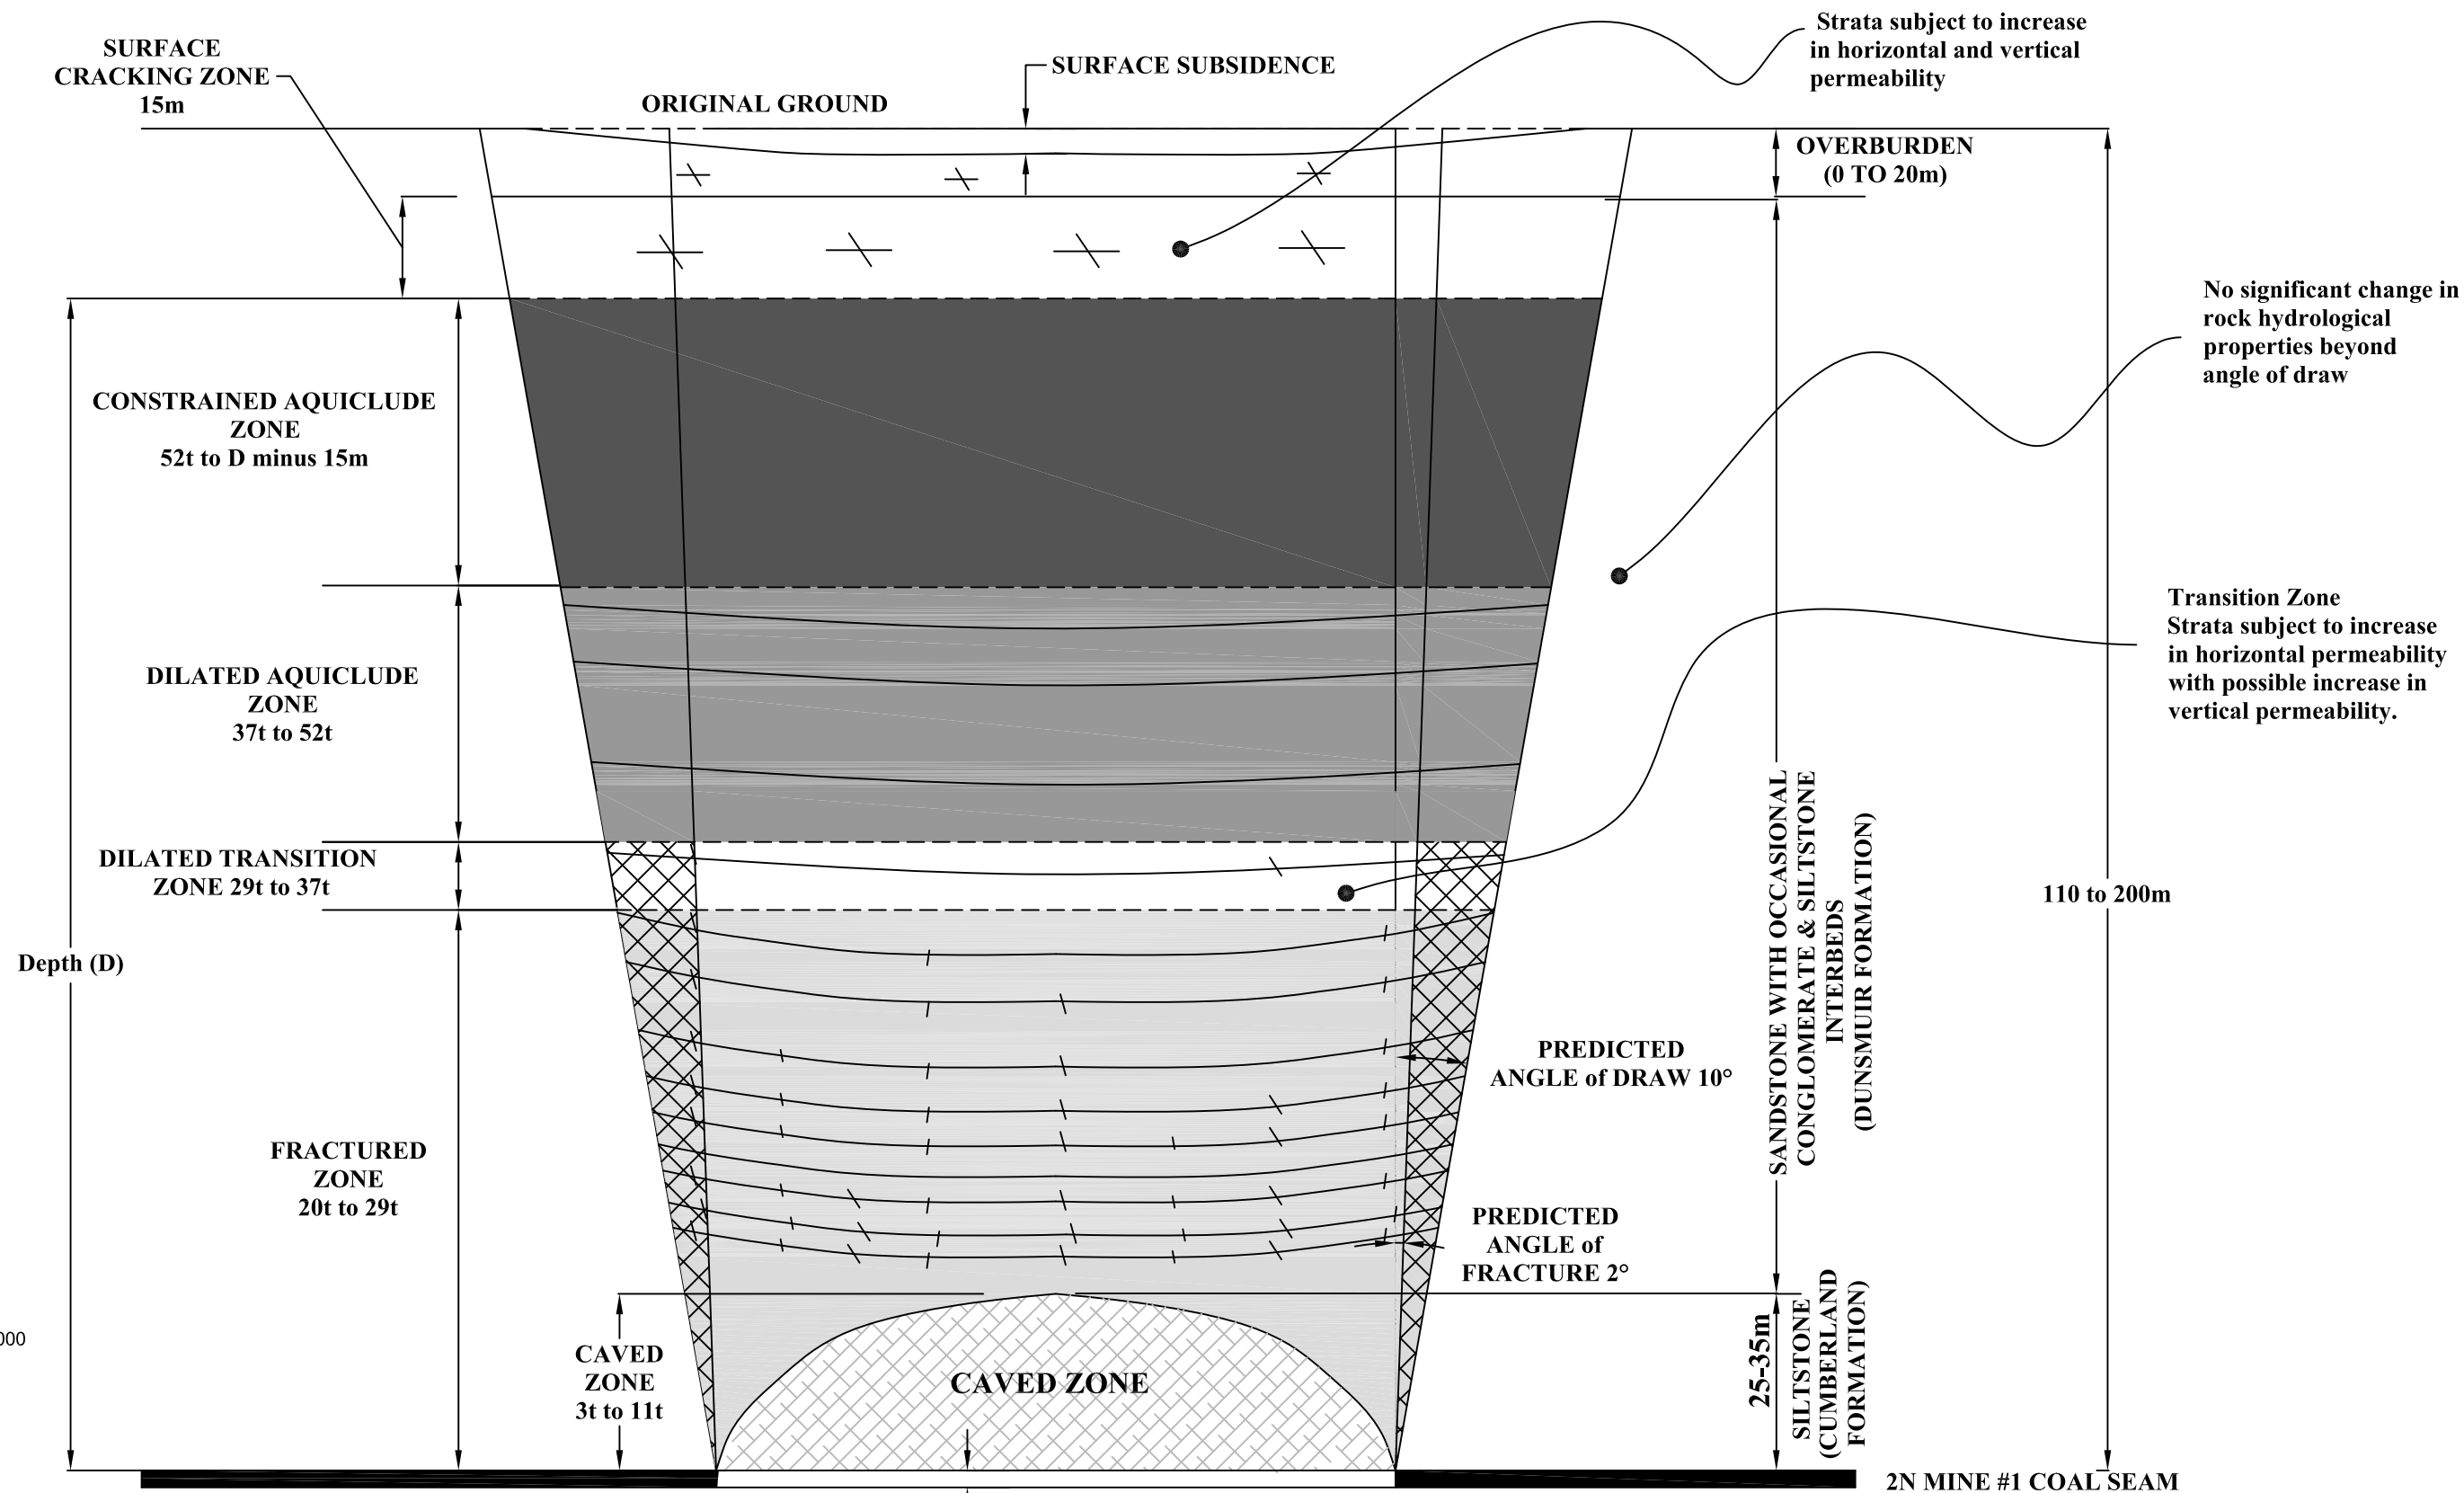
MICHAEL CULLEN GEOTECHNICAL LTD.				PROJECT QUINSAM COAL MINE SUBSIDENCE ASSESSMENT		
CLIENT HILLSBOROUGH RESOURCES QUINSAM COAL MINE				TITLE SUBSIDENCE ZONES ABOVE #1 SEAM		
DATE	2011/02/01	DWN.	JMG	CHKD.	MC	FILE NO. 2009-16
						FIGURE 15

Strata movement in area between angle of draw and angle of fracture is primarily bending and bed separation resulting in an increase in horizontal permeability only.

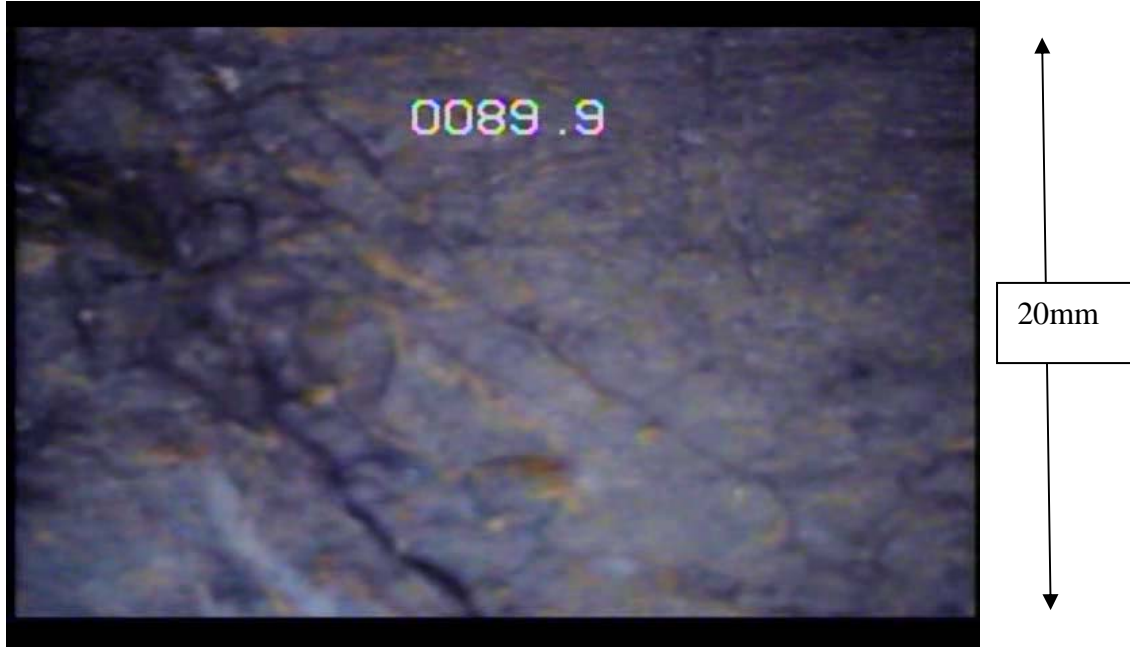
Photo 1: DH Qu10-15 26m depth.

Surface fracture zone. Fractures appear new but on pre-existing weakness plane.

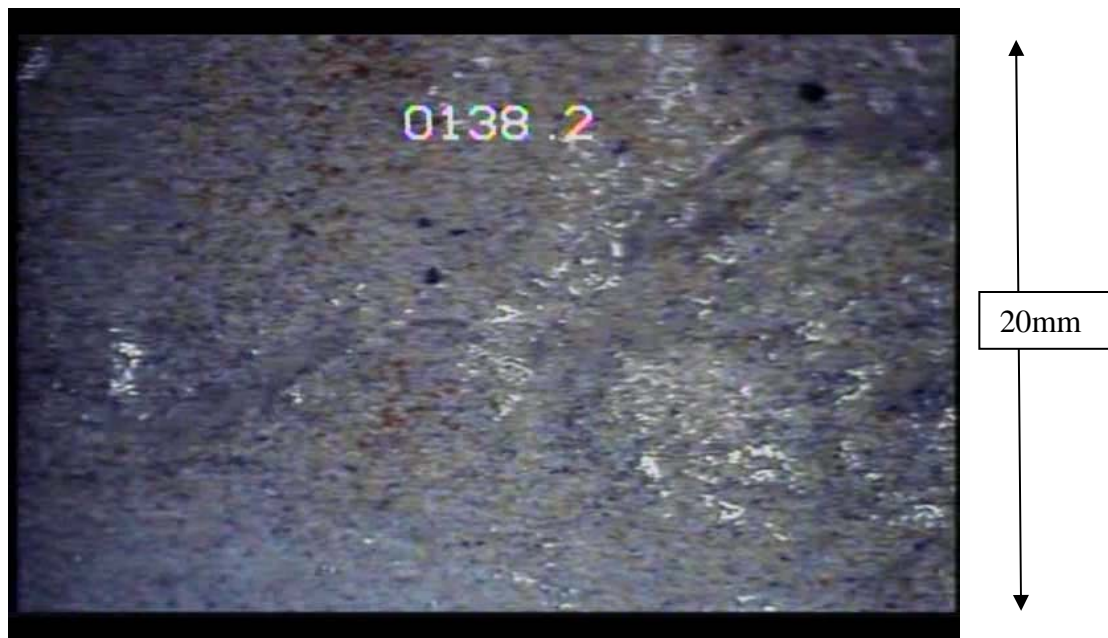
Photo 2: DH Qu10-15 40m depth.

Sandstone within constrained zone, $K < 1E-8$ m/s

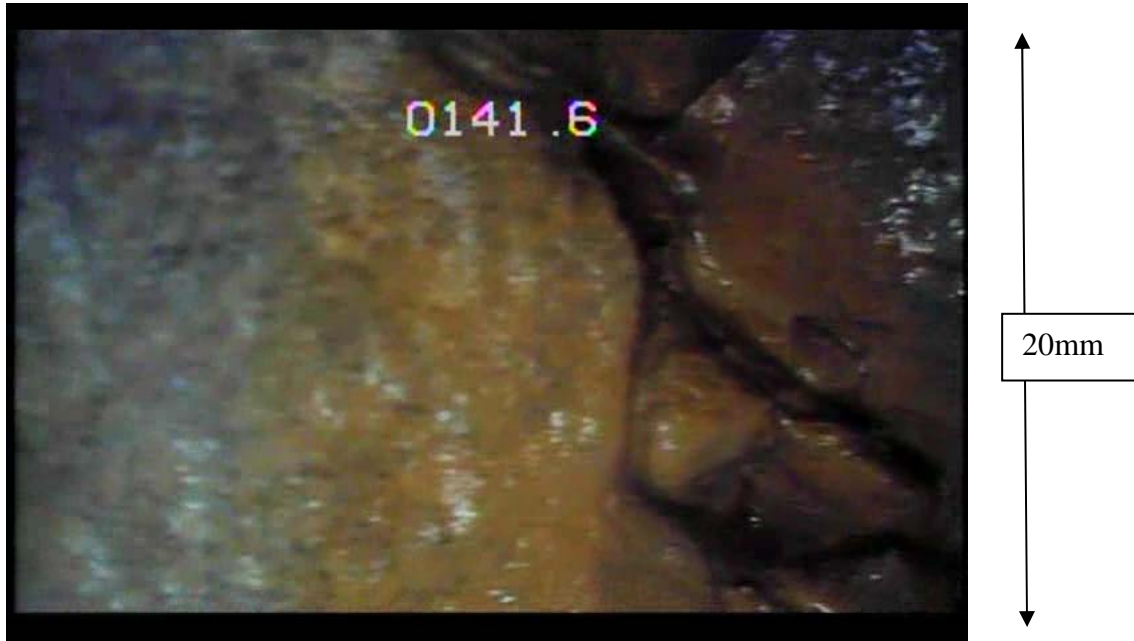
Photo 3: DH Qu10-15 41m depth.

Sandstone within constrained zone, pre-existing fracture, open and fe stained.

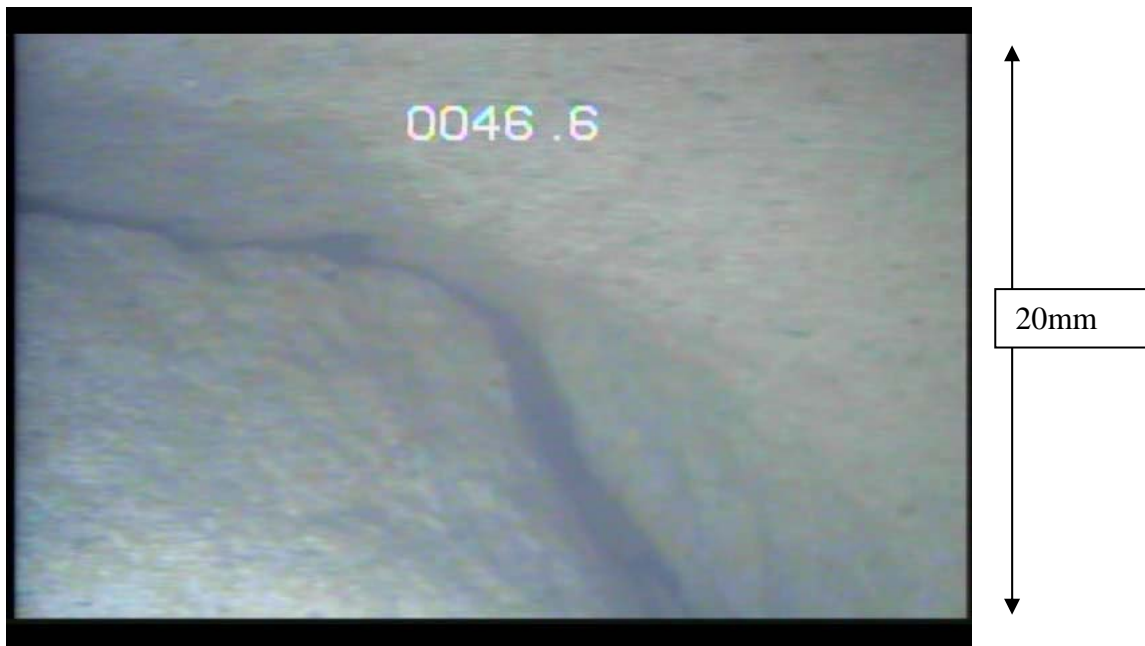
Photo 4: DH Qu10-17 14m depth.

Pre-existing fracture within constrained zone . Encountered large inflow of water during drilling.

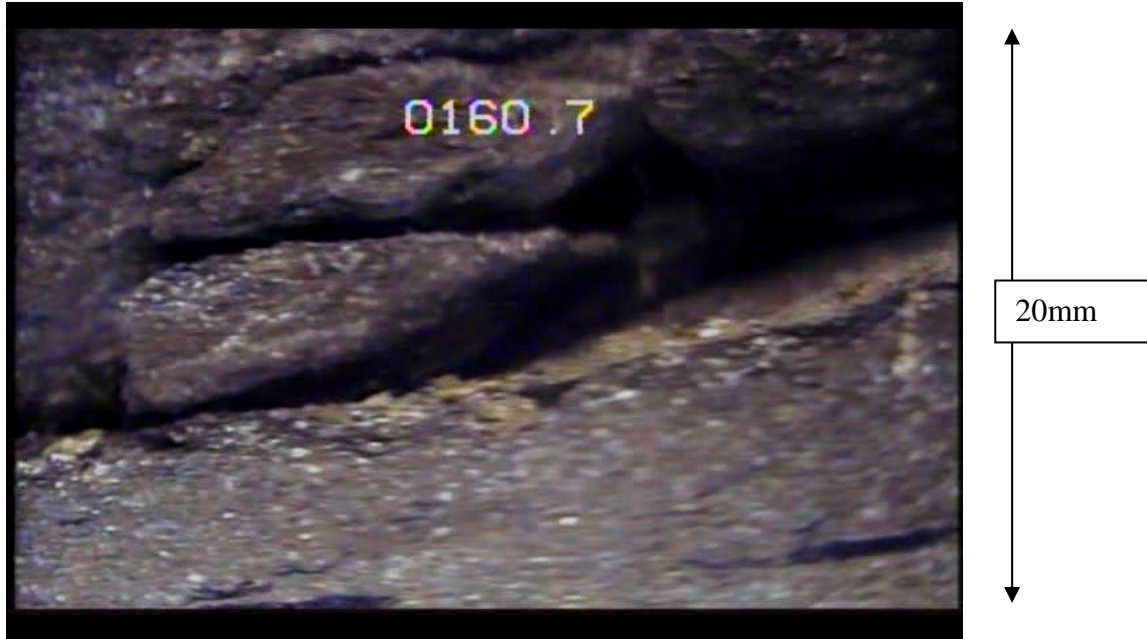
Photo 5: DH Qu10-17 48m depth.

Open bedding plane fractures within dilated aquiclude zone.

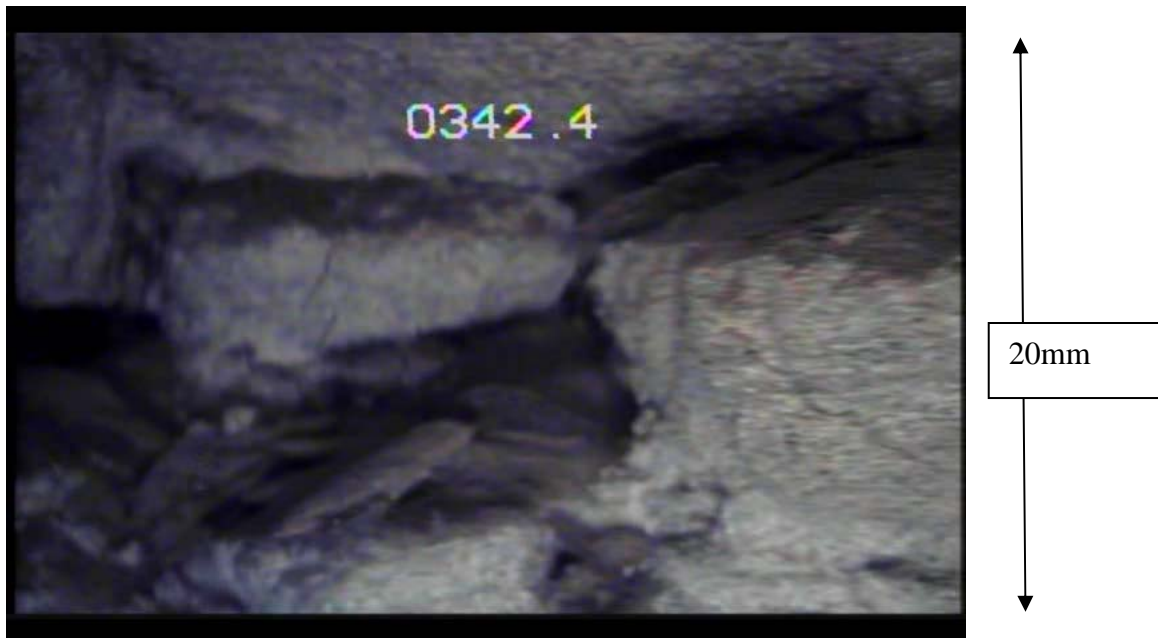
Photo 6: DH Qu10-14 100m depth.
Rubble zone within caved or lower fractured zone.

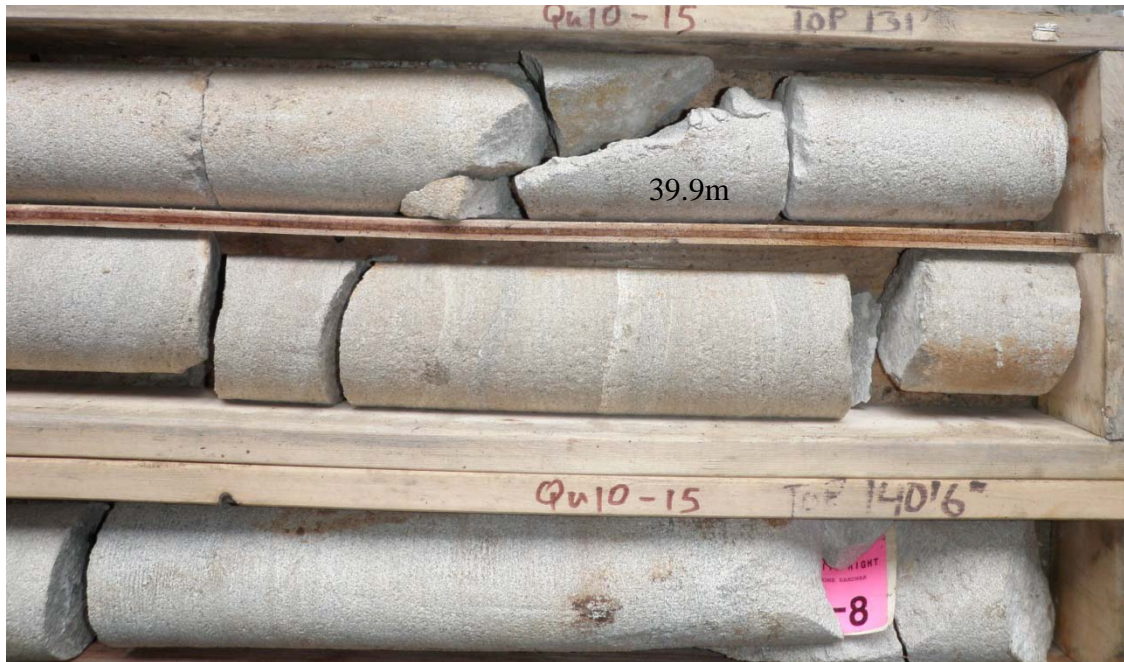
Photo 7: DH QU10-15, 39.9m depth. Pre-existing fracture 20 degrees TCA with fe stain.

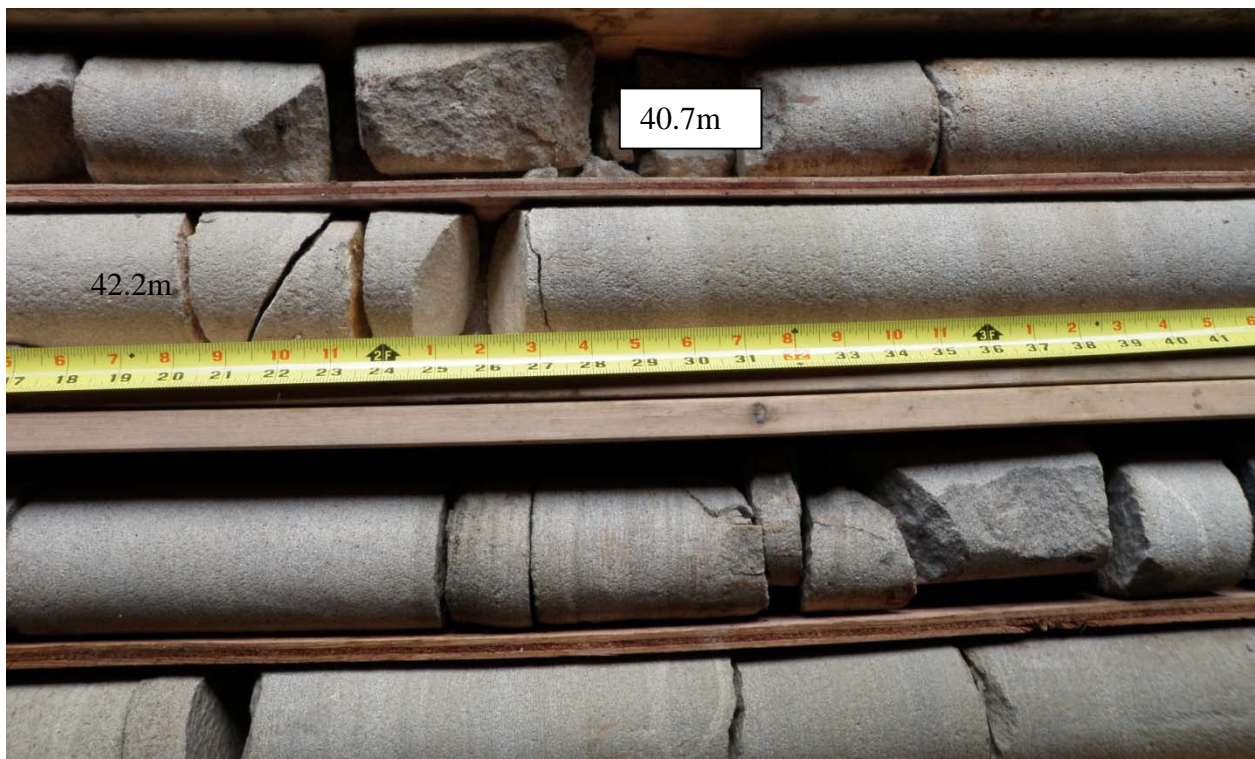
Photo 8: DH QU10-15. 40.7m depth, joint/fault 15 degrees TCA with trace gouge (non softening). 42.2 joints at 85 and 65 TCA with Fe stain

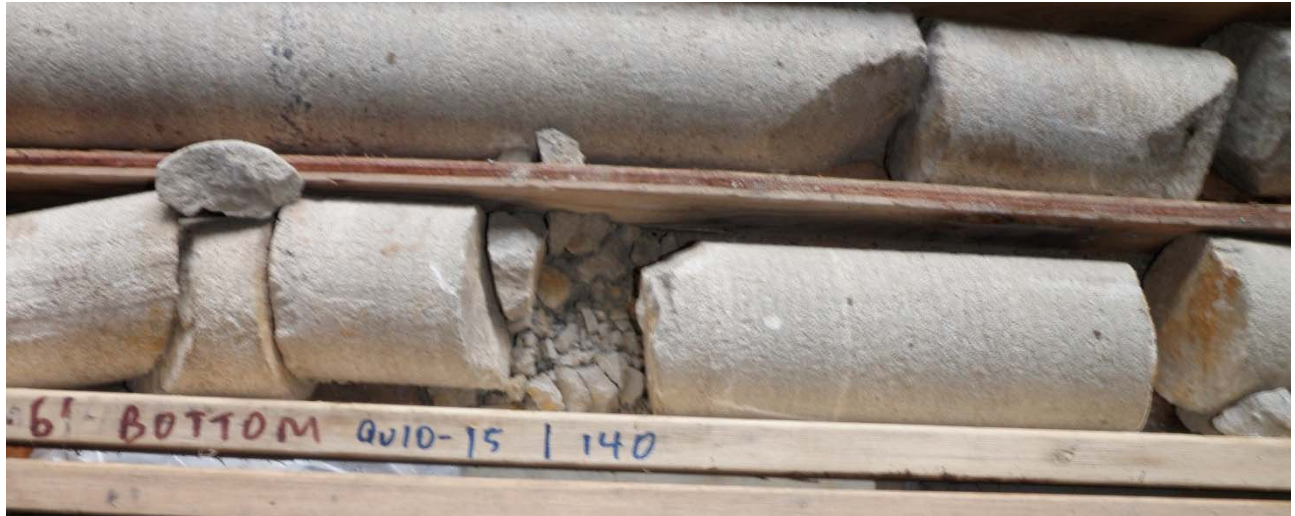
Photo 9: DH QU10-15. 42.7m (140 ft) depth . 30mm fault zone with gouge and rubble on bedding plane

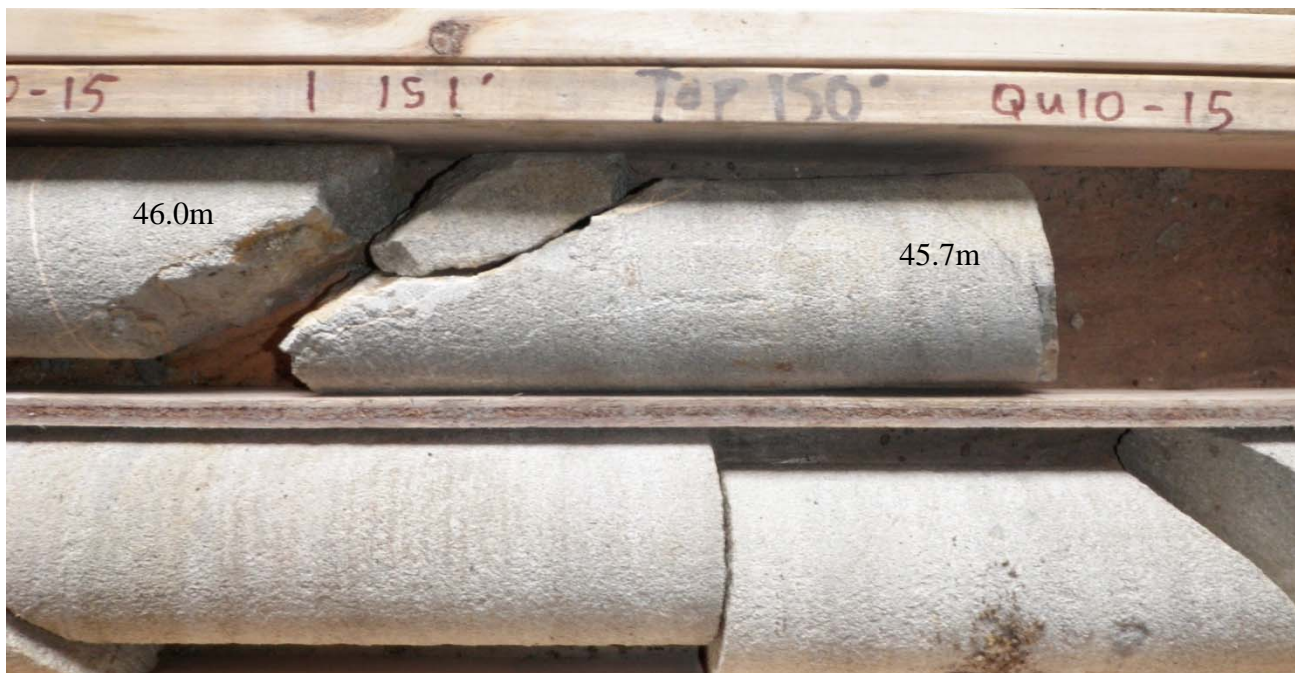
Photo 10: DH QU10-15. 45.7m depth open micro-fracture 65 degrees TCA. 46.0m depth fault with trace gouge, fe stain, calcite coating

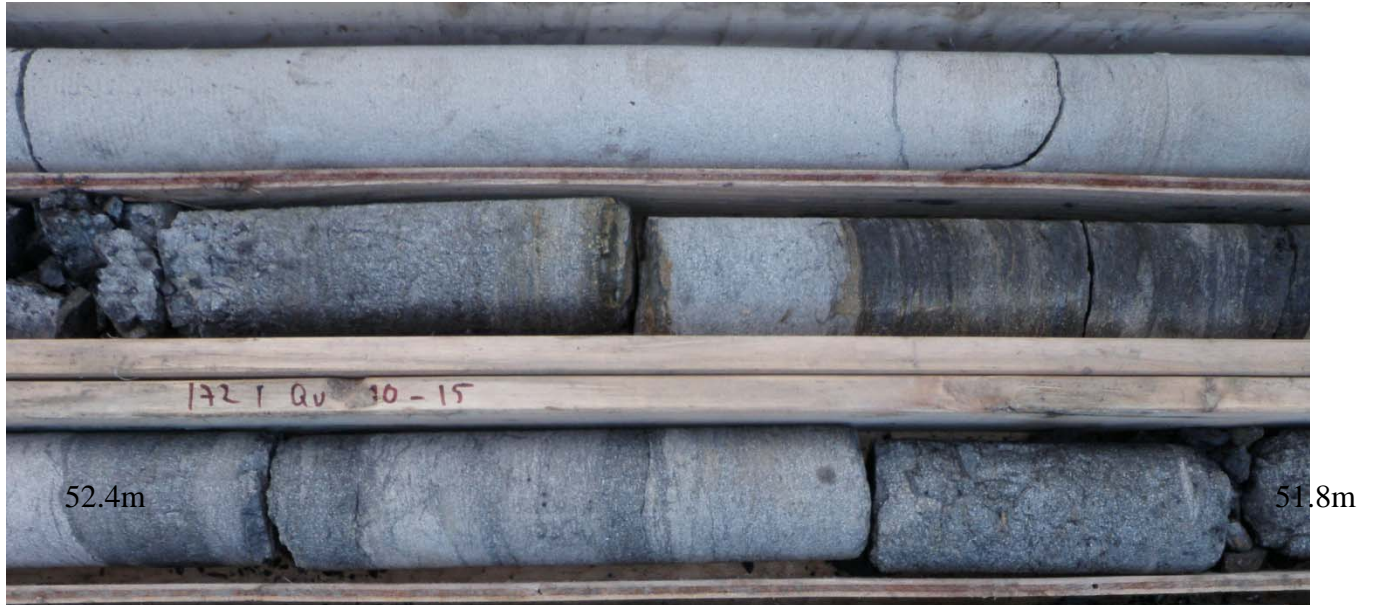
Photo 11: DH QU10-15 51.8m to 52.4m open micro-fractures in carbonaceous sandstone

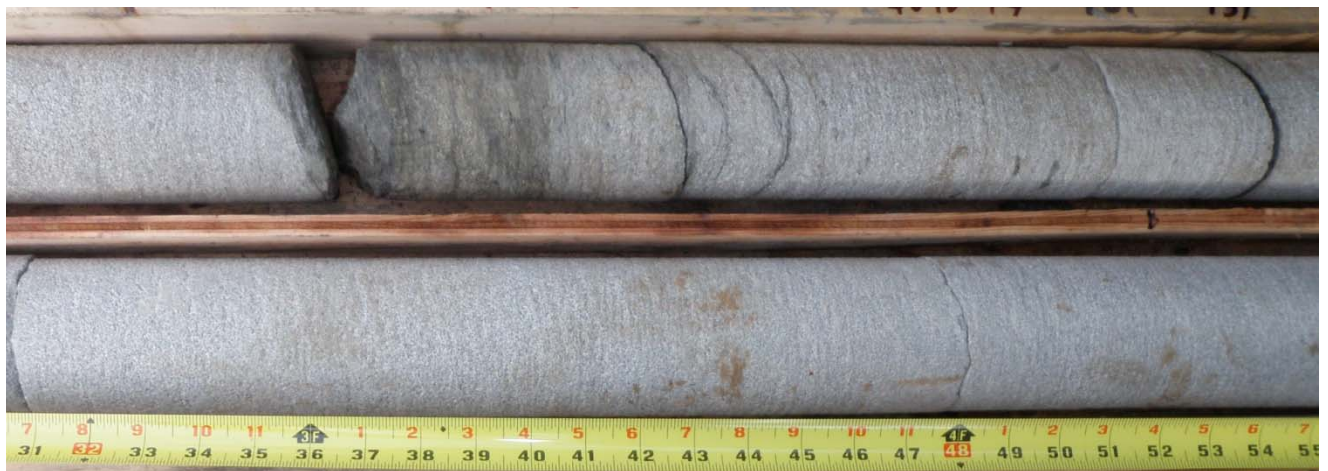
Photo 12: DH Qu10-17 46.5m. Open micro-fractures on dark mineral bands
