2021 TDF Dam Safety Inspection Report

Myra Falls Mine Ltd.
Myra Falls Mine Tailings Disposal Facilities
Project # NX14001B3.1

31 March 2022

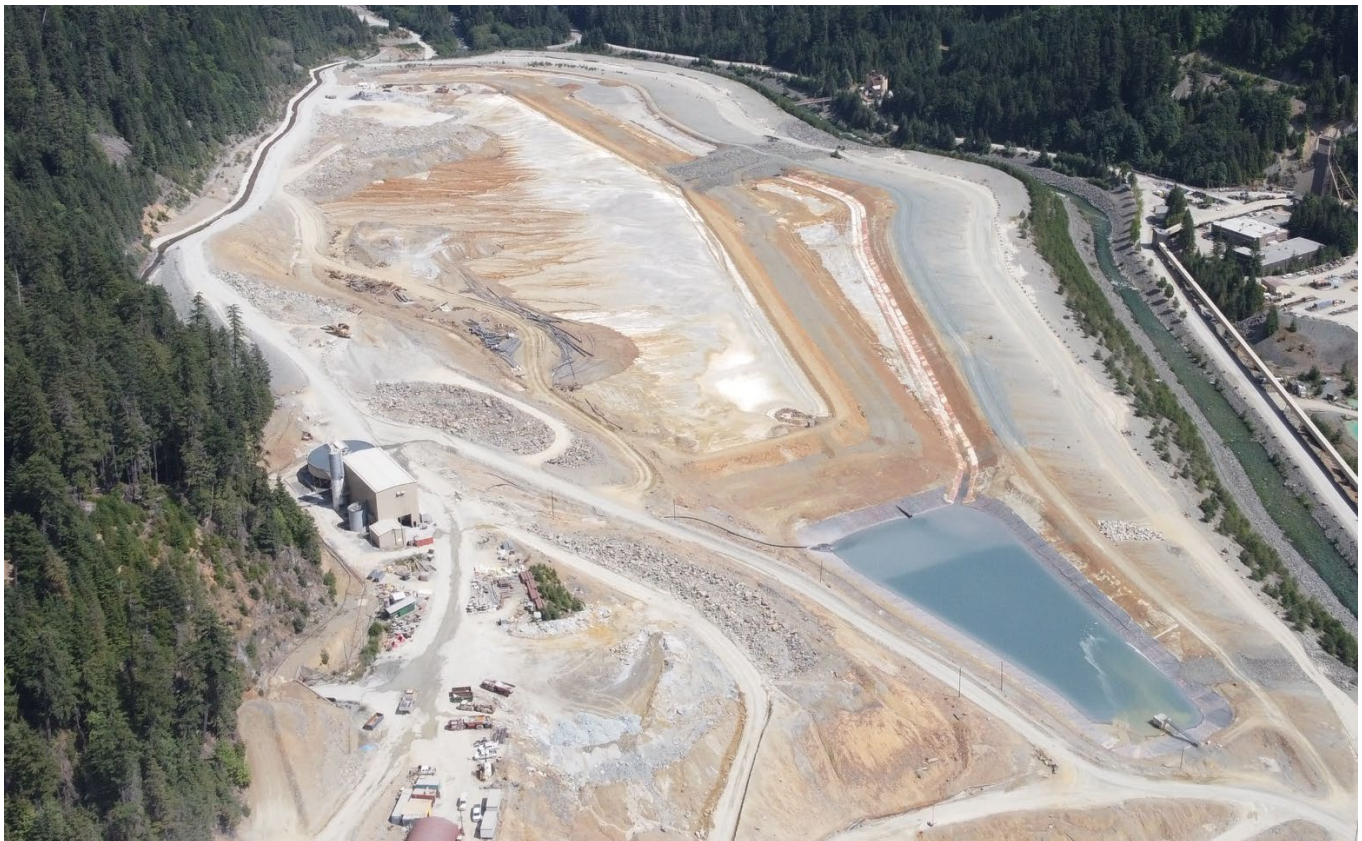
Photo 12: Old TDF and Surge Pond overview. (Image by MFM, July 2021)
