REPORT NO. 212022/2

MYRA FALLS MINE

2021 RECLAMATION REPORT FOR MINES ACT PERMIT M-26

March 2022

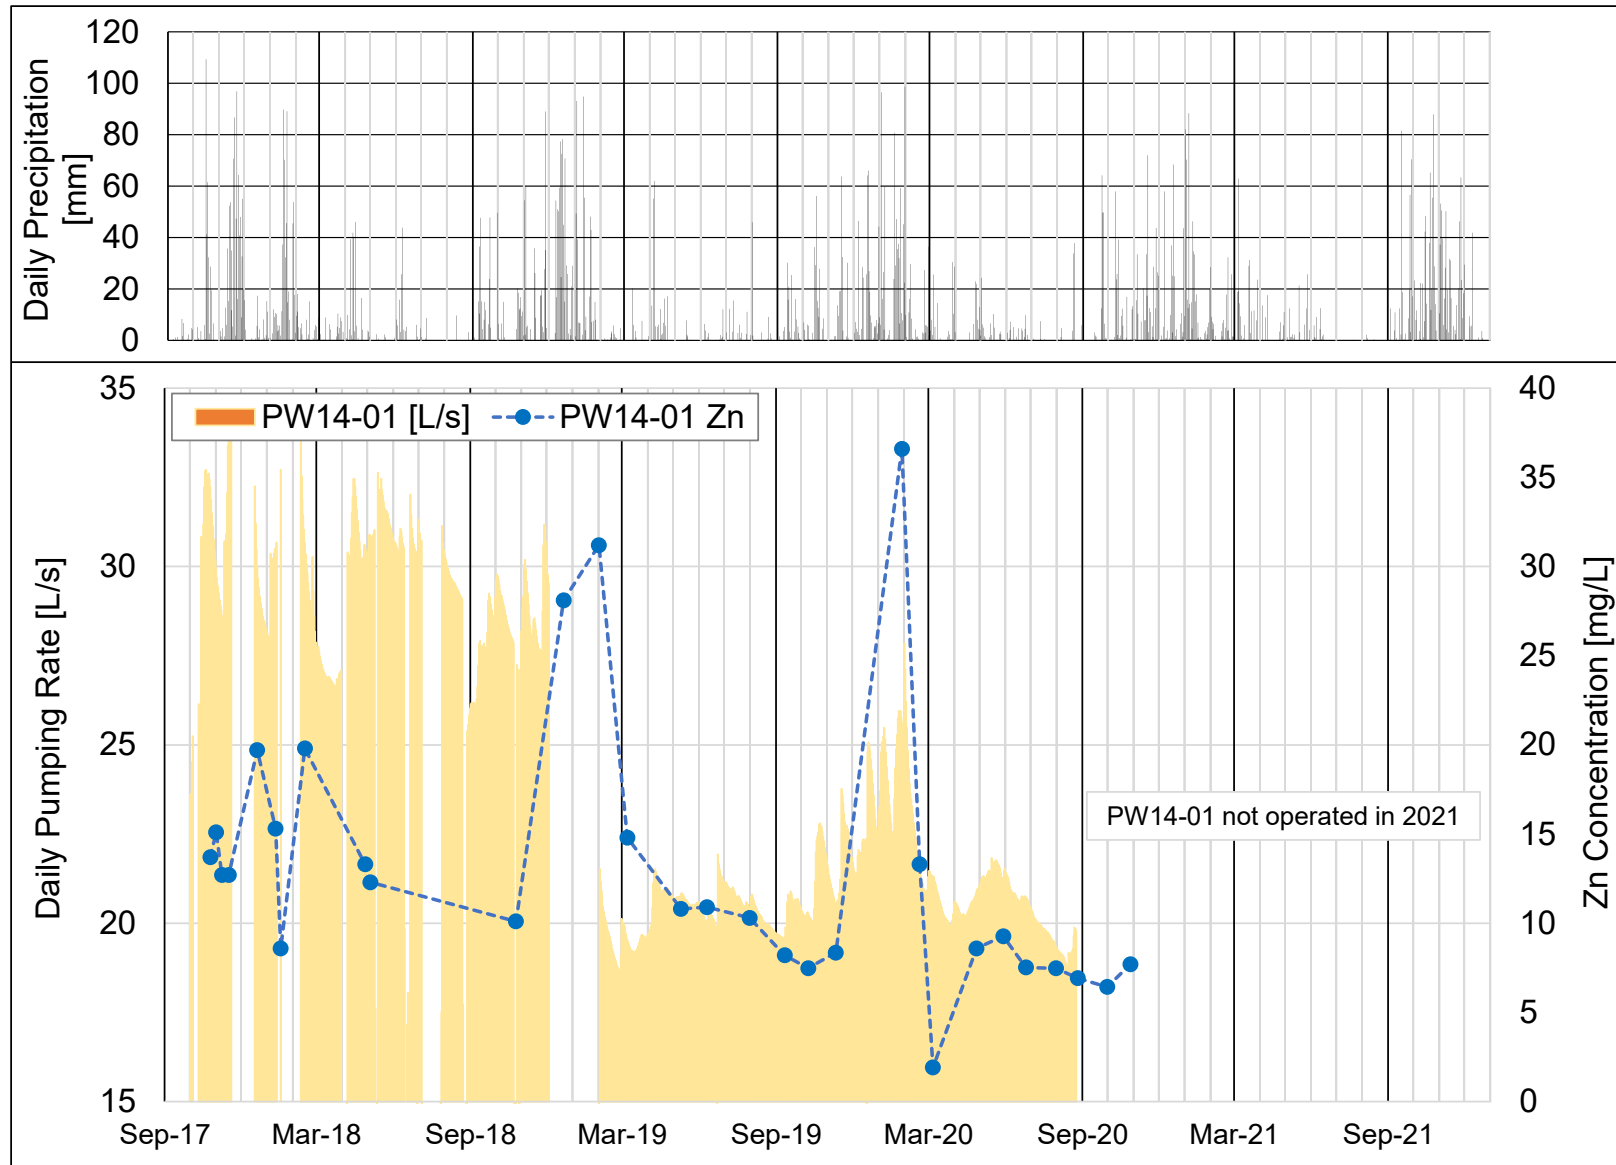
- *Pumping Well PW14-01.* The battery of the data logger died on August 24th, 2020, and hence recording of the pumping rate and dynamic water level in this pumping well stopped in mid-2020. MFM personnel reported that pumping well PW14-01 has not been operated since November 2020. The last water quality sample collected at pumping well PW14-01 was on October 28th, 2020. The wellhead was reconnected in September 2021 and electrical systems restored in November 2021 after RGC's site visit. Restarting of the system, however, failed with fault codes reading a stall prevention error indicating potential seizing of the motor.

Figure 4-5. Observed Pumping Rate and Zn Concentration at Pumping Well PW14-01. Note: This pumping well was not operated in 2021

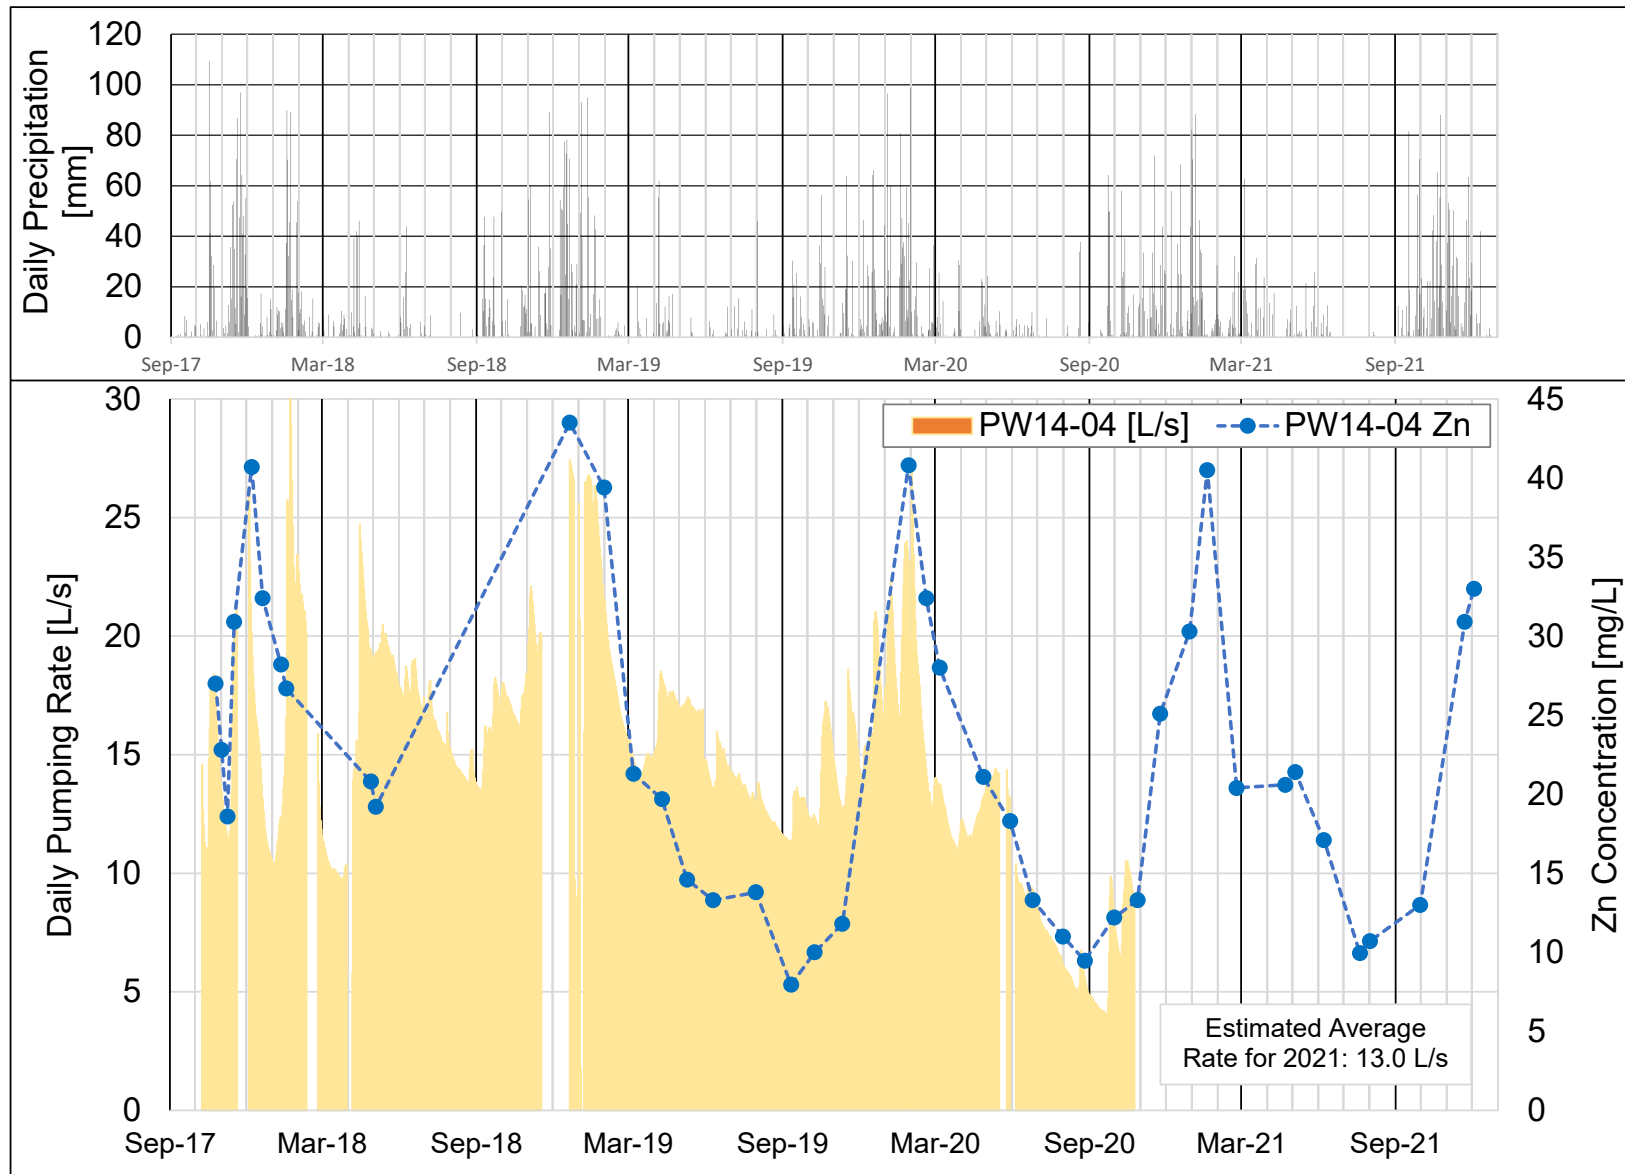
In 2021, pumping well PW14-04 did not appear to provide full hydraulic capture, hence some bypass of ARD/ML-impacted groundwater most likely occurred. This is supported by groundwater levels observed in November 2021 and routine groundwater water quality results for wells downstream of the Phase I Lynx SIS (see discussion below). Note, the Interim Phase II Lynx SIS was not operating at the time of the groundwater level survey in November 2021 and shallow groundwater was likely discharging to Myra Creek, as indicated by horizontal hydraulic gradients directed towards the creek.

- *Pumping Well PW14-04.* No flow records exist beyond October 24th, 2020, due to dead batteries for the data logger. Batteries were replaced and the flow logger restarted in March 2022. However, water quality observations for late 2020 and 2021 suggests that pumping well PW14-04 continued to operate for most of 2021. Water quality sampling and observations by MFM field personnel suggest that pumping well PW14-04 was not operating for some time in October 2021 but resumed after this interruption. The pump likely operated at an increased set level throughout most of 2021 resulting in a decrease of pumping rates by around 35% (relative to 2020 rates).

Figure 4-7. Observed Pumping Rate and Zn Concentration at Pumping Well PW14-04

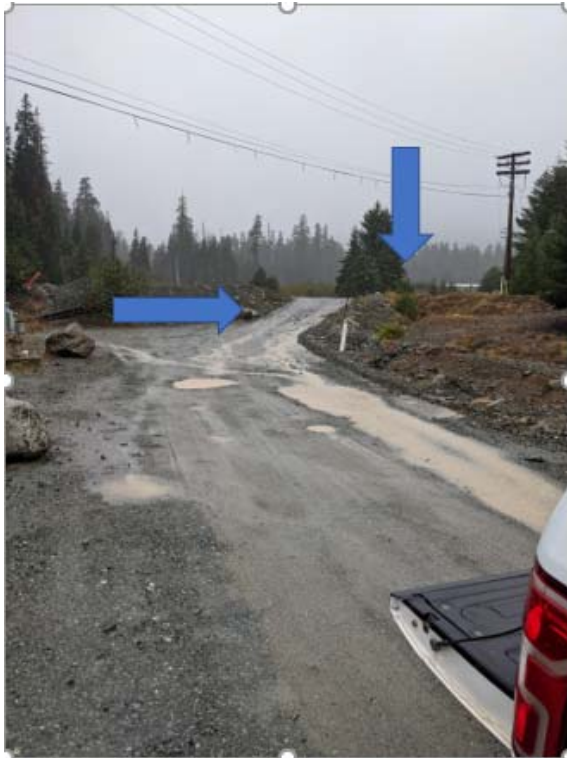
Figure 2 shows the water flowing down the road near 25 sump (horizontal arrow), with the drainage ditch indicated in the background by the vertical blue arrow.

Figure 2: Water running down road, with ditch in background

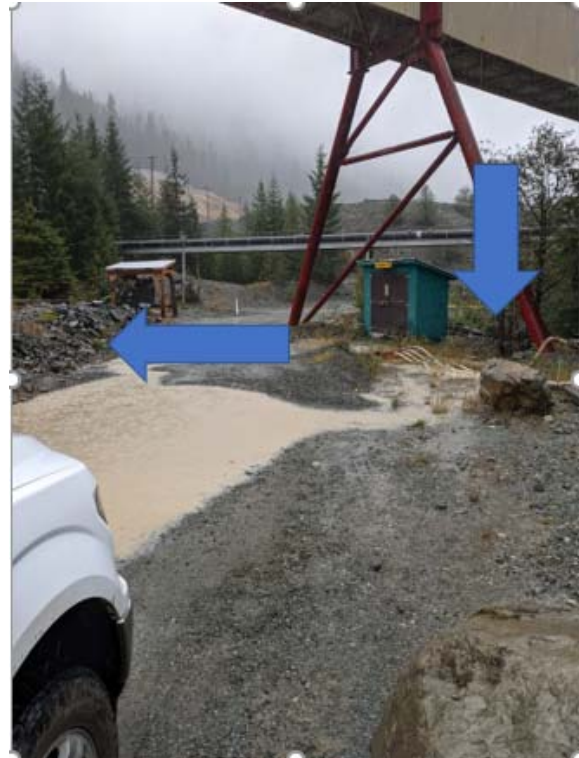
Figure 3 shows the 25 sump inlet ditch berm (horizontal arrow) in the background, with the pooled water in the foreground. The vertical arrow shows the location the water was draining to Myra Creek.

Figure 3: Water discharge location, with ditch berm in background

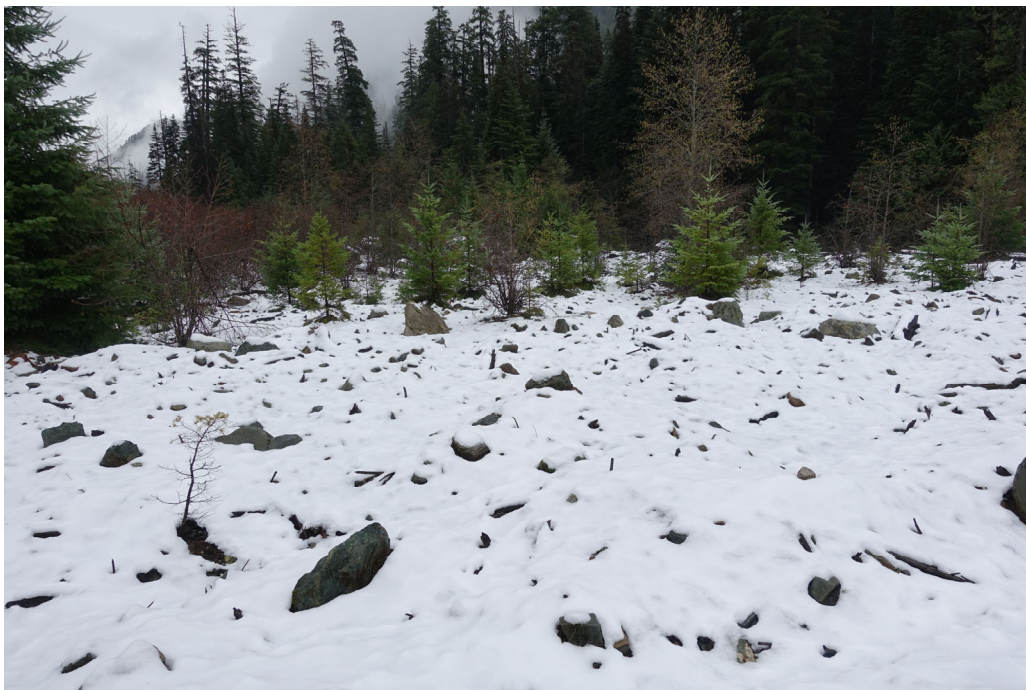
Figure 1. Bare (foreground) and naturally regenerating (background) areas at the ETA.

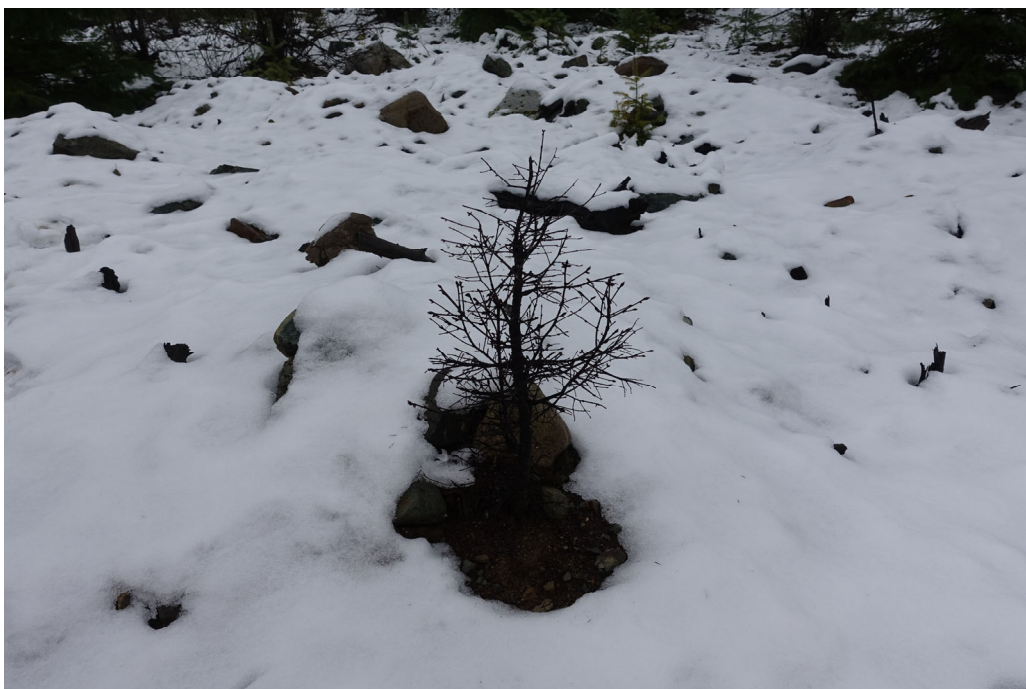
Figure 2. Dead seeding in an unvegetated area on the ETA.

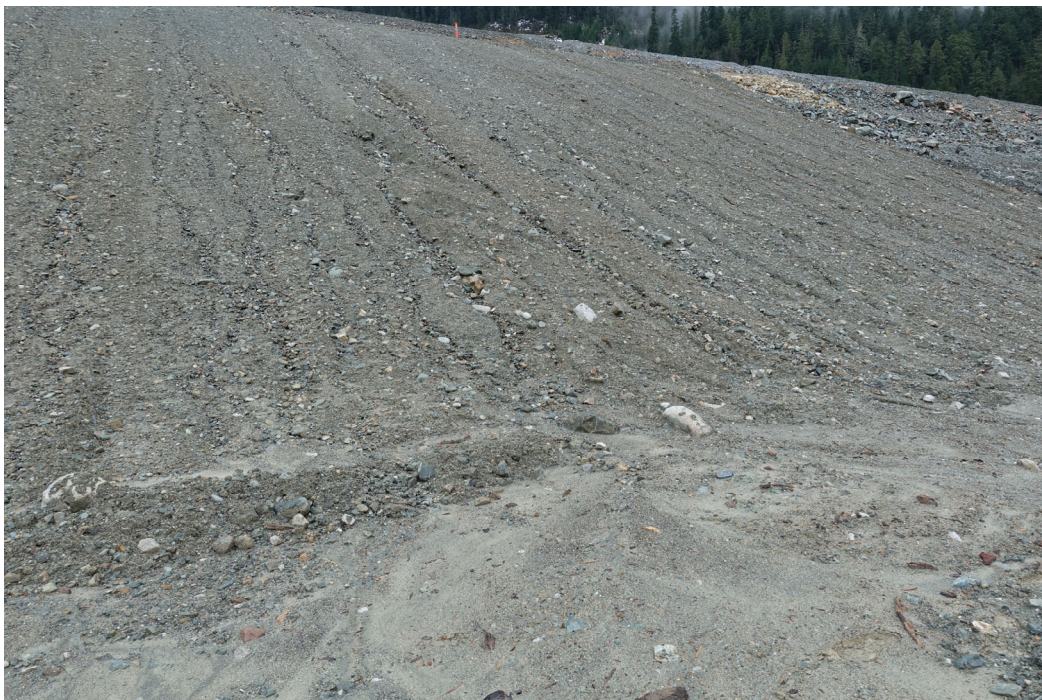
Almost 300 mm of rain fell at the Myra Falls Mine between the date of cover completion on October 31, 2021 and the date of this reclamation inspection on November 11, 2021, including 180 mm of rain in the four-day period from Nov. 2-5, and another 50 mm of rain on Nov. 9. The cover trial consists of a 60-m long section of a 20-m 2H:1V slope length. On this slope length and gradient, surface erosion from the above precipitation was relatively substantial (Figure 4), with formation of rills 5-20 cm deep (Figure 5) and correspondingly large/deep deposition fans at the toe of the covered slope (Figure 6). There was an additional 40-cm deep erosion hole in the cover, likely caused by a combination of local slumping and downward washing of cover materials (Figure 7).

Figure 4. Erosion rills and deposition fans on the Lynx TDF closure cover trial.

- Fall cover placement is difficult, as fall and winter precipitation is delivered and runs off prior to any establishment of vegetation. Cover performance will likely be enhanced if covers can be placed in the spring, revegetated immediately, and have a full vegetation growing season prior to being subjected to substantial precipitation delivery in the non-growing-season months.

- Although hydroseeding can be expensive and over-used, the configuration and materials of the Lynx cover material lend themselves to this application technique. The combination of some fine materials and steep, relatively short slopes means that hydroseeding is feasible, and would likely be effective at retaining seeds on the cover surface (i.e., resisting erosion of seeds). The addition of mulch in the hydroseed could provide some initial erosion protection, and co-delivery of water at the time of seeding could assist in seed germination in the spring. Seeding species selection or mixes do not have to be altered for hydroseeding, but application rates should be increased to account for damage to seed during the application process.

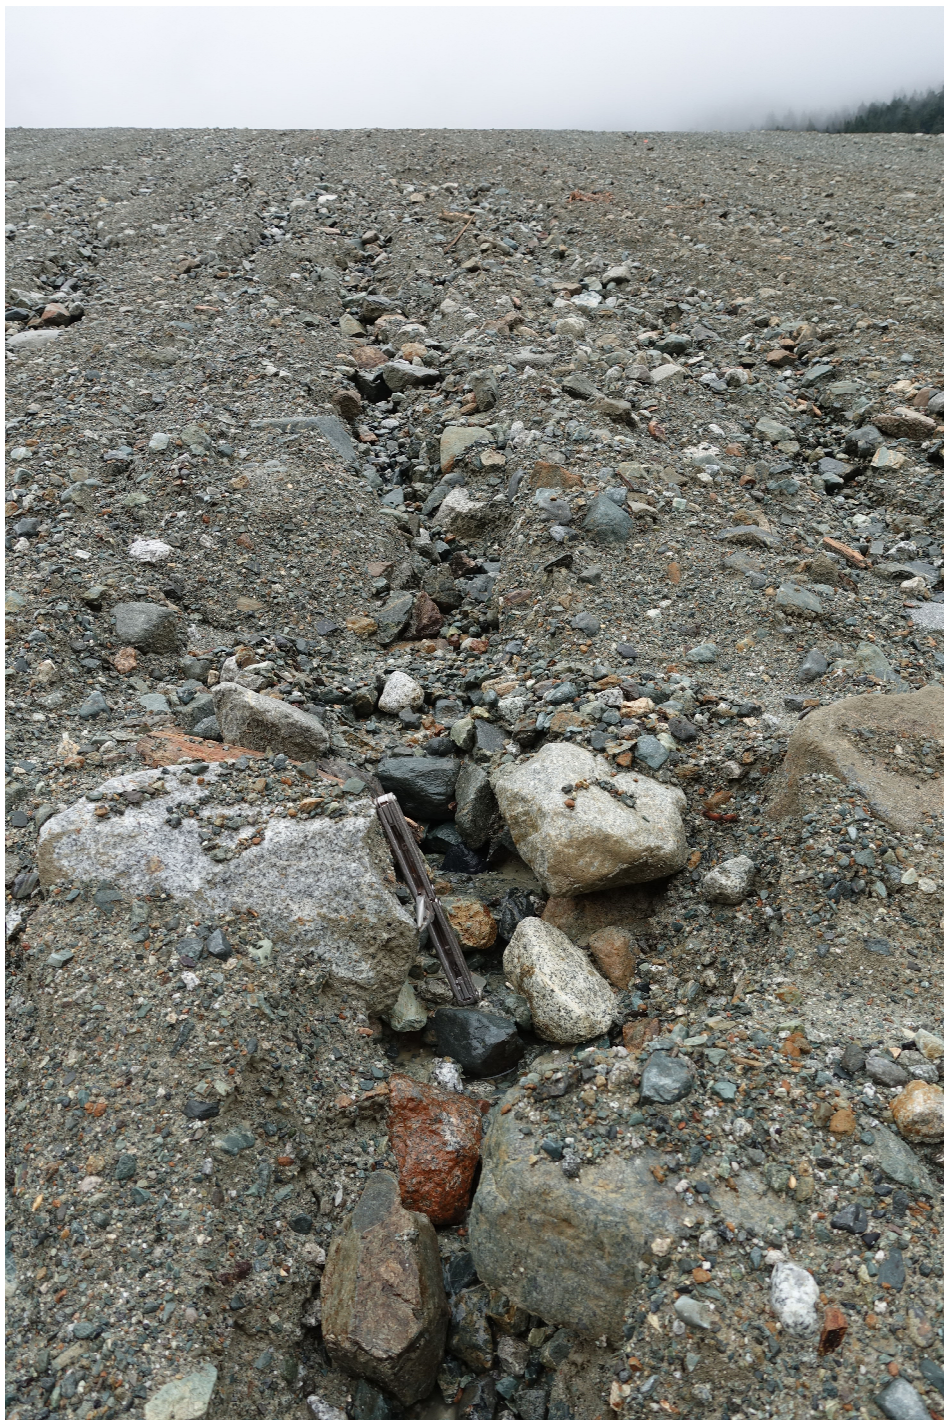
Figure 5. Erosion rill on the Lynx TDF closure cover trial (multi-tool for scale—tool is 20 cm from one end of the handle to the other).

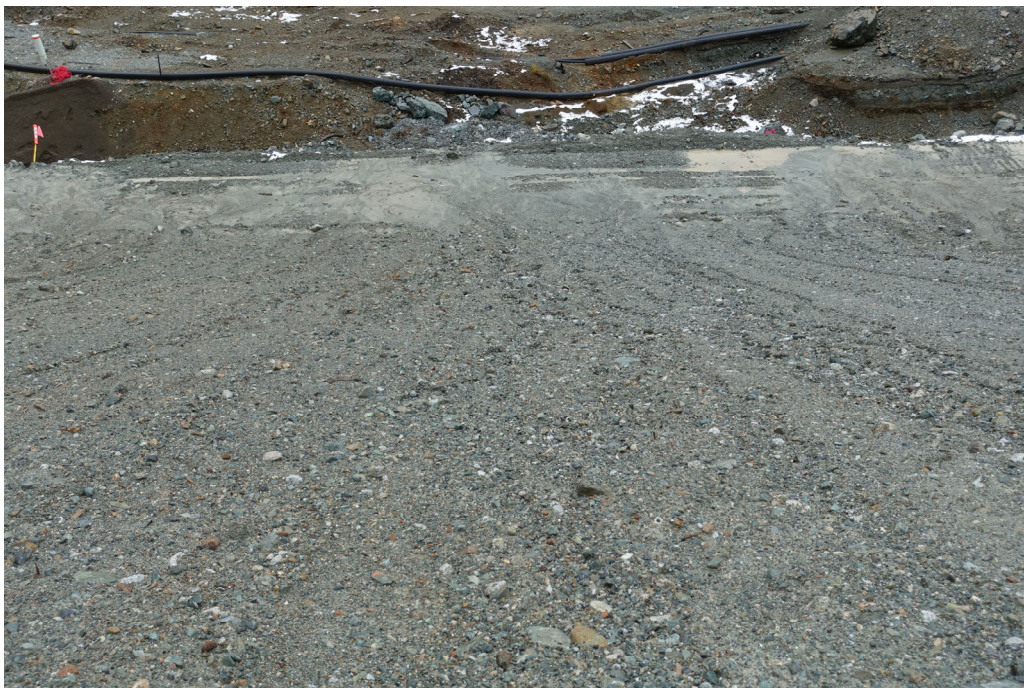
Figure 6. Erosion fans (background) at the toe of the Lynx TDF closure cover trial.

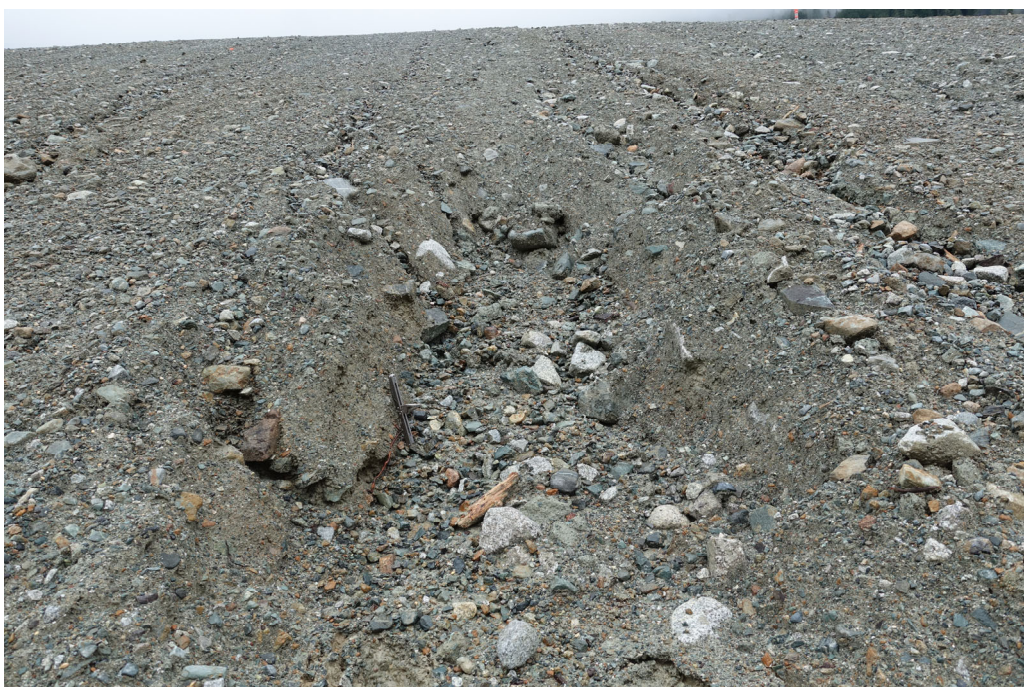
Figure 7. Erosion hole in cover, 40-cm deep (20-cm multi-tool for scale).

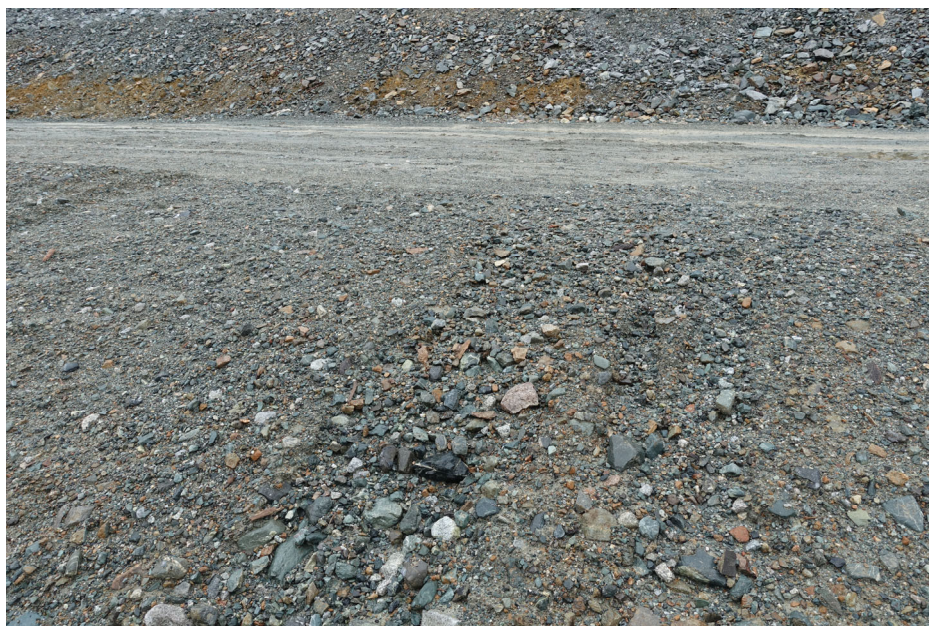
Figure 8. Erosion initiating at the top of the Lynx TDF closure cover slope, likely caused in part by run-on water flowing off the bench and on to the slope crest.
