Overview & Level 1 Fish Habitat Assessment and Level 2 Enhancement Recommendations

Woods Creek, Campbell River,
BC

Prepared for
Campbell River Salmon Foundation

June 9, 2020 (Rev. 1)

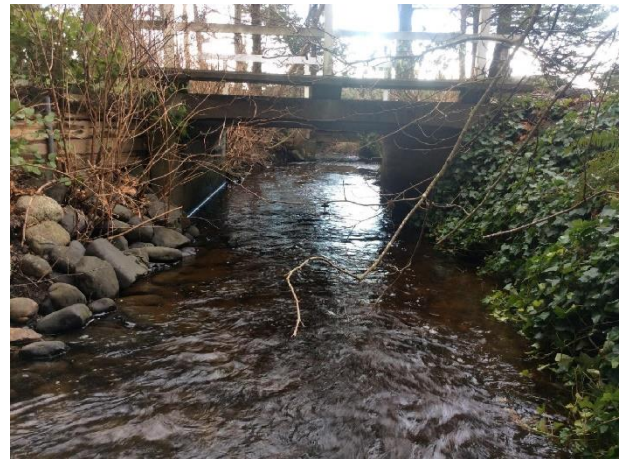
Photo 1 & 2. Views upstream of Reach 1 at km 0+122 (above left; Feb. 11, 2020) showing concrete retaining wall, historical counting fence structure (right of image), and riparian removal on right bank (left of image); and view downstream (above right; Feb. 11, 2020) showing riparian disturbances from driveway bridge installation, rock revetment (left bank) and English ivy encroachment (right bank).

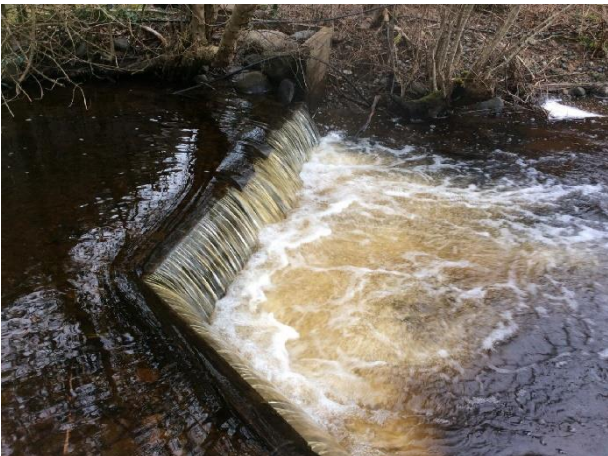
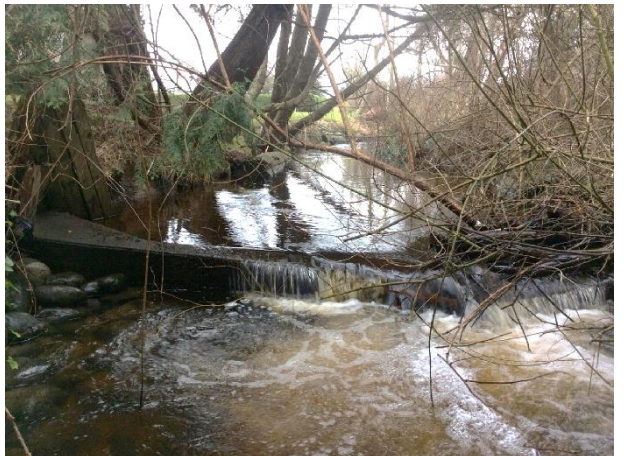
The existence of two weirs, one wooden, the other concrete (Figure 7; Photos 3-4), are potential partial barriers to fry migration as they have 0.25 m and 0.30 m vertical plunge drops, respectively. The drops at both sites flow into plunge pools of 0.65 - 0.75 m depth and are expected to be passable by adult salmon under most flow conditions but are barriers to upstream fry migration. Removal of approximately 30 cm of boards from the wooden structure should be considered to enhance passage for all salmon life stages while avoiding complex replacement techniques that might involve complete removal of the weir for completion prior to failure of the structures as they appear to be falling into disrepair (Photo 4). Artificial bed elevations resulting from the presence of existing weirs should be allowed to stabilize for at least one calendar year and re-assessed for suitability of installing permanent Newbury style rock weirs. Restoration prescriptions are discussed in Section 6.1.1.

Photo 3 & 4. View of wooden weir 0.25 m falls into a 0.65 m plunge pool at km 0+018 that is an obstruction to juvenile salmon migration (above left; Feb. 11, 2020), and view upstream of a concrete weir that is beginning to show signs of failure located near km 0+135 with a drop of 0.30 m into a 0.75 m plunge pool.

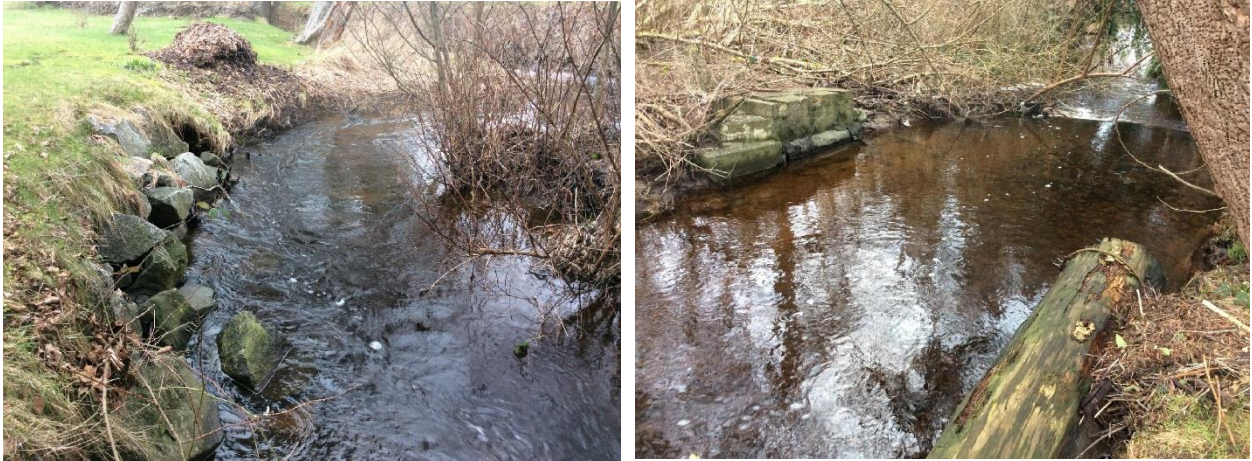
Photo 5 & 6. Upstream view of riparian clearing to the top-of-bank and *ad hoc* revetment using angular boulders near km 0+155 (above left; Feb. 11, 2020), and view downstream (above right) of the pool located behind the concrete weir (Photo 4) showing single cabled LWD piece in the entire reach (bottom right of image), and a historical counting fence abutment (top-left of image).

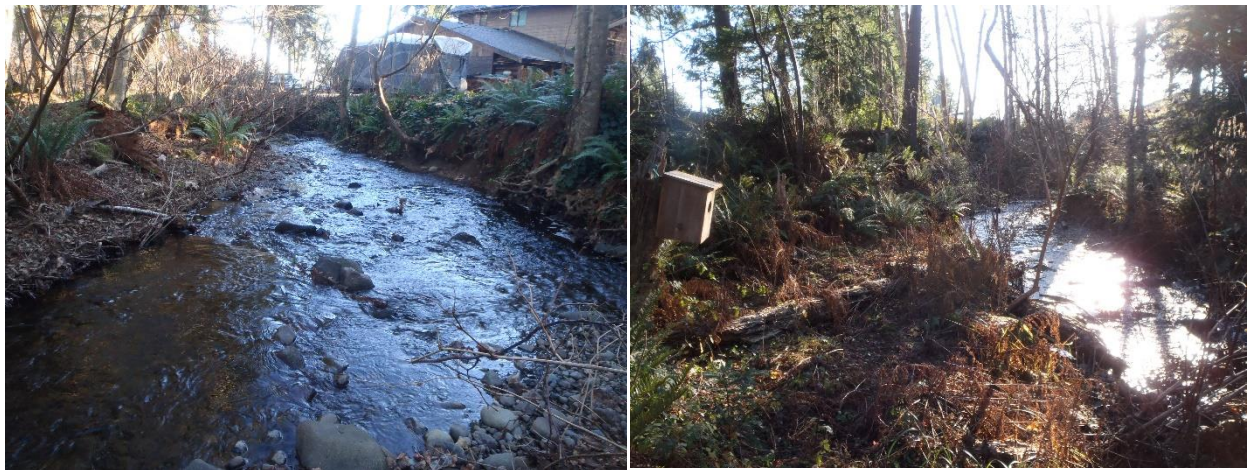
Photo 7-8. Downstream view of an upper-Reach 2 site near km 1+160 showing urban development up to the top of bank (above left; background) and upstream view showing riparian clearing related to forest harvesting practices at the same location (above right; background) (Nov. 28, 2019).

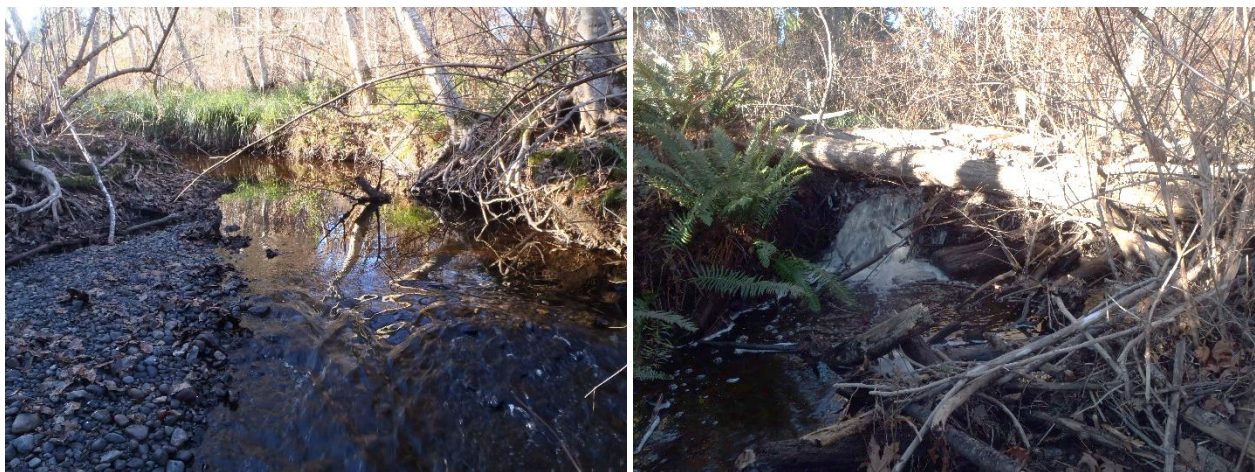
Photo 9-10. View upstream of the site of a salmon spawning redd located above the crest of a natural riffle near km 0+900 (above left; Nov. 28, 2019) and view upstream of a beaver dam at km 0+950 detaining sediment upstream and causing a partial barrier to fish migration (above right; Nov. 28, 2019).

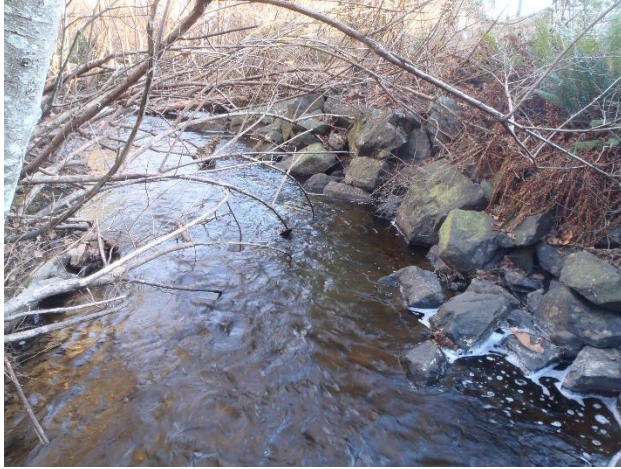
Photo 13. *Ad hoc* bank revetment structure composed of angular rock present near 1+160 km, providing evidence of erosive forces combined with anthropogenic bank modifications including native riparian vegetation removal affecting this section of Reach 2.

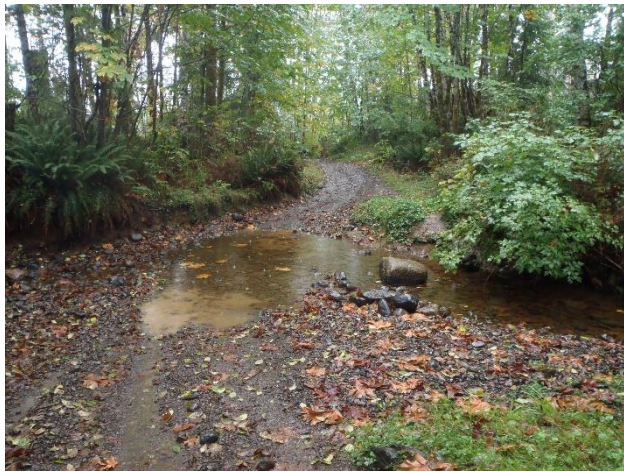
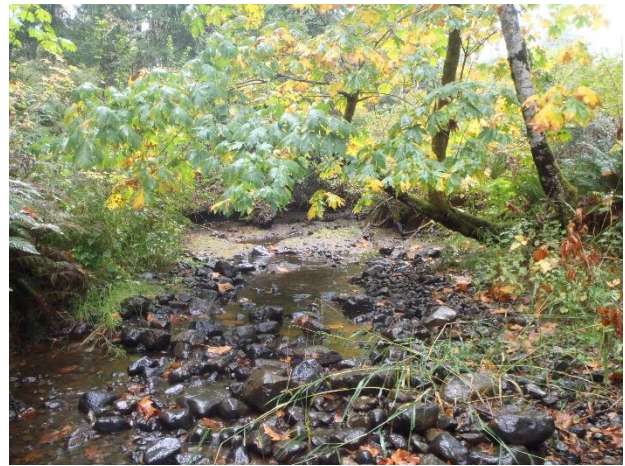
Photo 12 & 13. View south (above left) of the ATV crossing site over Reach 3 near km 1+500 showing spawning gravels disrupted by vehicle traffic (Sept. 28, 2019), and the upper habitat unit between km 1+500-1+585 steeper gradient channel dominated by coarse substrates and exposed hardpan (above right; Sept. 28, 2019).

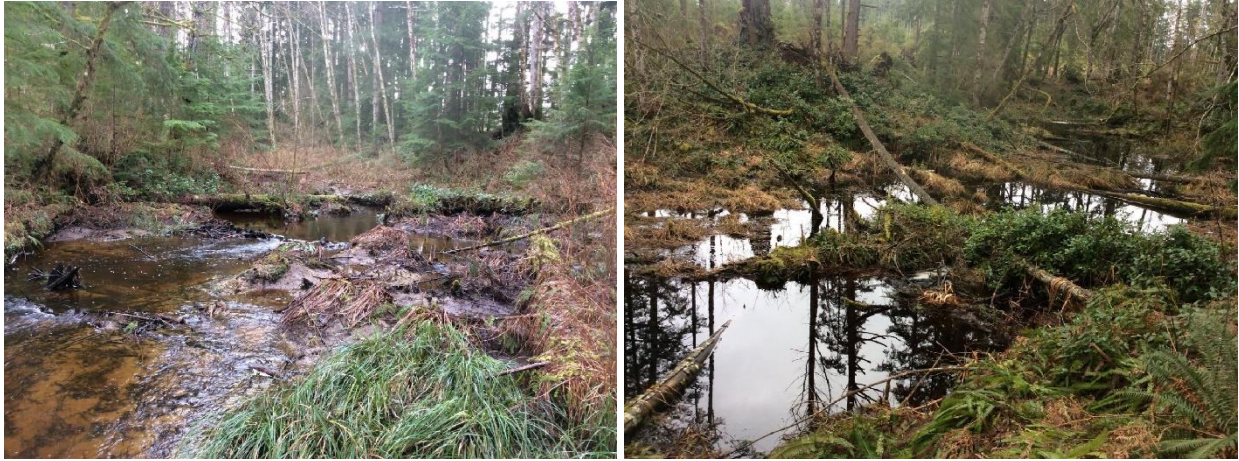
Photo 17 & 18. View downstream of the wide, sinuous, low-gradient channel in Reach 5 (above left) with high frequency beaver dam and LWD recruitment (above right). Feb. 12, 2020.

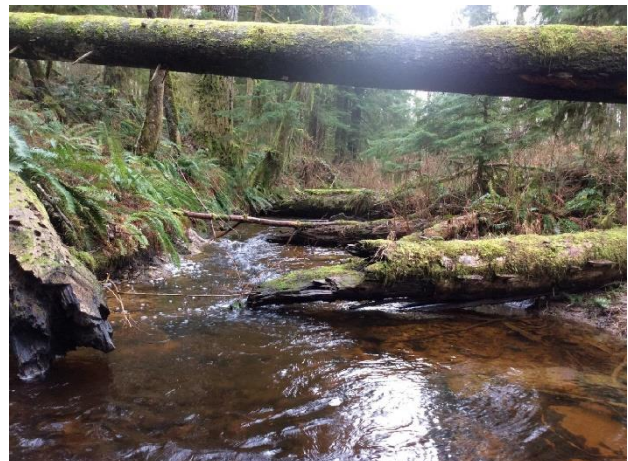
Photo 21 & 22. Views upstream of relatively wide bankful channel width compared to wetted width resulting in a *Poor* % wetted area calculation (above left), and *Good* LWD frequency associated with the mature forest canopy (above right).

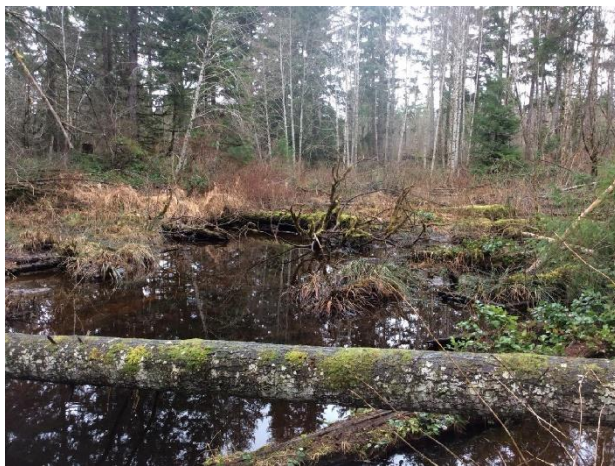
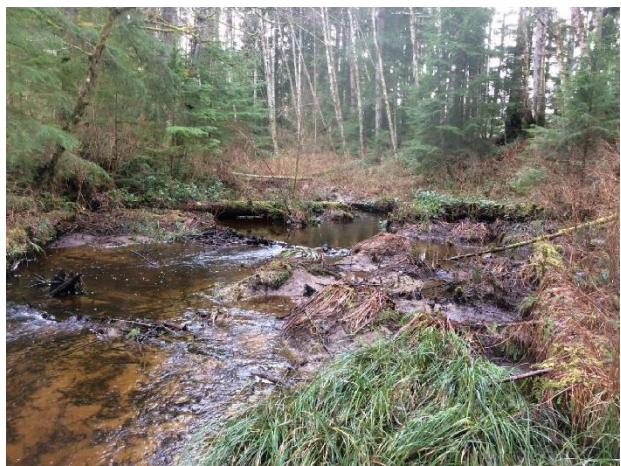
Photo 23 & 24. View upstream of Reach 7 near km 3+925 (above left) showing typical wetland habitat formed by downstream beaver dams that characterize the reach, and flows through the wetland swamp in the sampled habitat unit showing floodplain inhabited by facultative hydrophytes activated under peak flows (above right). Feb. 12, 2020.

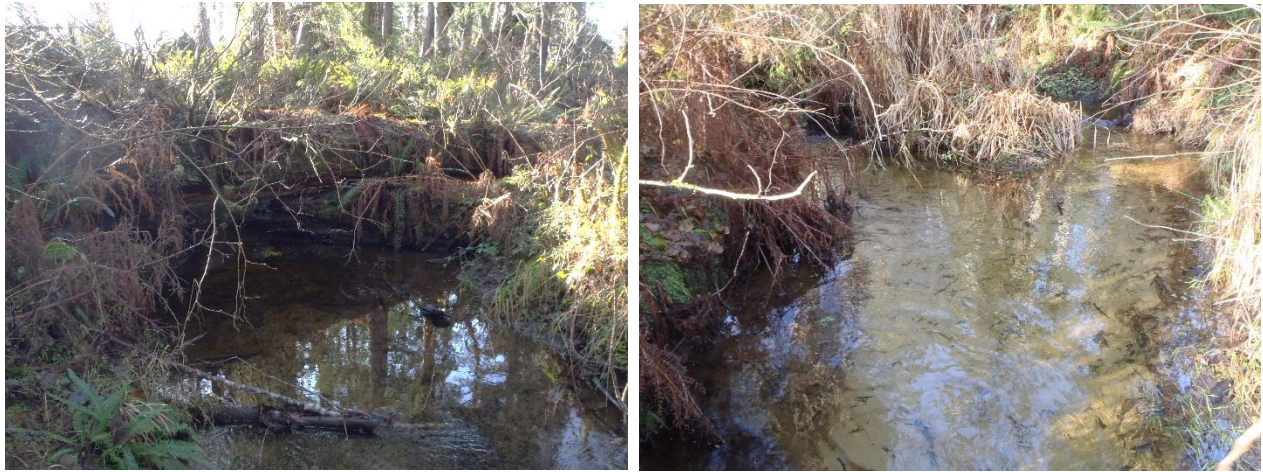
Photo 25-26. View upstream of one of a series of log jams between km 1+465 – 1+505 resulting in part from windthrow related to forest harvesting practices along the right bank of the upstream end of Reach 2 (above left; Nov. 26, 2019), and entrained sediment upstream of the same log jam inundating gravels (above right; Nov. 26, 2019).

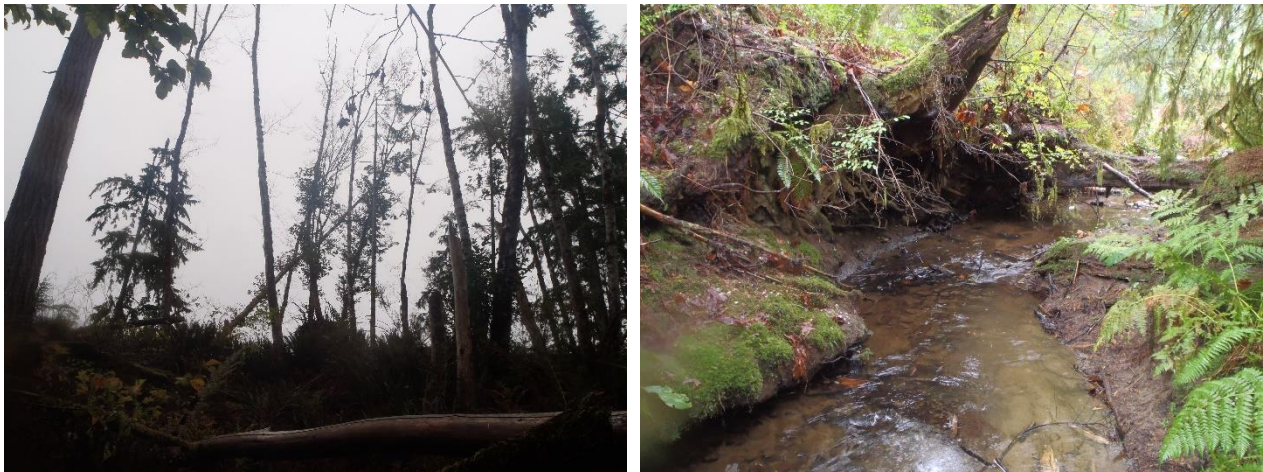
Photo 27-28. View south of right bank canopy taken from the South Fork stream channel of Reach 8 near km 1+460 showing the riparian canopy impacted by windthrow resulting from forest harvesting practices (above left; Sept. 23, 2020), and typical channel morphology of the sampled habitat unit near km 1+500 (above right; Sept. 23, 2020).

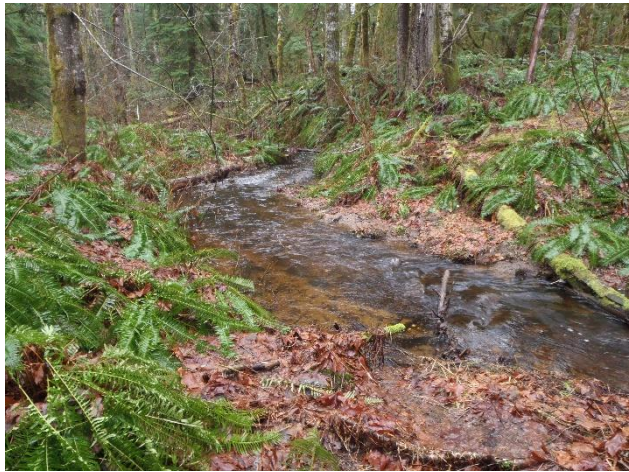
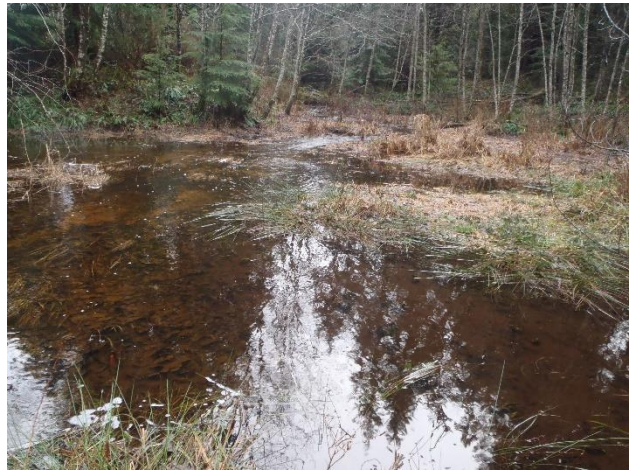
Photo 29-30. View upstream of higher gradient channel in the downstream habitat unit showing good riparian depth and stream substrates that include gravel and fines (above left; Jan. 28, 2019), and lower gradient channel in an upper habitat unit backwatered by a wooden weir near km 2+670 (above right; Jan. 28, 2019).

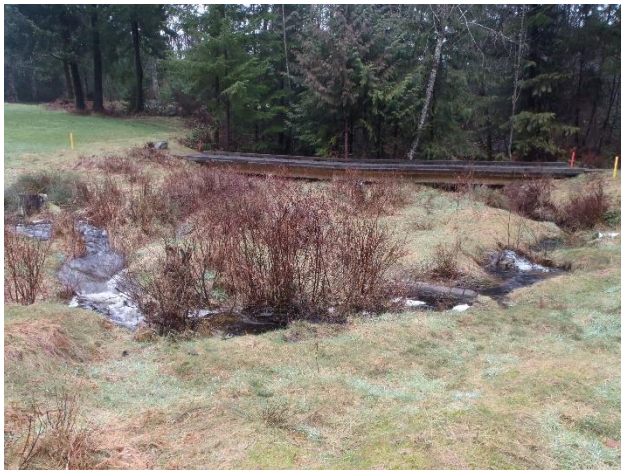
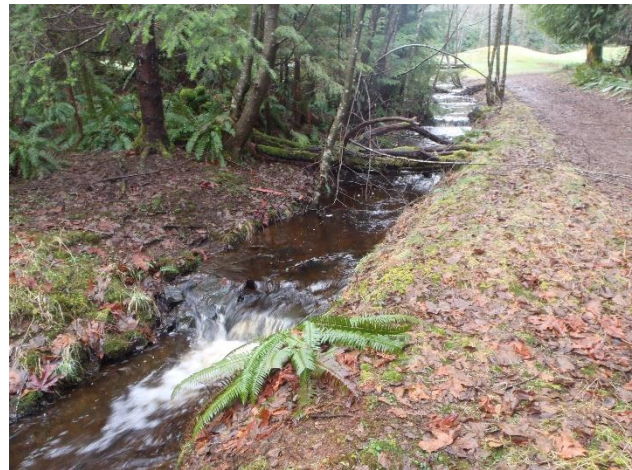
Photo 31-32. Upper habitat unit flowing through golf course fairway showing cleared riparian vegetation (above left; Jan. 28, 2019), and tributary channel enhanced with series of small rock weirs near habitat unit GC5N (above right; Jan. 28, 2019).

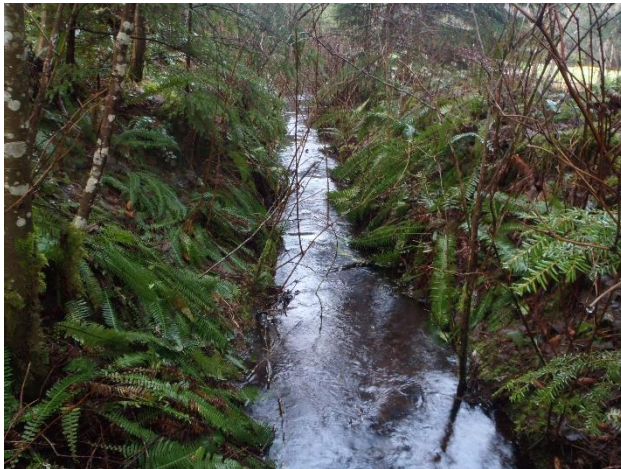
Photo 33. View downstream of the Tributary 1 channel taken from near the Storey Creek Golf Course driving range (right of image) showing channelized form and status of riparian vegetation.

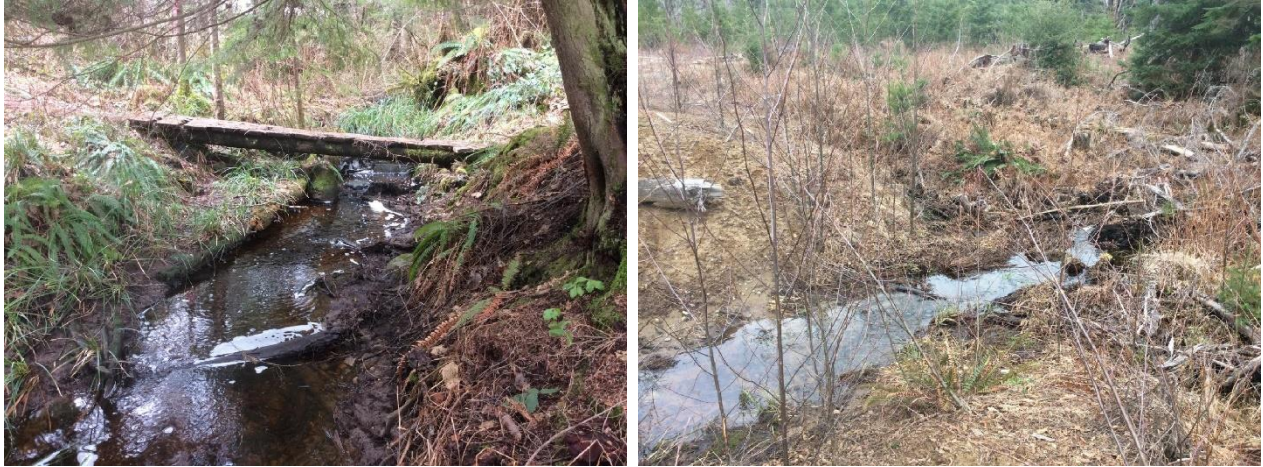
Photo 34 & 35. View downstream of Tributary 2 channel near its confluence with the North Fork of Woods Creek (above left) and a section of an upper habitat unit showing impacts from forest harvesting practices at a decommissioned road crossing site (above right).

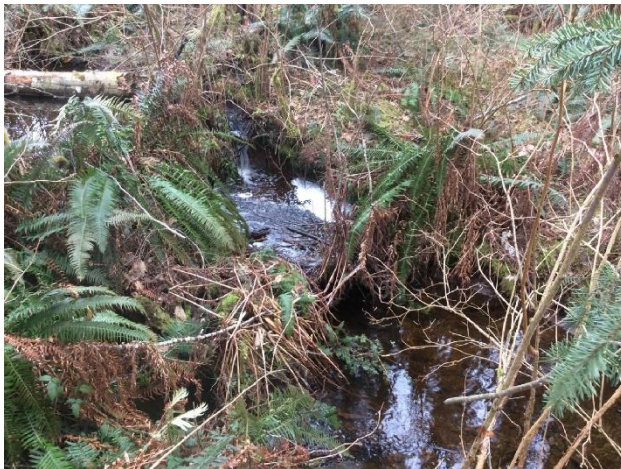
Photo 36. View upstream of Tributary 2a showing small cascades over debris jams located approximately 40 m upstream of the channel's confluence with the North Fork of Woods Creek.

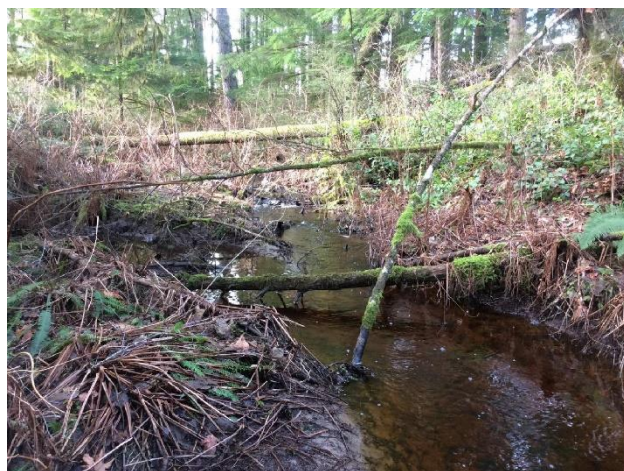
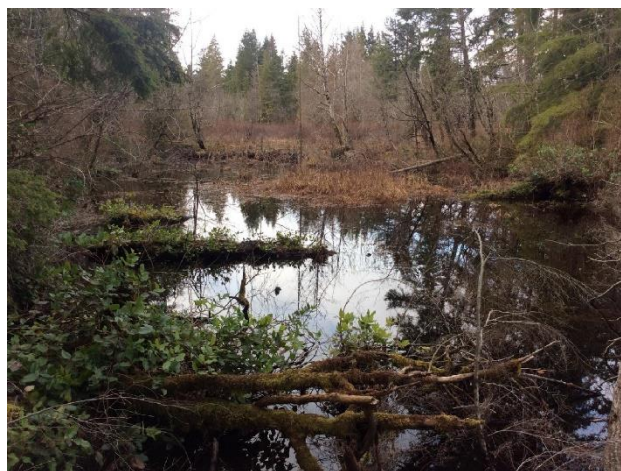
Photo 37 & 38. View upstream of assessed habitat unit located near km 3+195 showing well vegetated banks and sand dominated substrates (above left), and wetland habitat catalogued in SEI Polygon S0656 located upstream of a beaver dam built on the site of Rock Weir 2000c (above right).

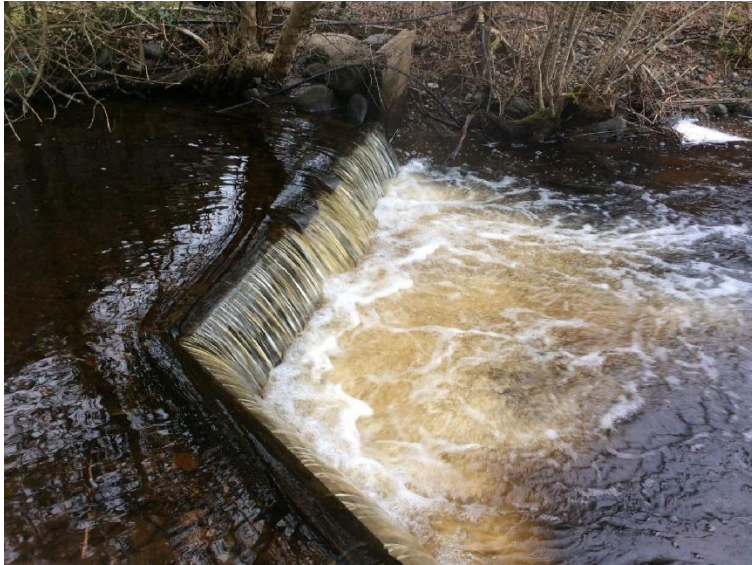
B- Concrete Weir	Reach 1	0+125	Partial obstruction to fry passage	Remove and replace with Newbury style riffle (Section 6.1.1)

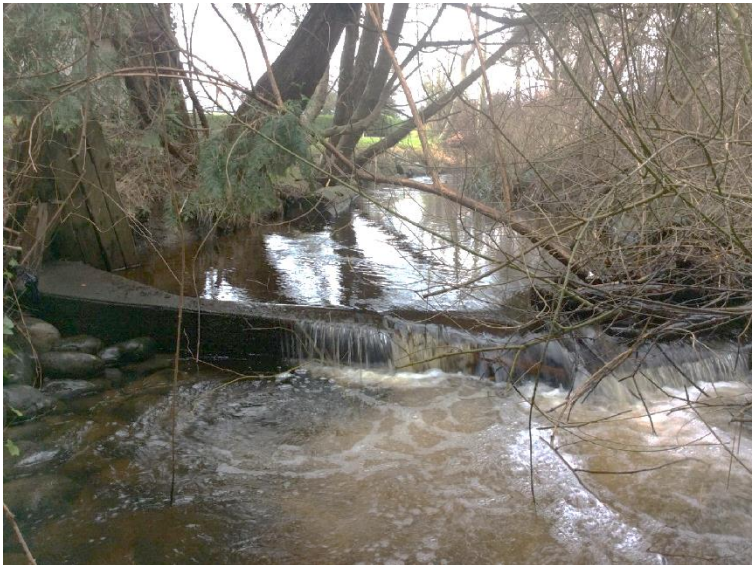
C- Rock Weir 2000a	Reach 4/5 break	2+170	Maintenance required	Rebuild crest and toe. Lengthen downstream face to reduce gradient/velocities. Nourish upstream face with spawning gravel.

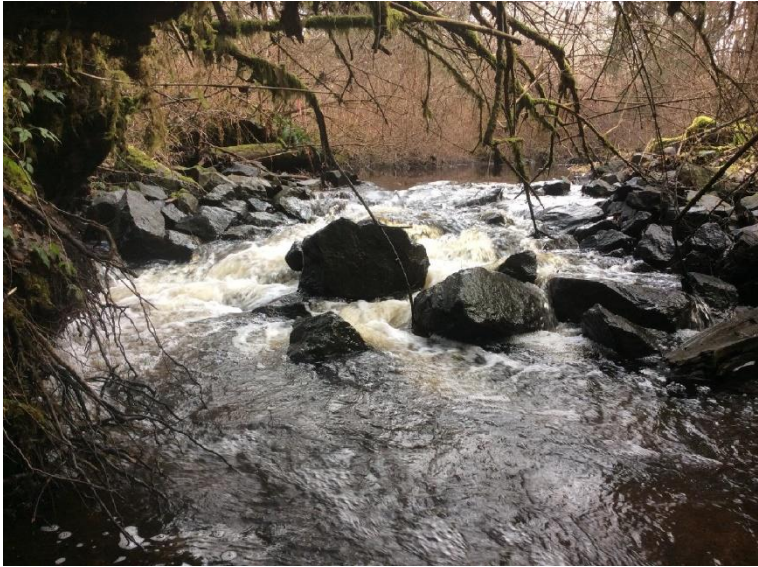
D- Rock Weir 2000b	Reach 5	2+400	Channel split at upstream side towards right bank. Some gravel exposed on upstream face partially embedded in sandy alluvium.	Leave in existing state.

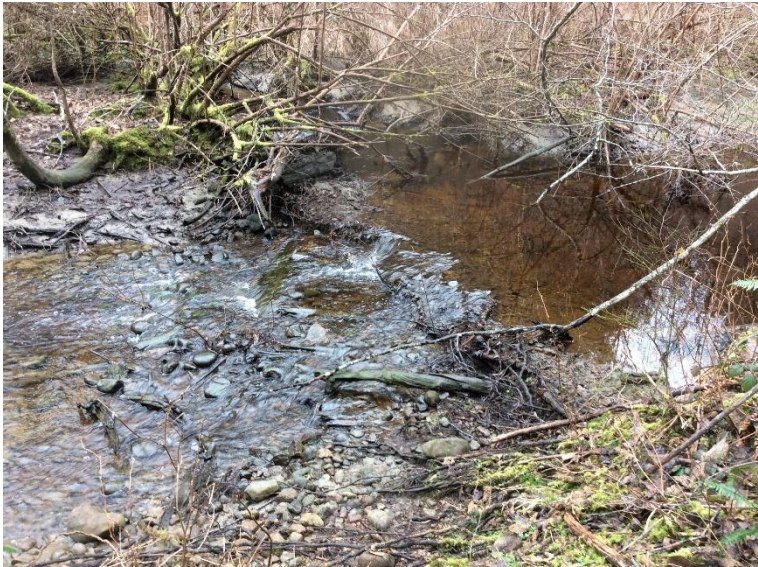
E- Rock Weir 1999a	Reach 5	2+830	Dysfunctional. 3 m of rock blown out on right bank by high velocity flows. Substrates dominated by fines.	Clean-up and remove. Machine labour required.

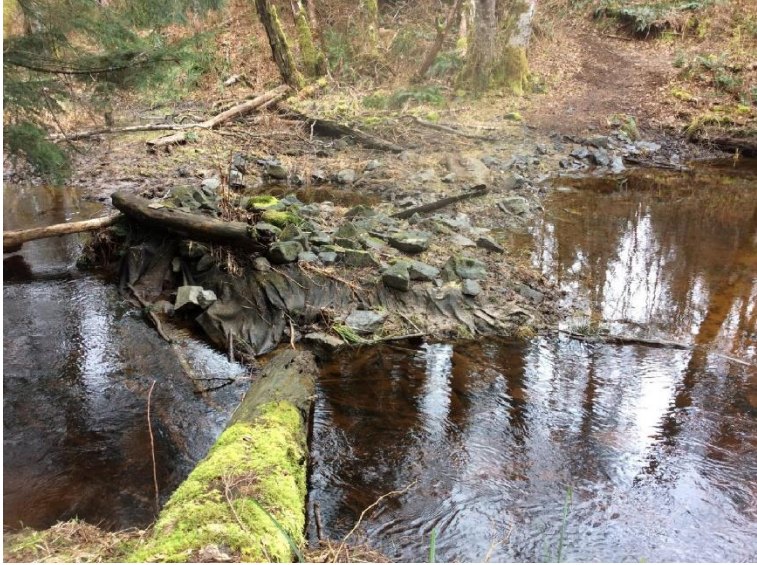
F- Rock Weir 1999b	Reach 5/6 break	3+040	Dysfunctional. Used as ATV crossing. Some gravel remains present upstream.	Abandon.

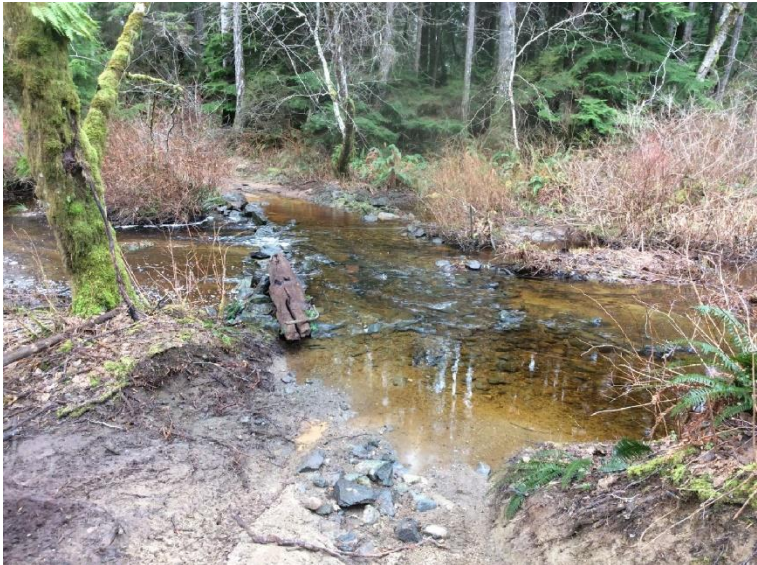
G- Rock Weir (date unk.)	Reach 6	3+120	Rock stable. High flows charge adjacent floodplain. Spawning gravels remain exposed.	Good condition. Nourish with spawning gravel.

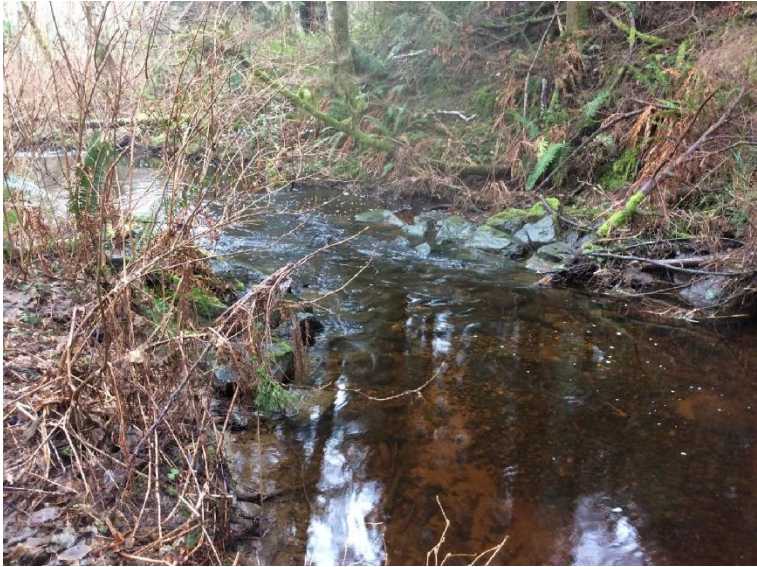
H- Log Weir 1999a	Reach 7	3+870	Partial barrier to fry migration. High flows avulsing left bank. Good pool maintained upstream. Reach dominated by fine substrates.	Remove and replace with rock weir (will improve passage but spawning potential limited by sandy alluvium) or remove and abandon.

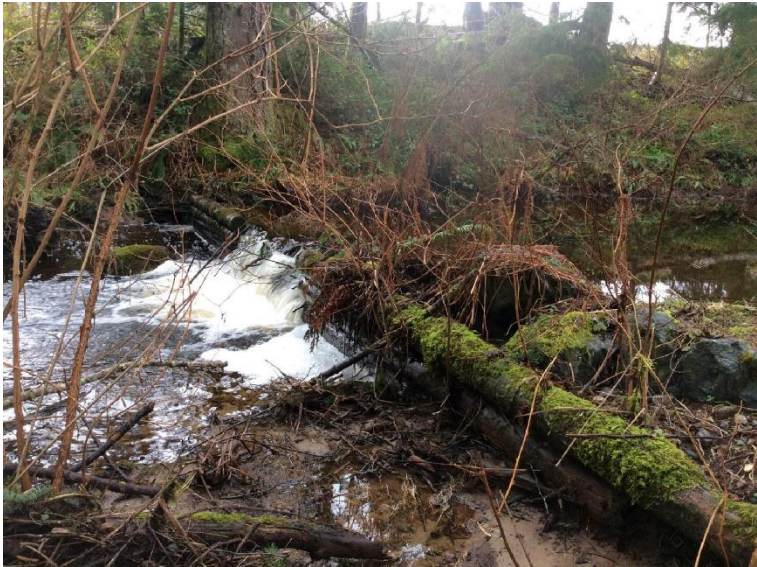
I- Log Weir 1999b	Reach 7	3+925	Intended to backwater upstream wood weir that has failed.	No action required or remove in conjunction with J- Wood Weir 1999 and replace using rock weir/riffle.

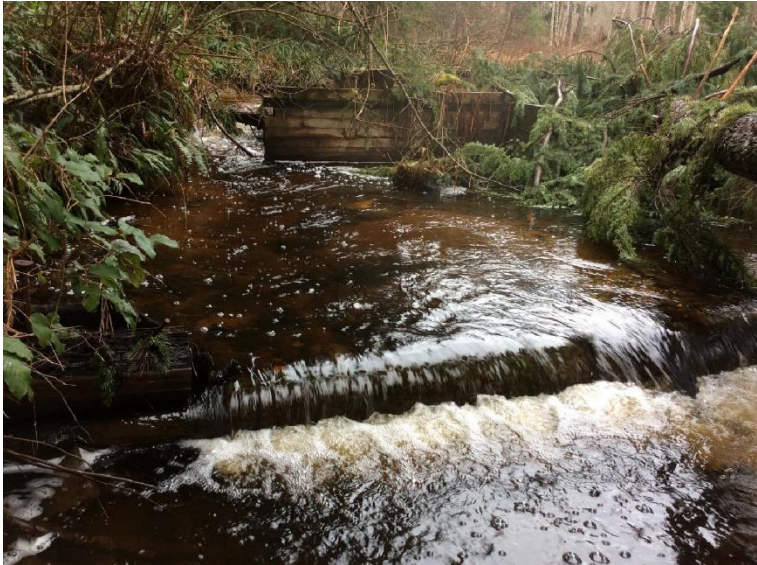
J- Wood Weir 1999	Reach 7	3+935	Dysfunctional. Right bank avulsed. Upstream water level maintained by hardpan control on right bank.	Remove and replace with rock weir/riffle to maintain upstream water levels in wetland.

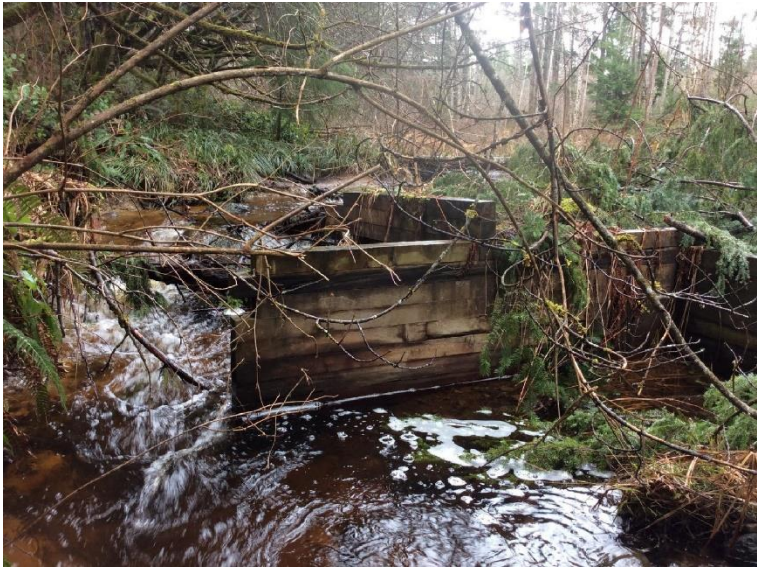
<p>View upstream J- Wood weir 1999 avulsion on right bank. (more photos next page)</p>

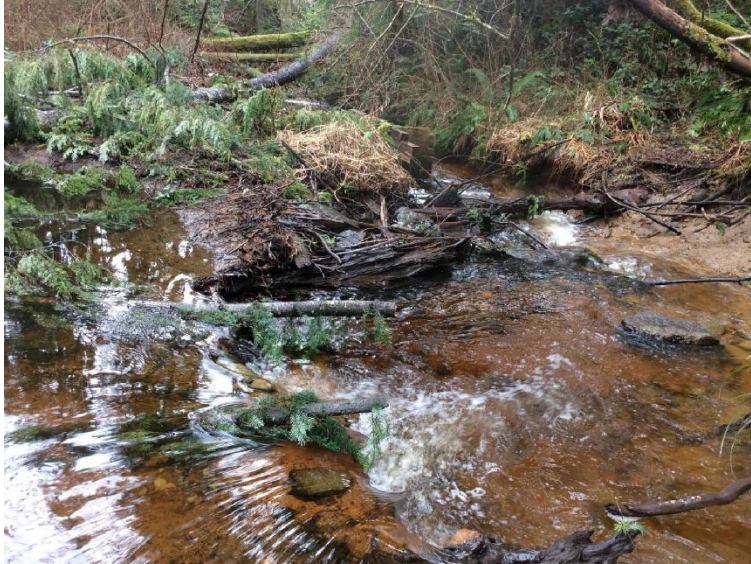
View downstream J- Wood weir 1999 avulsion on right bank (background) and control level provided by hardpan (foreground).

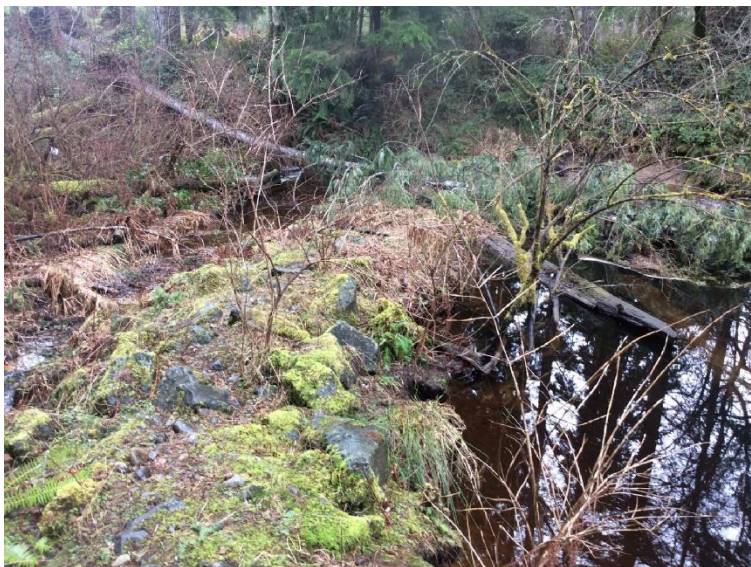
Rock berm on left bank (foreground) used to tie in original wood weir (hidden under fallen tree; background) remains intact and can be used to tie in a new rock weir/riffle K - Rock Weir structure to replace failed wooden weir.

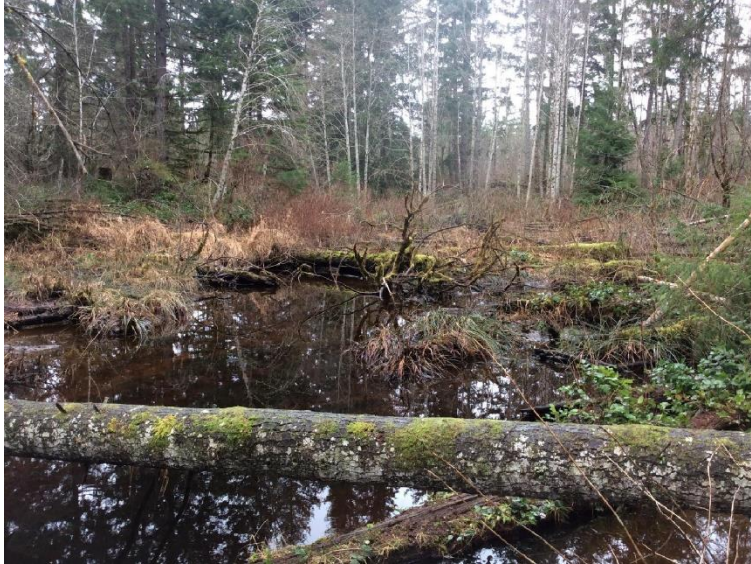
View of pool habitat upstream of failed J- Wood weir 1999 that is currently maintained by hardpan control.

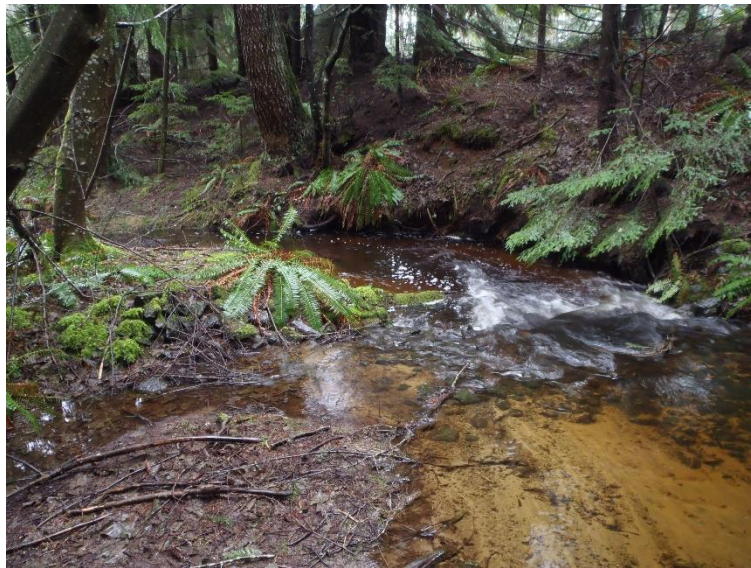
L- Wood Weir	Reach 9	2+675	Partial barrier to juvenile fish migration.	Remove and replace with rock weir/riffle. Maintain control elevation. Build tail out min. 10:1. Excavate bedload upstream.

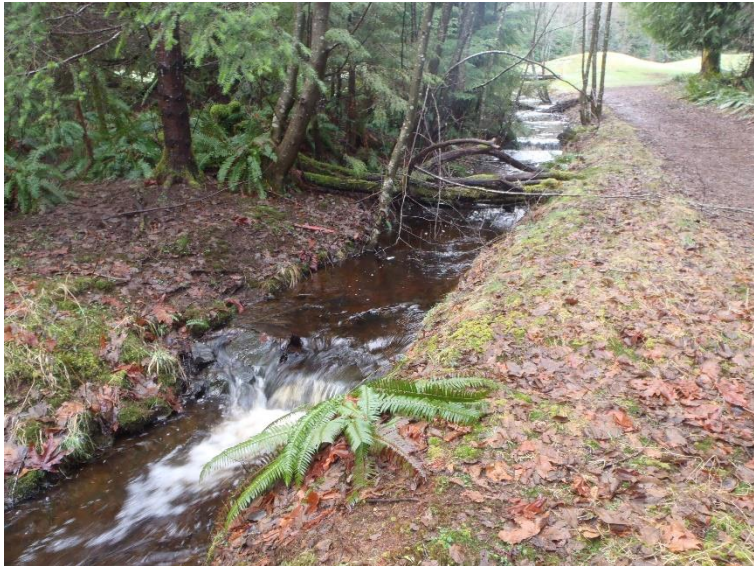
N- Series of small rock weirs	Reach 9	3+155	Weirs stable with exception of one creating a plunge drop that is likely partial barrier to juvenile migration (not shown).	Regrade weir causing partial barrier by placing additional rock(s) and re-nourishing with spawning gravel.

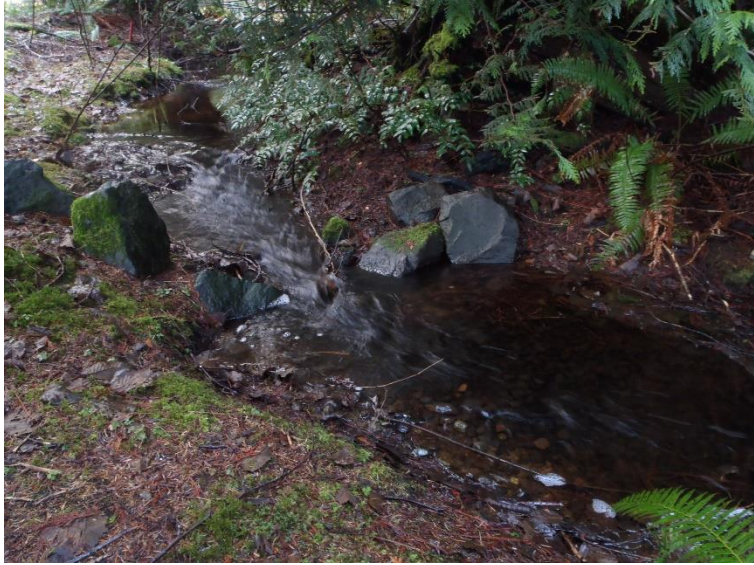
O- Rock Weir 2000	Trib. 3	3+220	Weir used as trail crossing site. Rock stable with little to no gravel present or obscured by sand.	No action required. Little to no habitat function.

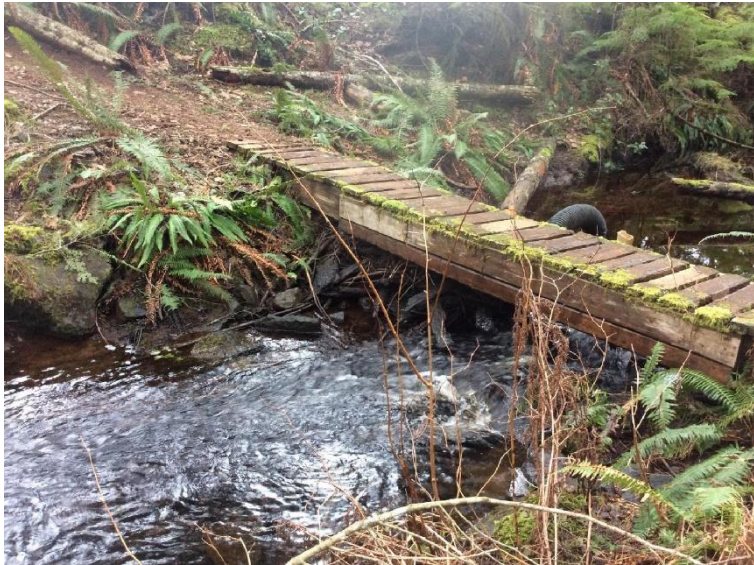
P- Wood Weir 2000	Trib. 3	3+320	Wood sill control elevation absent (rotten). No function remains. Backwatered by debris jam downstream and beaver dam upstream serving same purpose.	Abandon.

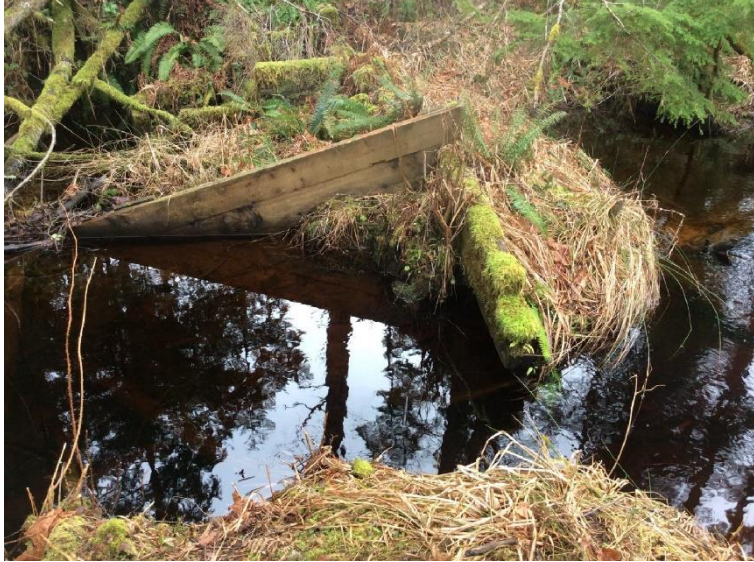
Q- Rock Weir 2000	Trib. 3	3+520	Completely obscured by large beaver dam.	No action required.

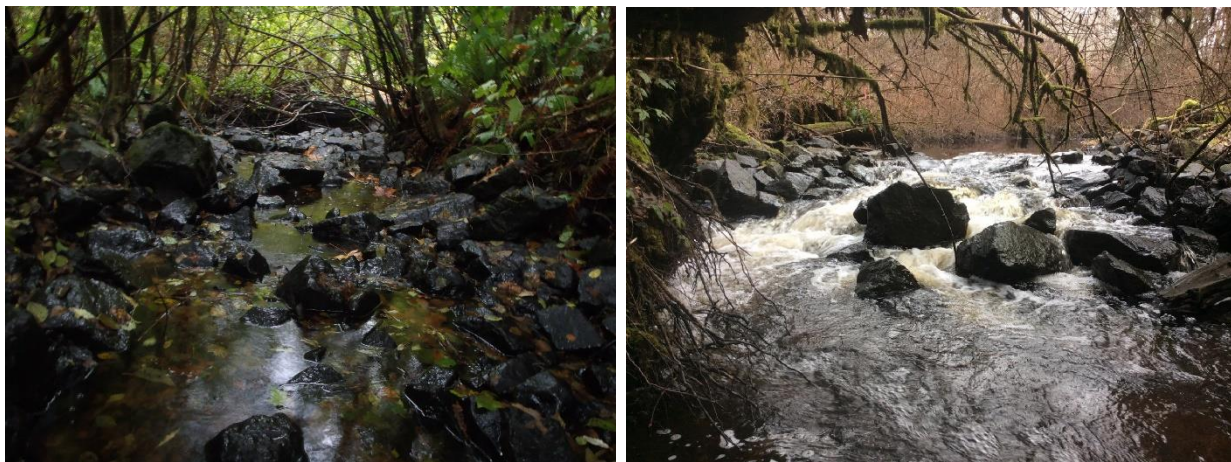
Photo 39 & 40. View downstream of angular rock associated with the McGimpsey Road crossing at the site of proposed spawning riffle enhancement near km 1+650 (above left), and view upstream of Rock Weir #3 constructed in 2000 that has been identified for enhancement/maintenance (above right).
