2022 LYNX TDF DAM SAFETY INSPECTION REPORT

MYRA FALLS MINE LTD.
A TRAFIGURA COMPANY
CAMPBELL RIVER, BC

PROJECT NO.: NX14001B4.3
DATE: 29 MARCH 2023

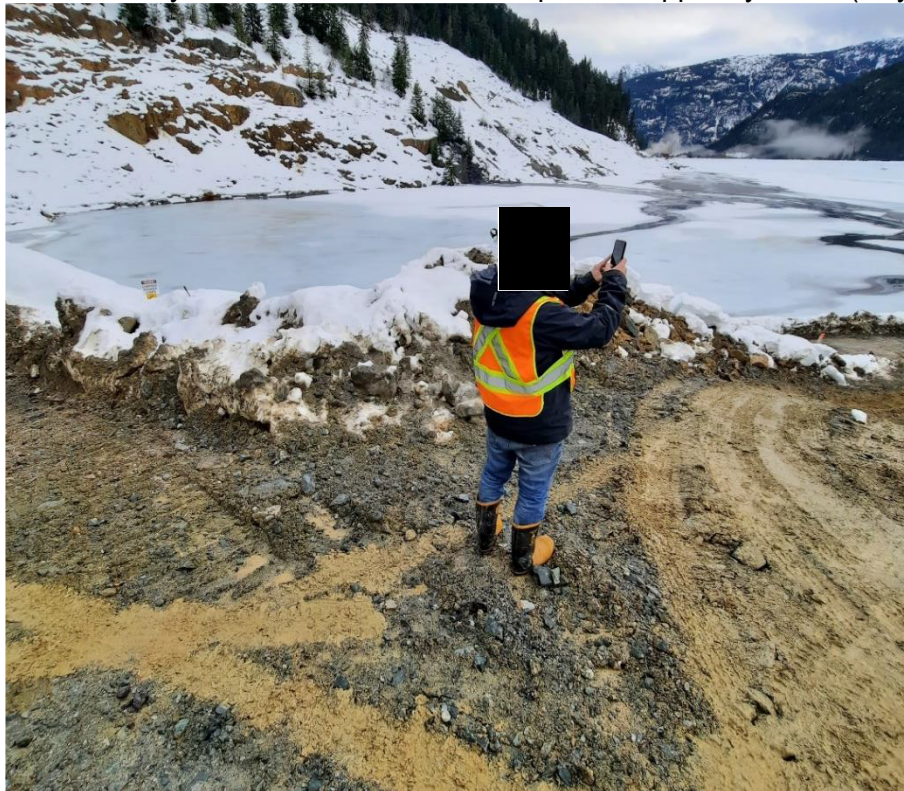
Photo 2: MFM personnel documenting the Lynx TDF reclaim pool conditions during a joint Dam Safety Inspection with WSP. (January 14, 2022)

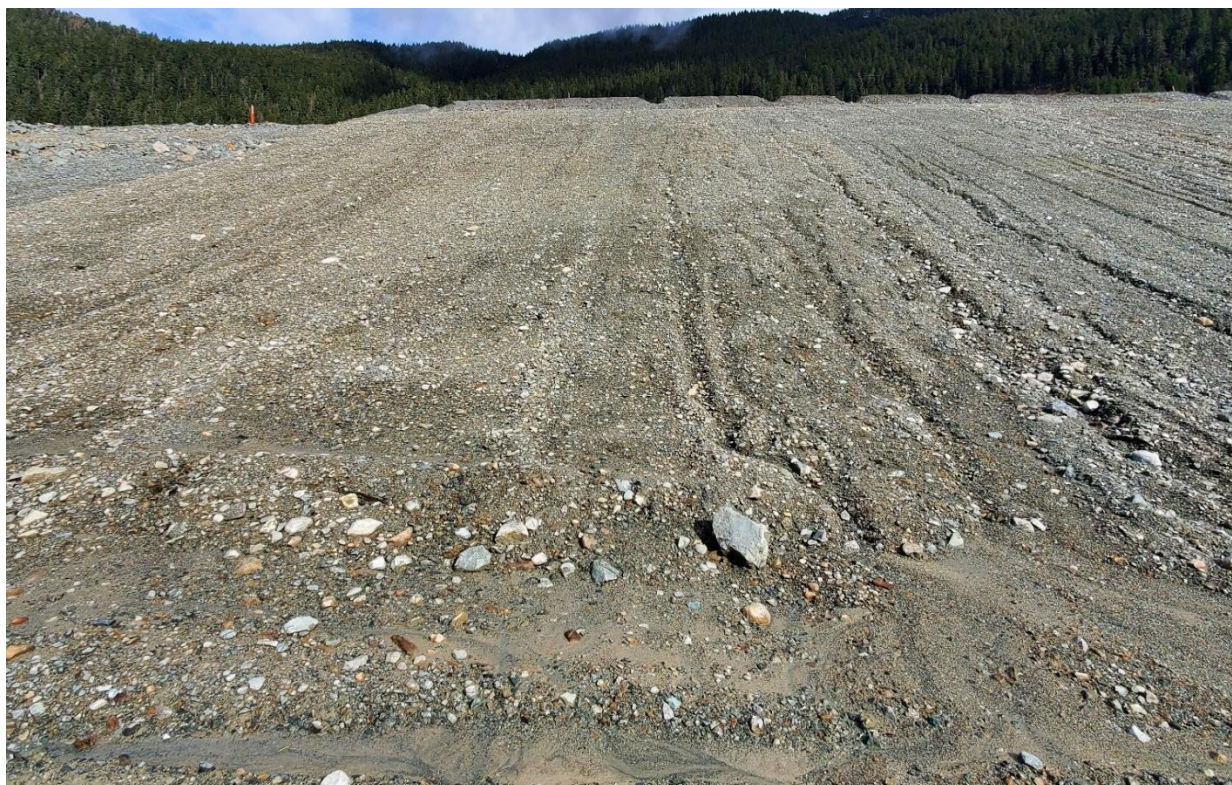
Photo 5: Lynx TDF downstream toe which was used for Closure Cover Trials in 2021. Erosion gullies observed in the clean cover for this area. (March 25, 2022)

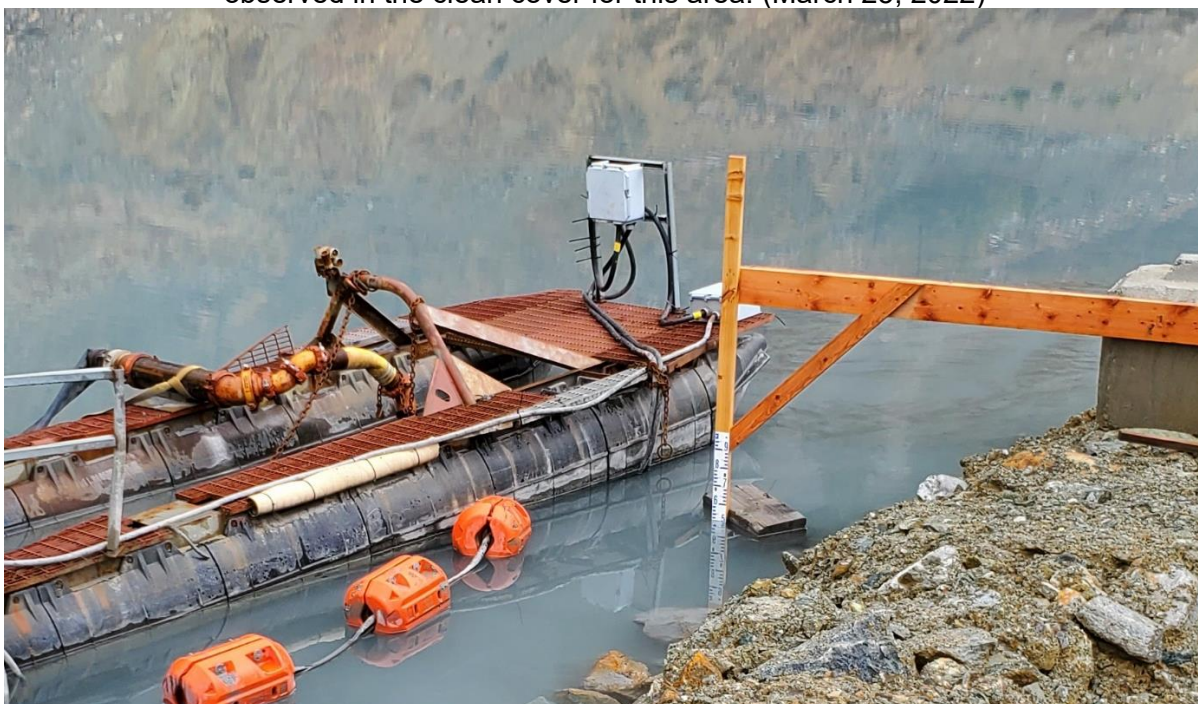
Photo 6: Lynx TDF staff gauge. (March 25, 2022)

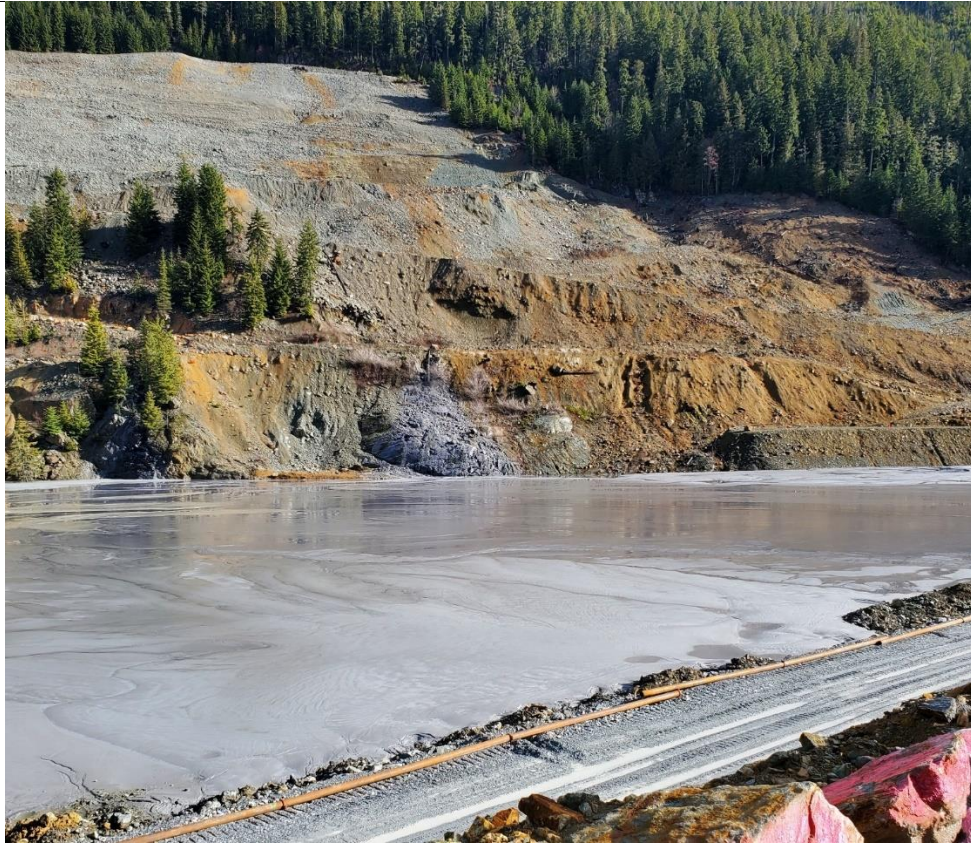
Photo 7: Lynx TDF, looking north-east. Standing on the crest. It can be observed that the upstream bench has not yet caught up to the crest elevation of 373.5m. (March 25, 2022)

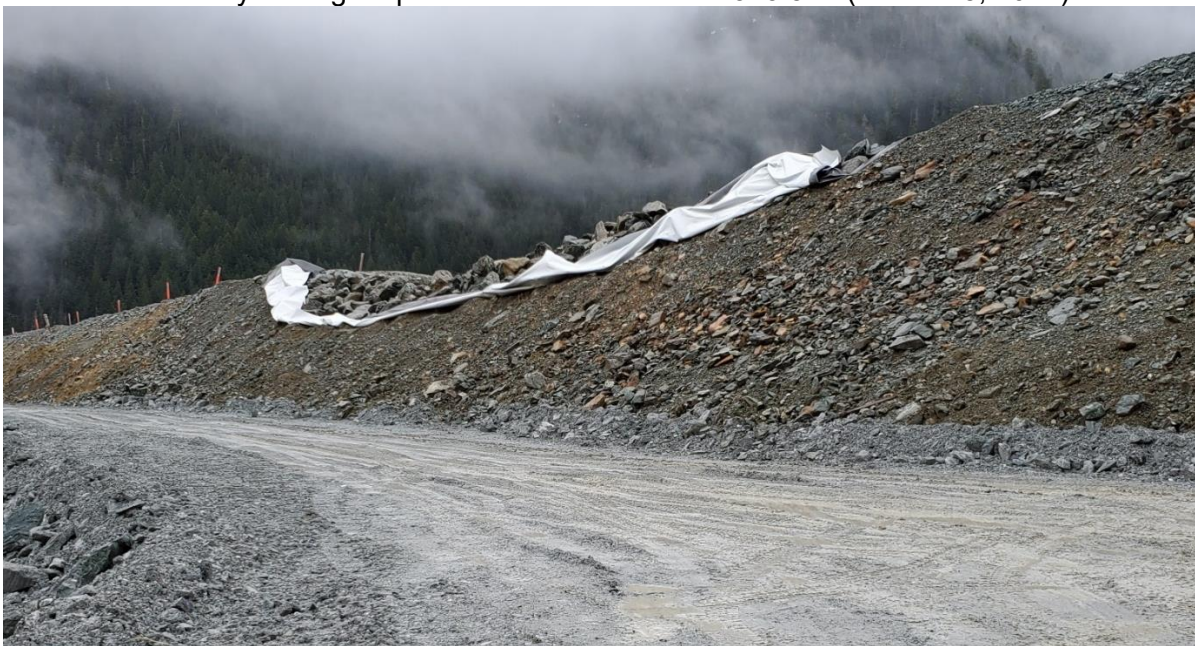
Photo 8: Lynx TDF dam crest (looking north-west). Shown is the uncompleted portion of the spillway invert which needs to be extended across the upstream bench -photo taken standing upstream bench. (March 25, 2022)

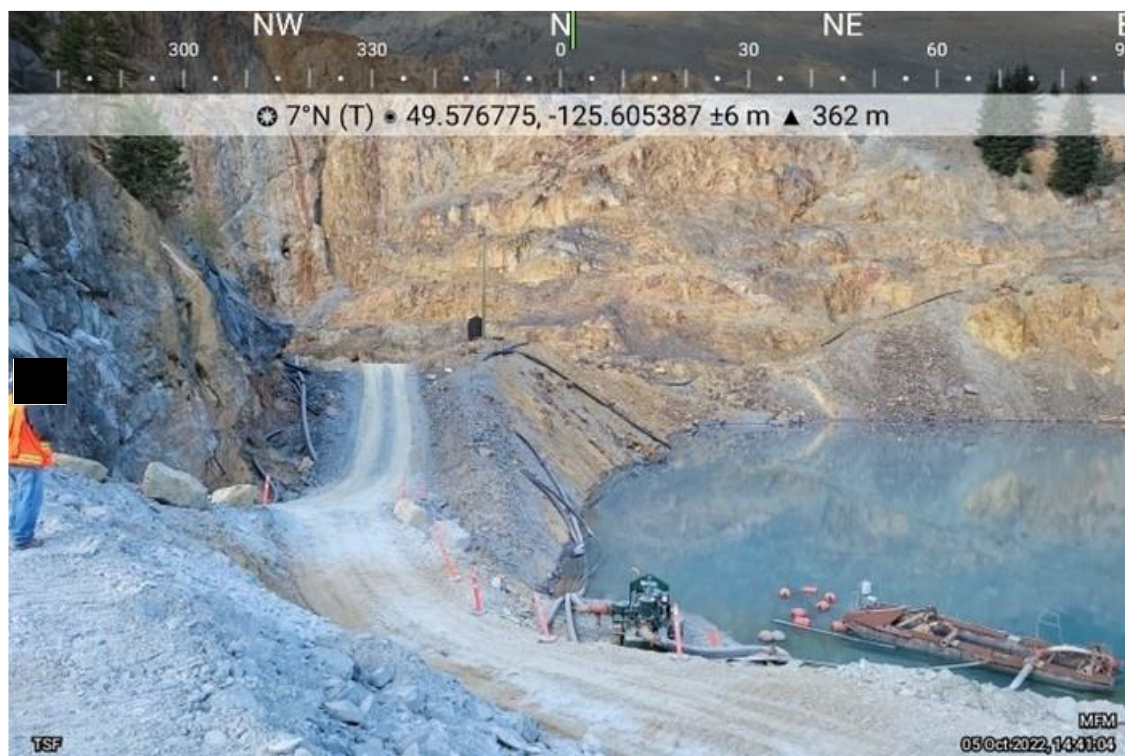
Photo 14: North end of the Lynx TDF where pool and pump were observed. (October 5, 2022)

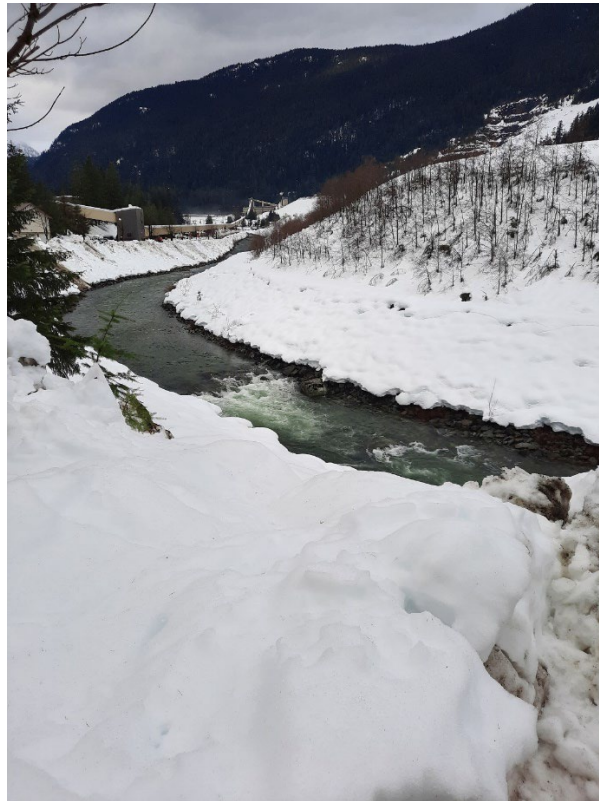
Photo 1a: Old TDF outer embankment

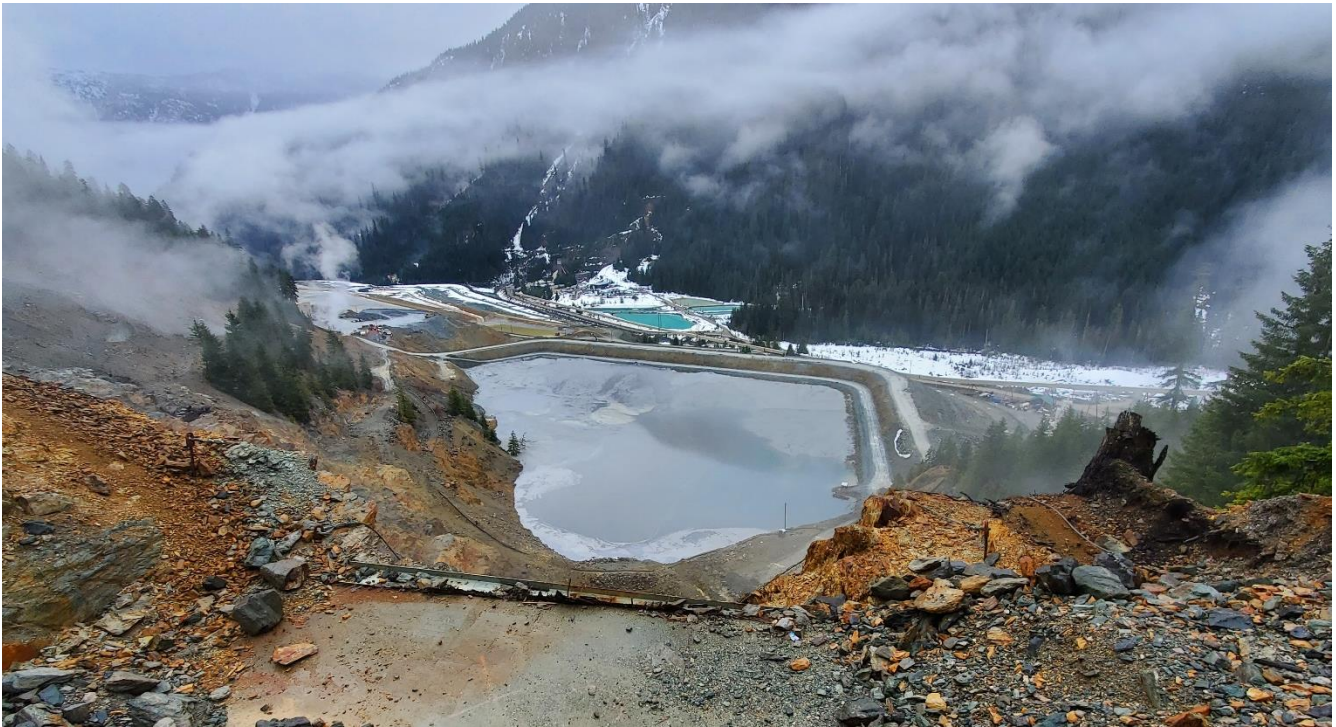
Photo 1: Overview of the Lynx TDF taken from lookout point in Upper Lynx Pit. (March 22, 2022)

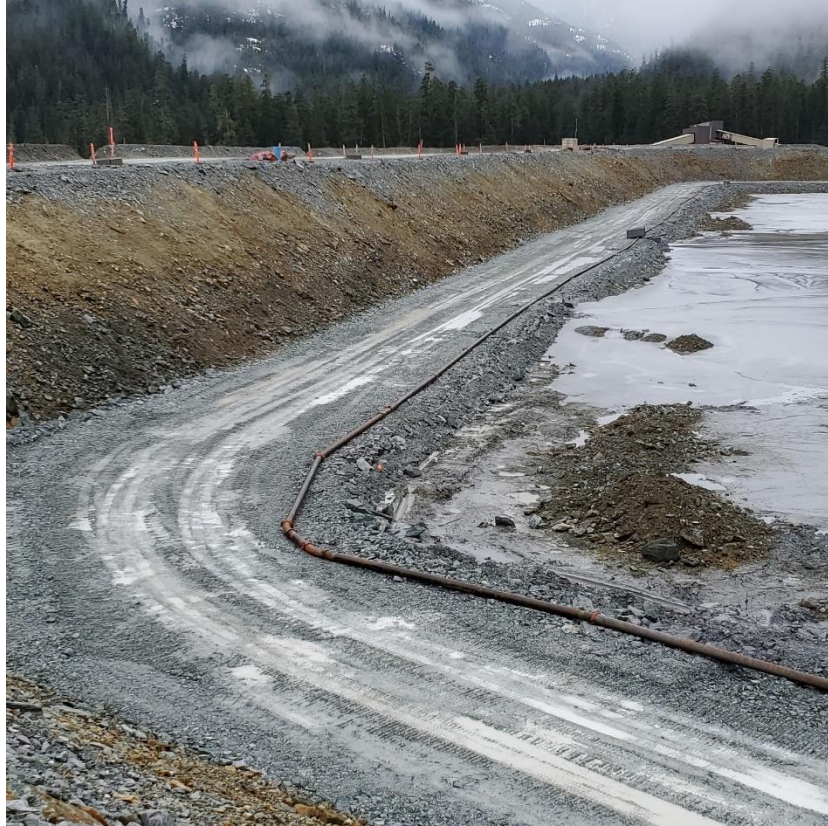
Photo 7: South-east corner of Lynx TDF, looking west. Crest Elevation at 373.5m. Active tailings deposition was observed from a spigot located at the east end of the TDF. (March 22, 2022)

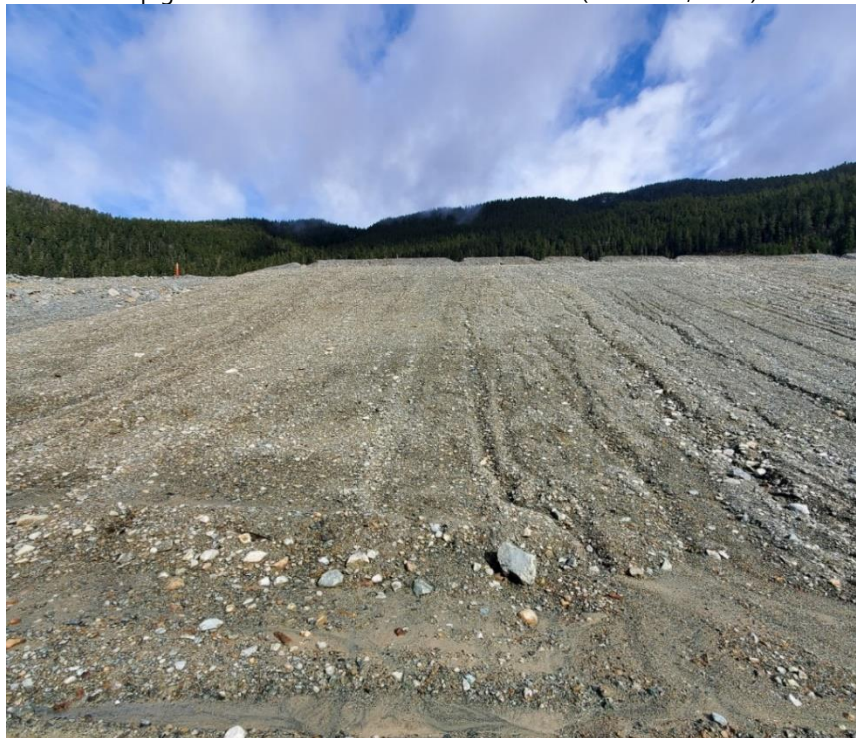
Photo 8: Lynx TDF Downstream toe area of the Closure Cover Trials. Some erosion observed in the Cover Trial area. (March 23, 2022)

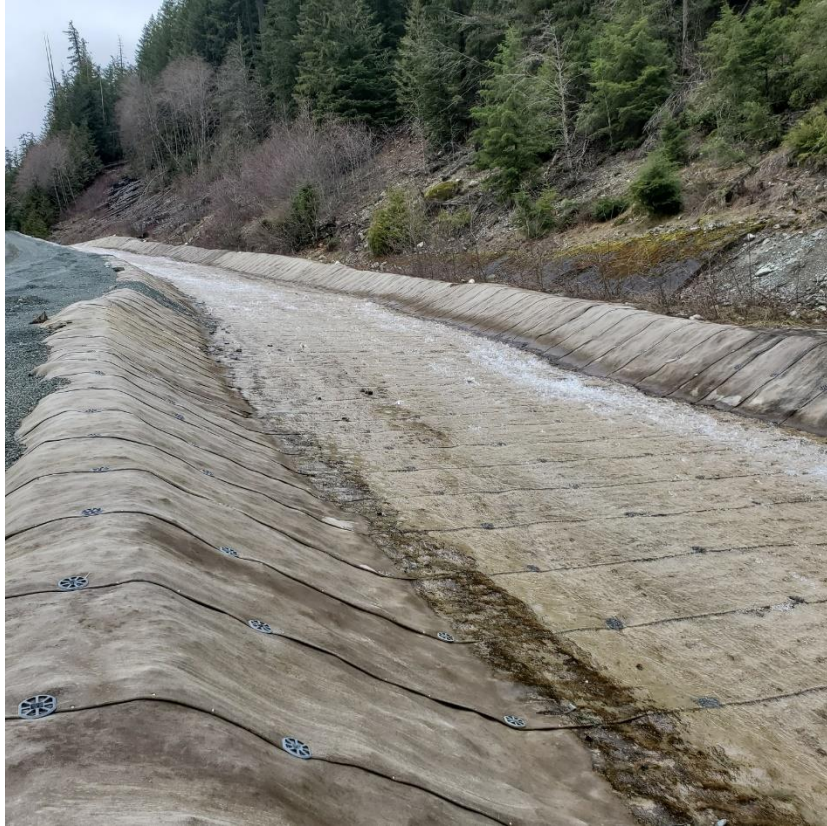
Photo 9: Lower Lynx Diversion Ditch. No unusual performance observed. (March 22, 2022)

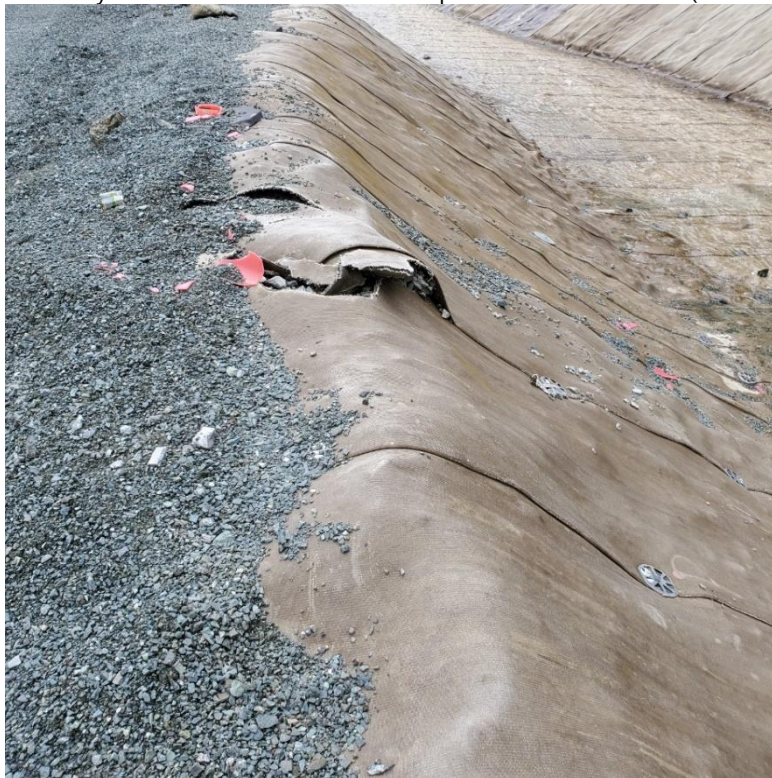
Photo 10: Lower Lynx Diversion Ditch damage to concrete cloth observed. (March 22, 2022)

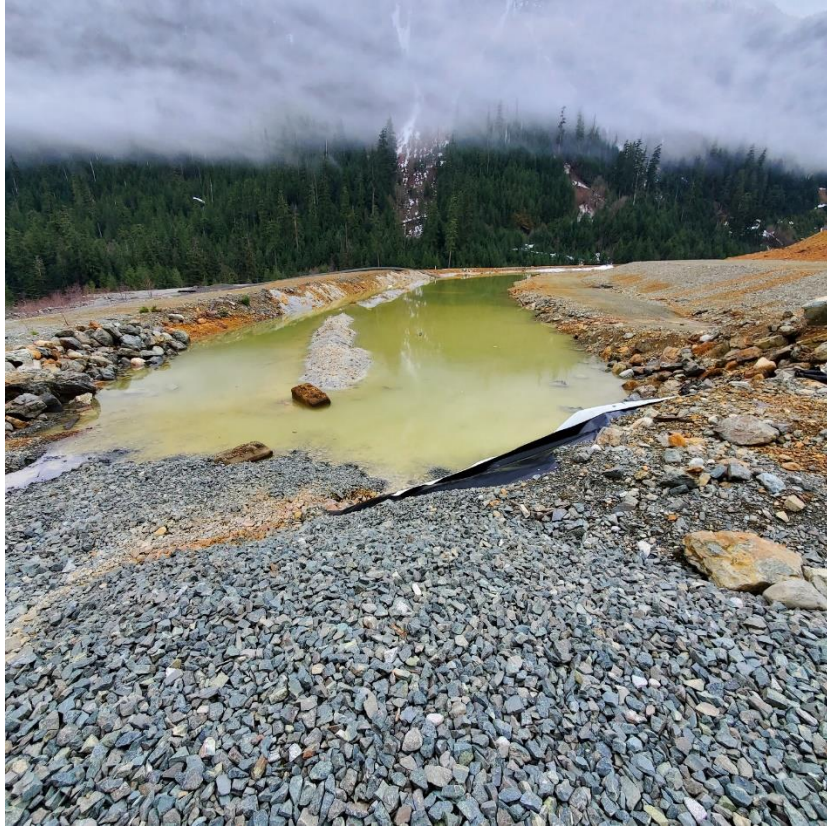
Photo 11: East Strip was essentially dammed by sediments near the Zim Pro discharge line. (March 22, 2022)

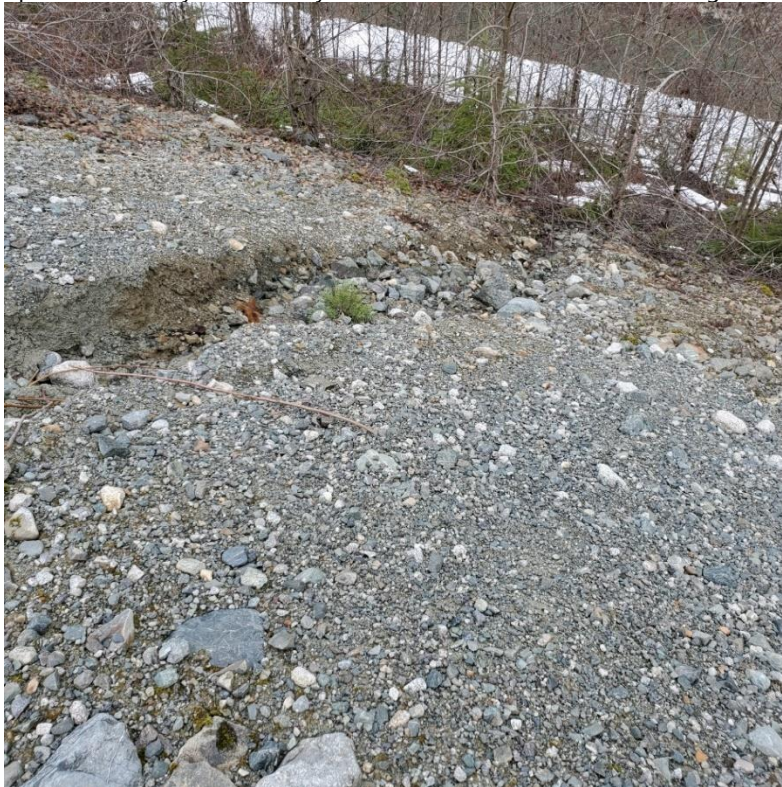
Photo 12: Erosion gullies observed on downstream of SUB to be addressed in 2022 Closure Phase 1 Construction. (March 22, 2022)

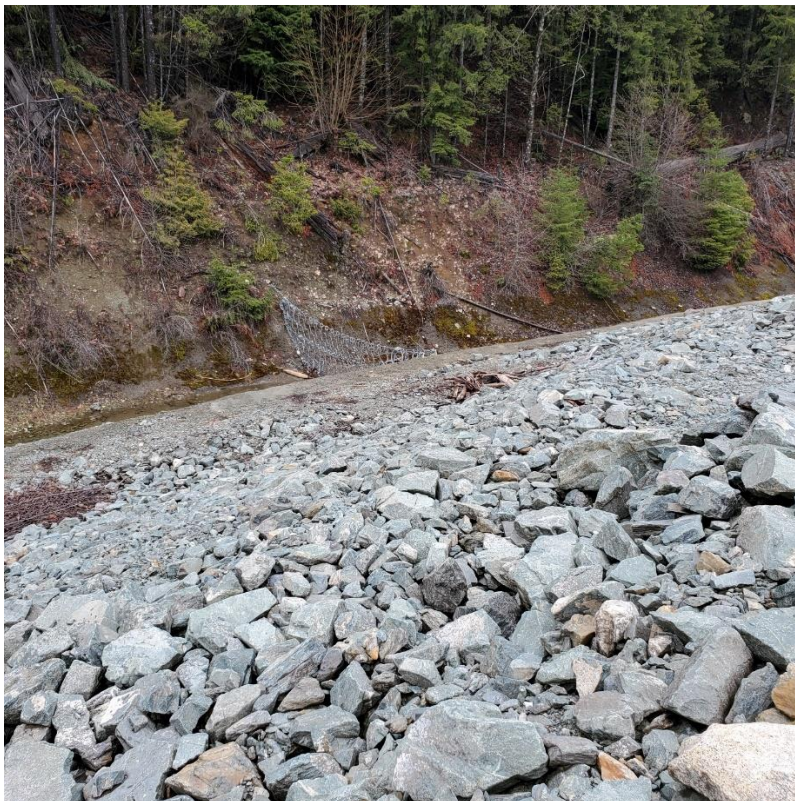
Photo 13: West end of the Lower Lynx Diversion Ditch at the location of the interim debris retaining net. (March 22, 2022)

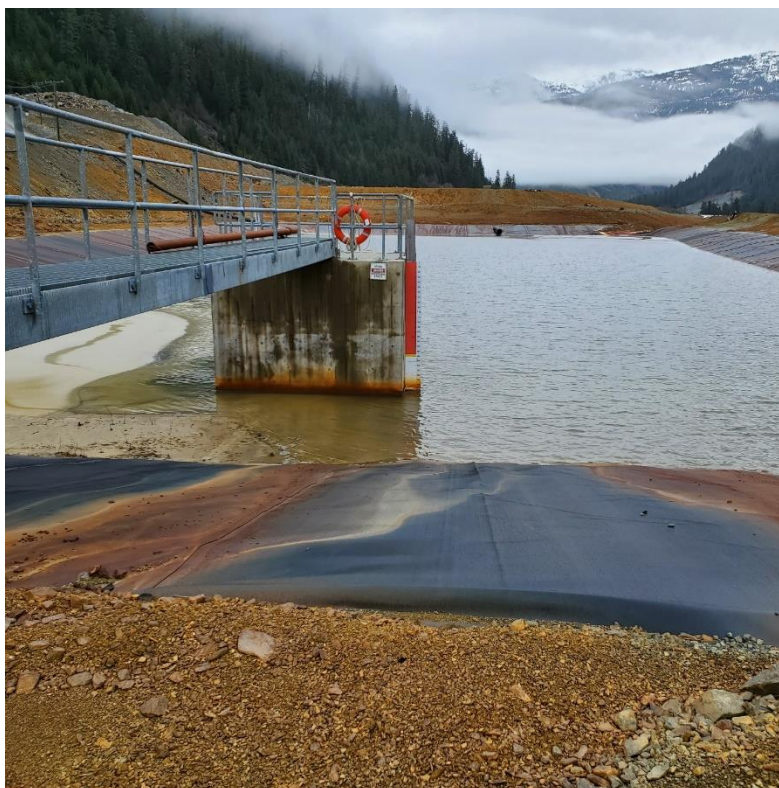
Photo 14: Surge Pond looking east. No unusual performance was observed. (March 23, 2022)

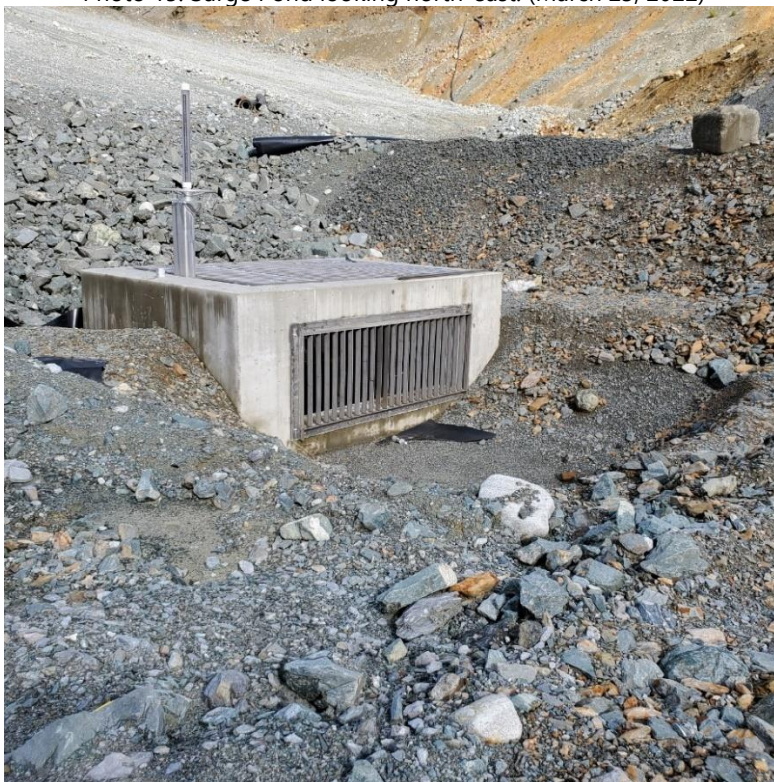
Photo 16: Temporary Lynx Spring Drain Sump. Functioning as intended with discharge observed to be clear. (March 23, 2022)

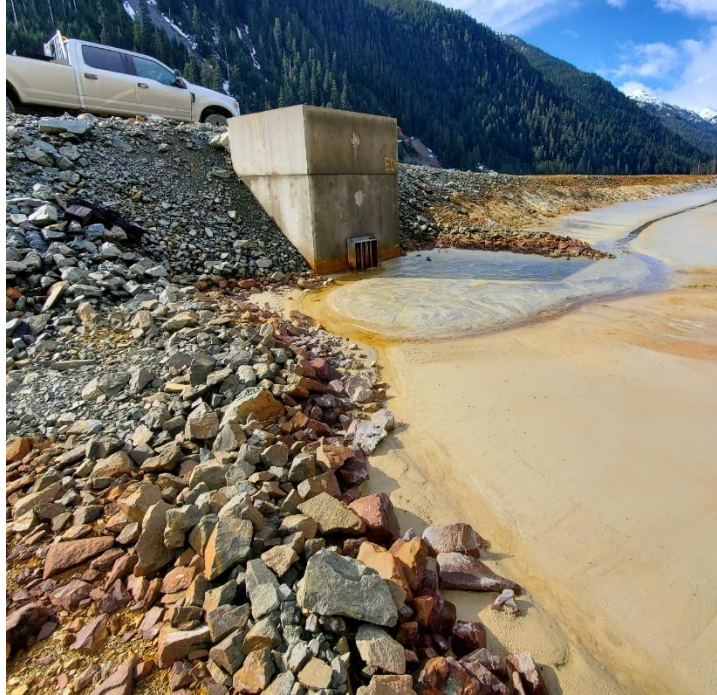
Photo 17: East Decant structure. Grating decant needs to be replaced due to acidic dissolution of lower portion of the vertical grating. (March 23, 2022)

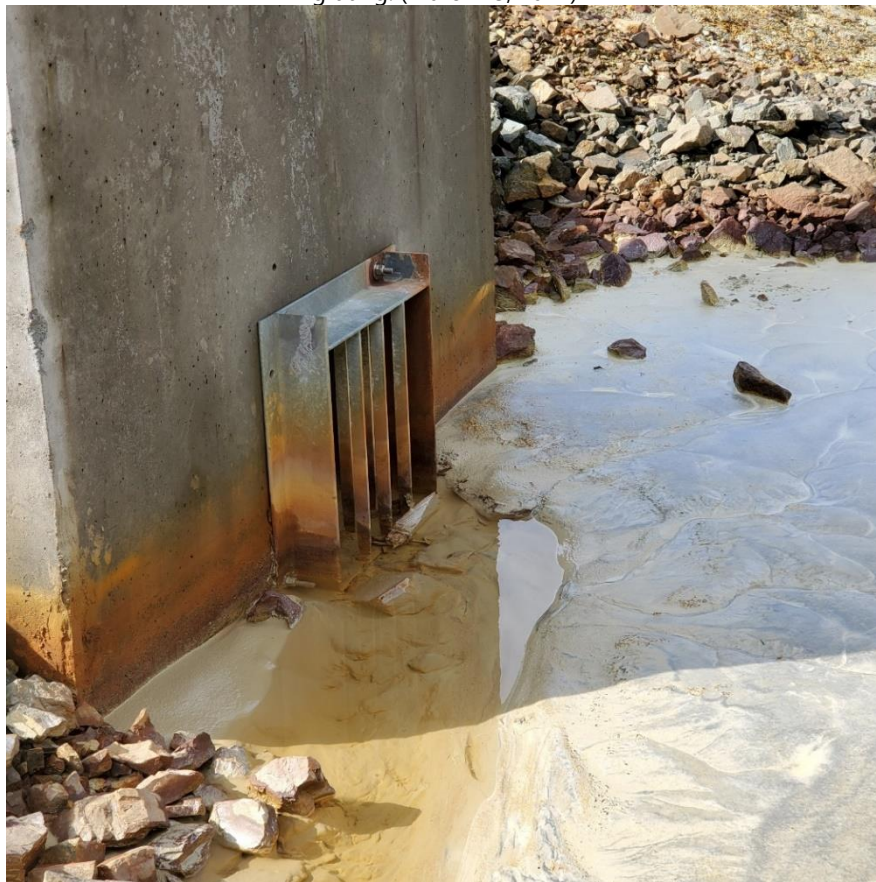
Photo 18: Grating decant needs to be replaced due to acidic dissolution of lower portion of the vertical grating. (March 23, 2022)

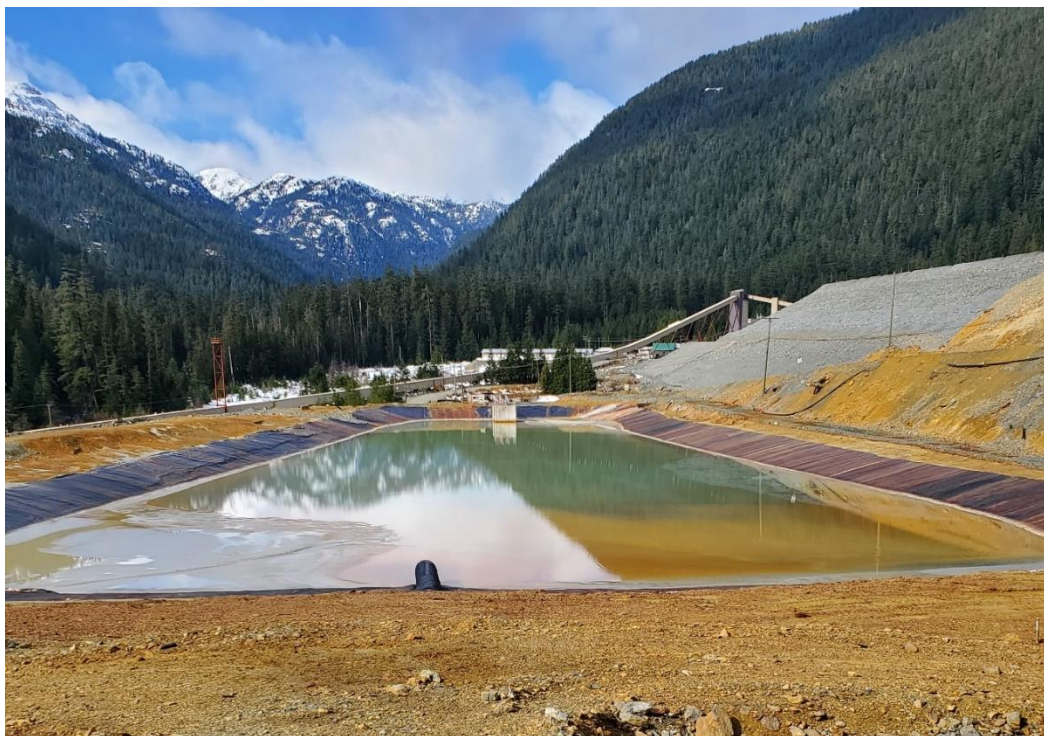
Photo 19: Super Pond at time of site inspection, no unusual performances observed. (March 23, 2022)

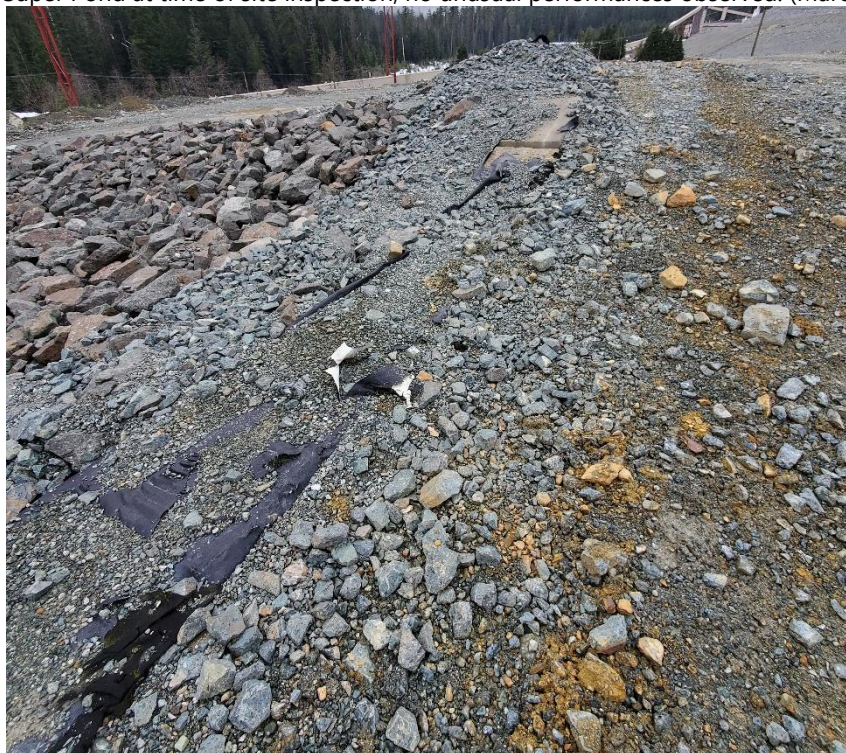
Photo 20: Geotextile/geomembrane over the buried lock blocks in the APA spillway observed to be damaged. (March 22, 2022)

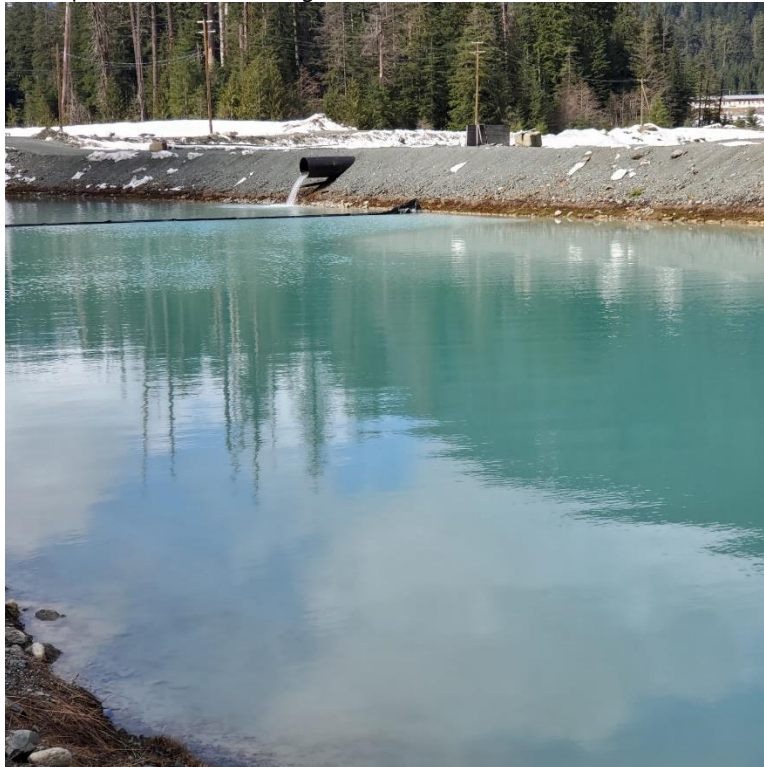
Photo 22: Polishing Pond 3A looking West. No unusual performance observed. (March 23, 2022)

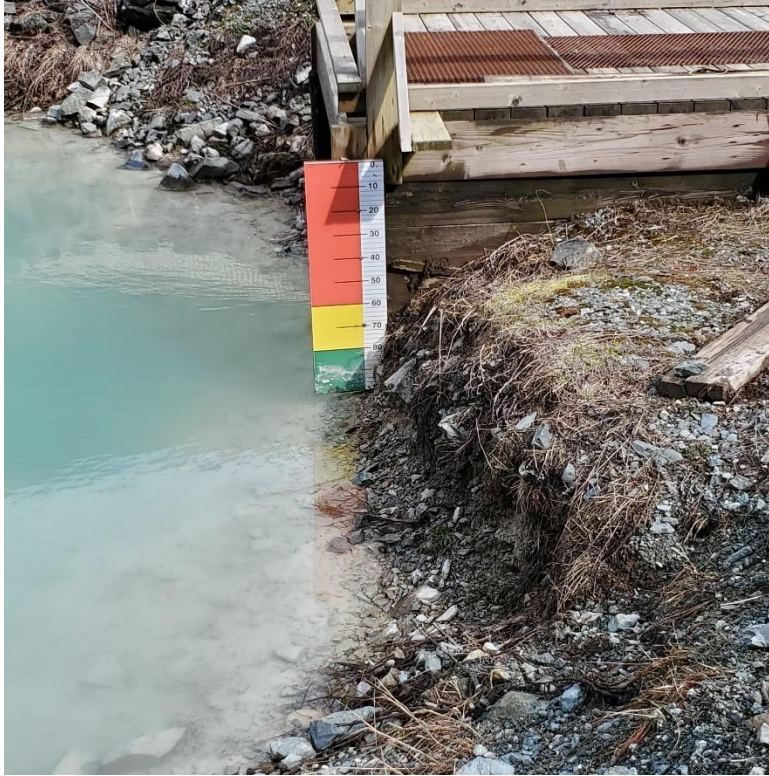
Photo 23: Polishing Pond 3A staff gauge in green zone. (March 23, 2022)

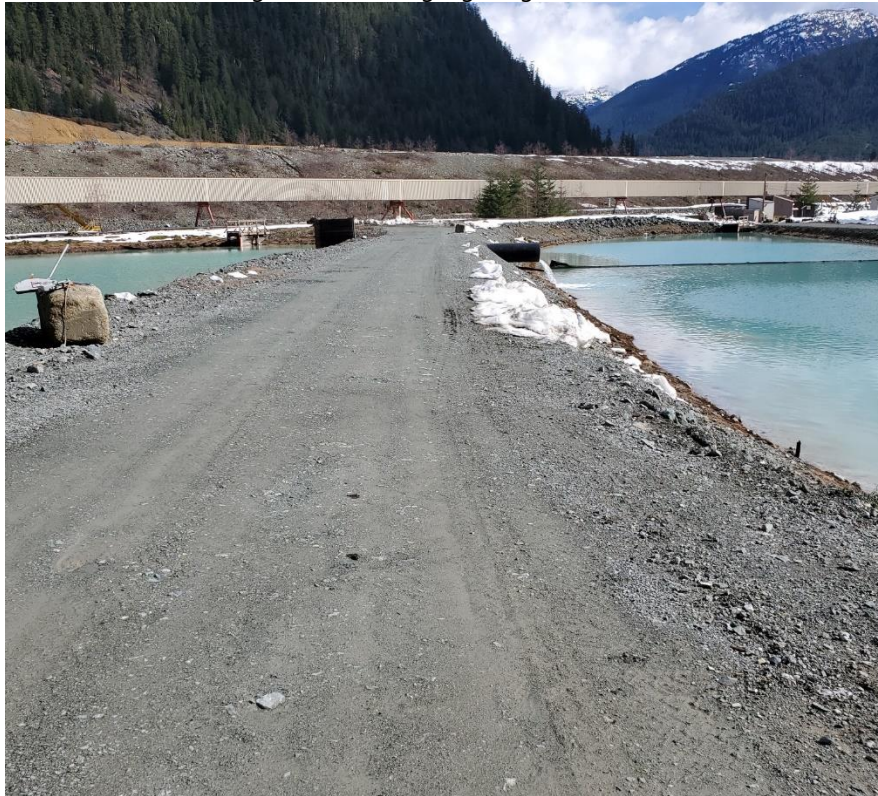
Photo 24: Crest between Polishing Pond 3A and Polishing Pond 4. No unusual performance observed. (March 23, 2022)

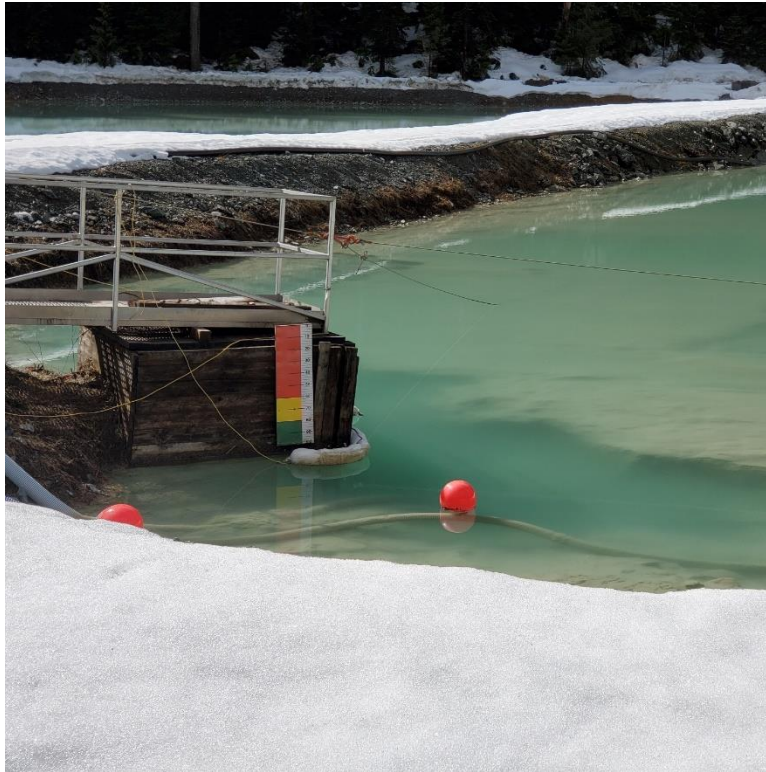
Photo 25: Polishing Pond 2A staff gauge in green zone. (March 23, 2022)

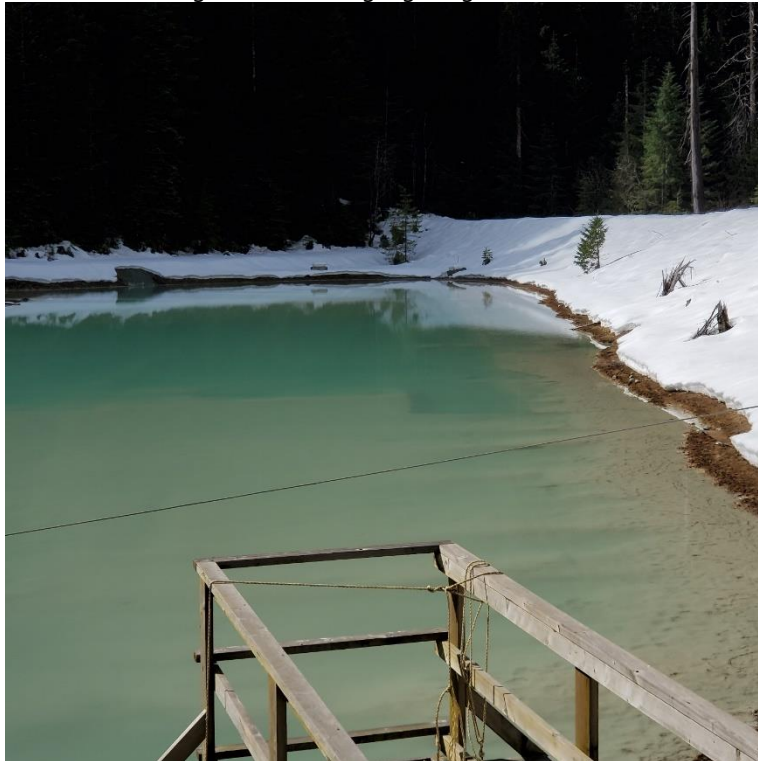
Photo 26: Polishing Pond 2A looking South. No unusual performance observed. (March 23, 2022)

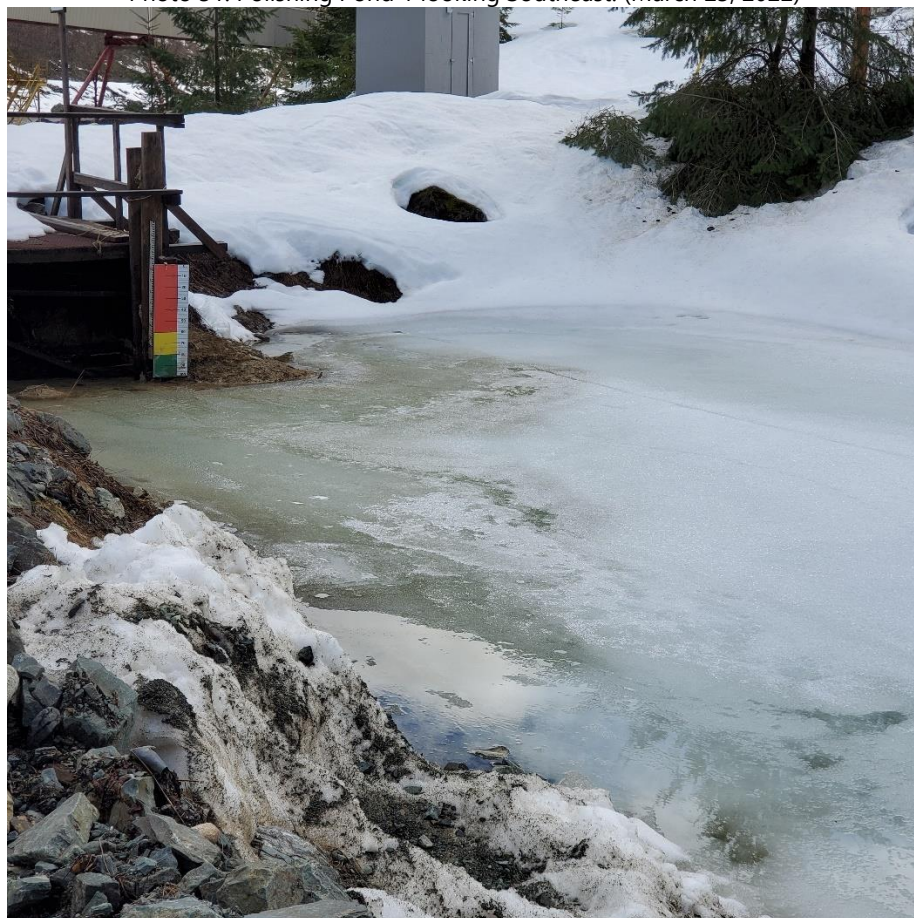
Photo 32: Polishing Pond 3 observed to be empty with staff gauge in green zone. (March 23, 2022)

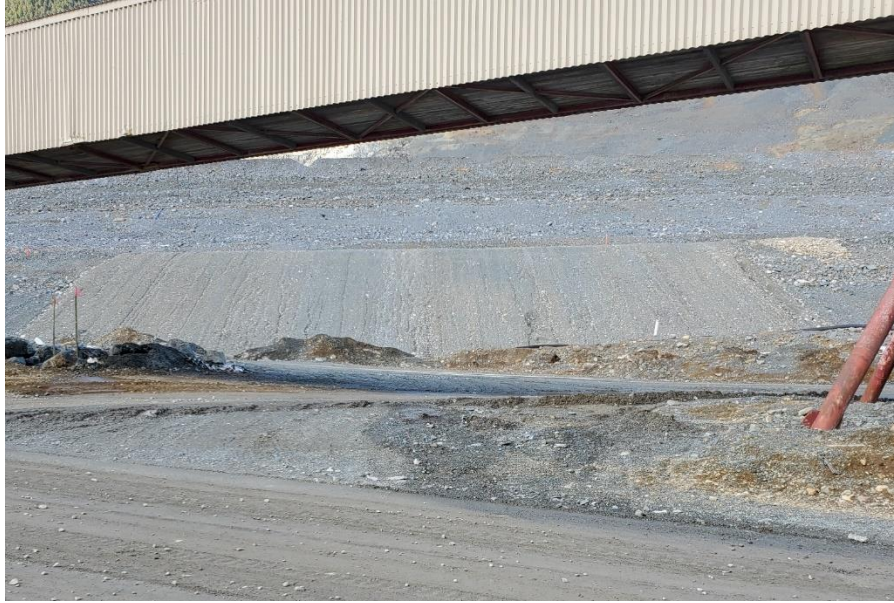
Photo 33: Area of the closure cover trials, sparse vegetation observed. (March 23, 2022)

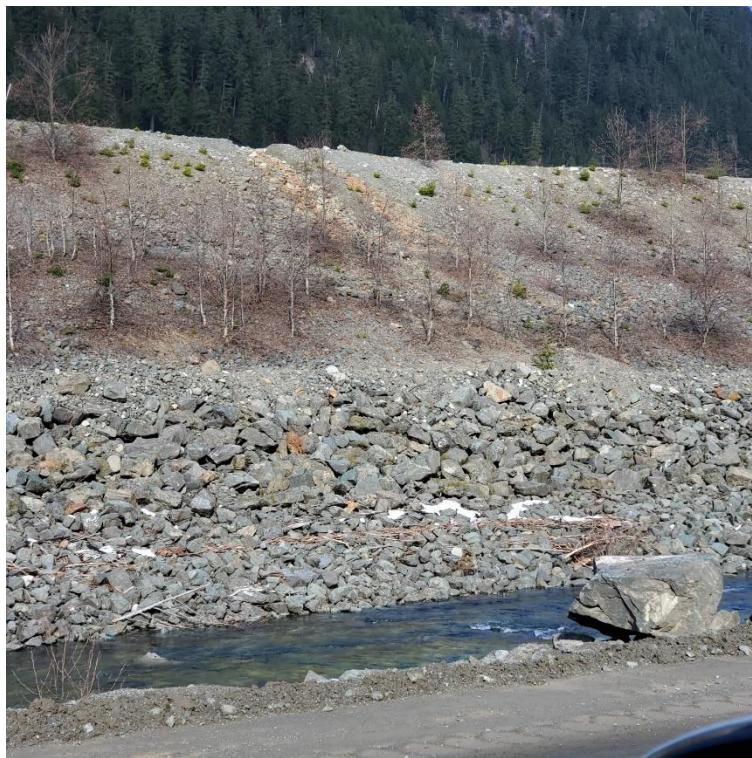
Photo 34: Gully erosion observed on downstream end of Seismic Upgrade Berm of the Old TDF, gully erosion to be addressed during Phase 1 Closure of Old TDF in 2022 construction season (March 23, 2022)

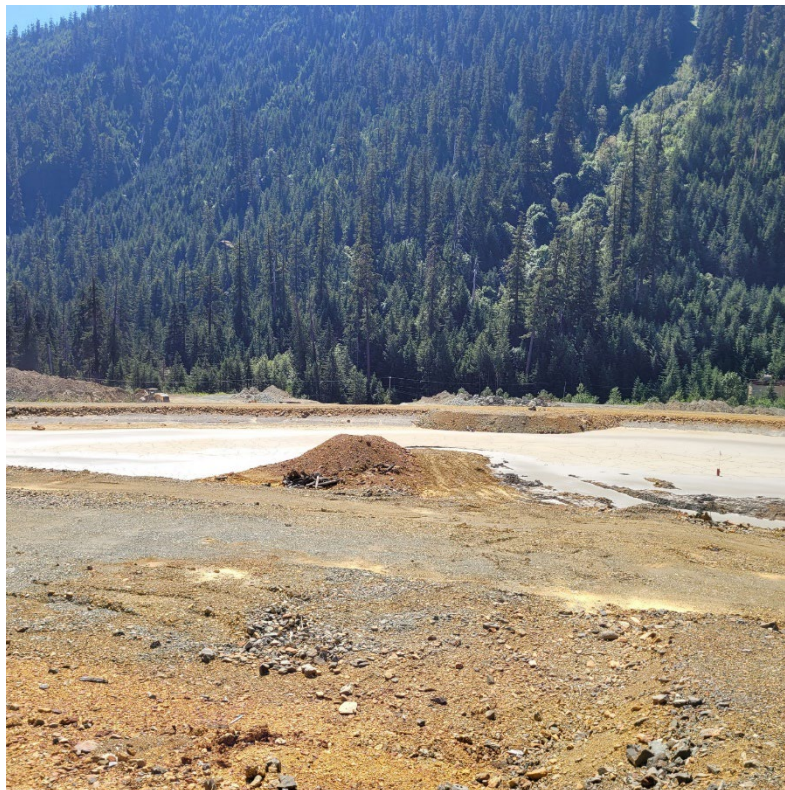
Photo 10: East Strip of the Old TDF filled with tailings from Zim Pro line

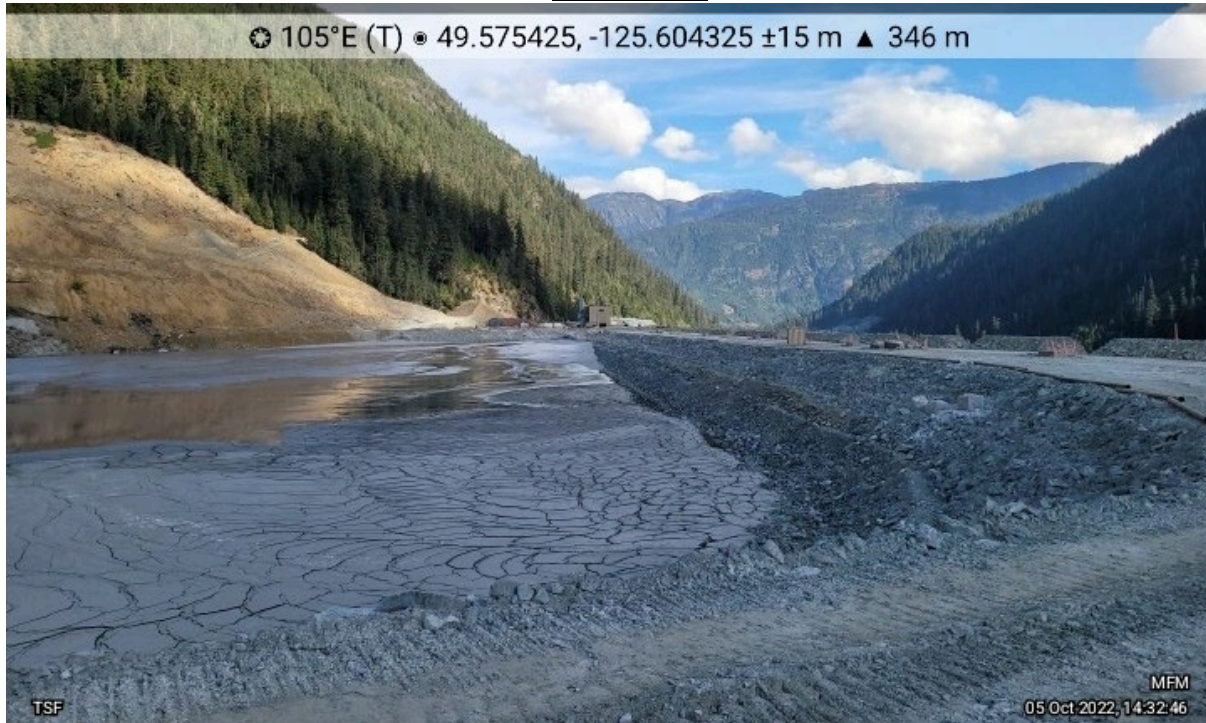
Photo 1: Lynx TDF looking East. Active tailings deposition was observed from a spigot located at the east end of the TDF

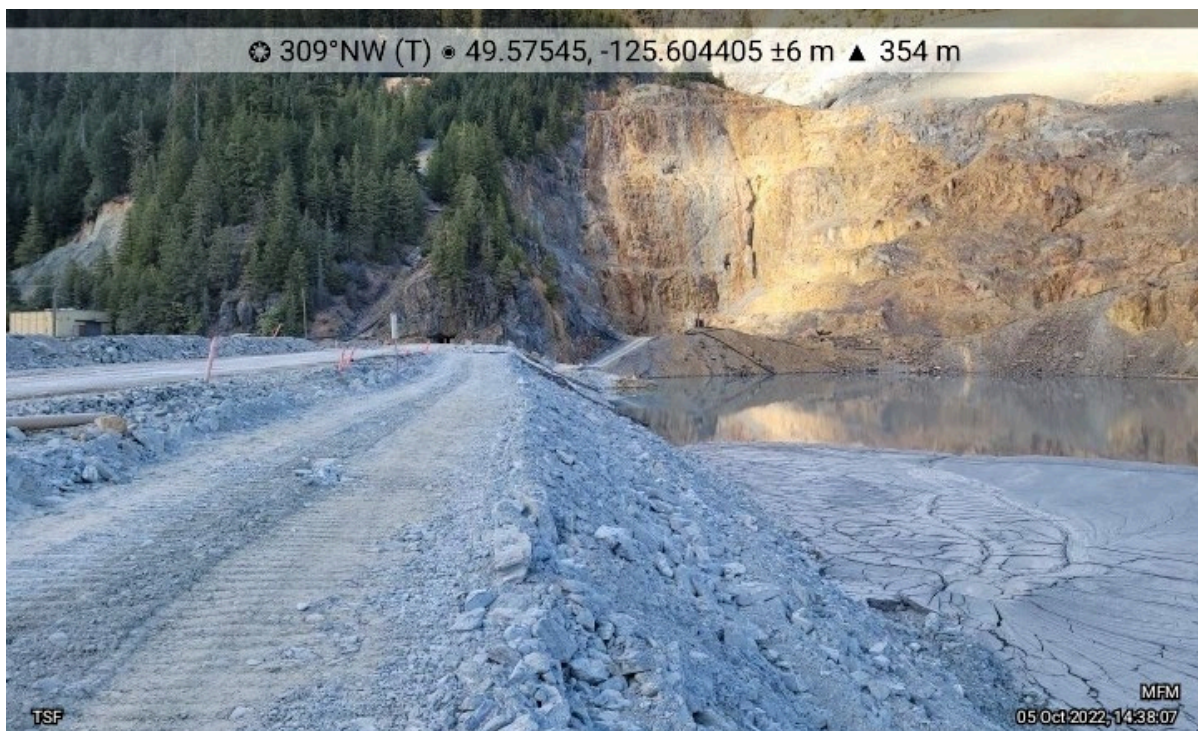
Photo 2: Lynx TDF looking northwest. Crest elevation is at 373.5 m.
