2022 LYNX TDF DAM SAFETY INSPECTION REPORT

MYRA FALLS MINE LTD.
A TRAFIGURA COMPANY
CAMPBELL RIVER, BC

PROJECT NO.: NX14001B4.3
DATE: 29 MARCH 2023

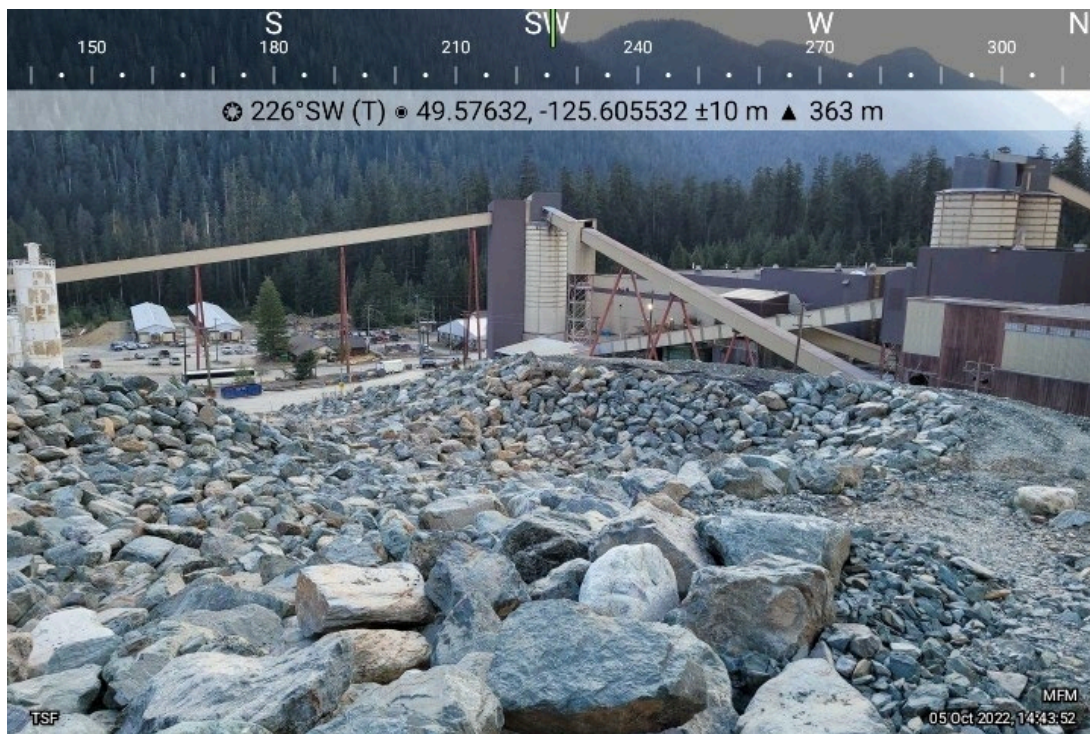
Photo 5: Lynx TDF spillway looking downstream to the mill and camp sites. Riprap was stable with no evidence of deterioration or segregation of sizes. Riprap stones are angular to subangular.

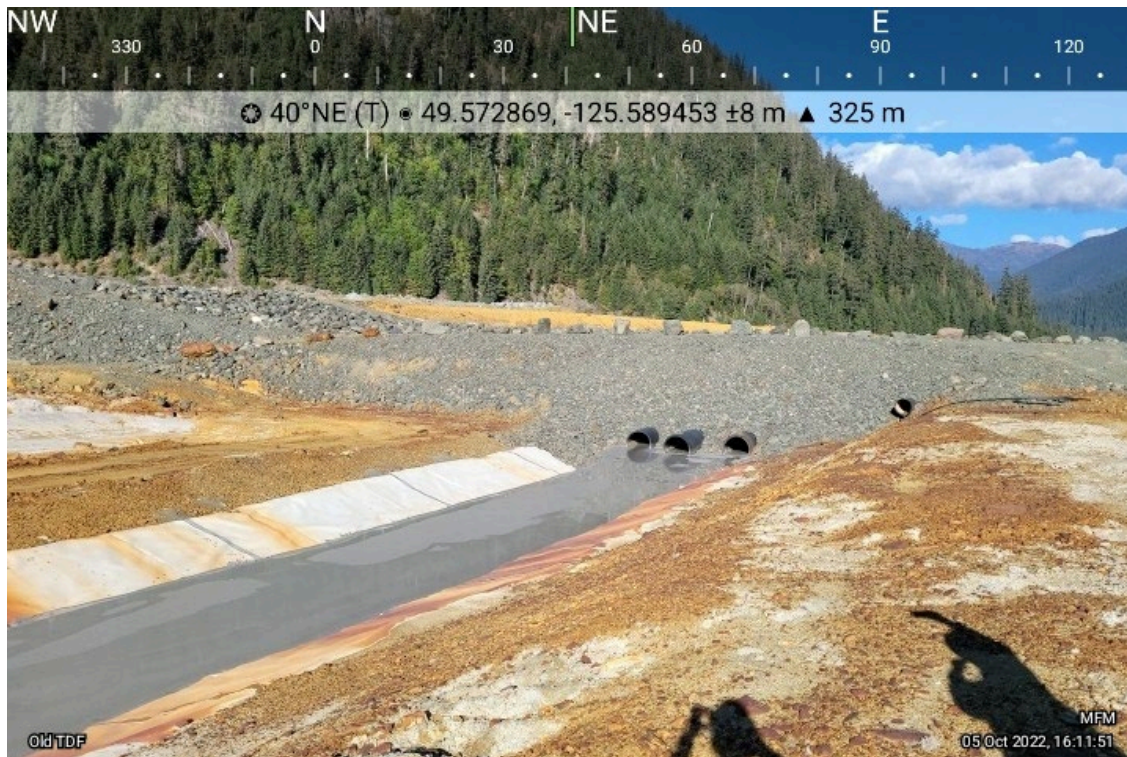
Photo 13: The West Strip of the Old TDF was filled with tailings obstructing the flow capacity of the spillway culvert pipes. This condition needs immediate attention before the wintertime.

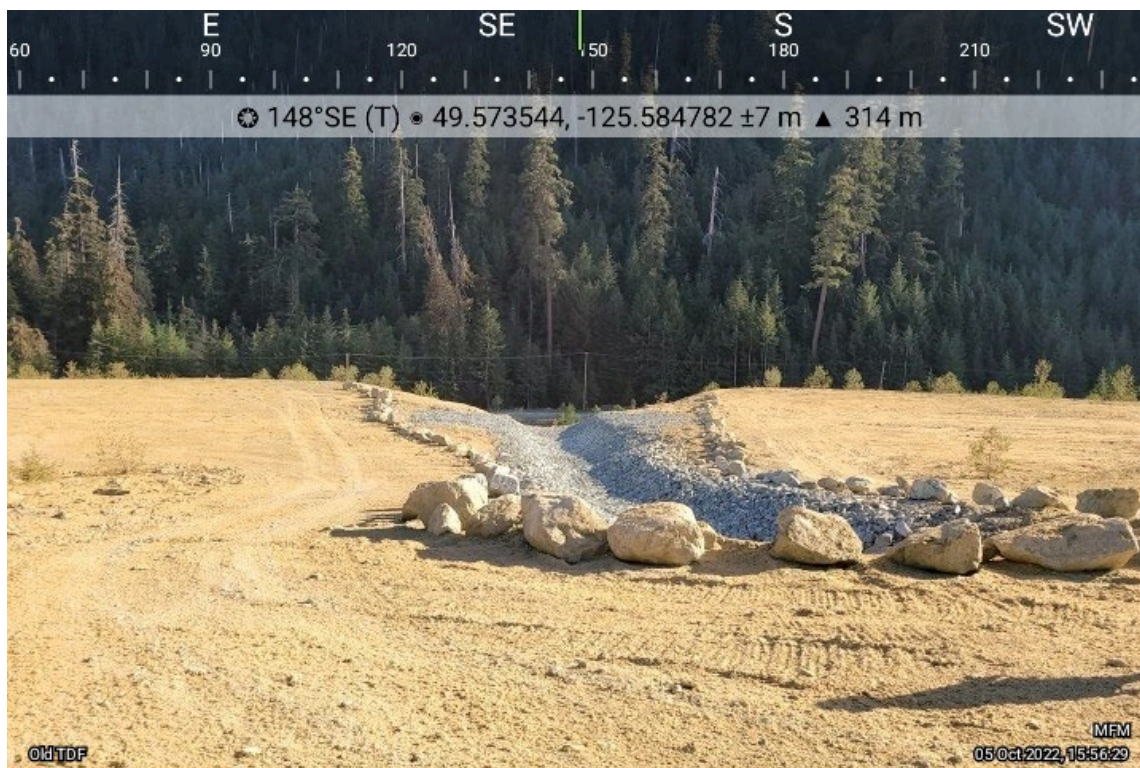
Photo 14: Old TDF Channel 1 looking downstream. The riprap is stable and in good condition.

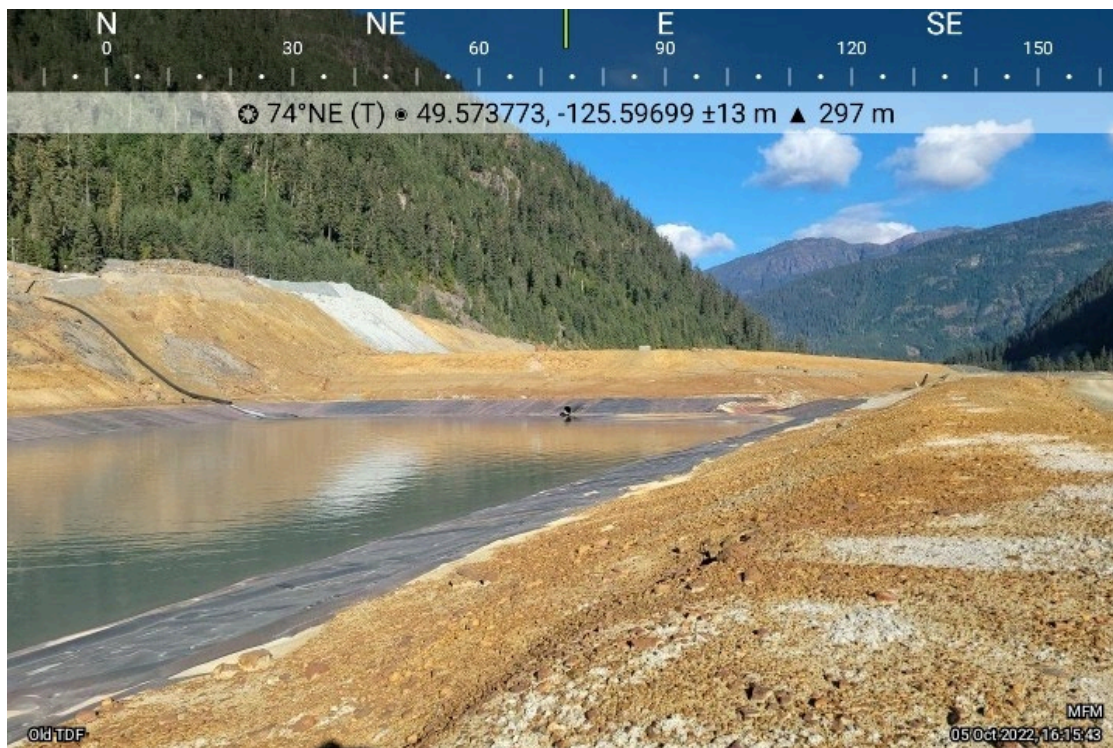
Photo 15: Surge Pond looking northeast. No unusual performance was observed.

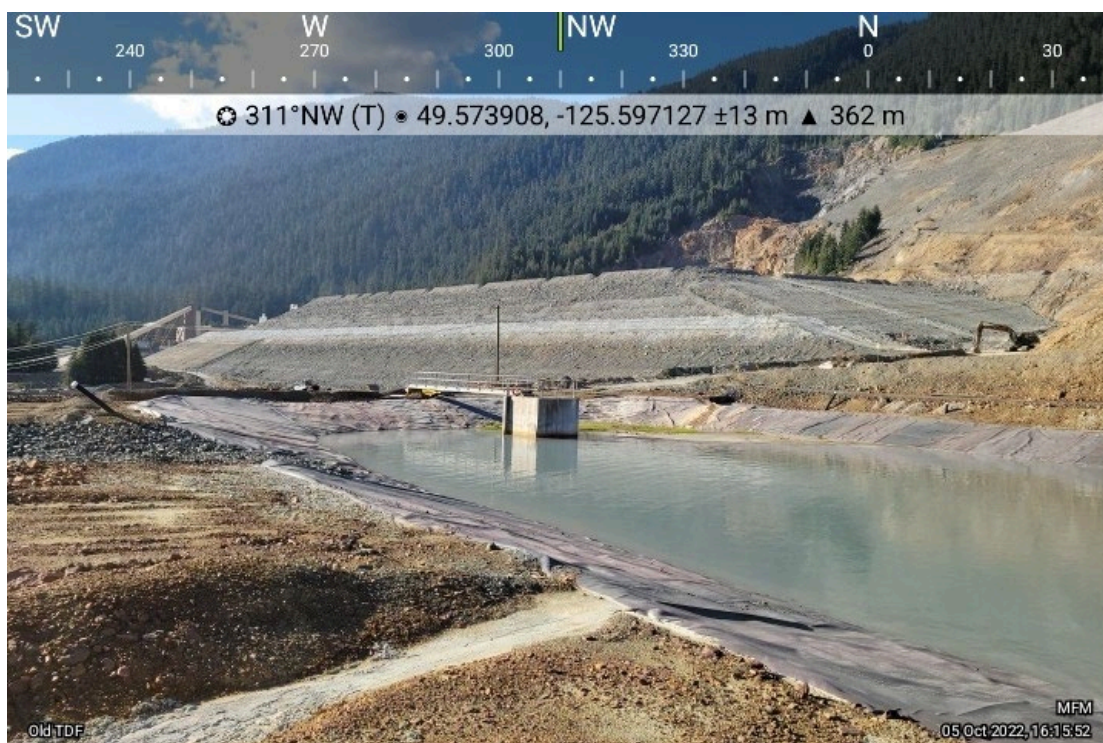
Photo 16: Surge Pond looking northwest. No unusual performance was observed.

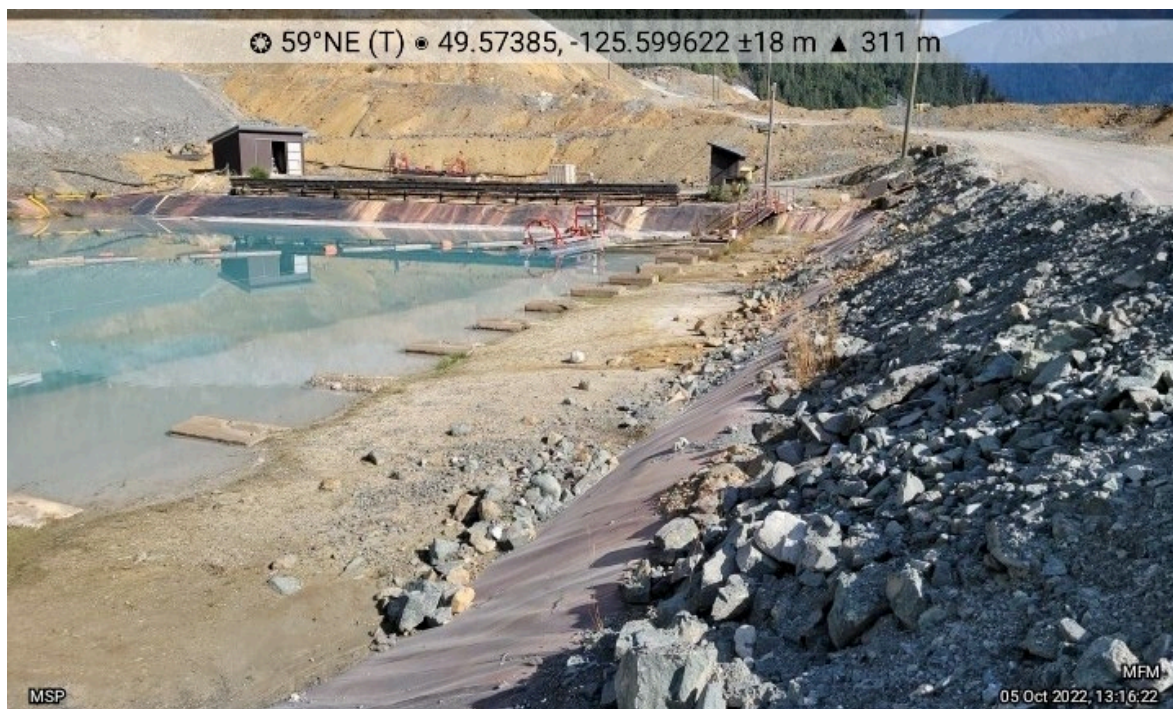
Photo 17: Super Pond looking northeast. No unusual performance was observed.

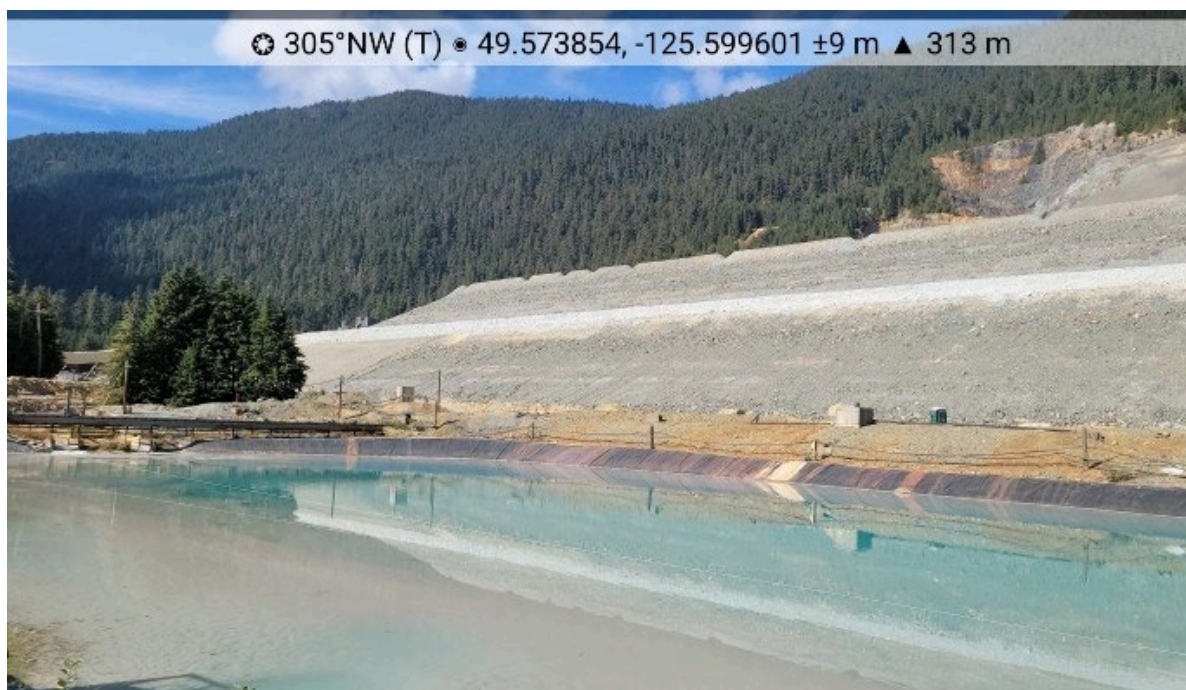
Photo 18: Super Pond looking northwest. No unusual performance was observed.

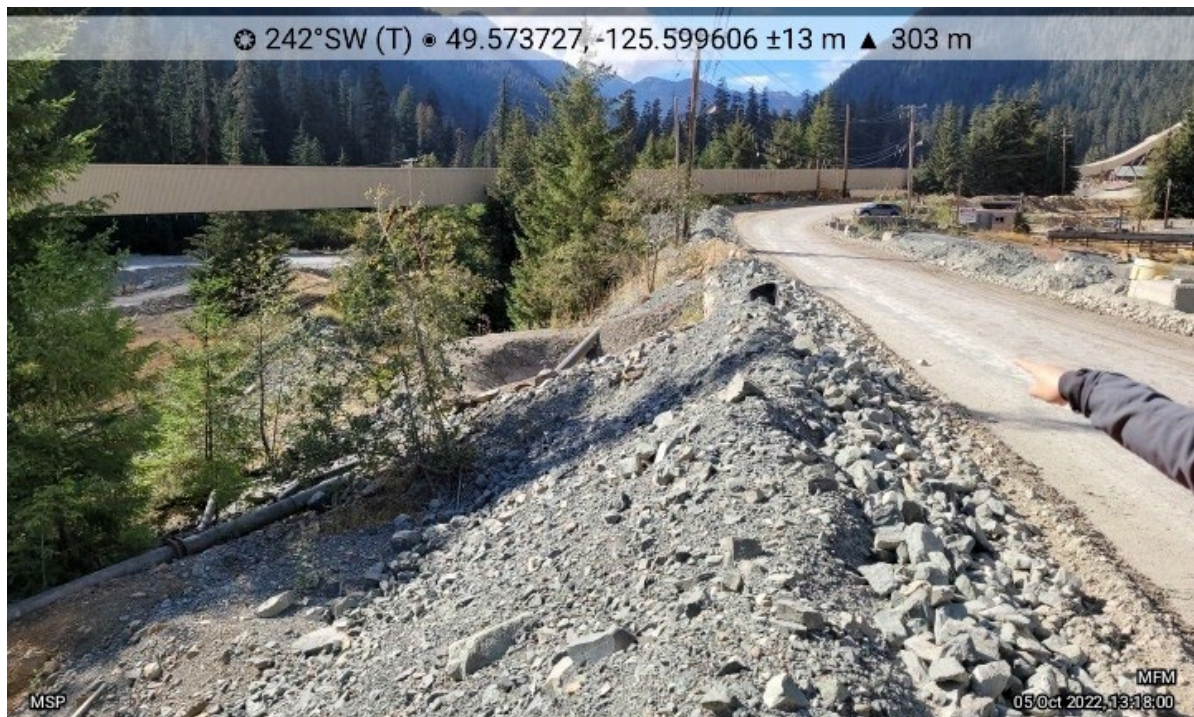
Photo 19: Super Pond looking at the downstream slope and the crest of the south retention berm of Super Pond. No unusual performance was observed.

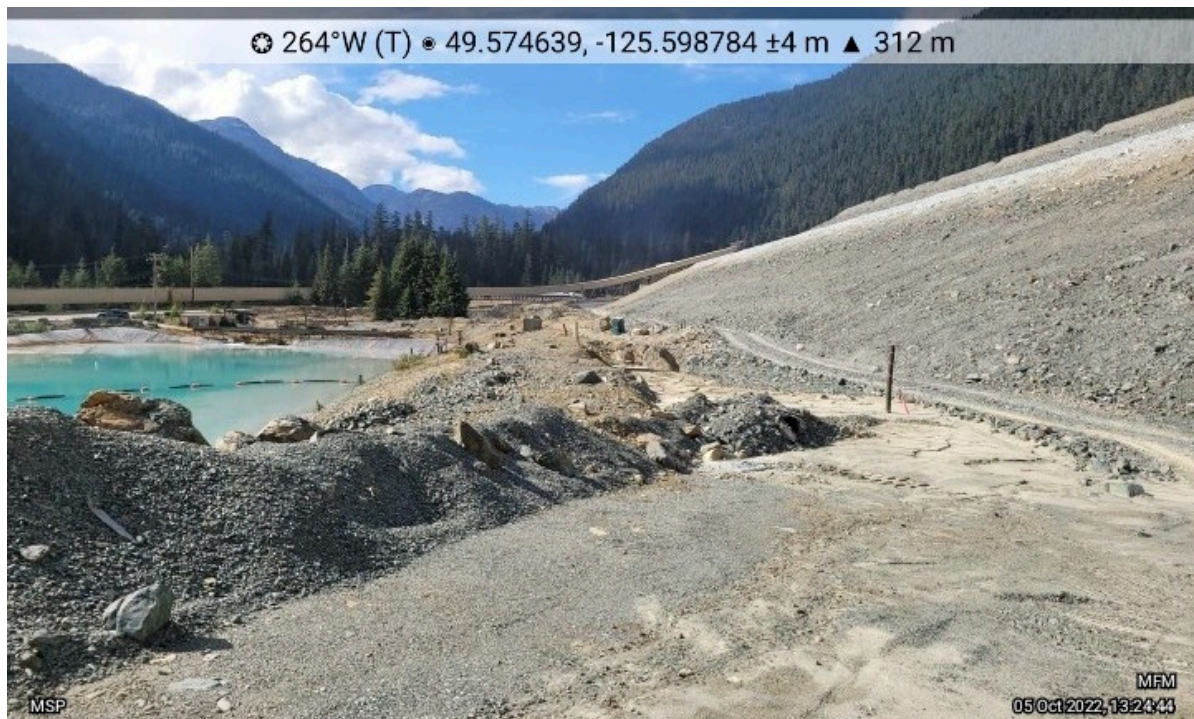
Photo 20: Super Pond looking upstream to the top of the pond and the berm that separates Super Pond from the downstream toe of Lynx TDF. No unusual performance was observed.

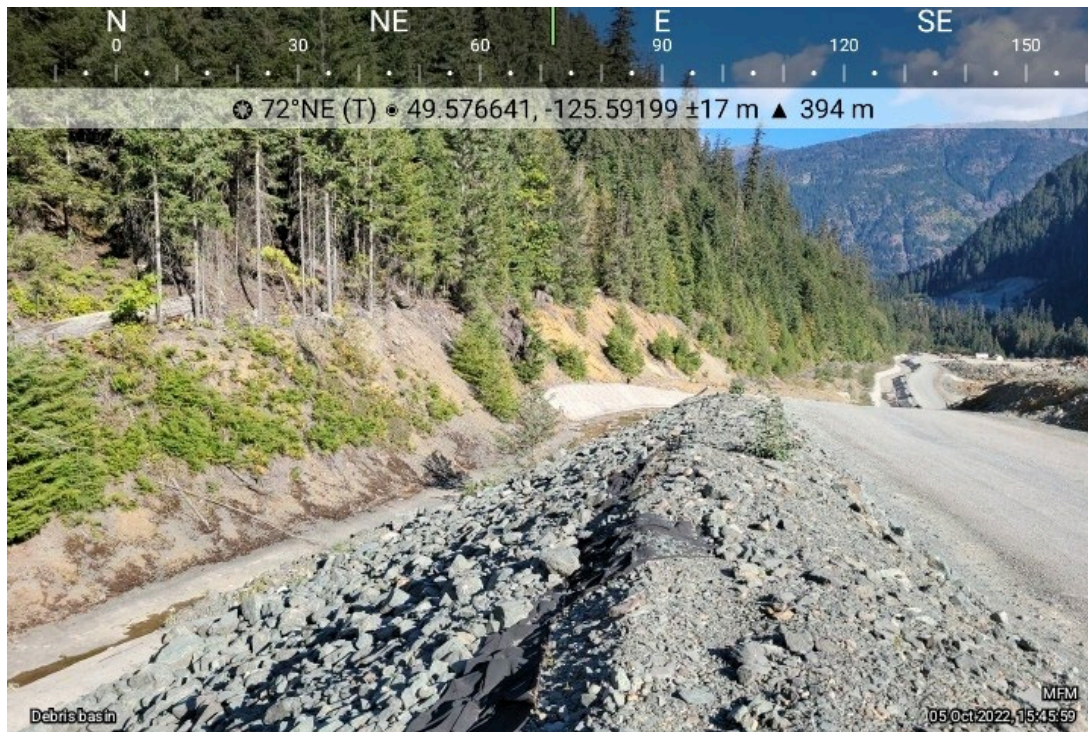
Photo 23: Lower Lynx Diversion Ditch with minimal flow. No unusual performance was observed.

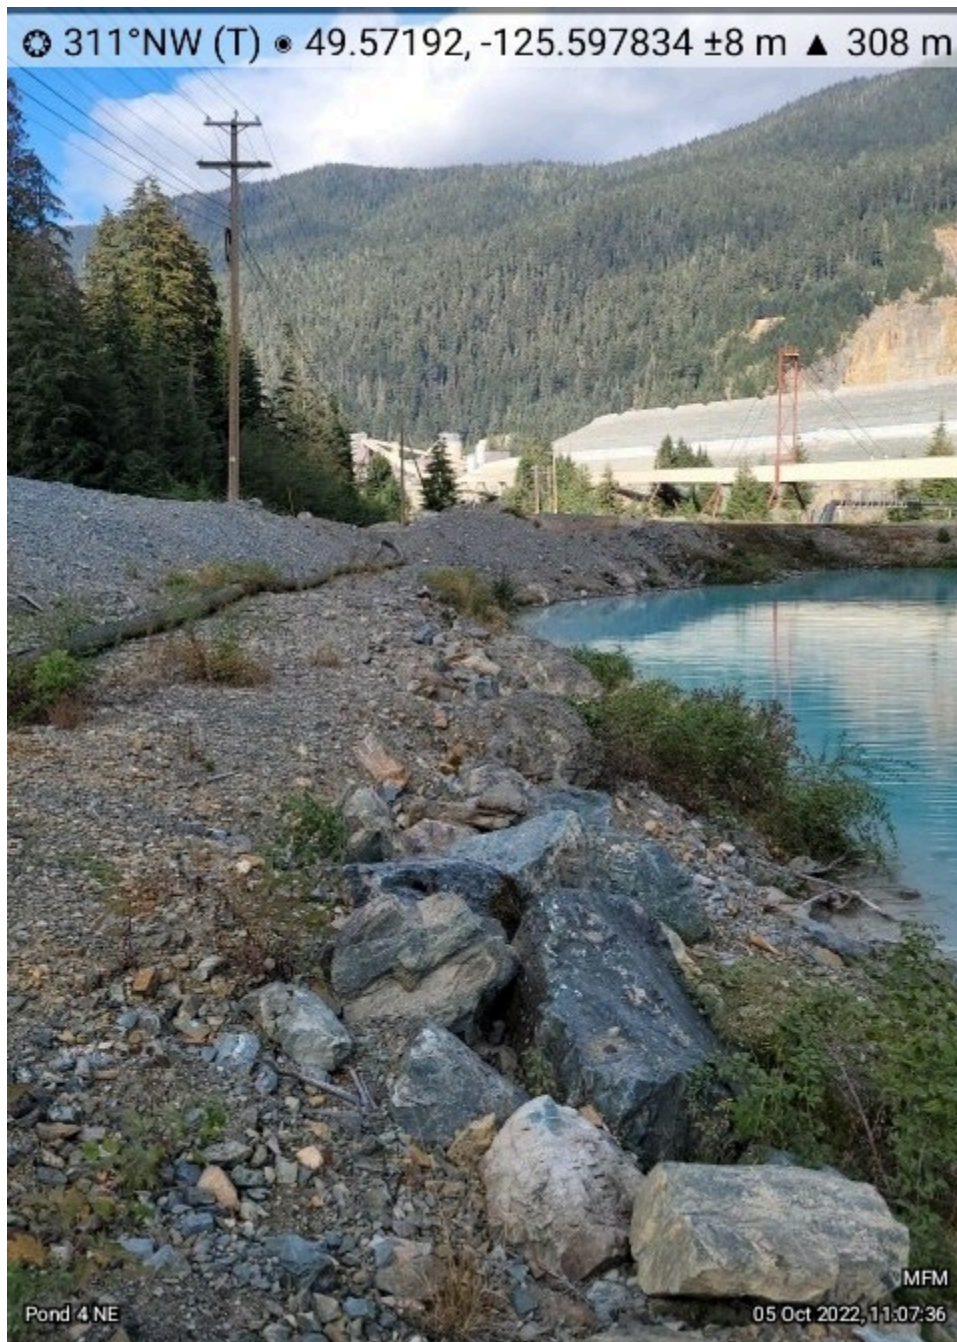
Photo 24: Polishing Pond 4. No unusual performance was observed.

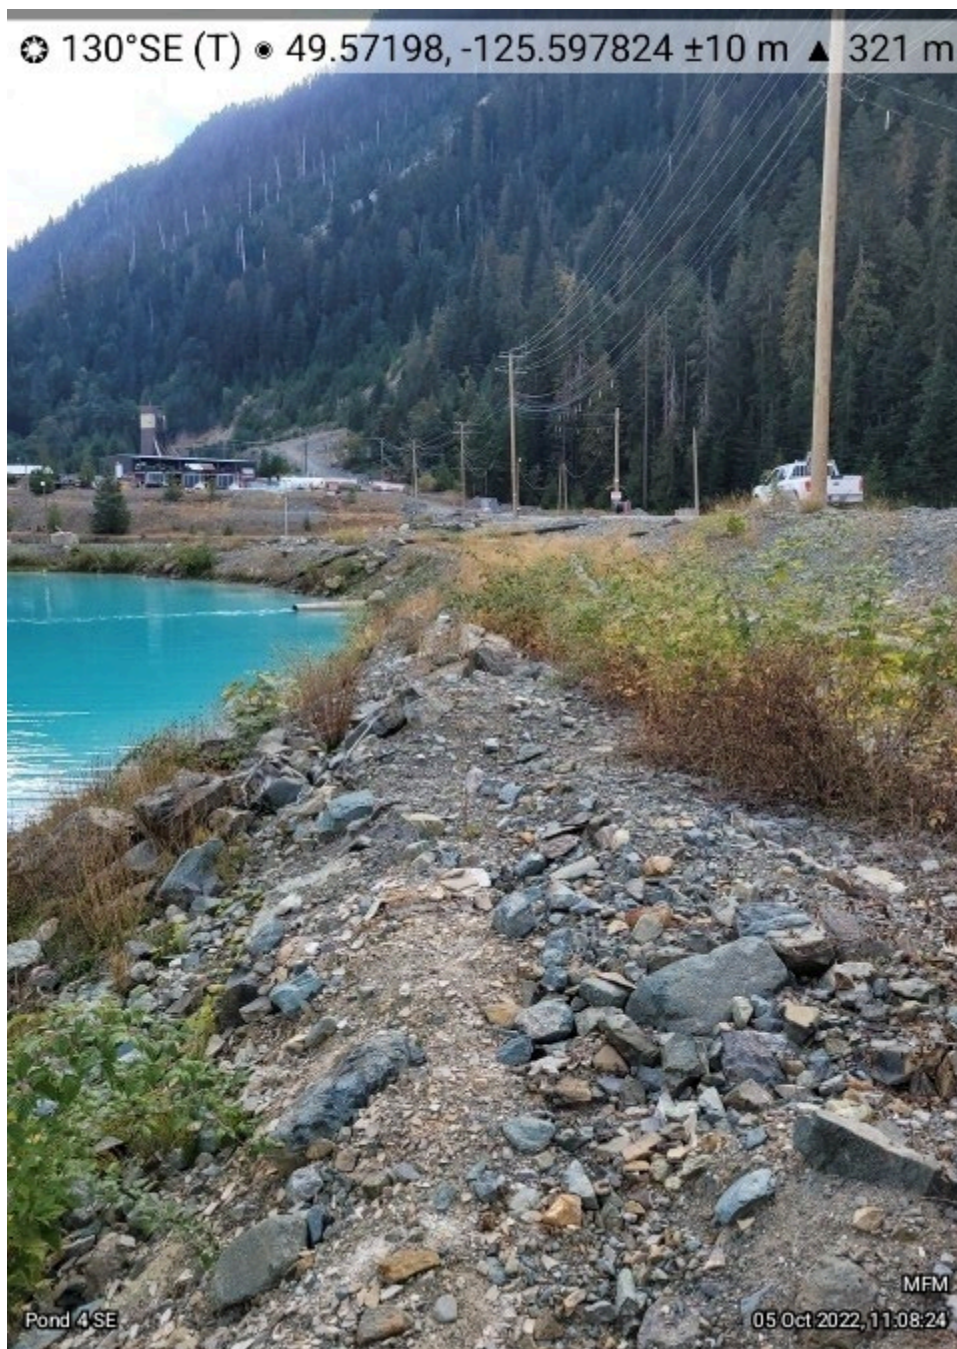
Photo 25: Polishing Pond 4. No unusual performance was observed.

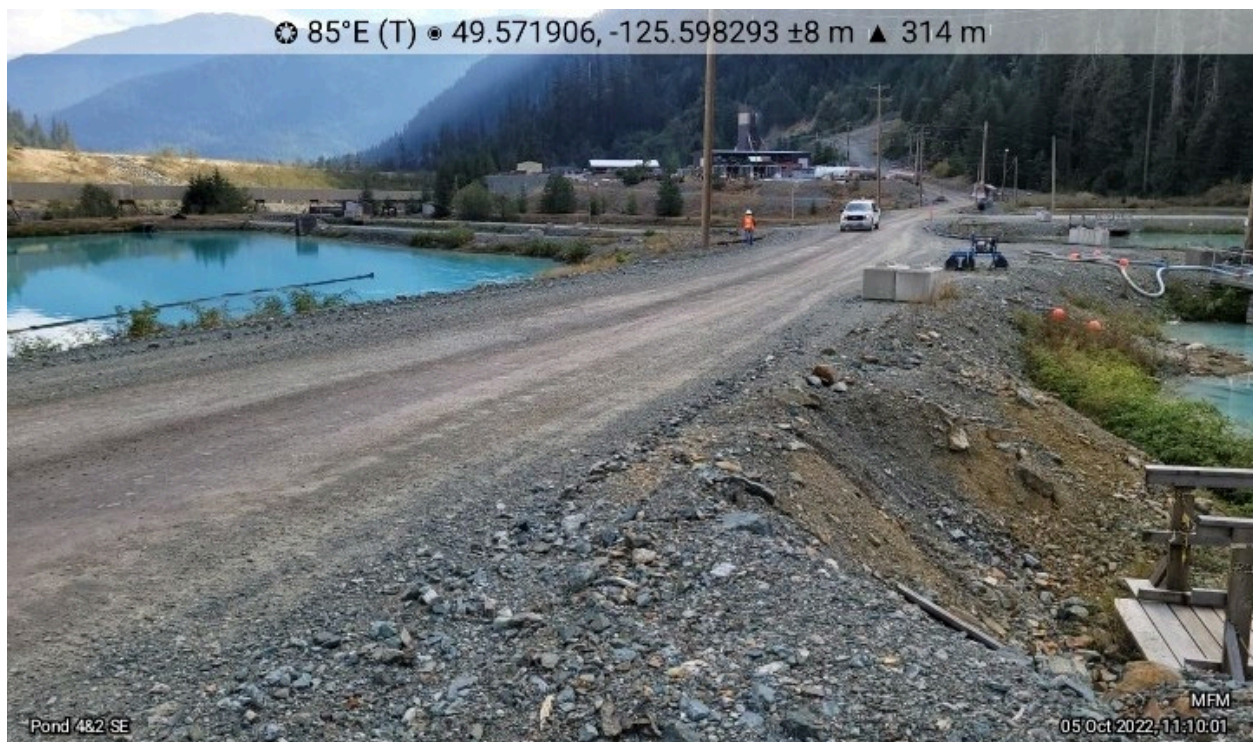
Photo 26: Crossing between Polishing Pond 4 and Polishing Pond 2. No unusual performance was observed.

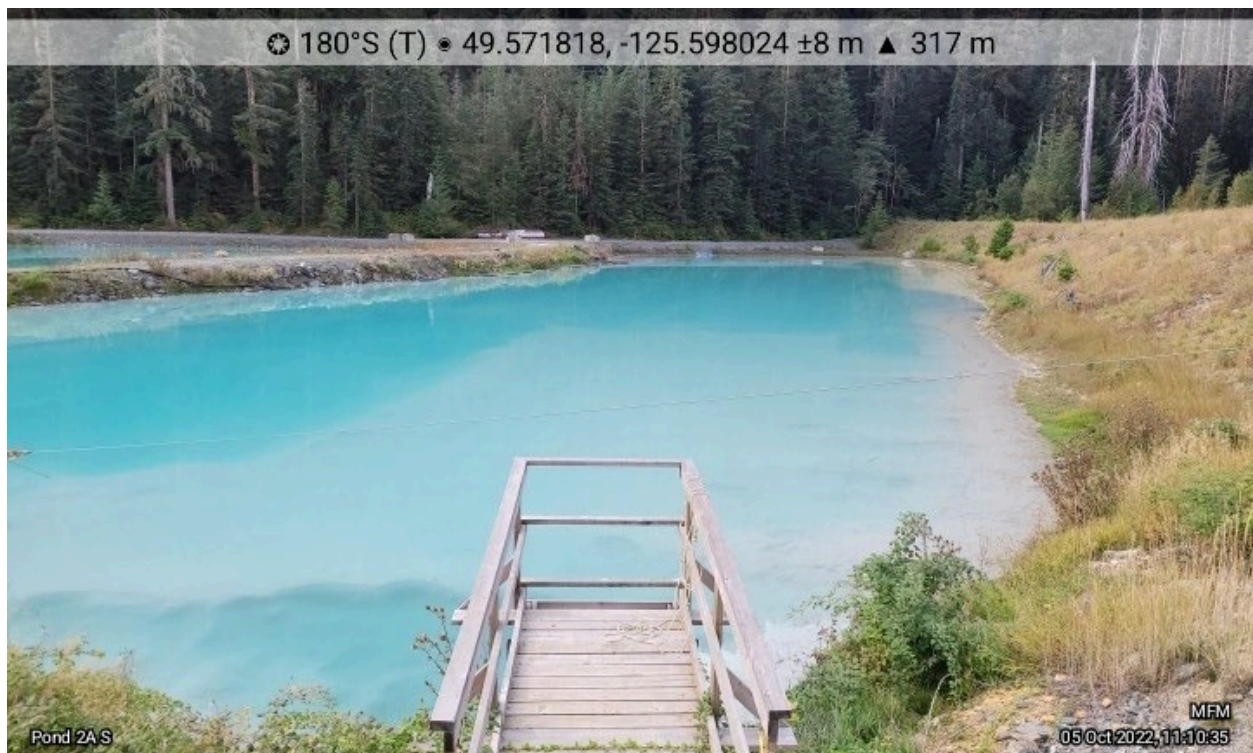
Photo 27: Polishing Pond 2A looking South. No unusual performance was observed.

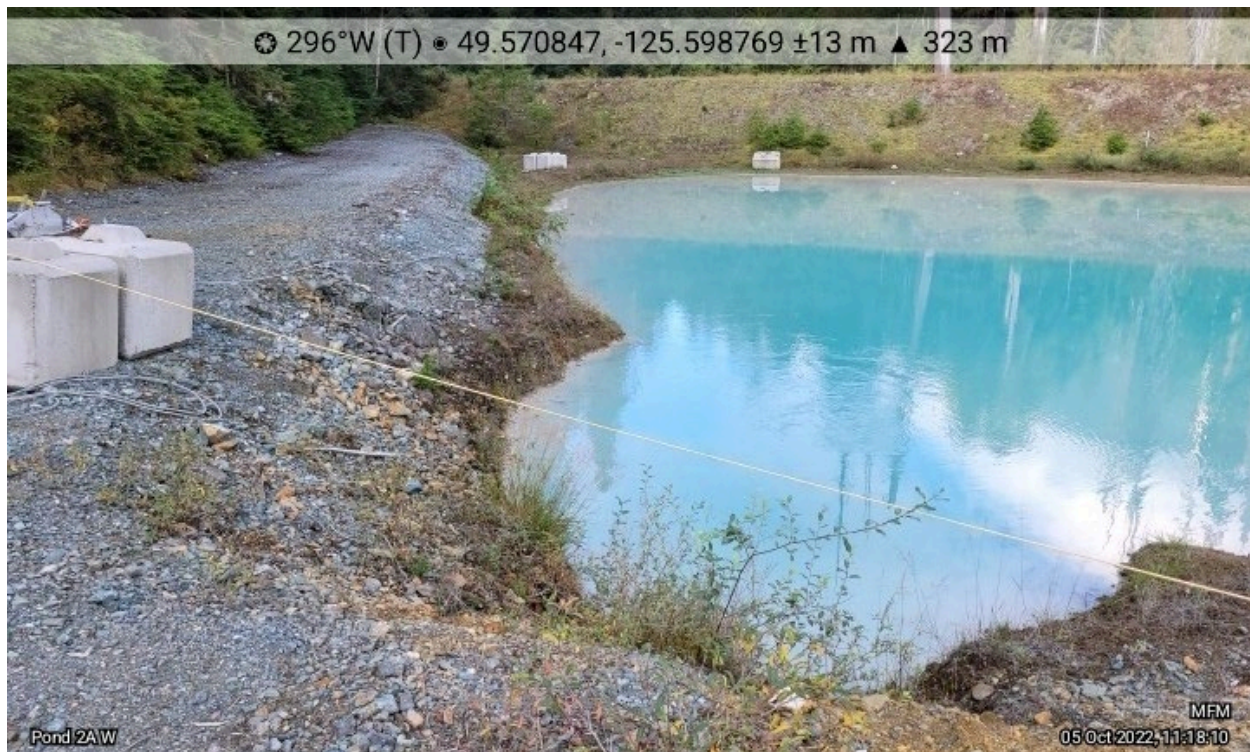
Photo 28: Polishing Pond 2A looking West. No unusual performance was observed.

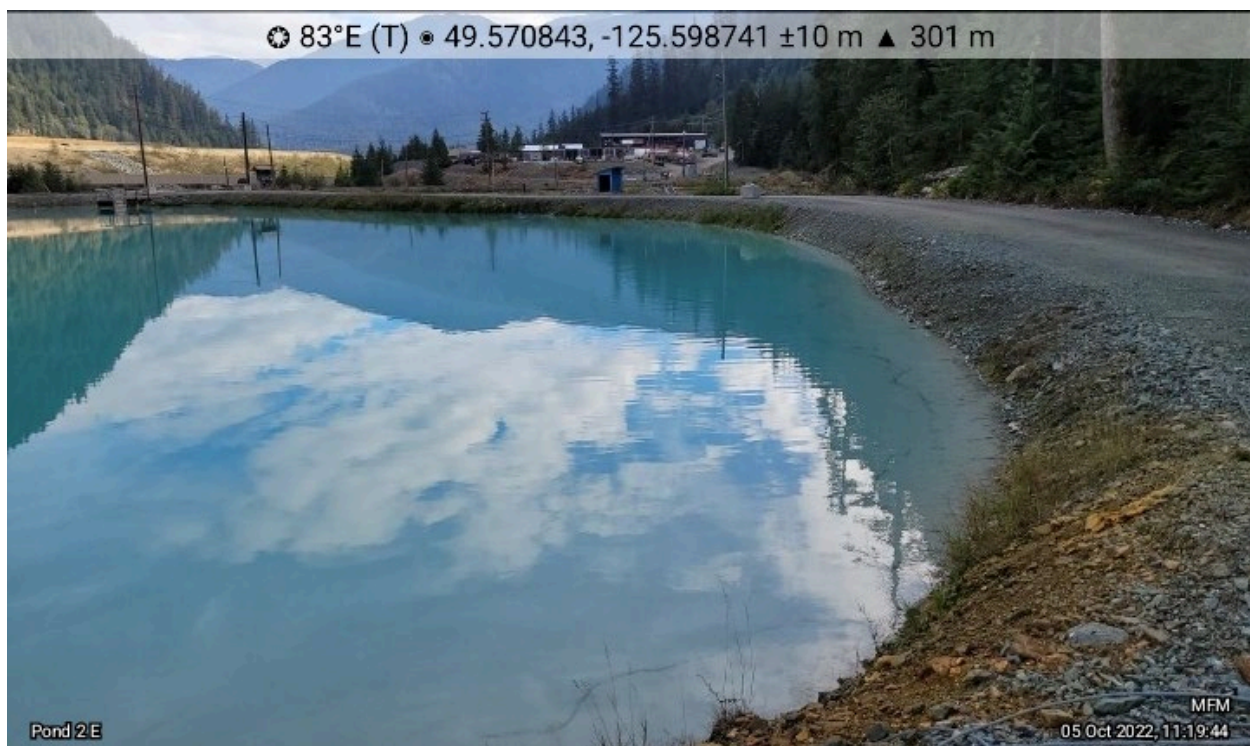
Photo 29: Polishing Pond 2 looking East. No unusual performance was observed.

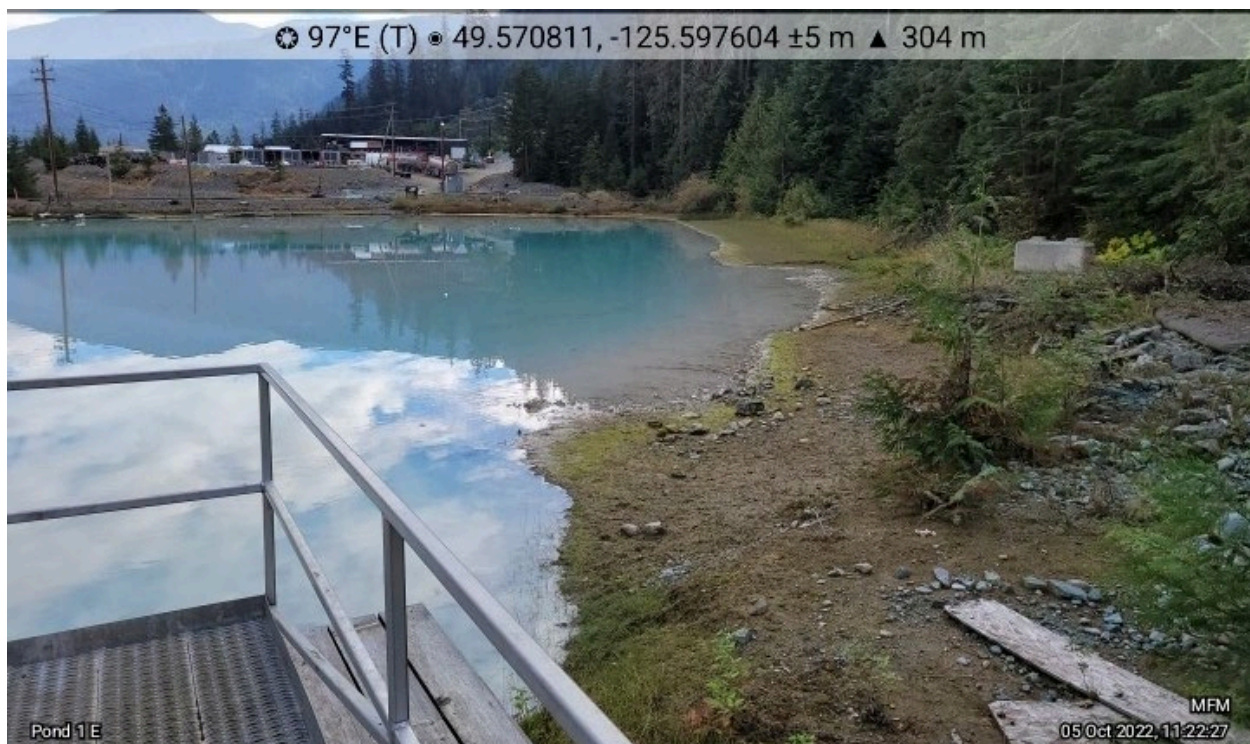
Photo 30: Polishing Pond 1 looking East. No unusual performance was observed. The lateral containment of the south end needs to be assessed against design flows.

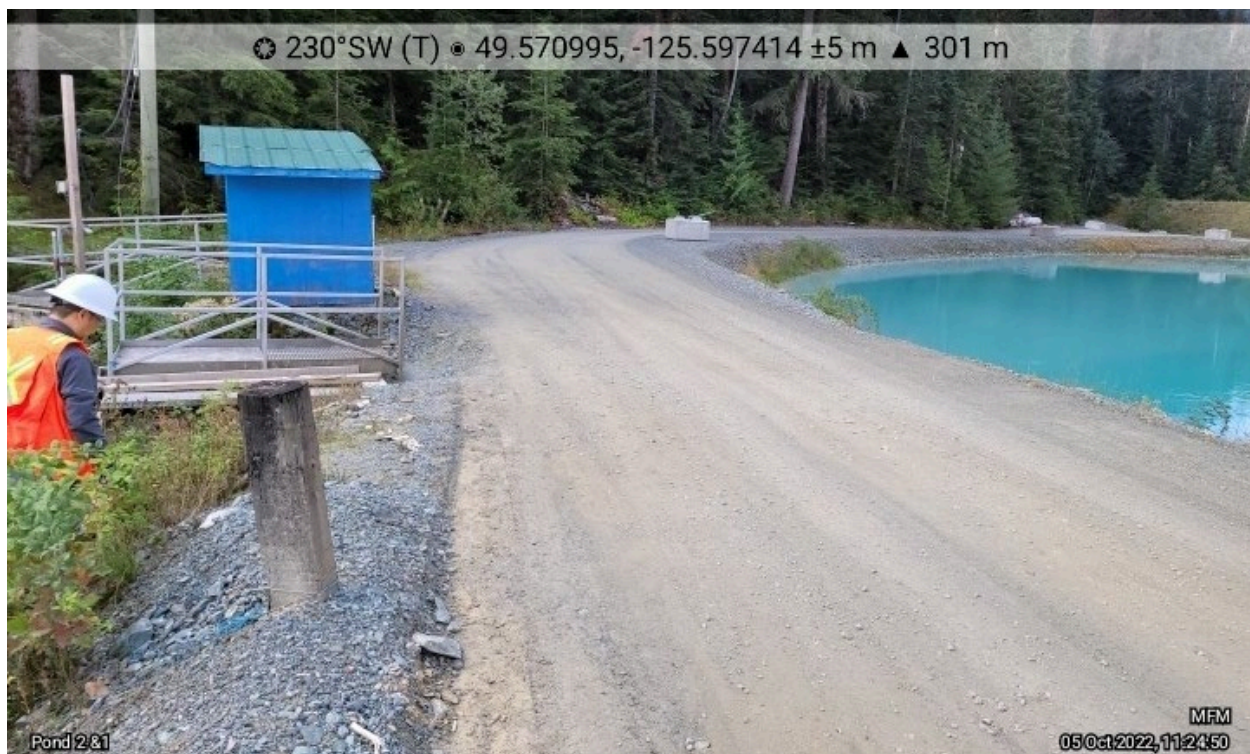
Photo 31: Middle berm between Polishing Pond 2 and 1 looking Southwest. No unusual performance was observed.

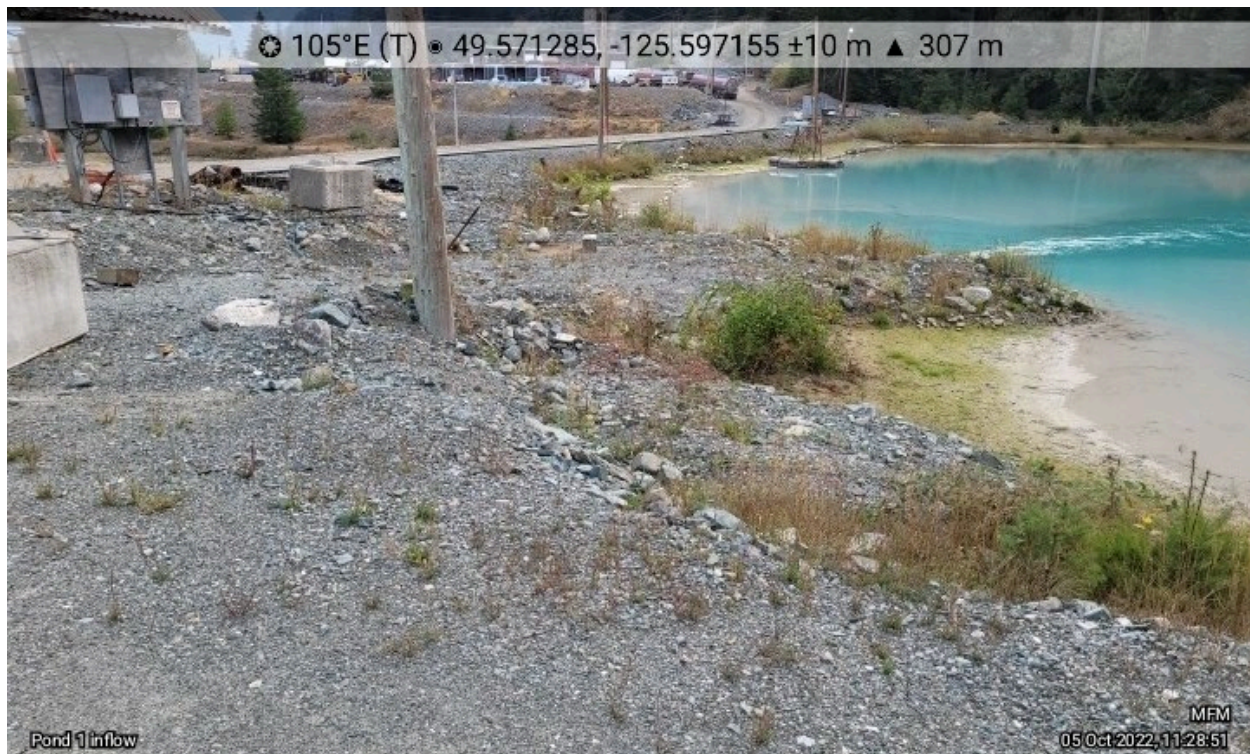
Photo 32: Polishing Pond 1 inflow looking East. No unusual performance was observed.

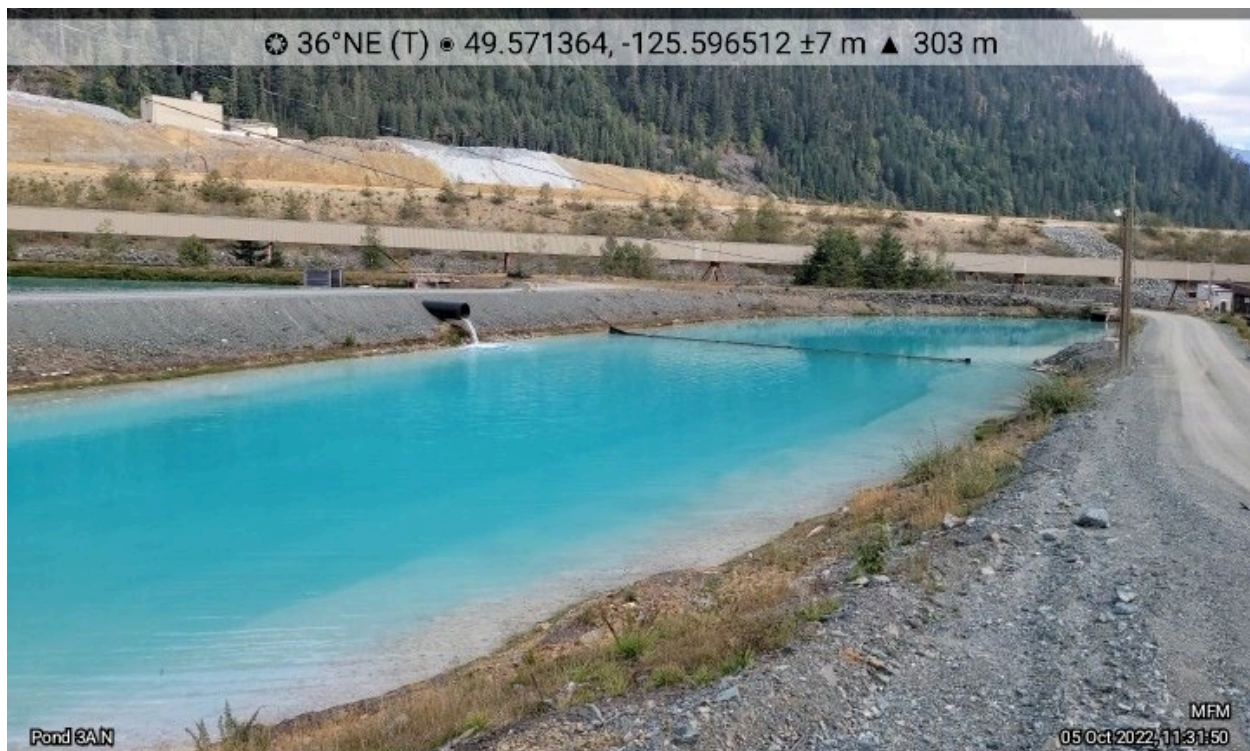
Photo 33: Polishing Pond 3A looking North. No unusual performance was observed.

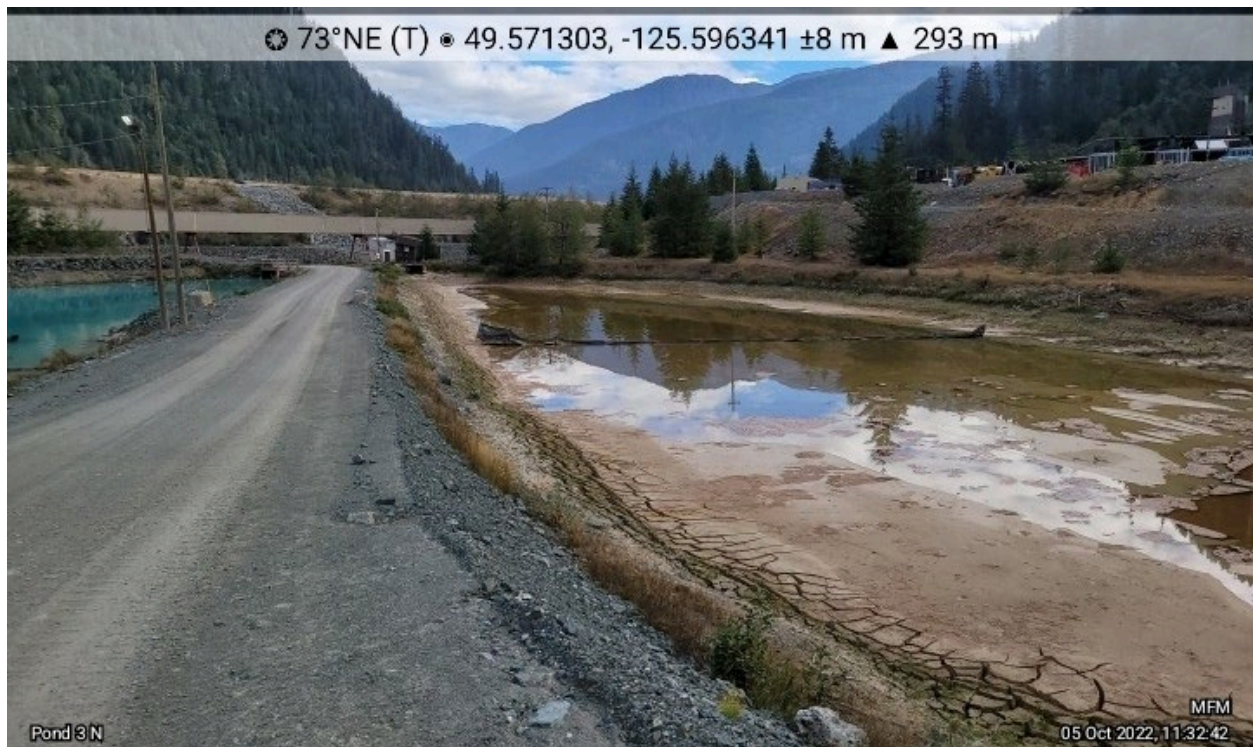
Photo 34: Polishing Pond 3 looking North. Observed to be empty

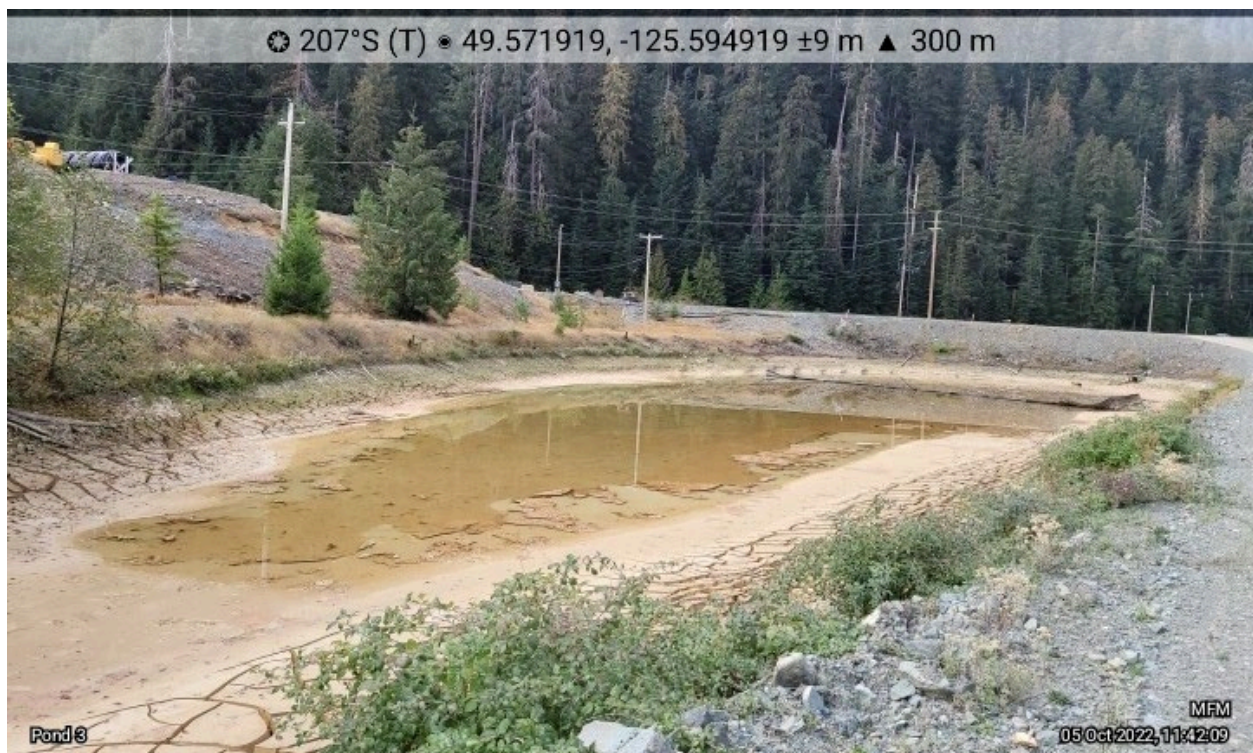
Photo 35: Polishing Pond 3 looking South. Observed to be empty.

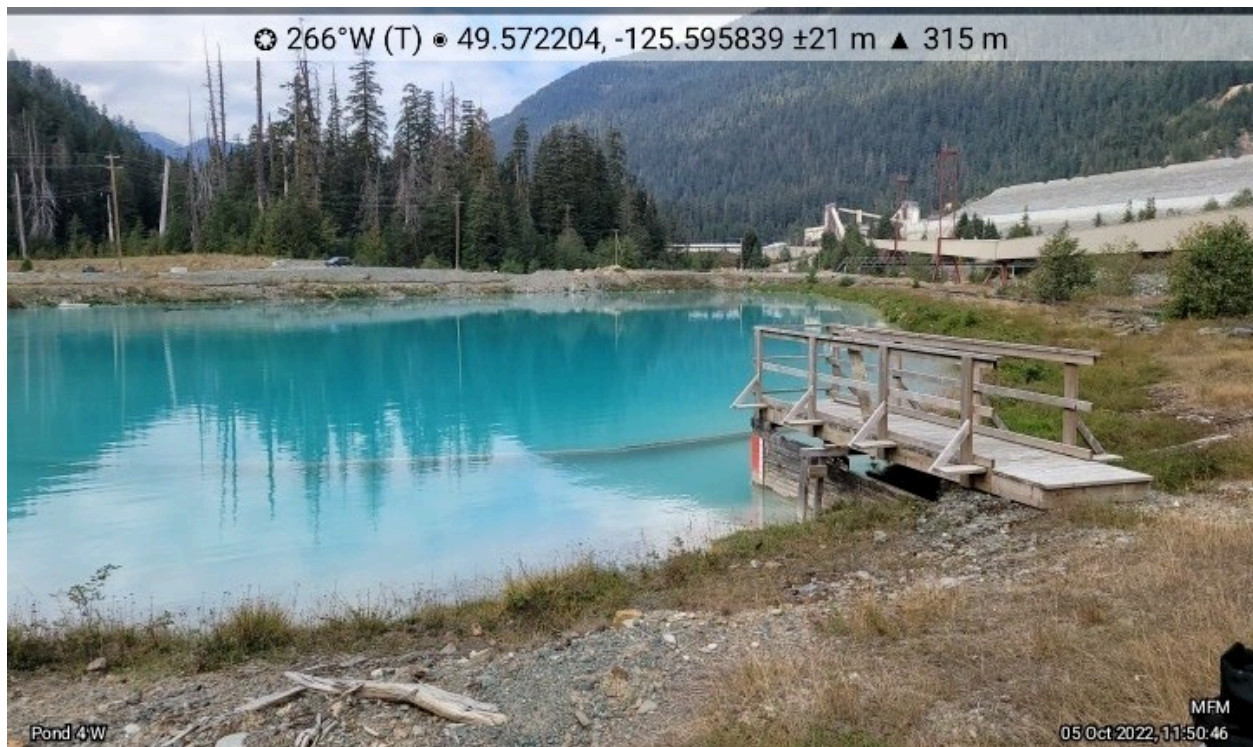
Photo 36: Polishing Pond 4 looking West. No unusual performance was observed.

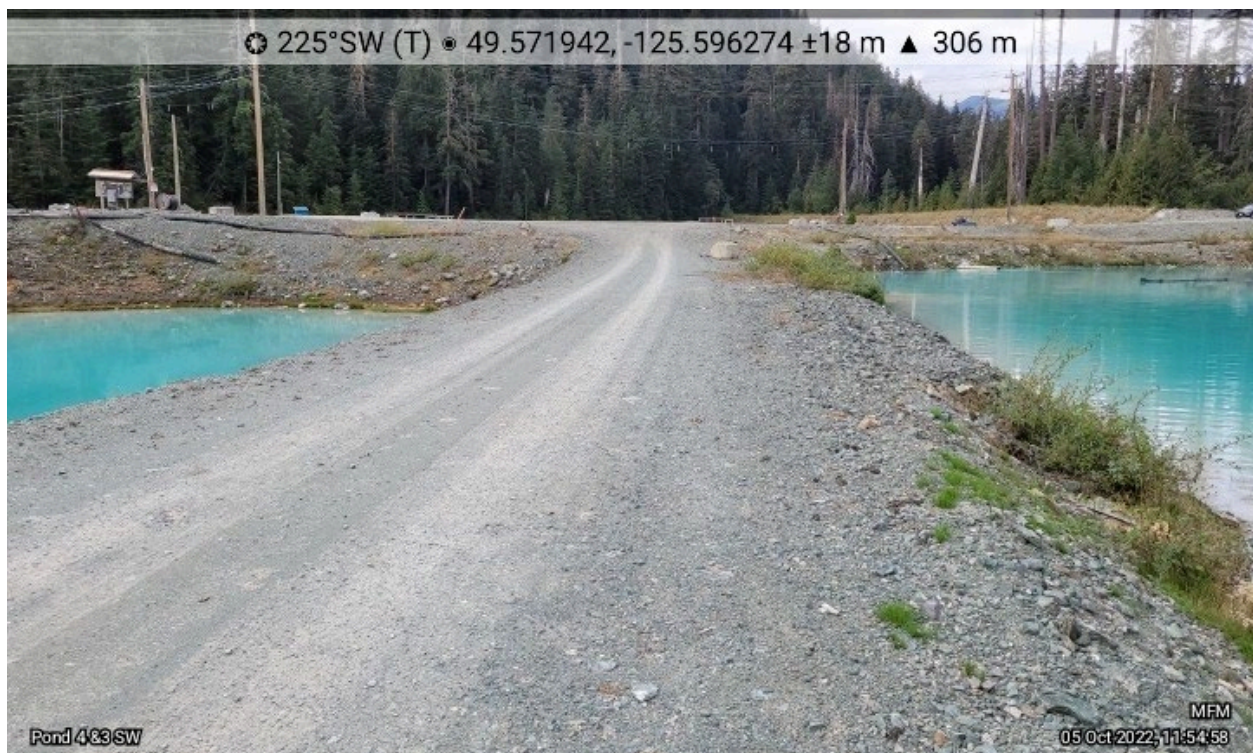
Photo 37: Middle berm between Polishing Ponds 4 and 3 looking Southwest. No unusual performance was observed.
