# 2022 OLD TDF DAM SAFETY INSPECTION REPORT

MYRA FALLS MINE LTD.  
A TRAFIGURA COMPANY  
CAMPBELL RIVER, BC

PROJECT NO.: NX14001B4.3  
DATE: 29 MARCH 2023

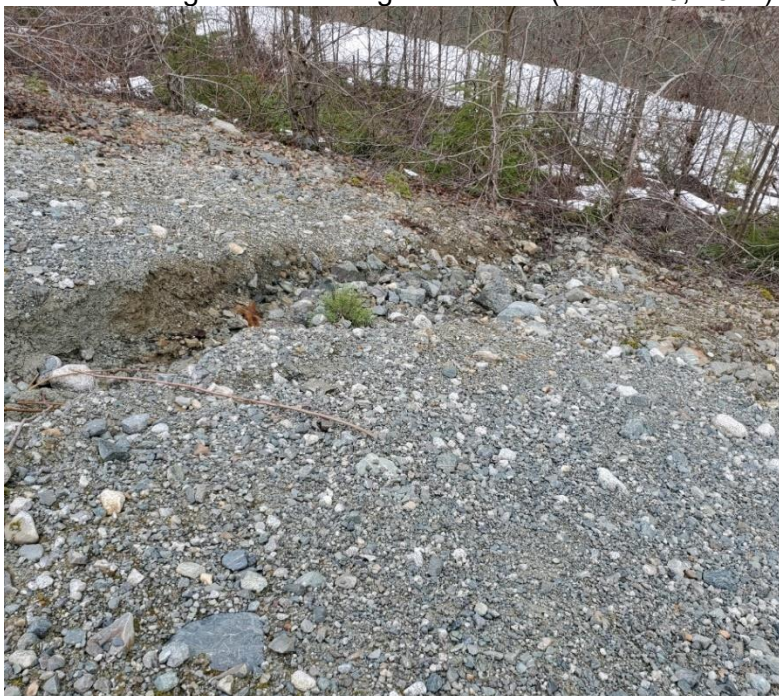
Photo 8: Erosion gullies observed on downstream of SUB to be addressed in 2022 Closure Phase 1 Construction. (March 22, 2022)

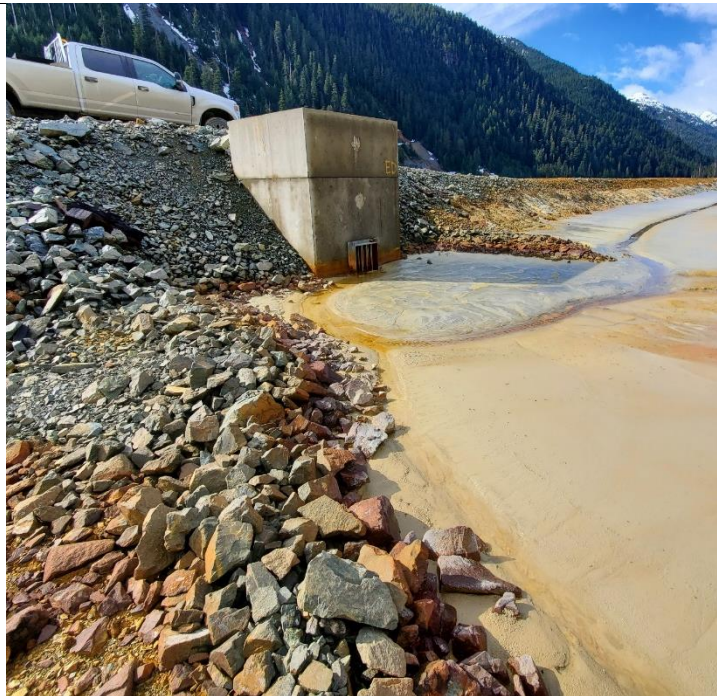
Photo 9: East Decant structure. Grating decant needs to be replaced due to acidic dissolution of lower portion of the vertical grating. (March 23, 2022)

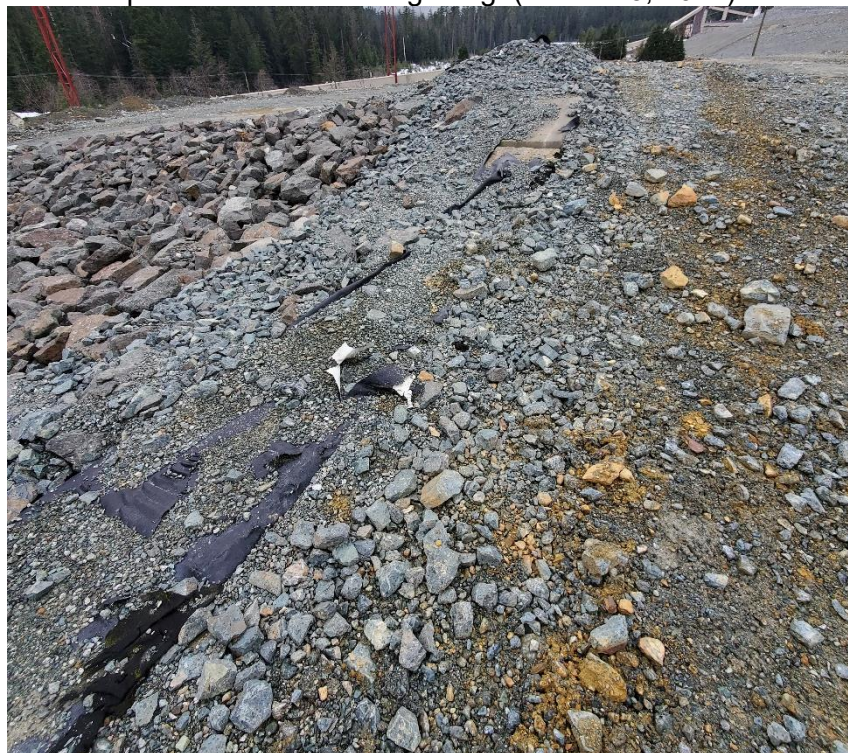
Photo 10: Geotextile/geomembrane over the buried lock blocks in the APA spillway observed to be damaged. (March 22, 2022)

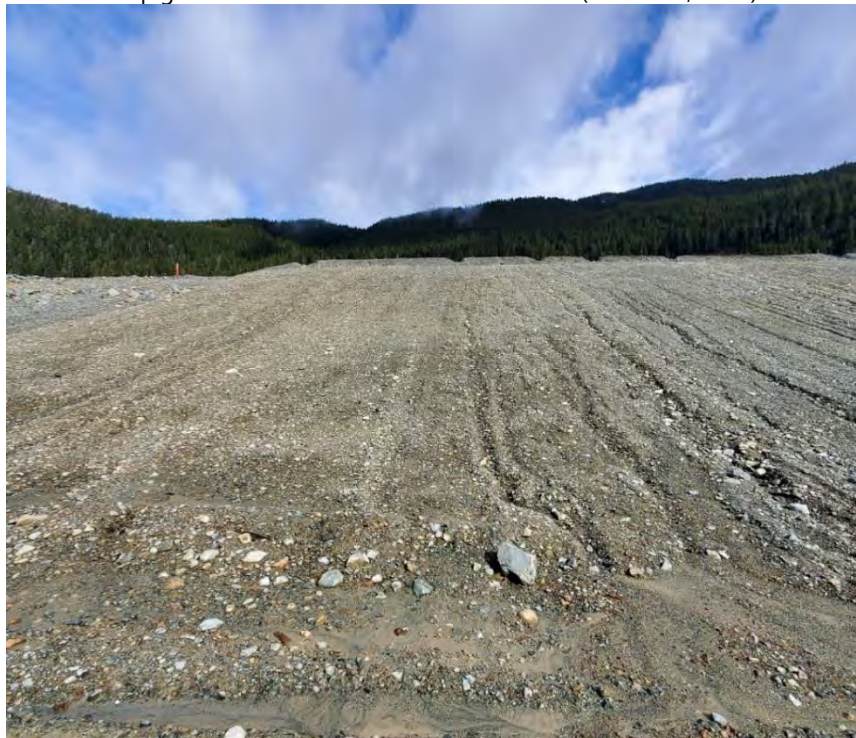
Photo 8: Lynx TDF Downstream toe area of the Closure Cover Trials. Some erosion observed in the Cover Trial area. (March 23, 2022)

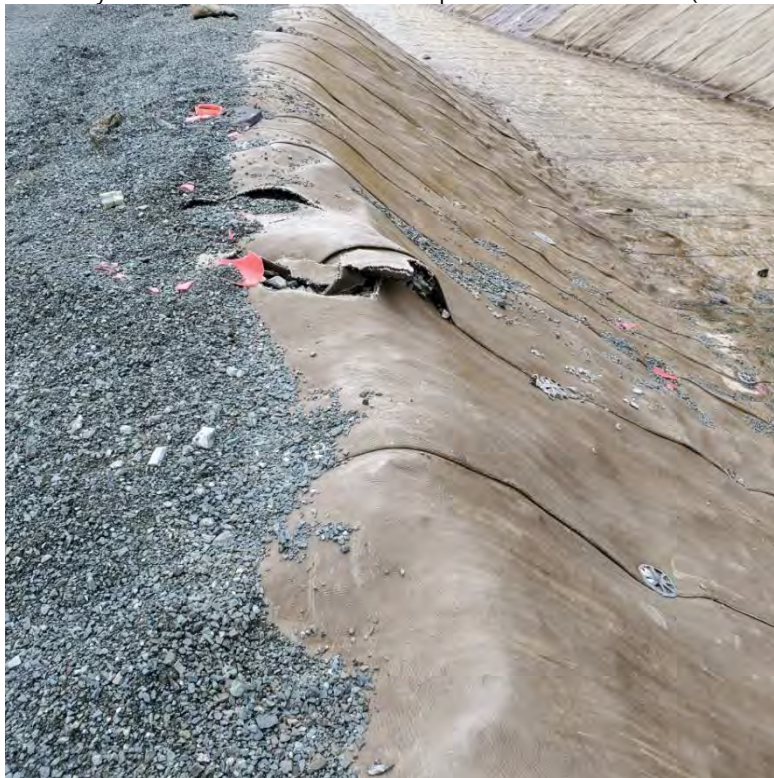
Photo 10: Lower Lynx Diversion Ditch damage to concrete cloth observed. (March 22, 2022)

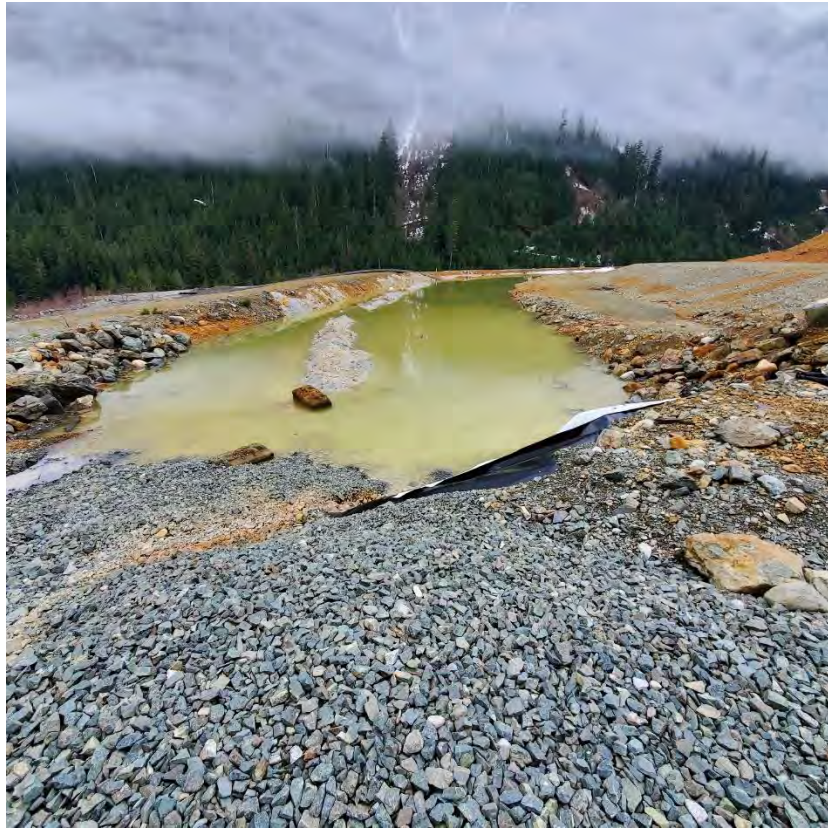
Contact water flows west from the East Strip, through 3 parallel culverts below the APA Operations Spillway, and through the geomembrane-lined West Strip Channel into the Old TDF Surge Pond. In 2022 WSP identified that the East Strip is full of sediments from the discharge of the Zim Pro line. The sediments prevent the free flow of water from the east abutment. The sediments should be removed as stated in the 2022 recommendations summary table in Section 10.2.

Photo 11: East Strip was essentially dammed by sediments near the Zim Pro discharge line. (March 22, 2022)

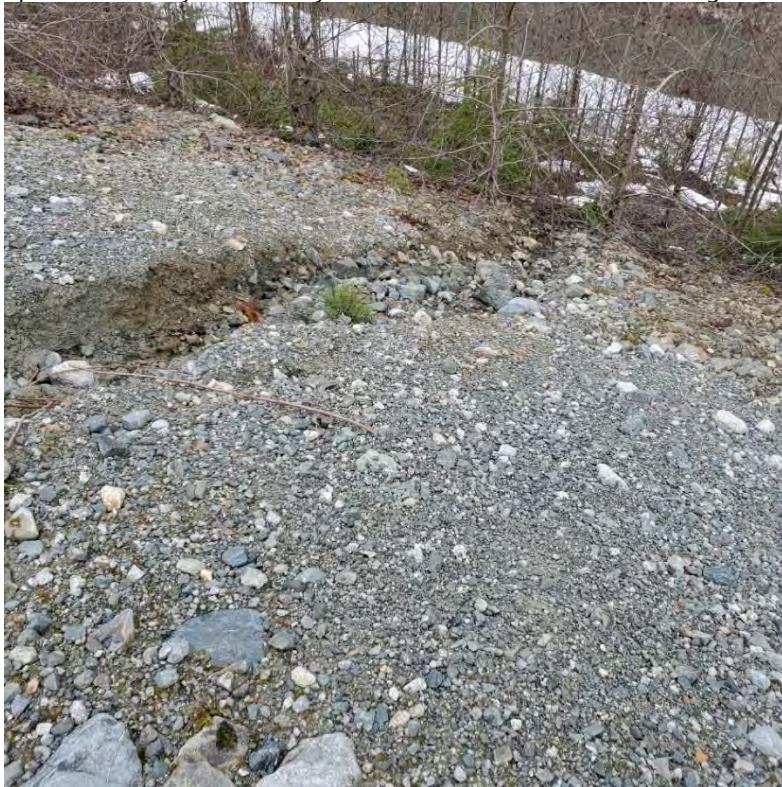
Photo 12: Erosion gullies observed on downstream of SUB to be addressed in 2022 Closure Phase 1 Construction. (March 22, 2022)

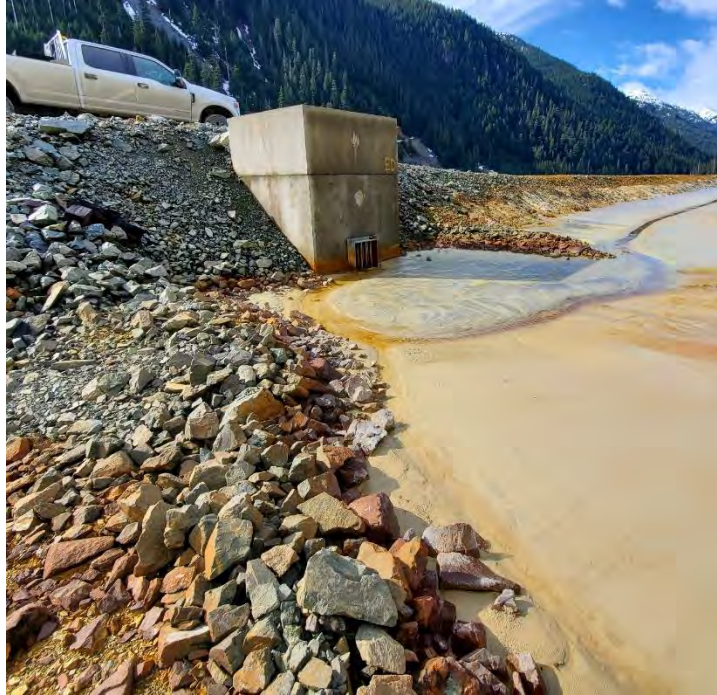
Photo 17: East Decant structure. Grating decant needs to be replaced due to acidic dissolution of lower portion of the vertical grating. (March 23, 2022)

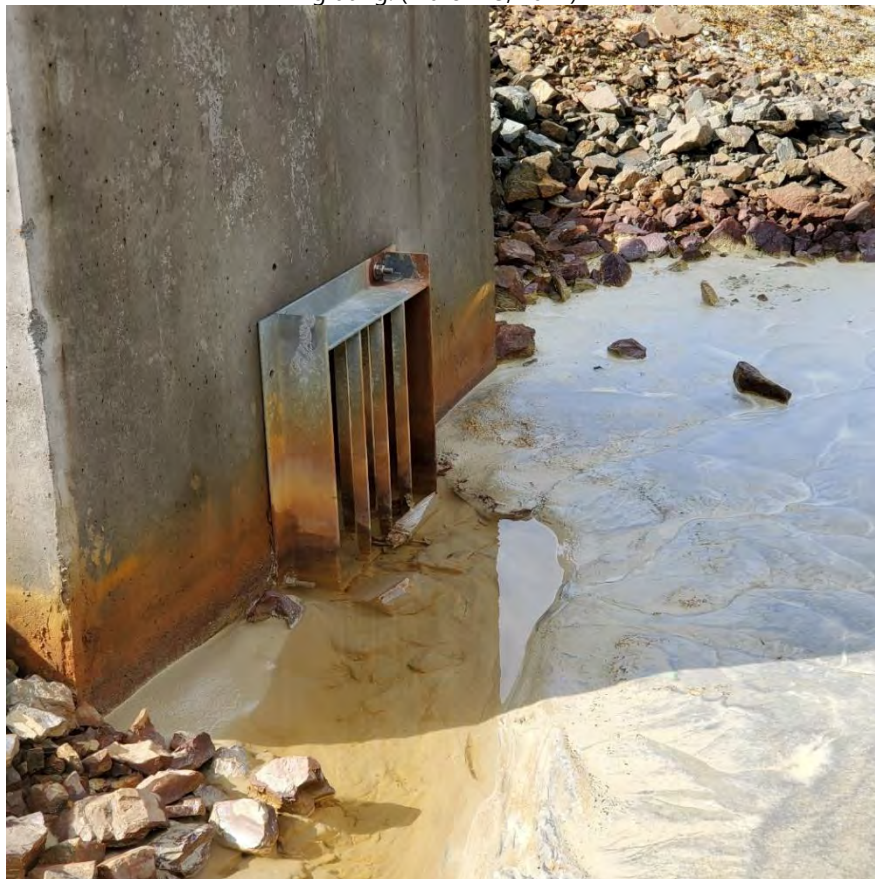
Photo 18: Grating decant needs to be replaced due to acidic dissolution of lower portion of the vertical grating. (March 23, 2022)

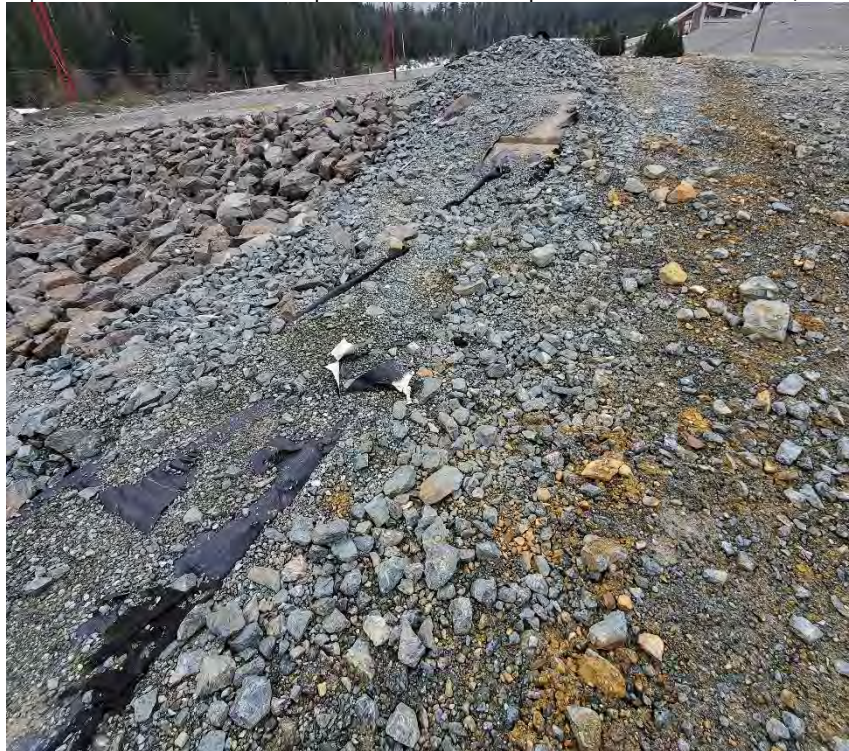
Photo 20: Geotextile/geomembrane over the buried lock blocks in the APA spillway observed to be damaged. (March 22, 2022)

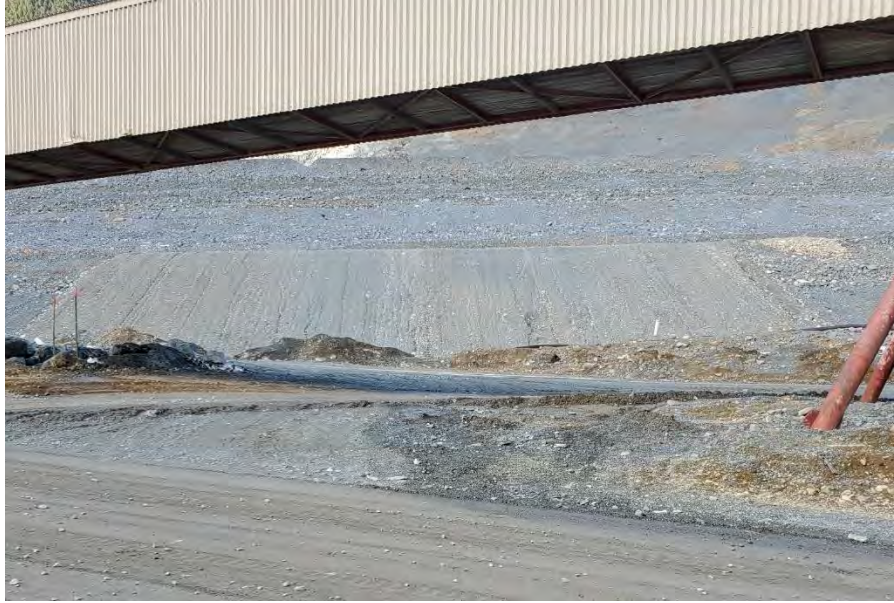
Photo 33: Area of the closure cover trials, sparse vegetation observed. (March 23, 2022)

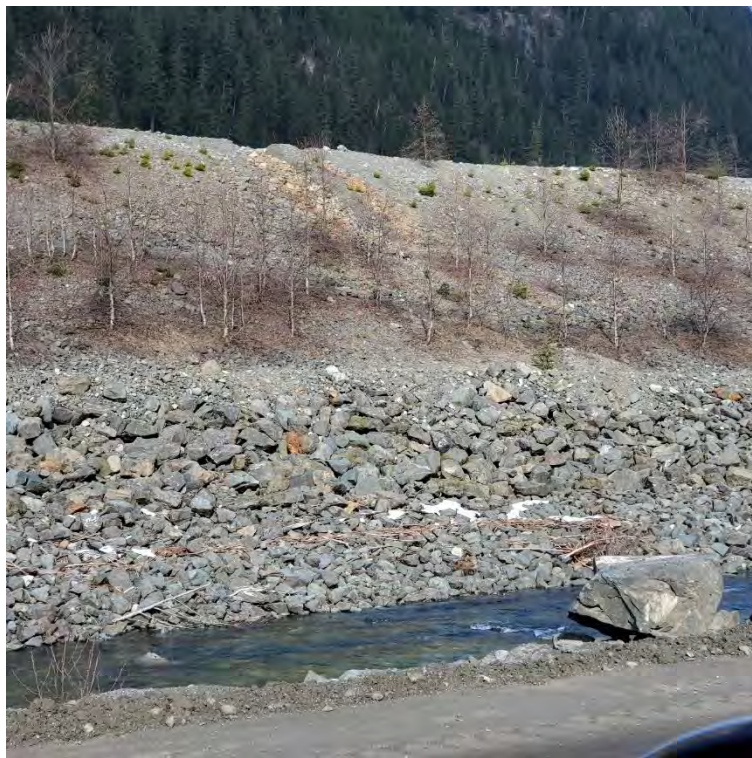
Photo 34: Gully erosion observed on downstream end of Seismic Upgrade Berm of the Old TDF, gully erosion to be addressed during Phase 1 Closure of Old TDF in 2022 construction season (March 23, 2022)

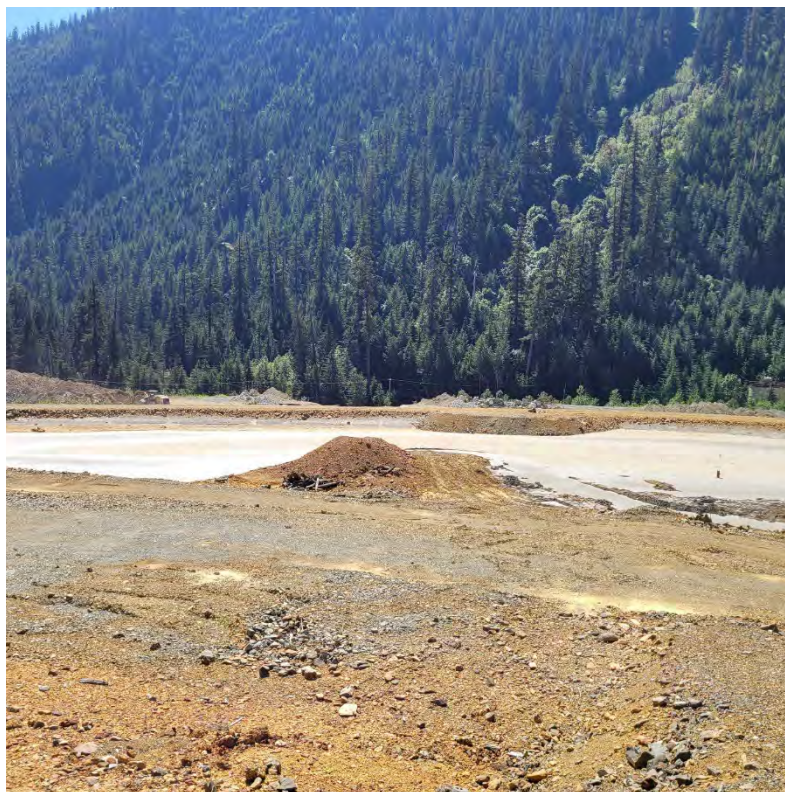
Photo 10: East Strip of the Old TDF filled with tailings from Zim Pro line

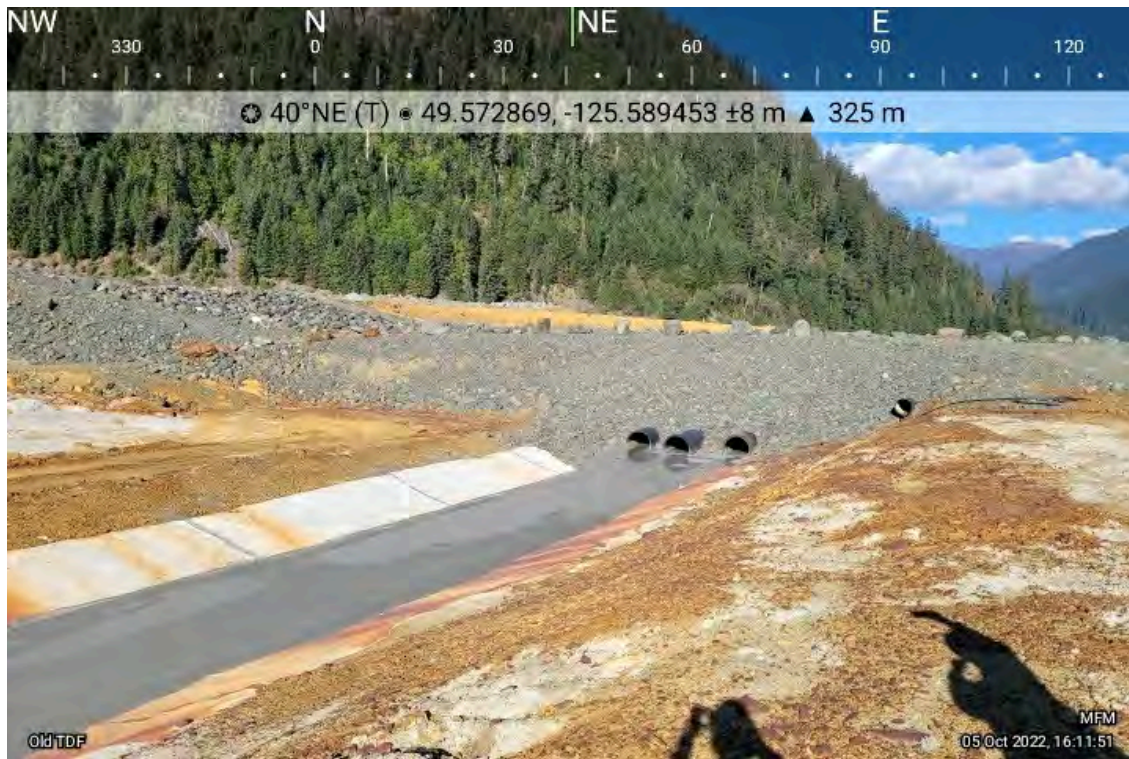
Photo 13: The West Strip of the Old TDF was filled with tailings obstructing the flow capacity of the spillway culvert pipes. This condition needs immediate attention before the wintertime.

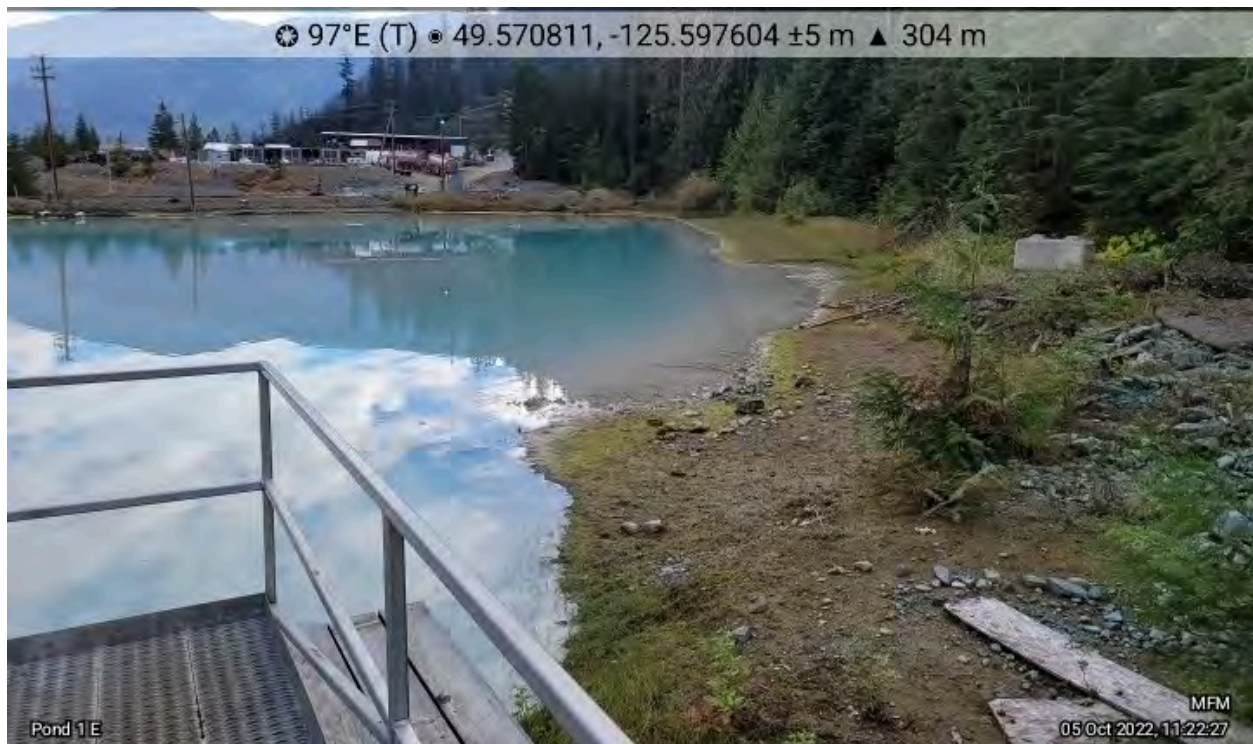
Photo 30: Polishing Pond 1 looking East. No unusual performance was observed. The lateral containment of the south end needs to be assessed against design flows.
