2023 Lynx Tailings Disposal Facility Dam Safety Inspection

Myra Falls Mine Ltd.

WSP Canada Inc.

March 28, 2024

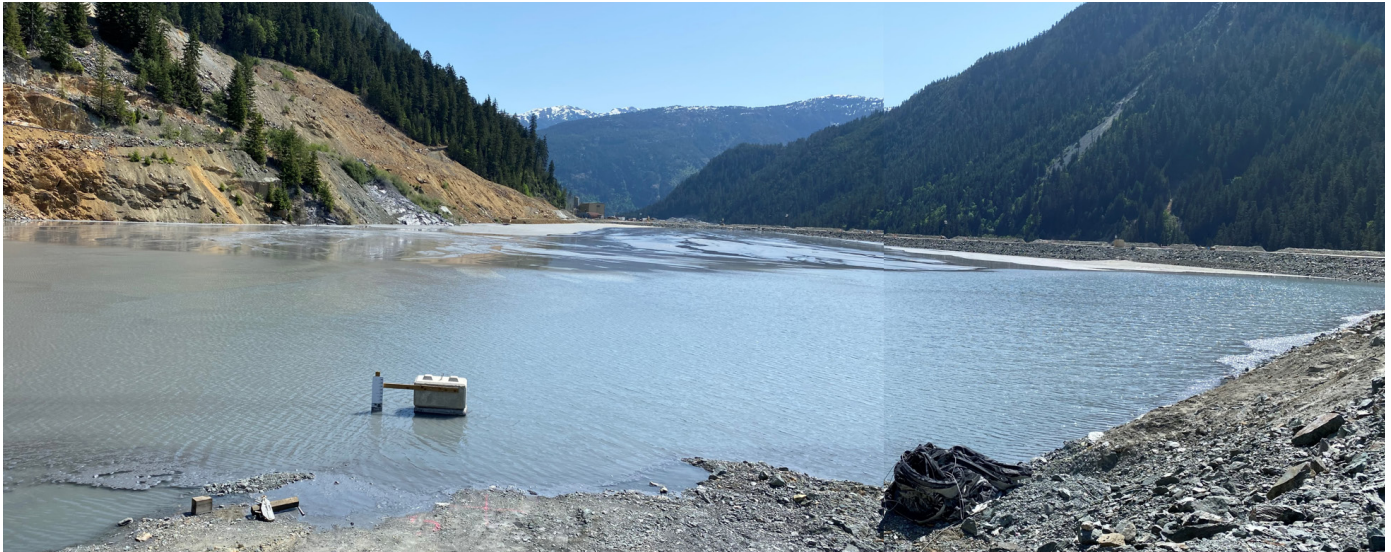
Photograph 1: Water Pounded along west arm and in southwest corner of facility with well established beach along east arm. Looking east from west arm abutment

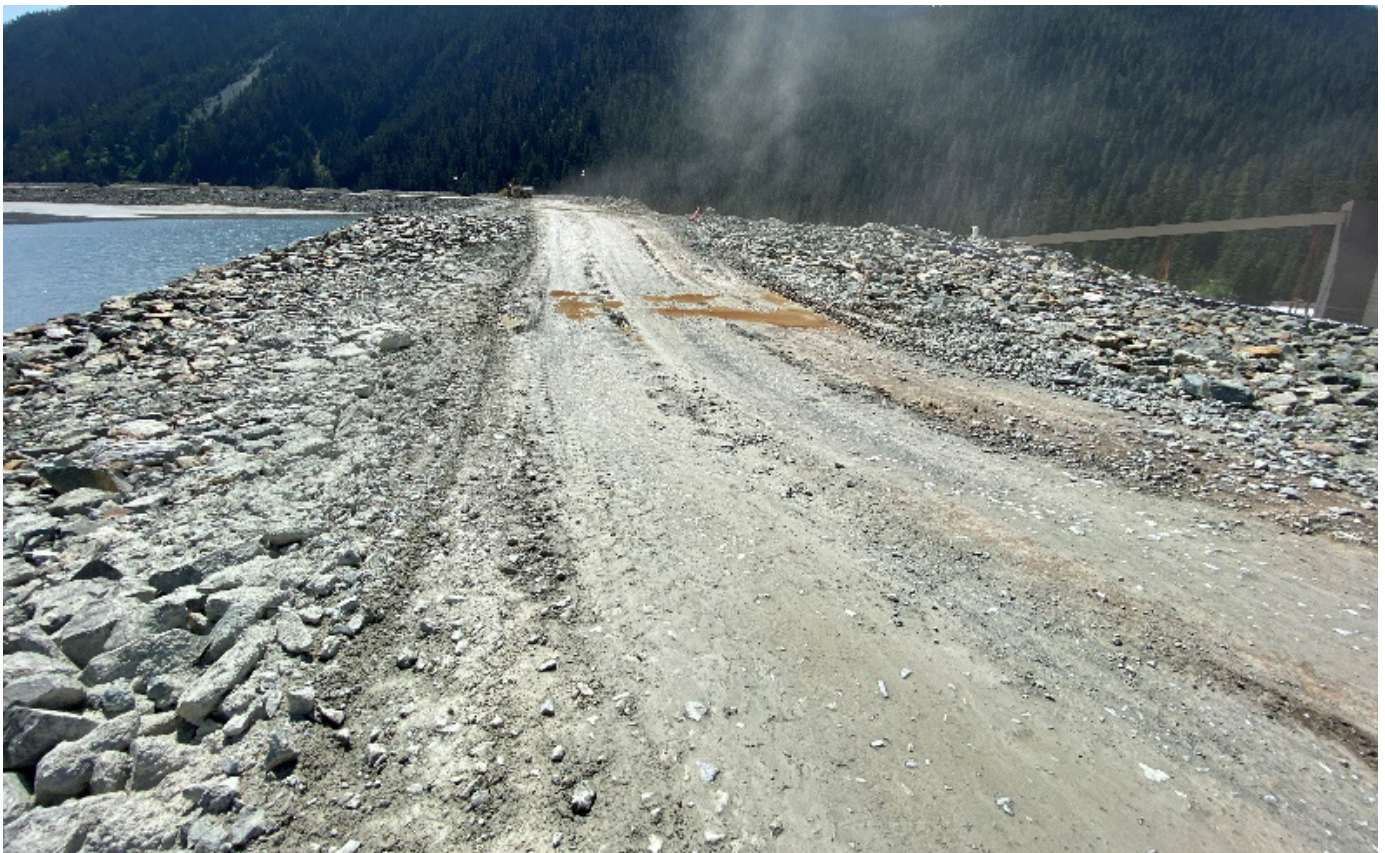
Photograph 2: Operational spillway across 373.5 m crest of west arm dam, looking south

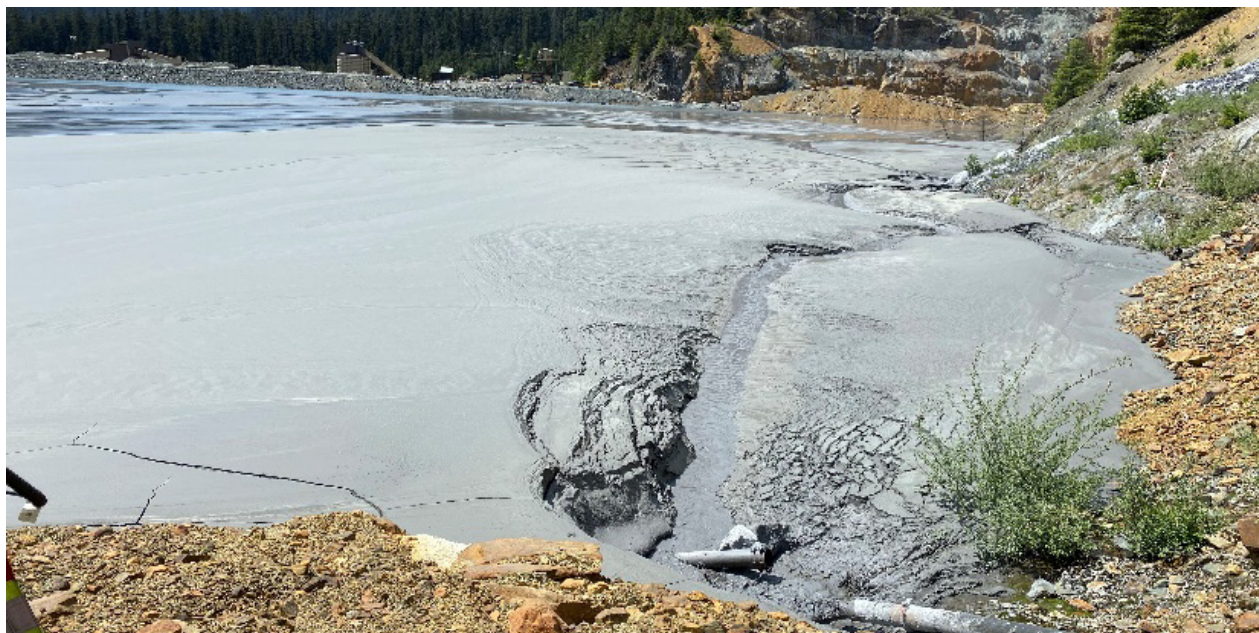
Photograph 3: Point discharge of tailings off of WRD1 filter upstream of east arm abutment

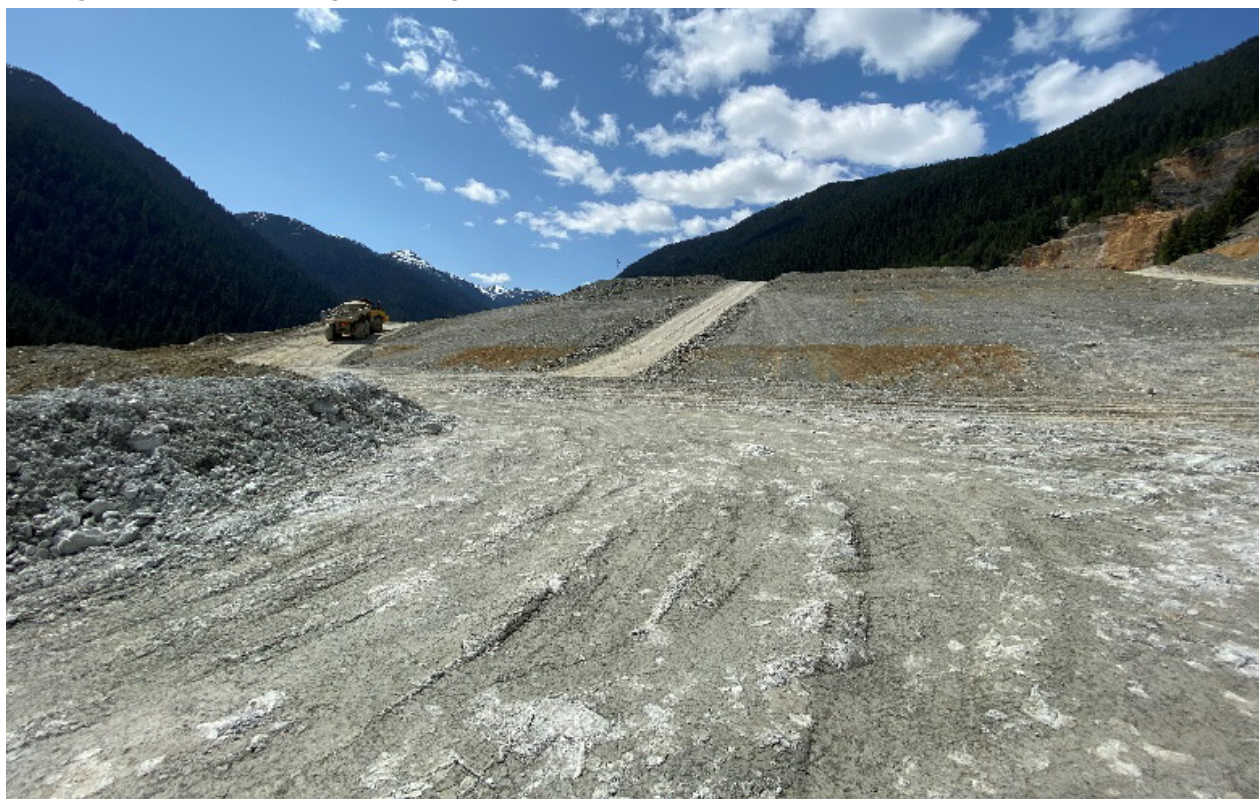
Photograph 4: Downstream slope of 4H:1V east arm downstream slope, looking west. Truck hauling Zone A for raising of south arm downstream shell

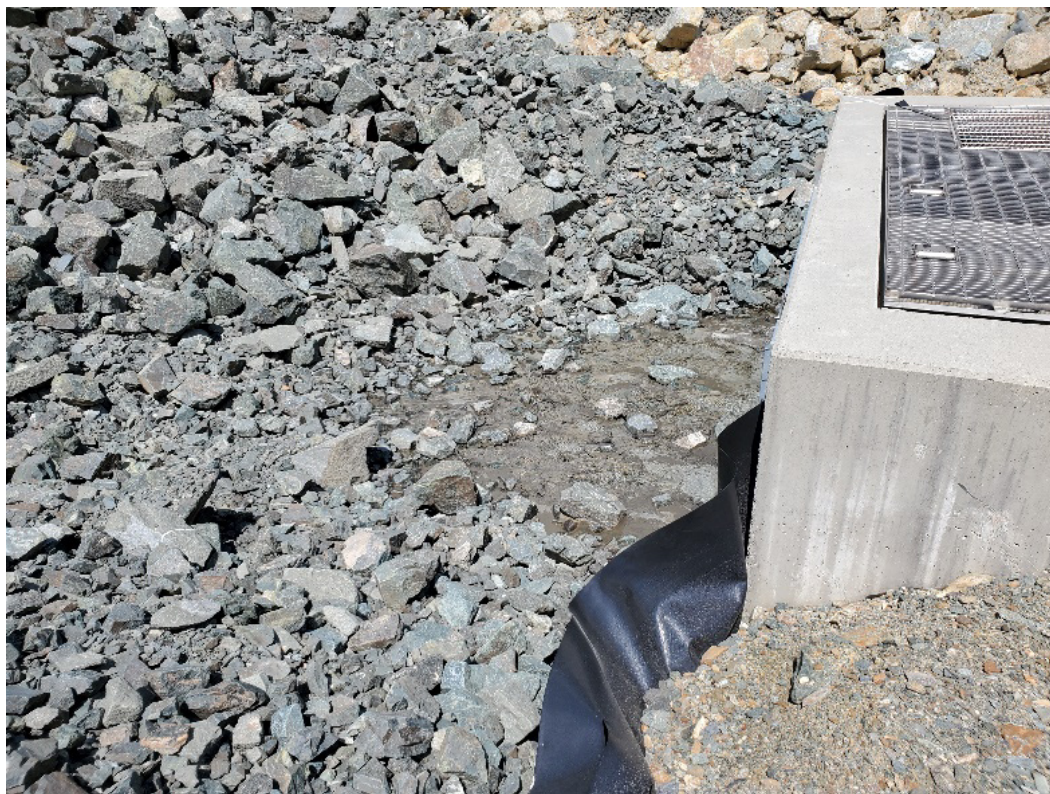
The Lynx Springs Drain functioned as intended during 2023. WSP observed relatively clear flows reporting to the Lynx sump box during 2023 site inspections. A new vibrating wire piezometer (VWP) was installed near the Lynx Springs Drain in January 2024 (Section 8.0) to replace two previously installed VWPs that had stopped working.

Photograph 5: Clear seepage flow entering Lynx Springs Drain

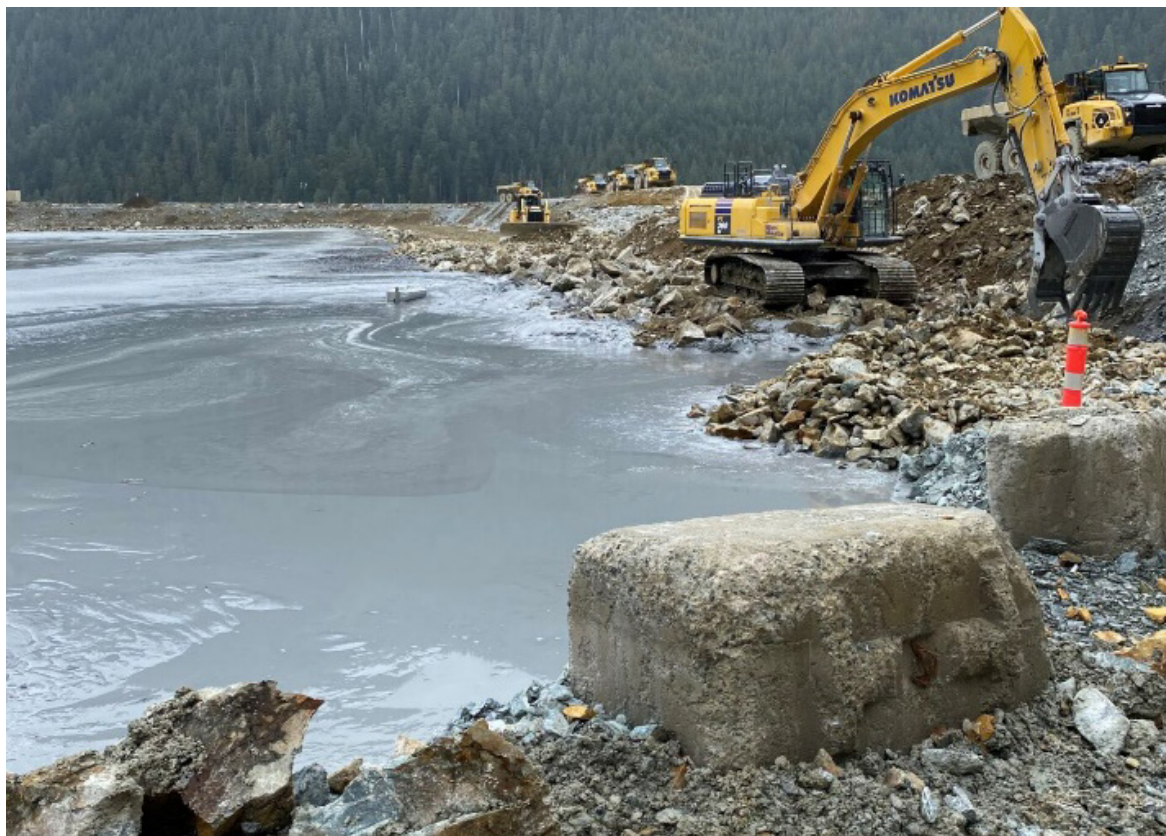
Photograph 1: Excavator placing boulders for initial lift of push out on tailings, looking south from upstream side of west arm abutment. D6 dozer in background placing Zone A rockfill over material initially placed by excavator

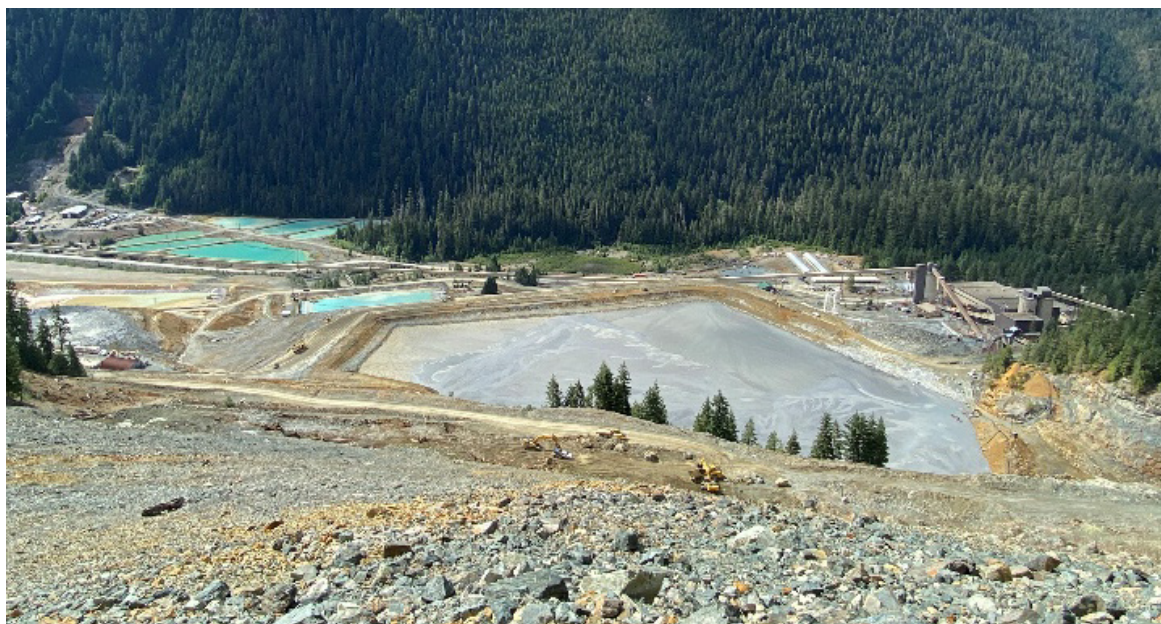
Photograph 2: Overview of Lynx TDF from top of WRD2. Tailings beach has been developed in southwest corner of facility since May visit

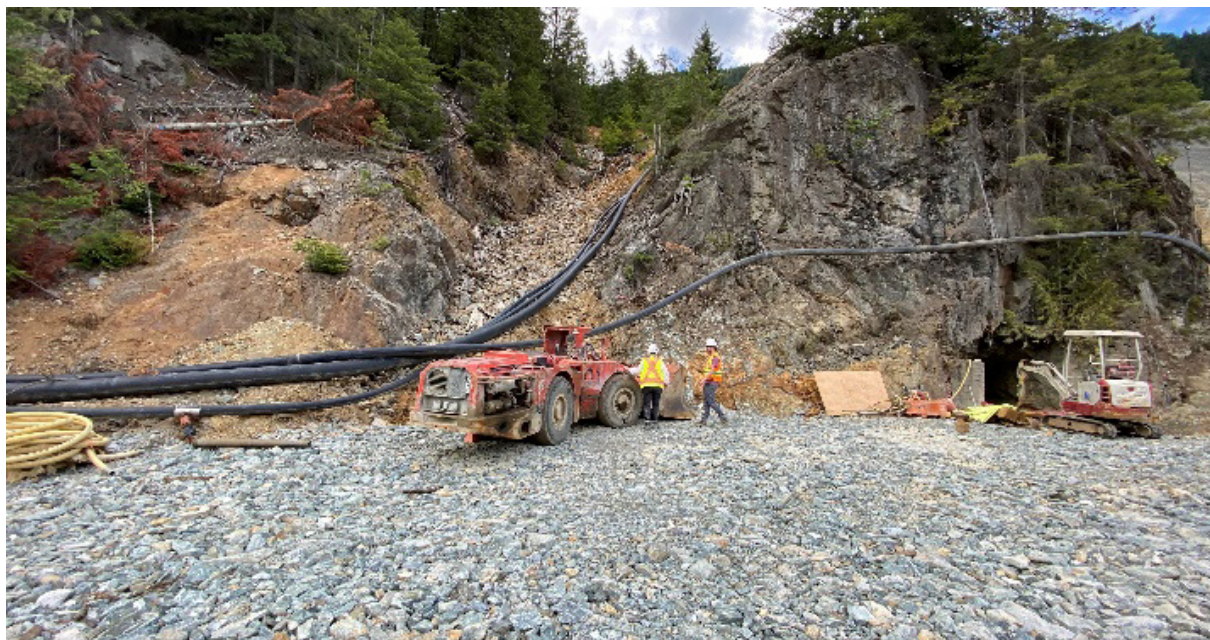
Photograph 3: Gully at downstream side of west abutment looking north.

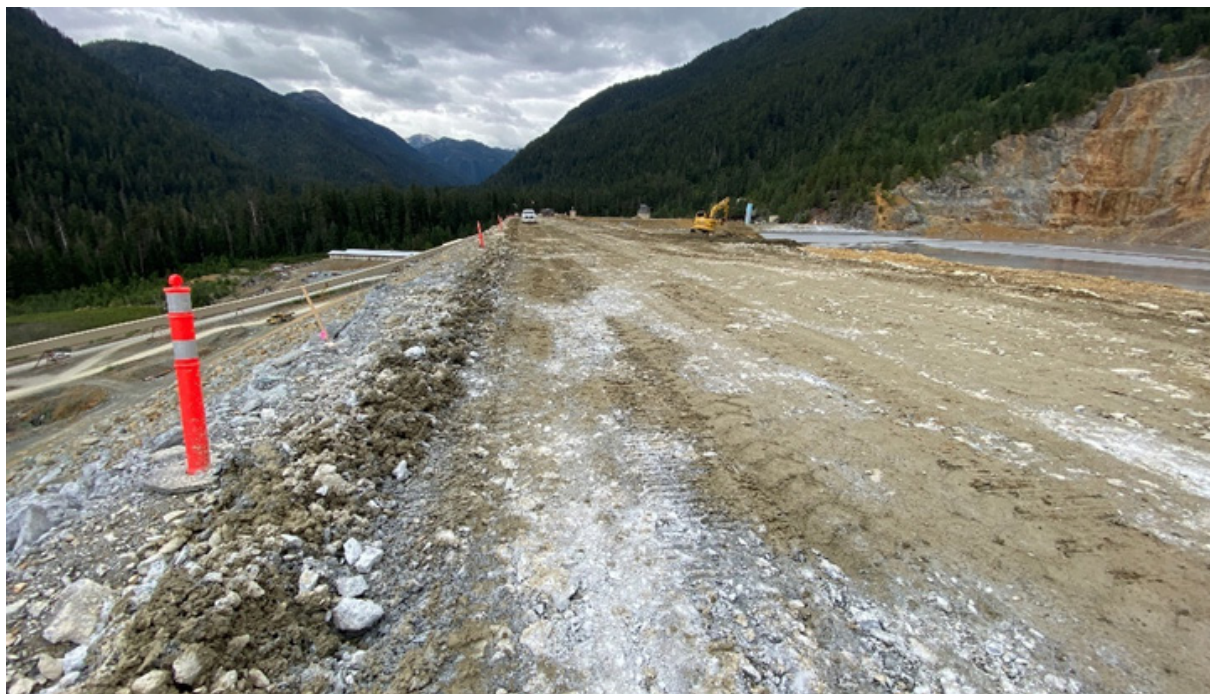
Photograph 4: Crest of south arm dam looking west. Crest raise to El. 378 m in progress

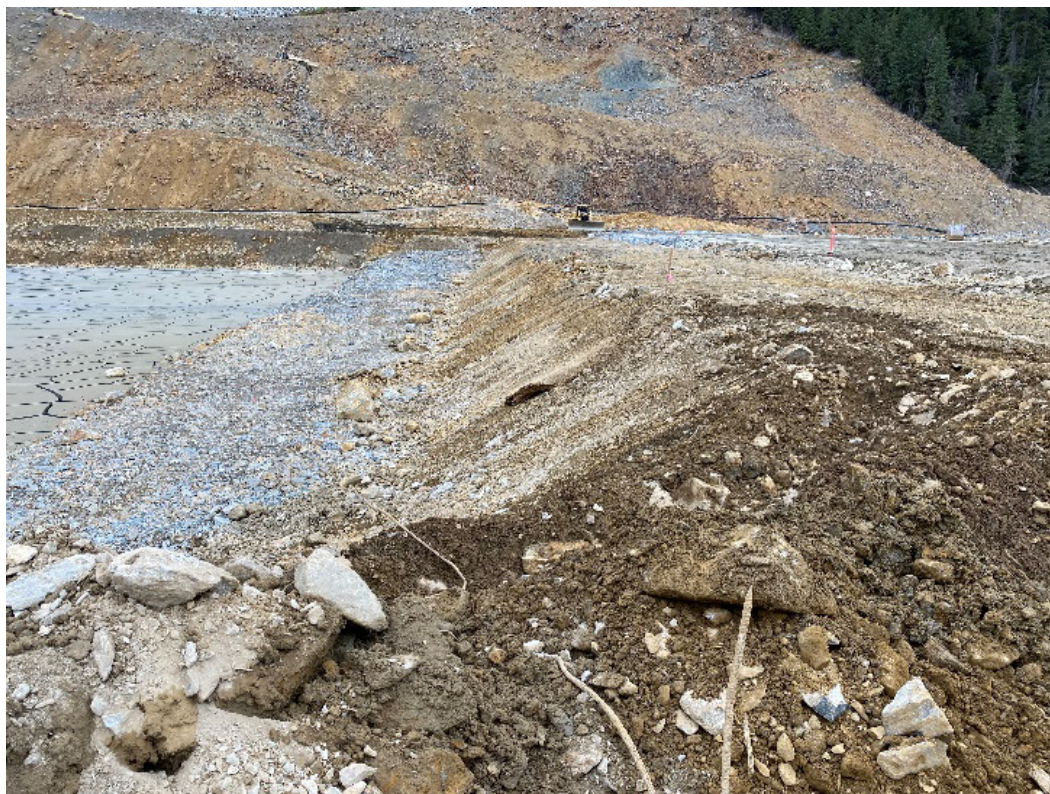
Photograph 5: Temporary over steepened upstream slope constructed to facilitate crest raise to El. 378 m ahead of constructing shell push out over tailings. Initial lift of push out complete

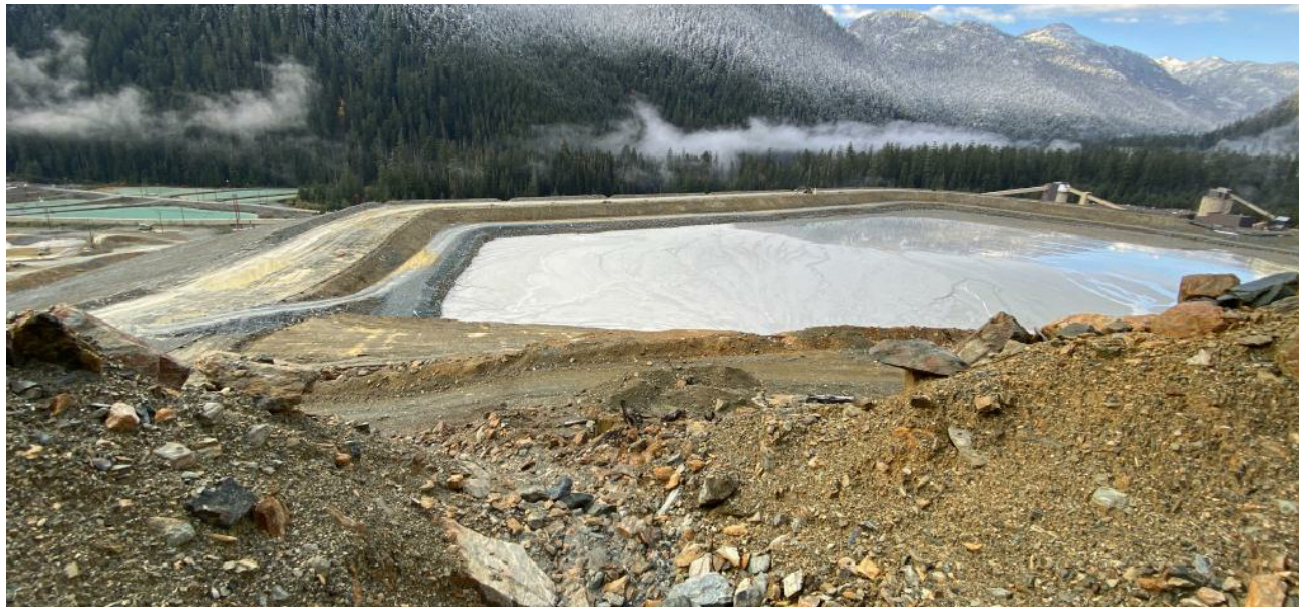
Photograph 1: Overview of Lynx TDF

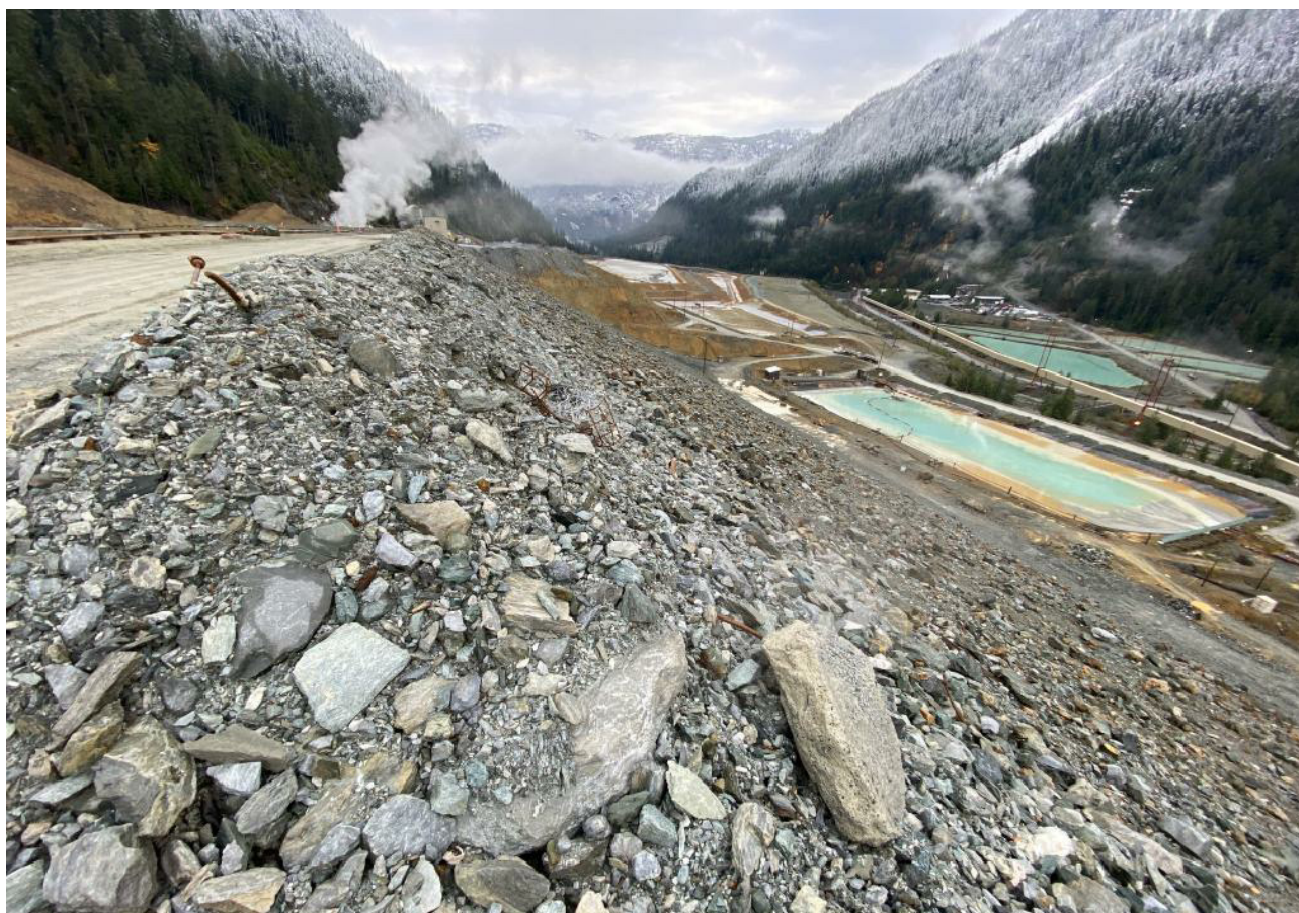
Photograph 2: Downstream slope of South Arm from crest, looking east

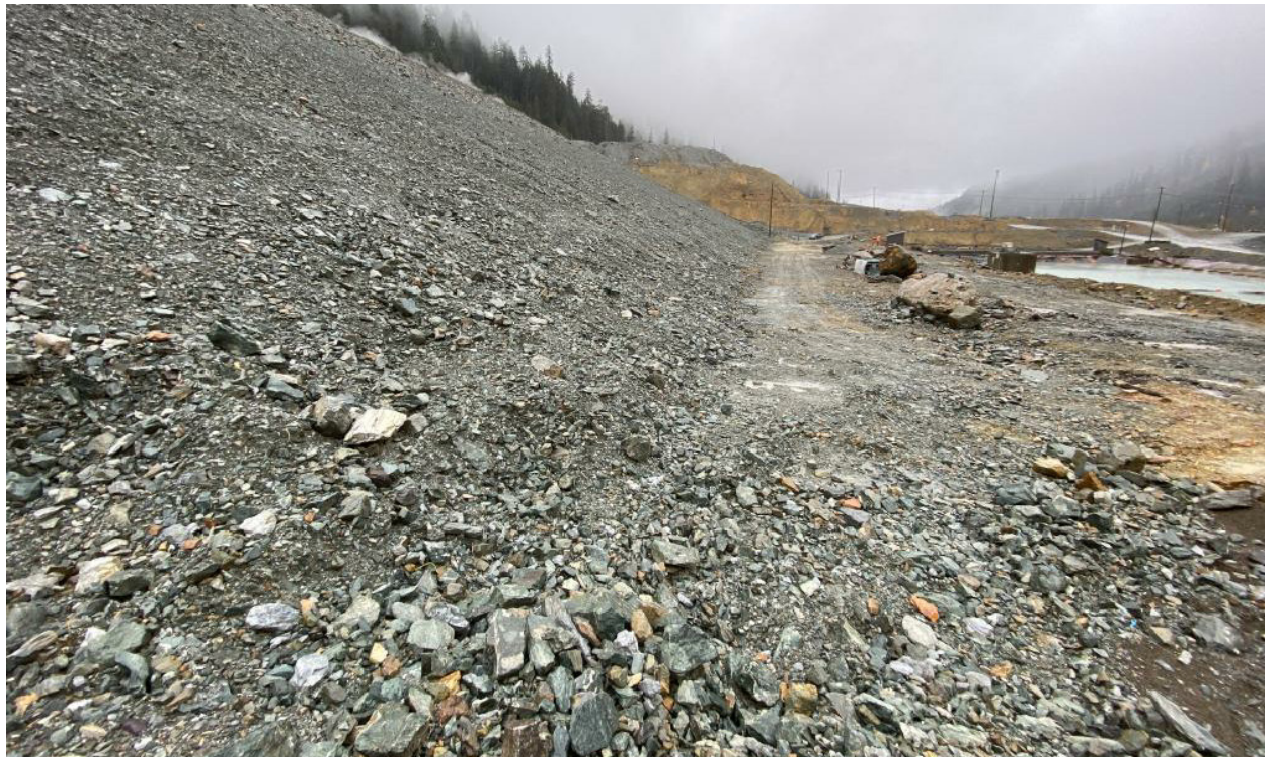
Photograph 3: Downstream slope and toe of South Arm, looking east

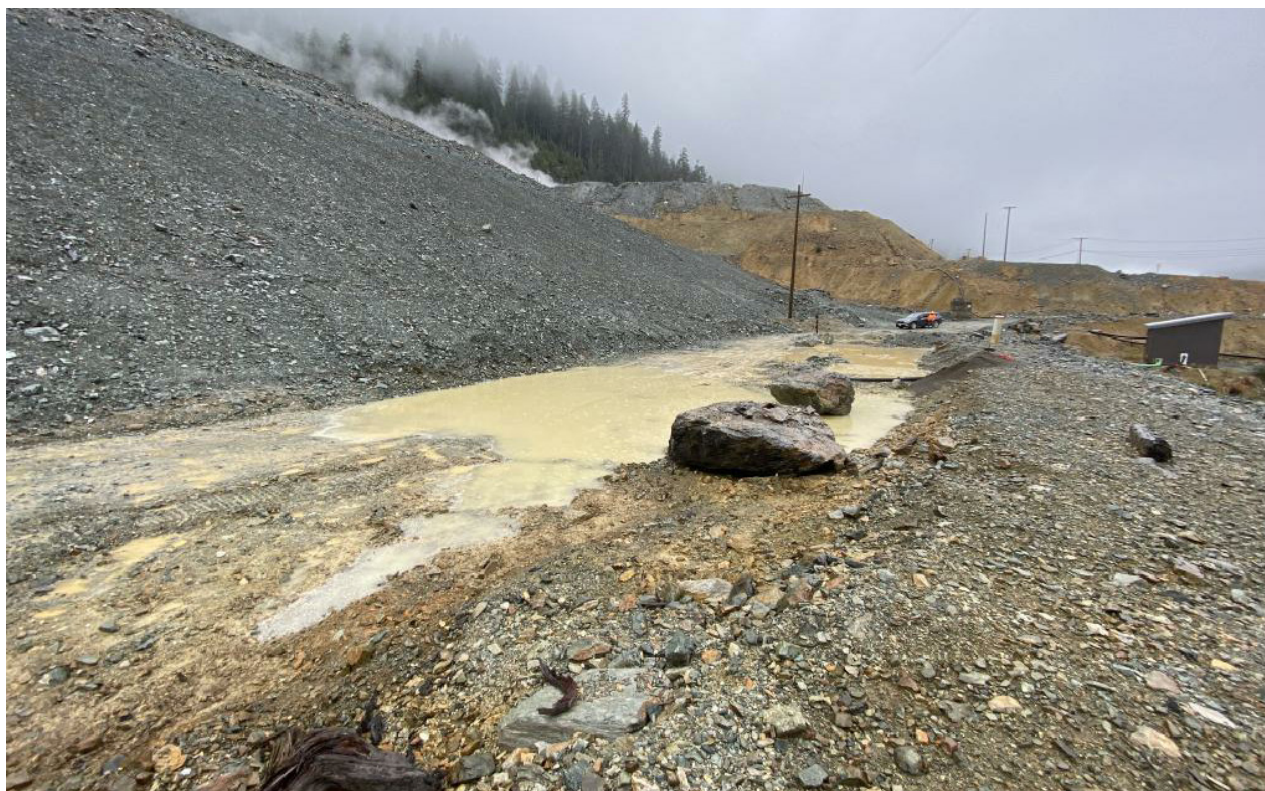
Photograph 4: Water ponding at southeast toe of dam, looking east

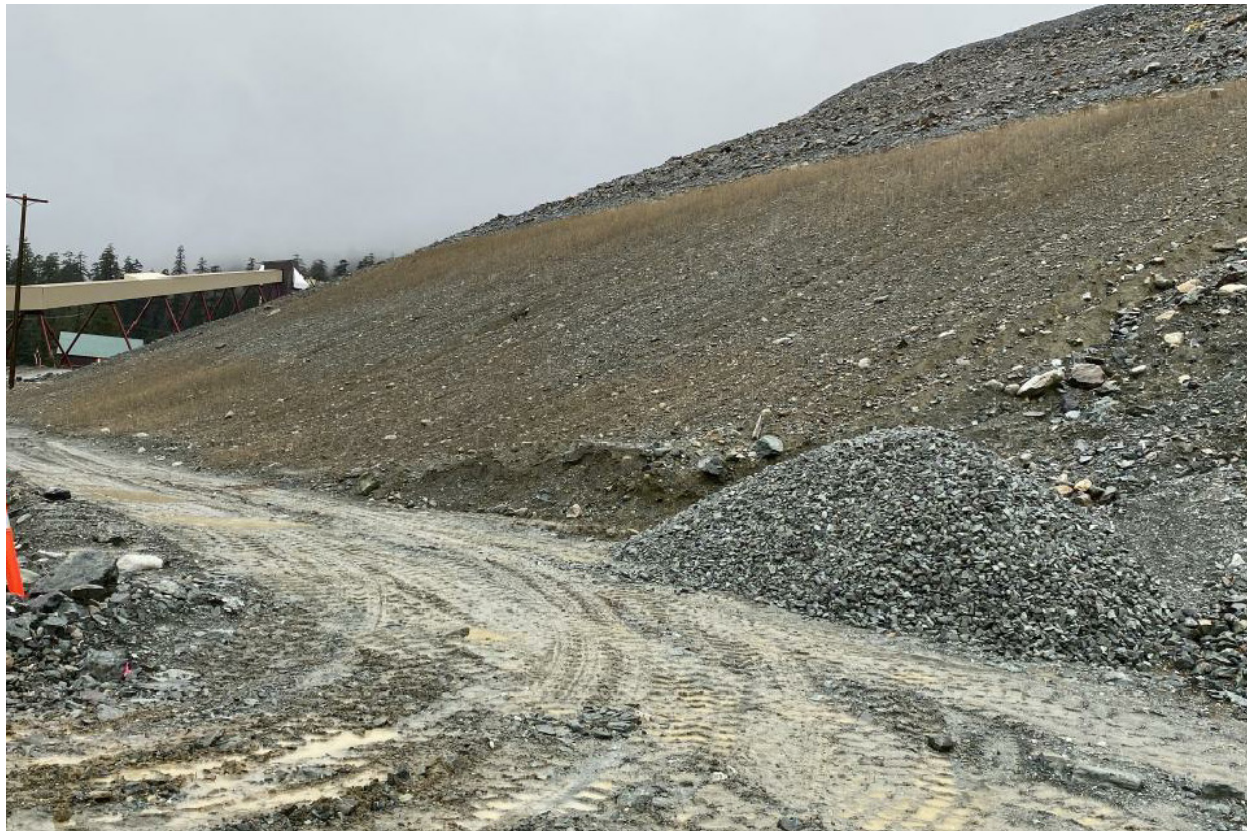
Photograph 5: Cover Trials on Downstream Slope at southwest corner of facility, looking northwest

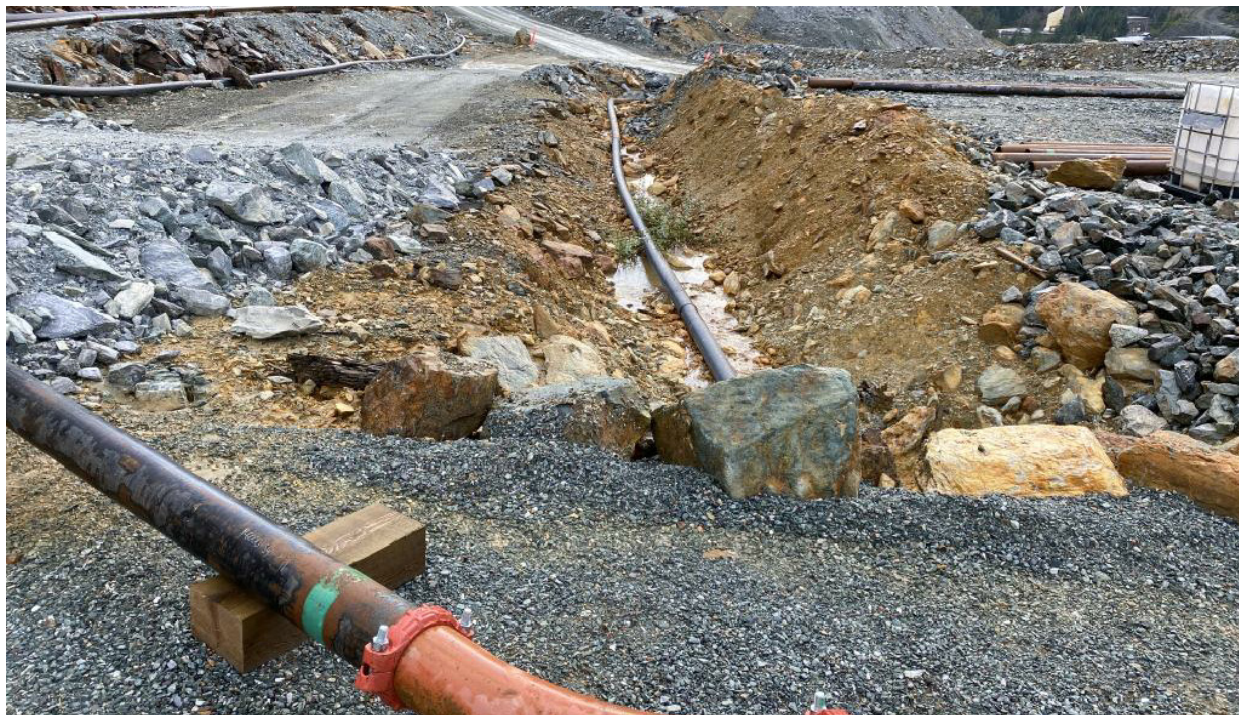
The volume of runoff and seepage observed at the mid-slope of WRD2 during WSP's inspection in October 2023 suggested that runoff and/or seepage were bypassing the ULDD and reporting to the Lynx TDF. WSP worked with MFM to develop a program for monitoring flows in Upper Arnica Diversion Ditch, ULDD and the seepage flows in WRD2, for comparison with site rainfall data, to better assess how effective the diversion ditches are and provide better data for refinement of the required EDF storage volume in Lynx TDF. The monitoring program

Photograph 6: Run-off water from WRD2 being directed over crest near East Arm abutment, looking east

Lynx TDF	2023-03	October	WRD2 Seepage flows bypassing Upper Lynx Diversion Ditch and being directed over the abutment of the East Arm and down the toe of the 4H:1V slope and WRD1.	MFM reported and provided photos that the WRD2 seepage runoff flows had been redirected into the Lynx TDF by late October. To be validated during next Engineer of Record inspection.	No change in recommendation.	3	MFM Reports this is complete

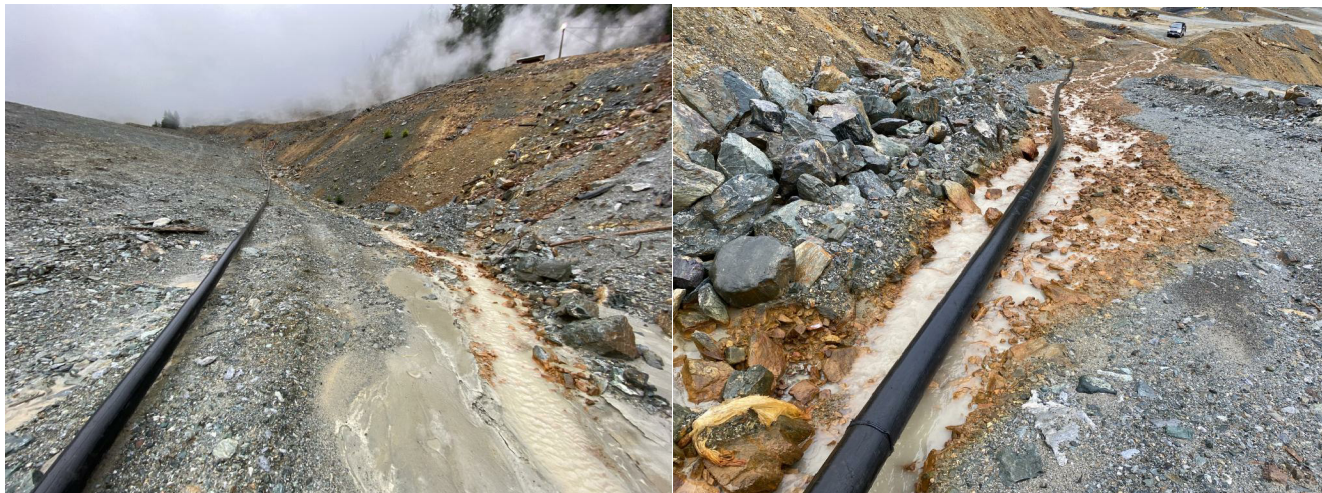
Photograph 7: Run-off water from WRD2 flowing down toe of 4H:1V East Arm and WRD1

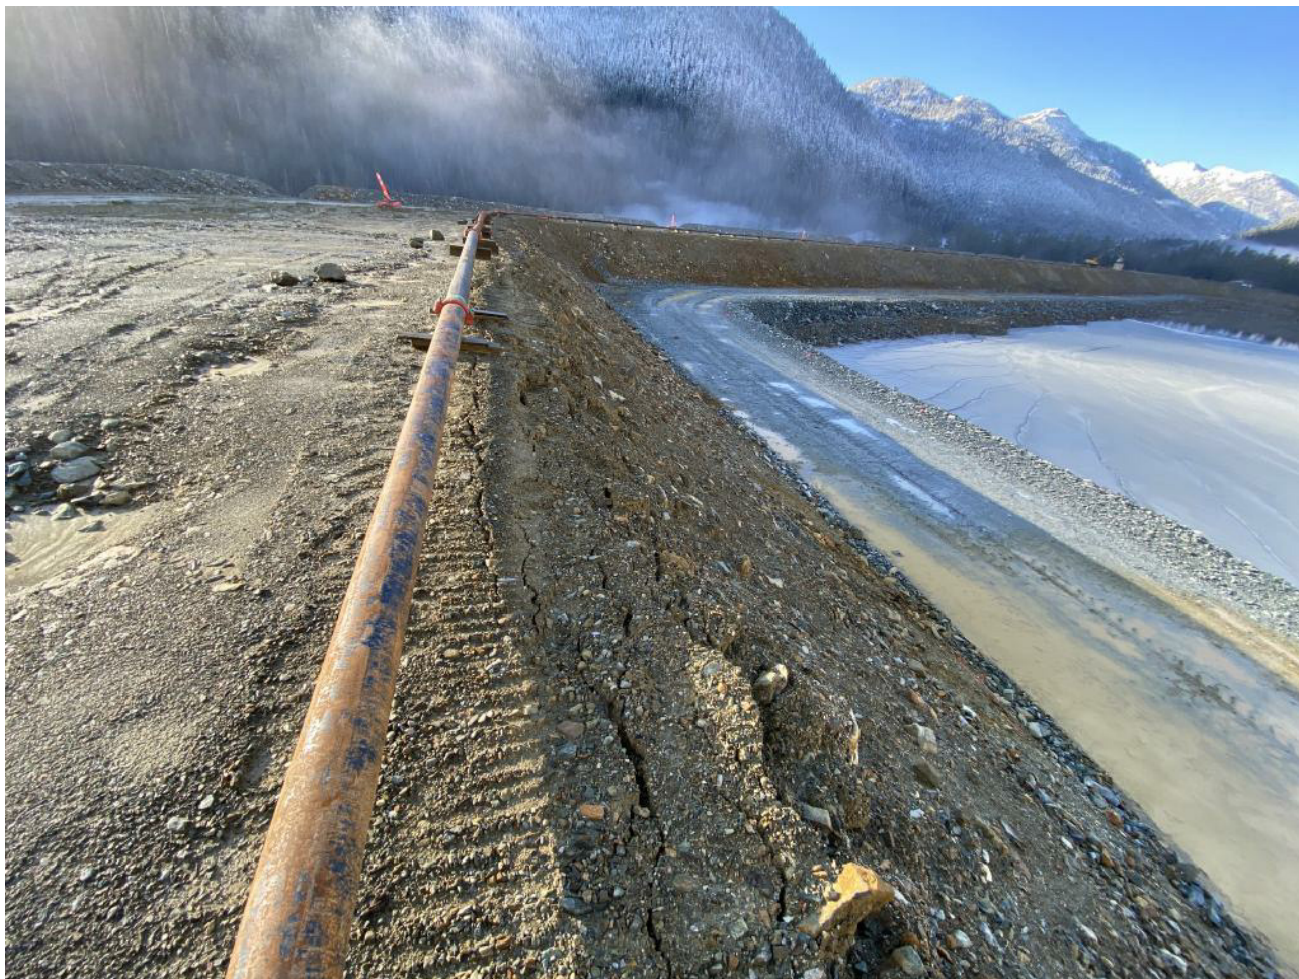
Photograph 8: Cracking in Temporary upstream slope on East Arm looking south

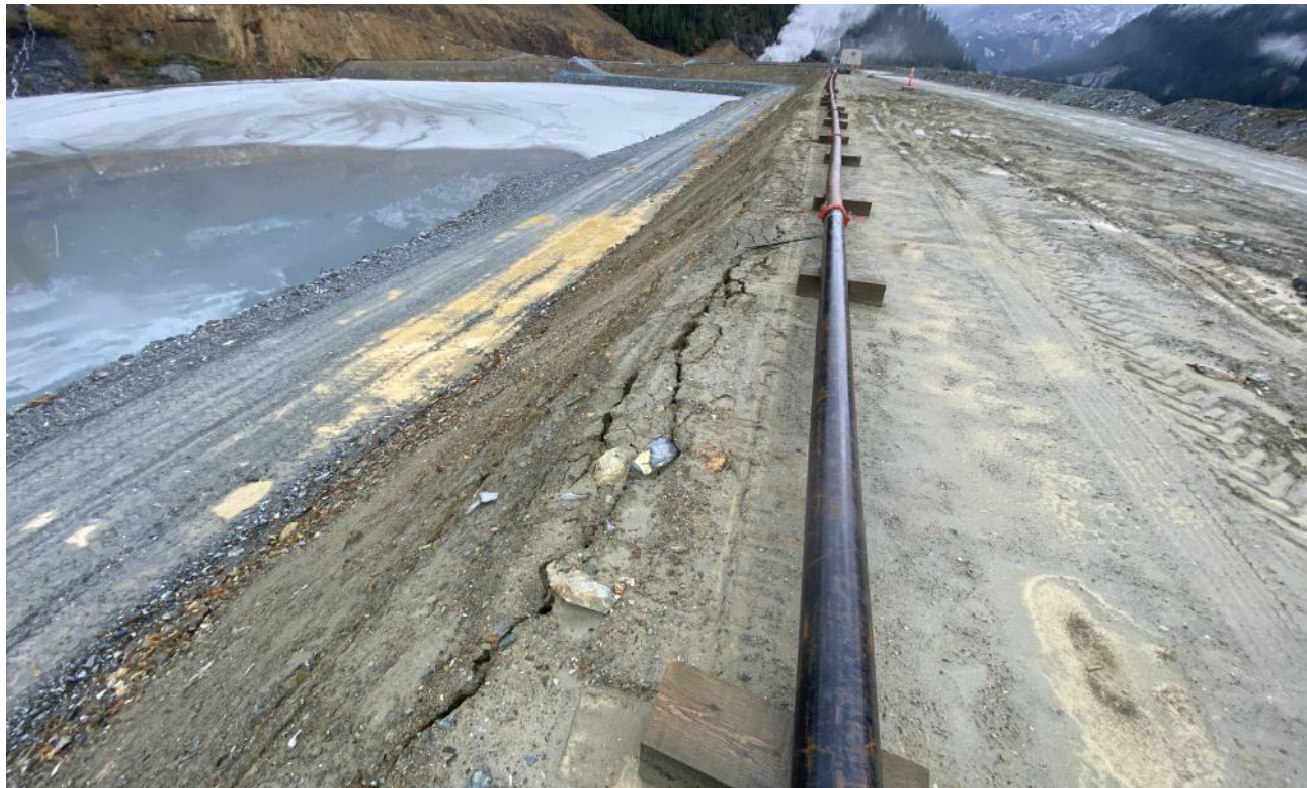
Photograph 9: Cracking in Temporary upstream slope on South Arm looking east

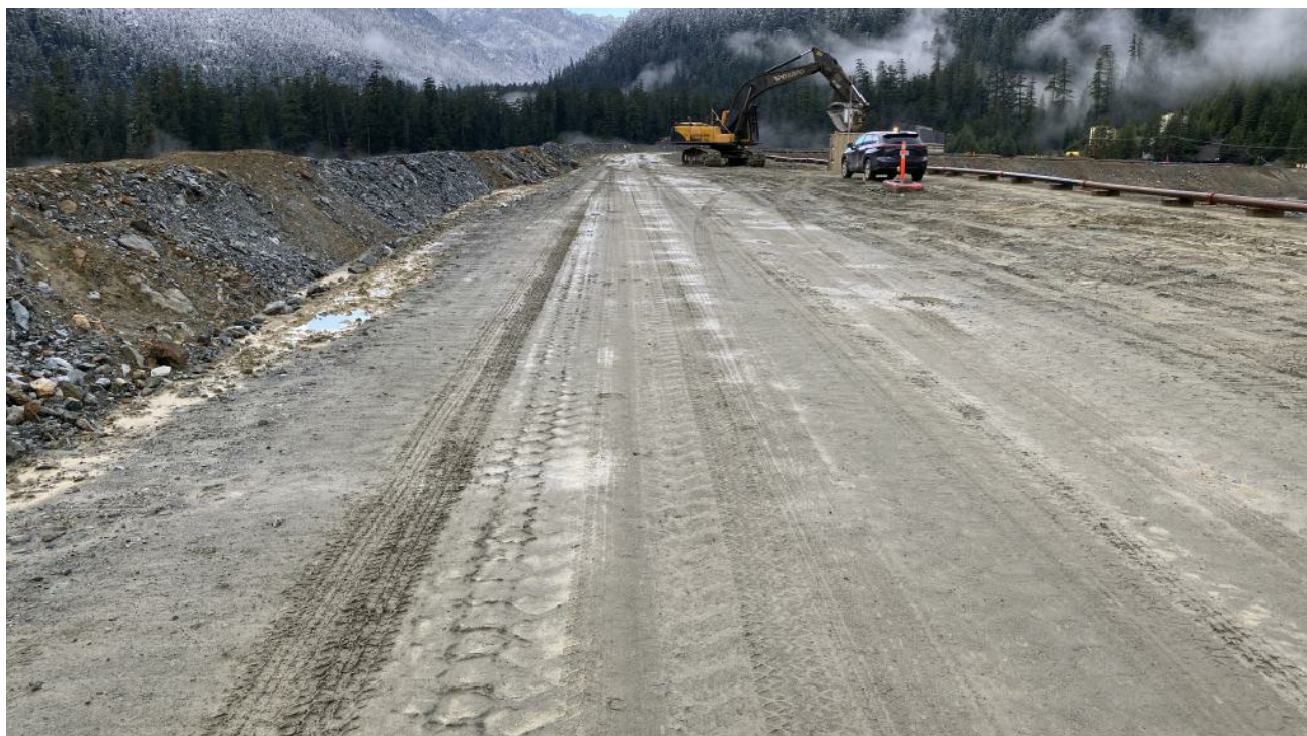
Photograph 10: Crest of South Arm looking west – Crest raise to El. 378 m complete, including capping layer to 378.5 m. Safety berm in place on downstream

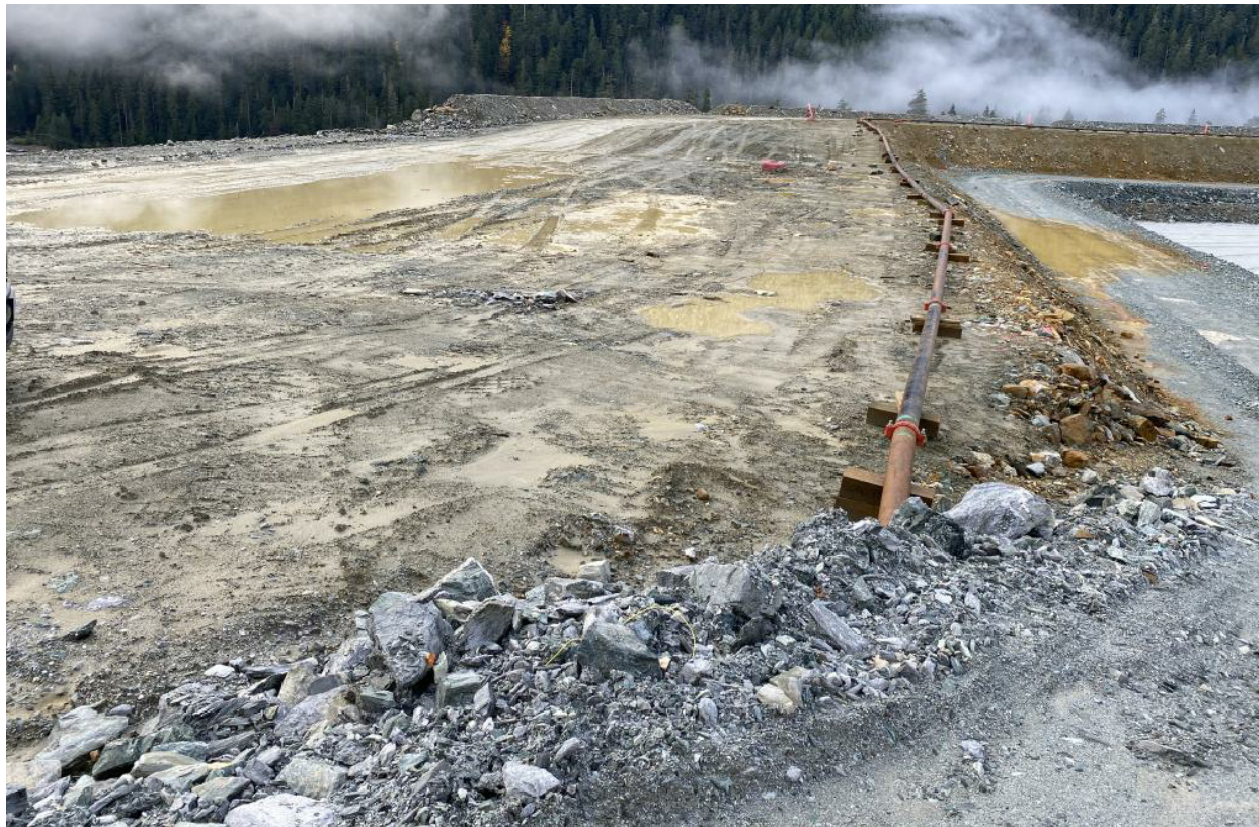
Photograph 11: Auxiliary Swale on East Arm looking south. Minor ponding within swale

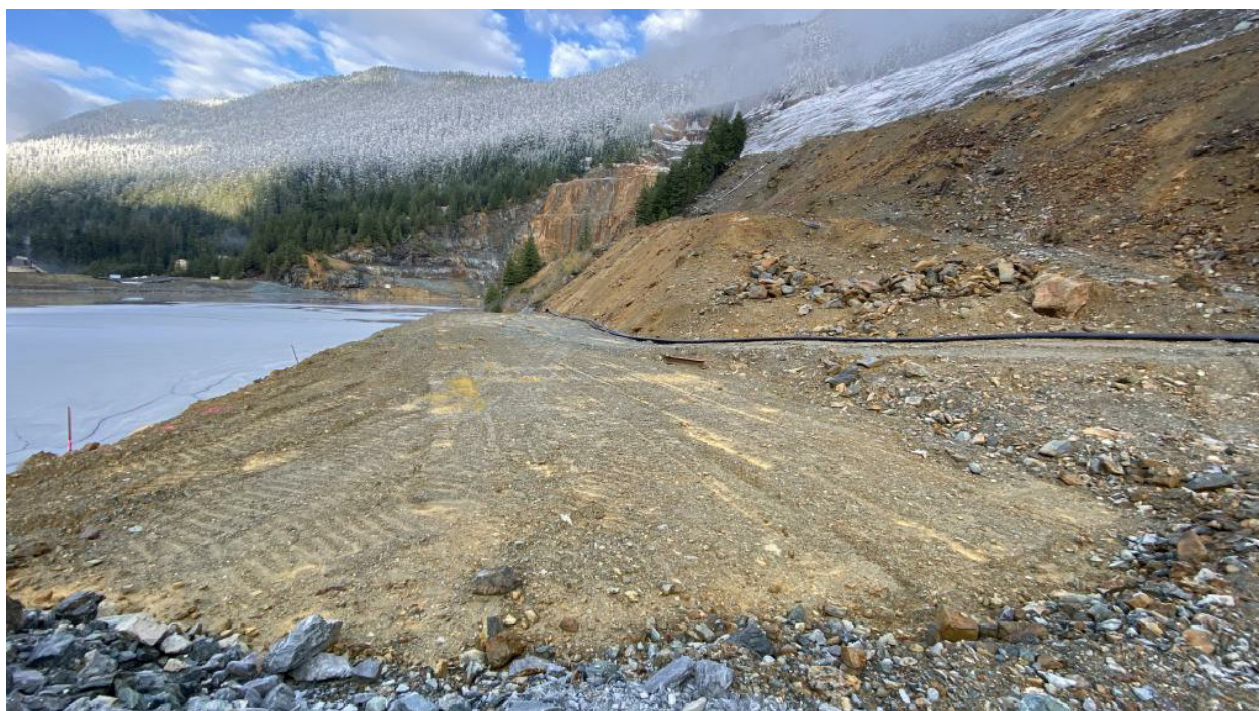
Photograph 12: North Abutment WRD1 Zone J filter at El. 378. Looking west.

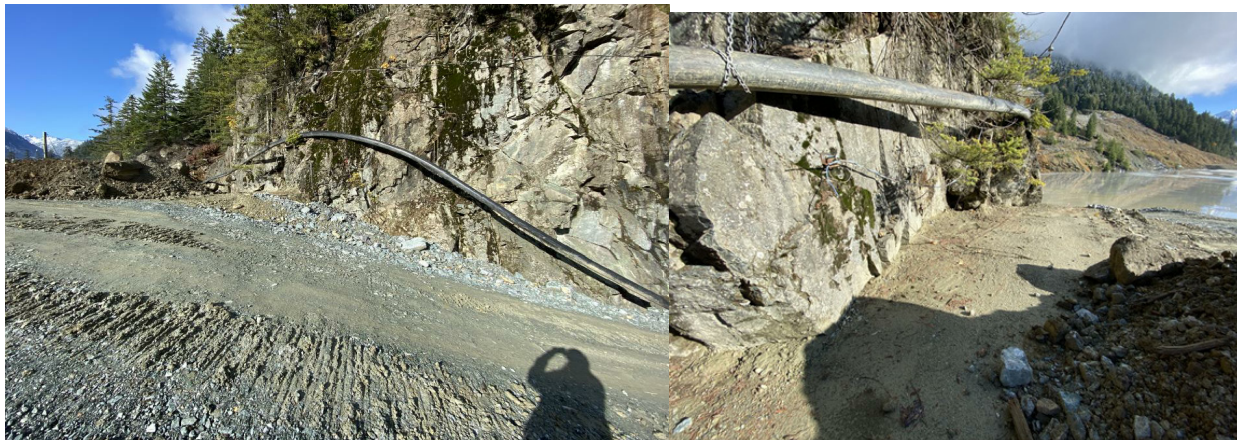
Photograph 13: West Arm abutment tie in, looking northwest and northeast

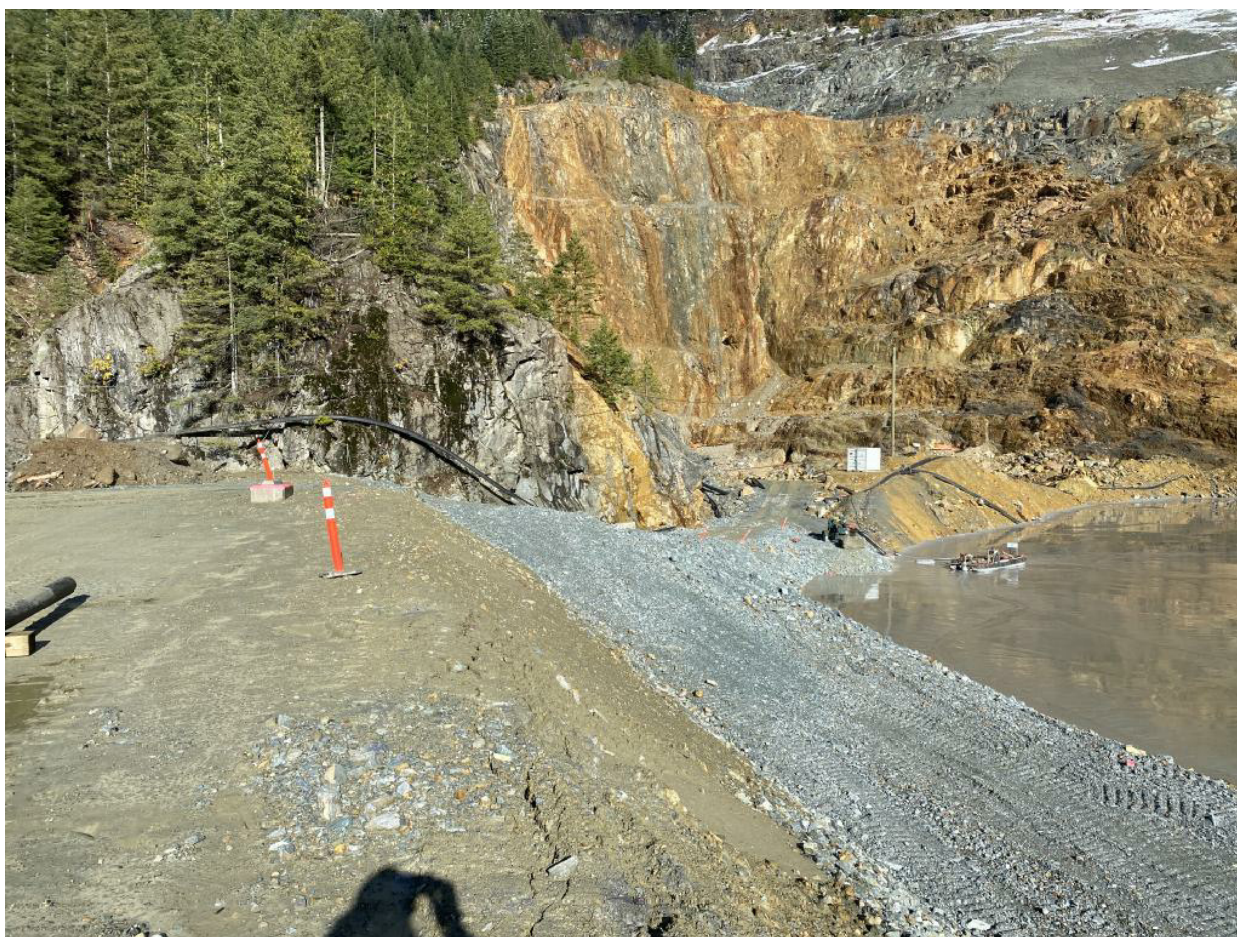
Photograph 14: West Arm crest and abutment tie-in, looking north
