2023 Lynx Tailings Disposal Facility Dam Safety Inspection

Myra Falls Mine Ltd.

WSP Canada Inc.

March 28, 2024

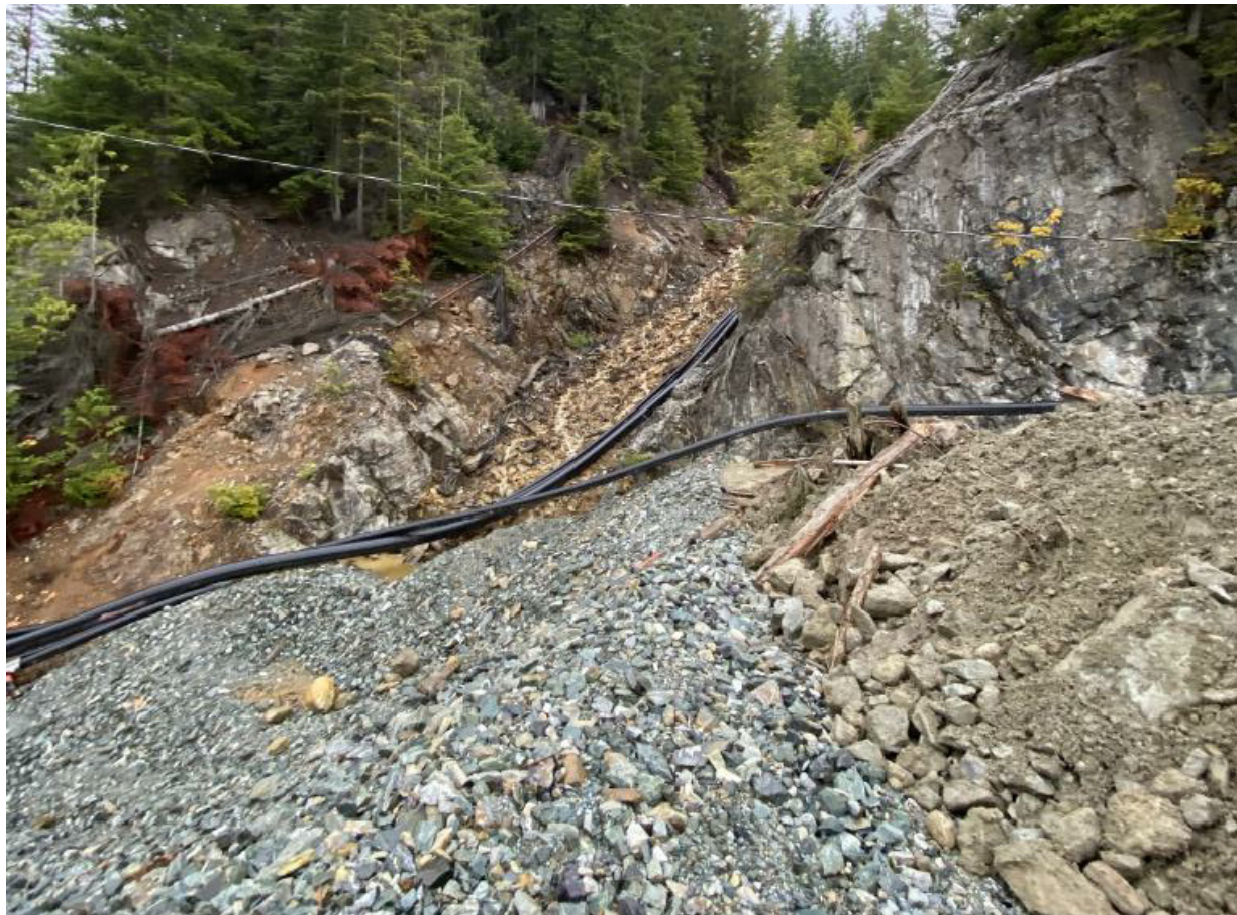
Photograph 15: Run-off water through gully on downstream of West Arm abutment tie in, looking north

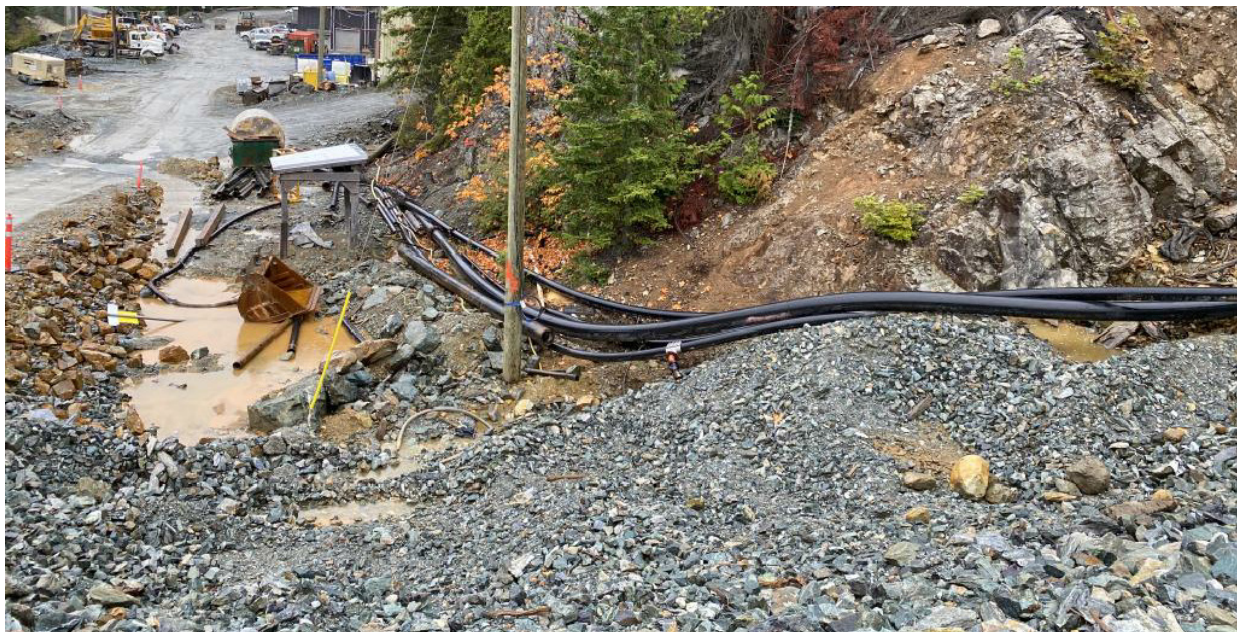
Photograph 16: Minor ponding of run-off water downstream of West Arm abutment tie-in, looking west

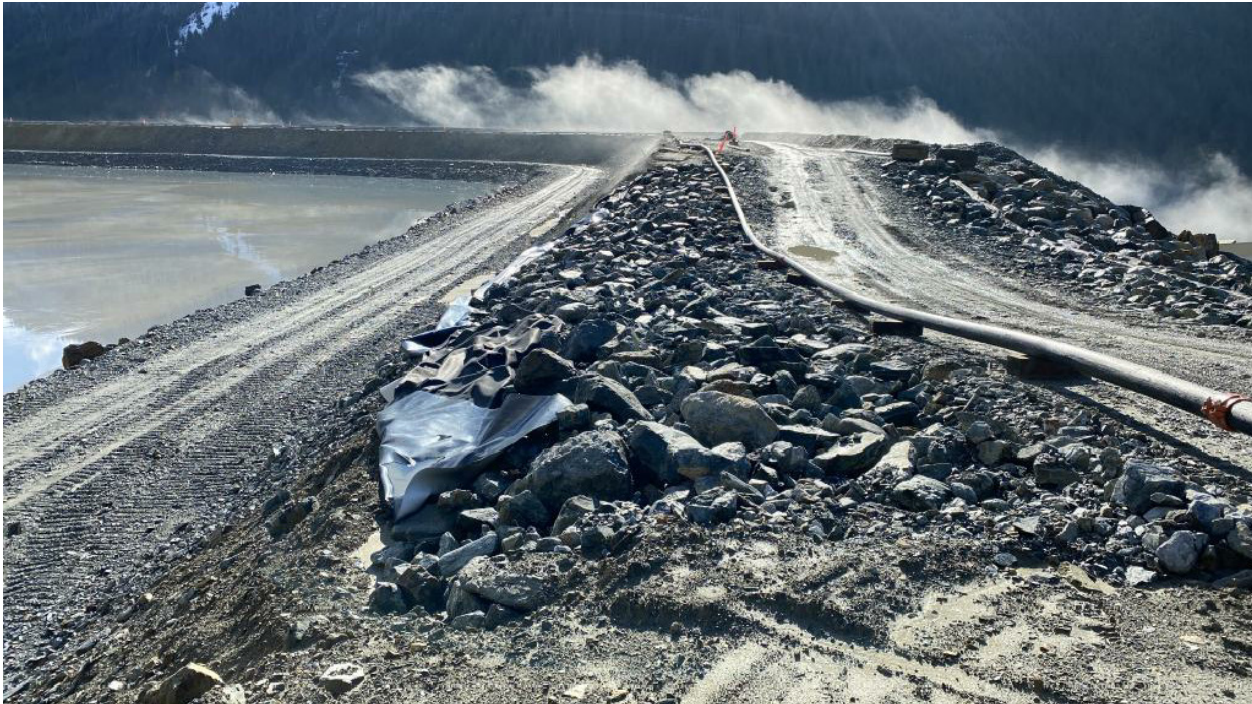
Photograph 17: Spillway invert across West Arm crest, looking south. Upstream push out not complete

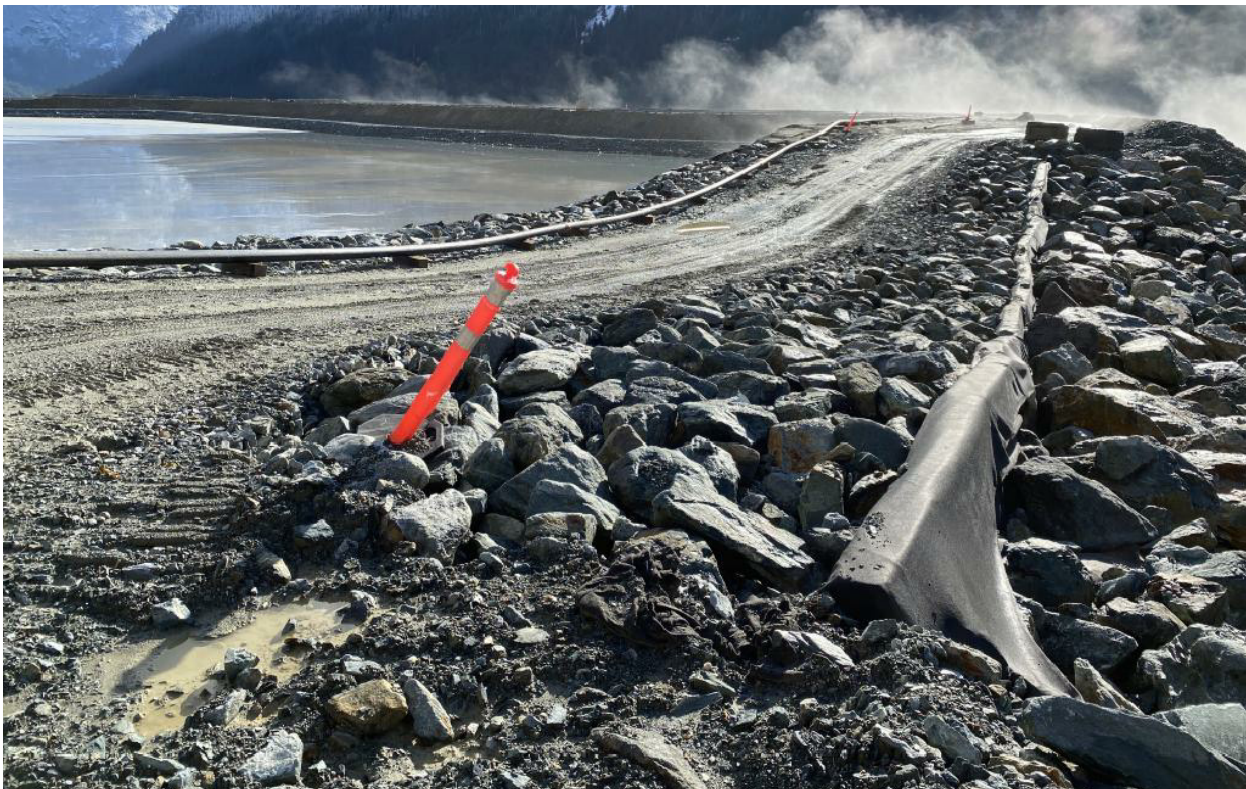
Photograph 18: Spillway invert across West Arm, looking southeast. Fabric over concrete Lock Blocks

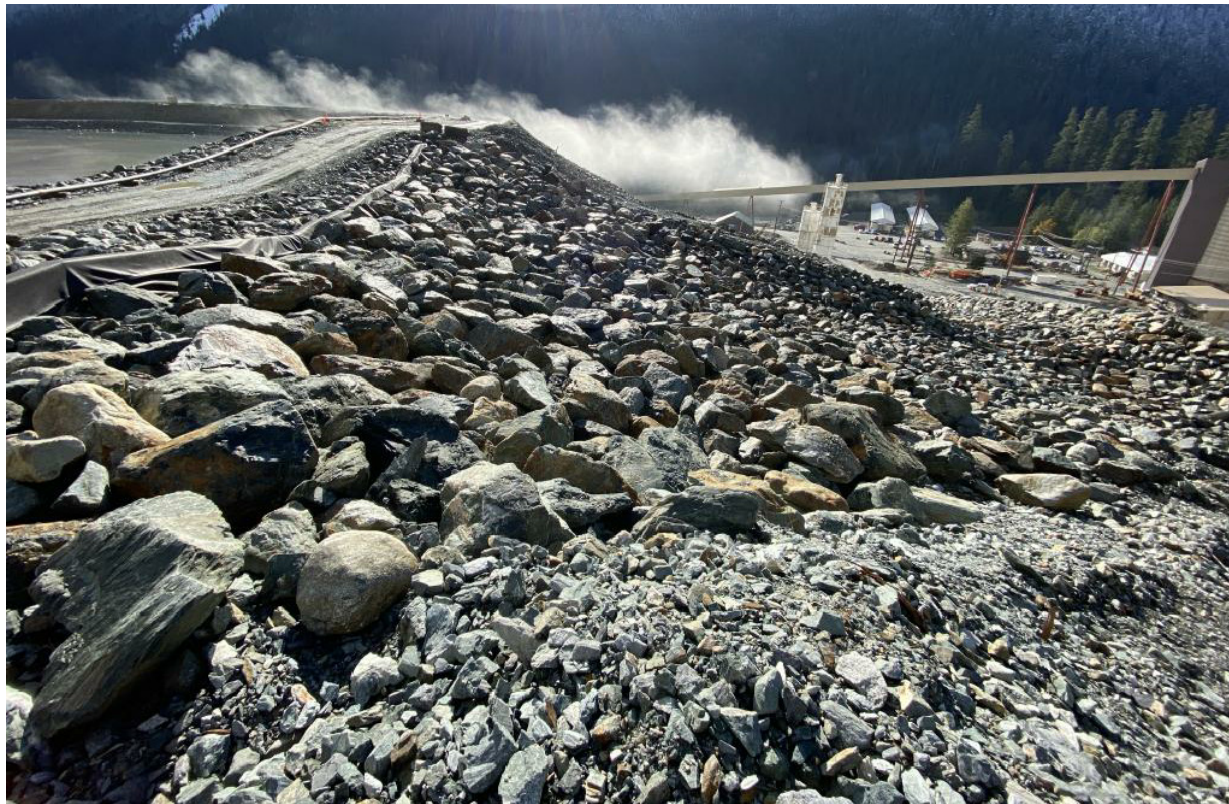
Photograph 19: Spillway channel on downstream slope of West Arm, looking south

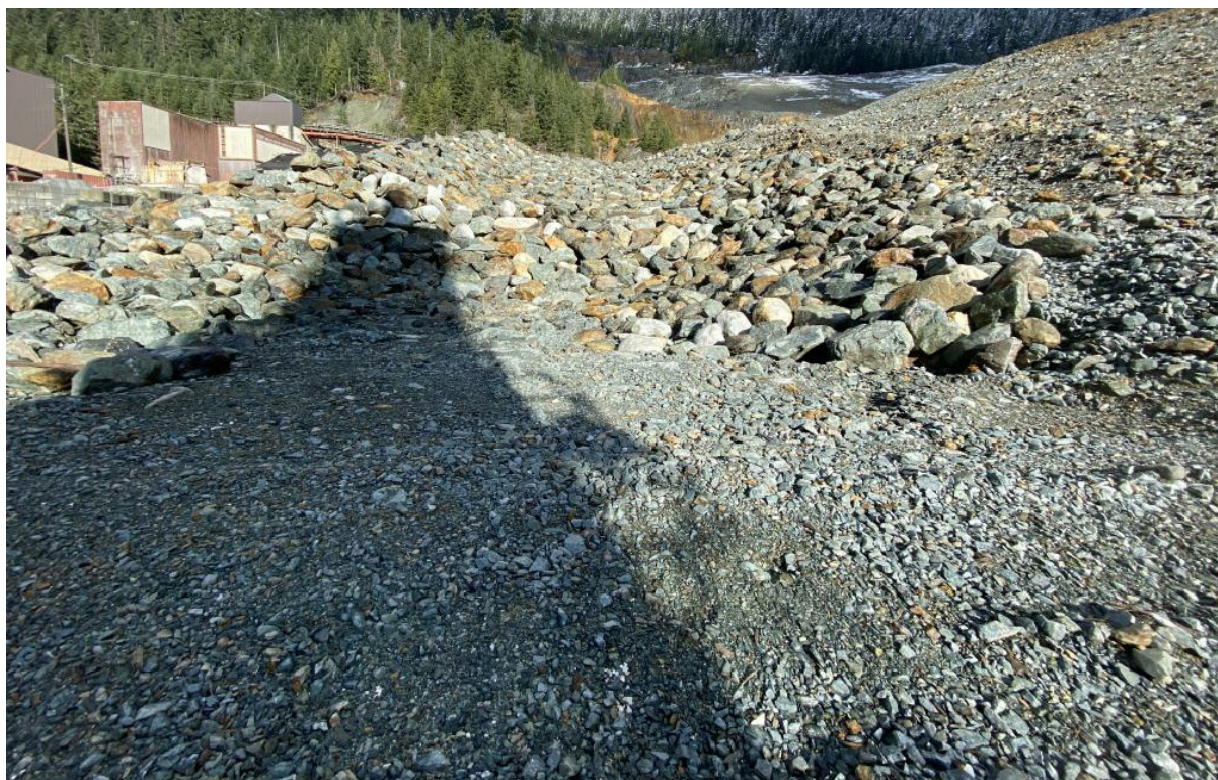
Photograph 20: Spillway channel outlet at toe of West Arm, looking north

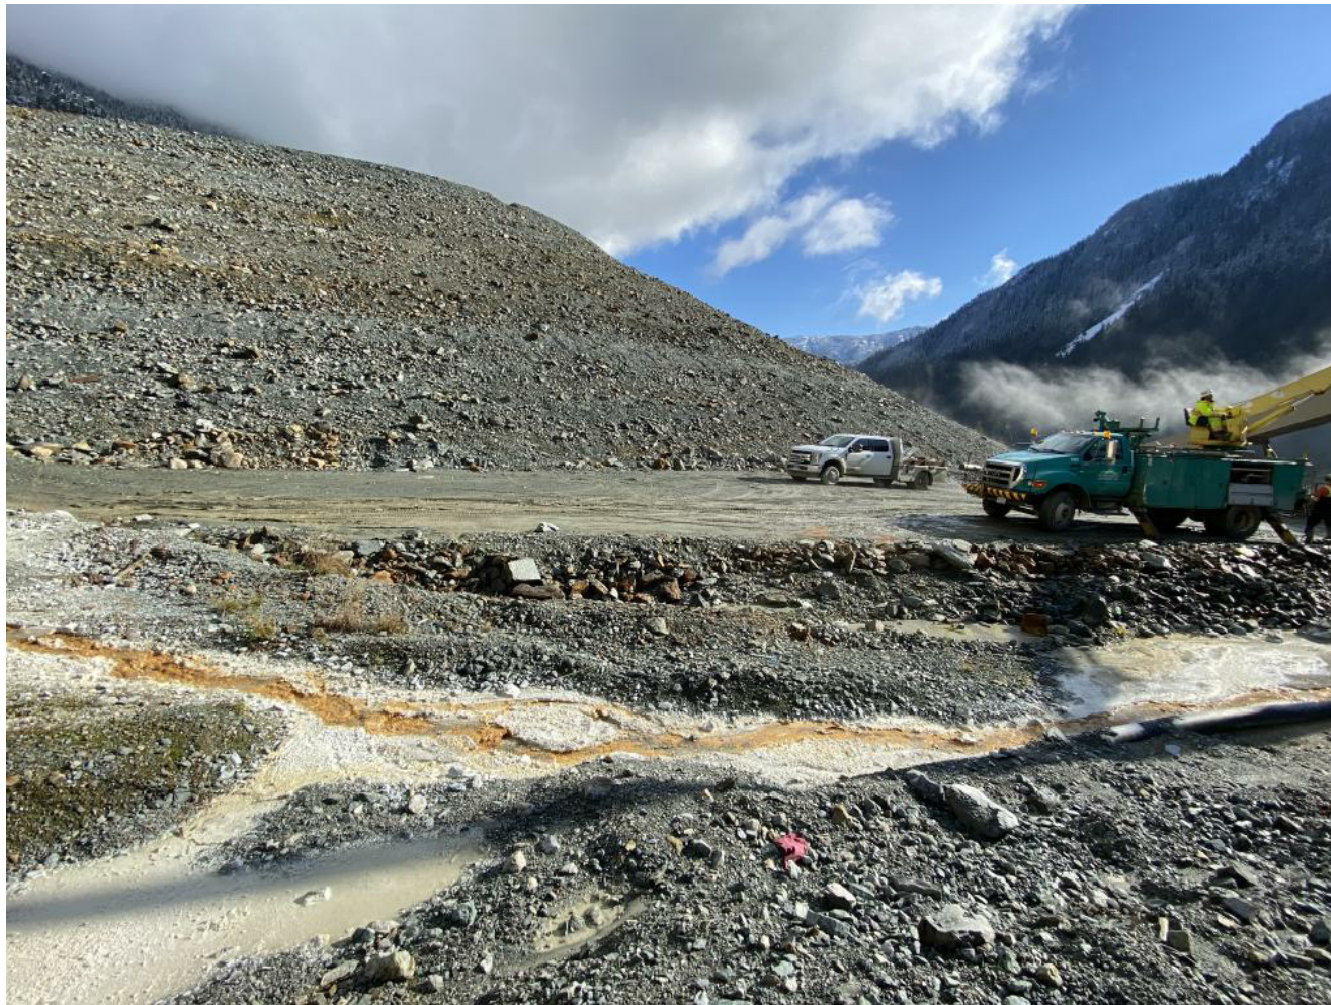
Photograph 21: West Arm downstream slope at corner with South Arm, looking east
