Re: **Review of GHD Technical Responses Task 7 and Task 8 - Upland Landfill – Waste Discharge Application Tracking Number 335965 and Authorization Number 107689 7295 Gold River Highway, Campbell River, British Columbia**

GW Solutions Inc. (GW Solutions) is pleased to present the following letter-report summarizing our review of the following documents:

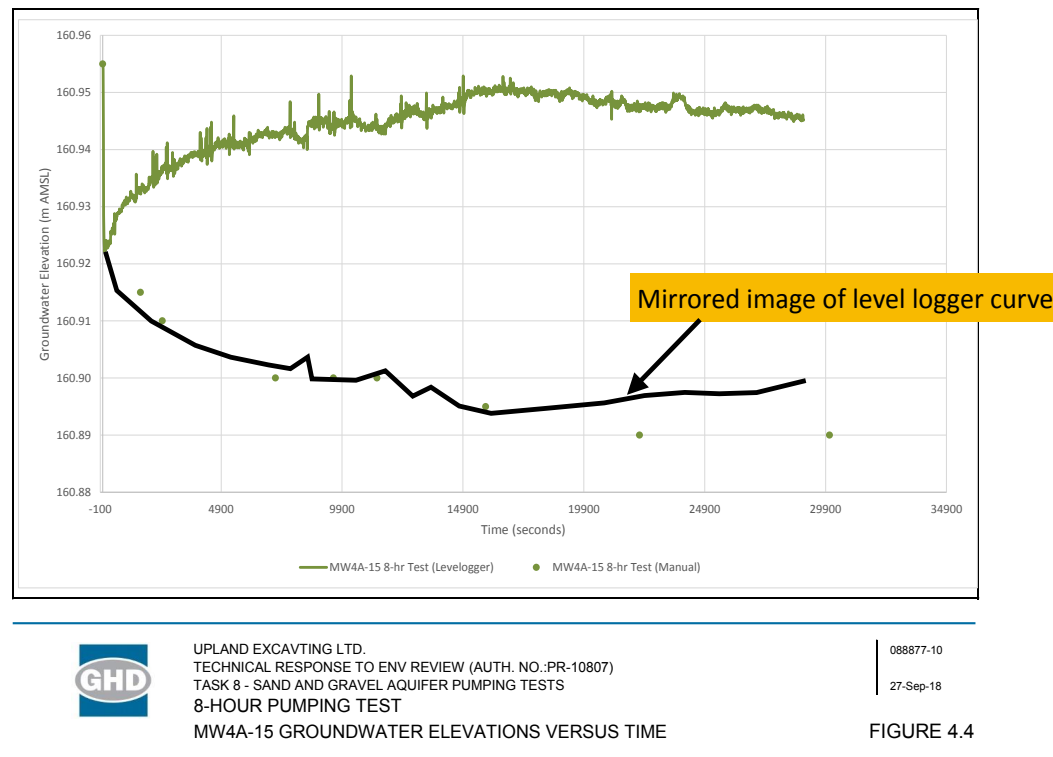
Figure 1: Data logger information - Potential misinterpretation (modified from GHD Figure 4.4)

GW Solutions disagrees with this interpretation. It appears that GHD has made a mistake in the processing of the data from the datalogger.

GW Solutions has noticed that the data logger curve seems to mirror the manual data (Figure 1). Therefore, it is unlikely that such a curve could simply be interpreted by a drift of the data logger. GHD analysis should be reviewed and corrected, should GW Solutions assumption be correct.

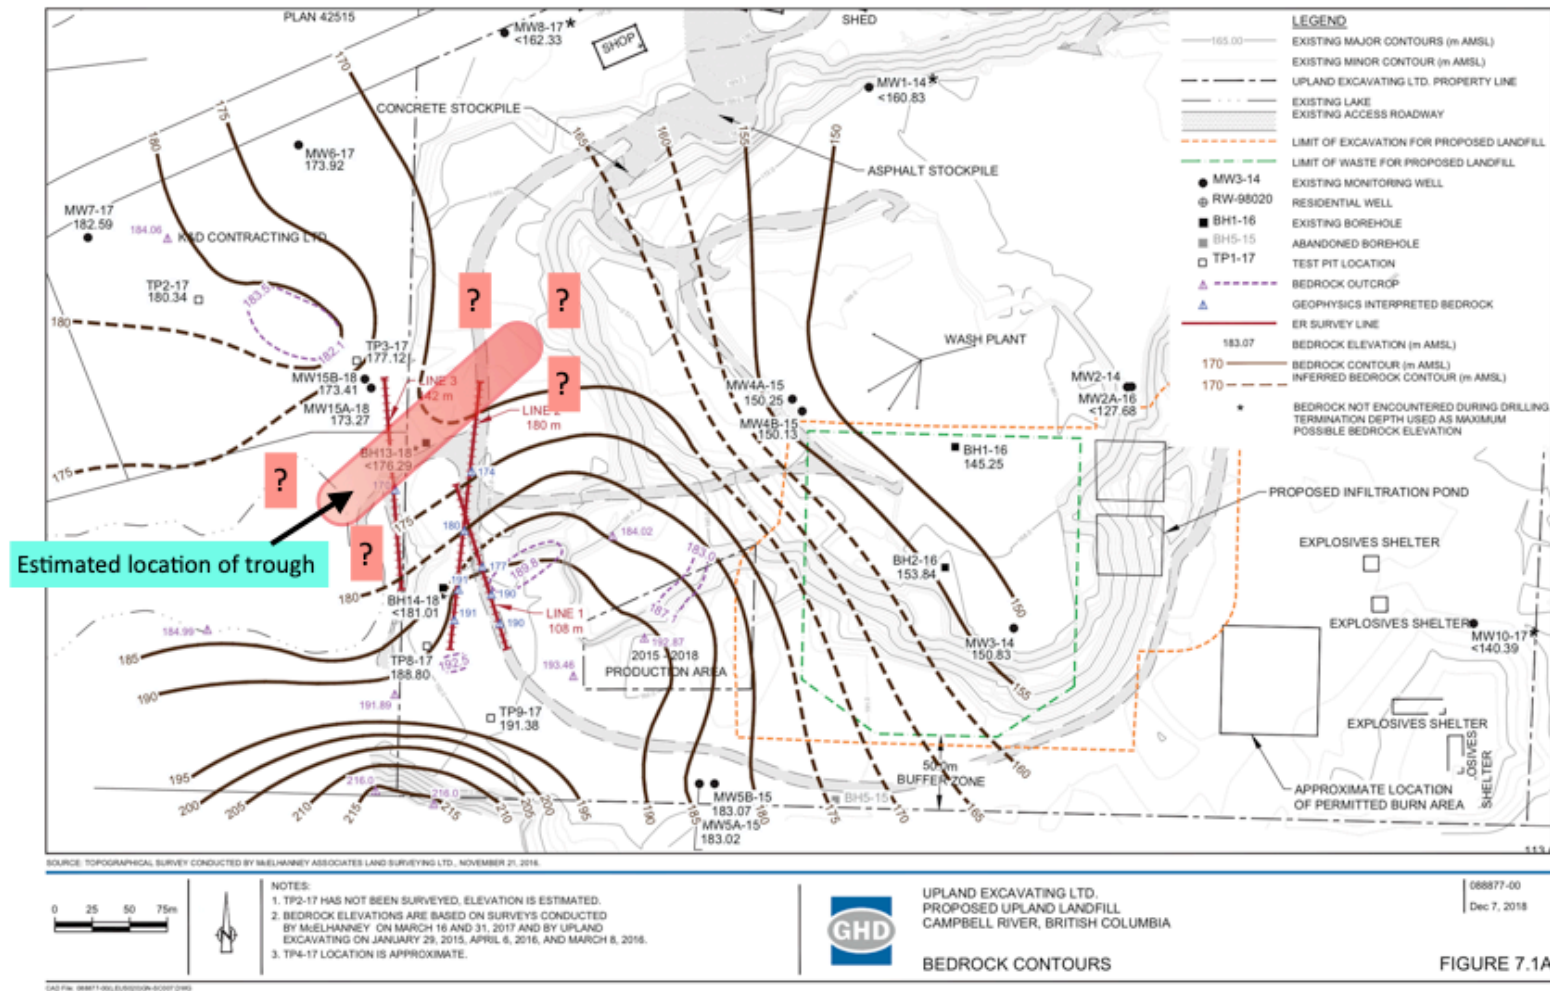
Figure 2: Bedrock topography and trough (estimated location) (Source: GHD Figure 7.1A modified)

- *Bedrock elevations between Rico Lake and the Pit were initially interpreted to range in elevations from 180 to 192 m AMSL. Based on new data collected, bedrock elevations between Rico Lake and the Pit are now observed to range between 170 to 193.46 m AMSL. A sand and gravel filled trough or scour channel in the bedrock surface appears to extend northeast from Rico Lake.*

GW Solutions globally agrees with this comment. This confirms a hydraulic connection between Rico Lake and the pit.

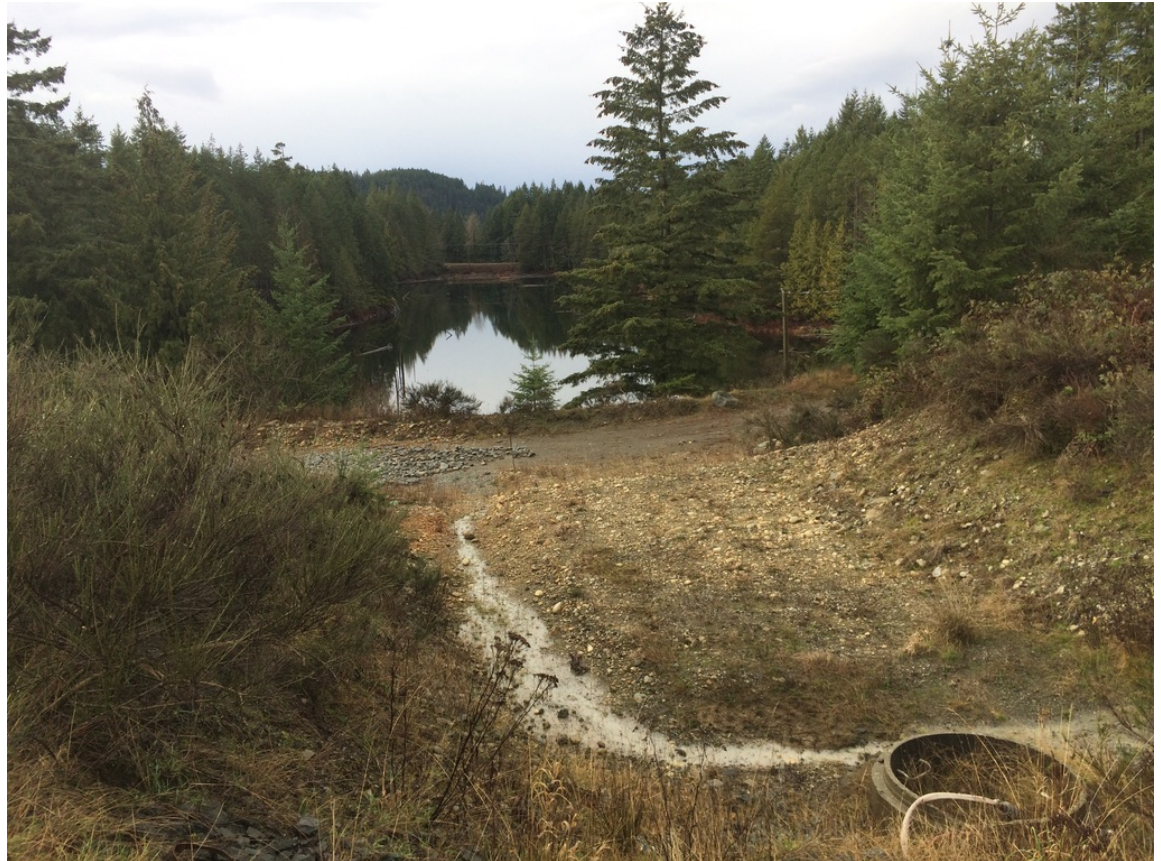
Photo 1: Rico Lake (looking west from Upland property)

GW Solutions understands that Rico Lake appears to discharge both westward toward McIvor Lake and eastward toward the Upland property.

Dr. Wendling visited the site on December 11, 2018 and noticed drainage discharging to Rico Lake from the Upland property (Photo 1). Therefore, the movement of water along the western boundary of the Upland site is complex and involves runoff, shallow groundwater movement, and deeper groundwater movement.

This needs to be further investigated and monitored.

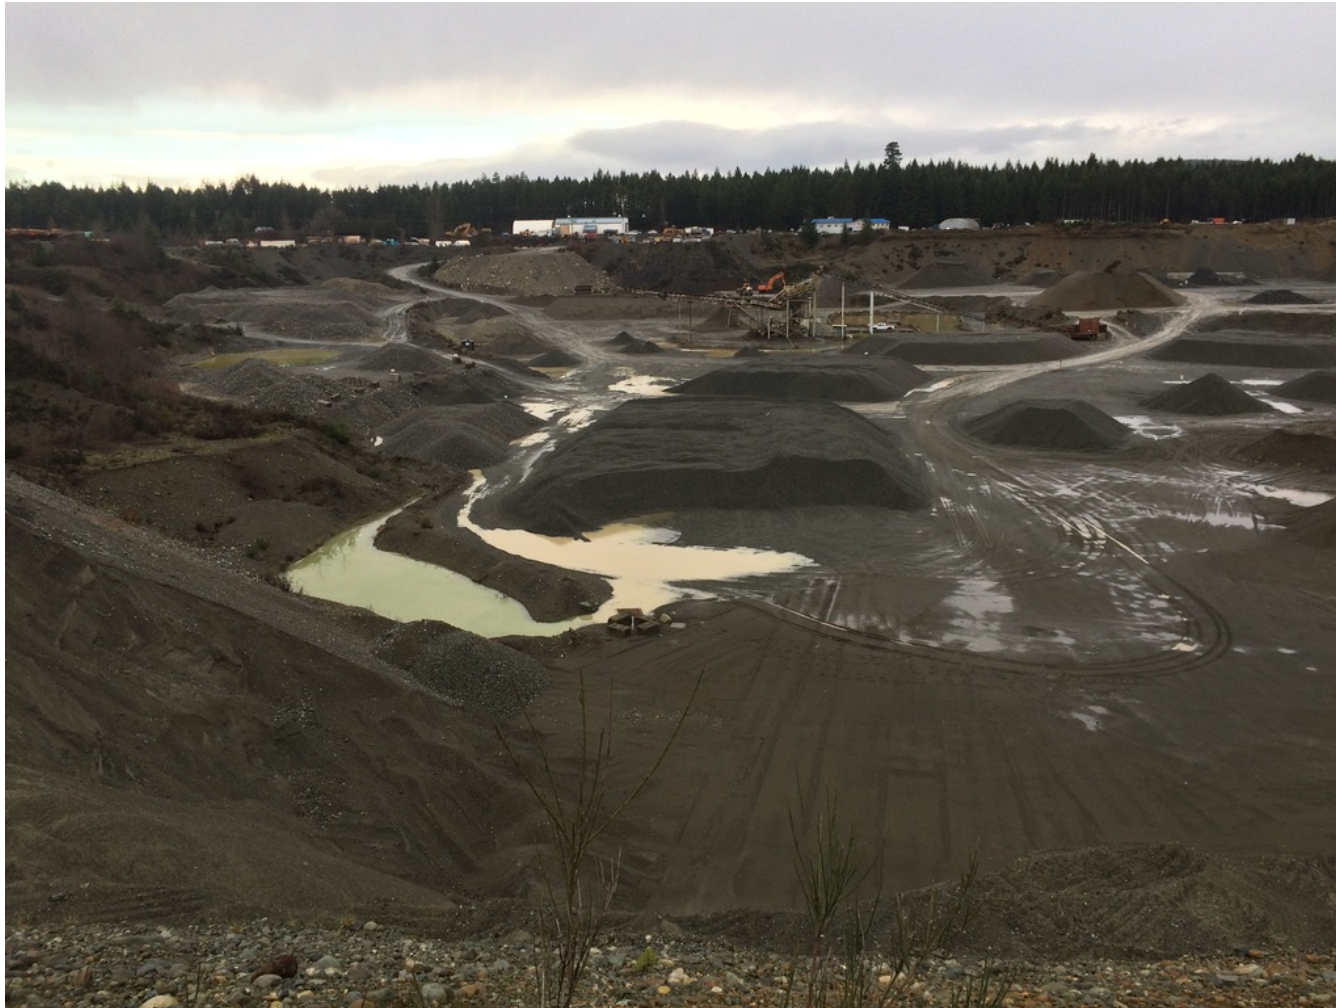
Photo 2: Gravel pit, looking north (Photo taken December 11, 2018)

During his site visit on December 11, 2018, Dr. Wendling noticed that water was ponding on the gravel pit floor (Photo 2 and 3).

According to GHD, the elevation of the pit floor is approximately between 168 m and 169 m (Figure 3), and the elevation of the water table is expected approximately between 154 m and 162 m (Figure 3). Therefore, the water table should be at least 6 m below ground.

According to GHD, the sand and gravel is thick under the pit (Figure 4), and its hydraulic conductivity 2×10^{-2} cm/s (Technical Response to ENV Review (Auth. No.:Pr-10807) Task 8). **With such a high hydraulic conductivity, water should not be ponding, and surface water is expected to infiltrate very rapidly through the pit floor.**

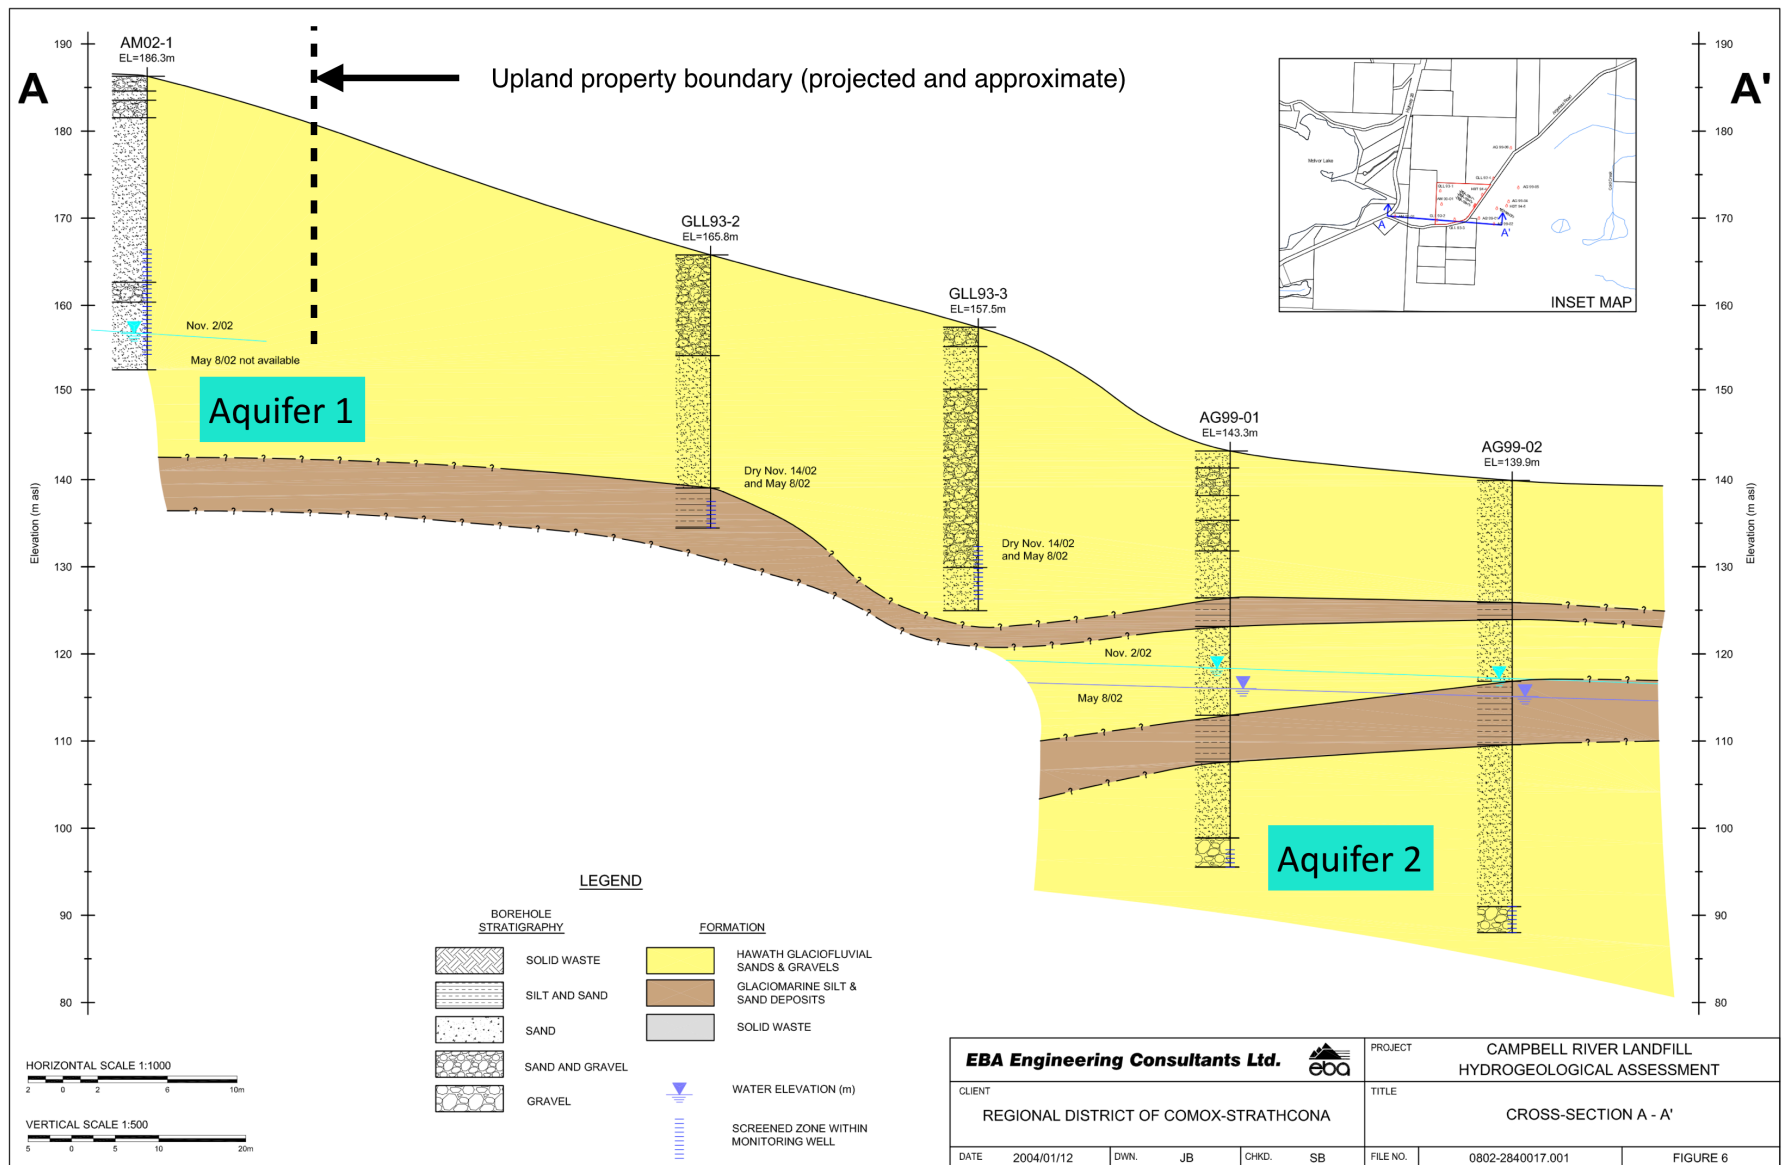
Figure 5: East-West cross-section showing two aquifers (Modified from EBA 2004, Figure 6)

In its *Campbell River Landfill Hydrogeological Assessment* (2004), EBA has produced a cross-section showing the presence of two aquifers in the sand and gravel deposits along Argonaut Road (Figure 5). These two aquifers, identified as Aquifer 1 and Aquifer 2 in Figure 5, are due to layers of sand deposits containing silt and acting as aquitards (shown in brown in Figure 5). **We note that Aquifer 1 is present at the right of the eastern boundary of Upland property.** Therefore, it is possible that the ponded water observed at the pit floor is daylighting groundwater from Aquifer 1, and that the presence of two aquifers in the sand and gravel deposit under the Upland property has been overlooked during GHD hydrogeological characterisation of the Upland property, in part due to the absence of monitoring wells in the northeast quadrant of the Upland property.

If the presence of two aquifers is confirmed under Upland property, this should be considered to a) assess whether Upland is meeting existing mining regulations in regard to protection of aquifers and b) assess how the presence of a shallow aquifer modifies the waste discharge application under review.
