PROPOSED UPLAND LANDFILL

HYDROGEOLOGICAL REVIEW

BY: DR. GILLES WENDLING, P.ENG.
GW SOLUTIONS

Campbell River, January 28, 2019

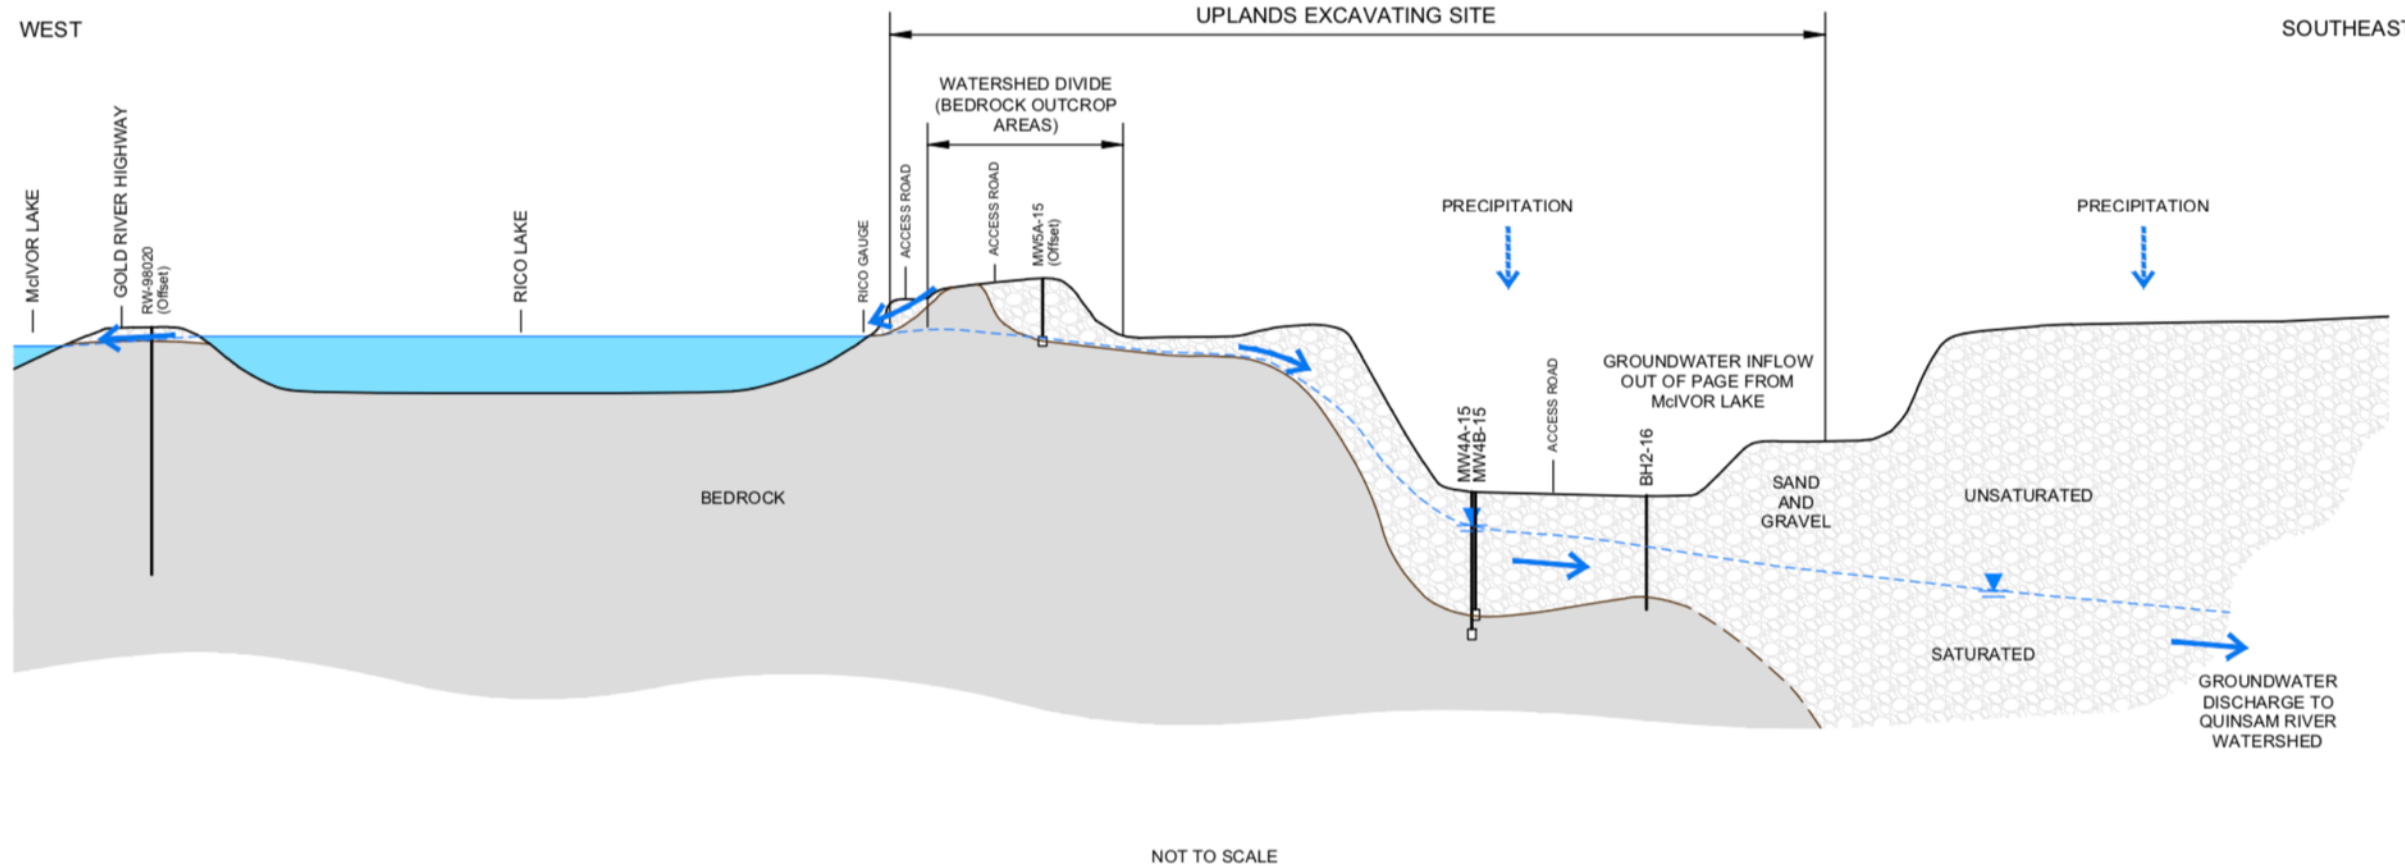
FIGURE 3.0C

- **Groundwater Flow in Bedrock**
- Risk of Impact to Rico Lake - Part of Drinking Water Source
- High Water Table in Existing Pit

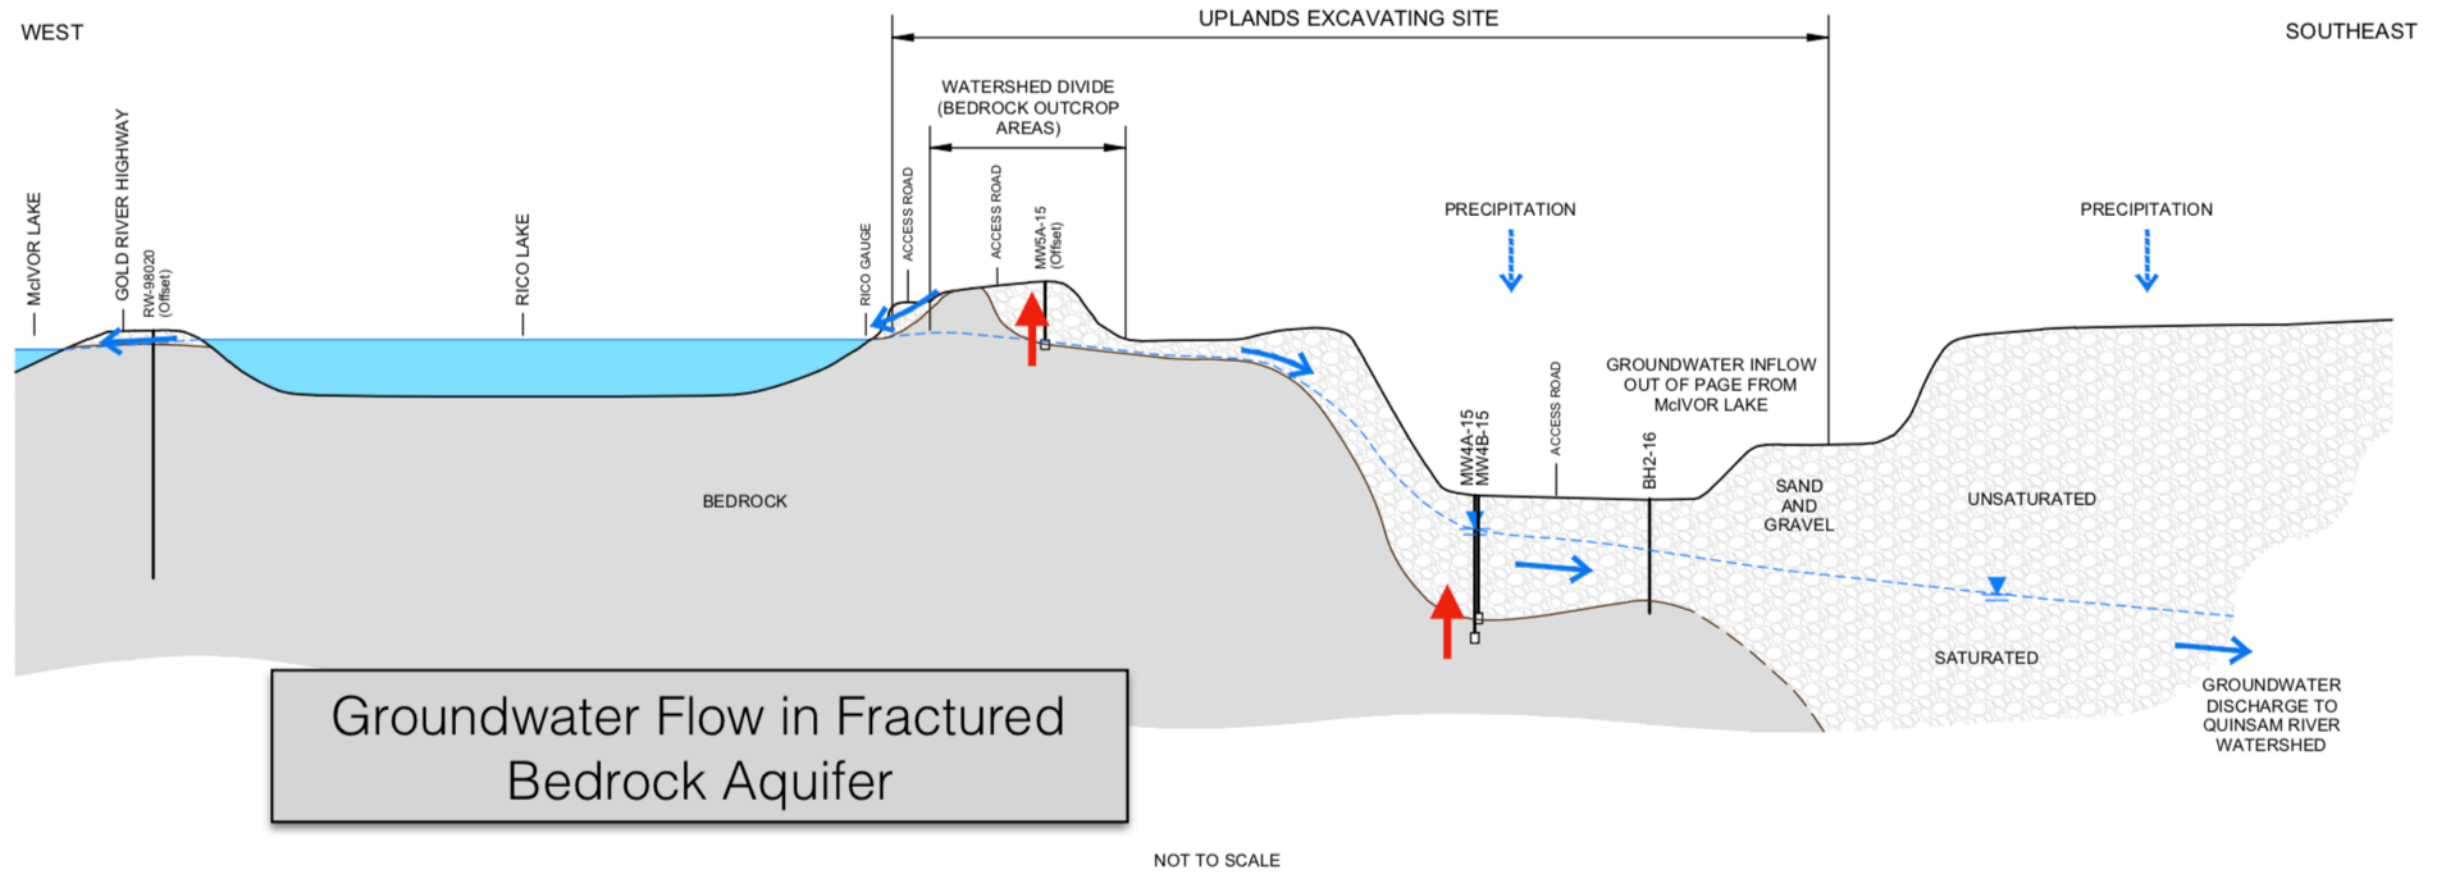
FIGURE 3.0C

Flow in Bedrock Aquifer still not Characterized

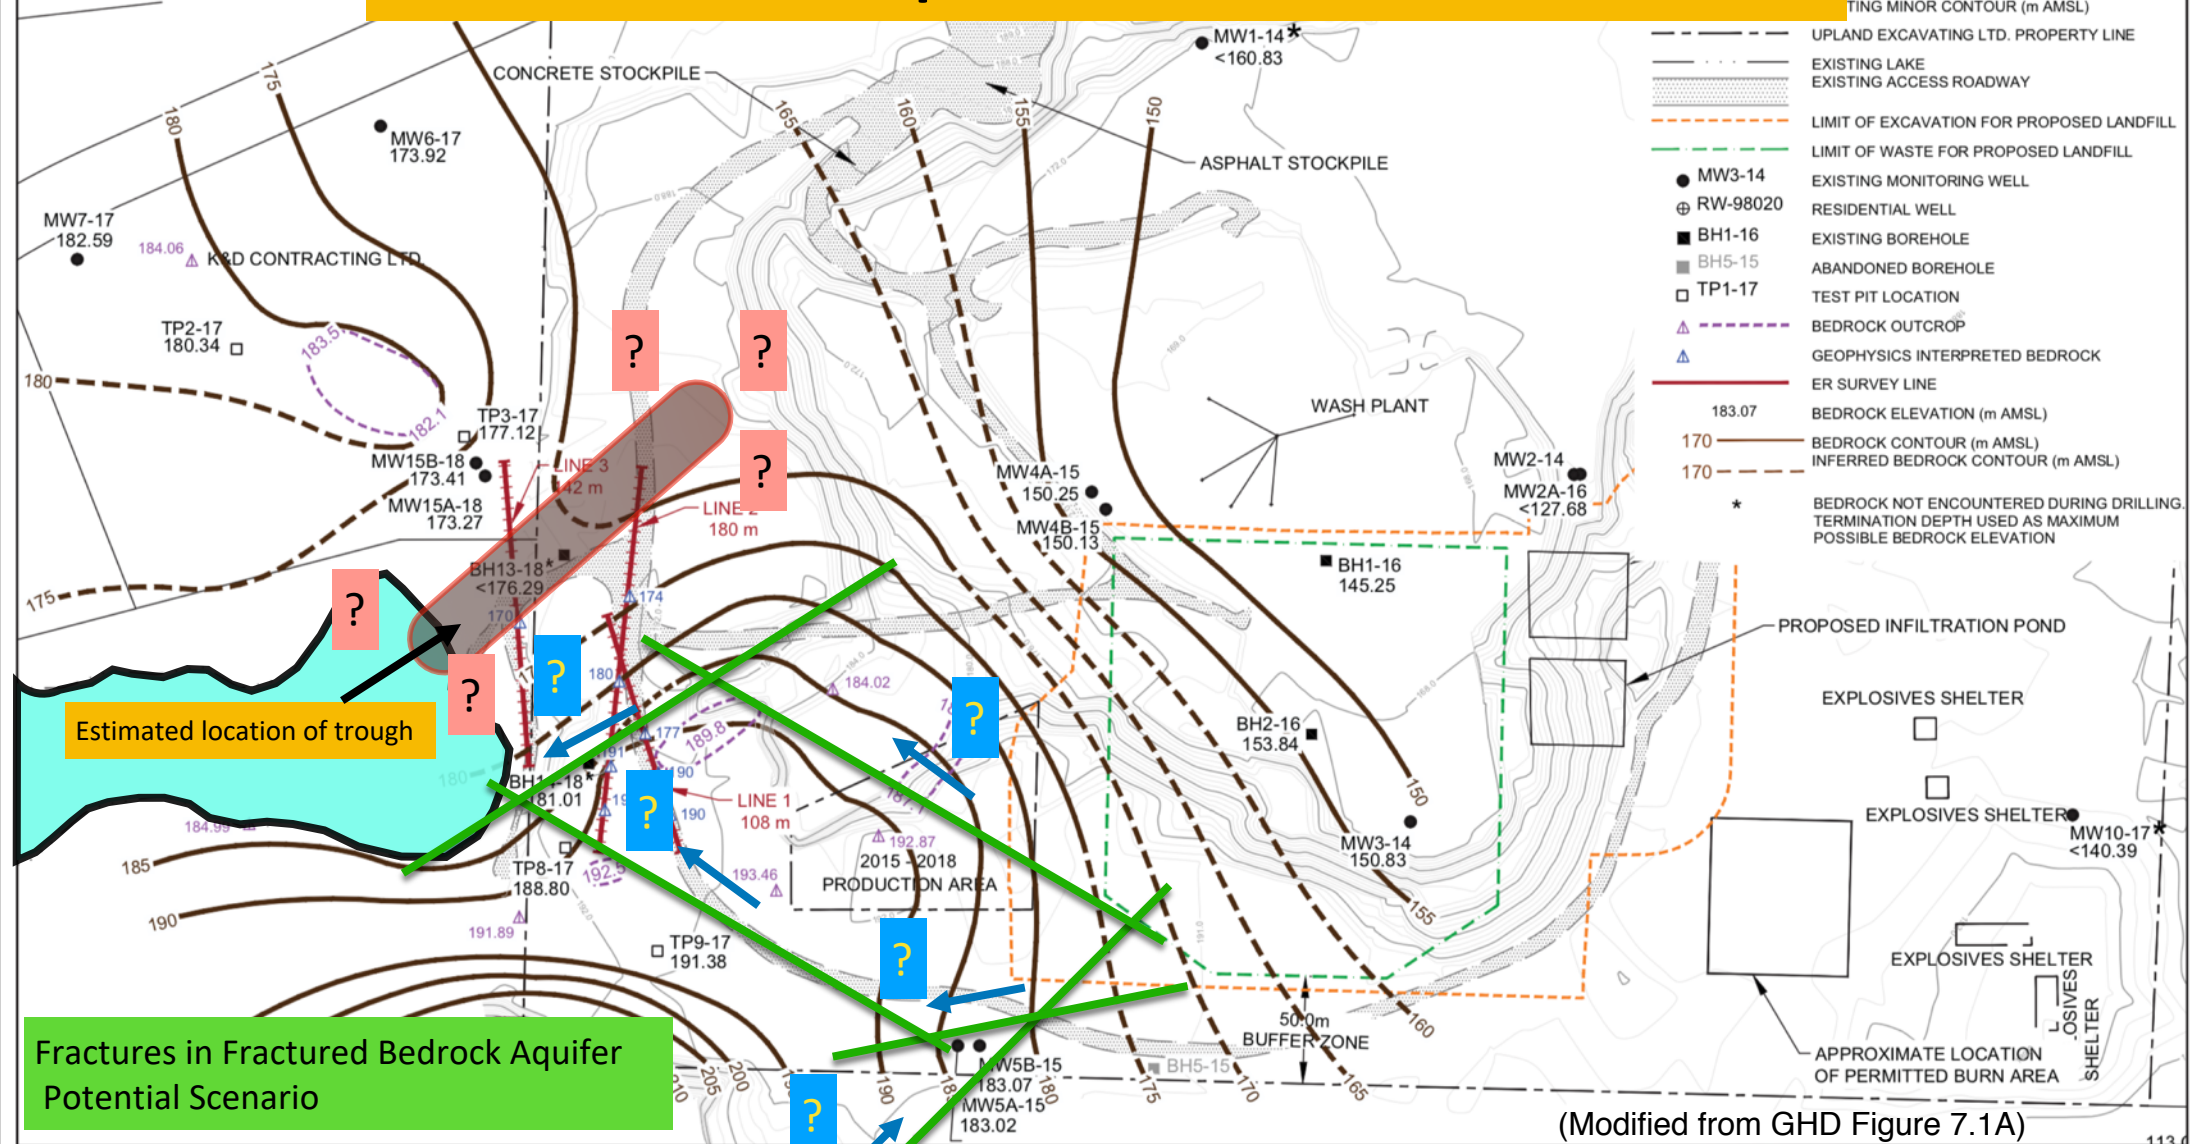
FIGURE 7.1A

BEDROCK CONTOURS

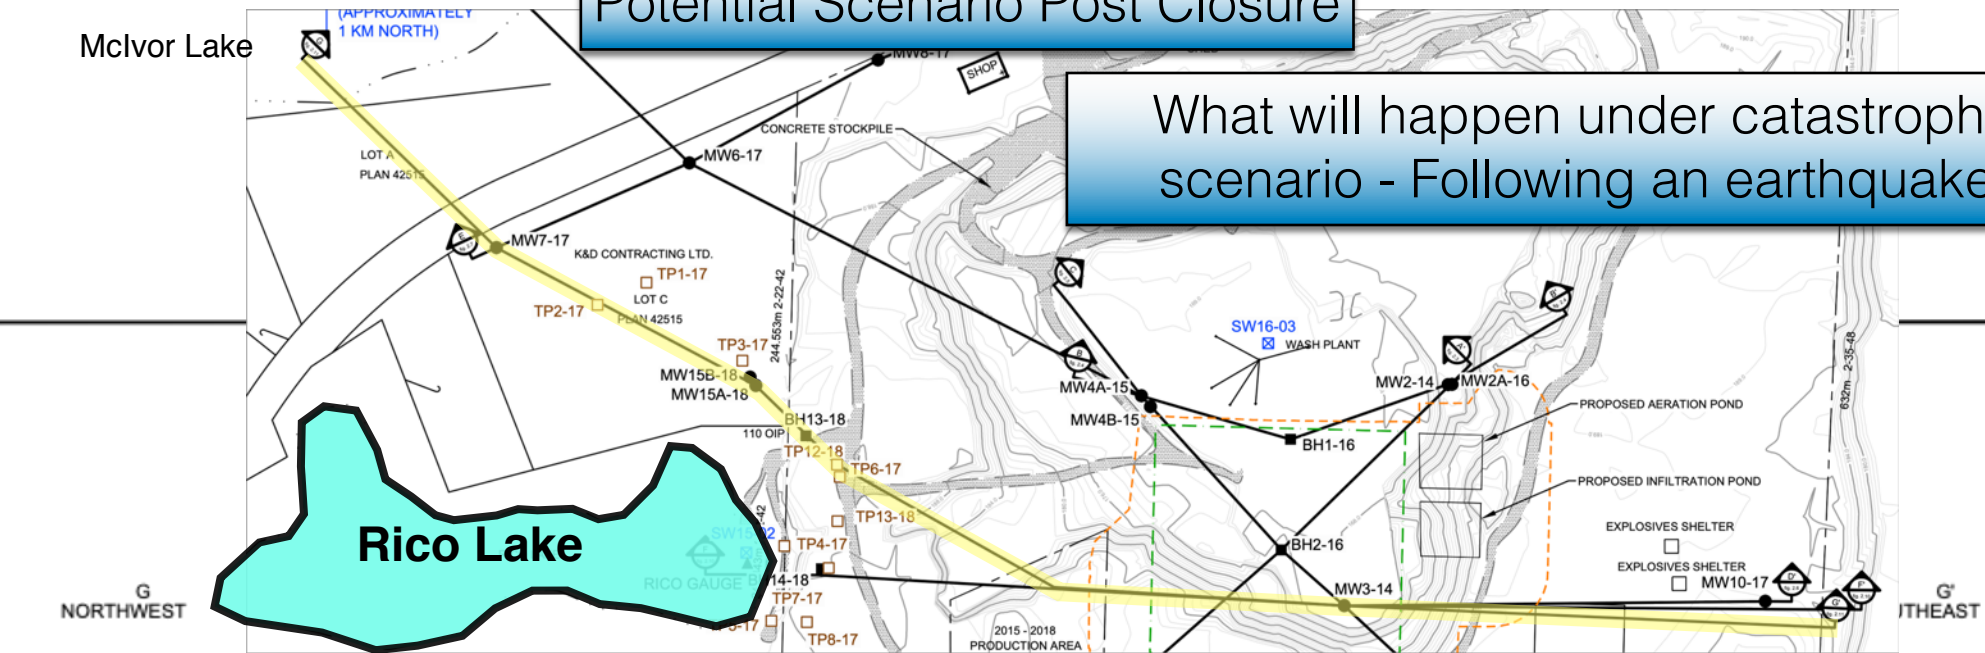
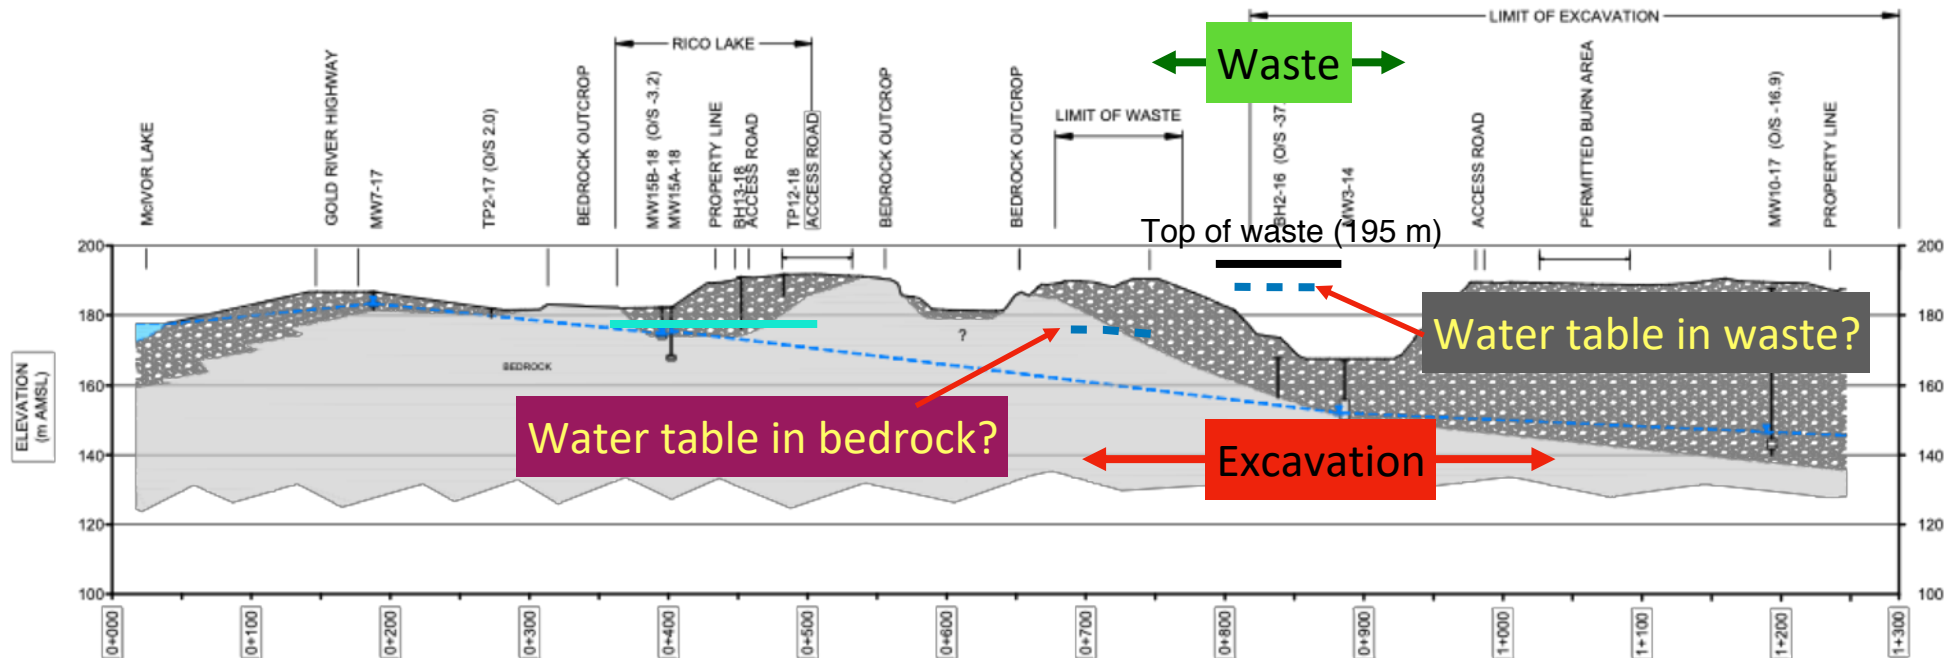
Potential Scenario Post Closure

What will happen under catastrophic scenario - Following an earthquake?

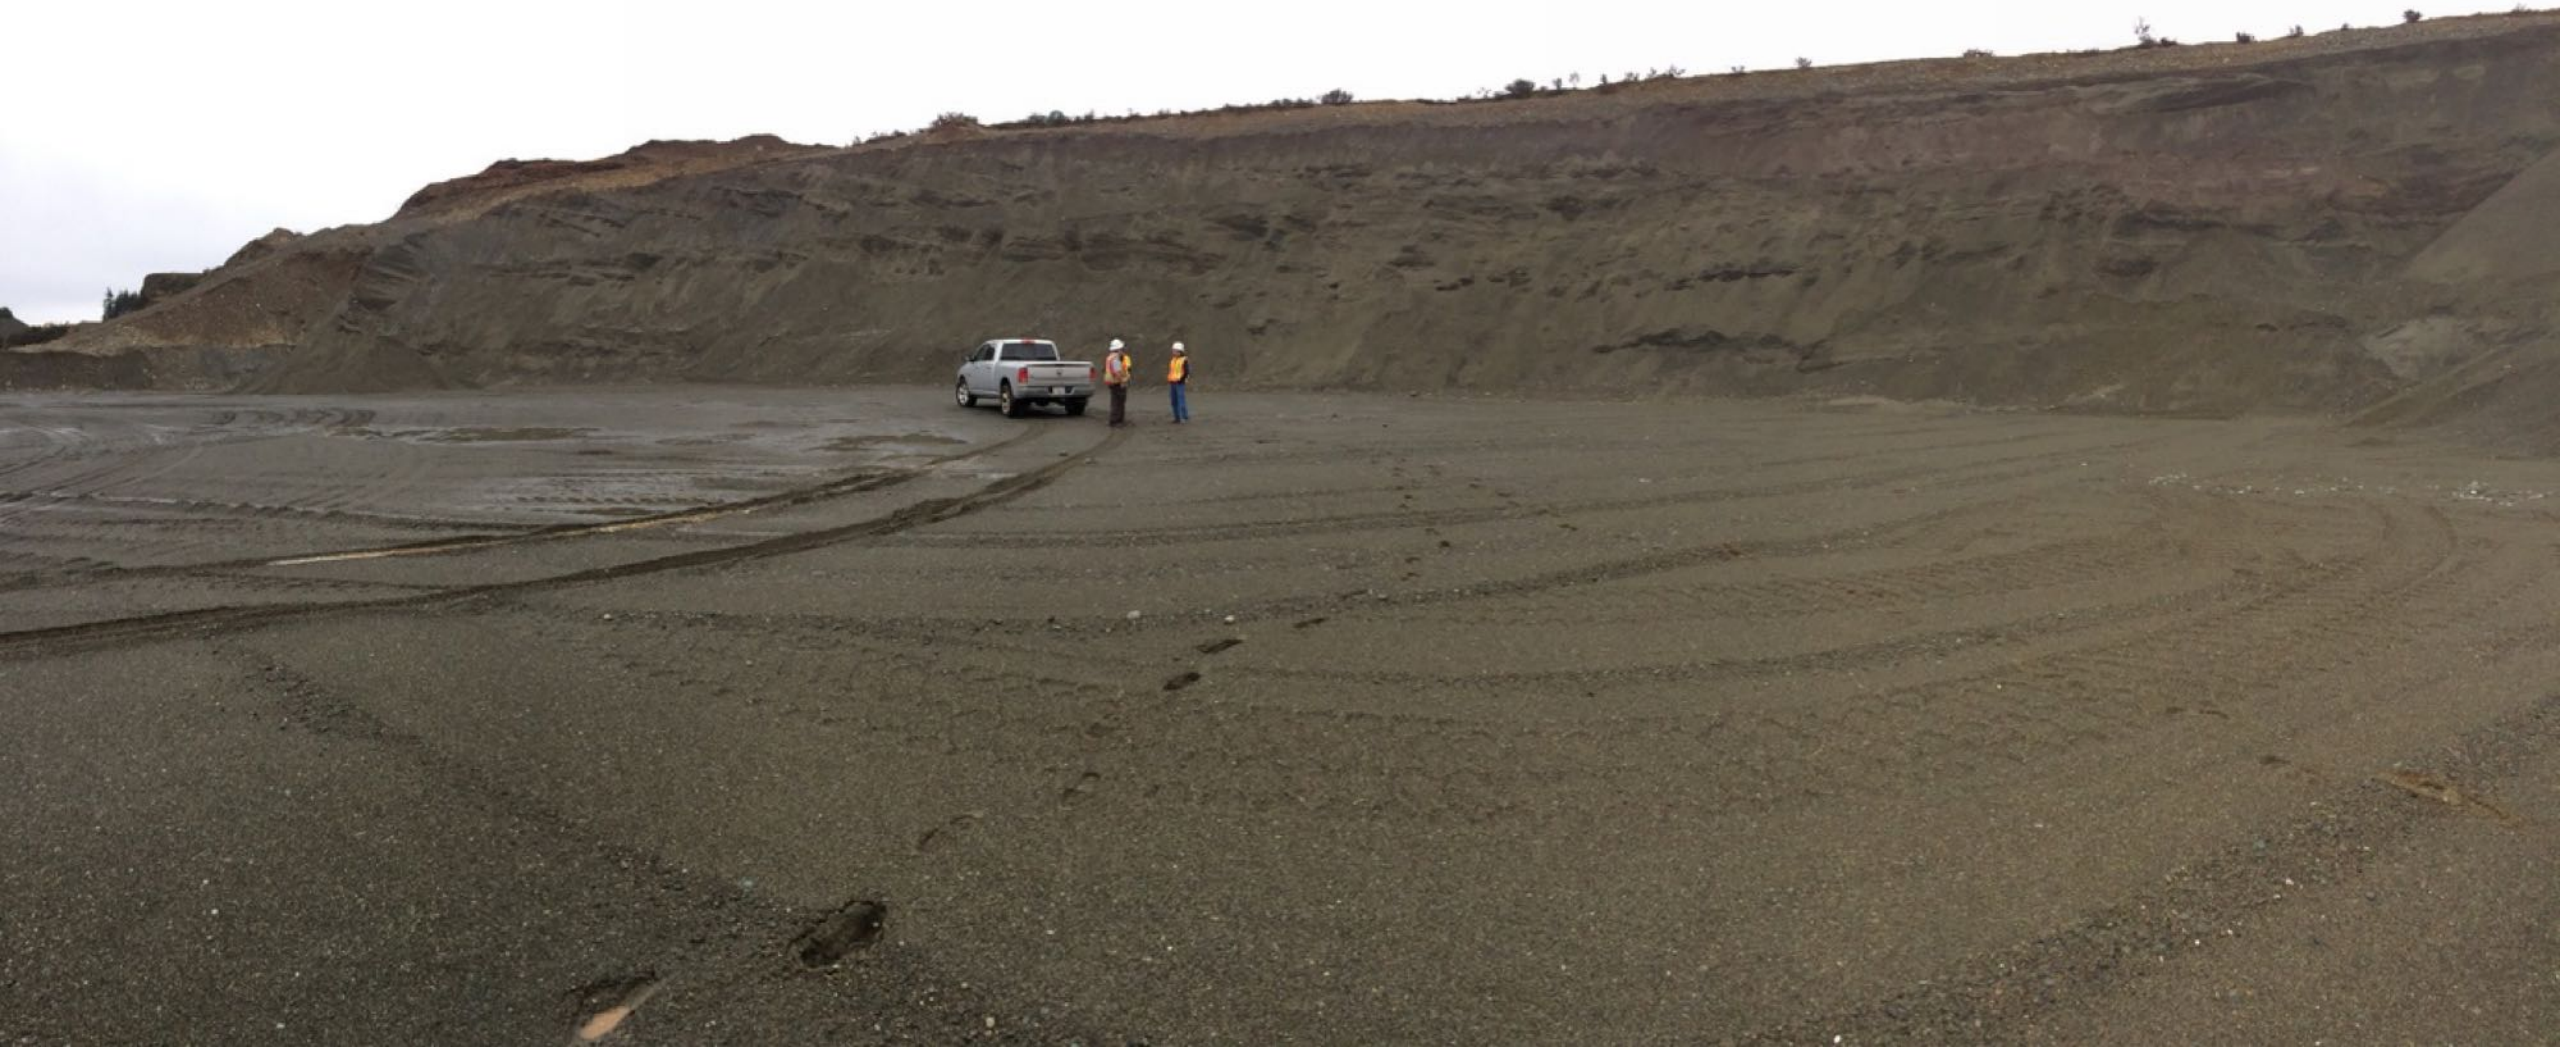
Picture taken on December 11, 2018

- Groundwater Flow in Bedrock
- Risk of Impact to Rico Lake - Part of Drinking Water Source
- **High Water Table in Existing Pit**
