Simms Creek Watershed Habitat Assessment and Restoration Plan.

January 2021

Prepared by
D.R. Clough RP Bio
D.R. Clough Consulting
6966 Leland Road,
Lantzville B.C. V0R 2H0
drclough@shaw.ca

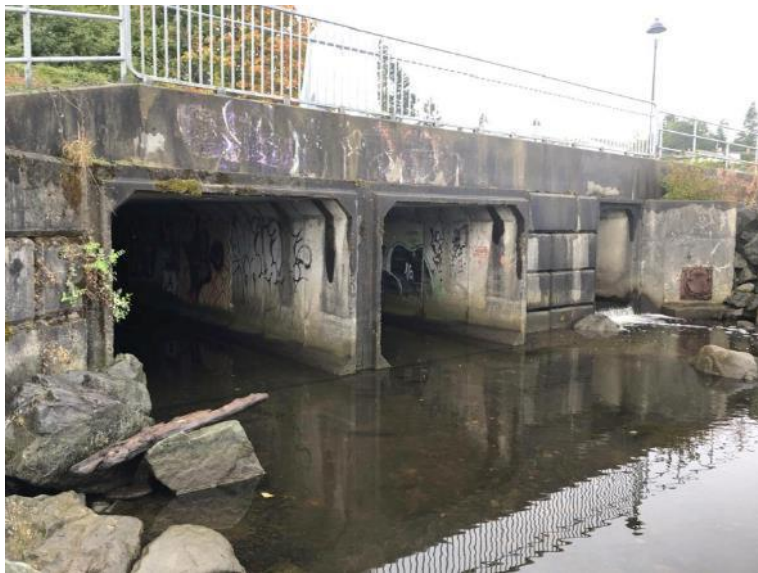
1.) R1- Hwy 19A culvert with fishway on far side.

There has been a rock crest installed in the tidal foreshore that helps fish stage for access through the pipes. The loss of gravel substrates at the culvert location was likely prime Chum spawning habitat. The existing culvert has likely diminished salmon access incrementally over time. This crossing needs to be replaced with a bridge in order to accommodate fish, flow and debris.

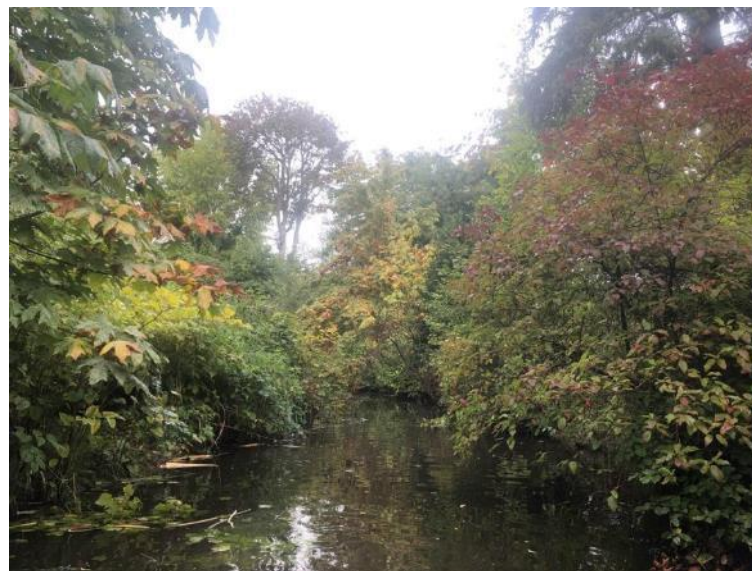
2.) Reach 1 riparian area, good shade but lacks conifers.

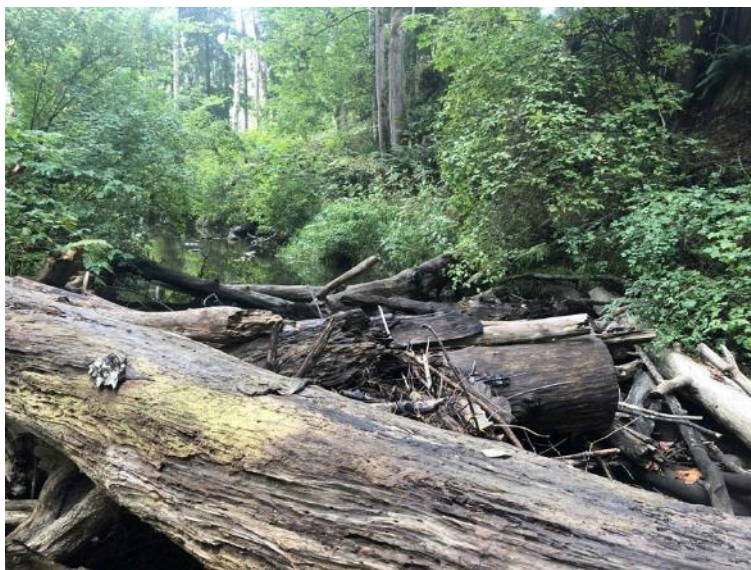
3.) Reach 1 Log Jam (Placemark 24).

Log Jams: There is plenty of log debris in the river but it is mostly Red Alder and contributes very little to good instream cover. There were no large Red Cedar logs in the reach to provide proper functional LWD. We observed one beaver dam and two log jams (Placemark 24 & 27) next to the oxbow at Carlisle Crescent. These full spanning log jams offer cover for fish, but are unstable and create considerable overbank flow. They are made of shorter chunks of Alder that are resting on perhaps one or two longer stems. The jams are likely to break and flush out shortly. In 2020, Greenways Land Trust made an effort to remediate the jam by removing the chunks plugging flow. Log Jam inspection in this reach should be done after every large storm; this should be the responsibility of the City as their park is the biggest source of wood.

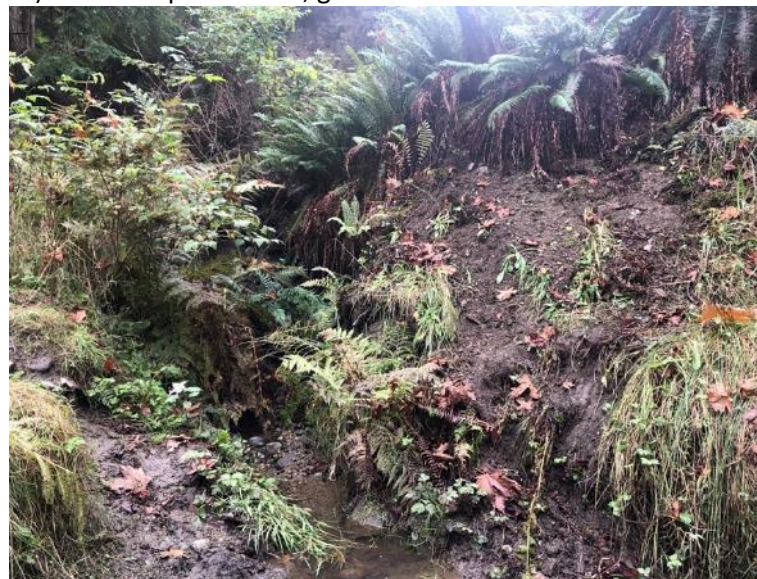
4.) Carlisle Outfall erosion – Placemark 26

Stormwater Runoff: The outfalls of these drains had eroding the banks and recent sediment deposits. The Carlisle Crescent storm drain pours over an exposed bank (Placemark 26). The 3m bank is eroding. A protective pipe should go all the down the bank followed by repair and native planting of the damaged areas. This appears to be a good site for an upland raingarden on the easement. This is a City outfall and staff should be involved.

R1	Erosion	Carlisle Street Storm outfall	The outfall eroding the stream bank. Extend pipe down to grade. Then repair bank and replant. City should be contacted. Consider a raingarden on easement to intercept and settle first flush.	H
R1	Erosion	Vista Bay Storm Outfall	The Vista Bay storm drain ditch entry (Placemark 19). This ditch route is lined with heavy sediment that spills into the creek. The drainage ditch needs to have the sediment removed and a sediment trap installed at a convenient location for maintenance.	H
R1	Erosion	Throughout i.e. Placemarks 2,16,20 26, 32	Bioengineering (wattles and stakes) and other native planting are recommended along the creek in the abundant erosion locations. Geotechnical applications such as fibre mats and logs are suggested at the steeper harder sites. Bank erosion protection with LWD and rock placement has opportunities but there is no obvious access for machinery	M-H

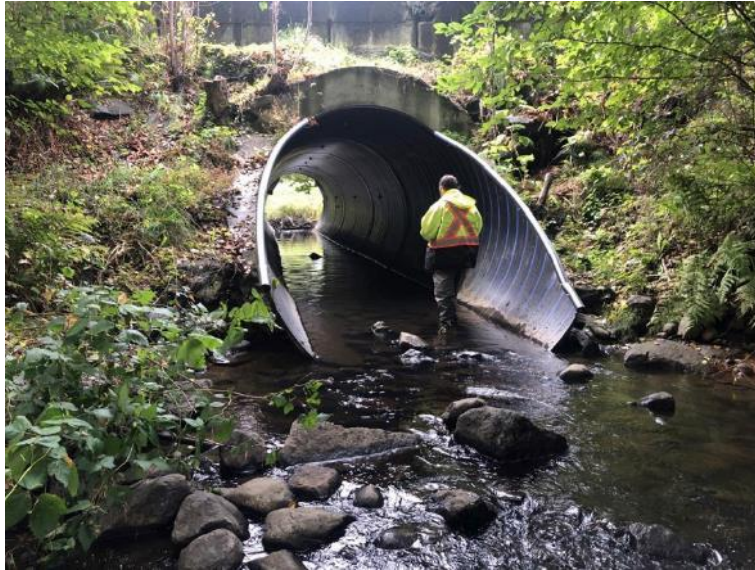
1.) R2 Galerno culvert is surcharged in winter, shallow in summer.

- Obstructions
Reach 2 fish entry through the Galerno Culvert is a barrier when flows are very high or low. The 3.0 m diameter is easily plugged by beaver dams or floating debris. This culvert does allow Coho and trout to pass but would be unlikely to pass. Chum salmon are weaker swimmers and will not pass. The culvert needs to be replaced to meet the DFO/BC Environment standards for fish passage.

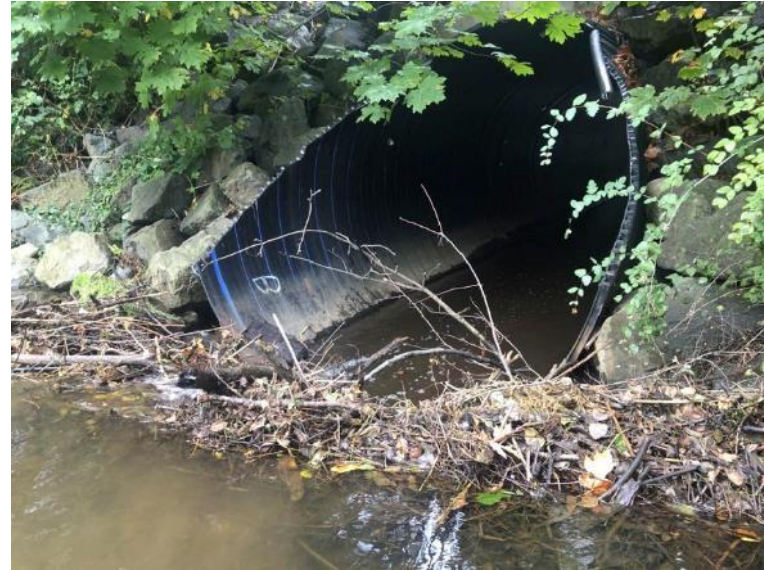
2.) R2 Galerno culvert is easily plugged by Beaver or other debris

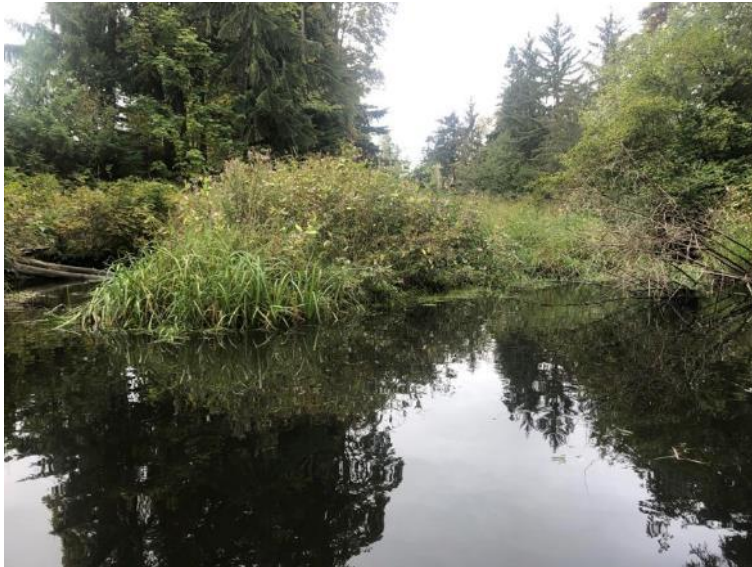
3.) R2 wide pools and wider floodplain throughout

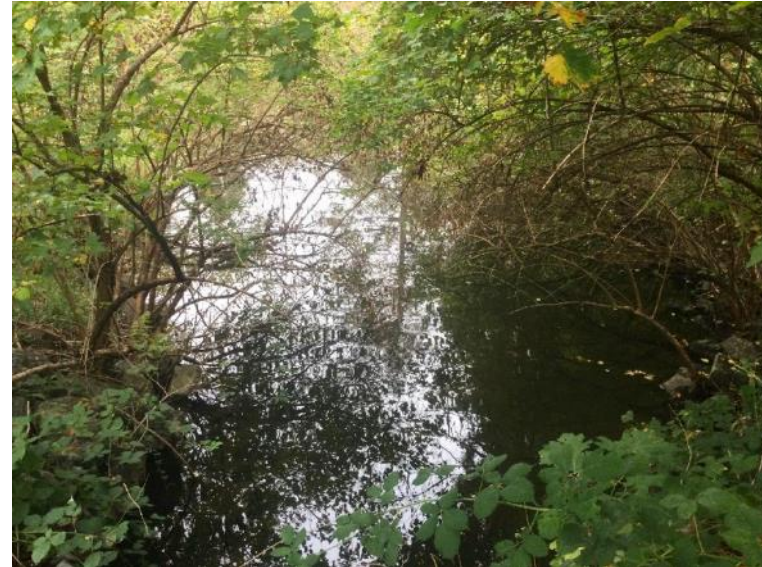
4.) R2 pools/ponds extend up to South Alder Culverts.

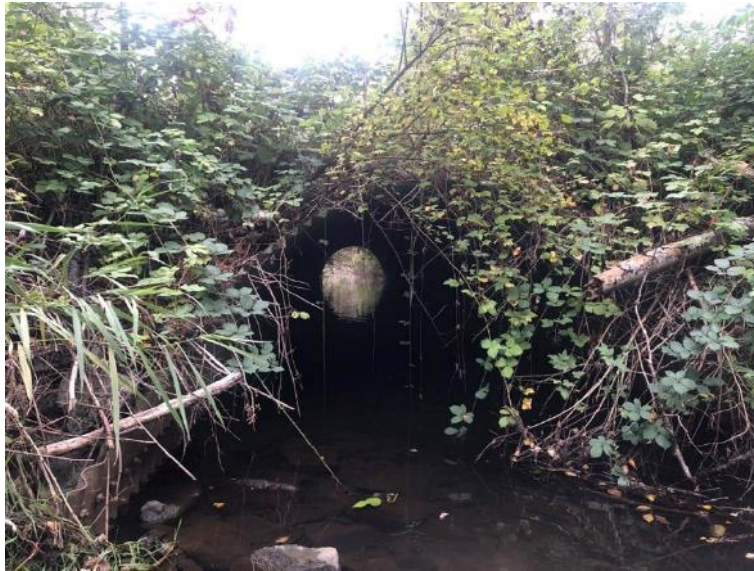
1.) R3 – S. Alder culvert is embedded Arch – passable

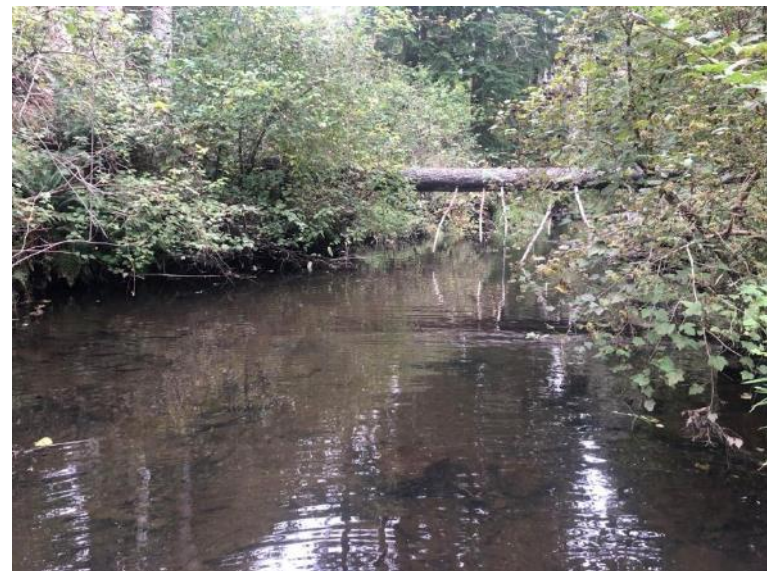
2.) R3 –Pool 1 in Reach 3 fair veg. cover despite no LWD

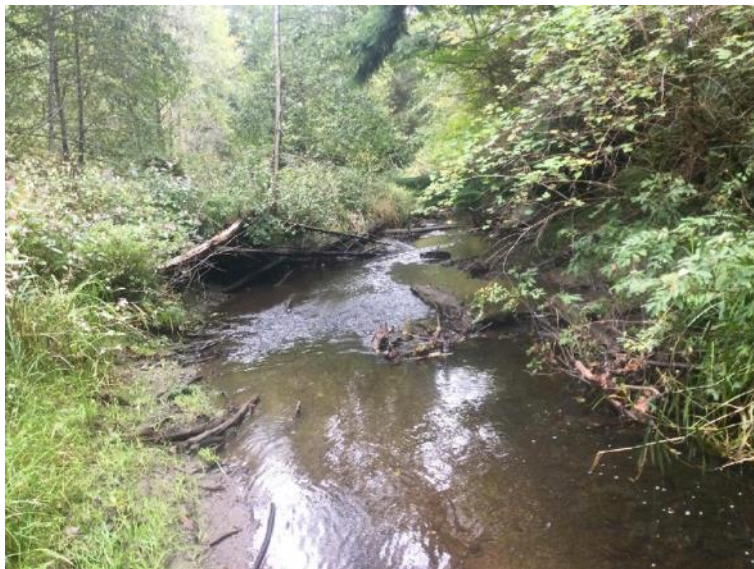
3.) R3 –Riffle 2 alongside Willows Park.

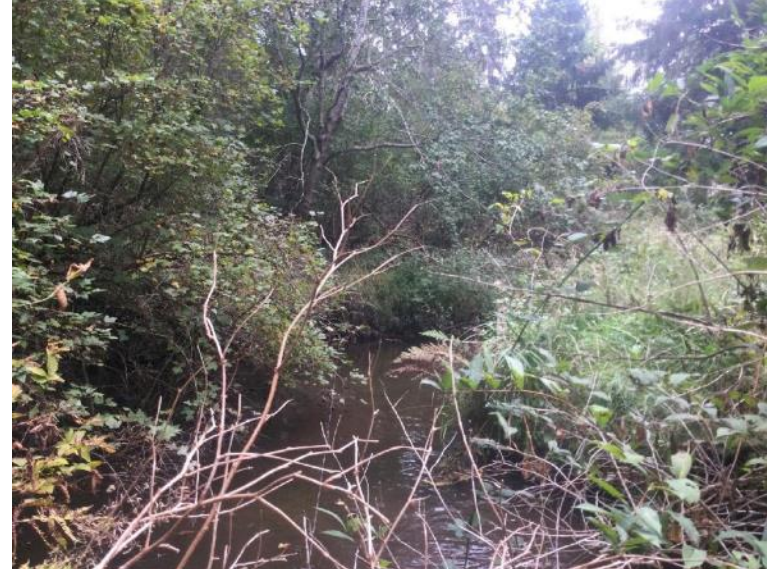
4.) Pool 10 with typical Riparian of mostly deciduous with some conifer.

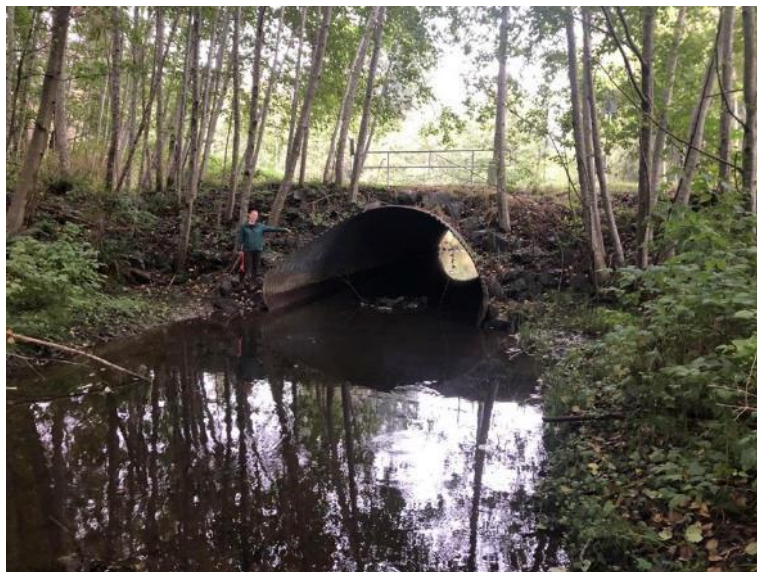
1.) R4 - Rockland 4.2m flat bottom culvert.

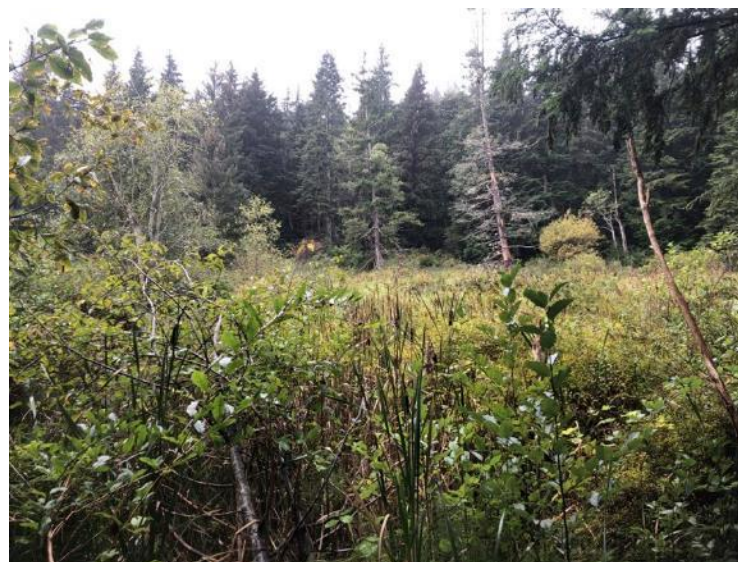
2.) R4 Typical 30-80m wide wetland

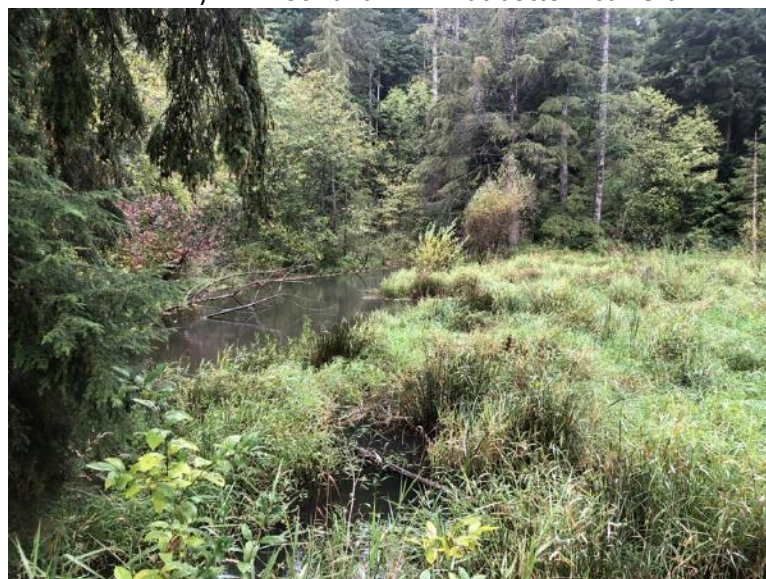
3.) R4 –Beaver dams cross the wetland (60m)

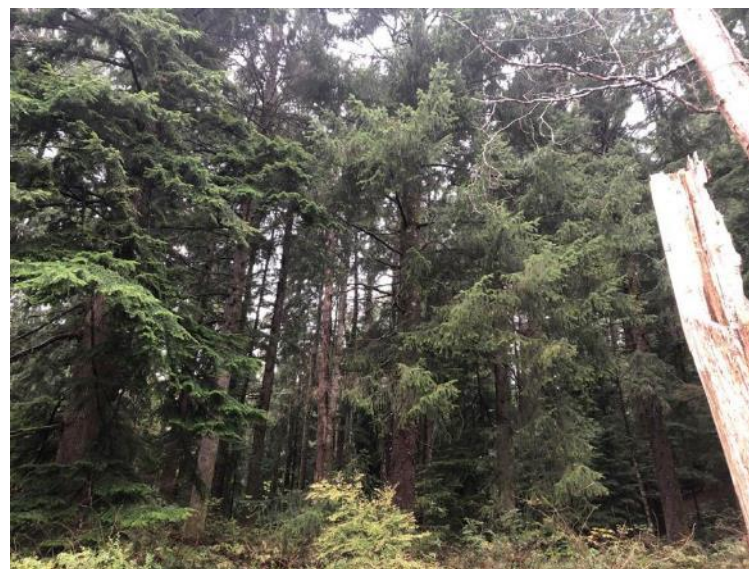
4.) R4 South (right) bank riparian forest is 150m deep.

The riparian condition of the south east bank is excellent. There is a regenerating second growth forest on a gently rising slope that extends an average of 150m deep.

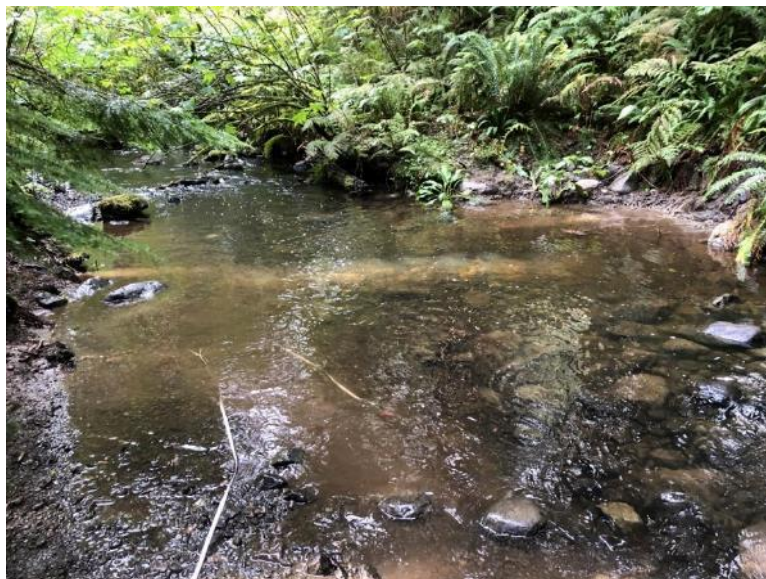
1.) R5 Pool 1 – note lack of cover, sediment..

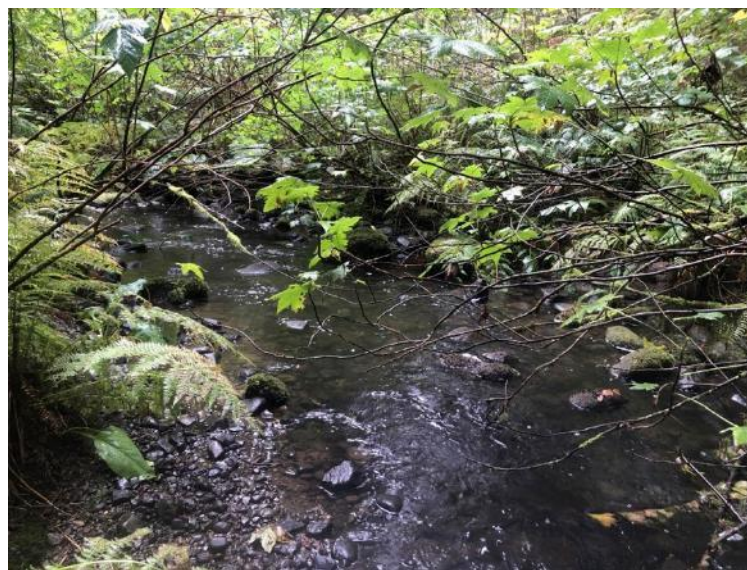
2.) R5 Riffle 1 habitat in better shape with gravel and cobble.

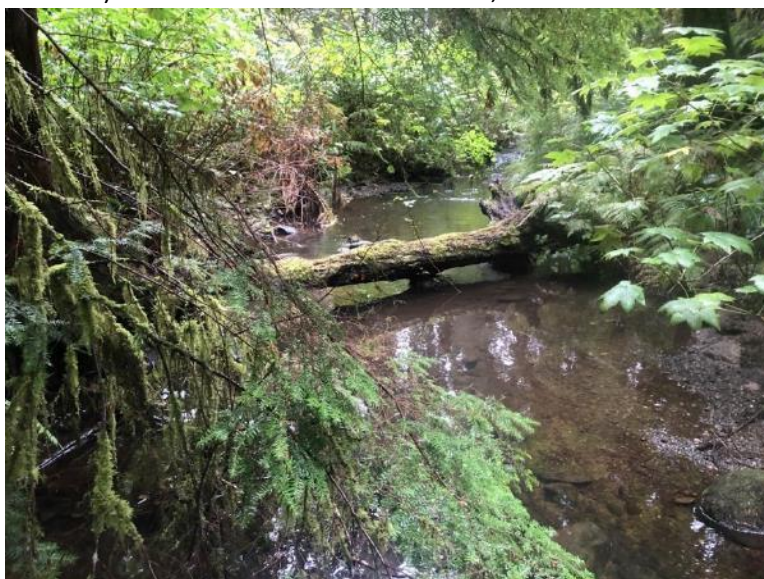
3.) R5- Pool 3 with only log in reach

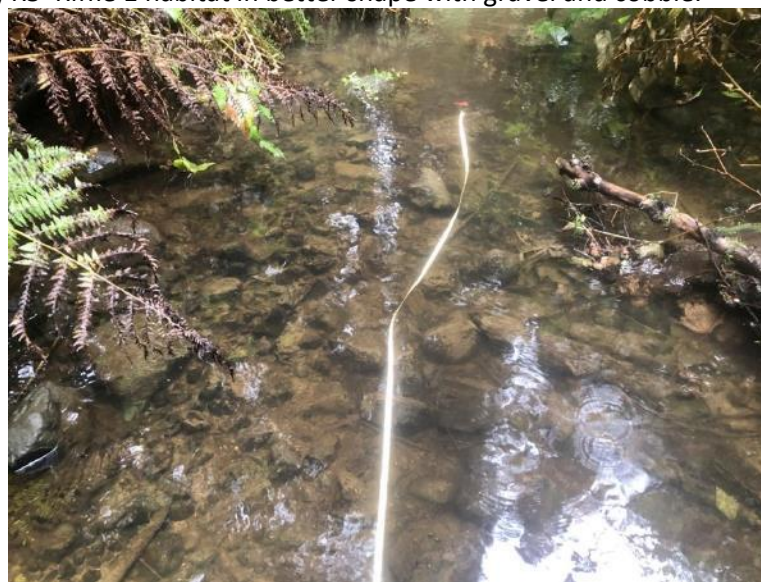
4.) R5- Riffle 6 with sedimented substrates

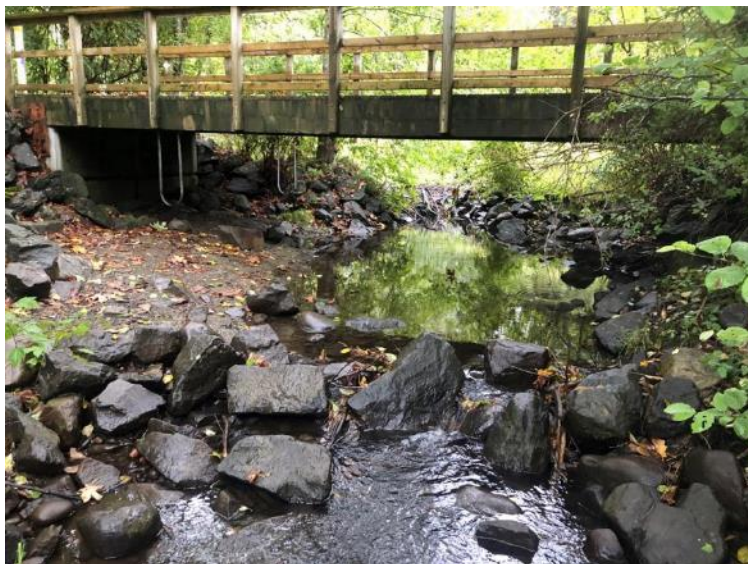
1.) SS R1 – Willows Park trail bridge at confluence – note beaver dam

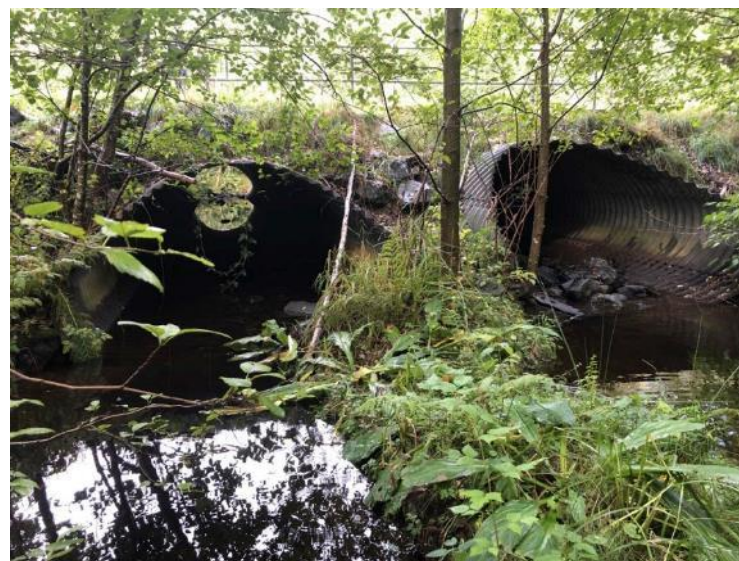
2.) R1 – Twin 3.2m Arch culverts at Rockland Crossing

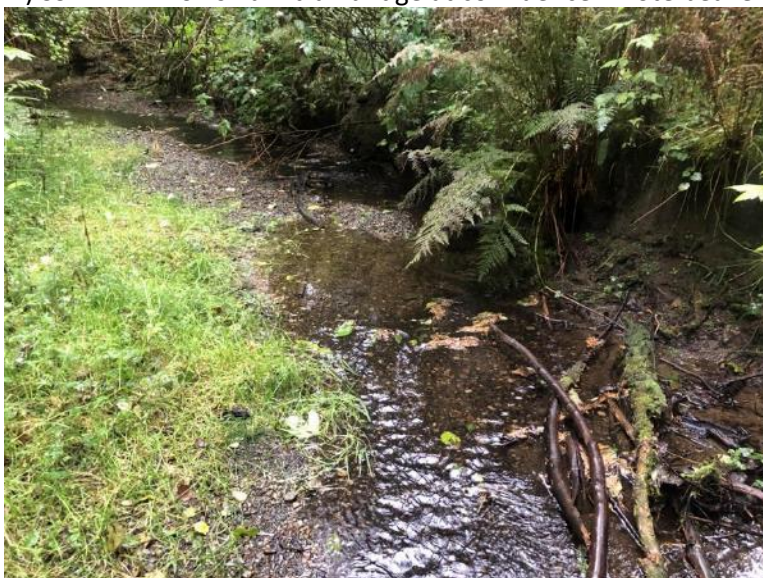
3.) SSR1 – Riffle 1 above Dogwood – good spawning gravel content

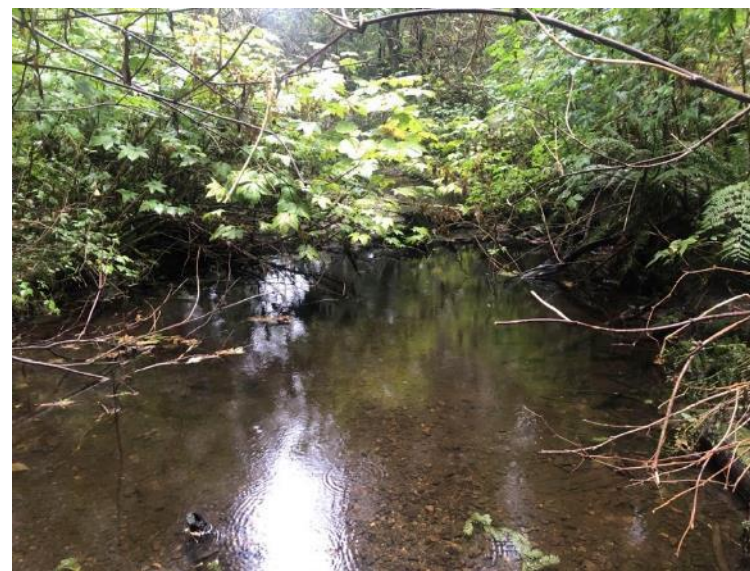
4.) SSR1 – Pools lack instream cover LWD/Roots

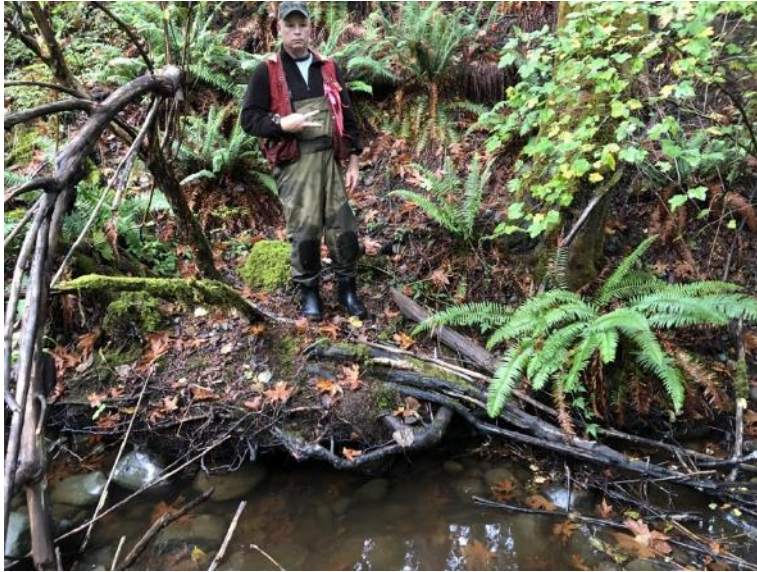
1.) Pool 2 with the only undercut we found in reach.

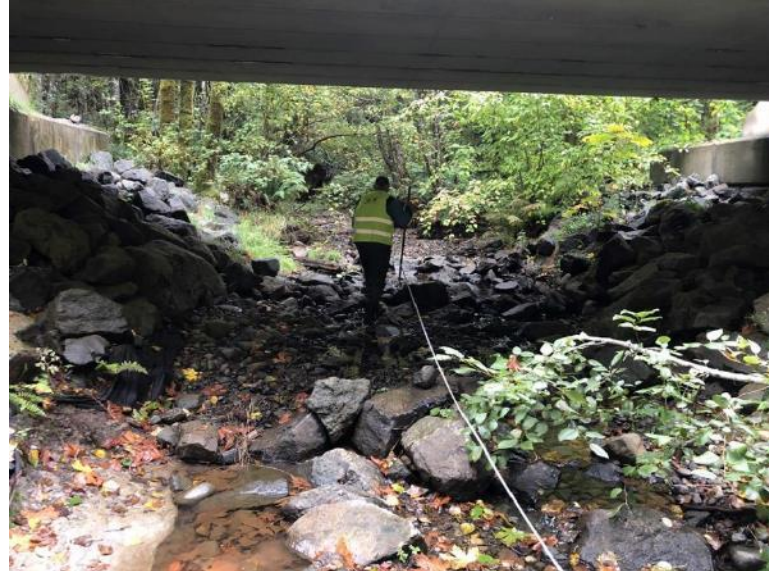
2.) Riffle 2 – under ERT bridge – shallow passable.

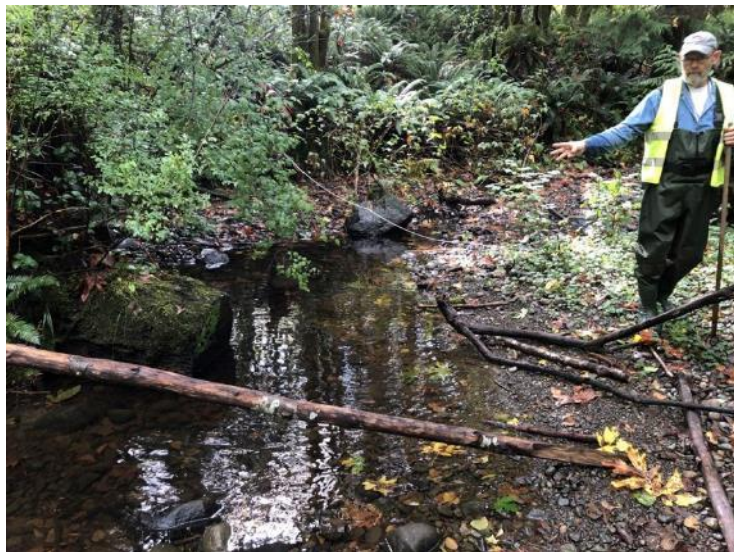
3.) Pools 3 (Stn 126) typical shallow poor cover

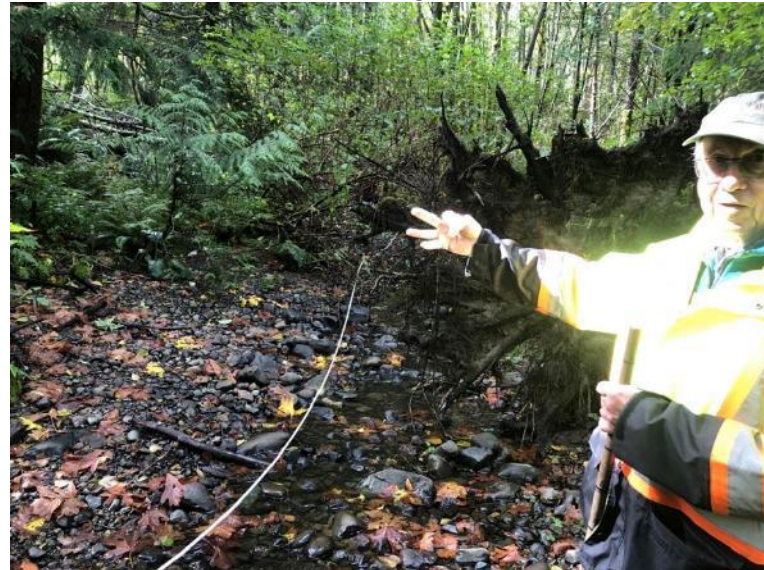
4.) Riffle 3 (Site 127) offers good spawning gravel

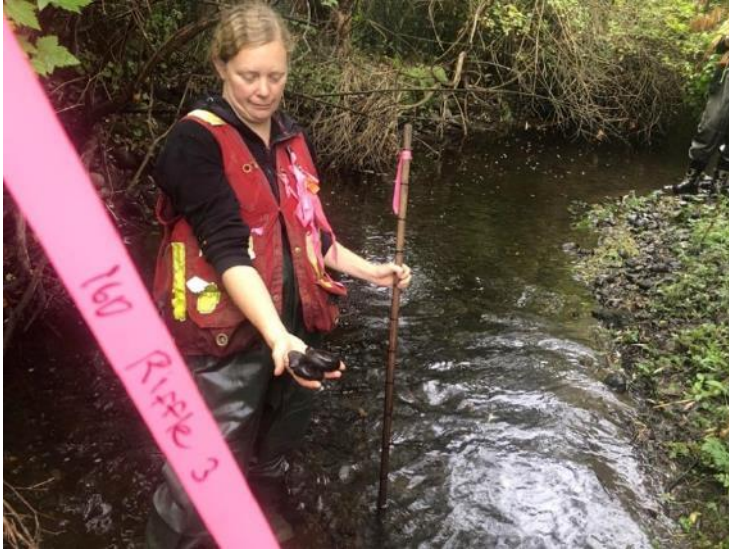
R1 – Site 10 Riffle 3 has gravel, could use Boulders

R1	Boulder Habitat	Riffles	Every riffle from the old fish trap (80m) upstream to Galerno (830m) is deficient in Boulder habitat for aeration and invertebrate/fry habitat. Addition of boulders is recommended in the easiest to access riffle/glide sites. This can be done by hand. Each site does need a specific prescription of how many and what size and position of rocks.	M-H

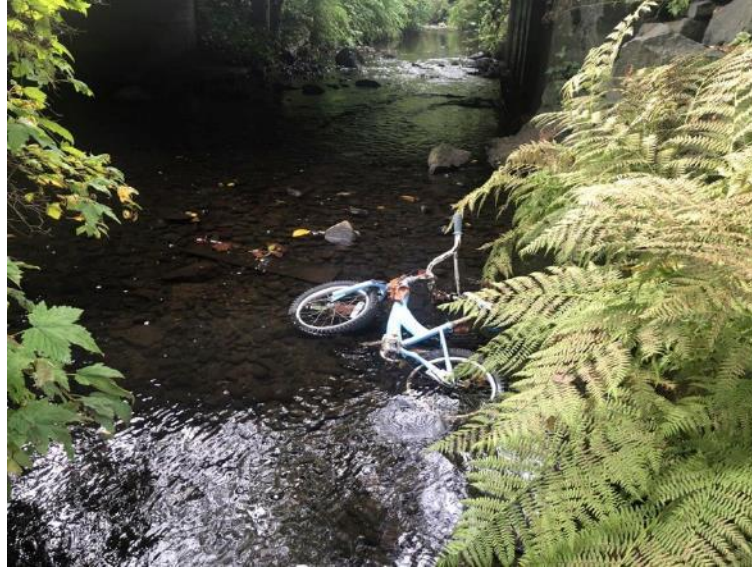
R1 – garbage is common near bridges (Site 12)

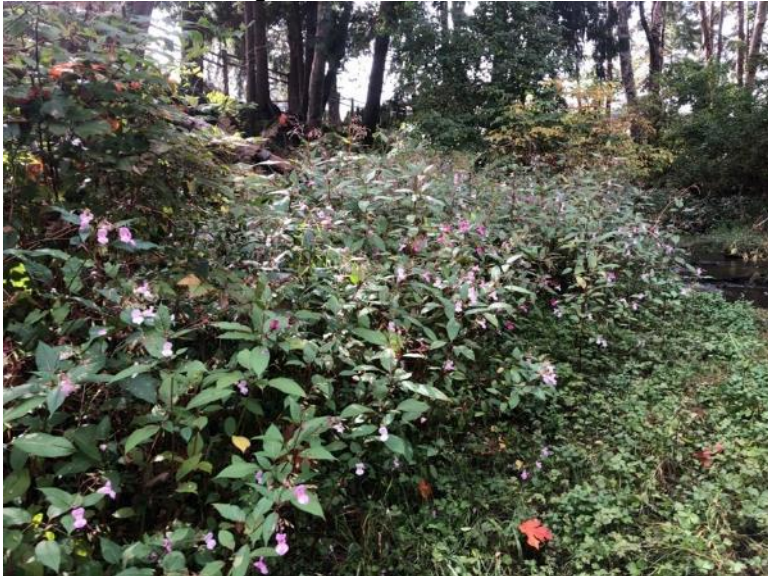
R1 – Invasive plants (Placemark 33)

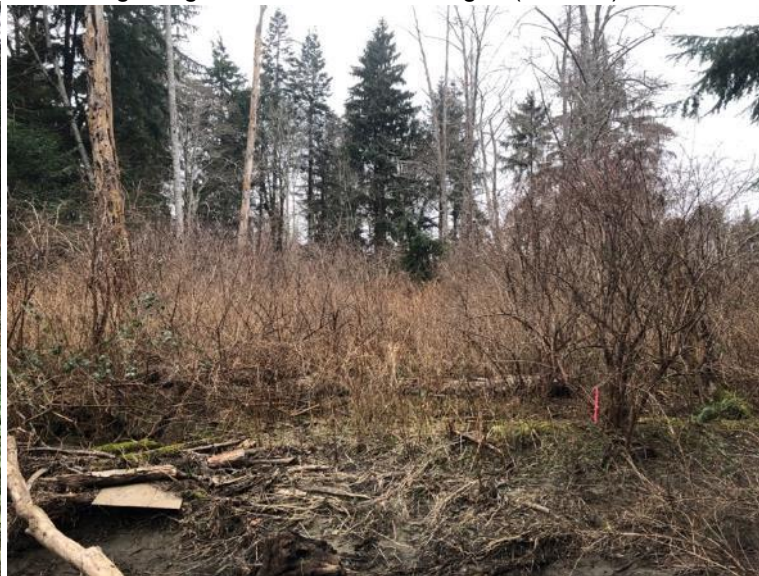
R1 – Salmonberry dominated area in need of conifer plantings (Site 30)

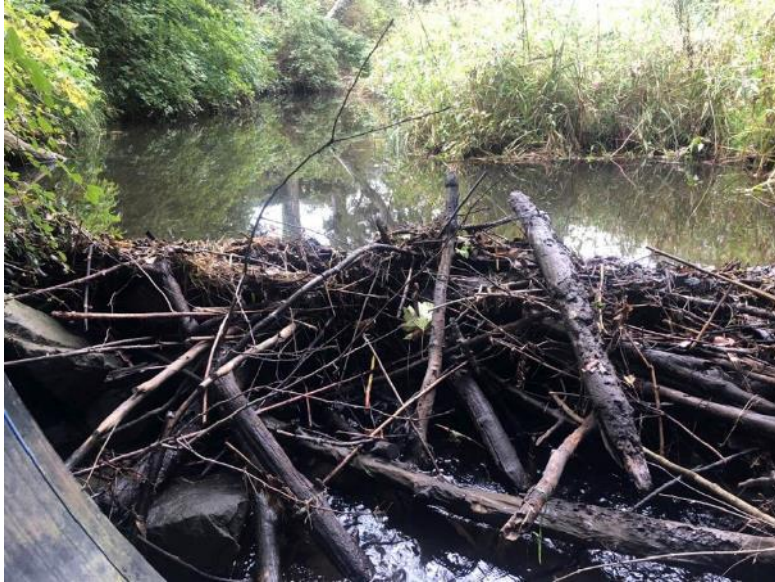
R2 - Beaver dam blocking exit of Galerno Culvert

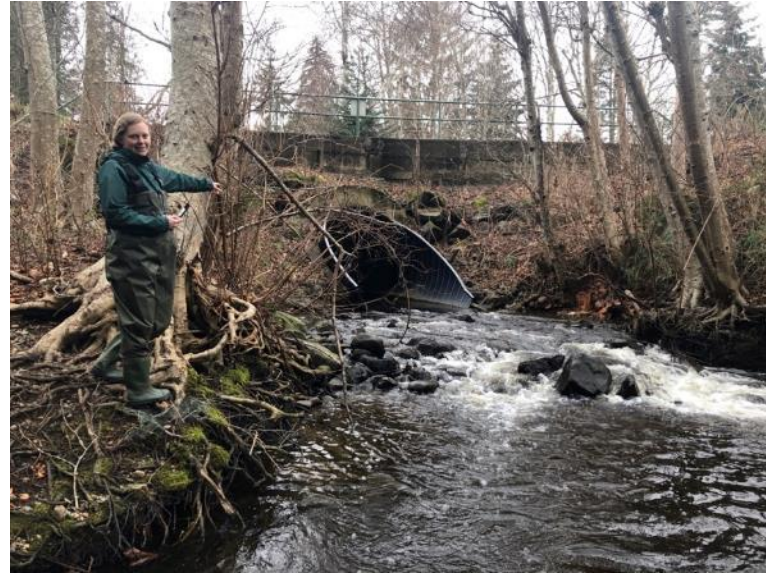
R2 – March flow (moderate flow) at culvert entrance

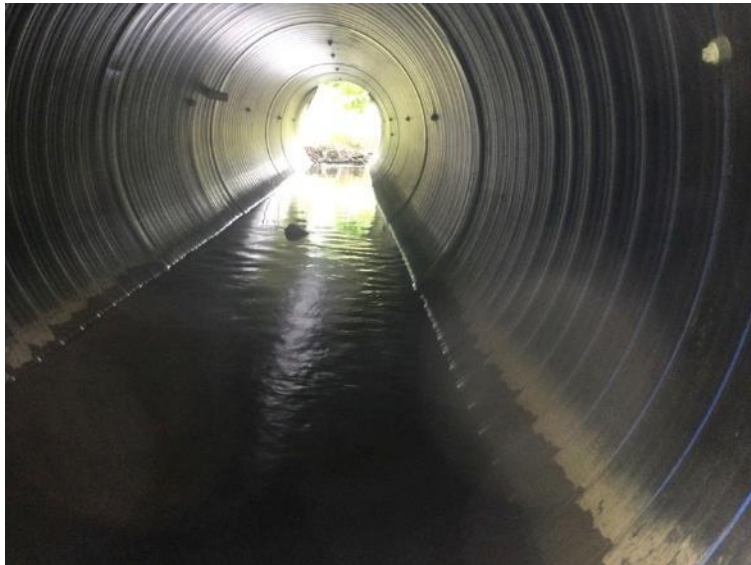
R2 – Culvert lacks embedded depth

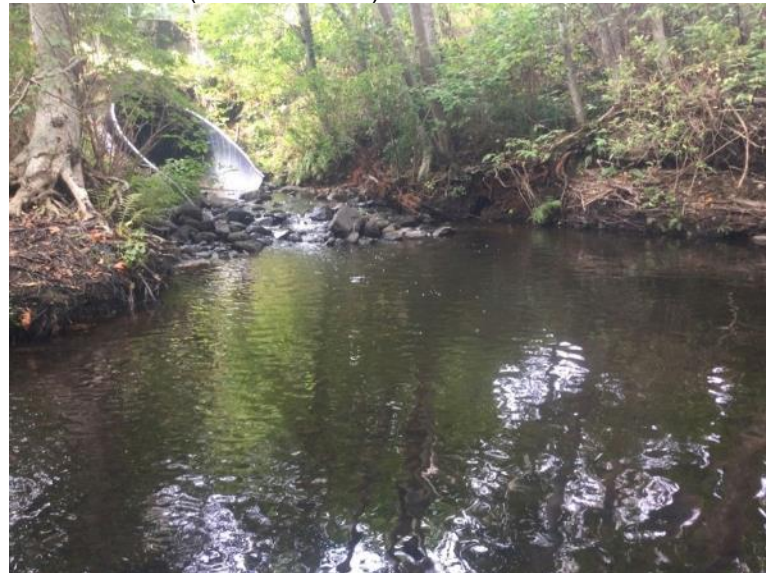
R2 – Galerno Culvert entrance at low flow.

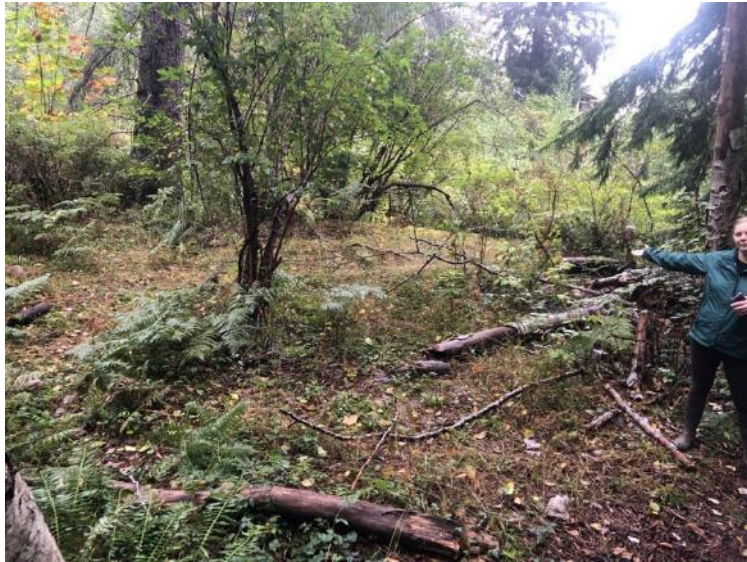
Reach 3 – Placemark 71 – planting site adjacent trail/creek

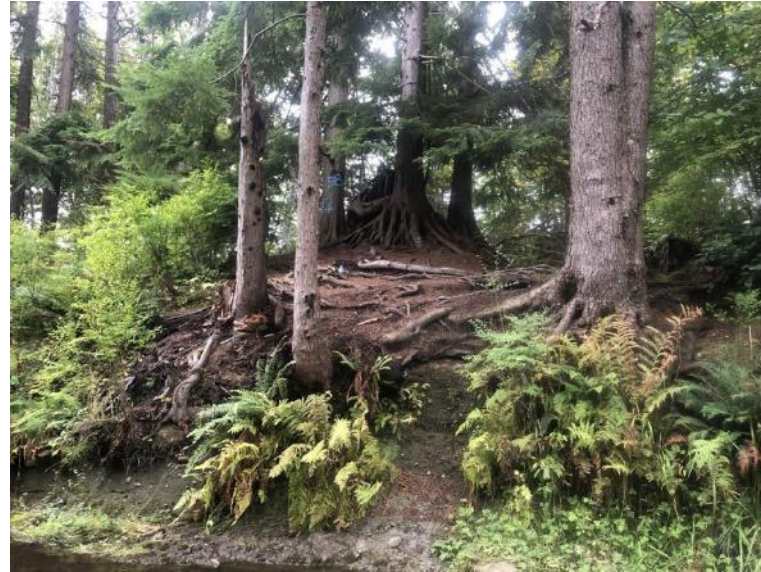
Reach 3 – Placemark 56 bank erosion

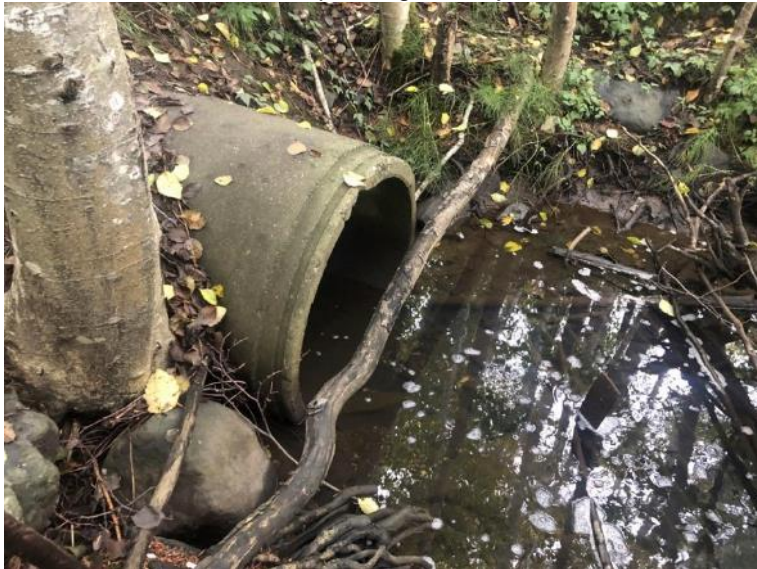
Reach 3 – Juniper outfall needs sediment traps (site 67)

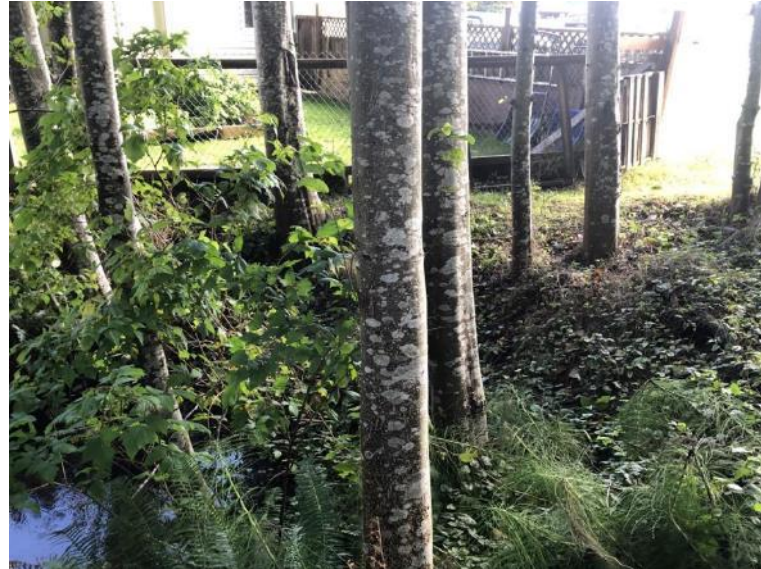
Reach 3 – Penfield Road storm drainage needs sediment traps (site 119)

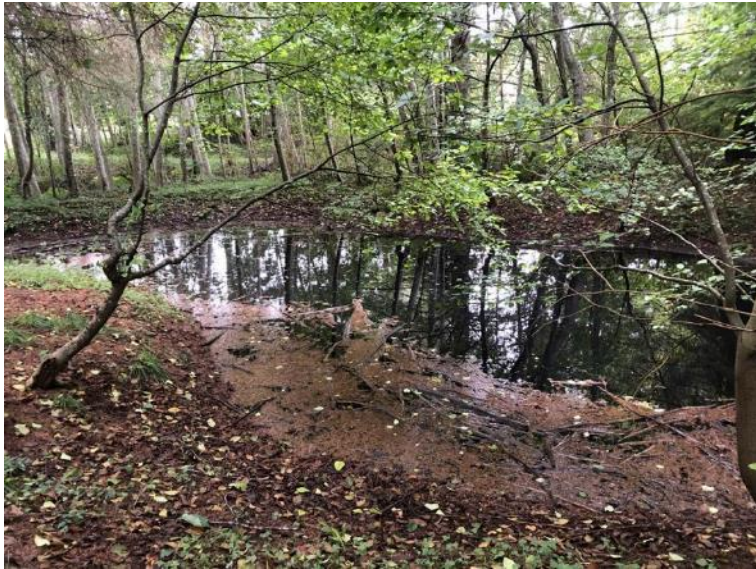
R4 – Rockland Storm Sump and culvert filled w sediment

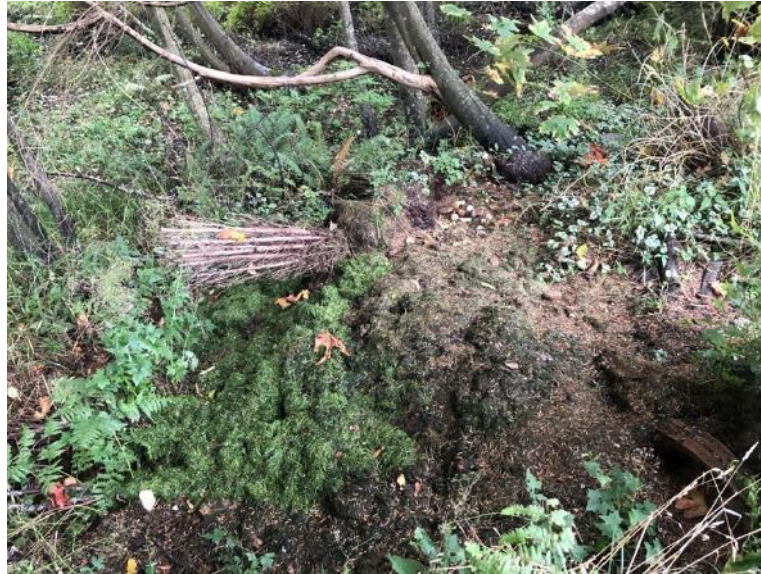
The Springbok trail side (north west) is much poorer condition. It has a thin riparian strip 5 to 25m wide along a paved trail that is against residential house fence line. There are heavy impacts to the riparian area; adjacent property owners and trail users have been dumping lawn clippings and garbage into this vulnerable riparian area. They are killing the trees and degrading water quality.

R4 – Garden waste buried 1m deep into riparian off trail (Site 77,78,79)

- 1.) Remove the garden waste and garbage along trail.
- 2.) Infill plant the damaged areas with plants (Shrubs, Fir, Cedar), consider Crabapple and Wild Rose close to the trail to prevent further encroachment.
- 3.) Fence sensitive areas and place signage.
- 4.) Consider installing an elevated boardwalk viewing area into the wetland at a natural opening to mitigate for the opportunistic access that has been occurring.

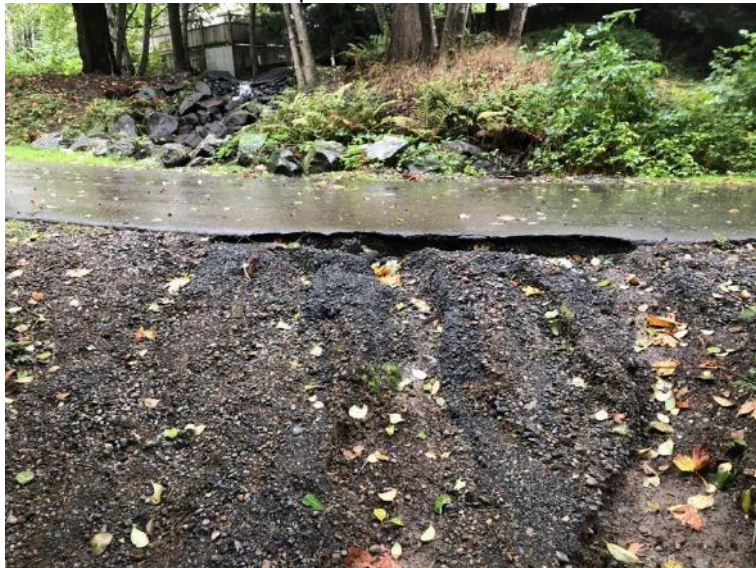
The reach drains the fully paved and developed Springbok and McPhedran neighborhoods. There is a storm water drainage at the Eland /Springbok Trail entrance (Placemark 82). The drainage pipe dumps into a 5m by 5m by 1.0 m (wet) settling pond. The pond discharge is eroding and overflowing resulting in washouts along the trail that deposit directly into the creek. It may also permit fish access to enter the ditch line. Repair is recommended this summer. Empty the pond of accumulated sediments at that time.

R4 – Stormwater overflow/erosion across trail (Site 82)

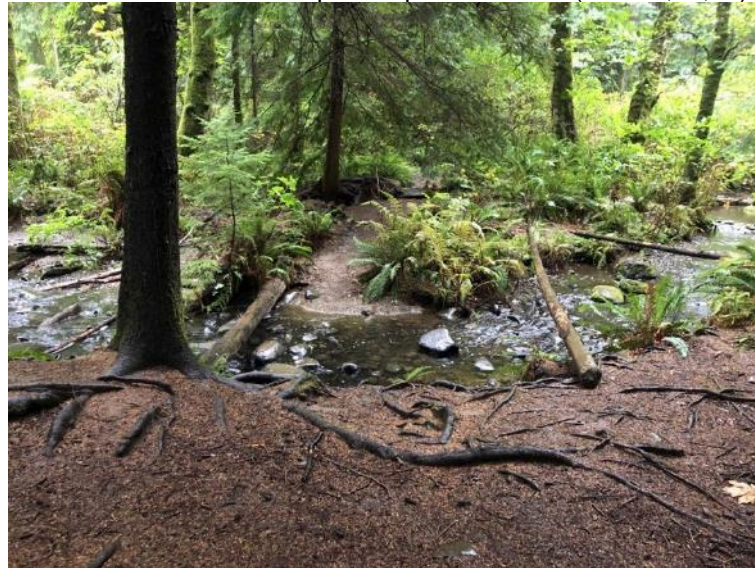
The Sandowne Trail bridge to Dogwood bridge area has heavy erosion resulting in loss of streamside plants and degraded stream banks. Mitigate with coarse woody debris, fencing, signage and planting (soil and mulch may be required). There are rocks under the Dogwood bridge that may be used as bank erosion protection and stream stepping stones. The crossings need to be either blocked or bridged.

R4 – Bike/Foot trail near Dogwood has erosion & plant loss (Site 84)

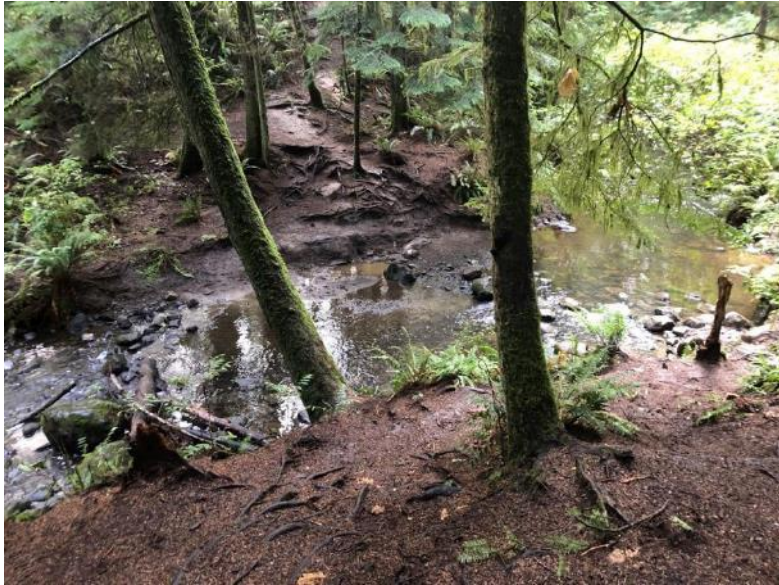
- High % Fines - The current source of bank erosion is from park trails and crossings. There is a ford crossing and exposed banks. This crossing site is at the midway point of the trail and gets a lot of use. A foot bridge crossing is recommended as it appears the many access points would circumvent barriers.

R5 –Erosion at crossing(Site 141) needs bridge

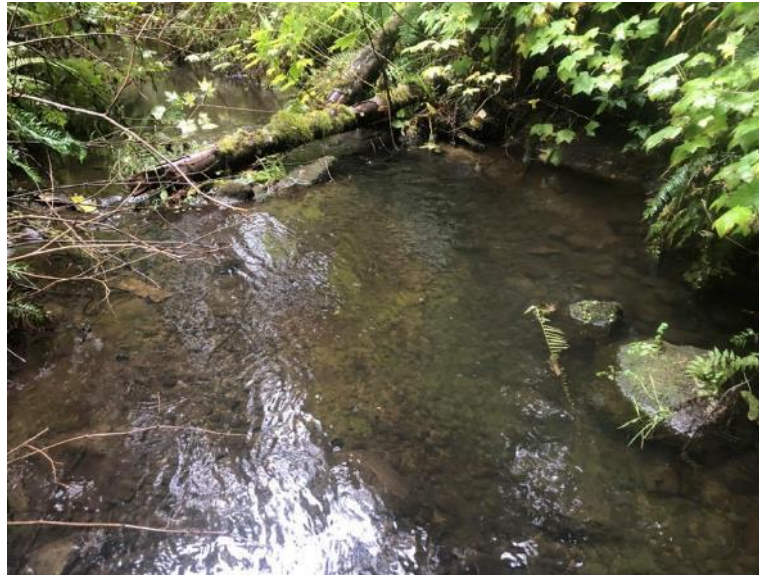
R5 – Perennial Pools lack Cover (Pool 4)

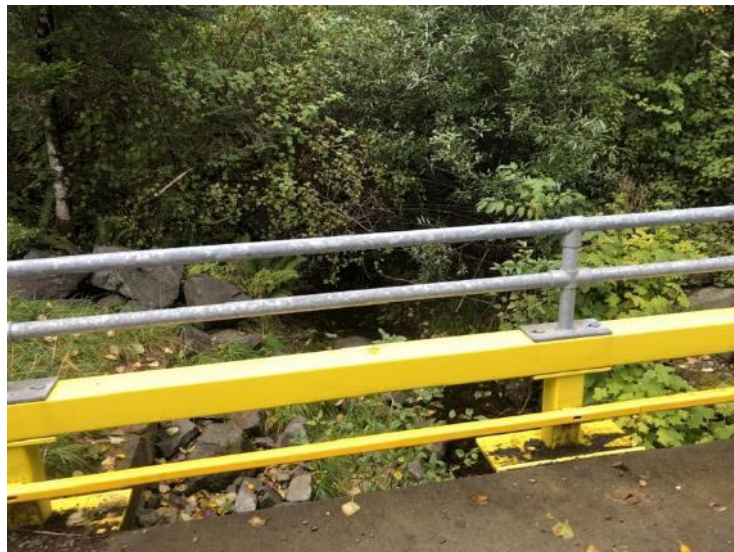
R5 – ERT Crossing – OK but seasonal flow, small perennial pools

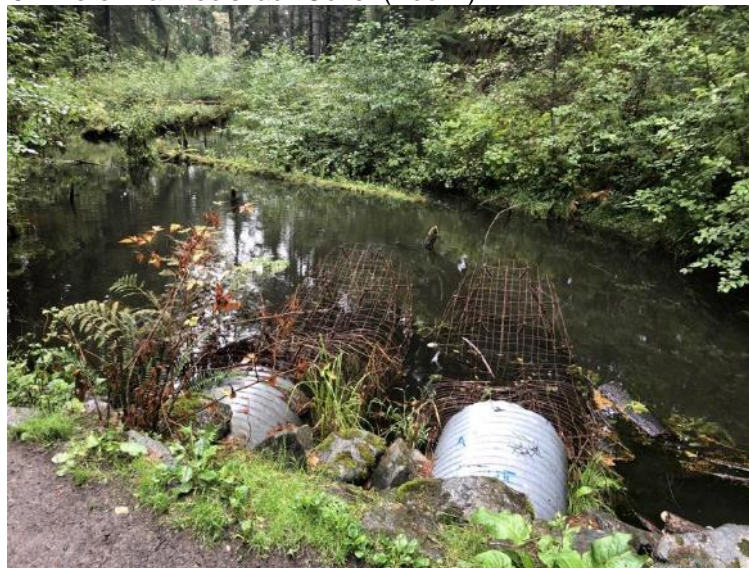
R5) Heritage Trail tributary need bridge to avoid beaver conflict
