Simms Creek Watershed Habitat Assessment and Restoration Plan.

January 2021

Prepared by
D.R. Clough RP Bio
D.R. Clough Consulting
6966 Leland Road,
Lantzville B.C. V0R 2H0
drclough@shaw.ca

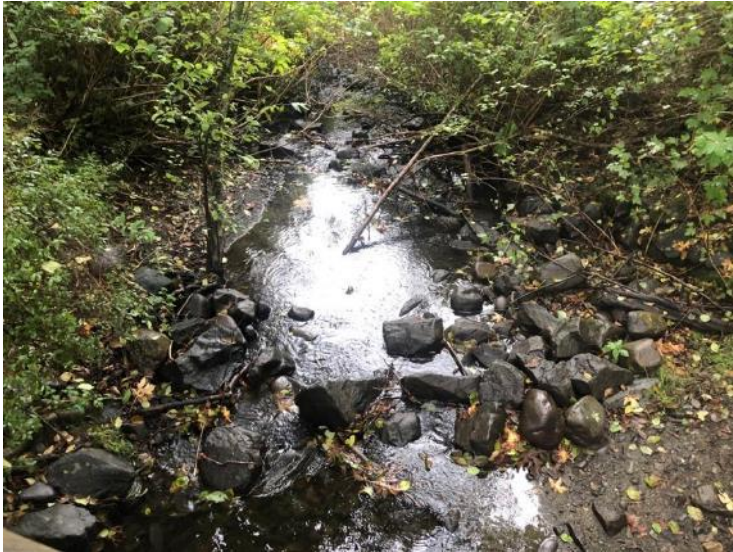
Downstream at the Willows trail bridge is an alteration that should be repaired. There are three manmade boulder crests in the channel under the bridge. They are washed out and creating erosion around the outer banks. The site has 4% gradient, which is fish passable without help. The beaver used the top of the upper rock crest for its dam foundation. The crests should be removed at low flow in summer and repositioned perhaps as rock spurs and boulder groups. They are small enough to be moved by hand or with a pry bar. Upstream is a wide floodplain that indicates Reach 1 was altered by dredging and its exit under the footbridge has confined the historic wetted entrance. The upland pool area floods the trail and the Penfield Road drainage was also dug to collect this overflow.

SS R1 – Willow Trail rock crests are in need of repair

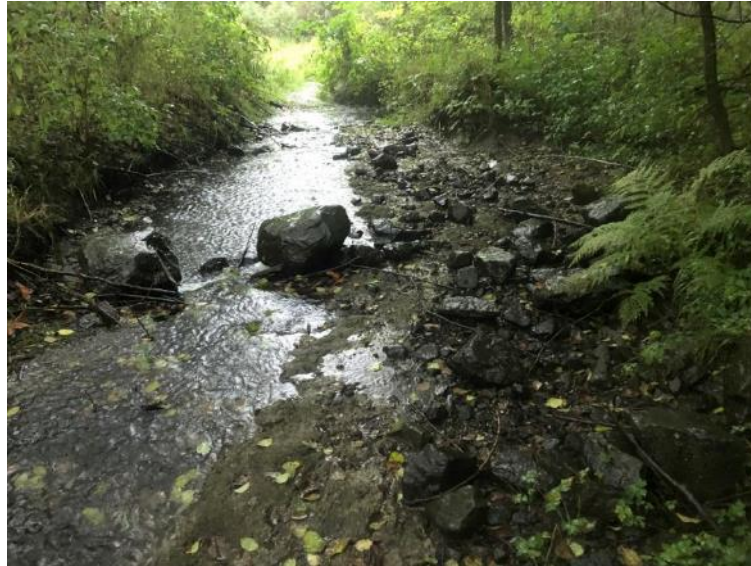
SSR1 – Rockland Rock crests failed as well

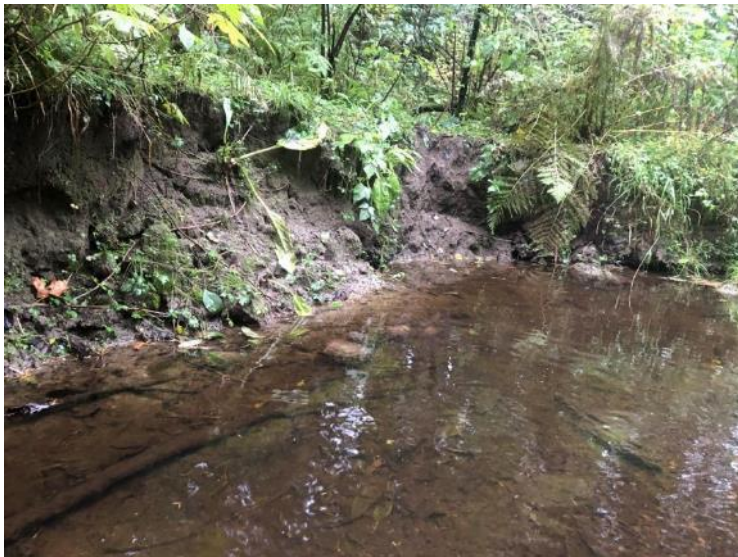
SSR1 – Pool 1 eroding banks (Placemark 98)

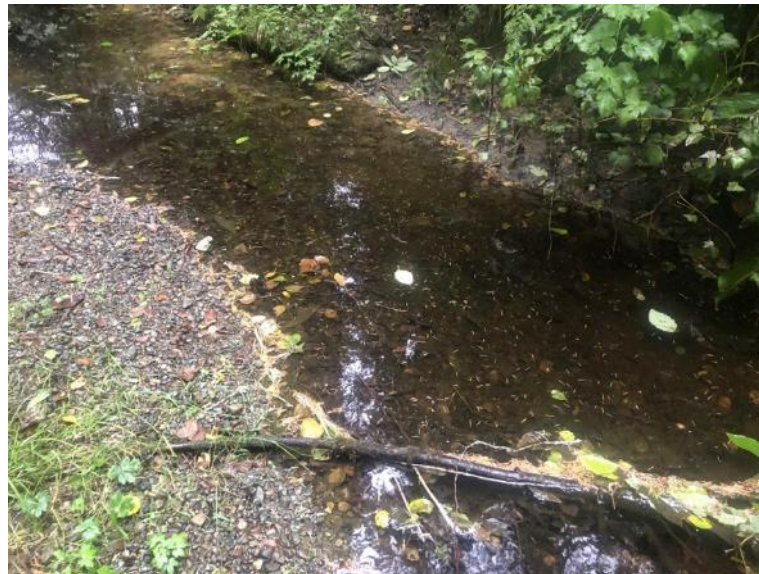
SSR1 – Riffle 3 lacks boulders to aerate and anchor gravel

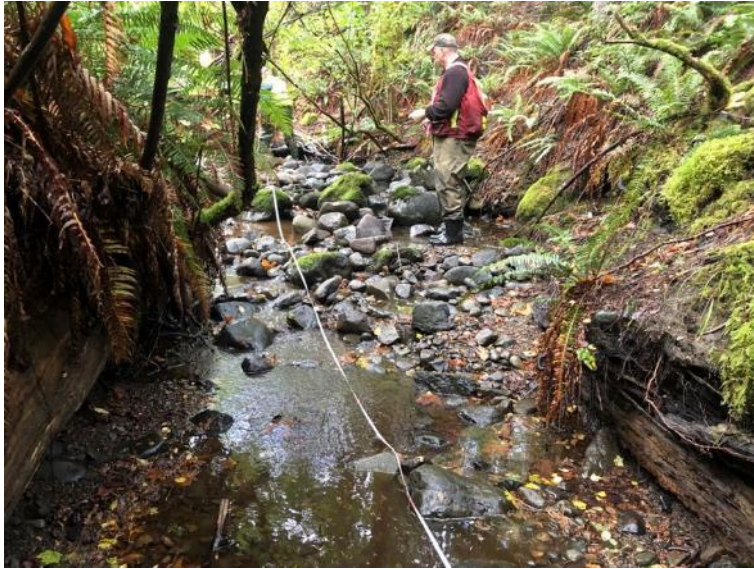
1.) Pool1 (Site 122) old logging crossing, has bank erosion

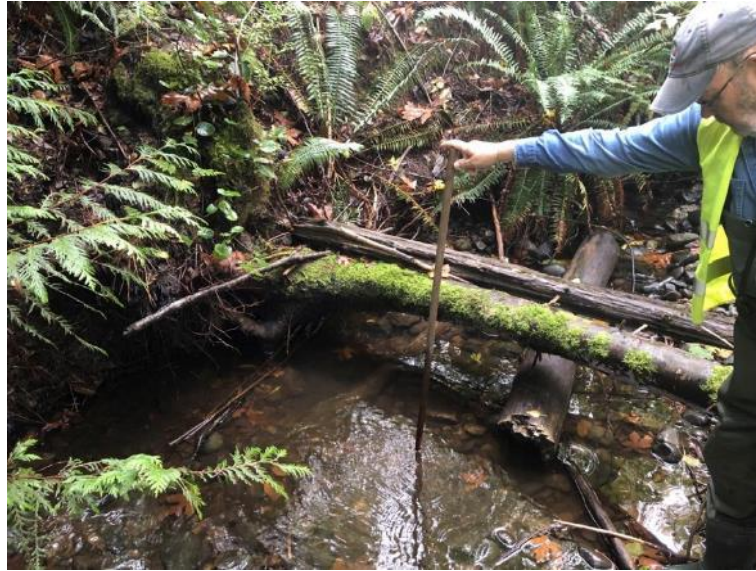
2.) Pool 4 (Site 128) lacks depth

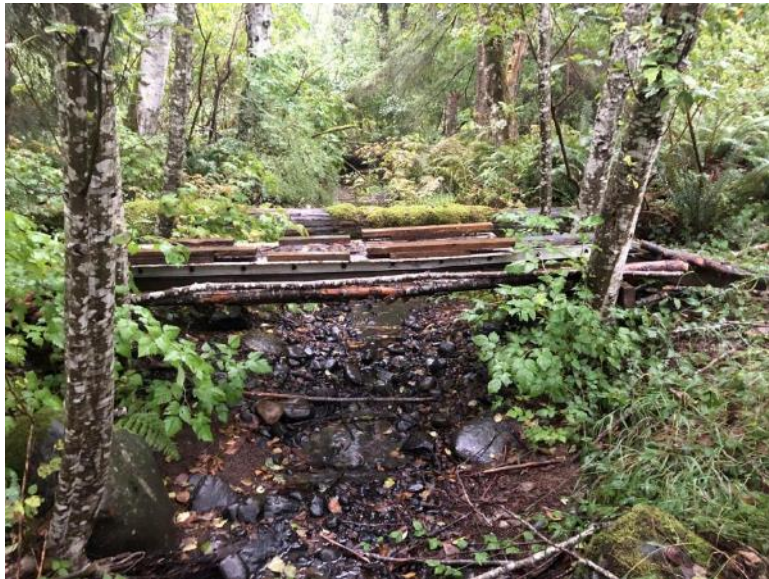
3.) Hwy 19 at top end of SSR2- seasonally dry

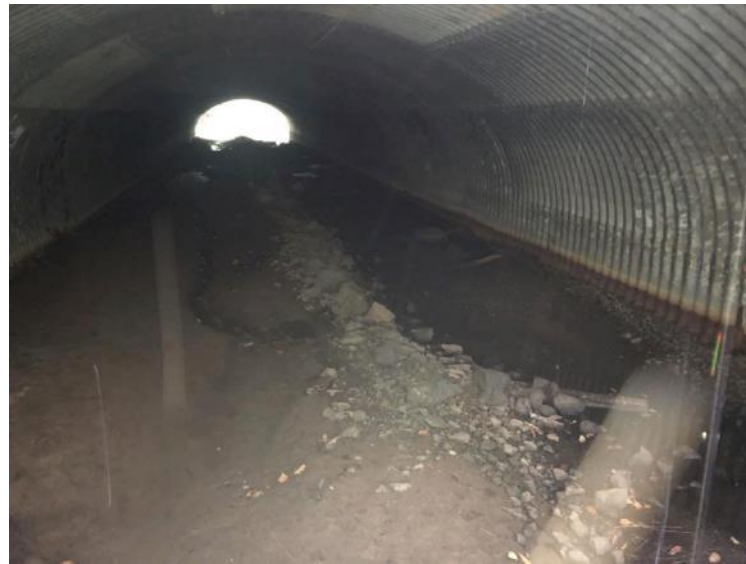
4.) Hwy 8m Arch culvert accommodates wildlife passage
