MEMORANDUM

TO:	Nicole Pesonen, Nyrstar Myra Falls
FROM:	Telsa Willsey
RE:	IEG 2019 site inspection
COPY:	Justin Straker, IEG

On Sept. 25 2019, Telsa Willsey and Justin Straker of IEG conducted a site inspection of the Nyrstar Myra Falls mine related to reclamation areas and activities. The assessment and recommendations cover five primary areas/topics:

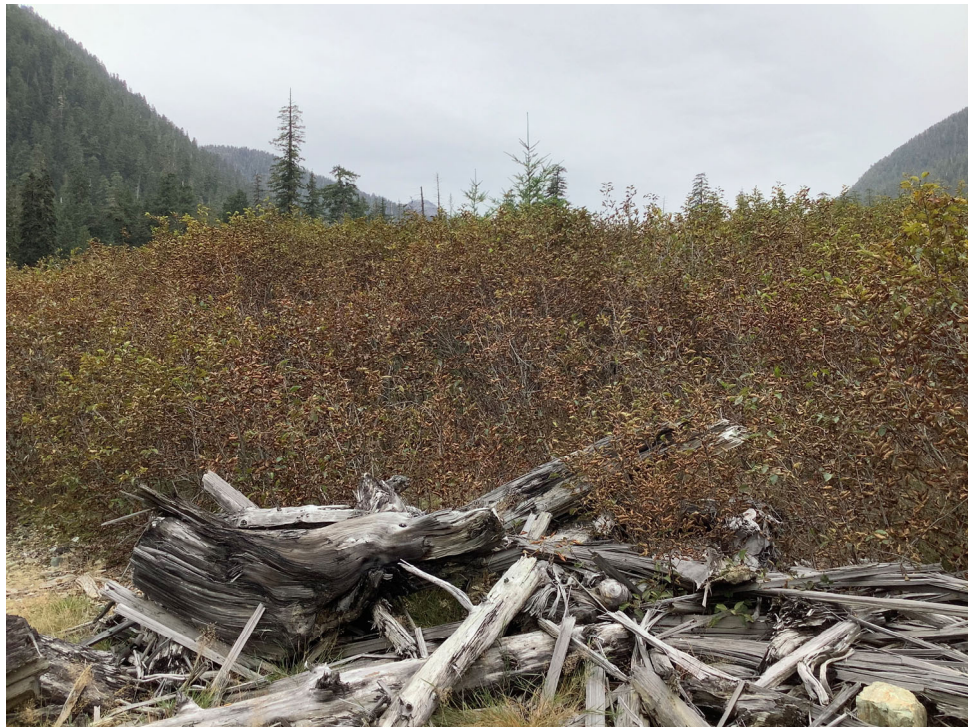
The former Emergency Tailings Area is located east of the new camp area, and was seeded with Sitka alder in 2006 areas part of site reclamation efforts. The alder seed was encapsulated and broadcast by hand, resulting in a densely vegetated stand (Figure 1).

Figure 1. Sitka alder growing in the Emergency Tailings Area (photo Sept. 2019).

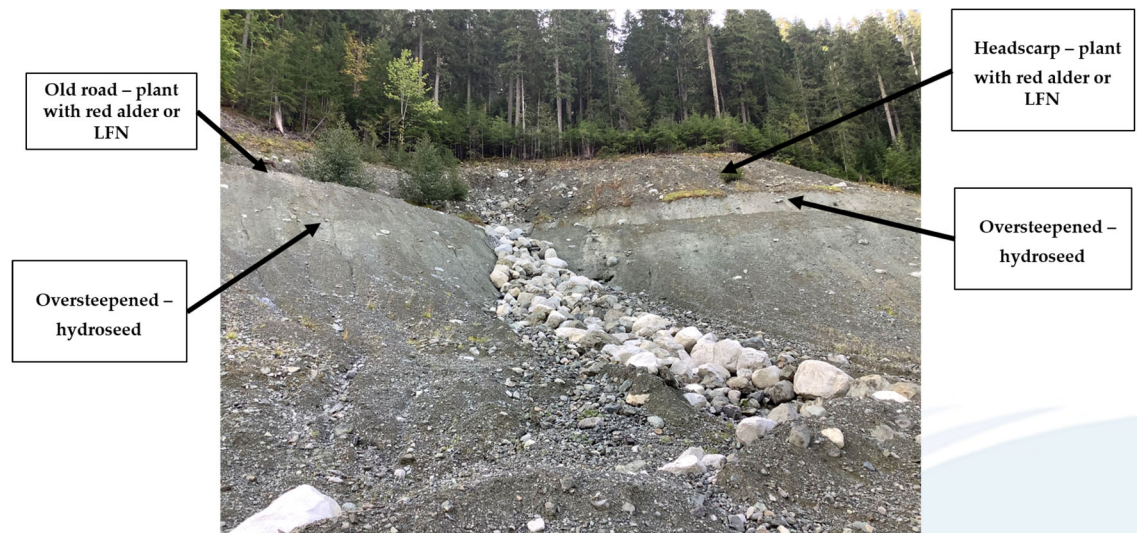
The Core Rack Borrow Area (CRAB) was hydroseeded in 2016 with a mix shown in Table 2. Surveys conducted in 2017 and 2018 found some species from the seed mix were growing in the area, particularly Oregon-grape, fireweed, pearly everlasting, and sedges, and natural ingress of species such as willow, fescue and alder from surrounding undisturbed areas was evident. However, germination from the hydroseeding was observed to be poor, and most of the area was unvegetated (Figure 2).

Despite the presence of the above listed species, this area remained primarily unvegetated when revisited in September 2019. The presence of Himalayan blackberry was also noted, suggesting that control for invasive species is warranted.

Figure 2. Core Rack Borrow Area. Options for reclamation in this area include hydroseeding oversteepened areas with an aggressive native seed mix, followed by planting the headscarp and old road areas with red alder or leaving these areas for natural revegetation (LFN) (photo Sept. 2019).

As noted in the Reclamation Inspection report for 2018, signs of significant, active erosion at the CRAB were not evident, but the area should be frequently monitored for signs of active erosion. Hydroseeding at the site has had limited success and is not likely to perform better without a new, more aggressive seed mix. A seed mix comprised of aggressive native grasses would likely create more cover than the 2016 hydroseed mix, but could risk altering vegetation successional pathways, preventing establishment of shrubs and trees. Planting red alder is likely to provide the best results, though some areas are steep, and will require safety precautions to be taken during planting. One option may be to plant the areas which are not steep slopes after hydroseeding the steep slopes with an aggressive seed mix, or leaving them to revegetate naturally (Figure 2). The roads should be decommissioned and de-compacted prior to planting. Himalayan

blackberry is also present at this site, so any revegetation efforts at this site will need to include control for this species.

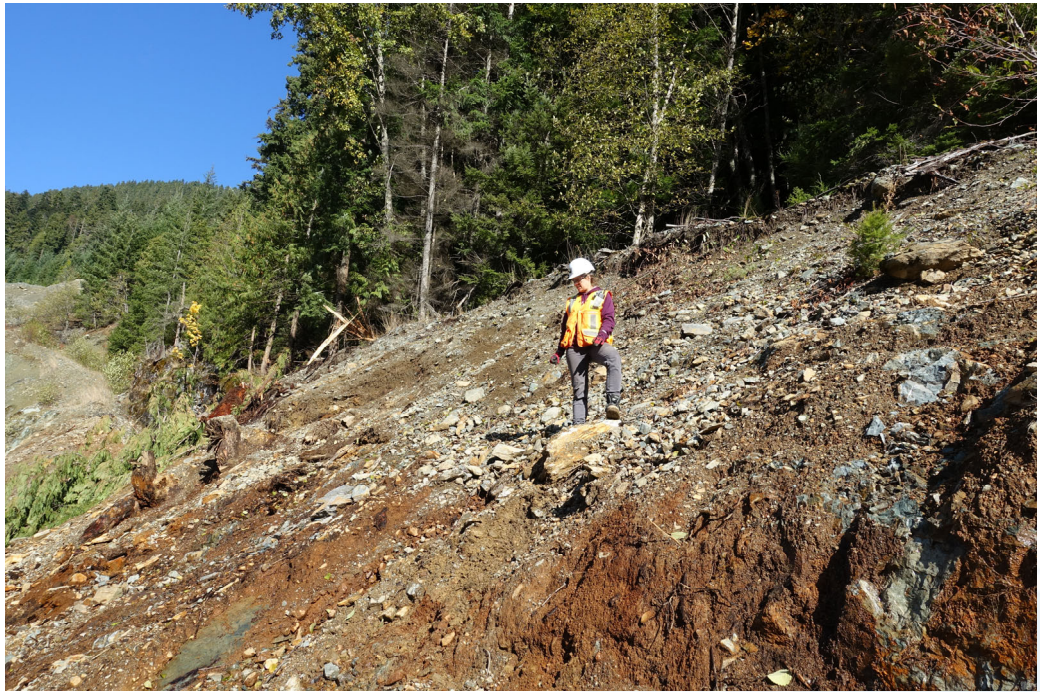
Myra Falls removed waste rock from the historic Waste Dump 2 location in the summer and early fall of 2017. Underlying materials at this location consist of native surficial materials—including soil and other surficial material—onto which the waste rock was

dumped (Figure 3). Analysis in 2017 indicated that these materials have the edaphic properties of the 03/HwCw – Salal site series in the CWHmm1 biogeoclimatic unit. Appropriate tree species for early revegetation are Douglas-fir and red alder, and seedlings of both species were observed in non-mined forest directly above the Waste Dump 2 location.

Figure 3. Area currently stripped and ready for revegetation in the previous Waste Dump 2 location (photo taken in 2018).

Appropriate treatment for this area includes planting of red alder and Douglas-fir, at approximate stem densities of 2500 and 1000 stems per ha respectively. Discussions with AMEC engineers in 2017 indicate that they do not expect erosion to be a primary issue at this site; therefore at this time no additional treatments such as seeding or bioengineering are recommended. Revegetation efforts should be coupled with the removal of invasive species from the area and planning for future control.

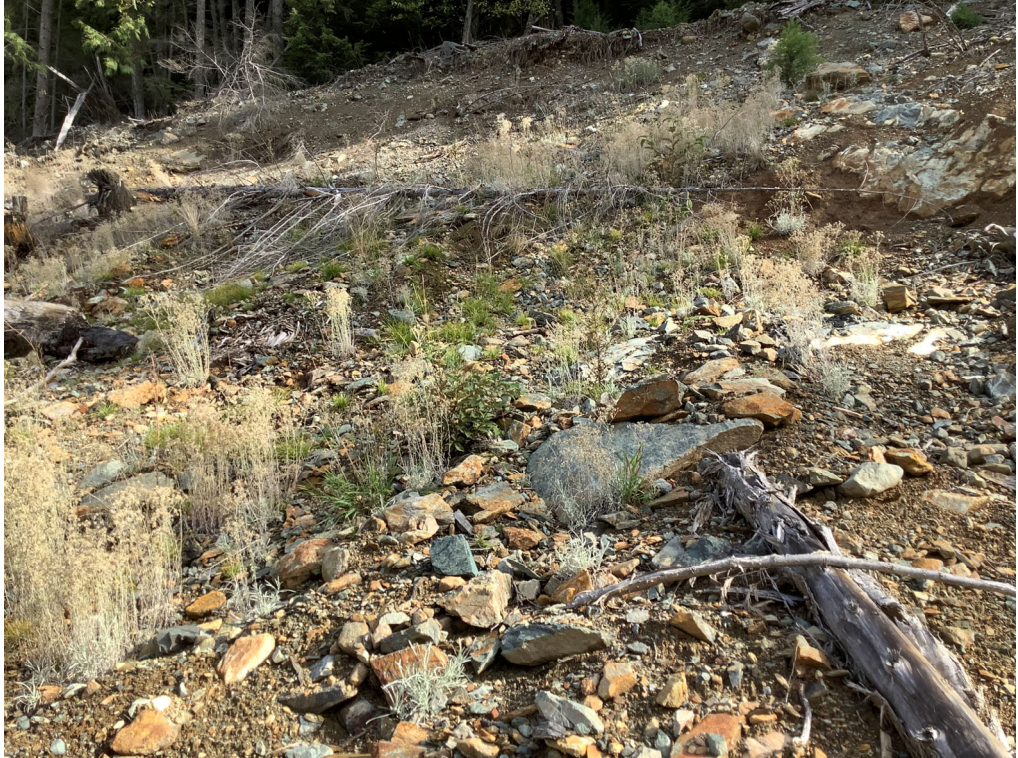
In 2018, surveys of the Waste Rock Dump 2 area found sparse vegetation establishing across the area, making up approximately 5% of the ground cover. The most common species are fireweed, miner's lettuce, thimbleberry, and pearly everlasting. Other notable native species present include Douglas-fir, red alder, and red elderberry. Similar observations were made in when the area was re-visited in 2019, including the establishment of invasive and non-native species (Himalayan blackberry and thistle).

Figure 4. Vegetation establishing at Waste Rock Dump 2 (photo taken in 2019).

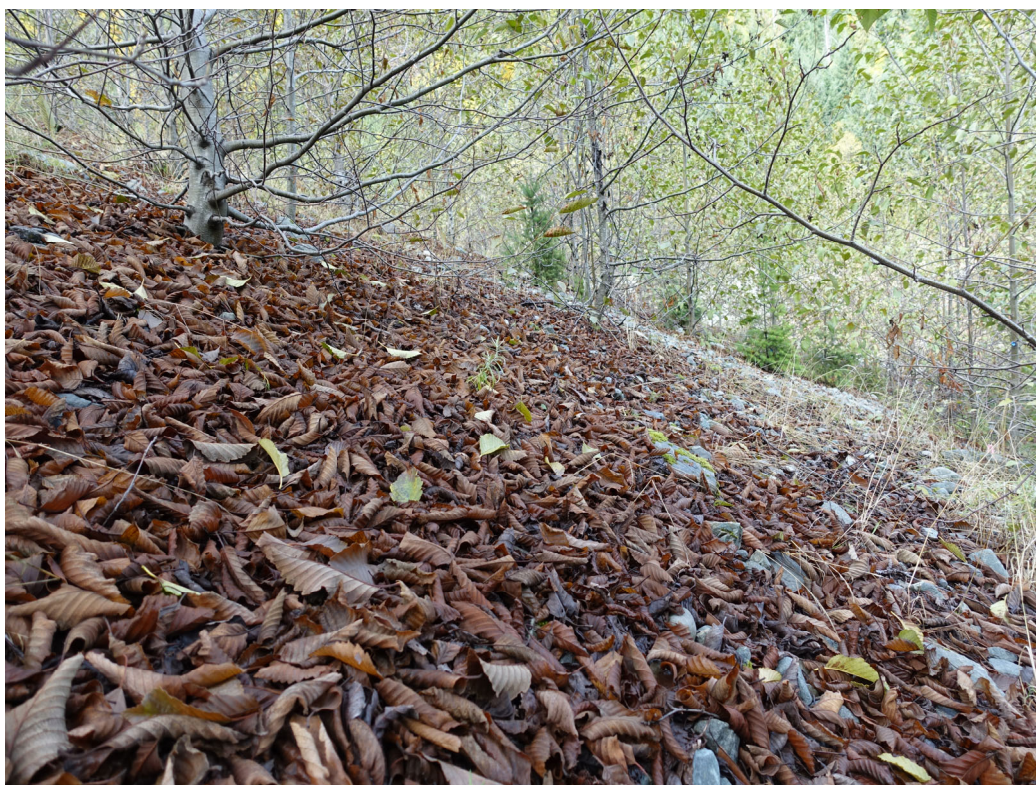
Consistent with observations made in 2018, the alder planted in 2008 on the eastern portion of the seismic berm was found to be growing well in 2019, with a continuous litter layer making up most of the ground cover (Figure 5). Substantial growth of Canada bluegrass (*Poa compressa*) was observed in the vicinity of plot 2-4, and several sedges (*Carex* sp.) were growing near plot 2-5 (in the south-eastern portion of the berm) (Figure 6). The canopy in this section appears to be, for the most part, preventing establishment of weedy species, though one occurrence of bull thistle was noted in 2018.

Figure 5. Seismic Berm ground cover (photo taken in 2018).

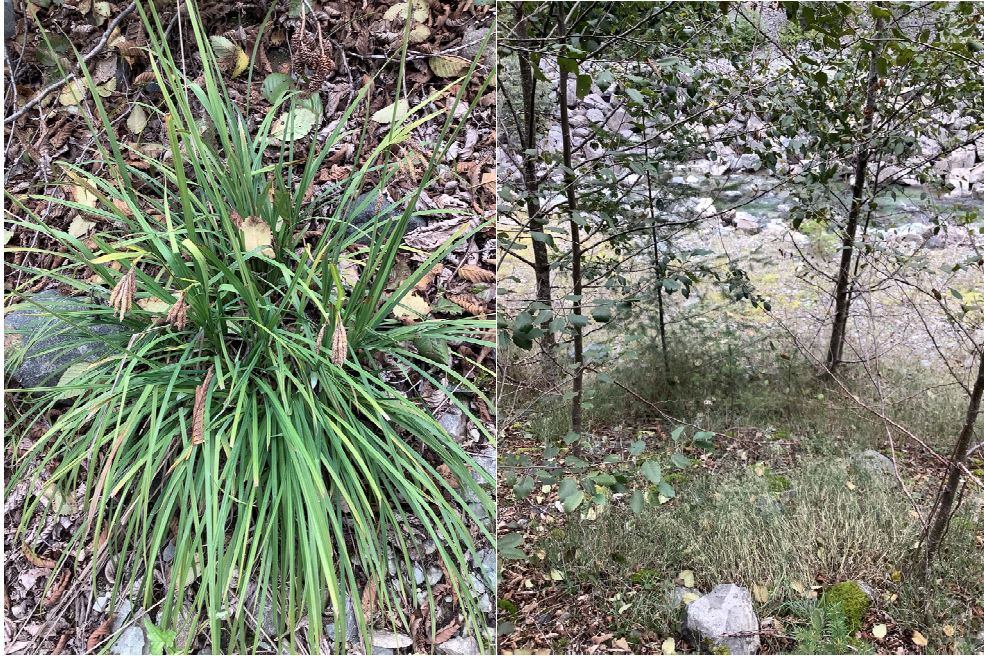
Figure 6. Establishment of sedge and Canada bluegrass in the south-eastern portion of the TDF Seismic Berm (photos Sept. 2019).

The more recently planted (2010) western section is not performing as well. The aspect is more southerly, and thus likely more prone to drought, and trees are smaller and produce less litter than those of the eastern section did at the same age. It is possible that this area only requires more time to initiate nutrient cycling and will continue to grow at a stable pace, but there are likely some low-cost interventions which could improve performance and may prevent possible mortality of planted trees. We recommend hydroseeding a mix of native understory species, along with fertilizer, mulch, and tackifier. Hydroseeding should be completed in the early spring to coincide with nutrient uptake, ideally before new leaves come out. The hydroseeding should occur from the top of the berm, down the slope, use minimum application pressure, and should focus on areas of bare soil, and avoid areas with higher tree cover. If hydroseeding of these areas is not possible, the areas would benefit from application of a slow release fertilizer, applied using a manual cyclone spreader.
