**MYRA FALLS TAILINGS STORAGE FACILITIES
2015 DAM SAFETY INSPECTION REPORT**

31 March 2016

Amec Foster Wheeler File: NX14001B

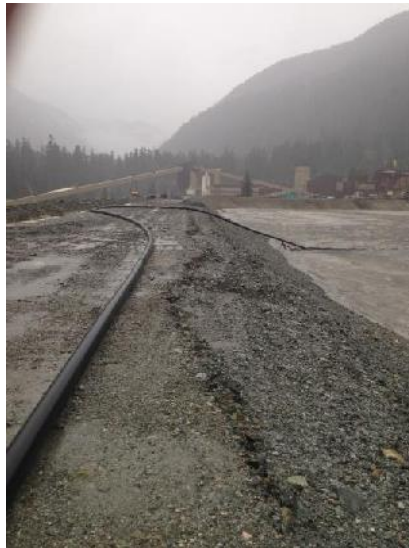
Photo 27 (left) – Trench in upstream half of Lynx Dam crest to route piezometer wires.
Photo 28 (right) – Cracking at the contact of the Zone J core and the upstream dam shell.
