2015 ANNUAL DAM SAFETY INSPECTION

2-North Pit Tailings Disposal Facility

Reference Number: 1528261-003-R-Rev0-1000

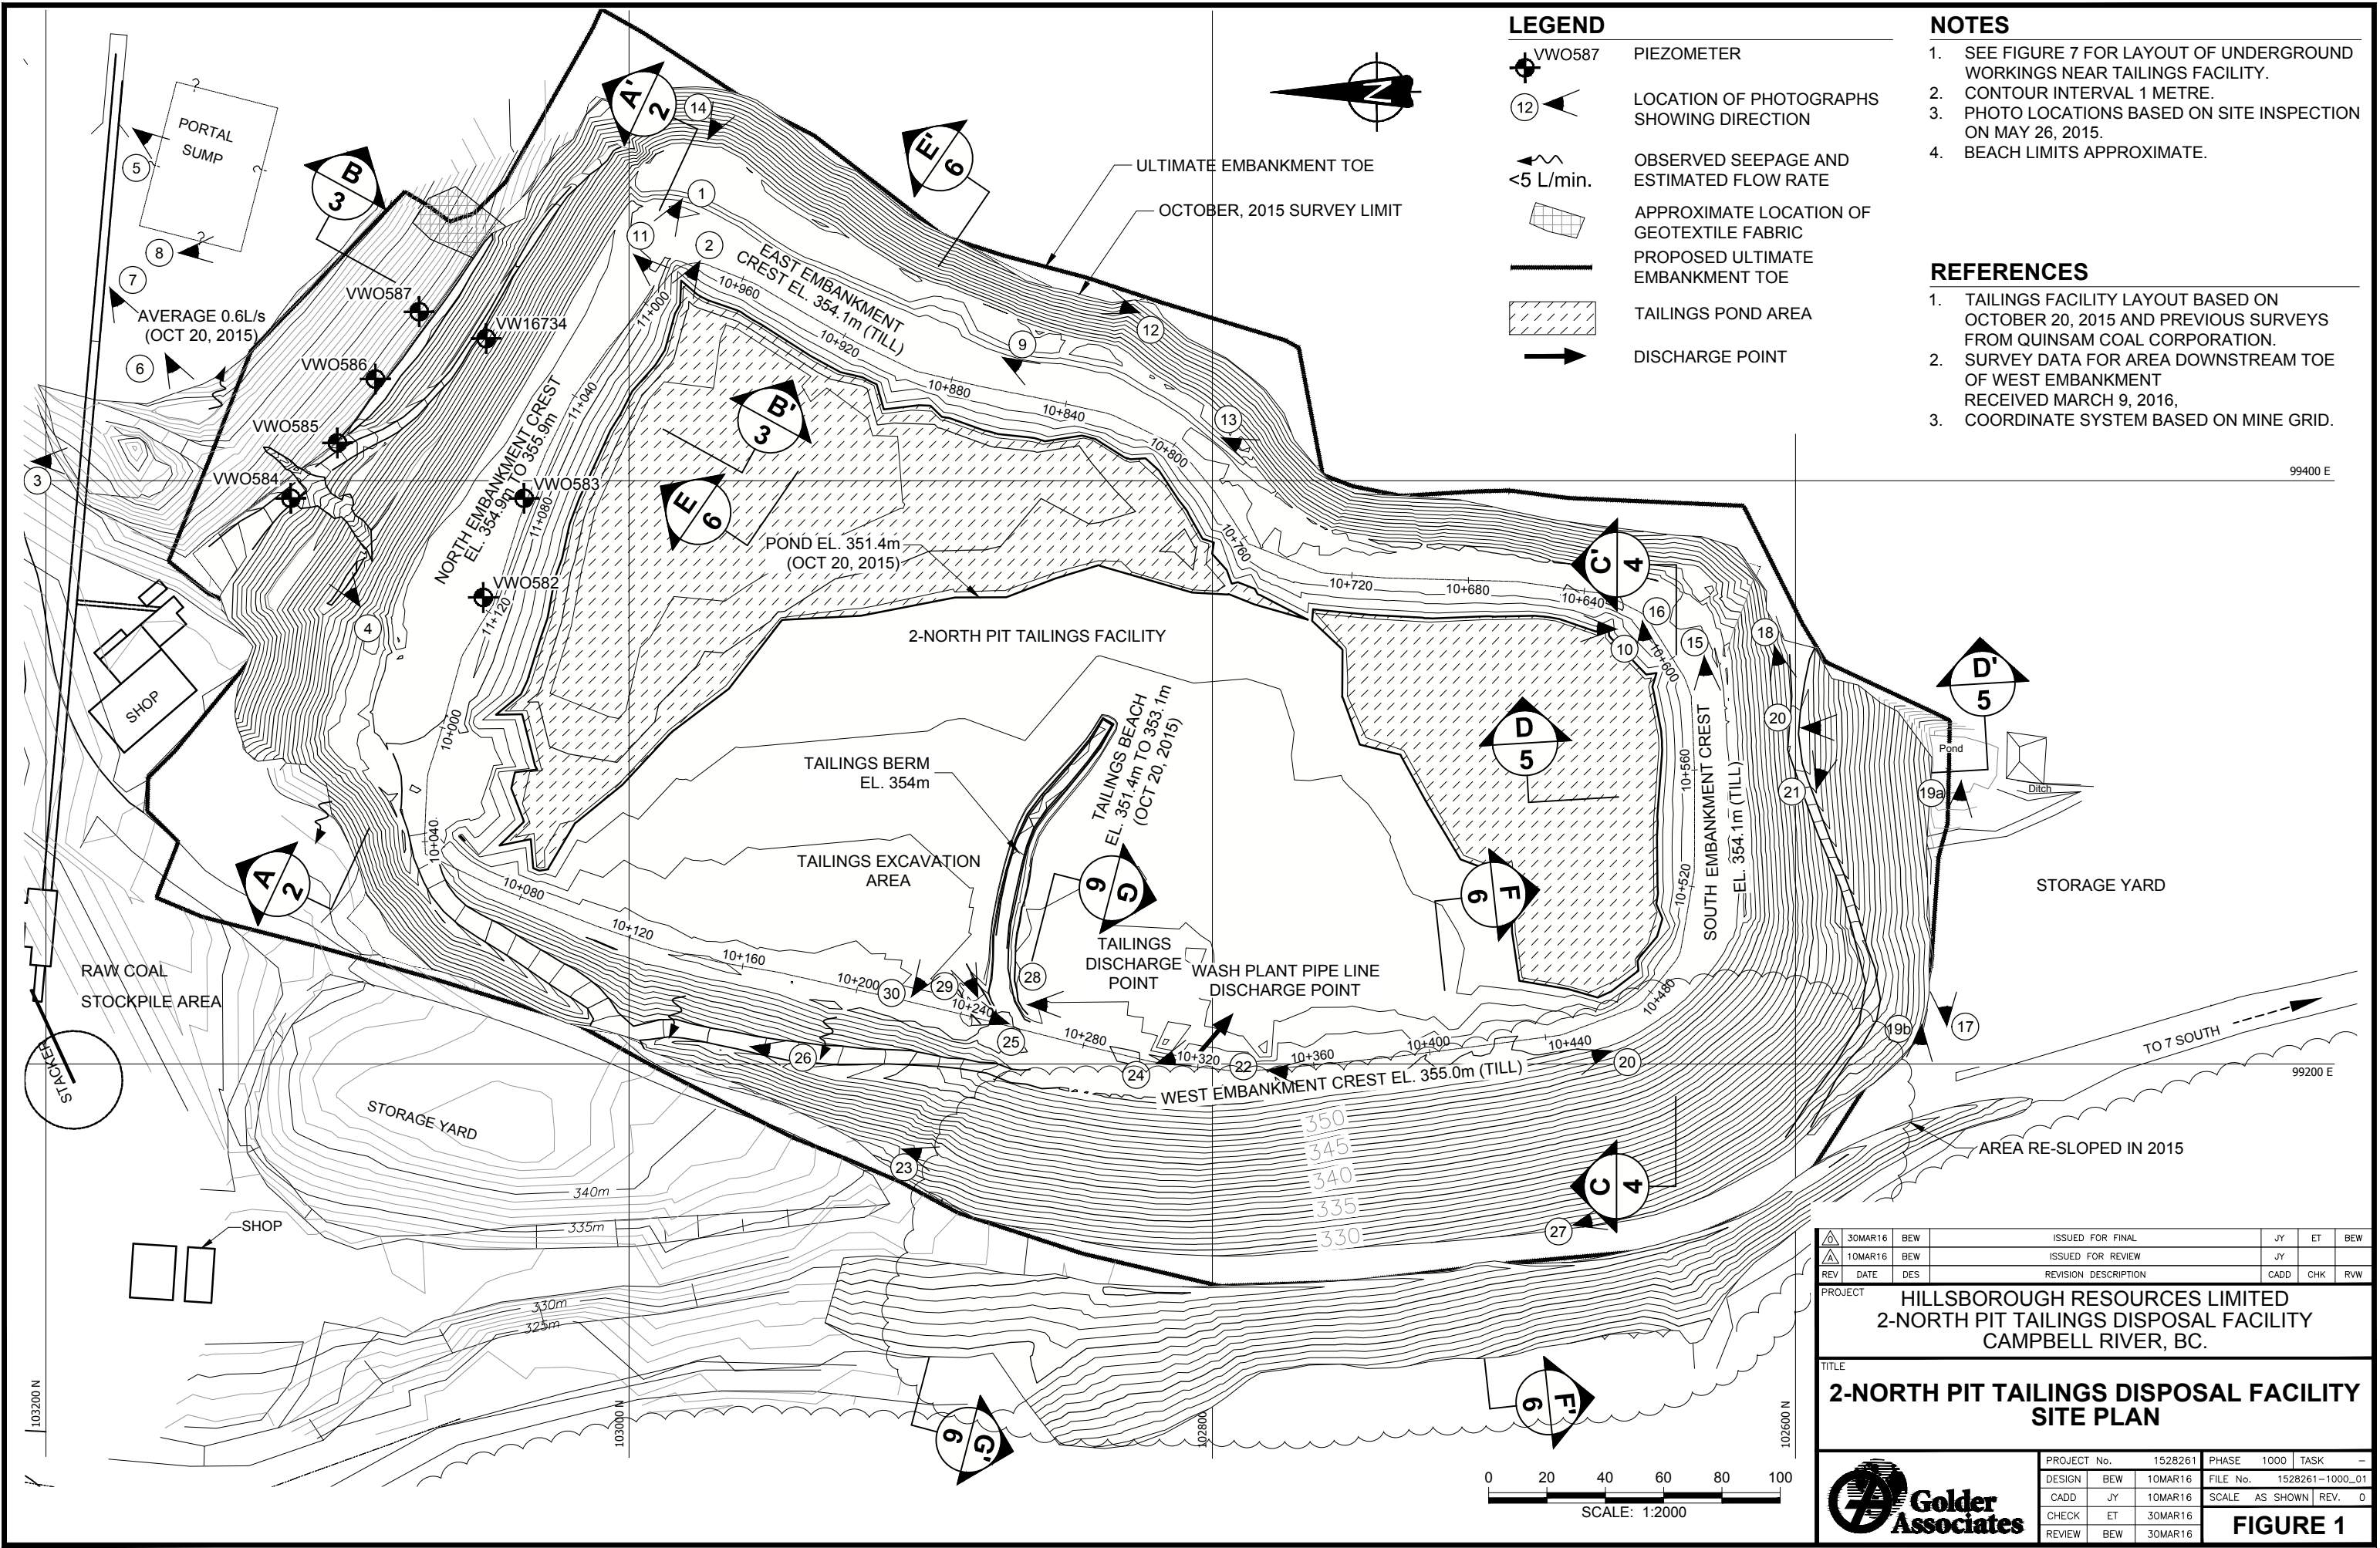
The North Embankment is shown in plan in Figure 1 and in section in Figures 2 and 3. The North Embankment is also pictured in Photographs 1 to 8 (Appendix A), taken during the May 26, 2015 inspection.

Piezometer VW 0587 malfunctioned in 2010. VW 16734 was installed in February 2011 to replace VW 0587. The piezometer locations are shown in plan in Figure 1 and in cross-section in Figure 3. Data since February 2011 from piezometer VW 16734 indicated higher water levels than other piezometers and was typically dry between June and October. Data for 2015 indicated that the water level was up to 0.27 m above the piezometer tip in February).

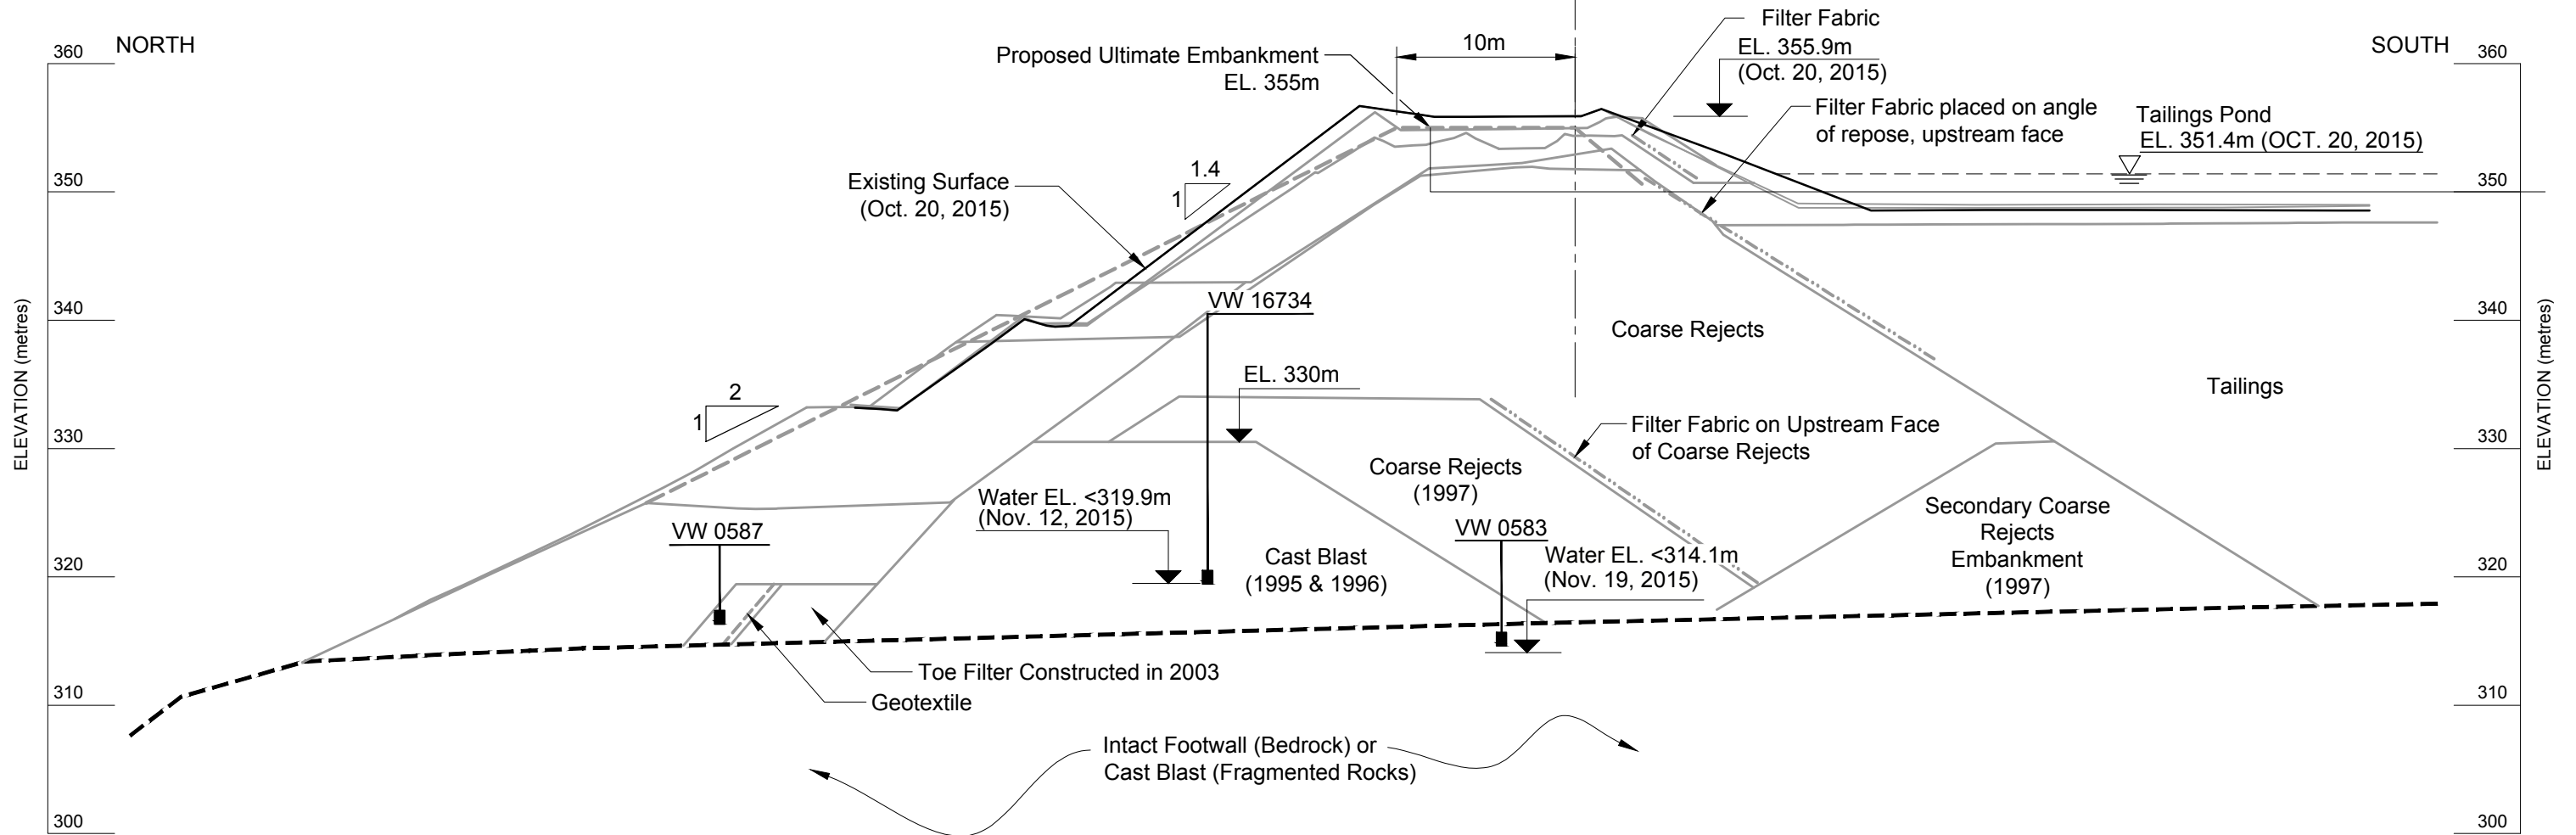
FIGURE 3

The secondary embankment was partially successful in reducing the amount of tailings carried through the North Embankment. However, in 2001 it was identified that some fines were still migrating through the coarse rejects. A toe filter including geotextile material was constructed downstream of the cast blast material to further reduce the flow of fines from the 2-North Pit, and is shown in Figure 3.
