Province of British Columbia  
MINISTRY OF ENERGY, MINES AND  
PETROLEUM RESOURCES

Report of Inspector of Mines

Geotechnical

Inspection No.: 91561  
Mine No.: 0800007  
Permit No.: M-26  
Total Orders: 2

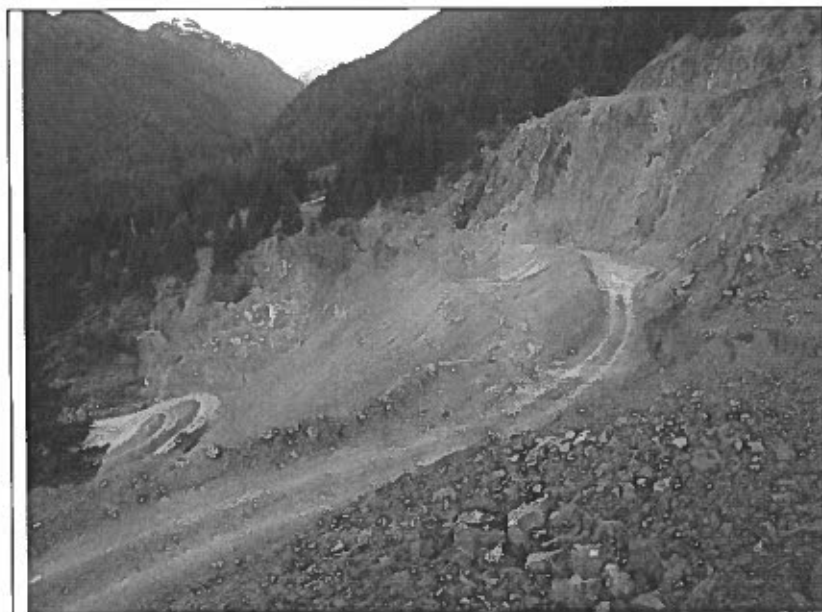
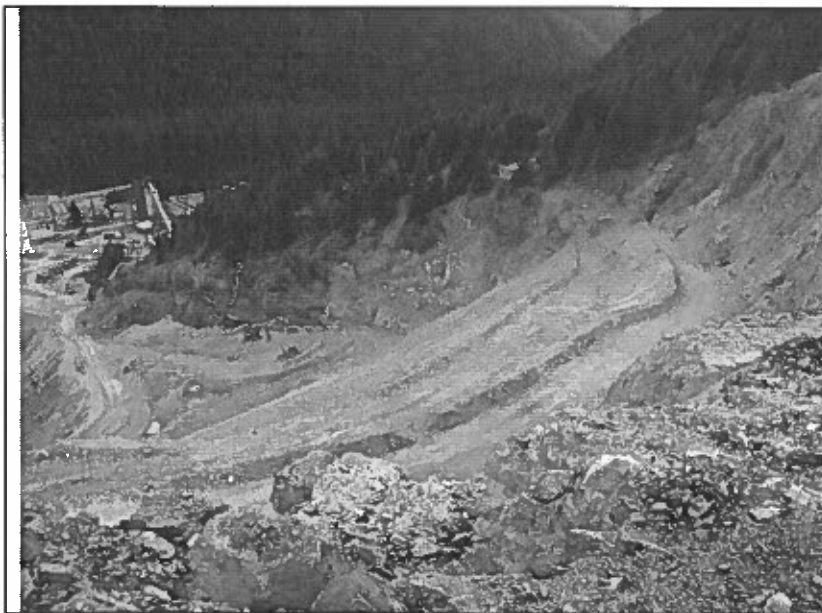
**Information Request 1:** EMPR was not able to clearly view the bench at the base of the 59 degree rock slope, the location of a planned thrust block and rock anchors. Please submit photographs of this area.
