Simms Creek Watershed Habitat Assessment and Restoration Plan.

January 2021

Prepared by
D.R. Clough RP Bio
D.R. Clough Consulting
6966 Leland Road,
Lantzville B.C. V0R 2H0
drclough@shaw.ca

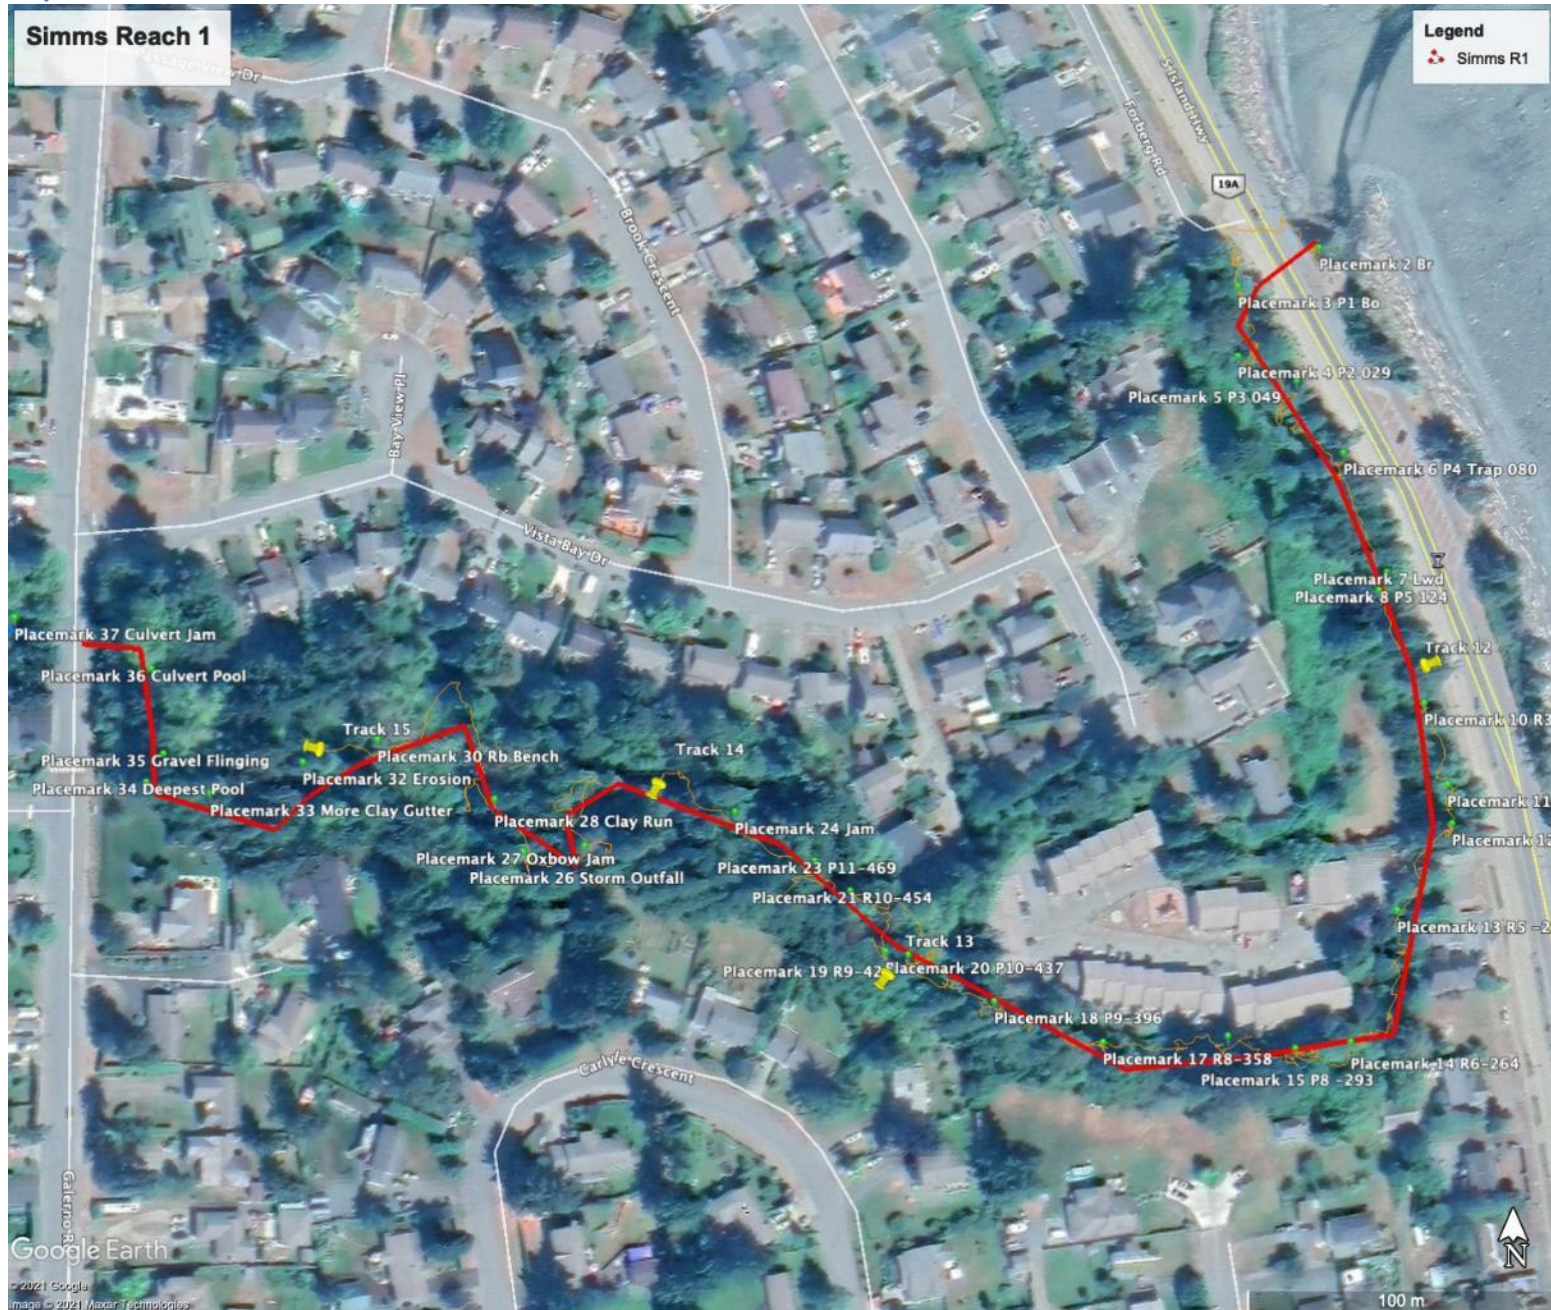
Simms R1 Survey Area with Placemarks

This reach had an average channel width of 6.84m and a wetted width of 4.7m. The reach is very low with a gradient of 0.8%. The water temperature was 15C. No fish were observed in the channel during the survey but there were freshwater mussels in the gravel beds. The results are shown in the table below. Figure 4 shows the reach with the placemarks 2-37 from the survey with the iPad.

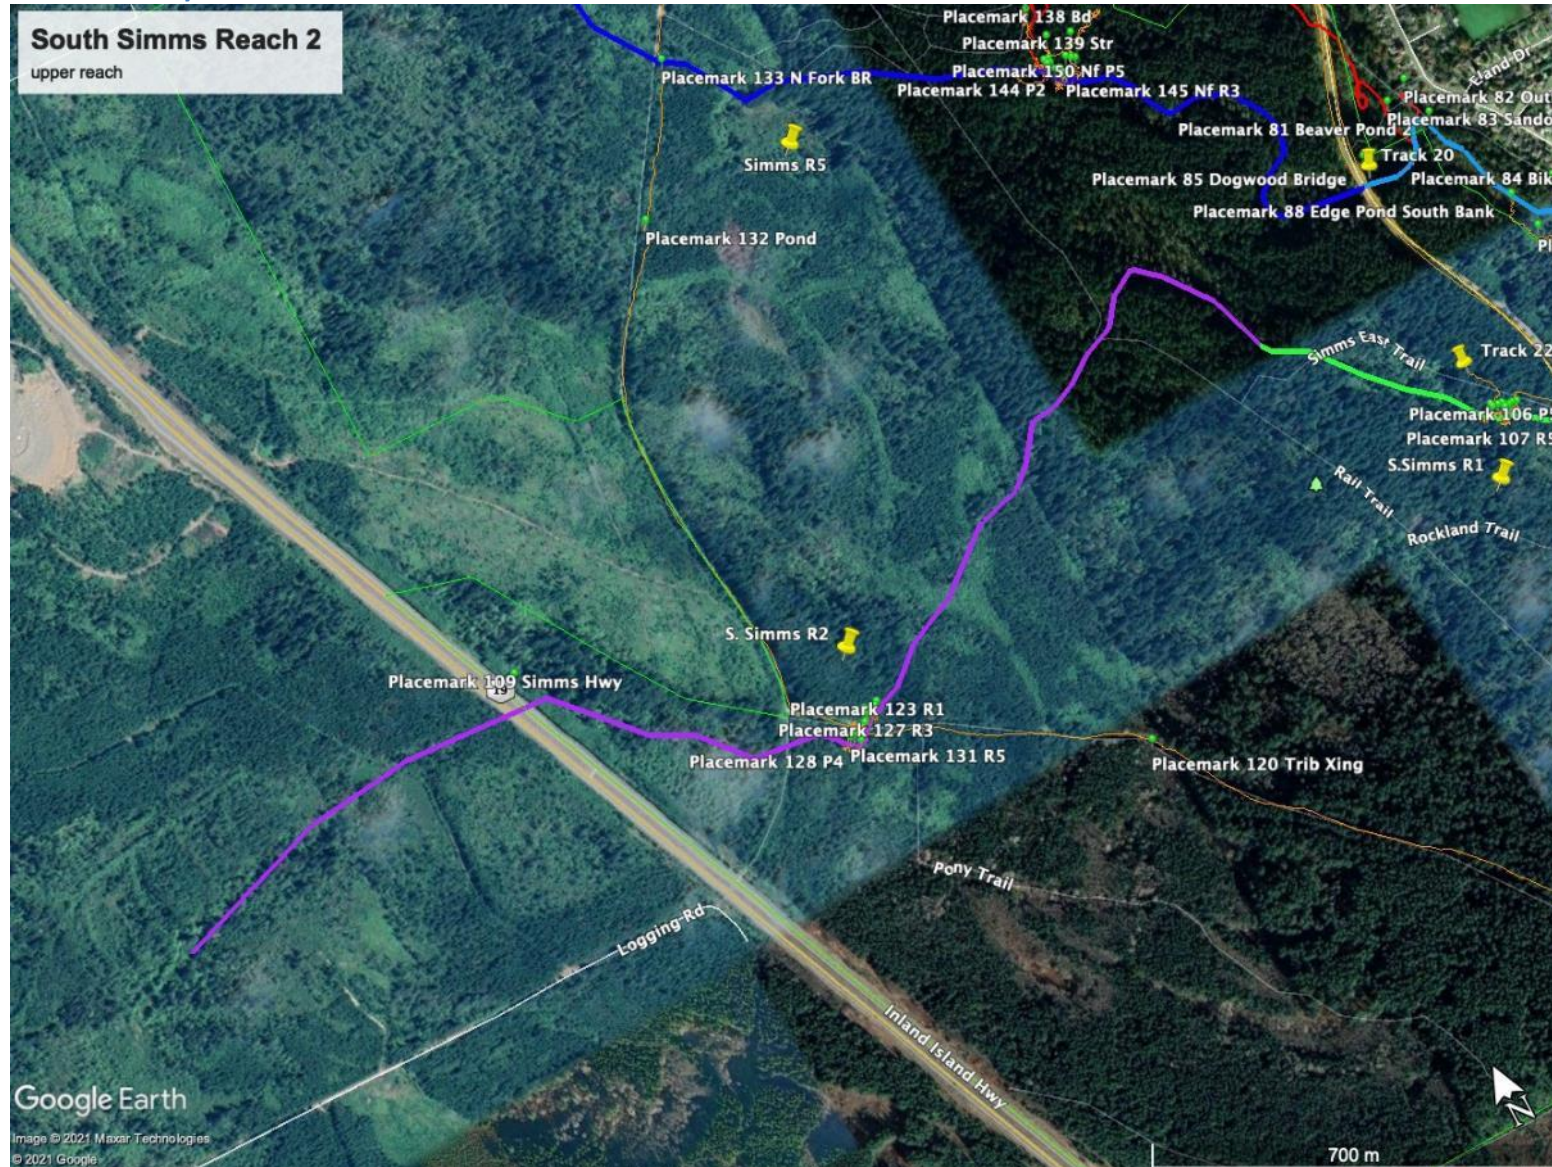
S. Simms Reach 2 Survey Area

This reach is in a protected forest area. It suffers from drying in summer. There is bank erosion from high water surges. The upland drainage alterations (Highway/Airport) are likely causes. The reach has plenty of gravel. It lacks deep pools and LWD cover. It offers spawning habitat but very little summer rearing area.
