## **Quinsam Coal Mine 2020 Dam Safety Inspections:**

**2 North Pit TDF and South Dam  
2 South Pit and 3 South Pit PAG-CCR Disposal Facilities  
Settling Pond 1 and Settling Pond 4**

PRESENTED TO  
**Bowra Group Inc.**

JUNE 16, 2021  
ISSUED FOR USE  
FILE: 704-ENG.DMPA03006-01

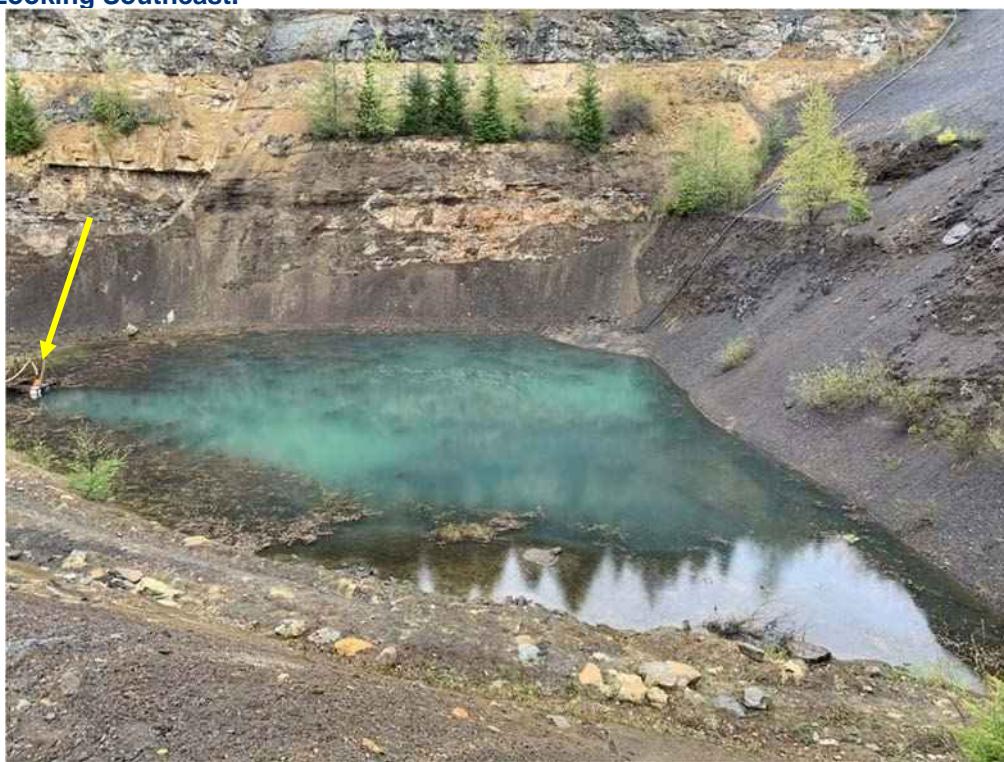
**Photo 2: 2-North Pit TDF, Ponded Seepage at the Toe of the North Embankment Downstream Toe and Pumping Barge identified by yellow arrow, Looking East.**

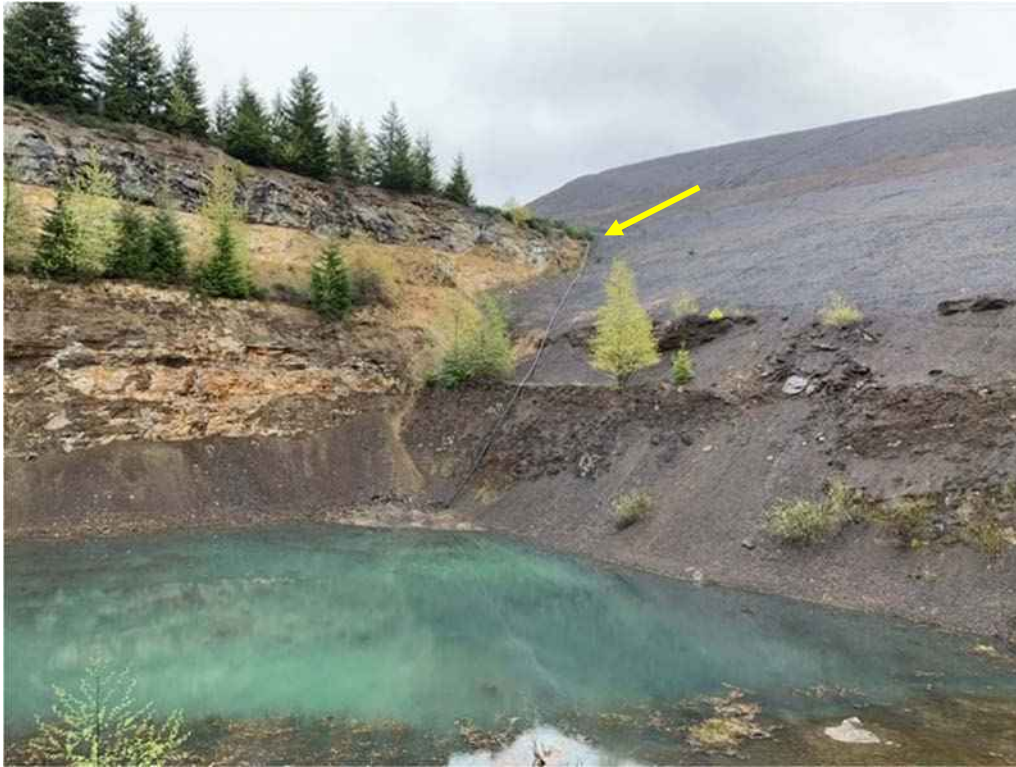
**Photo 3: 2-North Pit TDF, North Embankment Downstream Toe and Abutment, Siphon Pipe From Northeast Corner of TDF identified by yellow arrow, Looking East.**

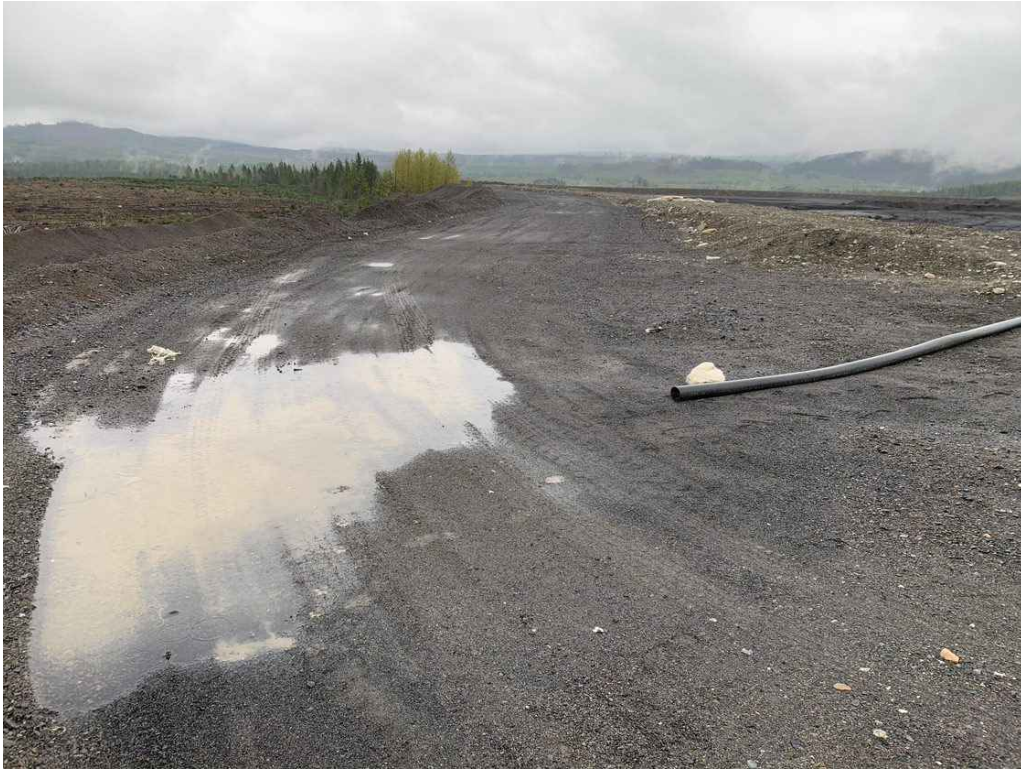
**Photo 11: 2-North Pit TDF, East Embankment Crest with Pondered Water, Looking South.**

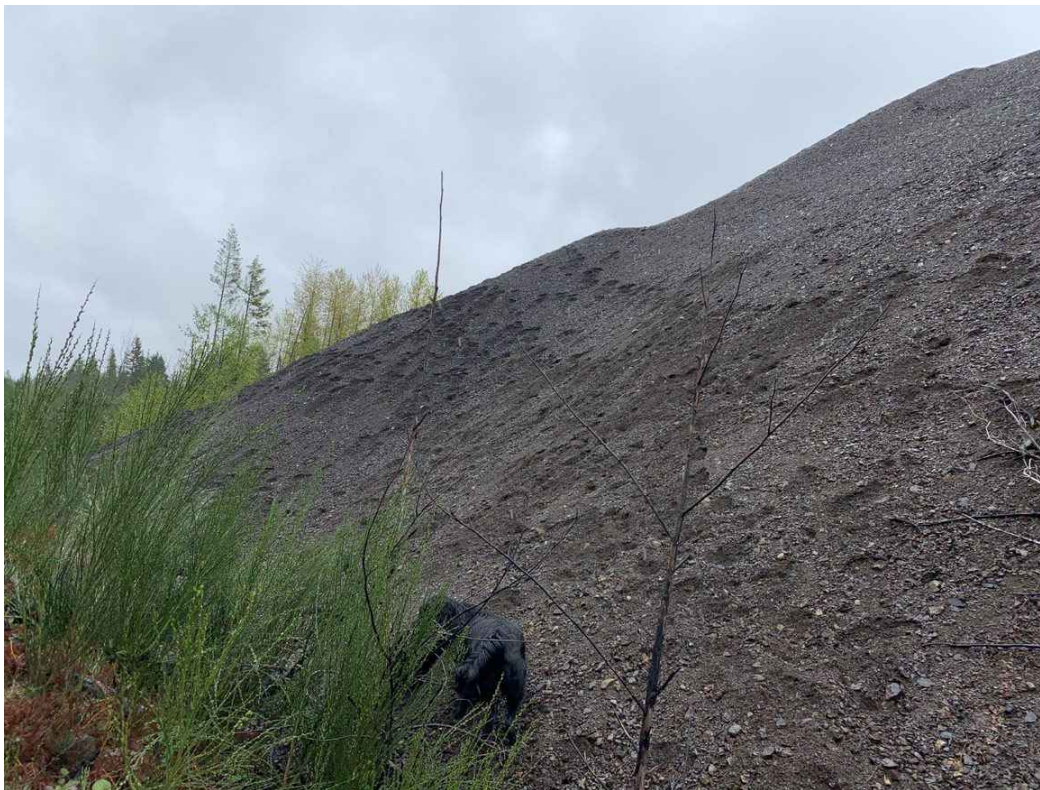
**Photo 13: 2-North Pit TDF, East Embankment Downstream Slope With Animal Tracks, Looking Southeast.**

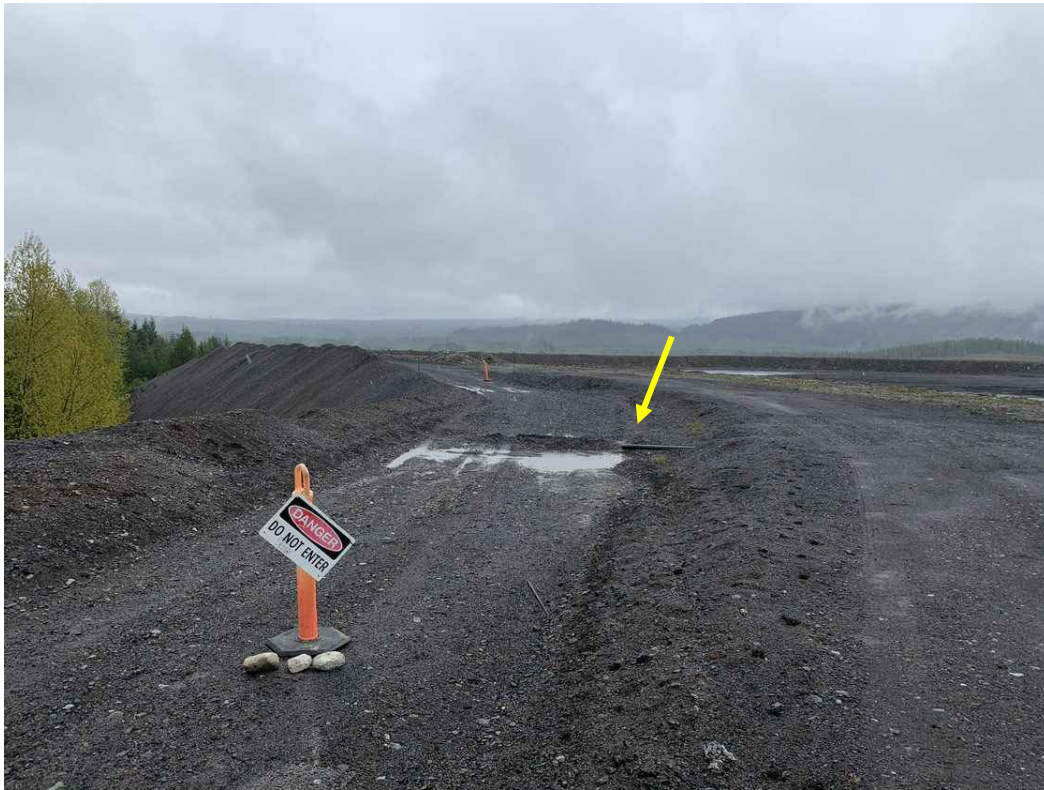
**Photo 15: 2-North Pit TDF, Ponded Water on East Embankment Crest Drained by Pipe into TDF, Looking Southeast. Pipe identified by yellow arrow.**

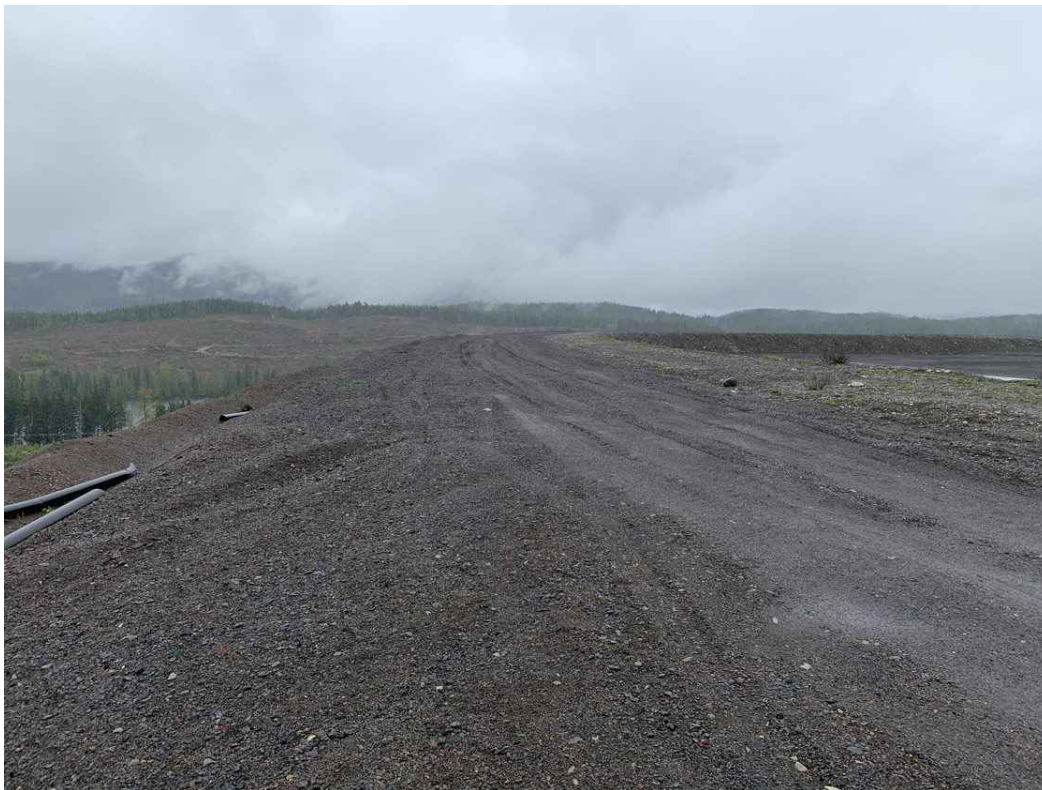
**Photo 17: 2-North Pit TDF, South Embankment Crest With Abandoned Pipe Pieces, Looking West.**

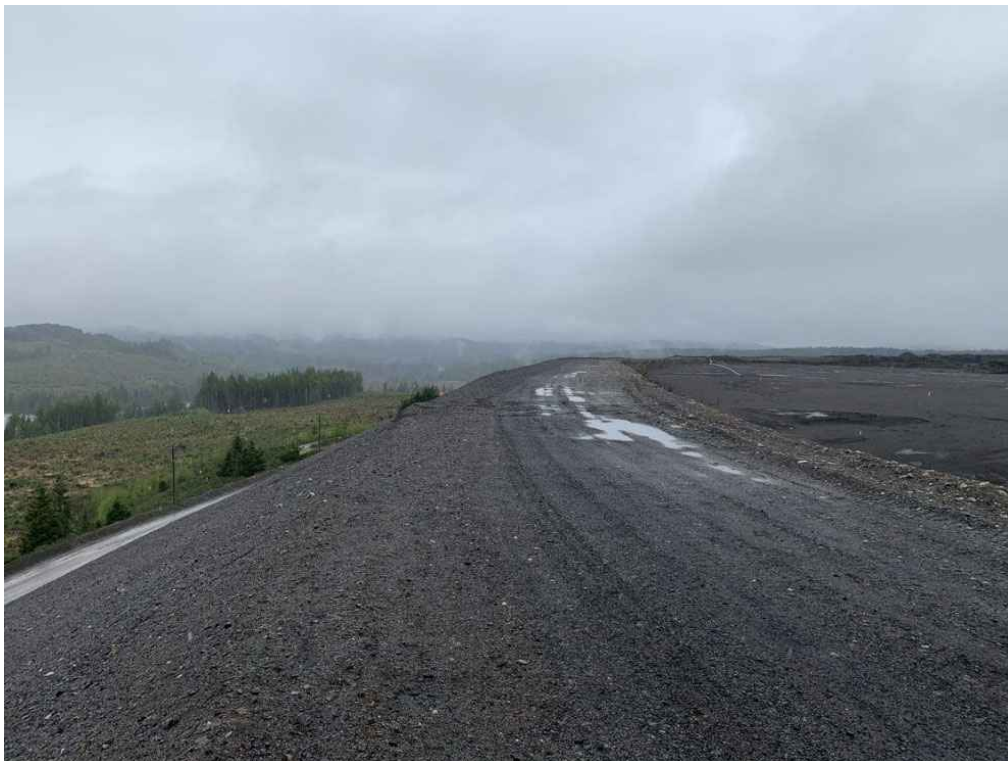
**Photo 21: 2-North Pit TDF, Ponding on West Embankment Crest, Looking North.**

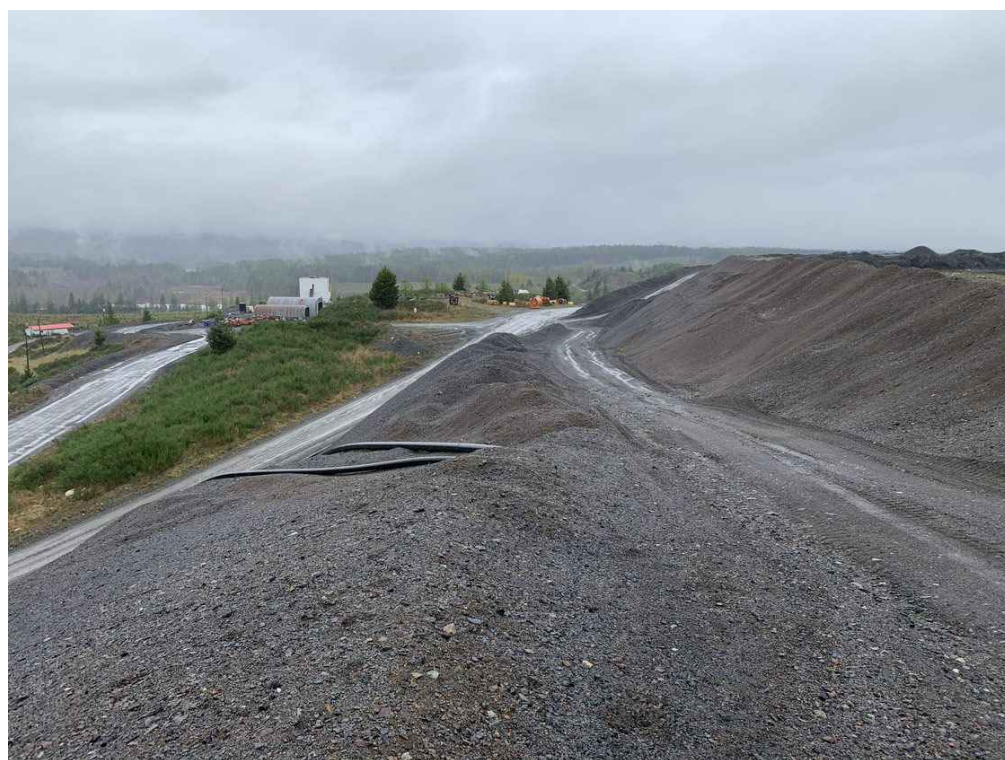
**Photo 24: 2-North Pit TDF, West Embankment Downstream Slope, Looking North.**

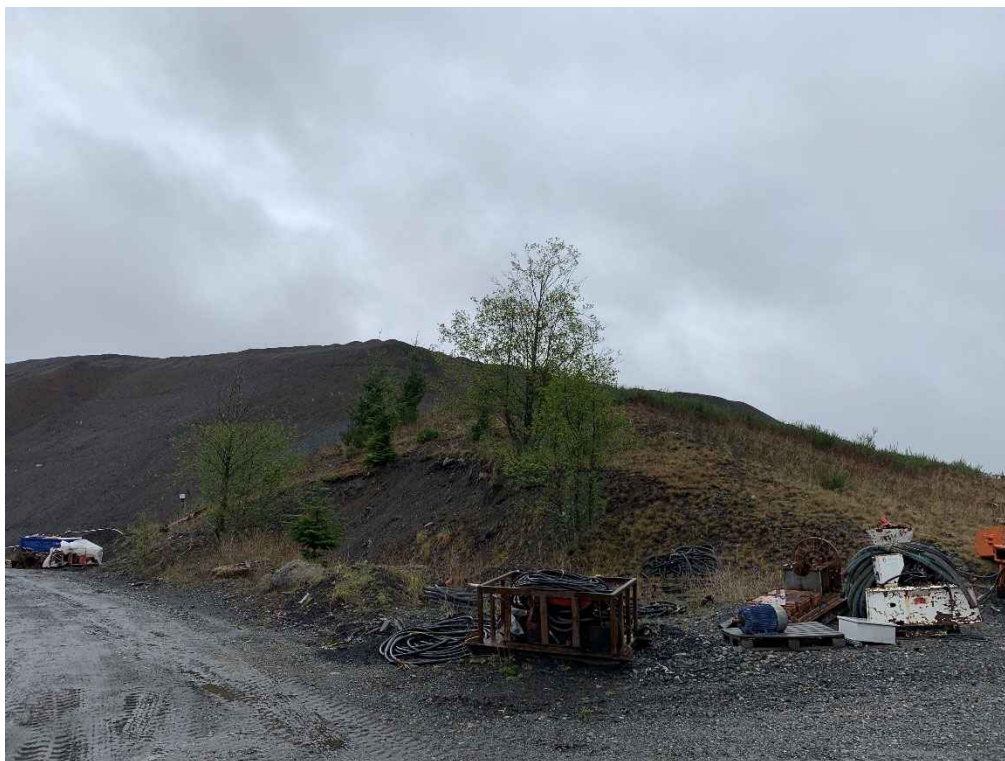
**Photo 25: 2-North Pit TDF, Northwest Corner, with Trees to be Removed.**

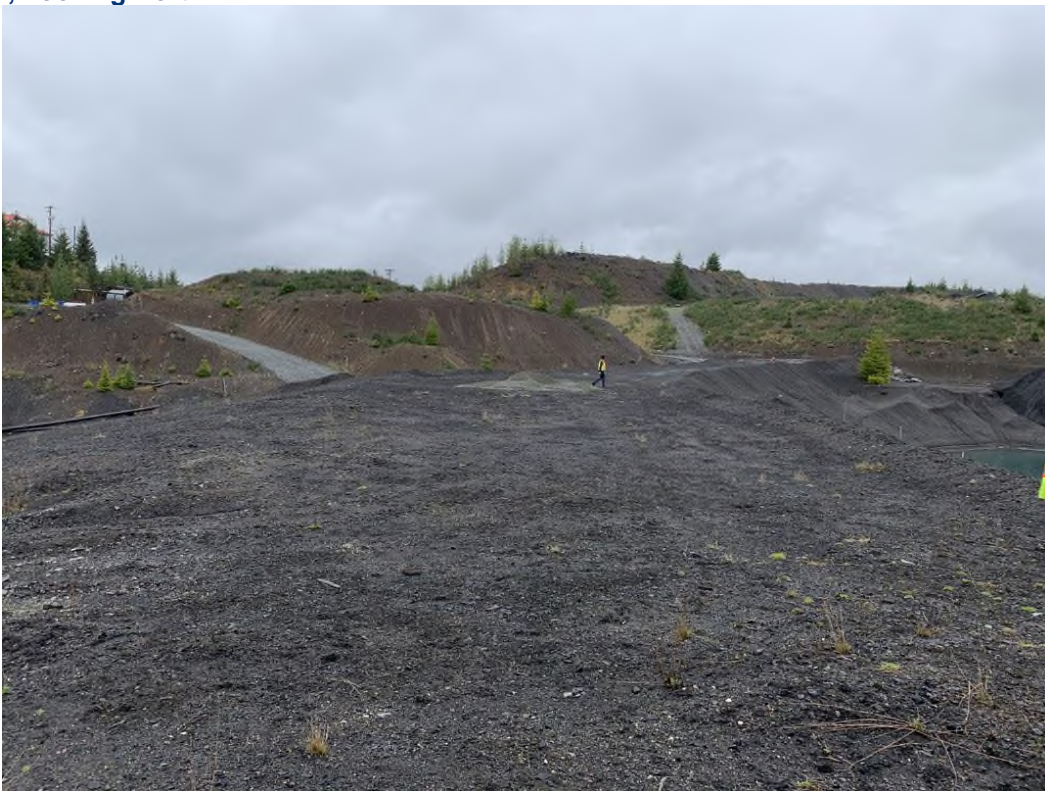
**Photo 2: Old TDF, South Dam Crest, Looking West.**

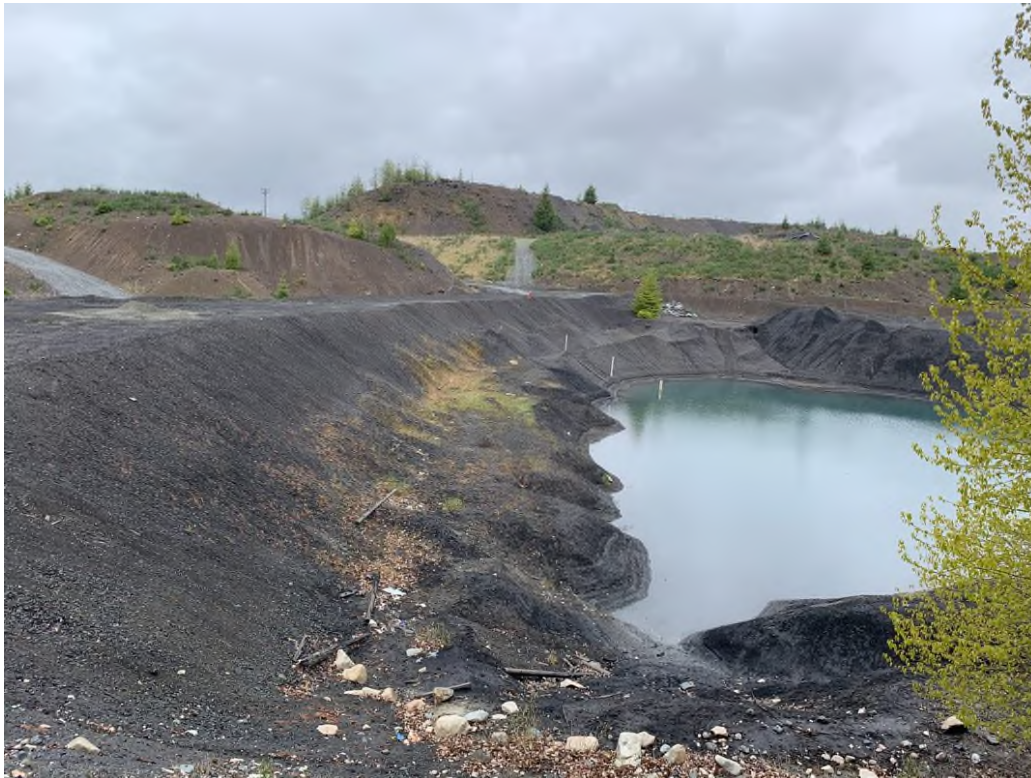
**Photo 3: Old TDF, South Dam Upstream Slope, Slope Surface is Irregular, Looking West.**

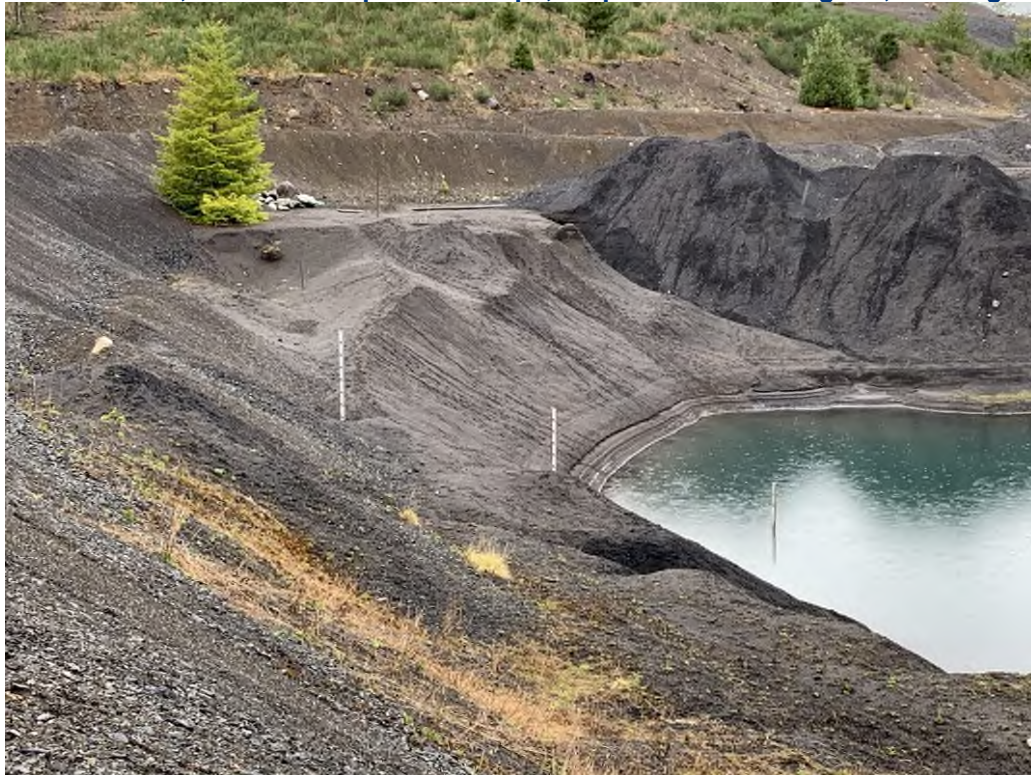
**Photo 4: Old TDF, South Dam Upstream Slope, Showing the Three Staff Gauges and Tree on the West Abutment, Looking West.**

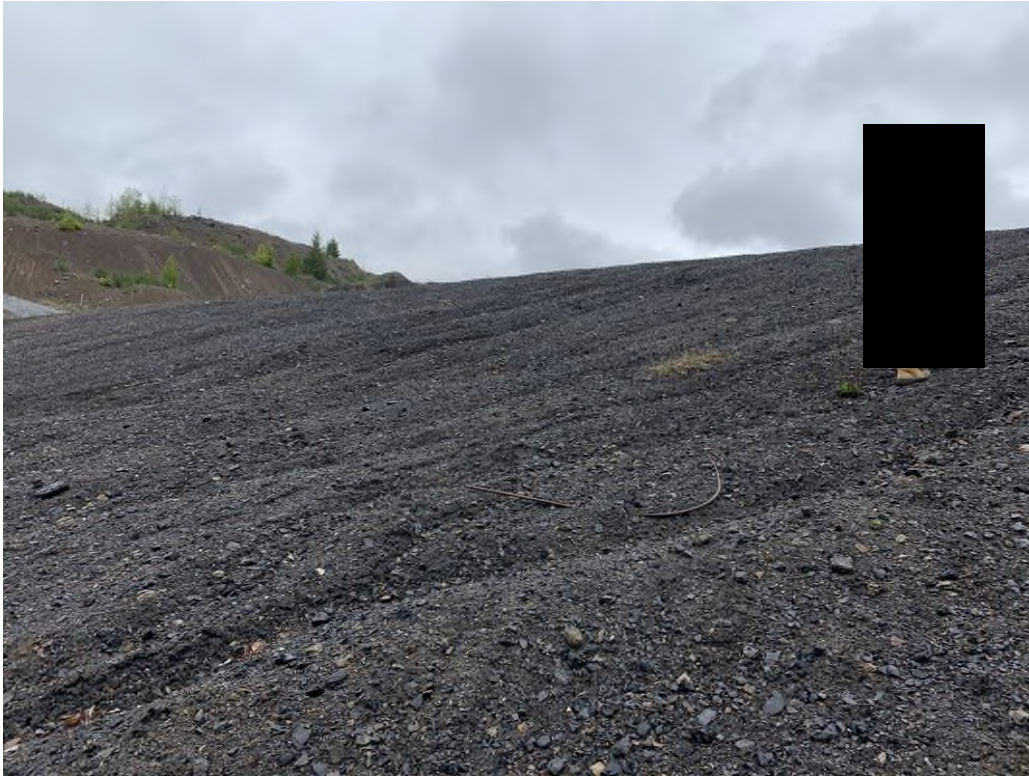
**Photo 5: Old TDF, South Dam Downstream Slope with Erosion Rills Across Surface, Looking West.**

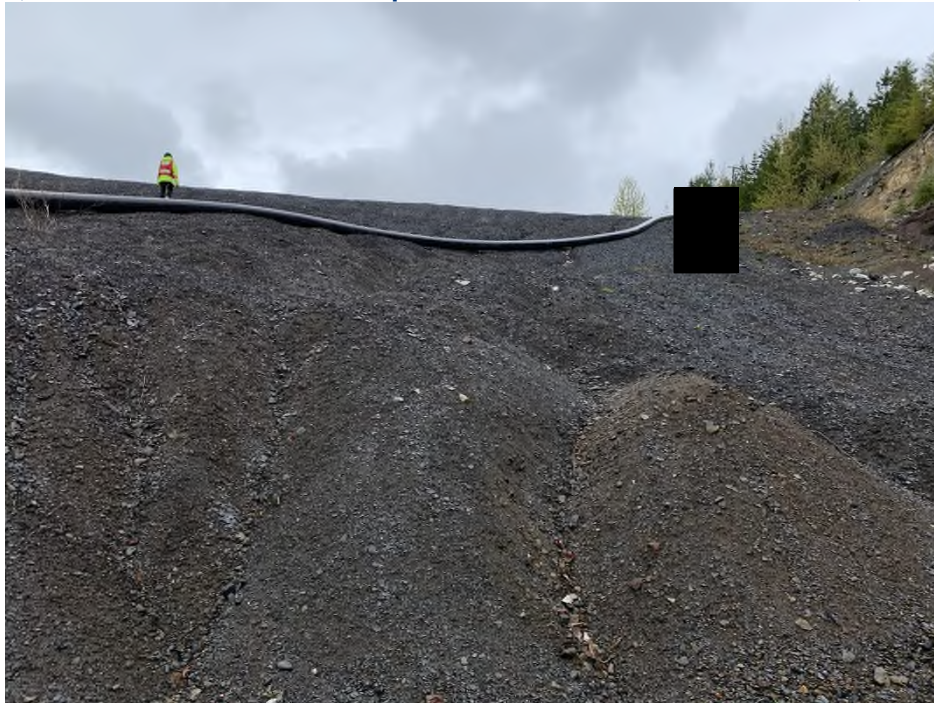
**Photo 6: Old TDF, South Dam Erosion Rills on Downstream Slope.**

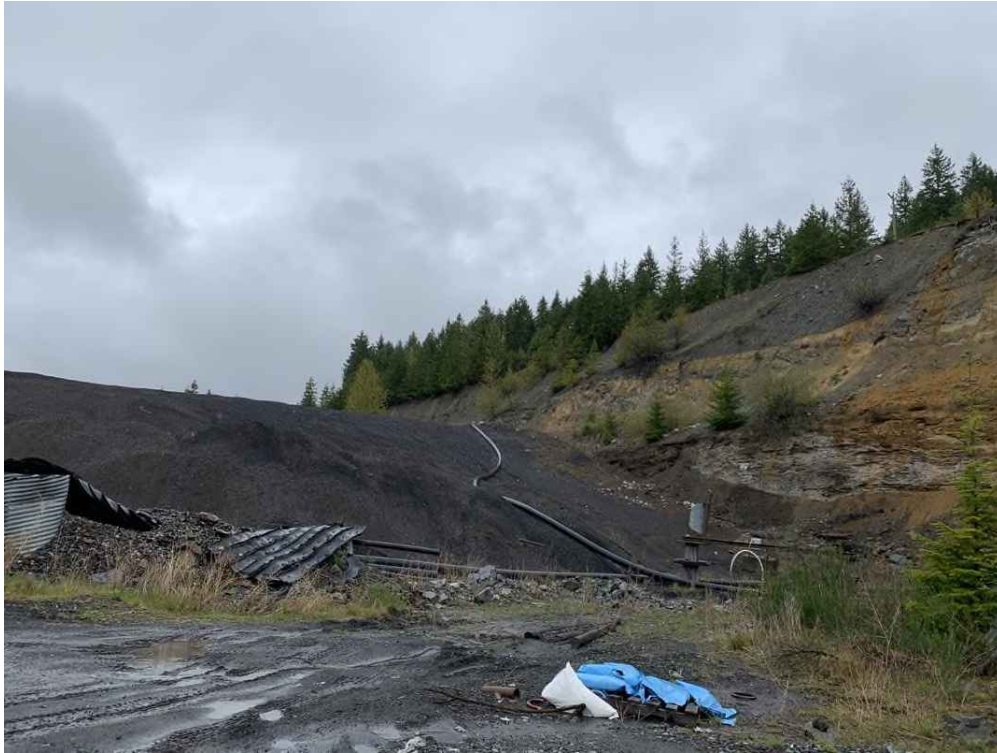
**Photo 7: Old TDF, South Dam Toe, Pipe on Dam Conveys Water from Underground Mine around Old TDF to Brinco Brook. Looking North.**

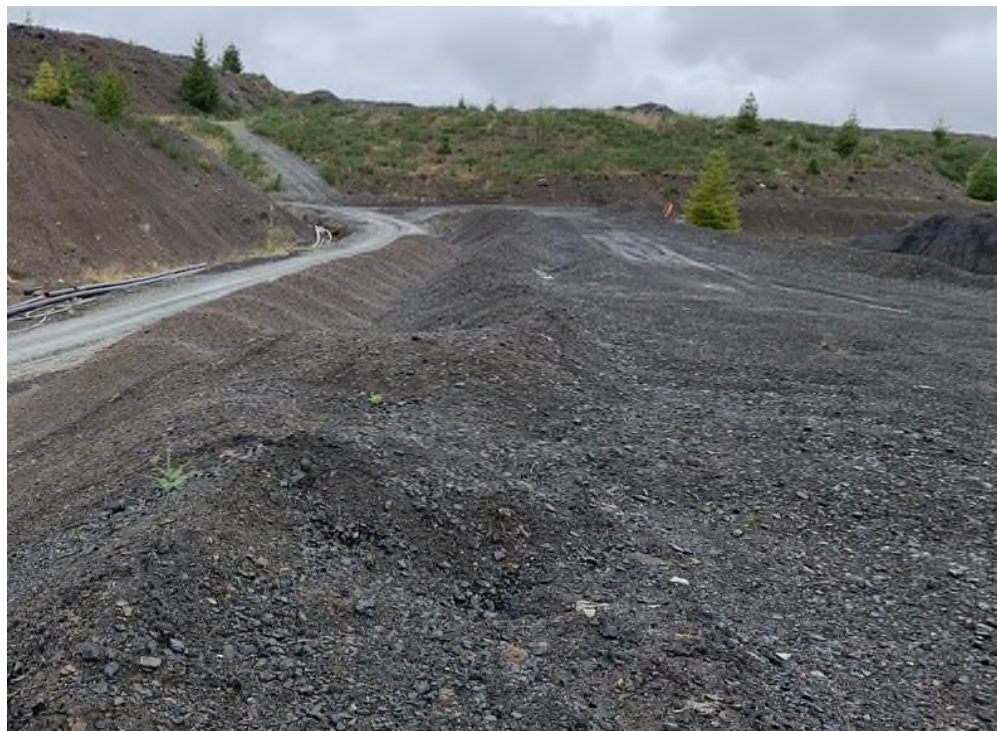
**Photo 8: Old TDF, West Abutment of South Dam, has Water Ponding and Vehicle Ruts Along Surface, Looking North.**

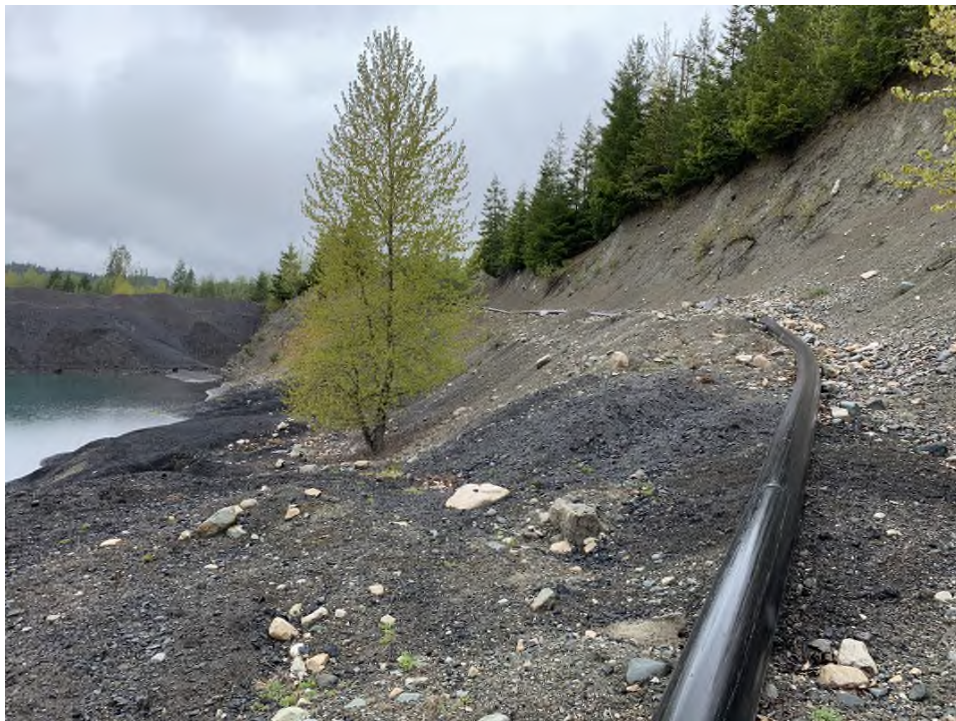
**Photo 9: Old TDF, East Abutment of South Dam. Pipe Conveys Water from Underground Mine around Old TDF to Brinco Brook. Looking North.**

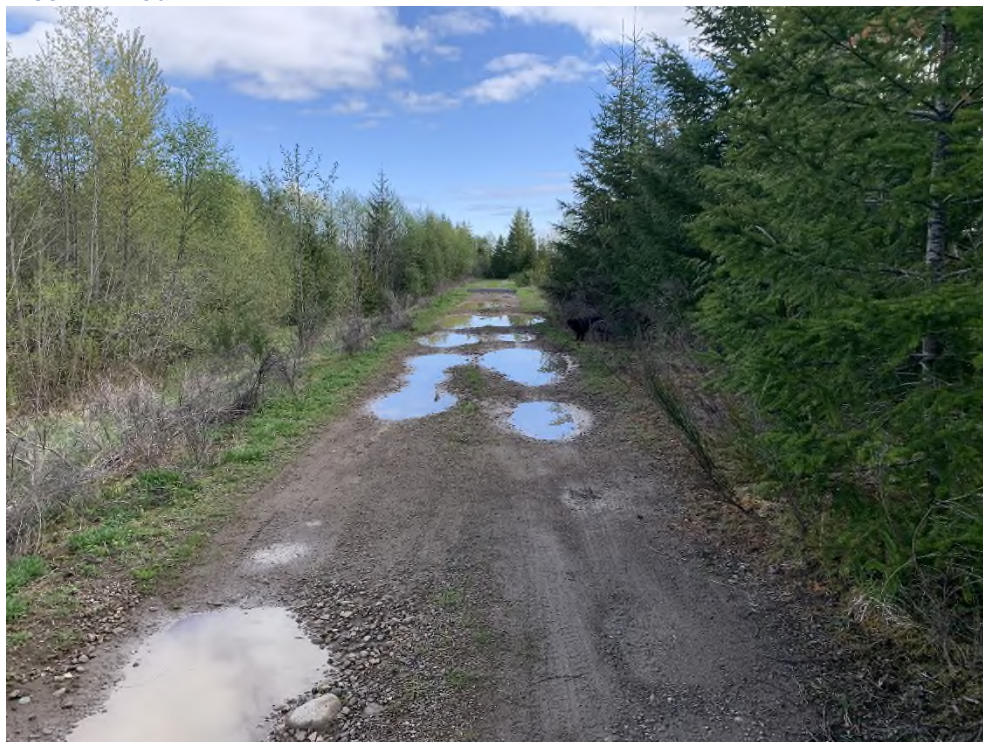
- No signs of instability, settlement, slumping or cracking.
- **Crest:**
  - Ruts near center of dam had been infilled. South end of the dam had deep ruts and ponding, these should be infilled and measures taken to prevent driving on the dam crest. (Photo 2)

**Photo 2: Settling Pond 1 Dam Crest, South End of the Dam with Deep Ruts and Ponding.**

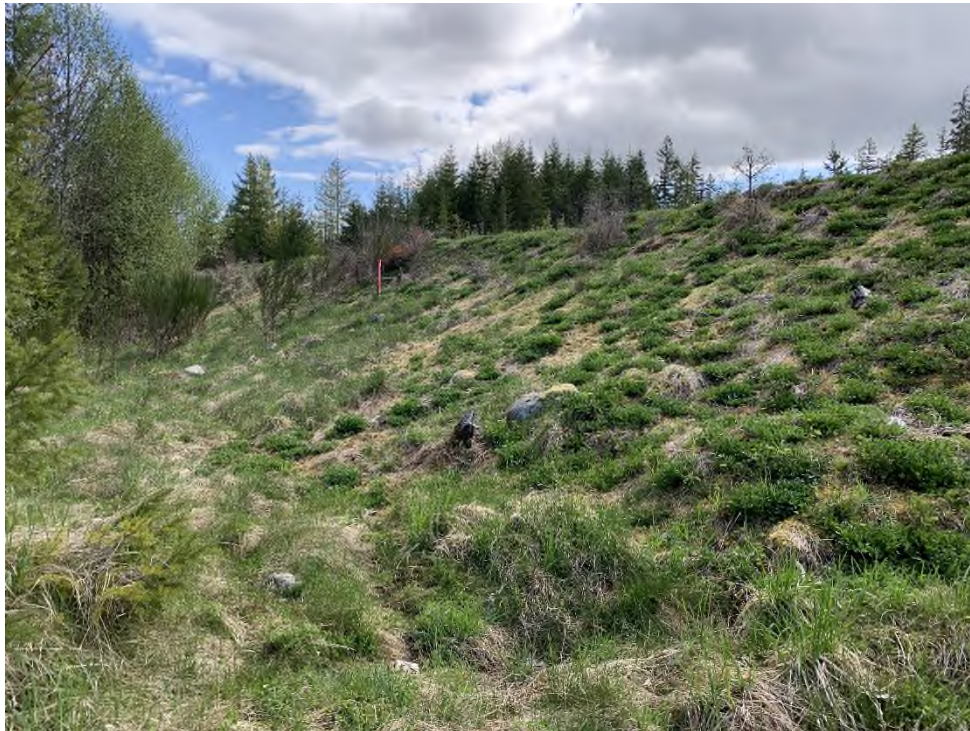
- Slumping near old utility pole near south end of dam. QP described that this was existing and area had not changed.
  - Trees had been cleared near crest of slope, large trees remain near lower portion of slope, these should be removed/cleared. (Photo 3)

**Photo 3: Settling Pond 1 Dam Downstream Slope, Looking Southeast.**

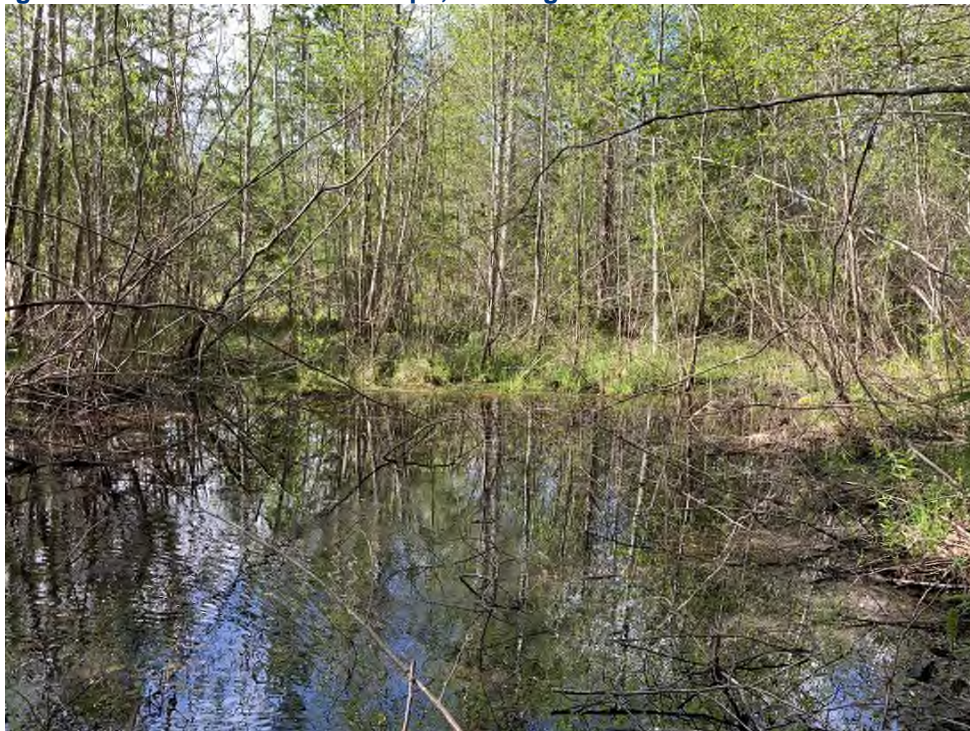
**Photo 4: Settling Pond 1 Water Ponding at the Downstream Toe.**

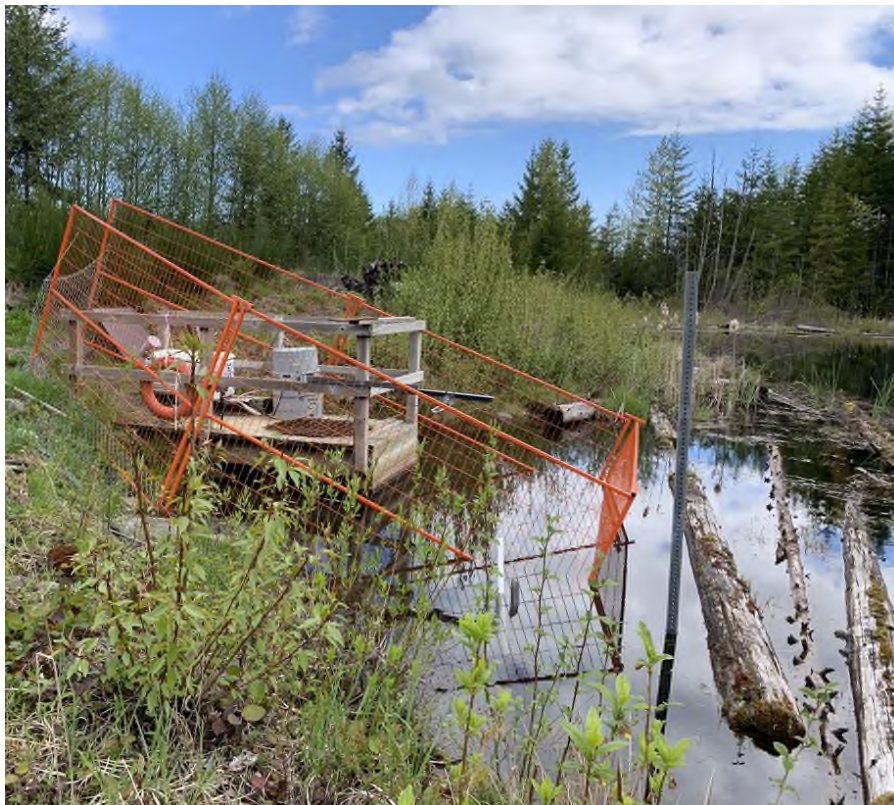
- **Outlet:** Decant inlet with vertical riser in pond, water level 1 cm above inlet. Discharges through metal pipe to channel downstream. Inlet had metal fencing installed around it to stop beavers from plugging outlet. Outlet is 50 cm in diameter, solid steel pipe with 2 cm thick walls. (Photos 5, 6, 8)

**Photo 5: Settling Pond 1 Upstream Decant, Fencing is to Prevent Beavers Blocking Decant, Facing Northeast.**

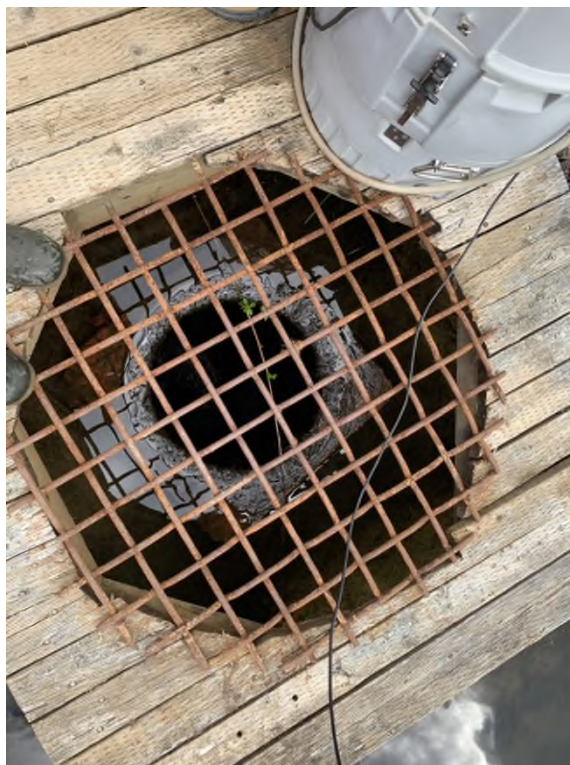
**Photo 6: Settling Pond 1 Upstream Decant.**

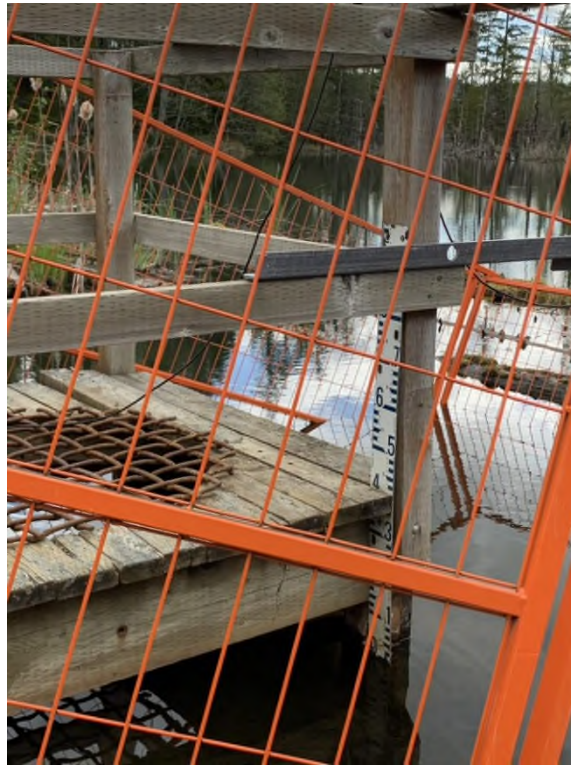
- **Reservoir:** No signs of instability observed. Approximately 1.6 m of freeboard at time of inspection, staff gauge 0 reading with water flowing into decant. Logs and woody floating debris observed in pond. Fencing around decant would prevent woody blocking decant. (Photo 7)

**Photo 7: Settling Pond 1 Staff Gauge.**

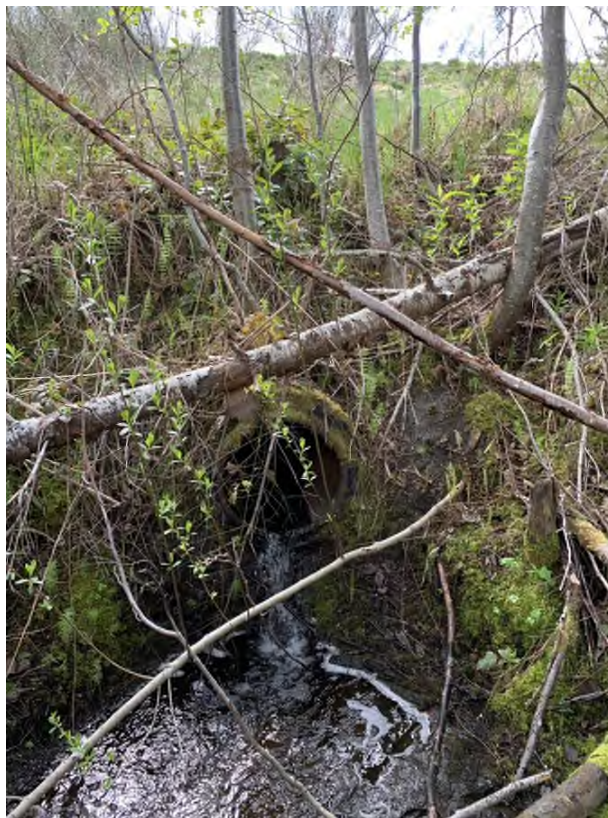
**Photo 8: Settling Pond 1 Low Level Outlet Downstream Discharge.**

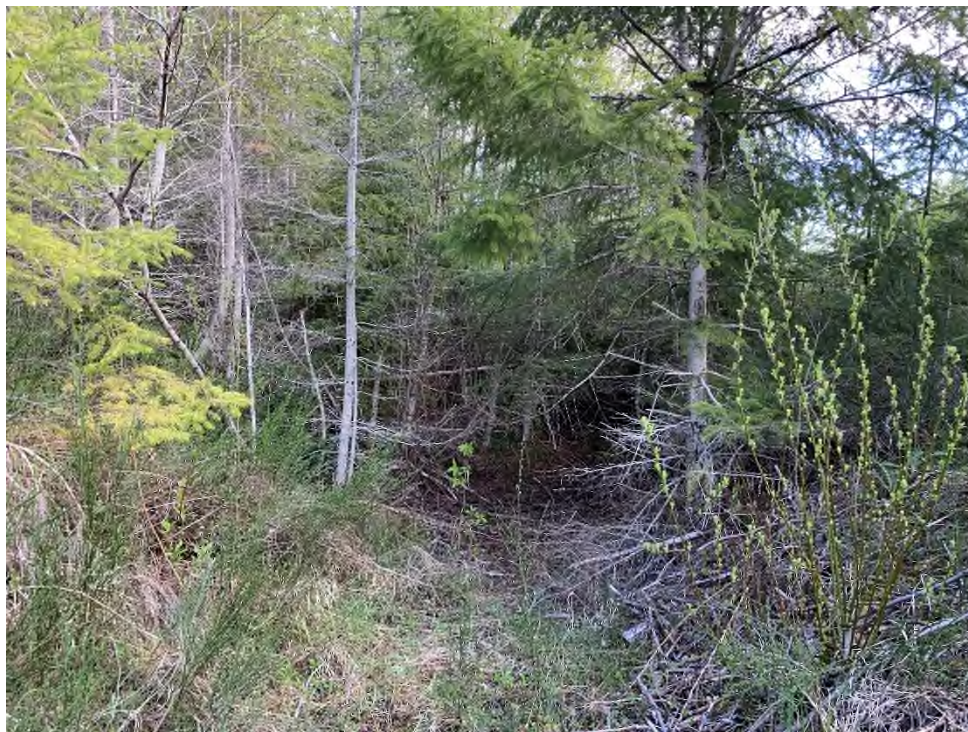
- **Emergency Spillway:** Spillway has bedrock sill approximately 0.9 m below dam crest. Vegetation cleared between pond and sill, remainder of channel overgrown with trees, these should be removed. (Photo 10)

**Photo 10: Settling Pond 1 Vegetation Growing in Emergency Spillway, Looking North in downstream direction from Bedrock Sill.**

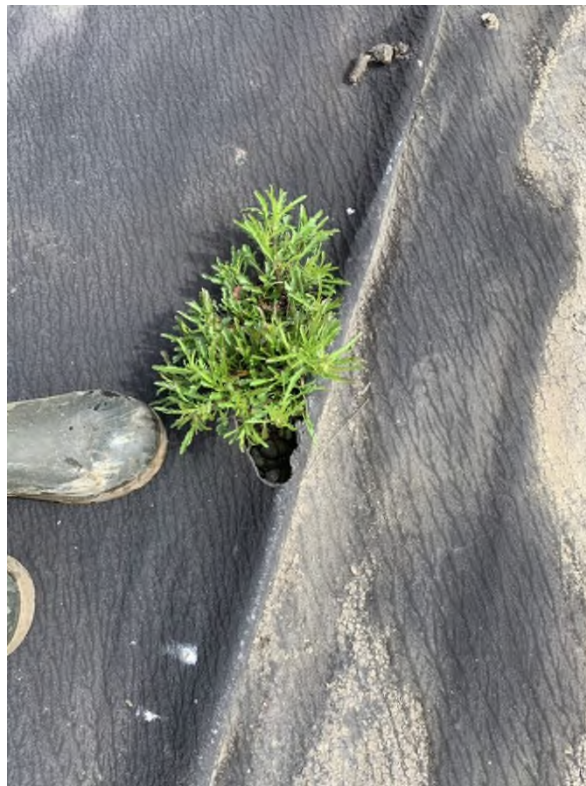
**Photo 15: 2 South Pit Outlet Spillway, Small Tears in the Geomembrane.**

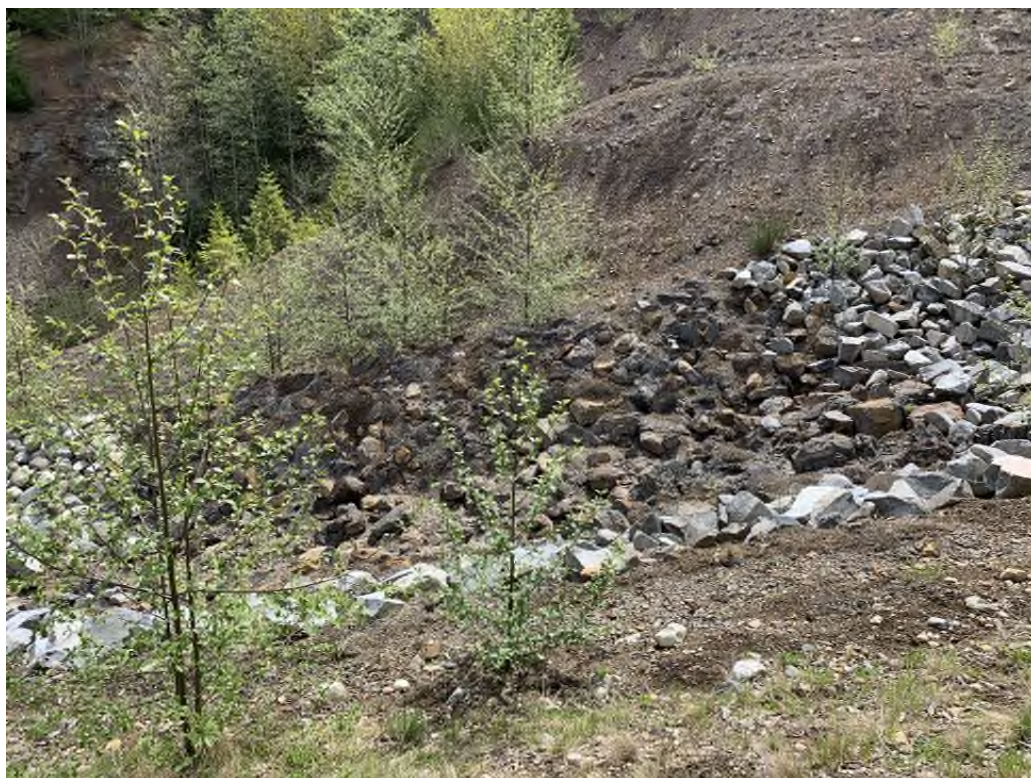
**Photo 18: 2 South Pit Armoured Outlet Channel to 3 South Pit, Riprap is Weathered, Looking North**

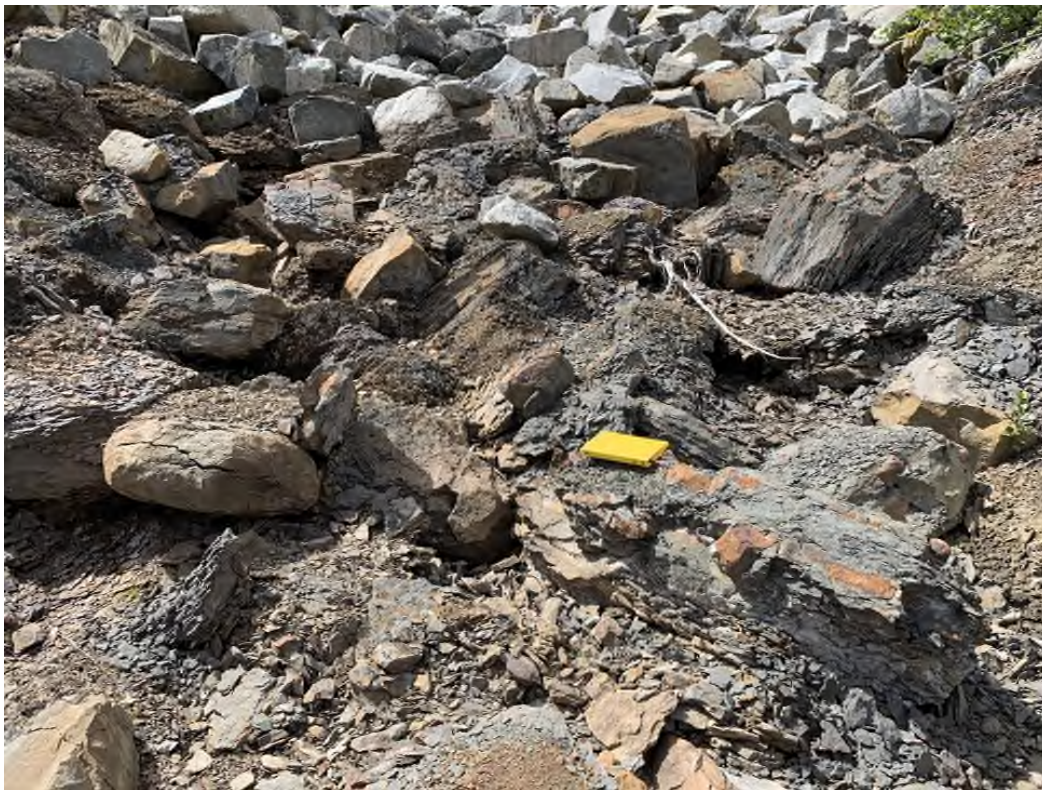
**Photo 19: Close Up of Weathered Riprap in Channel between 2 South Pit and 3 South Pit.**

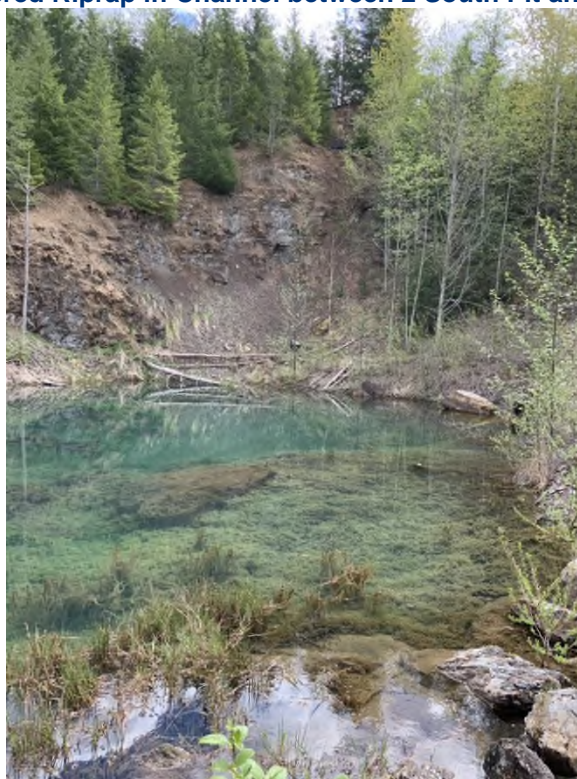
**Photo 20: Water Ponded at the Toe of the 2 South Pit Dam in the Channel between 2 South Pit and 3 South Pit.**

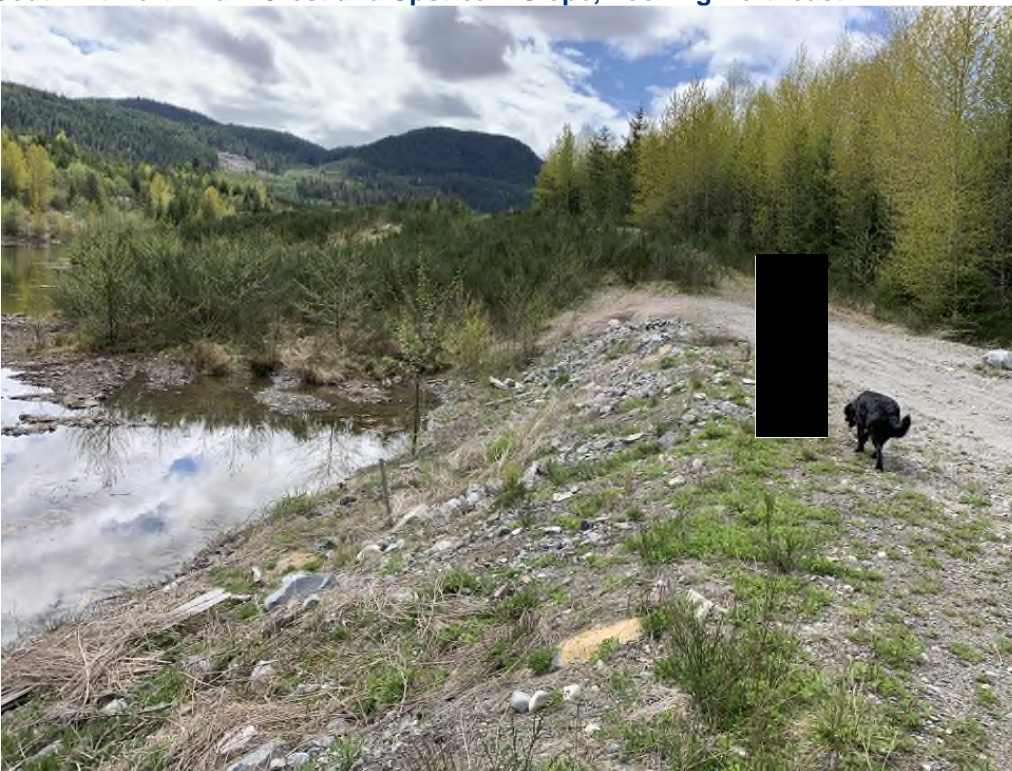
**Photo 27: 3 South Pit North Dam, Erosion Runoff Channel on Upstream side of Crest, Looking South.**
