## **Quinsam Coal Mine 2020 Dam Safety Inspections:**

**2 North Pit TDF and South Dam  
2 South Pit and 3 South Pit PAG-CCR Disposal Facilities  
Settling Pond 1 and Settling Pond 4**

PRESENTED TO  
**Bowra Group Inc.**

JUNE 16, 2021  
ISSUED FOR USE  
FILE: 704-ENG.DMPA03006-01

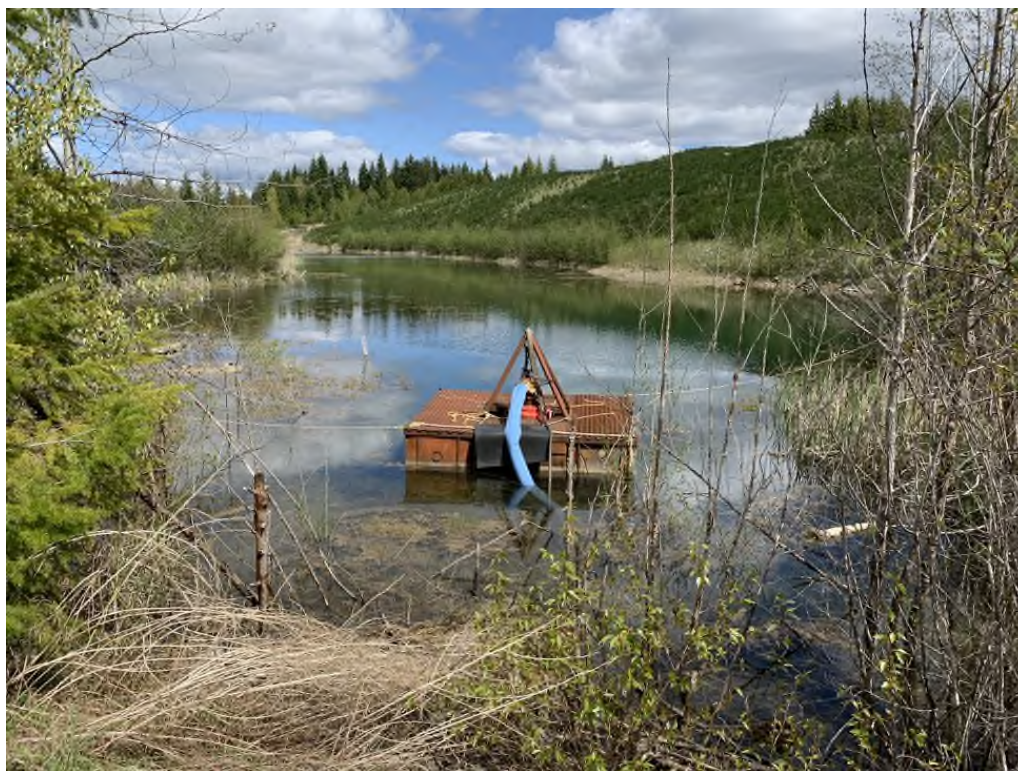
**Photo 30: 3 South Pit Floating Pump Barge.**

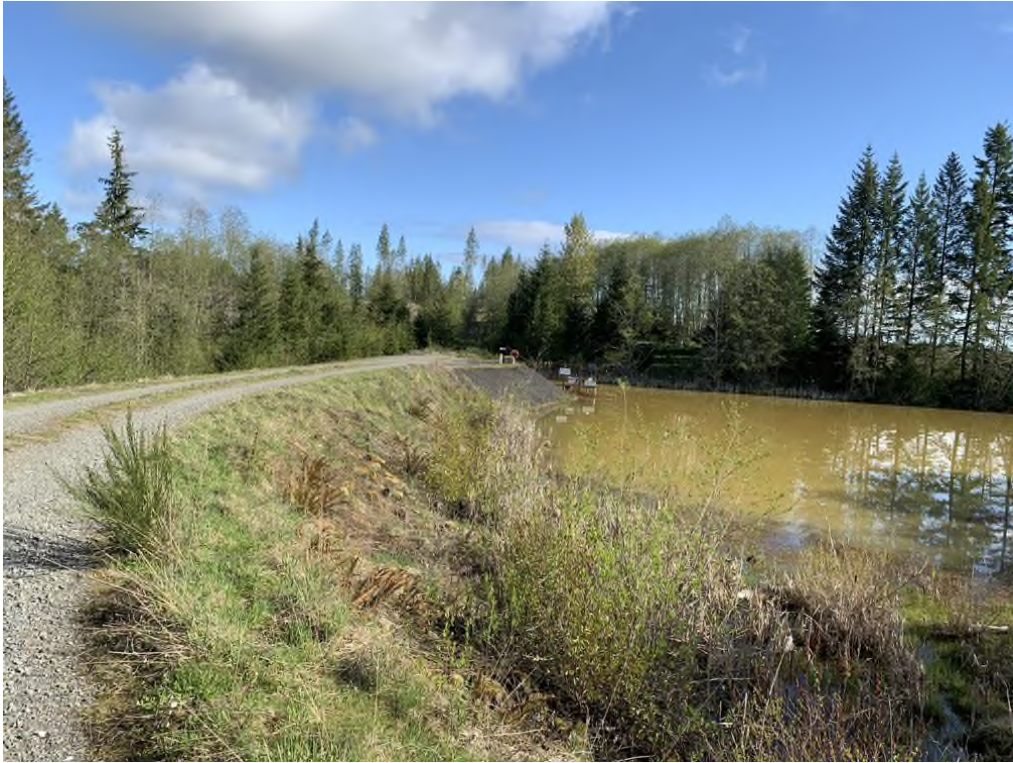
- **Upstream Slopes:**
  - Approximately 1.7V:1H. Ends covered in riprap, repair in middle is exposed CCR.
  - Small shrubs at ends of dam, these should be removed. (Photo 32)

**Photo 32: Settling Pond 4 Dam Crest and Upstream Slope, Looking North.**

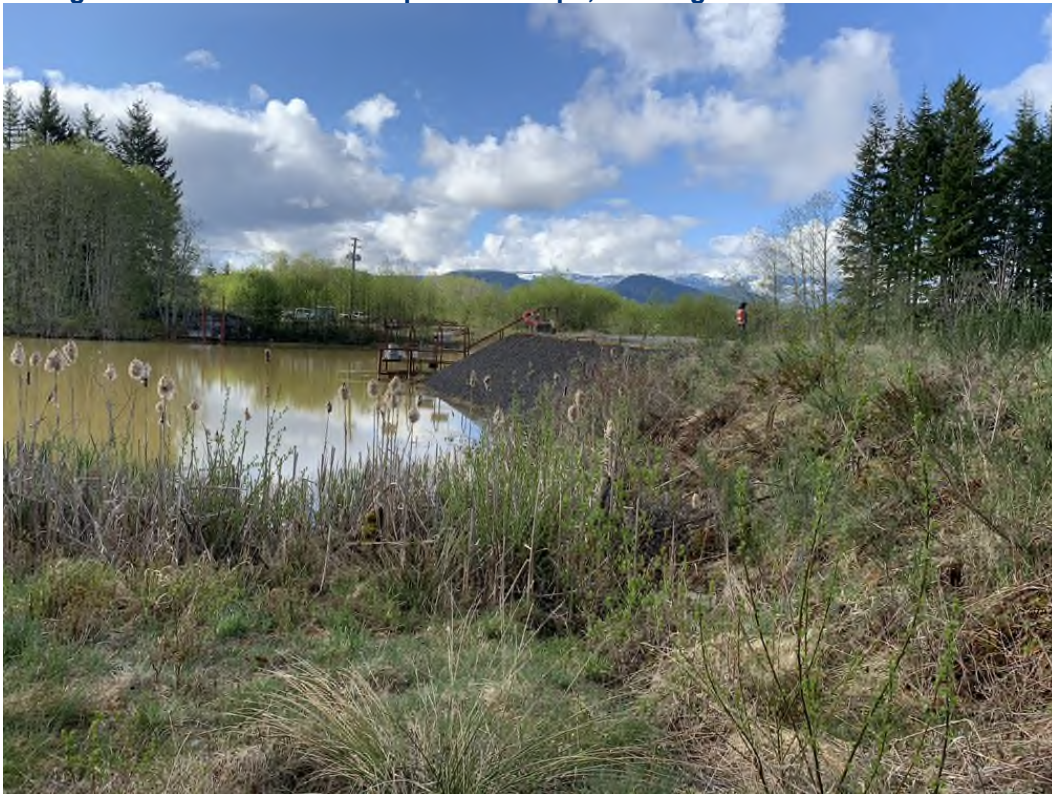
**Photo 33: Settling Pond 4 Dam Upstream Slope Looking South.**

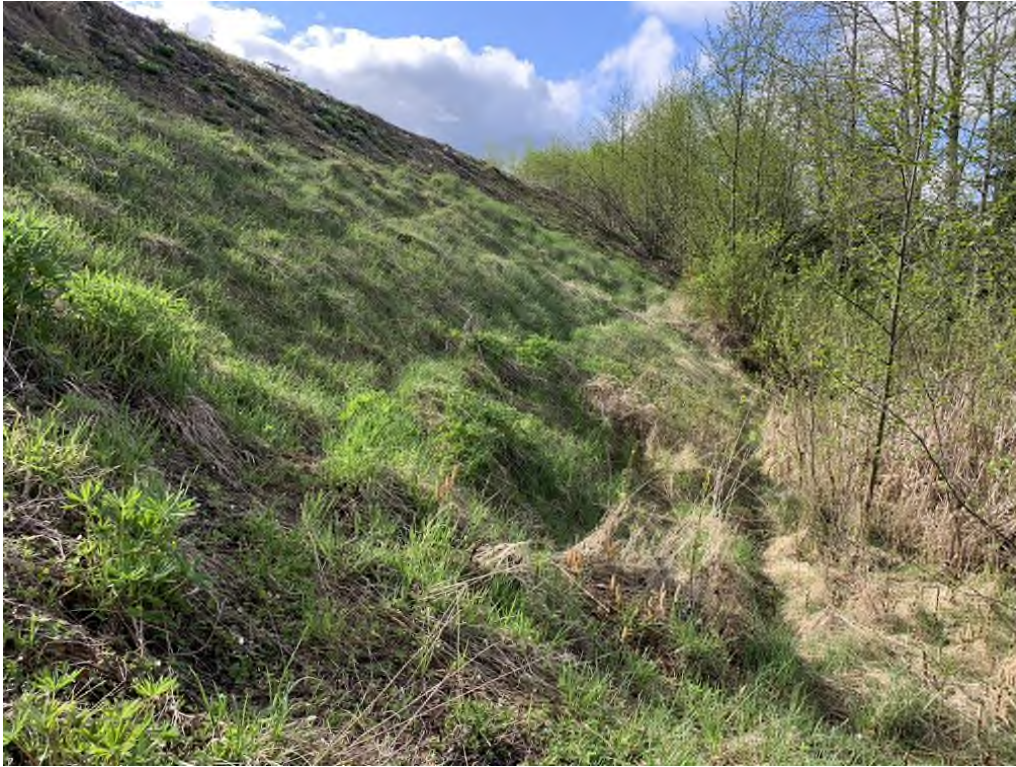
- **Downstream Slopes:**
  - Trees growing along lower portion of dam slopes. These should be removed. (Photos 34, 43)
  - Sloped at approximately 1.7 H:1V

**Photo 34: Settling Pond 4 Dam Downstream Slope, Looking South.**

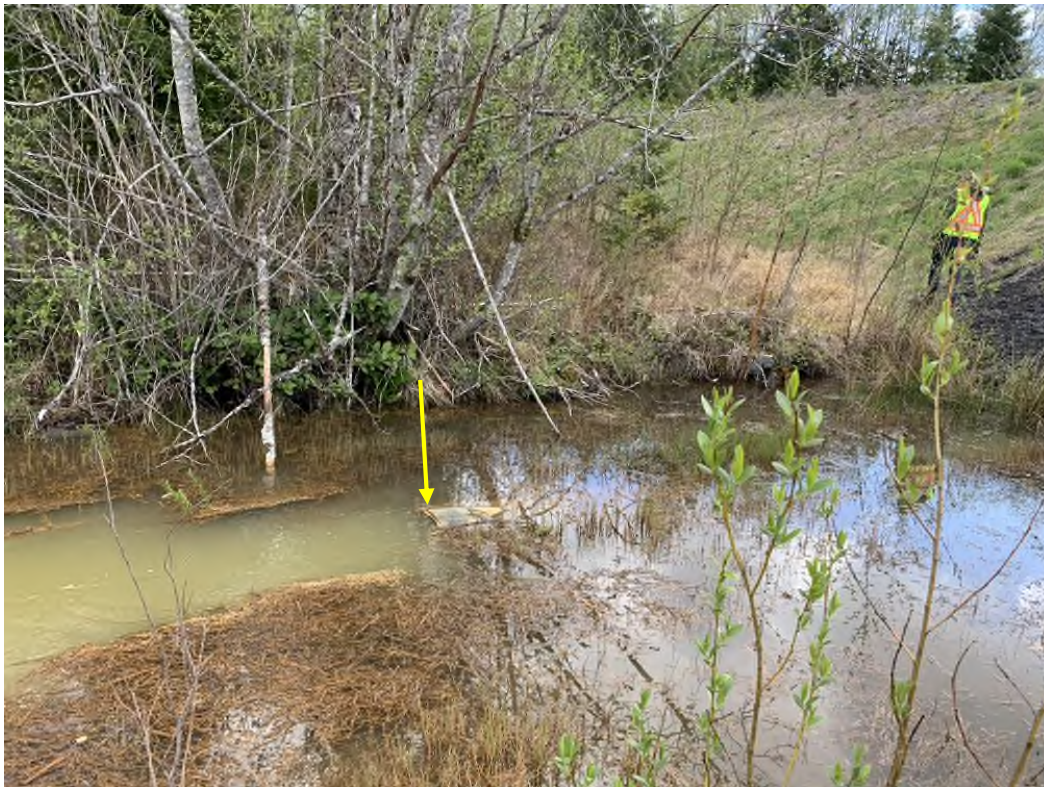
- **Outlet:** Decant inlet with vertical riser in pond, approximately 10 cm of water above inlet. Discharges through HDPE pipe to channel downstream, outlet mostly submerged. QP described that water at outlet is never low enough to look in and inspect pipe. (Photos 35, 37)

**Photo 35: Settling Pond 4 Submerged Downstream Outlet, identified by yellow arrow.**

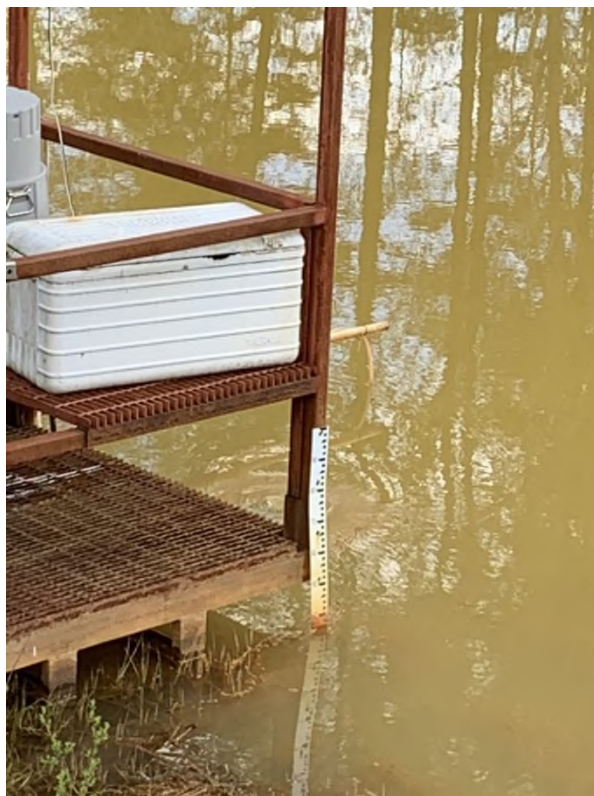
- **Instrumentation:** Staff gauge installed near decant inlet, QP noted that base of staff gauge at 16 cm, which is the elevation of the decant inlet. Flow meter installed in inlet to decant. 4 VVWs installed in dam, installation records not available. (Photo 38)

**Photo 38: Settling Pond 4 Close Up of Staff Gauge.**

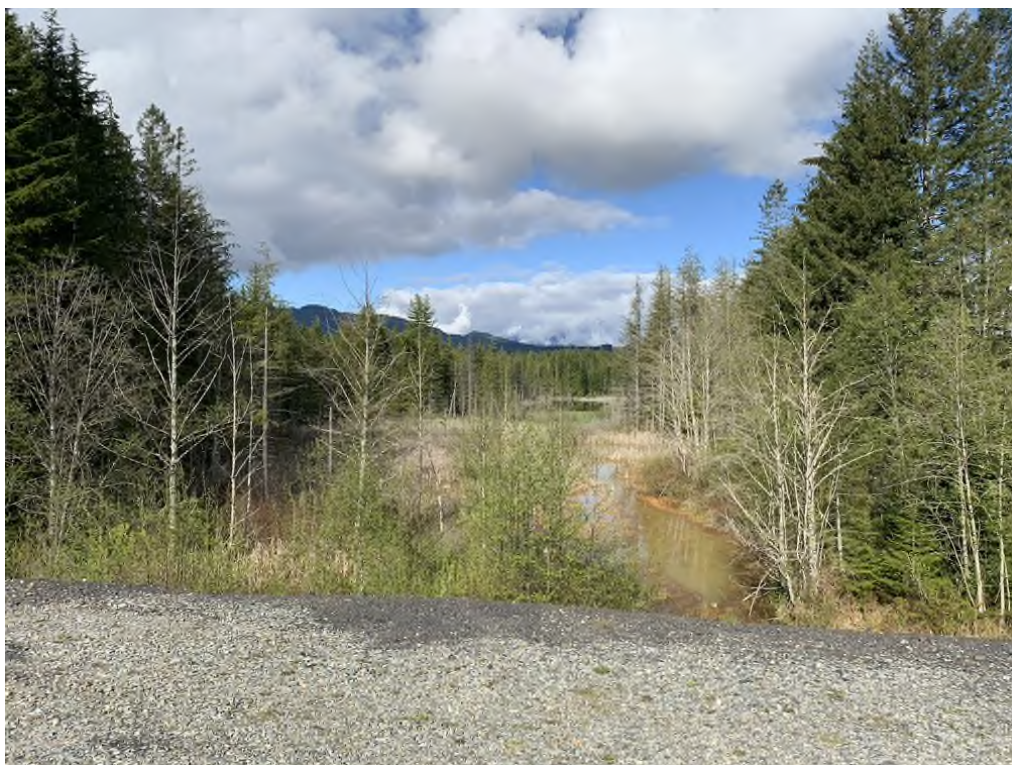
**Photo 39: Settling Pond 4 Looking Downstream/West.**

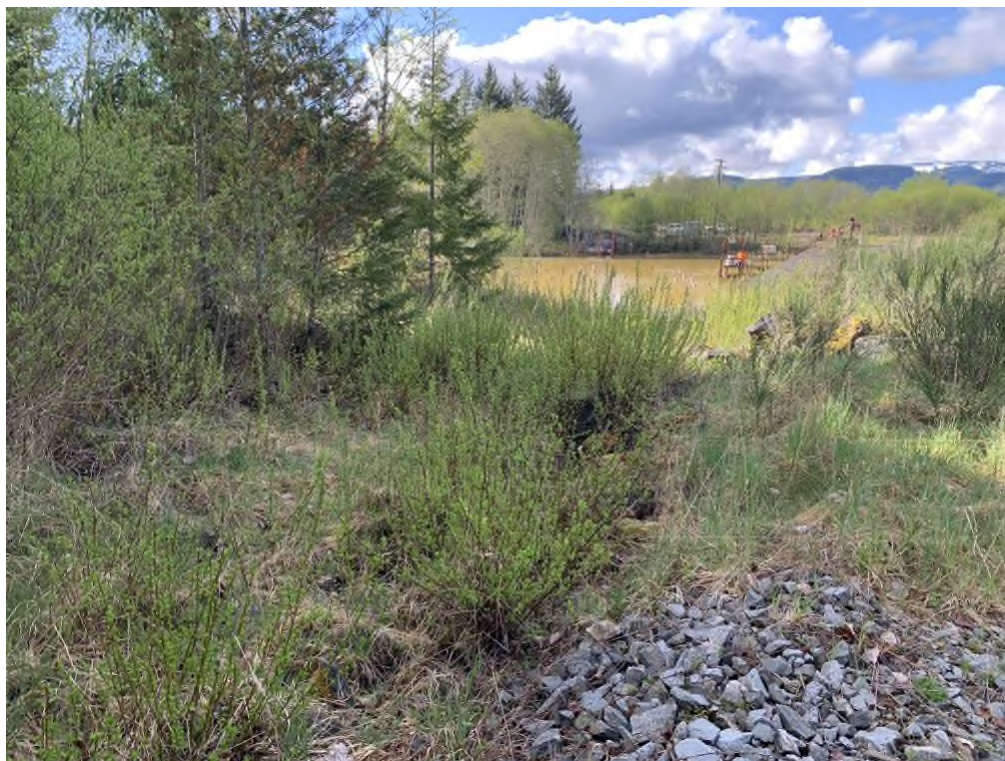
**Photo 40: Settling Pond 4 Spillway, Looking East/Upstream.**

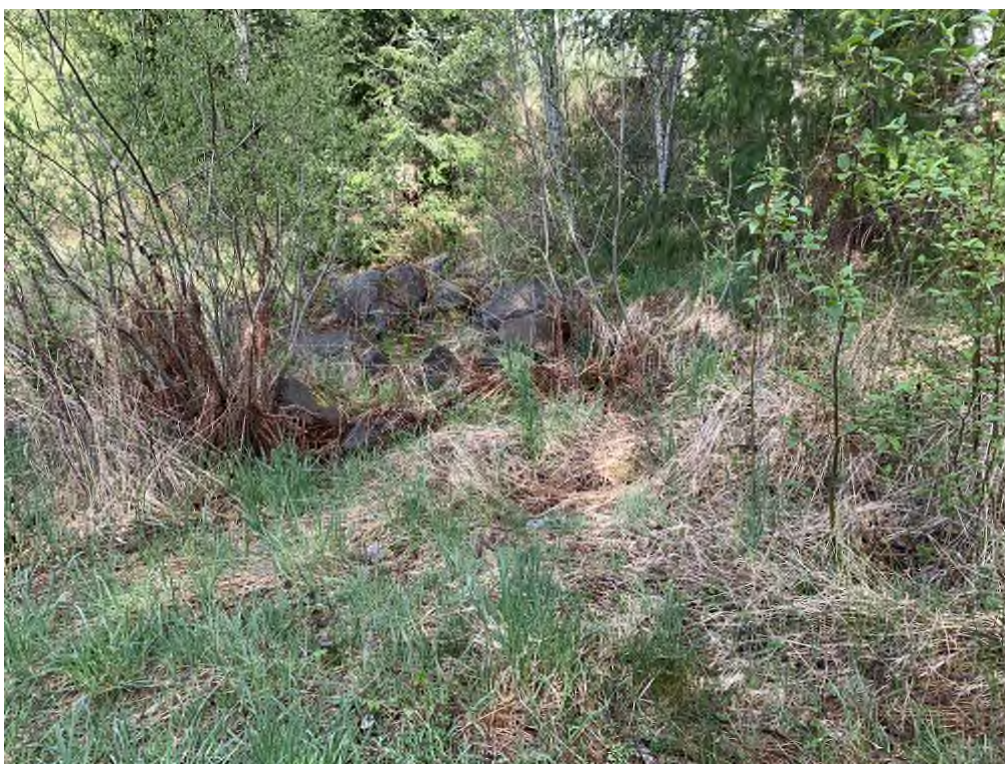
**Photo 41: Settling Pond 4 Spillway with Granular Fill, Looking West/Downstream.**

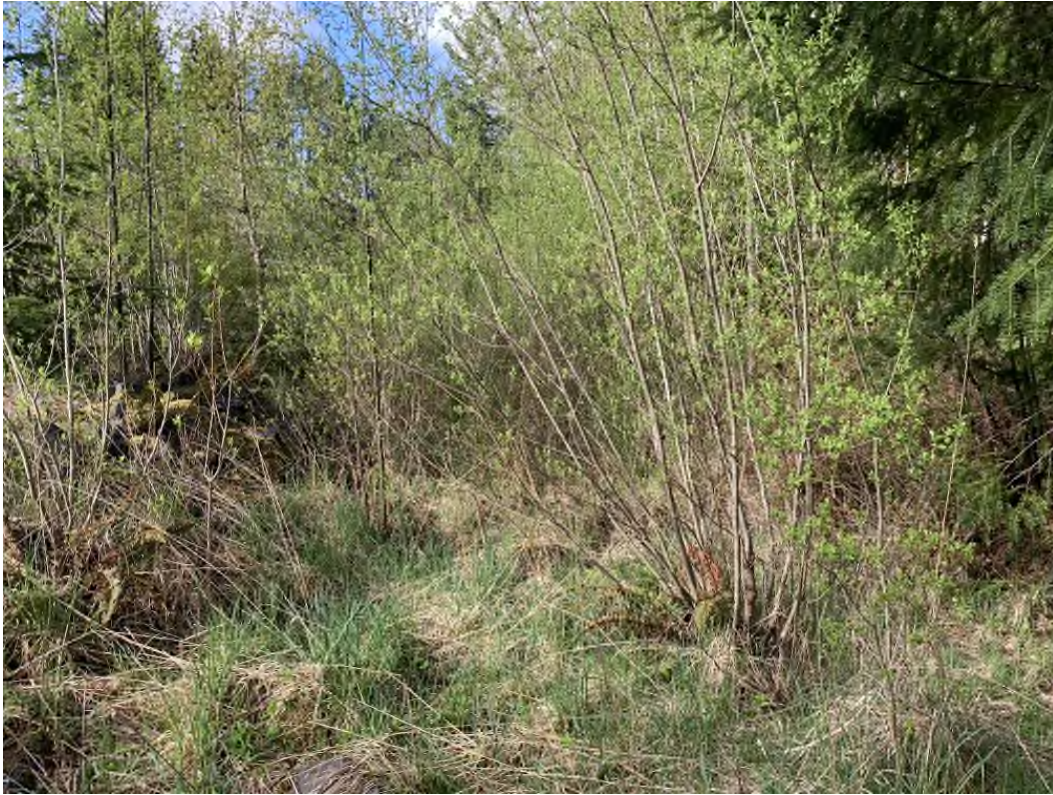
- **Emergency Spillway:** Spillway near dam crest infilled with gravel for road surface, invert of spillway approximately 1 m below dam crest. Shrubs growing in channel between reservoir and dam, channel downstream of spillway overgrown with trees. This vegetation should be removed. (Photo 42)

**Photo 42: Settling Pond 4 Vegetation Growing in Spillway, Looking Southwest/Downstream.**

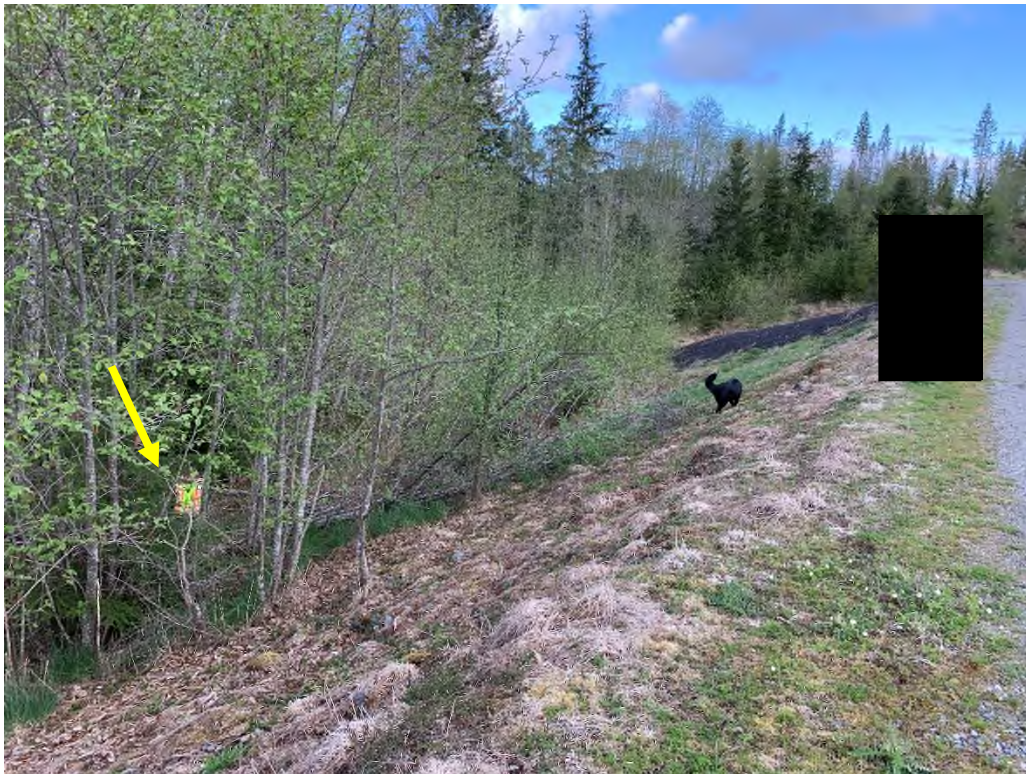
**Photo 43: Settling Pond 4 Trees growing on South Side of Downstream Embankment. Dam Toe marked by yellow arrow, all trees upslope should be removed.**

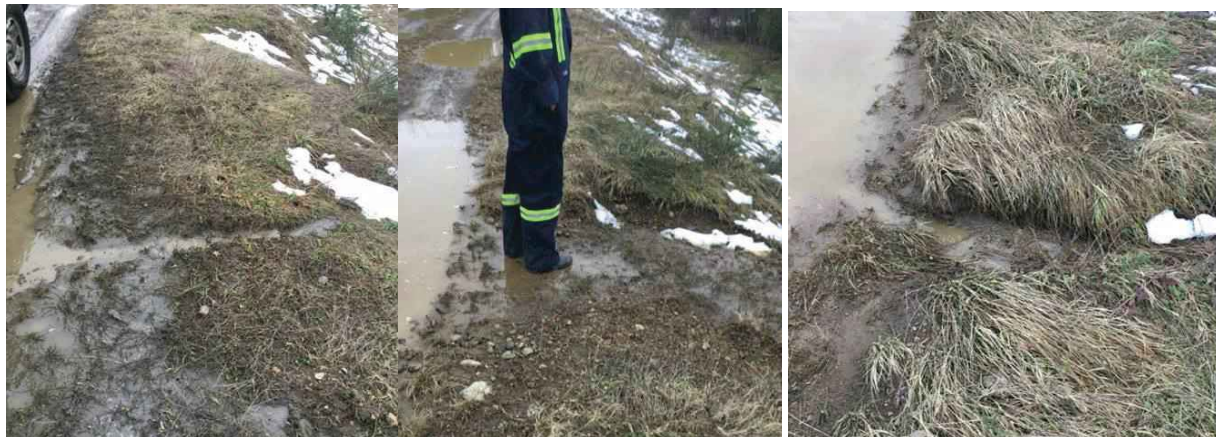
For proper operation, these channels/ditches should be dug towards to pond, if needed to.

Here are photos for these dug ditches.

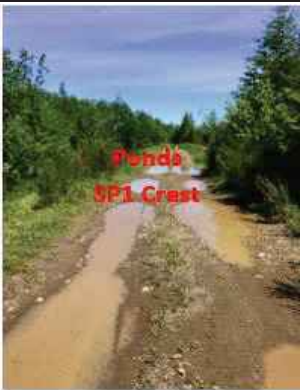
</div>
Settling Pond #1 (SP1)-South Water Management System		
Notes: Ruts in the SP1 crest needs be filled, causing water ponding on the crest (see photo)		
<div>Crest and Slopes Stability:</div> <div>Ponds in the crest; no gullies, cracks, sinkholes, slides observed on the downstream slope.</div>		
<div>Vegetation:</div> <div>Ongoing, spary on noxious weed on May 19 following pest management guideline</div>

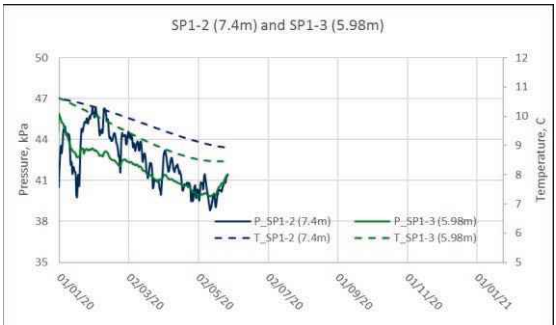
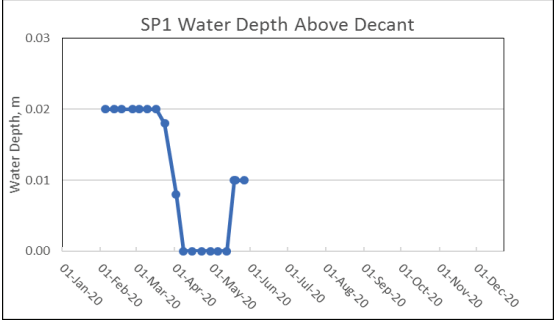
<div>Seepage:</div> <div>Wet spots on the downstream side are being monitored.</div>		
<div>Animal Activity:</div> <div>No burrowing is observed.</div>		
<div>Spillway:</div> <div>No overflow</div>		
<div>Water Management:</div> <div>Discharging at SP1 (see the plot below of water depth above decant); 3S water is pumping to SP1</div>		
Instrumentation: VVPs (2 shallow and 2 deep)		Staff Gauge
<div>

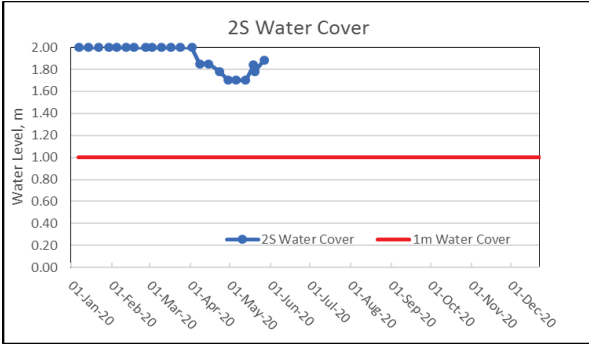
</div>
2-South PAG-CCR Pond (2S)-South Water Management System		
Notes: Vegetation needs to be controlled at 2S central passway.		
<div>Crest and Slope Stability:</div> <div>No settlement, gullies, cracks and slouging observed</div>		
<div>Vegetation Control:</div> <div>Trees and shrubs on the two slopes of the central connection way need be cut off.</div>		
<div>Seepage:</div> <div>Seeping to 3S pit through the Engineer designed channel</div>		
<div>Animal Activity:</div> <div>No burrowing is observed.</div>

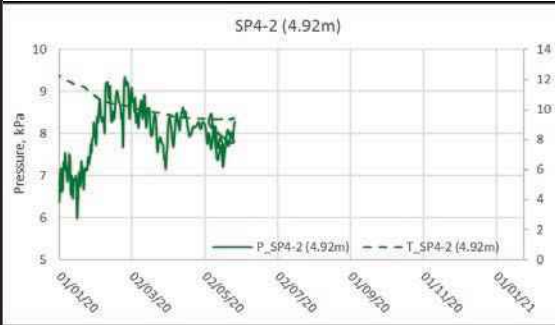
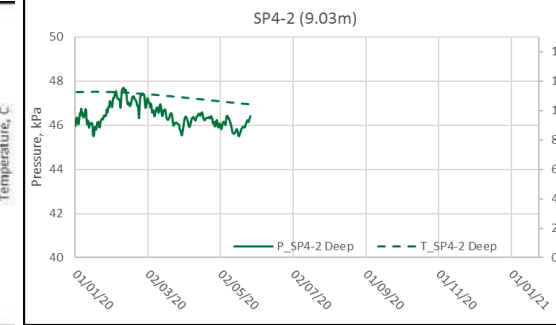
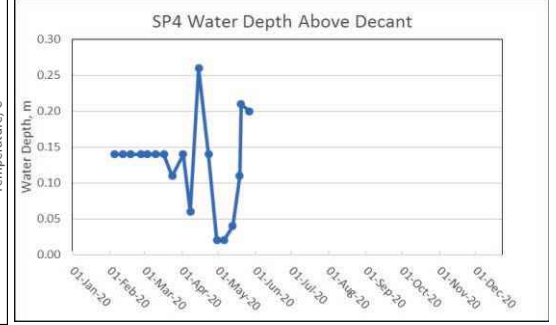
</div>
Settling Pond #4 (SP4)-North Water Management System		
Notes: Water color is orangy green; No water quality concern brought up by Environmental staff; Sprayed noxious weeds start withering.		
<div>Crest and Slope Stability:</div> <div>No cracks, gullies and sloughing observed</div>		
<div>Vegetation Control:</div> <div>Ongoing; Spary on noxious weed on May 19 following pest management guideline.</div>		
<div>Seepage:</div> <div>No seepage is observed on downstream slope and toe.</div>		
<div>Animal Activity:</div> <div>No burrowing is observed.</div>		
<div>Spillway:</div> <div>No overflow; debris and cut-branches need clean up.</div>		
<div>Water Management:</div> <div>The plant pump is off.</div>		
Instrumentation: VVPs (1 shallow and 1 deep)		Staff Gauge
<div>

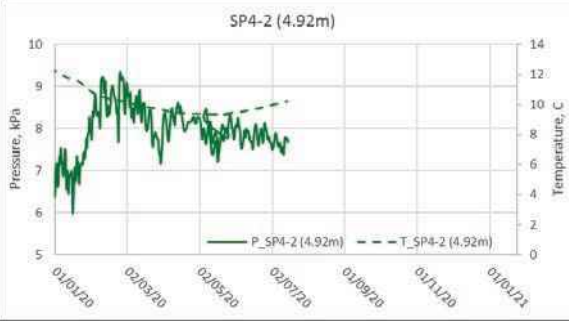
</div>
Settling Pond #4 (SP4)-North Water Management System		
<div>Notes: water color is clear (see photo). Water level is below the staff gauage (0).</div> <div>Crest and Slope Stability: No cracks, gullies and sloughing observed</div> <div>Vegetation Control: Well-controlled</div> <div>Seepage: No</div> <div>Animal Activity: No</div> <div>Spillway: No overflow in the spillway</div> <div>Water Management: No discharge at SP4; Plant pump is off.</div>		
Instrumentation:	VWPs (1 shallow and 1 deep)	Staff Gauge
<div><div>SP4-2 (4.92m)</div>

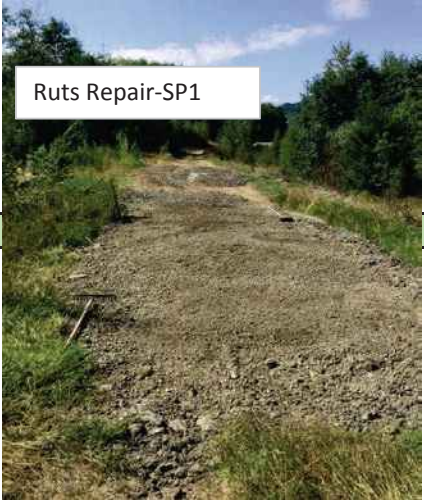
<div>Weekly Inspection Report</div> <div>Water Management Facility (WMF)-SP1, 2S, 3S and SP4</div>		<div>QUINSAM</div> <div>COAL</div>
Date: August 11, 2020		Weather: Sunny
Inspector: Sarah S		
<div>Weekly Summary:</div> <div>Ruts in the SP1 crest is repaired; A construciton report will be prepared</div> <div>More brushcutting on the SP1 crest</div> <div>Dischaging at SP4, no discharging at SP1</div> <div>Overflow at 2S to 3S through the designed channel</div> <div>No flow in the SP1 and SP4 spillways</div>		<div>Ruts Repair-SP1</div>

Settling Pond #1 (SP1)-South Water Management System		
Notes: Ruts in the SP1 crest is repaired with same construction material		
<div>Crest and Slopes Stability:</div> <div>Dry crest; no gullies, cracks, sinkholes, slides obseved on the downstream slope.</div> <div>Vegetation:</div> <div>the weeds around pizeomater and solar panel are cut off</div> <div>Seepage:</div> <div>Wet spots on the downstream toe are dry.</div> <div>Animal Activity:</div> <div>No</div> <div>Spillway:</div> <div>No overflow in the spillway</div> <div>Water Management:</div> <div>No Discharging at SP1</div>

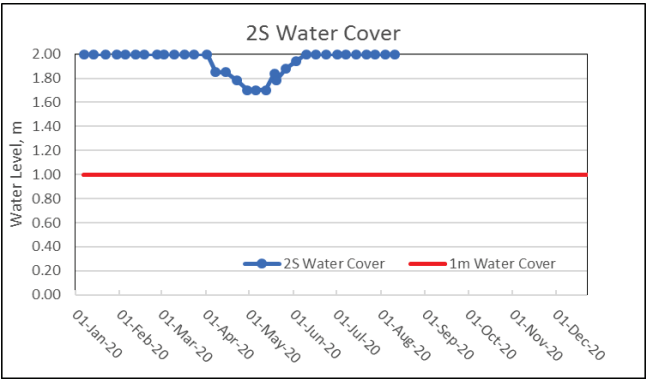
2-South PAG-CCR Pond (2S)-South Water Management System		
Notes: Water cover at 2S is above 2m;		
<div>Crest and Slope Stability:</div> <div>No</div> <div>Vegetation Control:</div> <div>Trees in the discharge channel need to be managed</div> <div>Seepage:</div> <div>Seeping to 3S pit through the Engineer designed channel</div> <div>Animal Activity:</div> <div>No</div> <div>Water Management:</div> <div>Low flow water management mode is on</div> <div>Instrumentation:</div> <div>No pizeometers at 2S pit.</div> <div>Flow at 2S Inlet (m)</div> <div>~0.17</div> <div>Spillway/Discharge Channel</div> <div>Overflow to 3S through the engineer designed channel.</div> <div>2S UG pump (l/s)</div> <div>6.5</div>

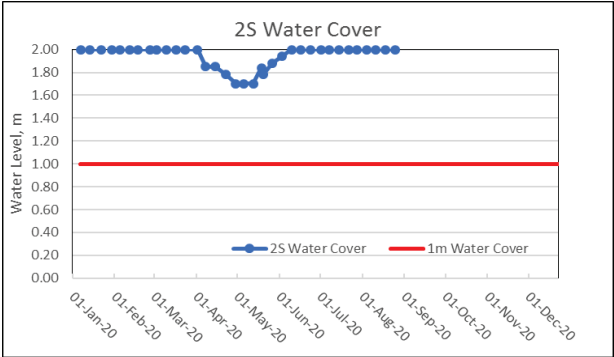
2-South PAG-CCR Pond (2S)-South Water Management System		
<div>Notes: Water cover at 2S is above 2m;</div> <div>Crest and Slope Stability: No</div> <div>Vegetation Control: Trees are cut off in the 2S discharge channel and 2S gate valves.</div> <div>Seepage: Seeping to 3S pit through the Engineer designed channel</div> <div>Animal Activity: No</div> <div>Water Management: Low flow water management mode is on (2S gate valves are open)</div> <div>Instrumentation: No pizeometers at 2S pit.</div> <div>Flow at 2S Inlet (m) ~0.17</div> <div>Spillway/Discharge Channel No overflow</div> <div>2S UG pump (l/s) 6.1</div>
