Report On
Quinsam Coal Mine Subsidence Assessment

Prepared for
Hillsborough Resources
Suite 950-1090 West Georgia
Vancouver B.C.
V6E 3V7

April 9, 2011

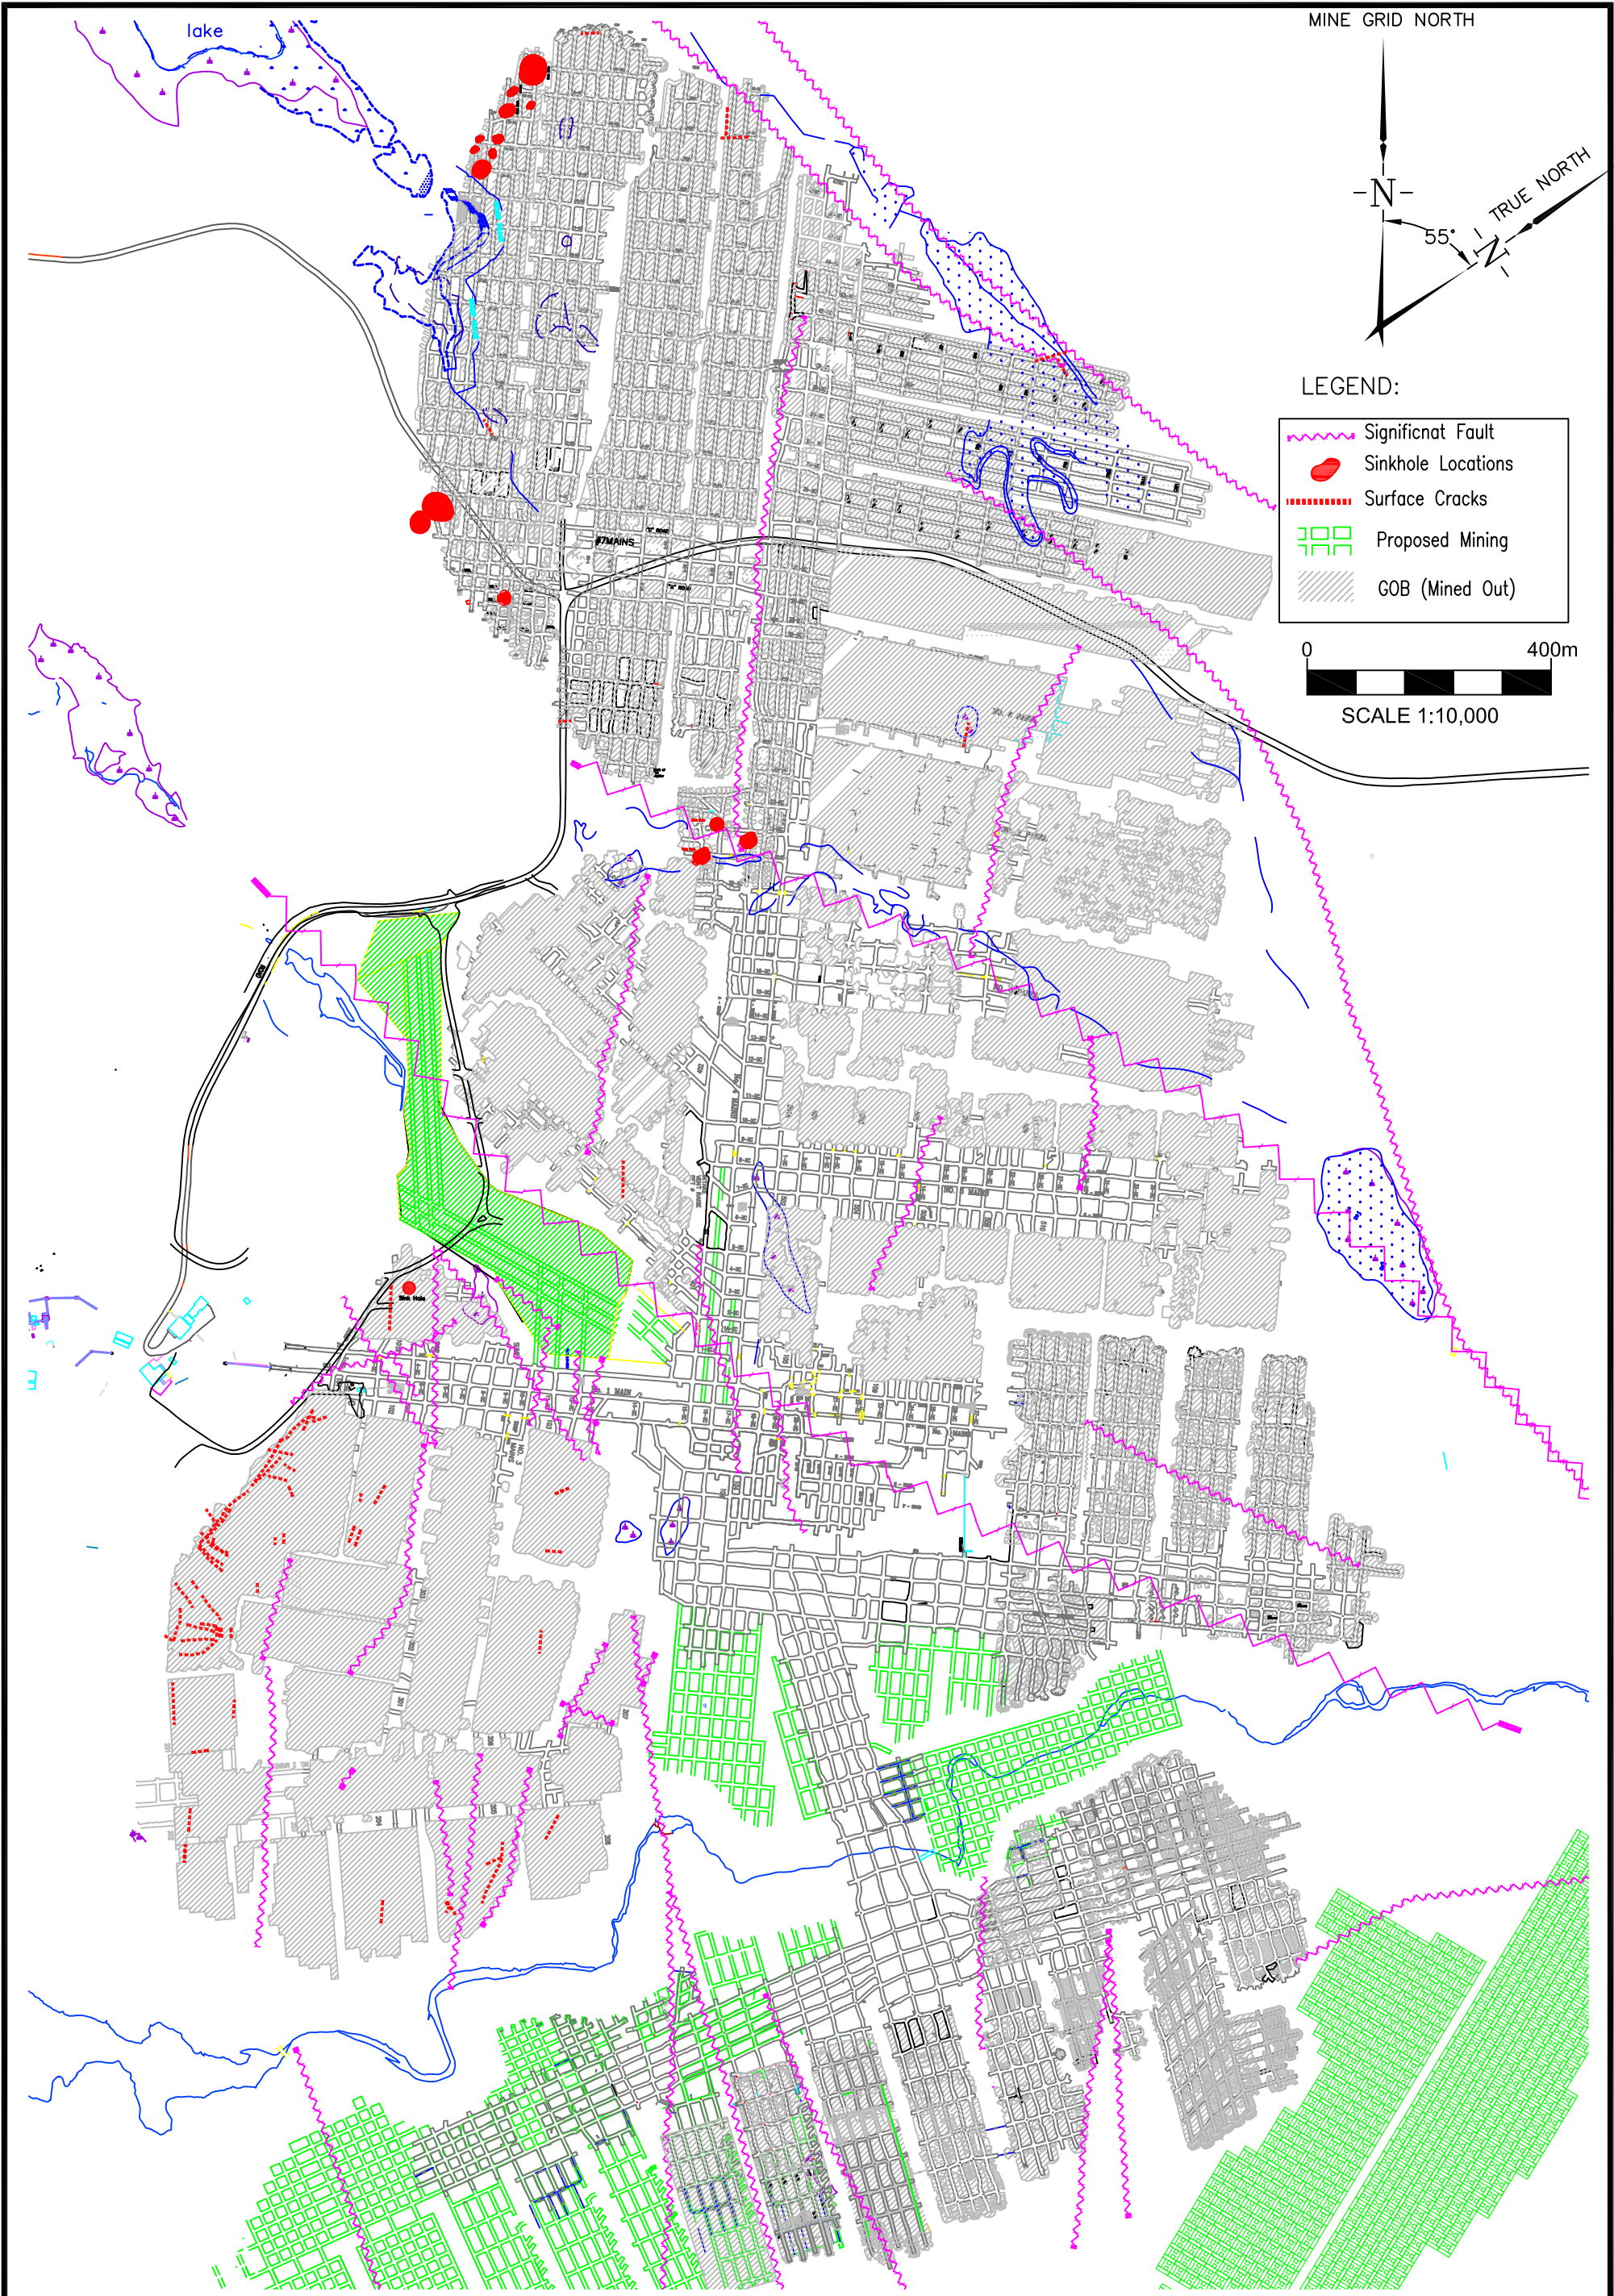
FIGURE 7

TITLE
LOCATION OF MINING INDUCED SINKHOLES
AND OPEN SUBSIDENCE CRACKS

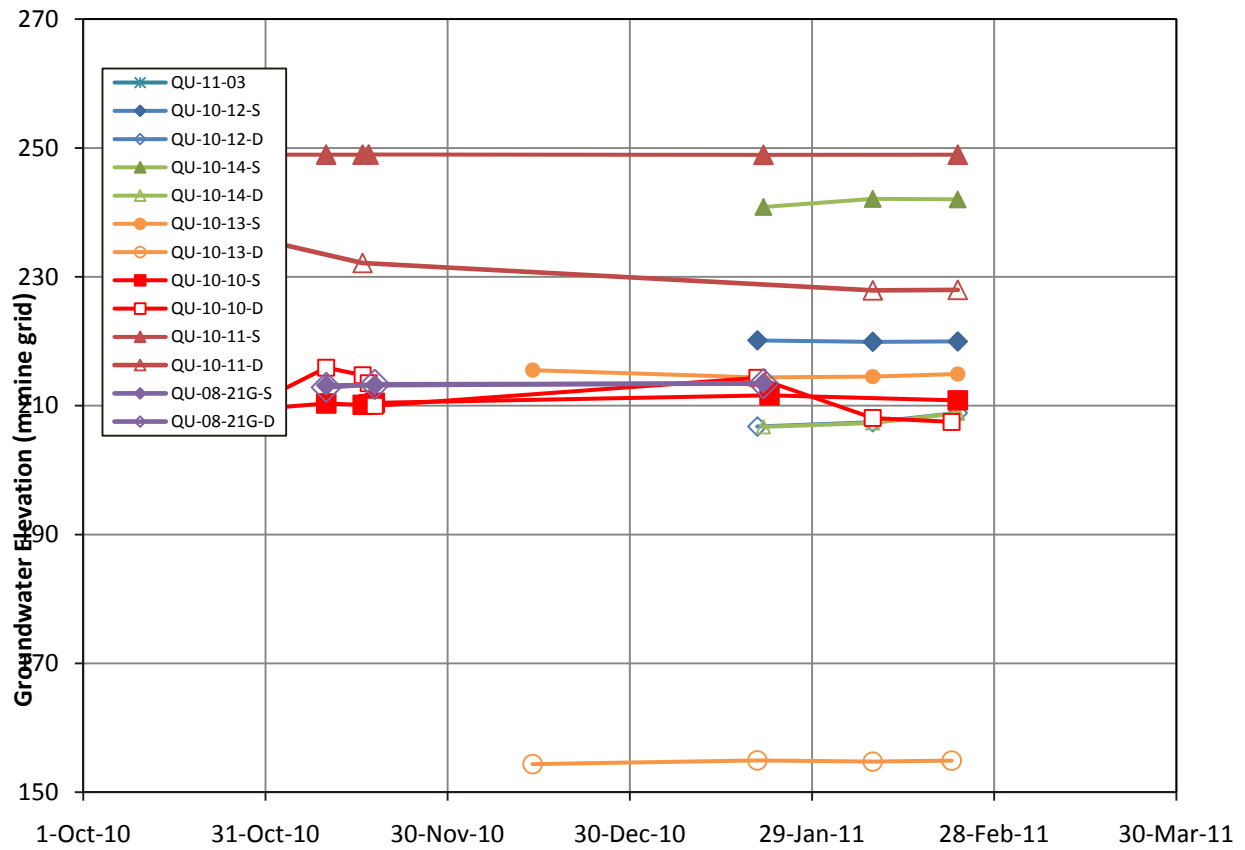
Figure 13: Groundwater Levels From Monitoring Wells in 2N

Figure 13 and 14 present results from the Quinsam Mine groundwater monitoring program being completed by MCG, Lorax and Golder Associates. Table 5 summarizes the results from the drilling, video logs, packer testing, and groundwater monitoring as well as presenting our interpretation of the results.

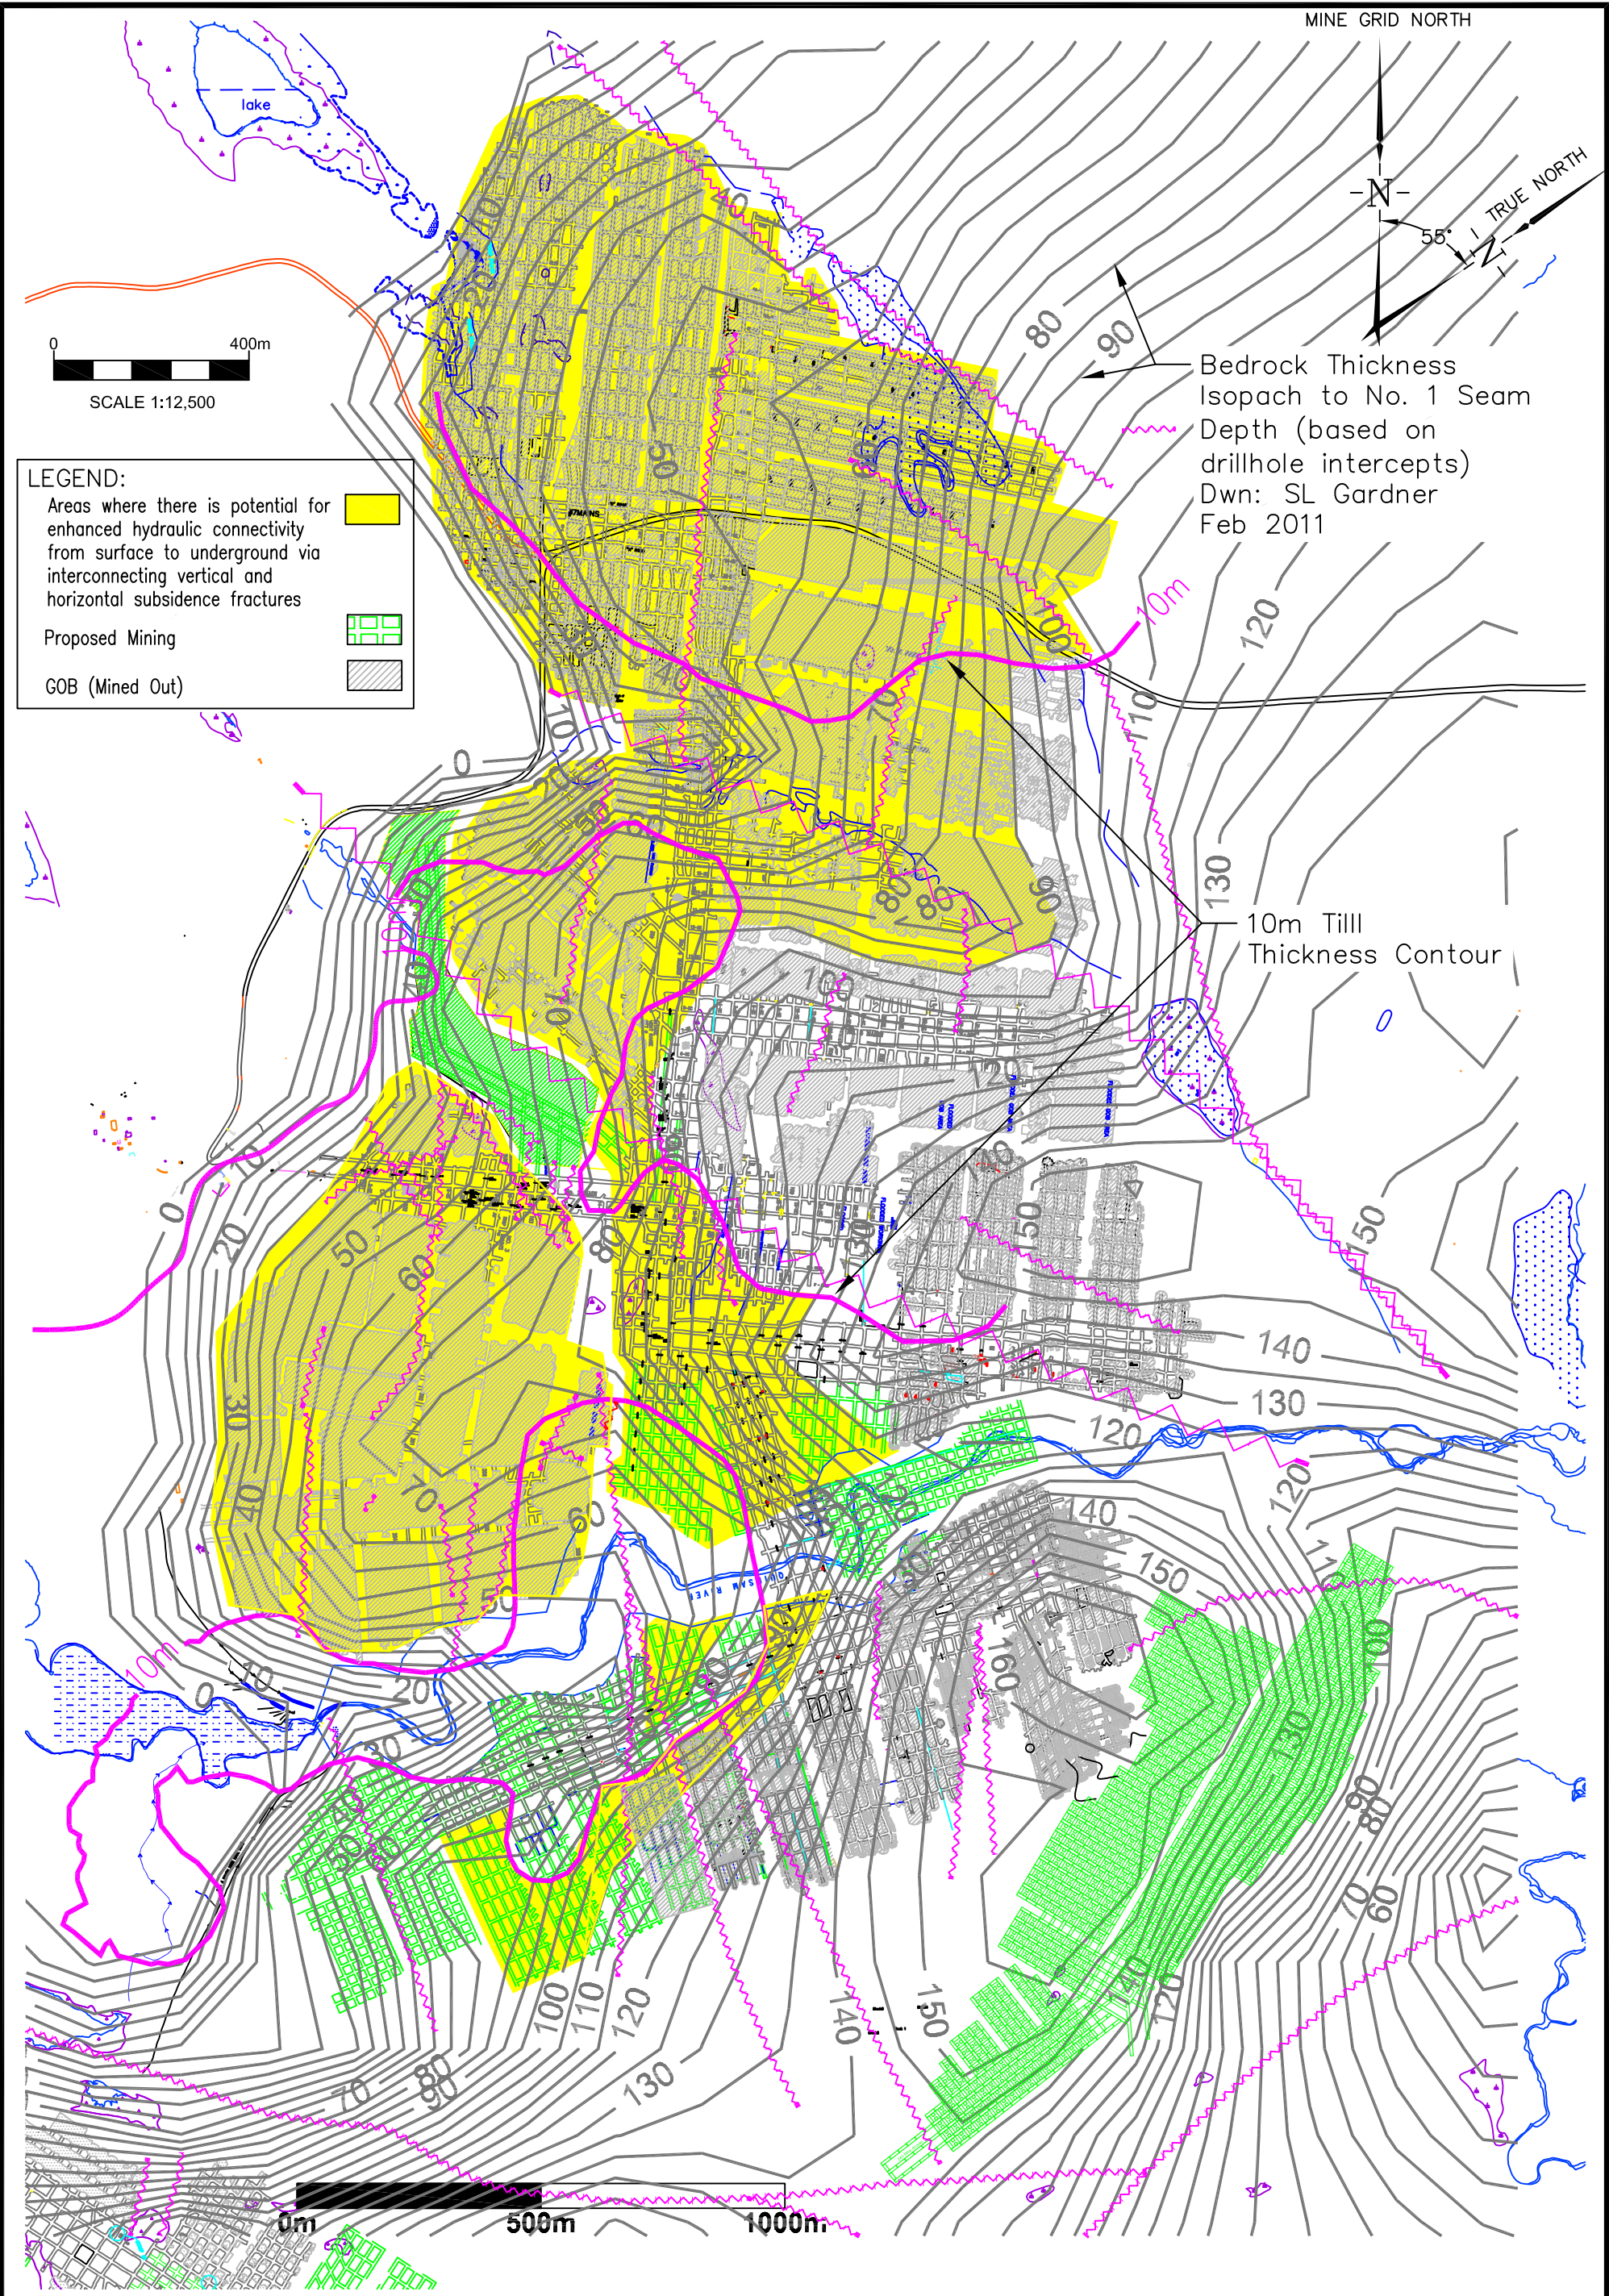
FIGURE 16

Figure 16 shows the areas over the 2N and 5S Mines where there is potential for enhanced hydraulic connectivity (e.g. flow on a network of connecting horizontal and vertical fractures induced by subsidence) between the ground surface and underground. It is defined by areas where retreat pillar mining has taken place, or is planned, and where the depth of till cover is less than 10m, and where the rock cover is less than 37t plus 15m. Where the thickness of till cover is more than 10m the limit on rock cover is 29t. Experience at QCM has shown that where the till layer is greater than about 10m thick it will bridge over and heal subsidence cracks.
