REPORT NO. 212022/2

MYRA FALLS MINE

2021 RECLAMATION REPORT FOR MINES ACT PERMIT M-26

March 2022

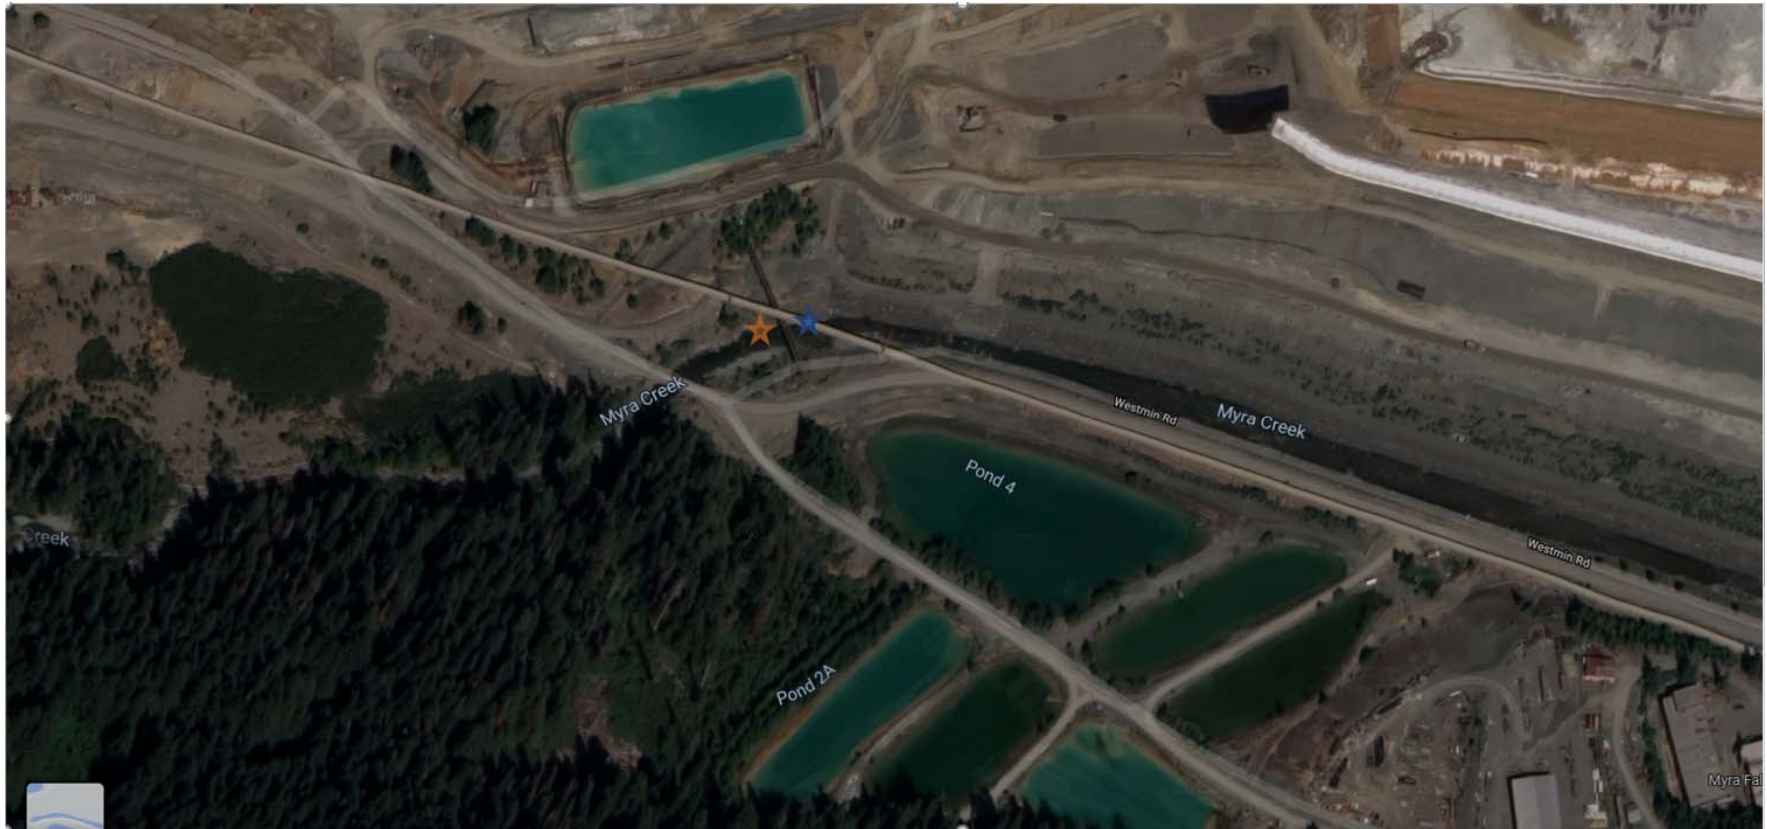
Figure 1: Sampling locations September 17, 2021

At approximately 14:30 it was observed by the Environmental Staff that turbid water was running down the packed gravel section of the public road and entering Myra Creek between the car bridge and 25 sump (see Figure 1). The road run-off was measured to be flowing at a rate of 5 L/s.

The source water was entering the creek at the approximate location of the orange star and was sampled at this location. The mixing zone was sampled just under the conveyor, at approximately the location marked by the blue star in Figure 1.

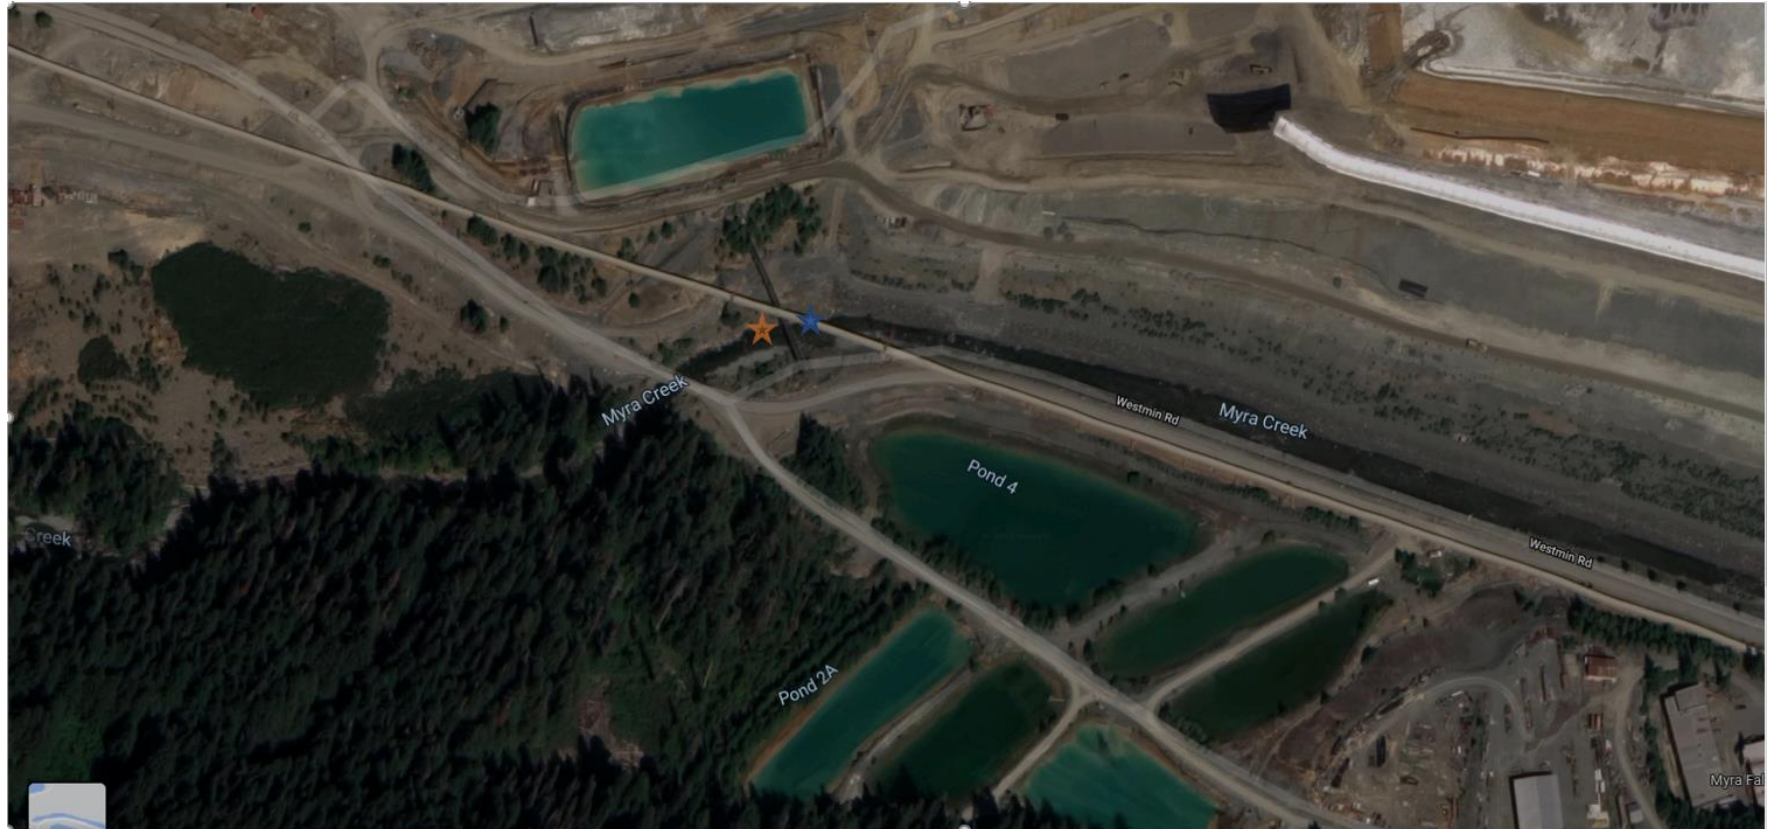
Figure 1: Sampling locations October 25, 2021

At approximately 16:20 it was observed by the Environmental Superintendent that turbid water was entering the overflow channel for 25 sump (see Figure 1). Turbidity was not observed in Myra Creek upon initial observation. A small turbidity cloud had formed in Myra Creek at the confluence with the overflow ditch by the time the Environmental Superintendent had arrived at the 25 sump location.

The sump water was entering the creek at the approximate location of the orange star and was sampled directly from the sump. The mixing zone was sampled just under the conveyor, at approximately the location marked by the blue star in Figure 1.

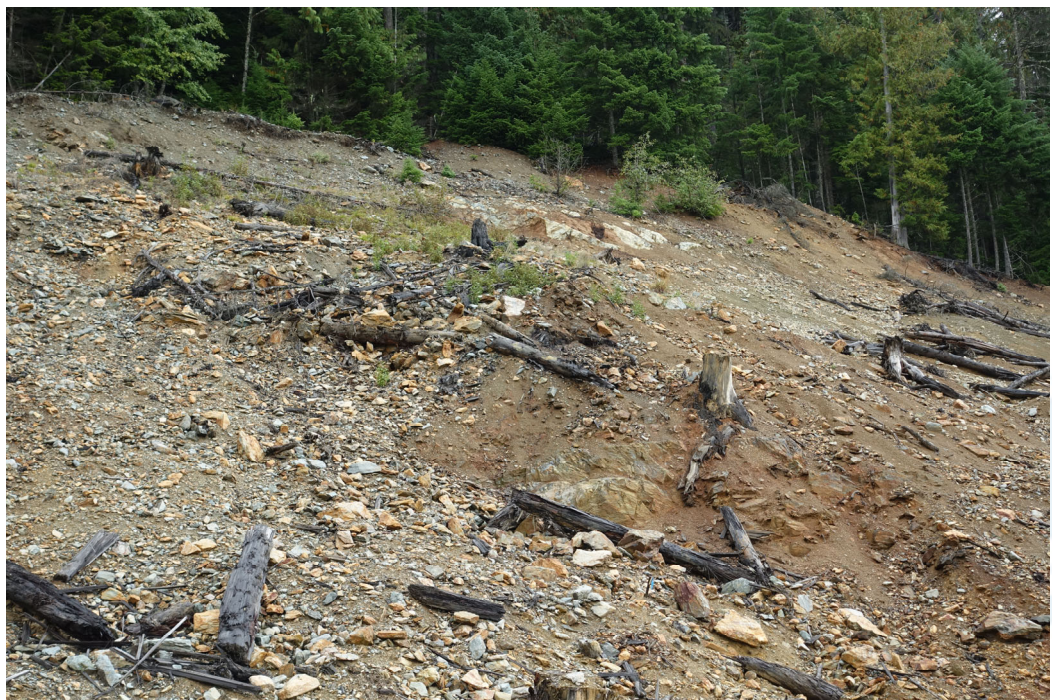
Myra Falls removed waste rock from the historic Waste Rock Dump 2 location in the summer and early fall of 2017. Underlying materials at this location consist of native surficial materials—including soil and other surficial material—onto which the waste rock was dumped (Figure 3). Analysis in 2017 indicated that these materials have the edaphic properties of the 03/HwCw – Salal site series in the CWHmm1 biogeoclimatic unit. Appropriate tree species for early revegetation are Douglas-fir and red alder, and seedlings of both species were observed in non-mined forest directly above the Waste Rock Dump 2 location.

In 2018, surveys of the Waste Rock Dump 2 area found sparse vegetation establishing in the upslope portion directly adjacent to the intact forest above. This vegetation makes up approximately 5% of the ground cover in this area (Figure 3). The most common species are fireweed, miner's lettuce, thimbleberry, and pearly everlasting. Other notable native species present include Douglas-fir, red alder, and red elderberry. Similar observations were made when the area was re-visited in 2019 and 2020, including the establishment of invasive and non-native species (Himalayan blackberry and thistle).

Figure 3. Revegetating upslope area in the previous Waste Rock Dump 2 location.

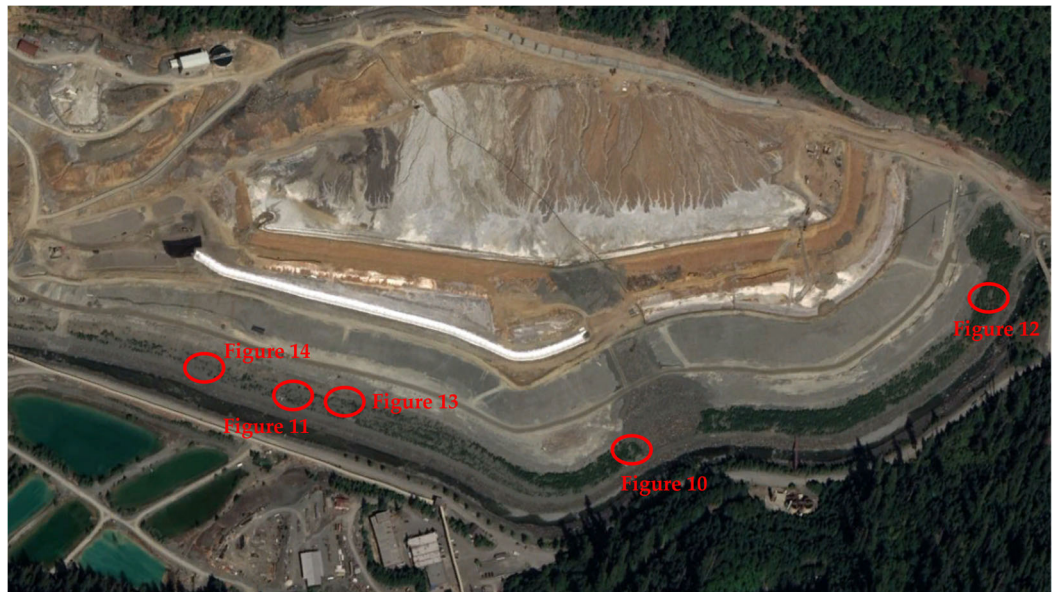
Vegetated ecosystems continue to develop slowly on the seismic berm, facilitated in part by red alder establishment in the eastern and central sections.² Recent satellite imagery (Figure 9) shows that alder has established vigorously where slope aspects are southerly or east of southerly, and less well on southwest slope aspects. This difference can be seen at ground level in a comparison between the areas where alder is more robust (Figure 10) and less robust (Figure 11). In the sections with a thicker alder cover, the benefits of this species, particularly its production of copious, nutrient-rich litter, and its changing of the understory micro-climate to facilitate colonization by less drought-tolerant mosses can be seen (Figure 12). However, Douglas-fir is reaching heights of 2 m even in the western, less-well-vegetated sections (Figure 13), and natural regeneration can be substantial in portions of these sections, particularly in less-occupied spaces at slope crests (Figure 14).

Figure 9. Satellite image of vegetation on the Old TDF seismic berm, showing locations of following figures (image copyright Maxar Technologies).

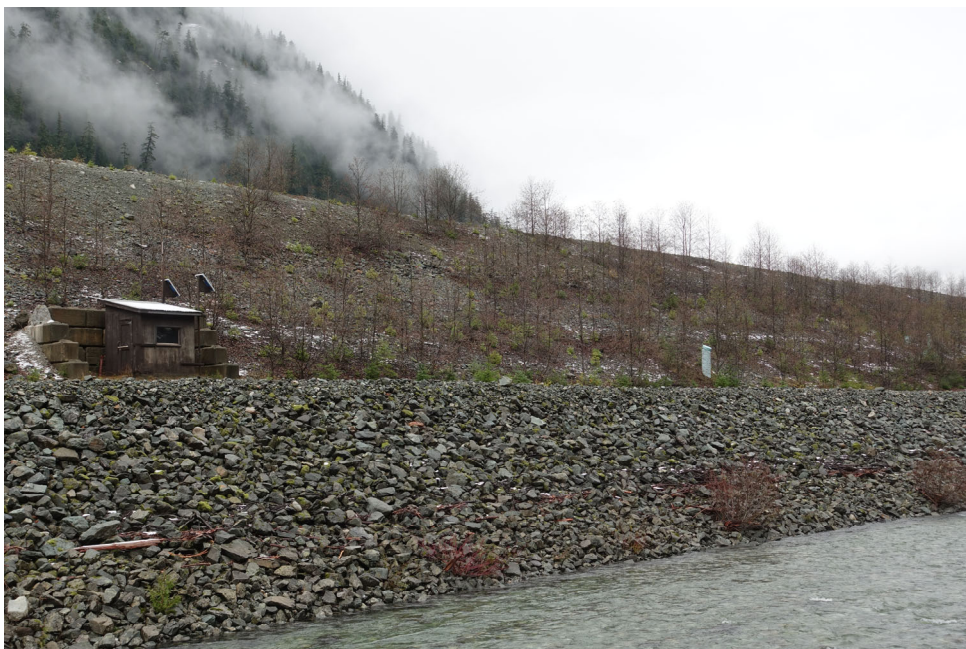
Figure 11. Vegetation with lesser alder components on the western section of the Old TDF seismic berm.

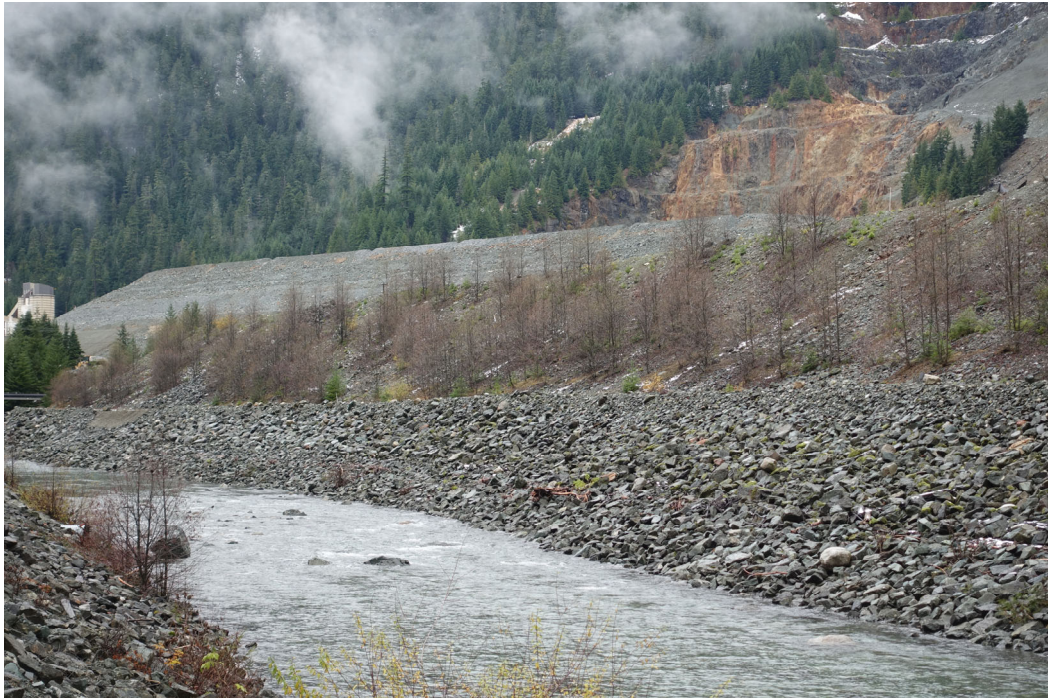
Figure 14. Western section of the Old TDF seismic berm, showing patches of natural conifer regeneration along the slope crest.
