Overview & Level 1 Fish Habitat Assessment and Level 2 Enhancement Recommendations

Woods Creek, Campbell River,
BC

Prepared for
Campbell River Salmon Foundation

June 9, 2020 (Rev. 1)

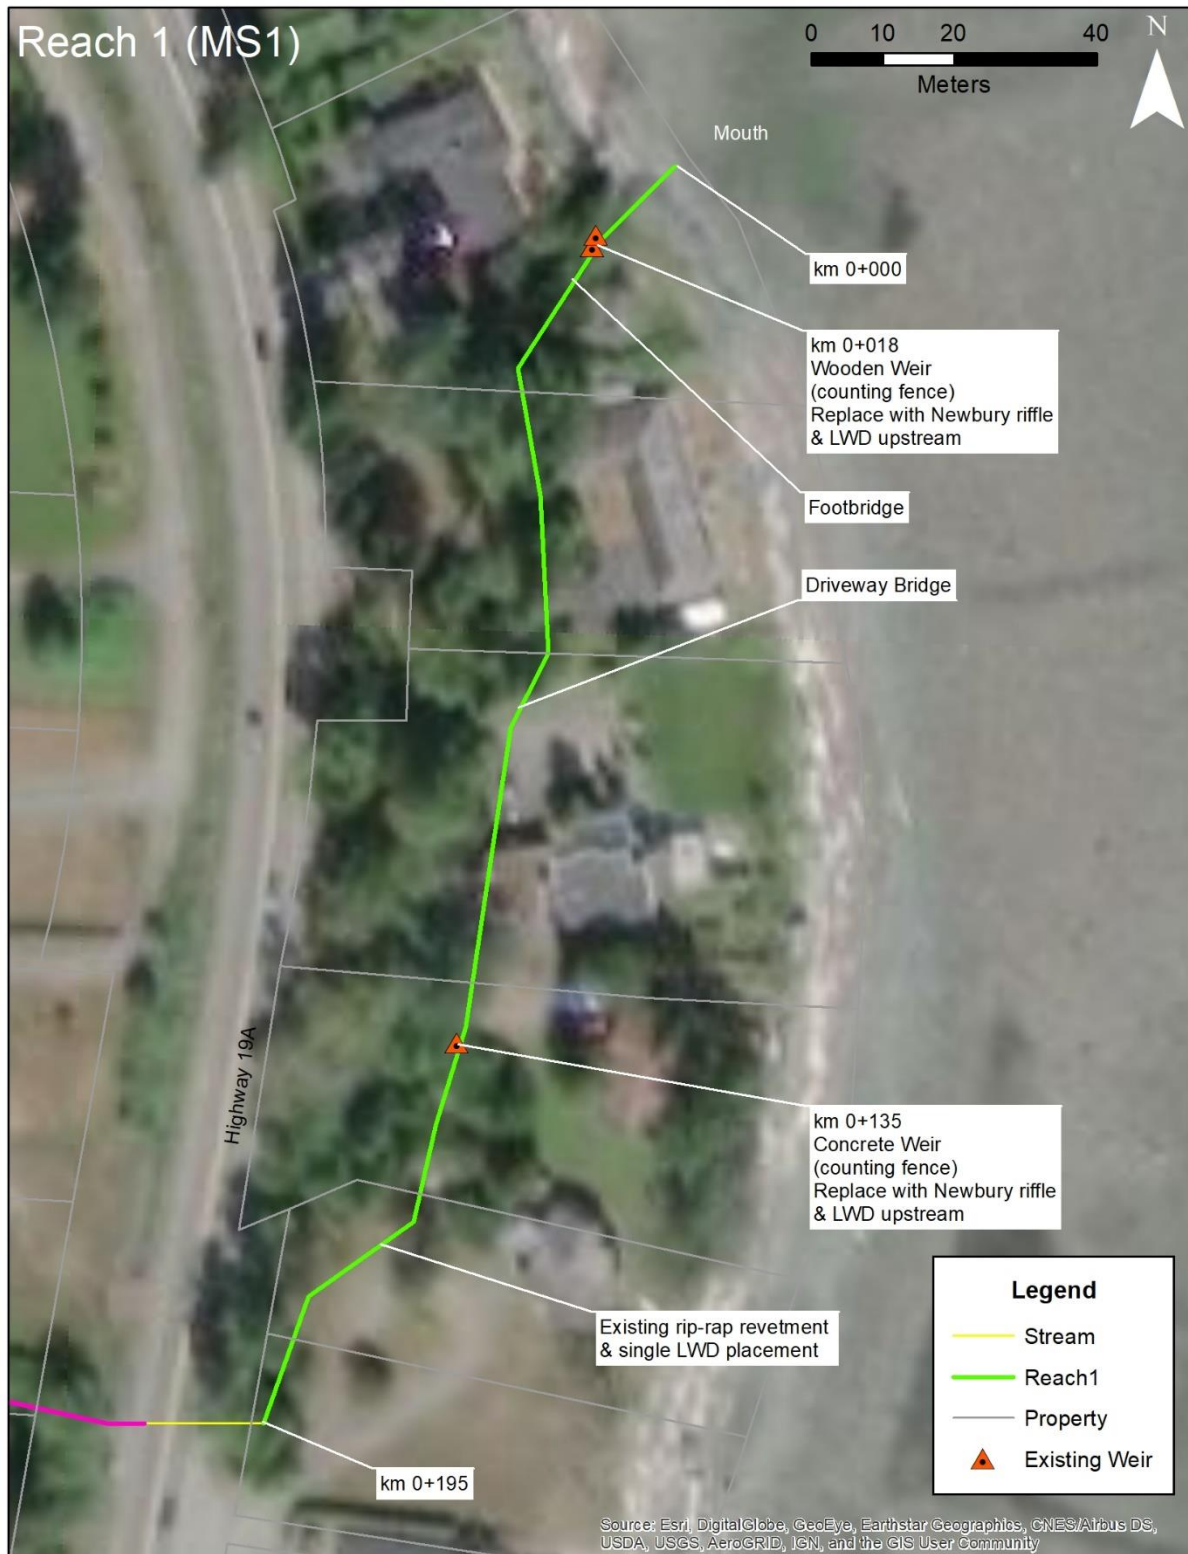
Figure 7. Reach 1, lower Woods Creek watershed showing existing conditions and proposed enhancement and restoration sites.

The existence of two weirs, one wooden, the other concrete (Figure 7; Photos 3-4), are potential partial barriers to fry migration as they have 0.25 m and 0.30 m vertical plunge drops, respectively. The drops at both sites flow into plunge pools of 0.65 - 0.75 m depth and are expected to be passable by adult salmon under most flow conditions but are barriers to upstream fry migration. Removal of approximately 30 cm of boards from the wooden structure should be considered to enhance passage for all salmon life stages while avoiding complex replacement techniques that might involve complete removal of the weir for completion prior to failure of the structures as they appear to be falling into disrepair (Photo 4). Artificial bed elevations resulting from the presence of existing weirs should be allowed to stabilize for at least one calendar year and re-assessed for suitability of installing permanent Newbury style rock weirs. Restoration prescriptions are discussed in Section 6.1.1.

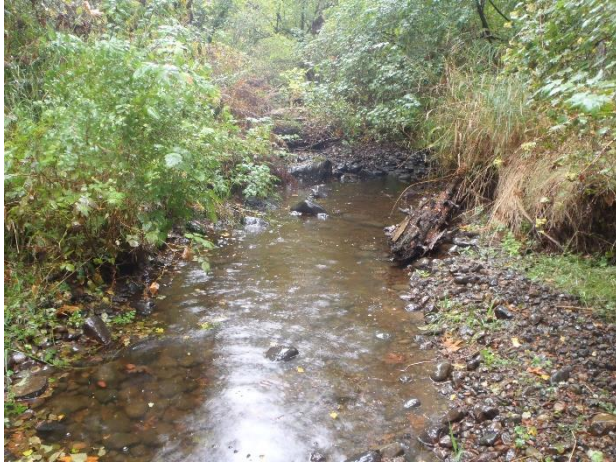
Photo 11. Typical view of the downstream habitat unit of Reach 3 (left) showing cobble dominated substrates and large woody debris presence (Sept. 23, 2019).

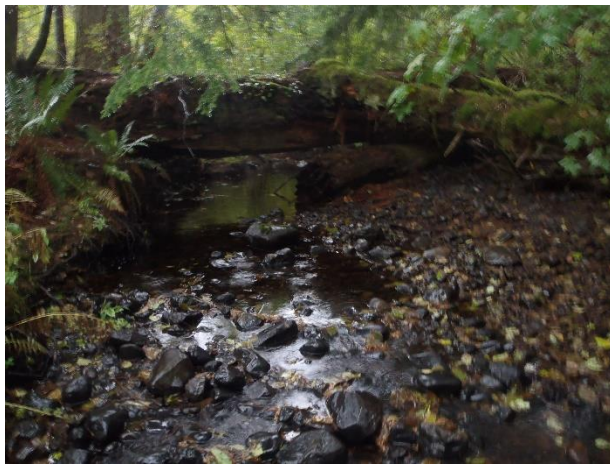
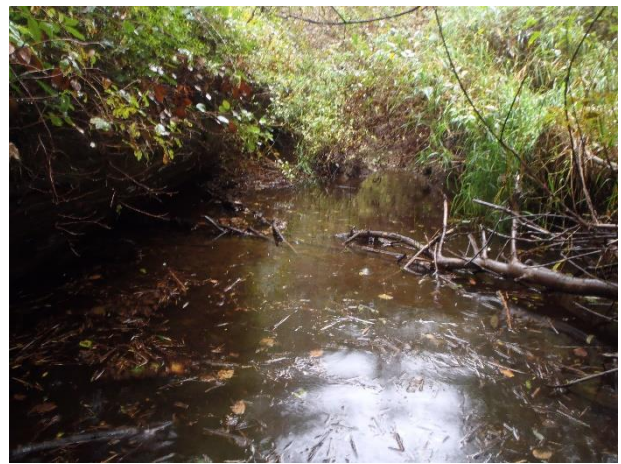
Photo 14 & 15. Upstream representative views of Reach 4 showing typical steeper riffle habitat (above left) and glide habitat (above right).

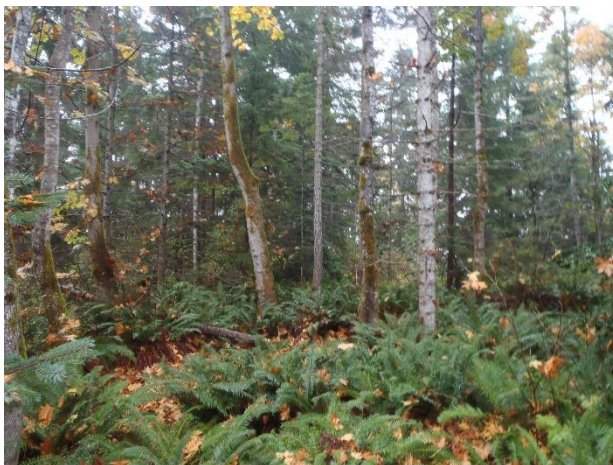
Photo 16. Example of the maturing mixed 2nd or 3rd growth forest canopy that characterizes the riparian area of Reach 4.

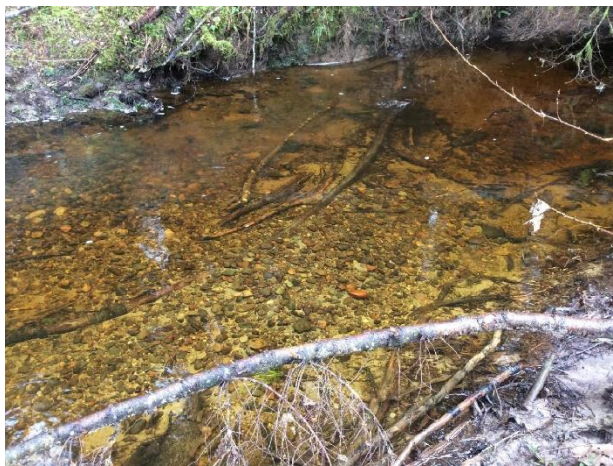
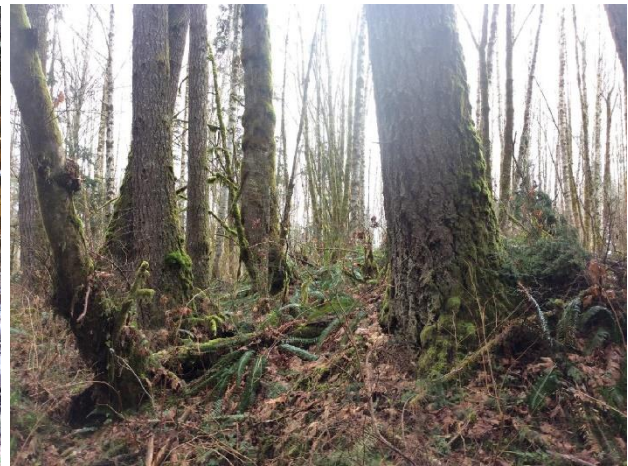
Photo 19 & 20. Example of spawning quality gravel substrate present in Reach 6 (above left); and older mixed riparian canopy present near the left bank with younger deciduous stand in background (above right) Feb. 12, 2020.

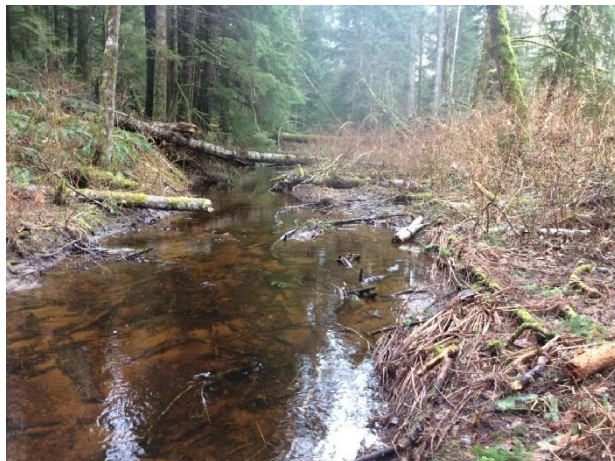
Photo 21 & 22. Views upstream of relatively wide bankful channel width compared to wetted width resulting in a *Poor* % wetted area calculation (above left), and *Good* LWD frequency associated with the mature forest canopy (above right).

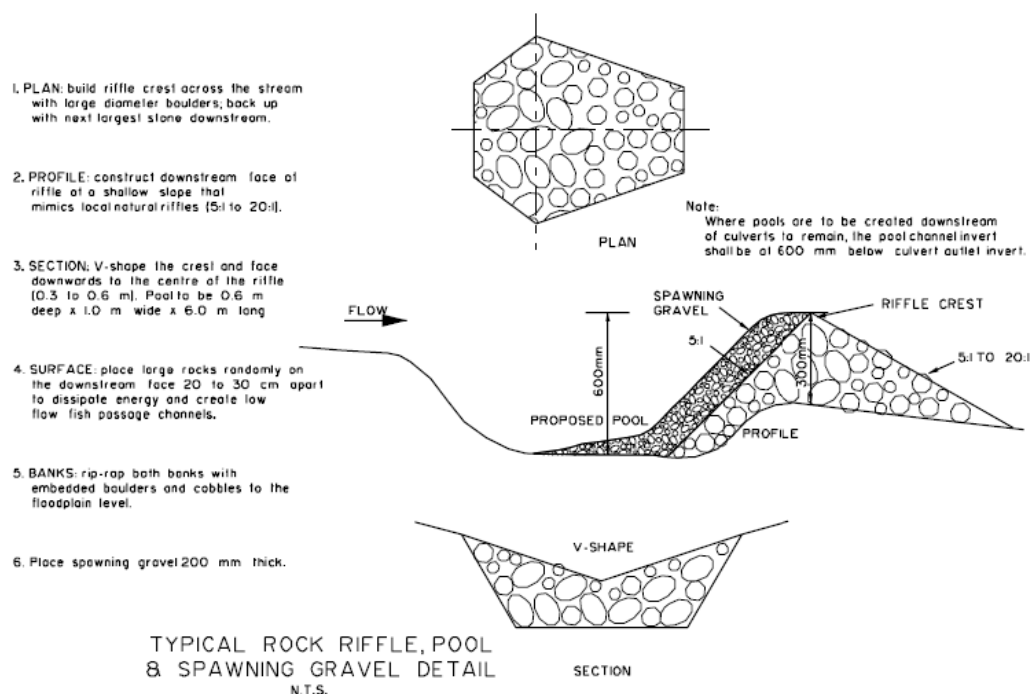
Figure 18. Rock weir/spawning bed conceptual design (adapted from Newbury et al., 1997)

The two weirs located in Reach 1 connected with historical counting fence operations have fallen into disuse and are currently partial barriers to juvenile salmon migration. The wooden weir at km 0+018 is recommended to have approx. 30 cm of wooden boards removed to lower the control elevation to enhance passage for all salmon life stages, while the concrete weir at km 0+135 are recommended to be replaced by Newbury style riffles that will also enhance salmonid passage at all life phases as well as providing additional spawning opportunities in this lowermost reach (Figure 18). The elevations of the upstream weir should be maintained with new riffle crest construction but tailouts extended to facilitate a more gradual downstream face to facilitate migration. The upstream face of the new riffle will be seeded with spawning gravel, and the pool upstream installed with LWD/boulder complexes to provide increased hydraulic complexity and shelter for rearing and migrating adulted spawners (Figures 19 & 20).

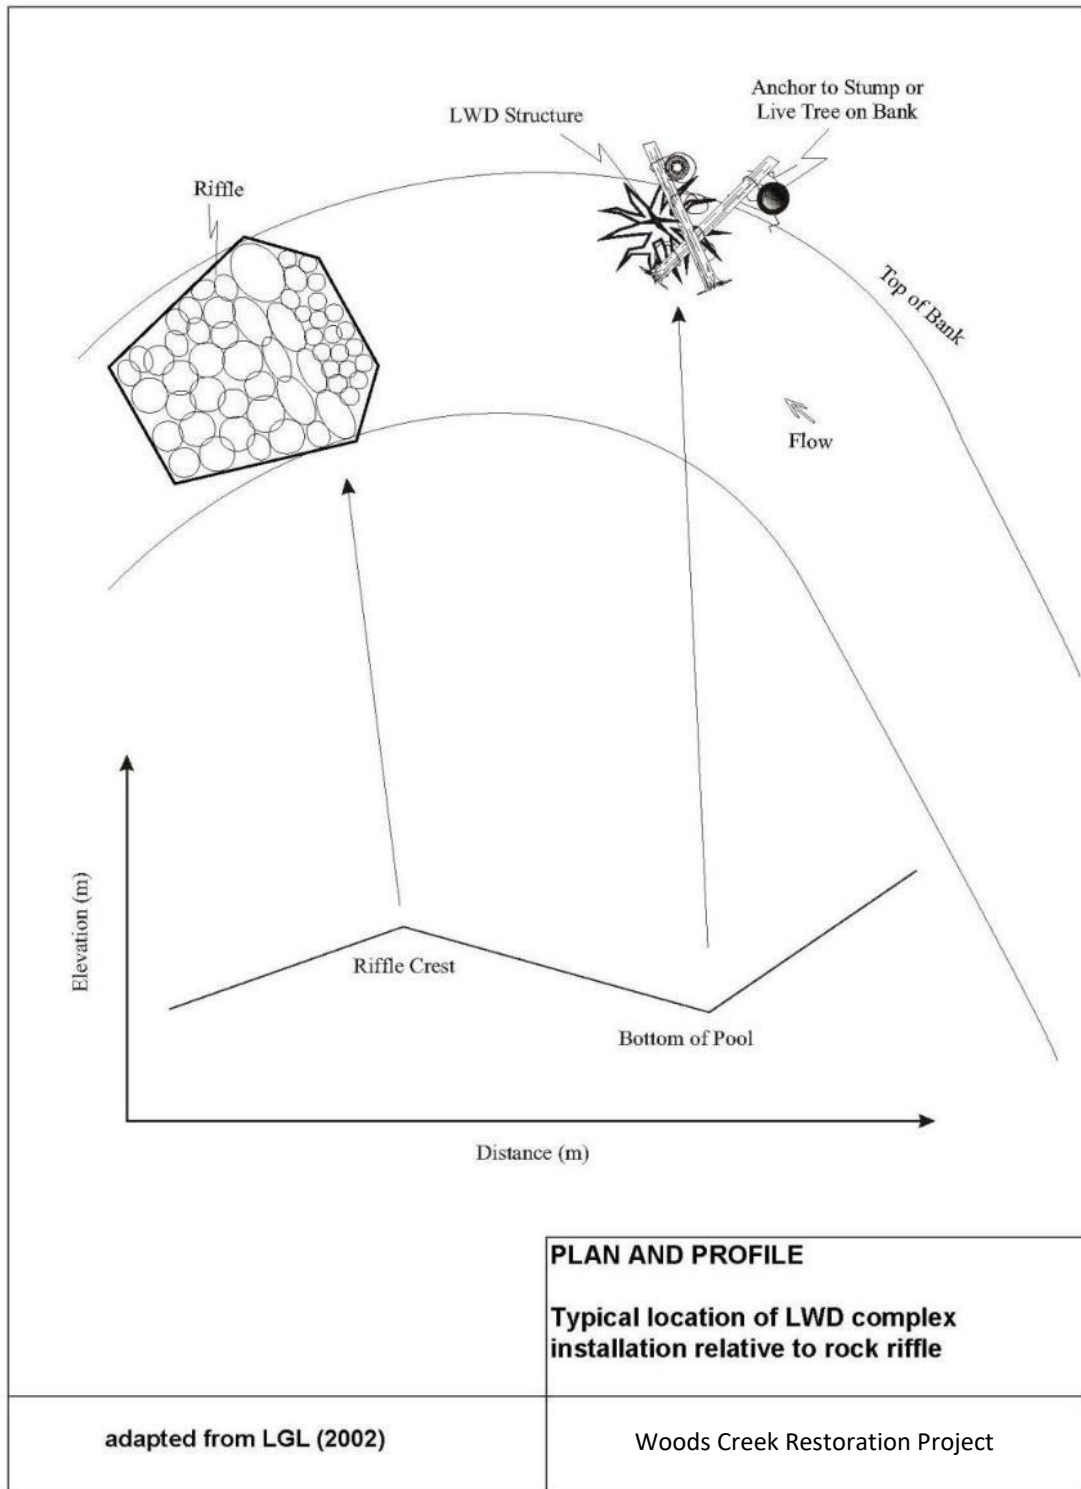
Figure 19. Conceptual layout of rock weir/spawning platform relative to LWD installation.

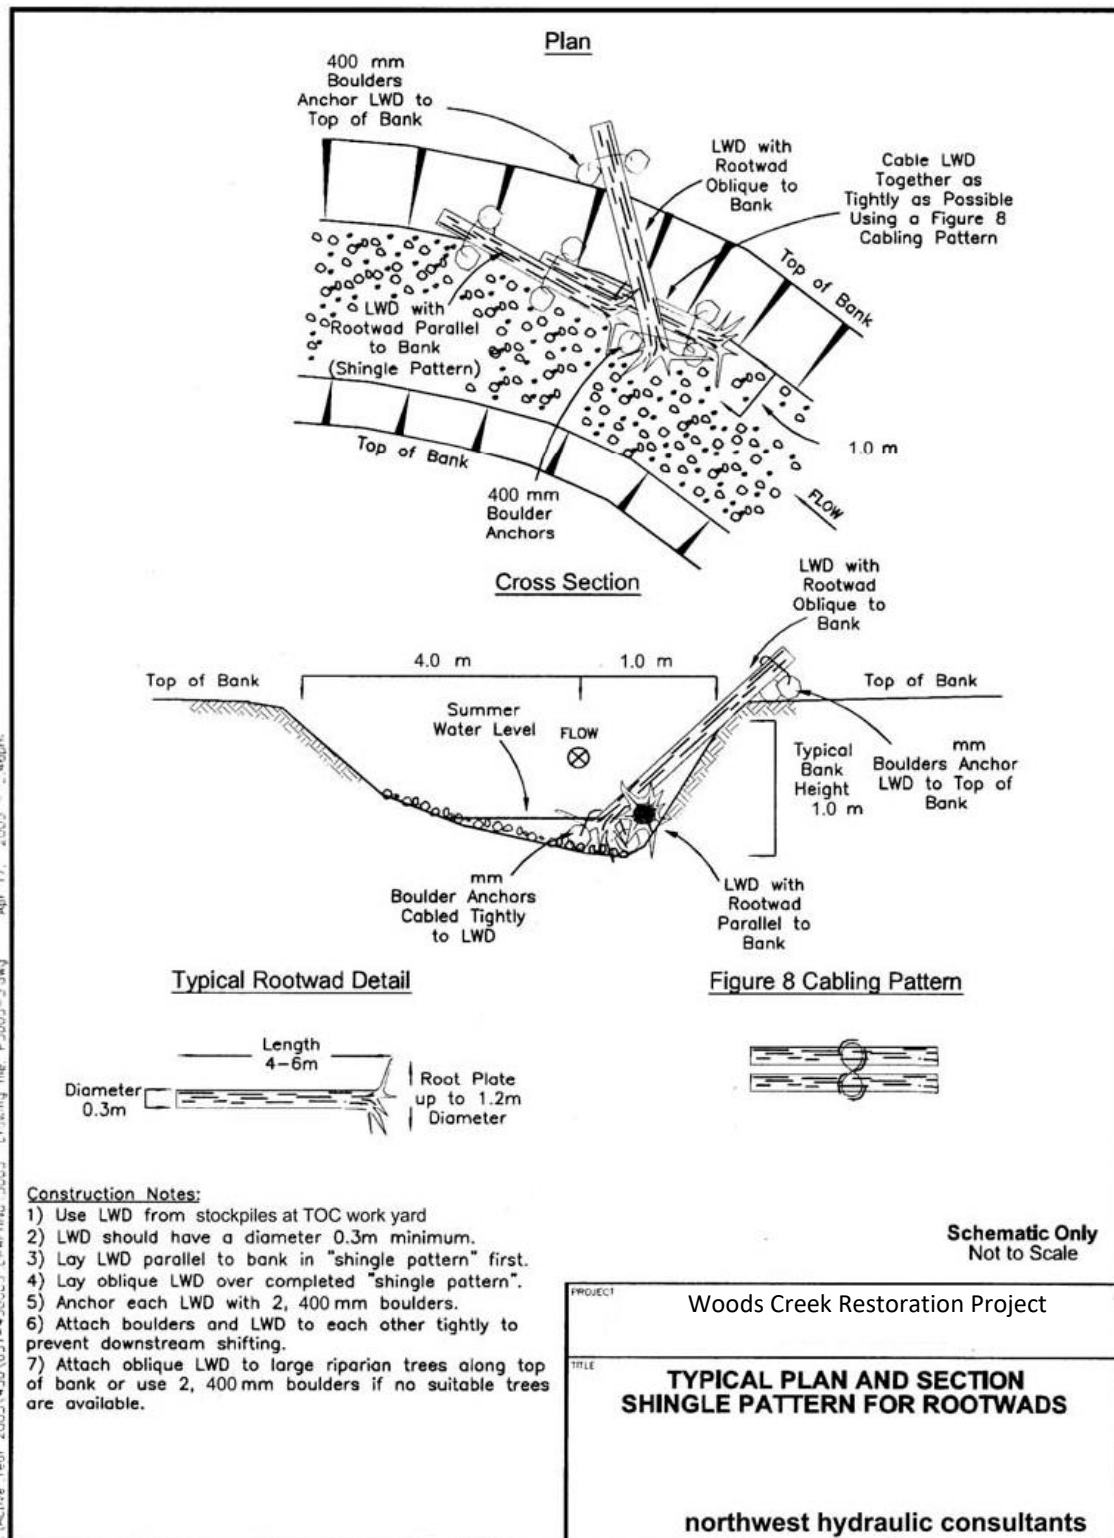
Figure 20. Conceptual design of LWD installation upstream of rock weir/spawning platform shown in Figures 18 & 19 above.

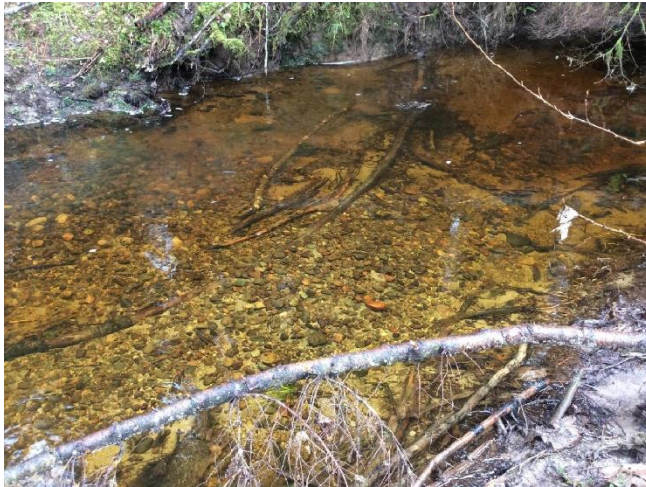
Upstream of the existing weir (G – date unknown) a section of higher gradient 2-3 % channel profile with areas of exposed gravels is a good candidate site for enhancement with a series of 3 rock weir/riffles and LWD pool complexes. Enhanced spawning and rearing habitat in this reach in the upper watershed will provide unique spawning potential that is lacking elsewhere in the upper watershed (Photo 41).

Photo 41. Example of native gravel substrates present in the subject section of Reach 6 recommended for enhancement.

An existing rock weir present at km 3+120 is in a state of good repair that would benefit from spawning gravel re-nourishment on its upstream face. Some gravels remain present, but the majority has either been transported downstream or is partially embedded in fine sediment.
