2023 Lynx Tailings Disposal Facility Dam Safety Inspection

Myra Falls Mine Ltd.

WSP Canada Inc.

March 28, 2024

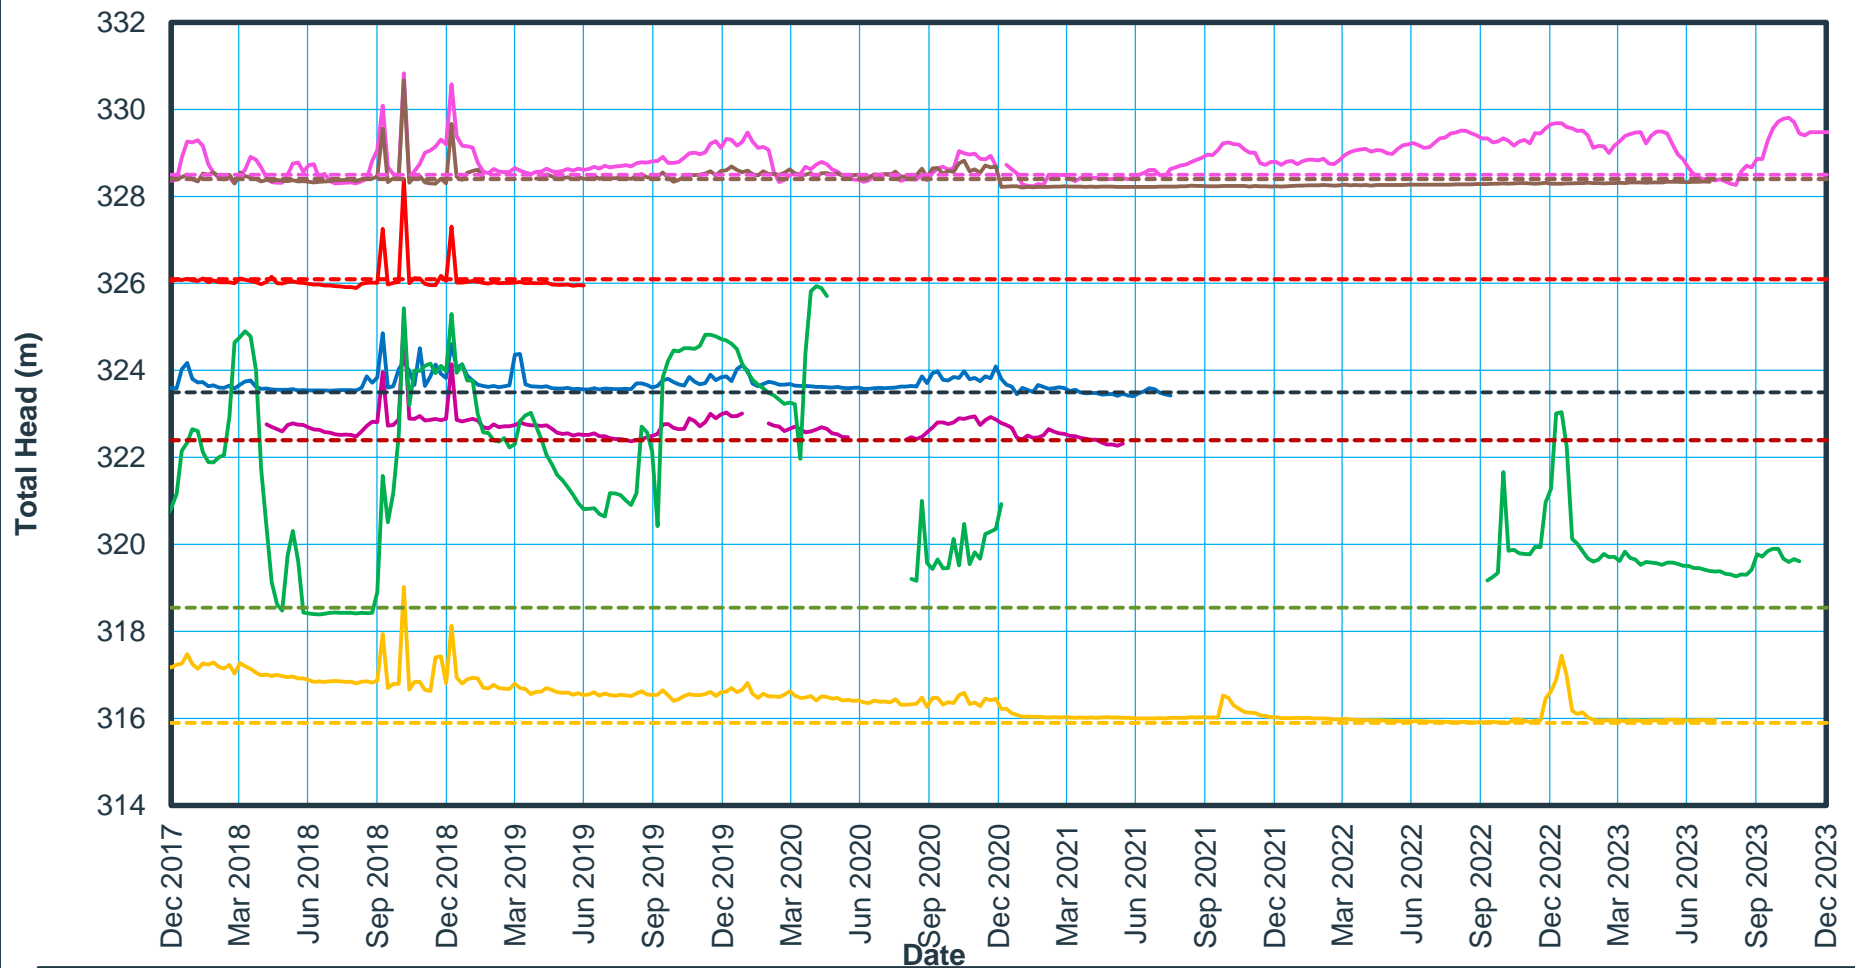
</div> <div> <div>CLIENT:</div> <div>   </div> </div>	PROJECT: MFM Lynx TDF 2023 DSI Report				
	TITLE: Lynx TDF - Shallow Foundation VWP Data				
	DATE: March 2024	JOB No.: CA0024329.4043.310	FILE: B2 Reporting Lynx TDF VWP - 2023_Dec.xlsx	FIGURE No.: B2	REV. 0

In 2023, piezometer readings within the foundation remained relatively stable with a moderate increase in the deep foundation piezometers of about 3 m and an increase in the shallow foundation of about 1 to 1.5 m in Q3, which is interpreted to be associated with the wet season. Piezometers in the dam fills remained dry over the reporting period. Pore pressures recorded during the reporting period generally showed similar trends consistent with previous years.
