Annual Environmental and Reclamation Report

2014

Nyrstar Myra Falls Annual Environmental Report for 2014

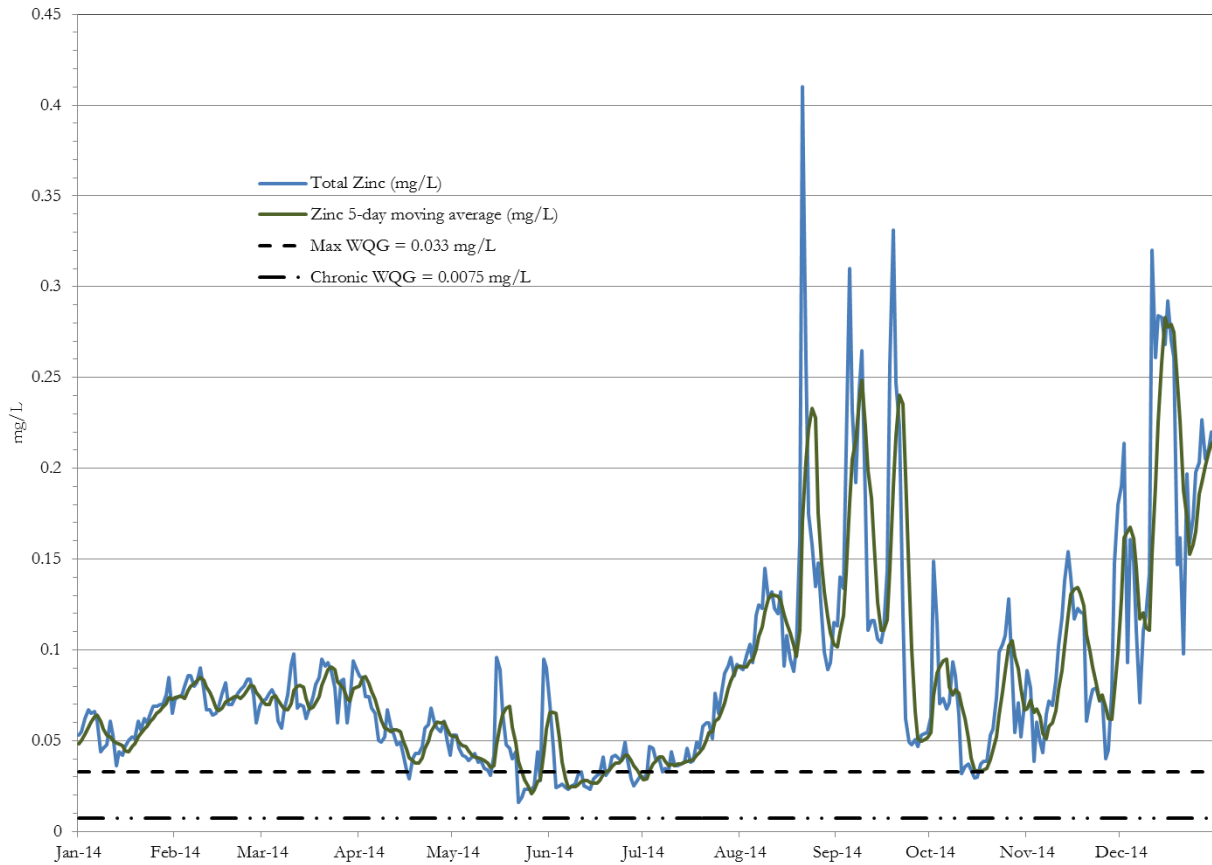
Figure 2-3 Daily Composite Results for Zinc at TP4 with 5-Day Moving Average

Figure 2-4 presents daily zinc results for 2014 with a 5-day moving average that can be compared to the 30-day chronic guideline for zinc (0.0075 mg/L). The maximum guideline of 0.033 mg/L is provided for reference.

The 5-day moving average for zinc consistently exceeds the 30-day average guideline, and 90.4% of the values also exceed the maximum guideline. A 10-year chart was prepared for multi-year comparison (Figure 2-4).

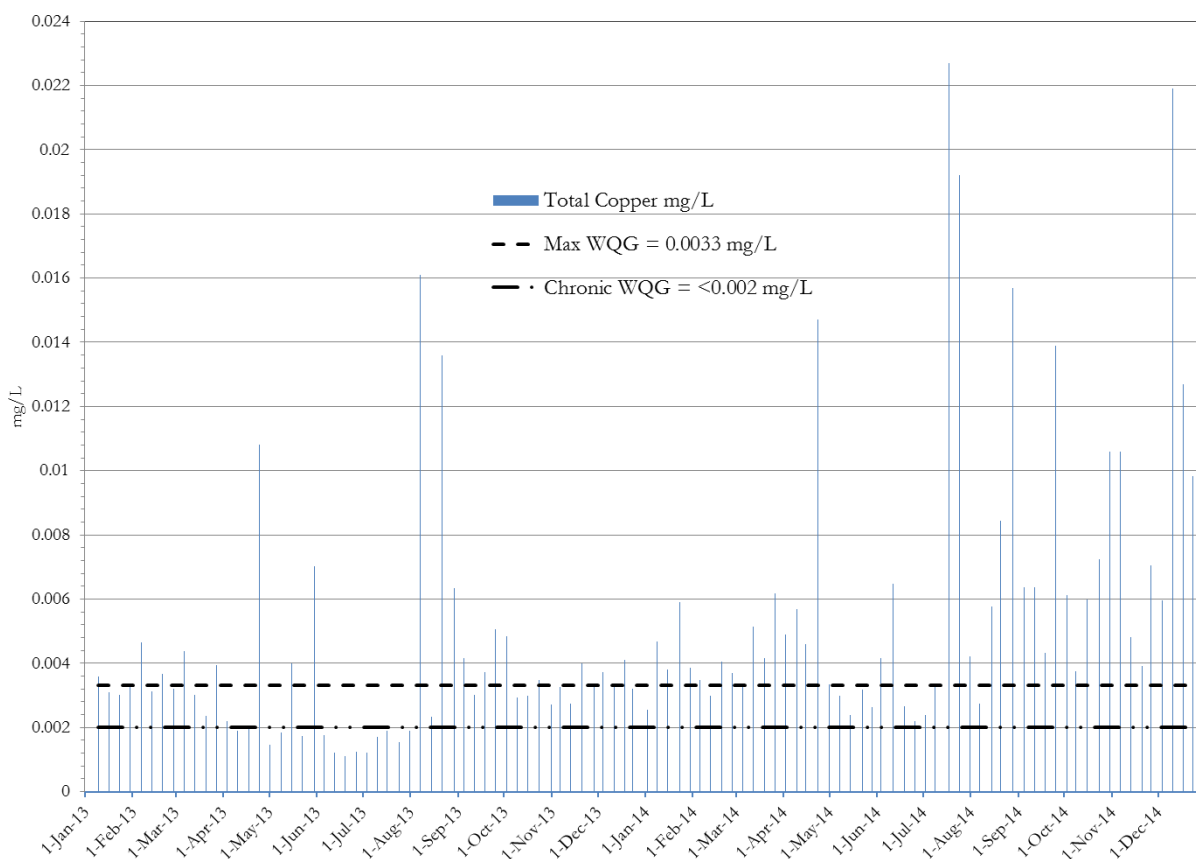
Figure 2-5 Weekly Composite Sample Results for Total Copper at TP4, 2014

Since January 2013, weekly composite copper samples have been taken in lieu of daily copper samples at TP4. The detection limits on the AA are too high for environmental copper, resulting in daily copper values of <0.020 for the entire year. The new weekly composite copper samples (comprised of 7 daily composite samples) are sent to the outside lab for analysis on the ICP-MS. Results are shown in Table 2-6 and Figure 2-5. Water quality exceeded the acute WQG of 0.003325 mg/L in 83% of the samples, and exceeded the chronic WQG of <0.002 mg/L in 100% of the samples.

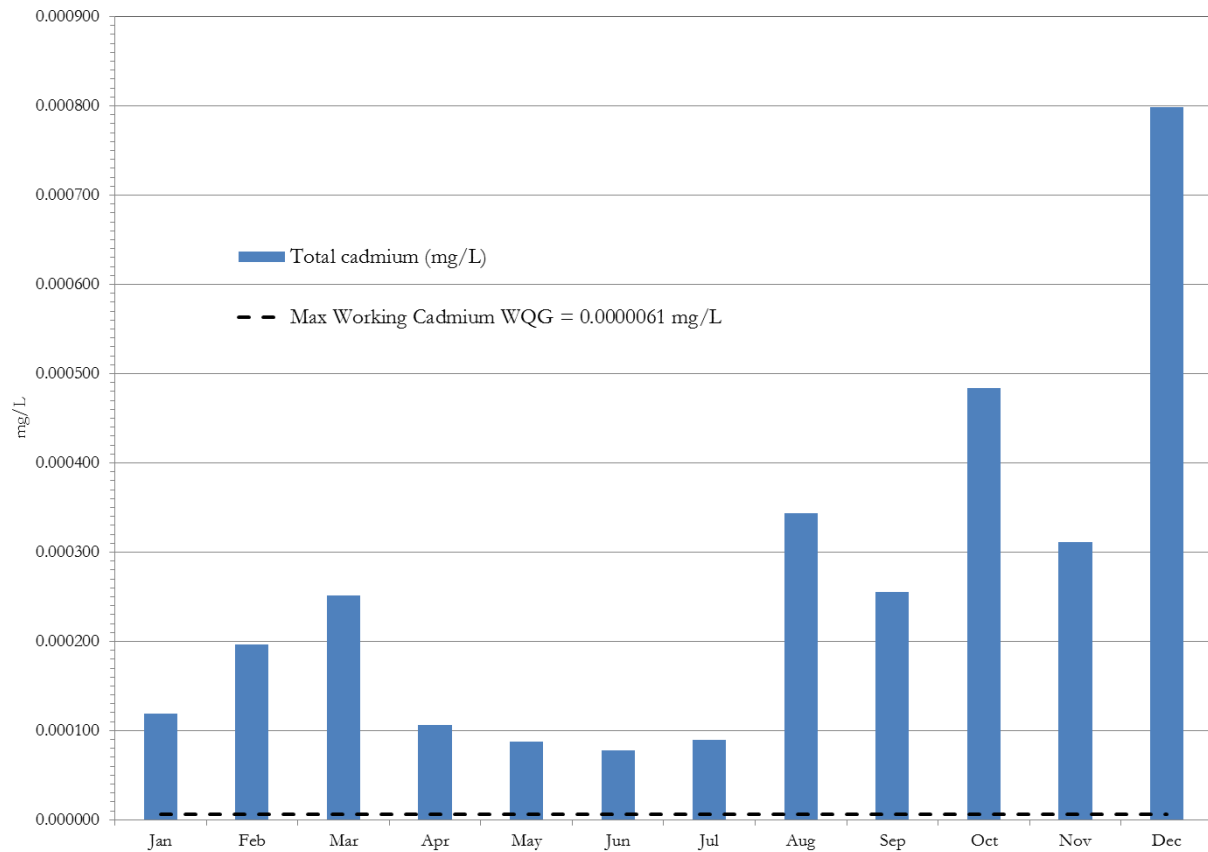
Figure 2-6 Monthly Grab Sample Results for Total Cadmium at TP4, 2014

The maximum working WQG for cadmium (0.0000061 mg/L) was exceeded in each sample throughout 2014.

Results for the monthly grab samples at TP4 are shown in Table 2-7 below. All of the tabled values are below the maximum water quality guidelines with the exception of cadmium (working guideline). As such, cadmium will be looked at in more detail. Figure 2-7 and Figure 2-8 present cadmium results for 2014 and 2005-2014, respectively. As there was no average (chronic) 30-day guideline for cadmium in 2014, it could not be included for comparison on the charts. WQGs were calculated using the average annual background hardness of 14.1 mg/L.

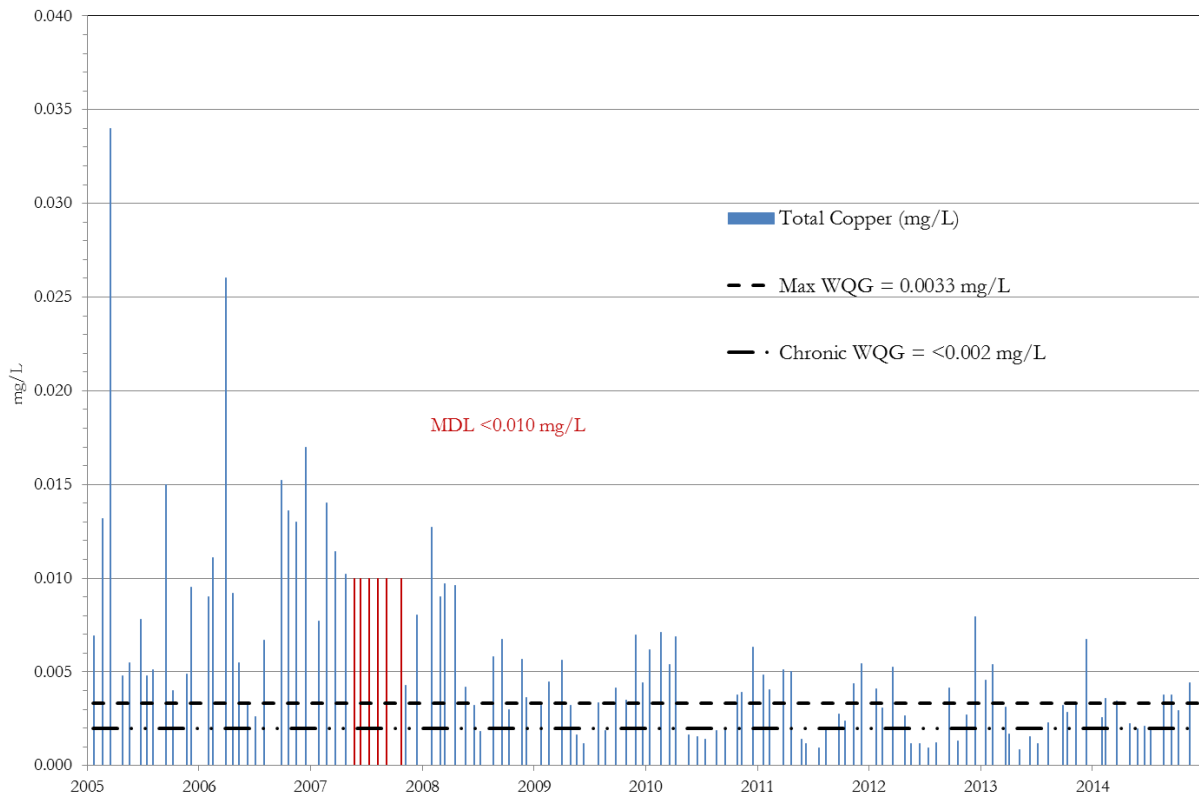
Figure 2-11 Total Copper at M2 2005-2014, Monthly Grab Sample

Six of the 12 samples from 2014 exceeded the maximum WQG (0.003 mg/L), and ten of the samples exceeded the chronic guideline (0.002 mg/L). 10 year chart reveals continuing improvement since 2008 due to the new outer drains and pumphouse.
