**MYRA FALLS TAILINGS STORAGE FACILITIES
2015 DAM SAFETY INSPECTION REPORT**

31 March 2016

Amec Foster Wheeler File: NX14001B

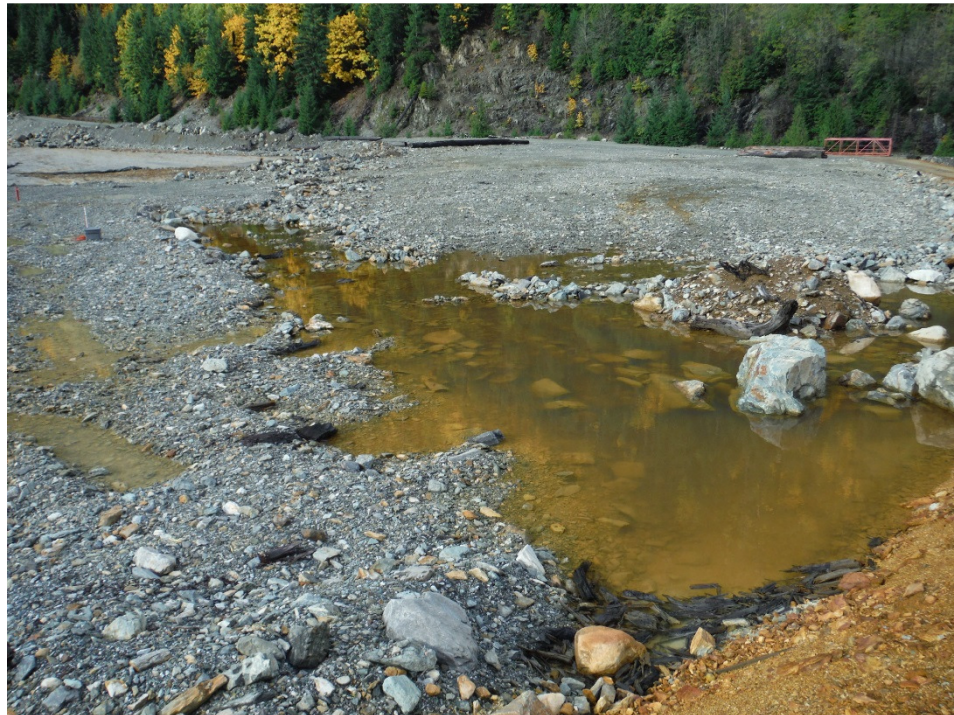
Photo 4: Water ponded at the southeast corner of the APA between the Paste Investigation Road and the northeast rock pad (October 23, 2014).

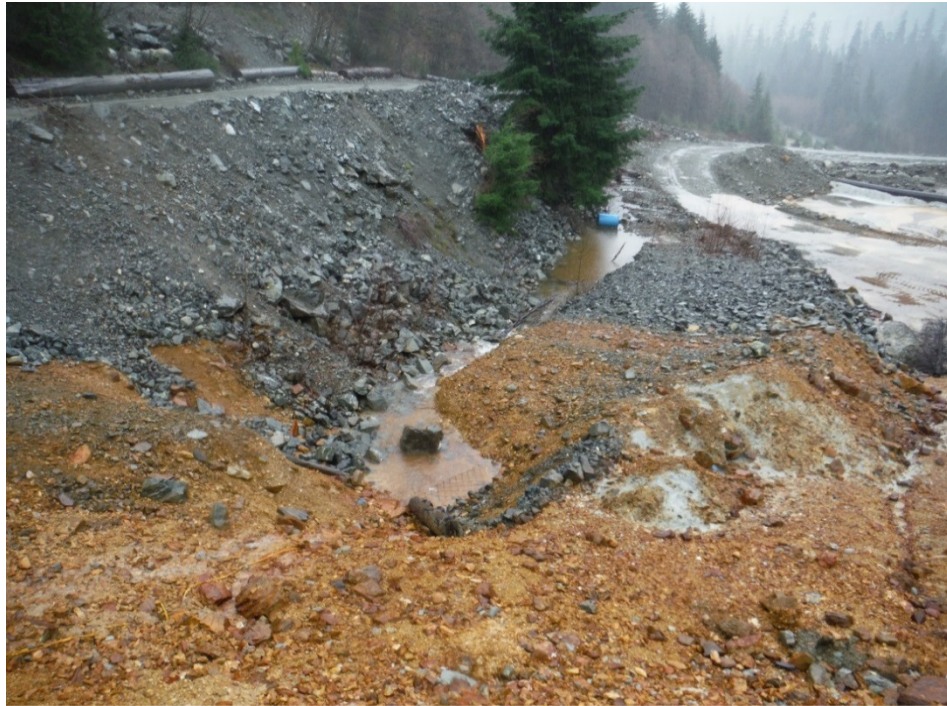
Photo 7: High water flow out of the main spring at the Paste Berm east abutment, looking east (November 27, 2014).

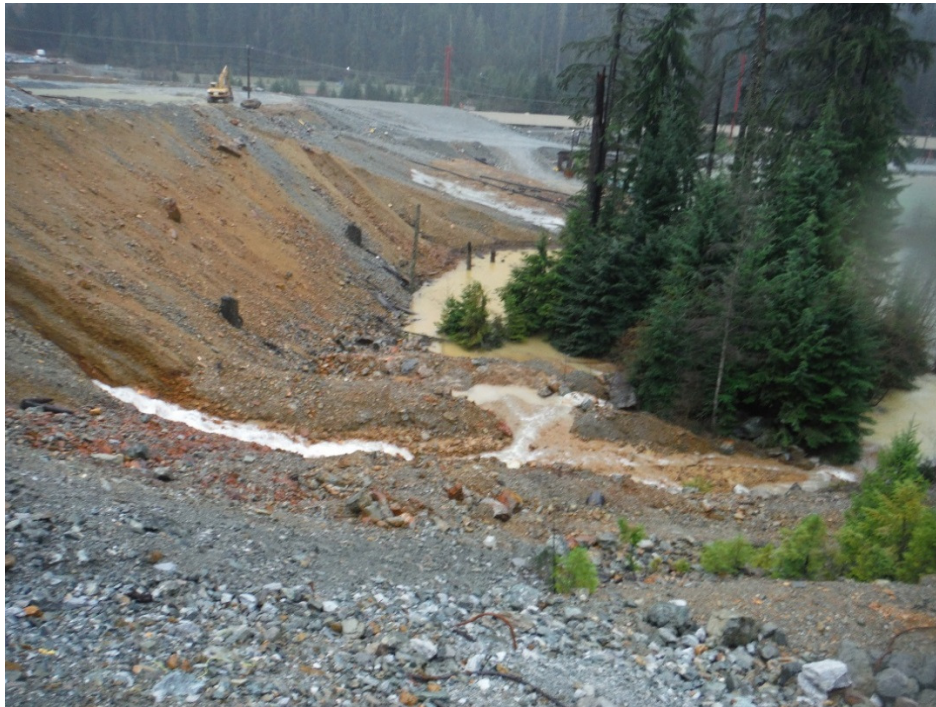
Photo 9: High flow of water from Phillips Reach into the flooded Phillips Reach Sump, looking south (December 10, 2014).

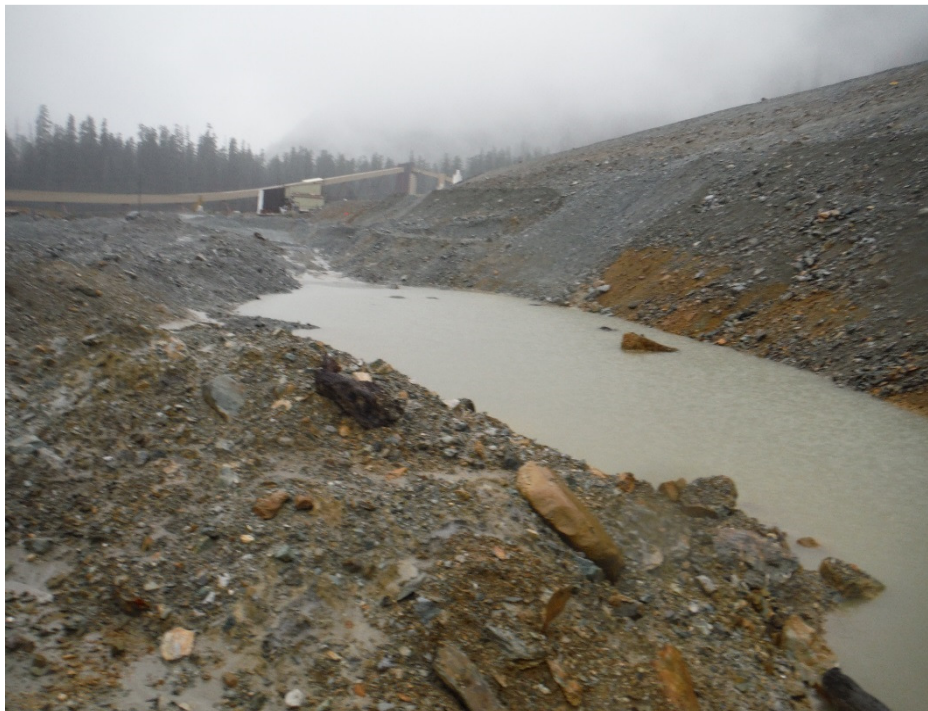
Photo 10: Flooding at toe of Lynx Dam, looking west (December 10, 2014).

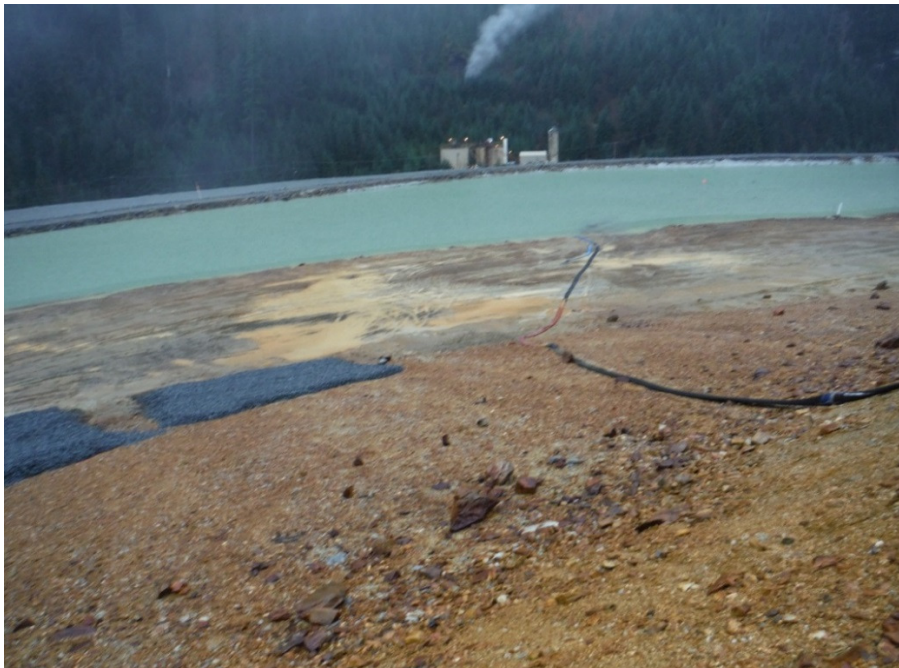
Photo 11: High water level in East Strip, required emergency actions (December 10, 2014).

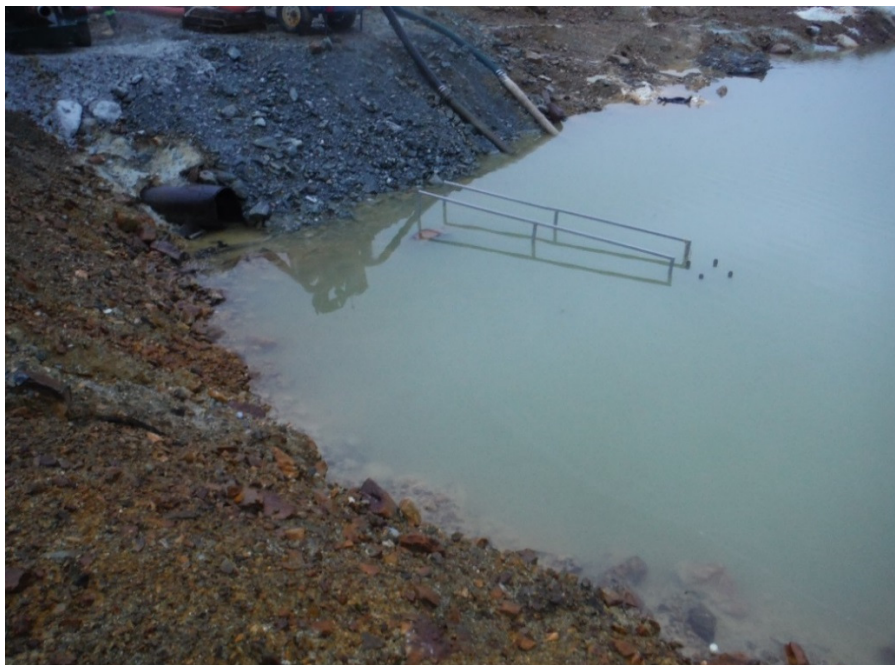
Photo 12: West Strip decant area completely submerged (December 11, 2014).

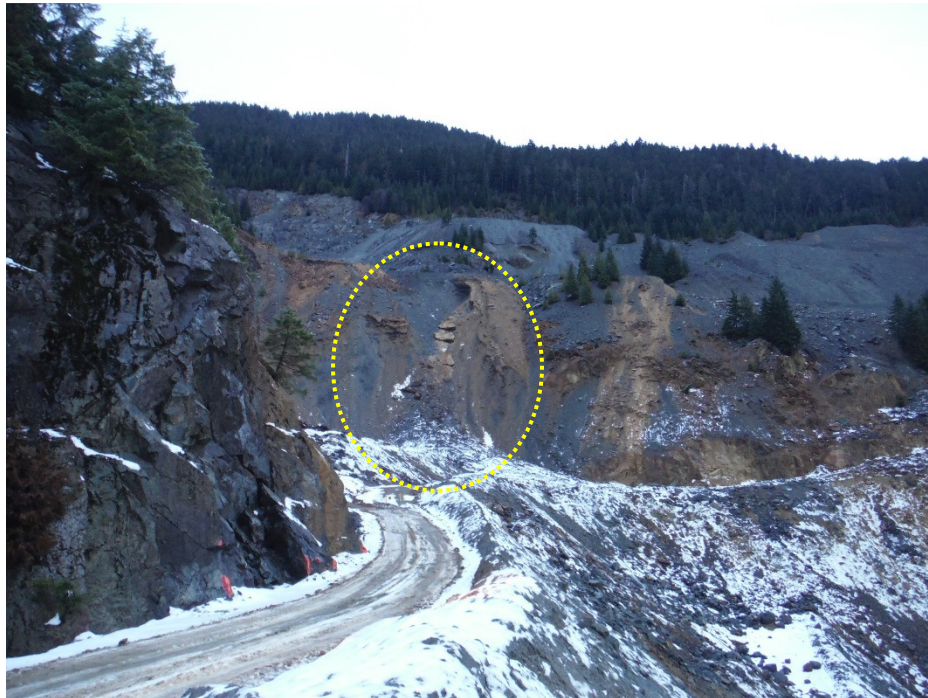
Photo 14: View of Lynx Pit Slide area, looking north towards waste dumps (January 9, 2015).

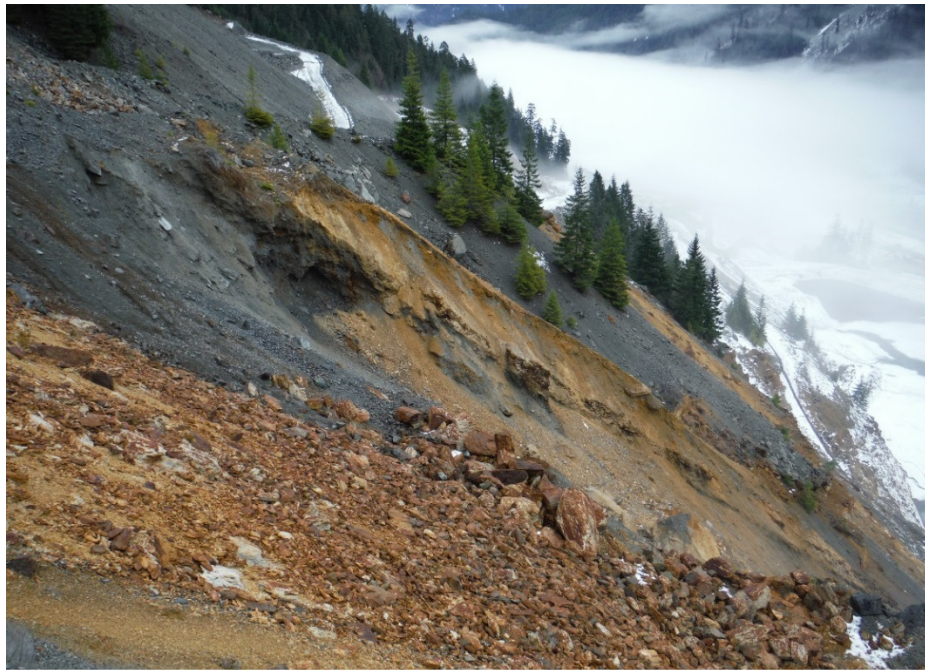
Photo 15: Head of Lynx Pit Slide area, looking east (January 9, 2015).

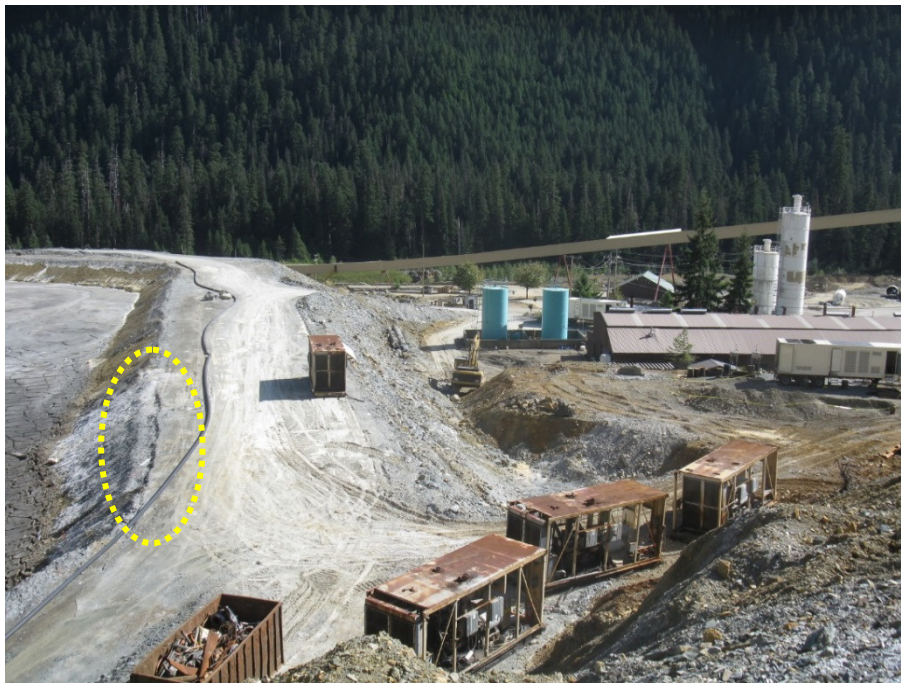
Photo 19: Lynx Dam west arm, looking south, showing minor sloughing of the upstream shell (August 24, 2015).

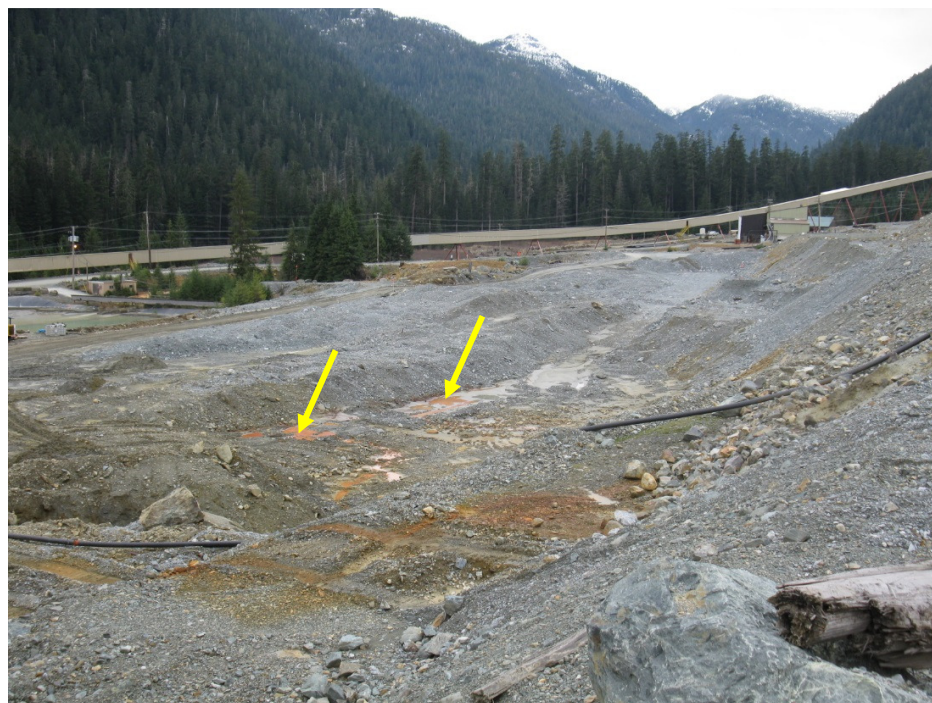
Photo 20: Ponding at the toe of the "Zone J" stockpile, showing Lynx Dam south arm east lower benches and toe area, looking west (March 5, 2015).

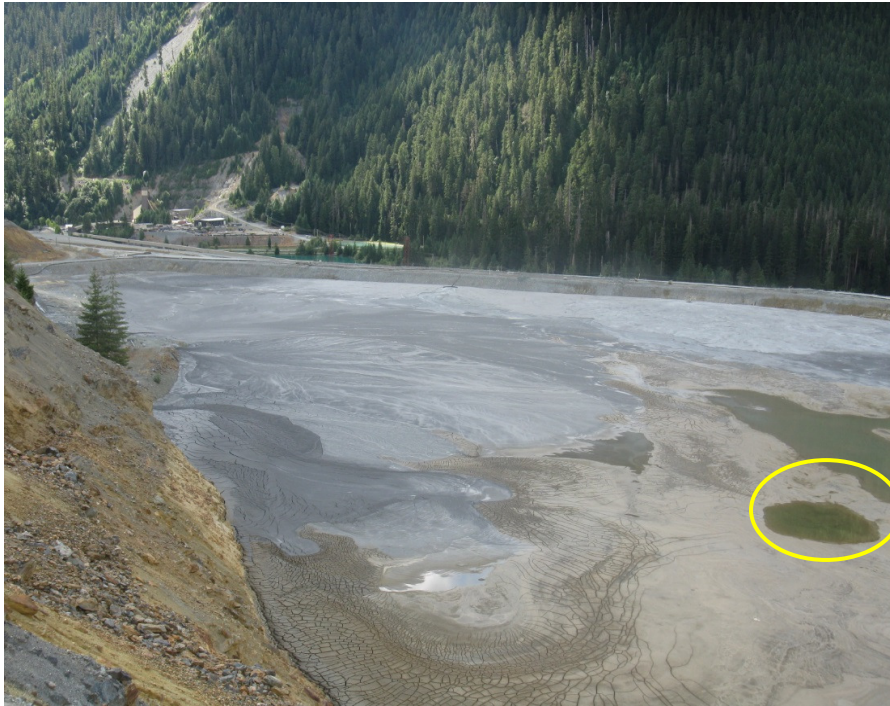
Photo 21: Overview of Lynx TDF in dry season, looking southeast, showing recurrent depression in yellow. Note tailings beach against south arm (July 23, 2015).

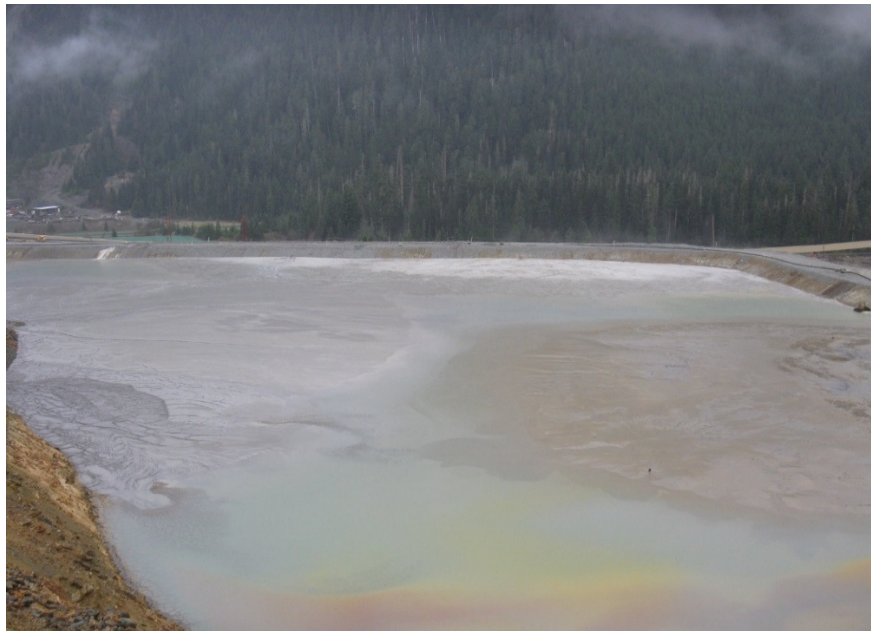
Photo 22: Overview of Lynx TDF in wet season, looking south. Note recurrent depression not visible (October 31, 2015).

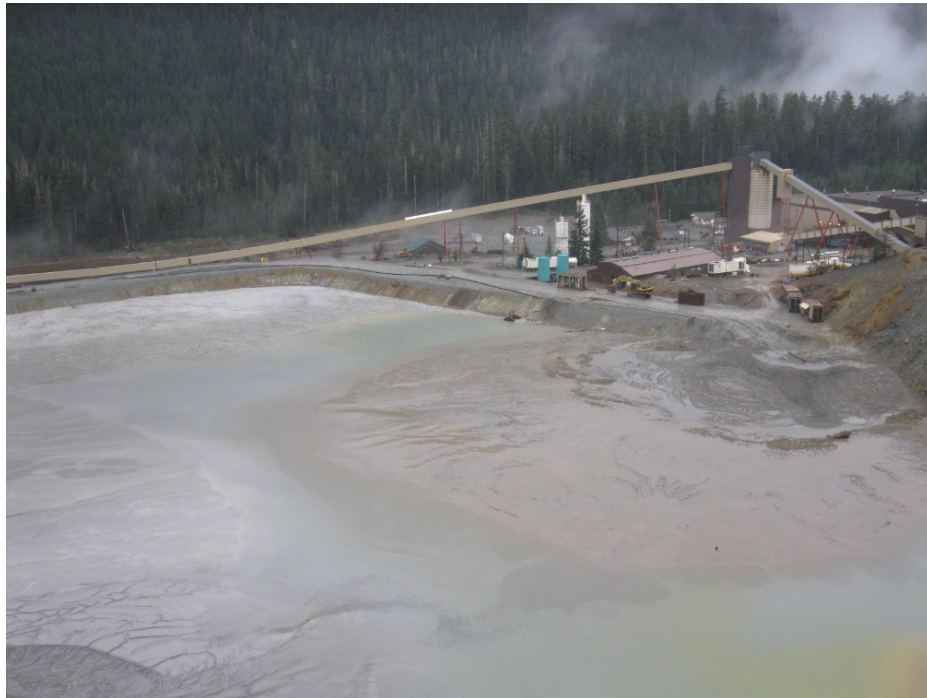
Photo 23: View of Lynx TDF, looking southwest. Note mud wave in tailings created by construction waste deposition in the northwest corner (October 31, 2015).

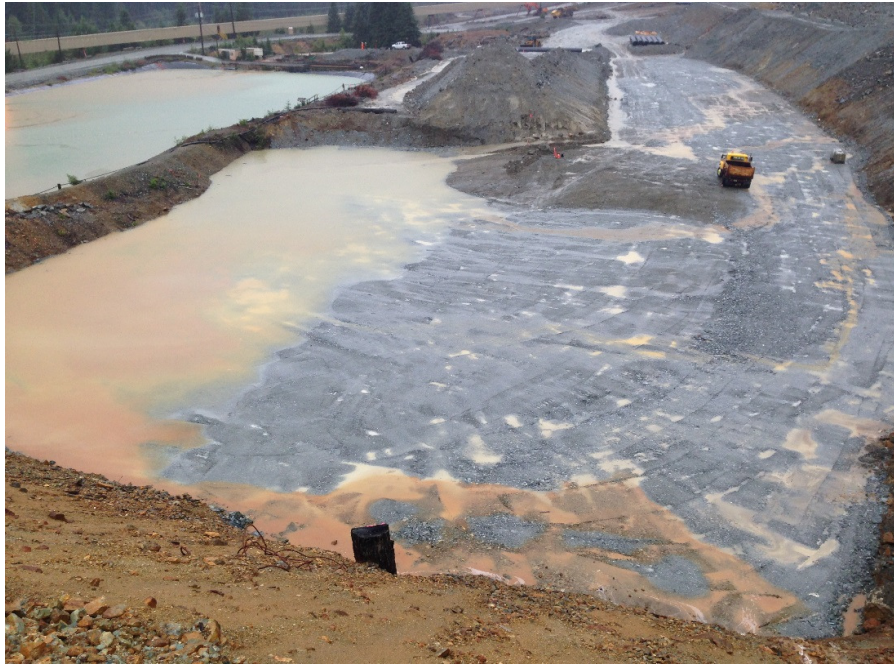
Photo 27: Panel area below Lynx TDF south arm inundated with water at the south end, looking west (September 24, 2015).

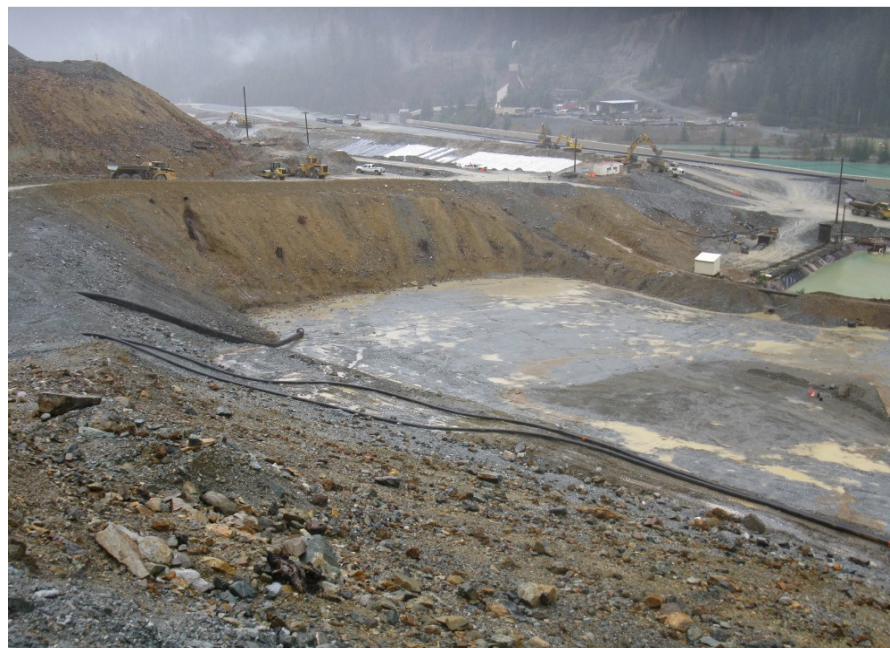
Photo 28: View of Lynx TDF panels area, looking southeast, showing improved drainage out of the south end due to a culvert leading to Super Pond (October 31, 2015).

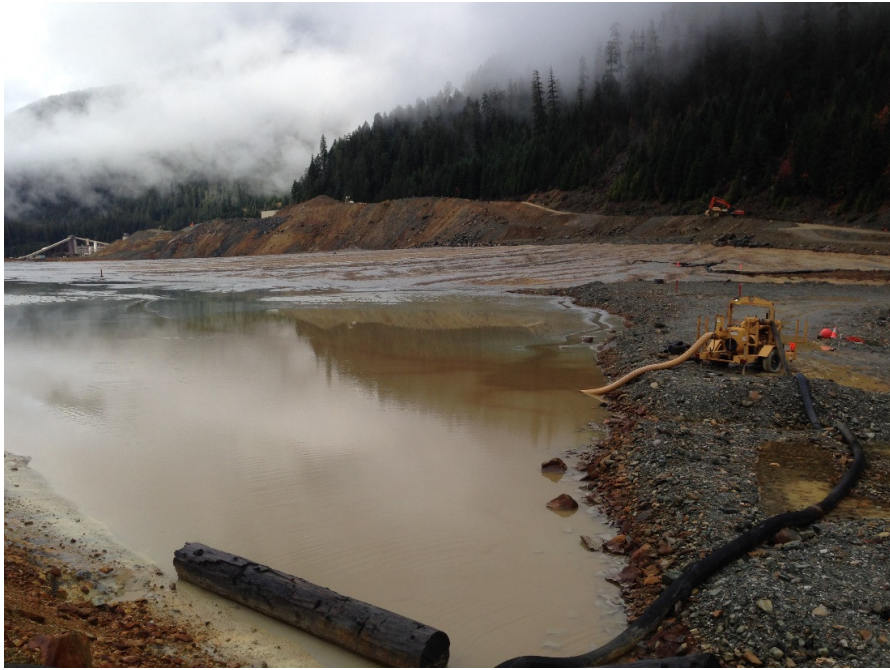
Photo 37: Pump located in southeast corner of APA, looking northwest (October 30, 2015).

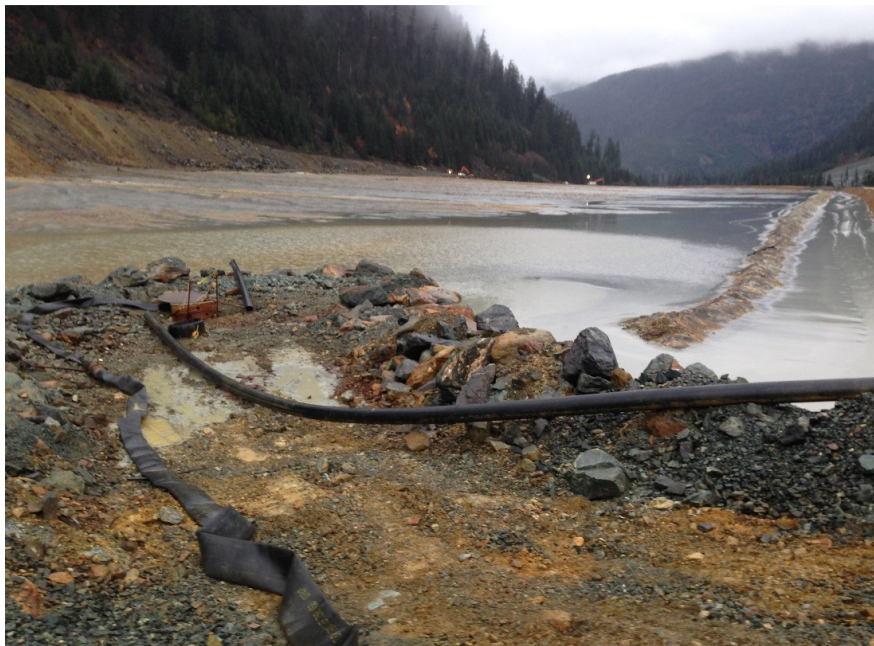
Photo 38: View of the APA ditch in wet season, looking east (October 30, 2015).

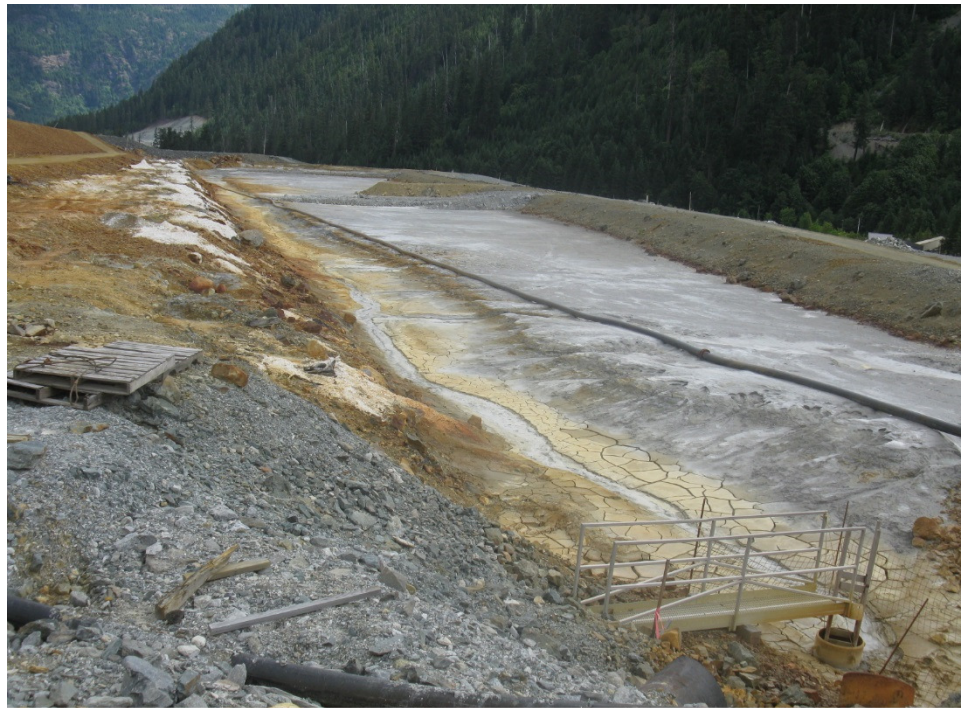
Photo 39: View of West Strip and strip decant area, looking east (July 23, 2015).

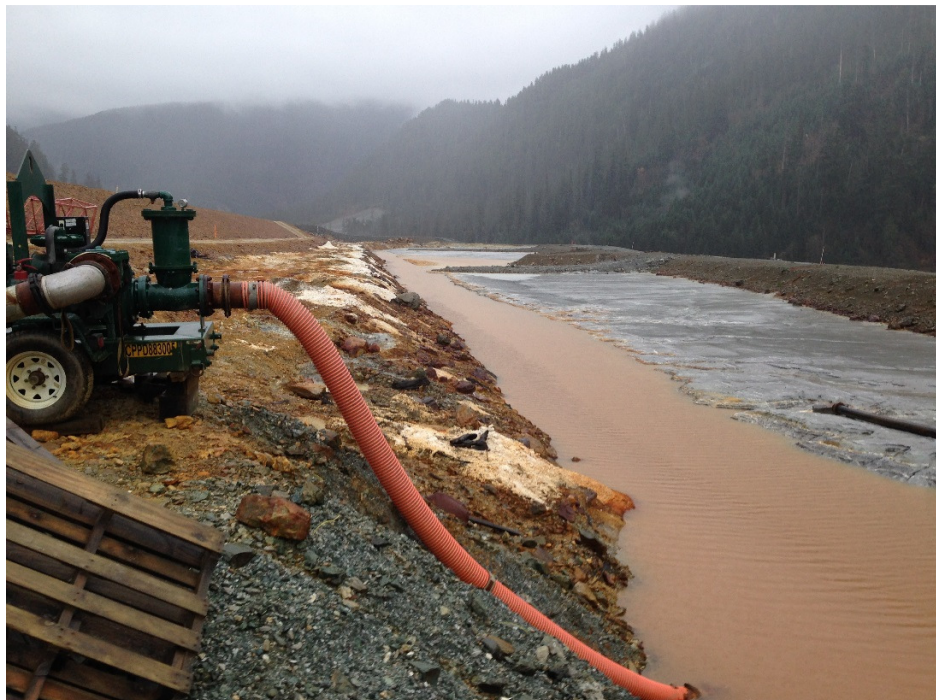
Photo 40: View of West Strip from the decant area, looking east. Note presence of pump to manage water levels (October 30, 2015).

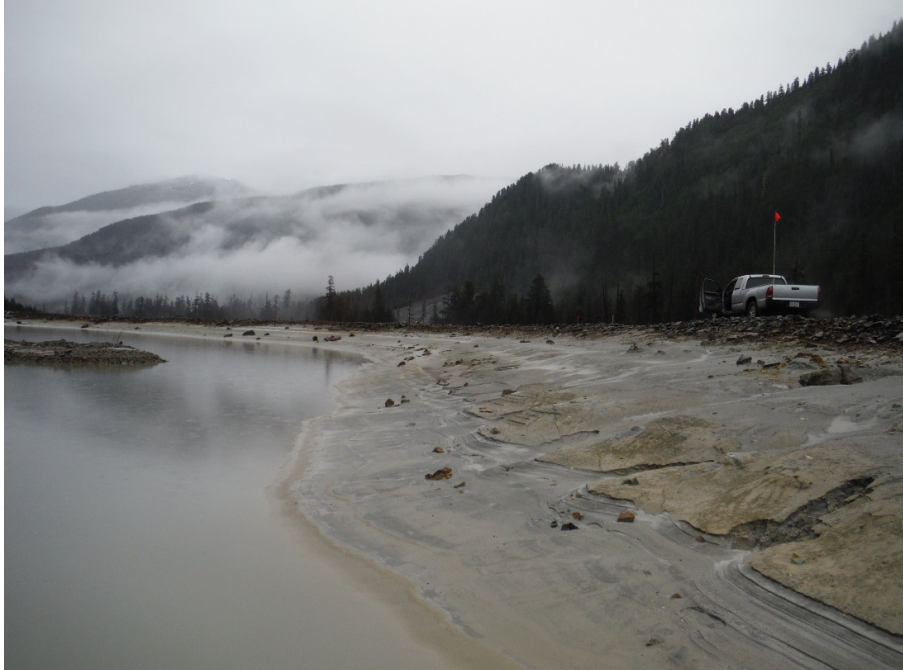
Photo 41: East Strip showing minor erosional features along the OEB upstream beach, looking east from the Old TDF spillway area (February 9, 2015).

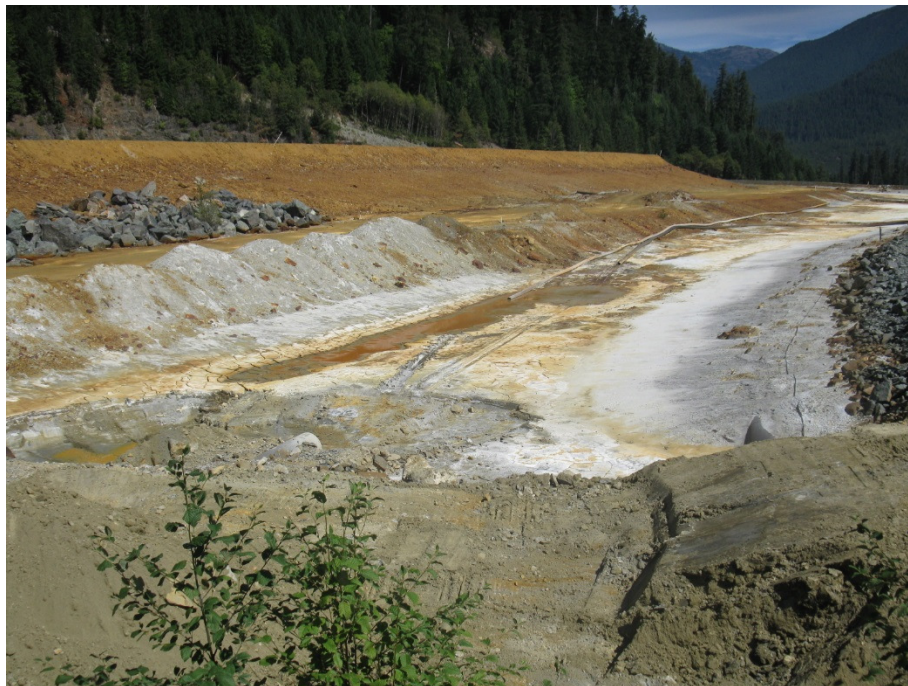
Photo 42: Dry East Strip, looking east (August 24, 2015).

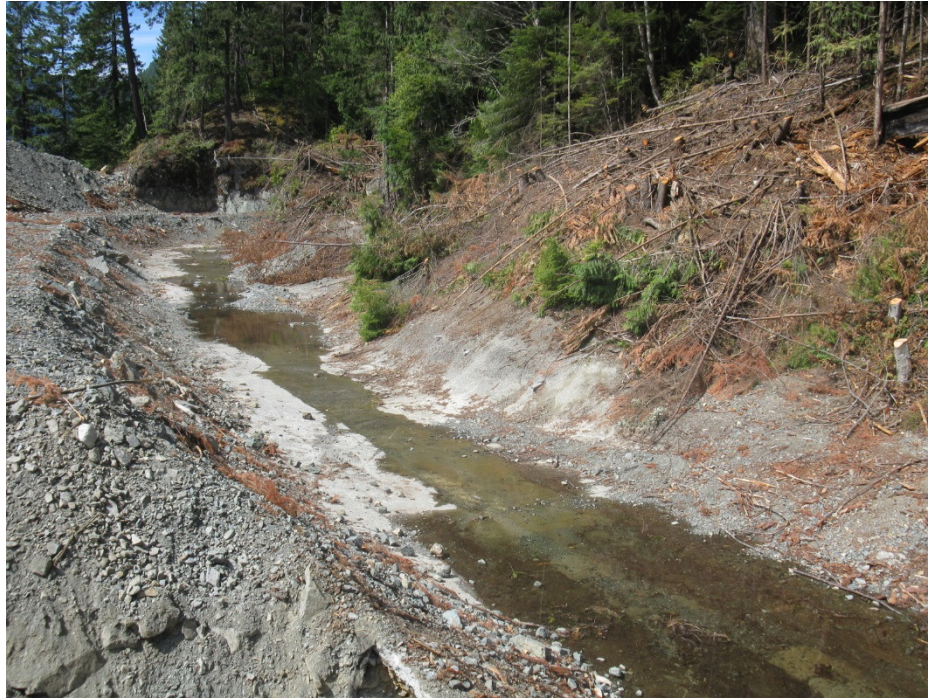
Photo 43: Lower Lynx Diversion Ditch near Cascade Reach outlet, looking east (August 24, 2015).

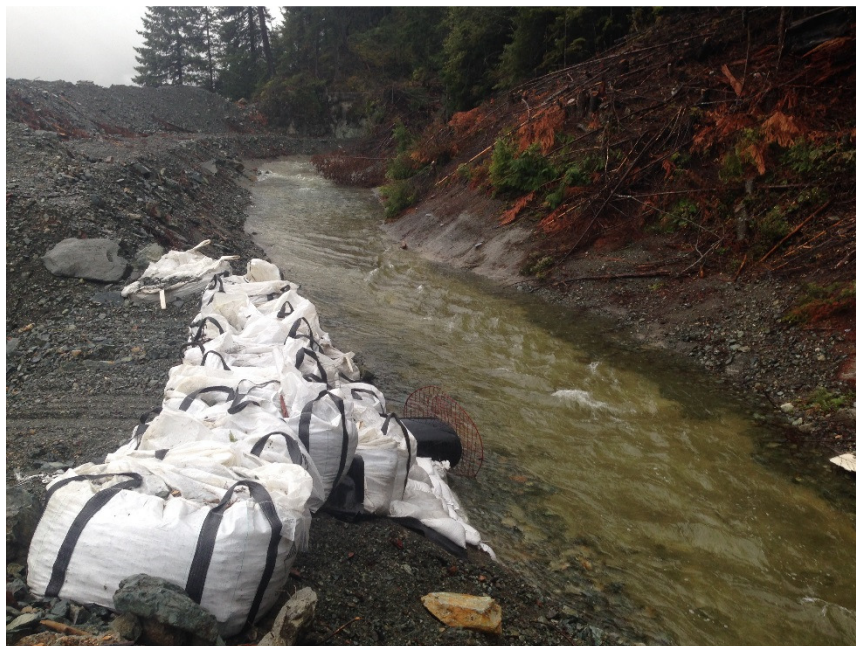
Photo 44: Lower Lynx Diversion Ditch near Cascade Reach outlet, looking east (September 24, 2015).

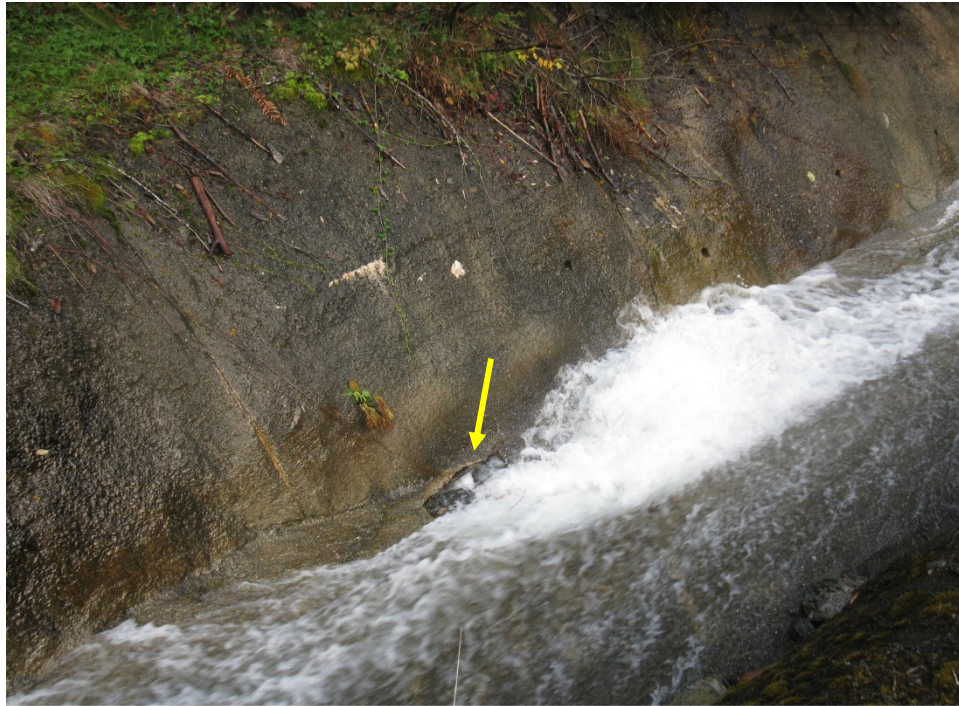
Photo 45: Hole in shotcrete lining of the Lower Lynx Diversion Ditch (October 31, 2015).

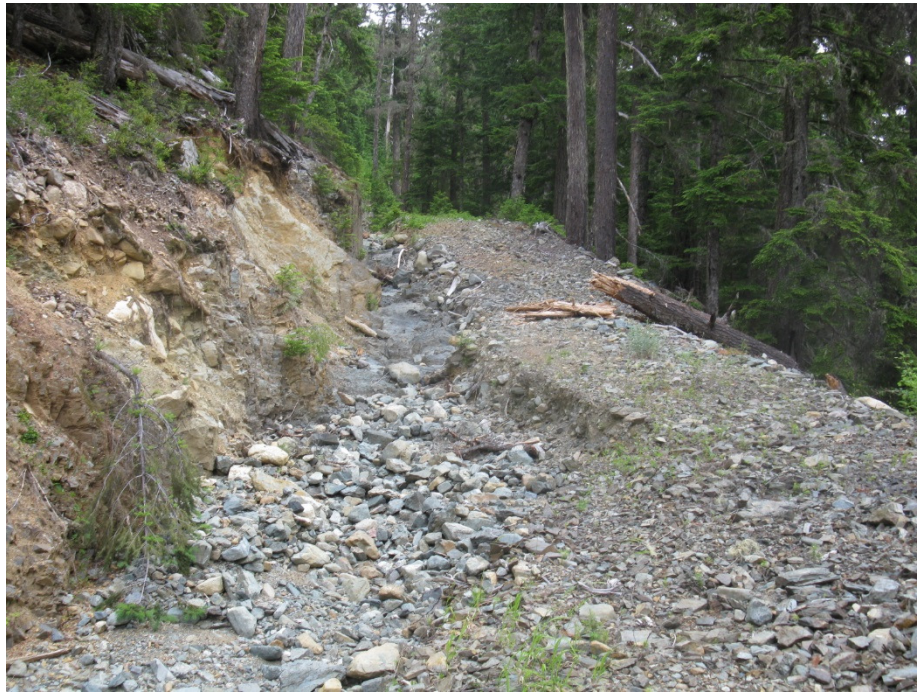
Photo 46: Lower Arnica Reach Ditch, looking upstream. Note side erosion to the right due to high water levels (June 17, 2015).

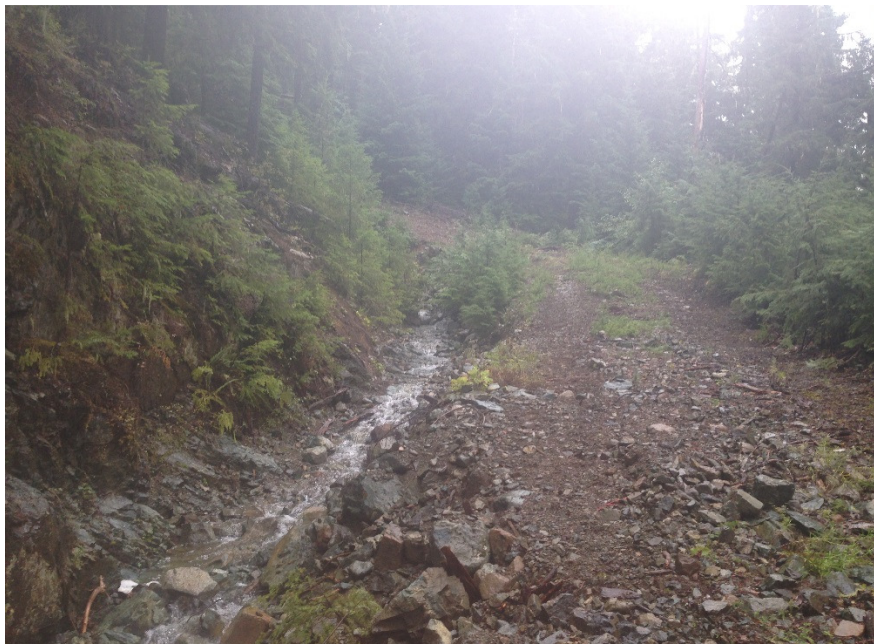
Photo 48: Lower Arnica Reach Ditch, looking upstream (September 24, 2015).

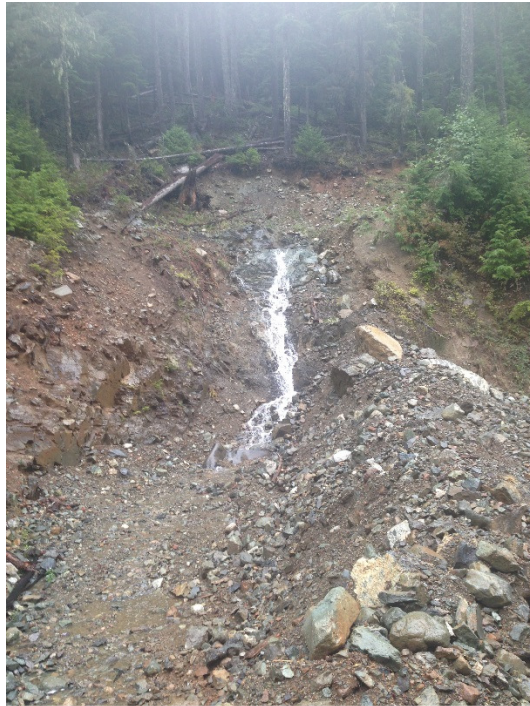
Photo 49: Junction of Upper Arnica Reach Ditch and Upper Lynx Diversion Ditch (September 24, 2015).

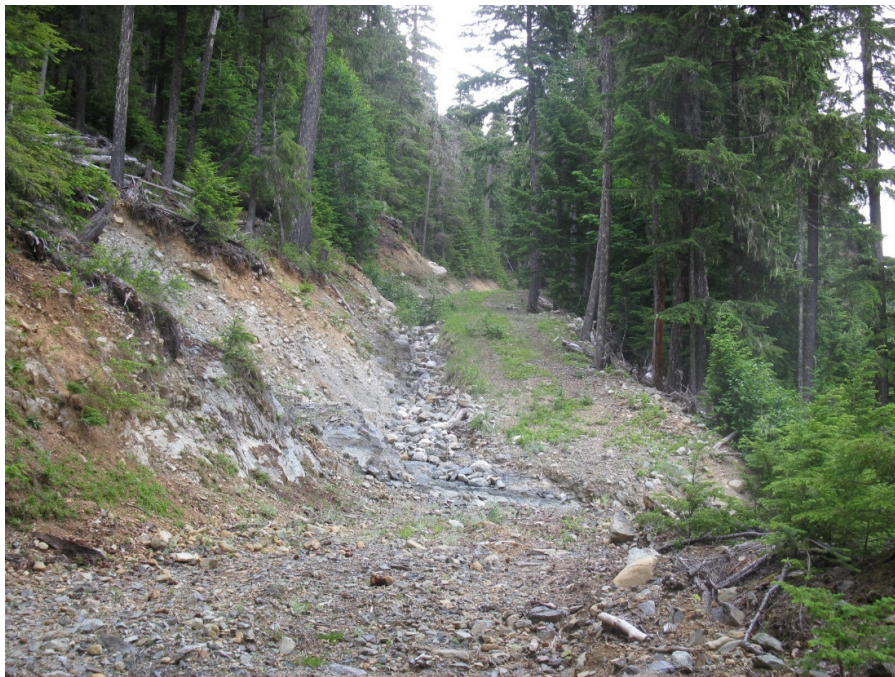
Photo 50: Upper Arnica Reach Ditch, looking upstream (June 17, 2015).

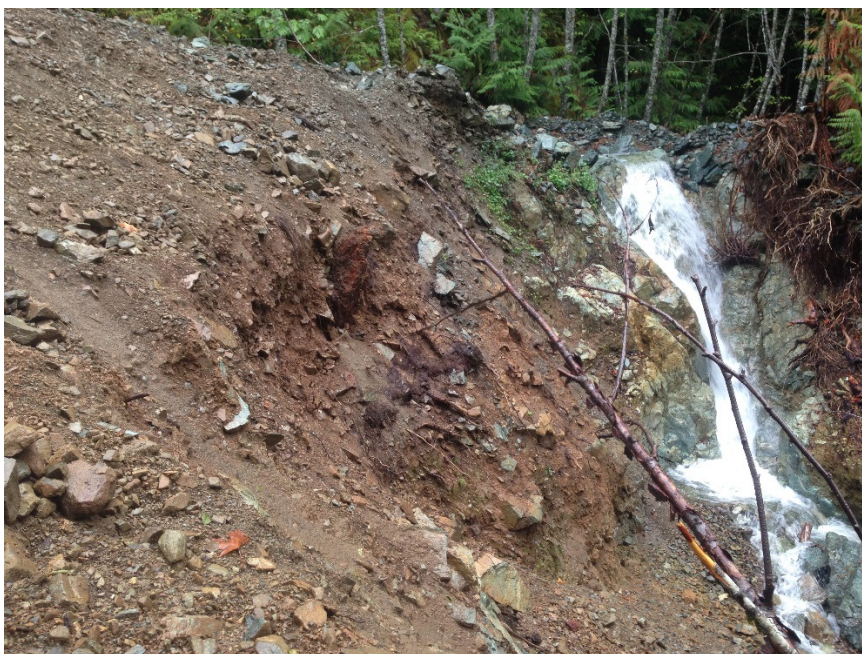
Photo 51: Erosion of slope at the east end of Upper Lynx Diversion Ditch near Cascade Reach (Taken September 24, 2015).

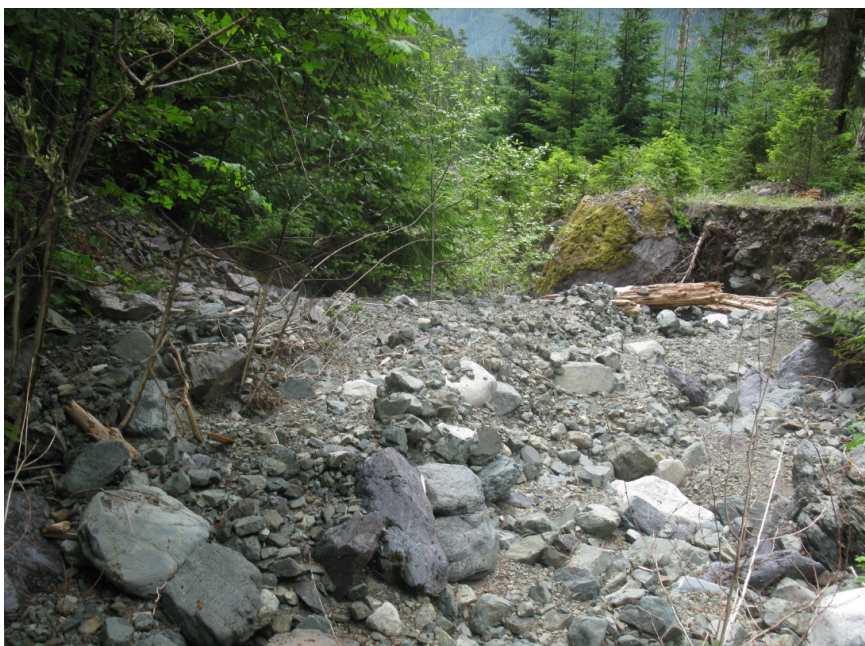
Photo 52: Debris blocking the Upper Lynx Diversion Ditch, looking downstream (June 17, 2015).

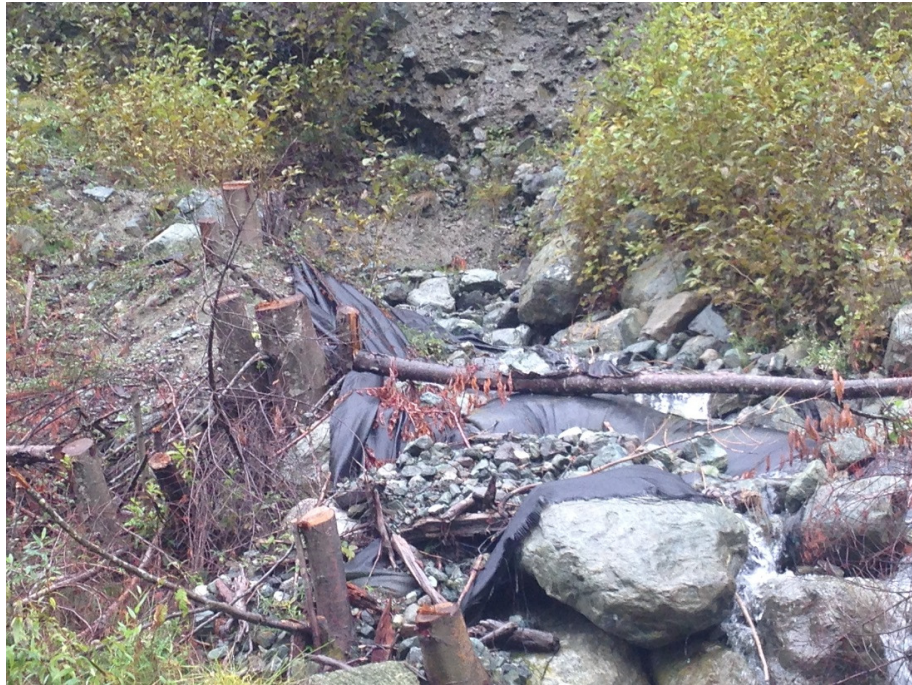
Photo 53: Debris at Alder Reach Ditch outfall into Lynx Lower Diversion Ditch (September 24, 2015).

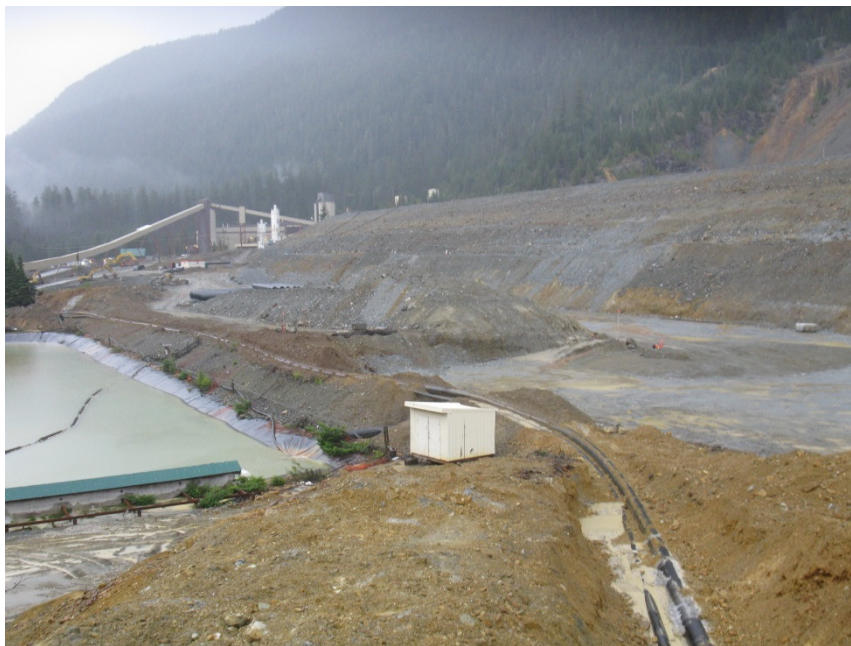
Photo 54: New decant pipeline along Super Pond, looking west (October 31, 2015).

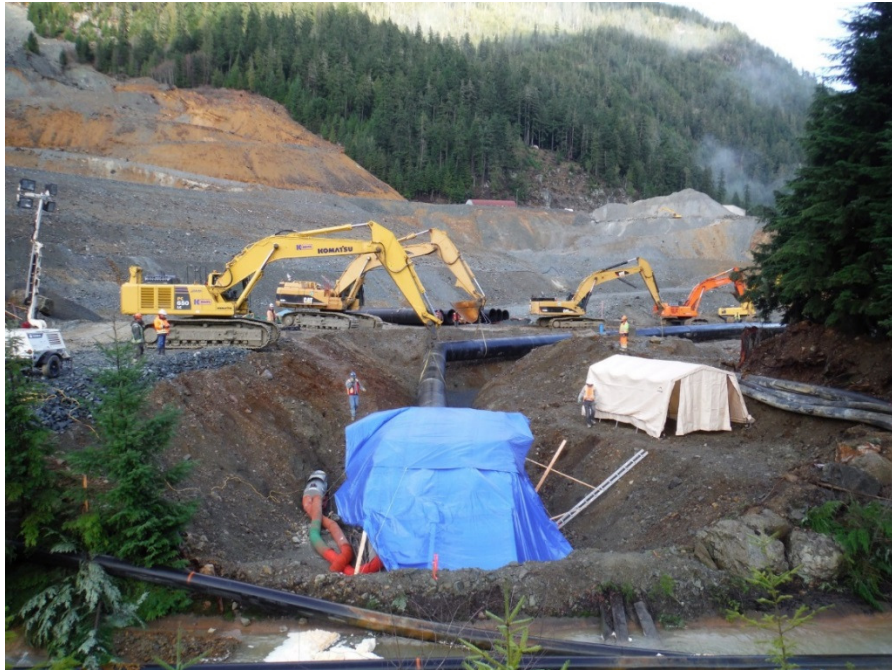
Photo 55: Decant pipeline leading to energy dissipater (December 15, 2015).

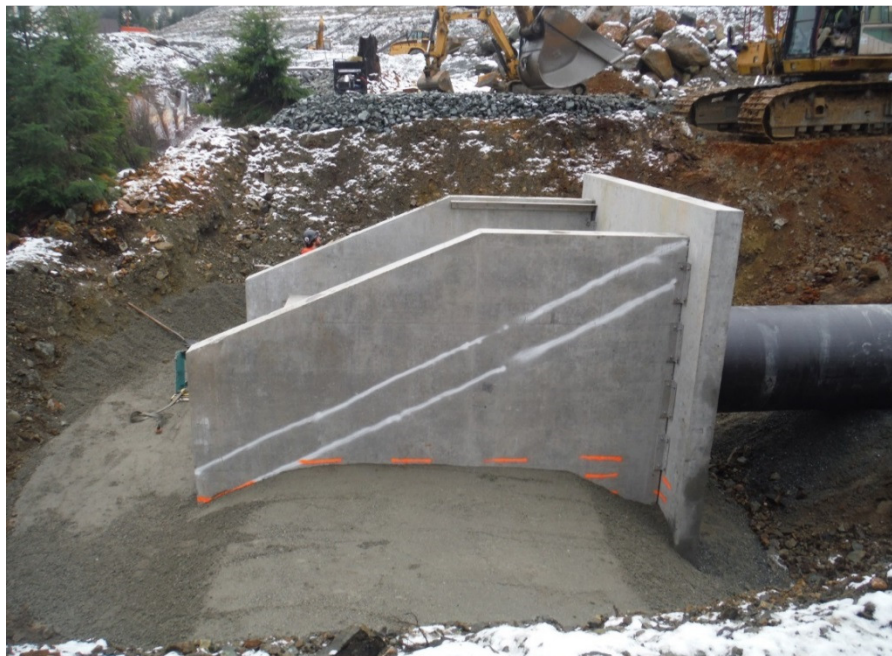
Photo 56: Energy dissipater at the end of the decant pipeline (December 15, 2015).

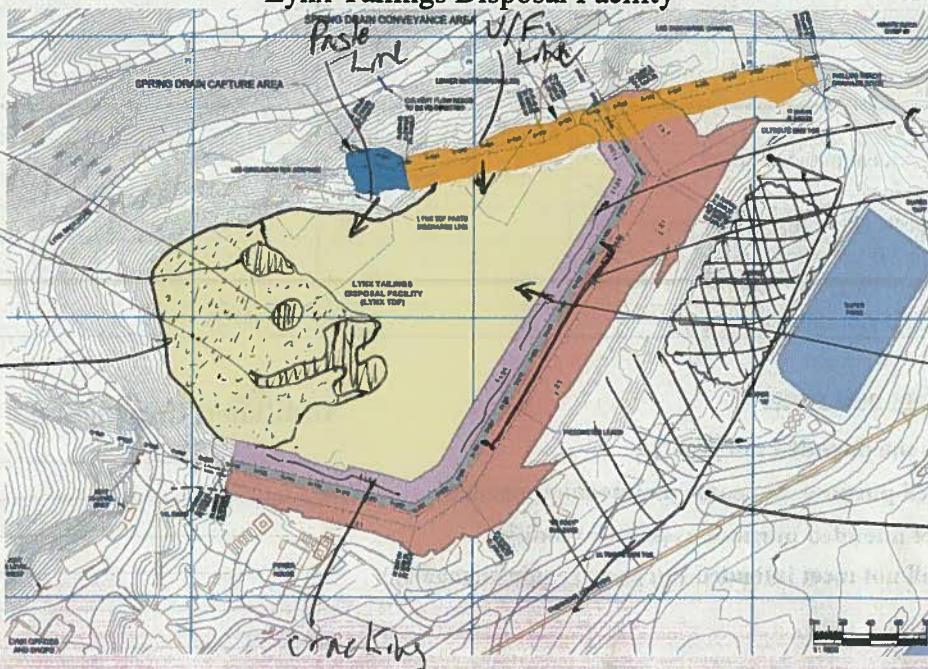
Dam Toe (Lynx) Prep underway
