**MYRA FALLS TAILINGS STORAGE FACILITIES
2015 DAM SAFETY INSPECTION REPORT**

31 March 2016

Amec Foster Wheeler File: NX14001B

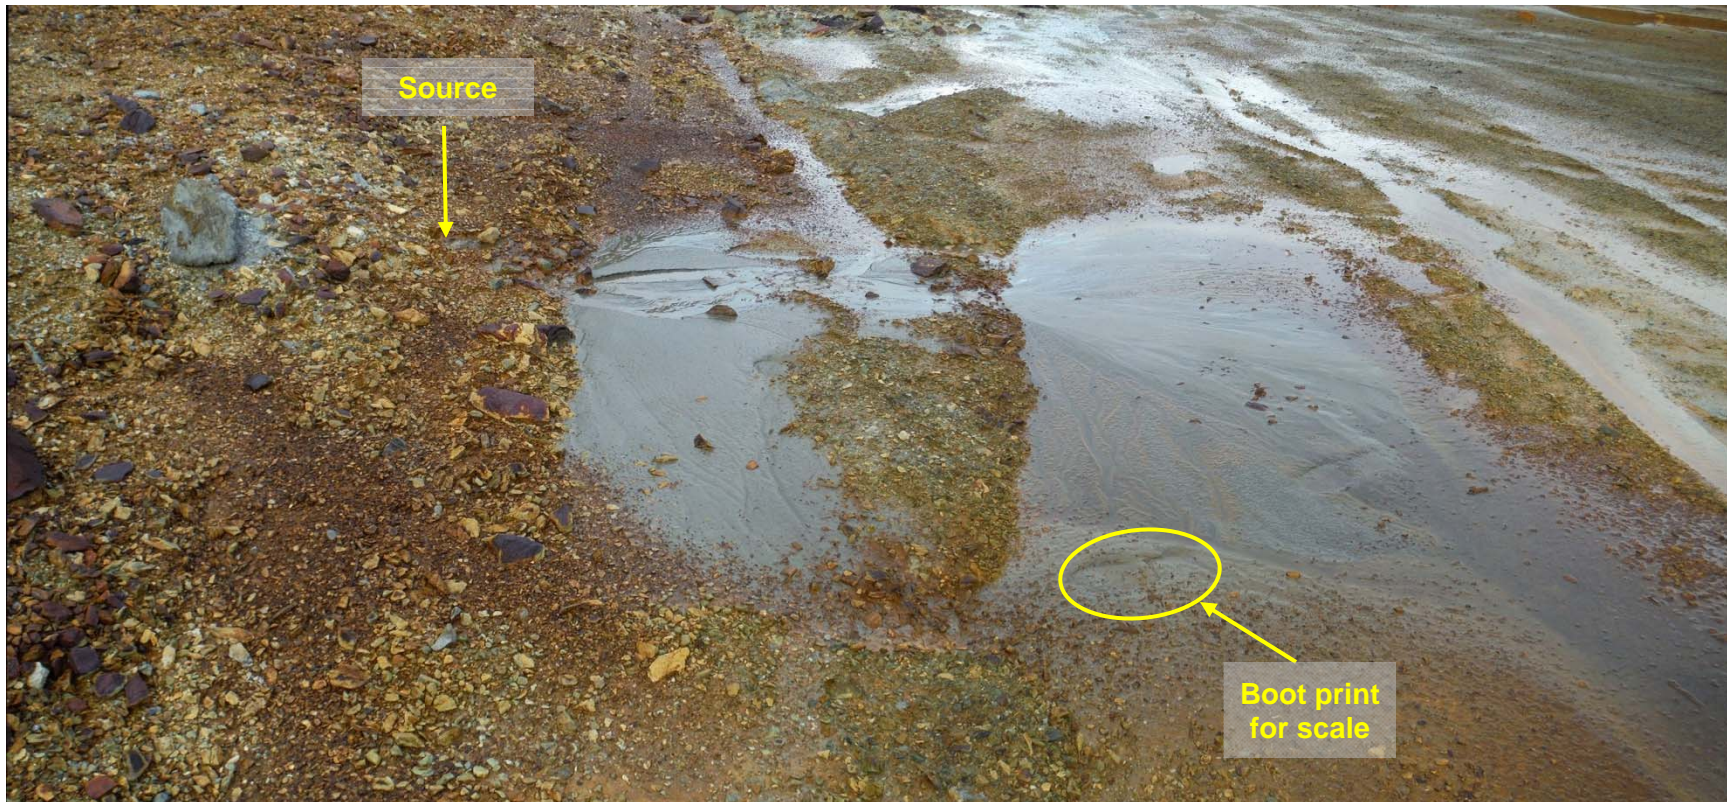
Photo 3 – Side view of piping area looking northwest along the toe of the Paste Berm.

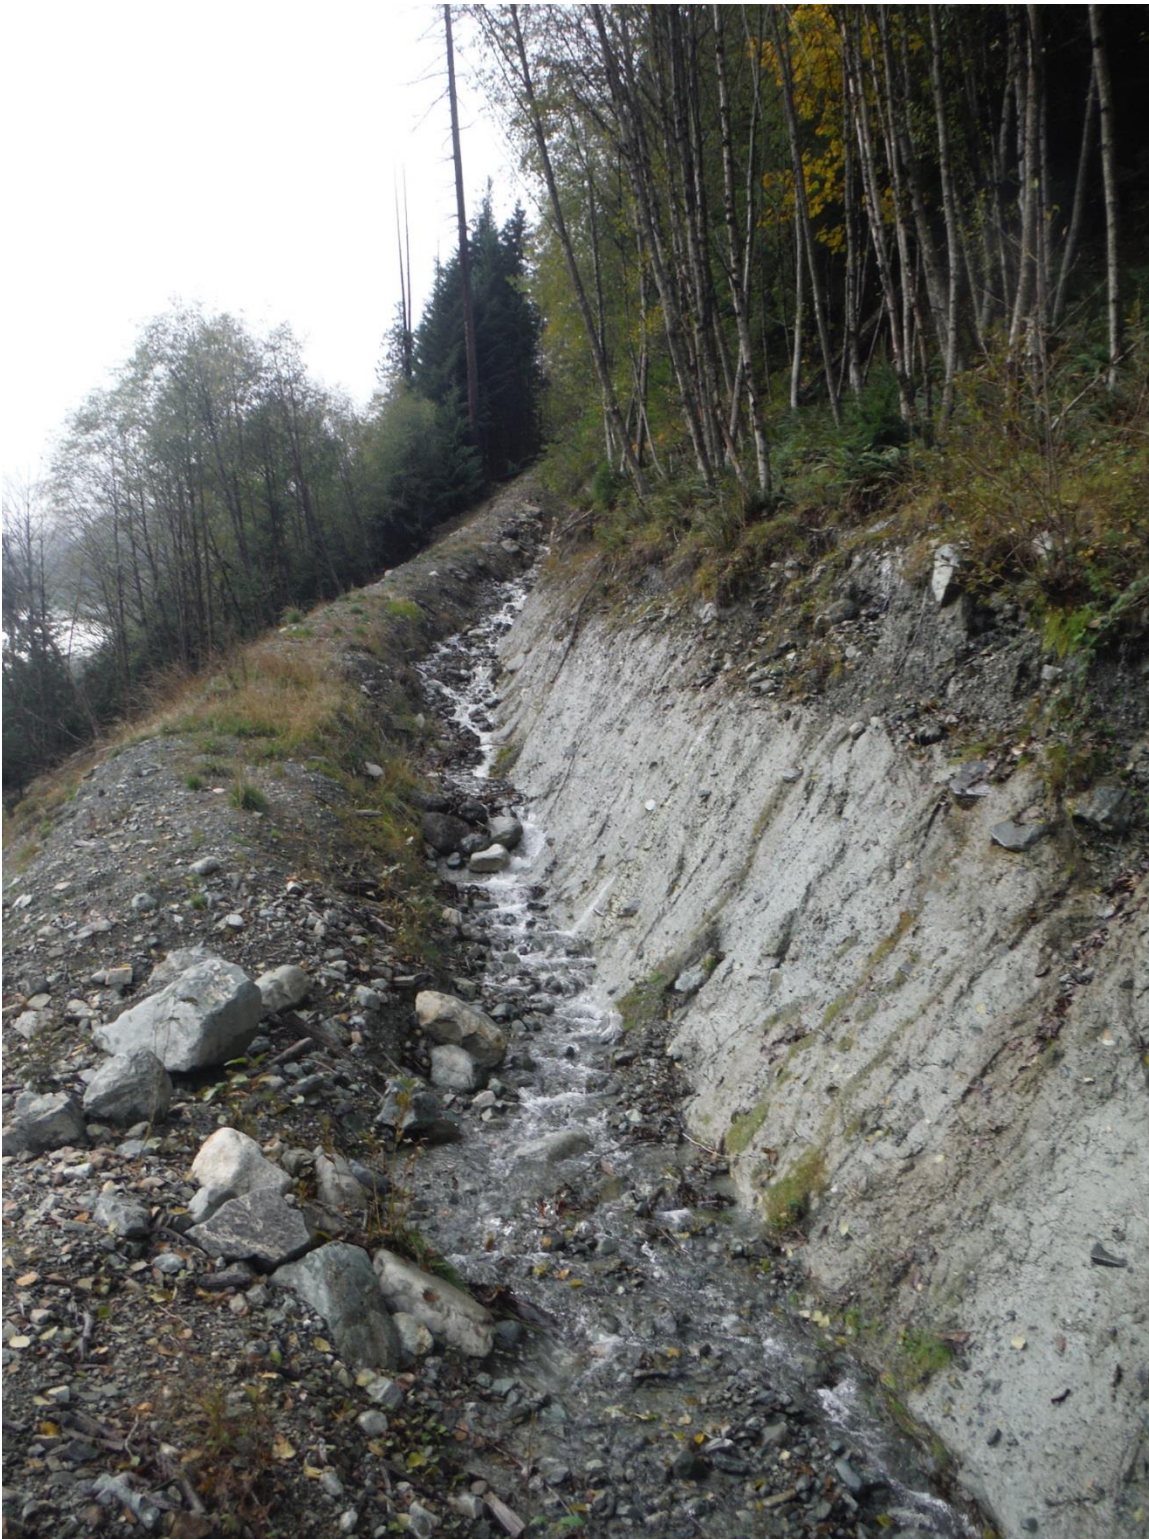
View looking up the Alder Reach from about 2+00, in October 2014.

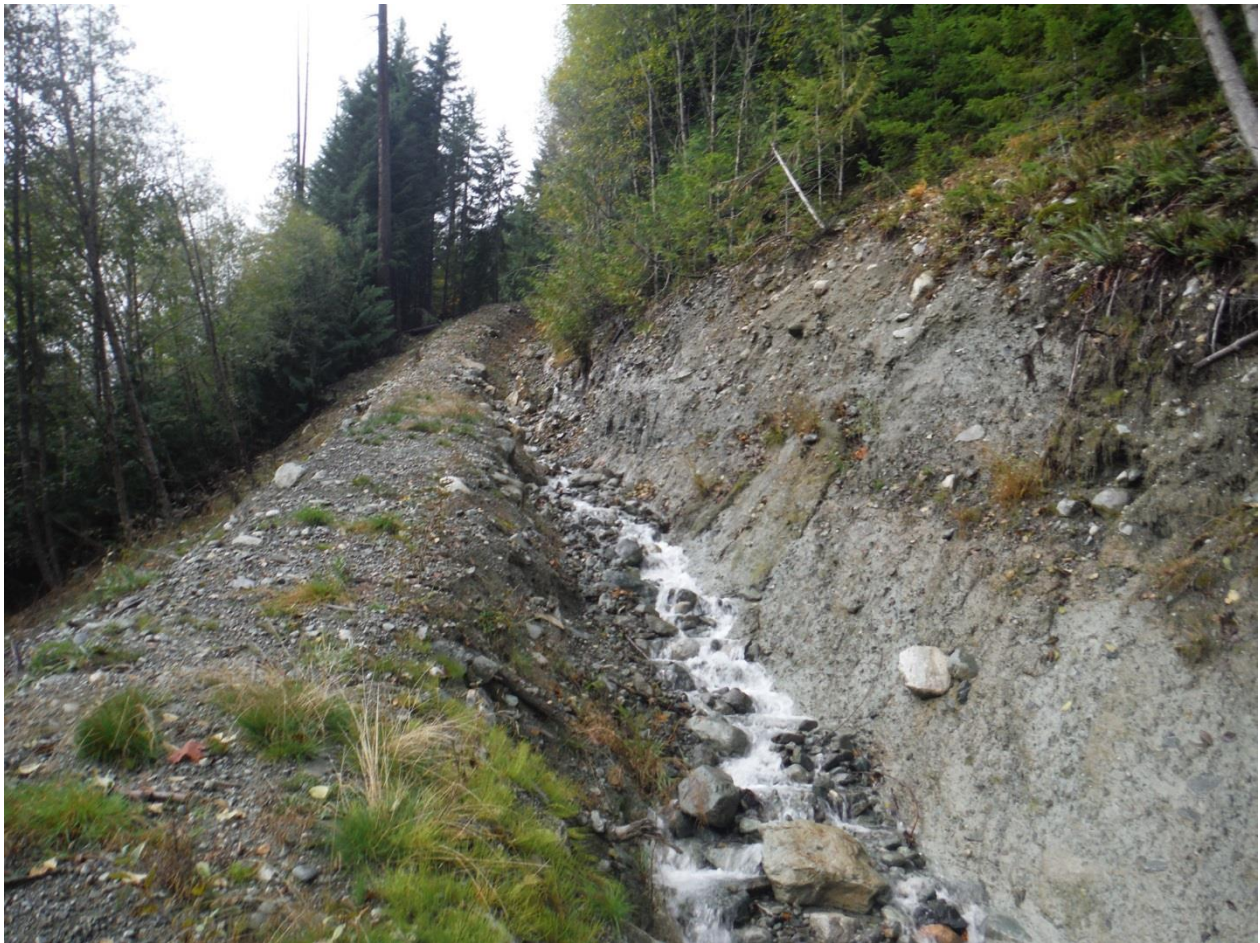
View looking up the Alder Reach from about 1+60 in October 2014.

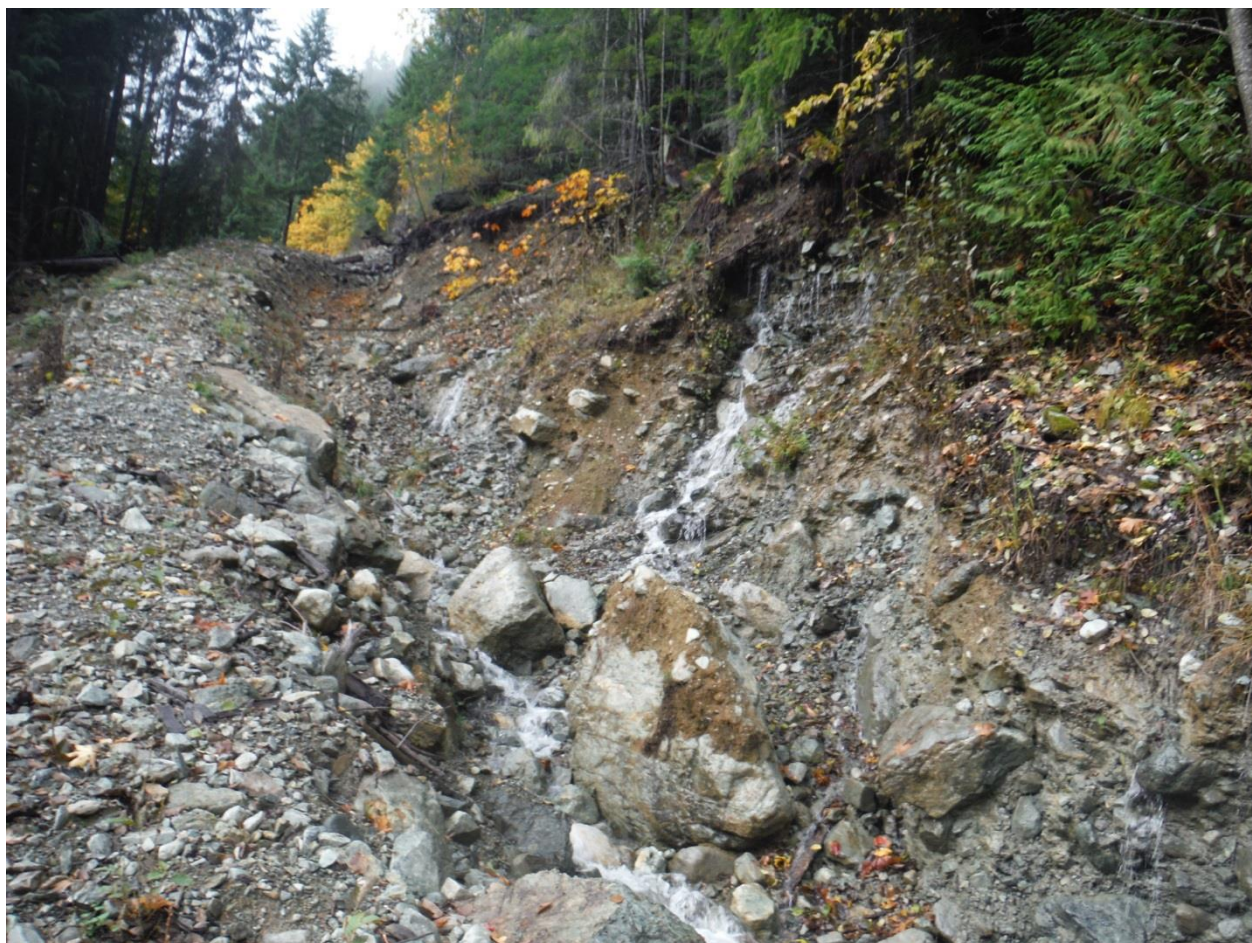
Main source of water at about 1+05, in coarse colluvium, October 2014.
A drainage swale will be required at this location or slightly below.

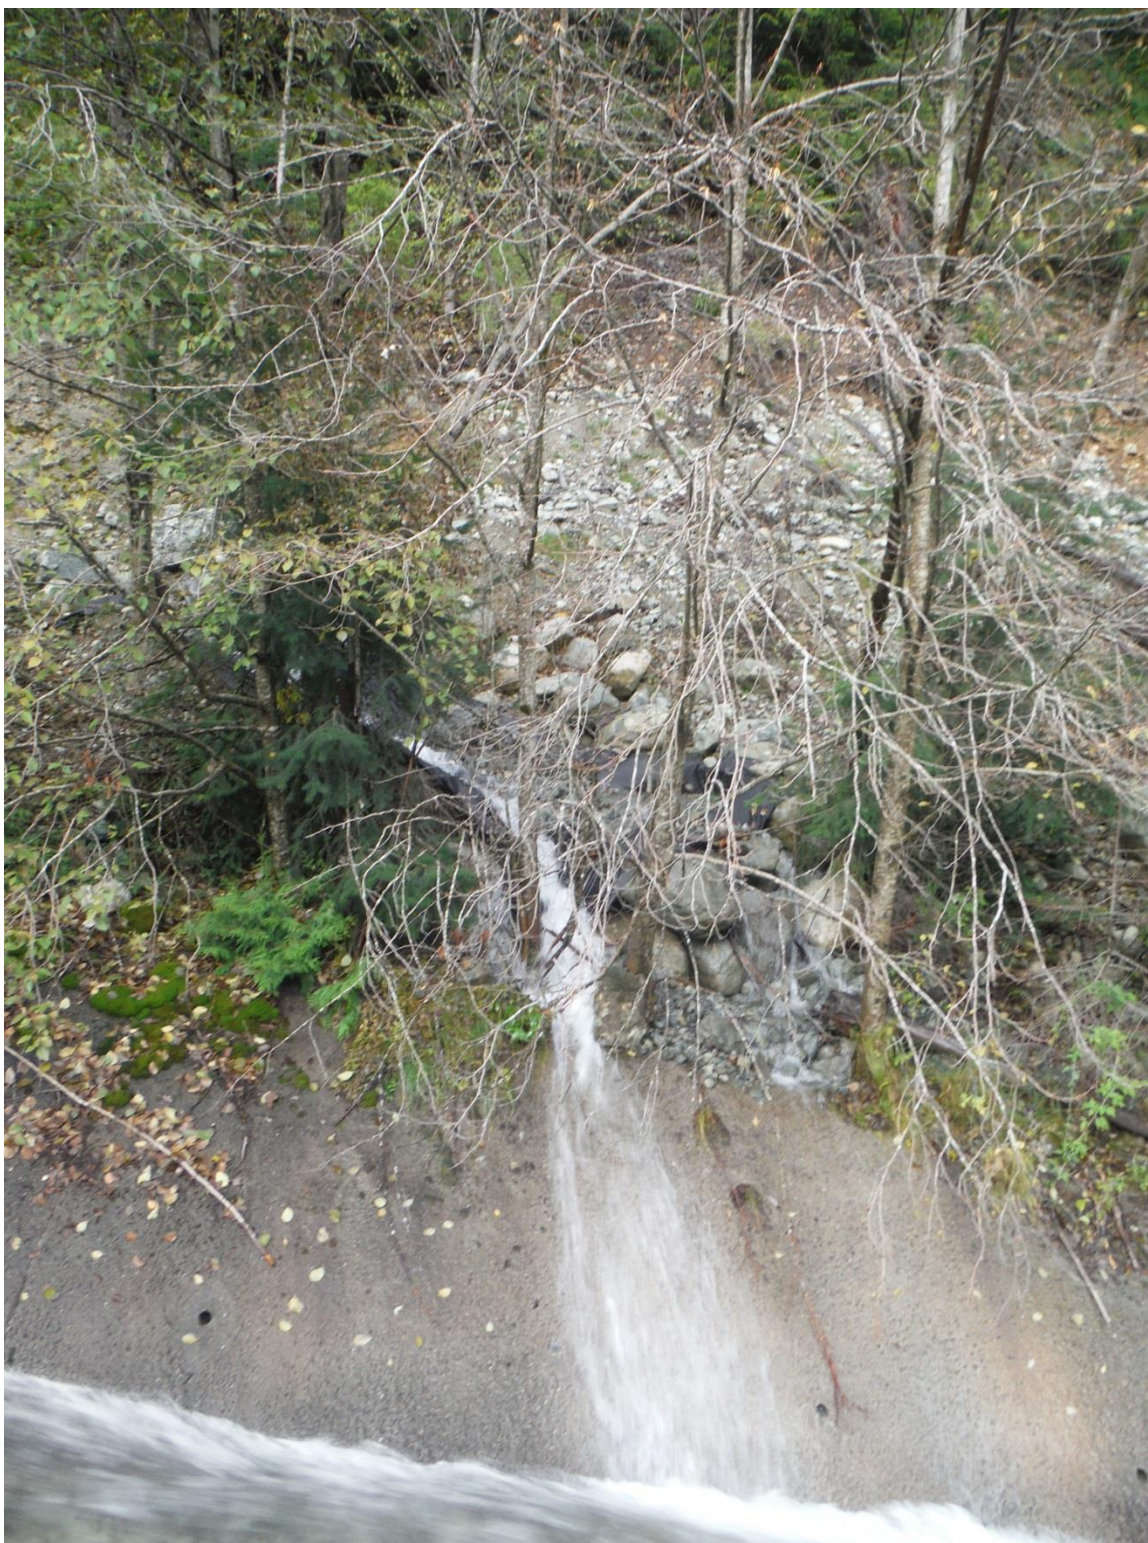
Water discharge at 2+40, at the Lower Lynx Diversion Ditch, October 2014.

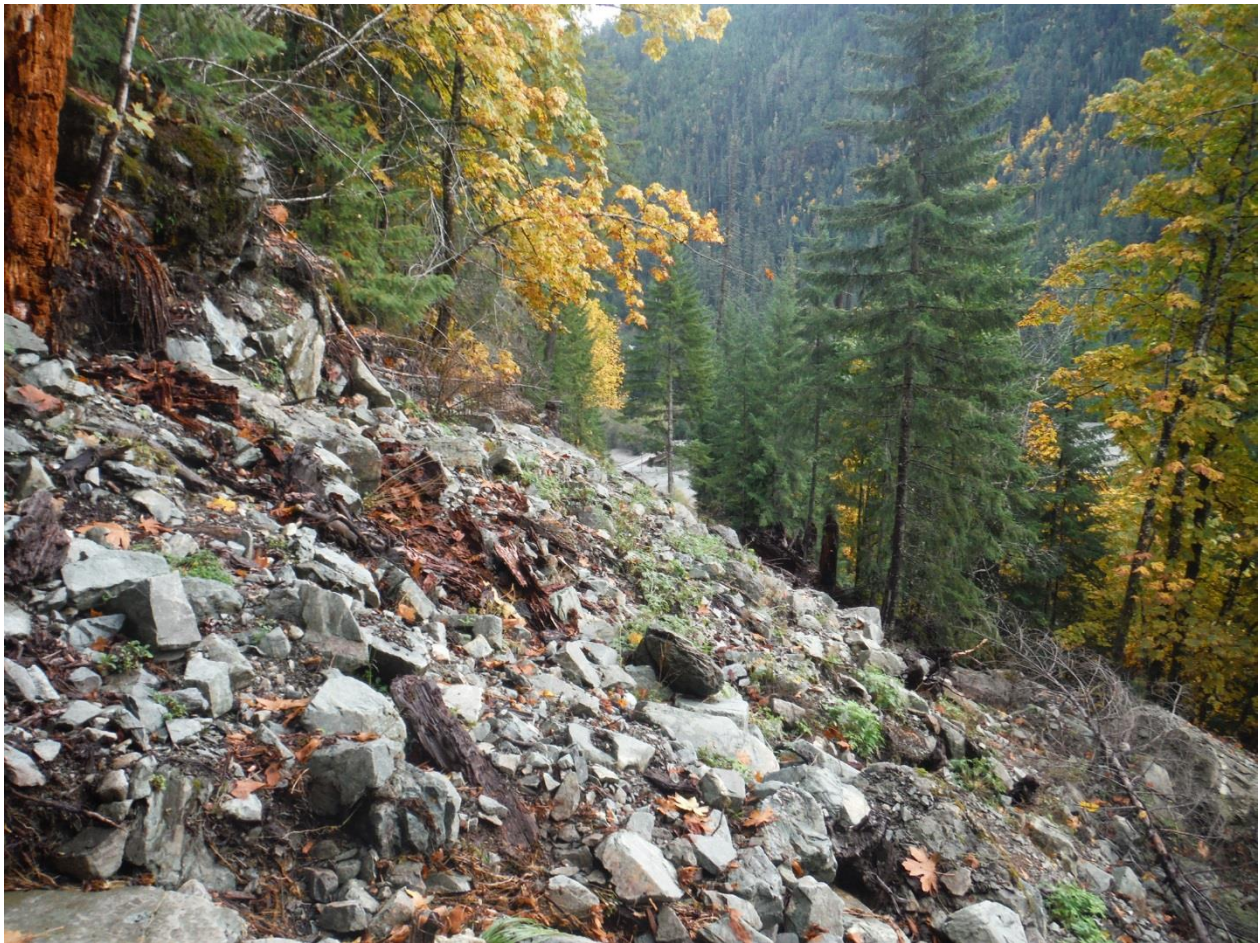
Previously deactivated section looking downslope from about 0+40, October 2014.

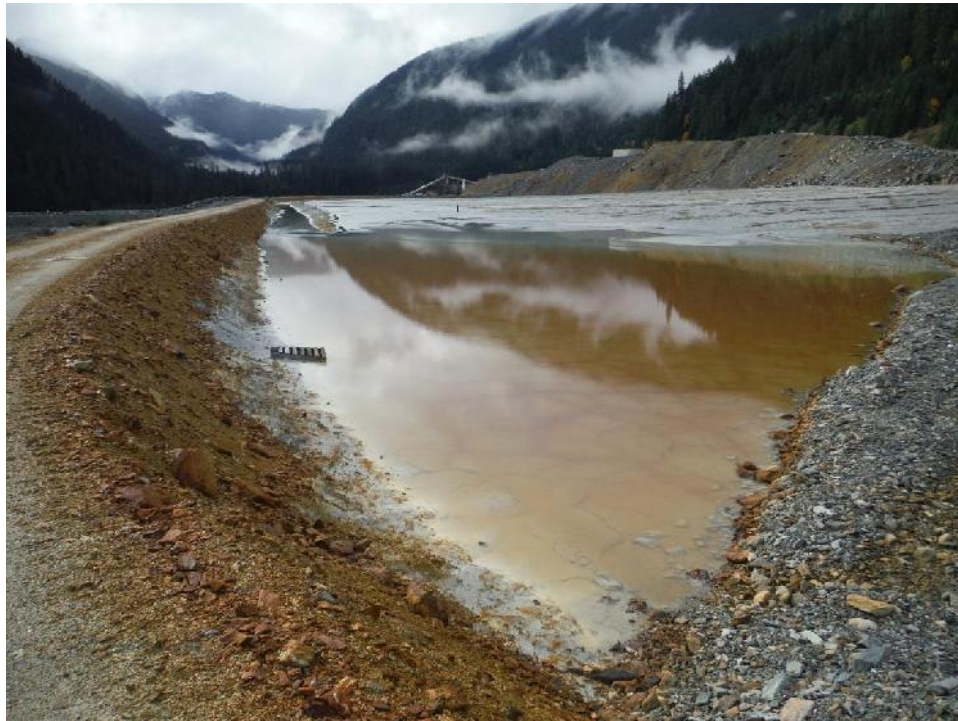
Photo 3 – Southeast corner of the APA, looking west.

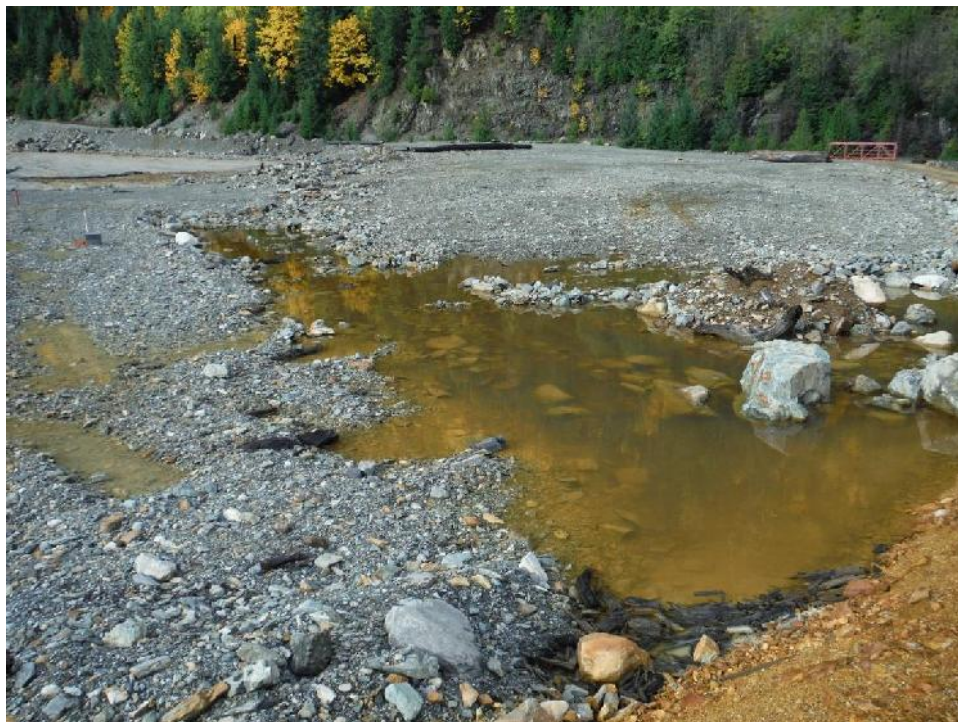
Photo 4 – Southeast corner of the APA showing ponded water between the Paste Investigation Road and the northeast rock pad.

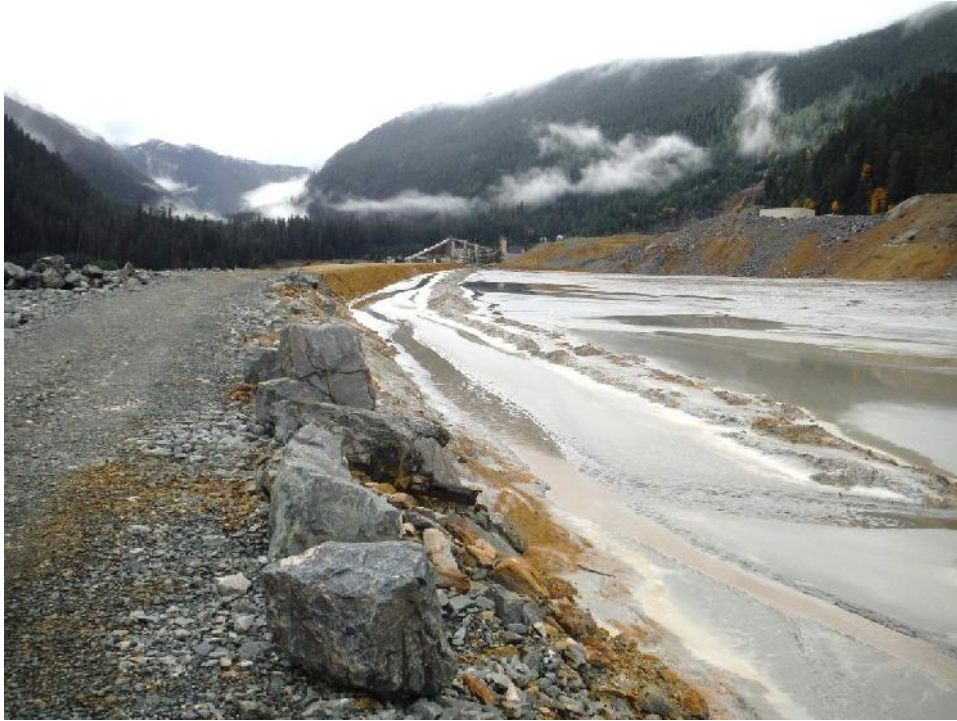
Photo 5 – APA Ditch along the Paste Berm, looking west from the Old TDF spillway.

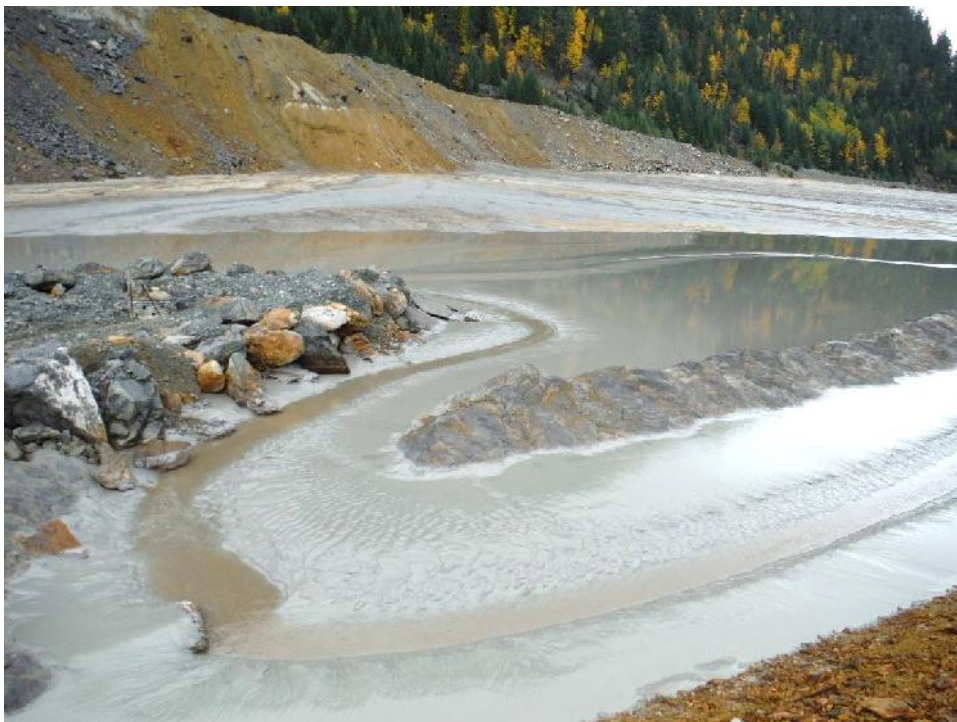
Photo 6 – APA ditch near the decant, looking north/northeast.

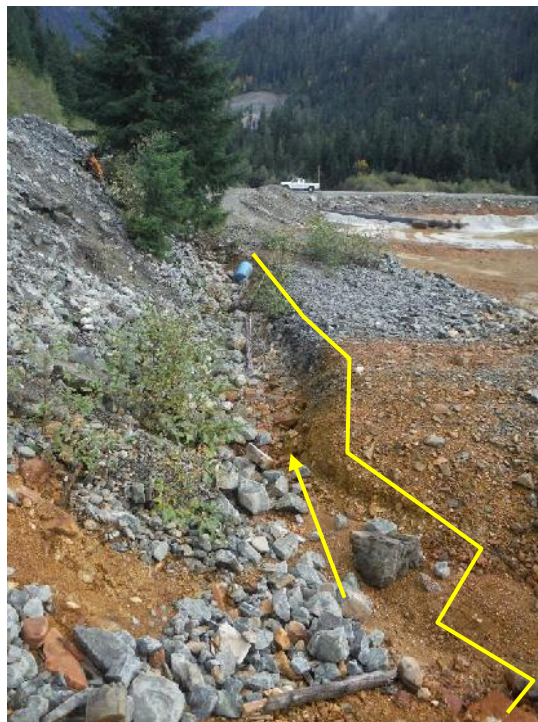
Photo 8 – Main spring at the toe of the Paste Berm east abutment, looking towards the north end of the East Strip.

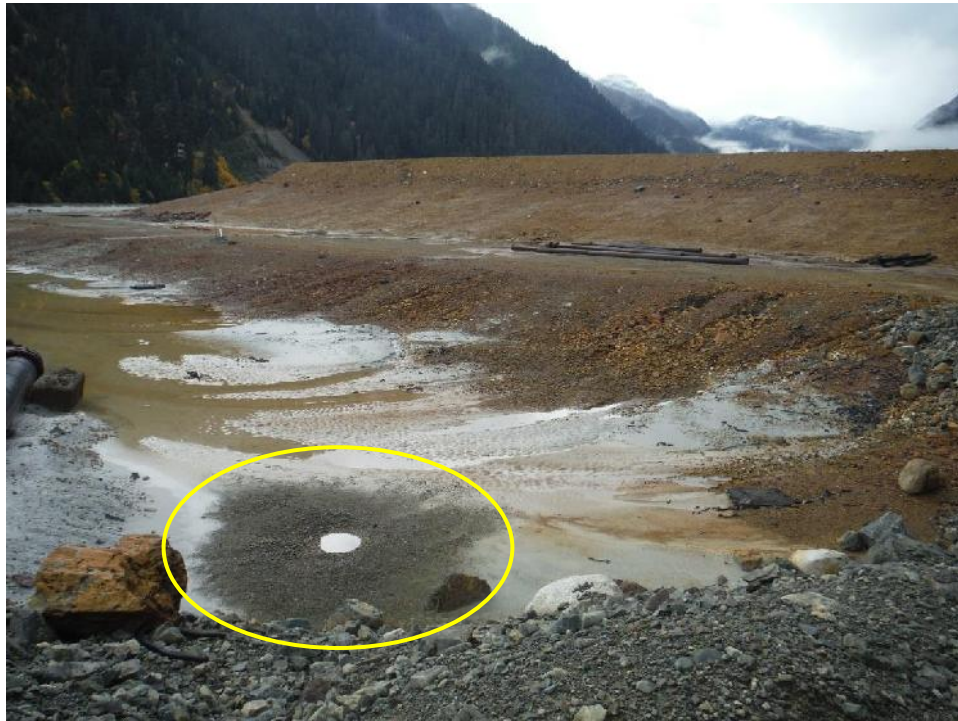
Photo 9 – North end of the East Strip, looking south/southwest. A water boil area formed a cone of coarse sand around the “vent”.

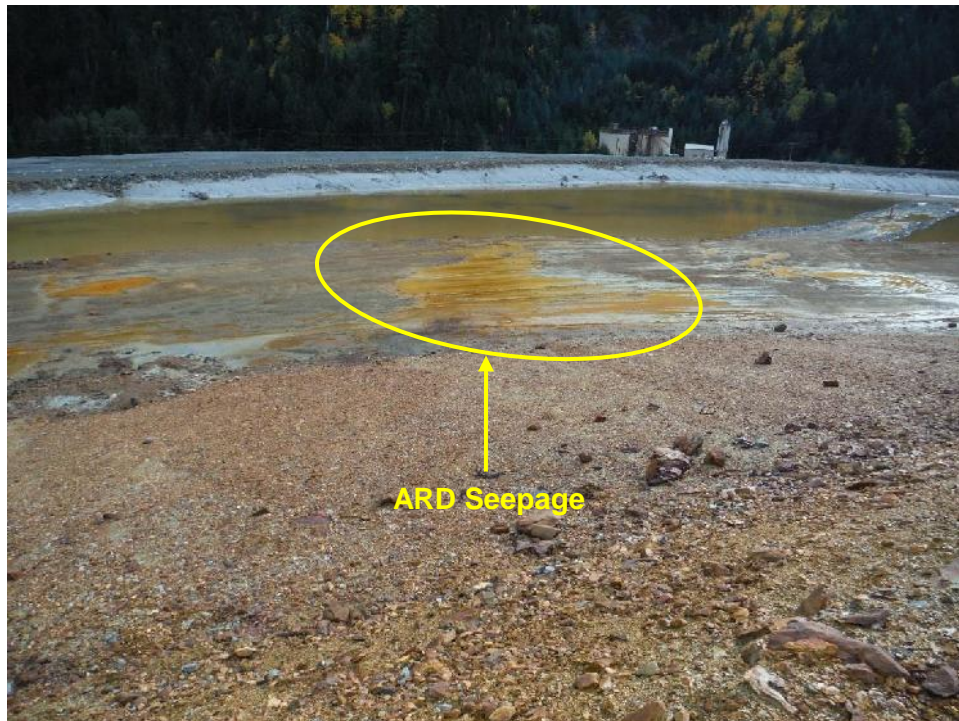
Photo 11 – Looking south down from the Paste Berm towards the Paste Backfill Plant. ARD seepage at the base of berm reporting to the East Strip.

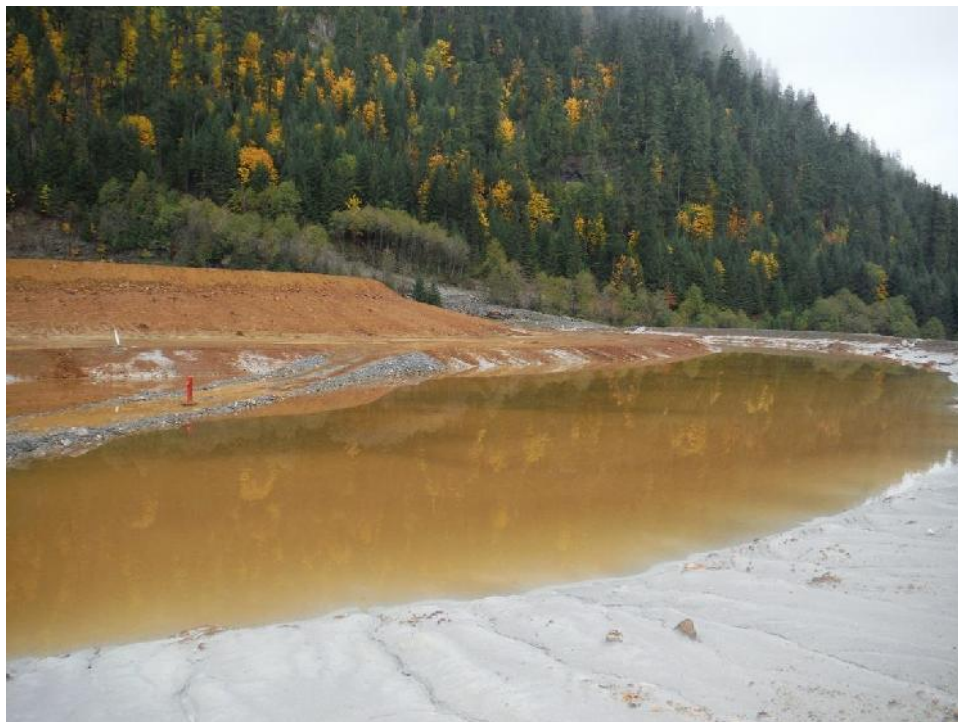
Photo 12 – East Strip and beach, looking northeast.

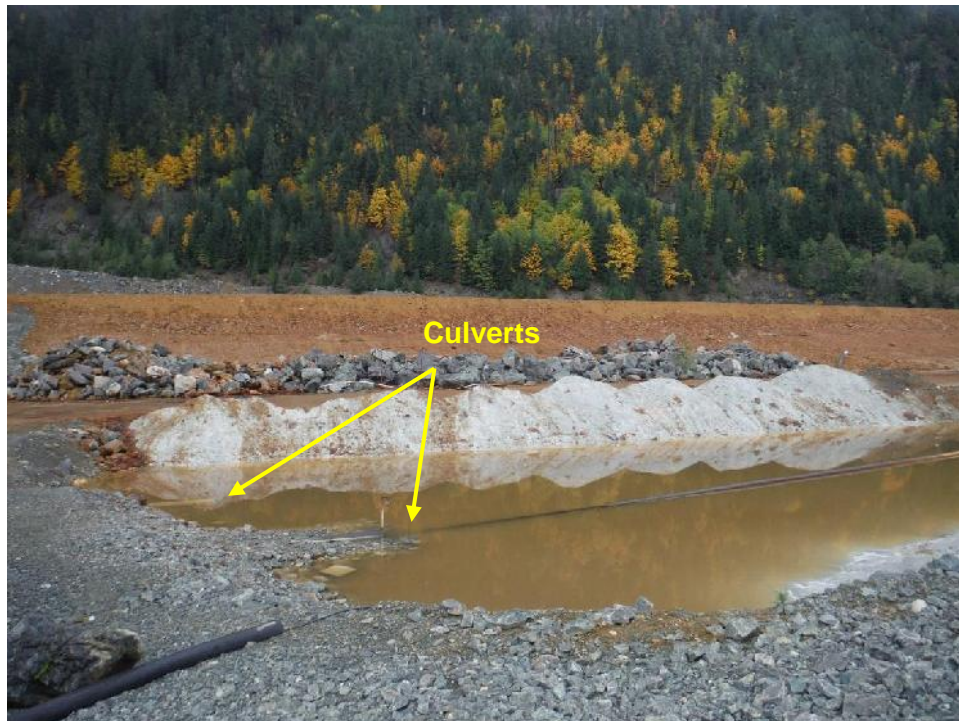
Photo 13 – Lime piles along the west end of the East Strip, looking north. Water level is above the intake of the two culverts passing under the Old TDF spillway.

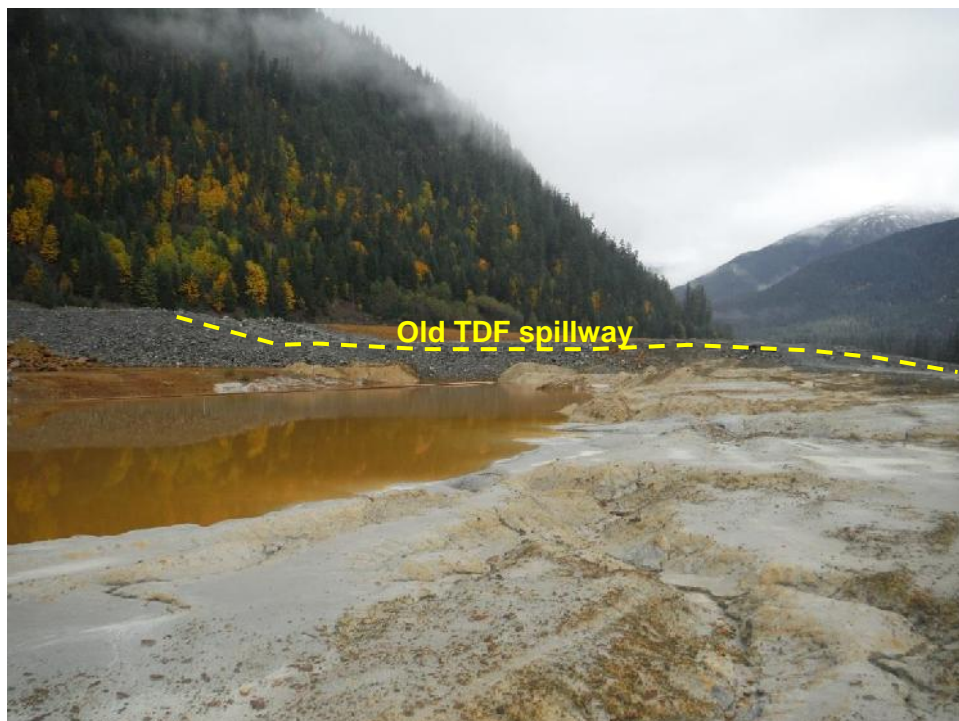
Photo 14 – East end of the West Strip, looking east.

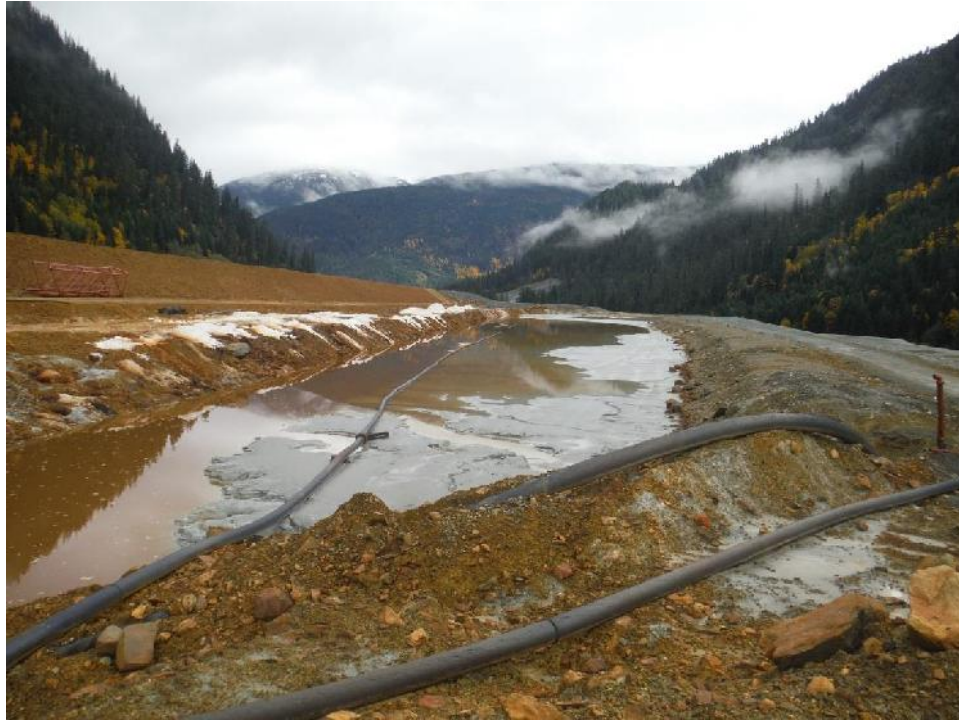
Photo 15 – West Strip, looking east from the decant area.

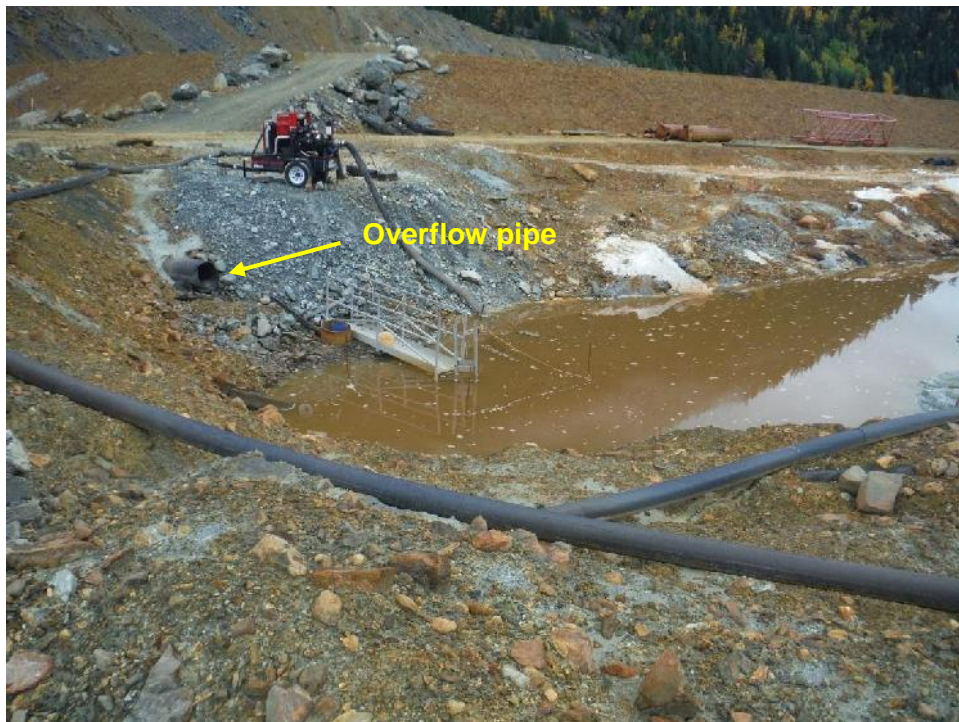
Photo 16 – West Strip decant structure and overflow pipe with four inch pump.

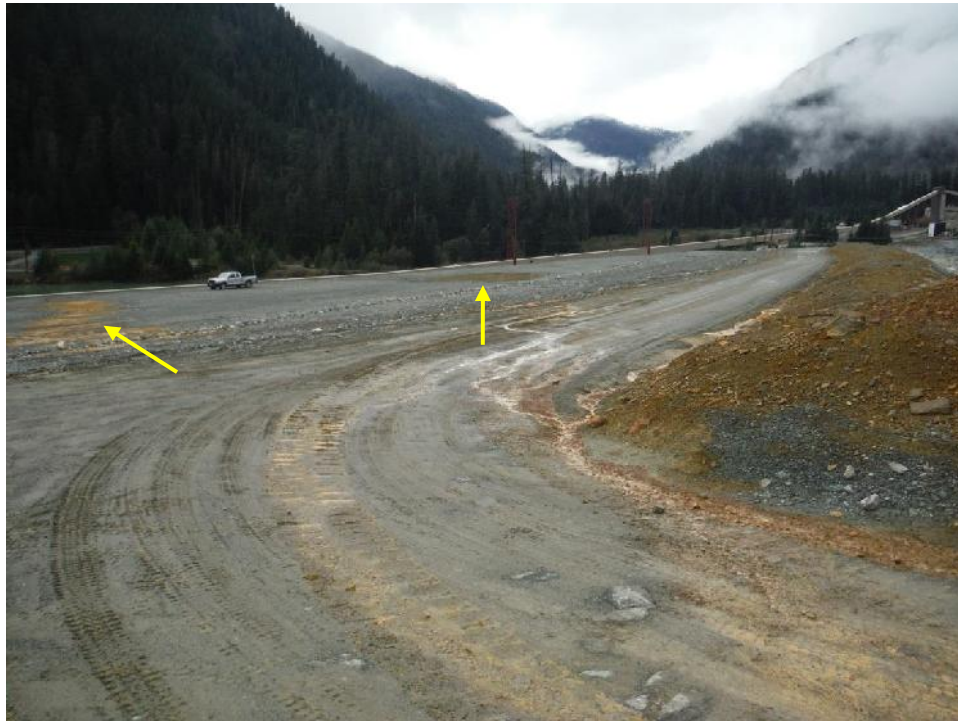
Photo 17 – Areas of ARD seepage on the Seismic Berm fed by runoff from the access road between the West Strip and the RSA, looking southwest.

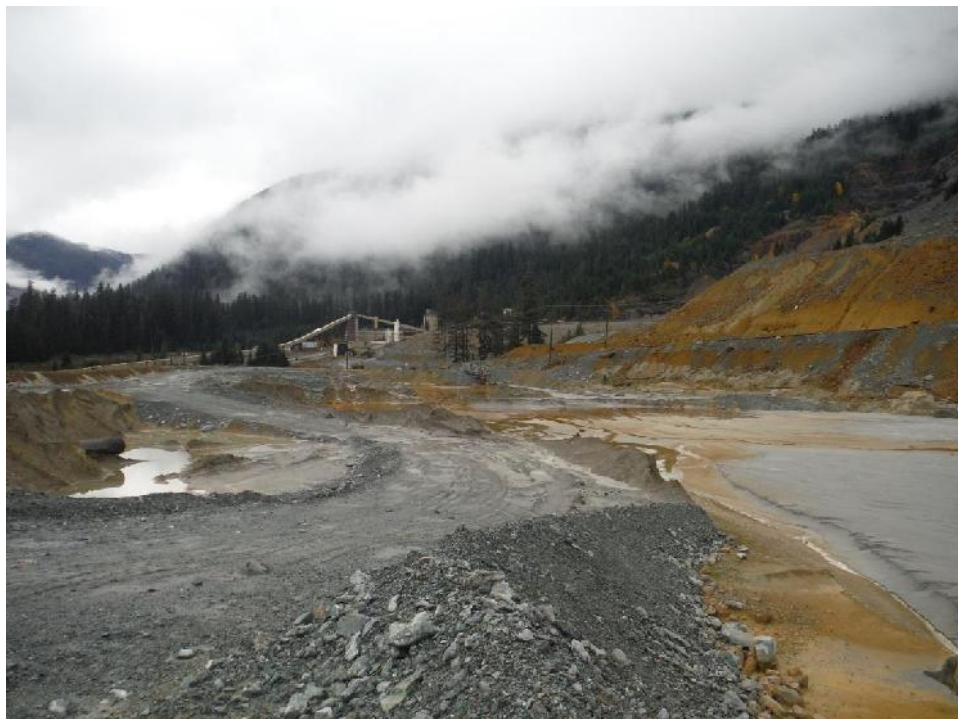
Photo 18 – RSA, looking west.

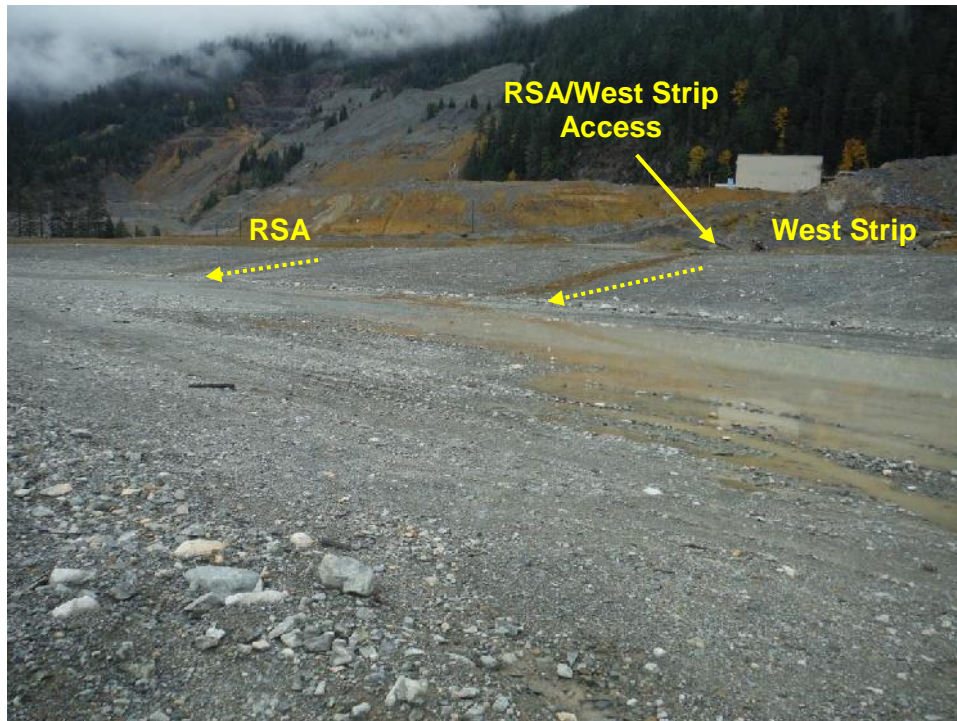
Photo 19 – ARD runoff on the 6:1 Slope coming in from the RSA/West Strip access and ponding on the surface of the Seismic Berm, looking northwest.

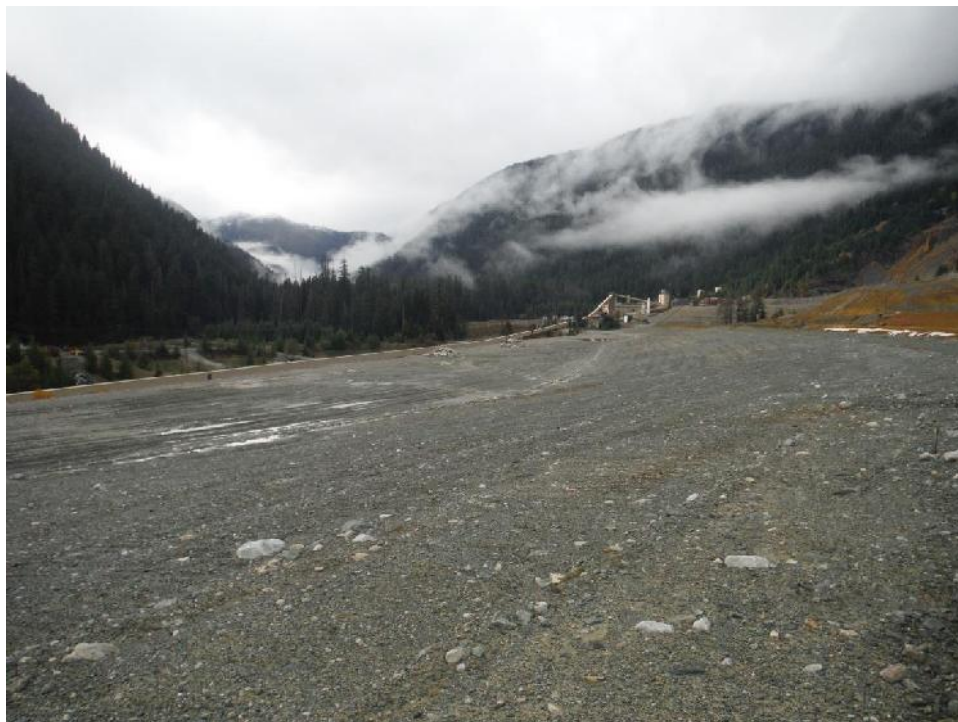
Photo 20 – Puddles in ruts left by traffic on the Seismic Berm, looking west from the west side of the Old TDF spillway.

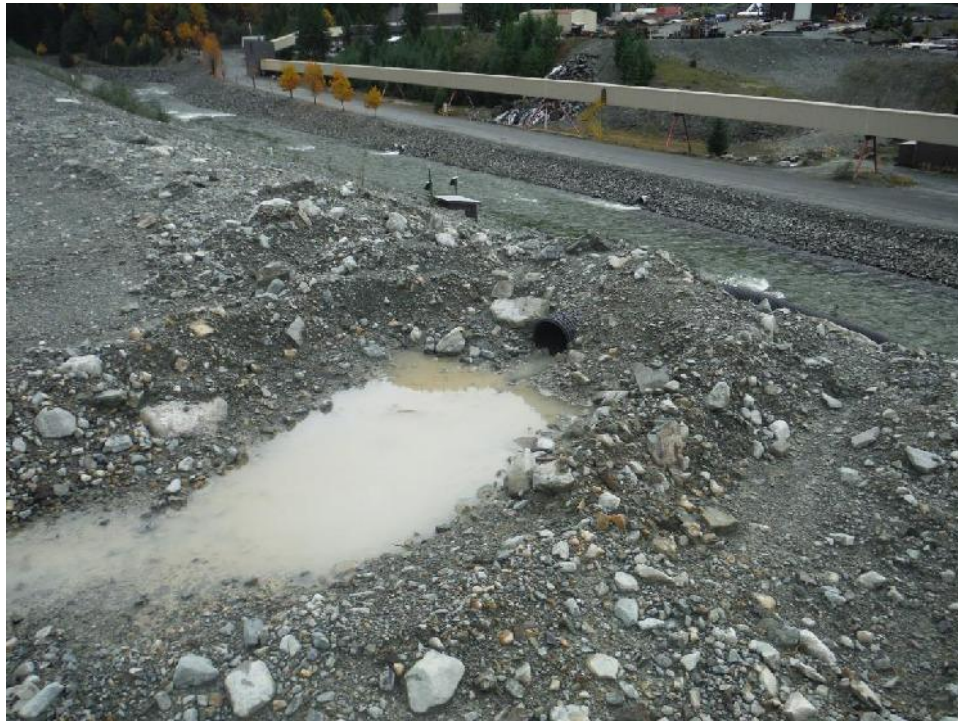
Photo 21 – Ditch and drainage pipe on top of the Seismic Berm downstream face, looking southeast near Instrument Plane A (Hut A and Myra Creek in background)

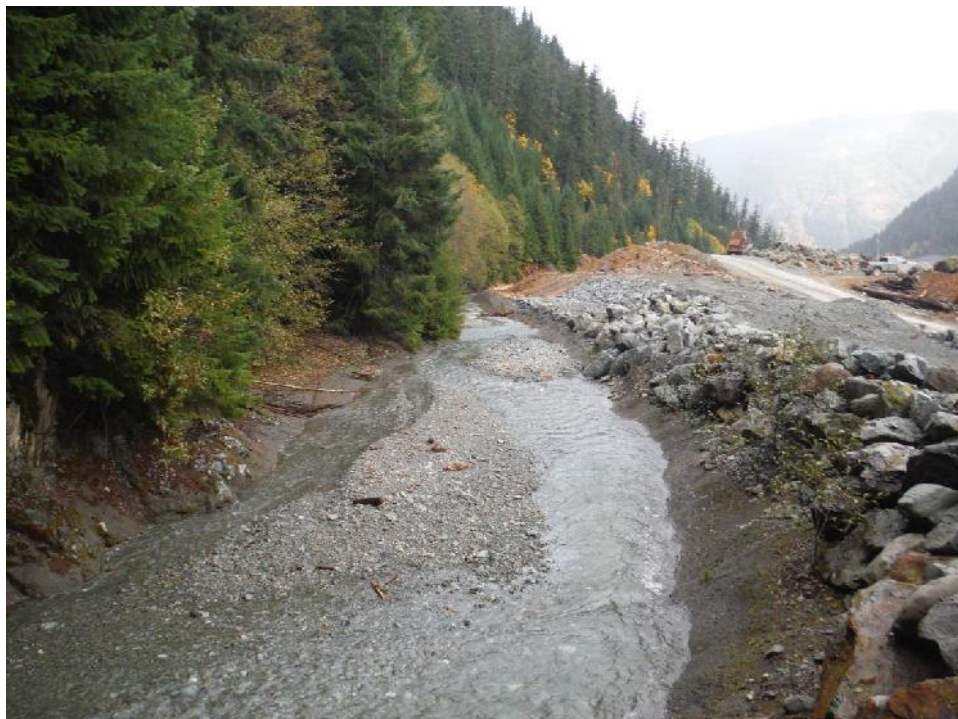
Photo 22 – Lower Lynx Diversion Ditch near Cascade Reach, looking east. Note the presence of gravel bars along the channel.

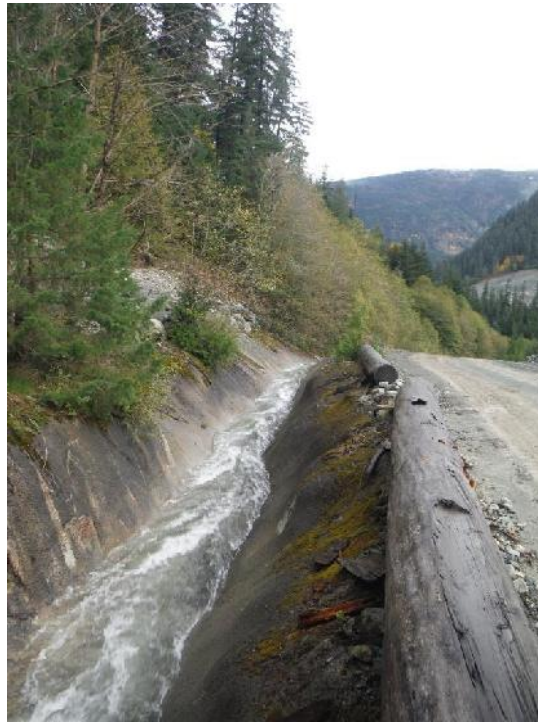
Photo 23 – Lined section of Lower Lynx Diversion Ditch near the Paste Berm east abutment.

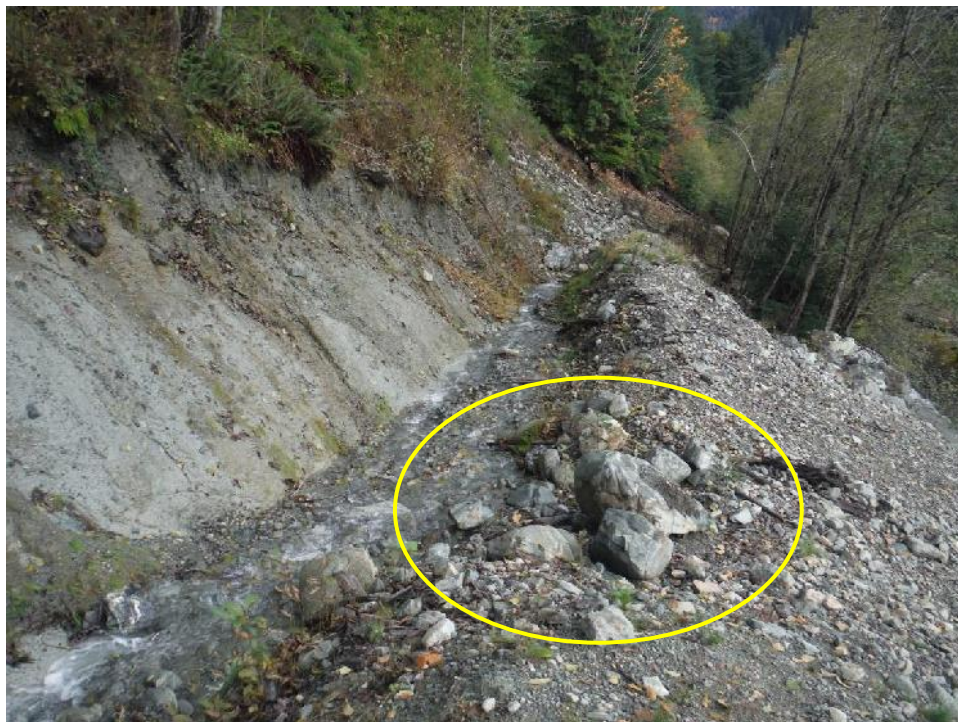
Photo 24 – Alder Reach, view of an area where a ripple/step was dug out.

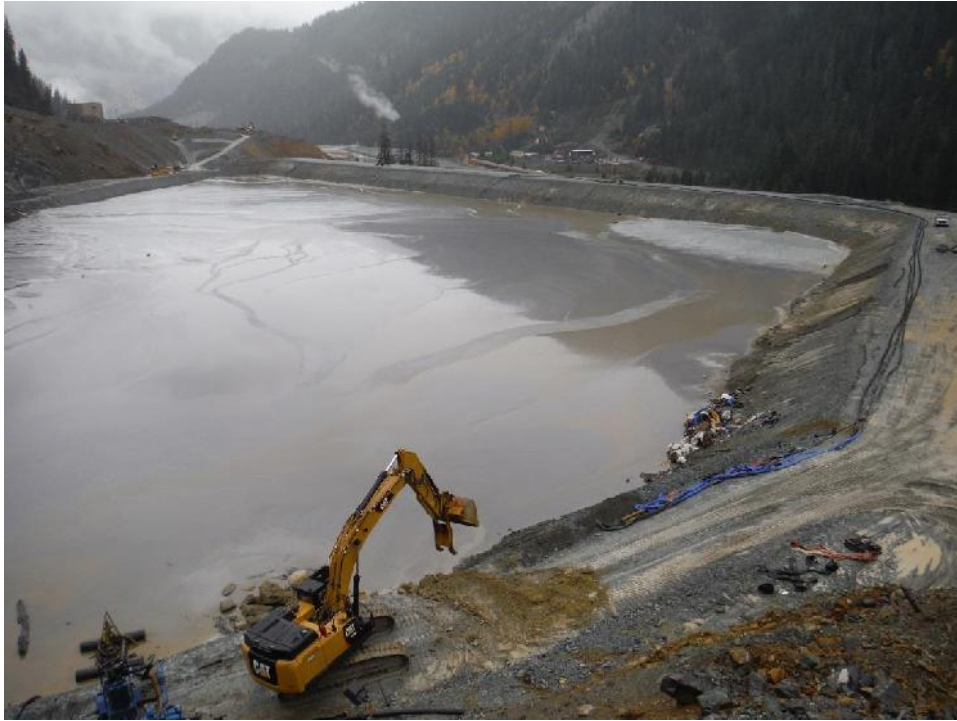
Photo 25 –Lynx TDF, looking east.
