**MYRA FALLS TAILINGS STORAGE FACILITIES
2015 DAM SAFETY INSPECTION REPORT**

31 March 2016

Amec Foster Wheeler File: NX14001B

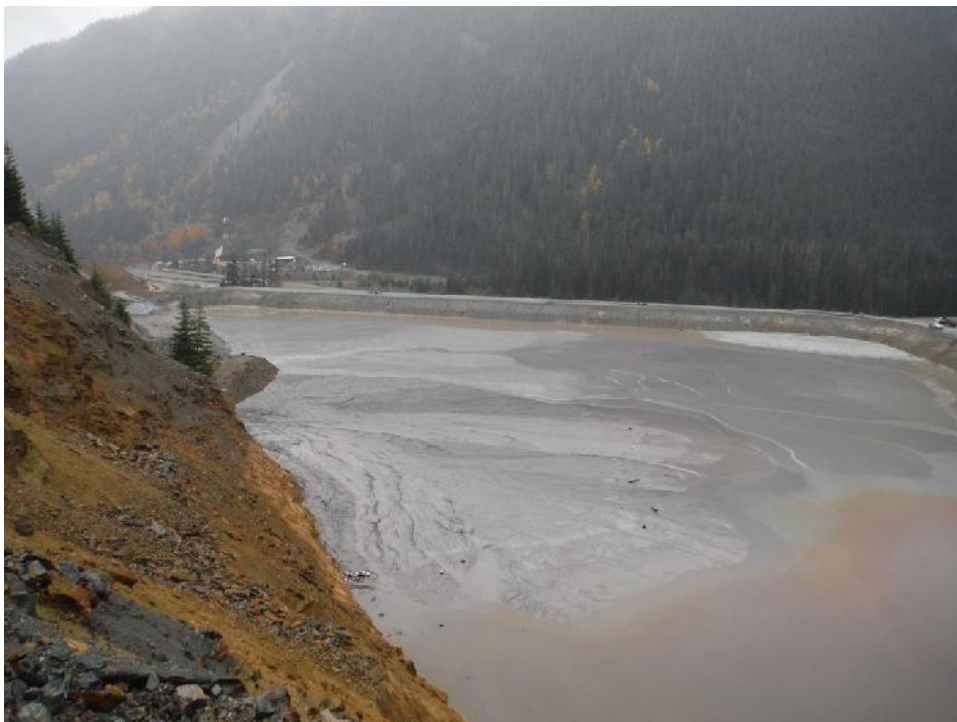
Photo 26 –Lynx TDF, looking south.

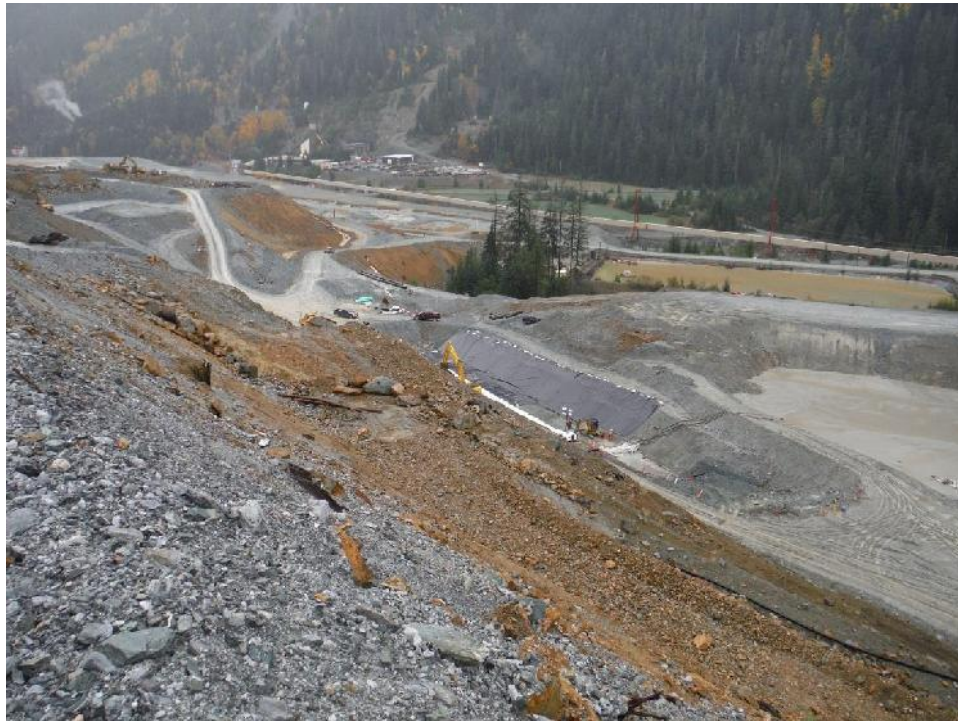
Photo 27 – Section of Lynx Springs Drain going through Lynx Dam east arm under construction, looking east/southeast.

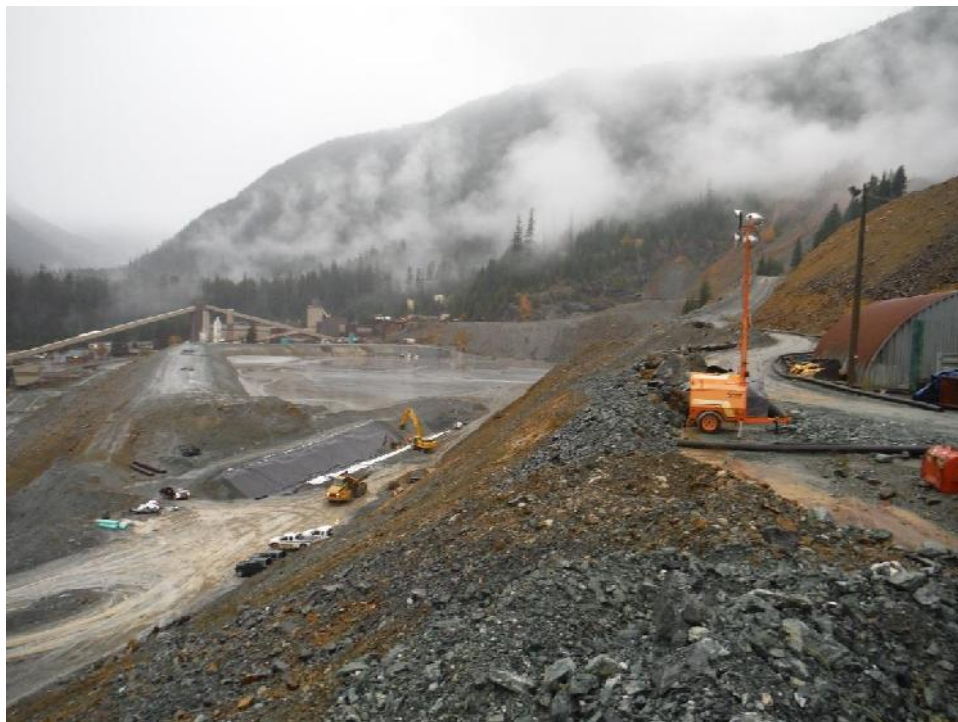
Photo 28 – Section of Lynx Springs Drain going through Lynx Dam east arm under construction, looking west.

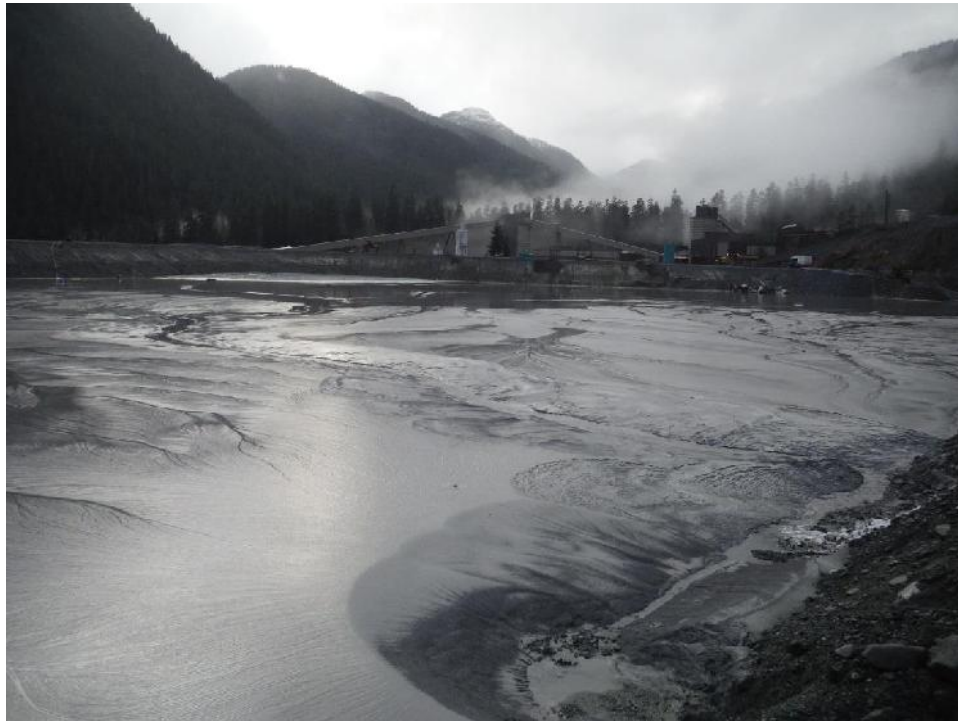
Photo 29 – Lynx Springs around the central portion of Lynx Pit back (to become the capture zone of Lynx Springs Drain).

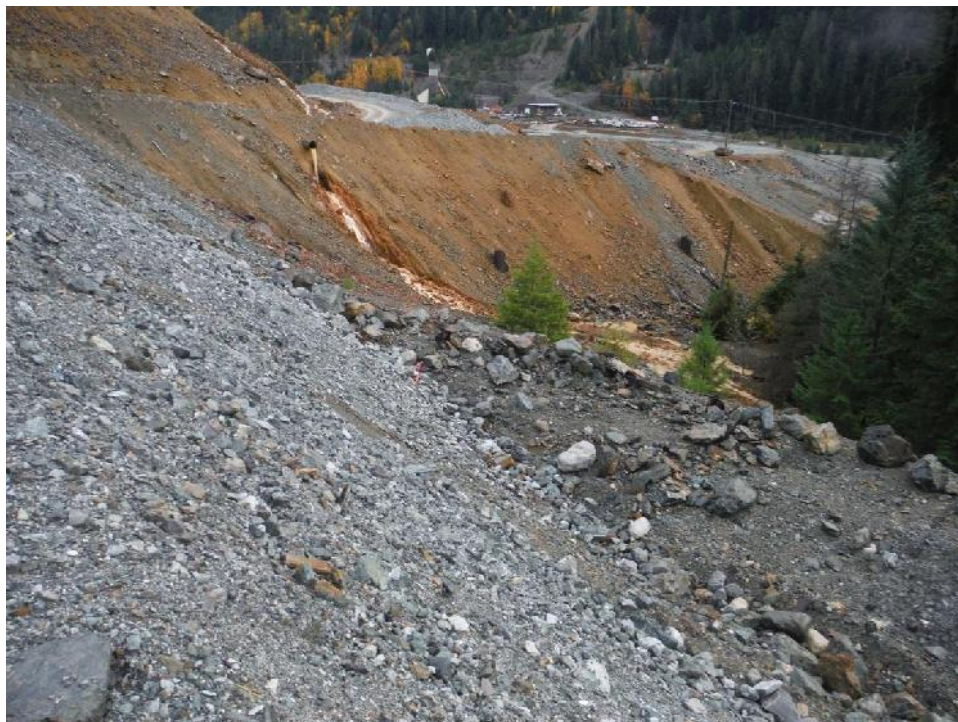
Photo 30 – Phillips Reach drainage pipe flowing towards Phillips Reach sump, east of Lynx Dam.

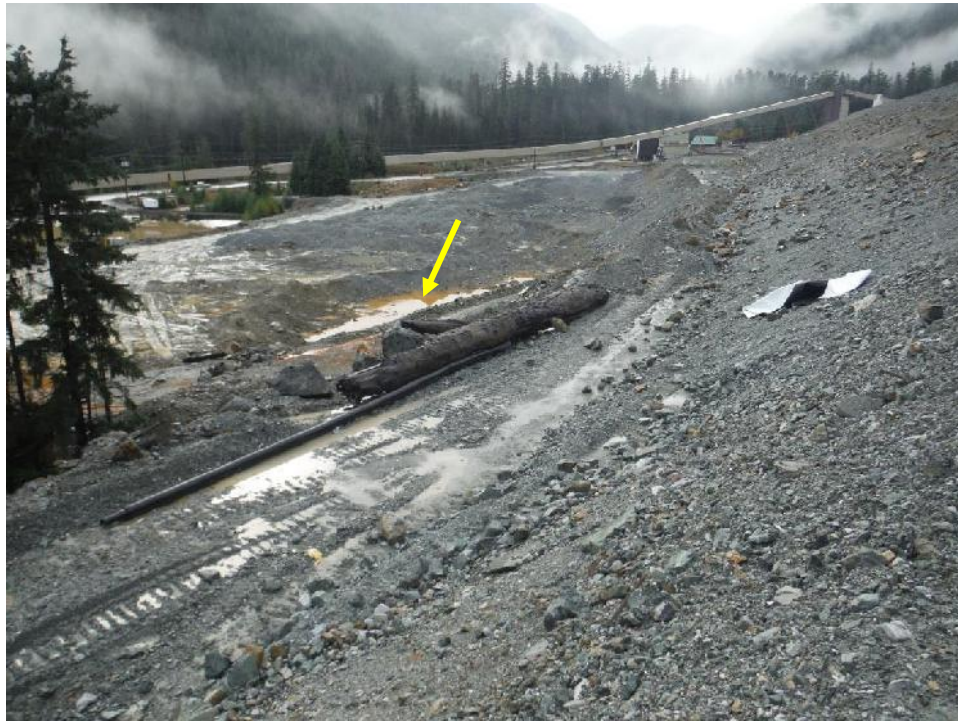
Photo 31 – Easternmost lower bench and toe of Lynx Dam south arm, looking west. ARD ponding between the remains of “Zone J material” Superpile and the dam toe.

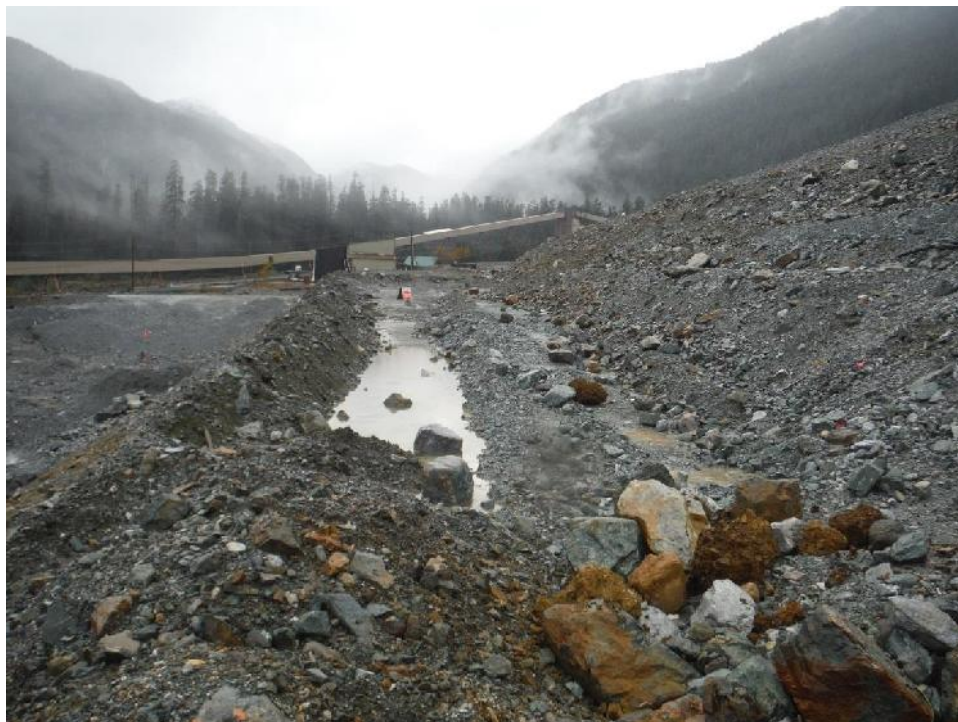
Photo 32 – Seepage and ponding on Lynx Dam “2011 Bench”, near Instrument Plane F, looking west.

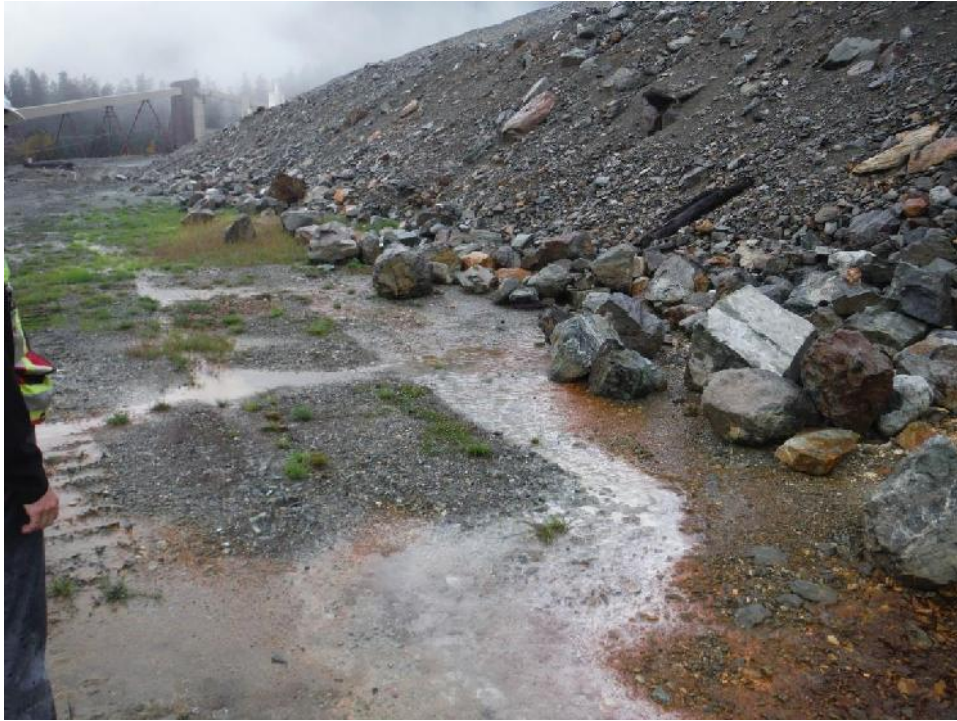
Photo 33 – Seepage on Lynx Dam “2011 Bench”, near Instrument Plane E.

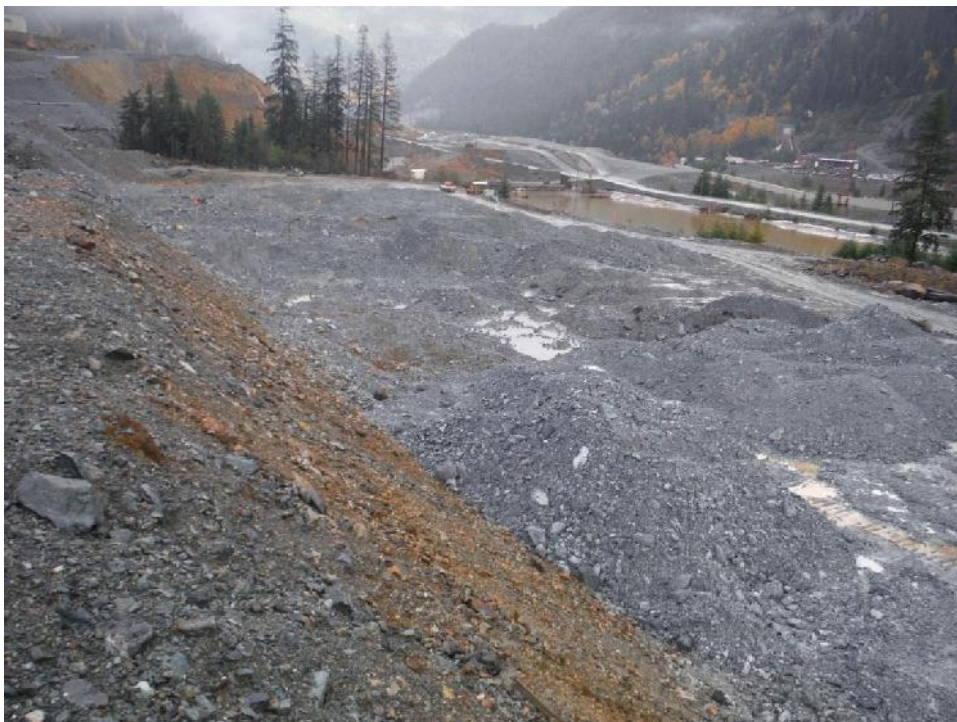
Photo 34 – Puddles between waste rock piles in Lynx Dam toe area, looking east.

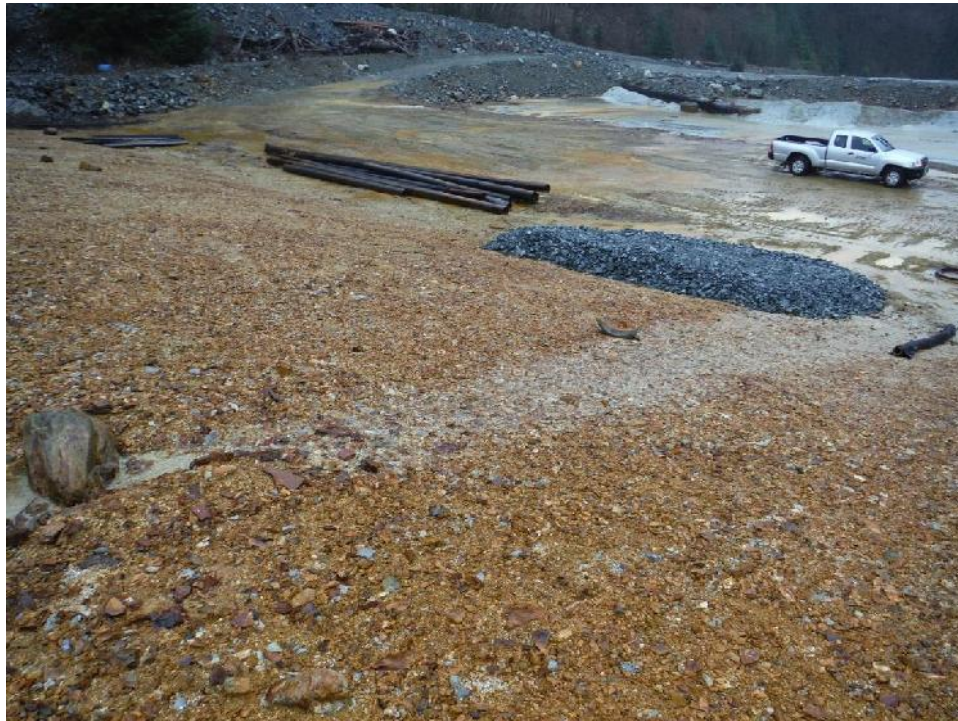
Photo 3 – Seepage from discrete source along the east arm of the Paste Berm (photo taken on 2014-11-27).

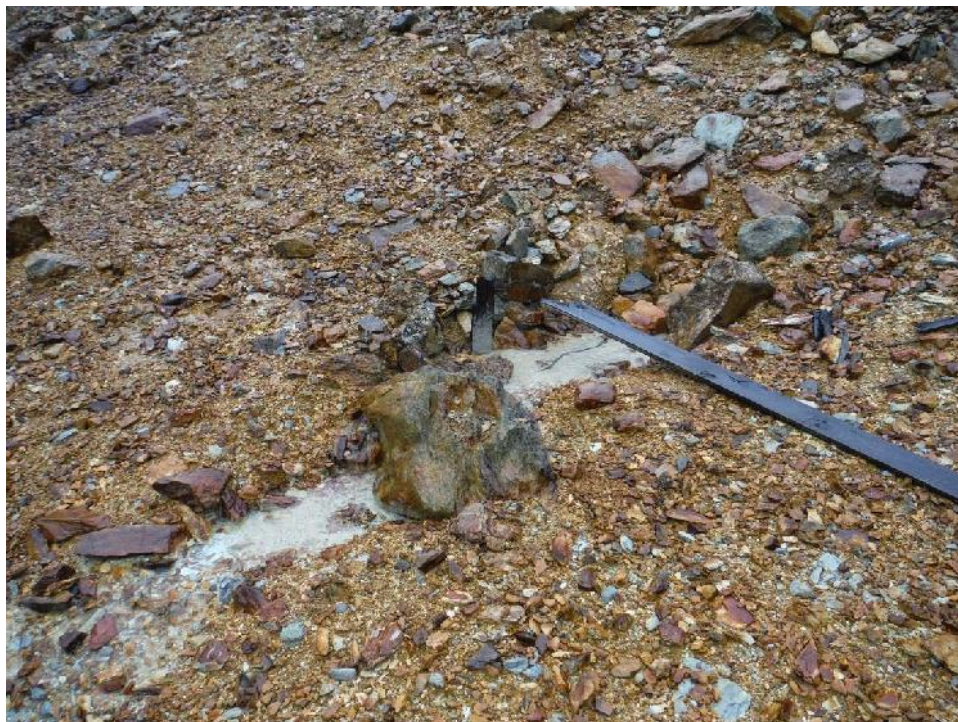
Photo 4 – Close-up view of the discrete seepage source along the east arm of the Paste Berm (photo taken on 2014-11-27).

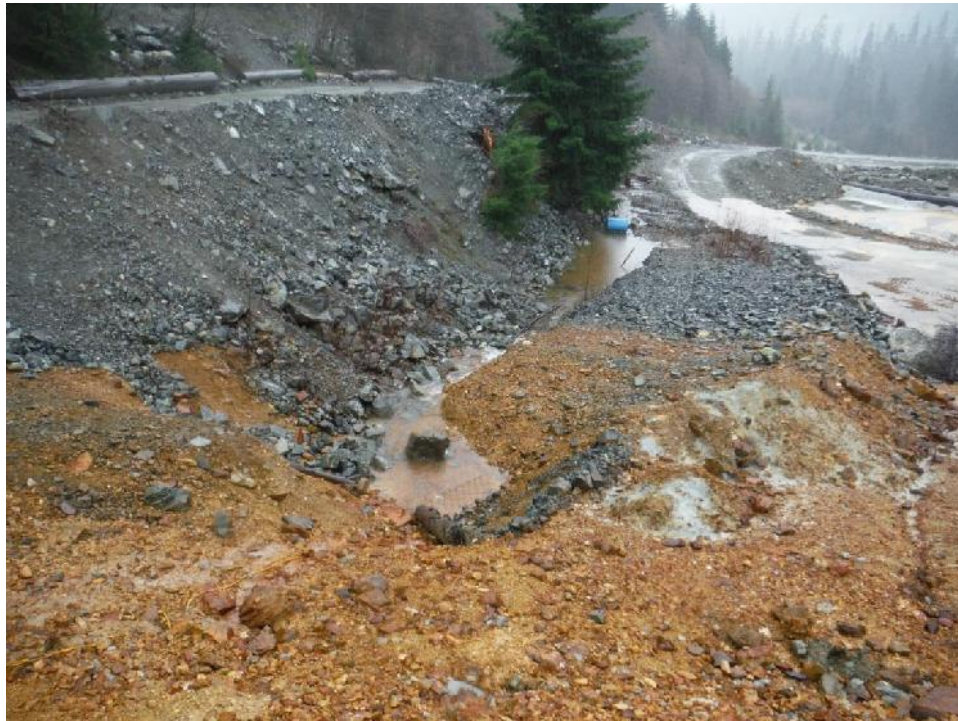
- Moderate water level in the APA, ponding mainly around the decant and on the west side of the spillway.
- High flow observed on 2014-11-27 at the main spring at the east abutment of the Paste Berm. Low flow following the end of the rainfall event observed on the following day (see photos).
- Discrete minor seepage sources observed along toe of the east arm of the Paste Berm. No indications of associated piping erosion
- Moderate to high water levels in the East Strip.

Photo 5 – High flow at the main spring on 2014-11-27 (toe of Paste Berm east abutment).

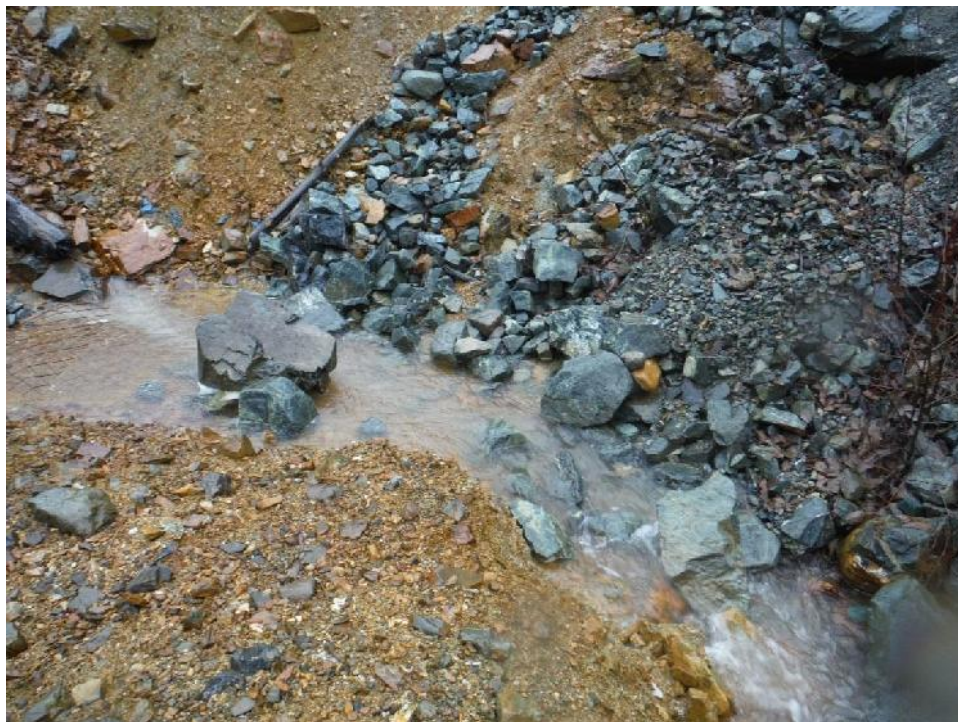
Photo 6 – Close-up view of the Paste Berm east abutment main spring on 2014-11-27.

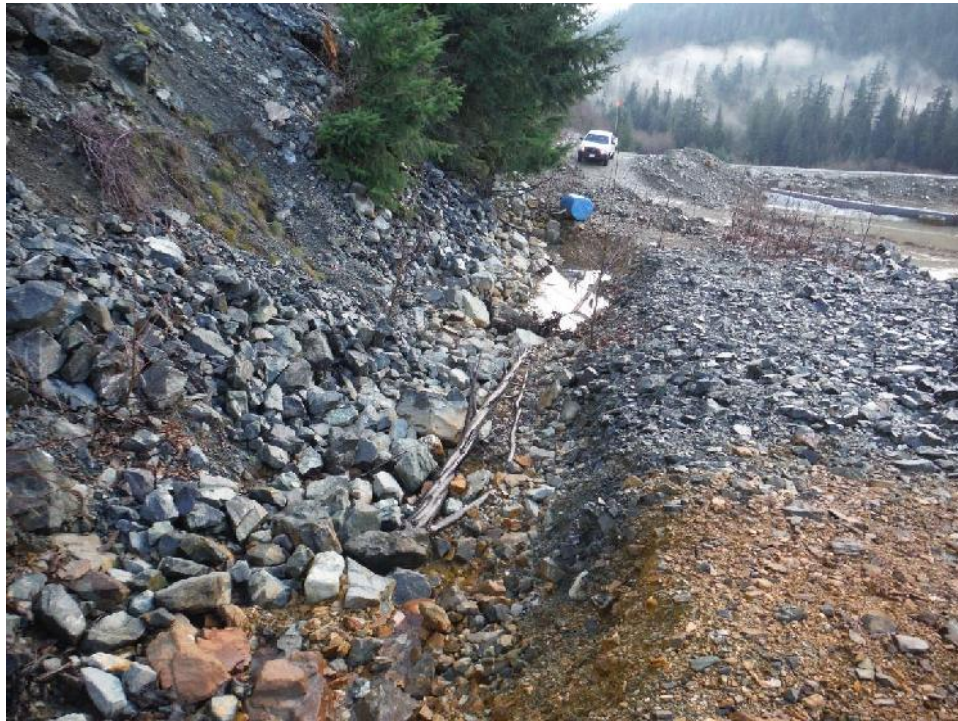
Photo 7 – Low flow at the Paste Berm east abutment main spring on 2014-11-28.

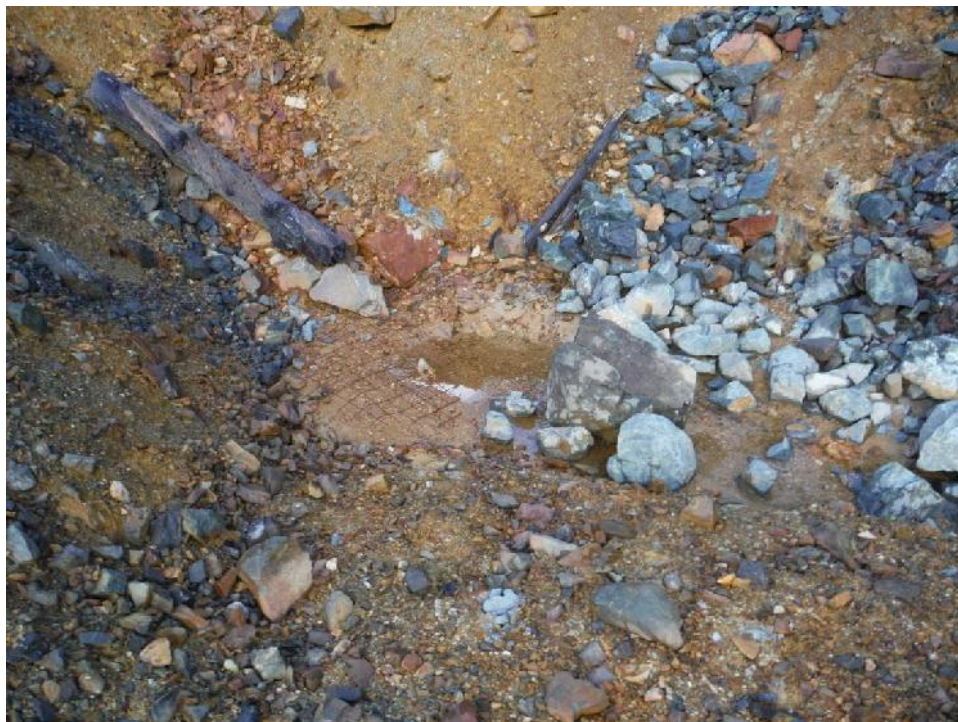
Photo 8 – Close-up view of the Paste Berm east abutment main spring on 2014-11-28.

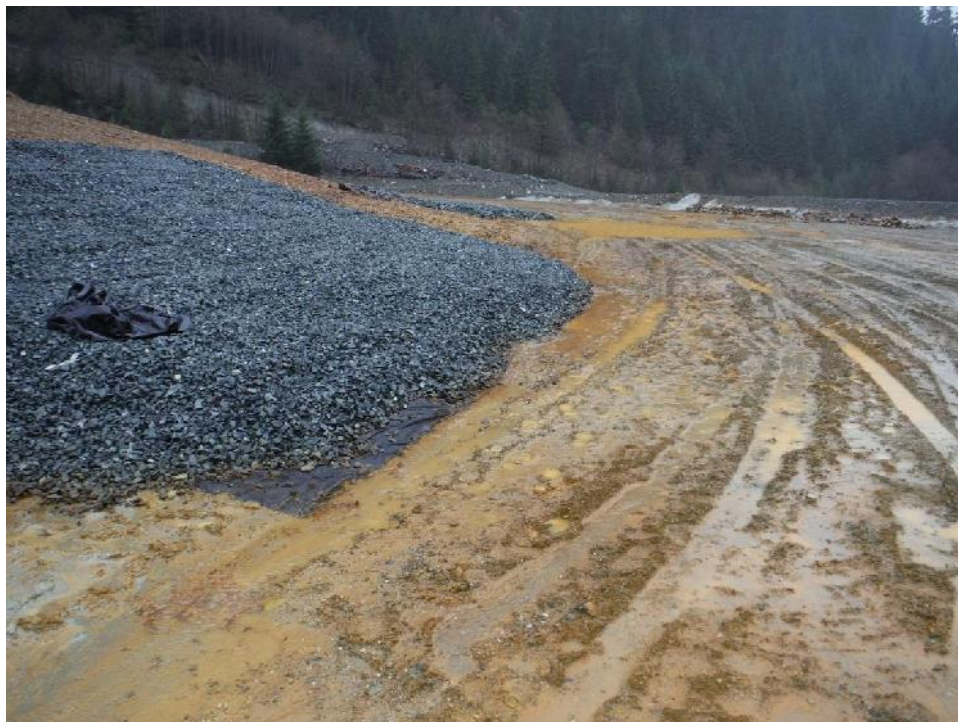
Photo 10 – Saturated soil and water pooling in ruts at the base of the Paste Berm, looking northeast.

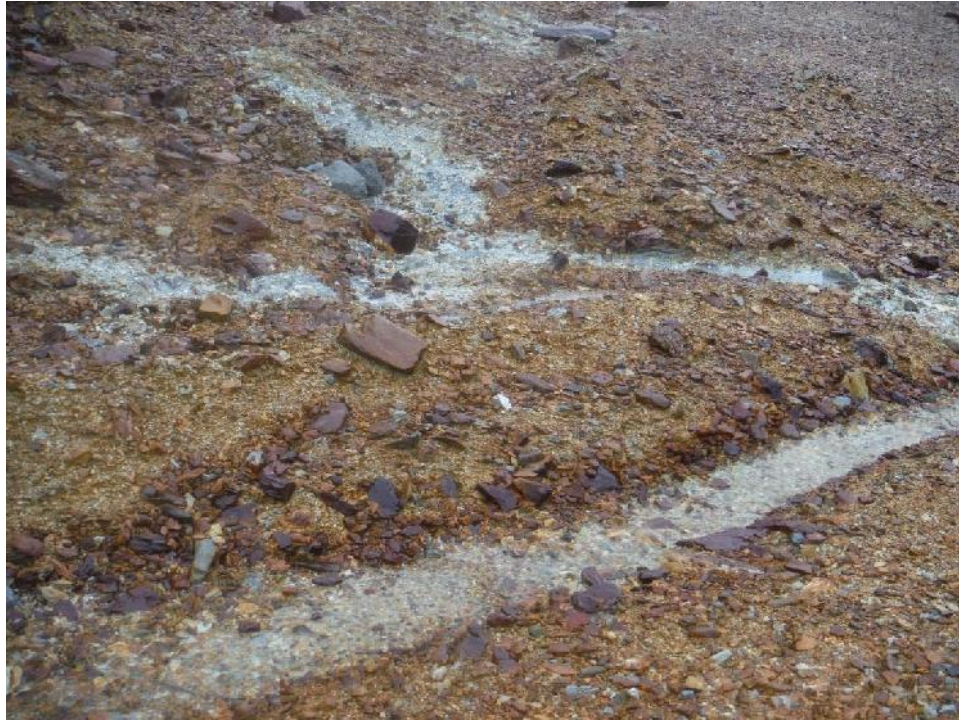
Photo 13 – Seepage areas at the base of the Paste Berm, Old TDF East Strip.

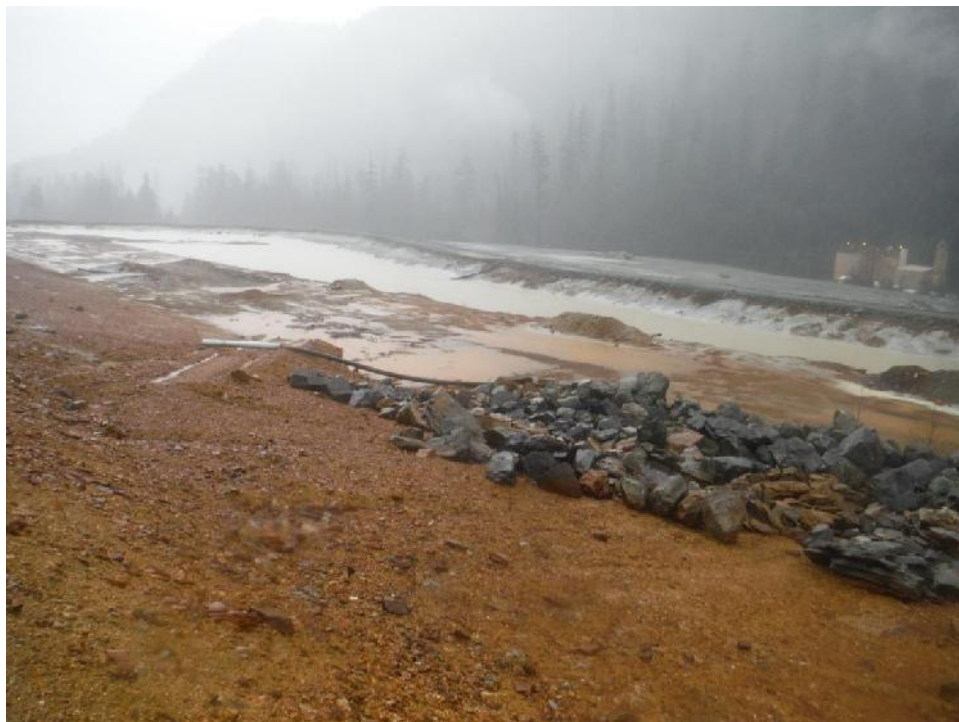
Photo 14 – Ponding water at the base of the Paste Berm and in the East Strip, looking southeast from the Old TDF spillway area.

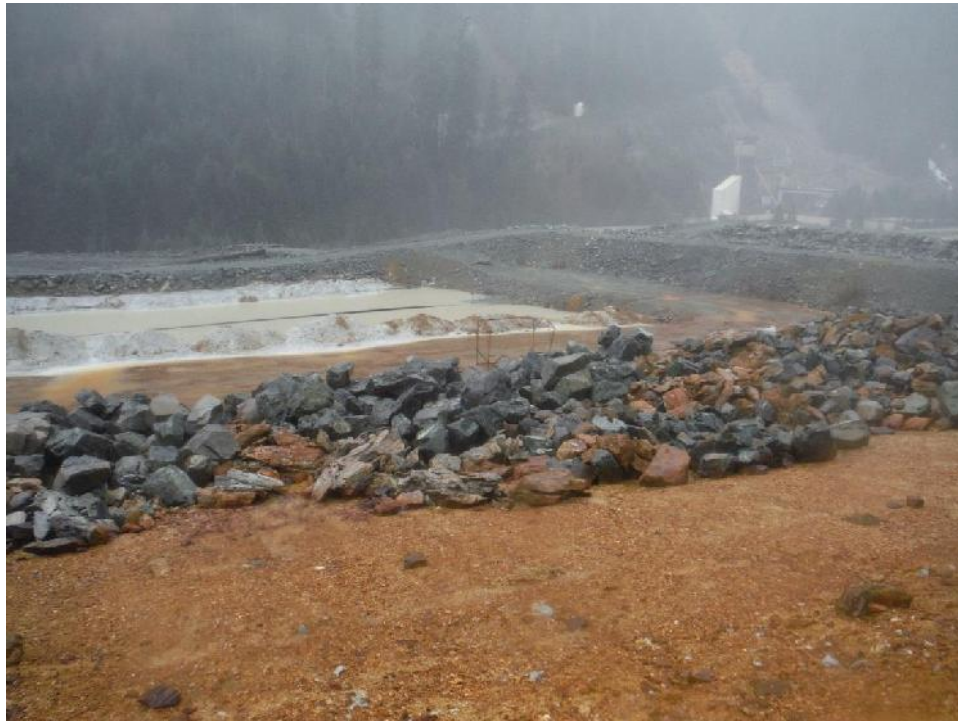
Photo 15 – Looking south, moderate to high water level in the East Strip, the inlets of the two spillway culverts are slightly submerged.

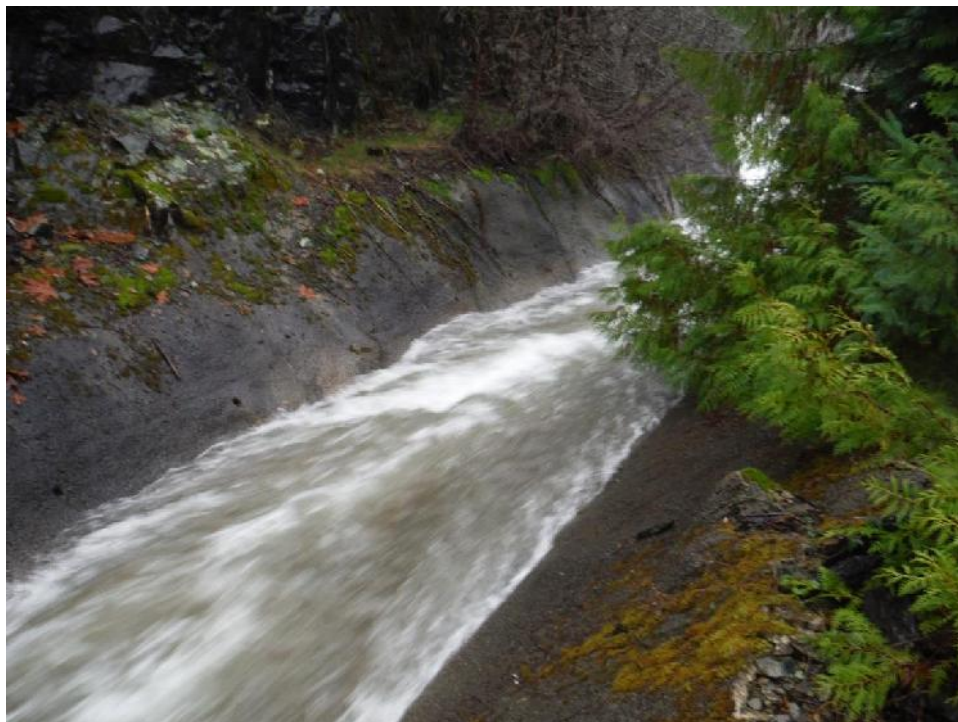
Photo 16 – High velocity flow in the lined portion of the Lower Lynx Diversion Ditch.

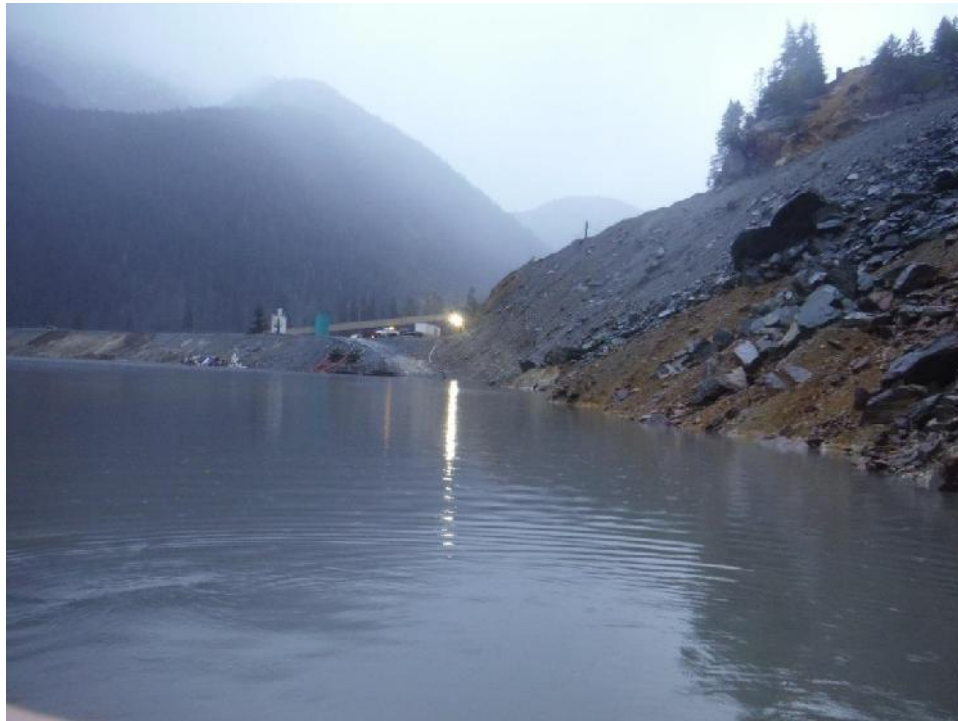
Photo 17 – Significant ponding of water in Lynx TDF on 2014-11-27, two diesel pumps present at the west arm. Photo taken from boat near pit highwall.

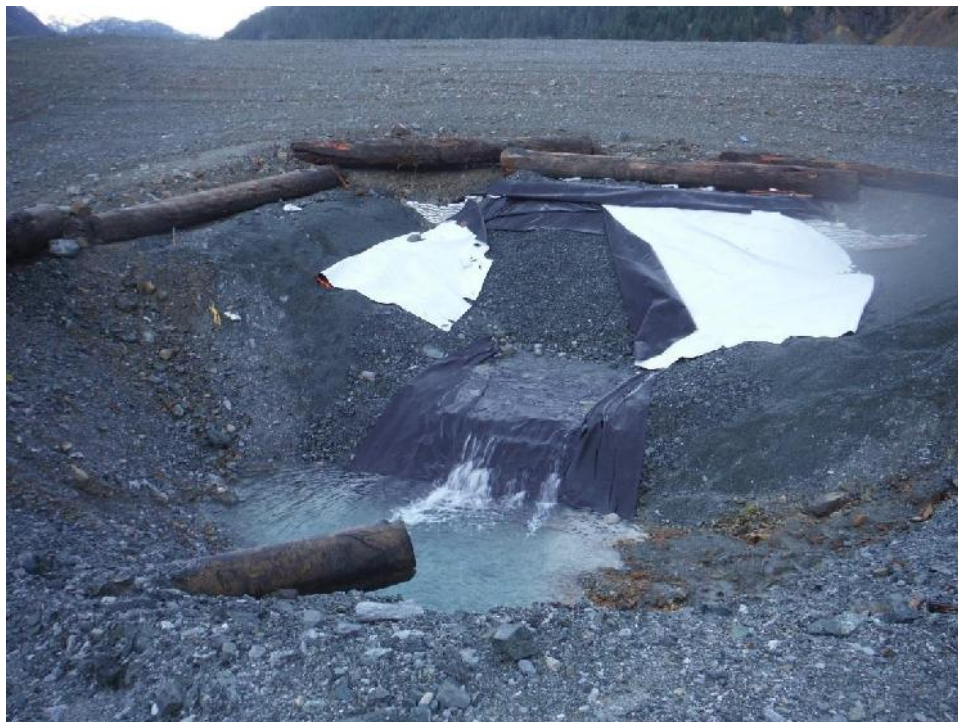
Photo 18 – High flow at the outlet of Lynx Springs Drain on 2014-11-27.

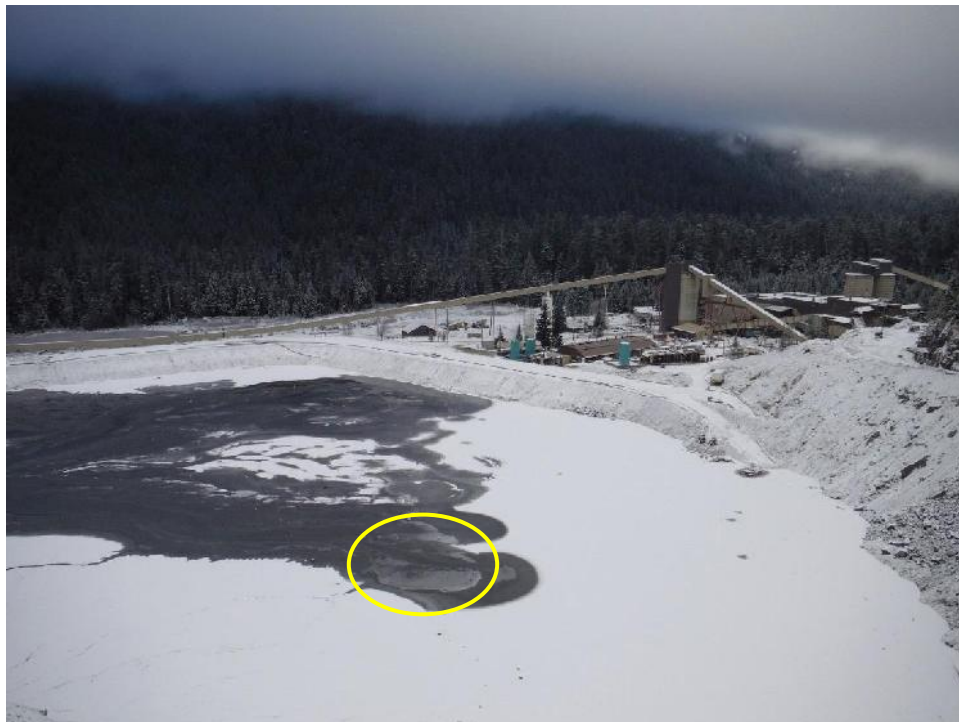
Photo 12 – Overview of Lynx TDF, looking southwest (recurrent depression in paste circled).

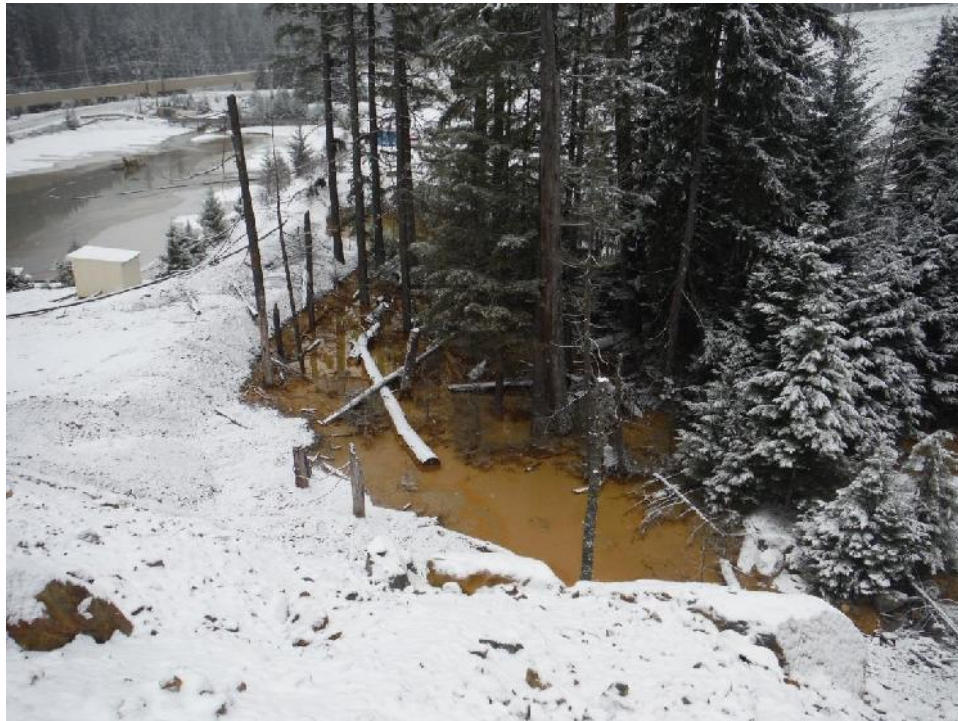
Photo 17 – Ponded water on southeast side of the treed area around Phillips Reach sump, looking west.

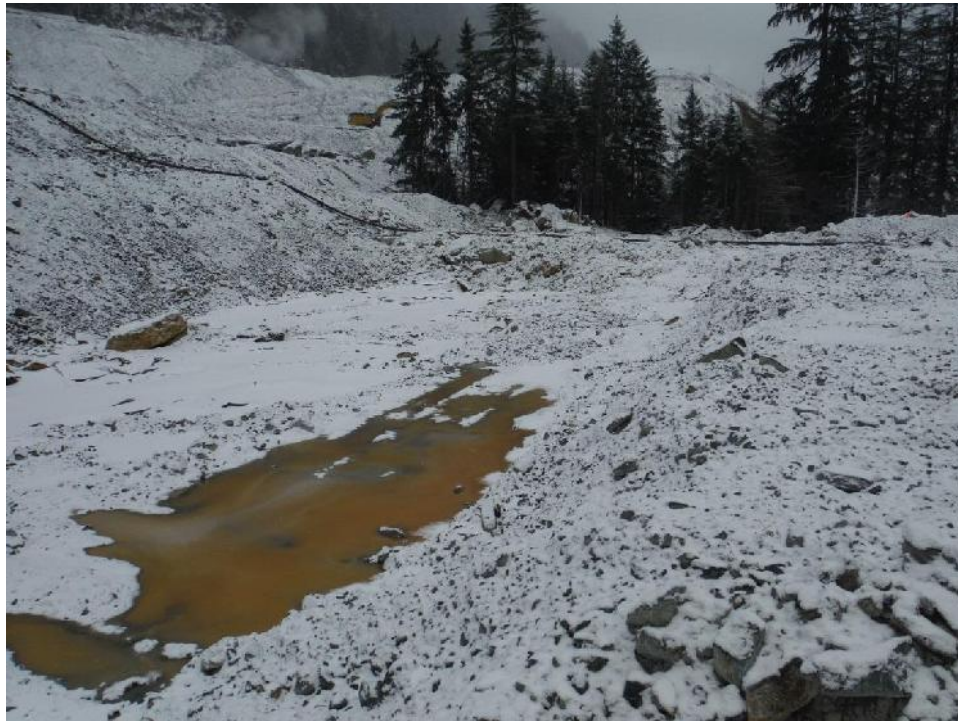
Photo 19 – Ponded water in the eastern portion of Lynx Dam toe, looking east.

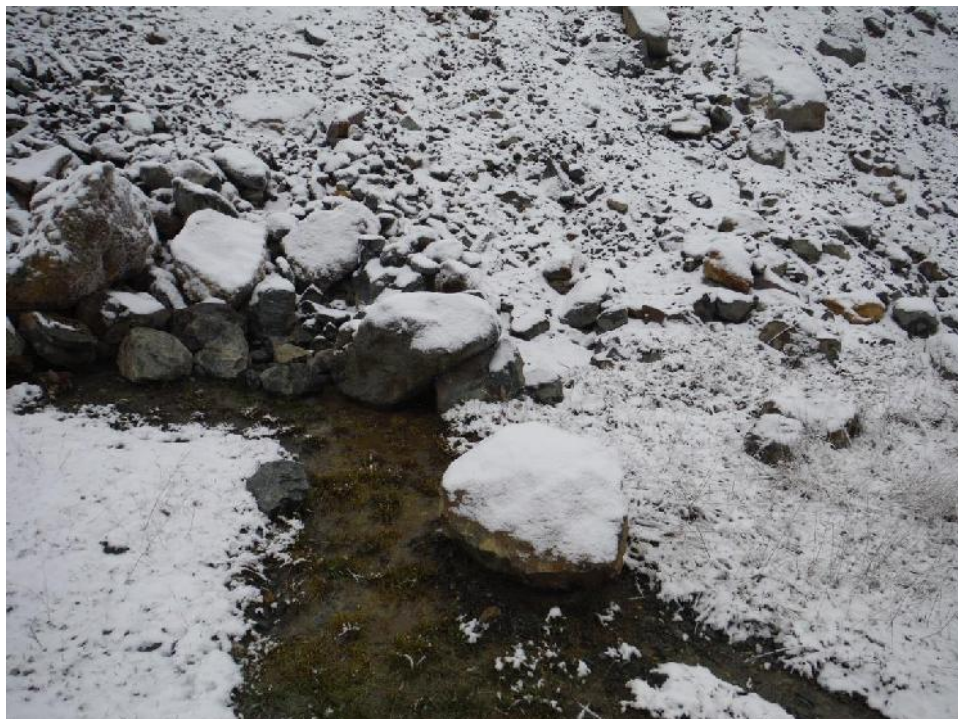
Photo 20 – Some seepage on the mid-level “2011 Bench” of Lynx Dam south arm.

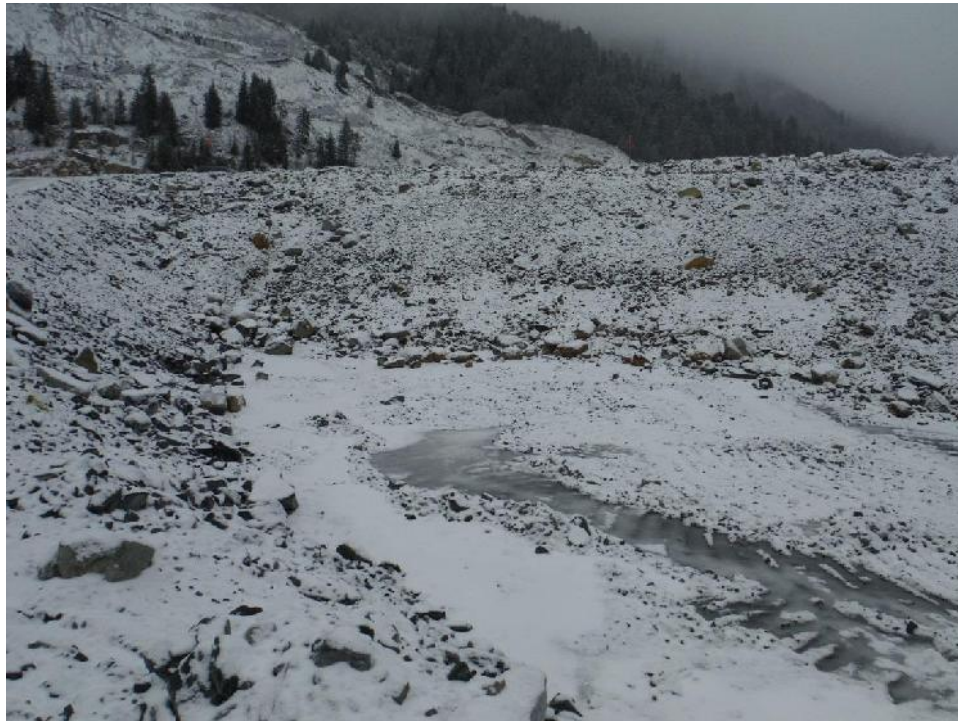
Photo 21 – Water accumulation east of the access ramp leading to Lynx TDF west arm, looking northeast.

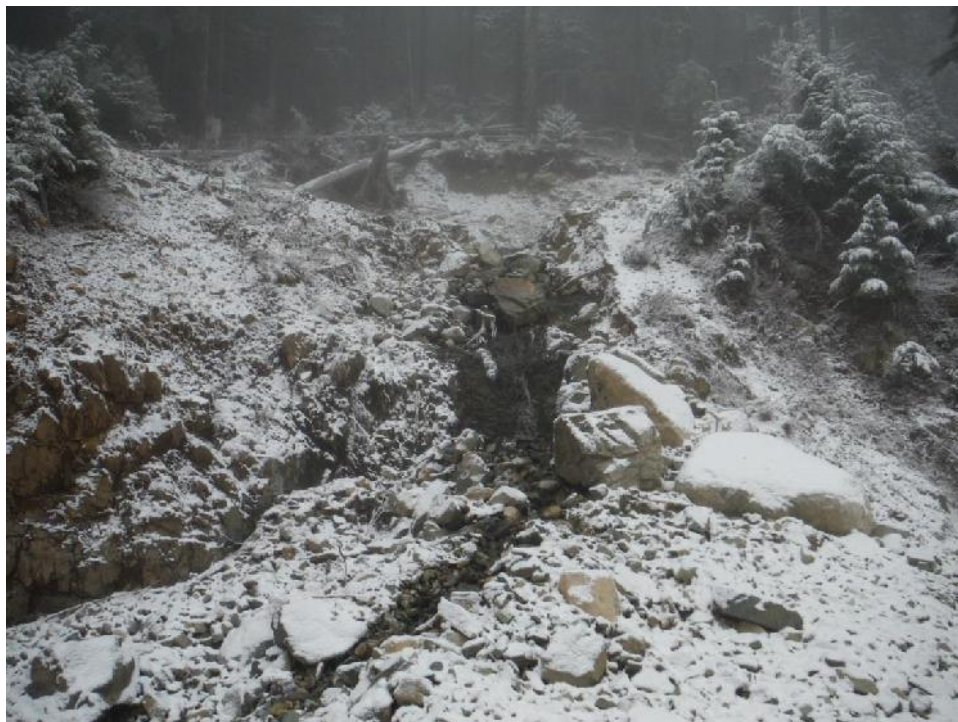
Photo 22 – Water flowing from Upper Arnica Ditch over the bedrock to Lower Arnica Ditch (at the Arnica – Upper Lynx Diversion Ditch junction), looking north.

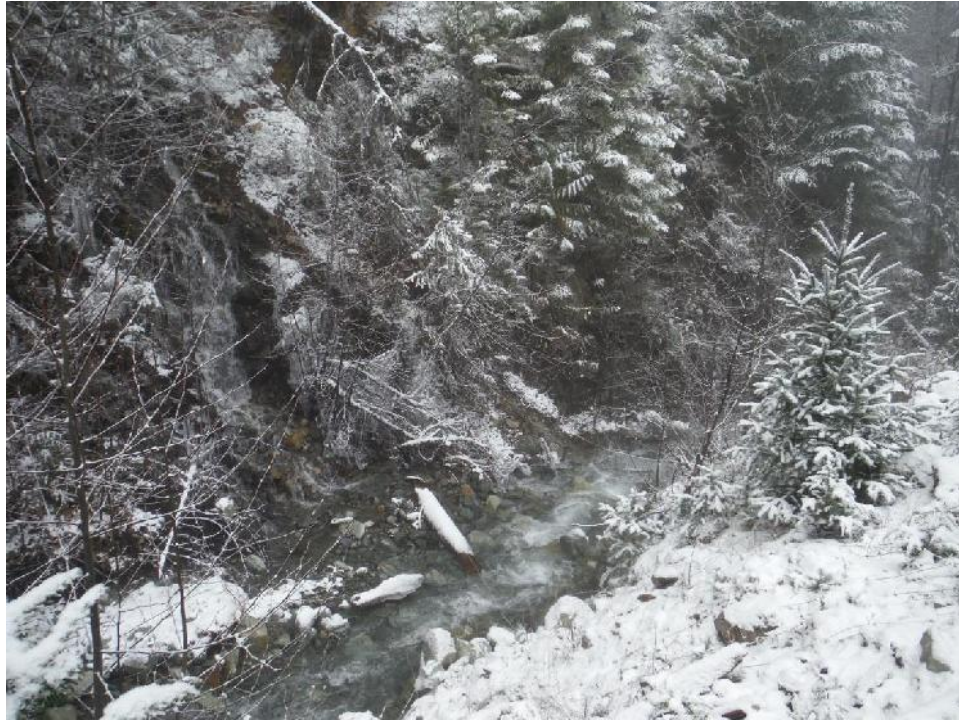
Photo 23 – Moderate flow in the main reach of the Upper Lynx Diversion Ditch.

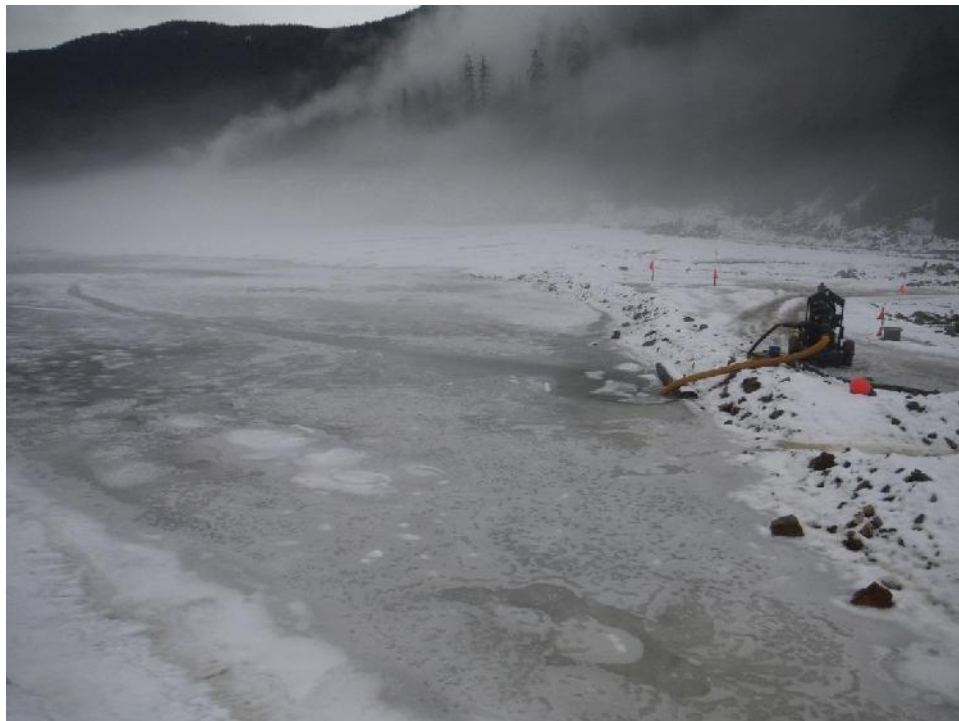
Photo 2 – Southeast corner of the APA, diesel pump on Paste Investigation Road fill.

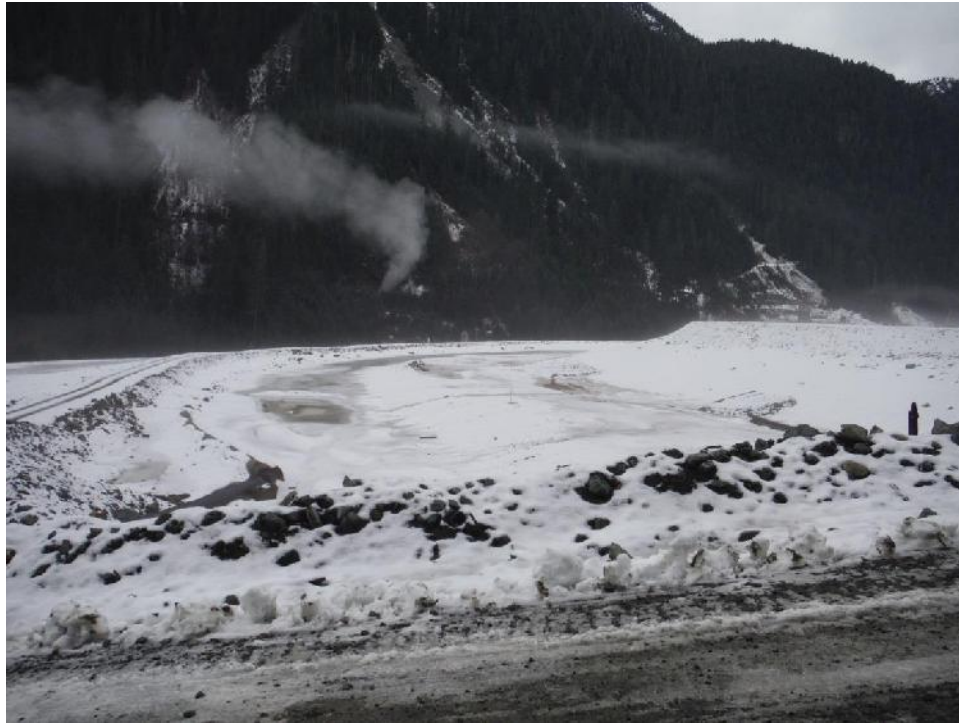
Photo 3 – Northeast portion of the East Strip, looking south.

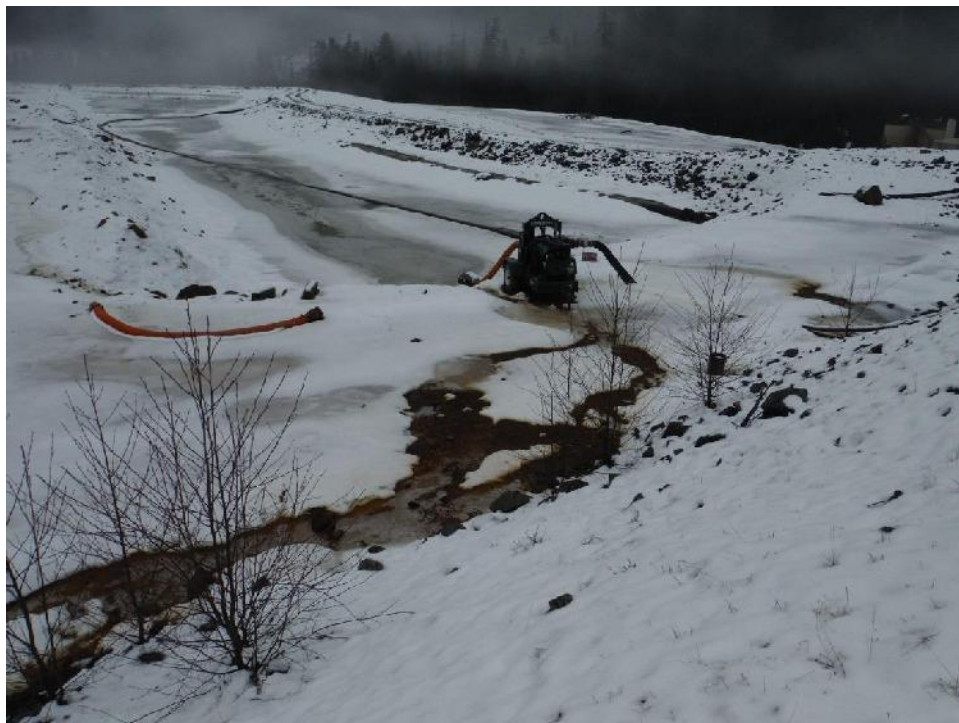
Photo 4 – West portion of the East Strip, looking east.
