**MYRA FALLS TAILINGS STORAGE FACILITIES
2015 DAM SAFETY INSPECTION REPORT**

31 March 2016

Amec Foster Wheeler File: NX14001B

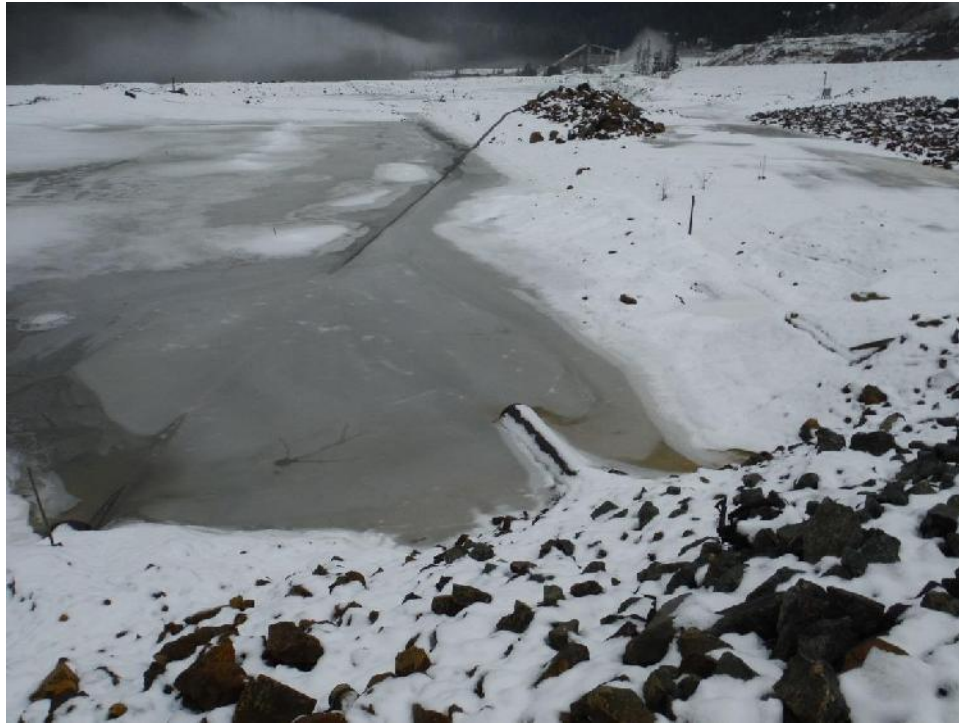
Photo 5 – West Strip showing Old TDF spillway culverts, looking west.

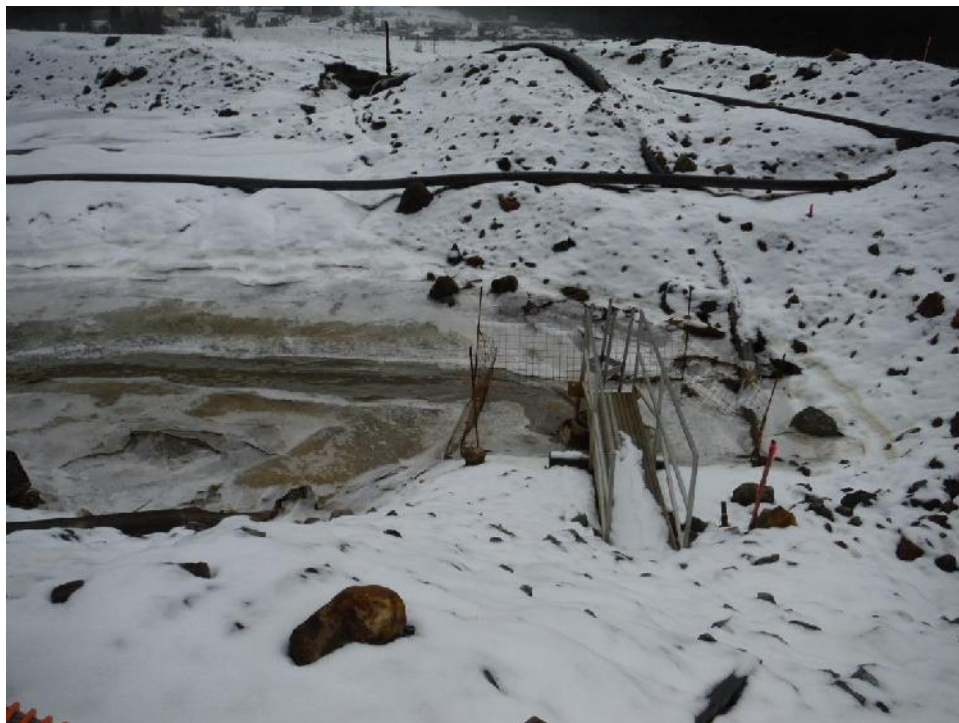
Photo 6 – Strip decant structure.

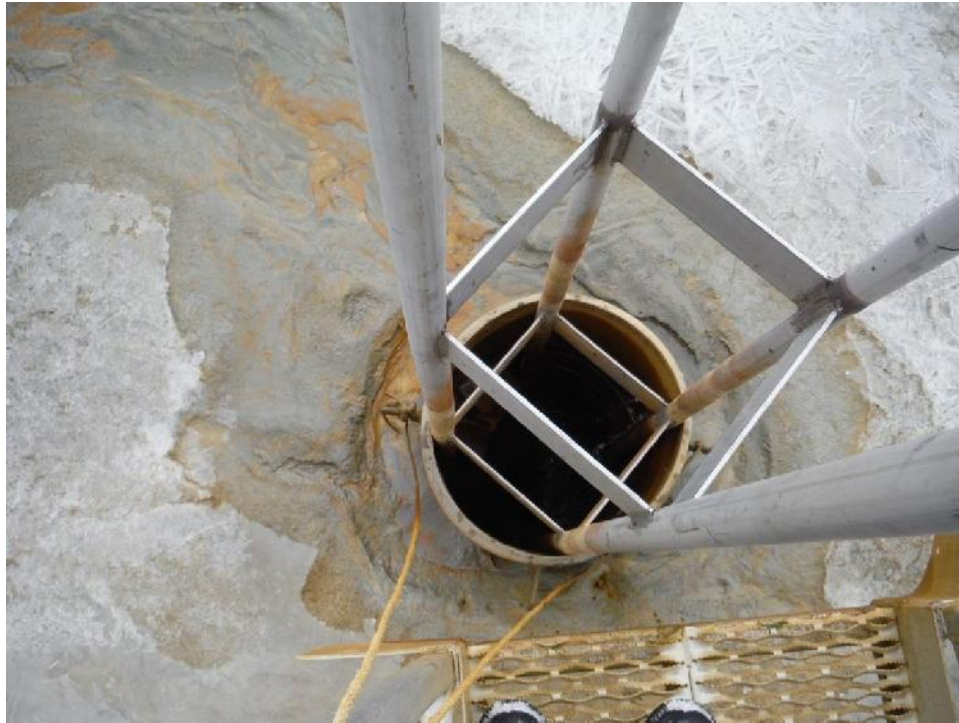
Photo 7 – Top view of Strip decant structure with ice around it.

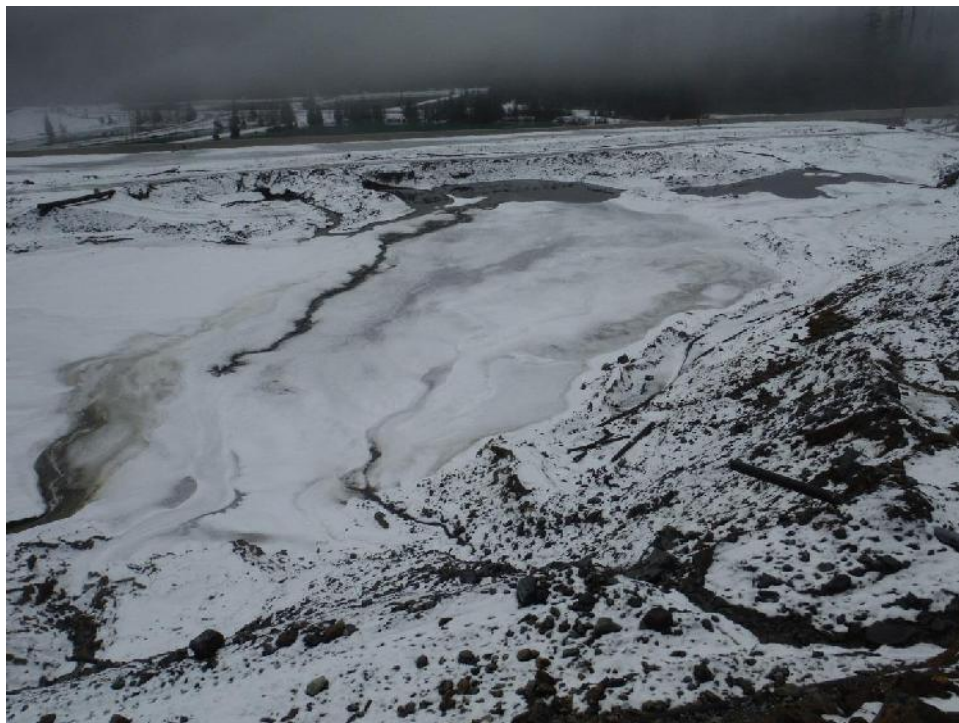
Photo 8 – Overview of the RSA looking south.

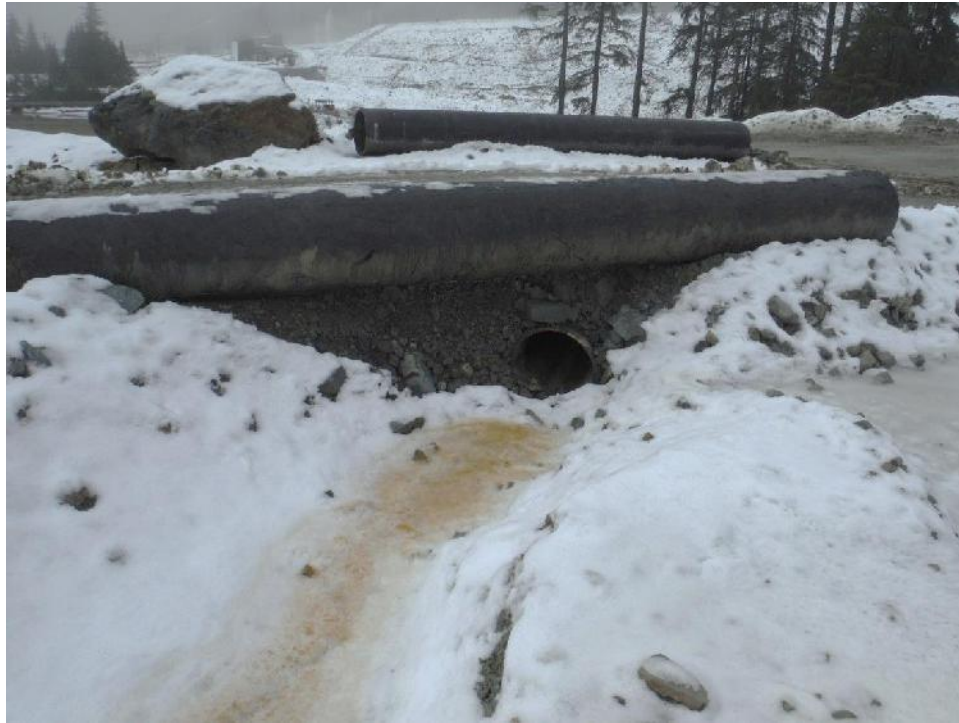
Photo 9 – Intake of new overflow structure at the RSA.

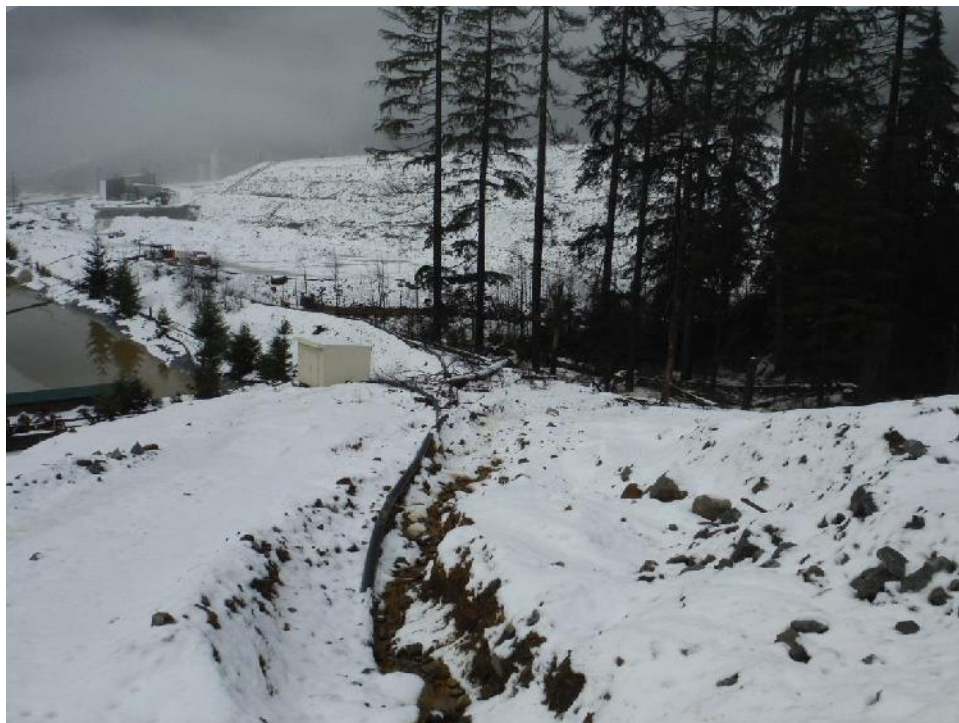
Photo 10 – Outlet of the new overflow structure at the RSA.

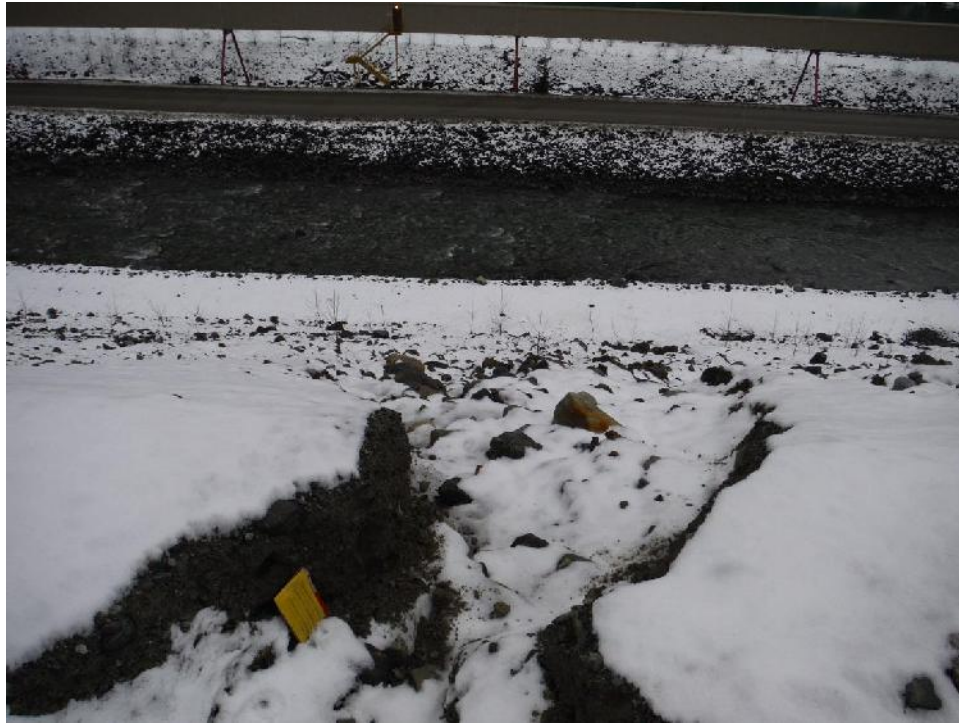
Photo 11 – New erosion gully into the Seismic Berm downstream face, just east of the Old TDF spillway.

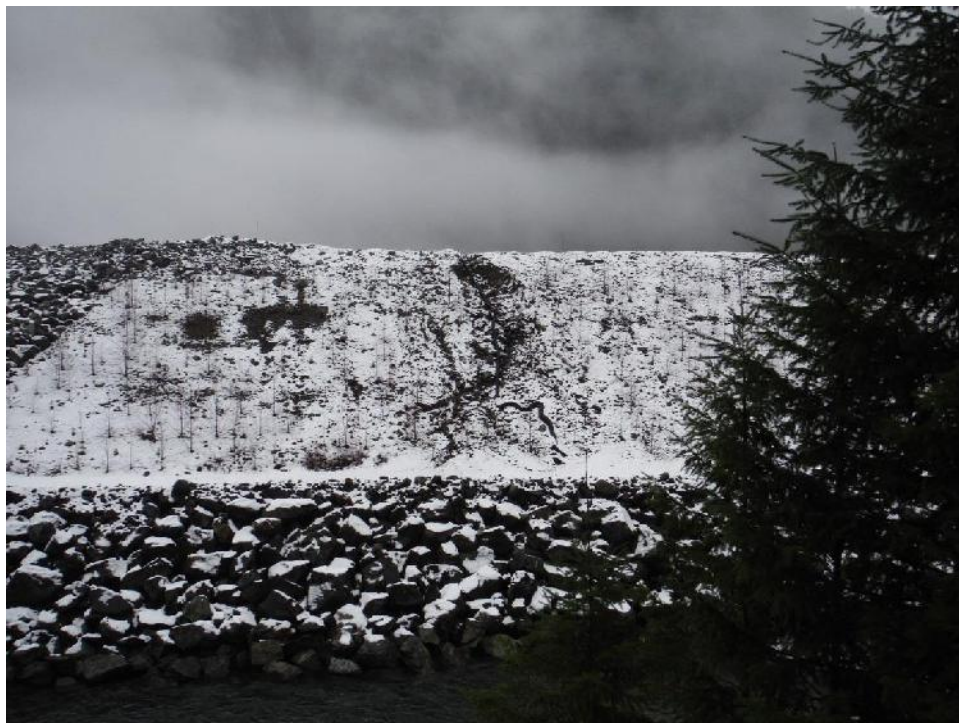
Photo 12 – New erosion gully into the Seismic Berm downstream face, just east of the Old TDF spillway.

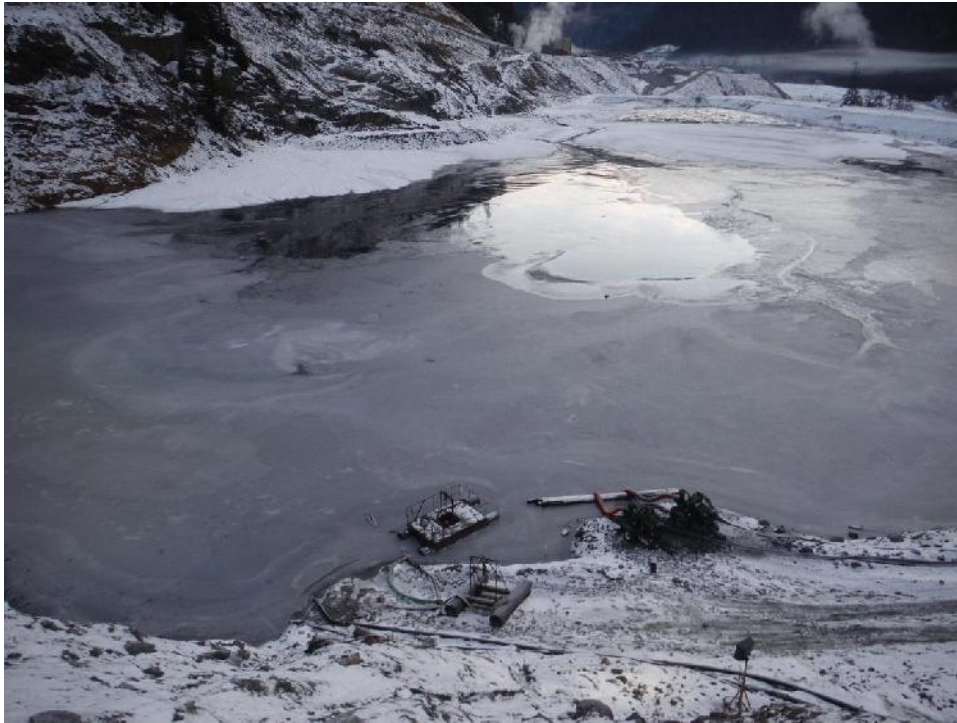
Photo 13 – Overview of Lynx TDF looking east.

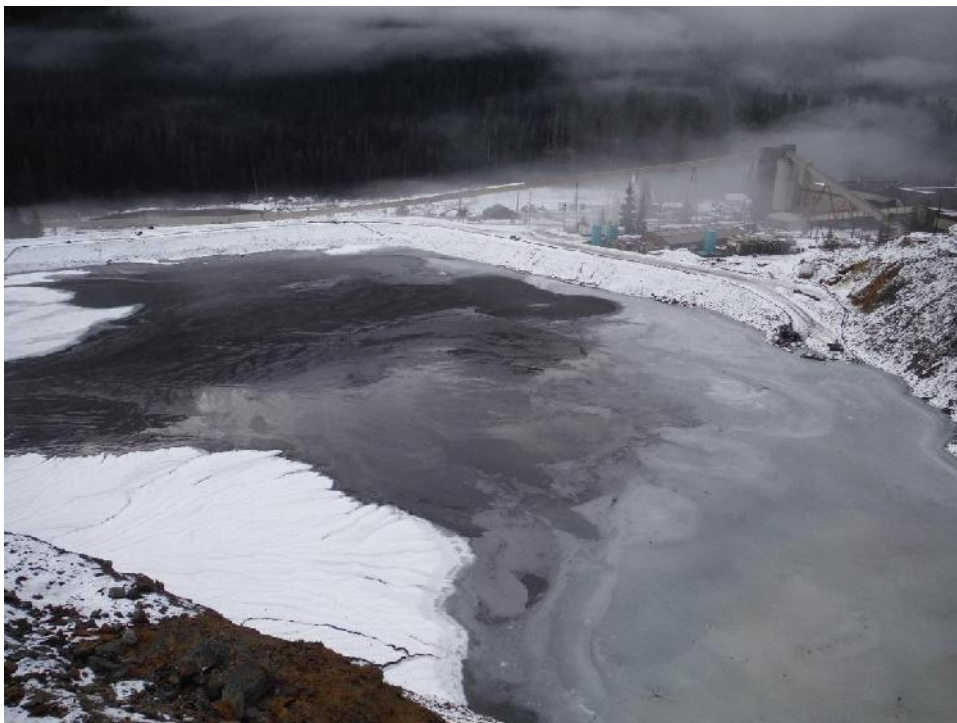
Photo 14 – Overview of Lynx TDF, looking southwest.

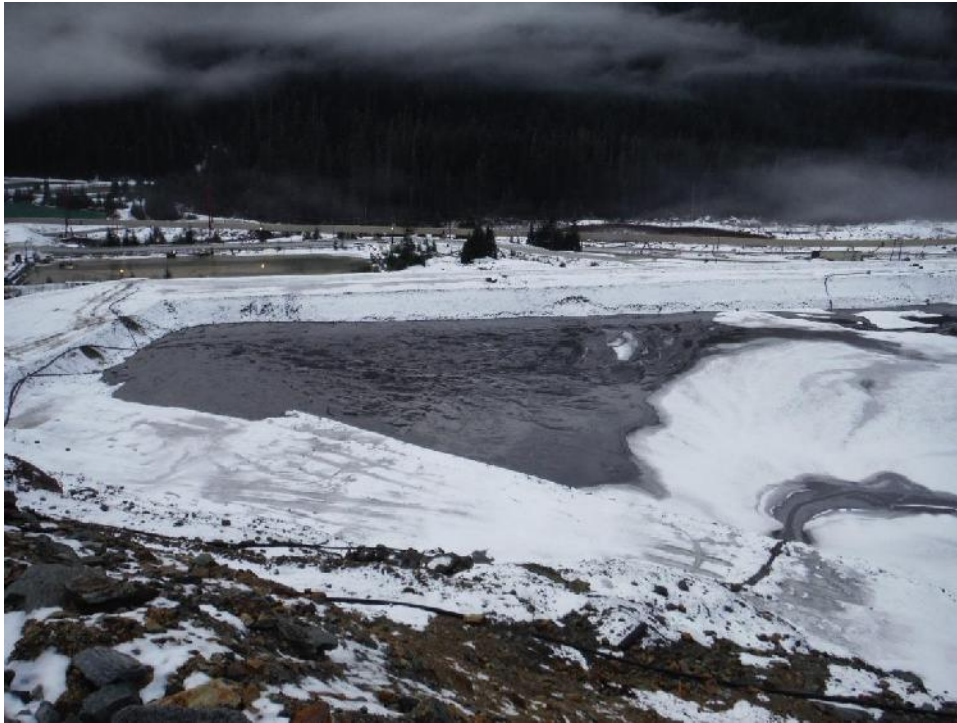
Photo 15 – East portion of Lynx TDF, looking south.

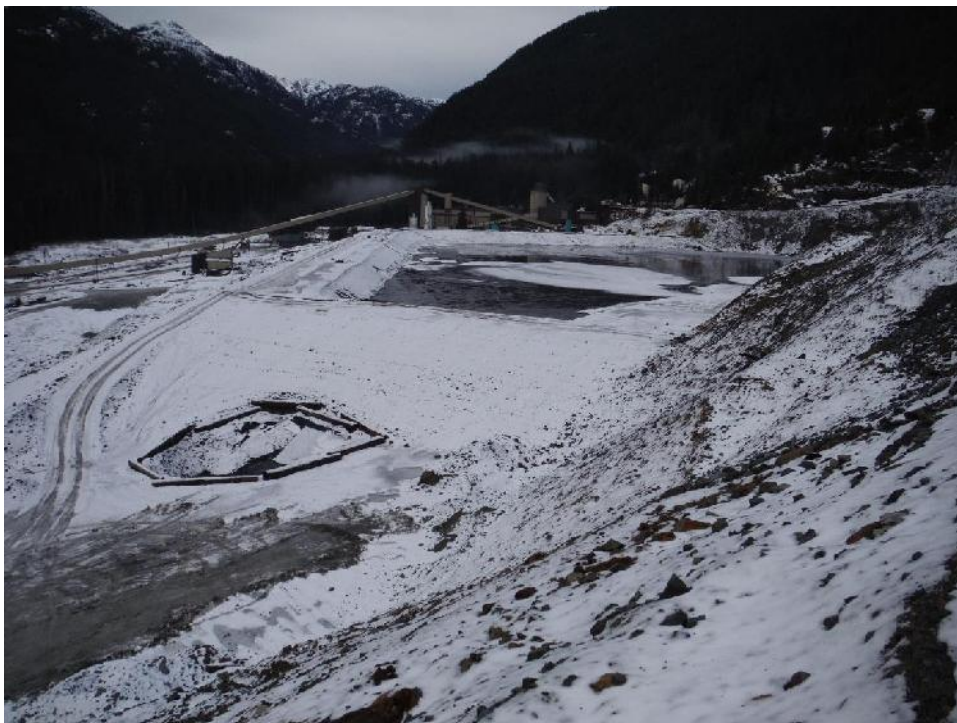
Photo 16 – Lynx TDF west arm, looking west.

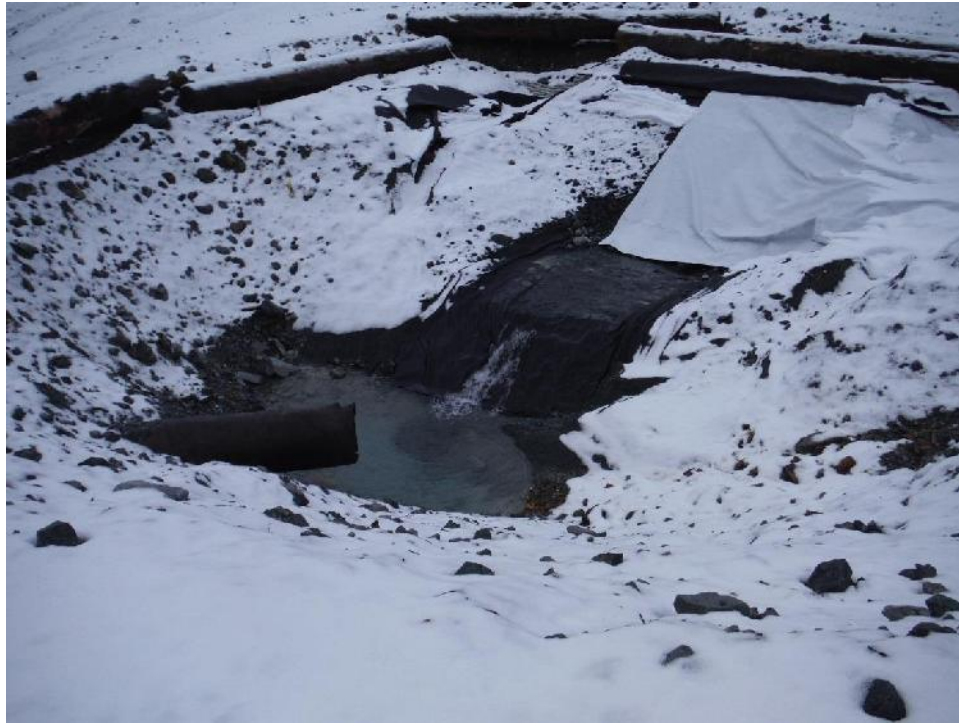
Photo 17 – Close-up view of Lynx Springs Drain discharge.

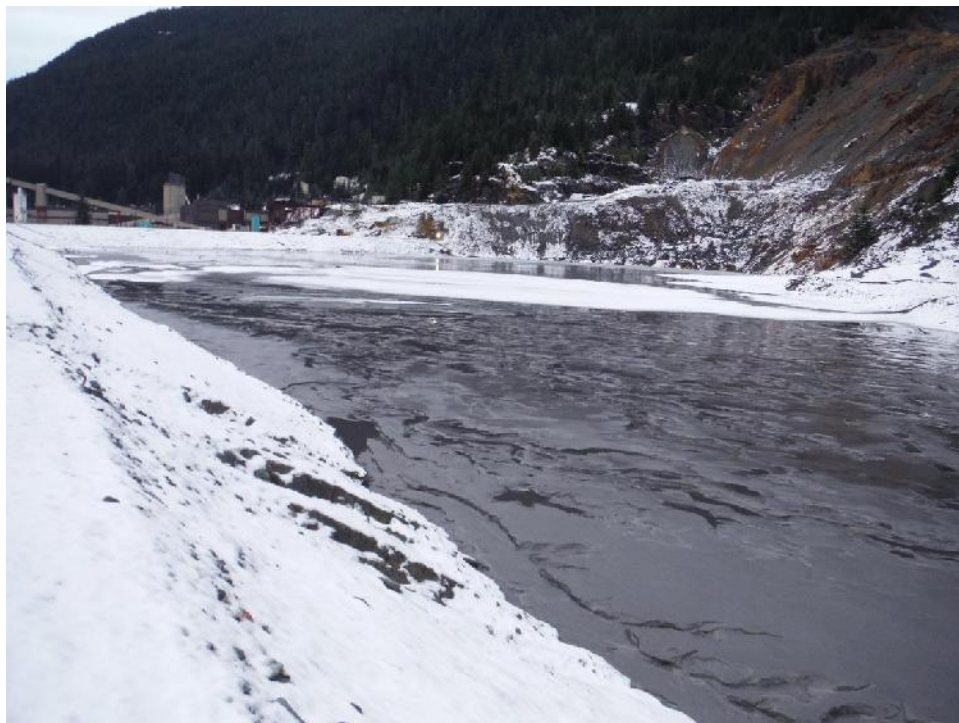
Photo 18 – Upstream Face of Lynx Dam south arm, looking west.

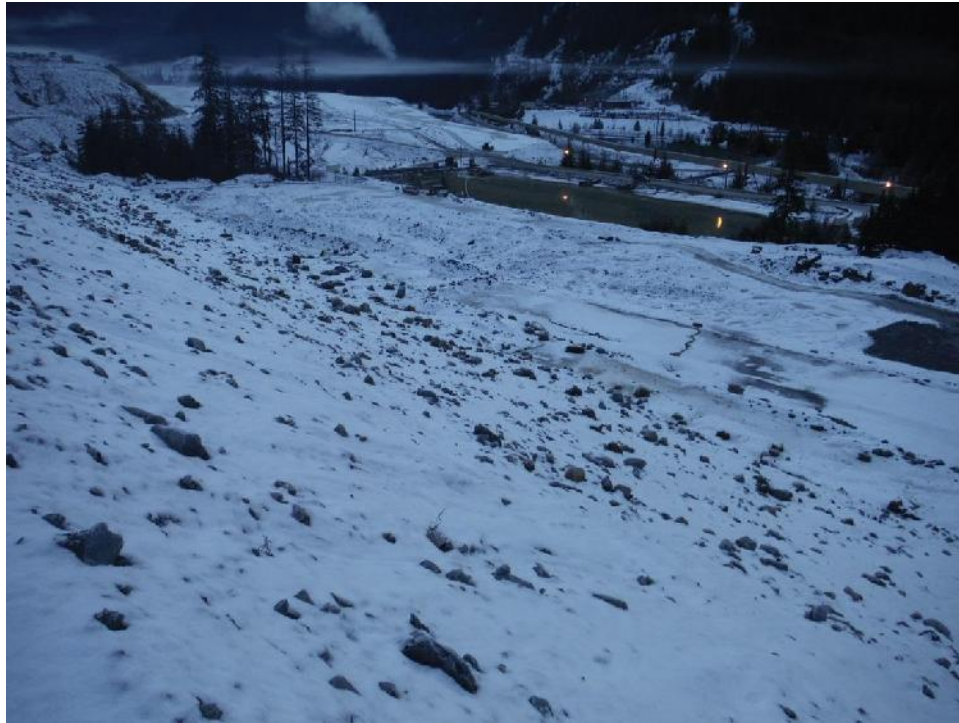
Photo 19 – Lynx Dam south arm downstream face, lower benches and toe area, looking southeast.

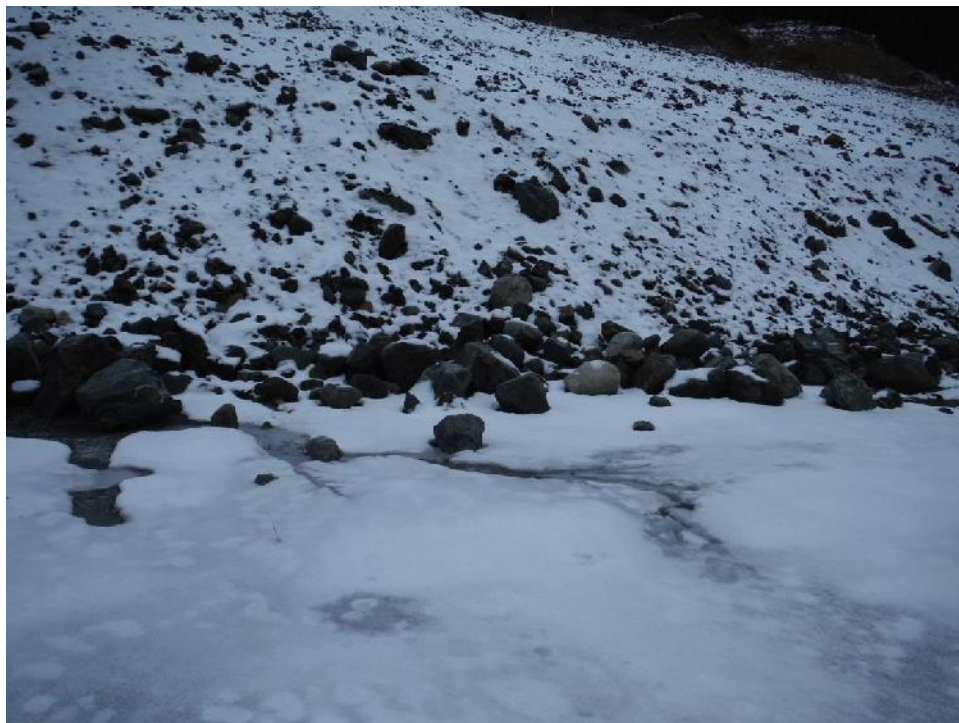
Photo 20 – Seepage flow on Lynx Dam lower bench near east end.

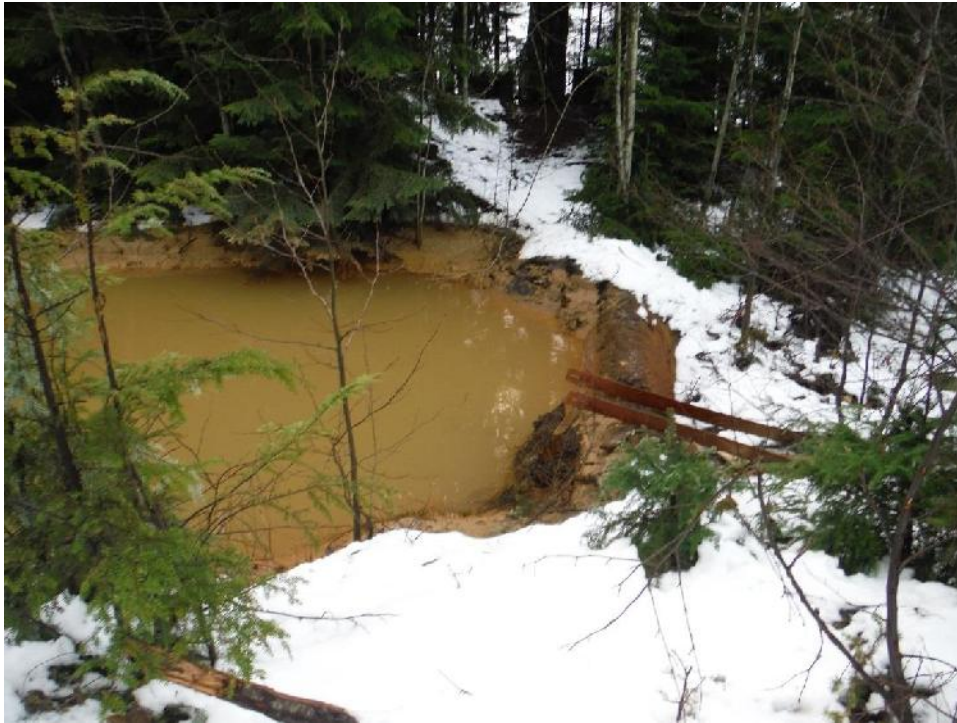
Photo 21 – Phillips Reach sump.

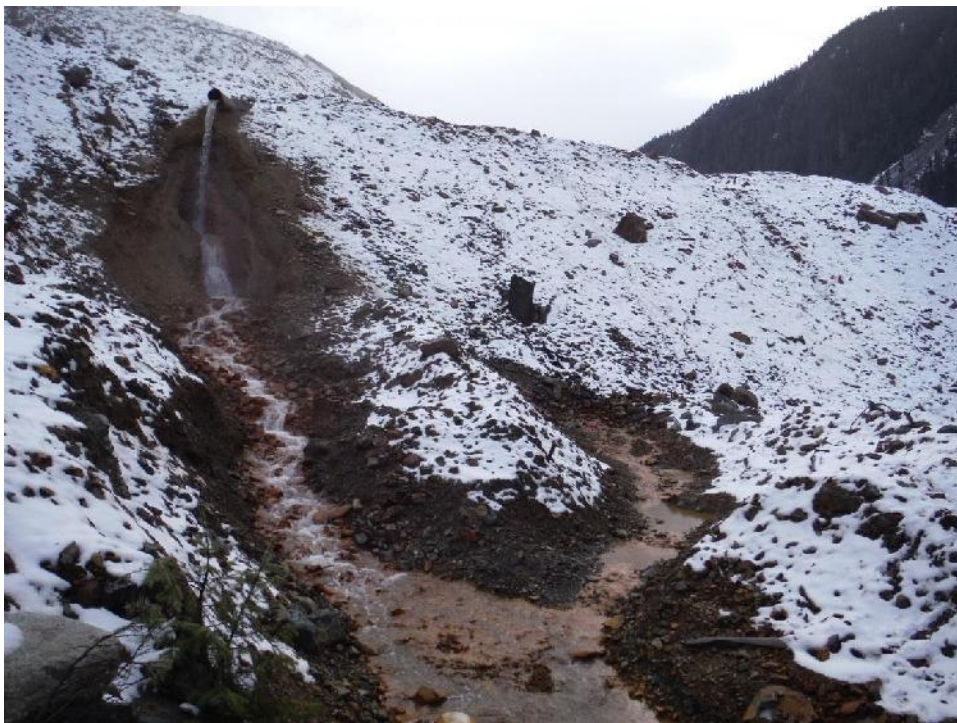
Photo 22 – Phillips Reach discharge below Waste Dump #1. Note seepage at the right side of photo.

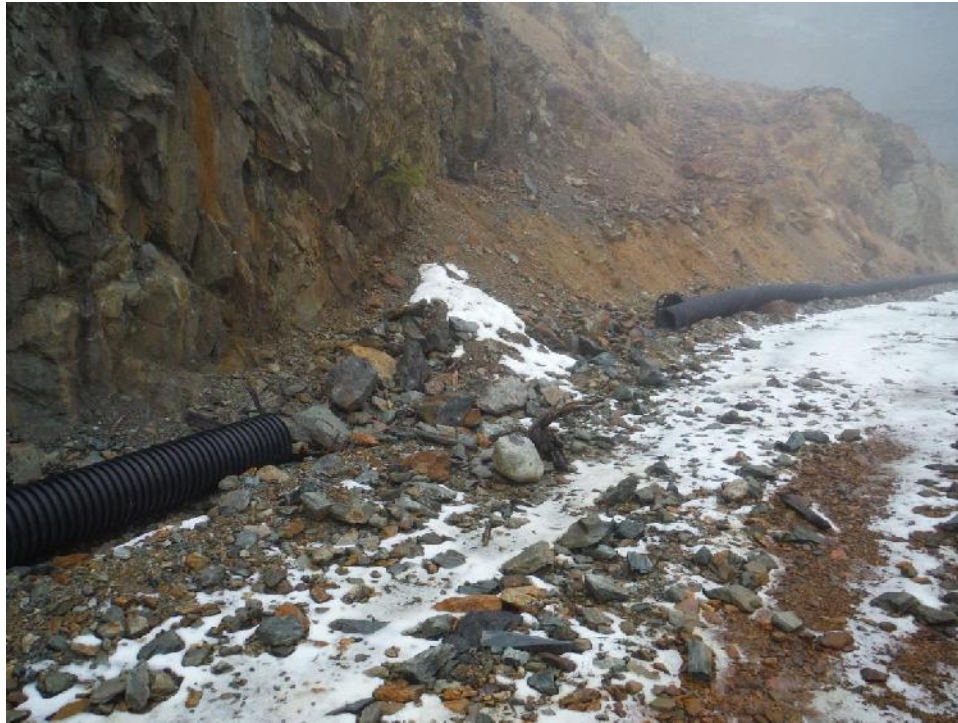
Photo 23 – Torn drainage pipe along water diversion just above Lynx Pit Slide area.

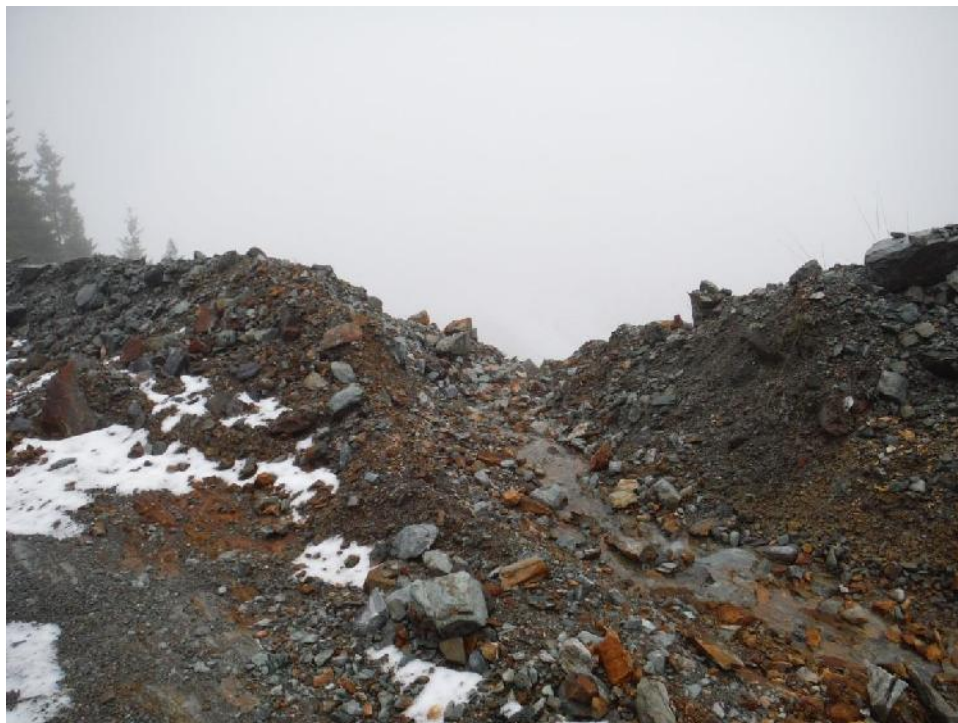
Photo 24 – Ditch flowing towards the top of Lynx Pit Slide area.

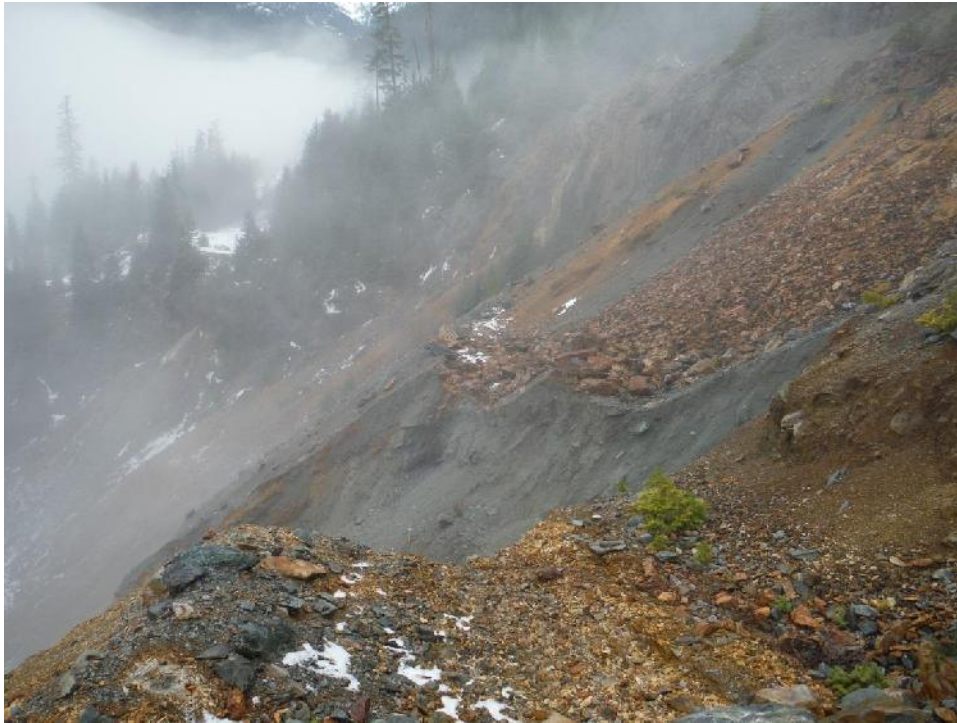
Photo 25 – Ditch directed towards the top of east side of Lynx Pit Slide area, looking west.

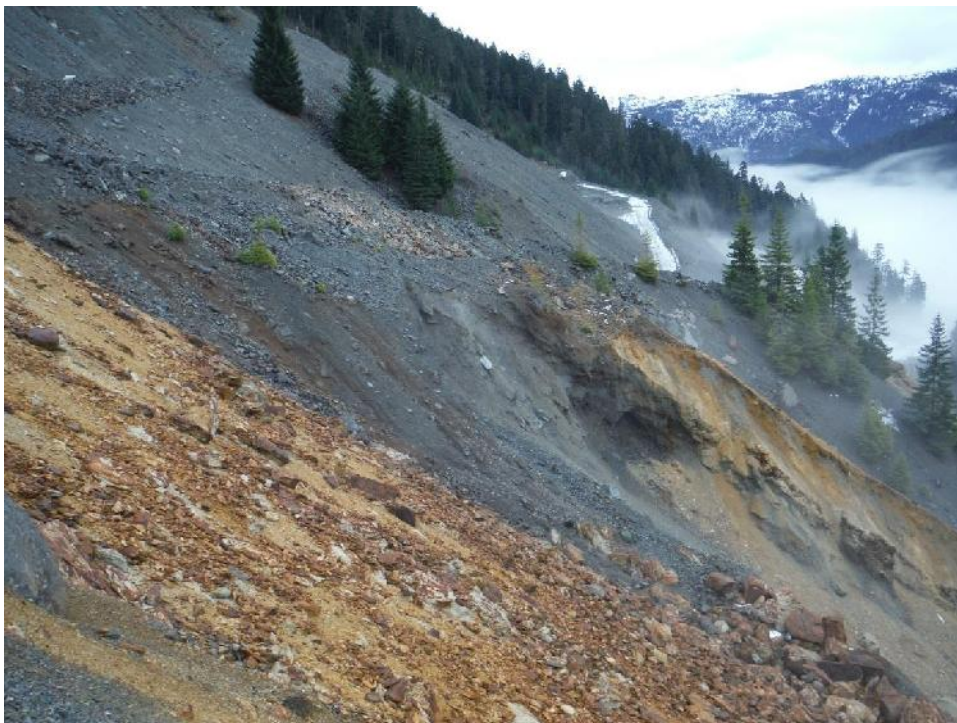
Photo 26 – Top of Lynx Pit slide area, looking east.

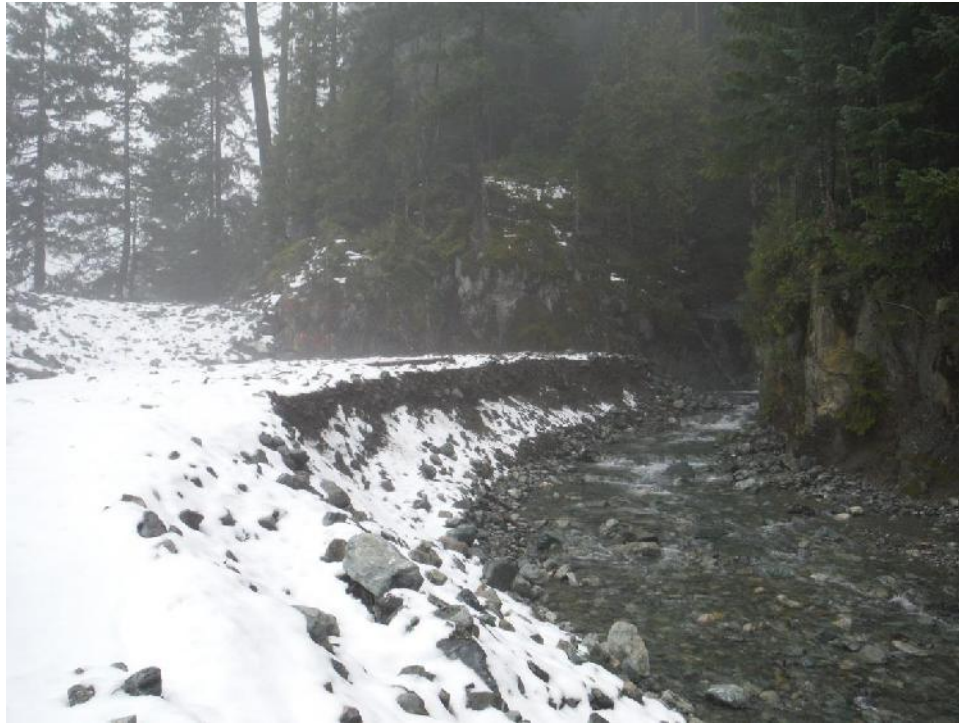
Photo 27 – Cascade Reach discharge below Waste Dump #1.

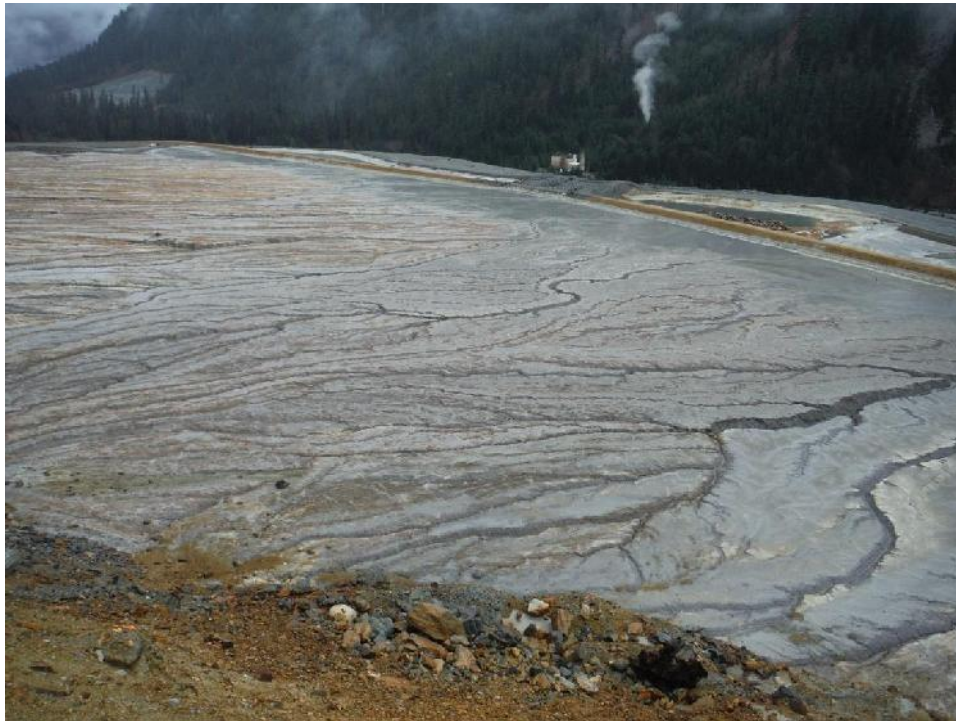
Photo 1 – APA from Waste Dump #6, looking southeast.

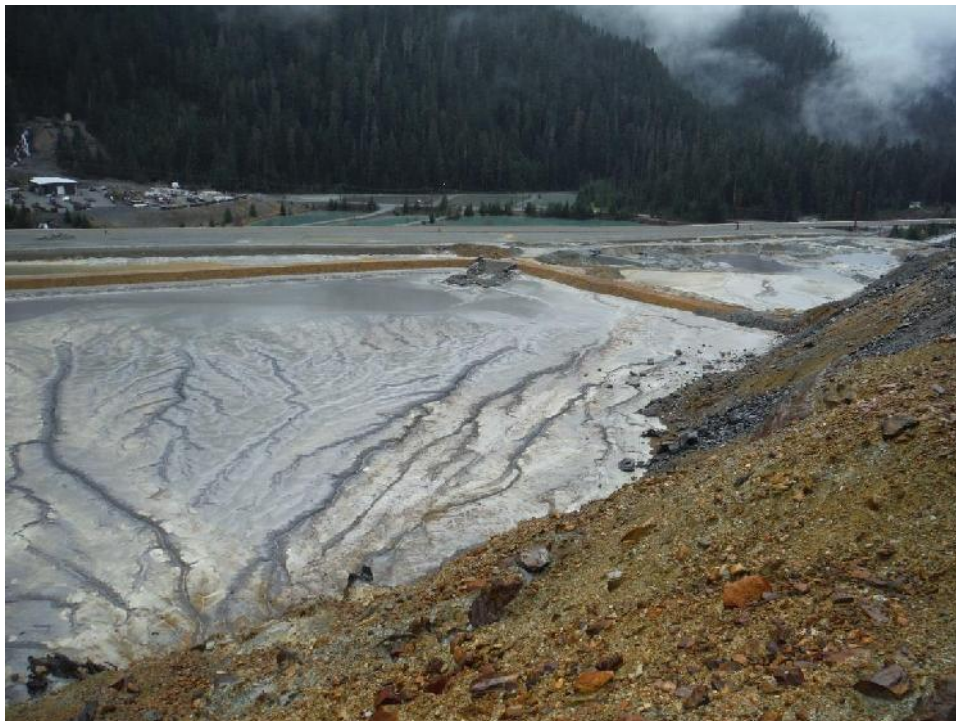
Photo 2 – APA from Waste Dump #6, looking south towards the APA decant and RSA.

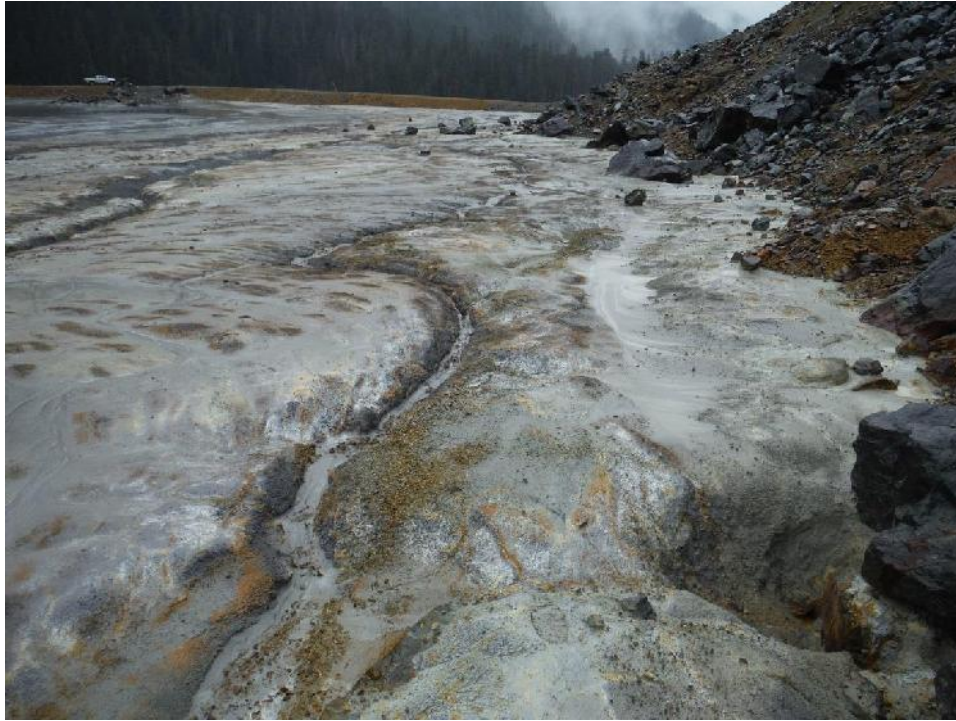
Photo 3 – Erosion holes and rills in the APA paste tailings at the Waste Dump #6 west side toe.

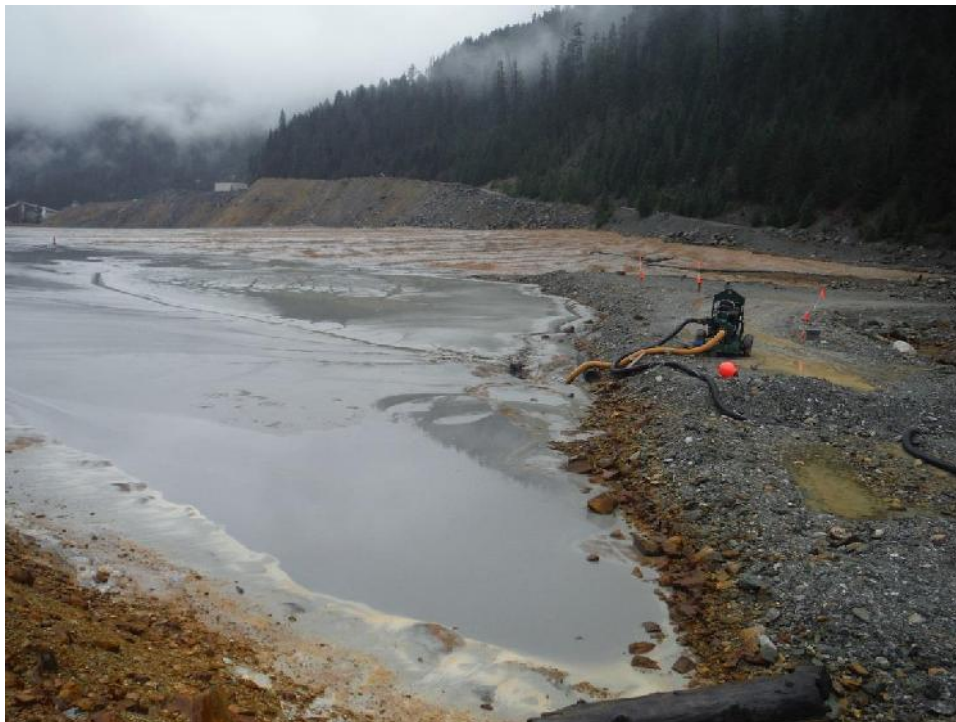
Photo 4 – Southeast corner of the APA with diesel pump on the Paste Investigation Road fill.

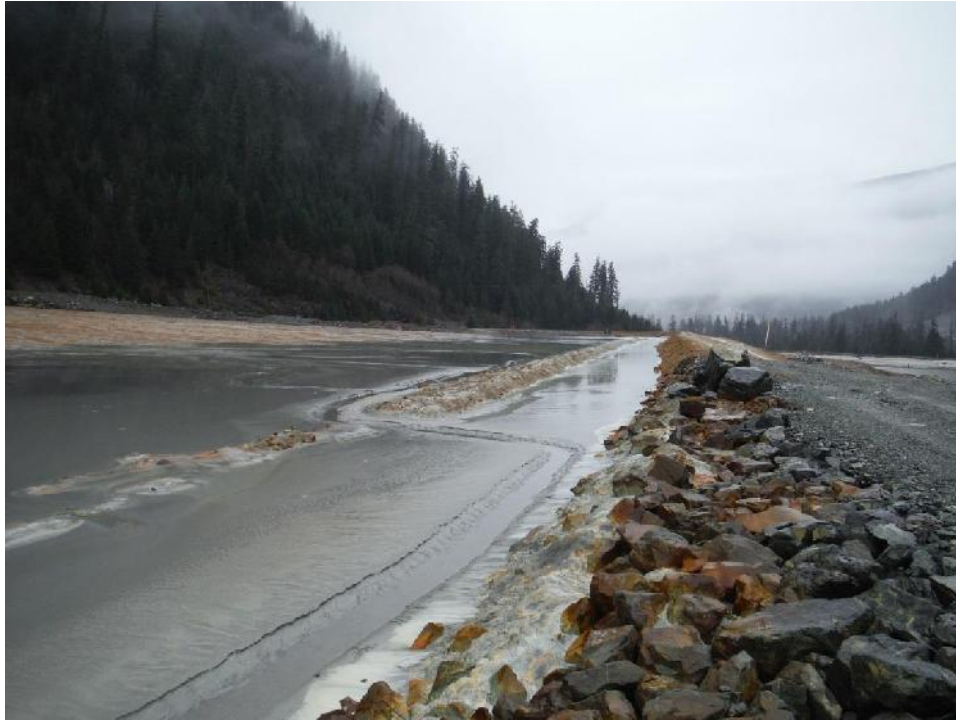
Photo 5 – APA ditch along the Paste Berm, looking east from the Old TDF spillway area.

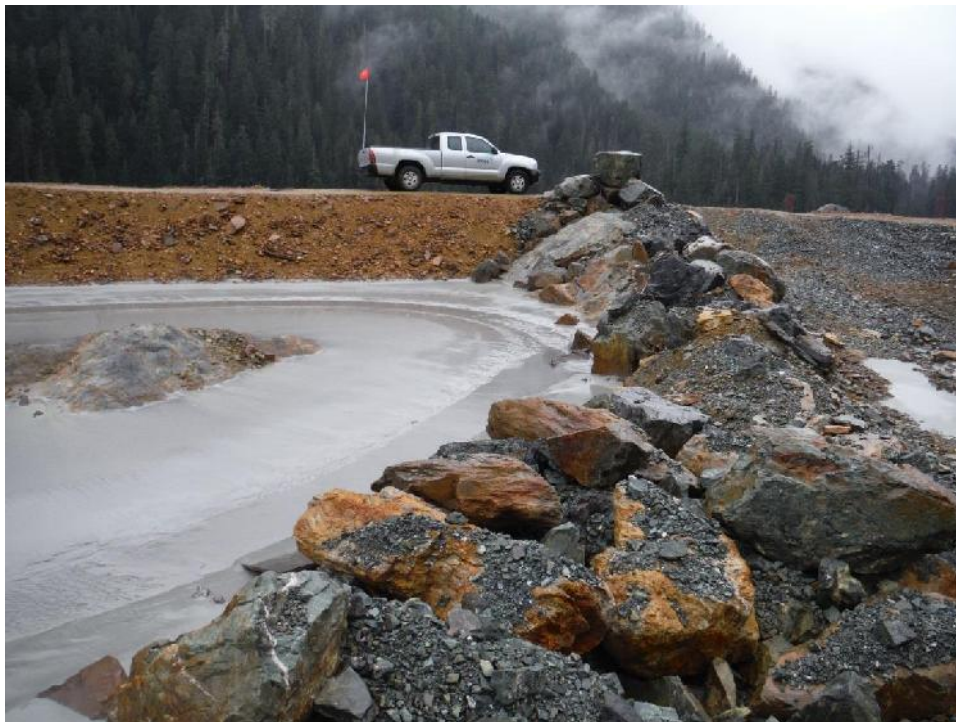
Photo 6 – Tailings slurry flowing through rocks at the APA decant, looking southwest (ramp leading to the decant structure immediately to the right of the photo)

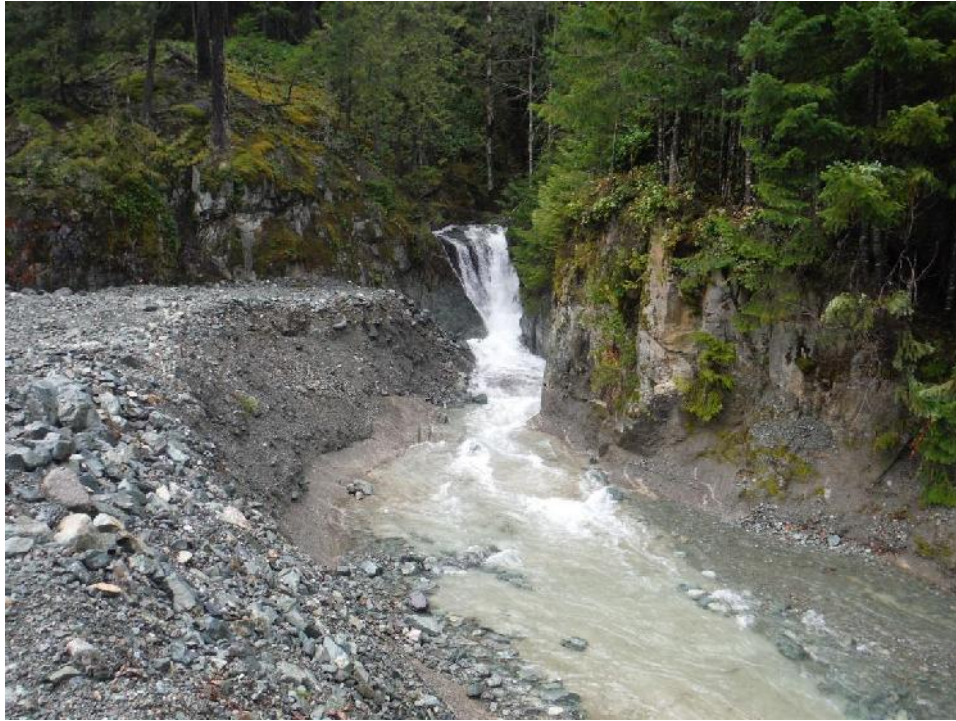
Photo 7 – Falls at the end of Cascade Reach and merge point with Lower Lynx Diversion Ditch, looking west.

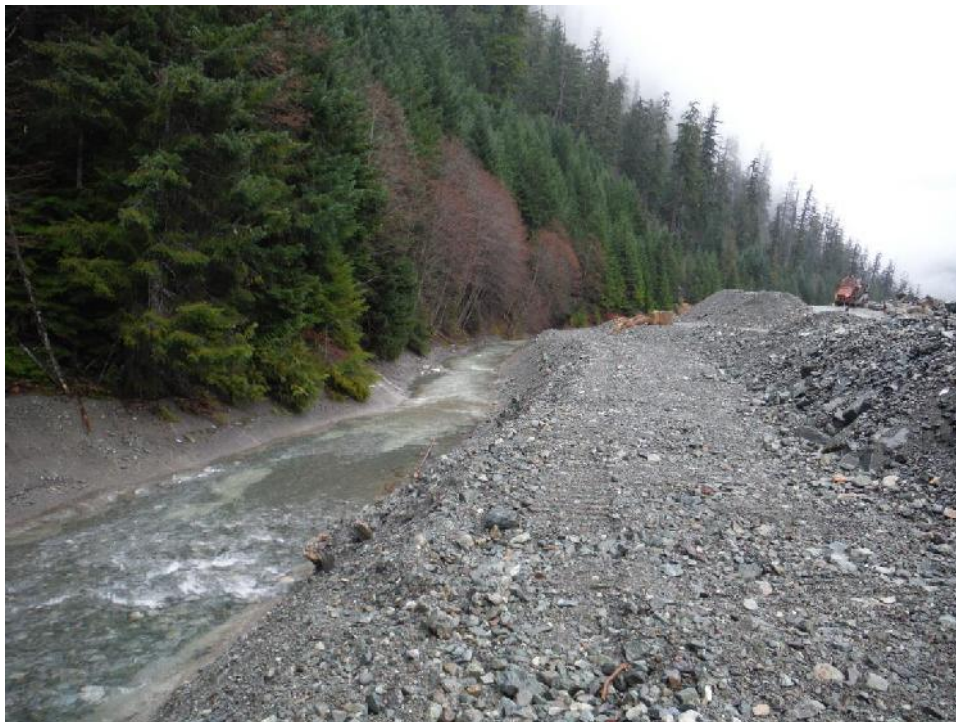
Photo 8 – Lower Lynx Diversion Ditch near Cascade Reach, looking east.

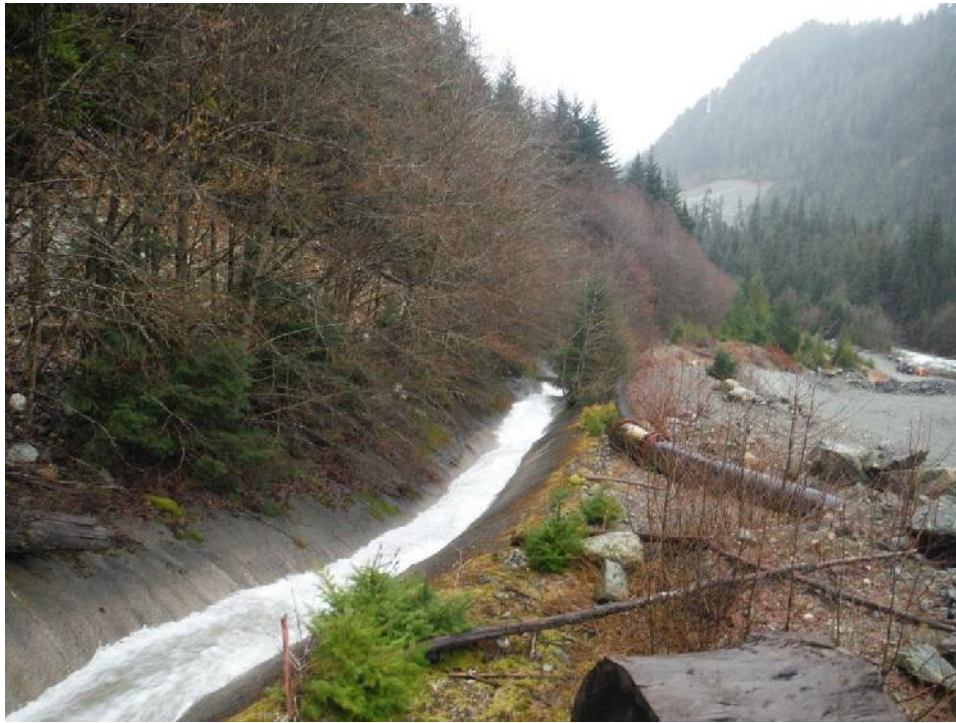
Photo 9 – Shotcrete lined section of Lower Lynx Diversion Ditch, about 50 m upstream of Alder Reach.
