**MYRA FALLS TAILINGS STORAGE FACILITIES
2015 DAM SAFETY INSPECTION REPORT**

31 March 2016

Amec Foster Wheeler File: NX14001B

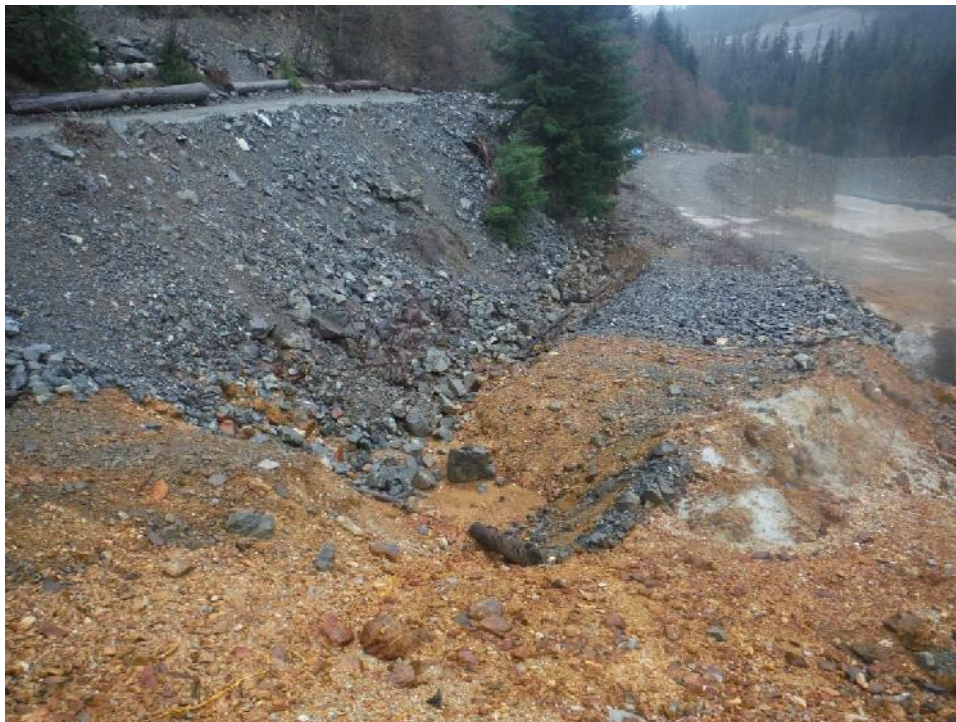
Photo 10 – Location of main spring at the toe of the Paste Berm east abutment.

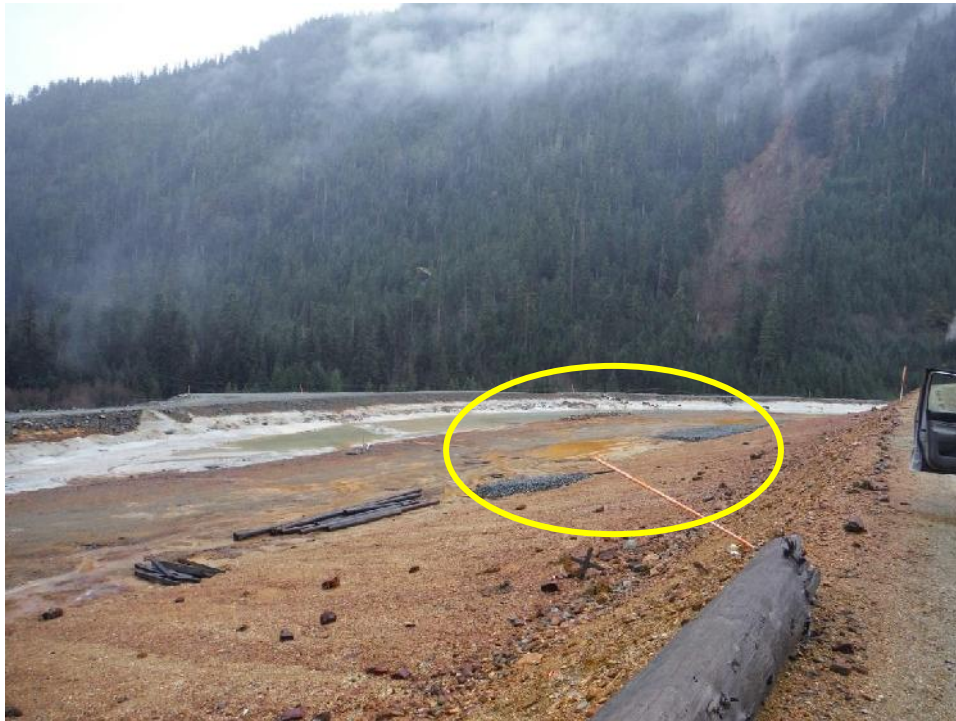
Photo 11 – View of the East Strip showing ARD seepage areas at the downstream toe of the Paste Berm and “anti-piping” pads (circled), looking south from the east abutment.

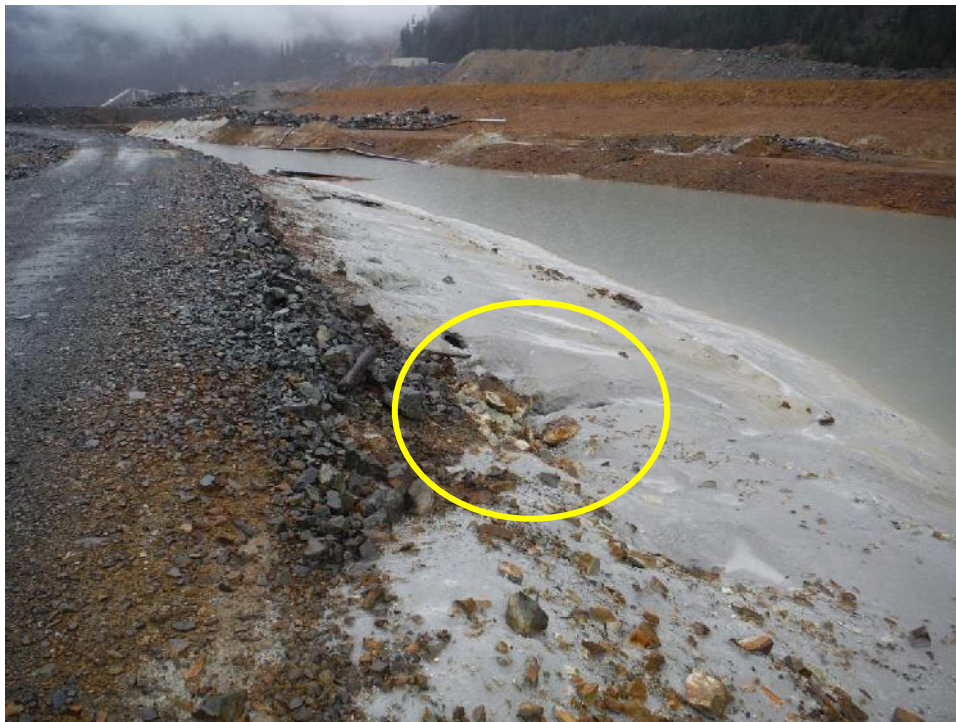
Photo 12 – East Strip, looking west from central area (yellow circle showing sinkhole into the OEB sand beach).

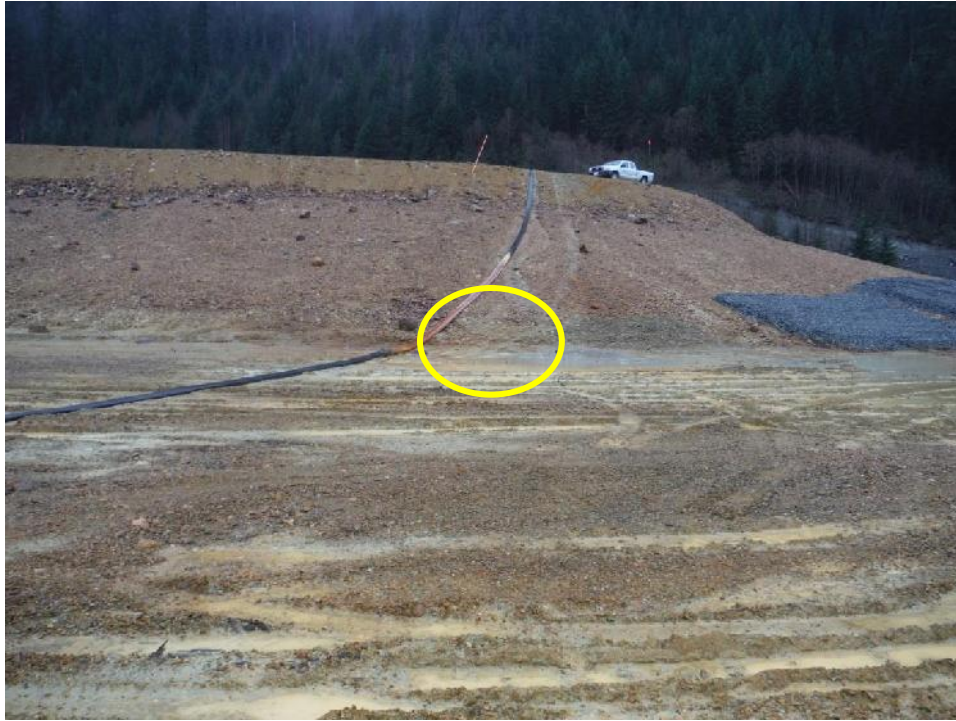
Photo 13 – Southeast corner of the Paste Berm, looking north. The base of the Paste Berm is soft and saturated due to poor drainage and distributed seepage.

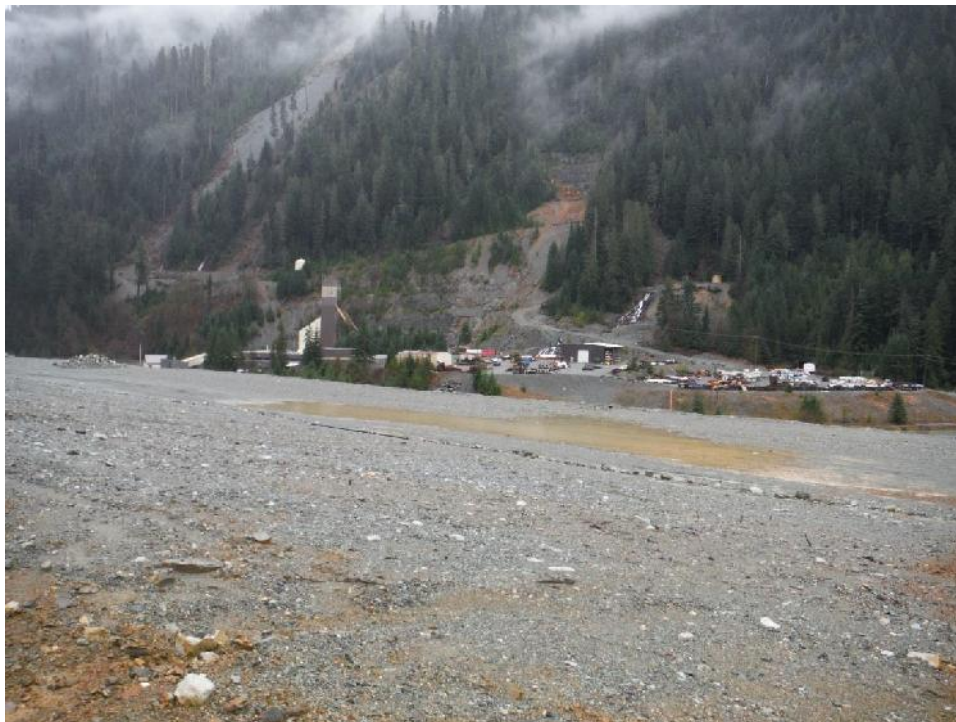
Photo 14 – Slight ponding on the Seismic Berm below the West Strip, looking southeast.

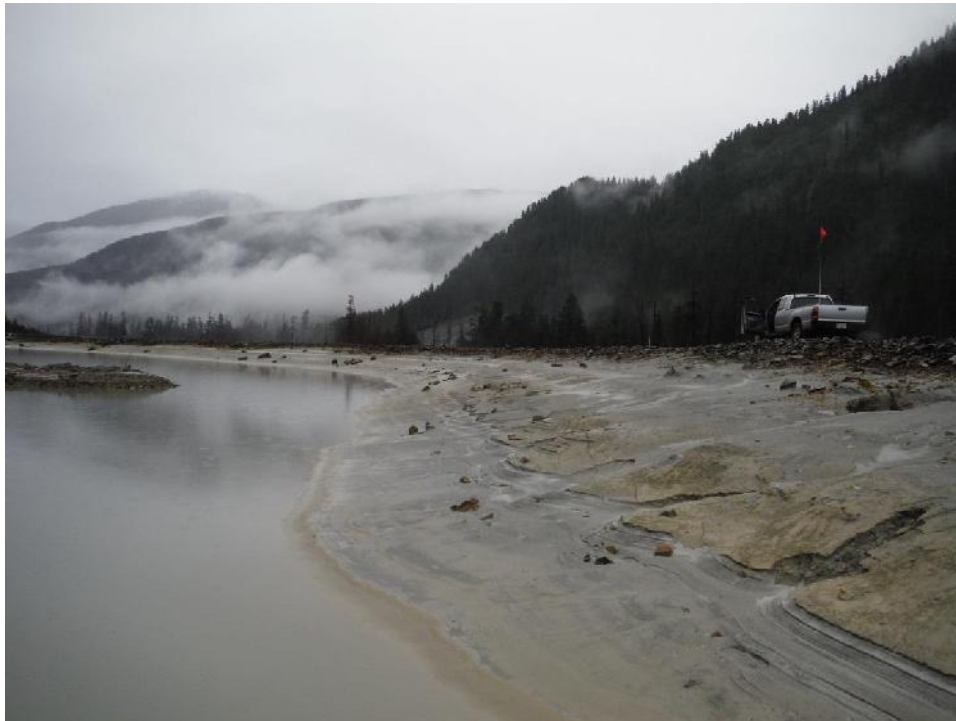
Photo 15 – View of the East Strip showing minor ravines (erosional features) along the OEB upstream beach, looking east from the Old TDF spillway area.

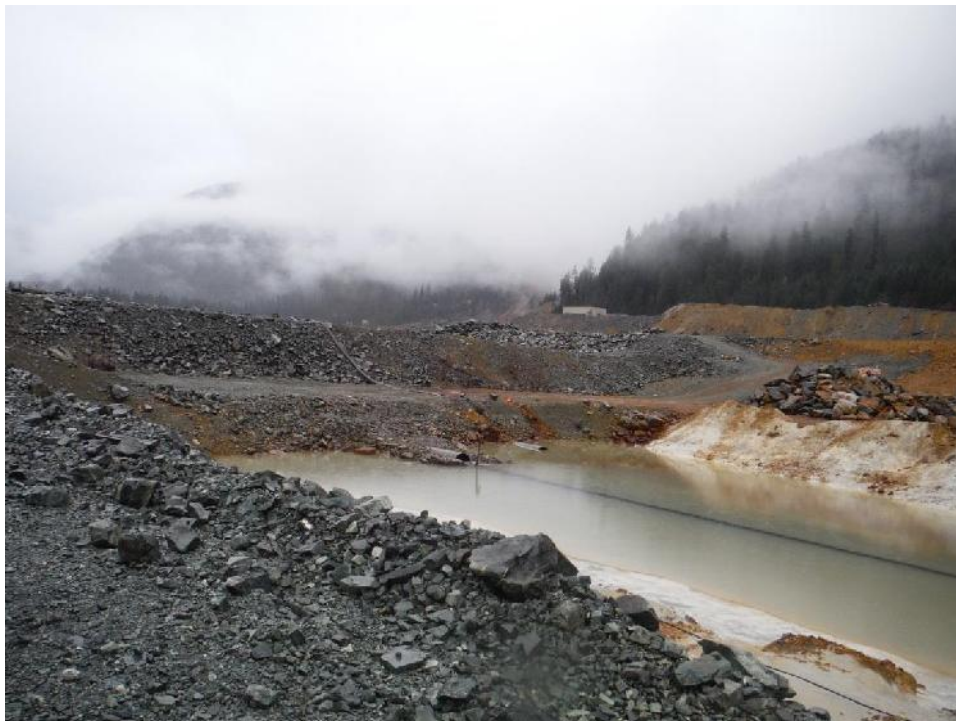
Photo 16 – Culverts under the Old TDF spillway at the west end of the East Strip.

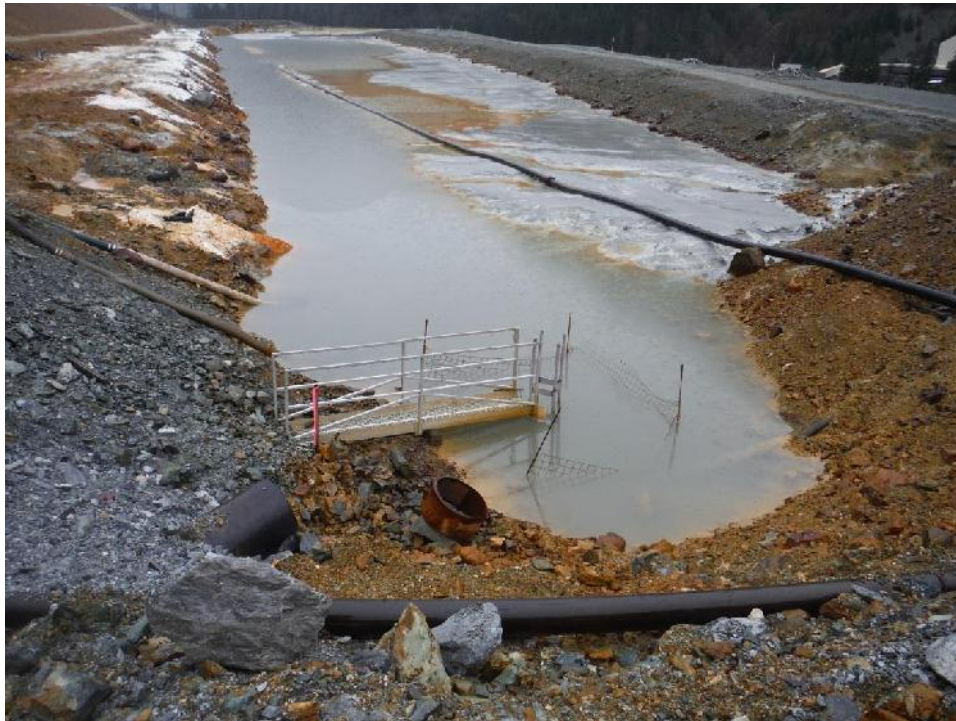
Photo 17 – West Strip decant structure, looking east.

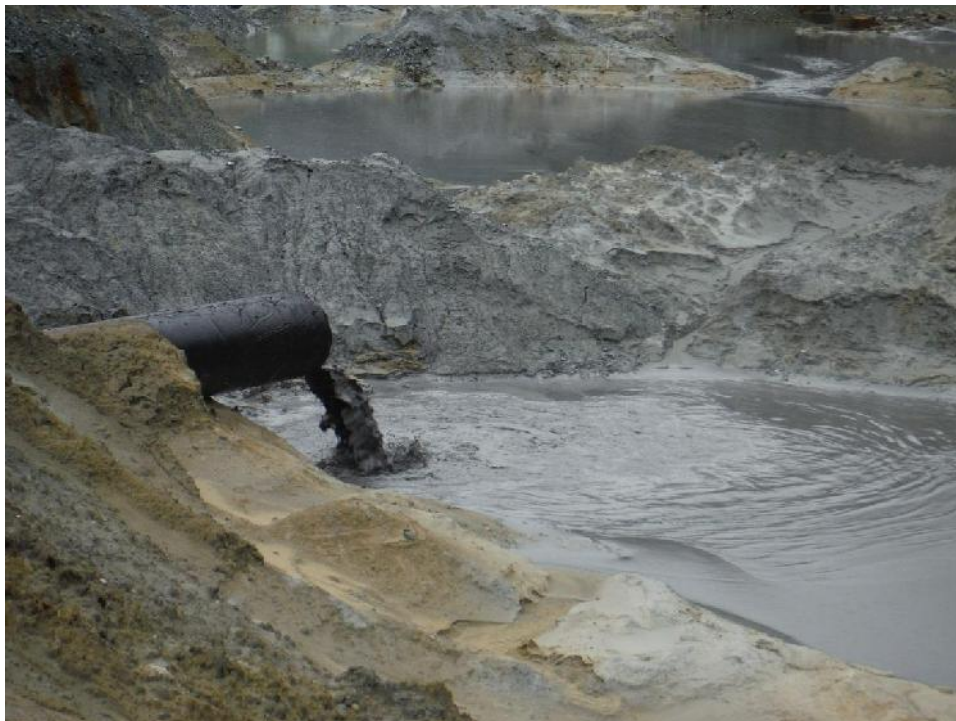
Photo 18 – Mine paste backfill overflow at the RSA.

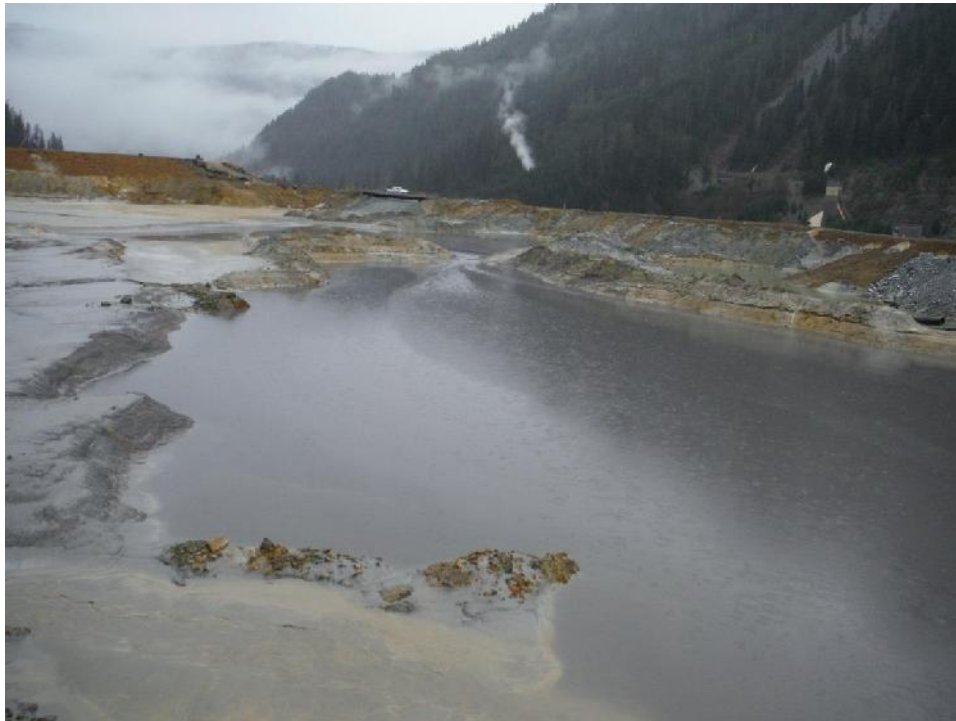
Photo 19 – General view of the RSA, looking east.

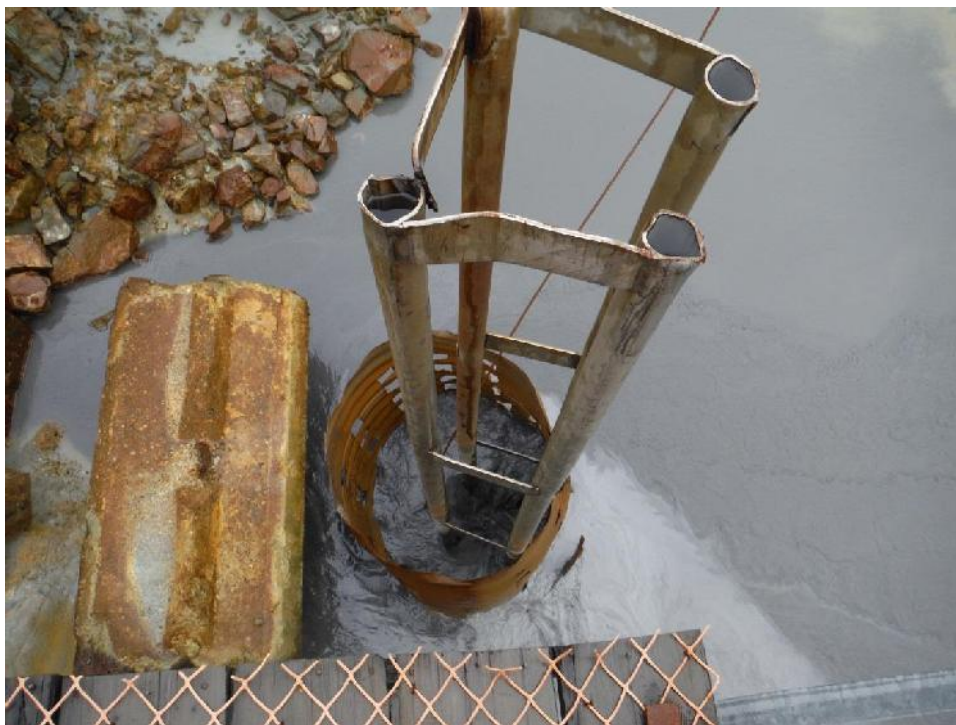
Photo 20 – Turbid water flowing into the RSA decant structure.

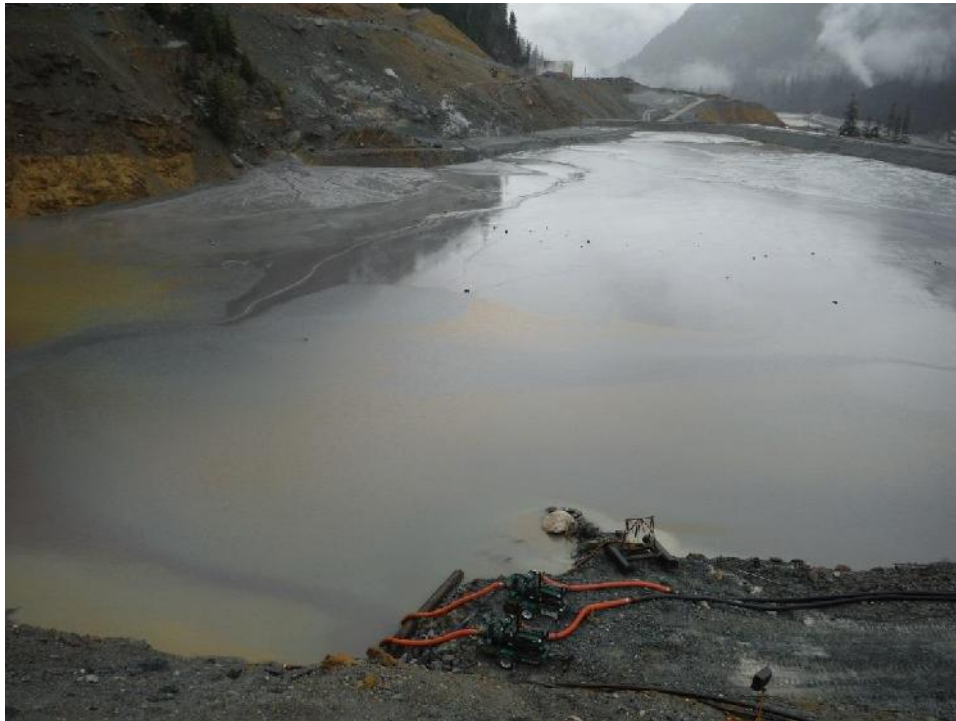
Photo 21 – General view of Lynx TDF, looking east.

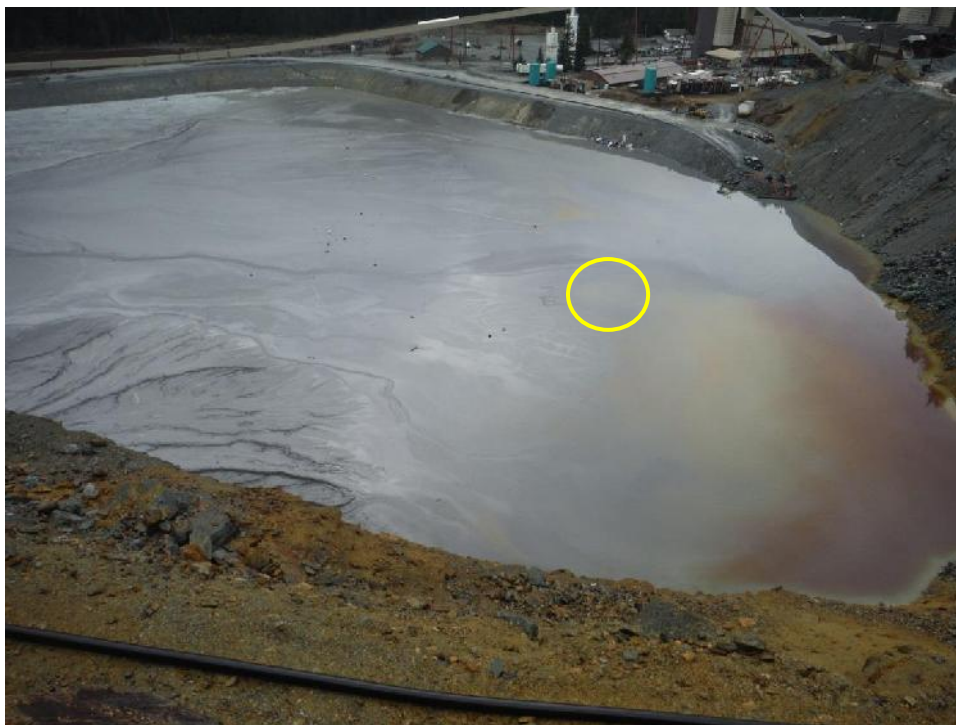
Photo 22 – Southwest view of Lynx TDF with sinkhole barely visible (circled area).

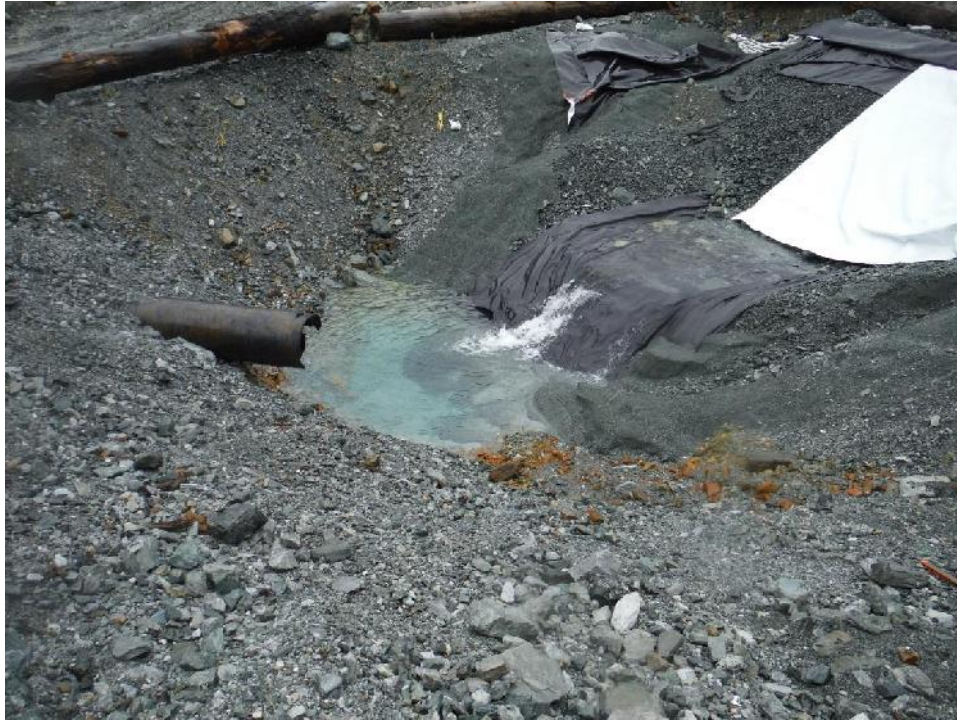
Photo 23 – Lynx Springs Drain outlet.

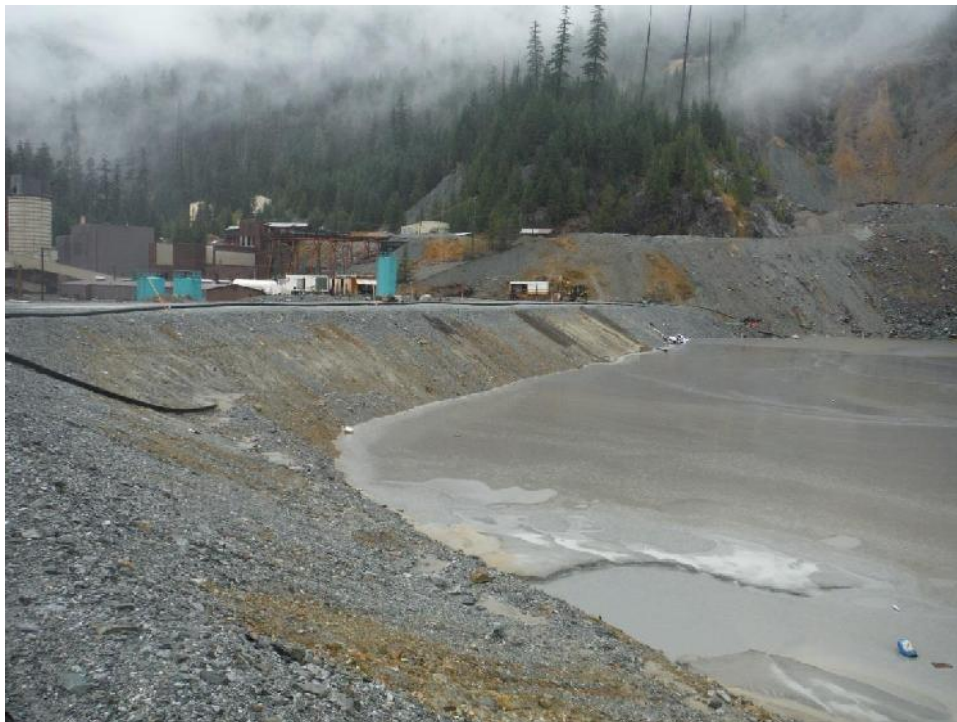
Photo 24 – Southwest corner of Lynx dam, looking northwest.

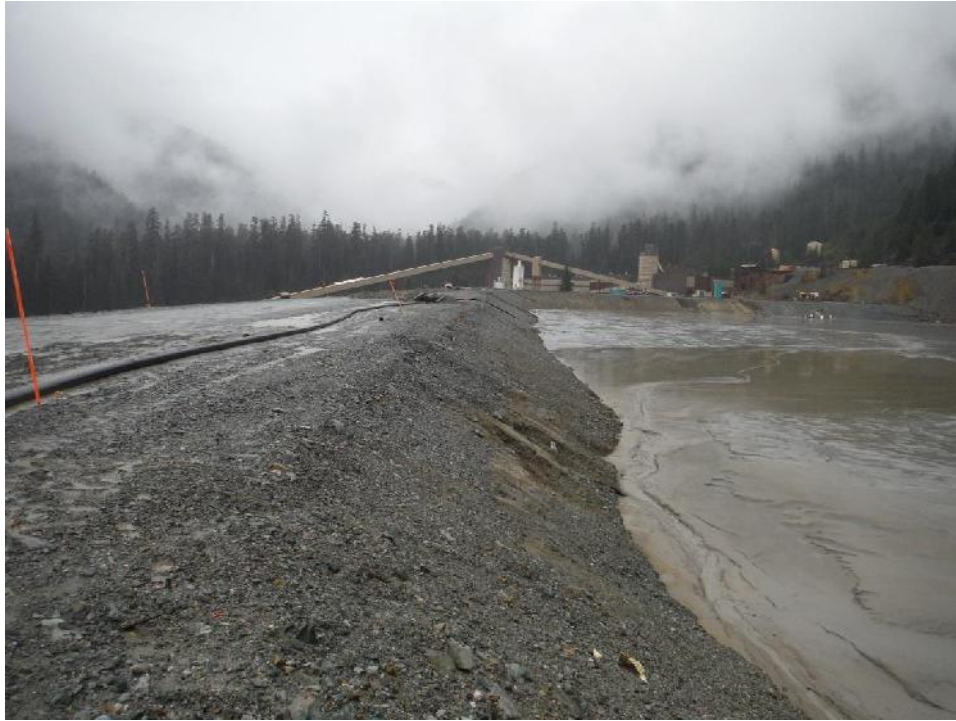
Photo 25 – South arm of Lynx Dam near the east end of the facility showing minor sloughing on upstream face, looking west.

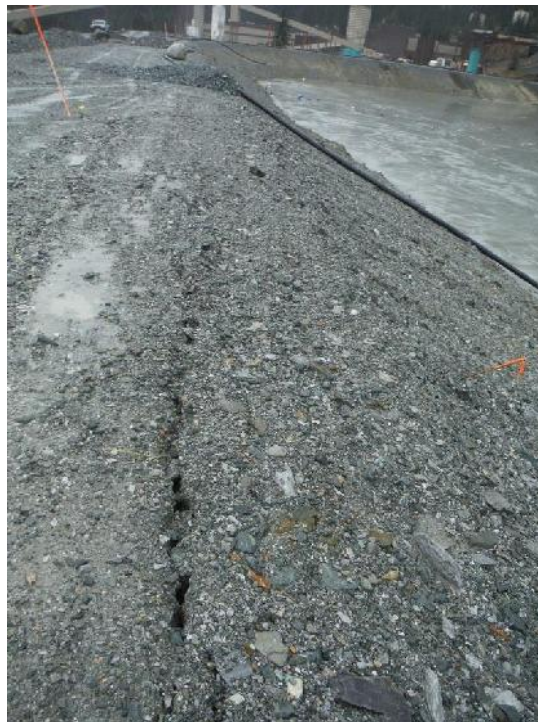
Photo 26 – Tension crack on the south arm downstream crest of Lynx Dam, approx. Sta. 3+50.

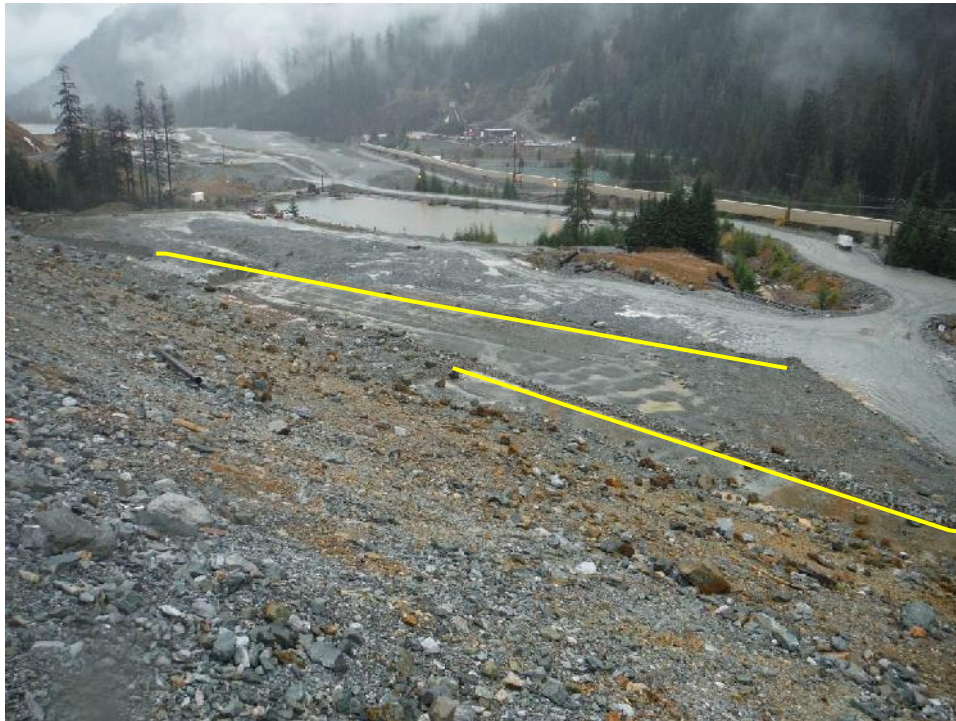
Photo 27 – Lynx Dam south arm lower benches and toe area, looking southeast.

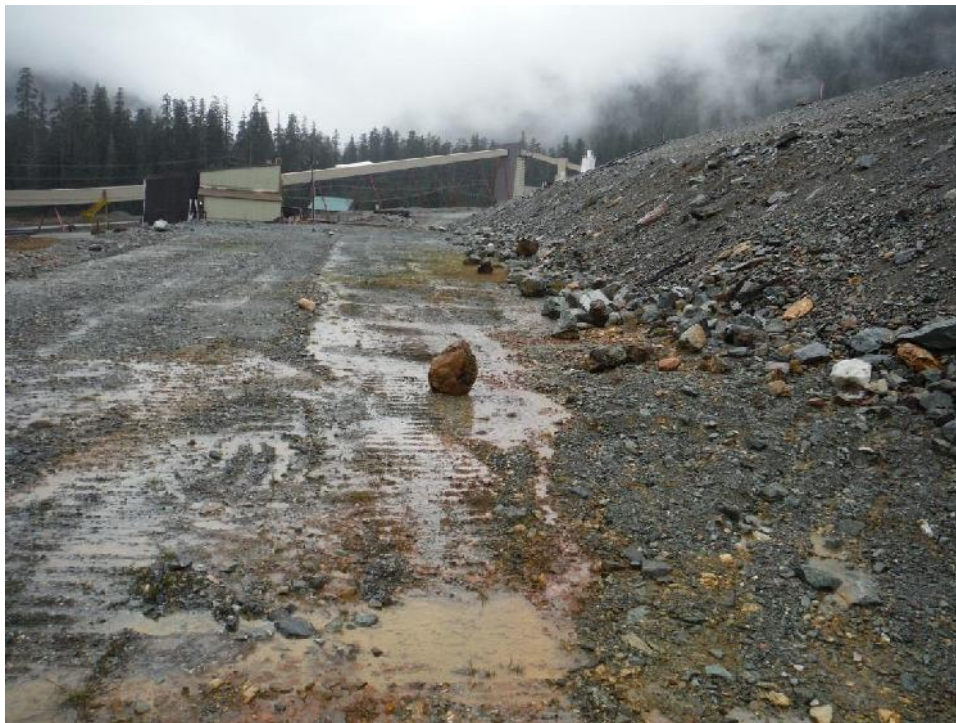
Photo 28 – Seepage on the “2011 Bench” of Lynx Dam, looking west.

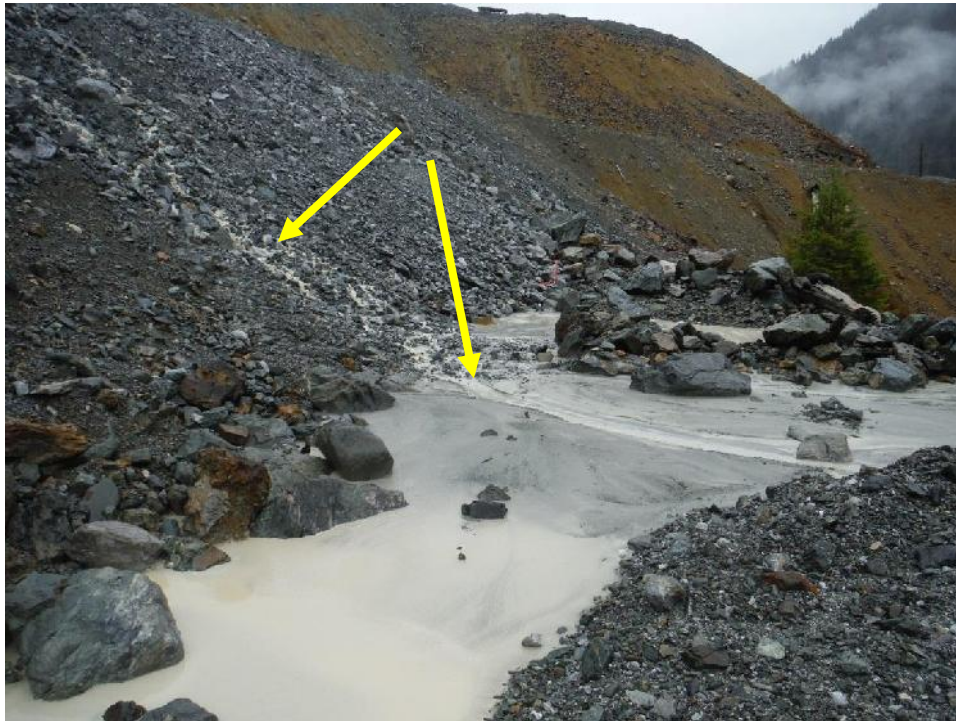
Photo 29 – Runoff on the side of A-Ramp embankment carrying sediments down to dam toe in Phillips Sump area.

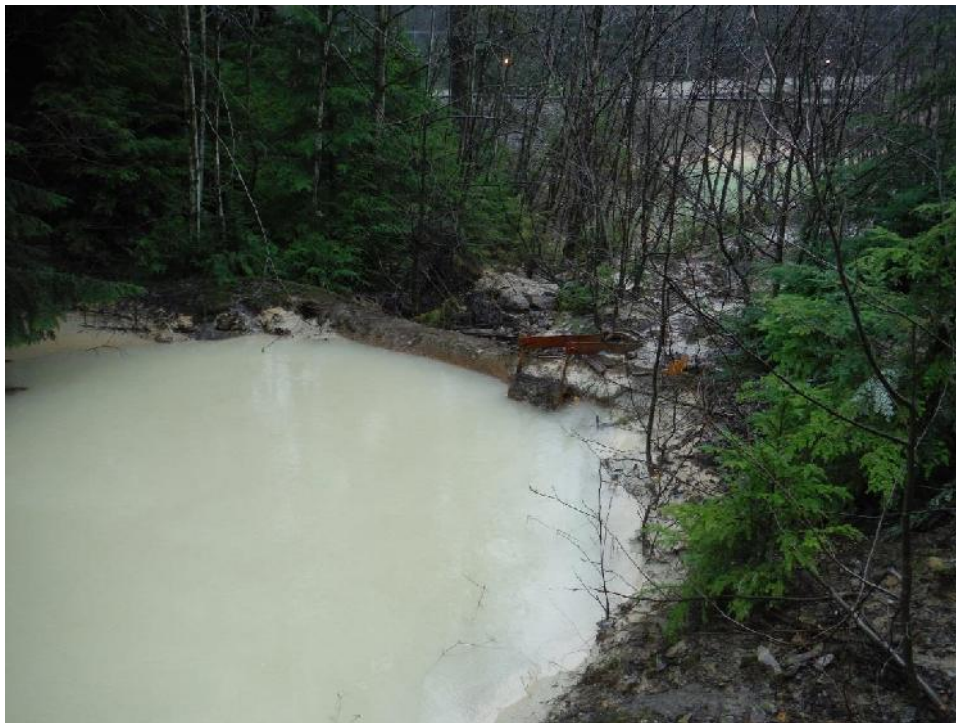
Photo 30 – Phillips Reach sump.

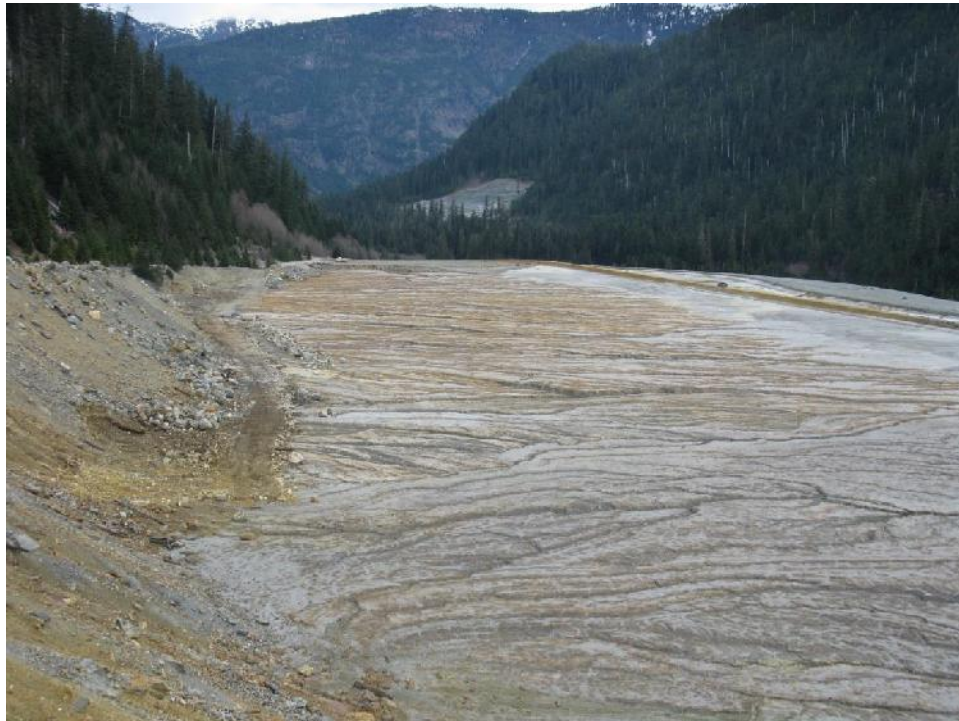
Photo 1 – APA from Waste Dump #6, looking east.

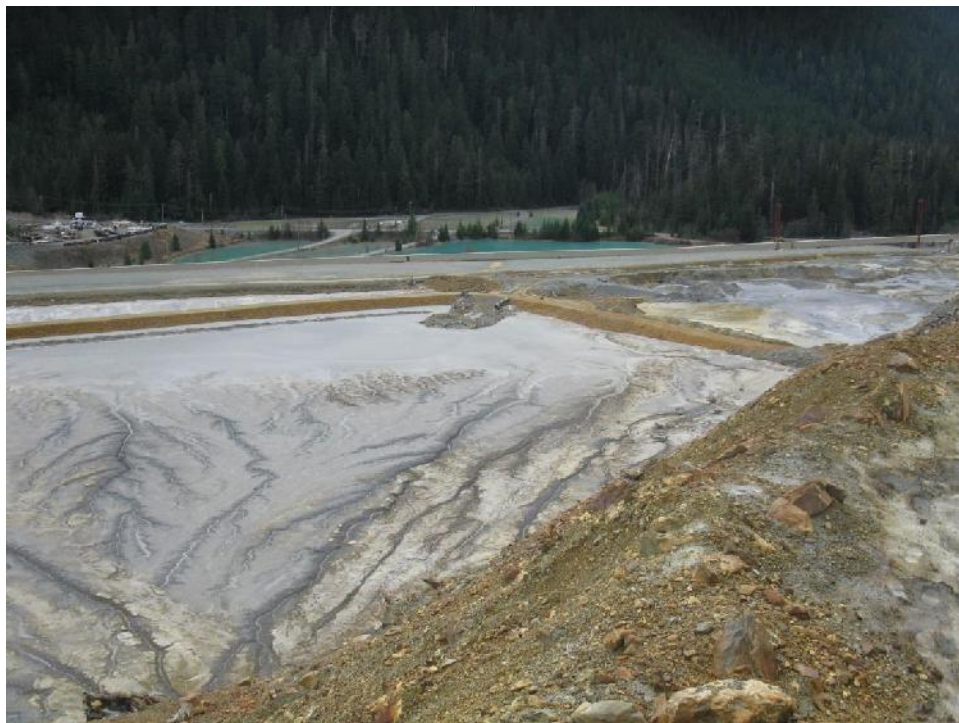
Photo 2 – West side of APA from Waste Dump #6, looking southwest.

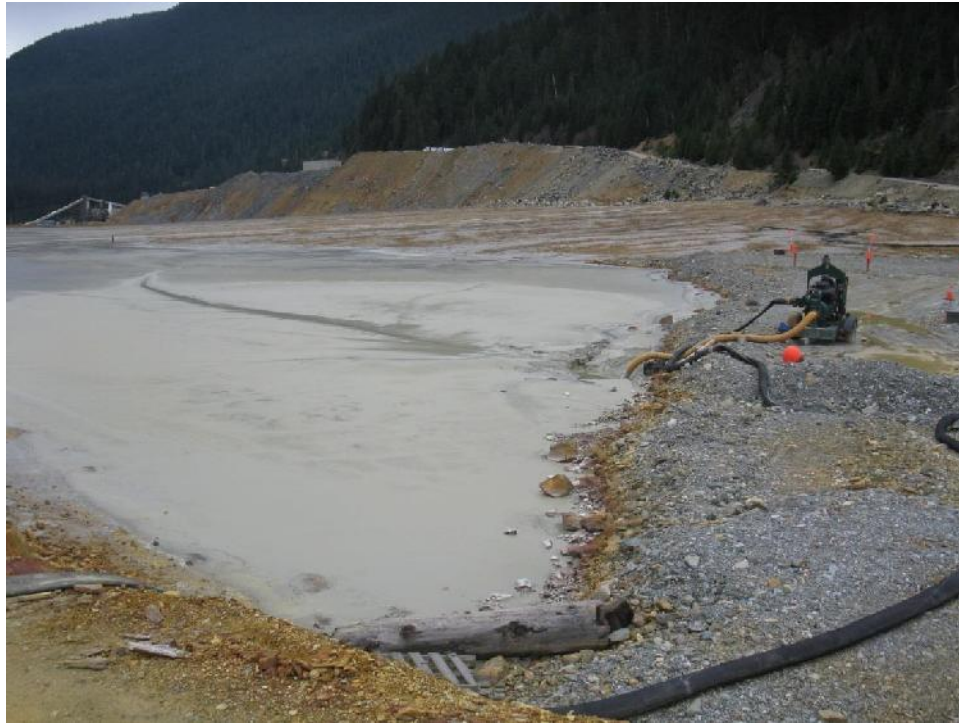
Photo 3 – Southeast corner of APA, looking west/northwest.

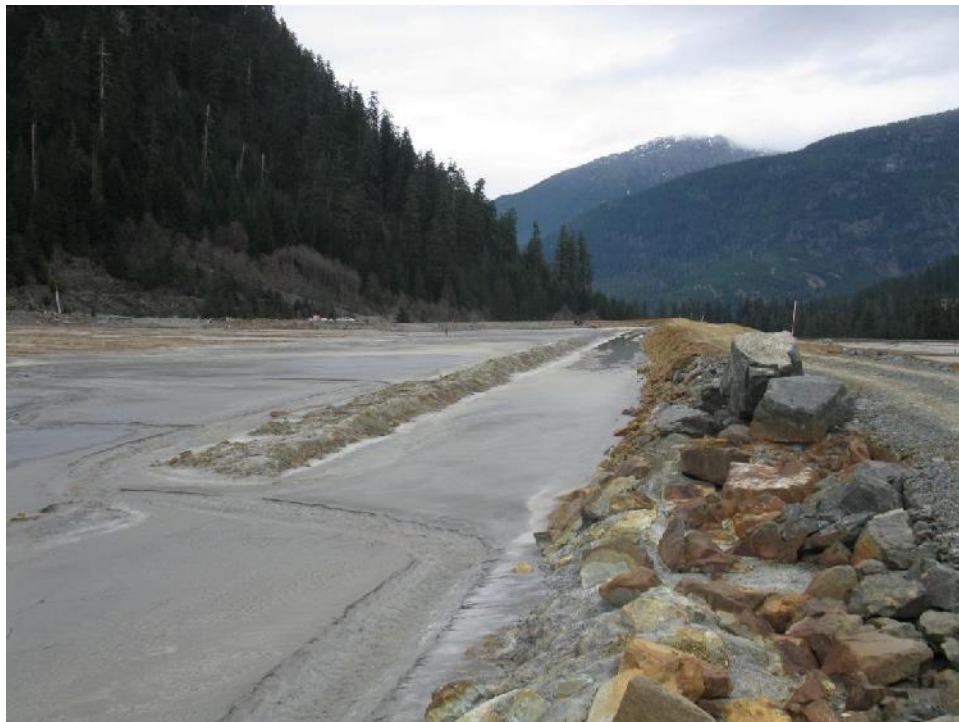
Photo 4 – APA ditch near the Old TDF spillway, looking east.

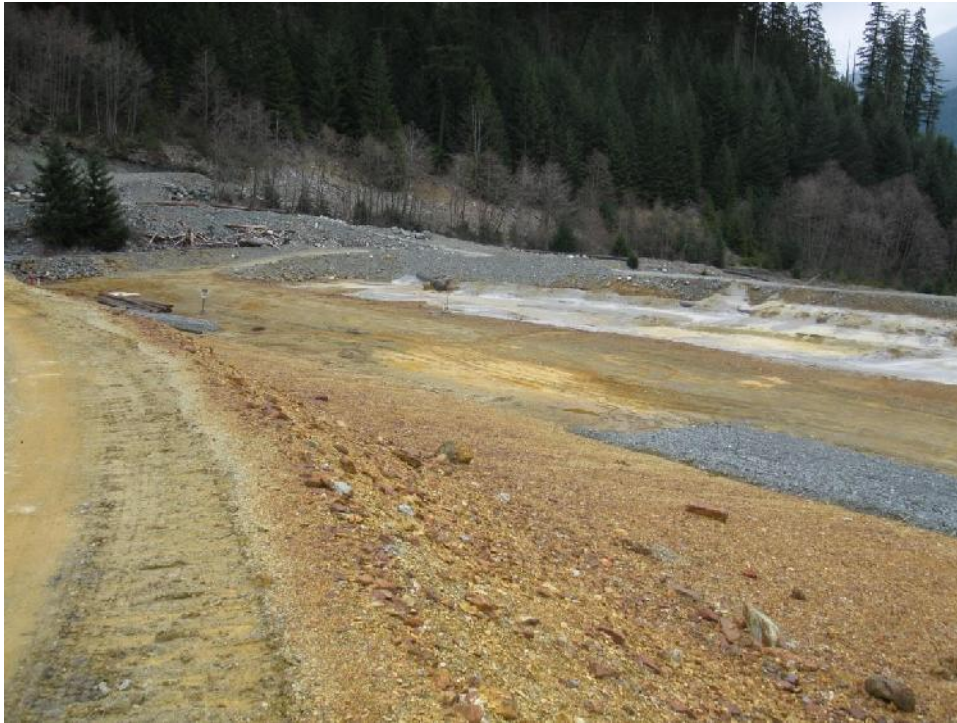
Photo 5 – Paste Berm East Abutment and east end of the East Strip, looking north/northeast.

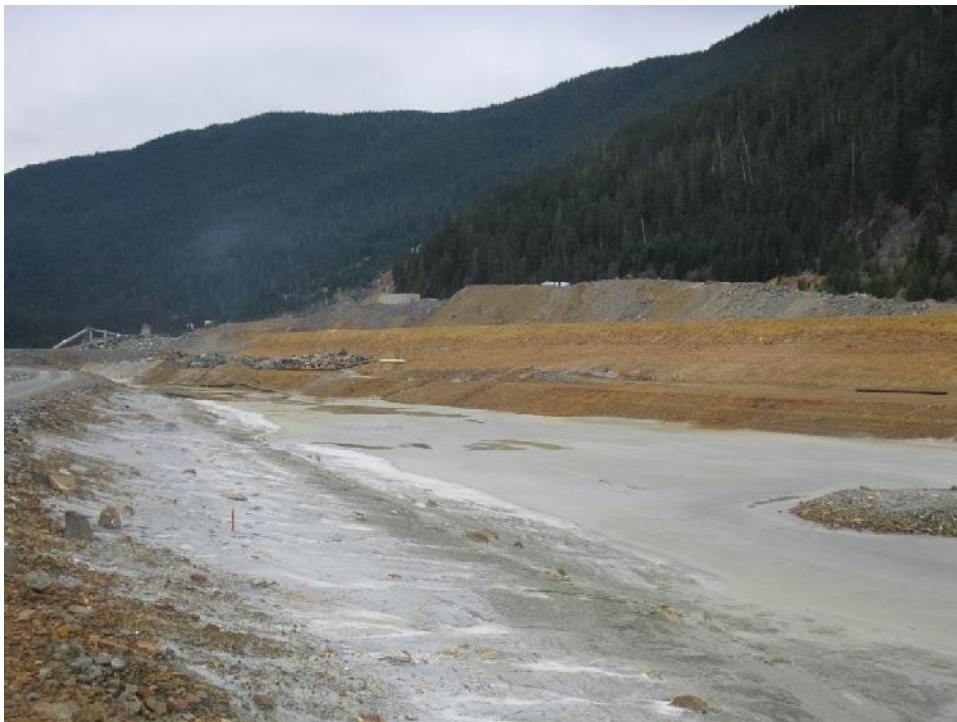
Photo 6 – East Strip, looking west.

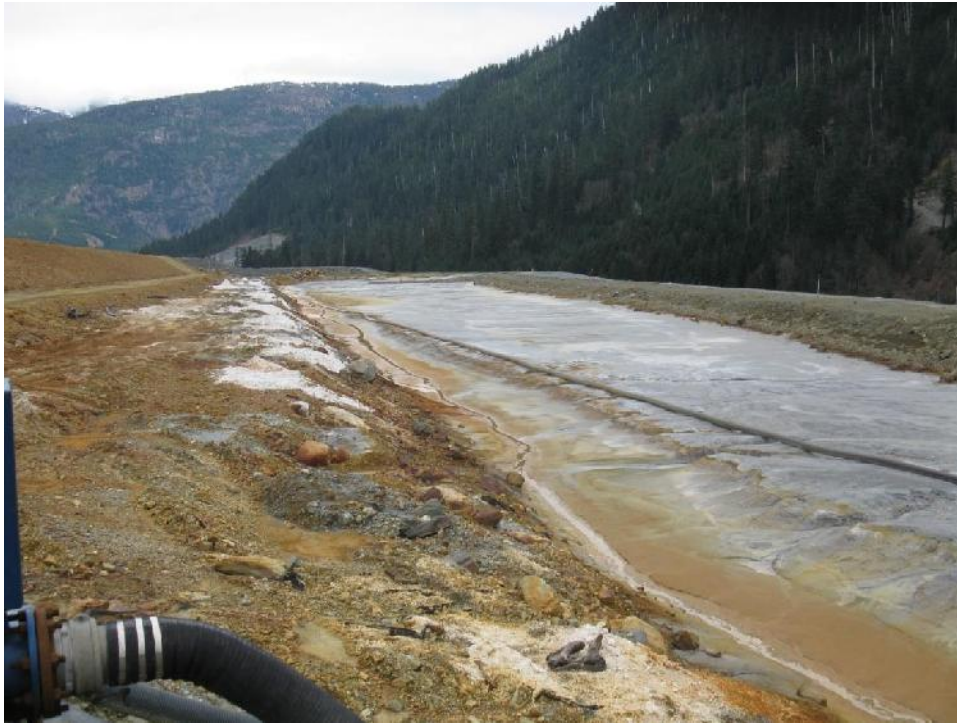
Photo 7 – West Strip, looking east.

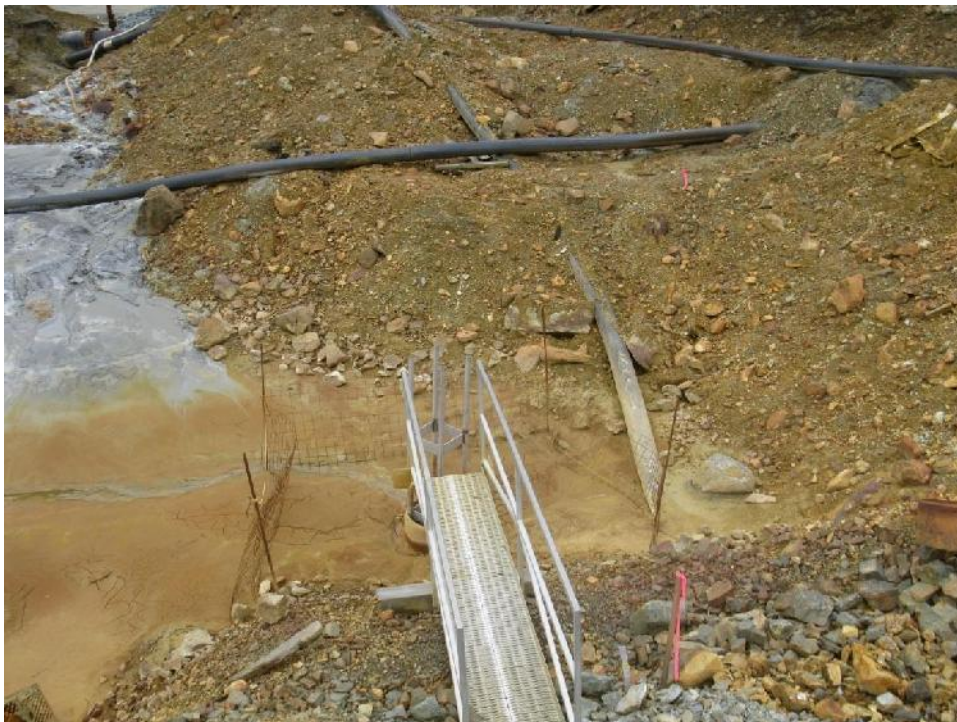
Photo 8 – TDF Strip decant.

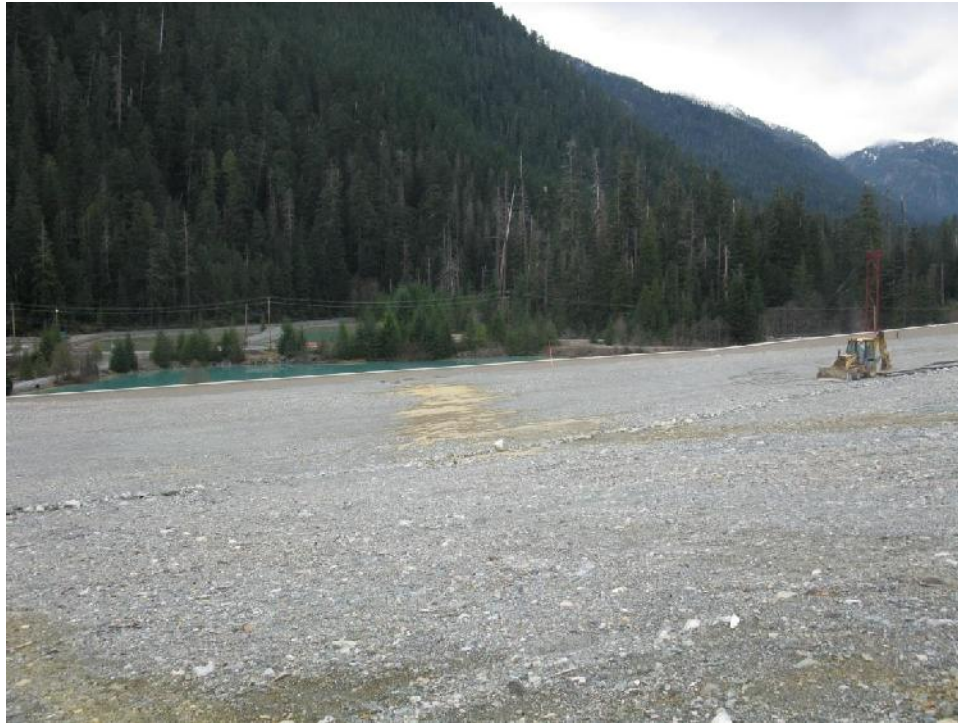
Photo 9 – ARD runoff/seepage at toe of 6:1 Slope and on the Seismic Berm near the access road between the RSA and the Strip.

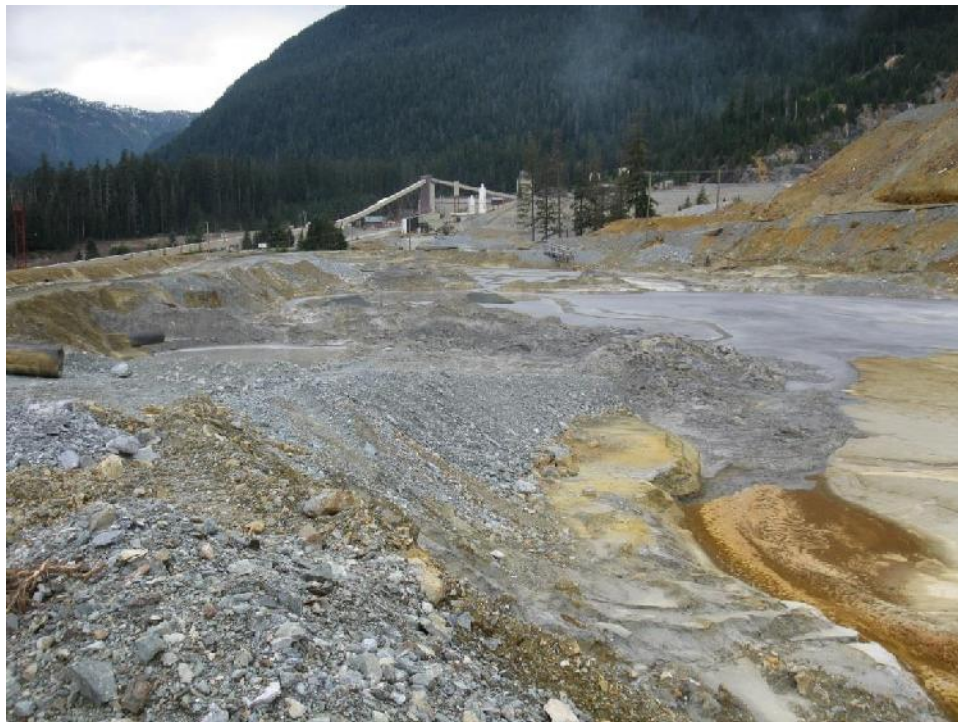
Photo 10 – RSA looking west.

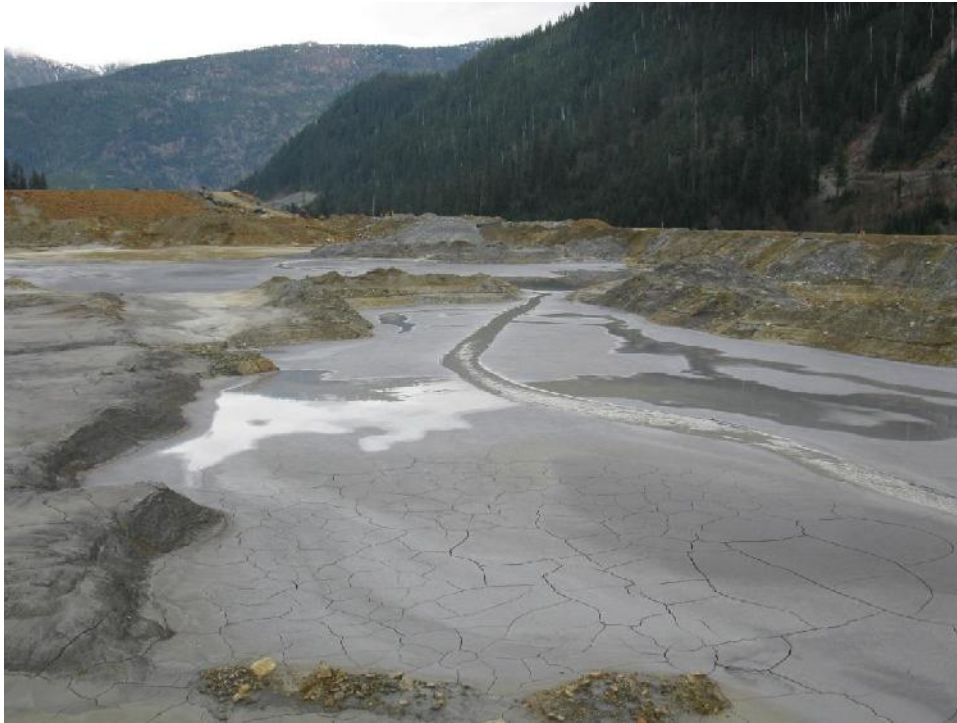
Photo 11 – RSA looking east.

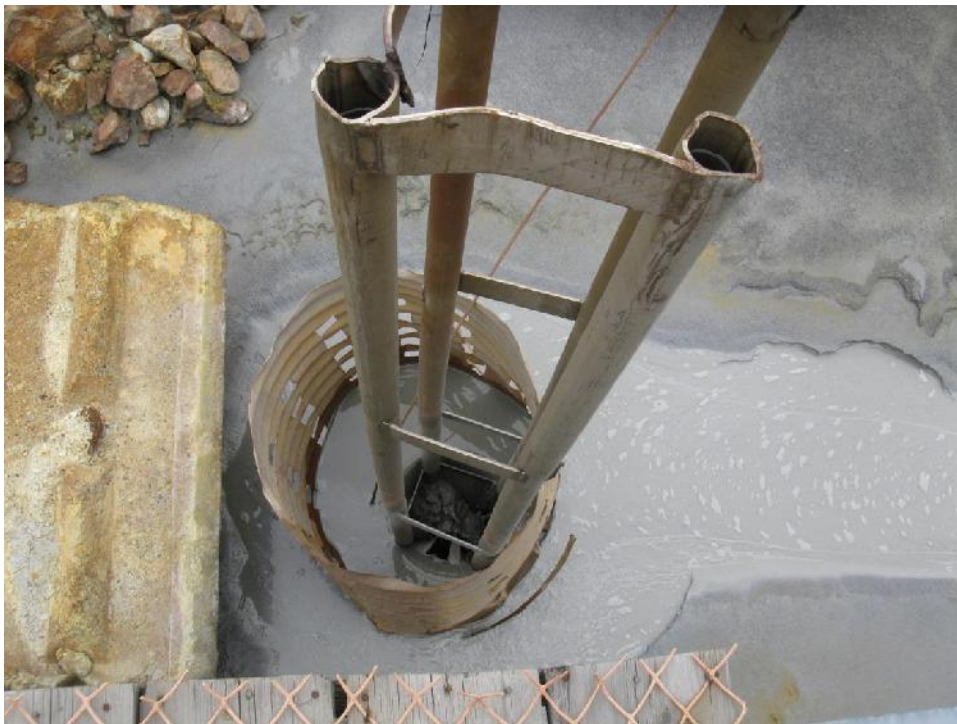
Photo 12 – RSA decant.
