**MYRA FALLS TAILINGS STORAGE FACILITIES
2015 DAM SAFETY INSPECTION REPORT**

31 March 2016

Amec Foster Wheeler File: NX14001B

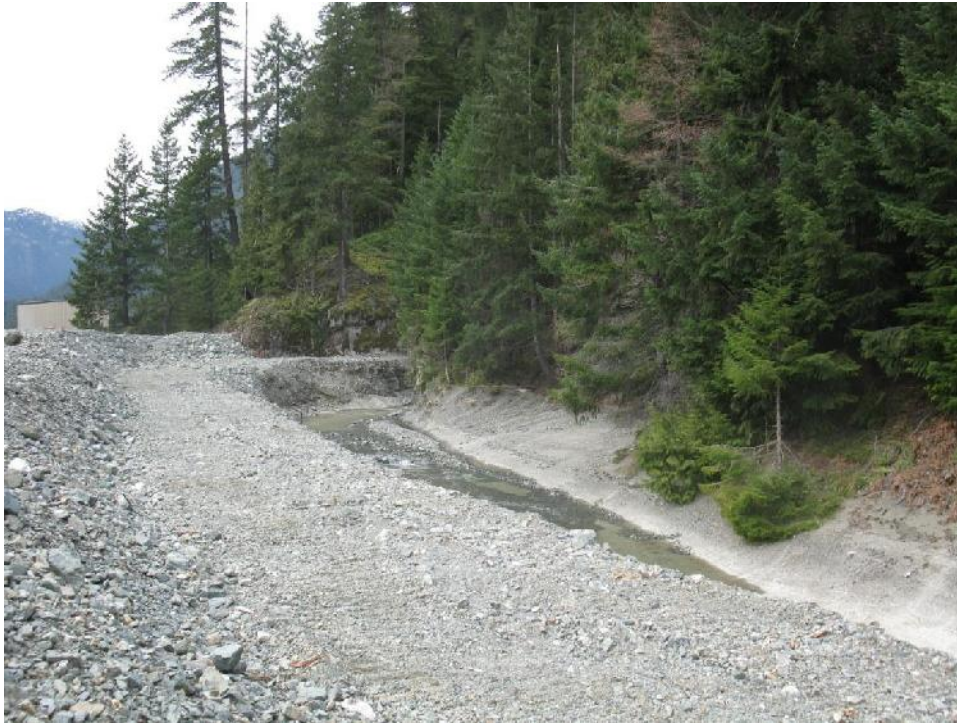
Photo 13 – Lower Lynx Diversion Ditch near Cascade Reach, looking west.

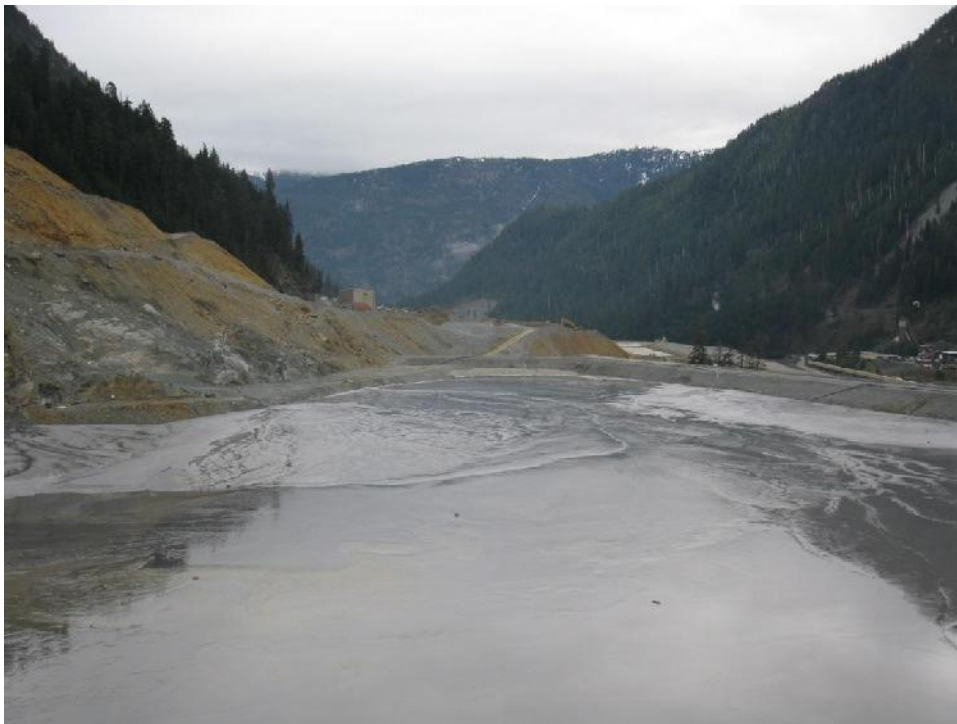
Photo 14 –Lynx TDF, looking east.

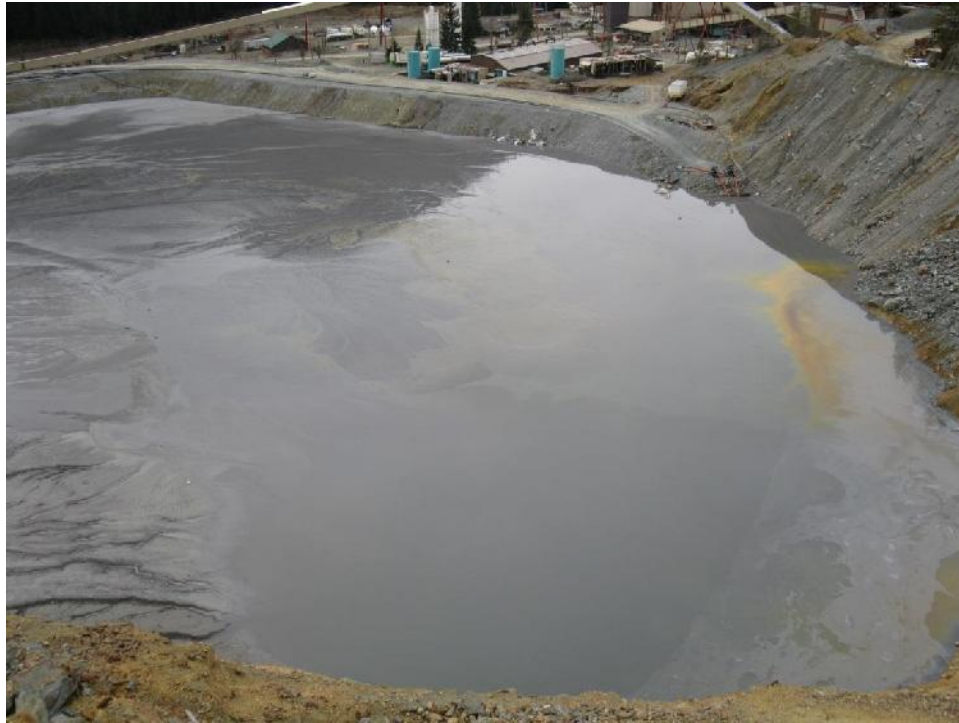
Photo 15 – Overview of Lynx TDF, looking southwest.

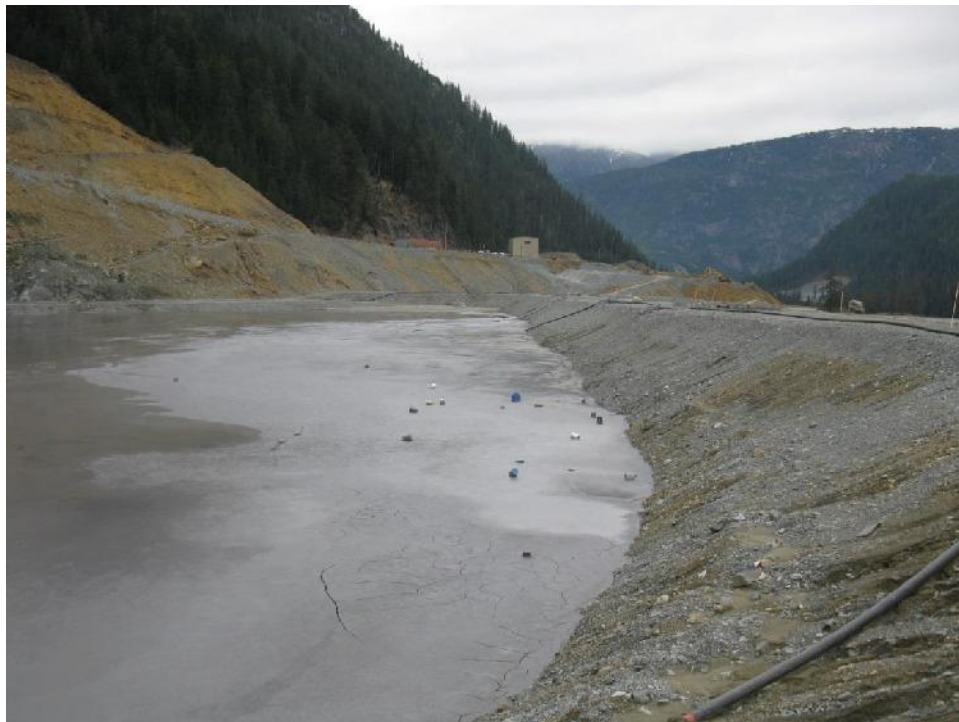
Photo 16 – Upstream face of Lynx Dam south arm, looking east.

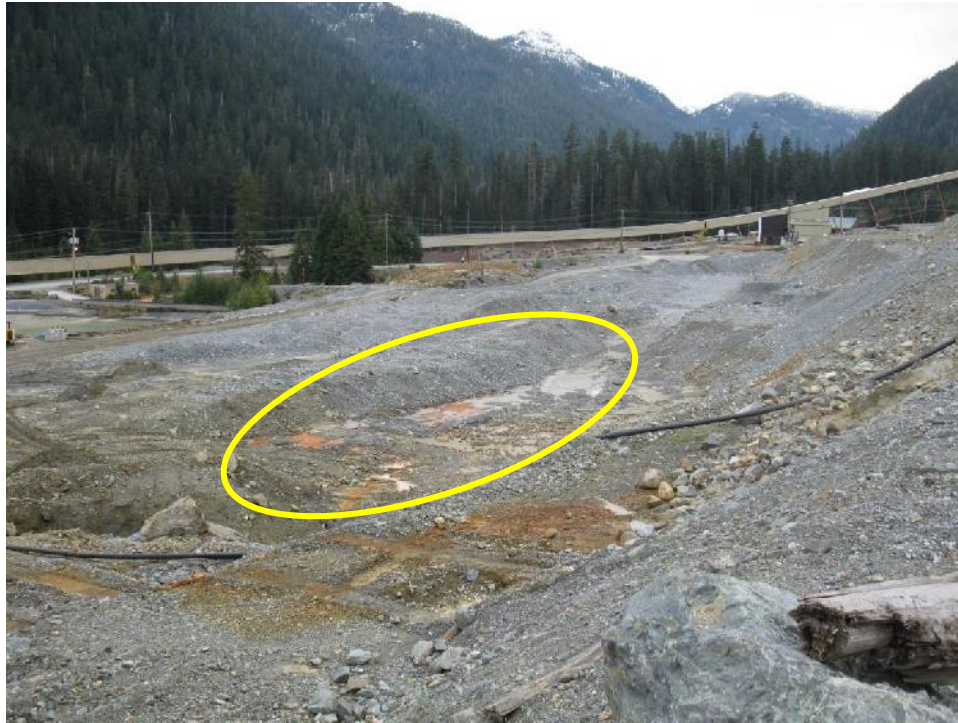
Photo 19 – Lynx Dam south arm east lower benches and toe area, looking west, showing ponding at the toe of the 'Zone J material' stockpile.

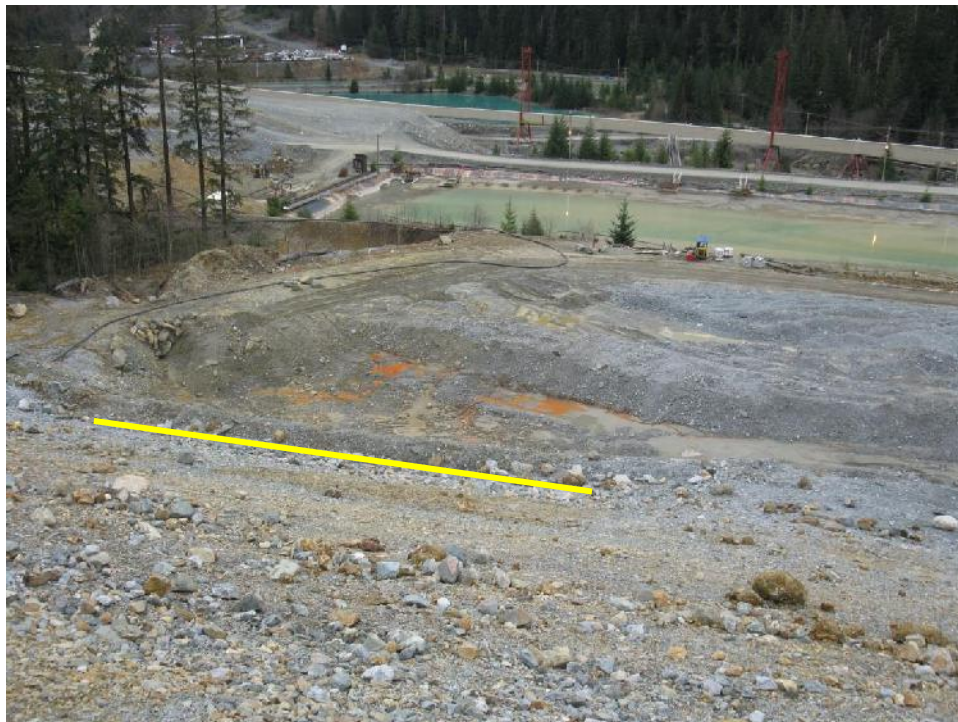
Photo 20 – Lynx Dam south arm east lower benches and toe area, looking south.

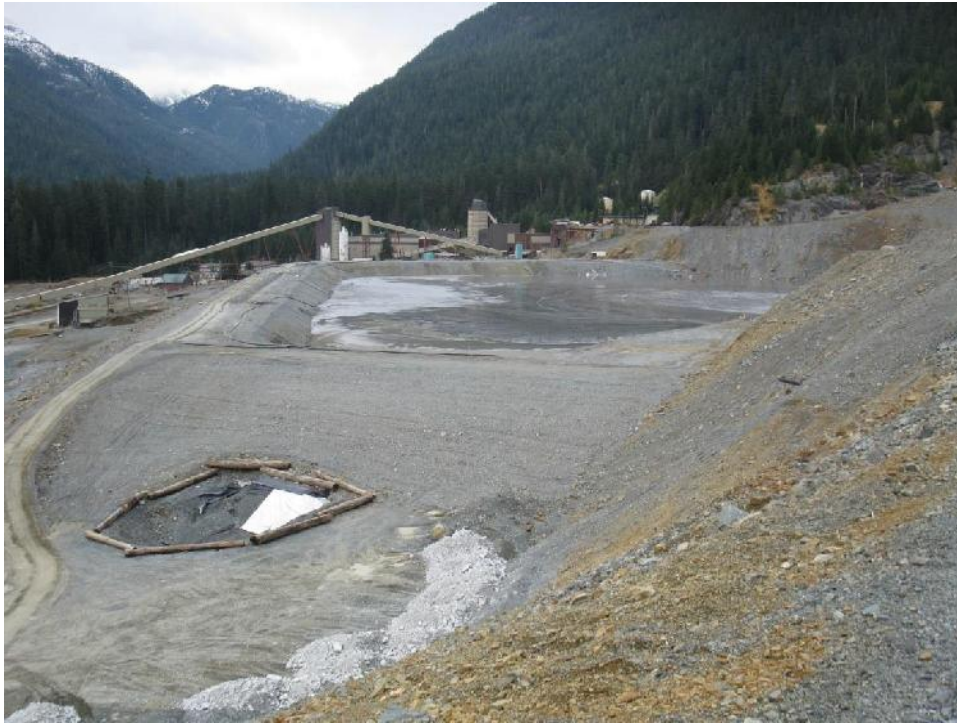
Photo 21 – West view of Lynx TDF.

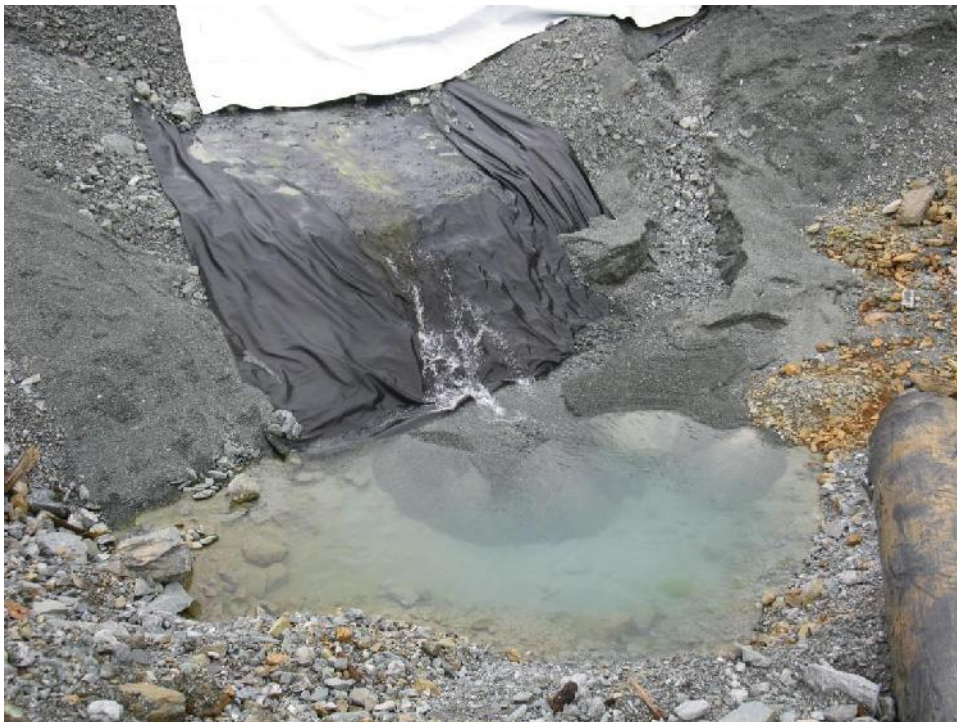
Photo 22 – Lynx Springs Drain outlet.

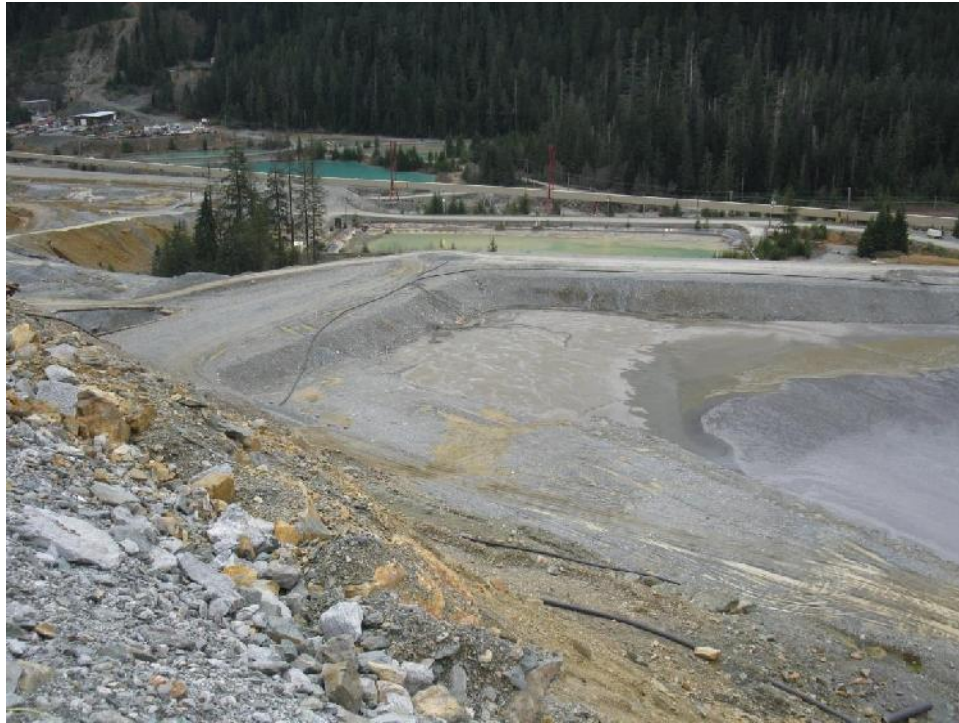
Photo 23 – East portion of Lynx TDF, looking south.

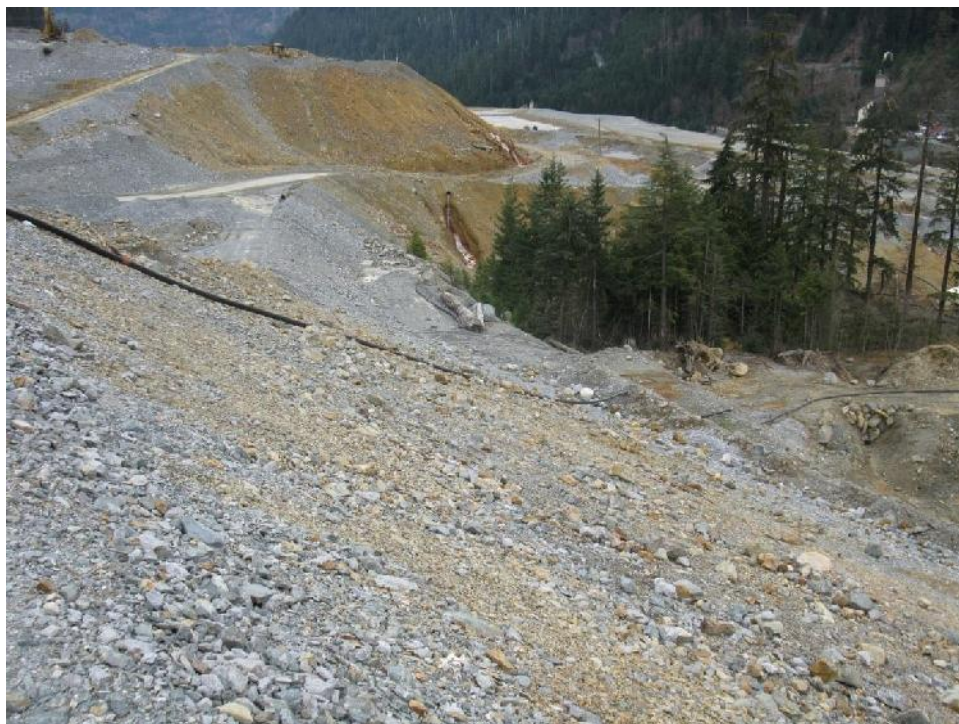
Photo 24 – Lynx Dam east lower benches and Phillips Reach sump area, looking east.

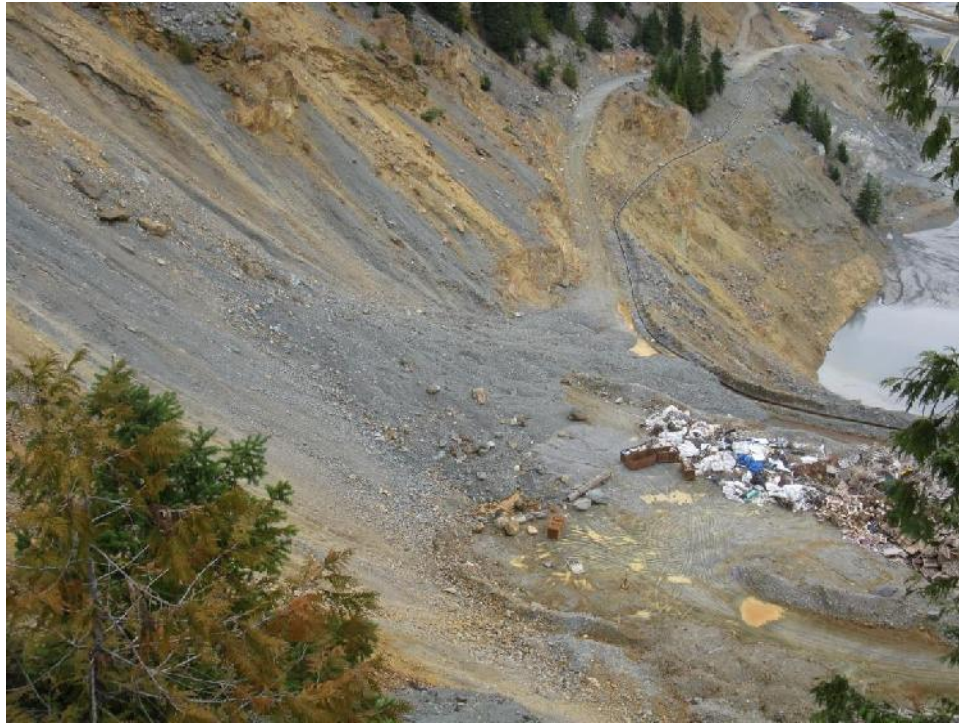
Photo 25 – Base of Lynx Pit Slide area, looking east.

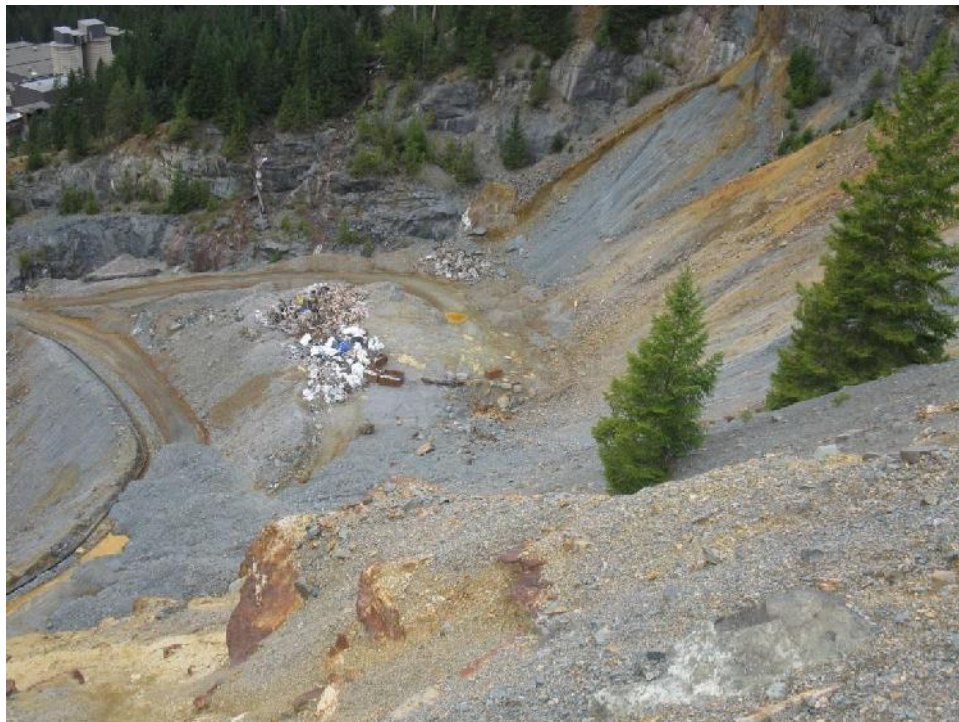
Photo 26 – Lynx Pit Slide area, looking west.

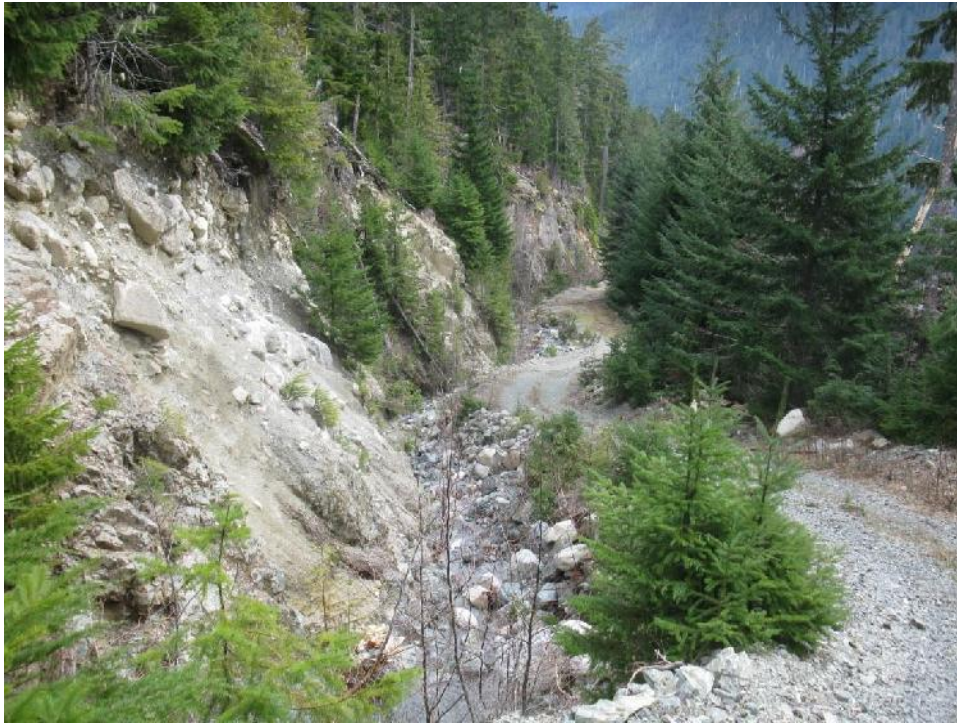
Photo 27 – Upper Lynx Diversion Ditch, looking east.

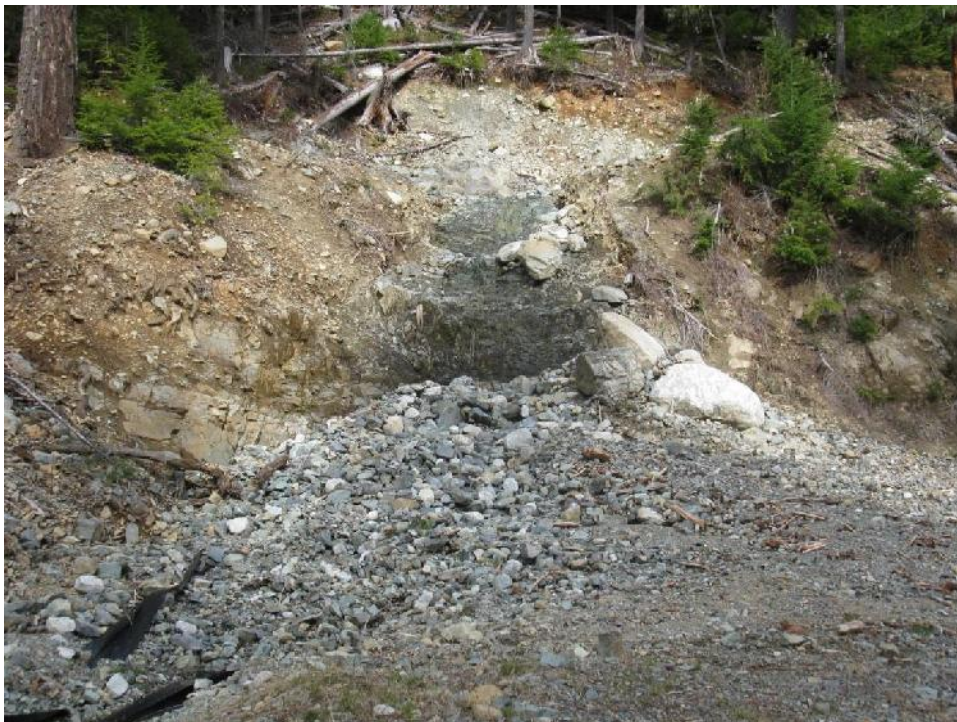
Photo 28 – Junction of Arnica and Upper Lynx Diversion Ditches.

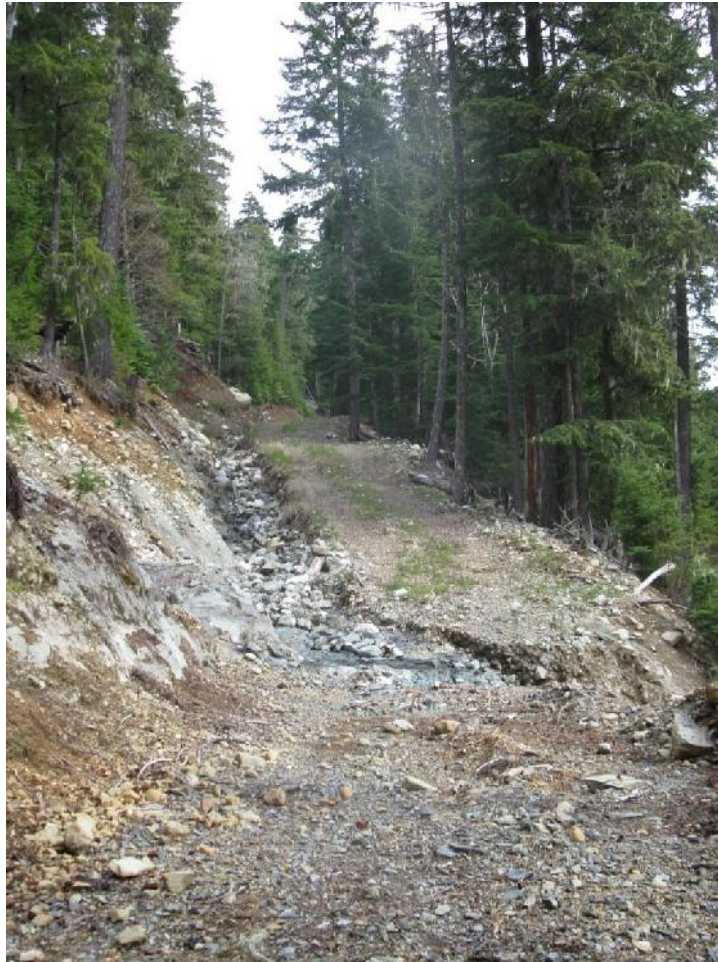
Photo 29 – Arnica Diversion Ditch looking east from Arnica – Upper Lynx Diversion Ditch junction.

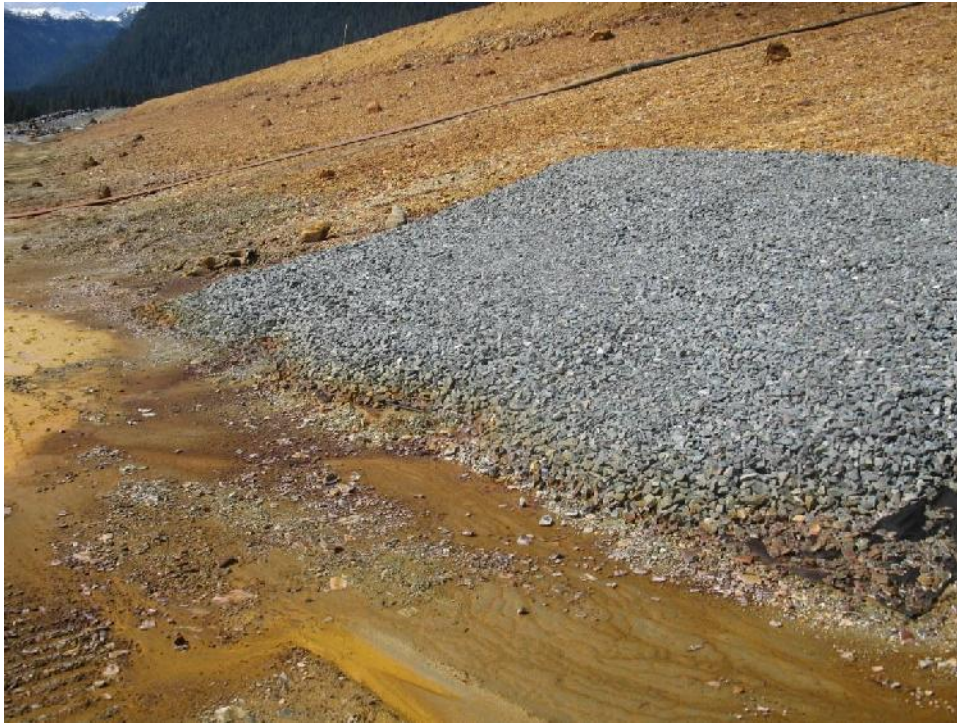
Photo 5 – ARD seepage at the base of the Paste Berm near Instrument Plane C, showing one of the clean rock pads built to prevent piping erosion.

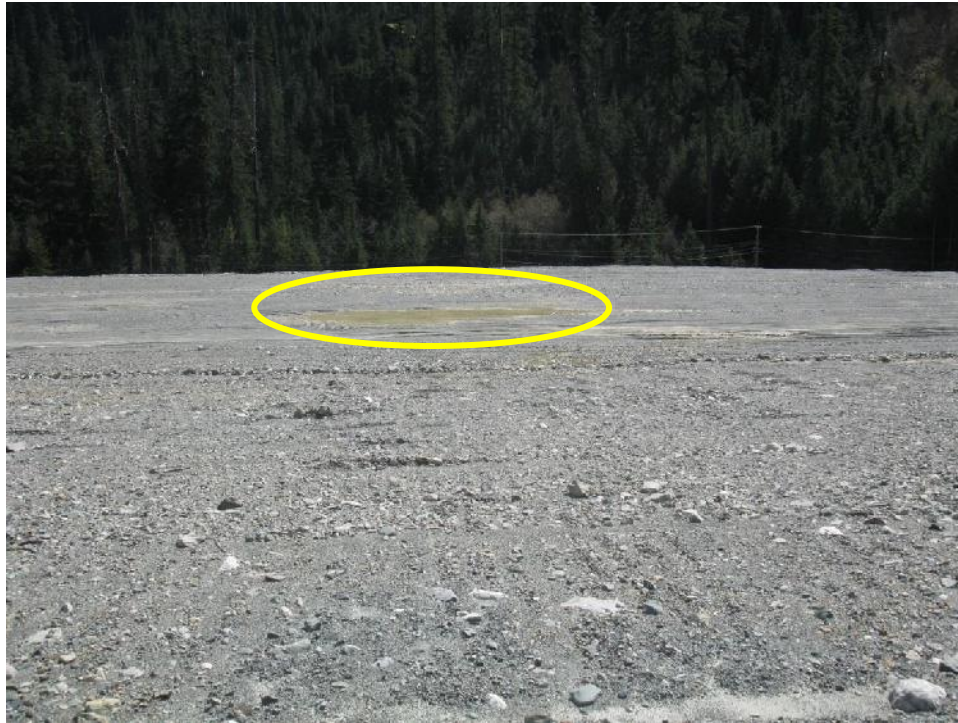
Photo 11 – ARD puddle at toe of 6:1 Slope near Instrument Plane C, looking south.

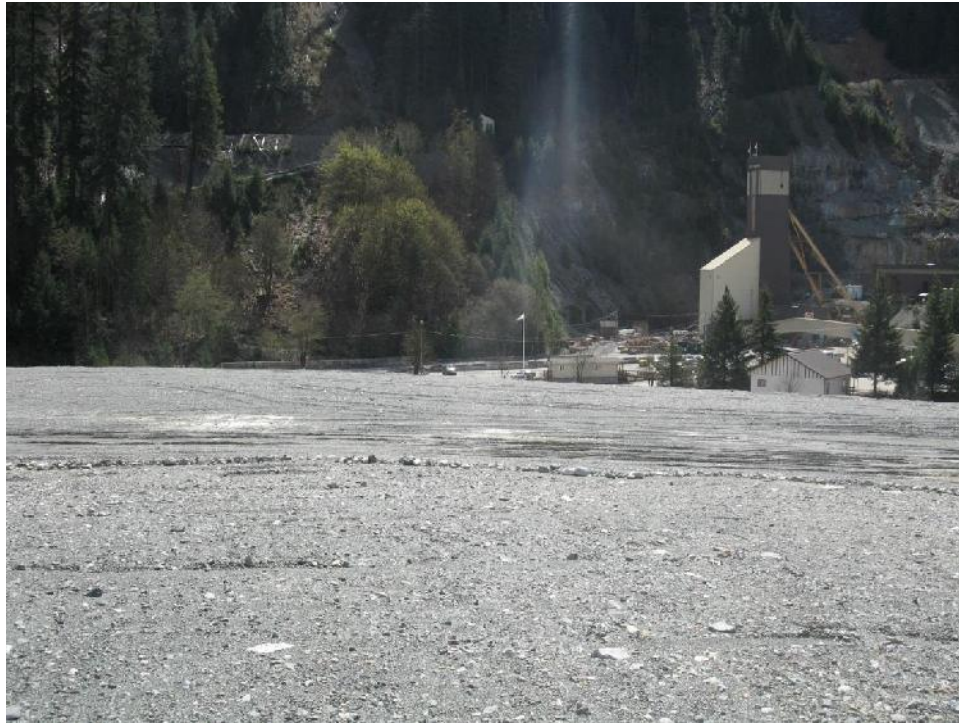
Photo 13 – Puddles and rutting on Seismic Berm ~ Sta. 0+700, looking south.

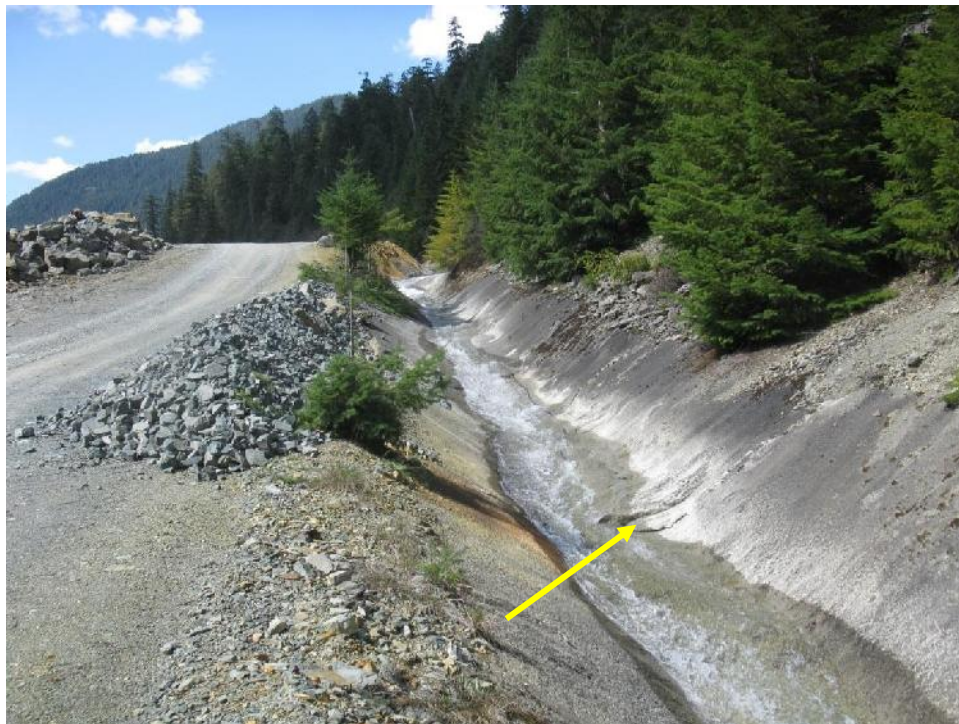
Photo 16 – Hole in Lower Lynx Diversion Ditch shotcrete liner.

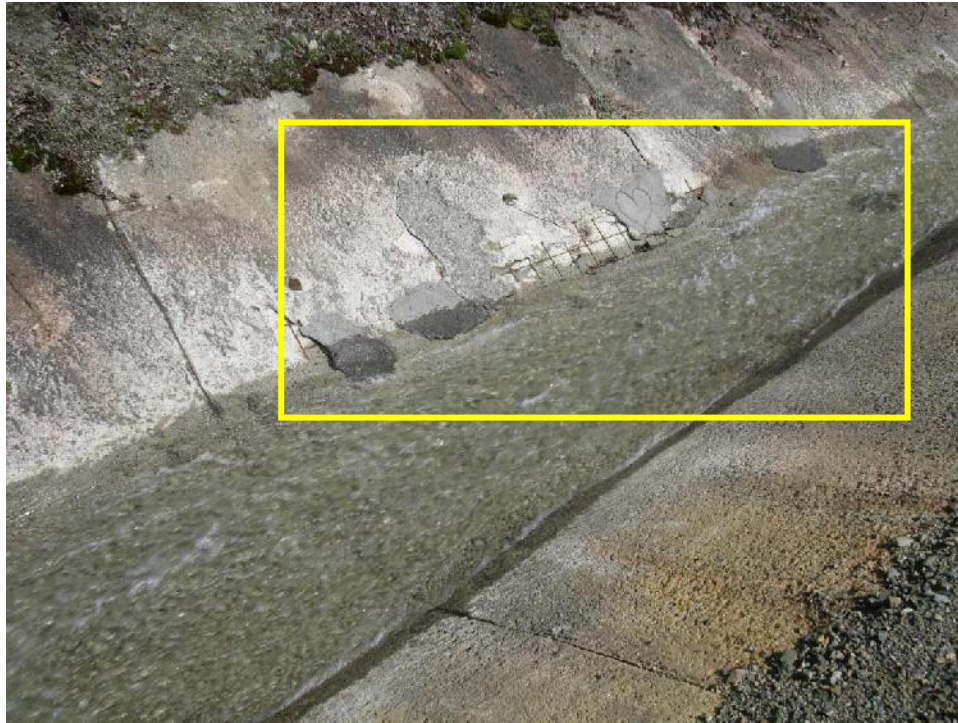
Photo 17 – Patches, exposed rebar and holes in Lower Lynx Diversion Ditch shotcrete liner.

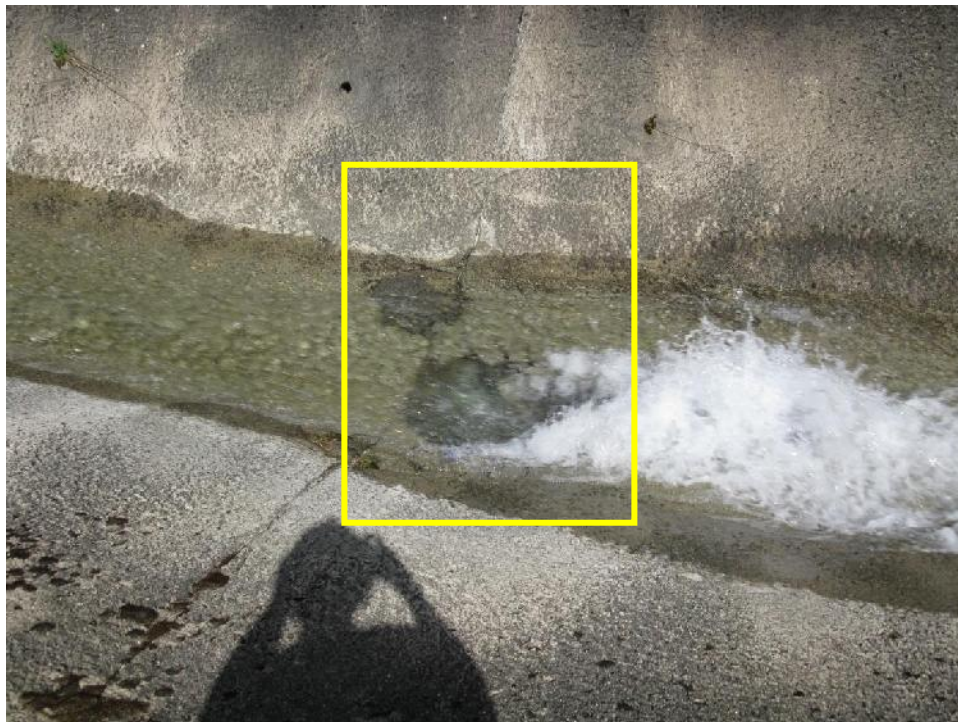
Photo 18 – Hole in Lower Lynx Diversion Ditch shotcrete liner.

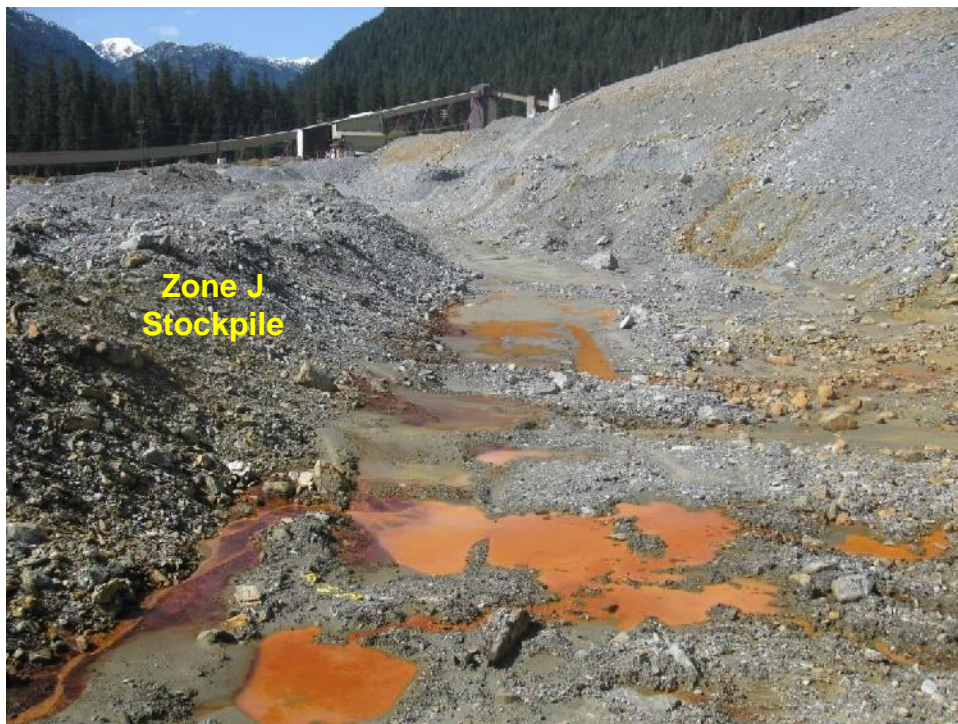
- Zone J stockpile at the toe of Lynx Dam still not graded to drain, resulting in continued seepage from stockpile material.
- Puddles at dam toe from stockpile seepage but no seepage from the dam. No surface outflow from toe area (implies infiltration).

Photo 24 – East portion of Lynx dam south arm toe area with ARD water accumulation (most seepage coming from the “Zone J” material stockpile), looking west.

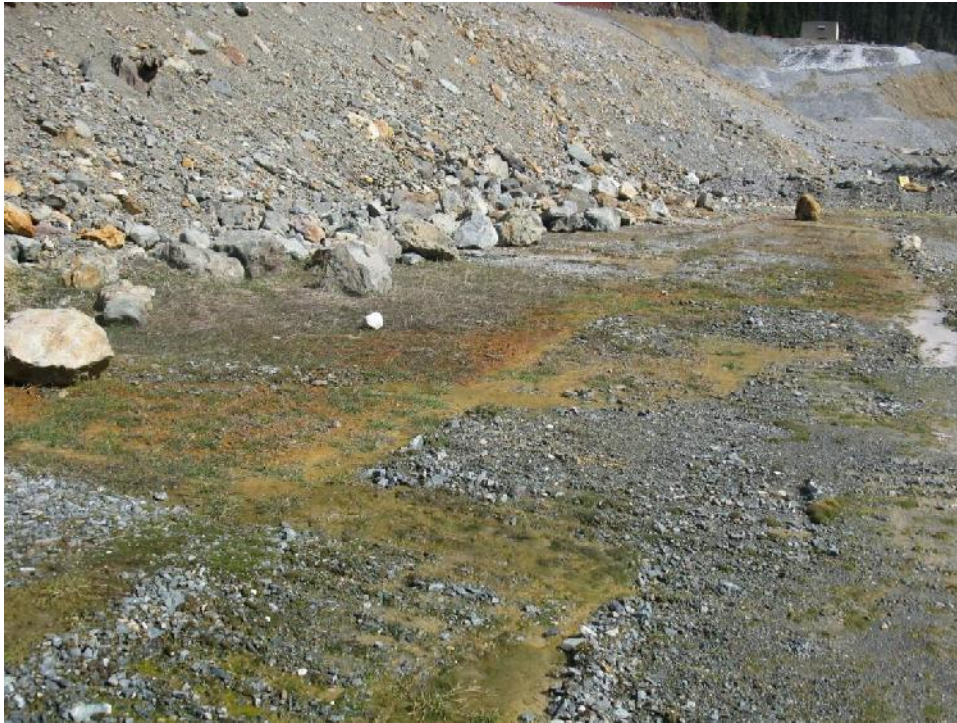
Photo 25 – Seepage and mossy area on the surface of Lynx Dam lower “2011 Bench” ~ Sta. 4+00, looking east/northeast.

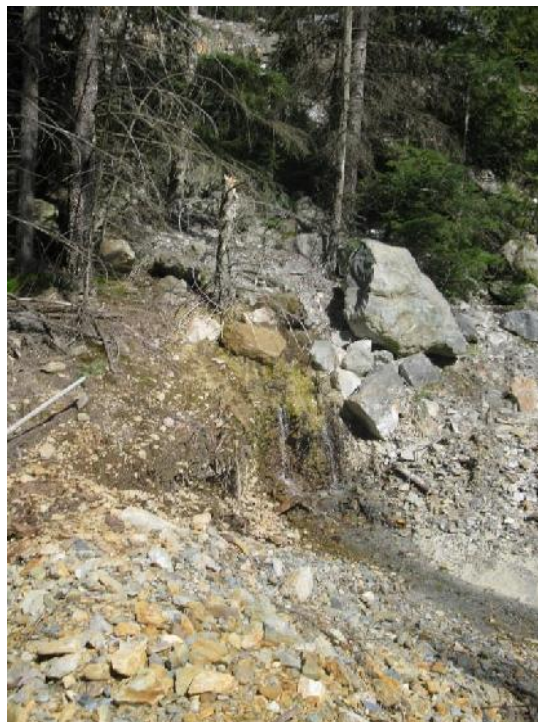
Photo 26 – One of Phillips Reach sump springs.

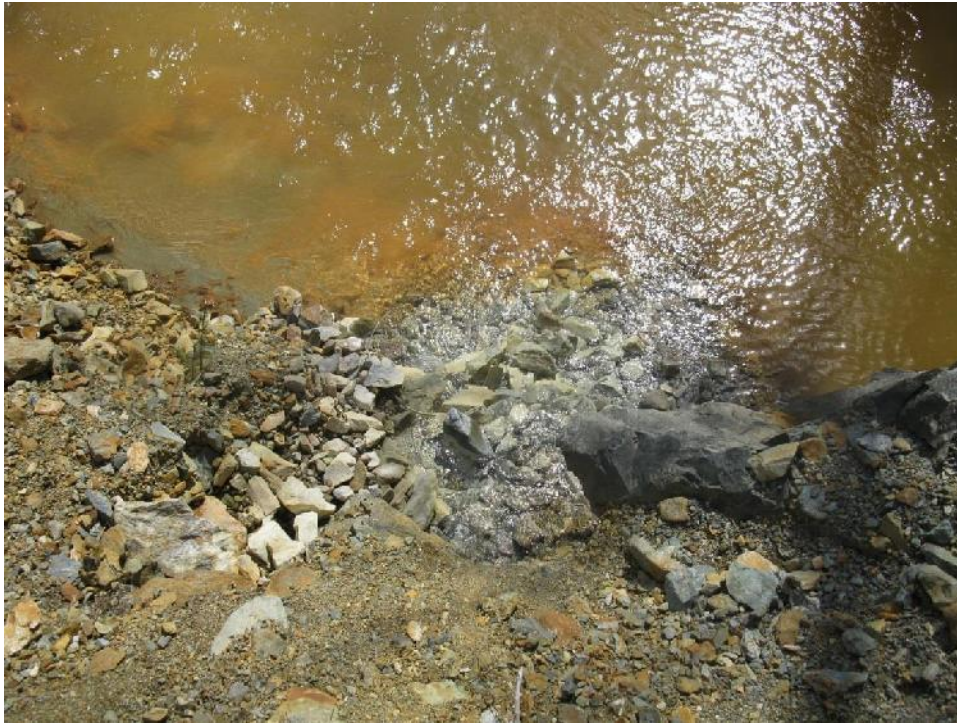
Photo 27 – Another one of Phillips Reach sump springs entering the pond.

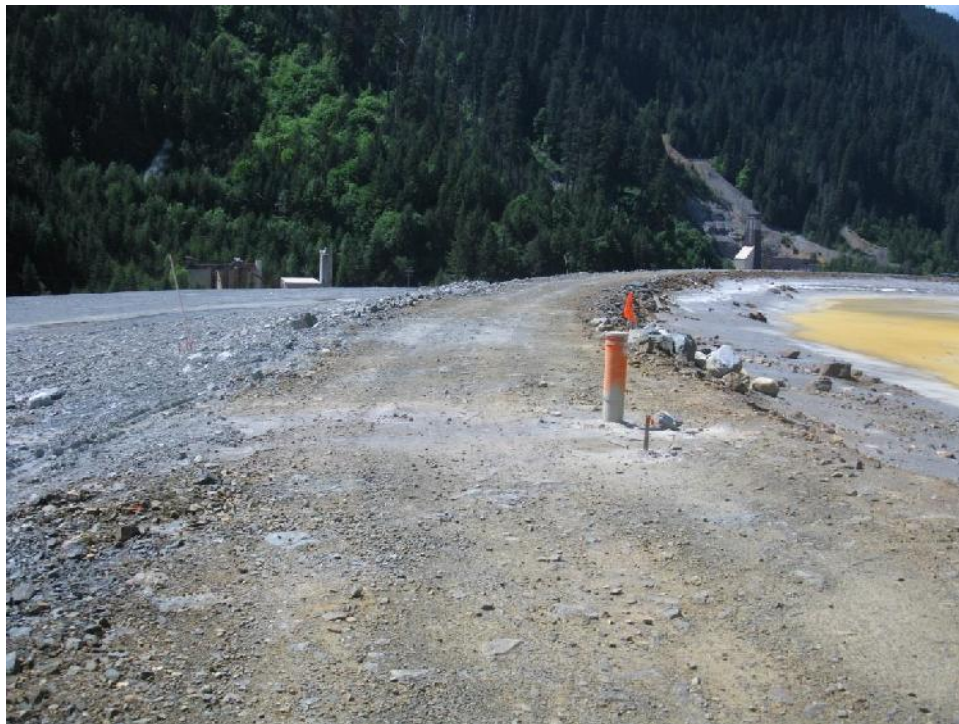
Photo 6 – Piezometer datalogger enclosure on the OEB road, looking south/southwest. This enclosure needs to be moved to the left of the road, down the 6:1 slope.

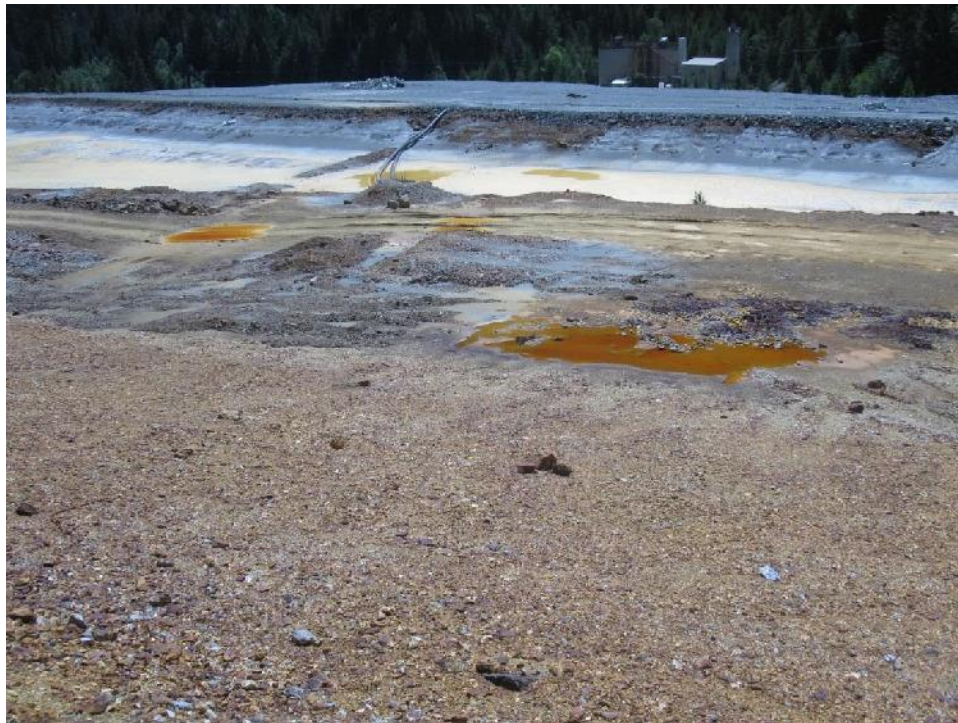
Photo 7 – ARD seepage at the toe of the Paste Berm near Instrument Plane 4, looking south. East Strip in the background.

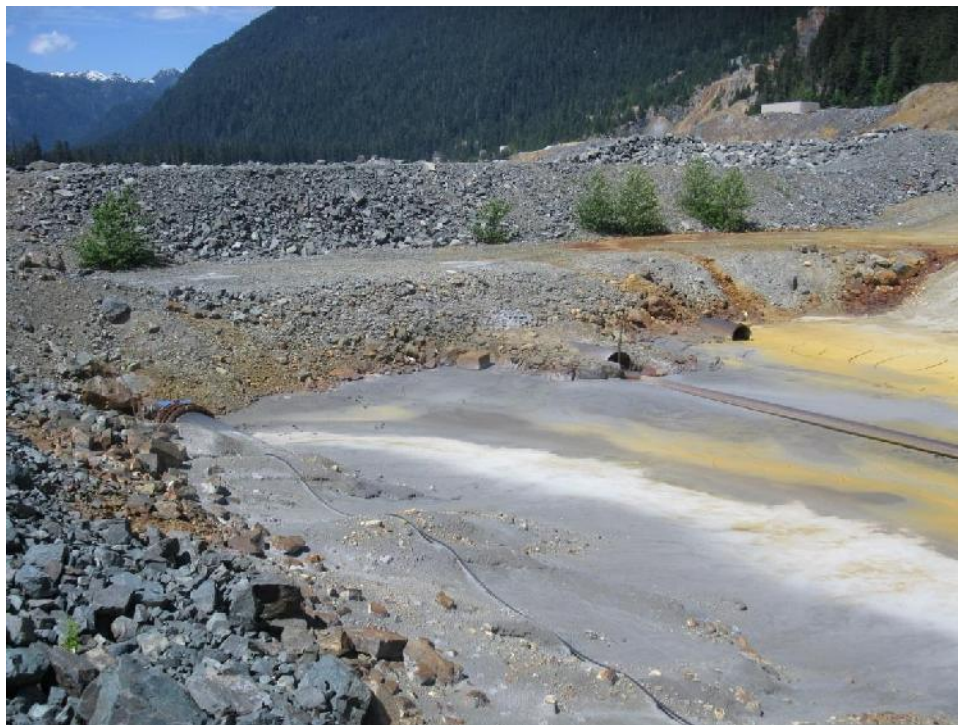
Photo 8 – Culverts going under the Old TDF spillway at the west end of the East Strip, looking west/northwest.

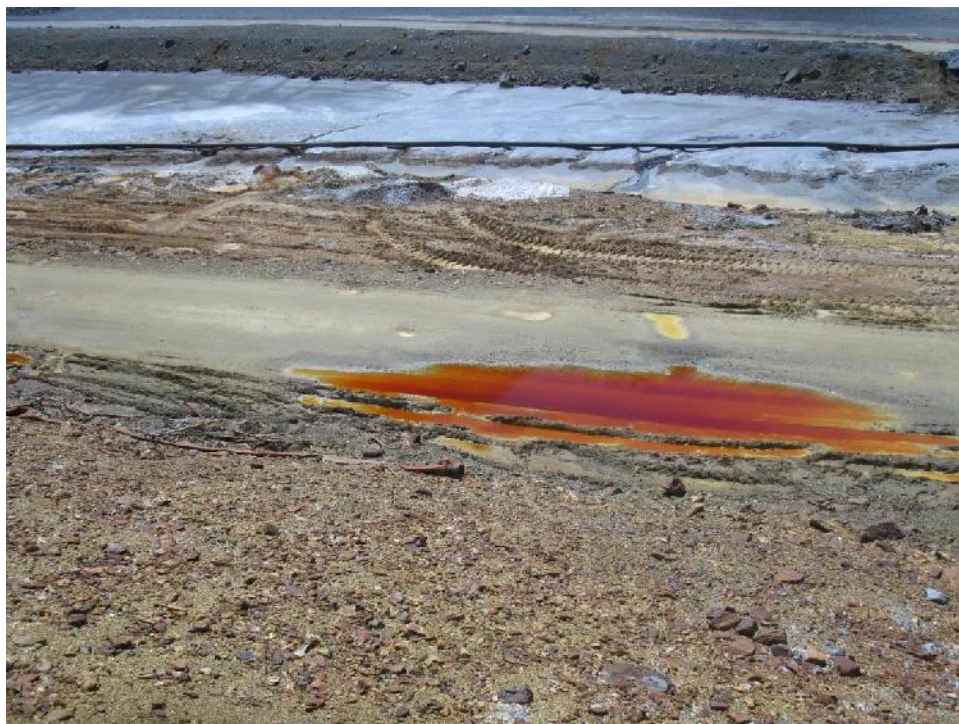
Photo 10 – ARD seepage at the toe of the Paste Berm near the Strip decant location (Strip decant is to the right).

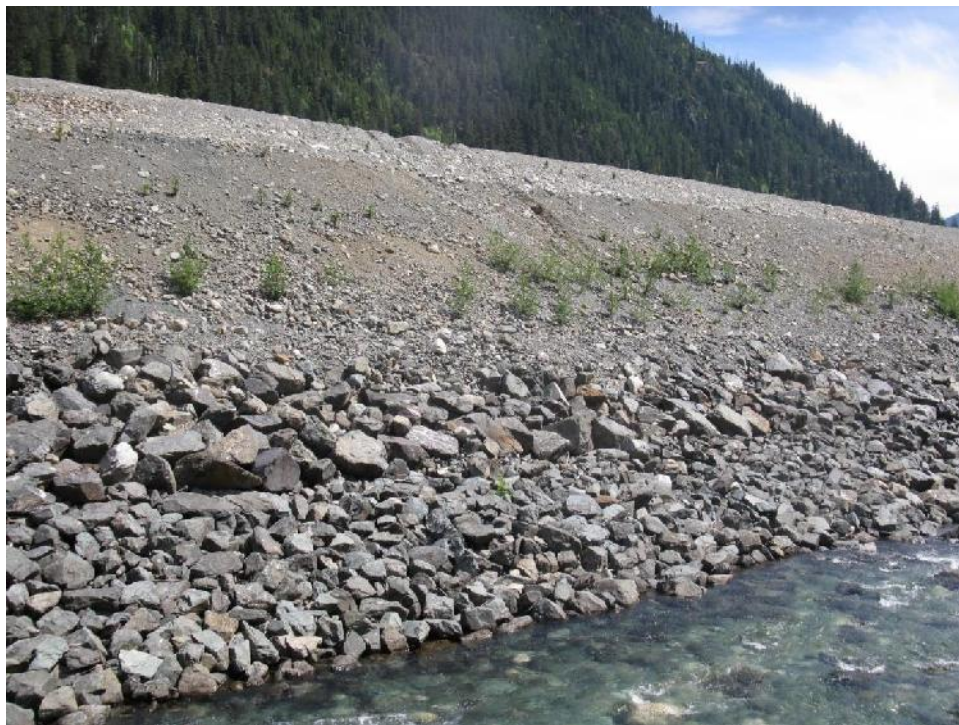
Photo 16 – Series of erosion rills on the Seismic Berm downstream face.

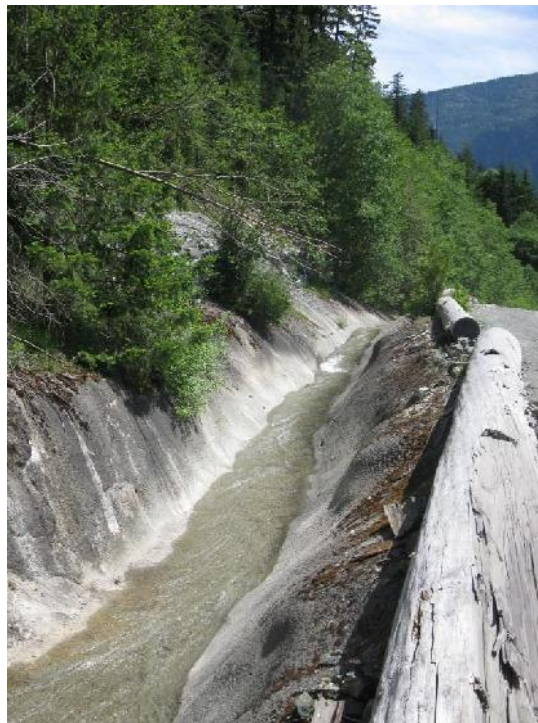
Photo 18 – Low flow into Lower Lynx Diversion Channel, looking east.

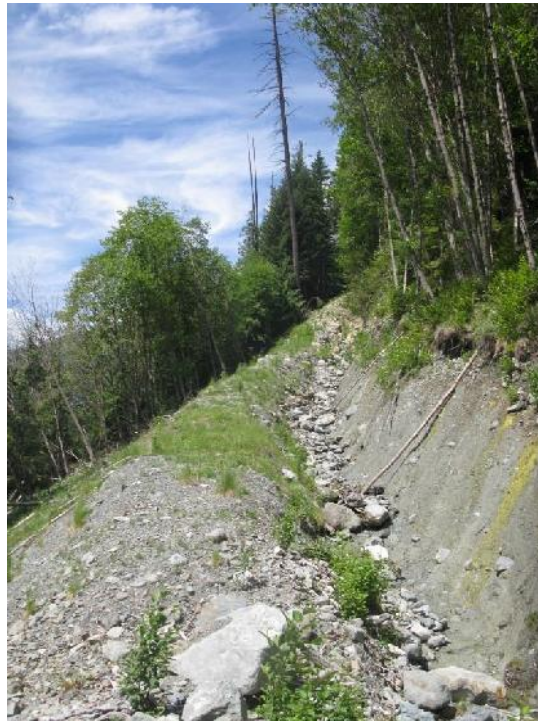
Photo 19 – Alder Reach with some rock debris along invert, looking west.

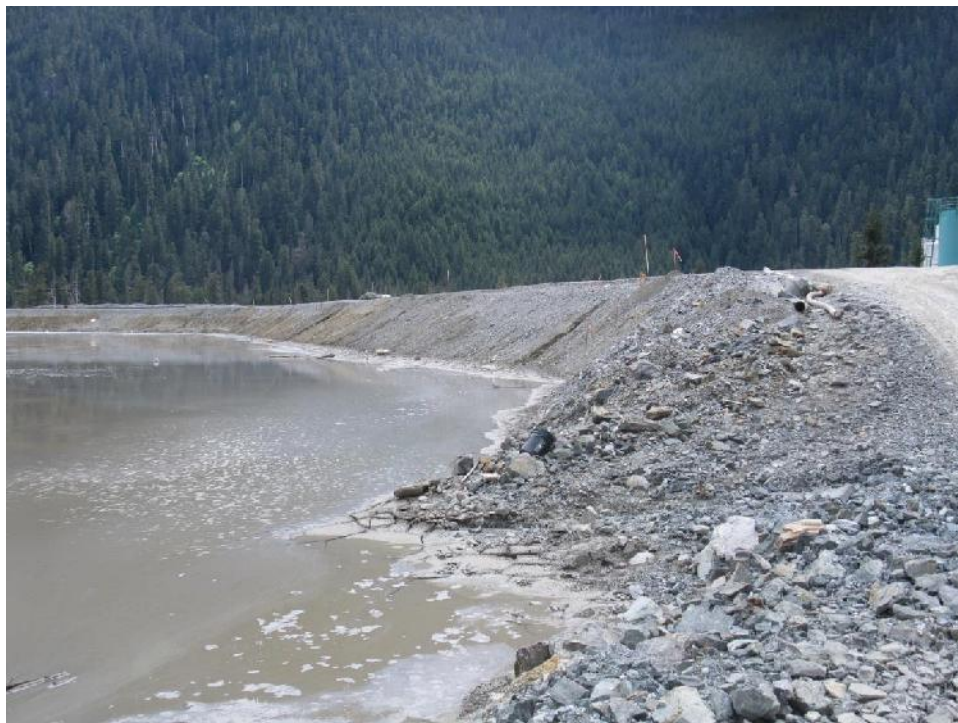
Photo 20 – Pump Road at Lynx Dam west arm, looking south. Froth floating on the water.
