**MYRA FALLS TAILINGS STORAGE FACILITIES
2015 DAM SAFETY INSPECTION REPORT**

31 March 2016

Amec Foster Wheeler File: NX14001B

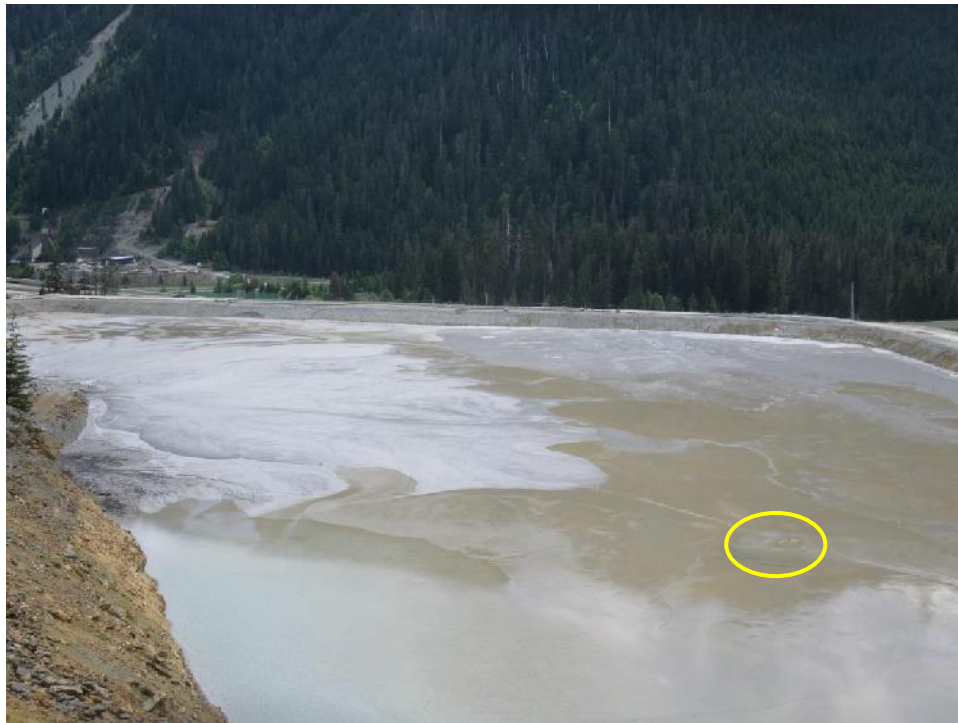
Photo 21 – Overview of eastern portion of Lynx TDF, looking south/southeast. Recurrent sinkhole marked with circle.

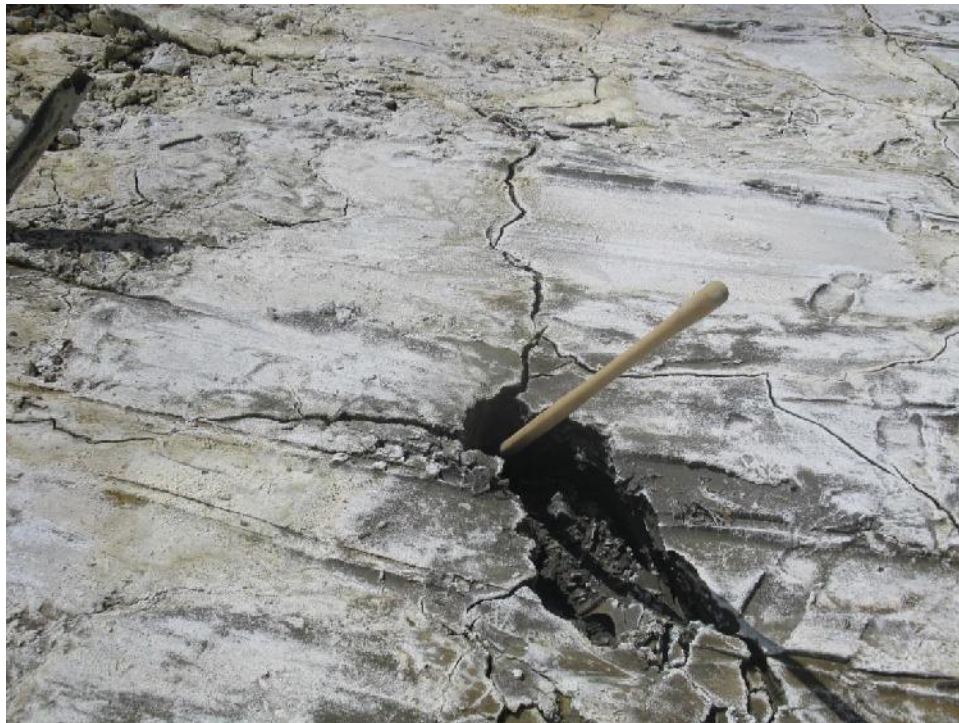
Photo 4 – Hole in the invert of the access road ditch. Shovel inserted into hole for scale.

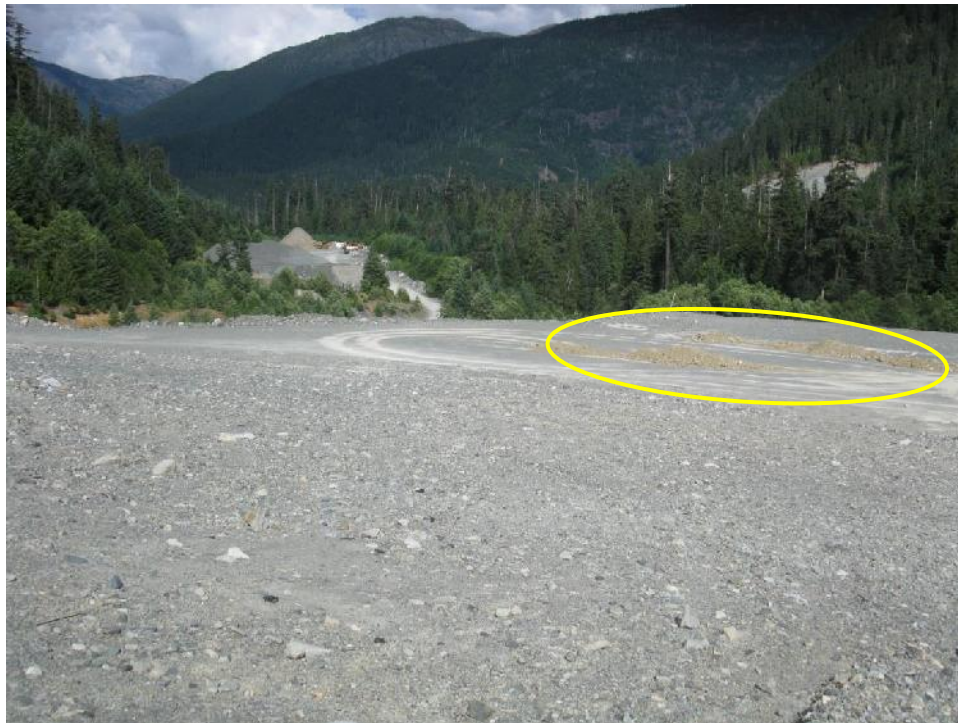
Photo 9 – East abutment of the Seismic Upgrade Berm, looking east towards the on-site Quarry. Piles of PAG mine waste are circled.

- The Old TDF and Lynx TDF facilities were inspected by Amec Foster Wheeler. The inspection included Lynx TDF upper water diversions.
- Action Items:
 1. Remove the piles of mine waste that have been dumped on the east end of the Seismic Upgrade Berm.
 2. Brush/remove debris in the lower and upper reaches of Arnica Ditch. Repair any breaches and re-establish adequate freeboard.
 3. Remove debris in the Upper Lynx Diversion Ditch. Cut trees as needed and trim and stabilize slopes to stop the erosion and re-establish the channel.

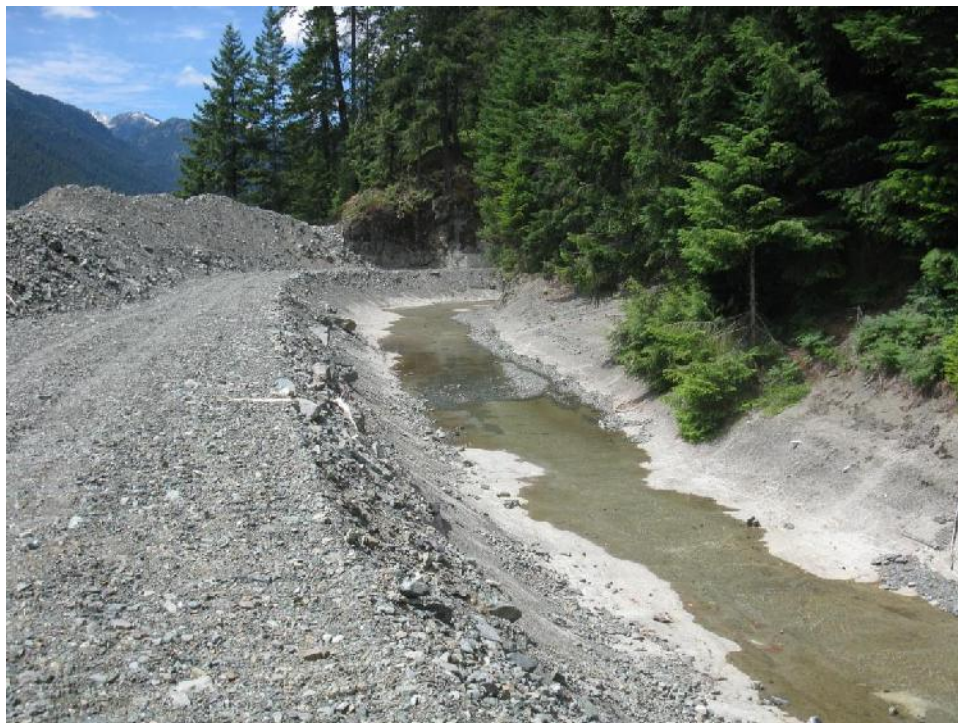
Photo 10 – Low flow in the Lower Lynx Diversion Ditch near Cascade Reach, looking west (on 2015-06-17).

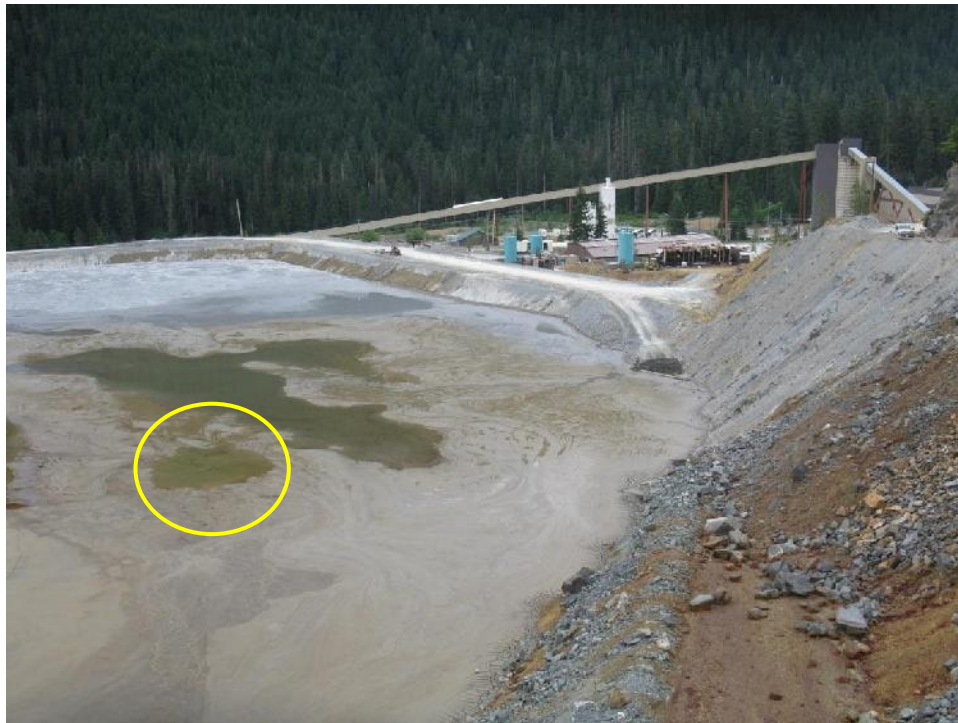
Photo 13 – Lynx TDF, looking southwest. No pumps at the bottom of the ramp (circle shows the location of the recurrent depression).

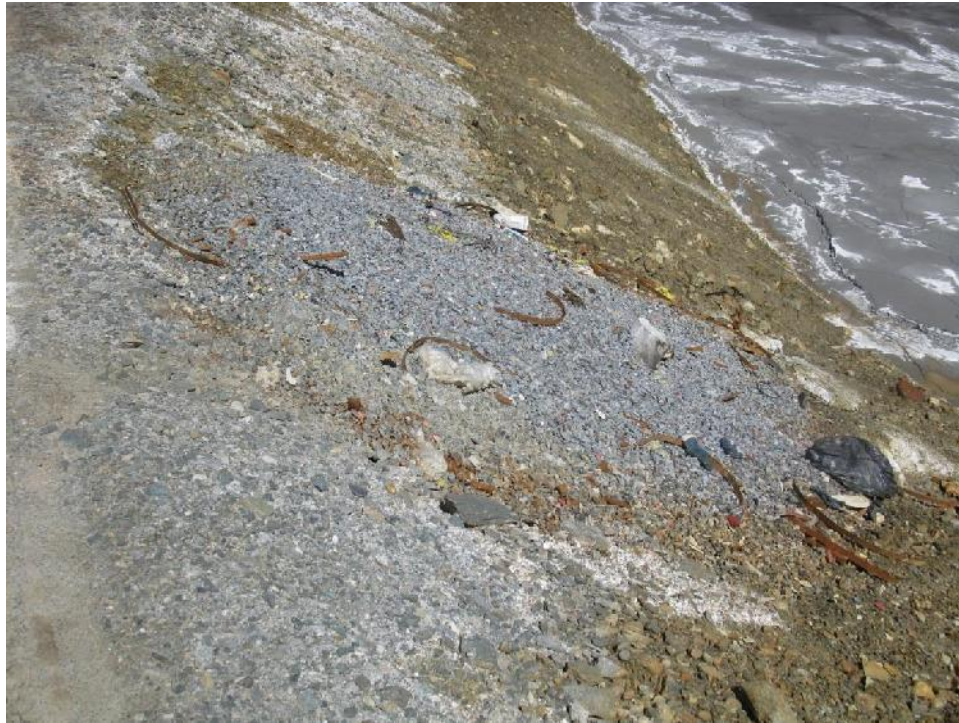
Photo 17 – Mine refuse on the upstream face of Lynx Dam west arm (southwest corner of the facility) (on 2015-06-16).

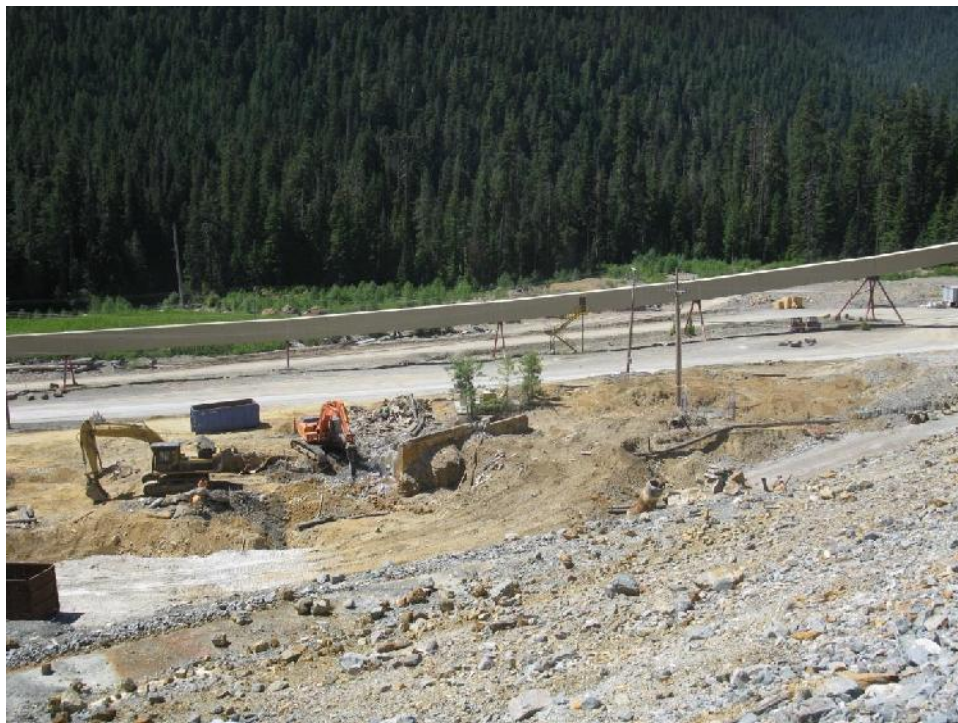
Photo 20 – 80-Foot building at Lynx Dam toe undergoing demolition, looking south.

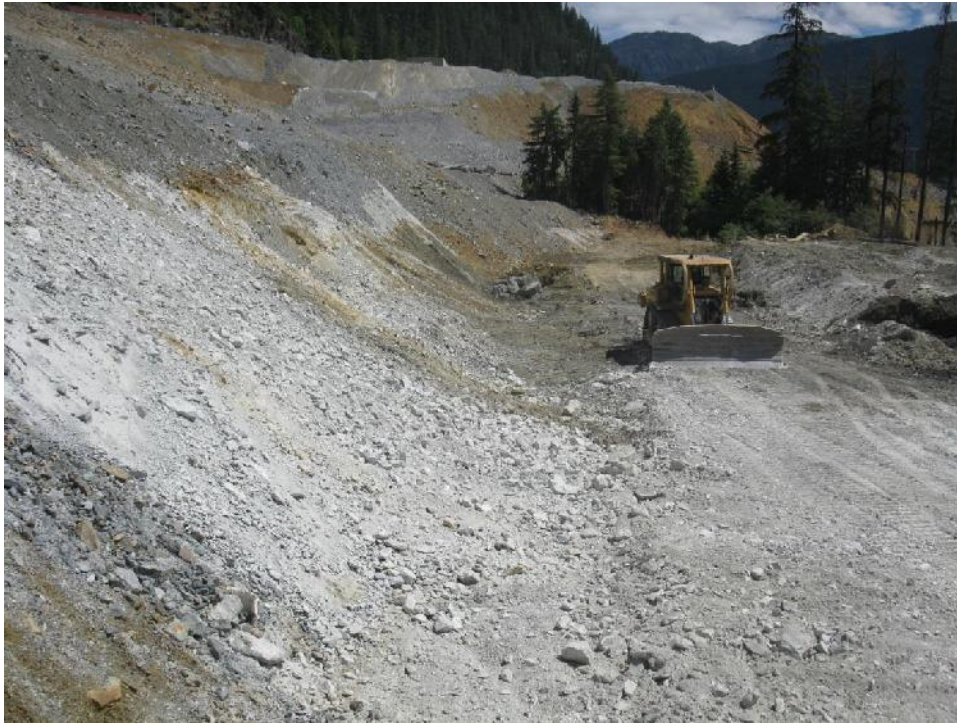
Photo 21 – Toe of Lynx Dam south arm, looking east (on 2015-06-16).

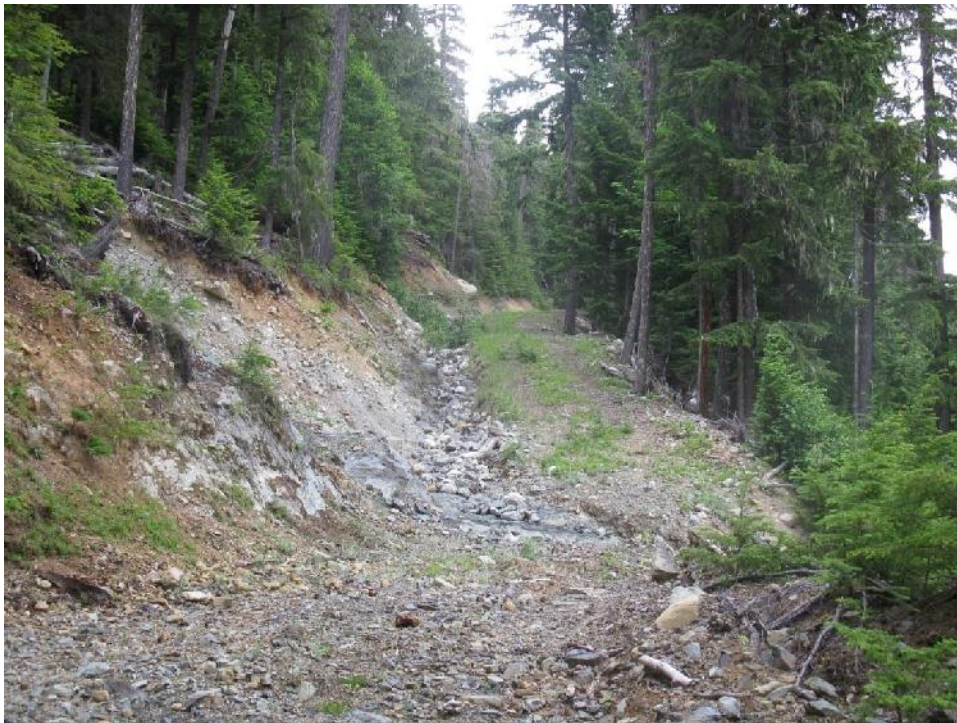
Photo 22 – Upper Arnica Reach Ditch, looking upstream (on 2015-06-17).

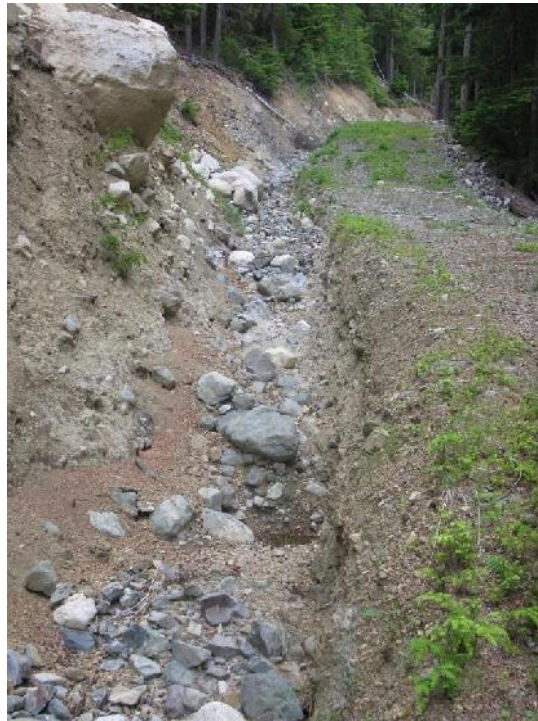
Photo 23 – Upper Arnica Reach Ditch, looking upstream (on 2015-06-17).

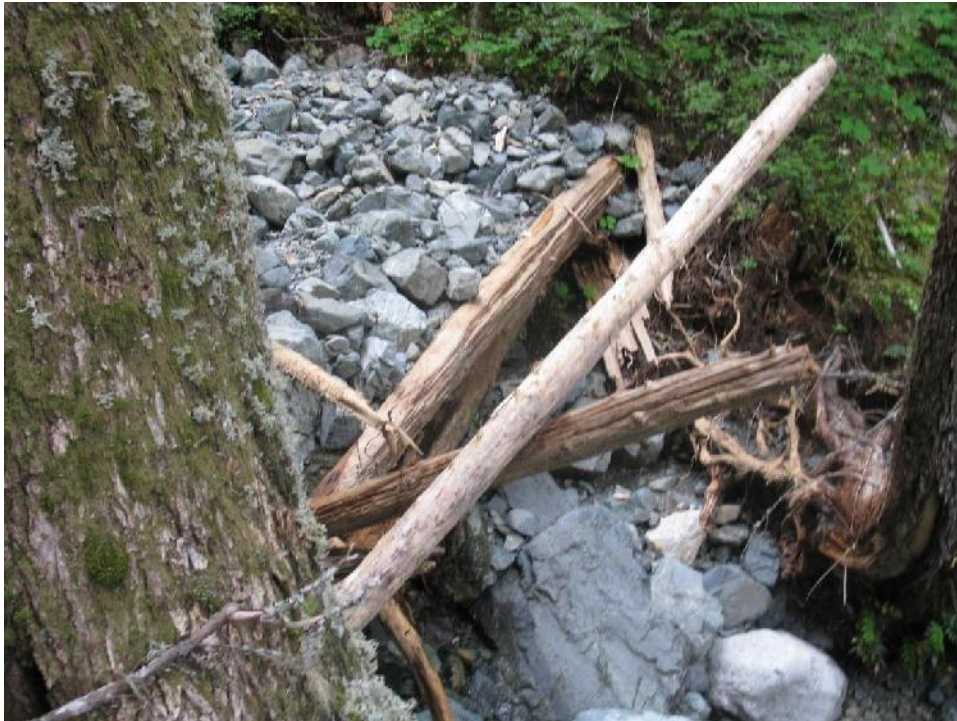
Photo 25 – Wood logs caught in the creek located at the head of Upper Arnica Ditch.

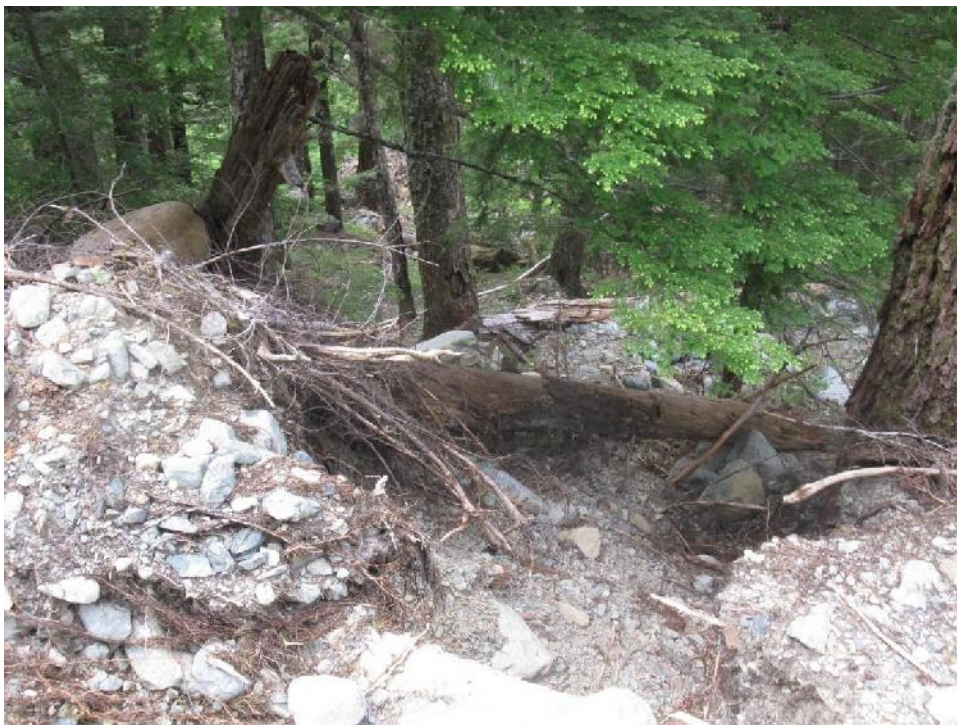
Photo 26 – Debris and fallen tree in breach along the lower reach of Arnica Ditch.

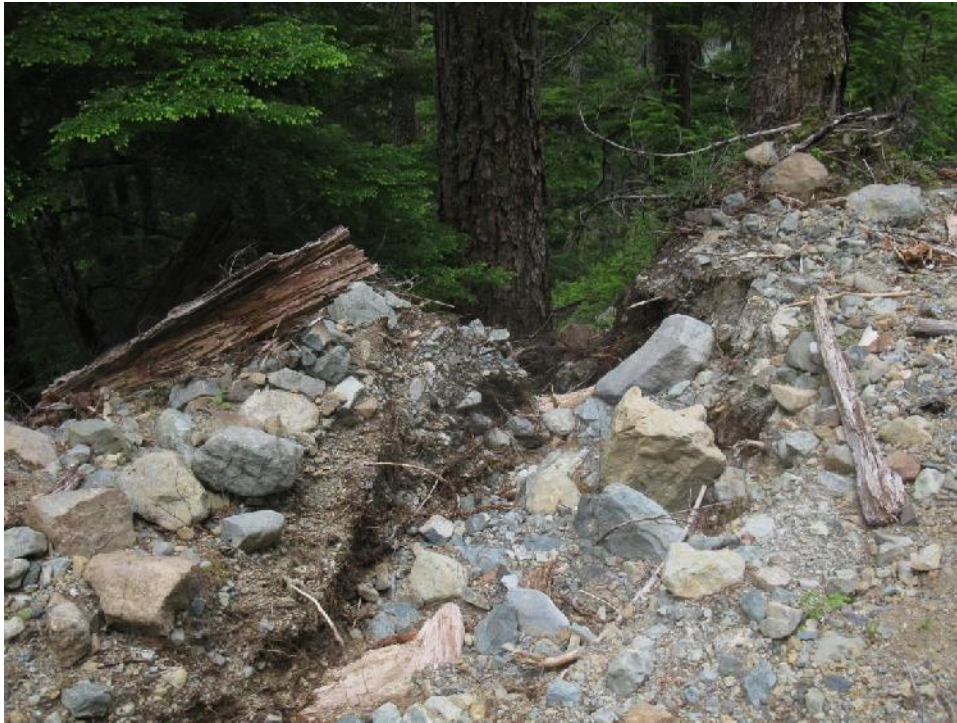
Photo 27 – Breach of lower Arnica diversion ditch near the lower end.

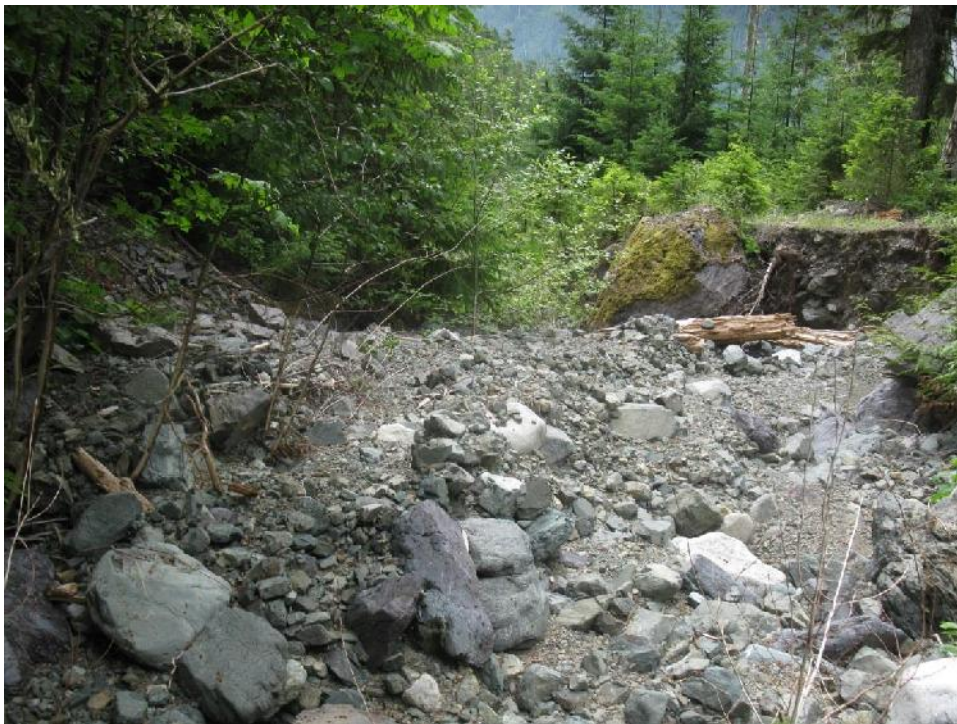
Photo 28 – Debris in the Upper Lynx Diversion Ditch just below the culvert section, looking downstream. Debris and erosion of the ditch is from the torrented stream in Photo 36 & 37.

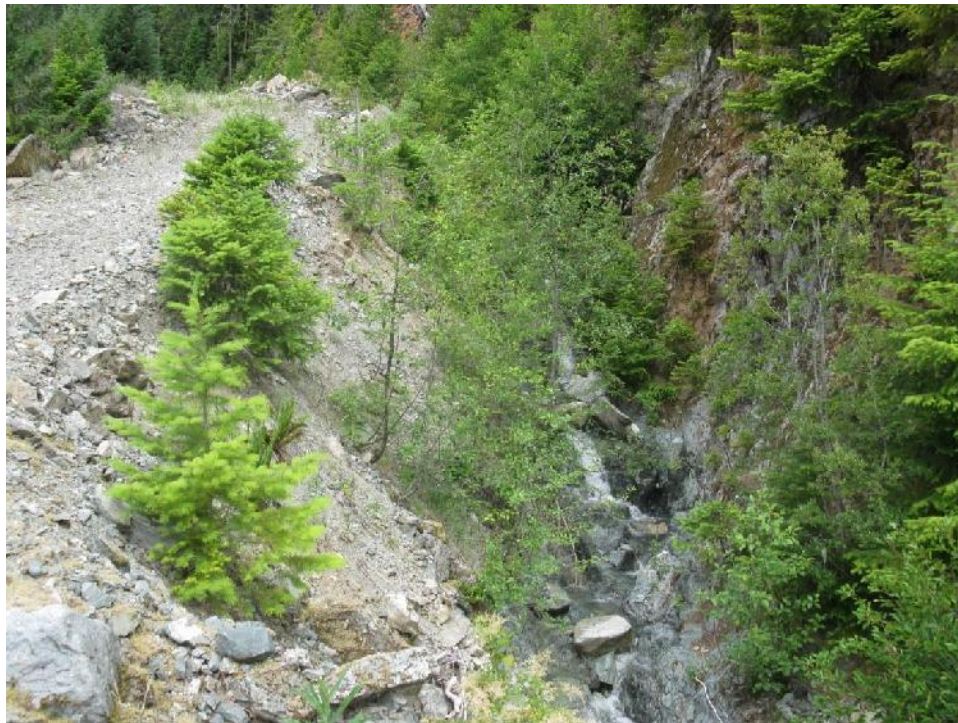
Photo 29 – Brush in Lynx Upper Diversion Ditch, looking upstream.

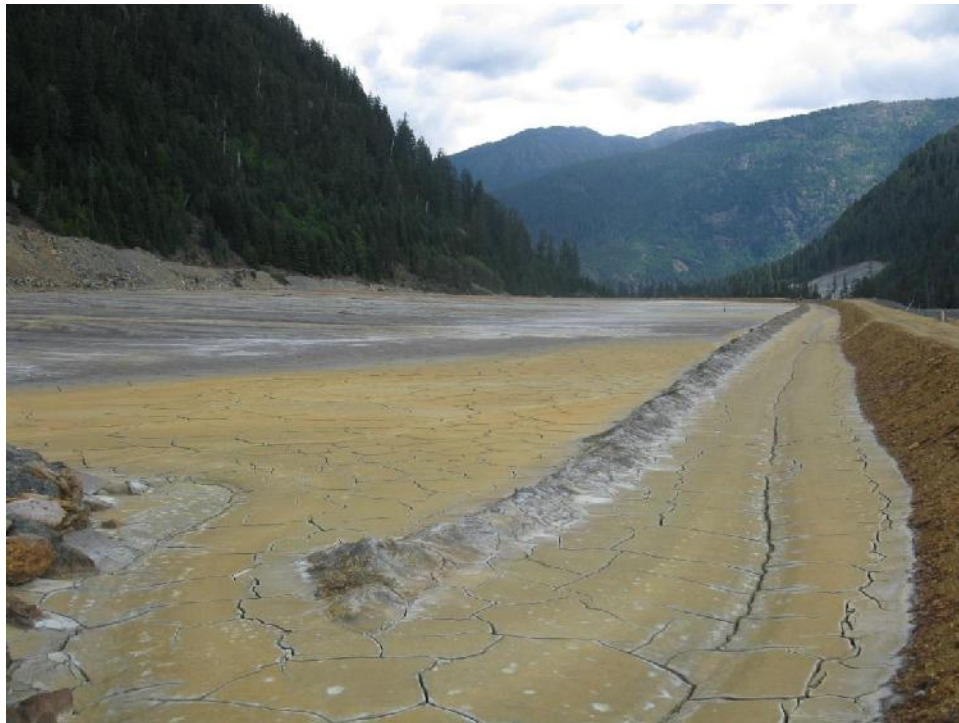
Photo 3 – APA Ditch, looking west from the decant access ramp.

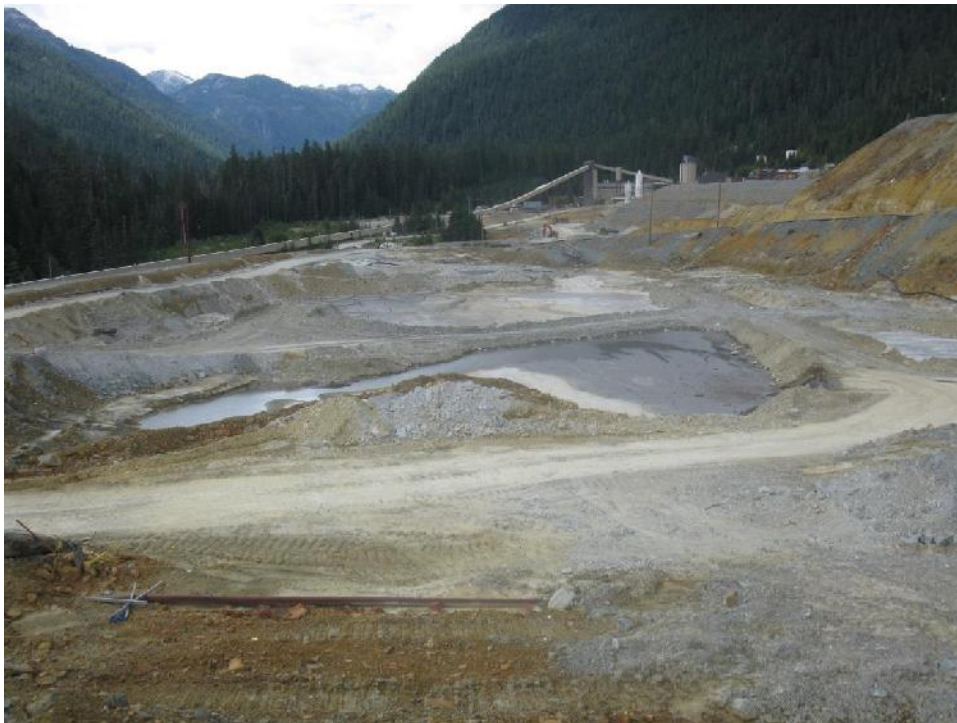
Photo 6 – RSA, looking west.

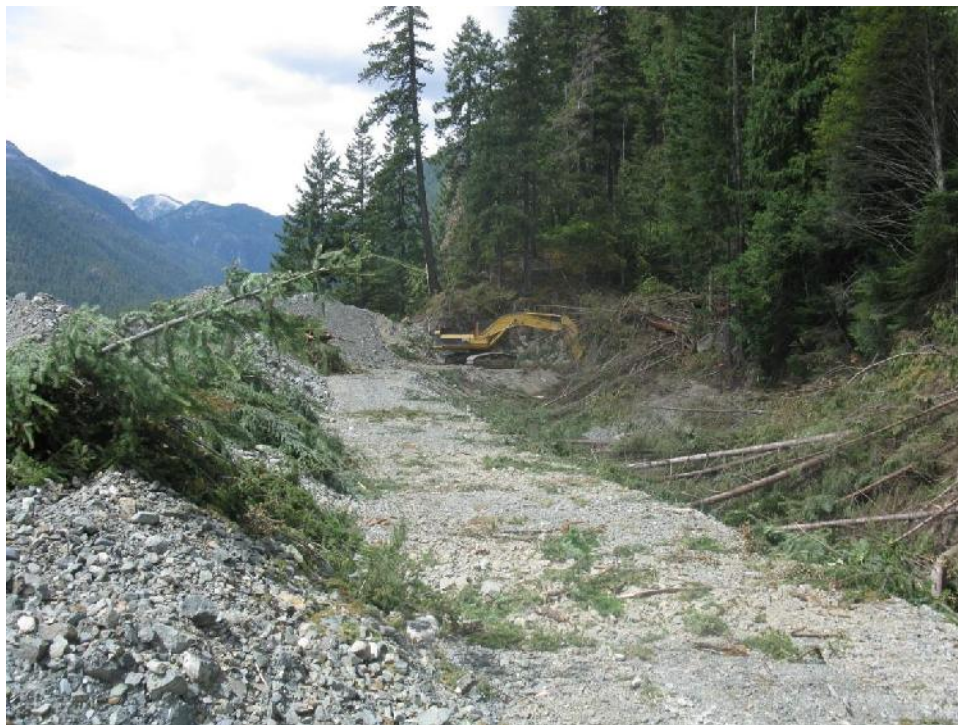
Photo 8 – Tree clearing along the Lower Lynx Diversion Ditch near Cascade Reach, looking west.

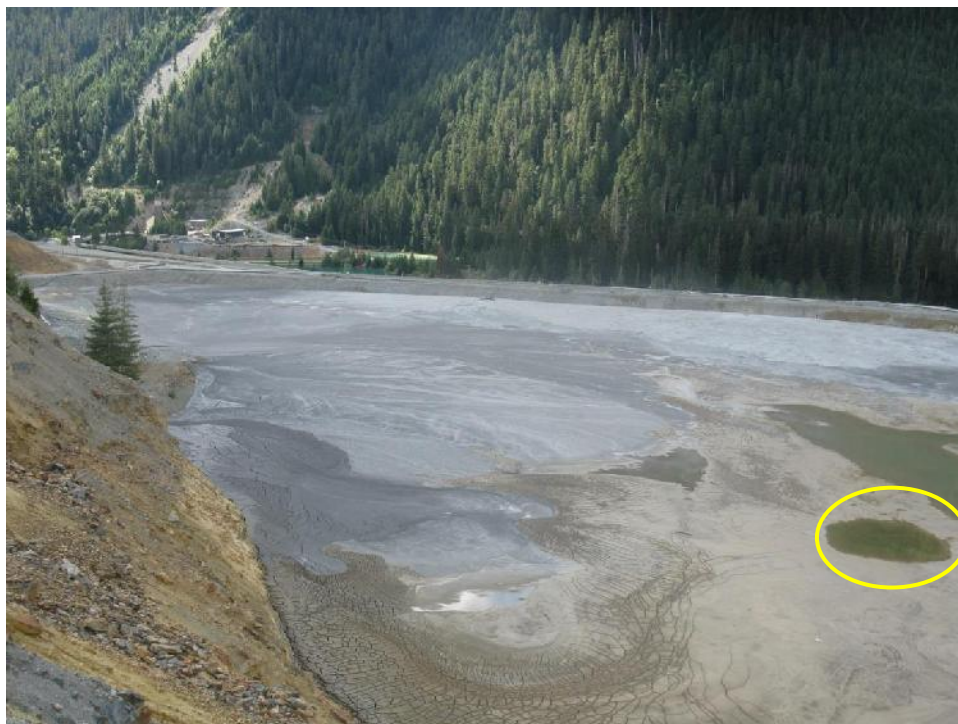
Photo 12 – Eastern portion of Lynx TDF, looking southeast.

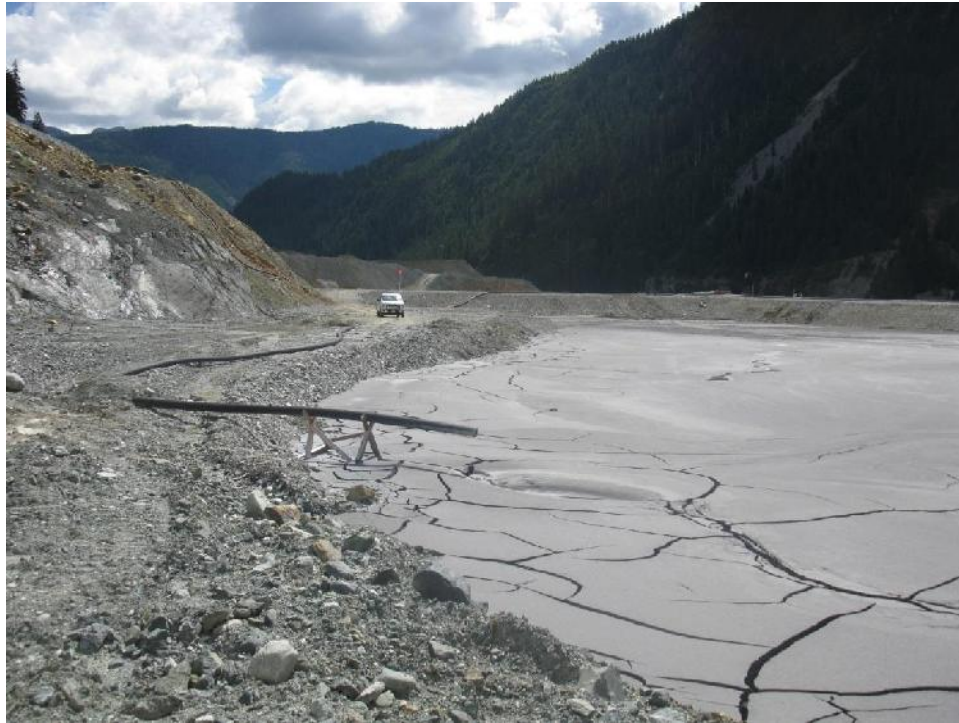
- Ponded water in a few spots in the northwest portion of Lynx TDF.
- Desiccation cracking of the tailings surface is well developed at the back of the pit and near the paste deposition point along Lynx Springs Drain.
- Recurrent depression is apparent, in its usual location and size.
- No pumps at the west abutment. Pumps and generators have been removed.
- Trace seepage entering Lynx Pit at the rock wall above the springs drain.

Photo 13 – Tailings surface and deposition point along the Springs Drain road, looking east.

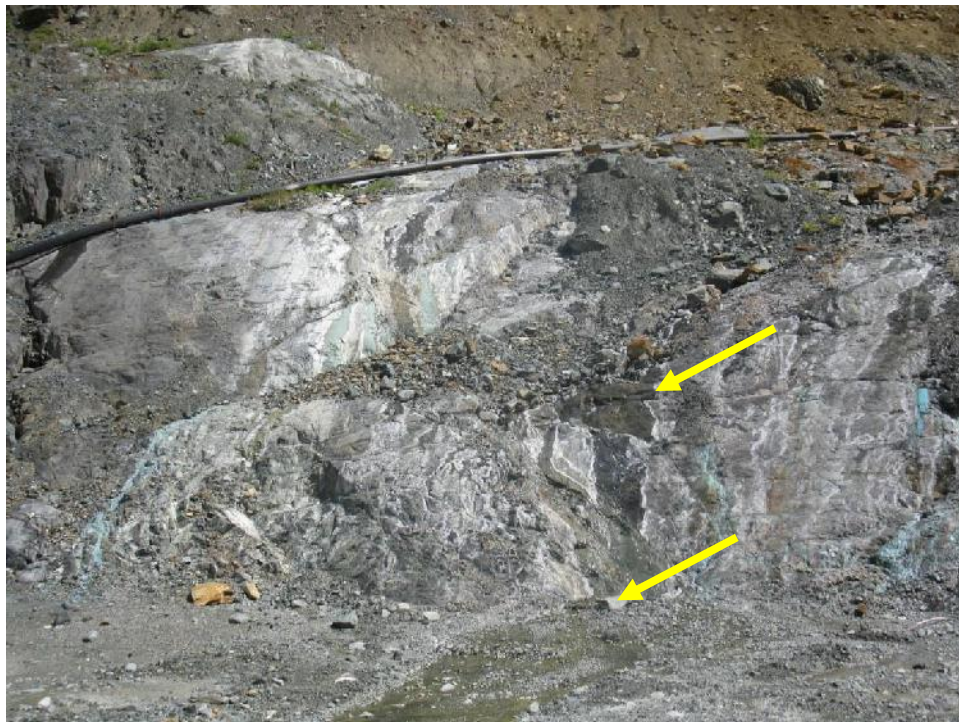
Photo 14 – Trace seepage entering Lynx Pit at rock wall above the springs drain, looking north.

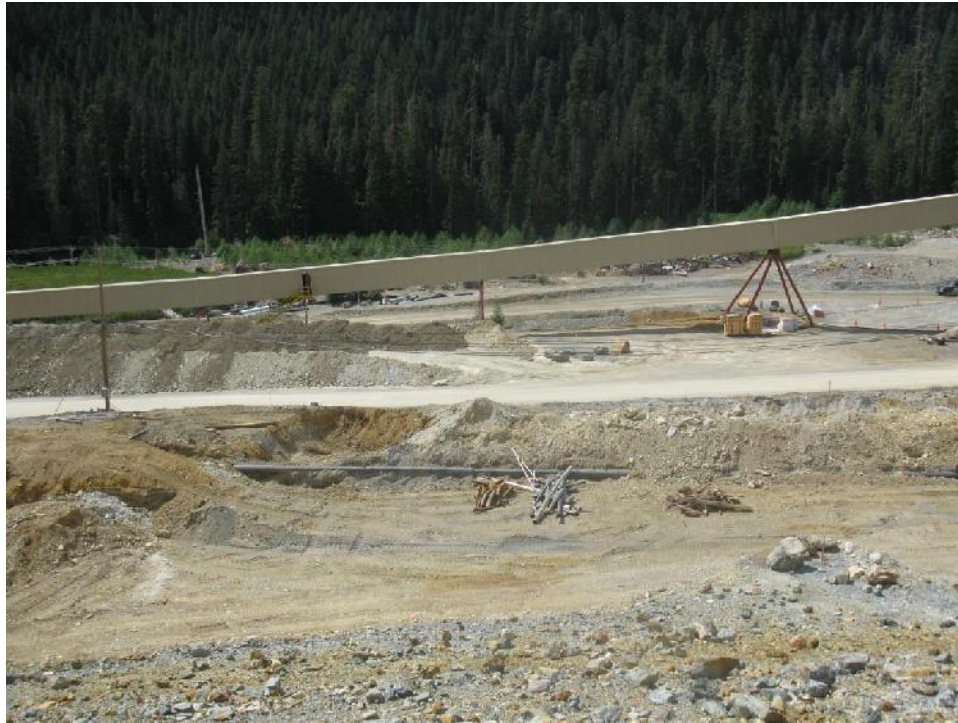
- The 80-Foot Building concrete foundation has been removed from Lynx Dam toe area.
- No seepage or water accumulation on Lynx Dam south arm mid-level benches or toe.
- Phillips Reach sump area has been logged and cleared. Some seepage in areas around former Phillips Reach springs.
- Excavation of foundation area along south toe continues.

Photo 15 – Former 80-Foot building area at the toe of Lynx Dam, looking south.

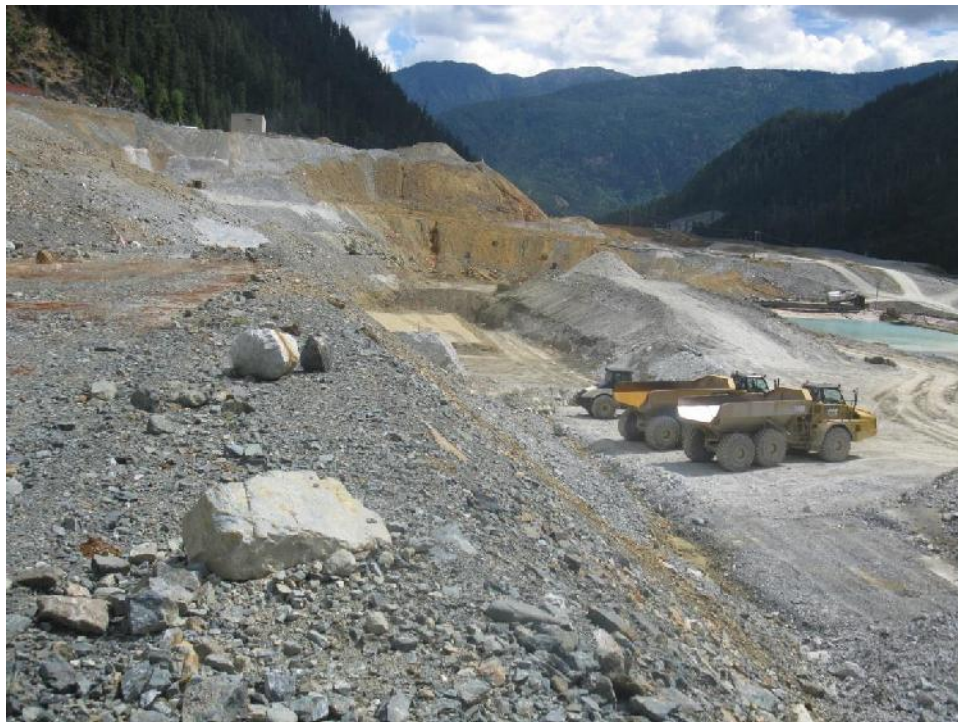
Photo 16 – Lynx Dam south arm toe looking east from the mid-level bench (note the foundation preparation work in the 3410 m elevation toe area).

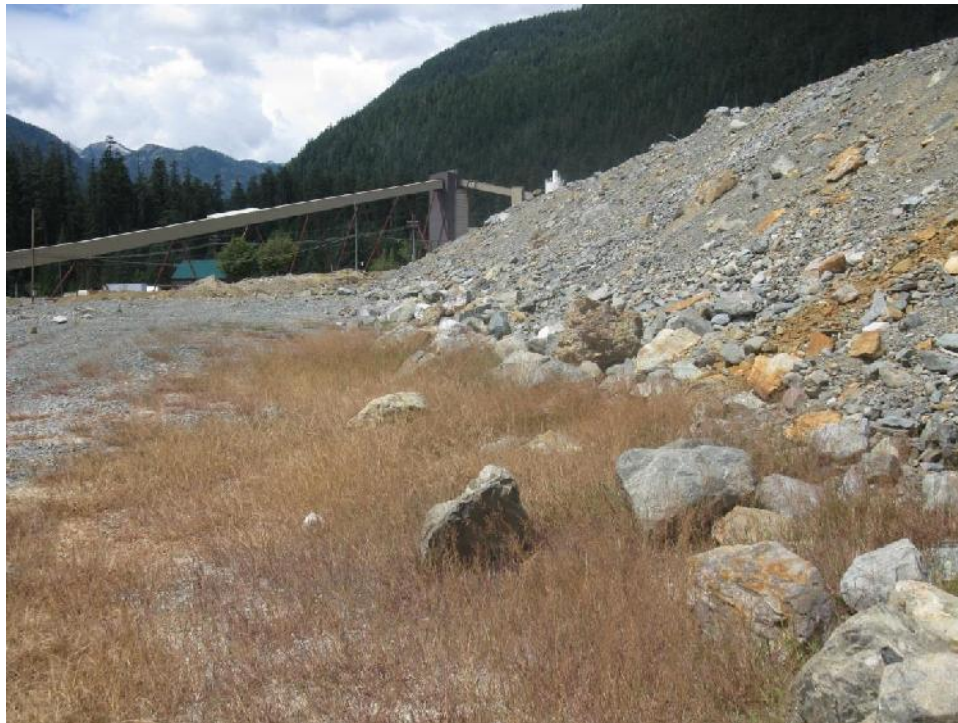
Photo 17 – Grassy area on mid-level “2011 Bench” where seepage is commonly observed, looking west. Seepage area is dry.

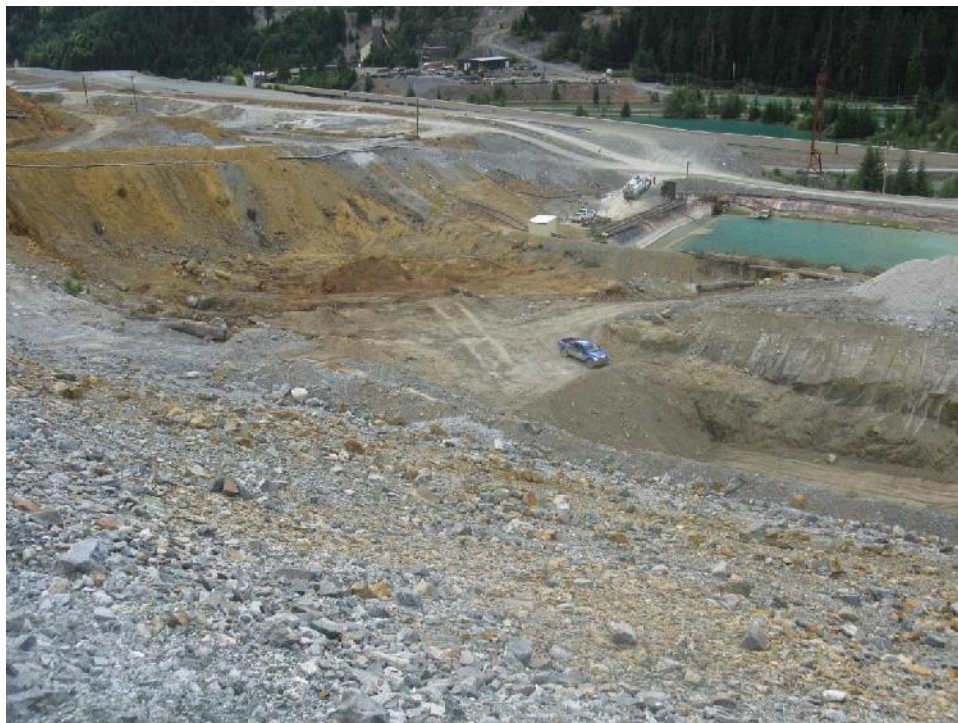
Photo 18 – General view of the southeast corner of Lynx Dam toe, looking southeast. The treed area around Phillips Reach sump was cleared and organics were removed.

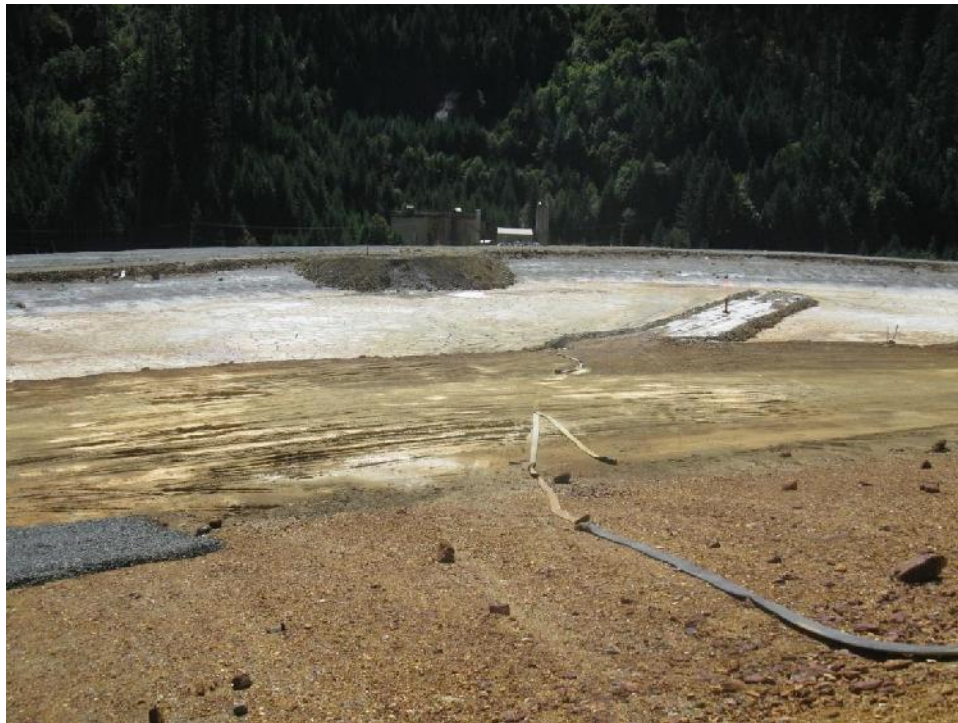
Photo 3 – 4:1 Slope and base of the Paste Berm and East Strip near Instrument Plane C, looking southeast (no water accumulation or trace of seepage).

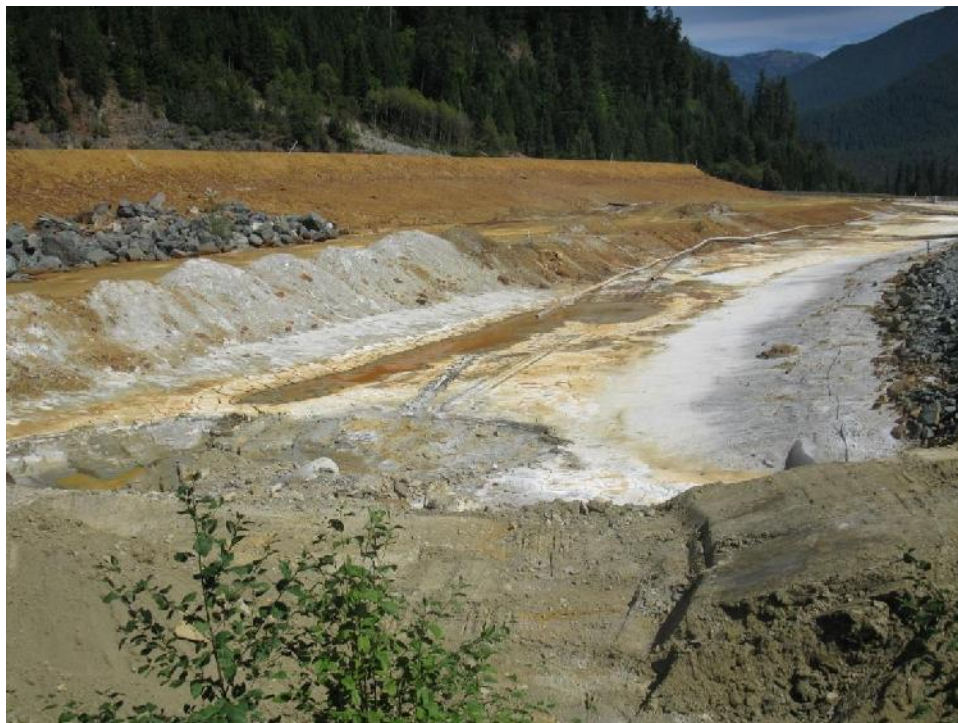
Photo 4 – Paste Berm and East Strip looking east from the Old TDF spillway. Excavation is in preparation for culvert cleaning.

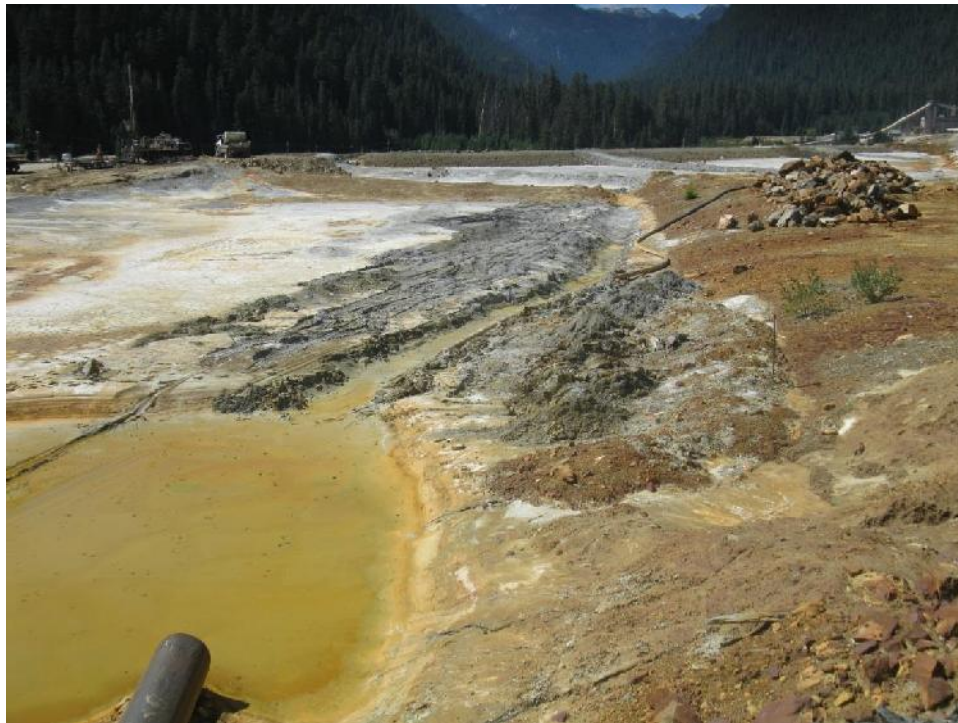
Photo 5 – West Strip looking west from the Old TDF spillway. Ditching to relieve water from excavation is in preparation for culvert clearing.

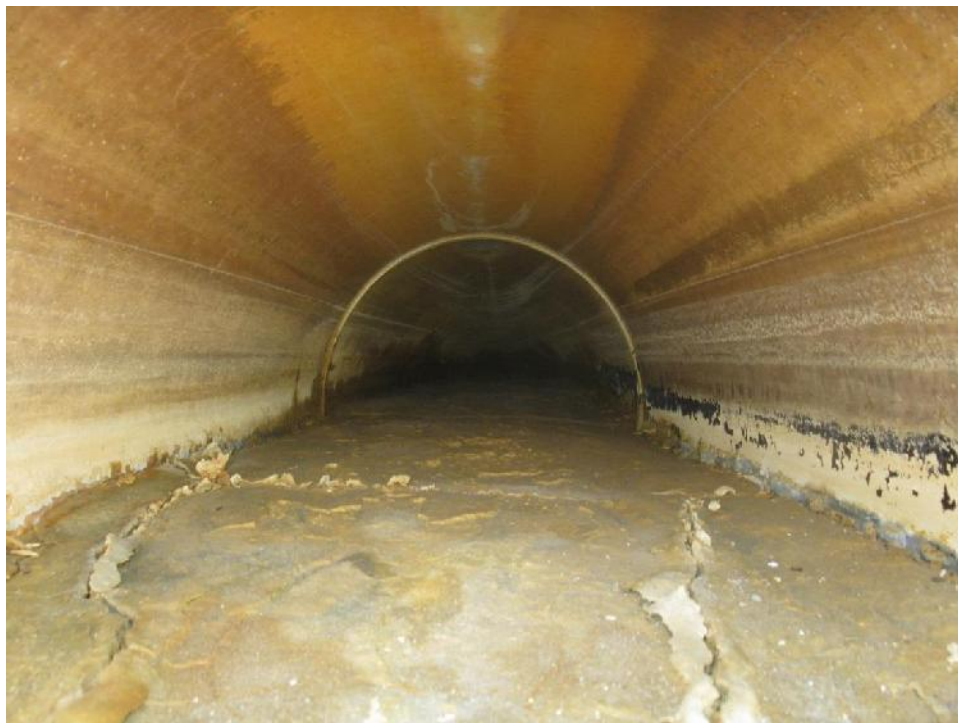
Photo 6 – Interior of one of the culverts under the Old TDF spillway. Culvert is completely plugged with tailings solids.

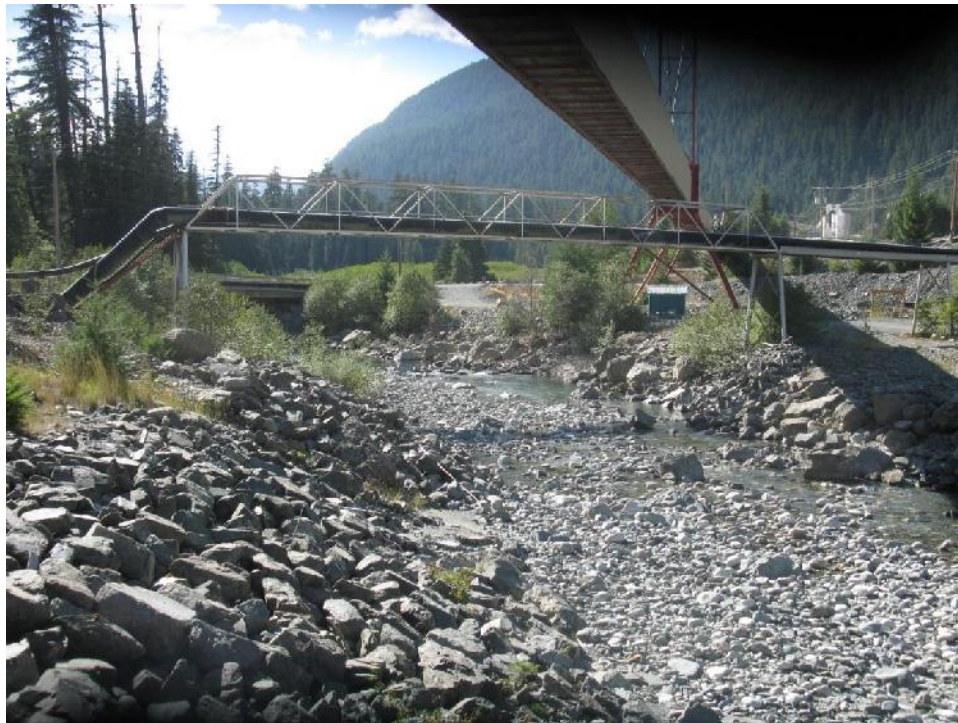
Photo 9 – Extremely low flow conditions in Myra Creek under ore conveyor bridge, looking west (upstream), just south of Superpond.

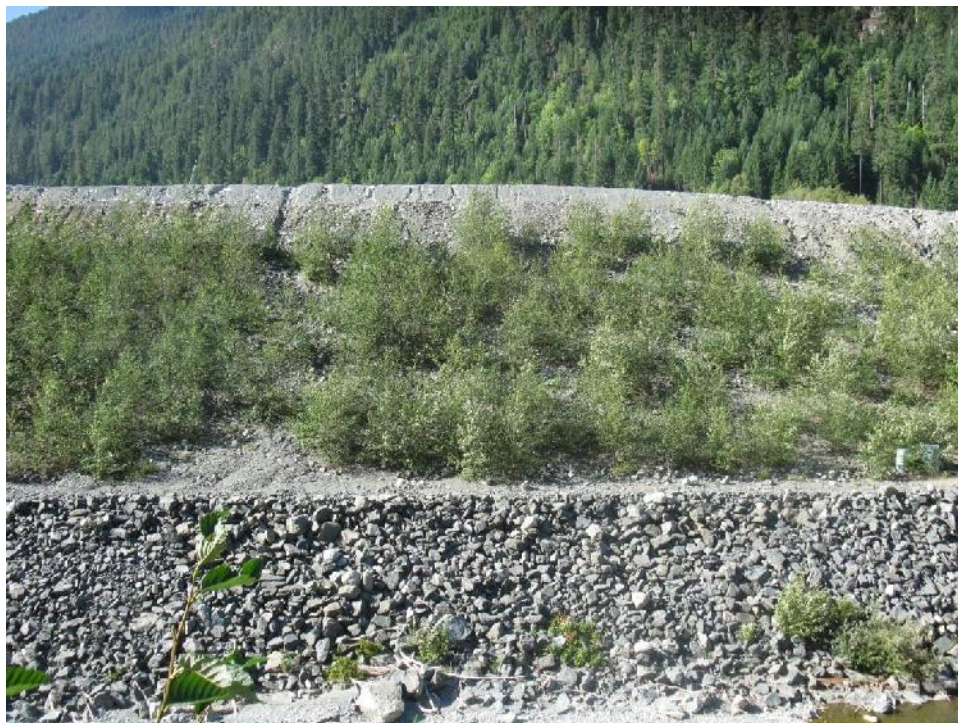
Photo 10 – Slope and rockfill toe of the Seismic Upgrade Berm, ~ Sta. 1+100.

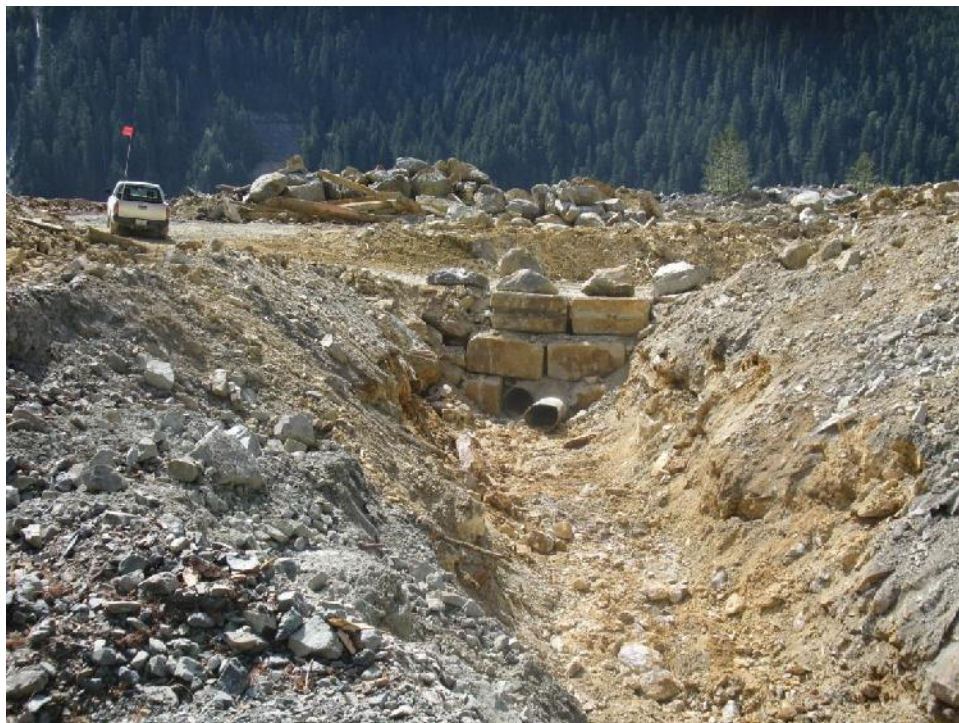
Photo 12 – Culverts across the access road at the head of the temporary water diversion for Lower Lynx Diversion Ditch upgrade works, looking south towards Waste Dump #6.
