**MYRA FALLS TAILINGS STORAGE FACILITIES
2015 DAM SAFETY INSPECTION REPORT**

31 March 2016

Amec Foster Wheeler File: NX14001B

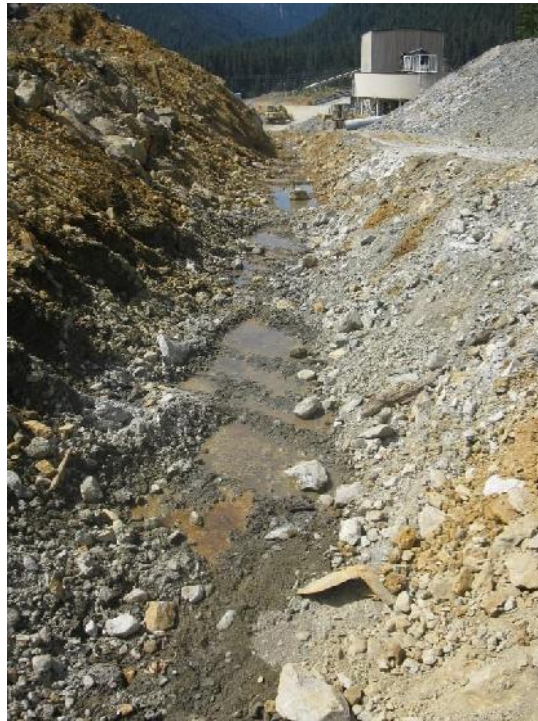
Photo 13 – Construction diversion along the access road for Lower Lynx Diversion Ditch, looking west towards Paste Plant. Seepage appears to be draining from the waste dump.

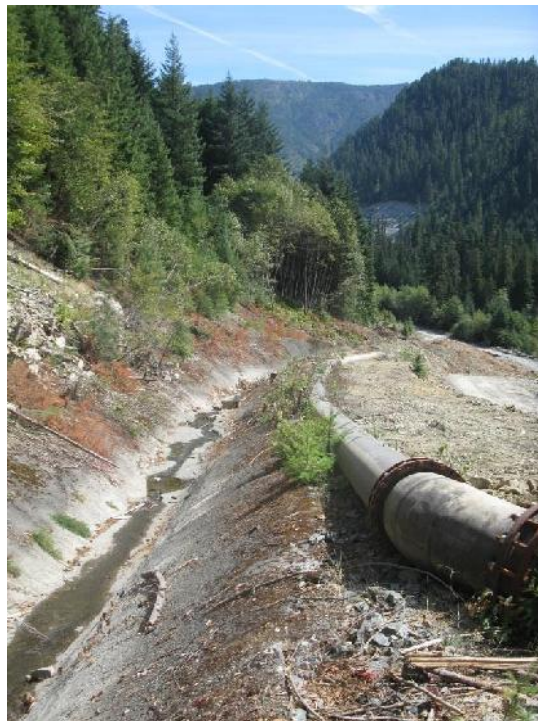
Photo 14 – Shotcrete-lined portion of Lower Lynx Diversion Ditch near Alder Reach Ditch, looking east.

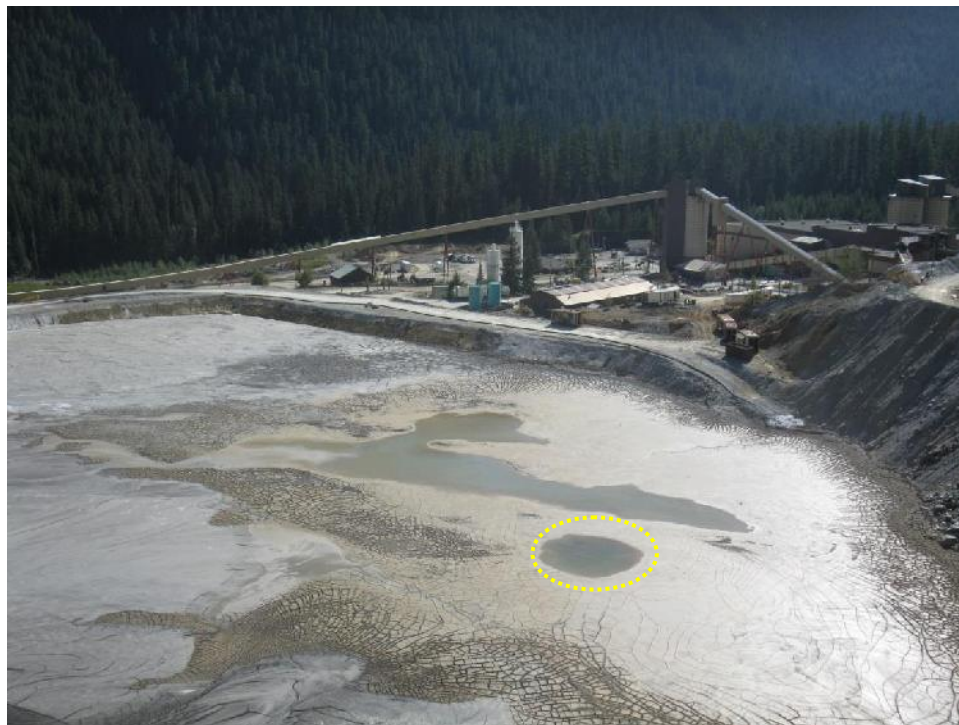
Photo 16 – Overview of Lynx TDF, looking southwest (recurrent depression in paste surface clearly visible, marked by dotted circle).

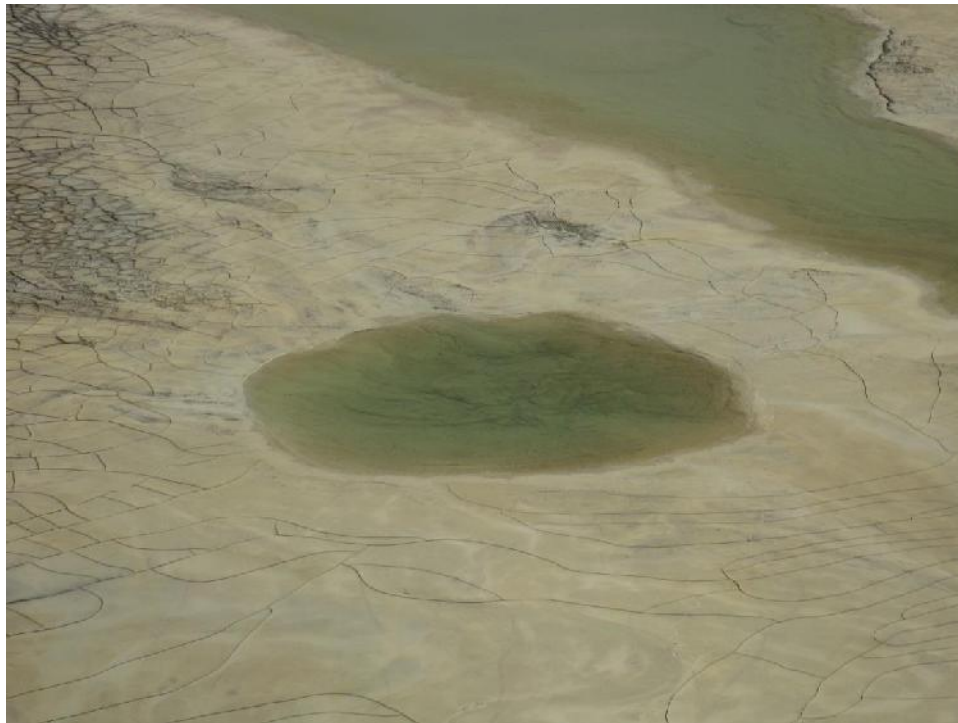
Photo 17 – Close-up view of the recurrent depression in Lynx TDF paste surface (see previous photo for location).

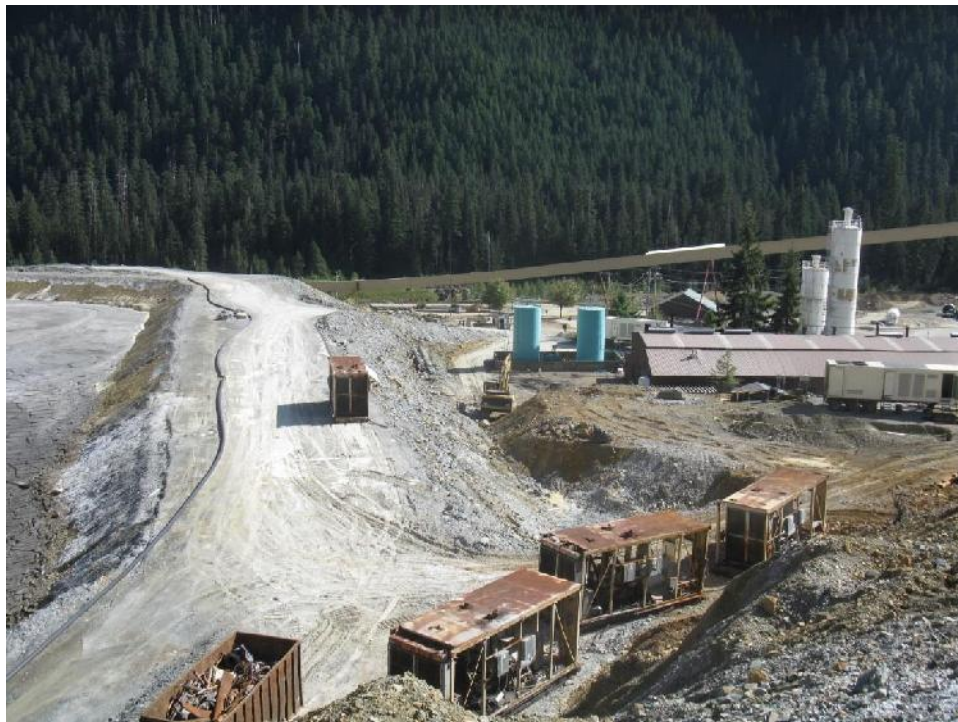
Photo 18 – West Arm of Lynx Dam, looking south.

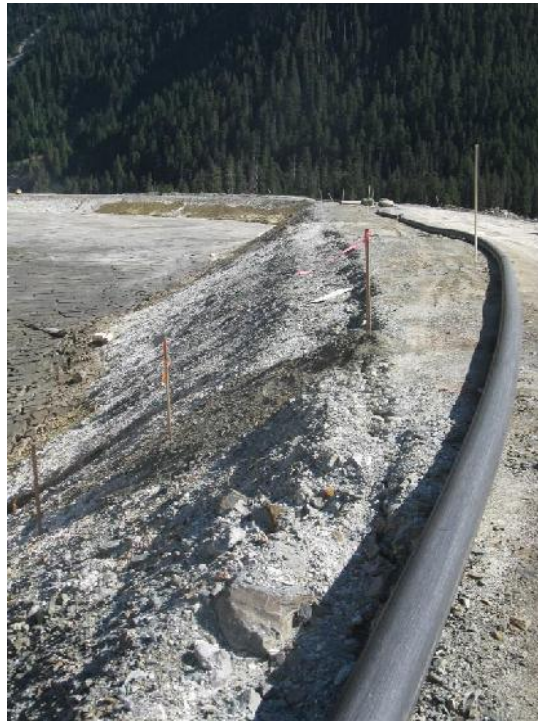
Photo 19 – Close-up view at the sloughing zone in the upstream shell of Lynx Dam west arm, looking south.

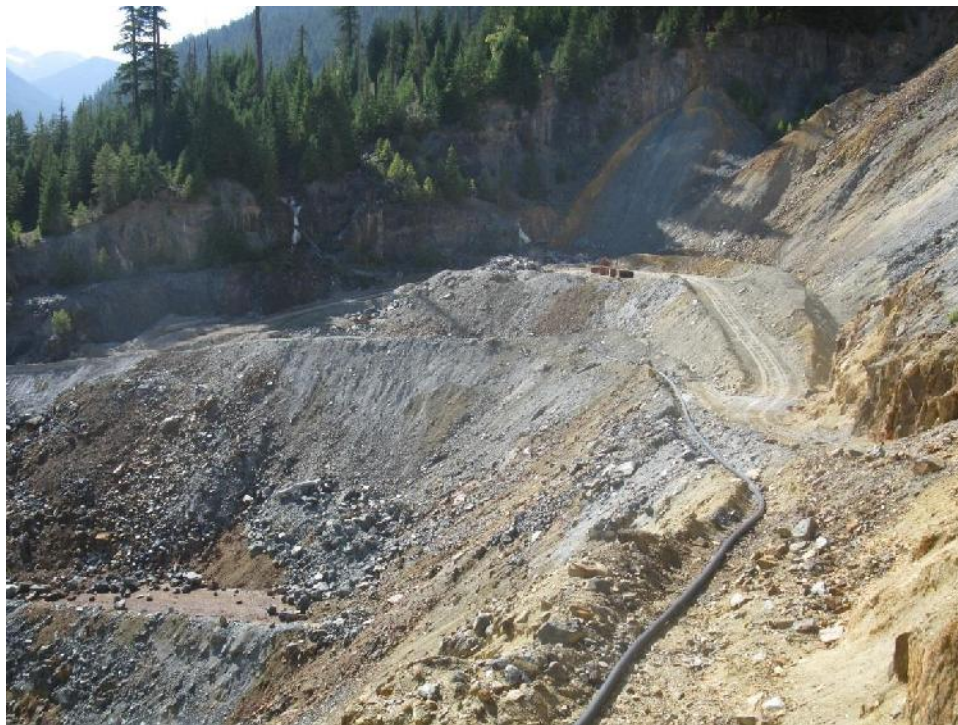
Photo 20 – Lynx Pit slide area, looking west. Berm has been constructed and road access has been restored through the top of the waste dump area.

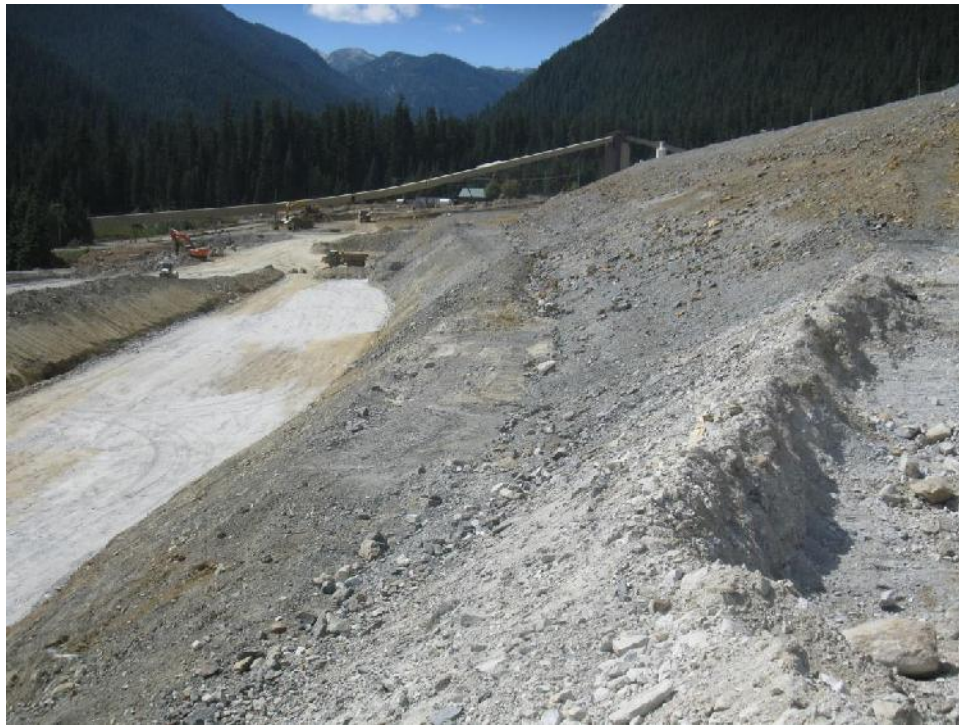
Photo 23 – Eastern portion of Lynx Dam south arm toe, looking west.

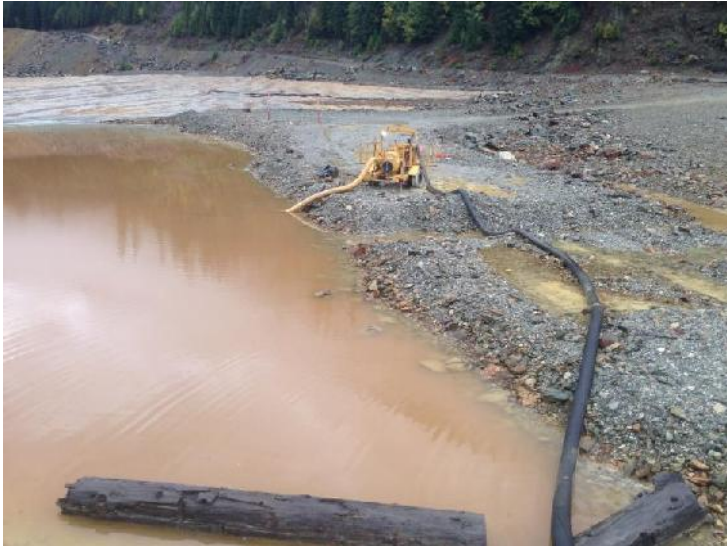
Photo 4 – Ponded water in the southeast corner of the APA up against the Paste Berm, looking west.

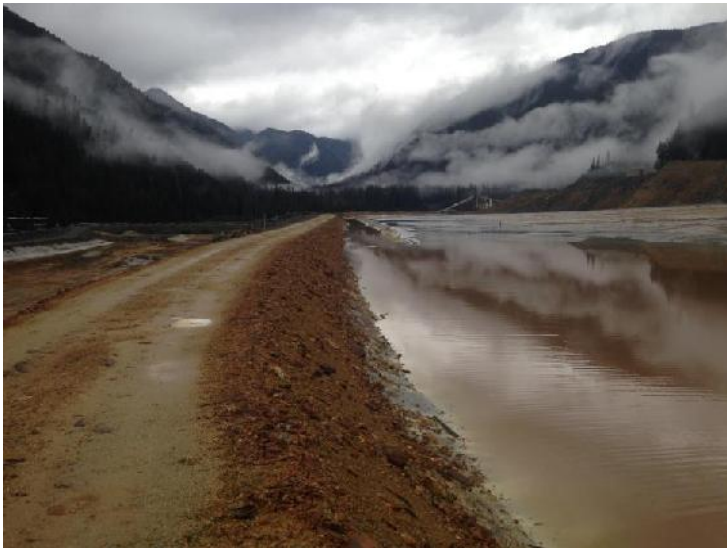
Photo 5 – APA Ditch along the Paste Berm, looking west from the Old TDF spillway.

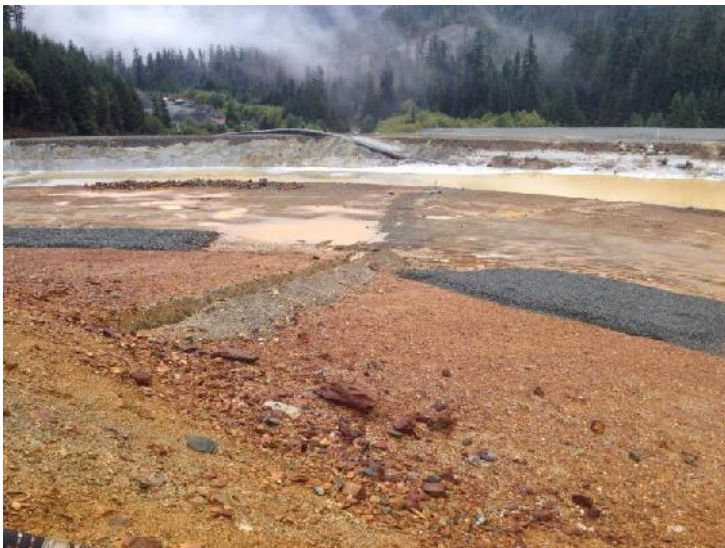
Photo 9 – Wet areas at the base of the Paste Berm and ponded water in the East Strip, looking west from the Paste Berm crest near Instrument Plane C.

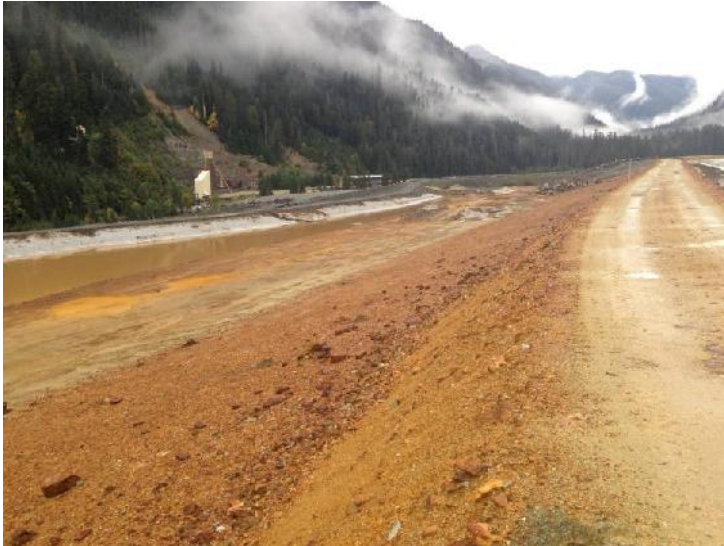
Photo 10 – Red ARD staining at the base of the Paste Berm and ponded water in the East Strip on the east side of the Old TDF spillway, looking southwest.

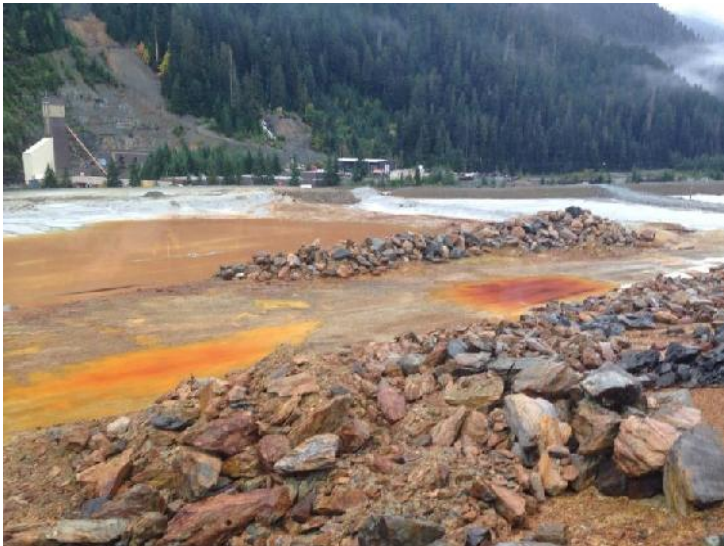
Photo 11 – Ponded water in the East Strip, looking east from the Old TDF spillway (the inlet of one of the culverts passing under the spillway located in the foreground).

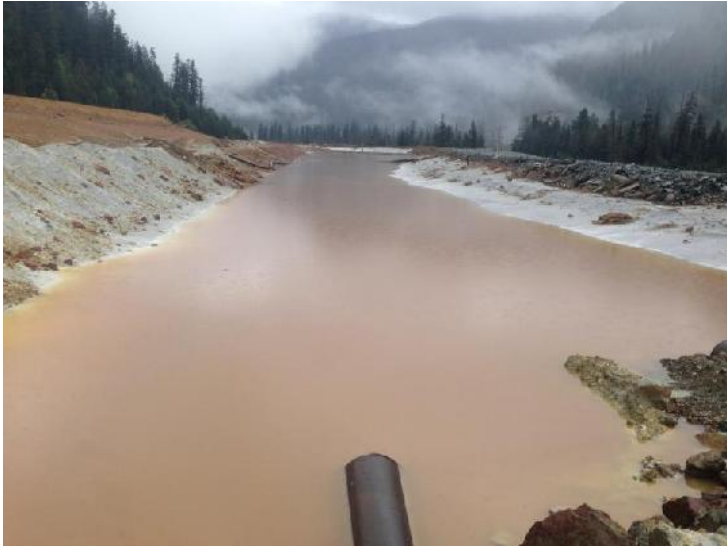
Photo 12 – Gangway leading to the Strip decant (under water).

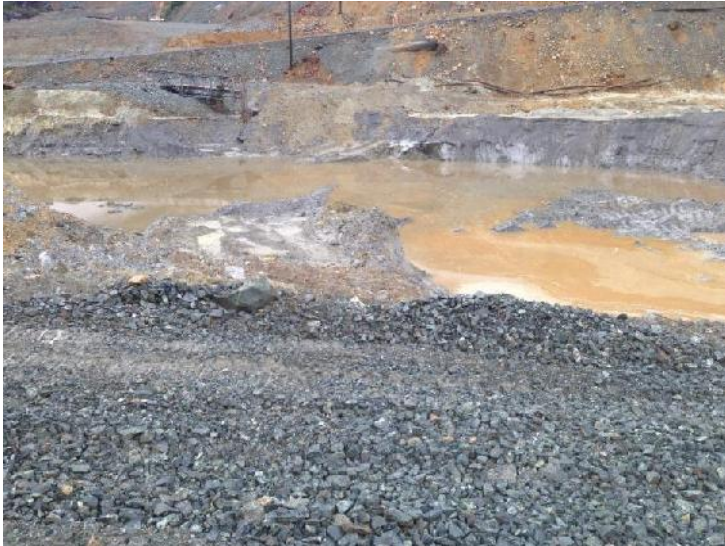
Photo 16 – Puddles at the toe of the 6:1 Slope along the Seismic Upgrade Berm main bench, east of the Old TDF spillway, looking towards the Backfill Plant.

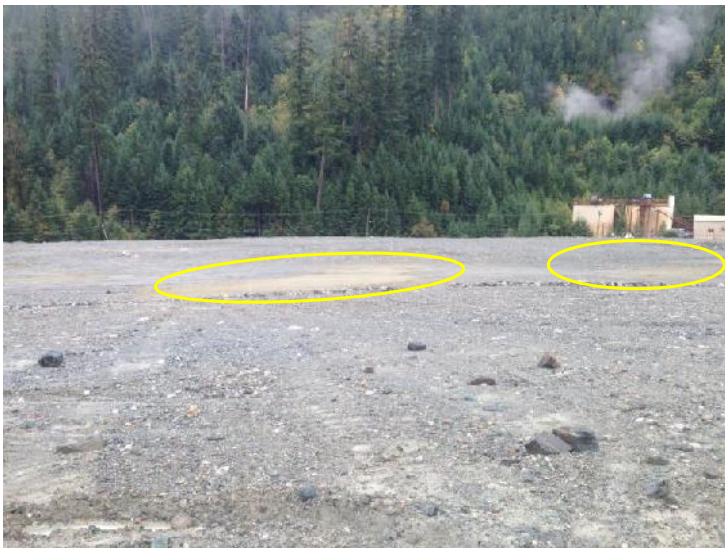
Photo 17 – Wet areas and puddles on the Seismic Upgrade Berm main bench near the access road between the RSA and the Strip, looking southwest.

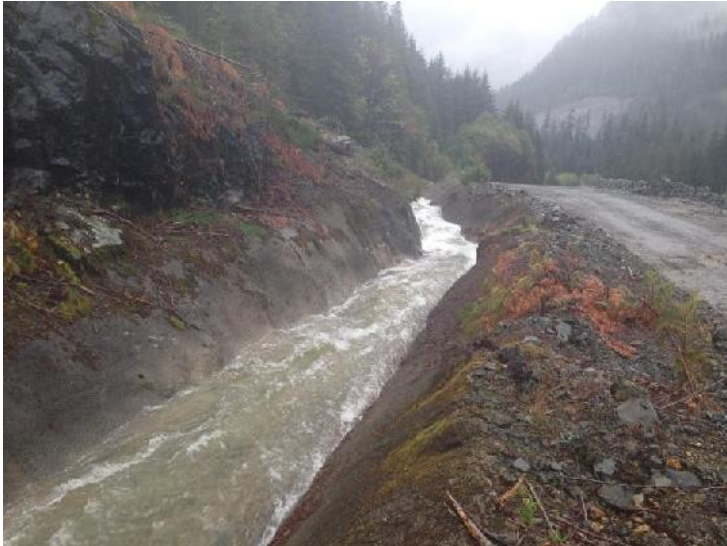
Photo 20 – Puddles downstream of the main spring area at the Old TDF east abutment, looking east/southeast (Pumphouse #4 pipeline can be seen in the background).

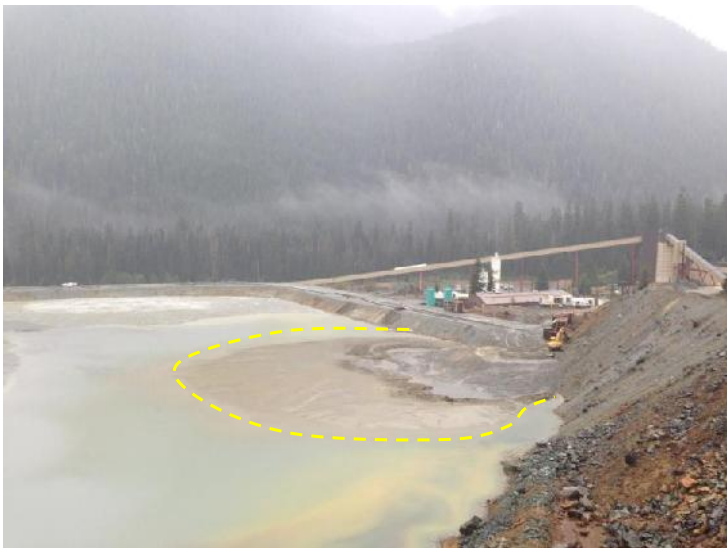
Photo 23 – Lynx TDF, looking south. Cracked area in the foreground is a paste tailings fan. The dashed line is delineating the sand beach above water. The recurrent depression in the paste surface is not visible.

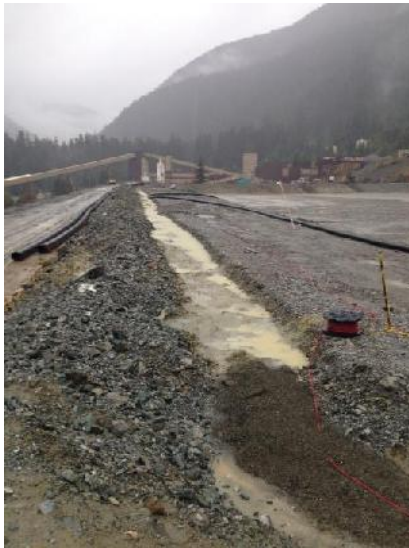
Photo 27 (left) – Trench in upstream half of Lynx Dam crest to route piezometer wires.
Photo 28 (right) – Cracking at the contact of the Zone J core and the upstream dam shell.

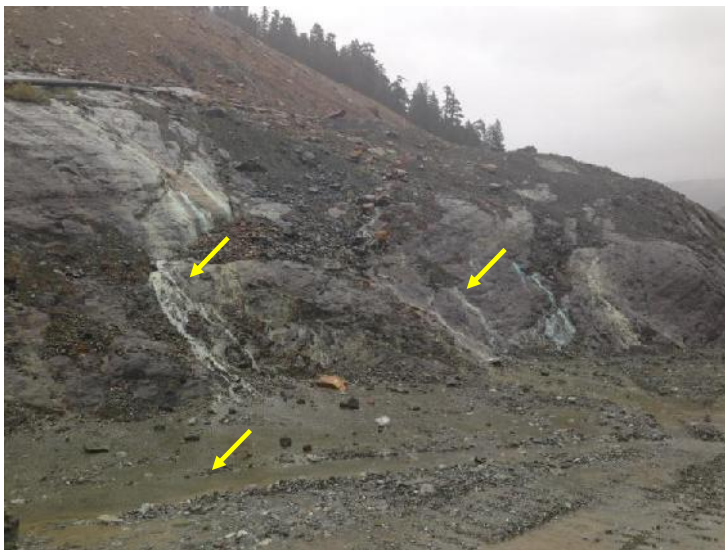
Photo 29 – Springs and surface runoff coming from the rock wall at the back Lynx Pit, looking northeast. Water reporting on the top of Lynx Springs platform.

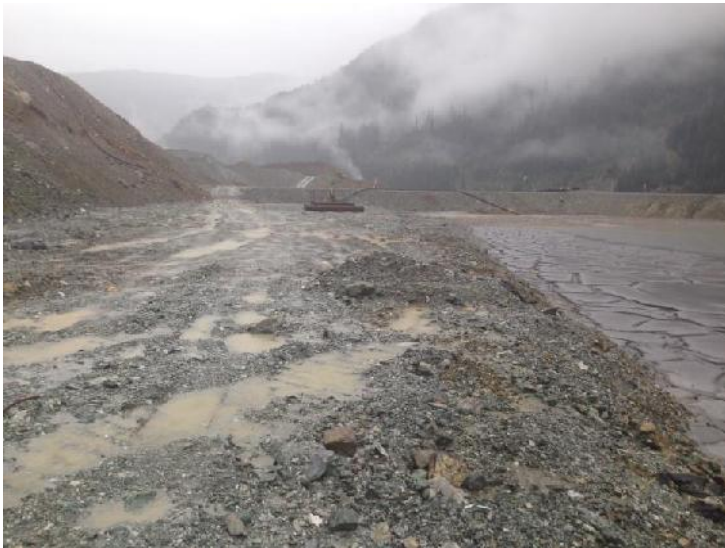
Photo 30 – Several puddles on top of Lynx Springs Drain platform, looking east.

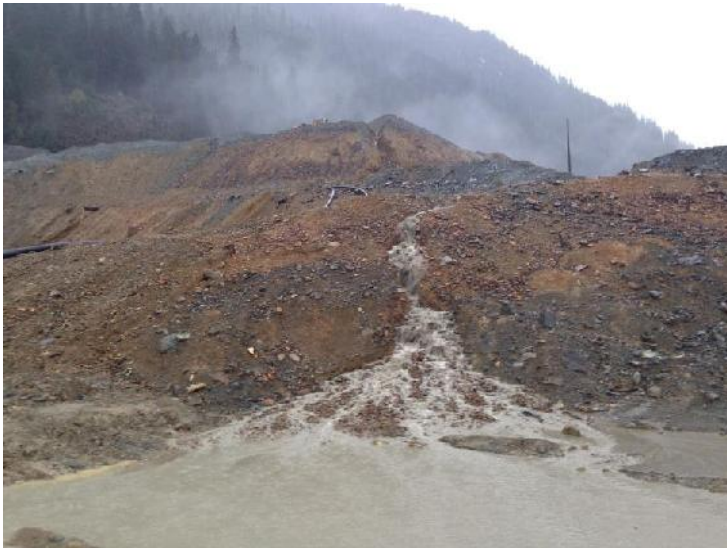
Photo 32 – Uncontrolled surface runoff coming from haul roads into Superpond outlet area.

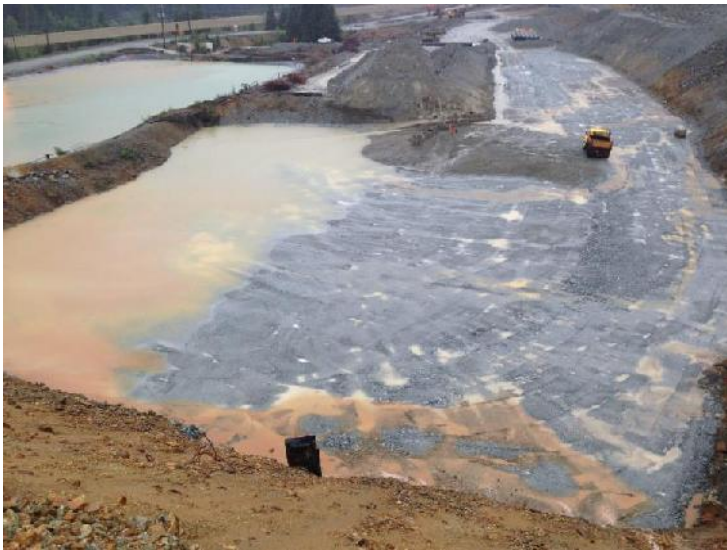
Photo 33 – South/east area of Lynx Dam foundation panels flooded.

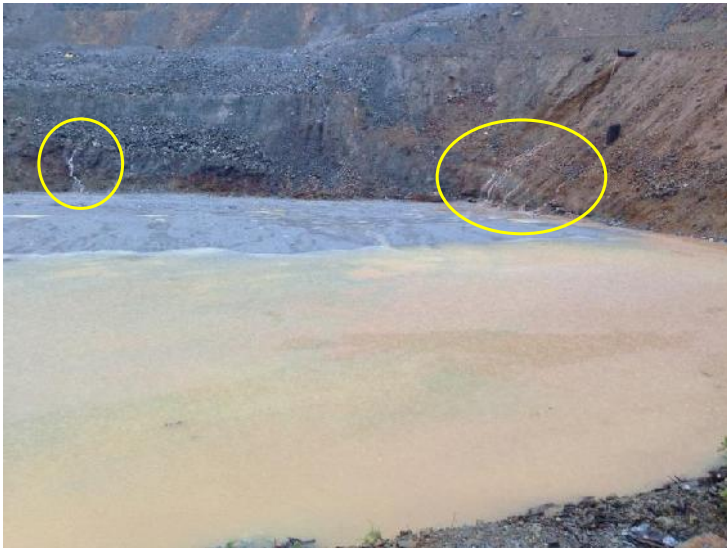
Photo 34 – Eastern area of Lynx Dam foundation panels flooded, looking north (seeps circled).

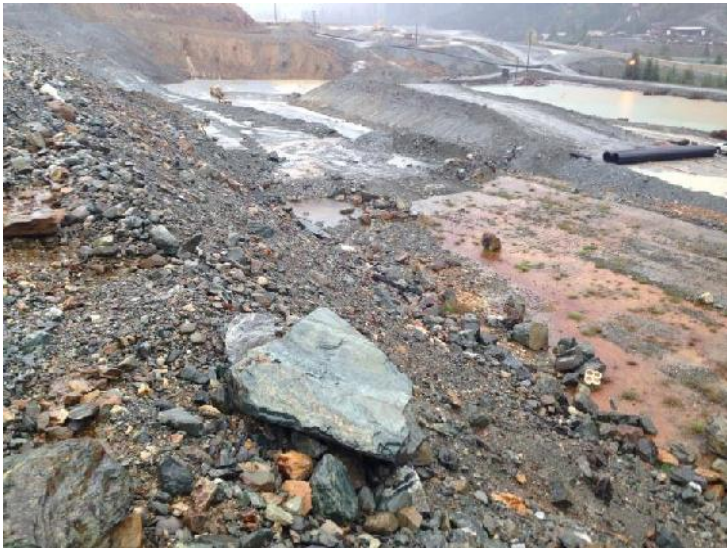
Photo 36 – Seepage and surface runoff on Lynx Dam mid-level bench (in foreground) and Lynx Dam foundation panels area, Zone J stockpile and Super Pond (in background), looking southeast.

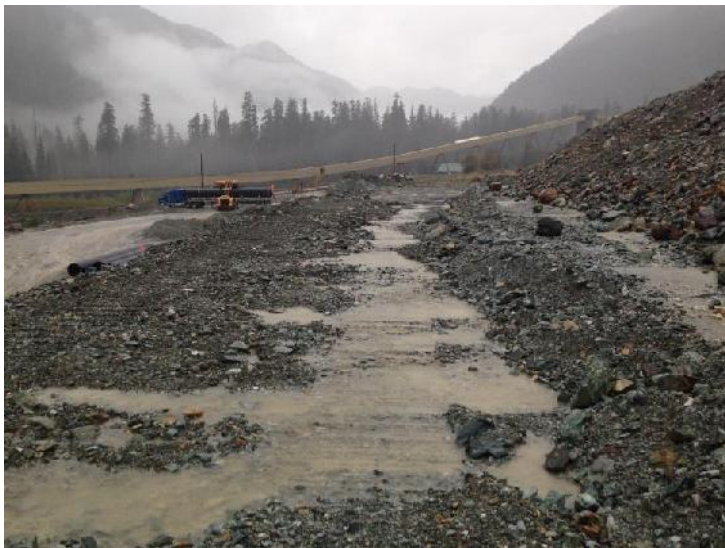
Photo 37 – Seepage and surface runoff on Lynx Dam mid-level bench, looking west.

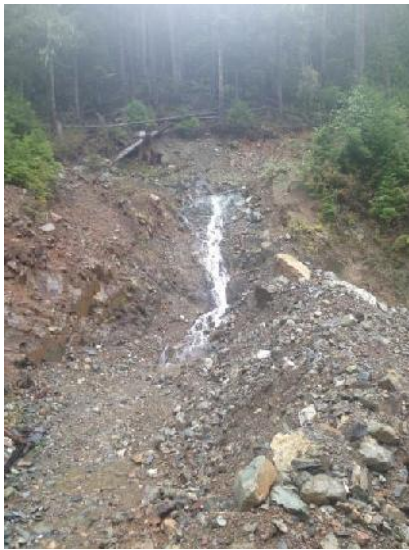
Photo 39 – Significant flow over the bedrock at the Arnica – Upper Lynx Diversion junction, infiltrating into ground and continuing into Lynx pit.

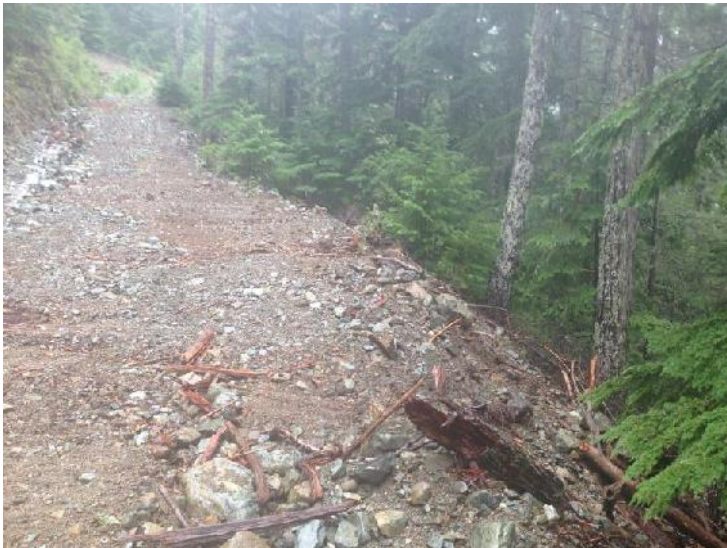
Photo 40 – Fill side-cast over wood and against trees during lower Arnica Reach repairs – side-cast material should be pulled back and used to increase freeboard by raising the road.

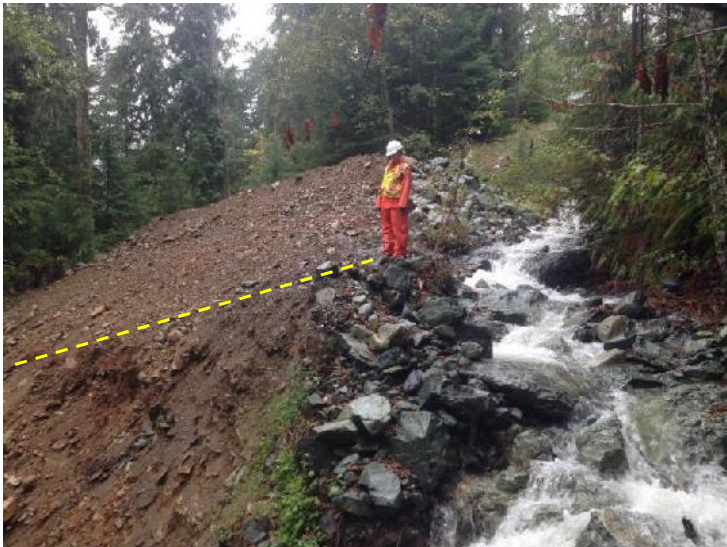
Photo 41 – Re-graded slope and remaining steep slope (above/below dashed line) at the slide area at the east end of the Upper Lynx Diversion Ditch. Additional pullback is recommended.

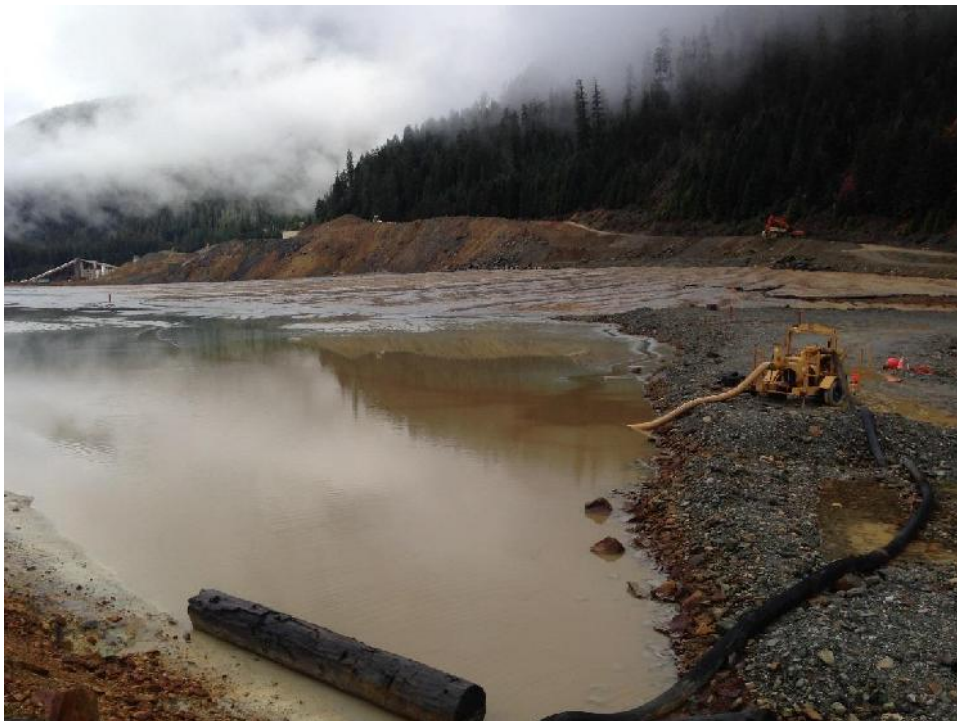
Photo 2 – Ponding in the southeastern corner of the APA, looking northwest (pumps running on 2015-10-30).

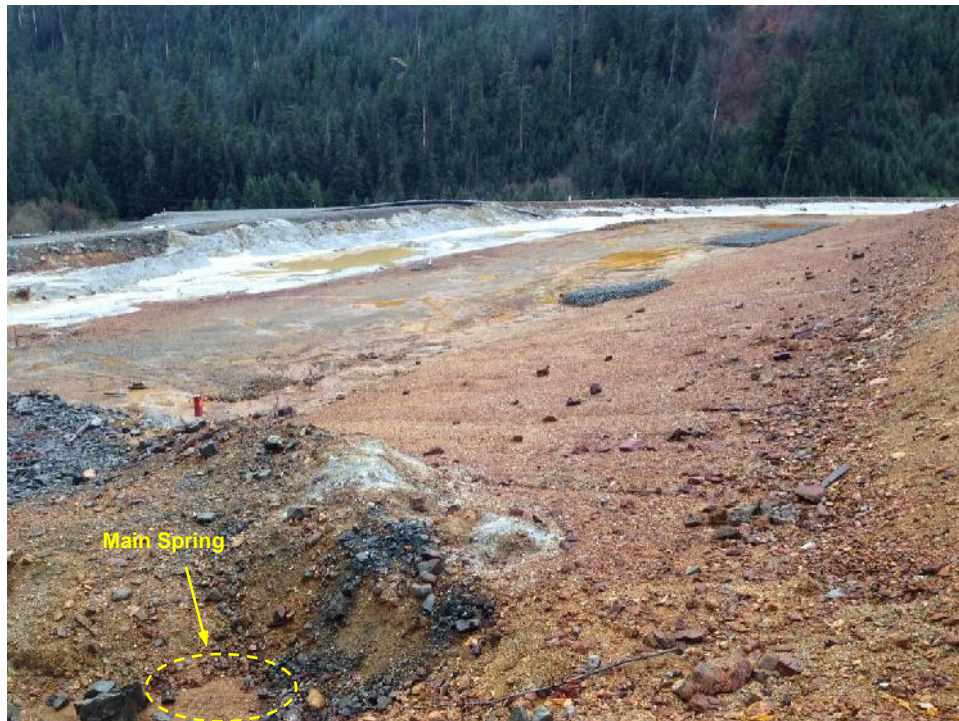
Photo 5 – East abutment of the Old TDF and seepage areas along the toe of the APA Paste Berm, looking south.

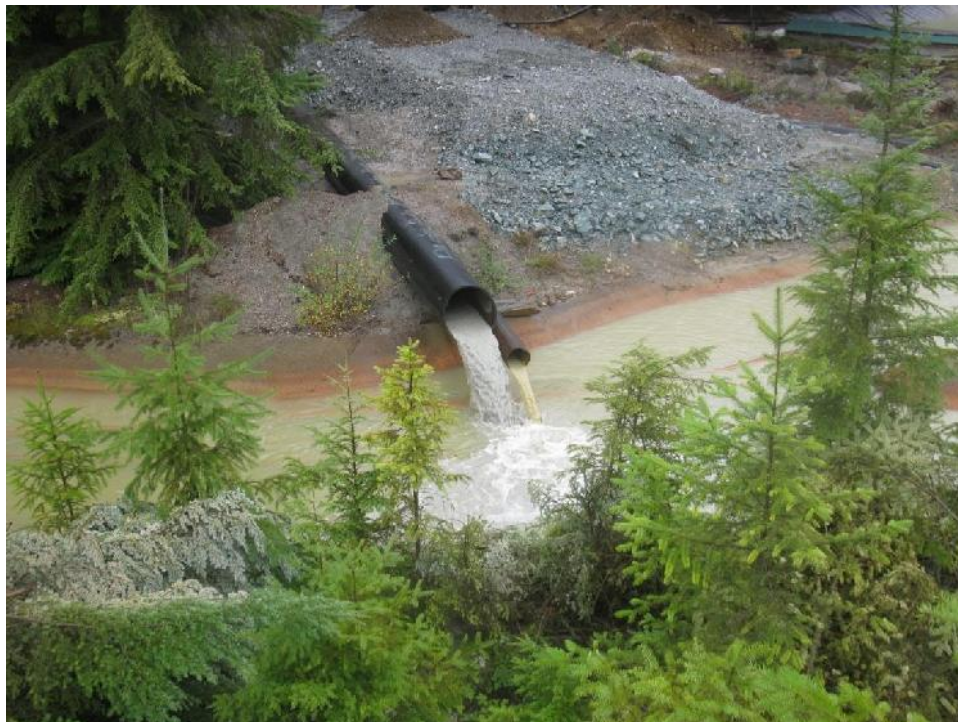
Photo 14 – Turbid water coming out of the APA (large diameter) and the RSA (small diameter) decant lines.

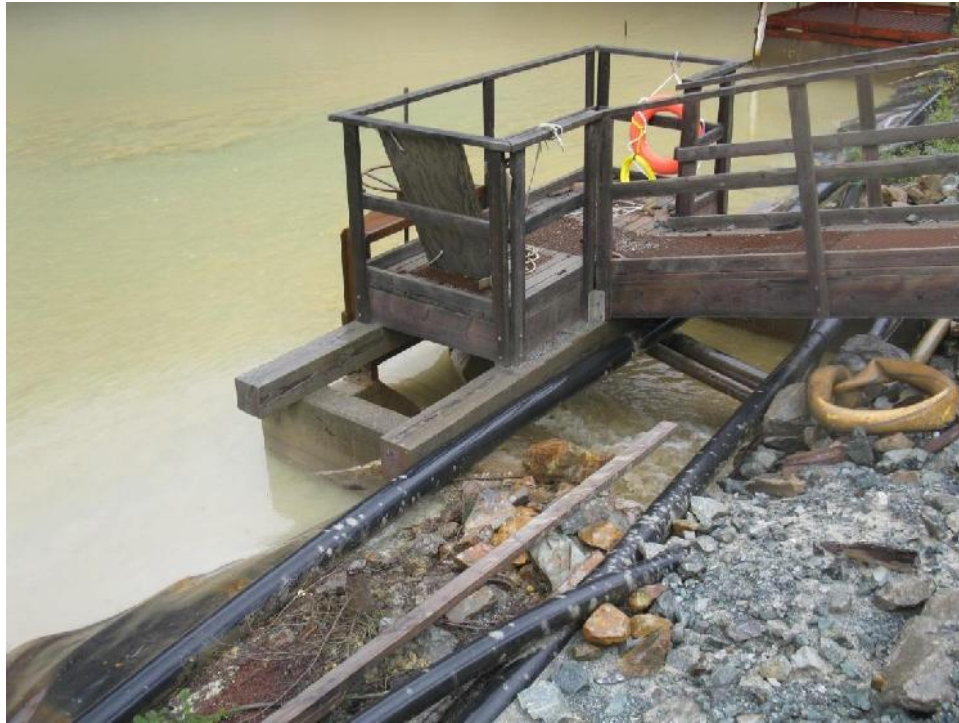
Photo 15 – Turbid water entering the Super Pond outlet.

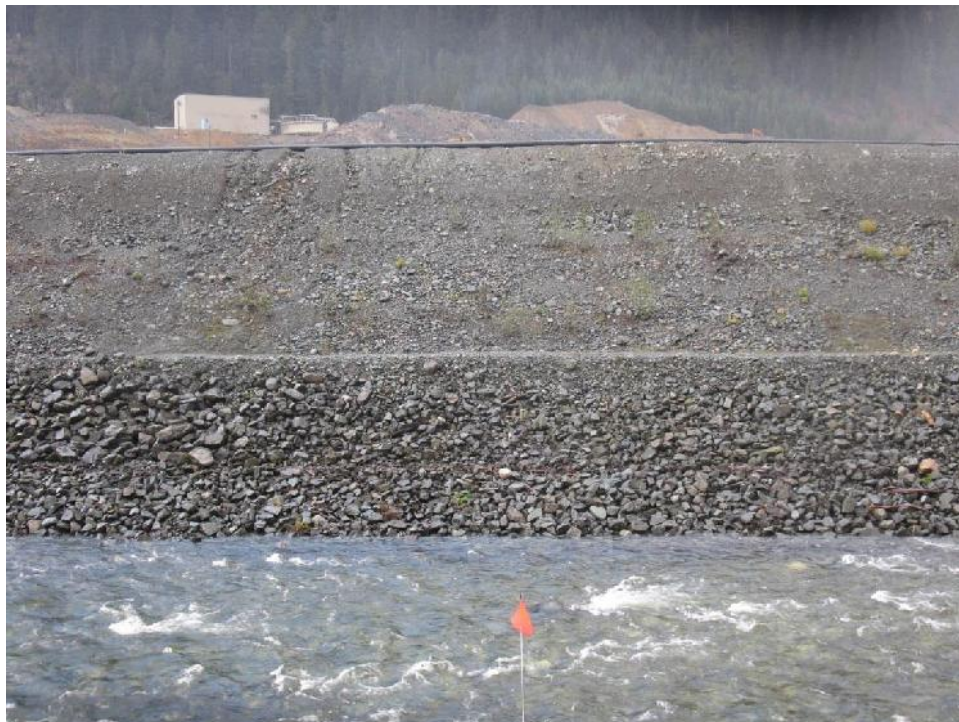
Photo 16 – Minor erosion rills on the 2:1 slope of the Seismic Upgrade Berm at approximately Station 0+200, looking north..

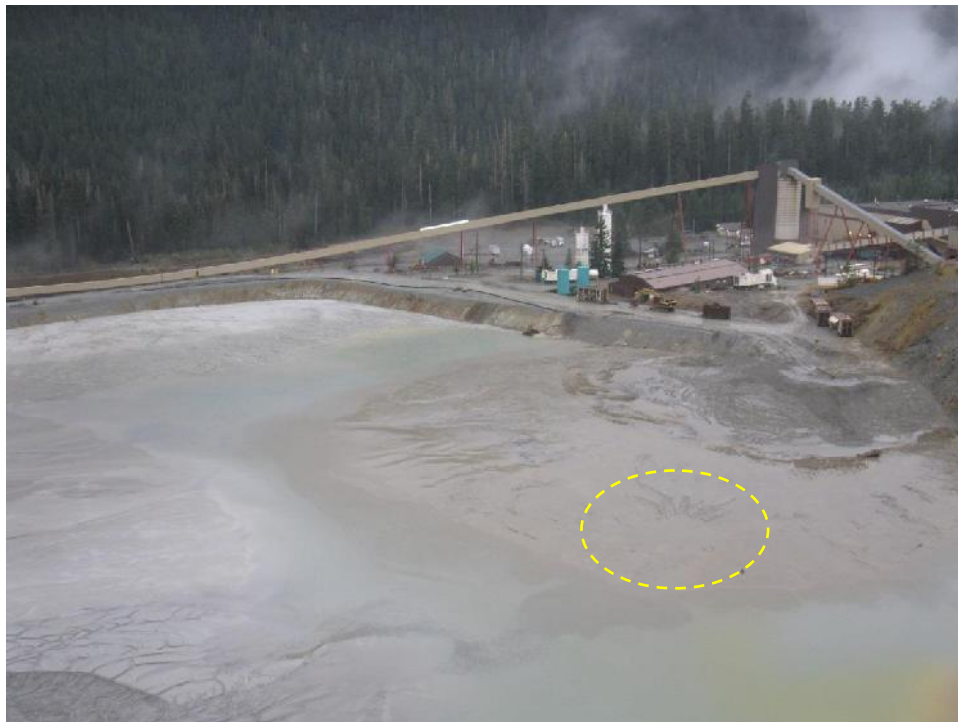
Photo 18 – Overview of the west part of Lynx TDF, looking southwest. The circled area corresponds to the location of the recurrent depression on the tailings surface.

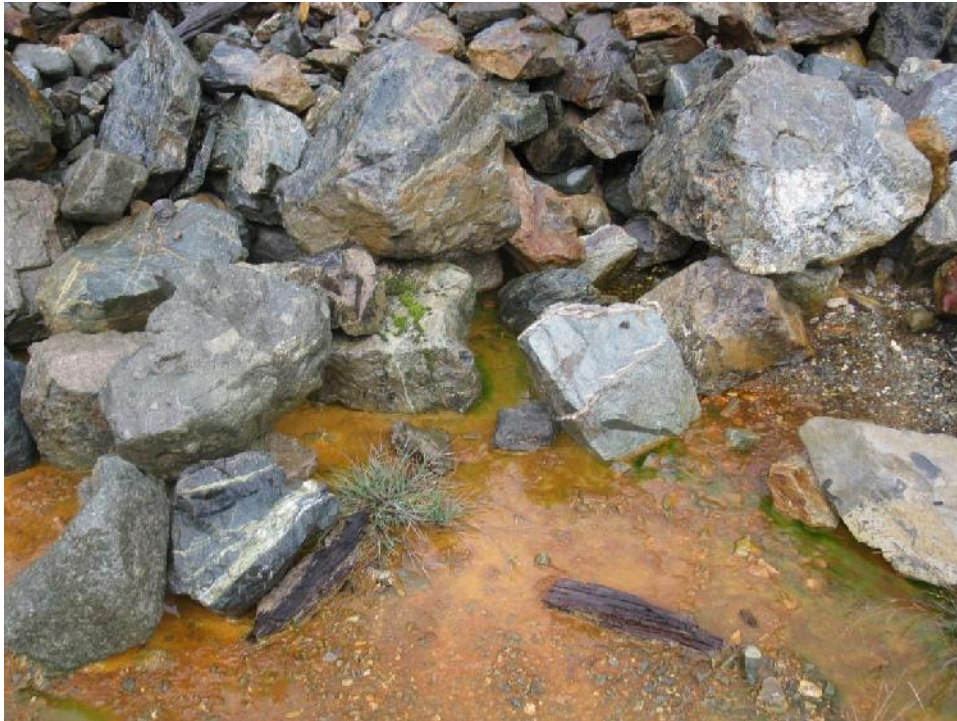
Photo 25 – Close-up view on a seepage location source on the mid-level bench of Lynx Dam south arm.

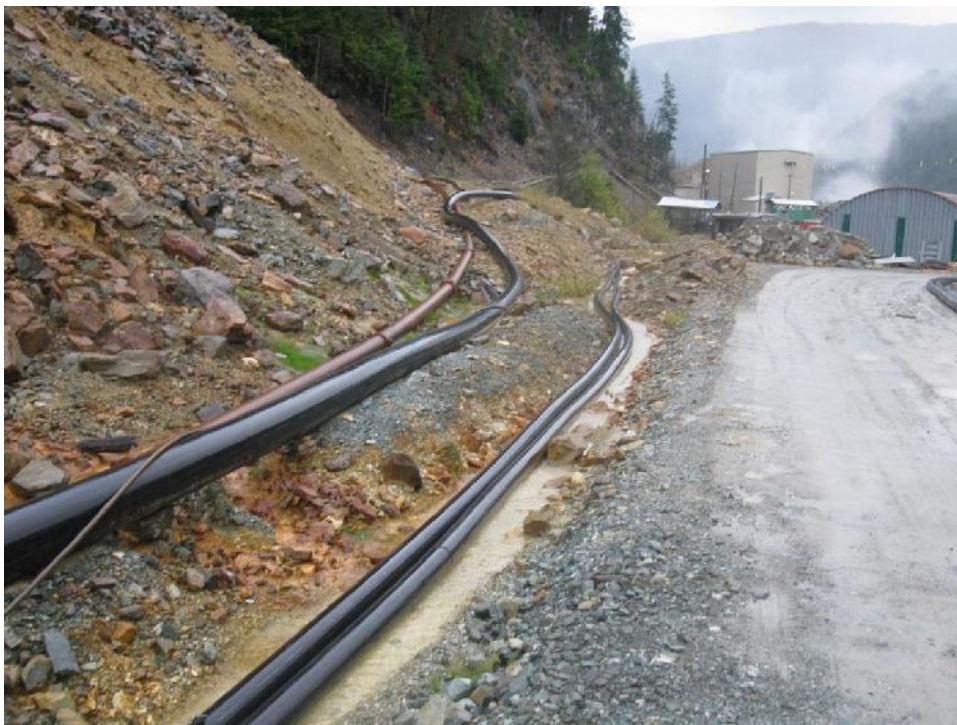
Photo 26 – Seepage and surface runoff collection along the access road at the back of Lynx TDF, looking east. Flow is collected near the Paste Plant (in the background).

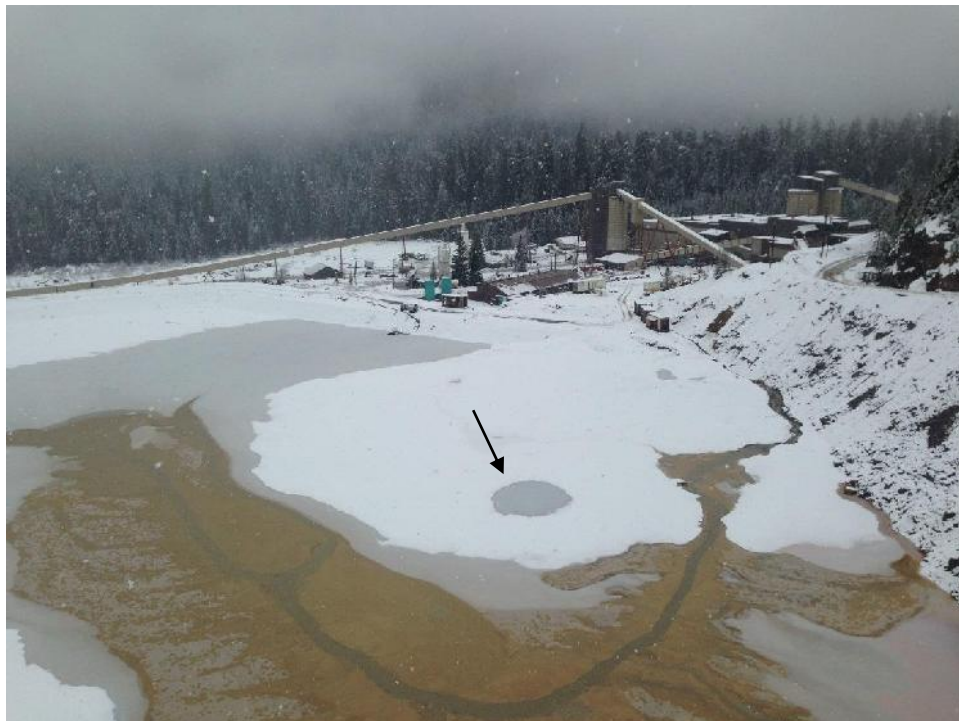
Photo 2 – Lynx TDF, looking southwest. The recurrent depression is visible in the edge of the mud wave, at the arrow.

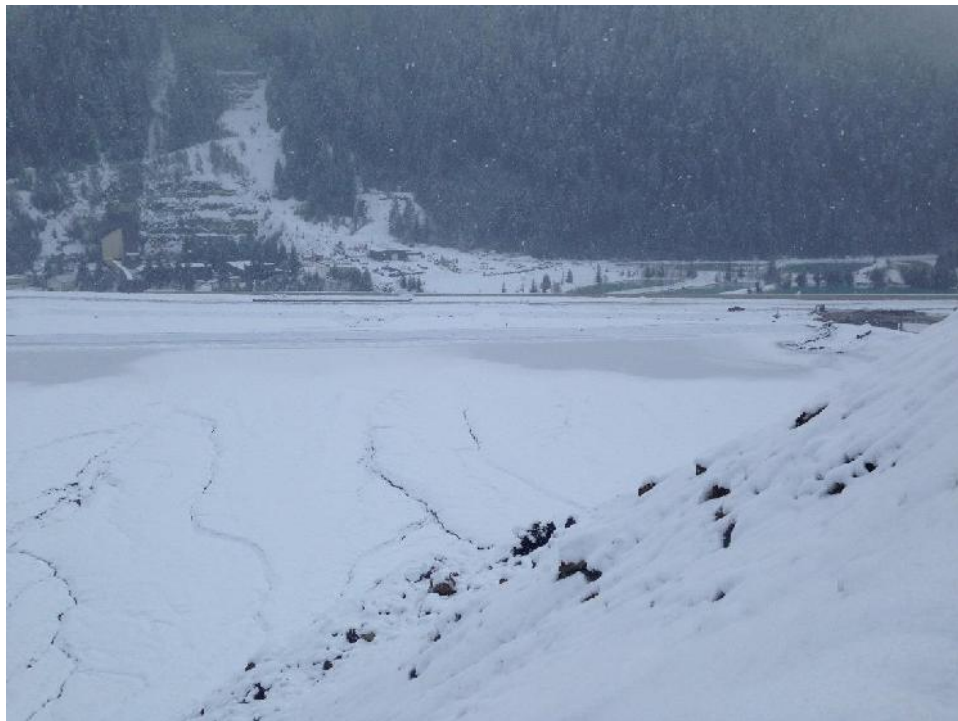
Photo 5 – West arm of Lynx dam, looking south.

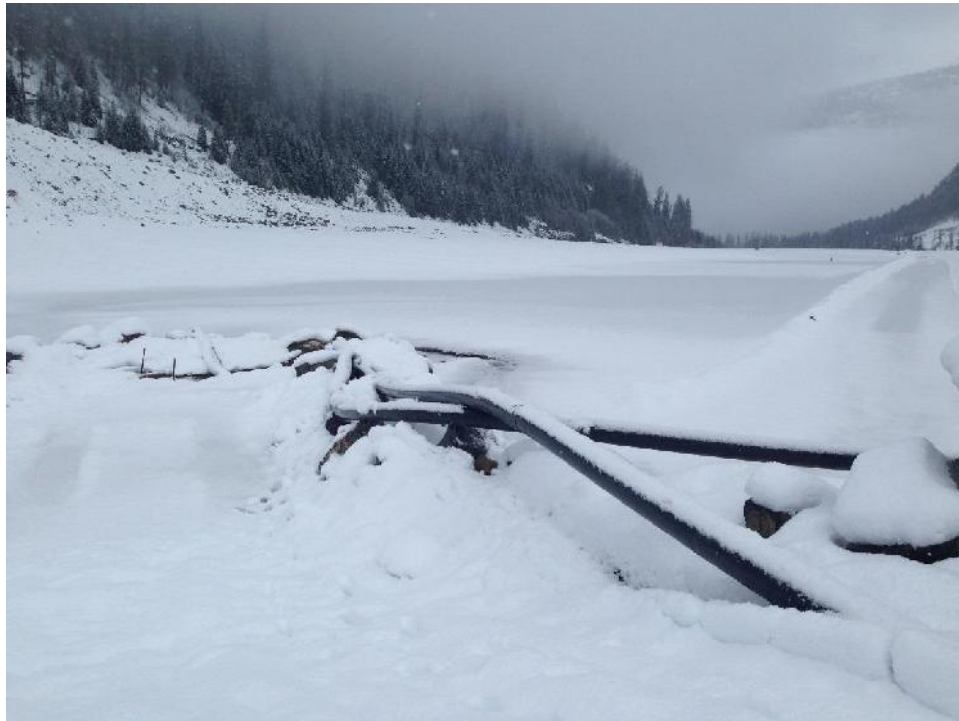
Photo 6 – West portion of the APA, looking south.

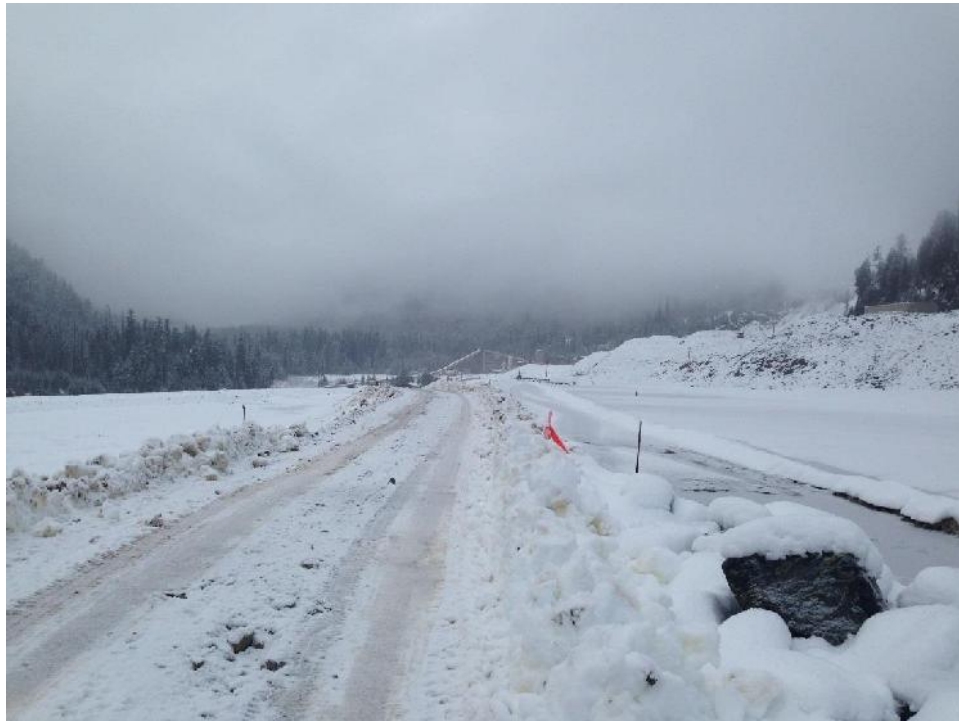
Photo 8 – Looking down the APA decant structure.

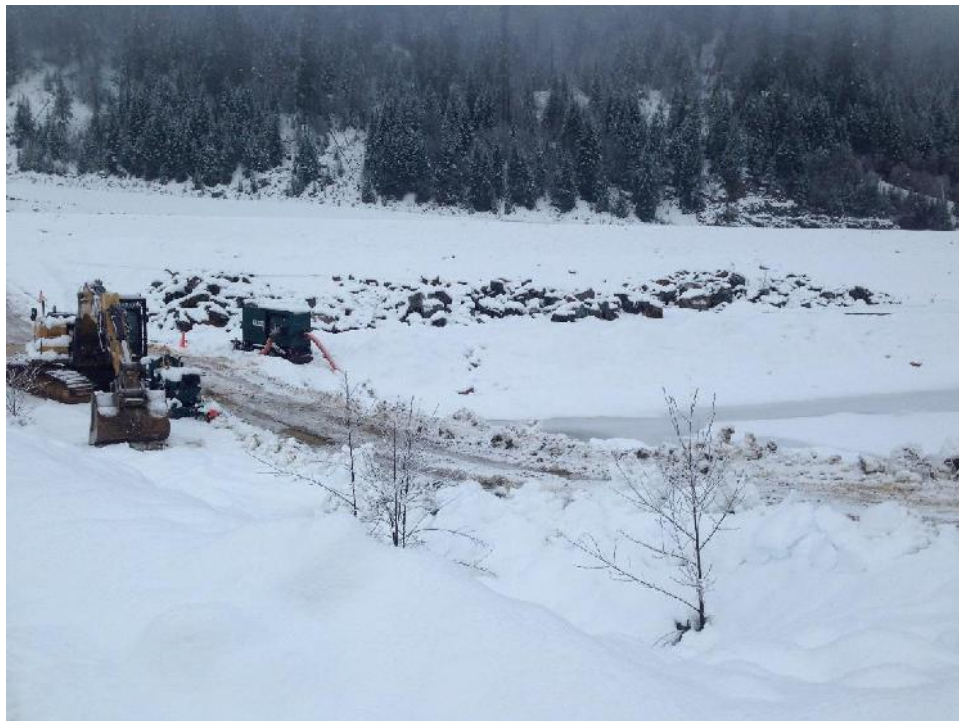
Photo 9 – APA Paste Berm near the APA operations spillway, looking west.
