**MYRA FALLS TAILINGS STORAGE FACILITIES
2015 DAM SAFETY INSPECTION REPORT**

31 March 2016

Amec Foster Wheeler File: NX14001B

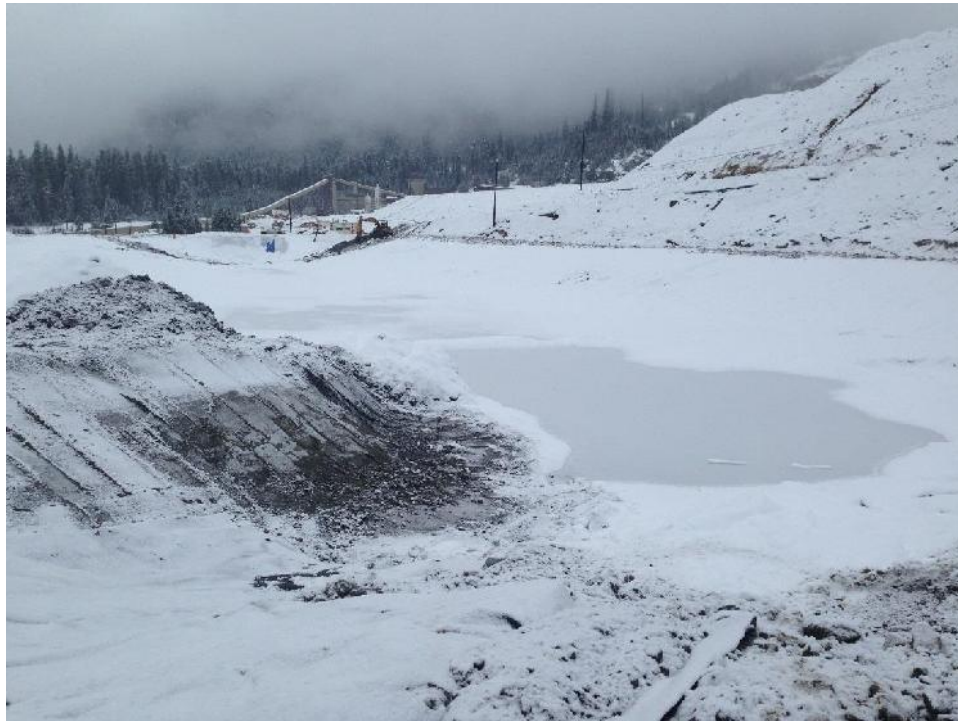
Photo 14 – Temporary West Strip overflow channel, looking west towards the RSA.

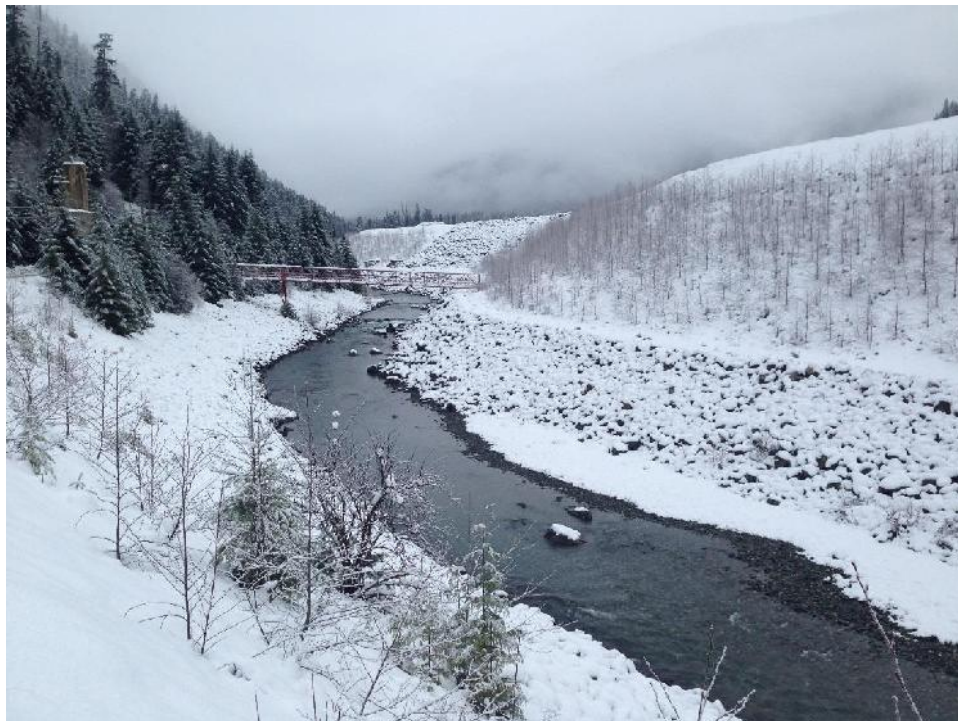
Photo 15 – Outlet of the temporary West Strip overflow channel and RSA, looking west.
