Appendix D – EOR Monthly Dam Inspections

Myra Falls Mine Tailings Facility Field Review Report

Date of Field Review:	21 January 2019	Date of Memo:	24 September 2019
File No.:	NX14001B1	Client:	Nyrstar Myra Falls Ltd.
Engineer:	Dan Hughes-Games, P.Eng.	To:	Keith Watson, P.Eng.
With:	n/a	Cc:	
Weather:	Sunny, few degrees below zero. Most of site in shade of Mt. Myra throughout the day. Discontinuous snow cover on site, particularly in the shade.

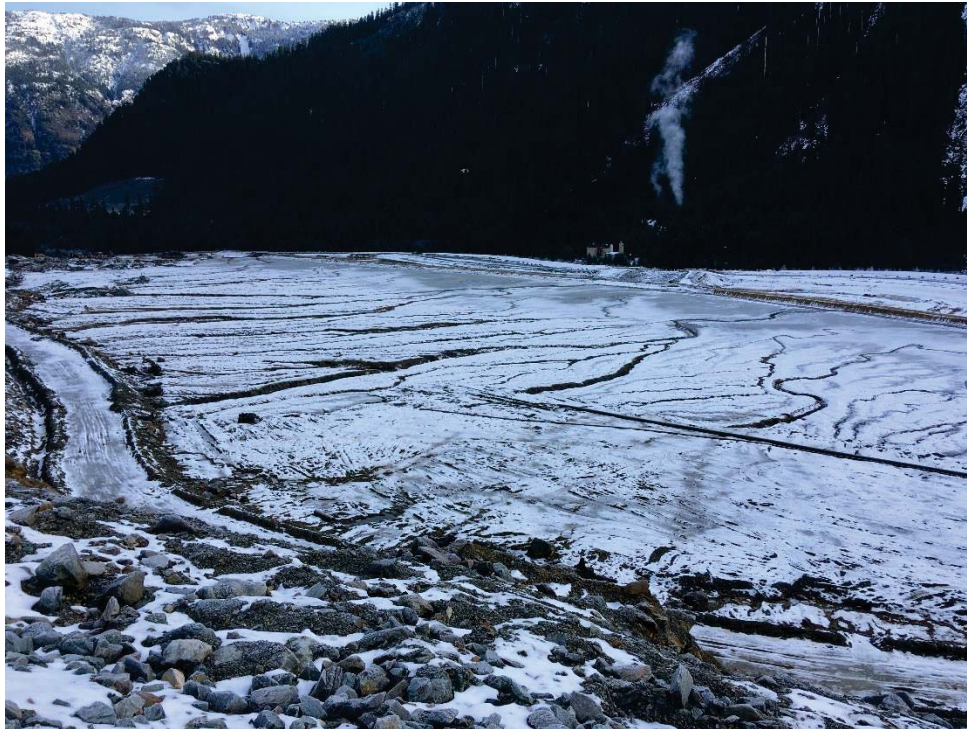
Photo 1: Overview of Old TDF

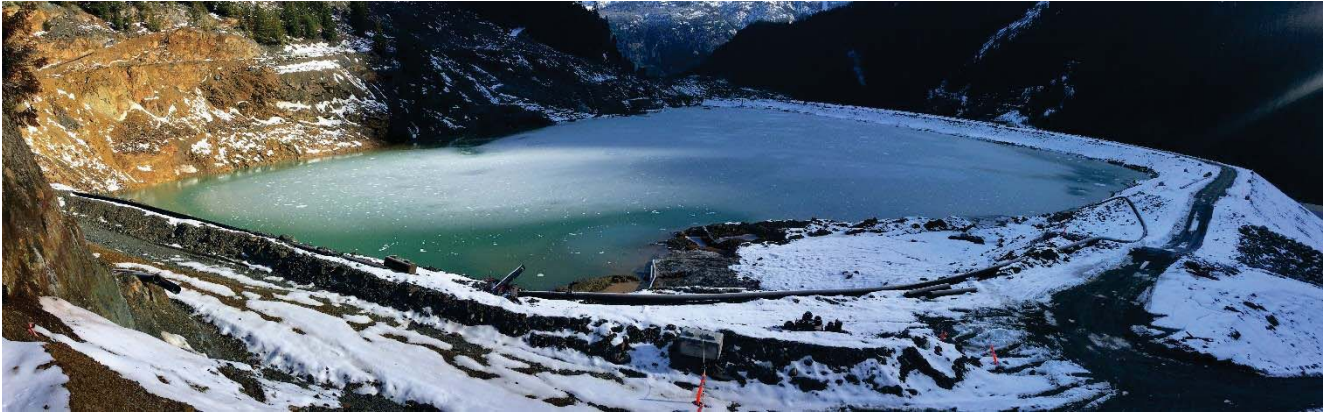
Photo 5: Panorama of Lynx TDF. Water level is about 1.5 m higher than normal.

- The Old TDF and Lynx TDF facilities were reviewed by Wood.
- Action Items:
 - Lower the water level in Lynx TDF, monitor pond levels with a staff gauge accurate to 1 cm.

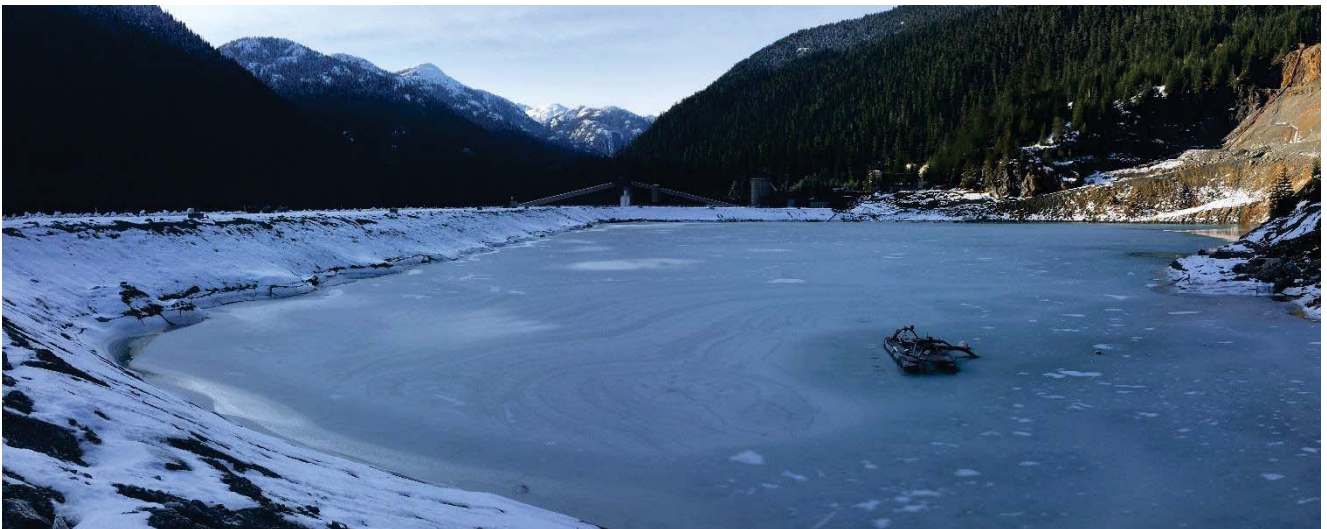
Photo 6: Panorama at pumping area. Note stranded ice on the upstream slope, indicating past higher water levels.

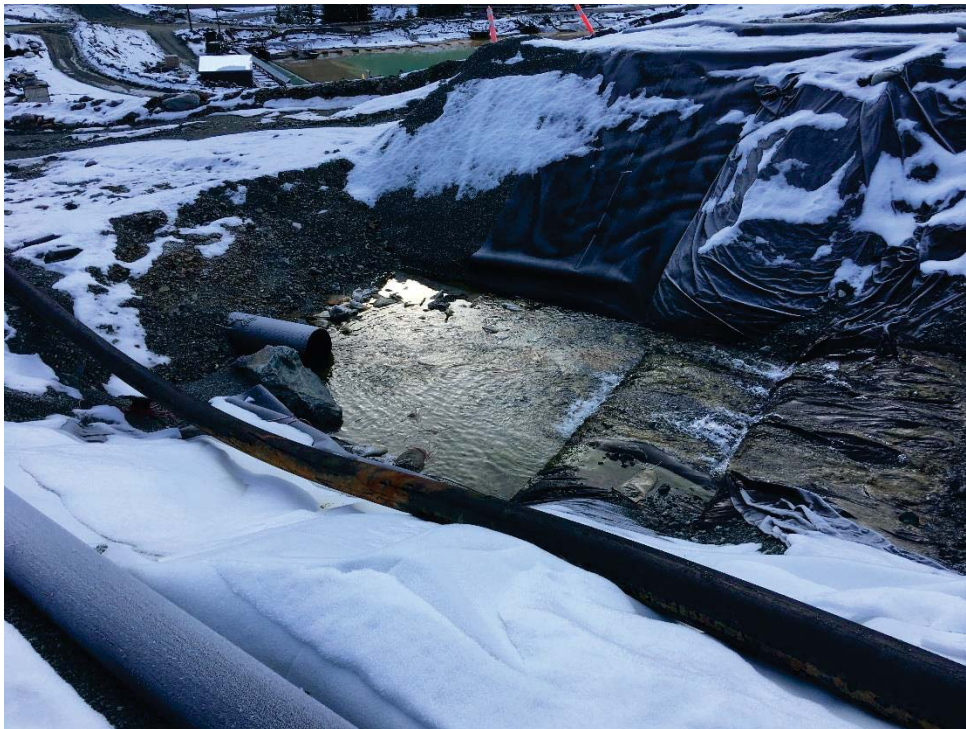
Photo 8: Moderate flow in the Lynx Spring Drain

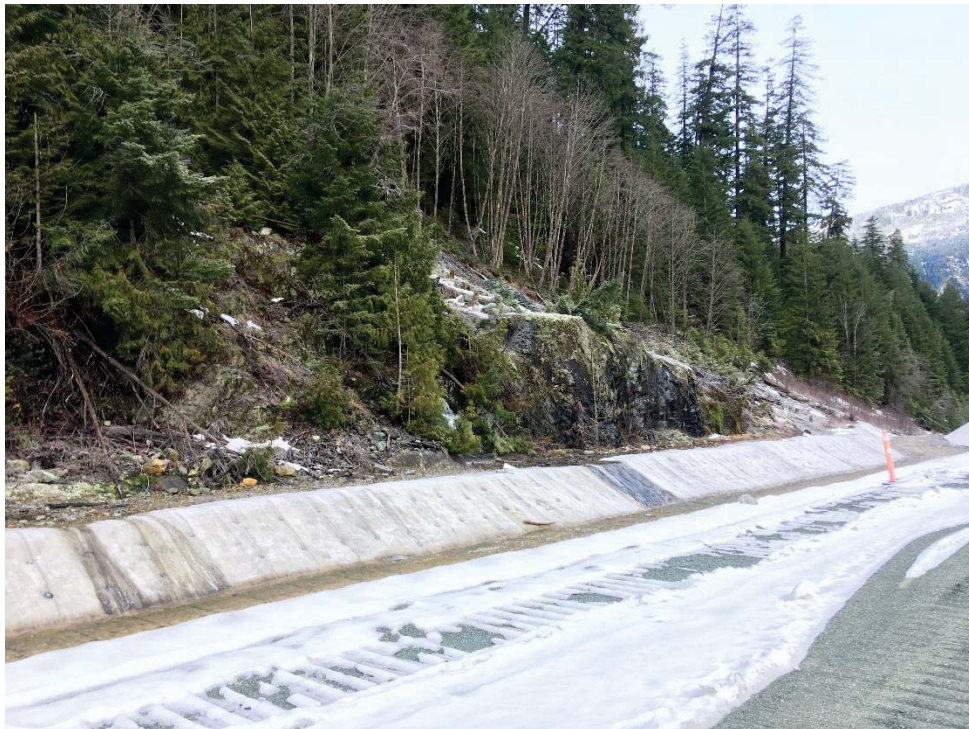
Photo 10: LLDD at Alder Reach

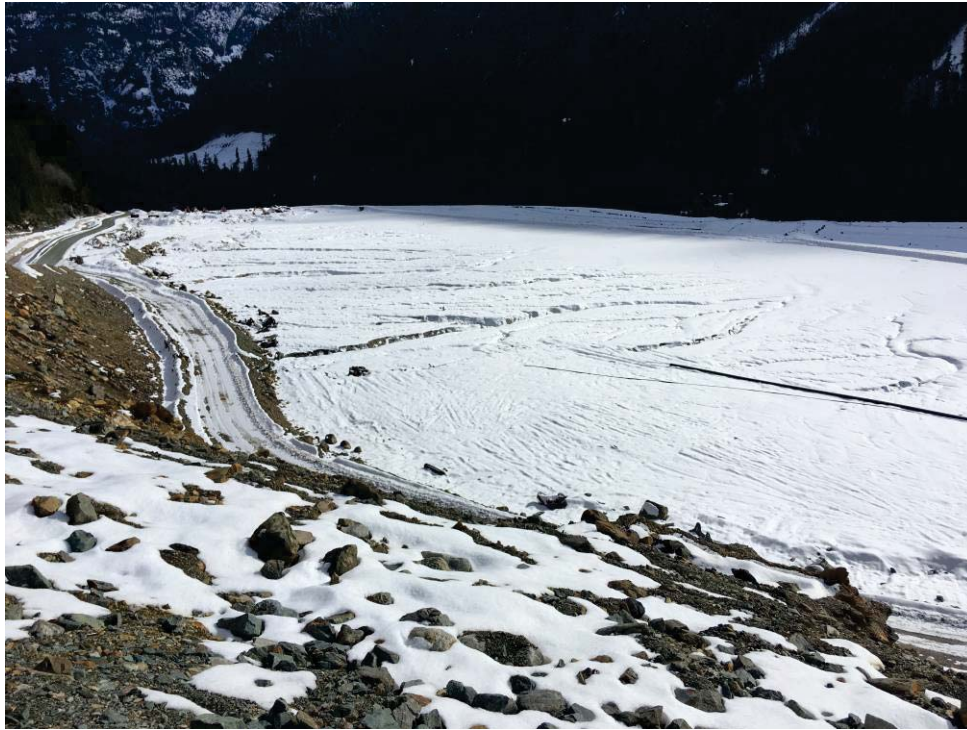
Photo 1: Overview of the APA

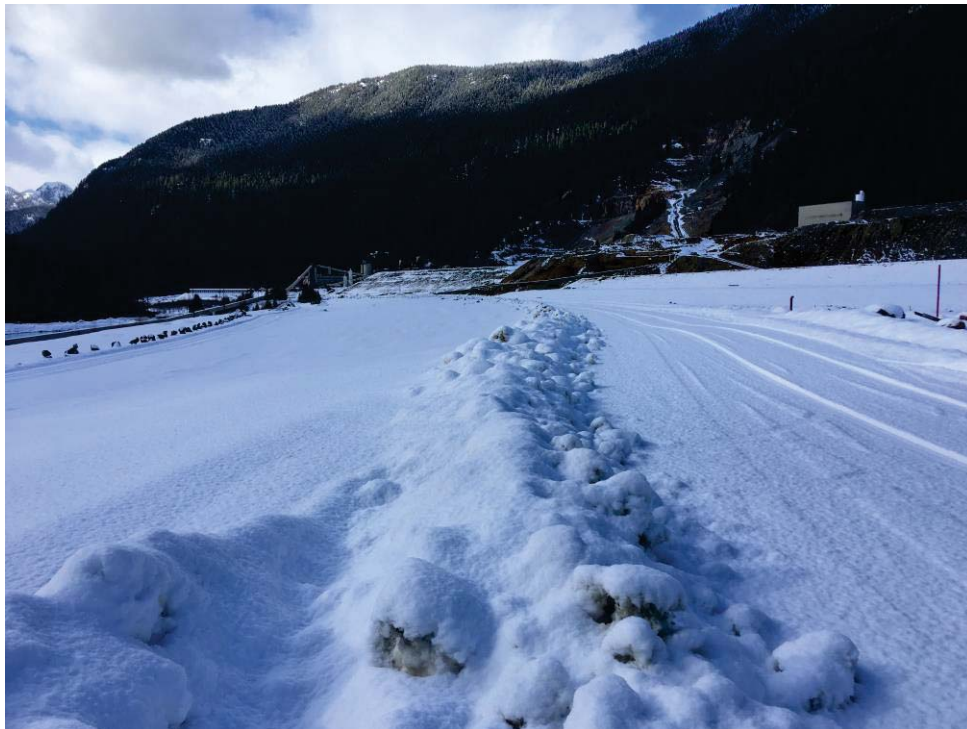
Photo 2: Old TDF looking west from the crest of the Seismic Upgrade Berm near the corner at about 0+650.

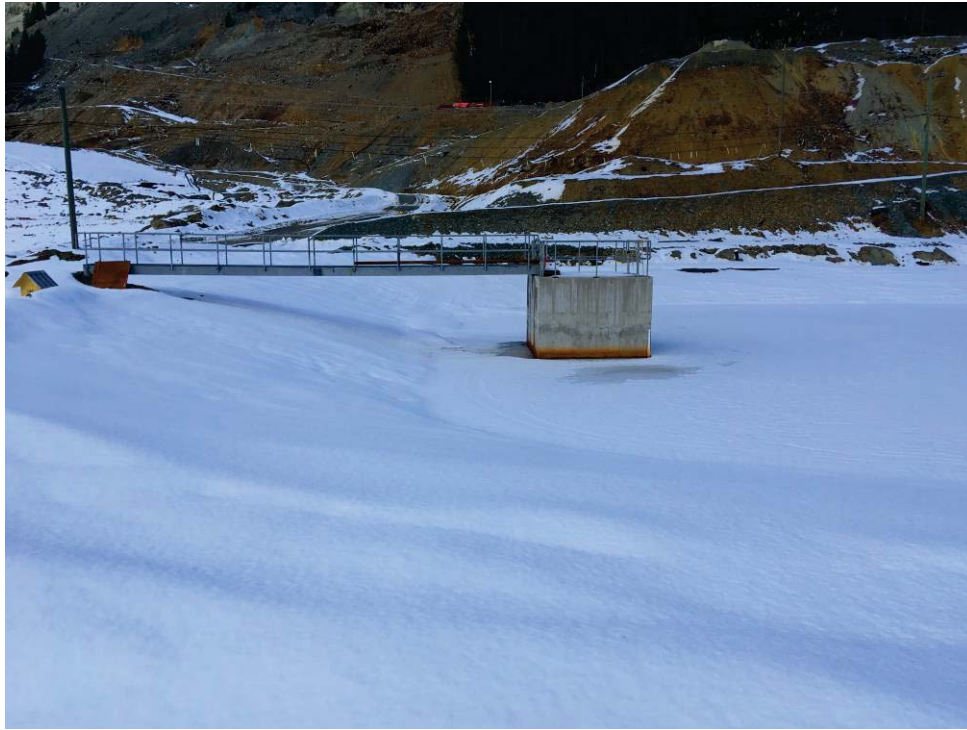
Photo 3: Old TDF Surge Pond decant with ice-covered pond. Water level is at design normal operating level for low flows.

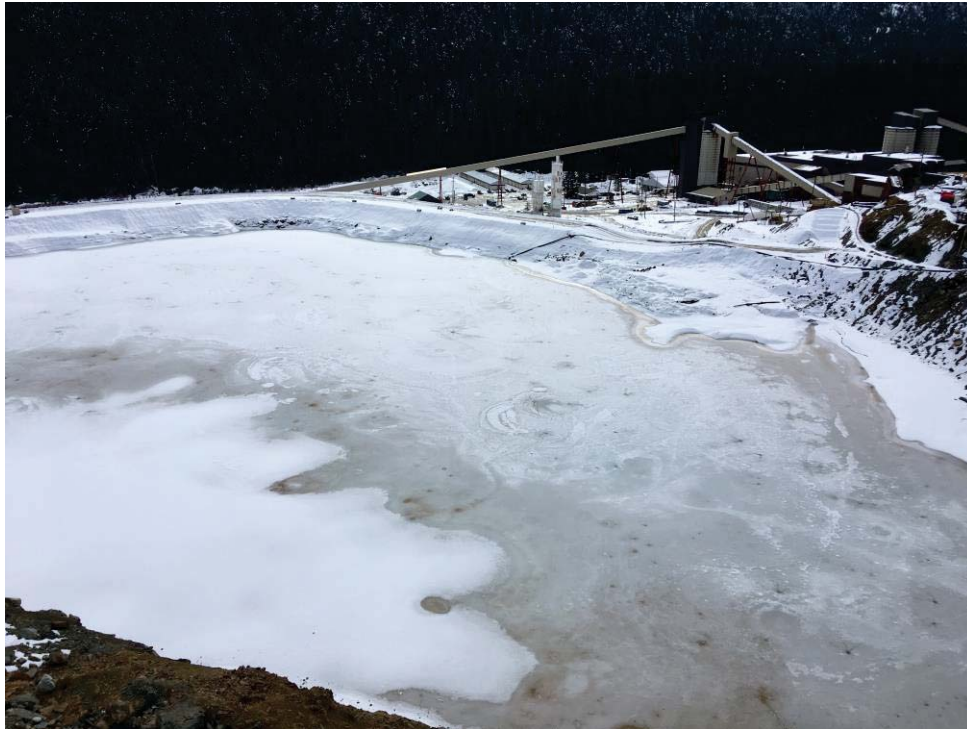
Photo 5: Ice covered Lynx TDF as viewed from the highwall.

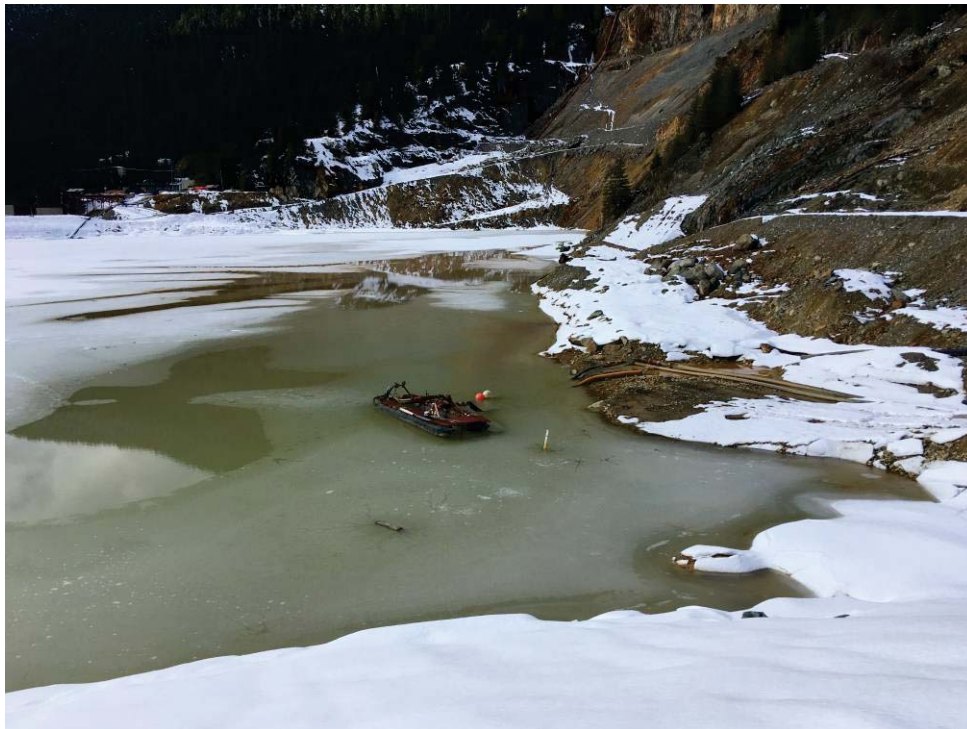
Photo 6: Lynx TDF pumping area at the east abutment. Water level is nominally around target levels for pumping.

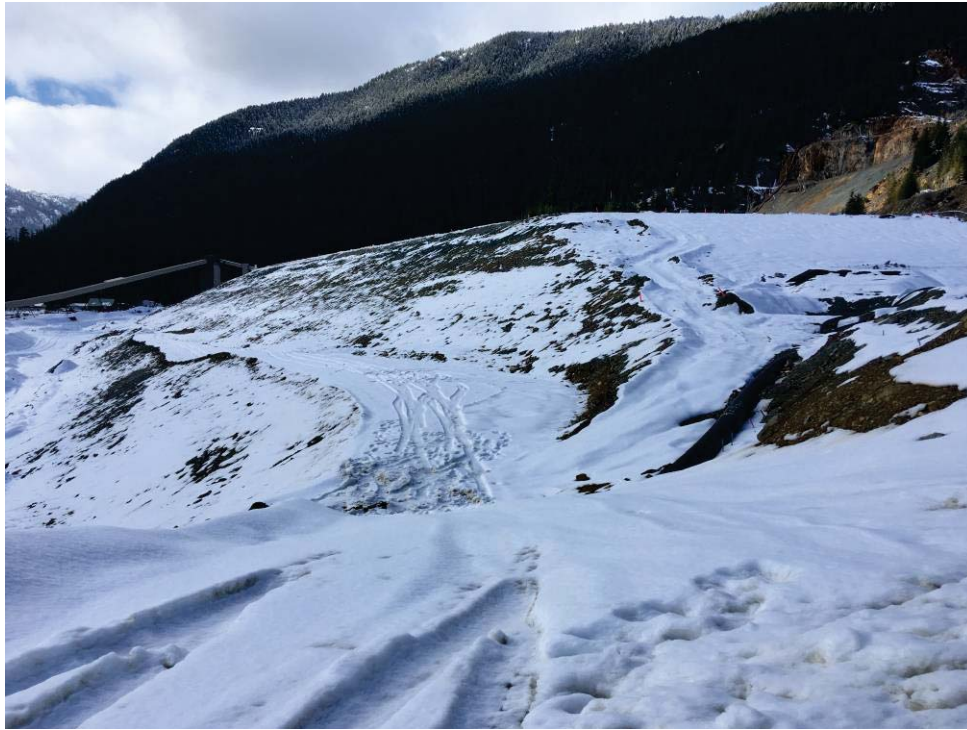
Photo 7: Downstream south face of Lynx TDF

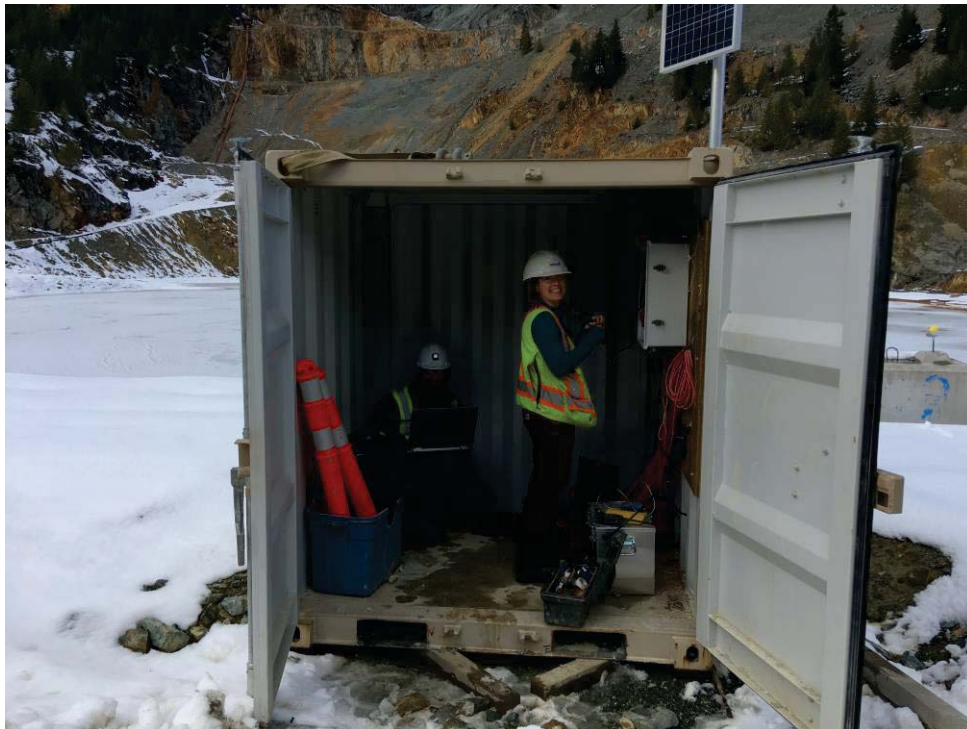
Photo 8: Instrumentation maintenance work in the Lynx Hut.

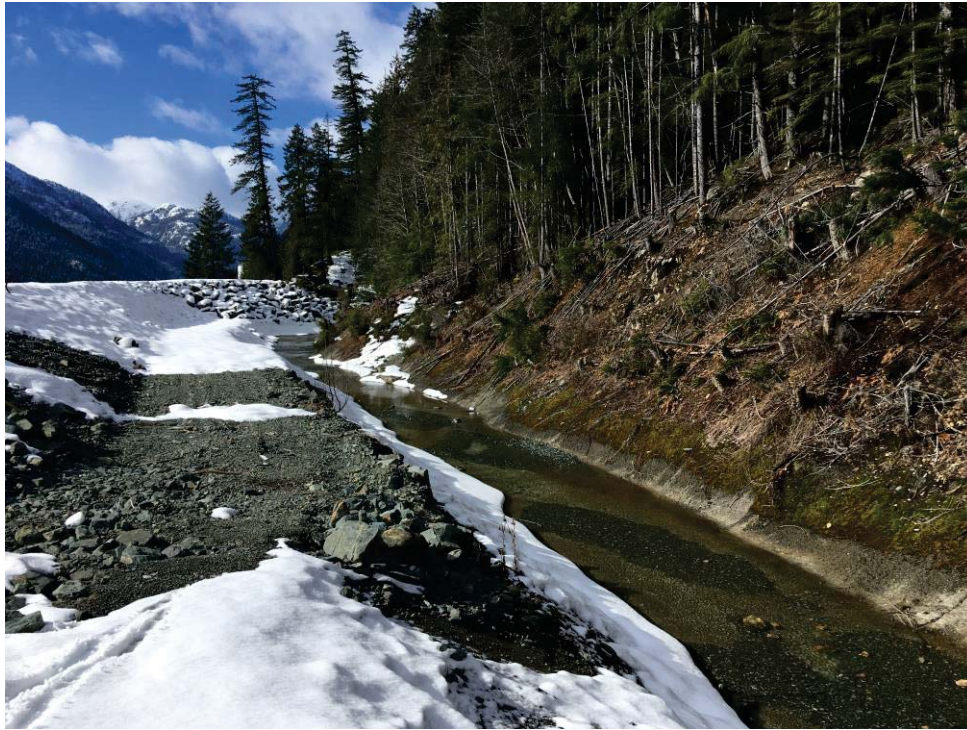
Photo 9: LLDD debris basin clear of accumulation.

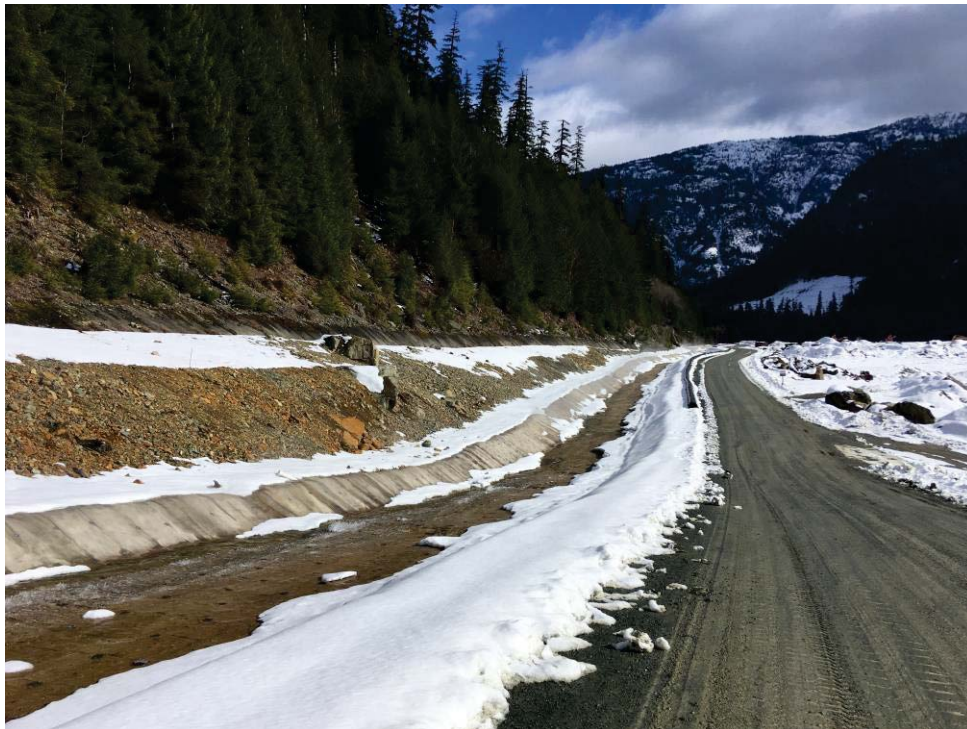
Photo 10: Minor ice and snow in the LLDD channel.

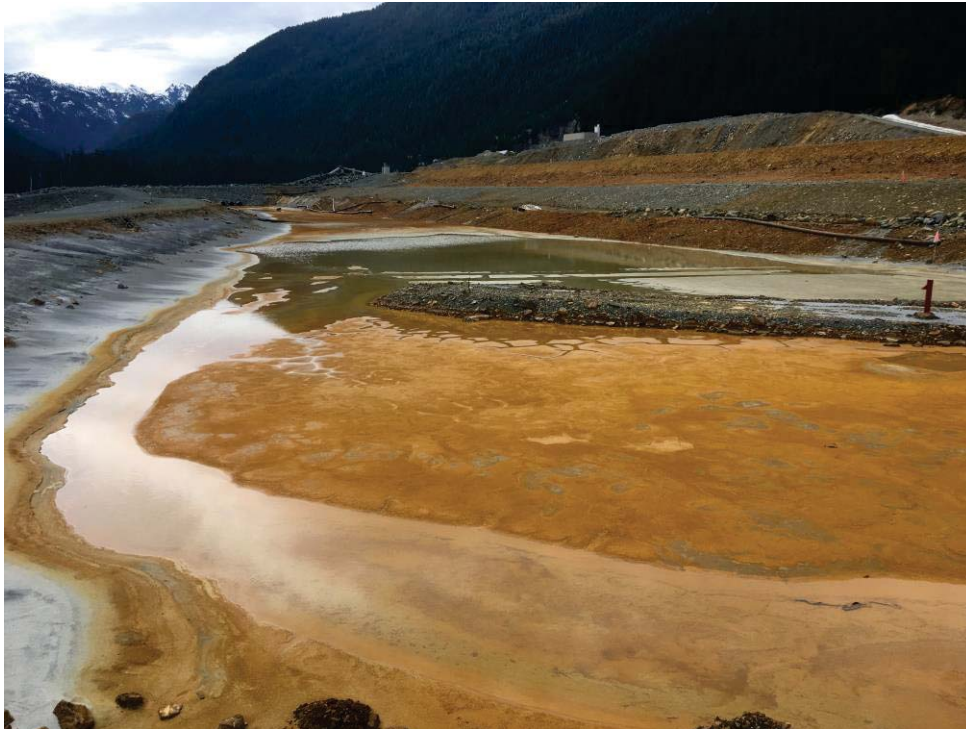
Photo 1: Old TDF – East Strip looking west from the corner.

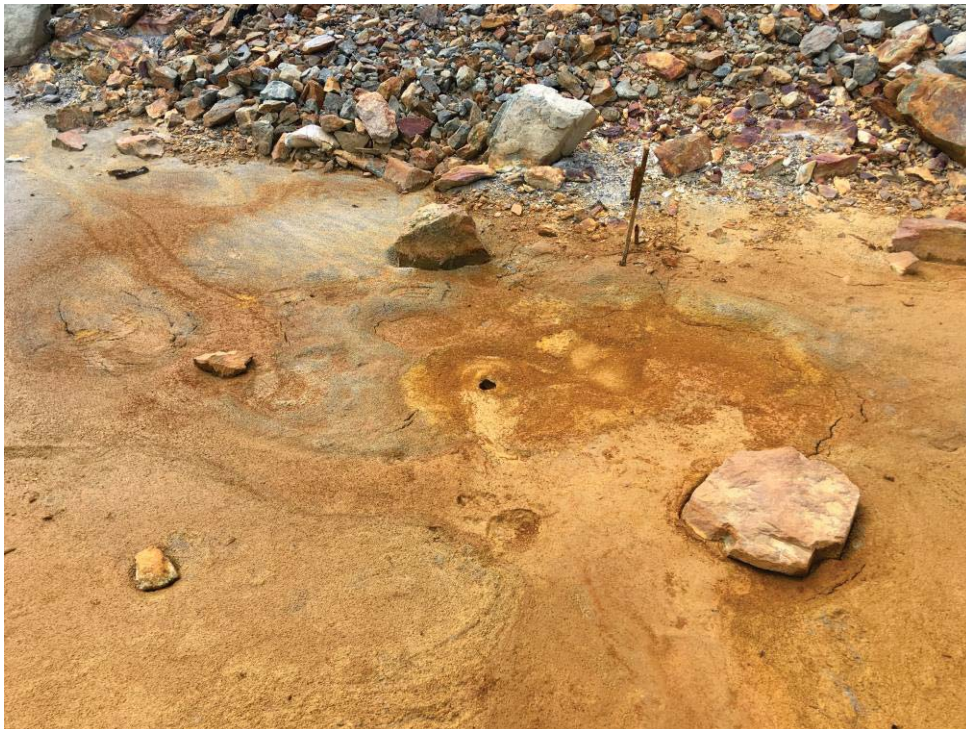
Photo 2: East Strip boils are dry. Some indication that flow may have reversed, with these springs acting as sinks.

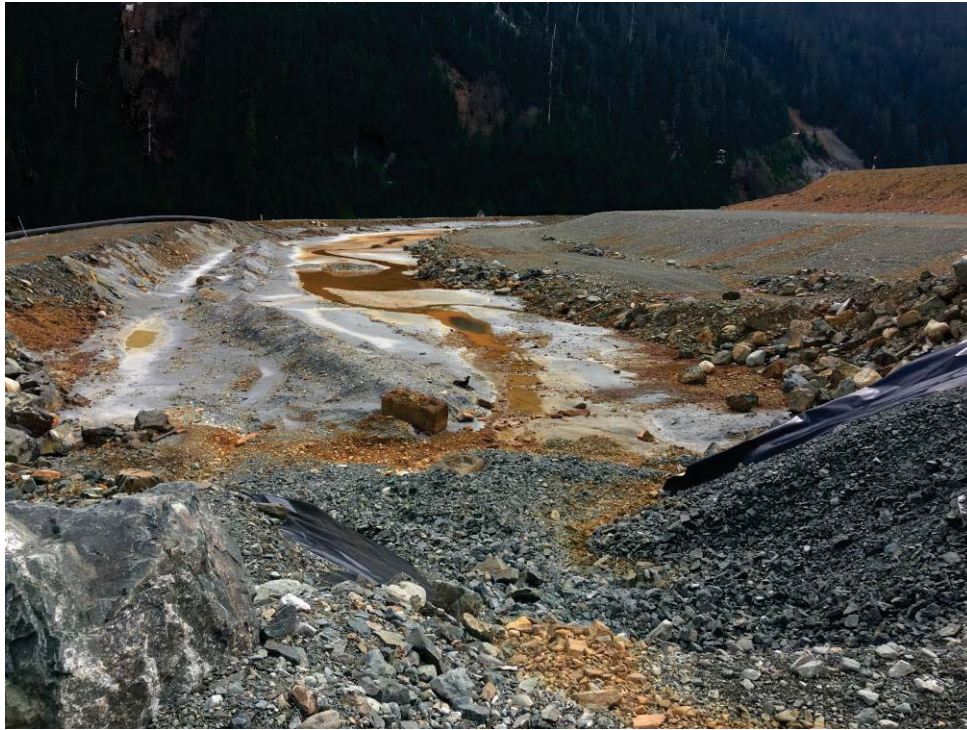
Photo 3: East Strip viewed from the DDSD outlet at the east abutment.

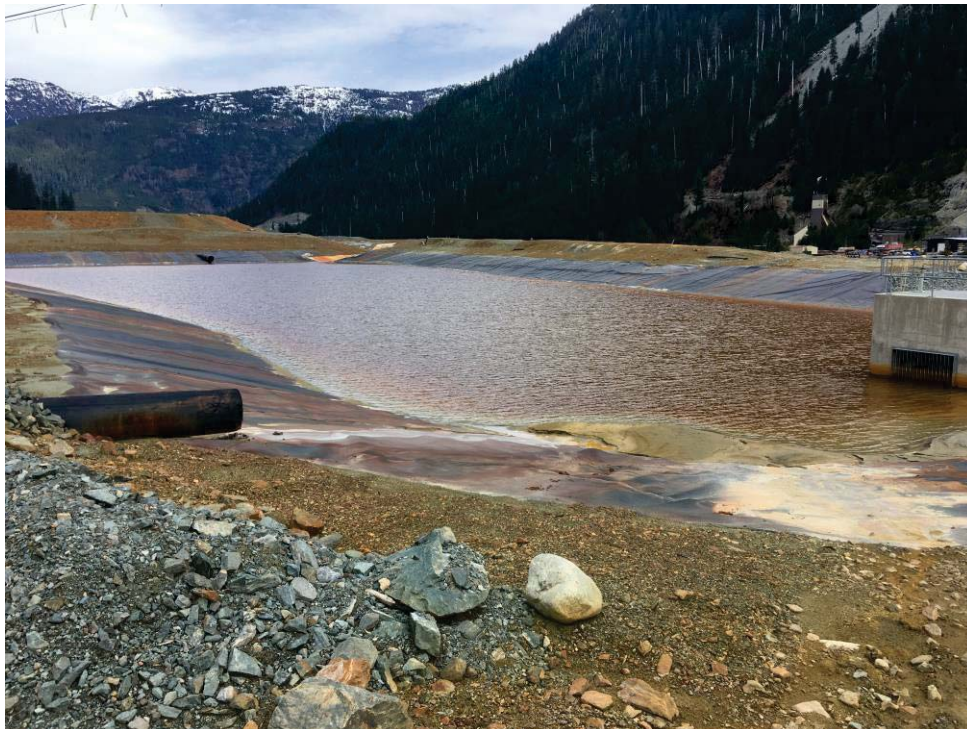
Photo 4: Old TDF Surge Pond, with water level at the design intent.

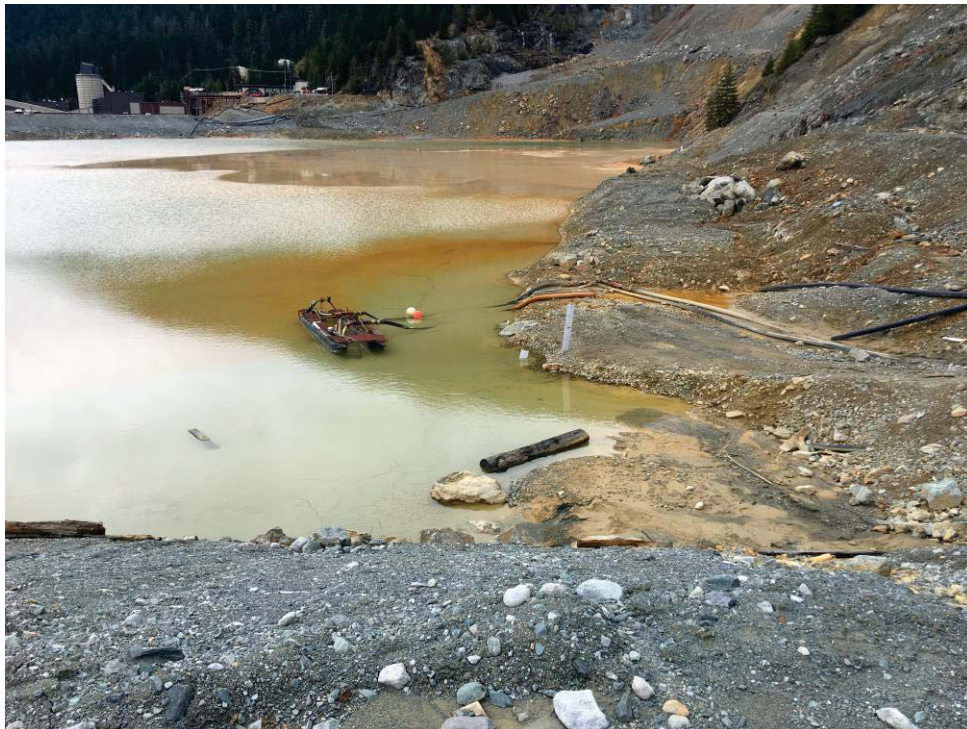
Photo 6: Pumping area in Lynx TDF, with new staff gauge.

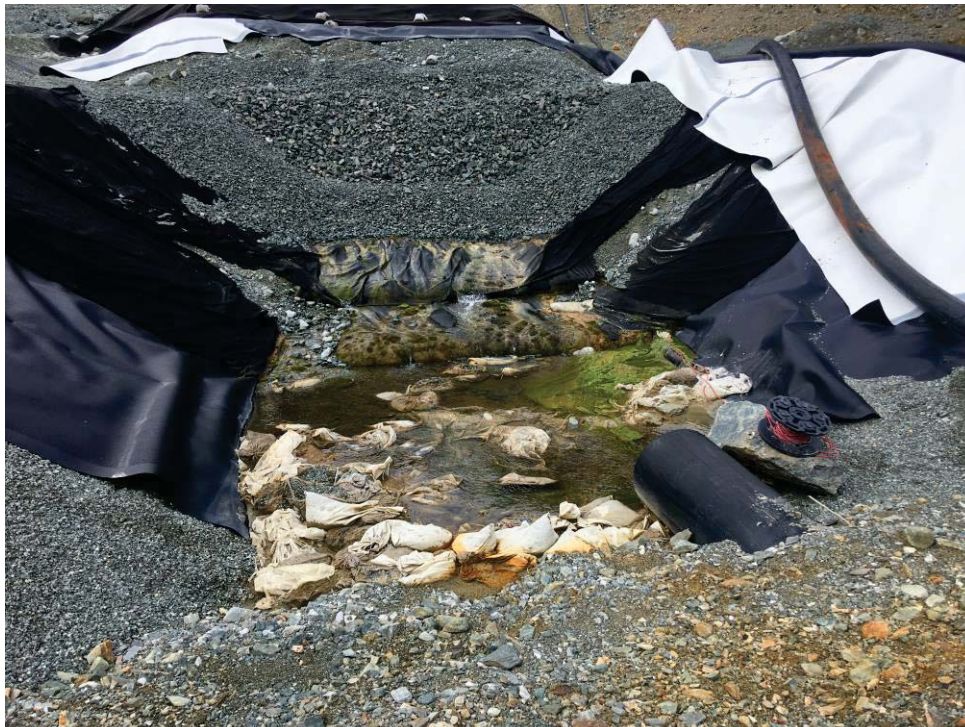
Photo 8: Low flow in the Lynx Springs Drain

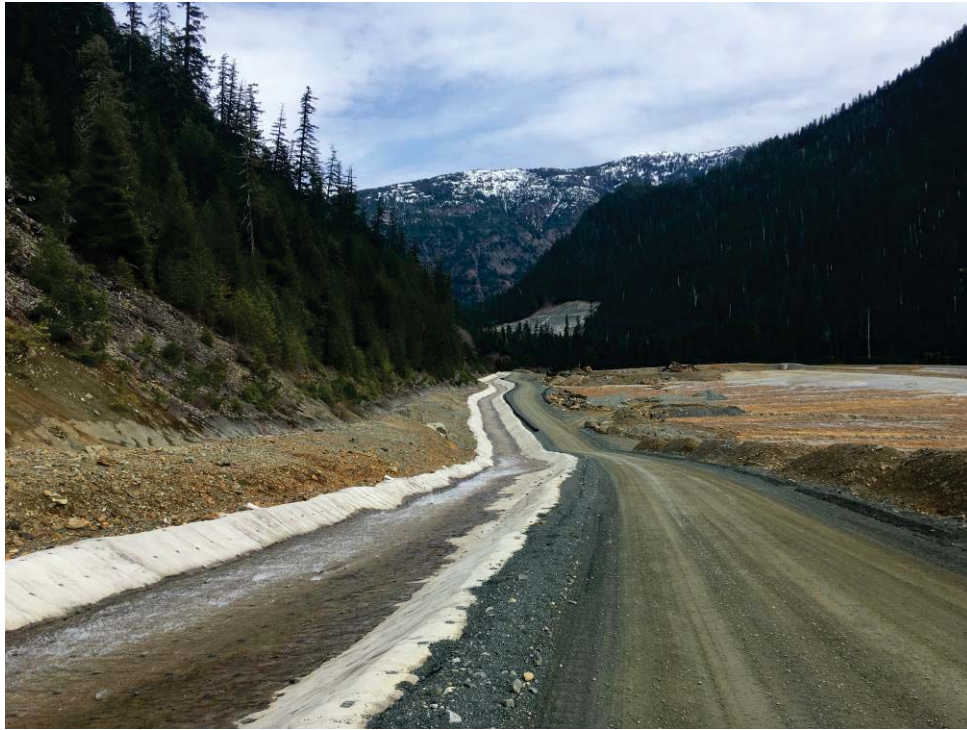
Photo 9: LLDD clear and functioning.

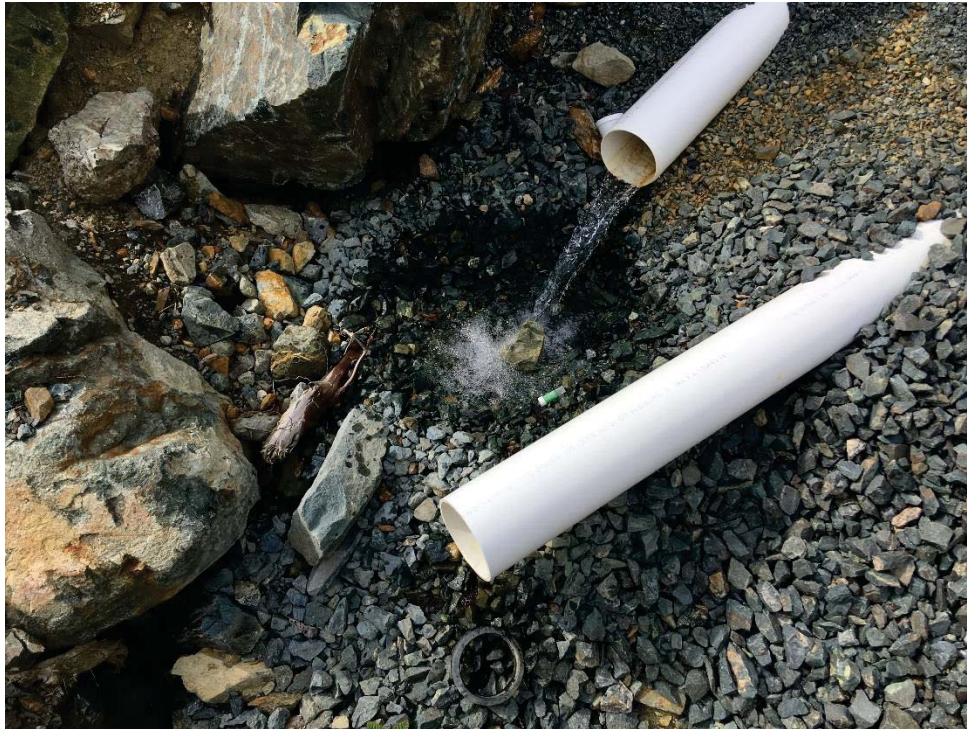
Photo 1: Subdrain flow at the APA East Abutment

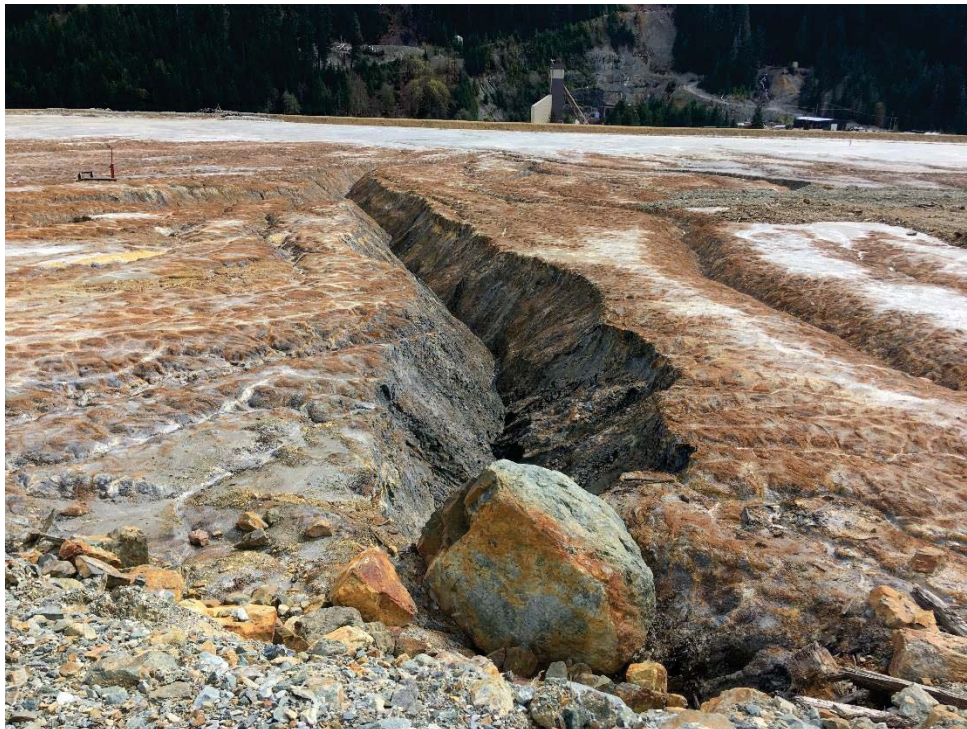
Photo 2: Active gully erosion on the APA below WRD 6

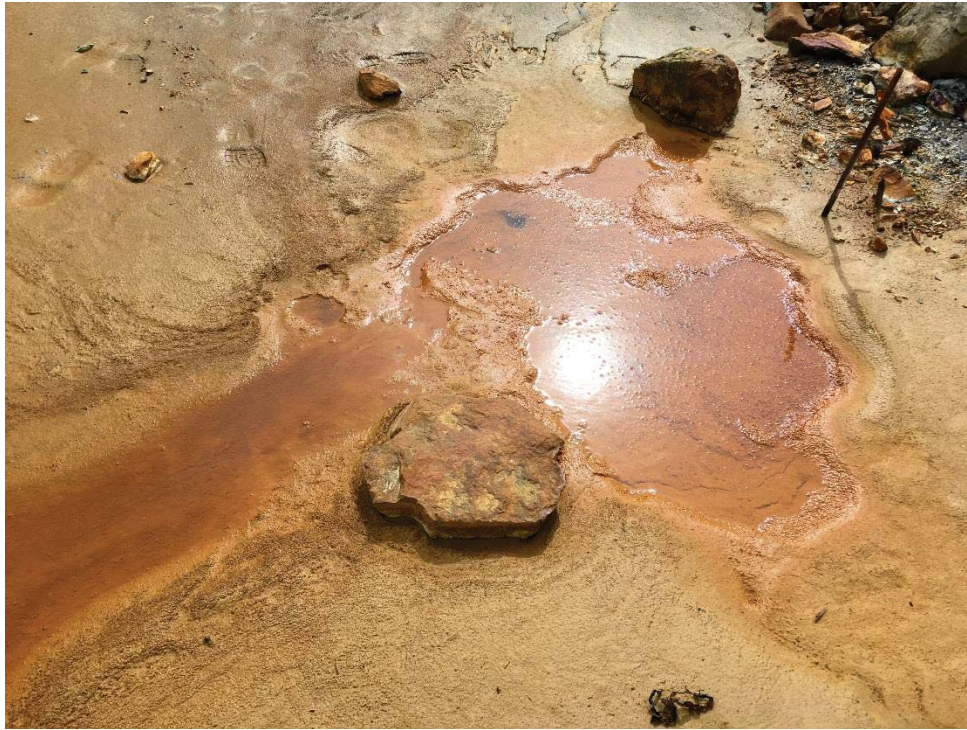
Photo 3: Surface water flowing into the East APA seepage boils area.

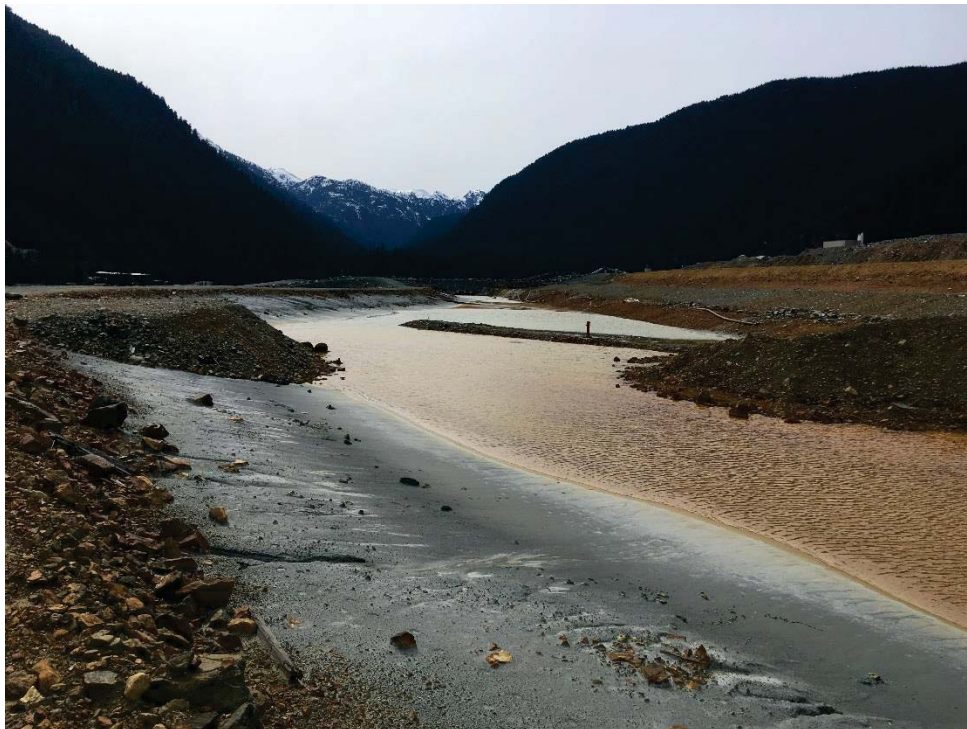
Photo 4: Shallow pond in the East Strip area.

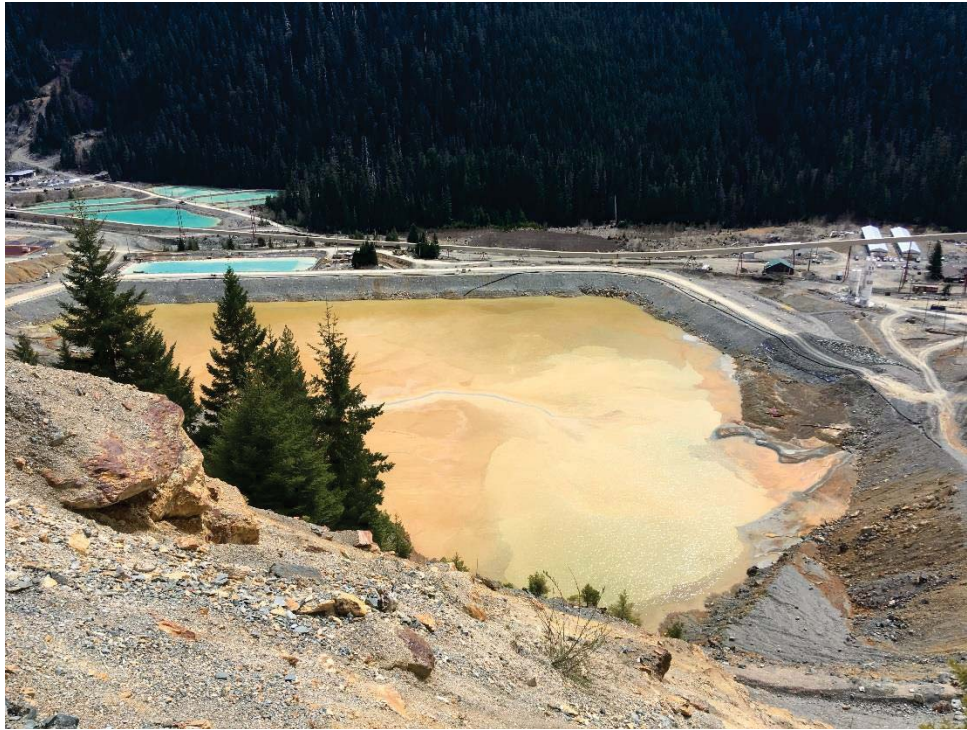
Photo 5: Lynx TDF overview from above WRD 3. Sinkhole is absent.

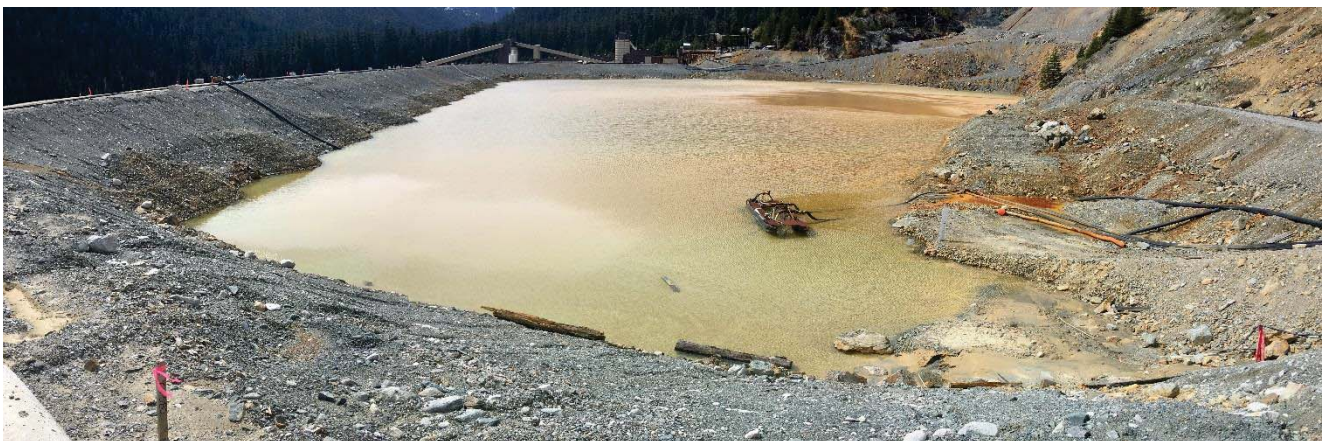
Photo 6: Panorama of Lynx TDF from the East Arm near the pumping station. Water level is approximately 355.0 m (NOWL).

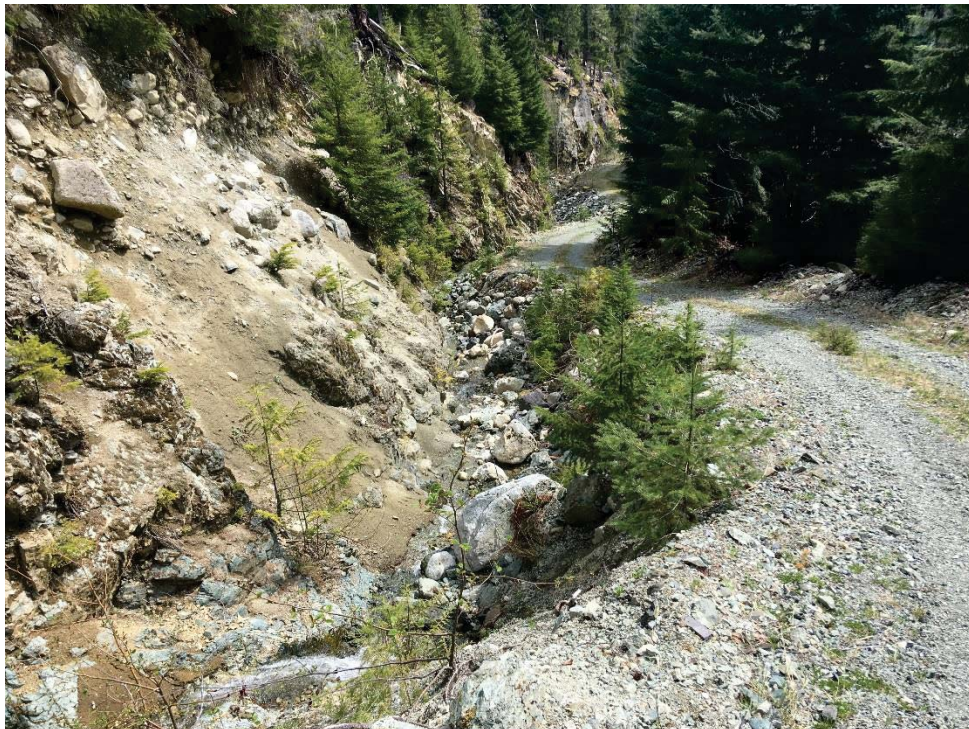
Photo 8: ULDD between Stream 1 and Stream 2, roughly above 5L East portal, looking downstream (east).

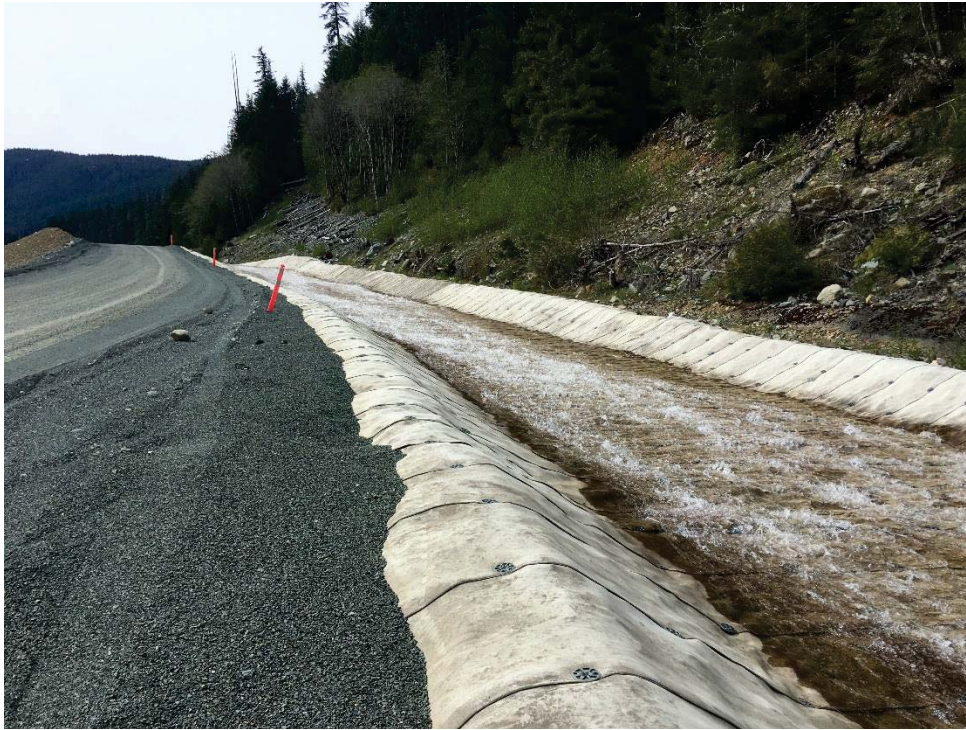
Photo 9: Terminal reach of the LLDD, just downstream of Alder Reach, looking upstream (west).

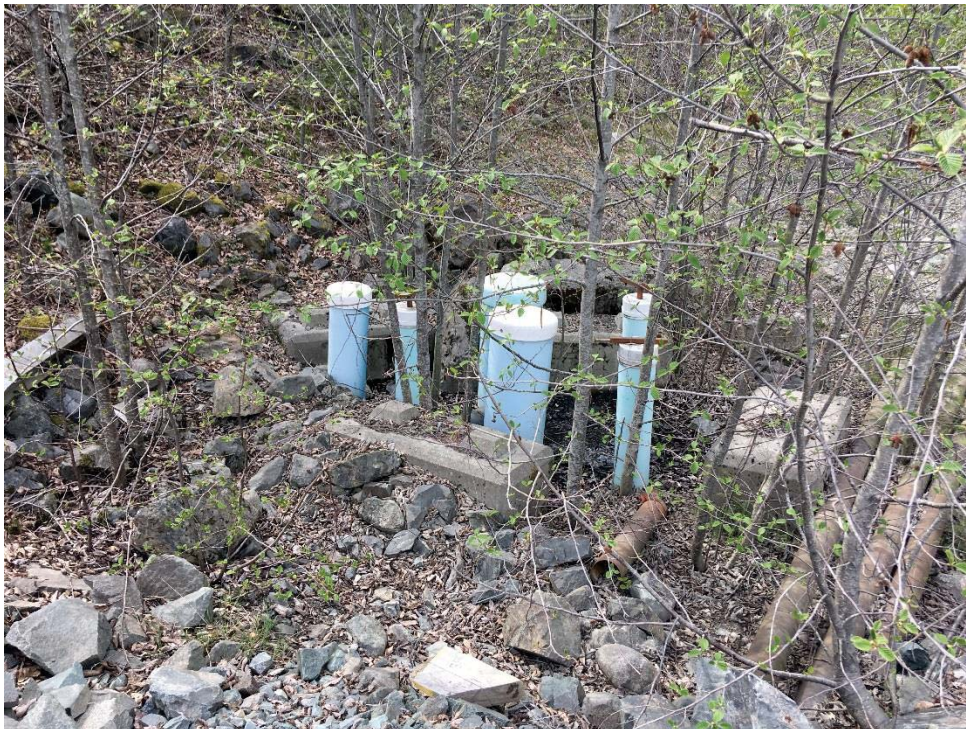
Photo 10: Trees growing around outer drain risers.

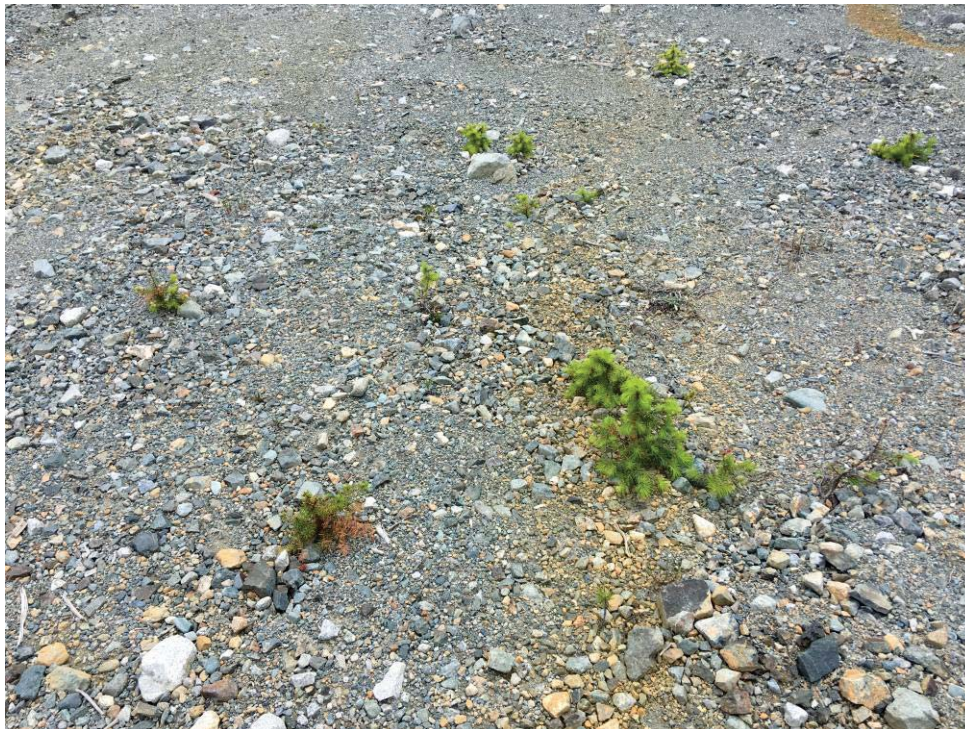
Photo 2: Volunteer seedlings on the APA 6H:1V slope.

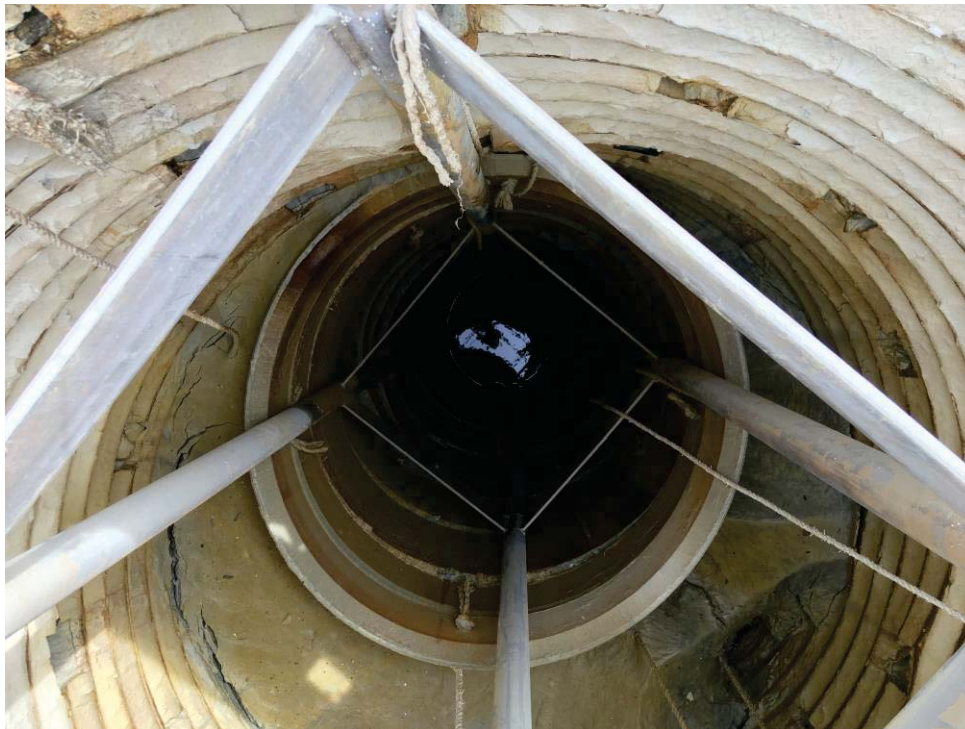
Photo 4: Looking down the old APA Decant. Water level in the tower is related to local groundwater phreatic level.
