Appendix D – EOR Monthly Dam Inspections

Myra Falls Mine Tailings Facility Field Review Report

Date of Field Review:	21 January 2019	Date of Memo:	24 September 2019
File No.:	NX14001B1	Client:	Nyrstar Myra Falls Ltd.
Engineer:	Dan Hughes-Games, P.Eng.	To:	Keith Watson, P.Eng.
With:	n/a	Cc:	
Weather:	Sunny, few degrees below zero. Most of site in shade of Mt. Myra throughout the day. Discontinuous snow cover on site, particularly in the shade.

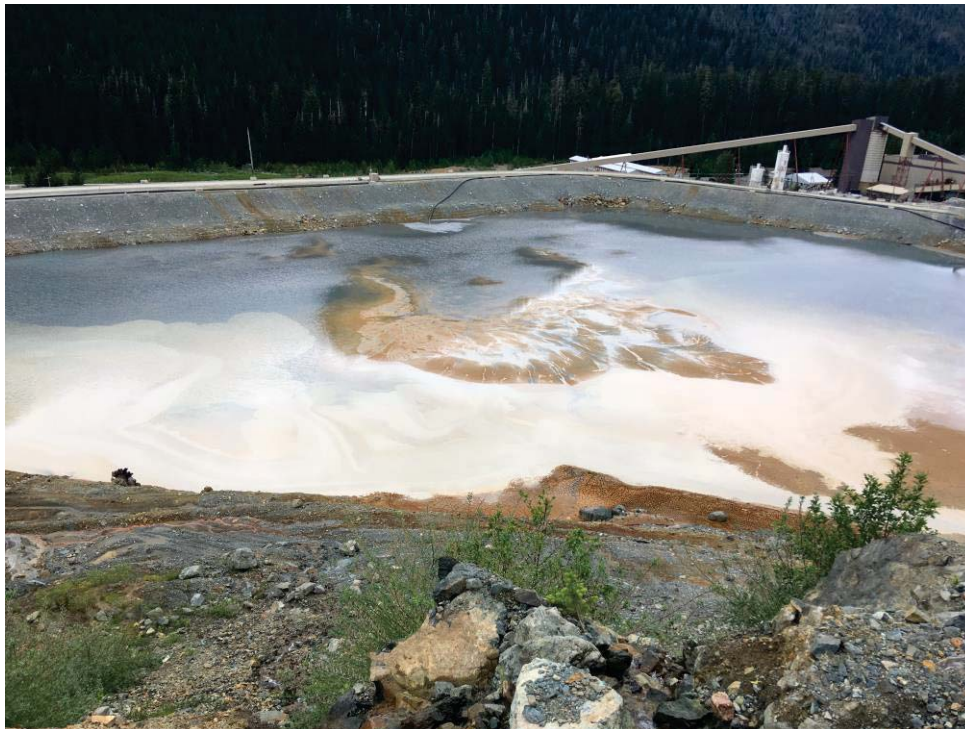
Photo 6: View from above the Lynx Springs Drain capture area showing slurry tailings deposition point on the south arm of the dam near Plane E and mud wave formed in dredgate following slurry deposition.

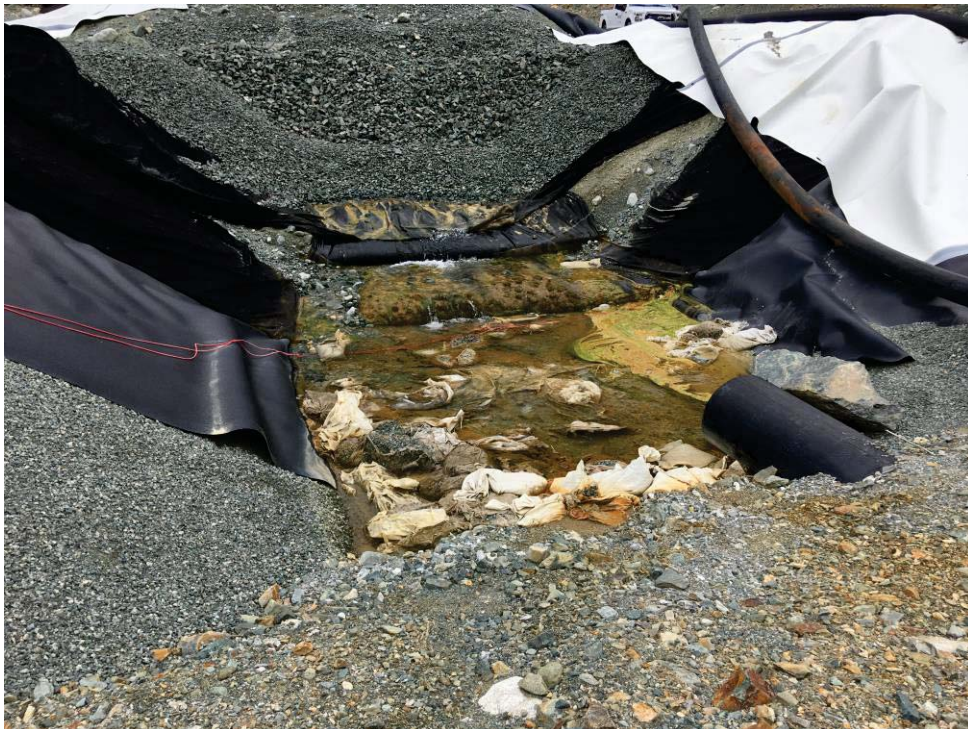
Photo 8: Low flow in the Lynx Springs Drain.

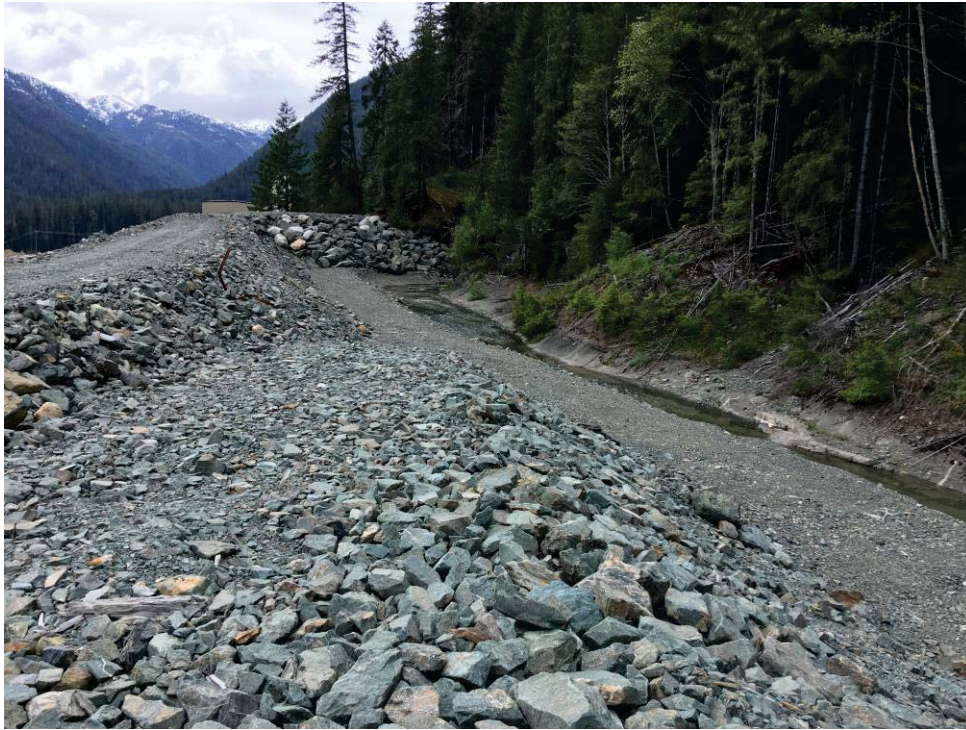
Photo 9: LLDD debris basin is clear of sediment/debris.

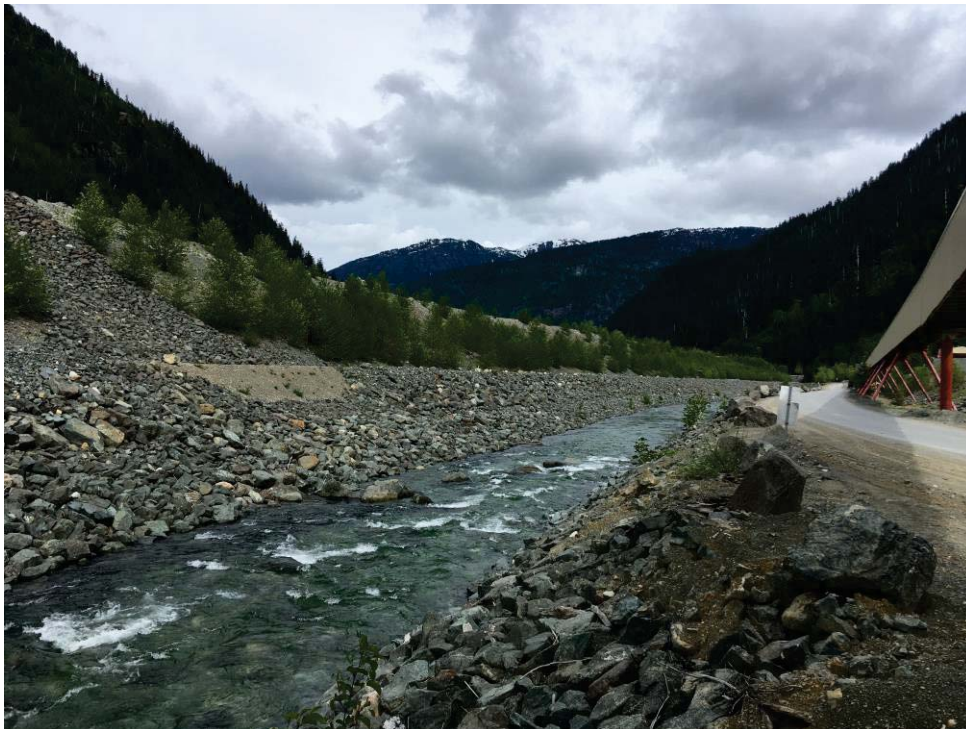
Photo 10: Myra Creek at the toe of the Old TDF. Scotch broom on the fuse plug in the Old TDF Surge Pond Spillway (at left).

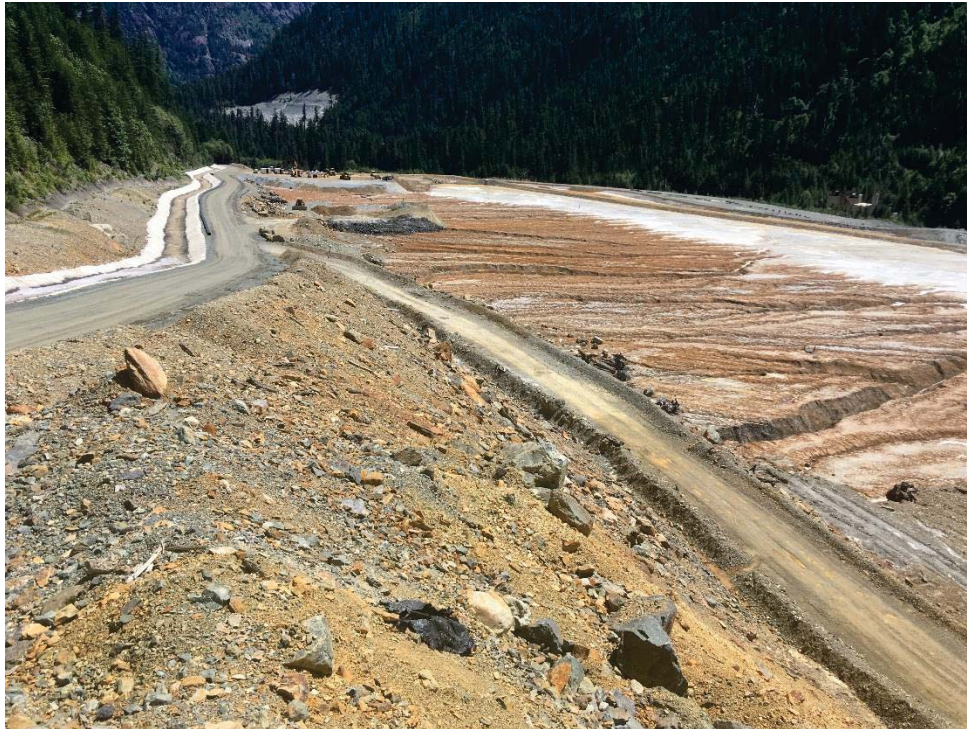
Photo 1: Overview of the APA and LLDD from the crest of WRD 6.

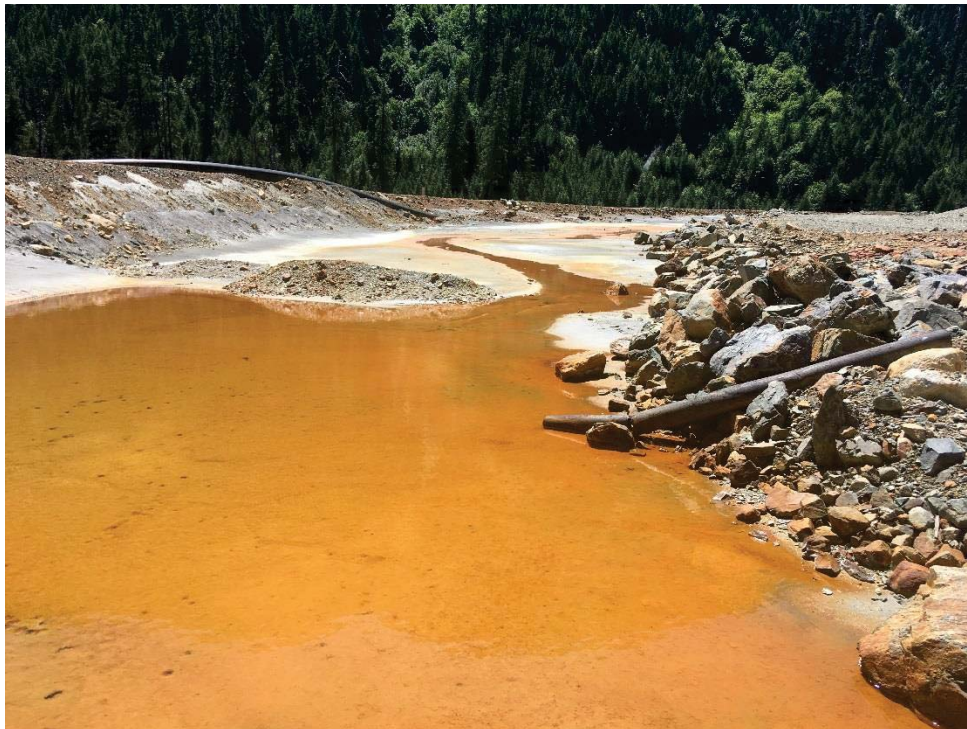
Photo 2: Shallow ponded water in the East Strip near the east abutment.

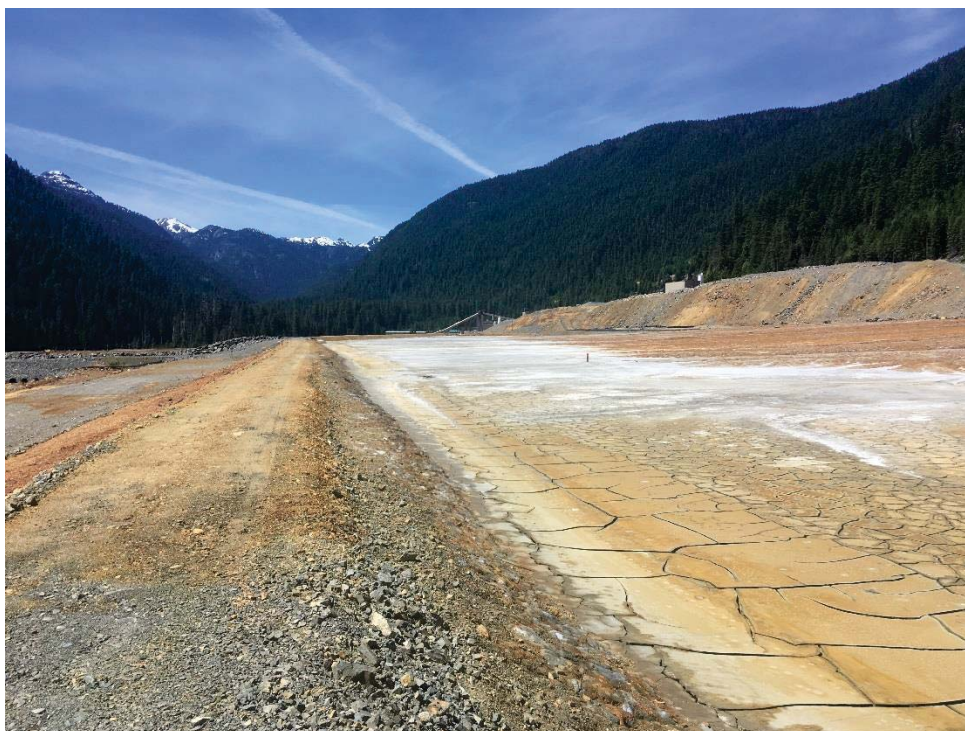
Photo 3: Dessicated surface of the APA, near the East Decant.

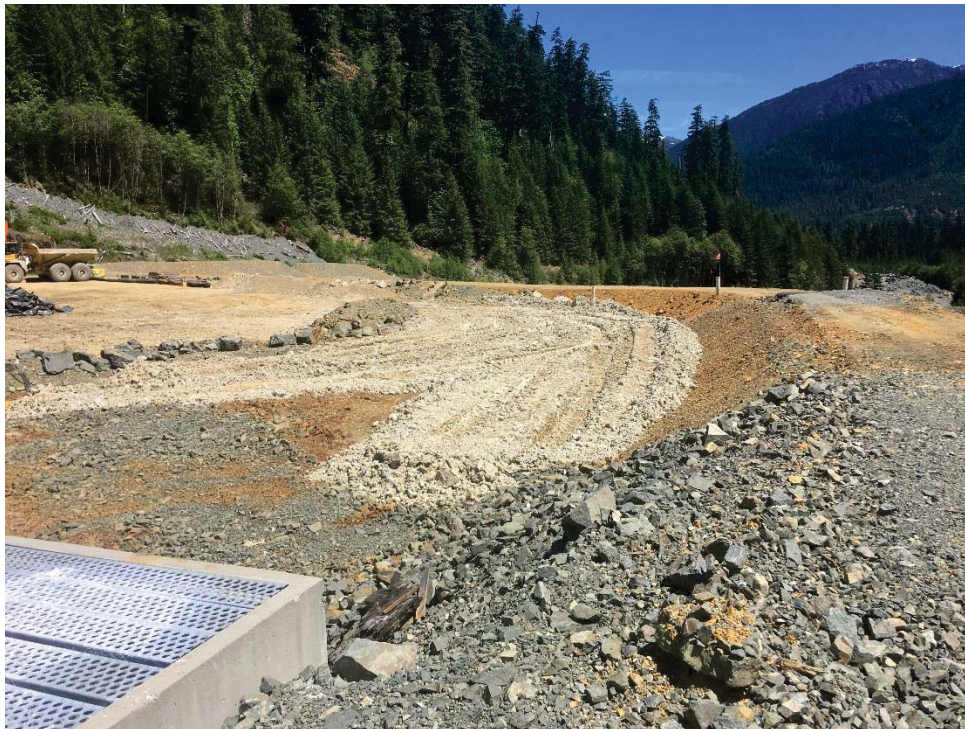
Photo 4: Stockpiles along the APA Berm crest removed. Some material was used to regrade the area and fill the closed depressions near the crest.

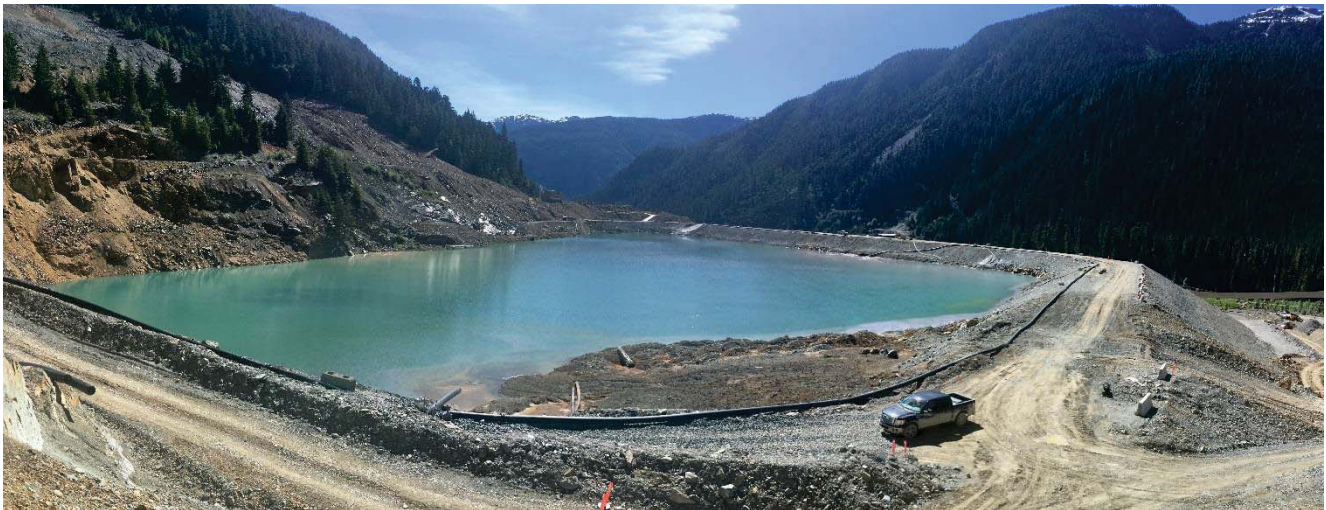
Photo 6: Panorama of Lynx TDF from 10L East portal. The sinkhole is faintly visible. Slurry tailings are depositing near Plane E on the South Arm, with the apex of the beach marginally above water level.

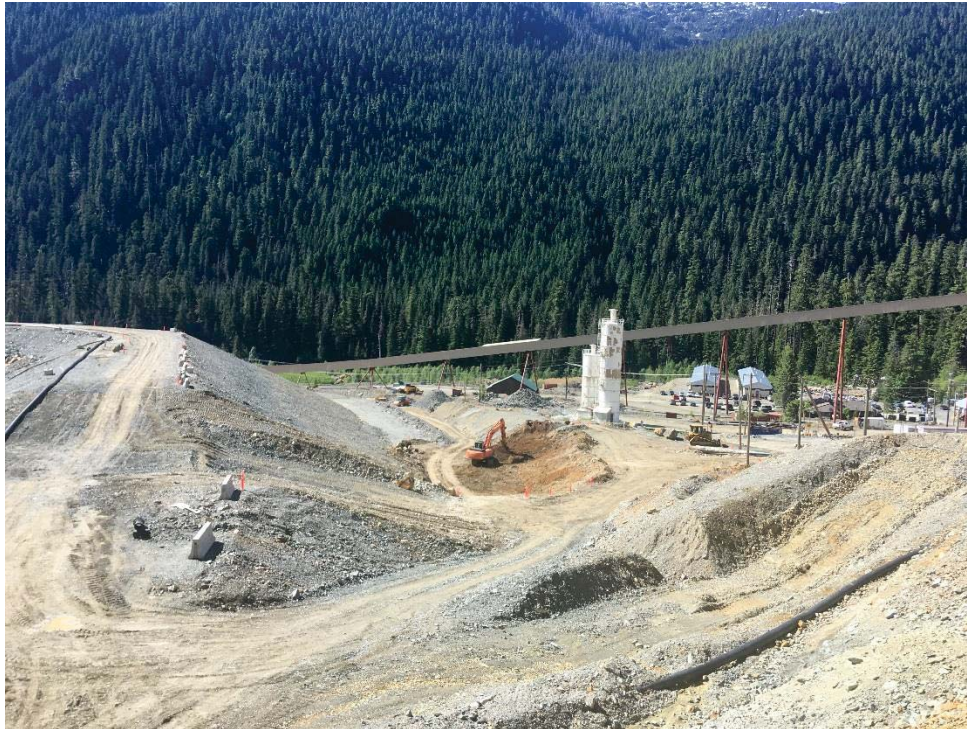
Photo 7: Spillway armouring fully removed. Excavation for raise foundation preparation is underway in Panel 4 area.

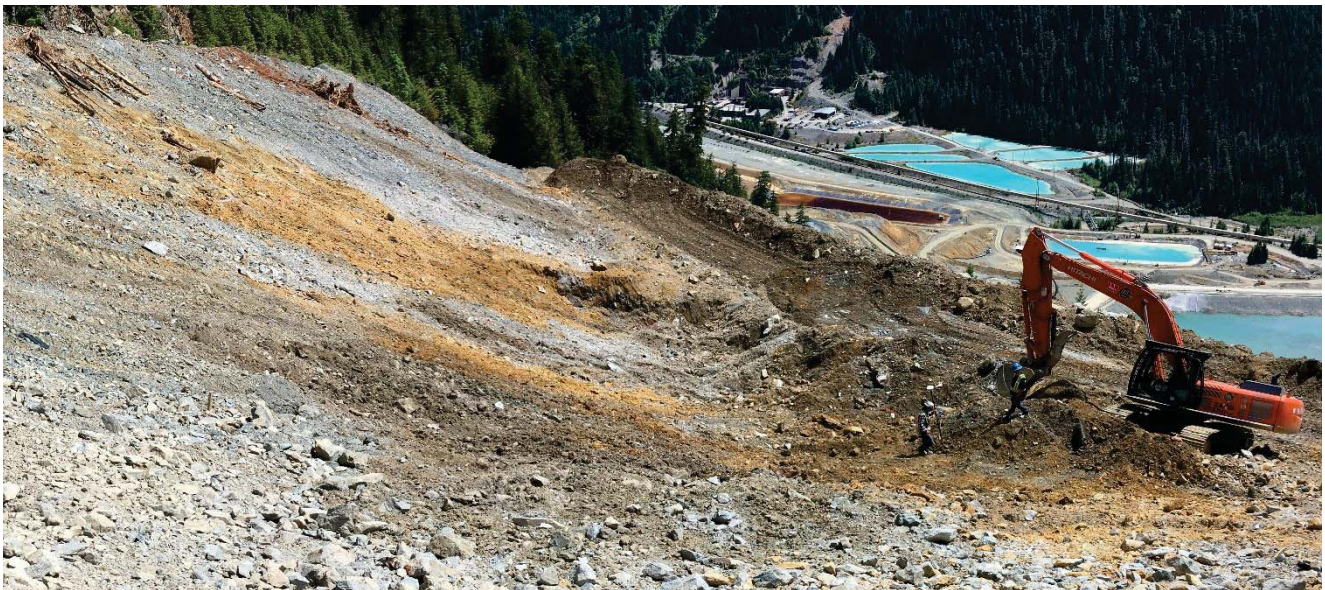
Photo 8: Removal of Waste Rock Dump 2 Phase 2, Area 1 is underway. The slope below the diversion is being trimmed at 1.5H:1V. Natural ground has not been encountered.

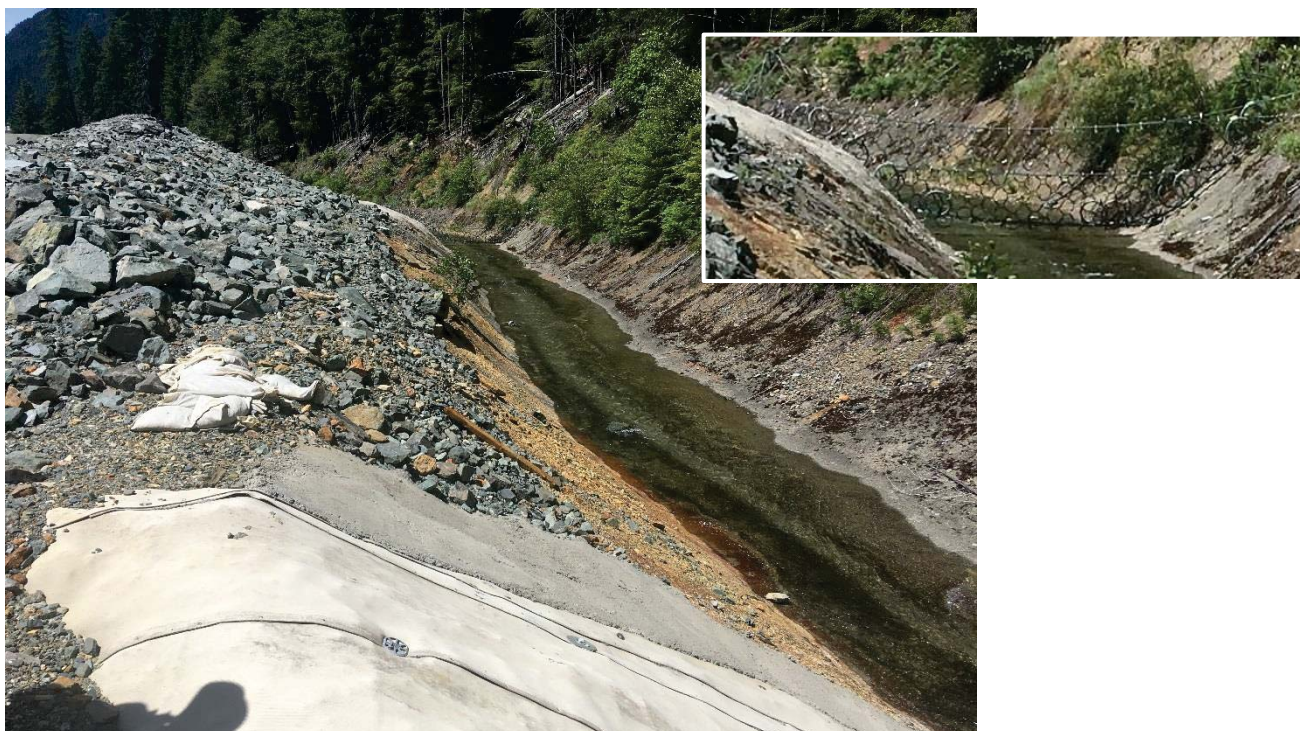
Photo 9: LLDD at the crest of the concrete cloth section. Debris net is clear (inset).

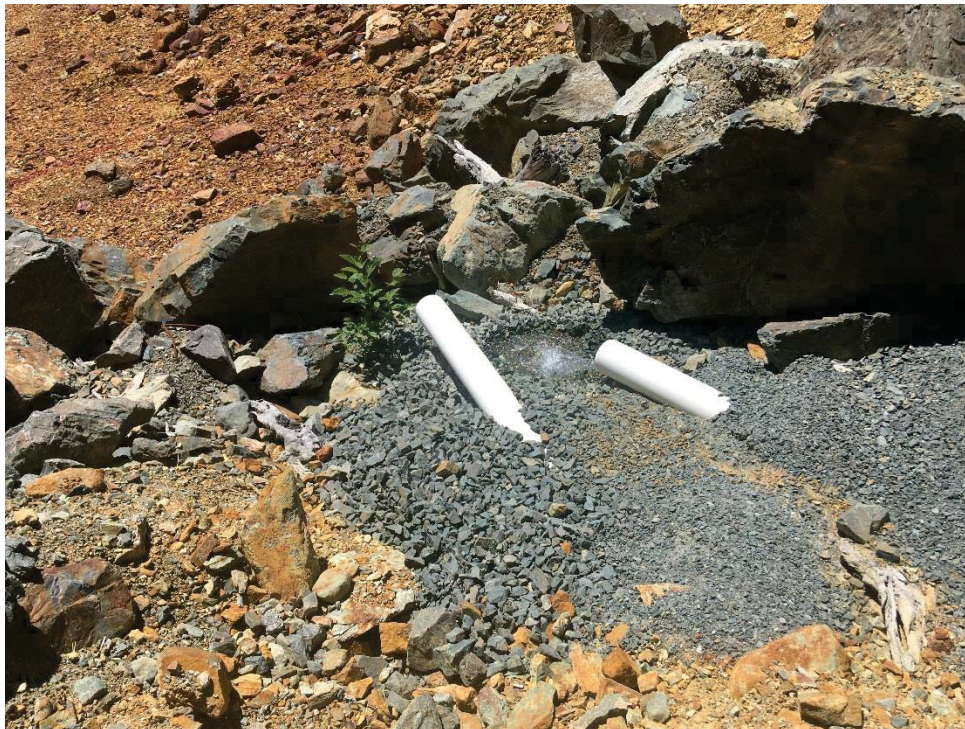
Photo 10: LLDD subdrain at the APA east abutment continues to flow at an estimated 0.5 L/s, similar to spring levels.

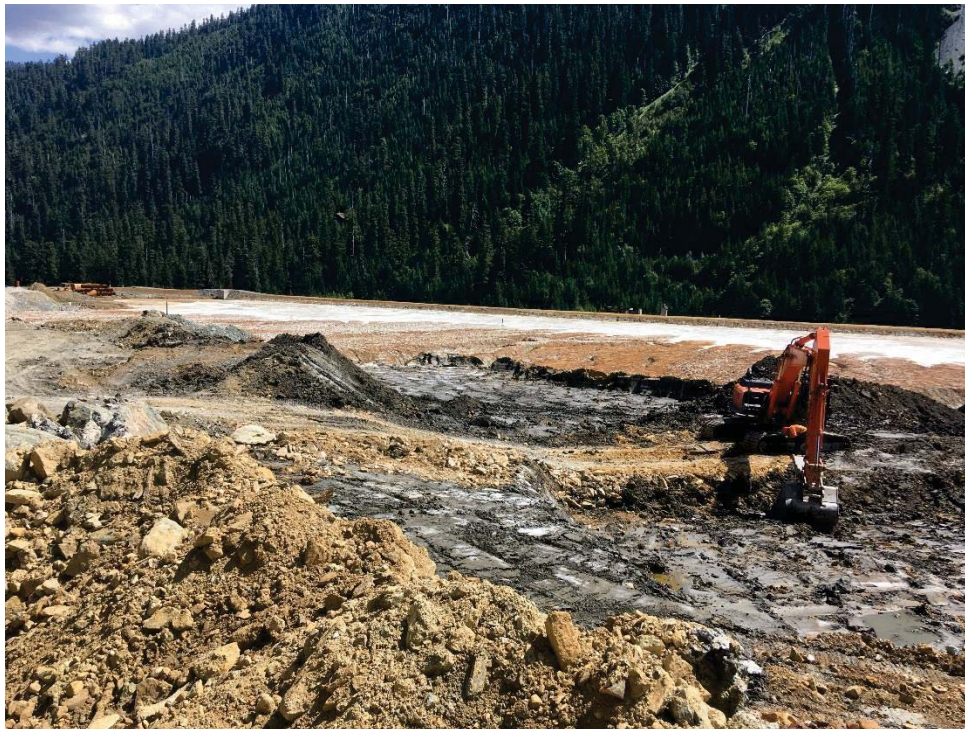
Photo 2: Tailings excavation at the apex of the APA for use in Lynx TDF construction.

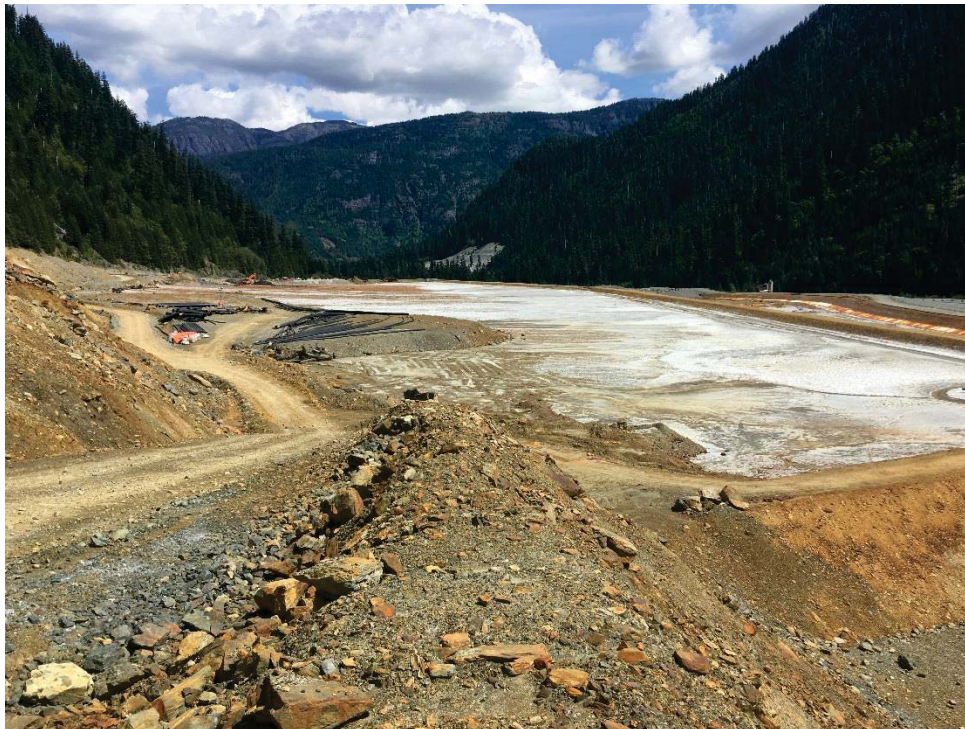
Photo 4: Overview of the APA looking east, from the WRD 6 Toe Haul Road.

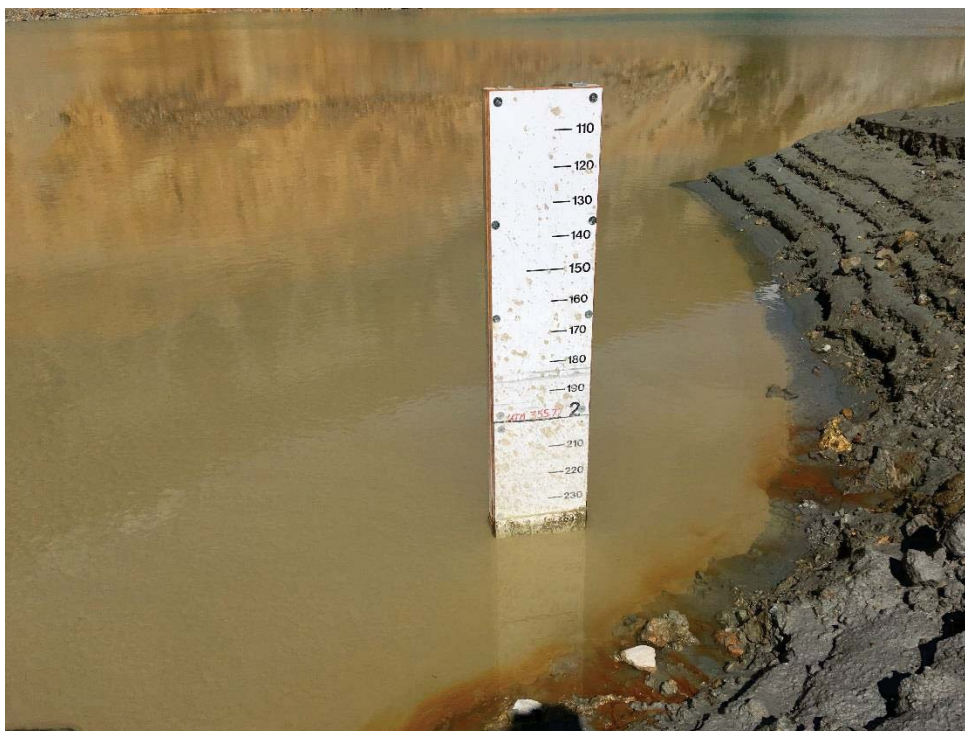
Photo 5: Staff gauge in Lynx TDF. Clear water level is 2.40 on the gauge. Sediment laden water level is 2.44 on the gauge. (29 July)

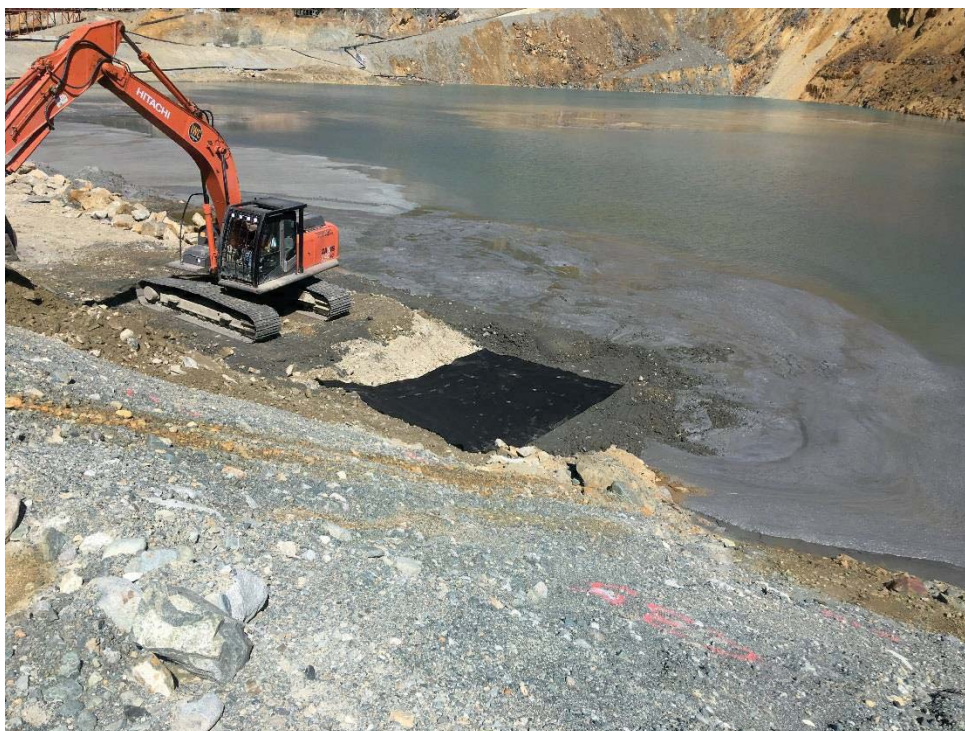
Photo 7: Construction on the upstream toe of the Lynx TDF dam raise (22 July).

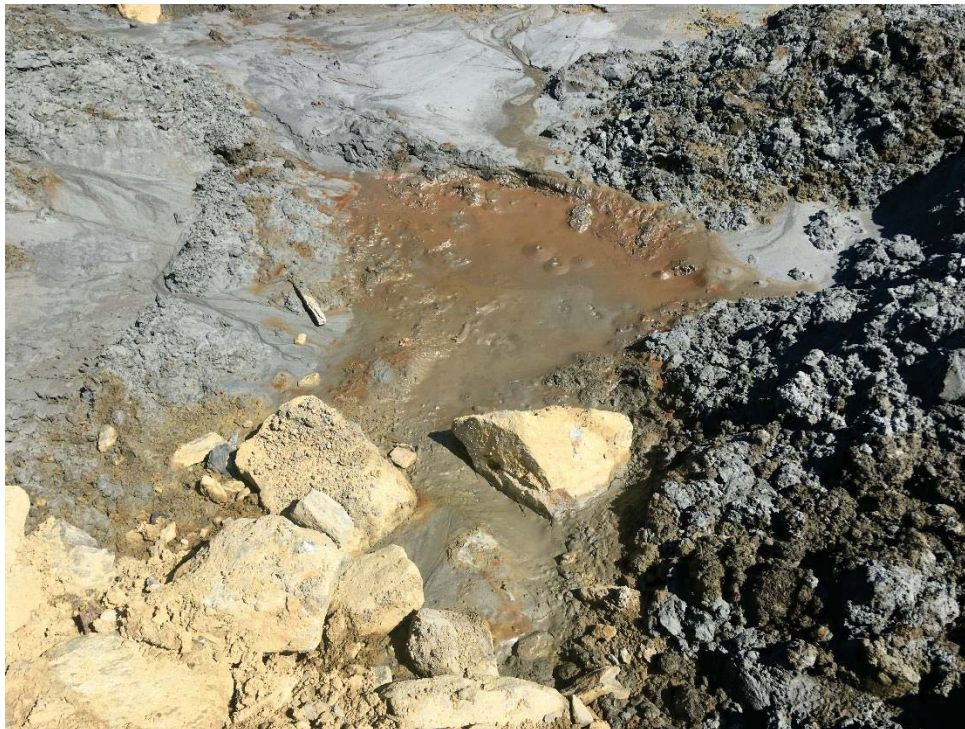
Photo 8: Indications of upwelling groundwater at the upstream toe of Lynx TDF construction, in response to consolidation (22 July)

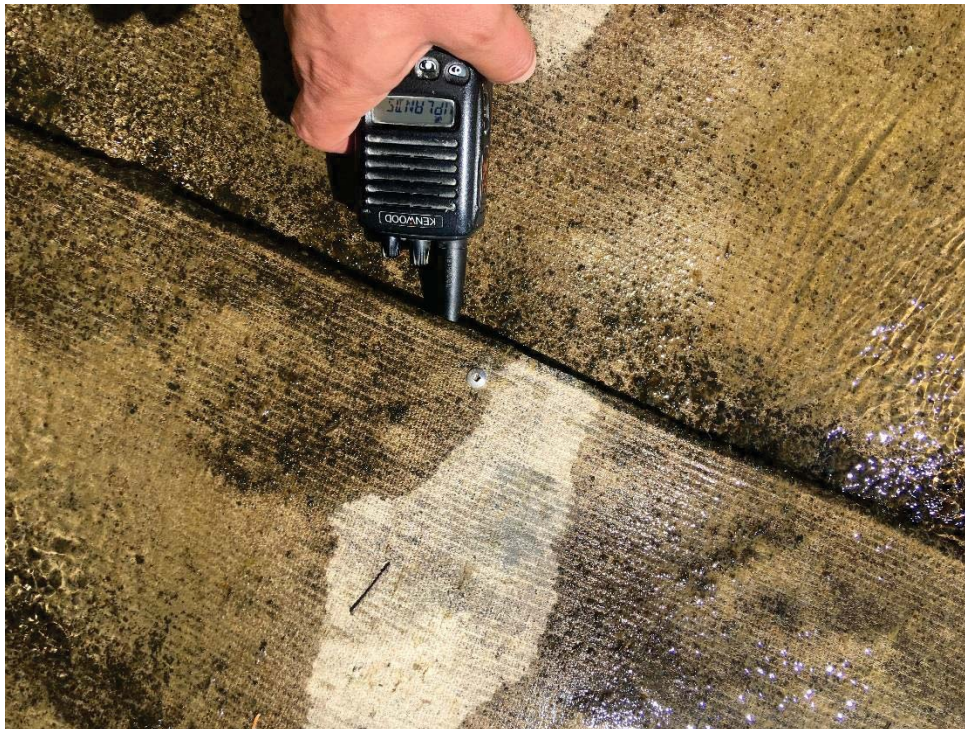
Photo 9: Example delaminated area in the LLDD.

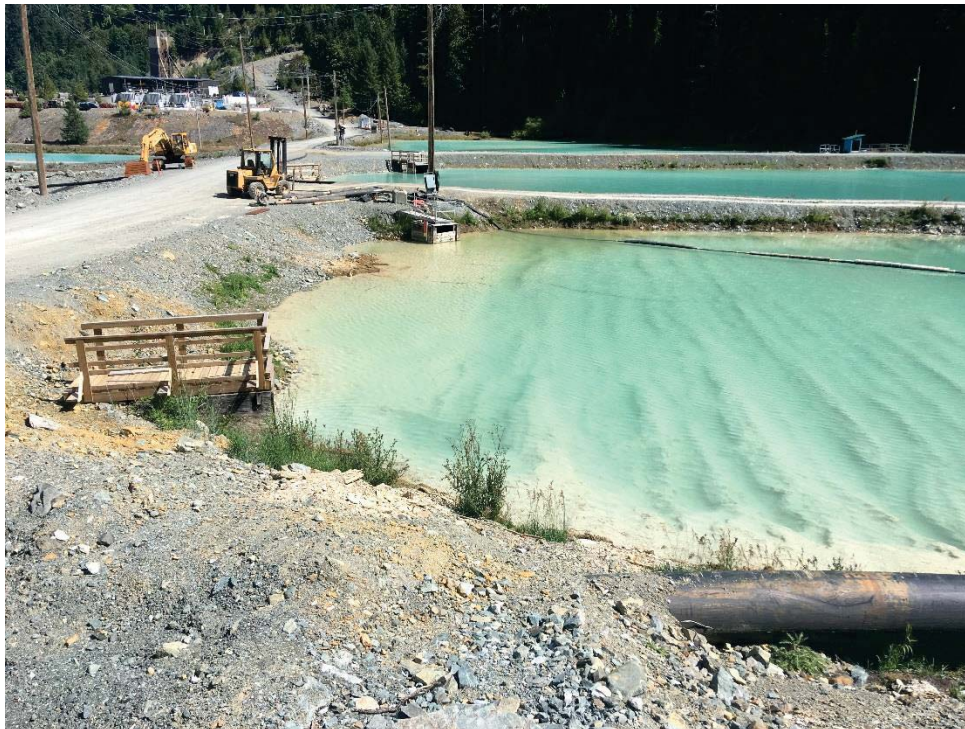
Photo 15: Example of stray disused pipes just above the Superpond liner.

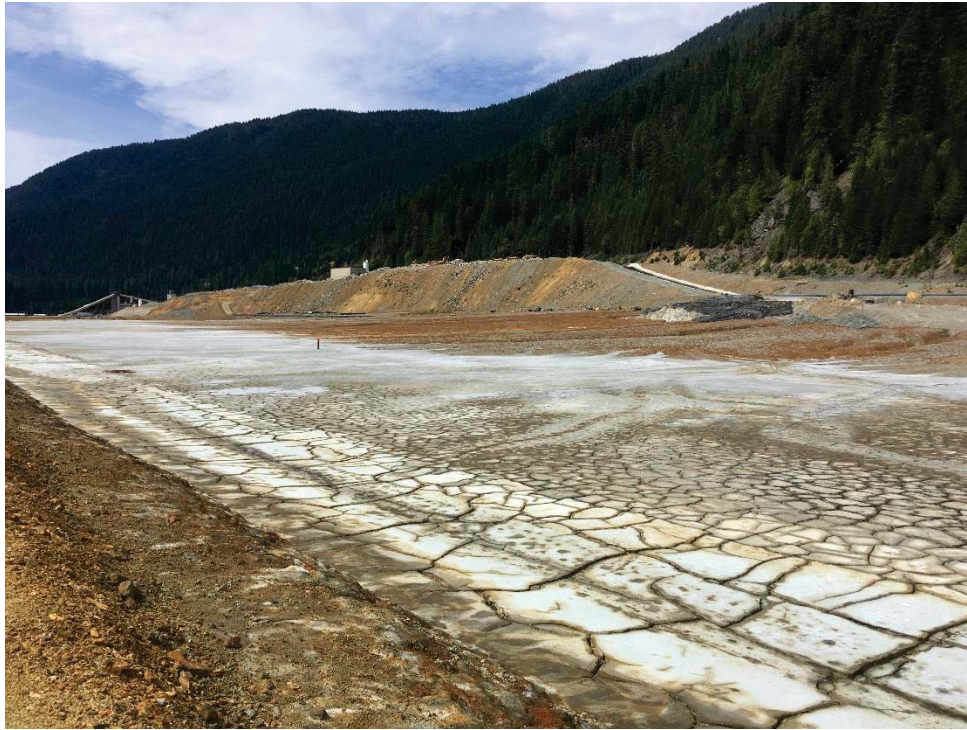
Photo 1: Old TDF viewed from near the East Decant. Surface has desiccated in the summer weather.

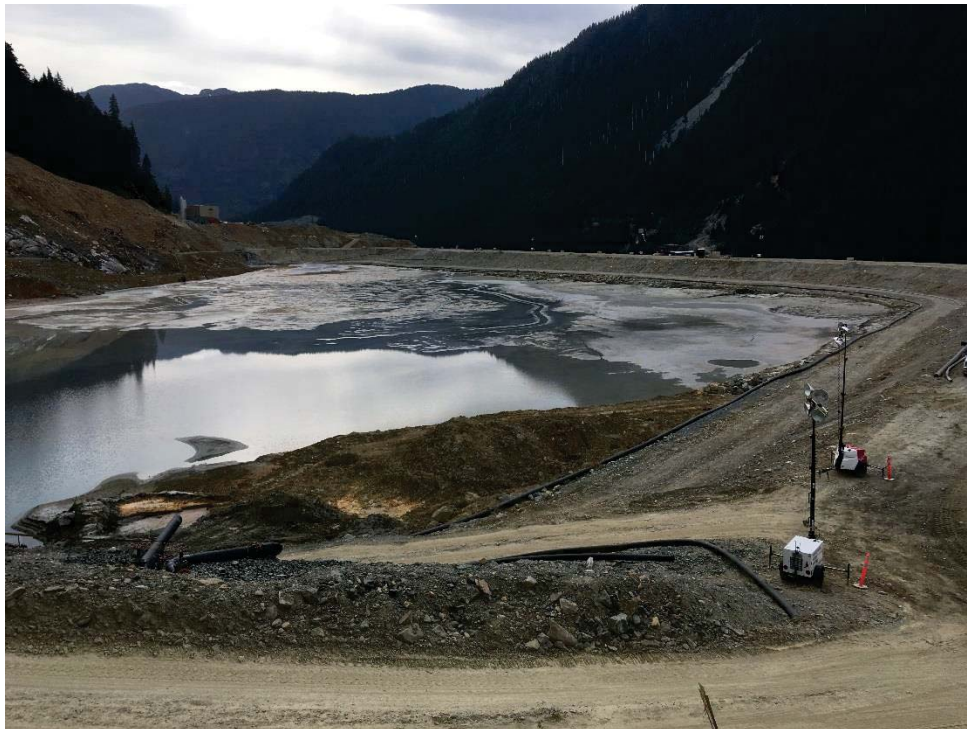
Photo 6: View of Lynx TDF from the 10L portal. The base lift/platform on the upstream side is complete. Construction on the upstream side has stopped pending additional stability modeling of the upstream slope configuration. Mud wave from paste deposition is visible.

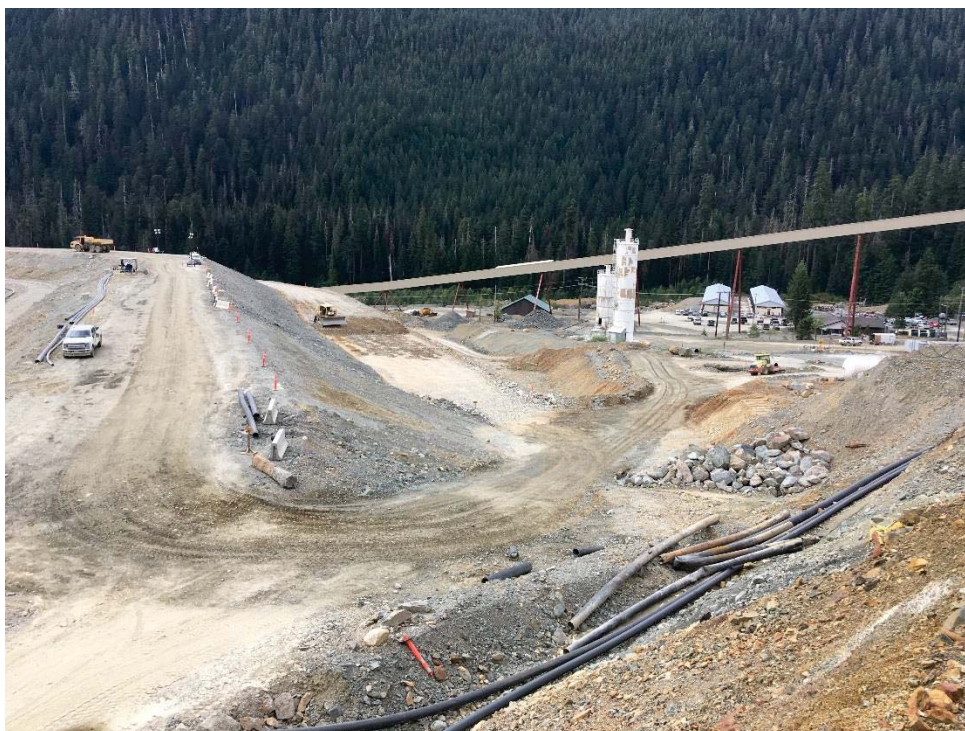
Photo 7: Construction of the downstream shell continues.

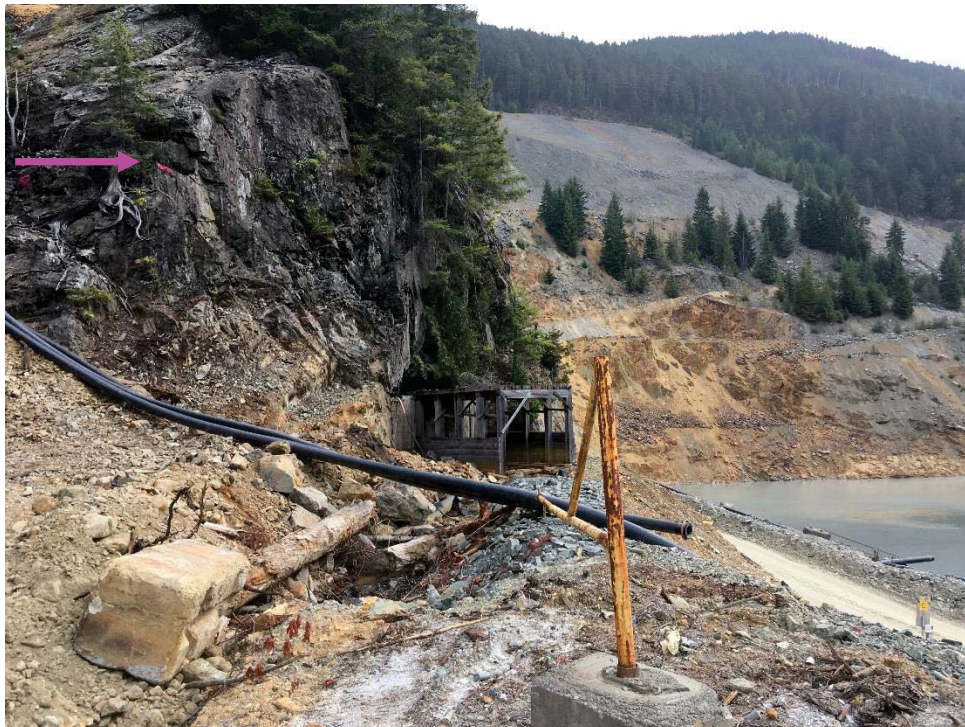
Photo 8: The ultimate final downstream crest of Lynx TDF Dam has been marked on the cliff above 10L East portal. Dam centreline is several metres on the other side of the portal.

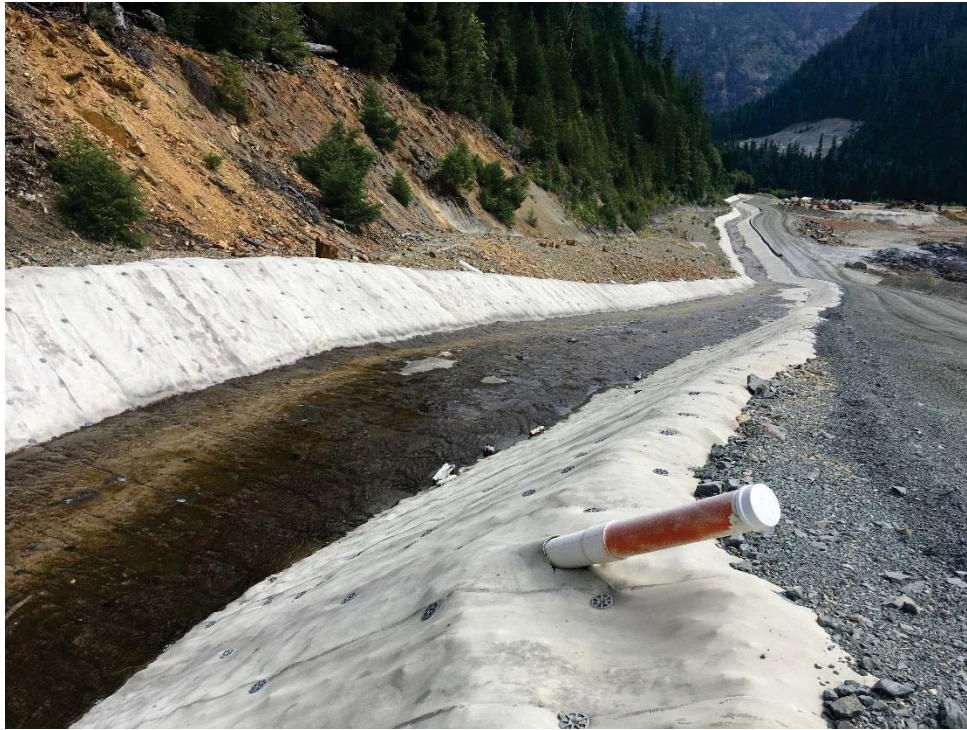
Photo 9: LLDD is clear. Flows are relatively low, albeit higher than usual for August.

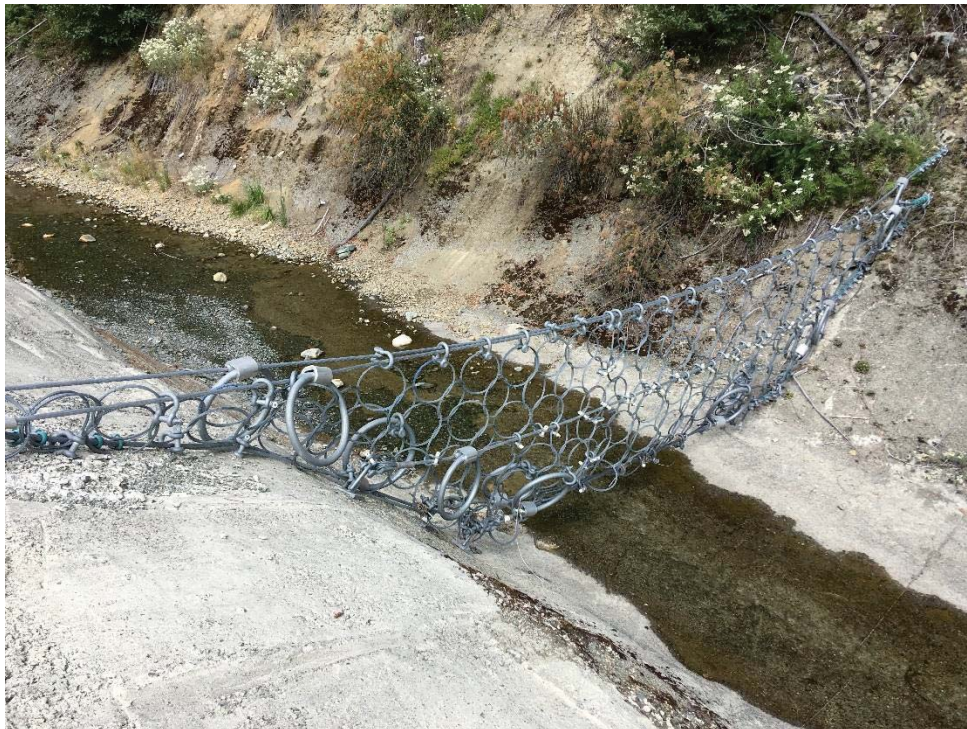
Photo 10: LLDD debris net is clear and in good condition.

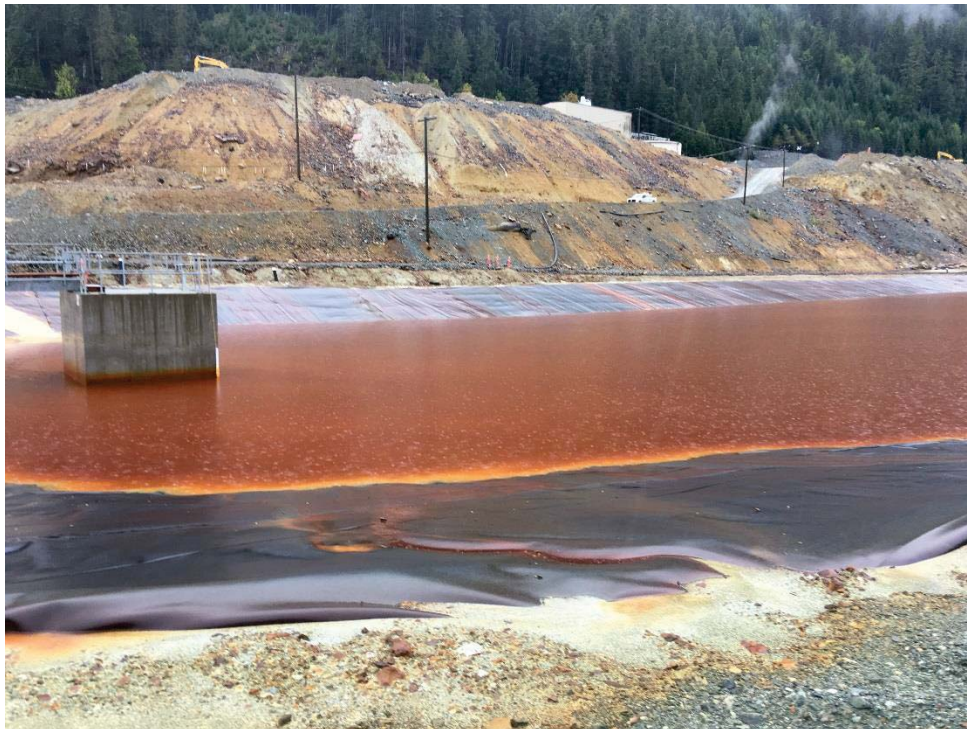
Photo 4: Old TDF Surge Pond water level is at the decant outlet, as intended.

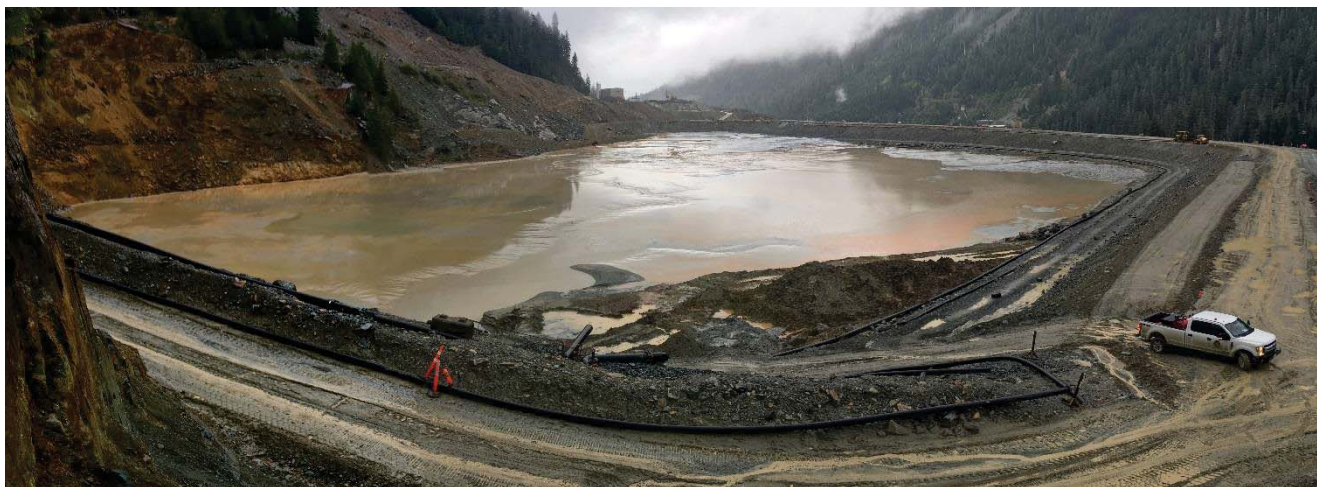
Photo 6: Panorama of Lynx TDF from the 10L East portal. Water level is at the achievable minimum, with dredgate exposed across most of the surface. The sinkhole is visible with size and location consistent with prior observations.
