2021 TDF Dam Safety Inspection Report

Myra Falls Mine Ltd.
Myra Falls Mine Tailings Disposal Facilities
Project # NX14001B3.1

31 March 2022

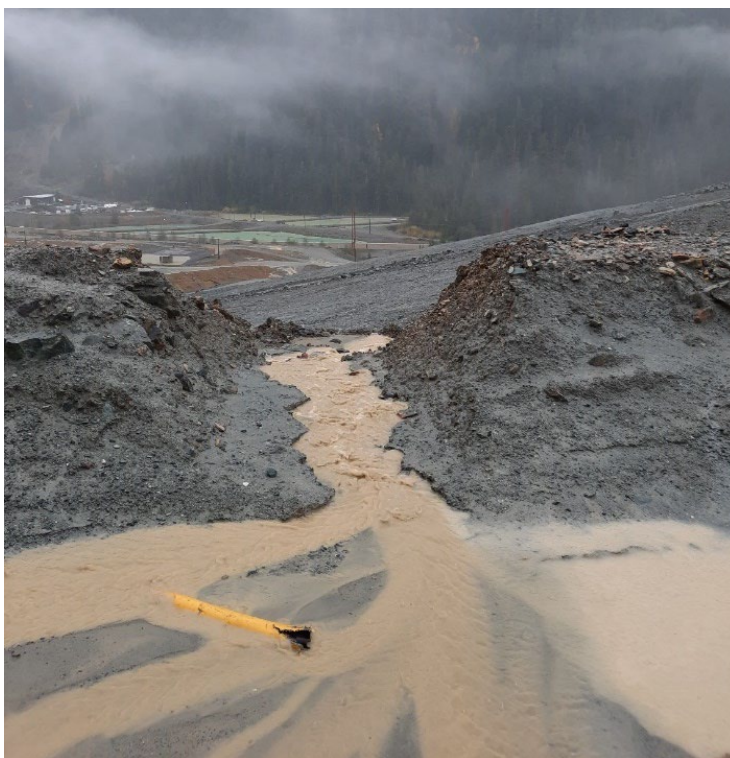
Photo 7: Lynx TDF punch-out in dam crest berm during precipitation event. (October 27, 2021)

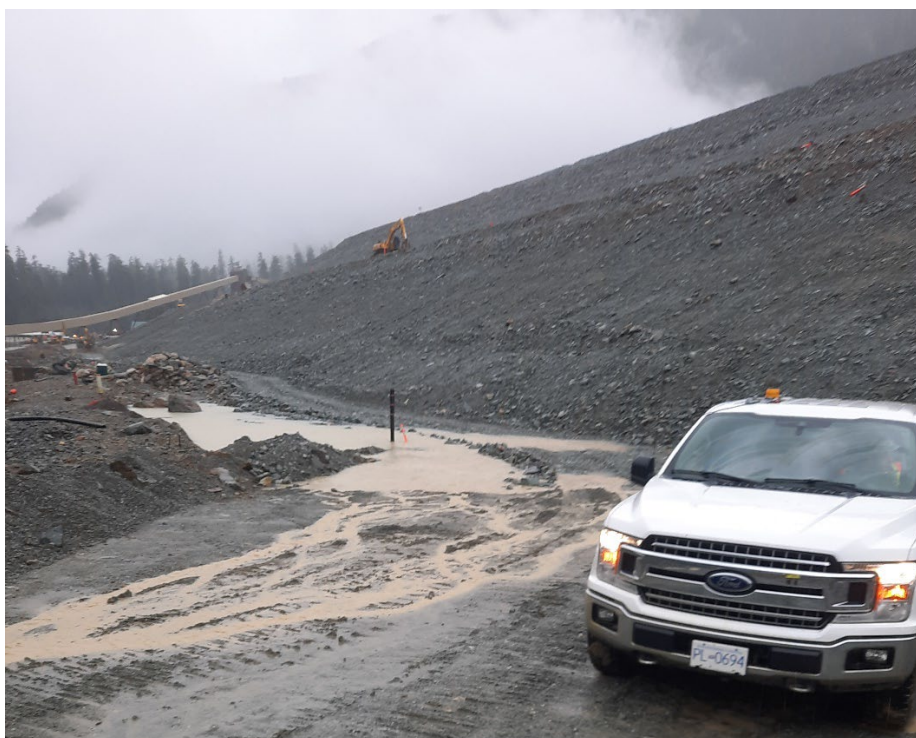
Photo 8: Lynx TDF – Water ponding around standpipe near the Panel 15 drain (October 21, 2021)

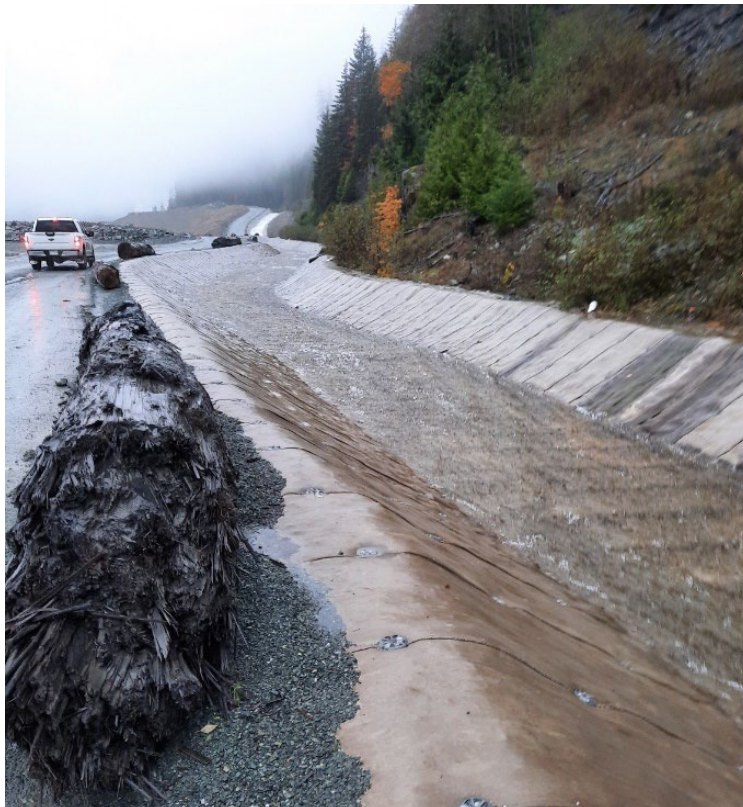
During the April 2019 inspection, erosion was observed in the Upper Lynx Diversion at the transition between Upper Arnica and Lower Arnica ditches which has damaged the geomembrane liner beyond functionality. The ditch would still function to divert peak flows, but low flows are likely to escape via groundwater to the Lynx Upper pit. MFM inspected the transition regularly during 2021. Their reports and photographs document that it was functioning as intended.

Photo 10: Lower Lynx Diversion Ditch view facing west. (October 21, 2021)

MFM completed repairs of the damage to the liner in 2019. No further damage was observed during Wood's 2021 inspections.

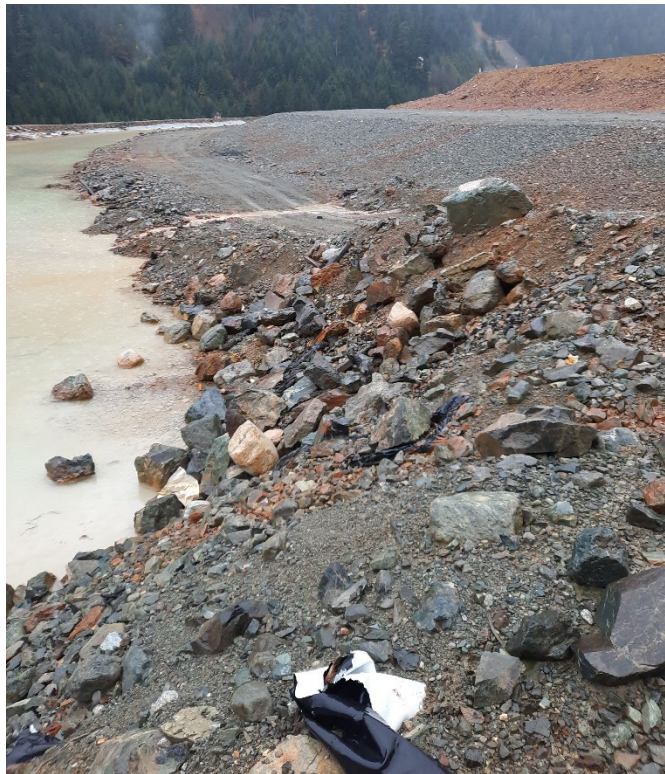
Photo 13: Old TDF, East end of East Strip - flow from APA drain shown in the background (October 27, 2021)

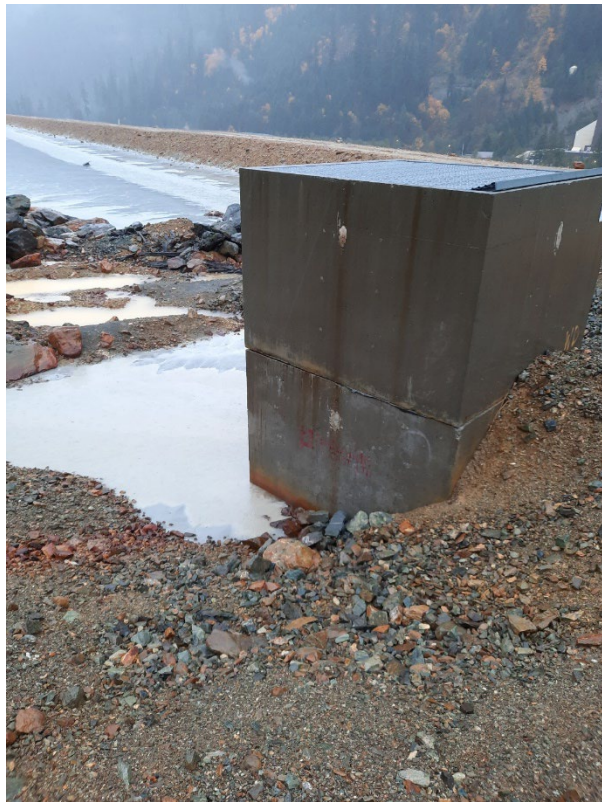
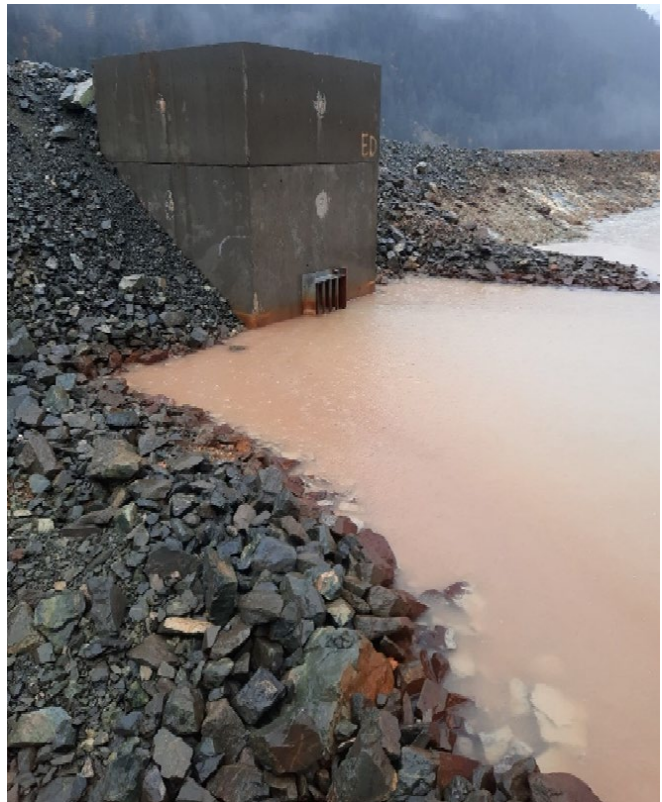
The old decant structure was the single means of passive drainage in operational conditions until 2016 when the East and West Decants were constructed. It is located near the new West Decant, and previously conveyed water through a pipeline directly to the treatment system inlet ditch. The portion of the old decant pipeline passing below the APA berm was to be decommissioned by grouting in 2017; however, equipment failures during the grouting operation resulted in only the downstream end of the section being grouted, as described in the 2017 DSI (Amec Foster Wheeler, 2018b). The upstream end of the pipe and the decant tower remain unfilled. Further work has been recommended to complete decommissioning of the old decant.

Photo 15: Old TDF APA west (left) and east (right) decants. (October 27, 2021)

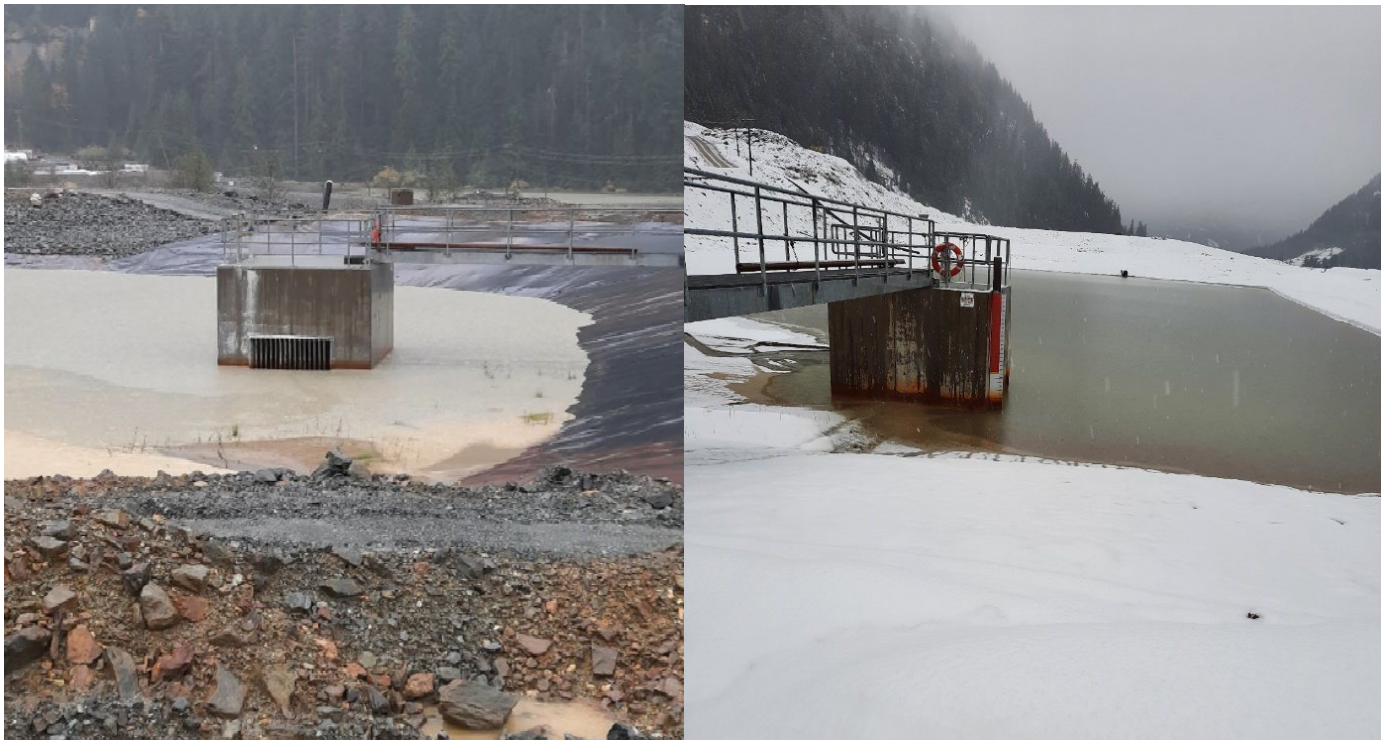
Photo 17: Surge Pond decant, view looking west (left) and east (right). (Oct 7 and Dec 10, 2021)

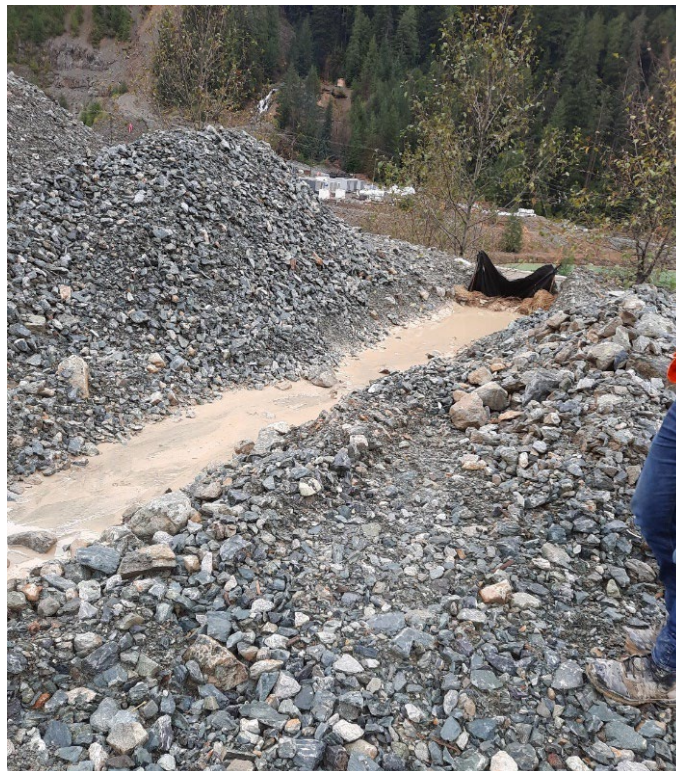
Following the completion of the Seismic Upgrade Berm in 2013 there have been some observed areas of ponded water on the relatively flat surface of its main bench. The Seismic Upgrade design assumes that the buttress remains unsaturated. Ponding water on top of the buttress potentially increases local infiltration and could reduce stability conditions, and therefore potentially represents a departure from the design. The 2013 Construction As-built Report recommended grading the surface of the seismic upgrade berm at a minimum of 2% towards Myra Creek to reduce ponding. Wood proposed a regrading design in the Old TDF Closure Cover Phase 1 Detailed Design (Wood, 2018b). The proposed regrading will direct surface runoff from the 6:1 slope and main bench areas through a central drainage swale towards the main drainage channels, which will convey surface water down to Myra Creek. Longitudinal profile slope gradients in the swales are a minimum of 1% towards the main channels.

Photo 18: Old TDF Seismic Upgrade Berm - surface run-off management. (October 27, 2021)

Work to remedy ponding on the Seismic Upgrade Berm was completed in 2018, and only relatively minor ponding was noted during subsequent inspections. This condition should be continually monitored, and additional grading complete when necessary to maintain good surface drainage and minimize erosion.

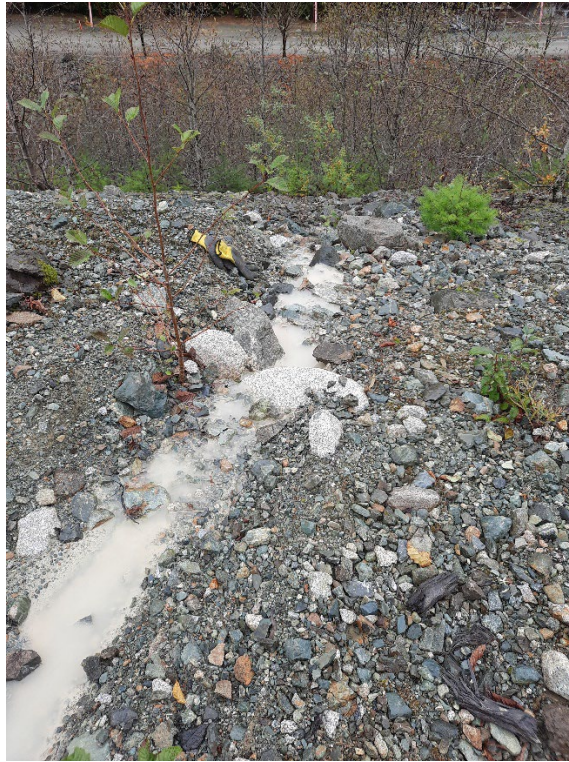
Photo 19: Old TDF Seismic Upgrade Berm – location of erosion, view looking south. (October 27, 2021)
