2022 LYNX TDF DAM SAFETY INSPECTION REPORT

MYRA FALLS MINE LTD.
A TRAFIGURA COMPANY
CAMPBELL RIVER, BC

PROJECT NO.: NX14001B4.3
DATE: 29 MARCH 2023

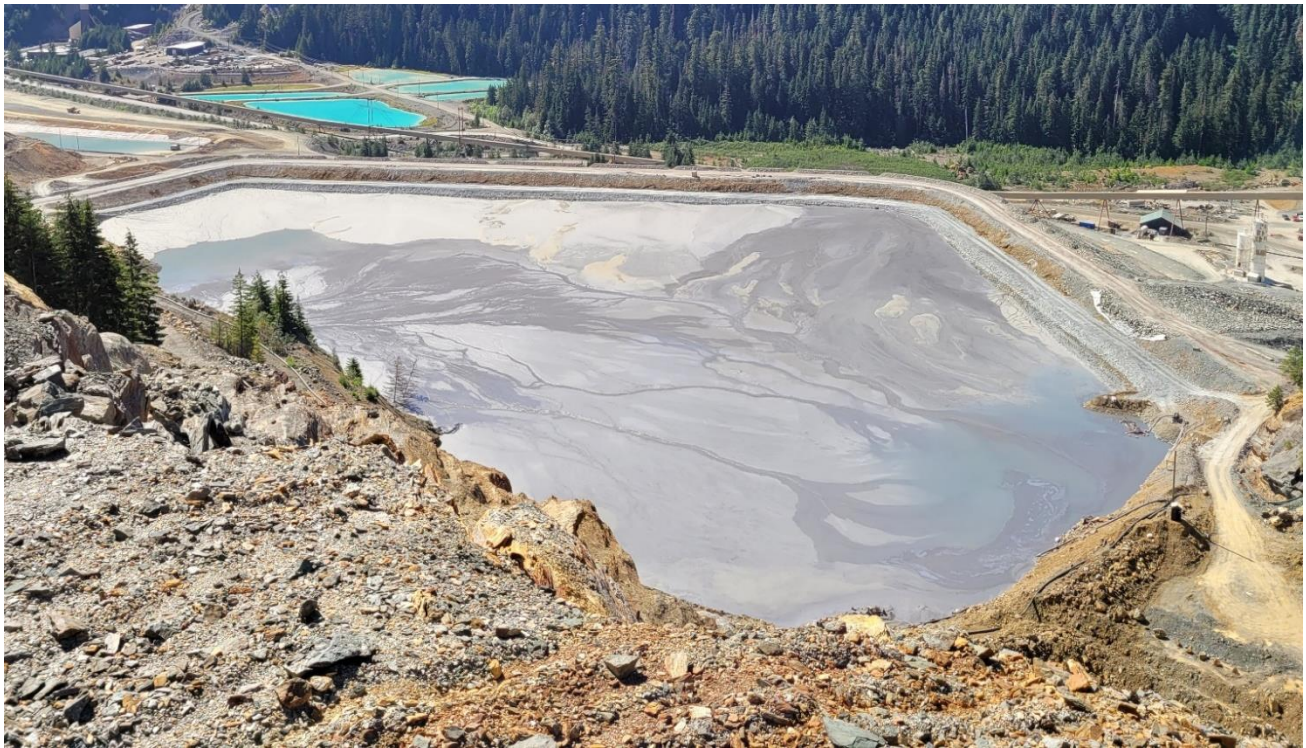
Photo 1: Overview of Lynx TDF taken from lookout point in Upper Lynx Pit. (July 26, 2022)

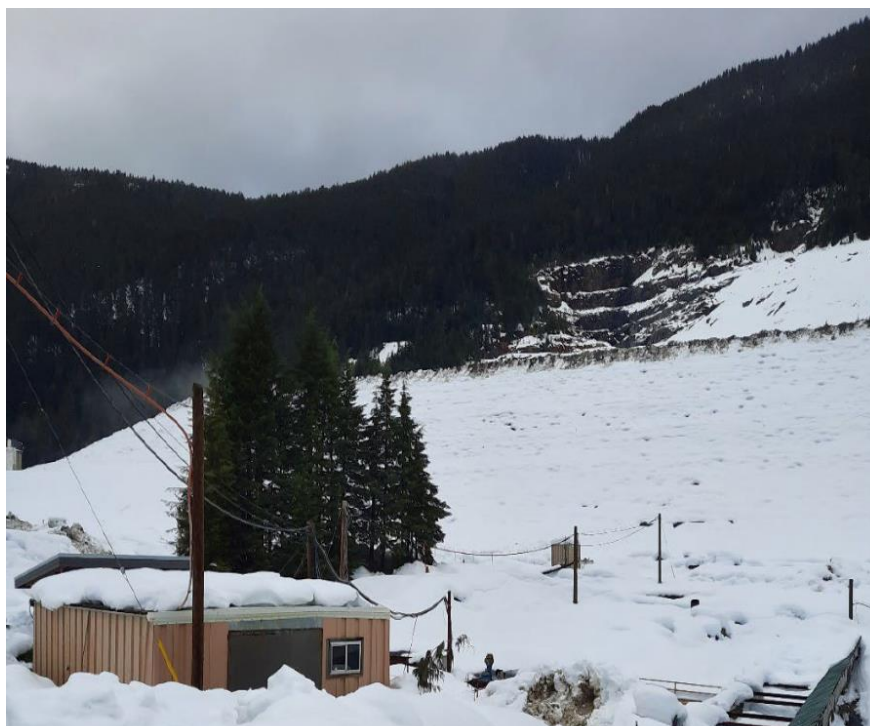
Photo 3: Lynx TDF south-west portion of downstream 2H:1V shell (January 14, 2022)

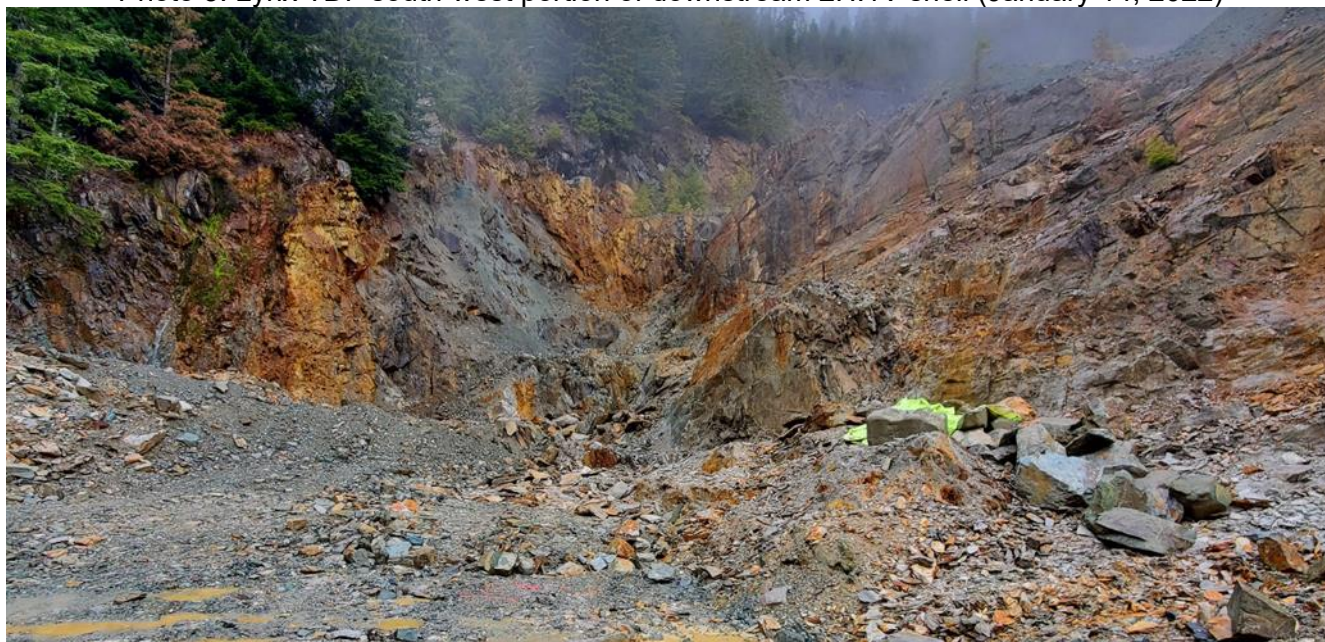
Photo 4: Upper Lynx Pit walls at north-west end of Lynx TDF. (March 25, 2022)

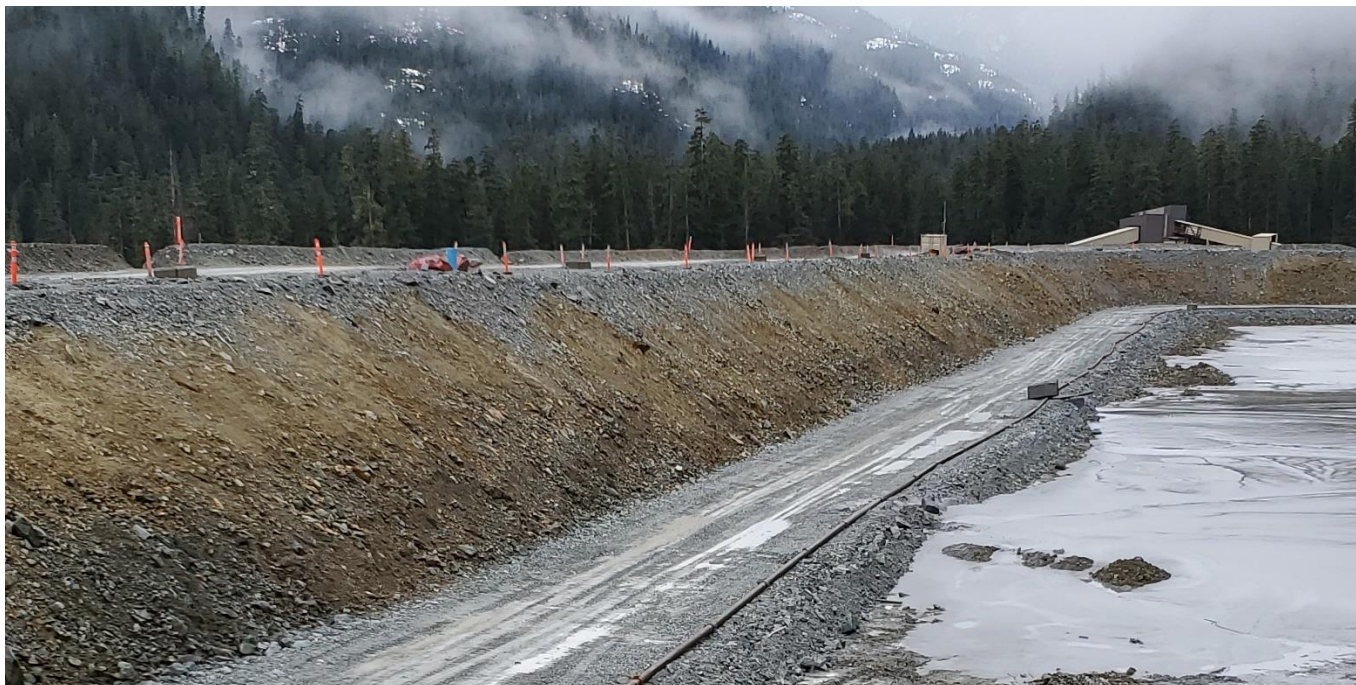
Photo 9: Lynx TDF (looking south-west). (March 25, 2022)

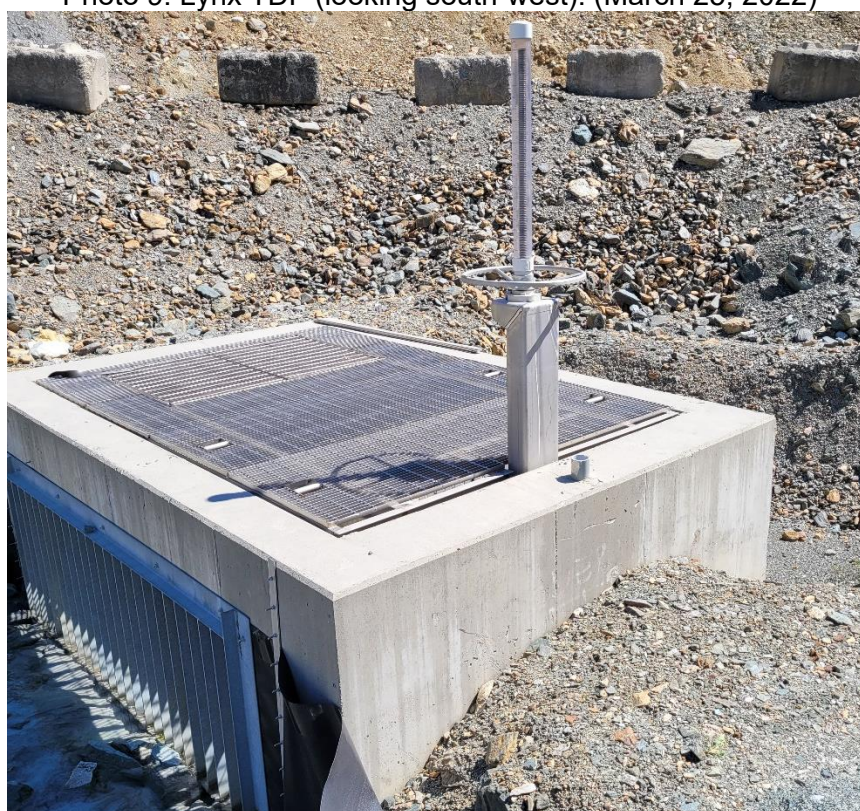
Photo 10: Lynx Springs drain flowing clear with opening to sump box clear of debris. (July 26, 2022)

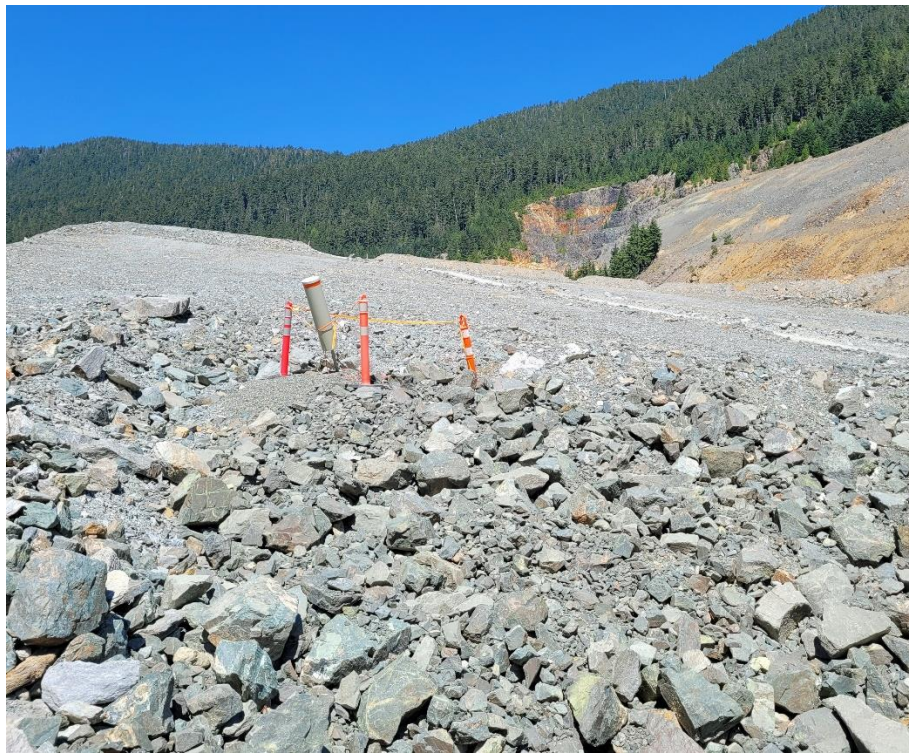
Photo 11: Lynx TDF 4H:1V sloped Downstream East side portion of dam. Shown also is RSTAR data logger DT2055-6. (July 26, 2022)

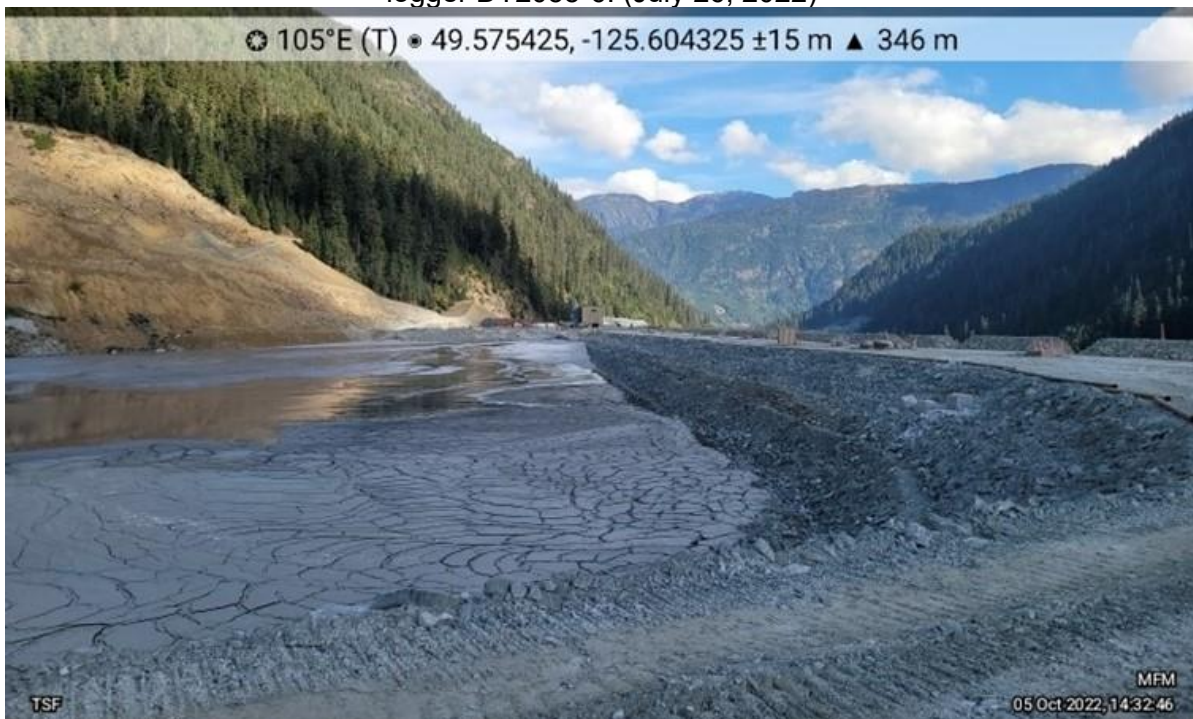
Photo 12: Lynx TDF looking East while standing on crest. (October 5, 2022)

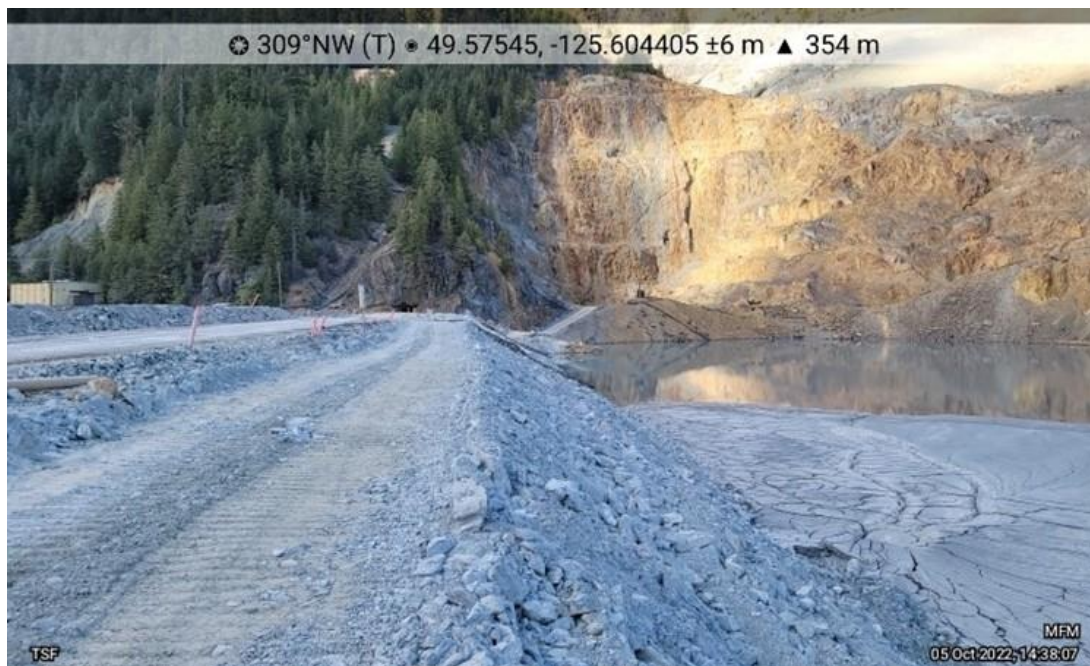
Photo 13: Lynx TDF looking northwest. Crest elevation is at 373.5 m. Photo taken from Upstream bench which was under construction to be raised to 373.5m. (October 5, 2022)

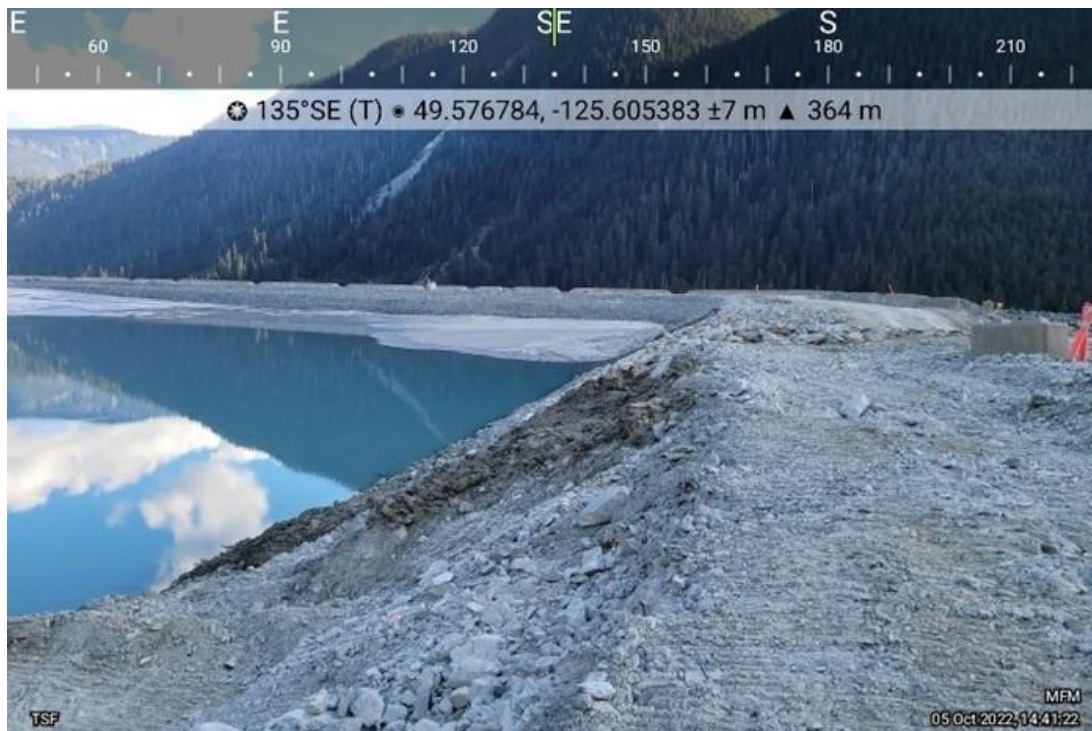
Photo 15: Lynx TDF looking southeast with the boundary of the tailings pond at the west end of the TDF covering about 2/3 of the tailings surface. (October 5, 2022)

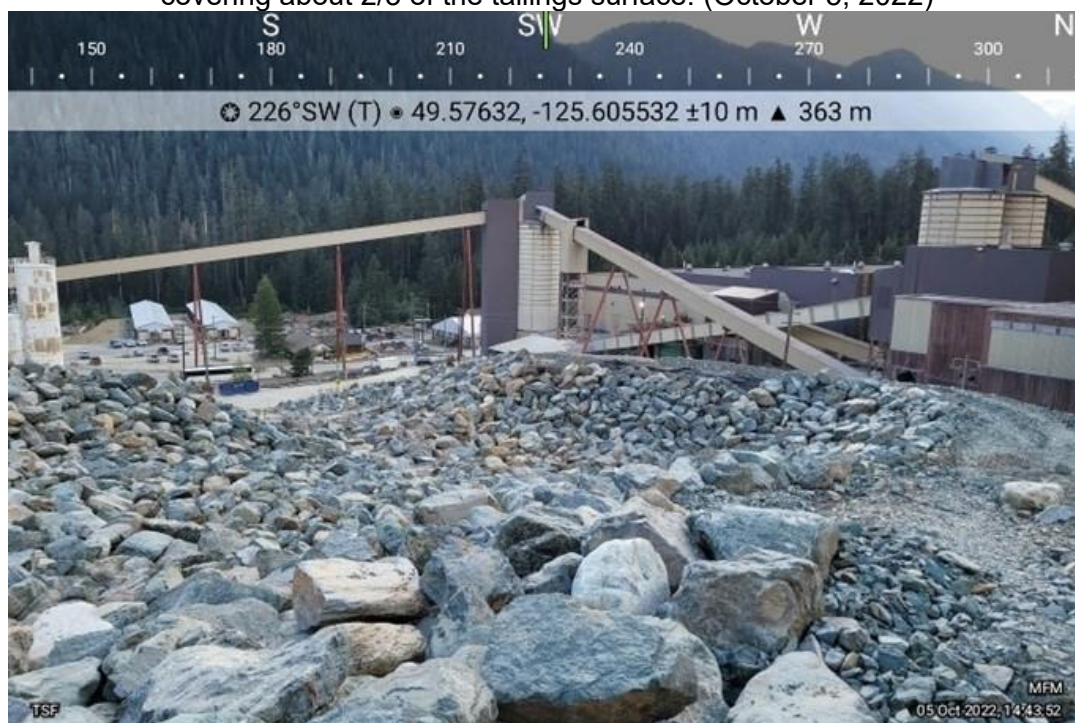
Photo 16: Lynx TDF spillway looking downstream to the mill and camp sites. (October 5, 2022)

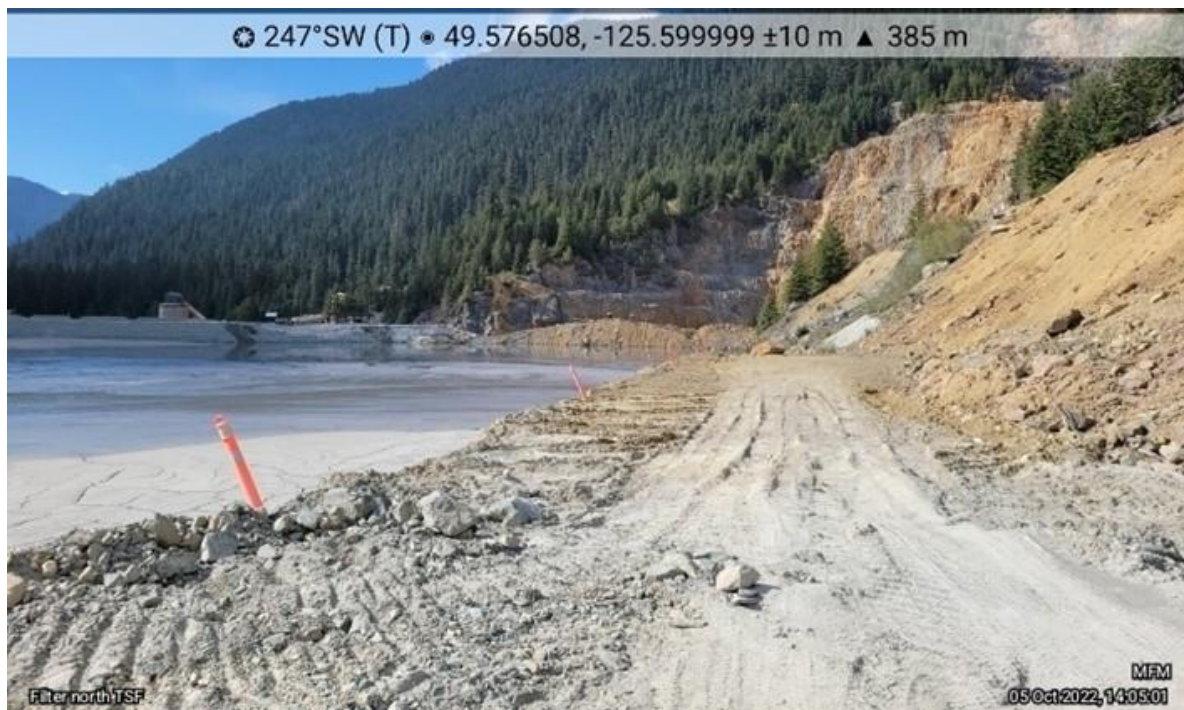
Photo 17: Lynx TDF WRD1 Zone J Filter connecting to Crest, looking northwest. (October 5, 2022)

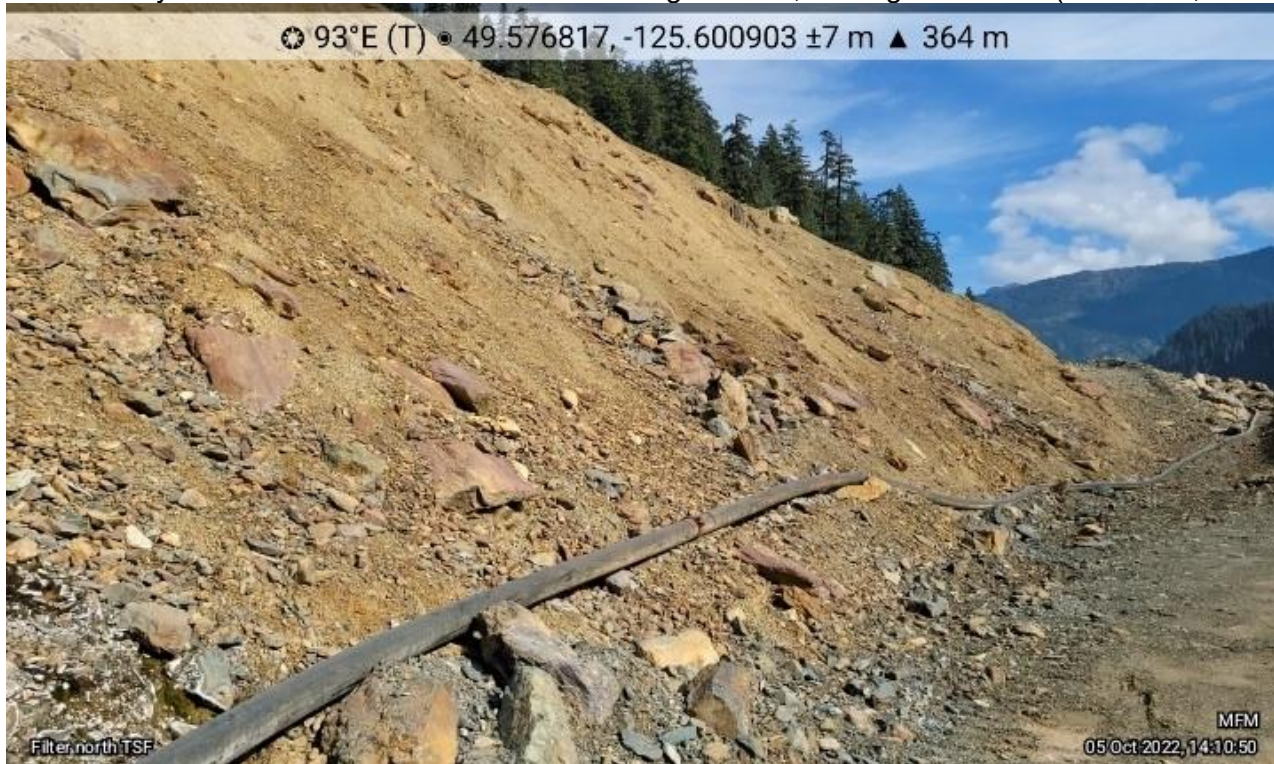
Photo 18: Lynx TDF East Abutment at WRD1, looking southeast. Pipe shown carries tailings from Paste Plant. (October 5, 2022)

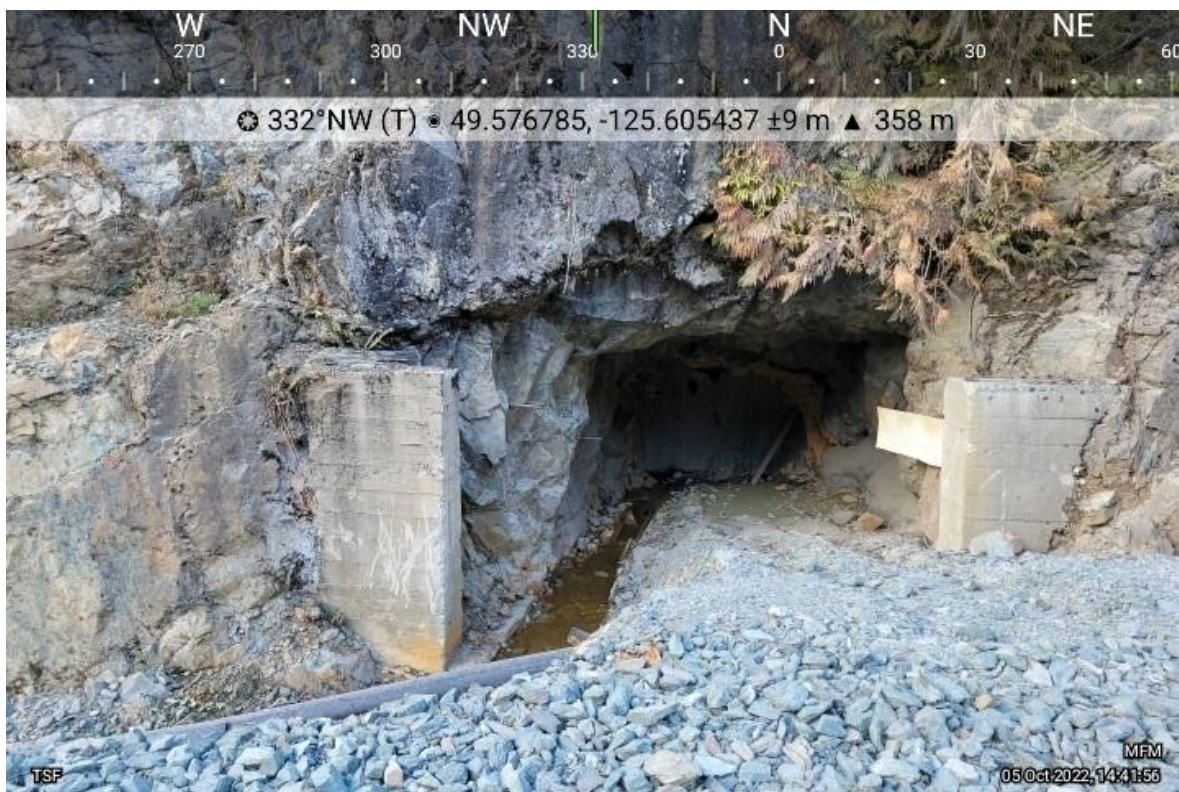
Photo 12: Lynx TDF West Abutment showing 10 Level Portal, looking north. (October 5, 2022)

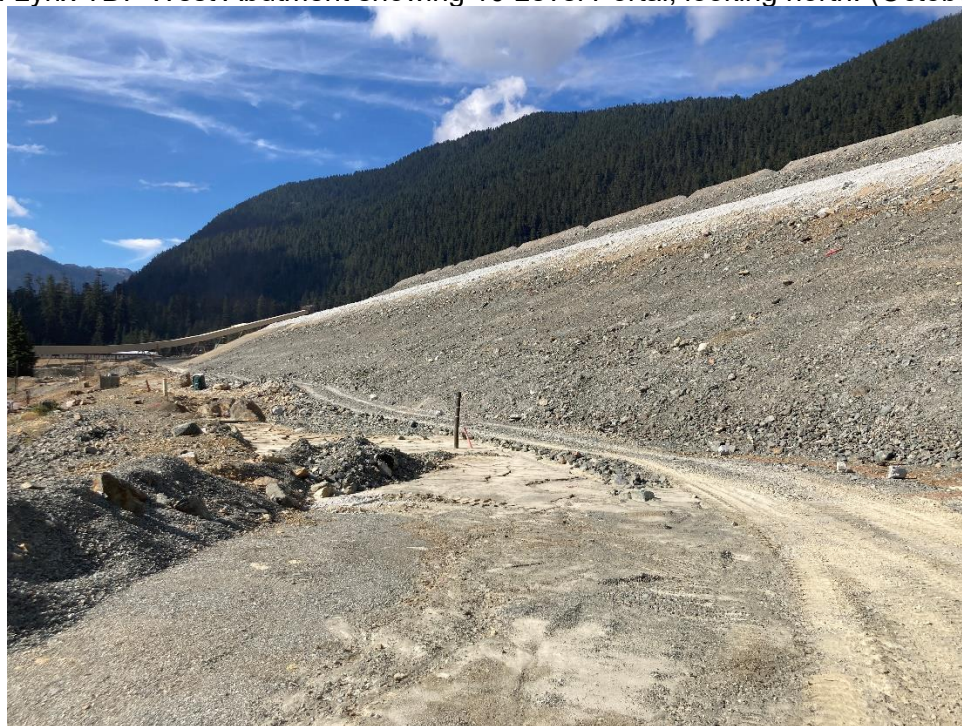
Photo 20: Lynx TDF 2H:1V Downstream dam shell looking north west October 5, 2022)

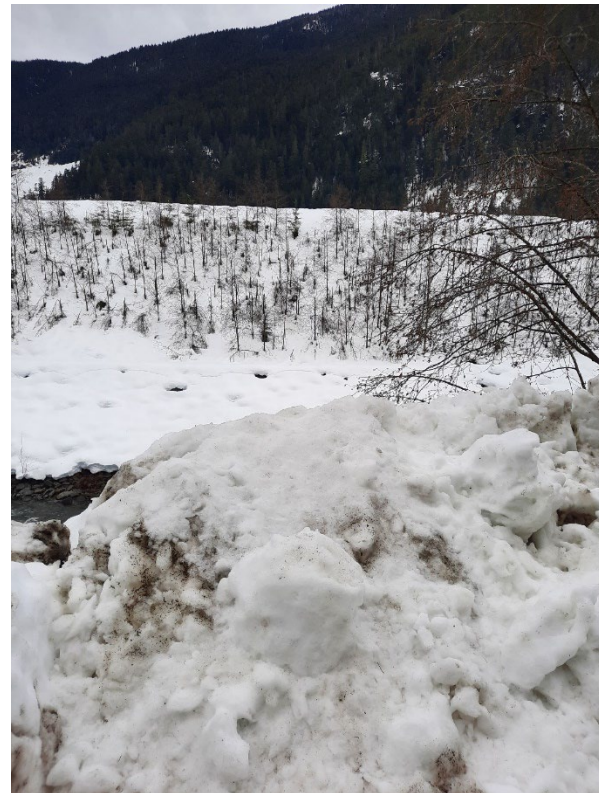
Photo 1a: Old TDF outer embankment

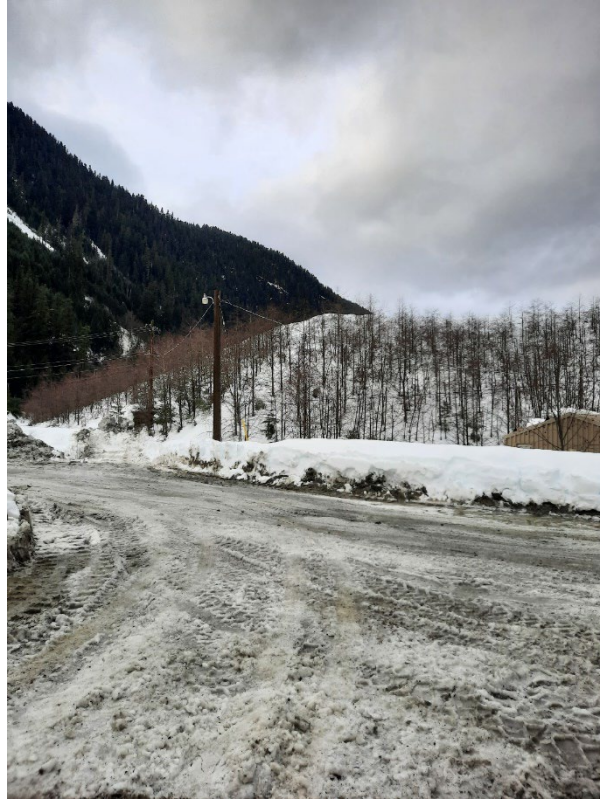
Photo 1b: Old TDF outer embankment

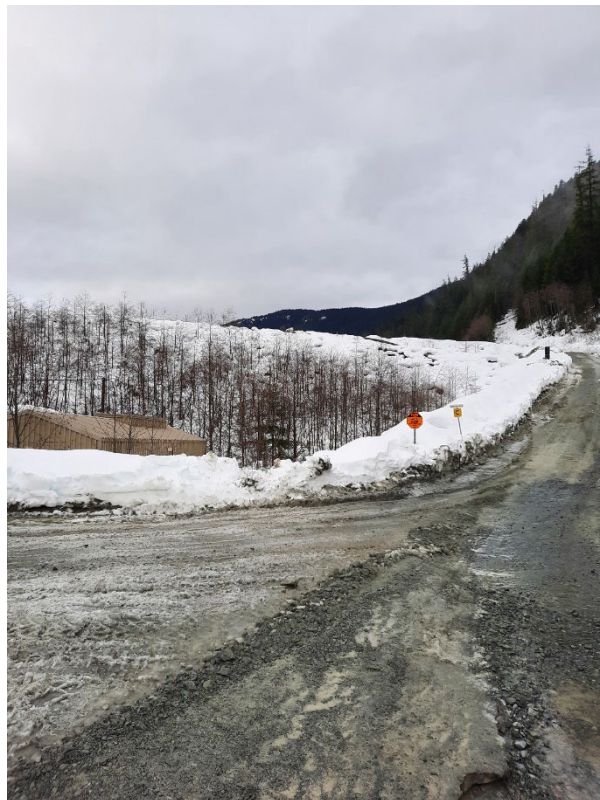
Photo 1c: Old TDF outer embankment

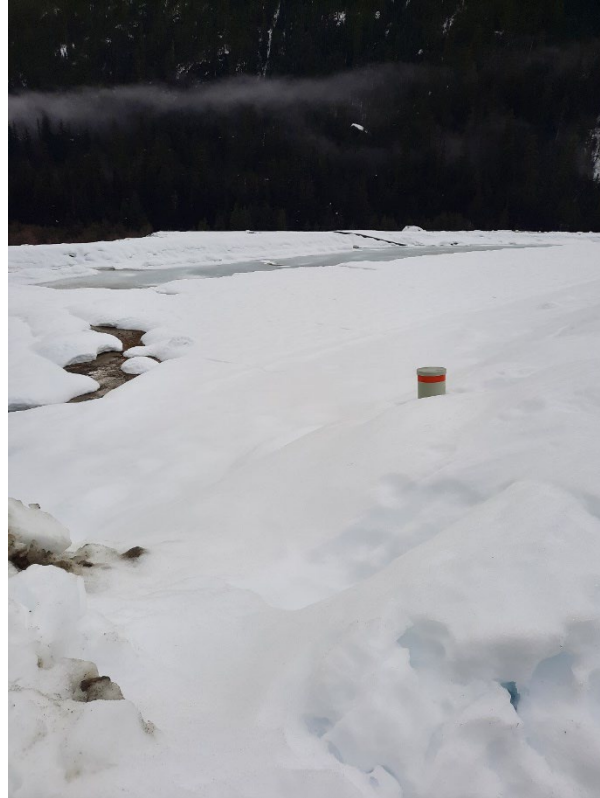
Photo 1d: Old TDF outer embankment

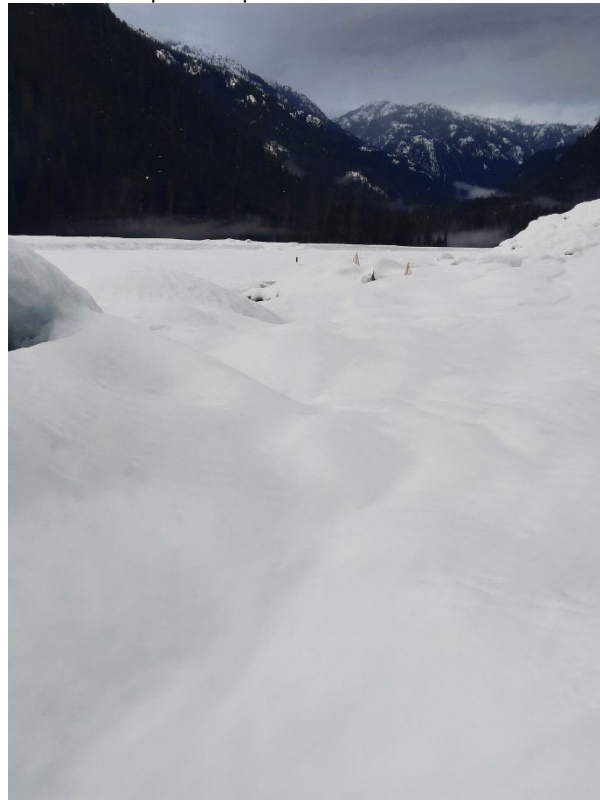
Photo 1e: Old TDF east end of the east strip. Note ponded water and flow from the LLDD underdrain (bottom left)

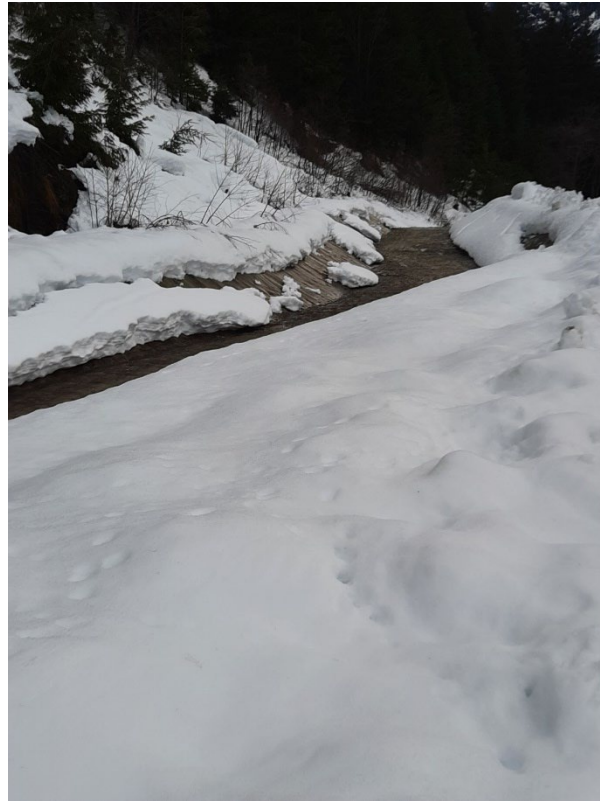
Photo 1f: Old TDF showing snow covered APA

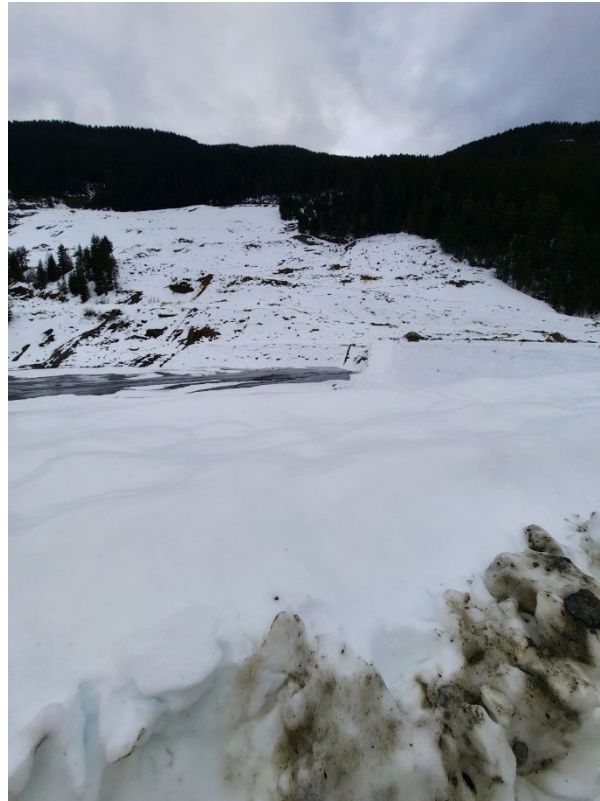
Photo 3a: Lynx TDF 4:1 slope

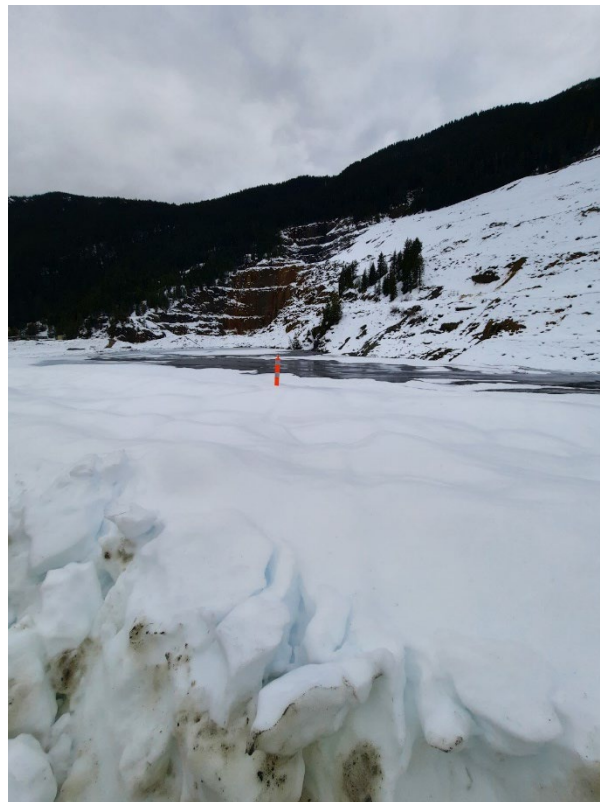
Photo 3b: Lynx TDF showing WRD1 filter and discharge of raw tails to the west of the filter

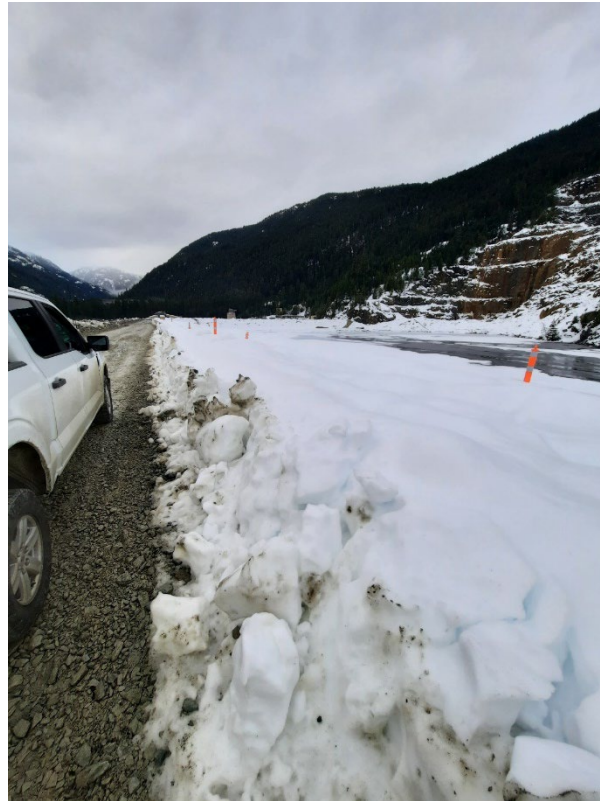
Photo 3c: Lynx TDF beach and pool

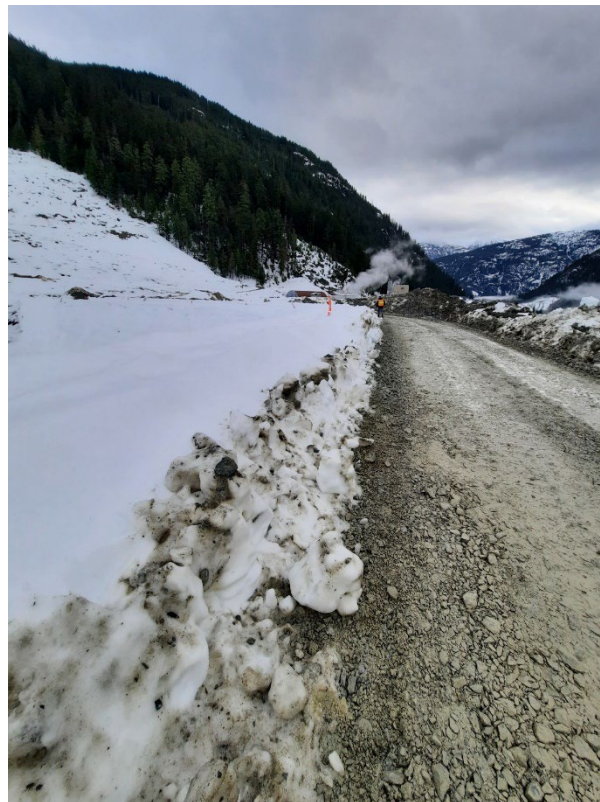
Photo 3d: Lynx TDF dam crest and upstream bench

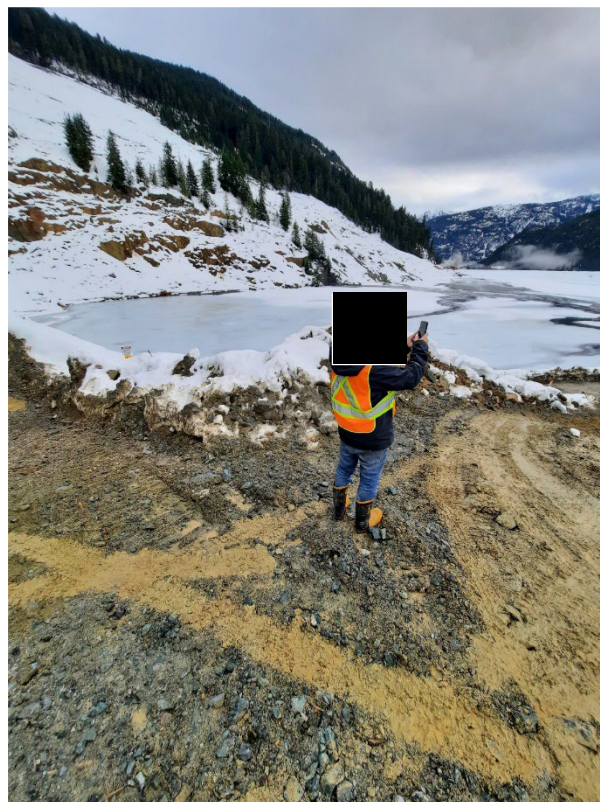
Photo 3f: Lynx TDF discharge of raw tails

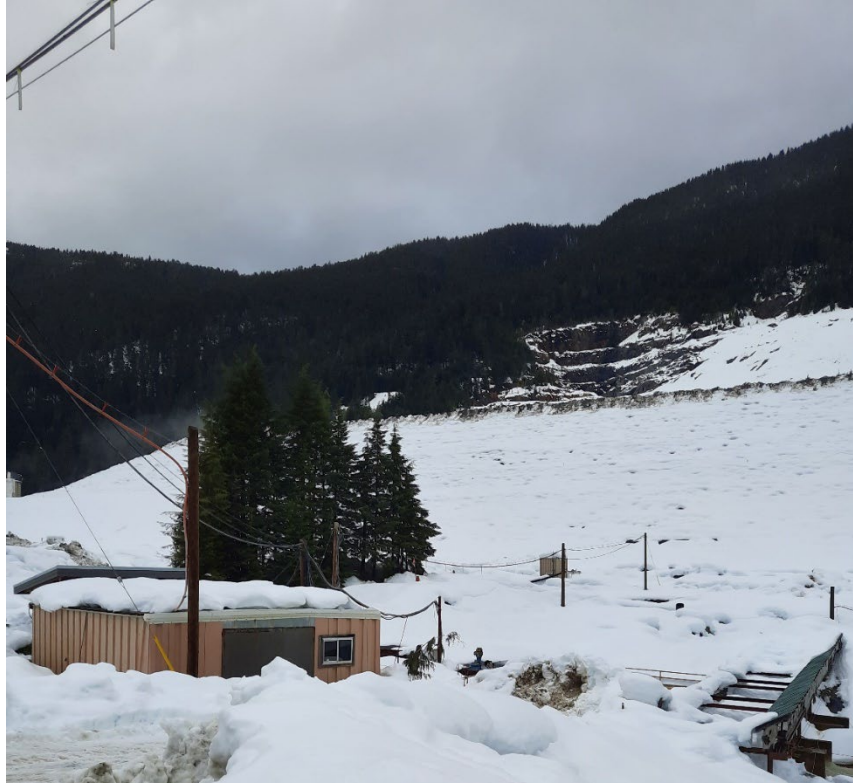
Photo 3g: Lynx TDF reclaim pool

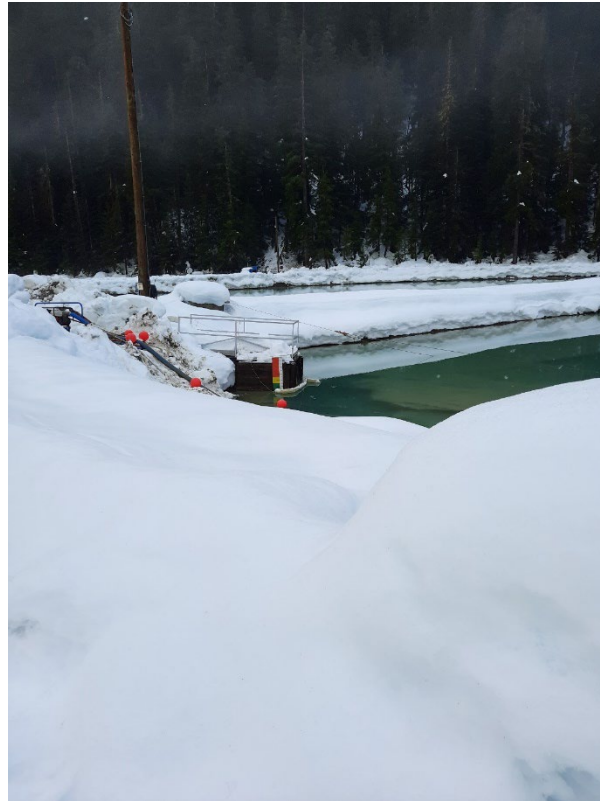
Photo 4a: WTP 3A, silt curtain installed

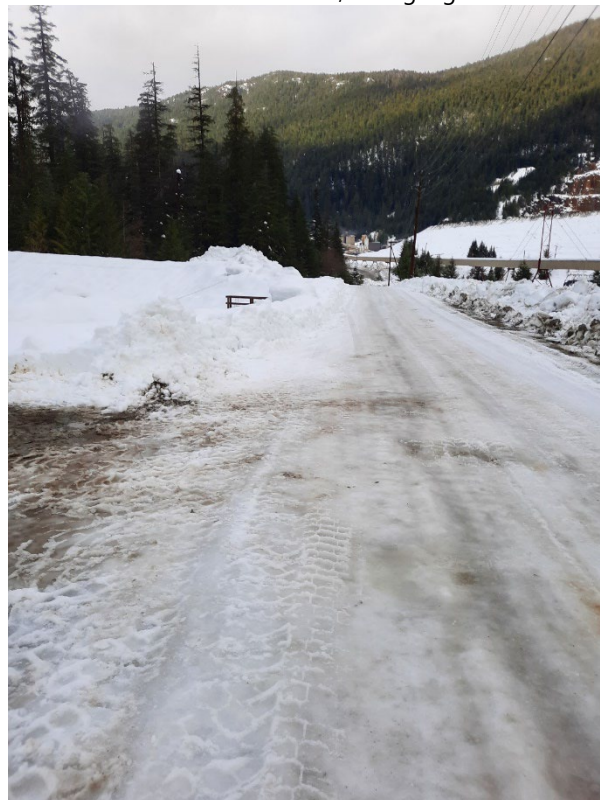
Photo 4b: WTP 2A, staff gauge

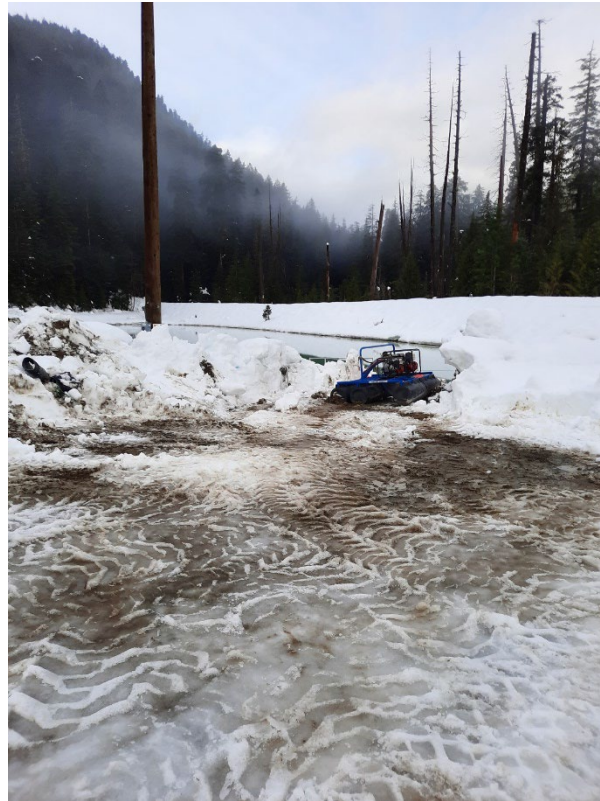
Photo 4c: Crest between WTPs

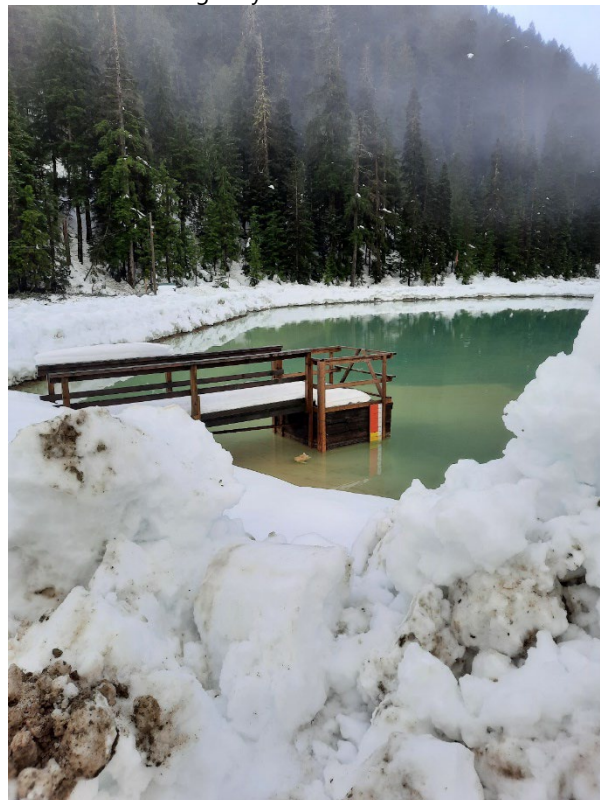
Photo 4d: dredge dry-docked S-E corner of WTP2A

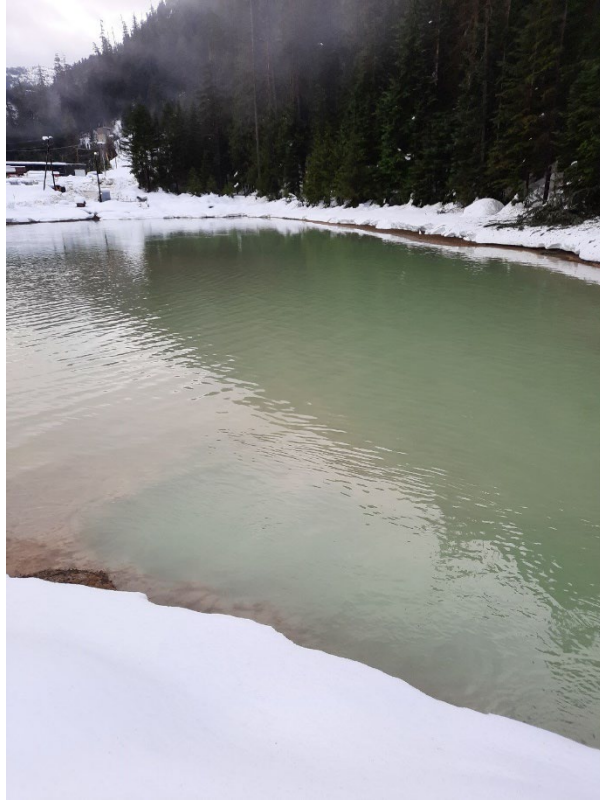
Photo 4e: WTP 2 staff gauge

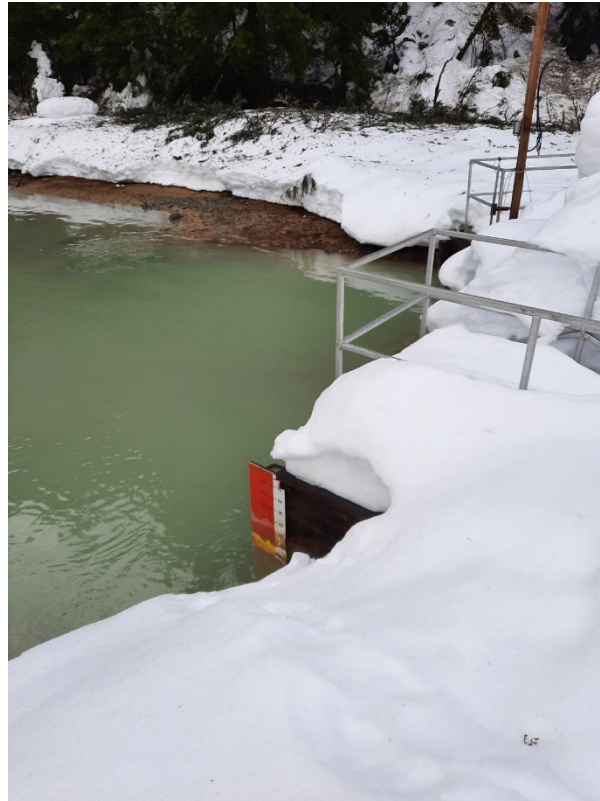
Photo 4g: WTP1 staff gauge

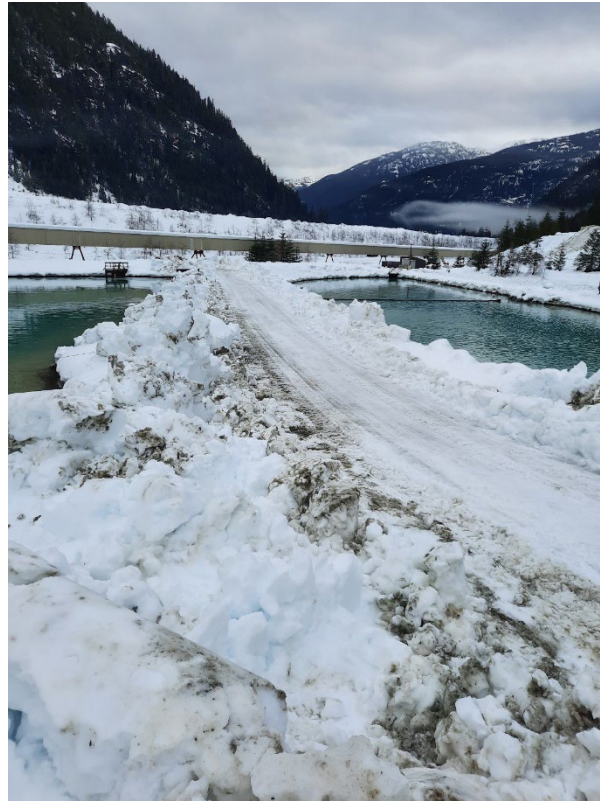
Photo 4k: Crest between WTP2 and WTP2A

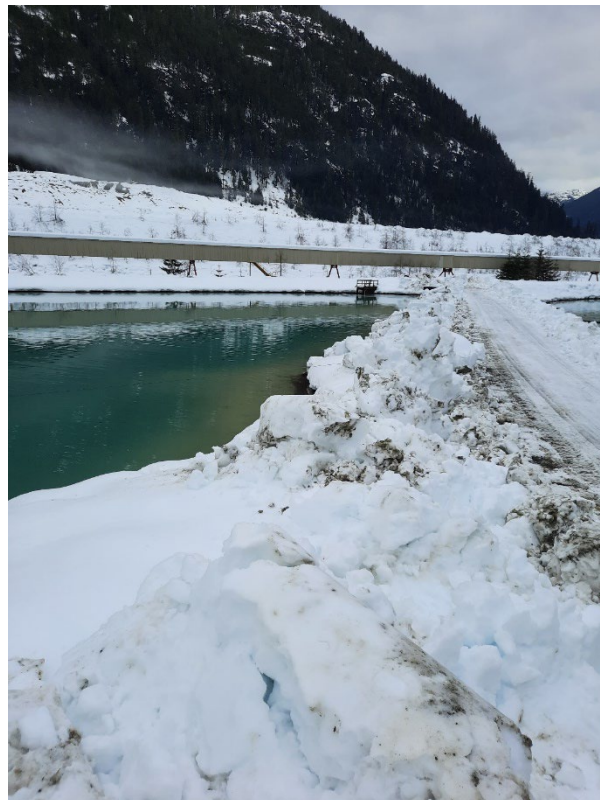
Photo 4l: Crest between WTP3 and WTP3A

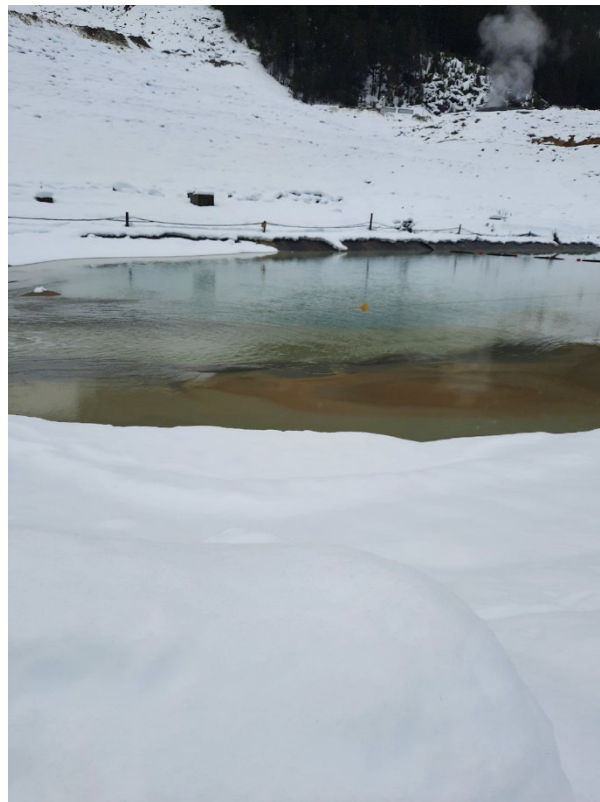
Photo 4n: WTP3A staff gauge

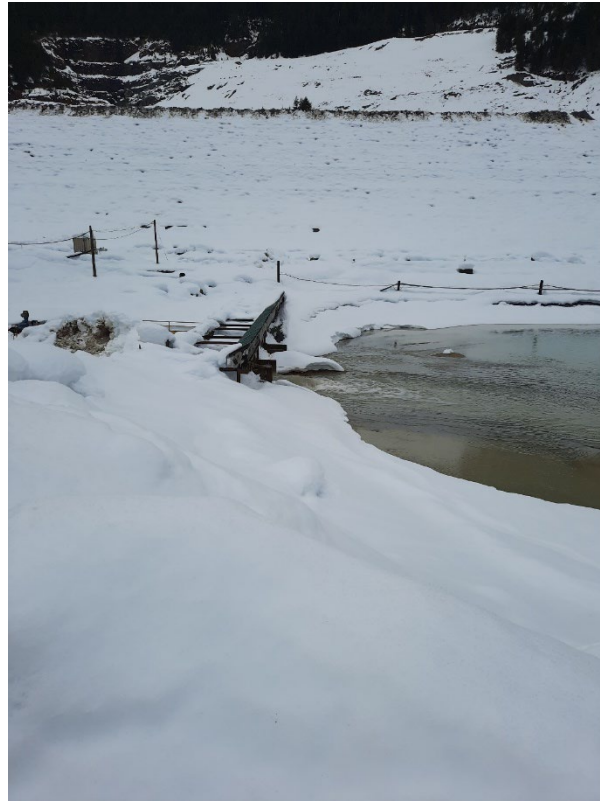
Photo 5a: Super Pond

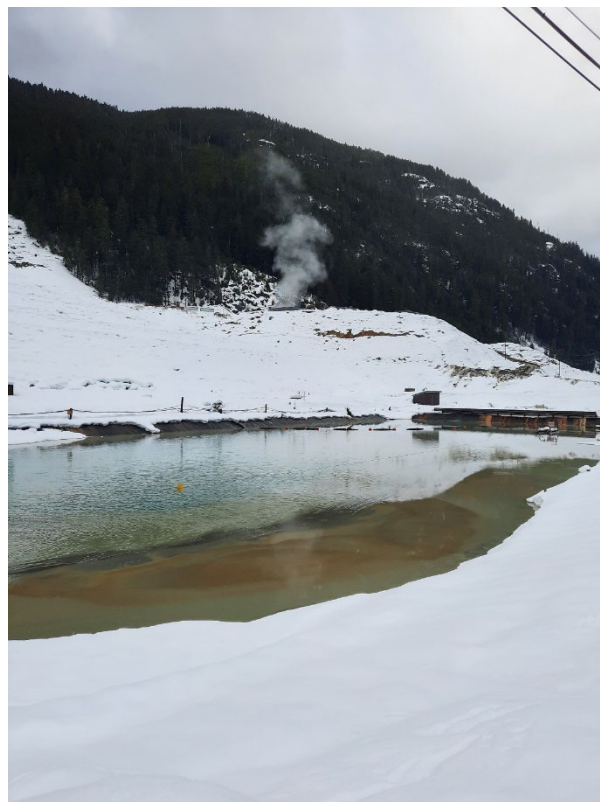
Photo 5b: Super Pond In
