2022 LYNX TDF DAM SAFETY INSPECTION REPORT

MYRA FALLS MINE LTD.
A TRAFIGURA COMPANY
CAMPBELL RIVER, BC

PROJECT NO.: NX14001B4.3
DATE: 29 MARCH 2023

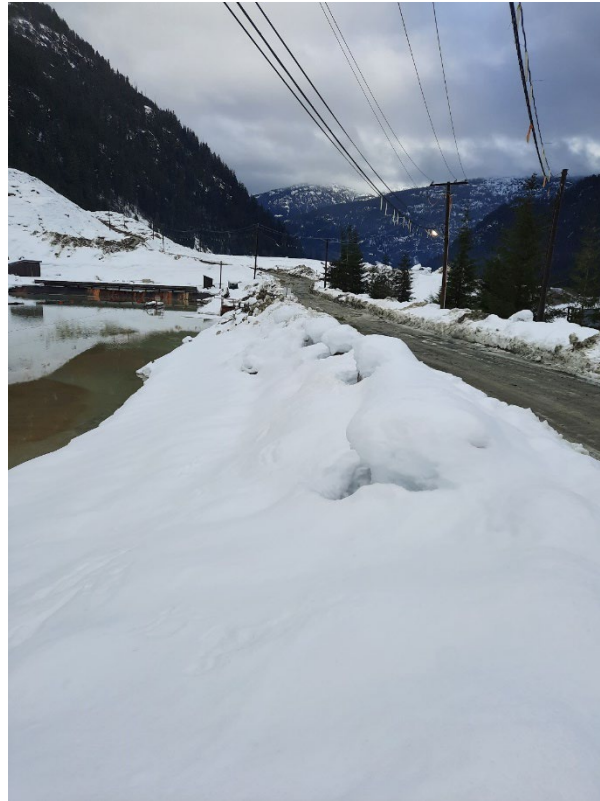
Photo 5c: Super Pond out

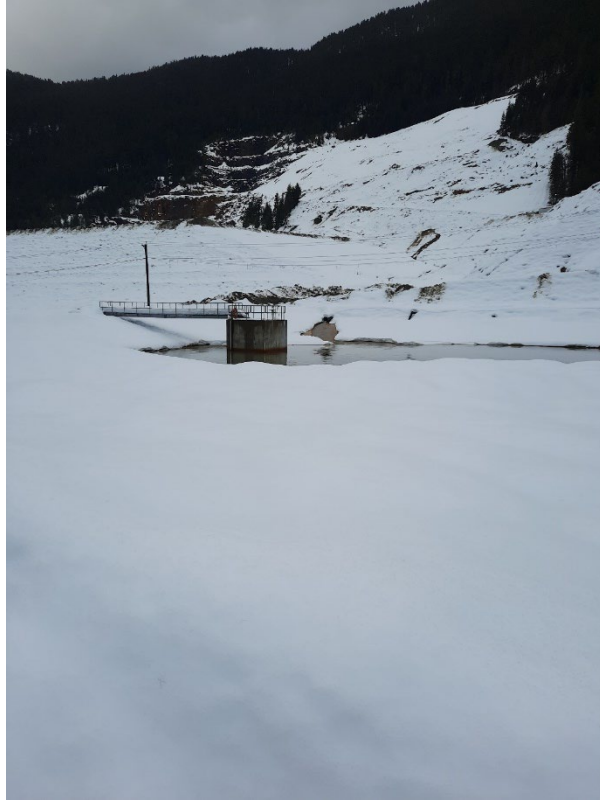
Photo 6b: SurgePond west decant

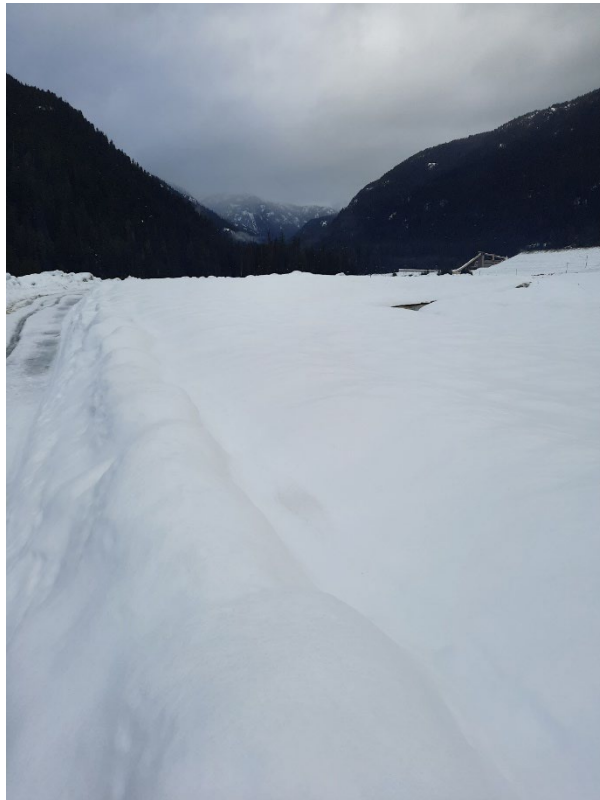
Photo 6c: Old TDF west strip channel

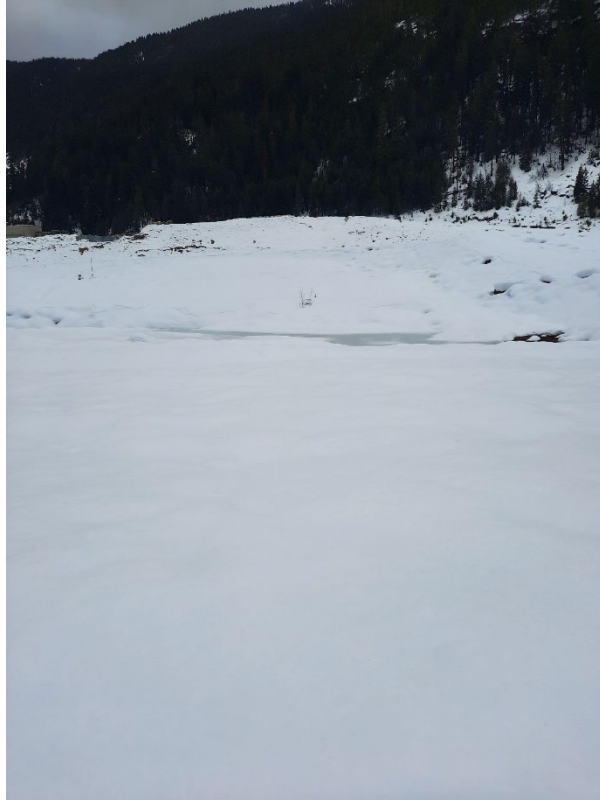
Photo 6d: Old TDF east end of the west strip, APA spillway and WRD6

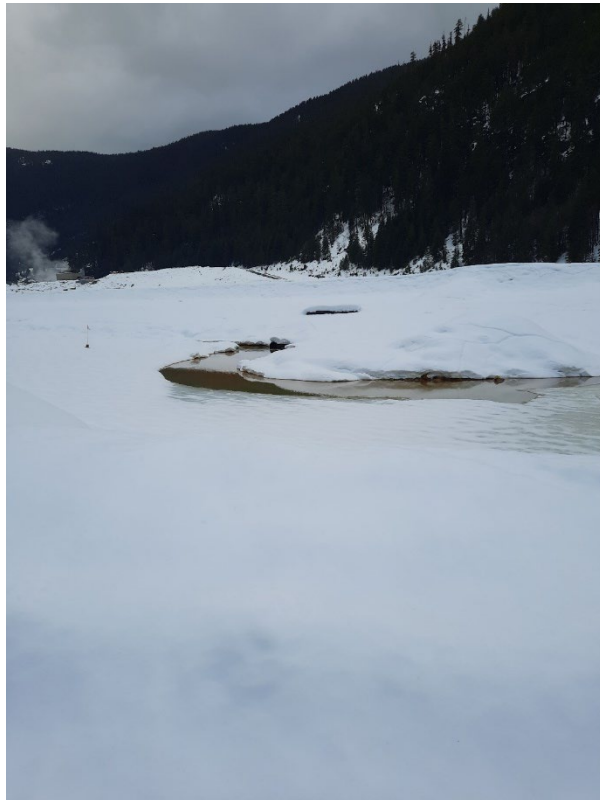
Photo 6e: Old TDF west end of the east strip, APA berm, APA spillway & APA spillway culvert crossings

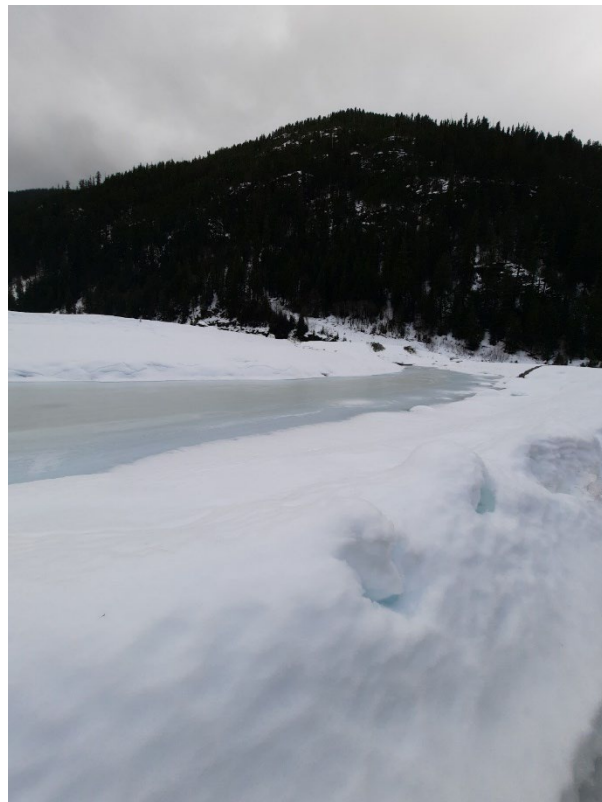
Photo 6f: Old TDF east strip and APA berm

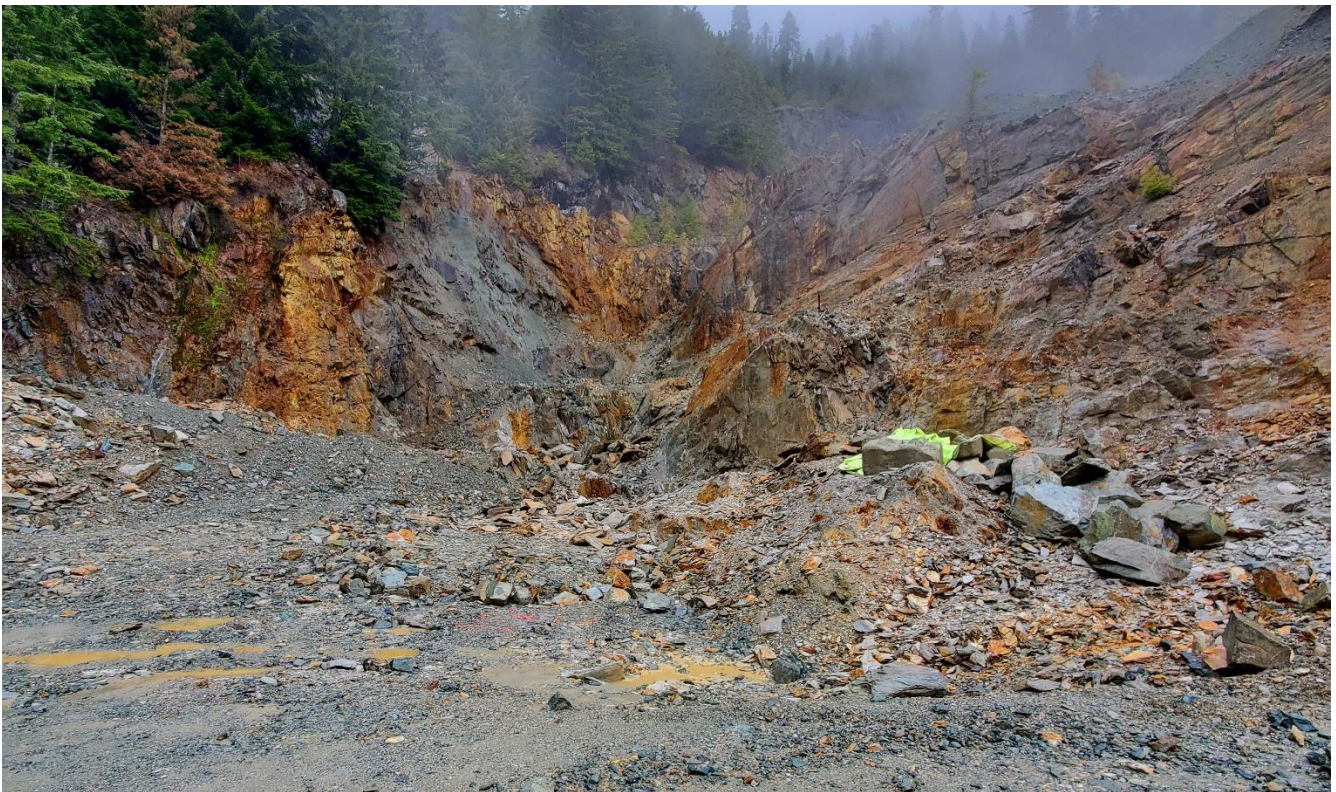
Photo 2: Lynx open pit walls north of Lynx TDF. (March 22, 2022)

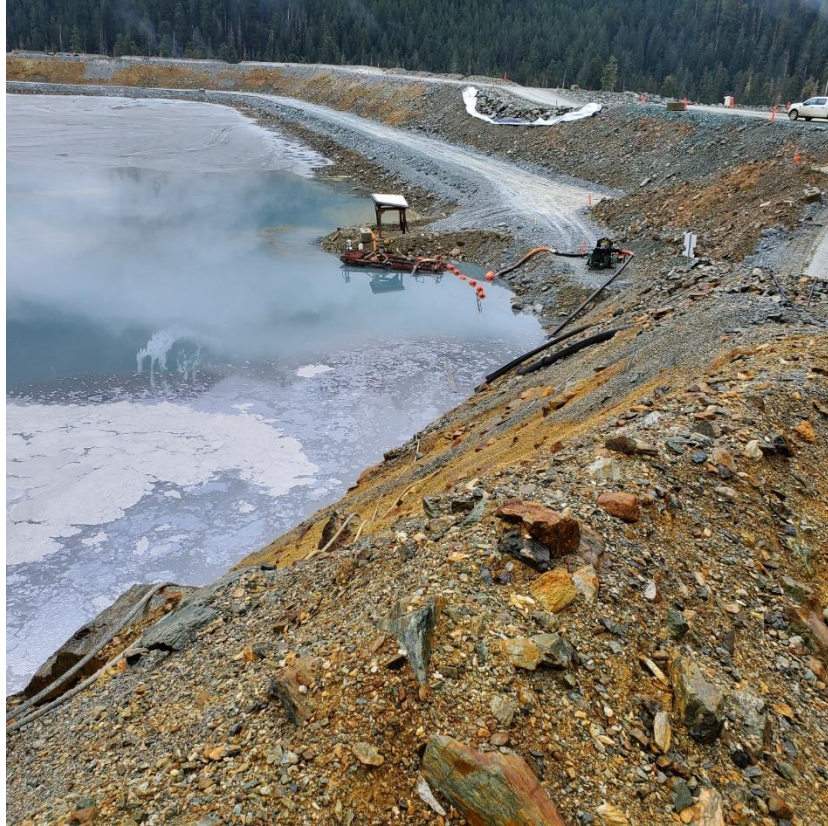
Photo 3: West end of Lynx TDF, looking east towards area of pump and staff gauge. (March 22, 2022)

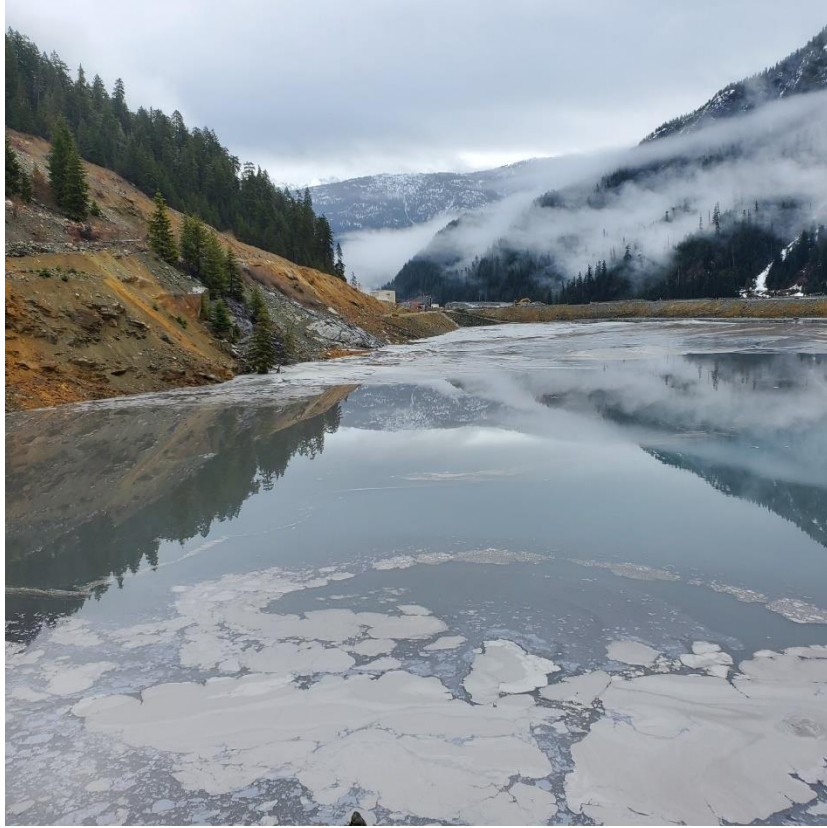
Photo 5: Lynx TDF, looking east with tailings pond covering about 2/3rd of the tailings surface. (March 22, 2022)

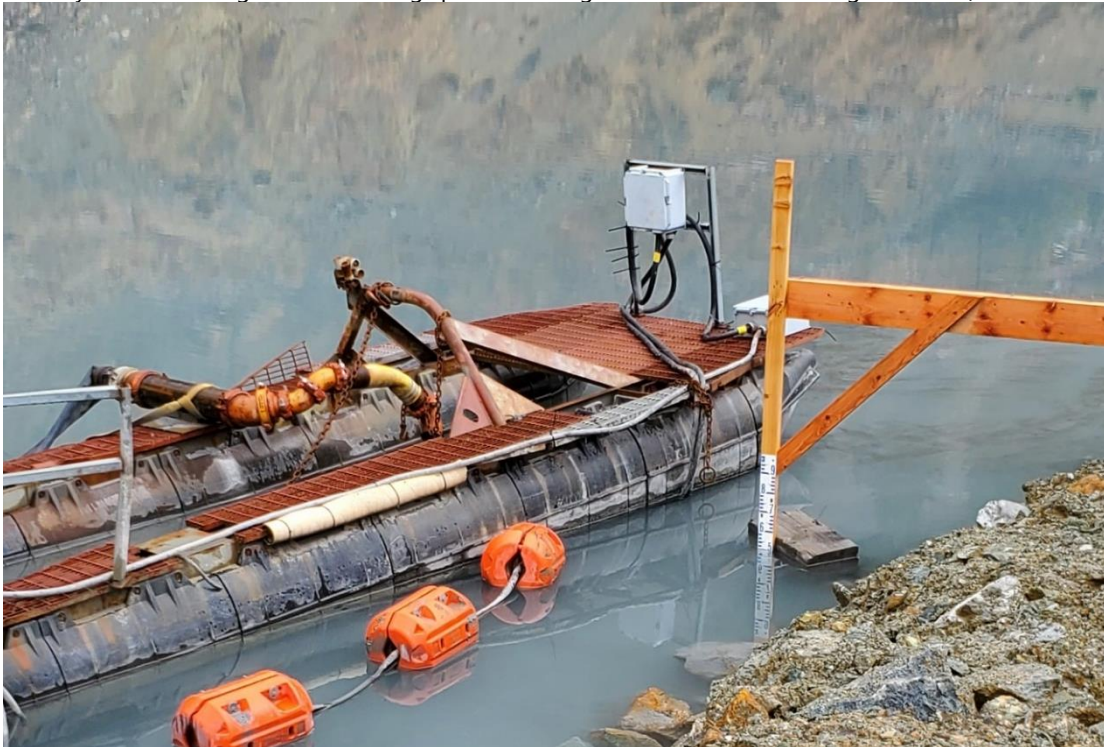
Photo 6: Lynx TDF staff gauge. (March 22, 2022)

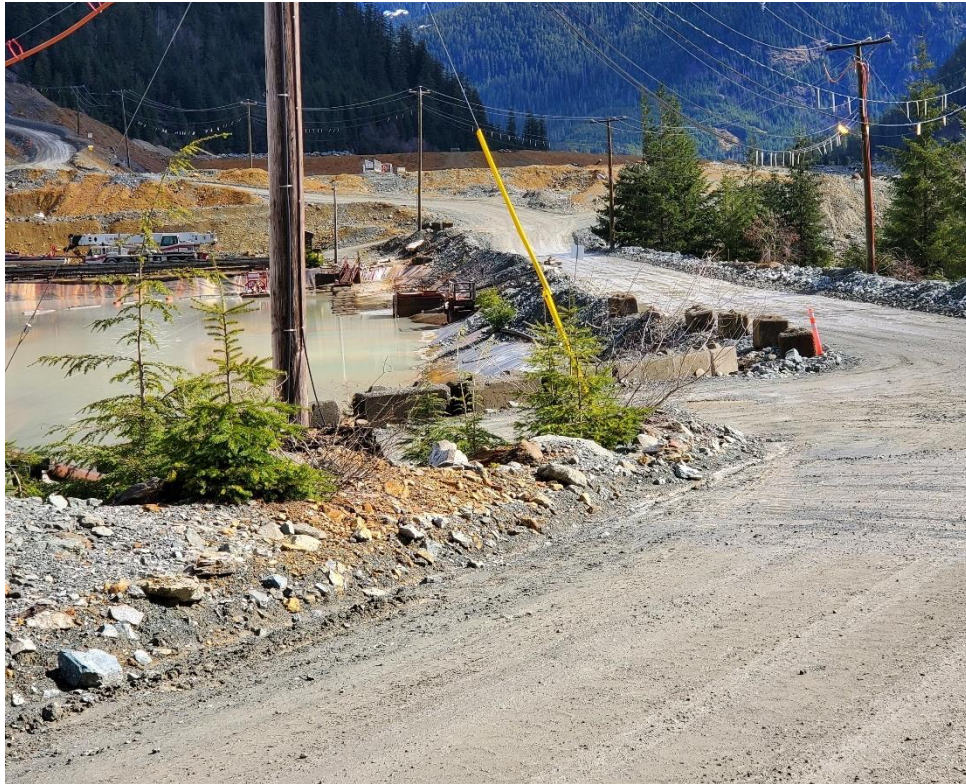
Photo 21: Super Pond Road looking Northeast towards the Old TDF. (March 23, 2022)

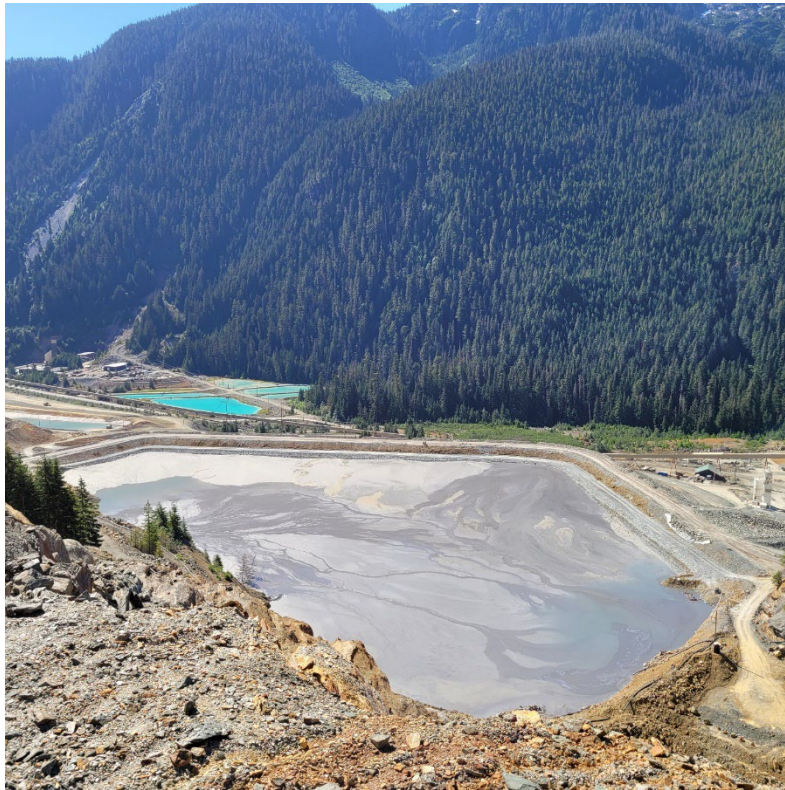
Photo 1: Lynx TDF

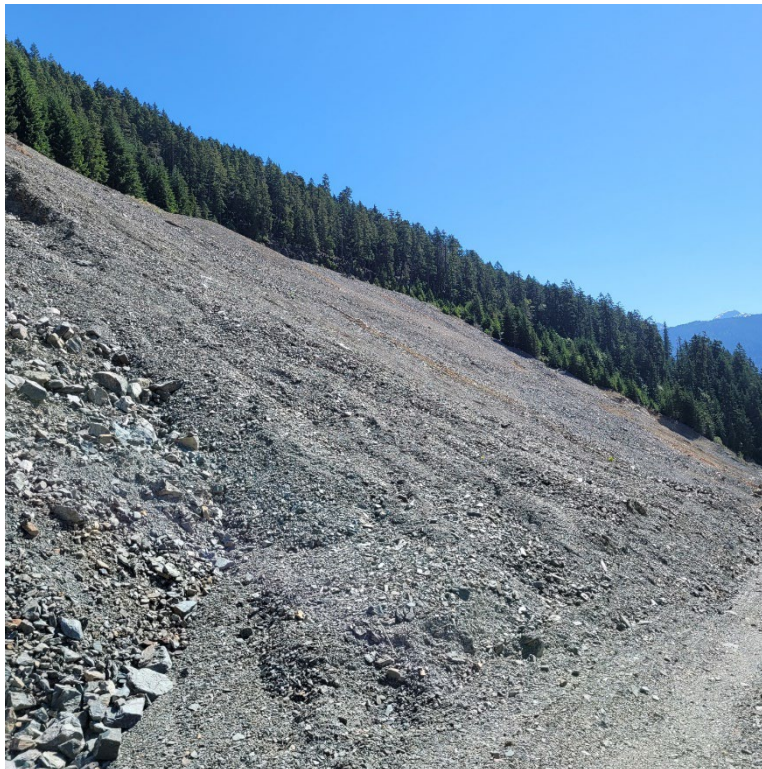
Photo 2: Waste Rock dump area in the northeast corner of the Lynx TDF

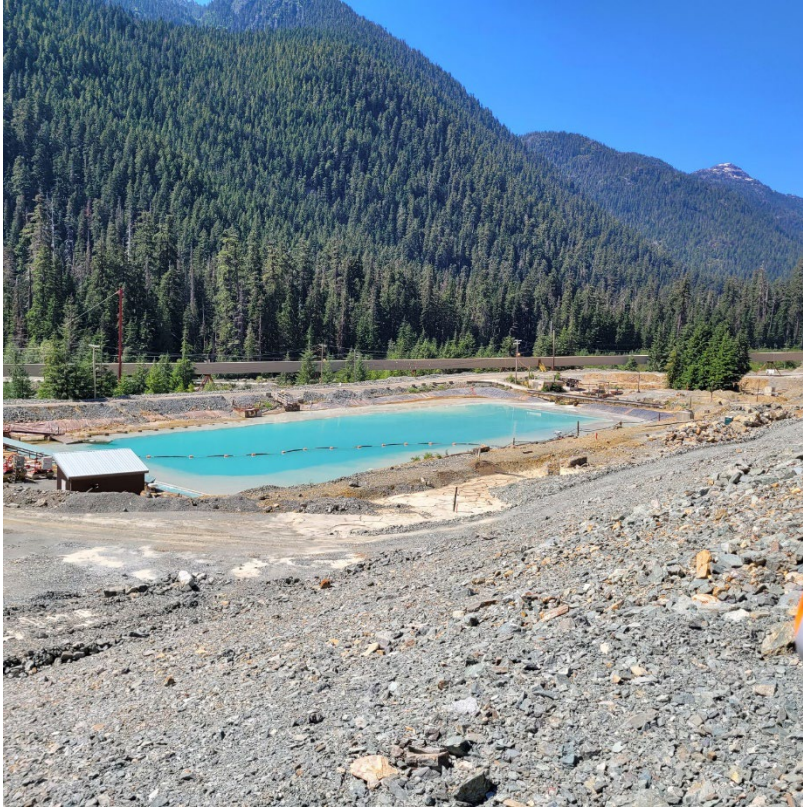
Photo 3: Super Pond at time of site inspection.

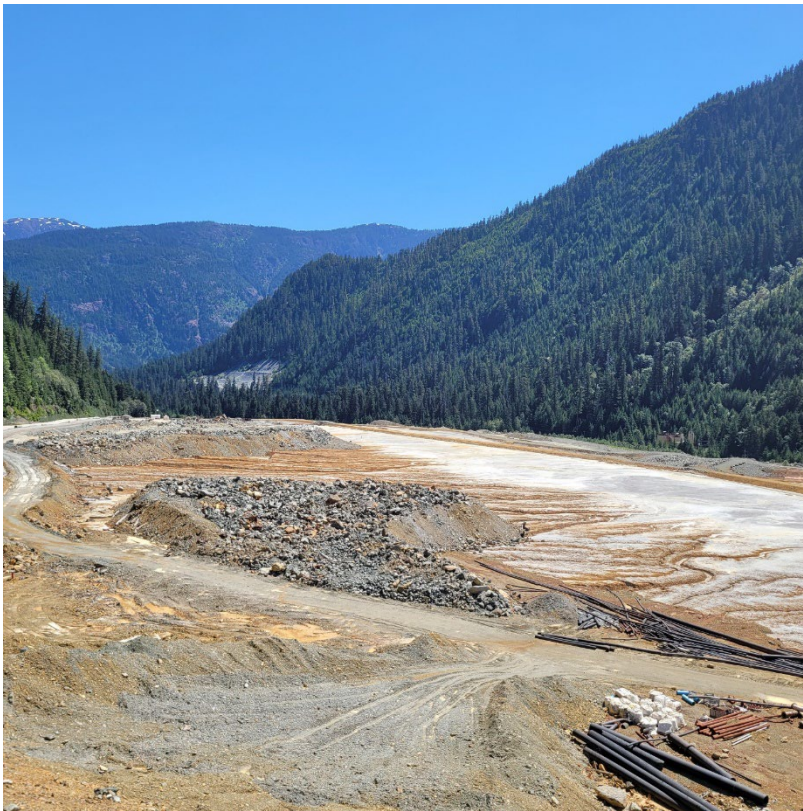
Photo 4: Waste rock stockpile at the back end of Old TDF

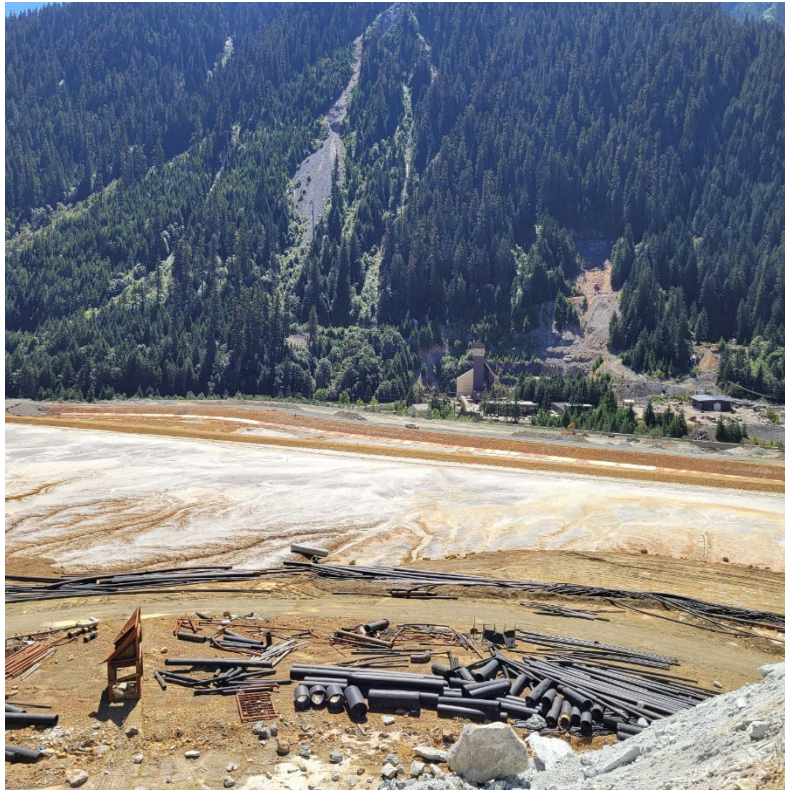
Photo 5: Storage area at the back end of Old TDF

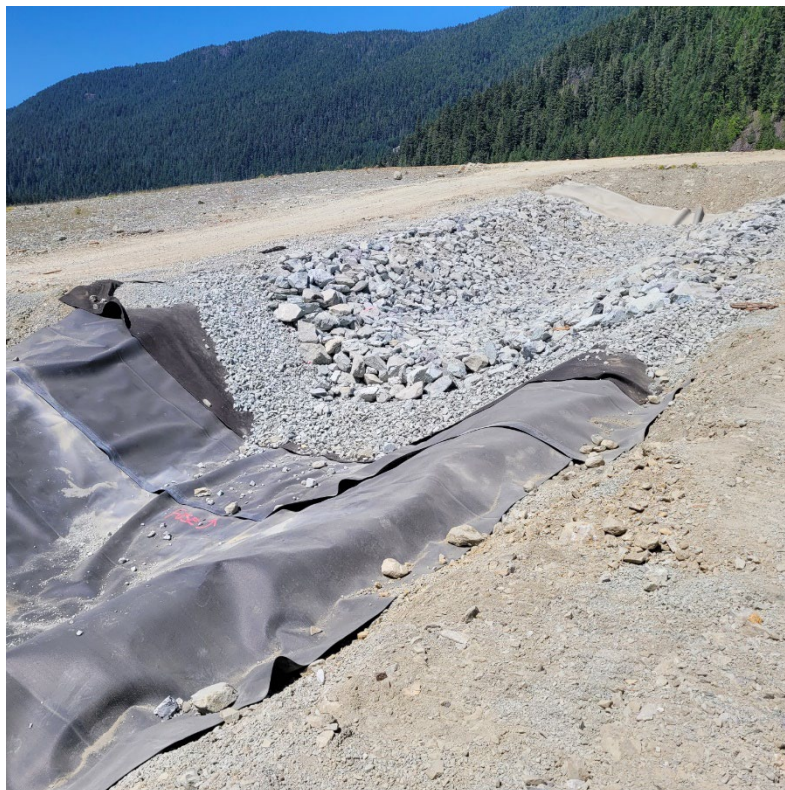
Photo 6: Geomembrane and geotextile liner along the spillway of Old TDF

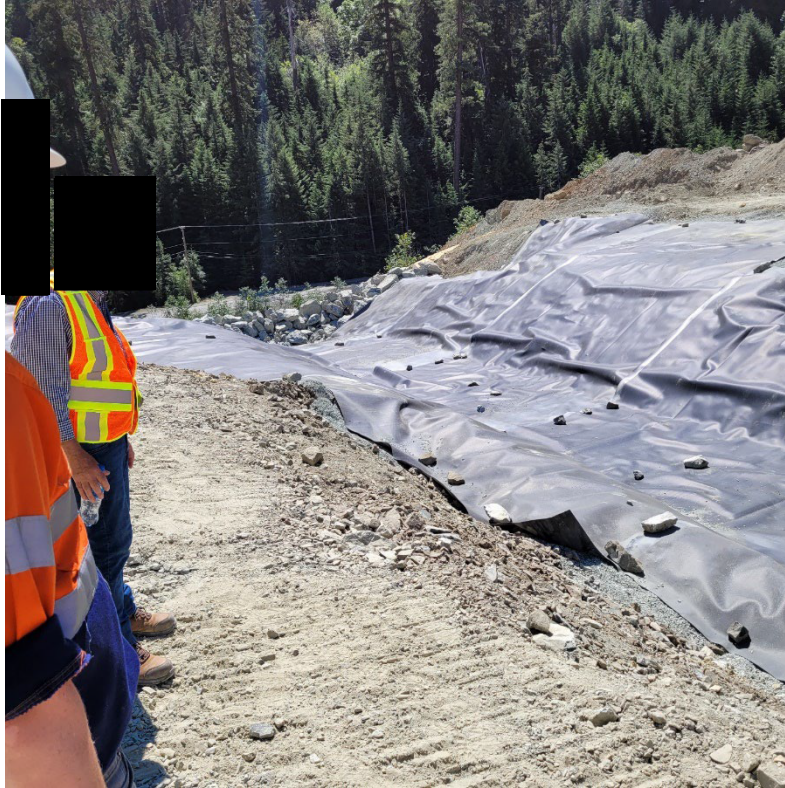
Photo 7: Liner system of the Old TDF spillway

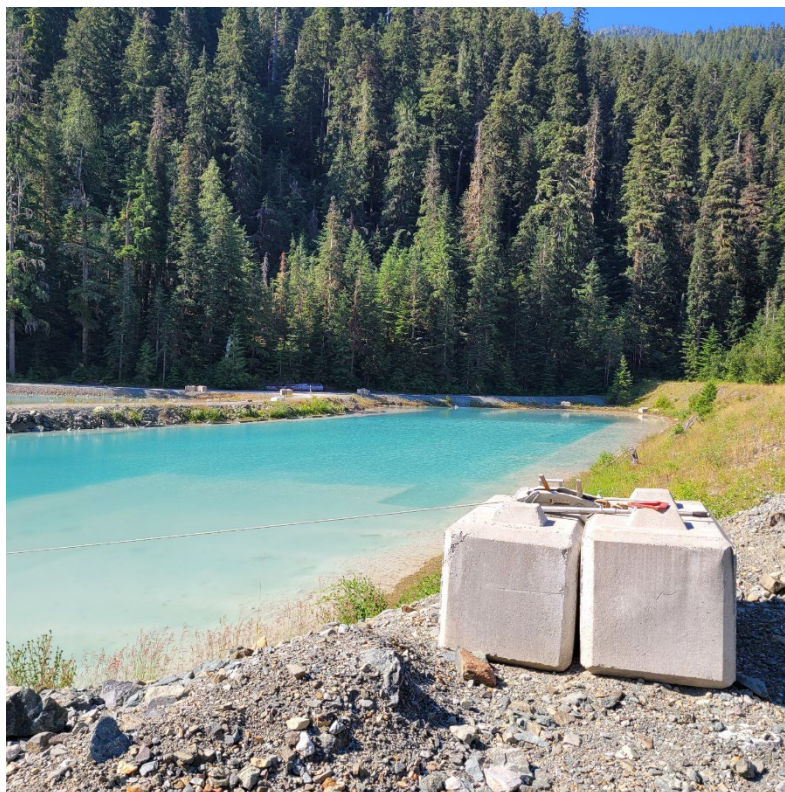
Photo 8: Polishing ponds under normal operating conditions

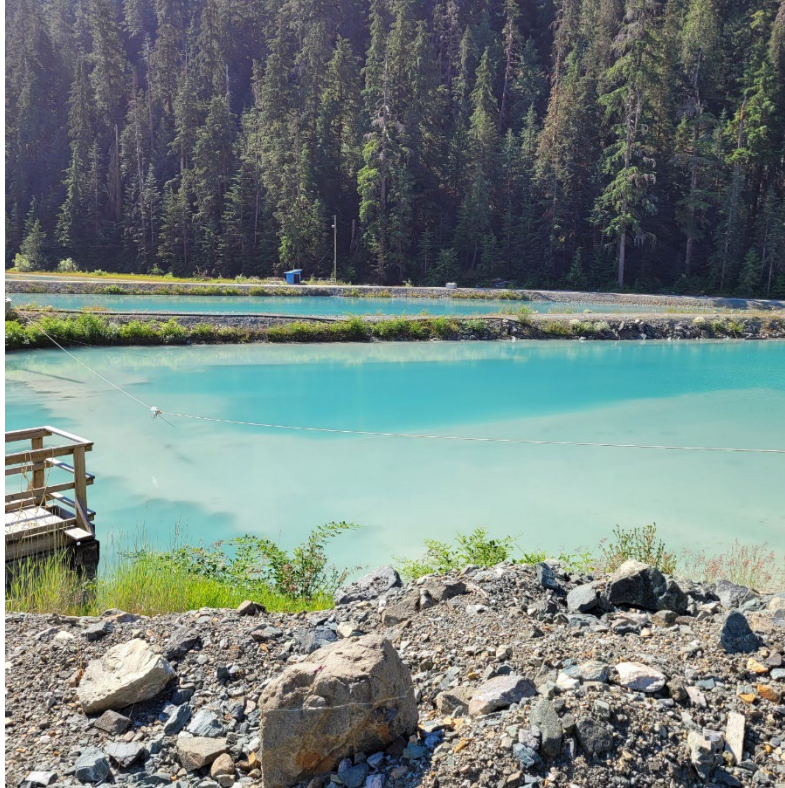
Photo 9: Polishing ponds under normal operating conditions

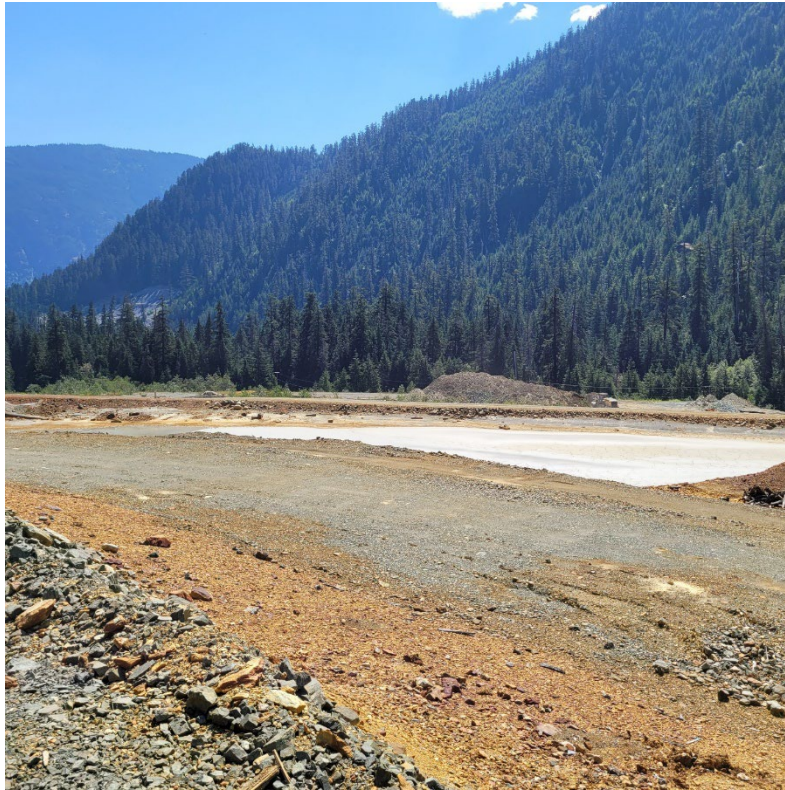
Photo 11: East corner of Old TDF with a small pond and tailings inside the East Strip

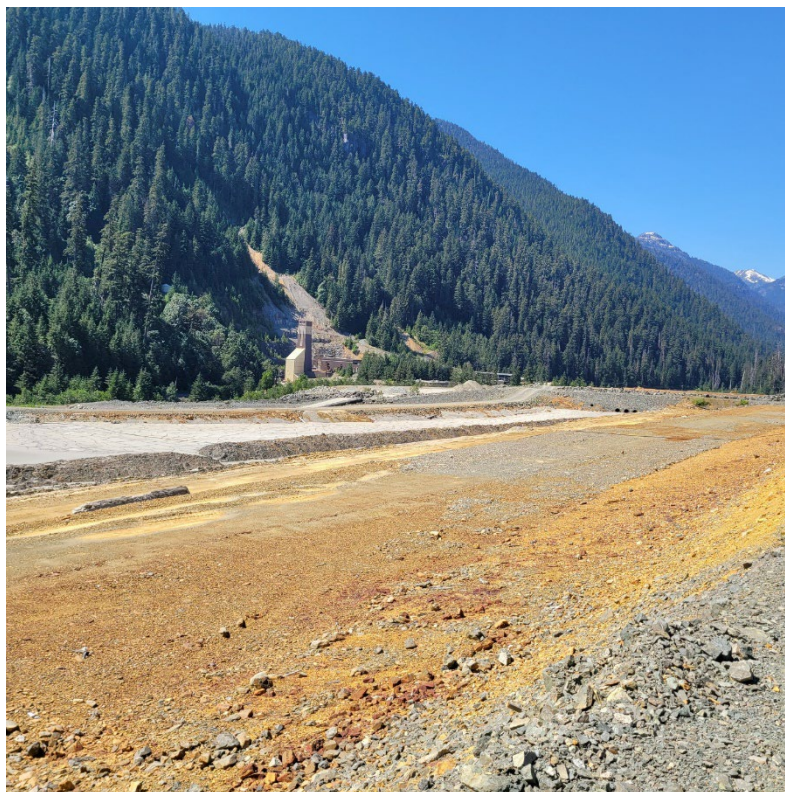
Photo 12: East Strip looking towards the west

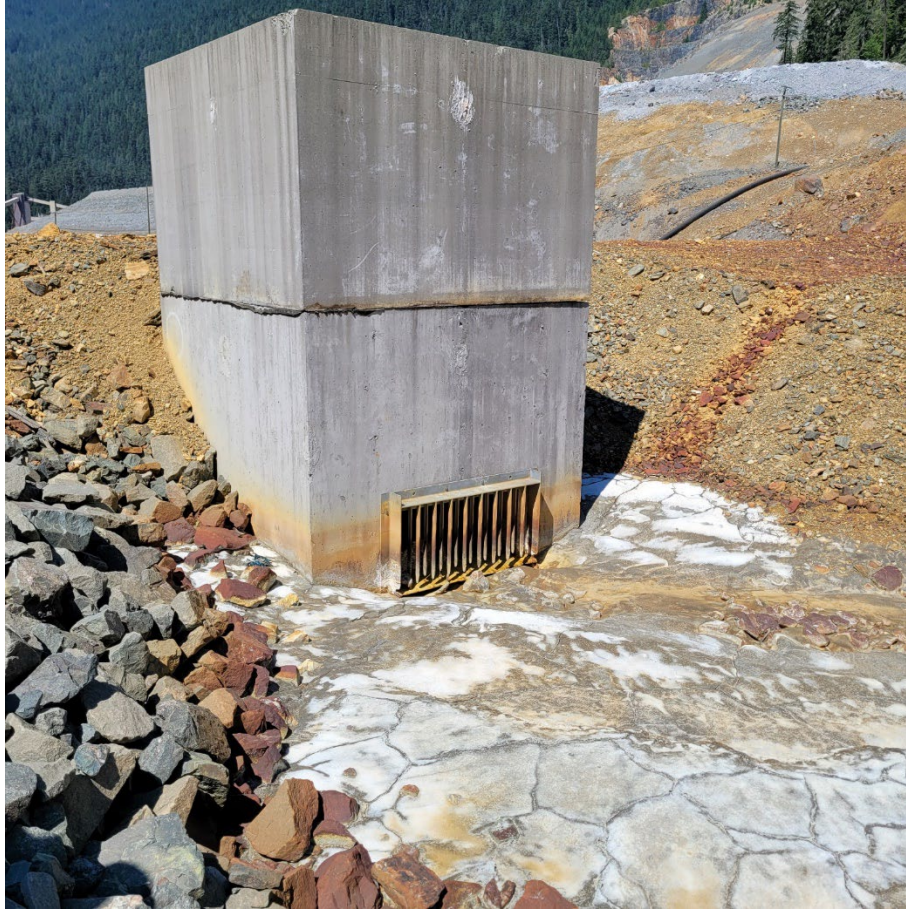
Photo 13: East decant structure with approximately half of the bottom 2 cm's of the vertical grating bars being dissolved.

- Rusted amalgamated paste area (APA) decant grates:
 - a. West decant: the bottom 2-3 cm of the vertical grating bars has been dissolved leaving a 2-3 cm gap at the bottom of the decant inlet.
 - b. East decant: the grate has degraded in a similar manner with approximately half of the bottom 2 cm's of the vertical grating bars being dissolved.
- Periodic cleaning and grading are recommended in the vicinity of the orifices of the East and West Decant Pipe Drop structures.
- The East Strip continues to be obstructed by tailings. The tailings should be removed to allow unobstructed flow from the east abutment to the spillway culverts. This was discussed with MFM at the time of the site visit. See Photographs 11, 12 and 13.
- The West Strip of the Old TDF was filled with tailings obstructing the flow capacity of the spillway culvert pipes. See Photographs 11, 12 and 13.

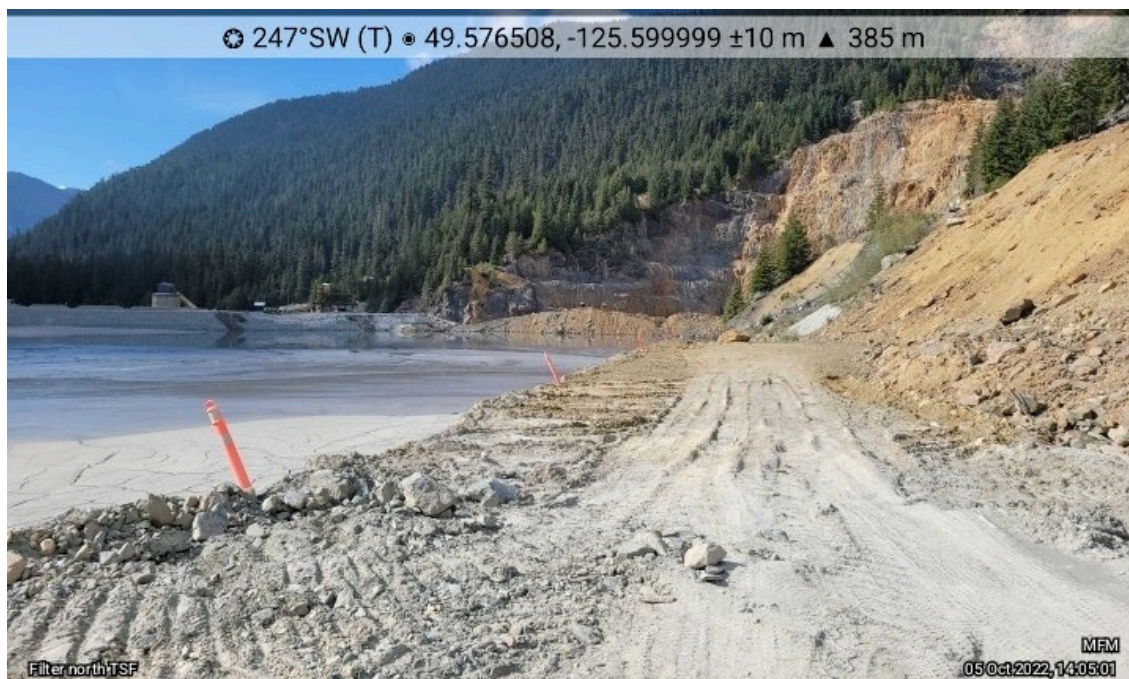
Photo 6: Lynx TDF WRD1 J Zone Crest, looking northwest.

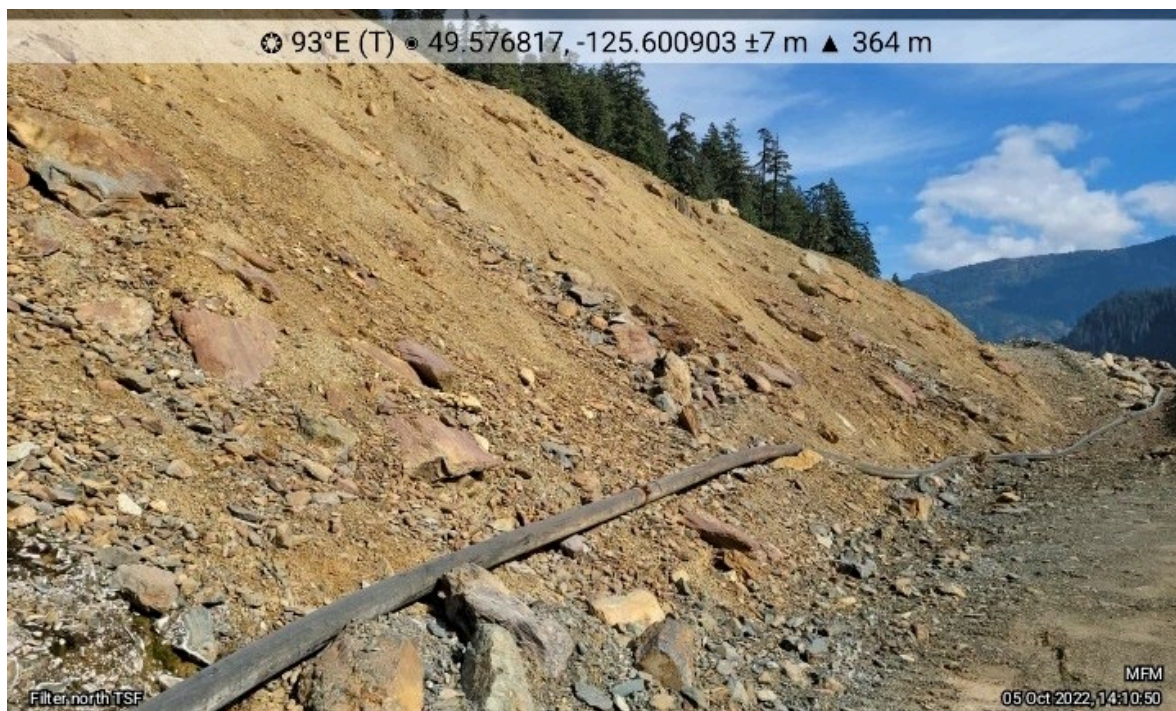
Photo 7: Lynx TDF East Abutment at WRD1, looking southeast.

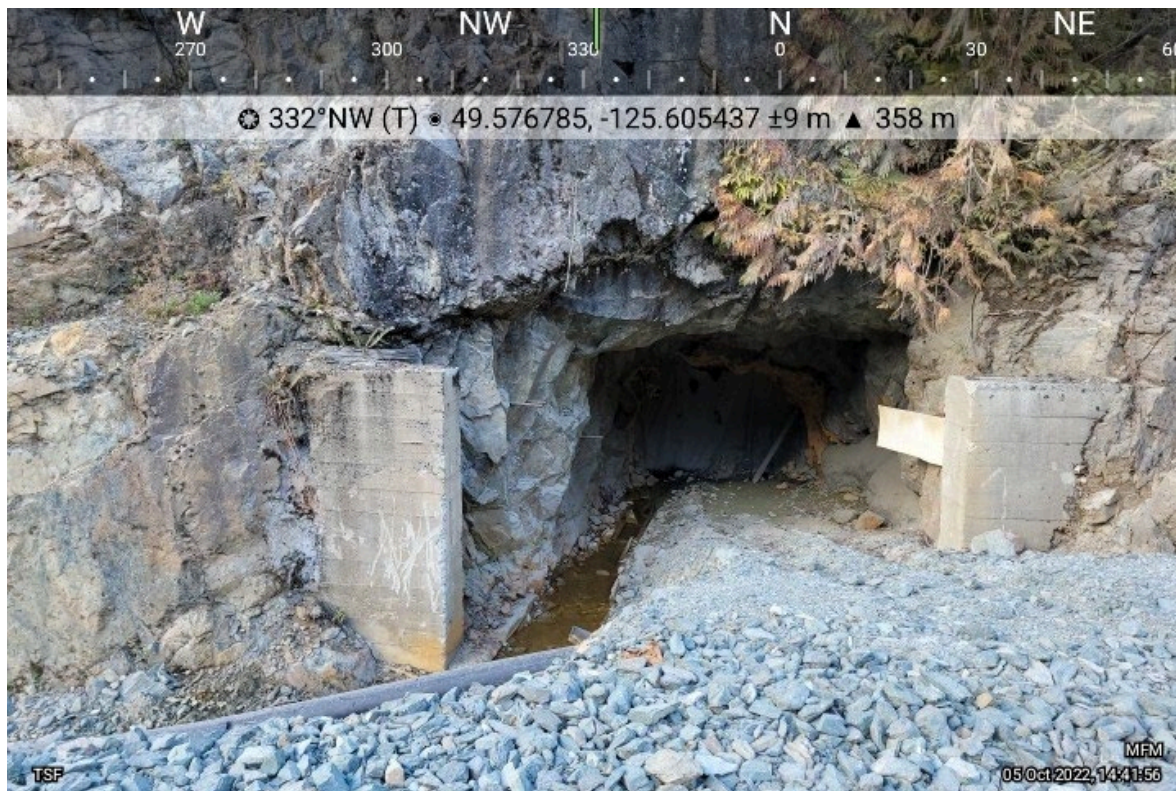
The 10 Level East Portal in the Lynx TDF West Abutment shows ongoing drainage flows from the portal. This portal needs to be plugged and sealed before next dam raise construction to El. 376.5 m. See Photo 8.

Photo 8: Lynx TDF West Abutment showing 10 Level East Portal, looking north. Ongoing drainage flows from the portal. The portal is to be plugged and sealed before next dam raise construction.

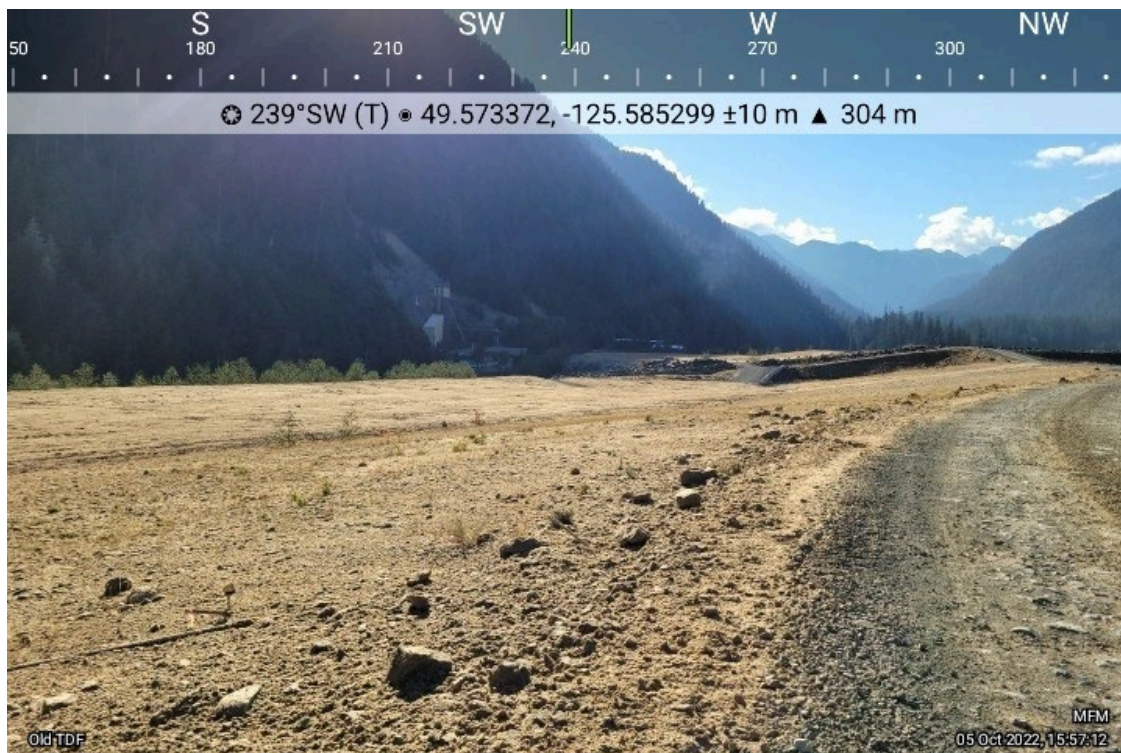
Photo 10: Hydroseeding was recently implemented along the berms of the Old TDF. This photo is looking towards the southwest.

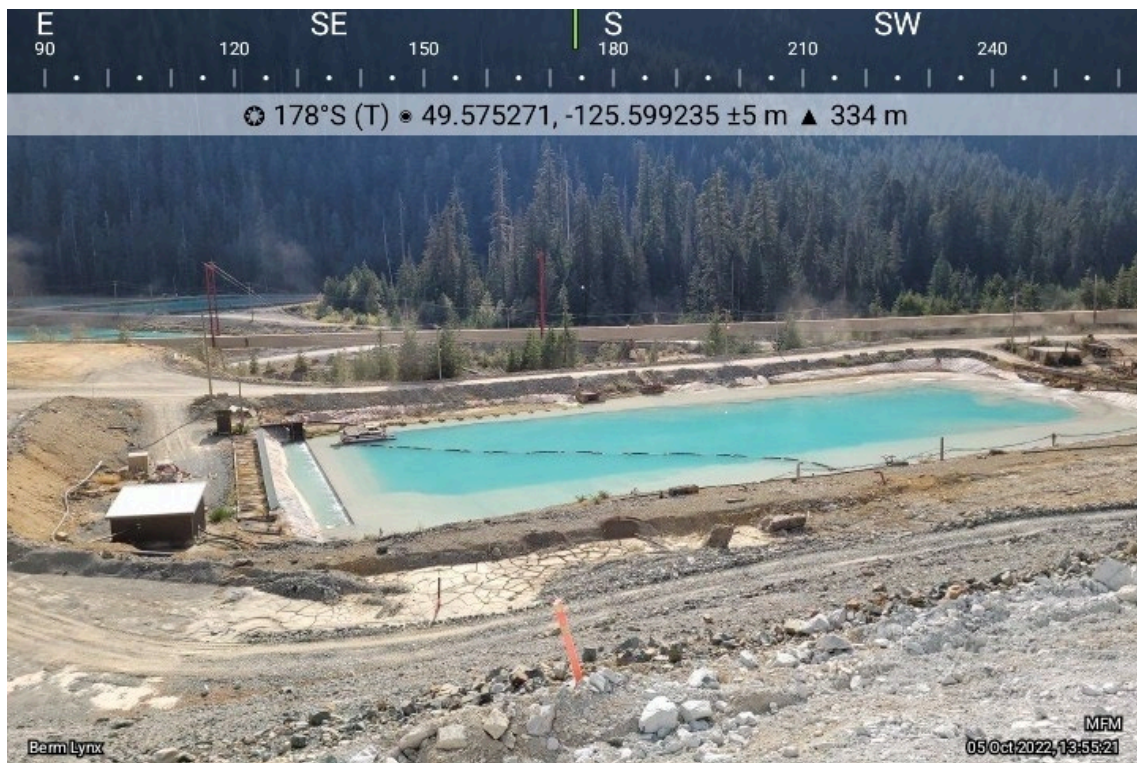
Photo 21: Super Pond looking downstream from the downstream bench (El. 343 m) of Lynx TDF

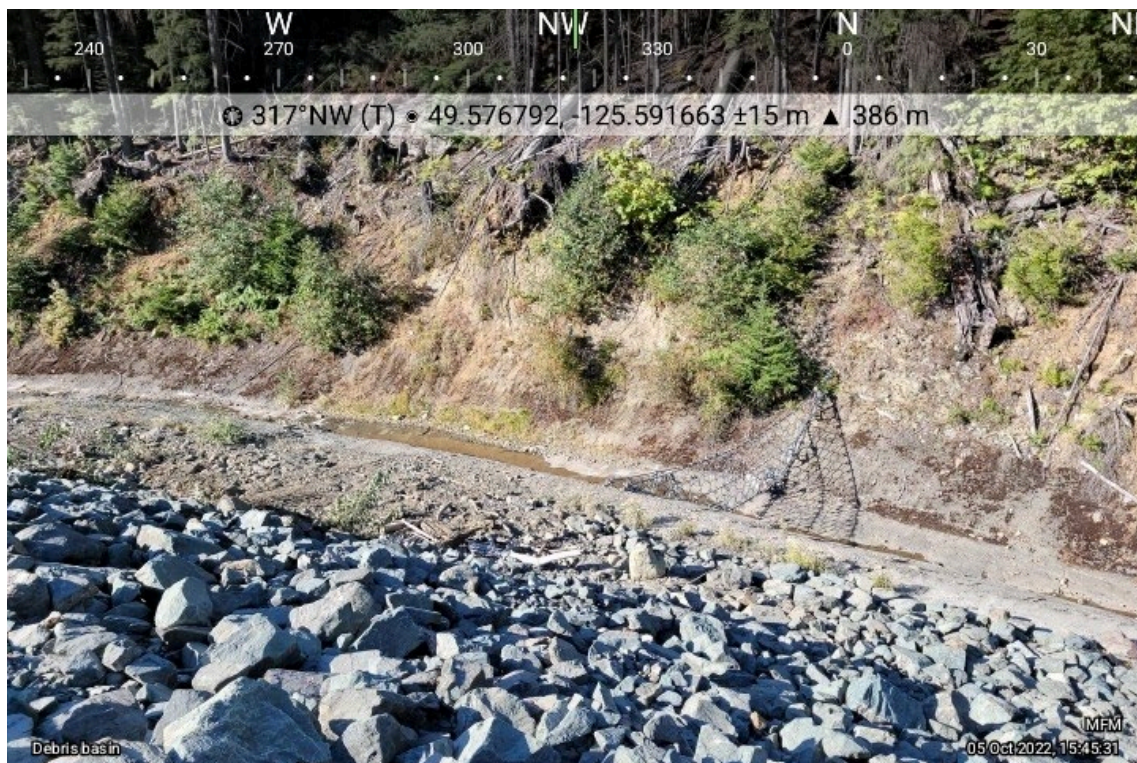
Photo 22: West end of the Lower Lynx Diversion Ditch at the location of the interim debris retaining net
