# 2022 OLD TDF DAM SAFETY INSPECTION REPORT

MYRA FALLS MINE LTD.  
A TRAFIGURA COMPANY  
CAMPBELL RIVER, BC

PROJECT NO.: NX14001B4.3  
DATE: 29 MARCH 2023

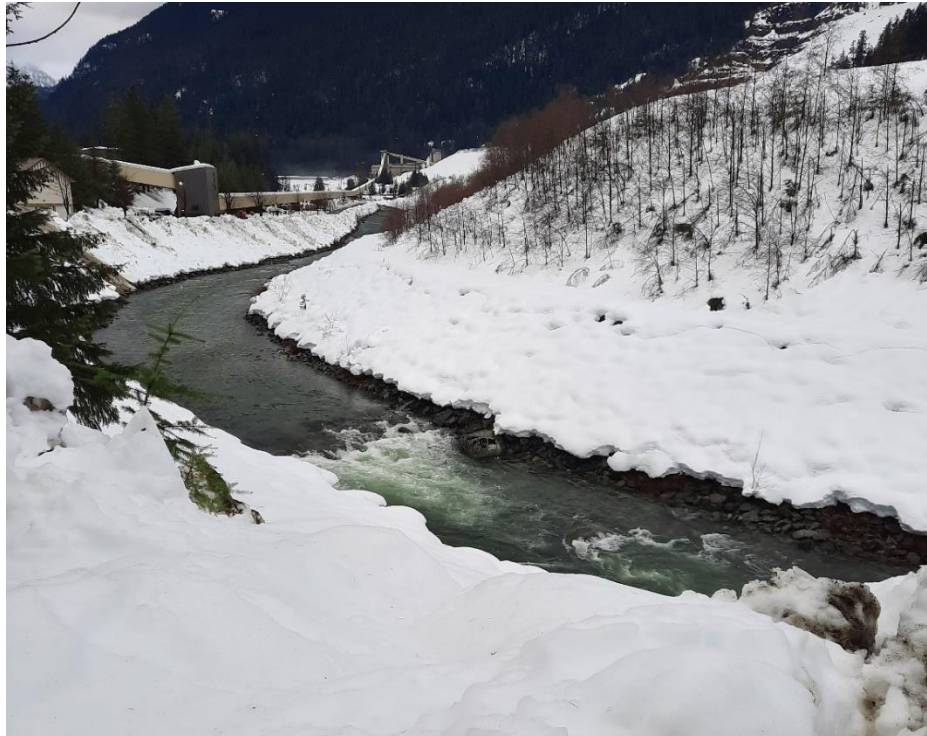
Photo 1: Old TDF Seismic Upgrade Berm downstream slope . (January 14, 2022)

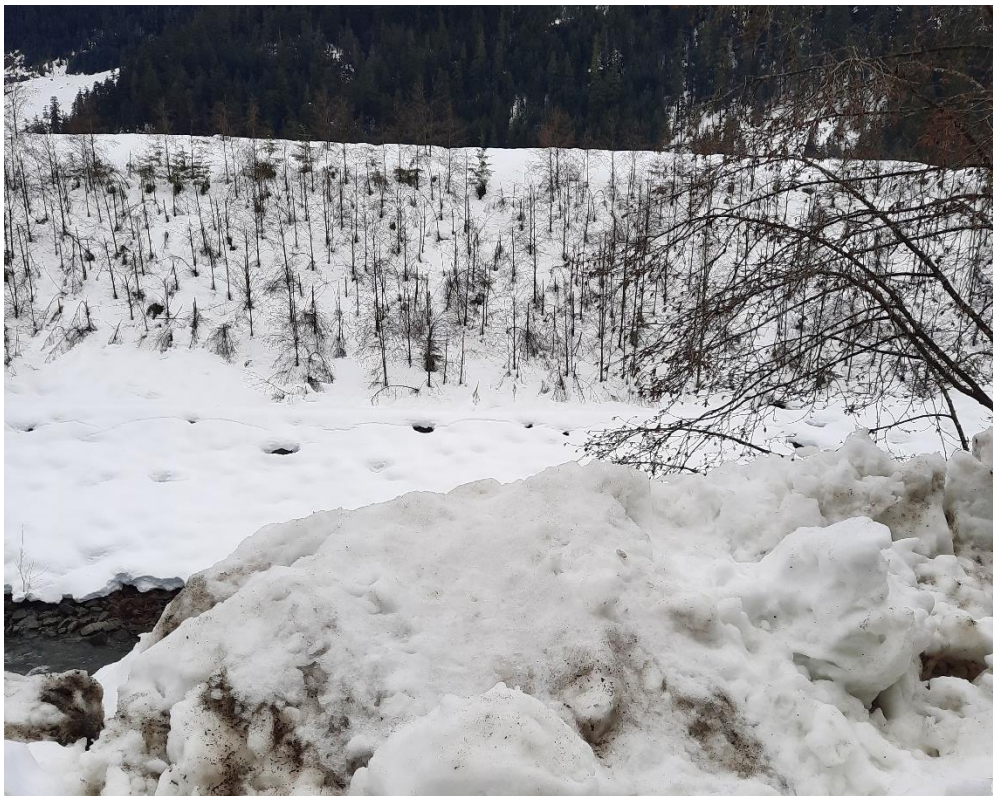
Photo 2: Old TDF Seismic Upgrade Berm downstream slope. (January 14, 2022)

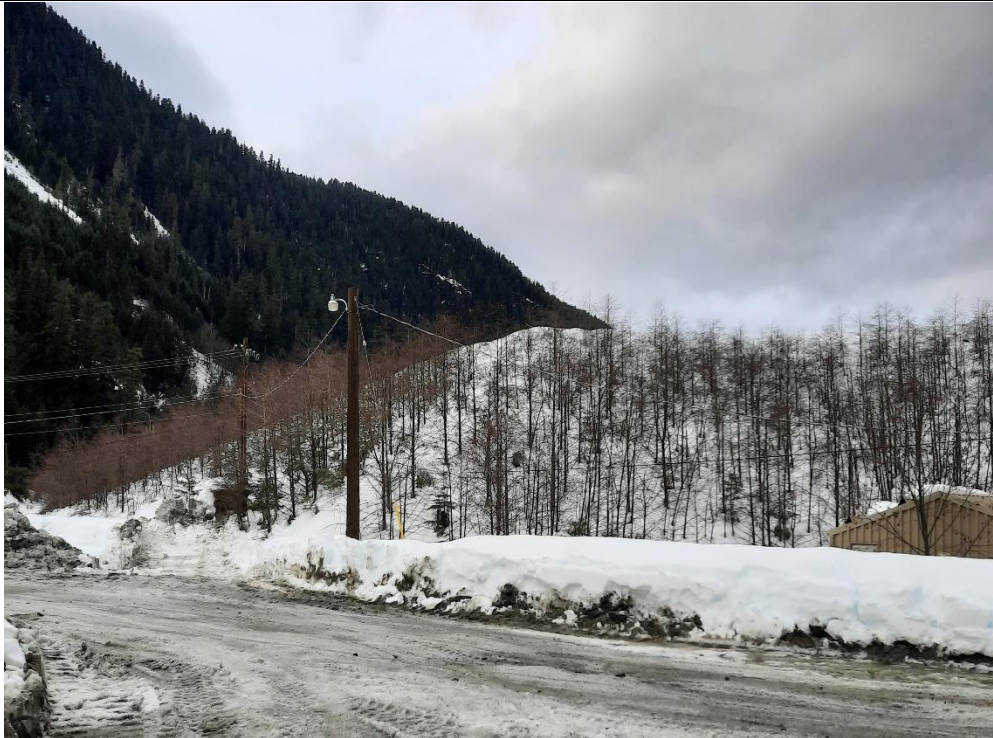
Photo 3: Old TDF Seismic Upgrade Berm downstream slope. (January 14, 2022)

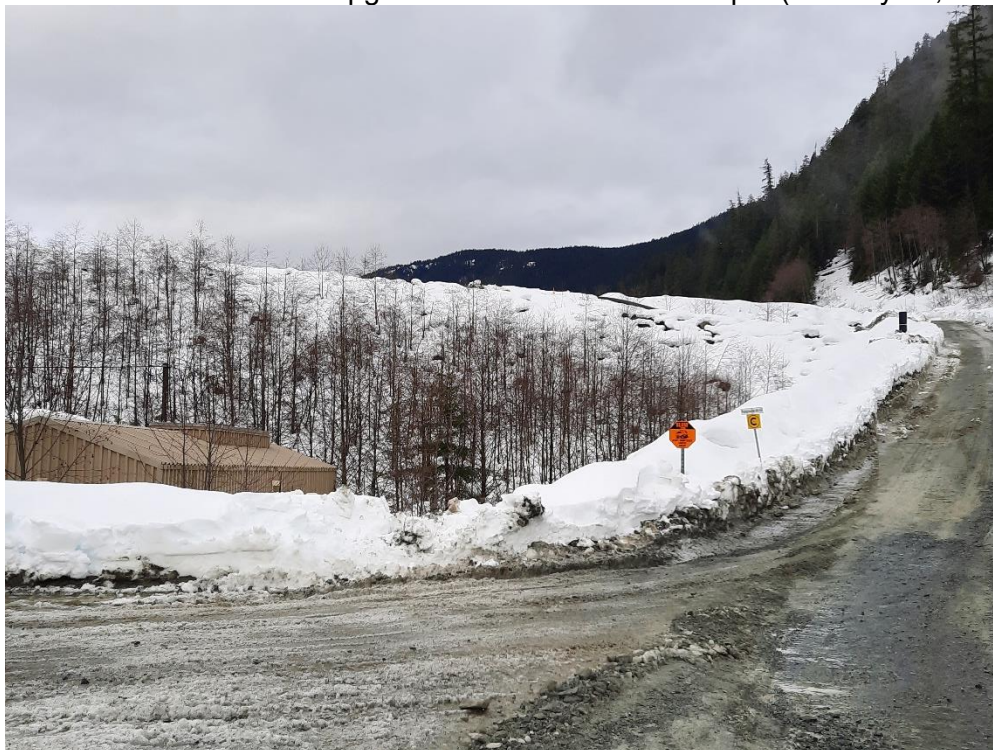
Photo 4: Old TDF Seismic Upgrade Berm downstream slope. (January 14, 2022)

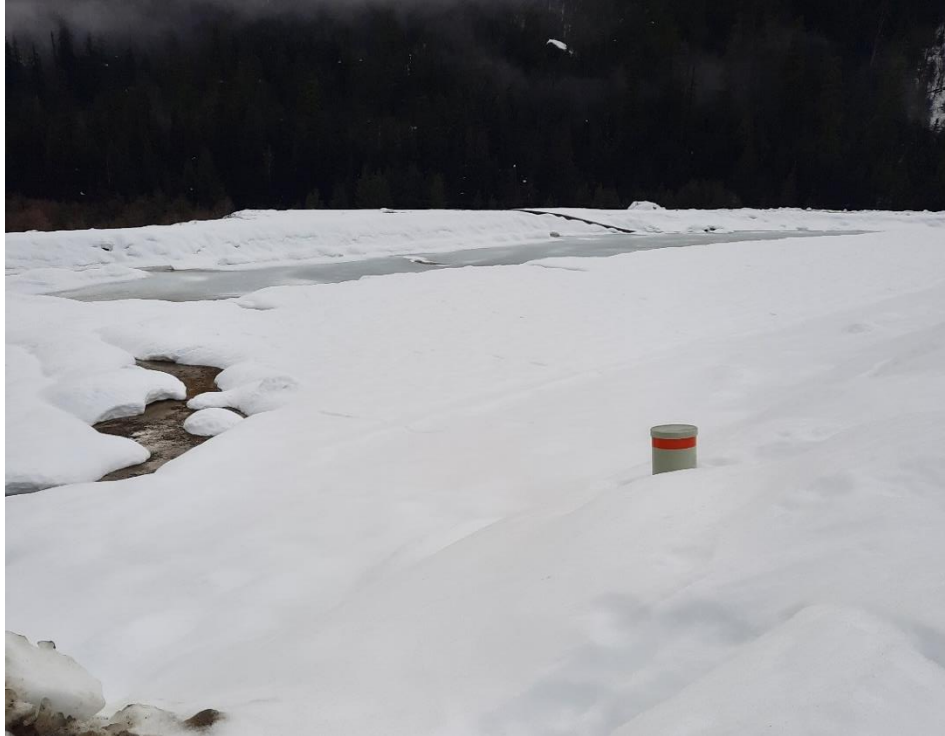
Photo 5: Old TDF Springs Drain Outlet. (January 14, 2022)

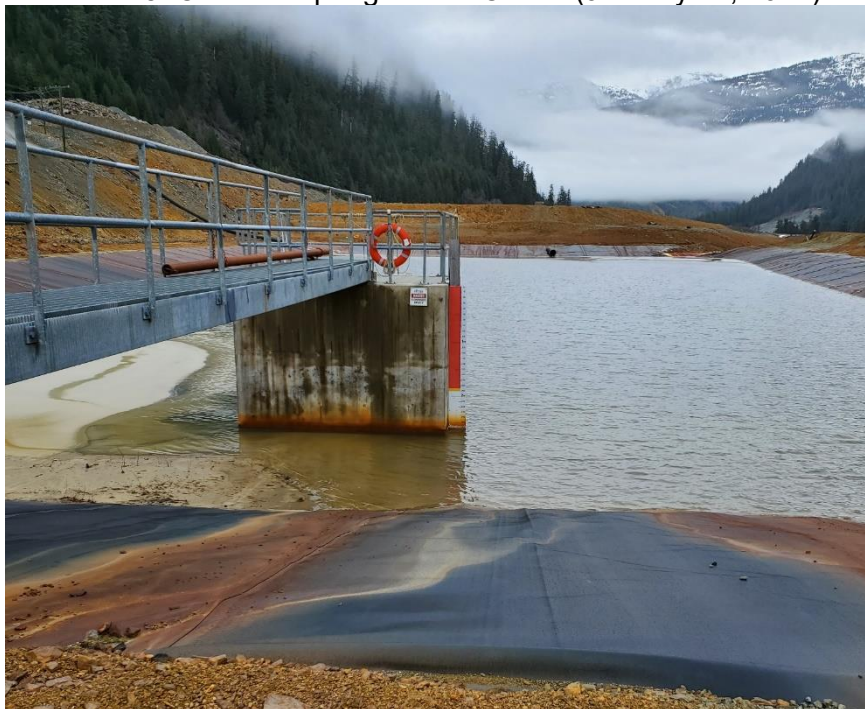
Photo 6: Surge Pond looking east. Sediments from paste plant run off to the left of the control structure seen in photo 6. (March 23, 2022)

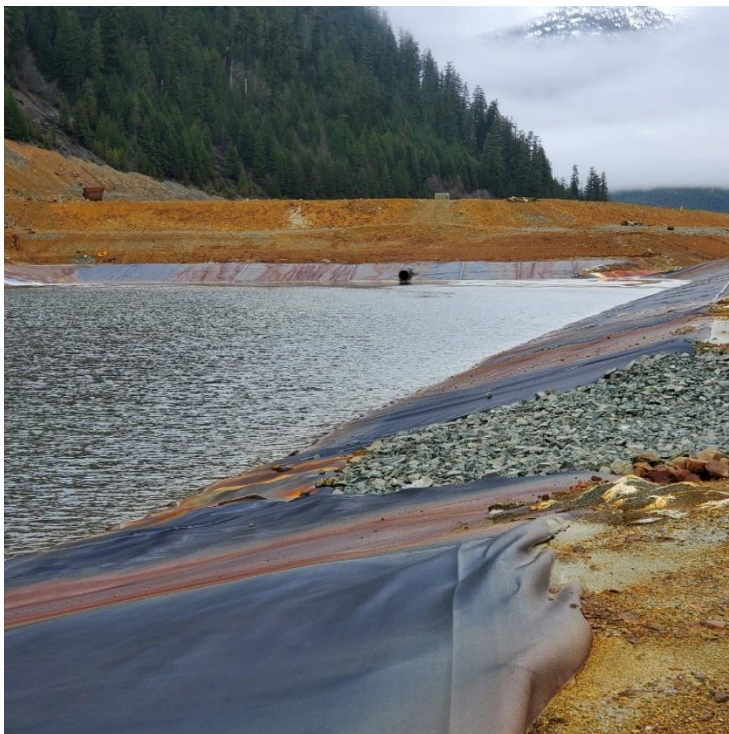
Photo 7: Surge Pond looking north-east. (March 23, 2022)

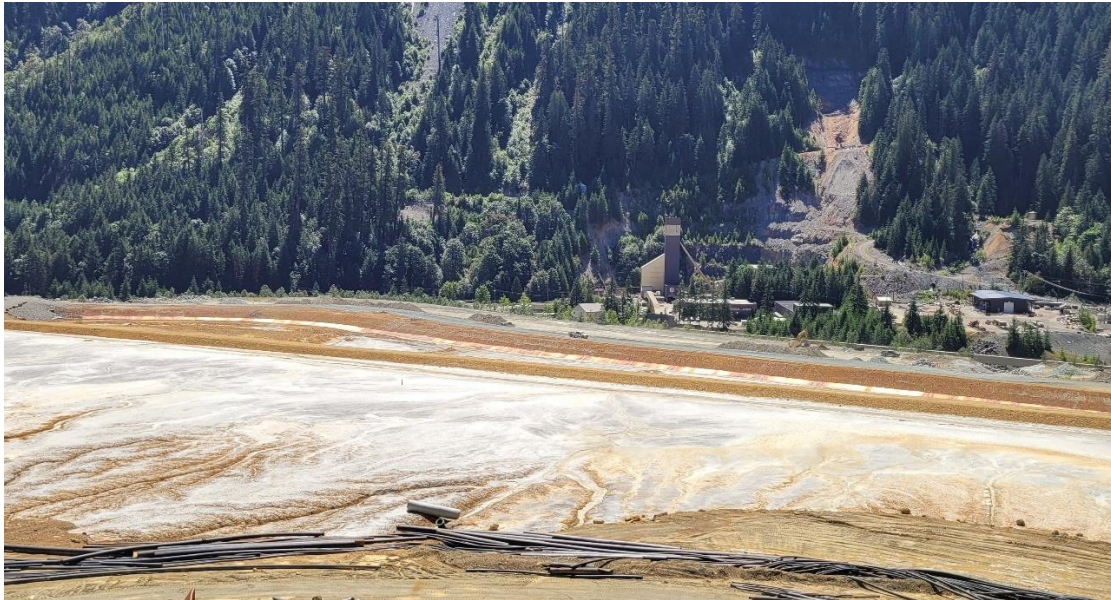
Photo 11: Overview of Old TDF looking South. Storage area at back end of Old TDF also shown. (July 26, 2022)

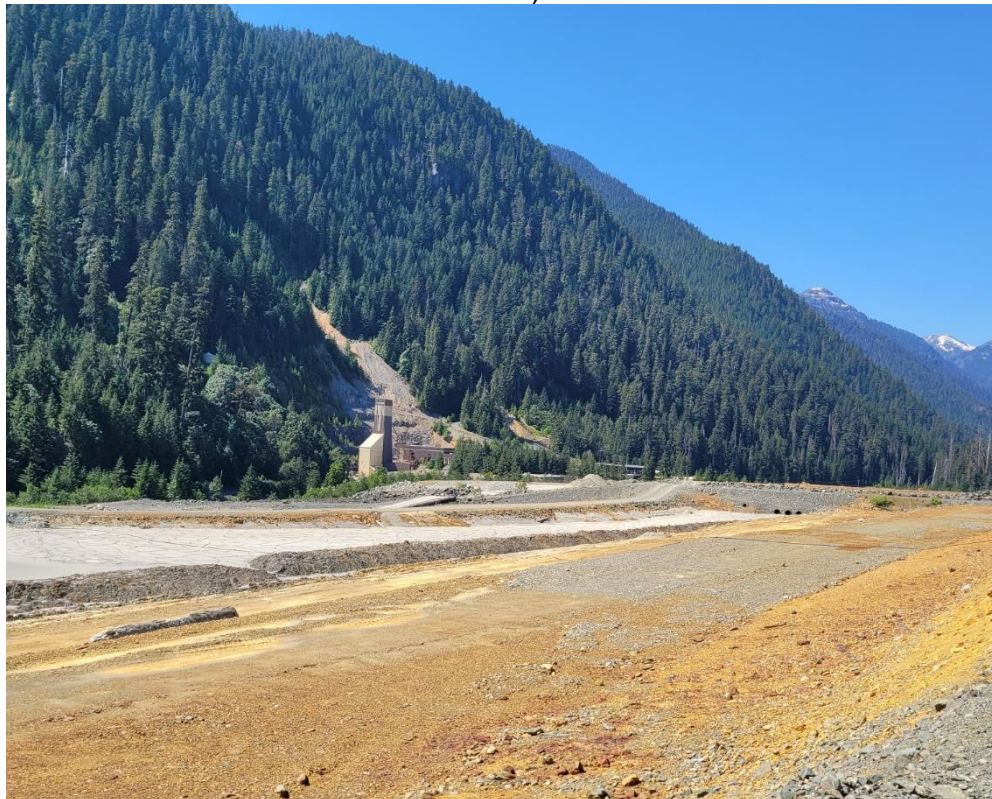
Contact water flows west from the East Strip, through 3 parallel culverts below the APA Operations Spillway, and through the geomembrane-lined West Strip Channel into the Old TDF Surge Pond. In 2022 WSP identified that the East Strip is full of sediments from the discharge of the Zim Pro line. The sediments prevent the free flow of water from the east abutment. The sediments should be removed as stated in the 2022 recommendations summary table in Section 10.2.

Photo 12: East strip of Old TDF filled with tailings from Zim Pro line, looking west. (July 26, 2022)

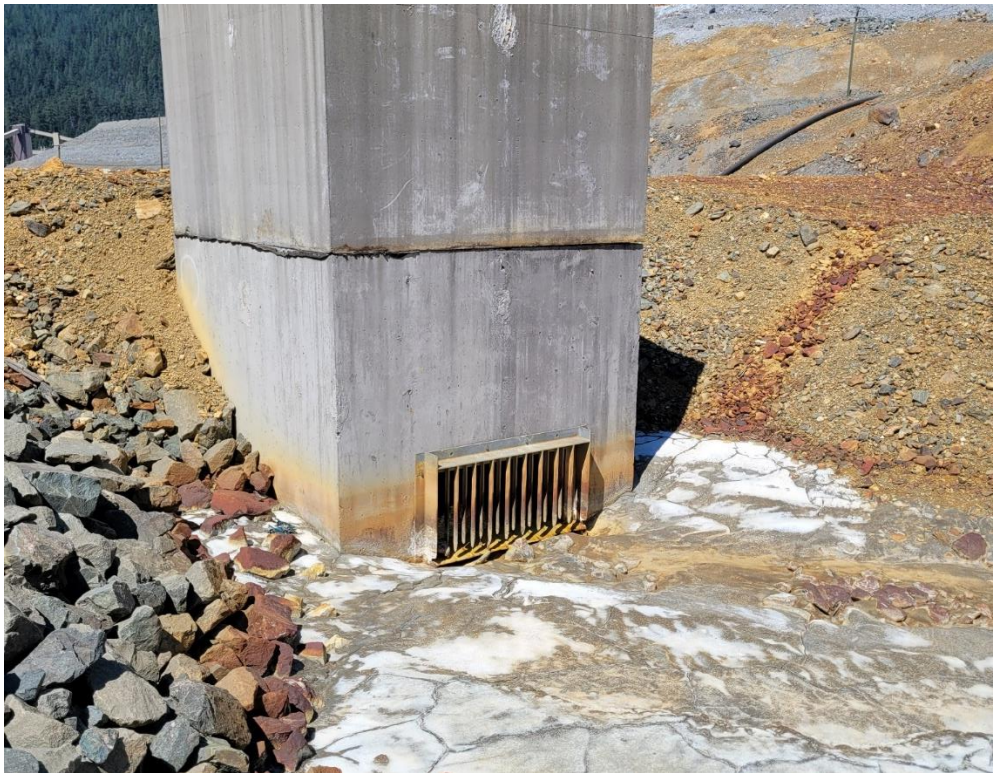
Photo 13: East decant structure with approximately half of the bottom 2 cm's of the vertical grating bars being dissolved. (July 26, 2022)

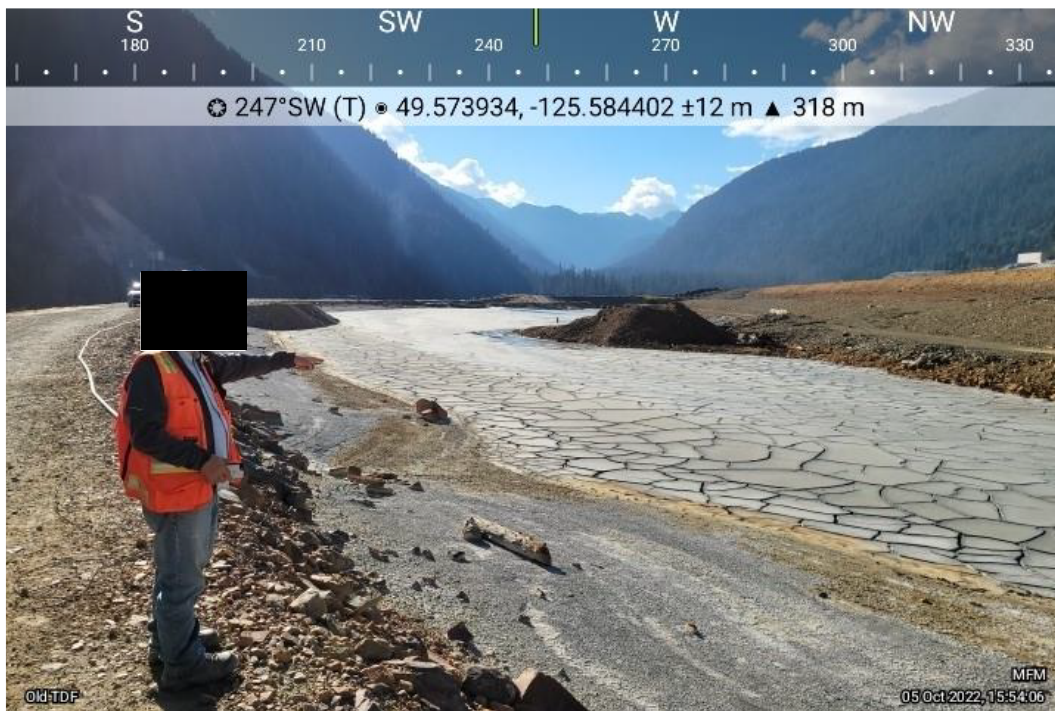
Photo 15: East Strip of the Old TDF continues to be filled with tailings. Tailings should be removed prior to onset of wet weather. (October 5, 2022)

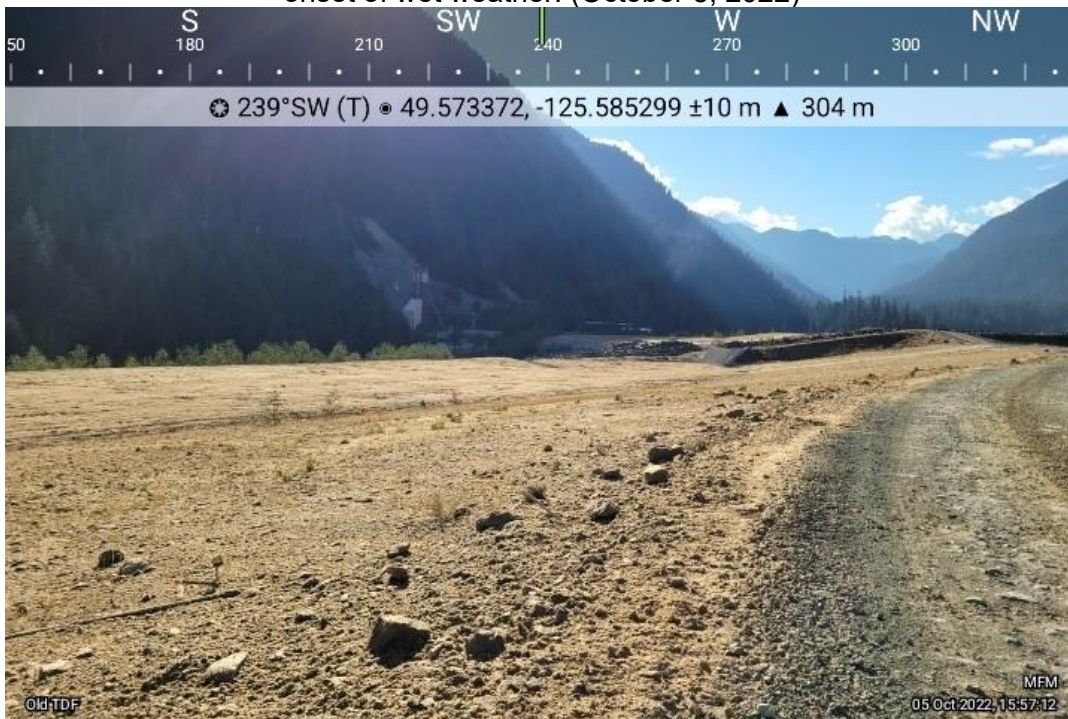
Photo 16: Hydroseeding was recently implemented along the berms of the Old TDF. Photo looking southwest. (October 5, 2022)

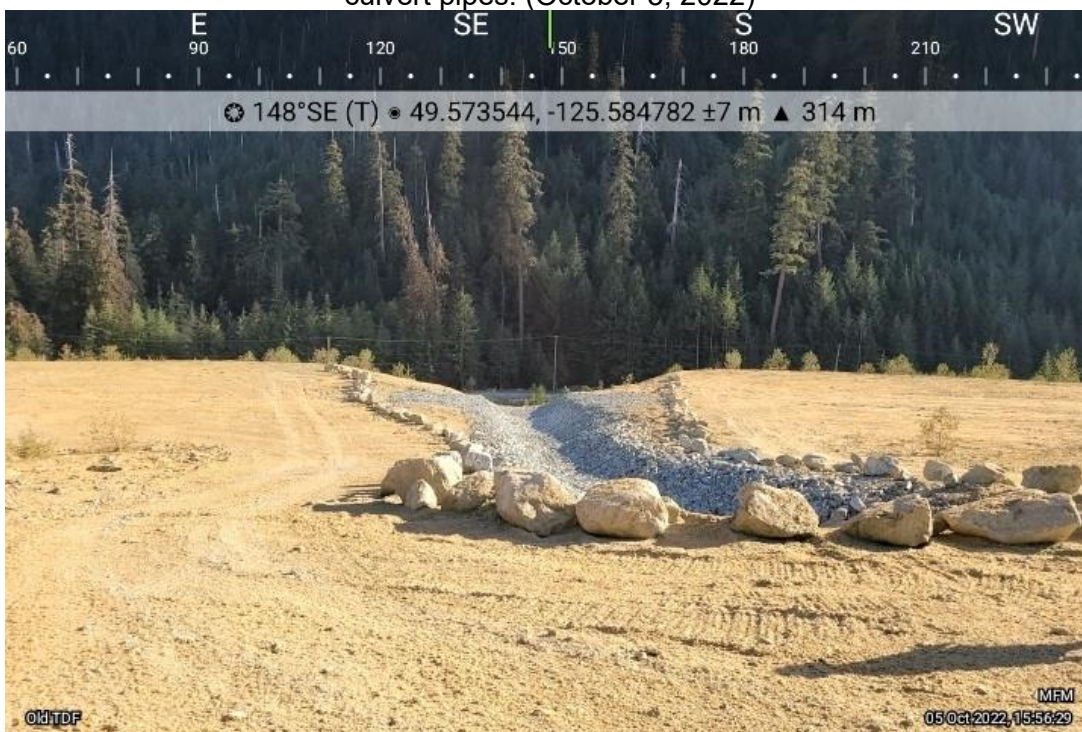
Photo 18: Old TDF Channel 1 looking downstream. Channel constructed in 2022.

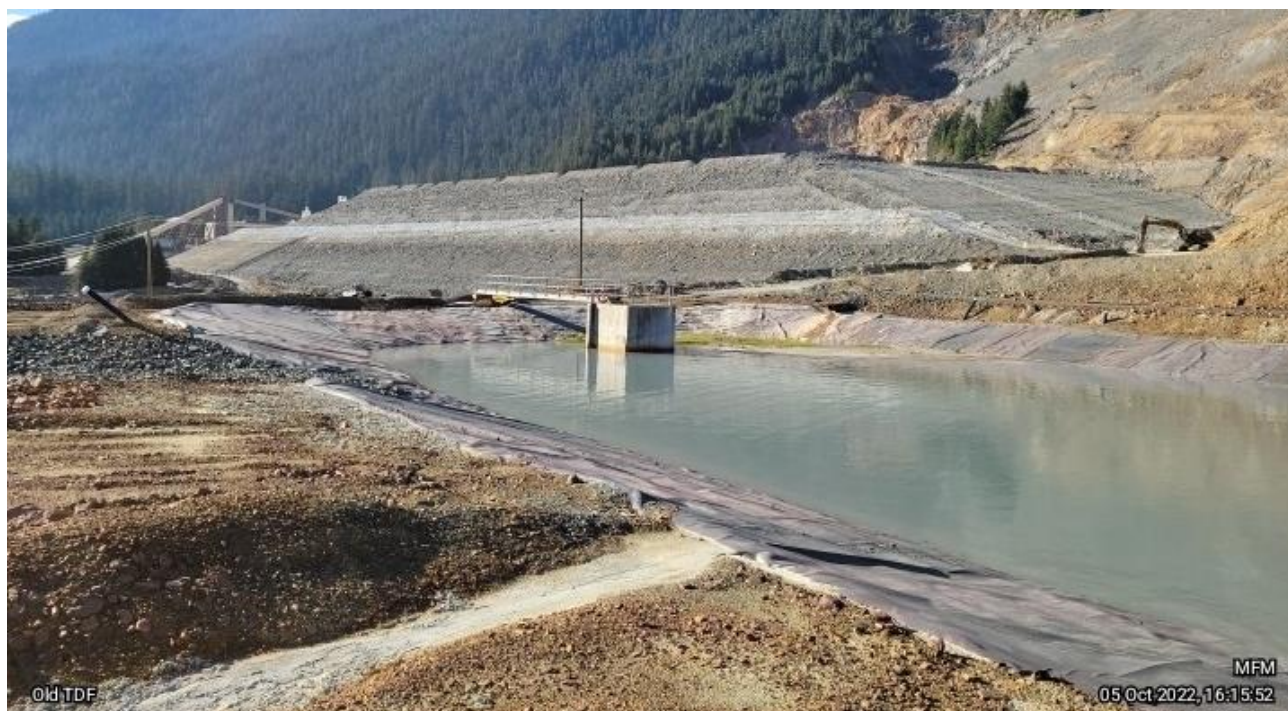
Photo 19: Surge Pond looking northwest. (October 5, 2022)

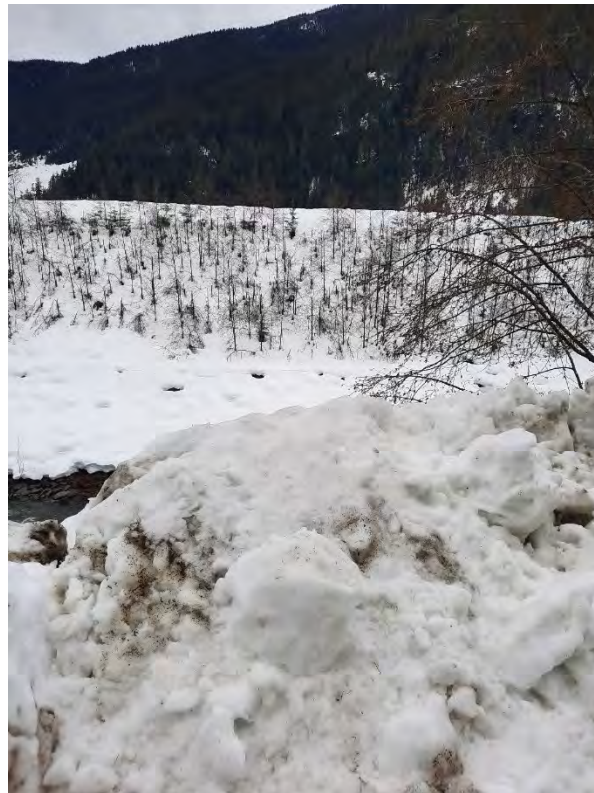
Photo 1b: Old TDF outer embankment

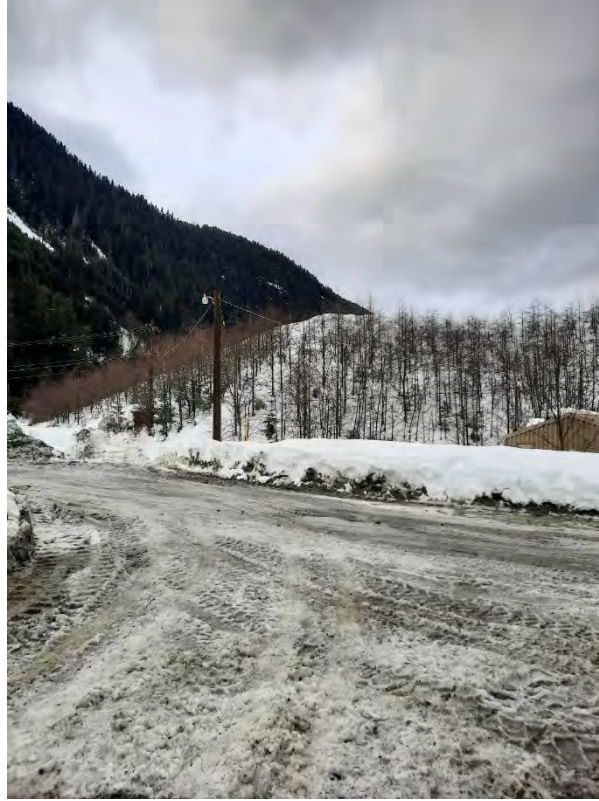
Photo 1c: Old TDF outer embankment

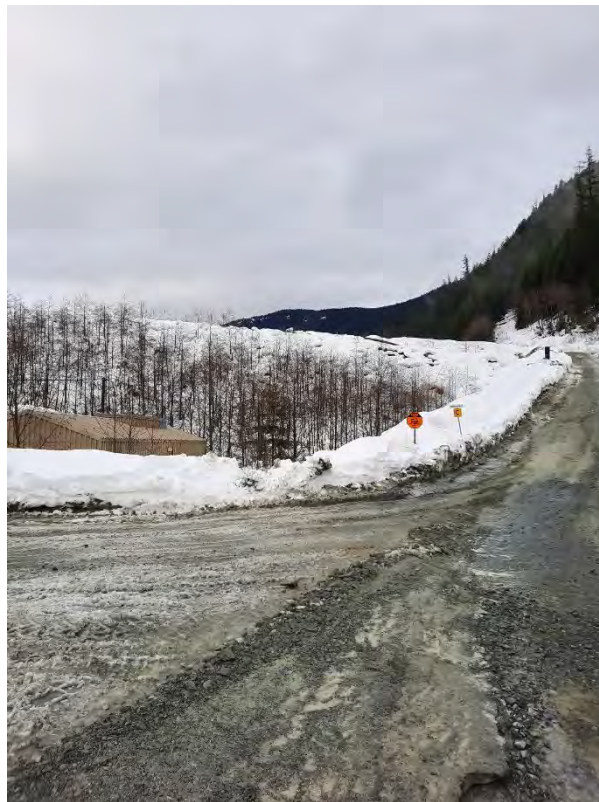
Photo 1d: Old TDF outer embankment

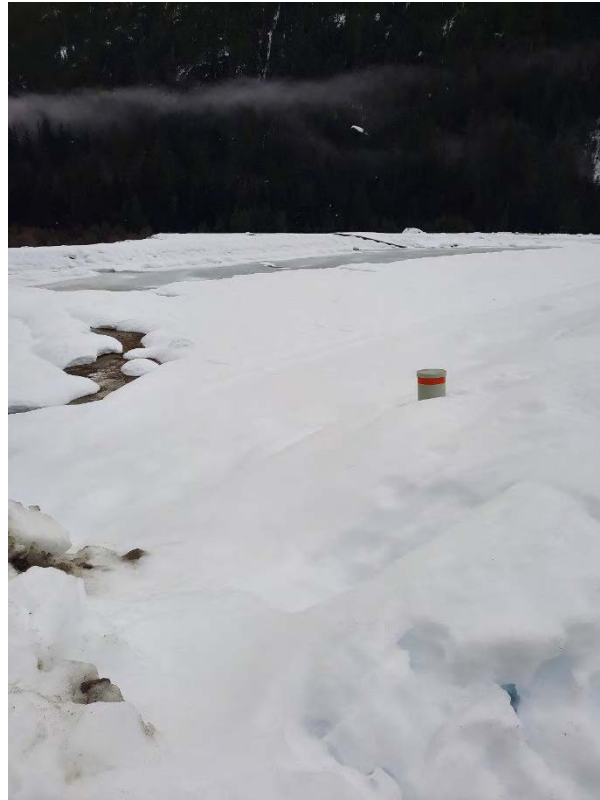
Photo 1e: Old TDF east end of the east strip. Note ponded water and flow from the LLDD underdrain (bottom left)

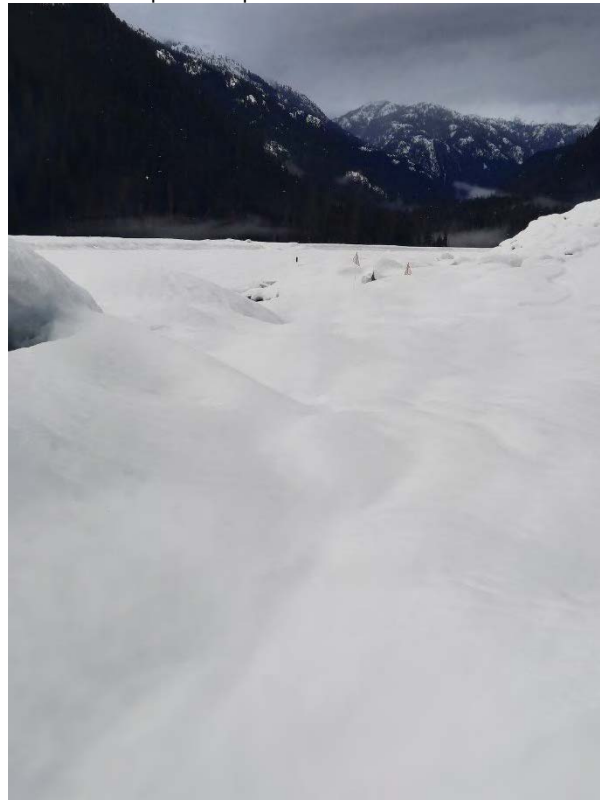
Photo 1f: Old TDF showing snow covered APA

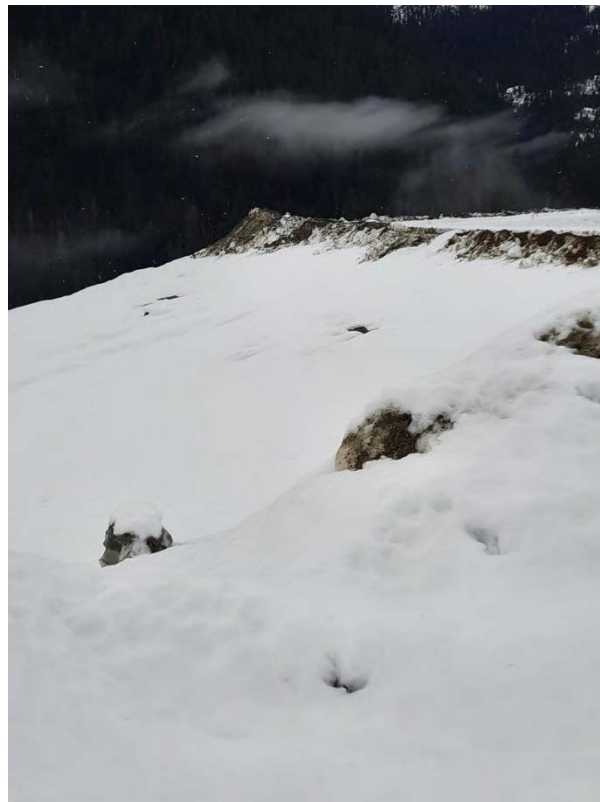
Photo 3a: Lynx TDF 4:1 slope

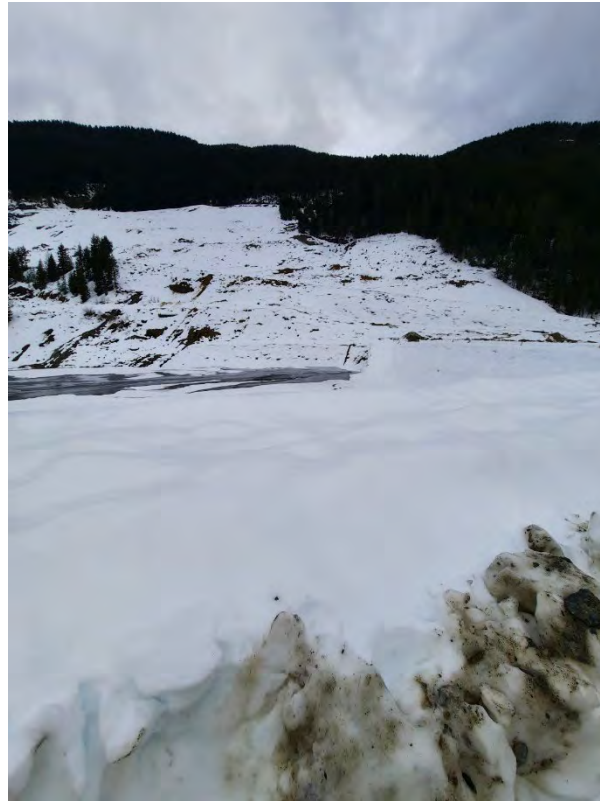
Photo 3b: Lynx TDF showing WRD1 filter and discharge of raw tails to the west of the filter

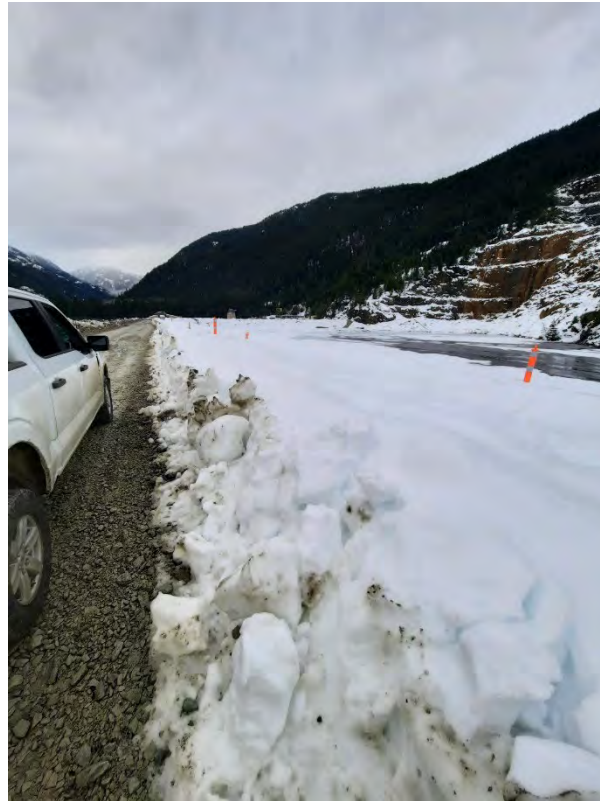
- The upstream bench is estimated to be 0.5 to 2.5 m above tailings or pond. The bench appeared to be in good condition with minor ponding on the surface following recent rainfall events.

Photo 3d: Lynx TDF dam crest and upstream bench

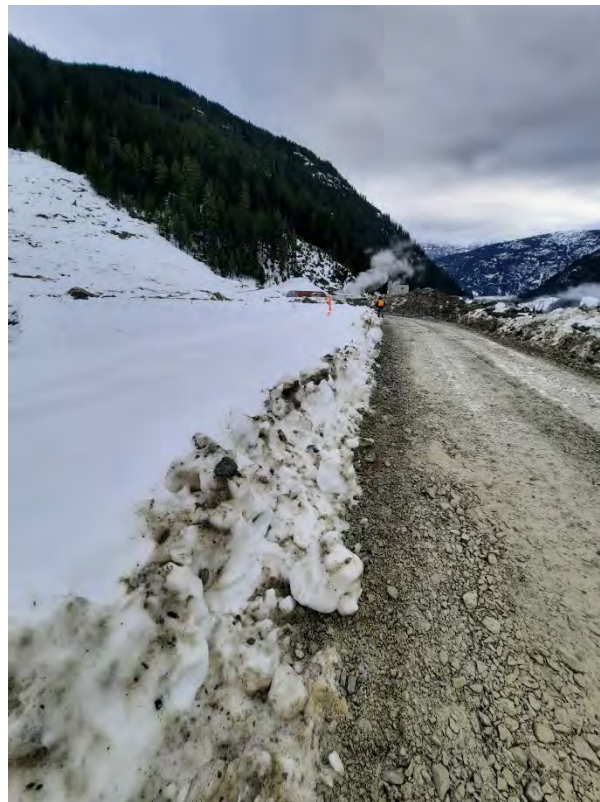
- The crest of Lynx Dam was generally in good condition, with muddy conditions, minor ponding and vehicle rutting on the road surfacing material. MFM indicated the crest had been re-graded a few times to maintain trafficable.

Photo 3e: Lynx TDF dam crest showing well maintained running surface with minimal pooling

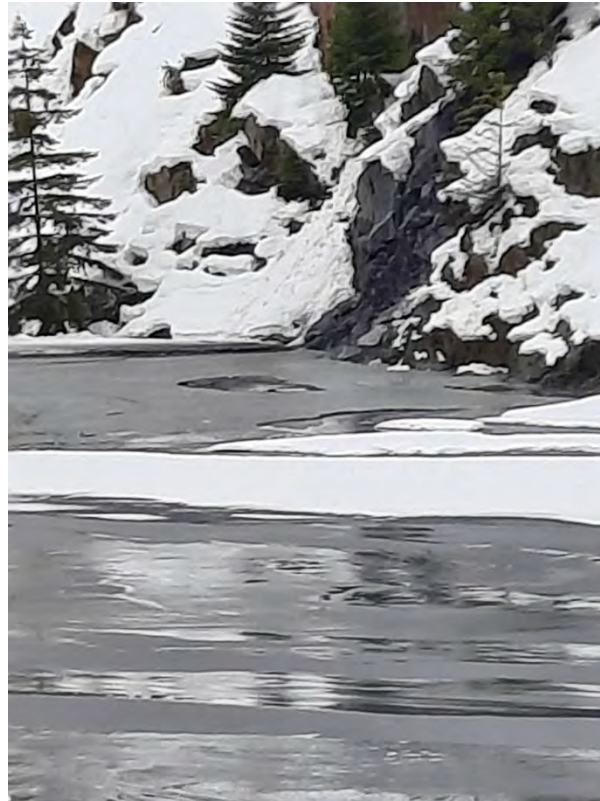
Photo 3f: Lynx TDF discharge of raw tails

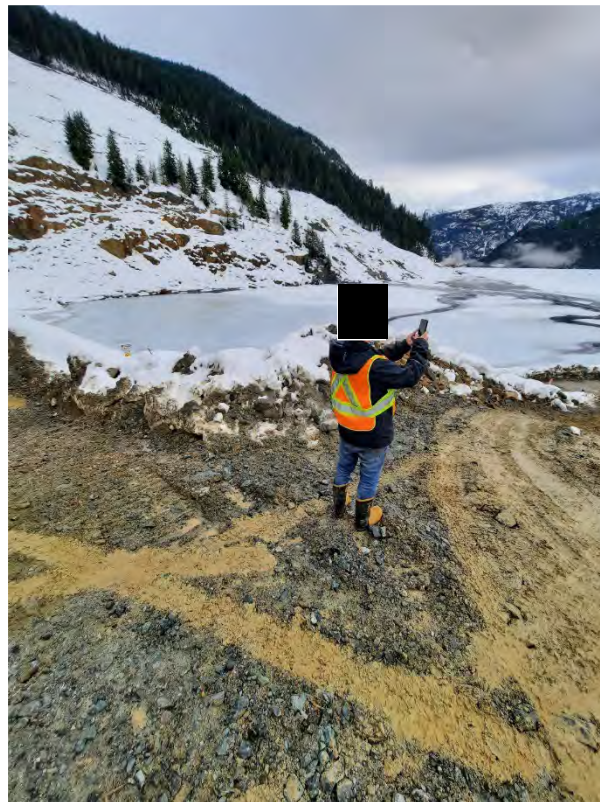
Photo 3g: Lynx TDF reclaim pool

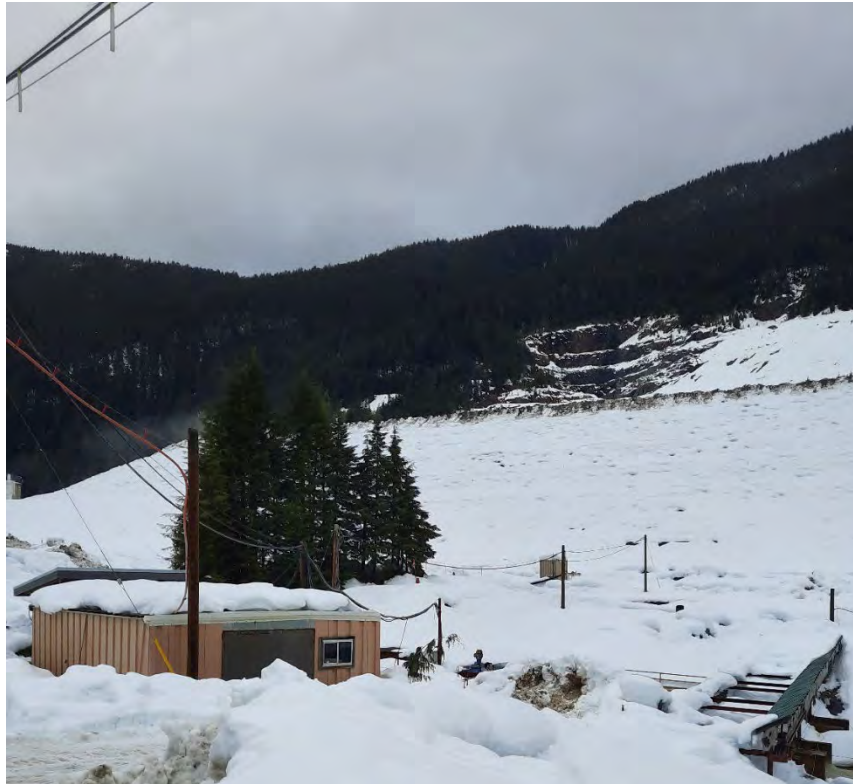
- Downstream slopes of the Lynx Dam are in good condition. No seepage or wet spots observed on the downstream dam face and toe.
- The downstream additional raise was completed at South Arm and West Arm, to elevations of about 346 to 347 m. Minor ponding and rutting was present at the bench. No signs of instability were observed.

Photo 3h: Lynx TDF south-west portion of downstream dam shell

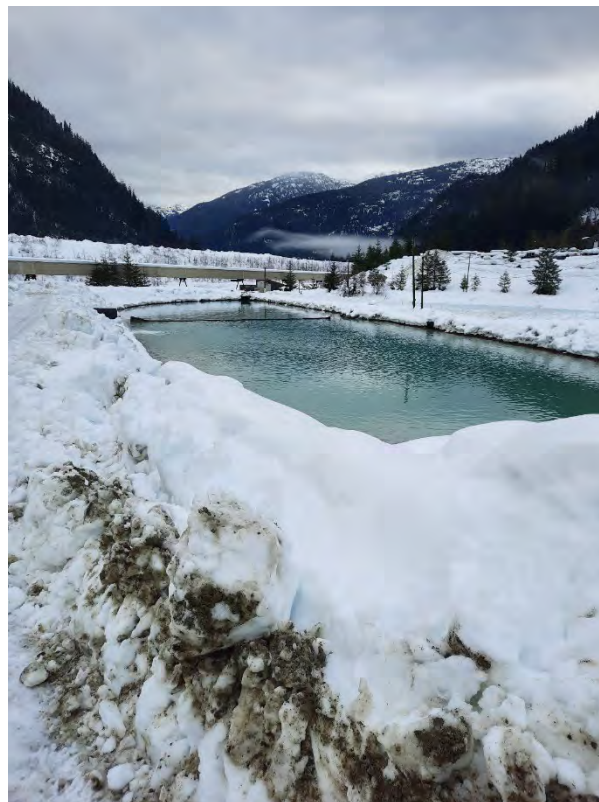
Photo 4a: WTP 3A, silt curtain installed

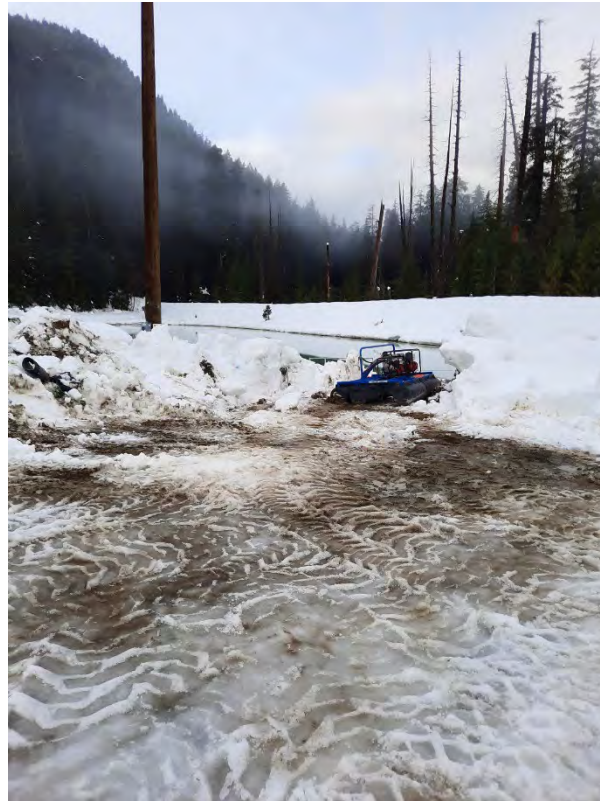
Photo 4d: dredge dry-docked S-E corner of WTP2A

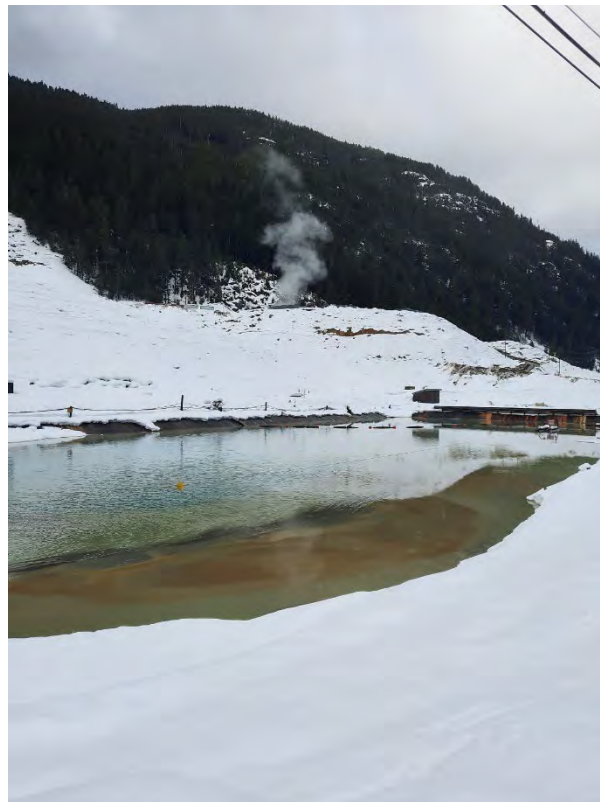
Photo 5b: Super Pond In

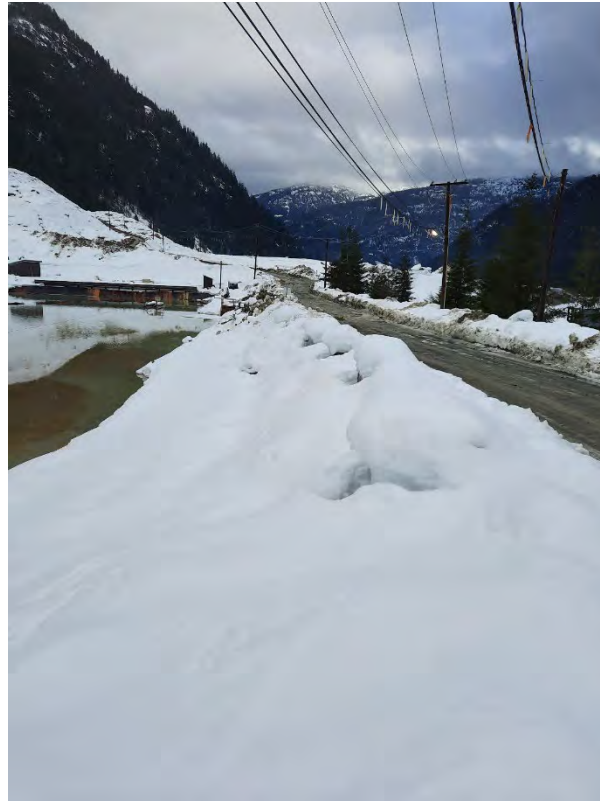
Photo 5c: Super Pond out

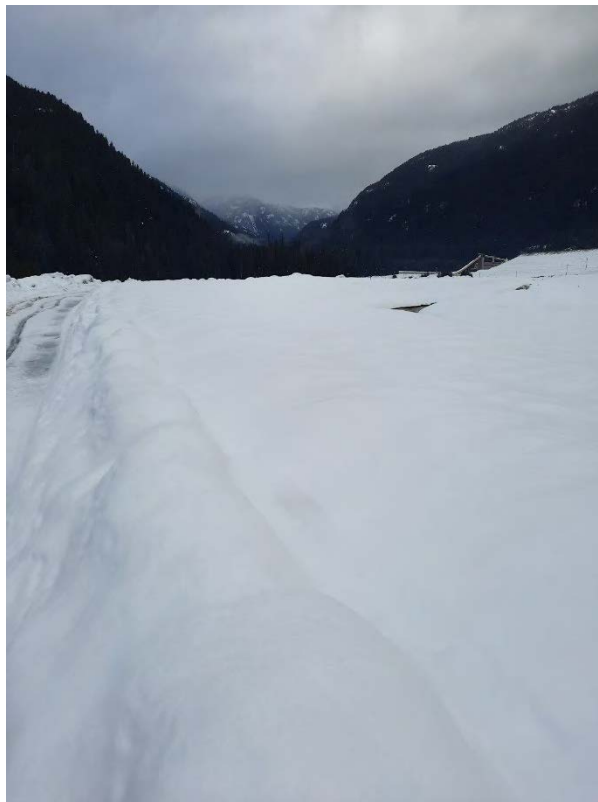
Photo 6b: SurgePond west decant

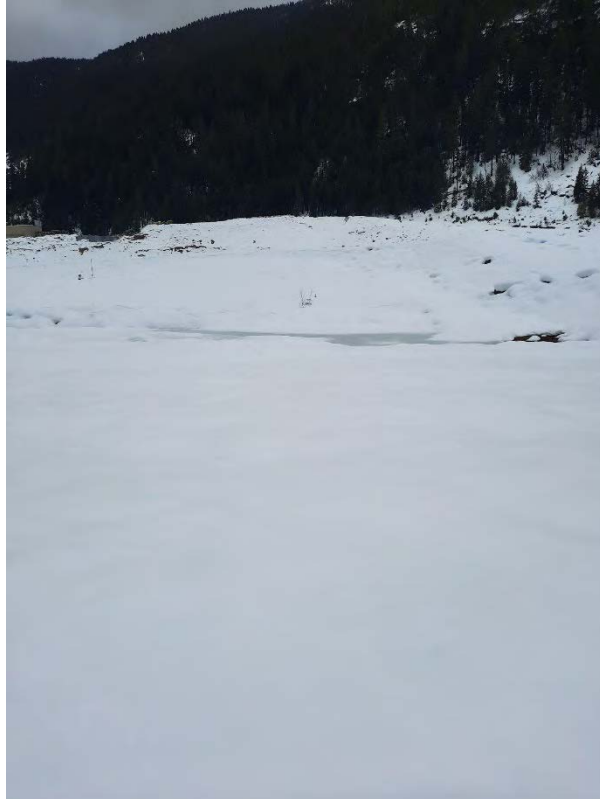
Photo 6c: Old TDF west strip channel

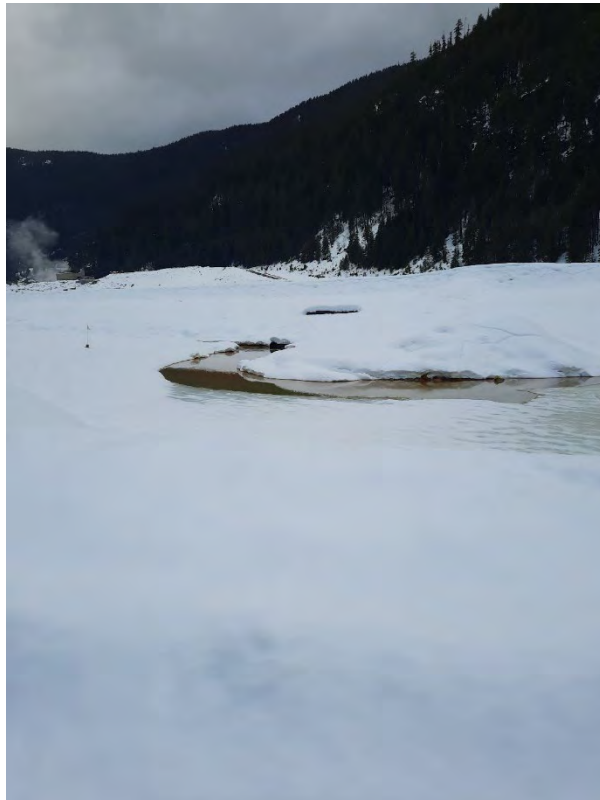
Photo 6d: Old TDF east end of the west strip, APA spillway and WRD6

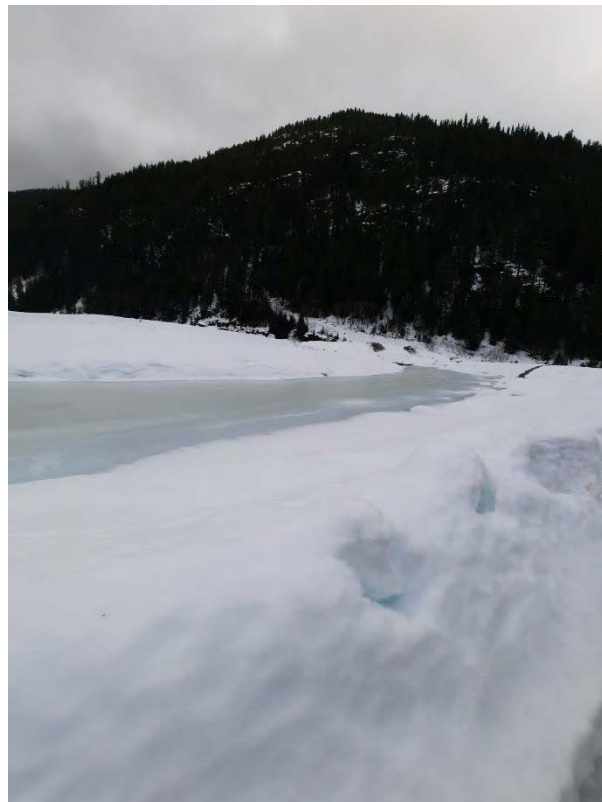
Photo 6f: Old TDF west end of the east strip and APA berm

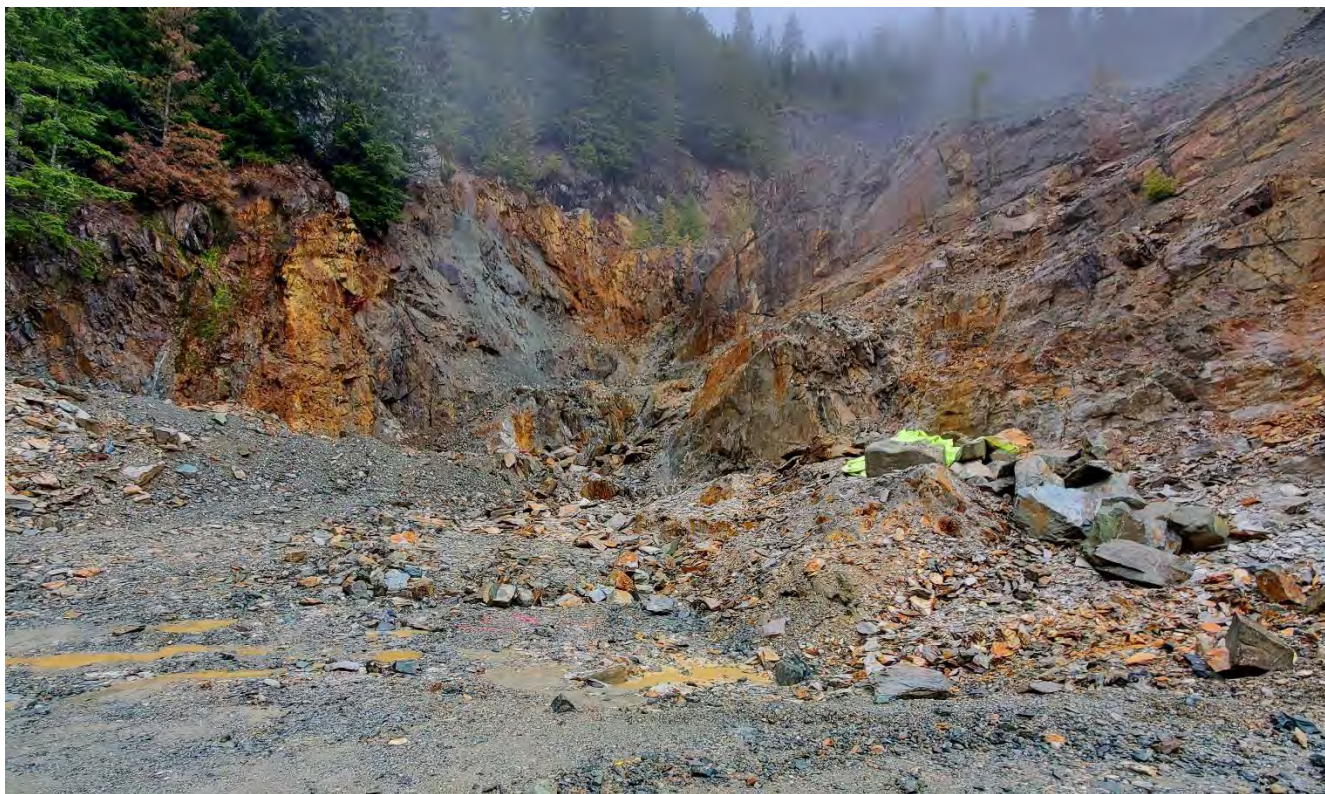
Photo 2: Lynx open pit walls north of Lynx TDF. (March 22, 2022)

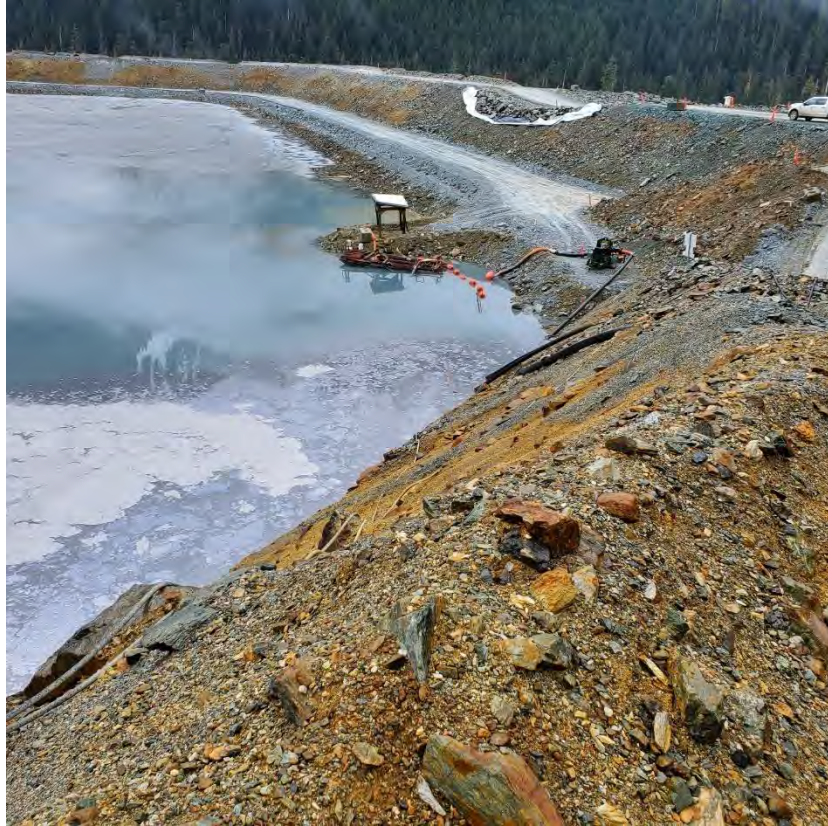
Photo 3: West end of Lynx TDF, looking east towards area of pump and staff gauge. (March 22, 2022)
